Montana Bureau of Mines and Geology
MBMG No. 379

**Abandoned/Inactive Mines
of the
Southern Beaverhead-Deerlodge National Forest**

September 1998

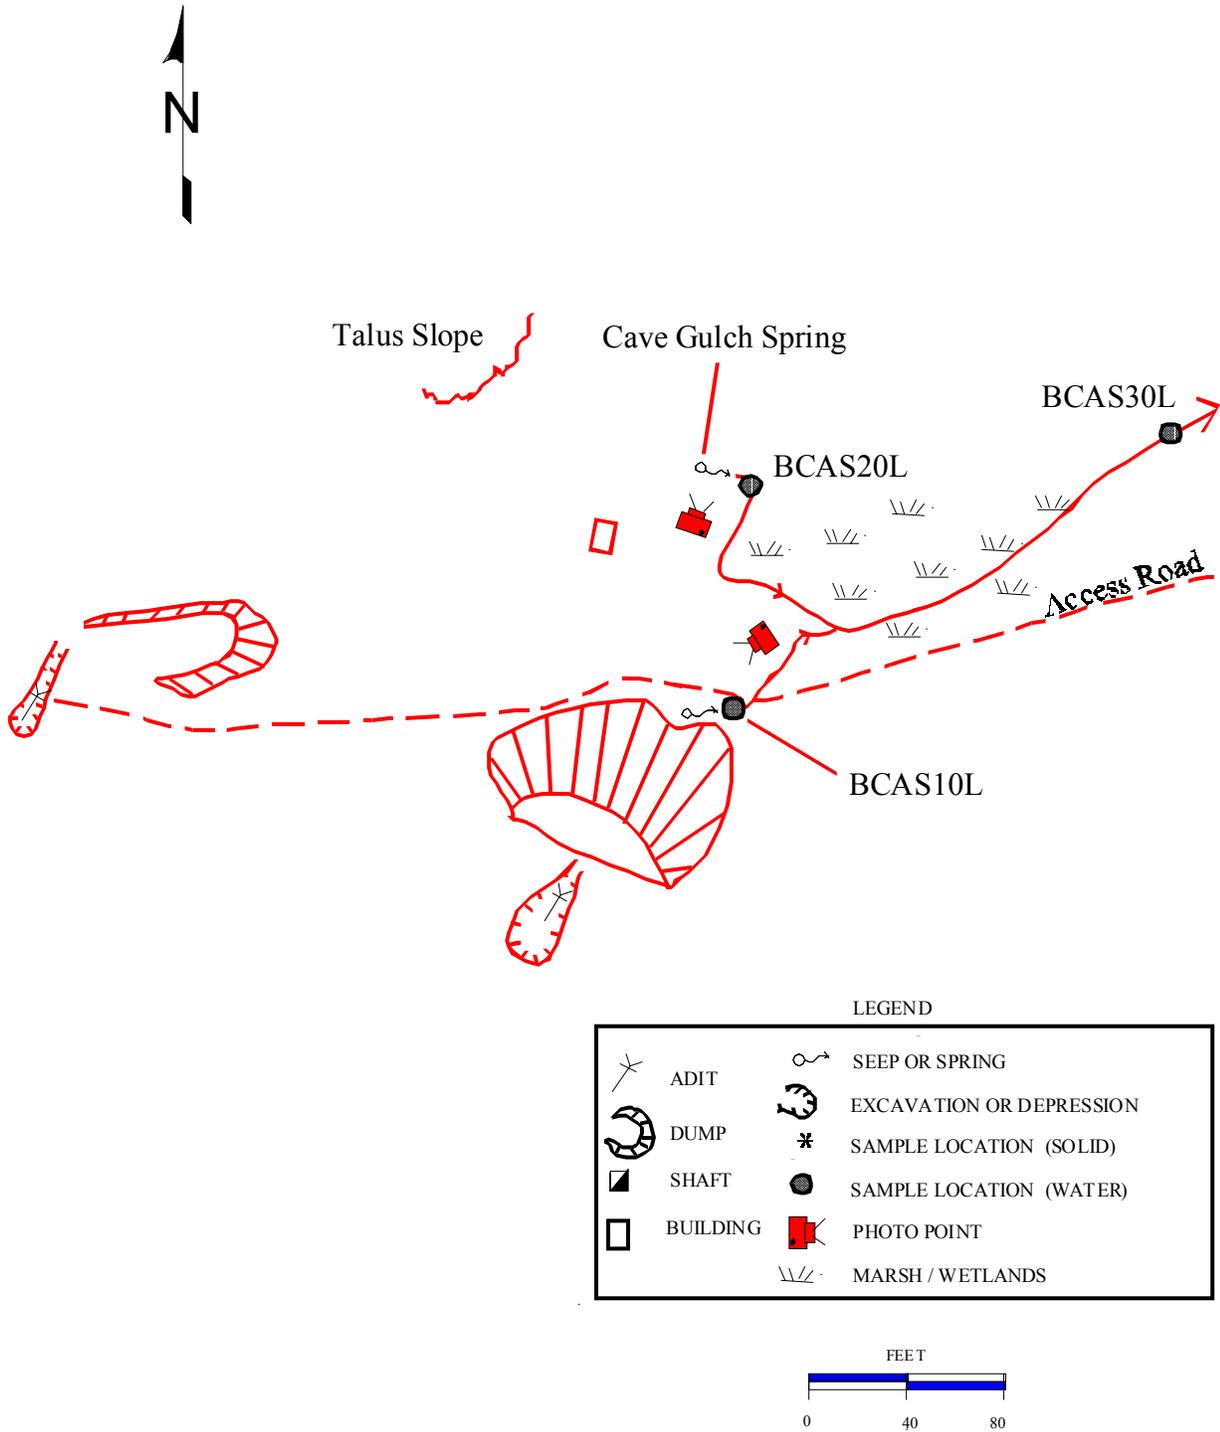
Figure 2.4 At the Capitol mine, a clear seep flows from the base of a waste-rock dump, September 1996.

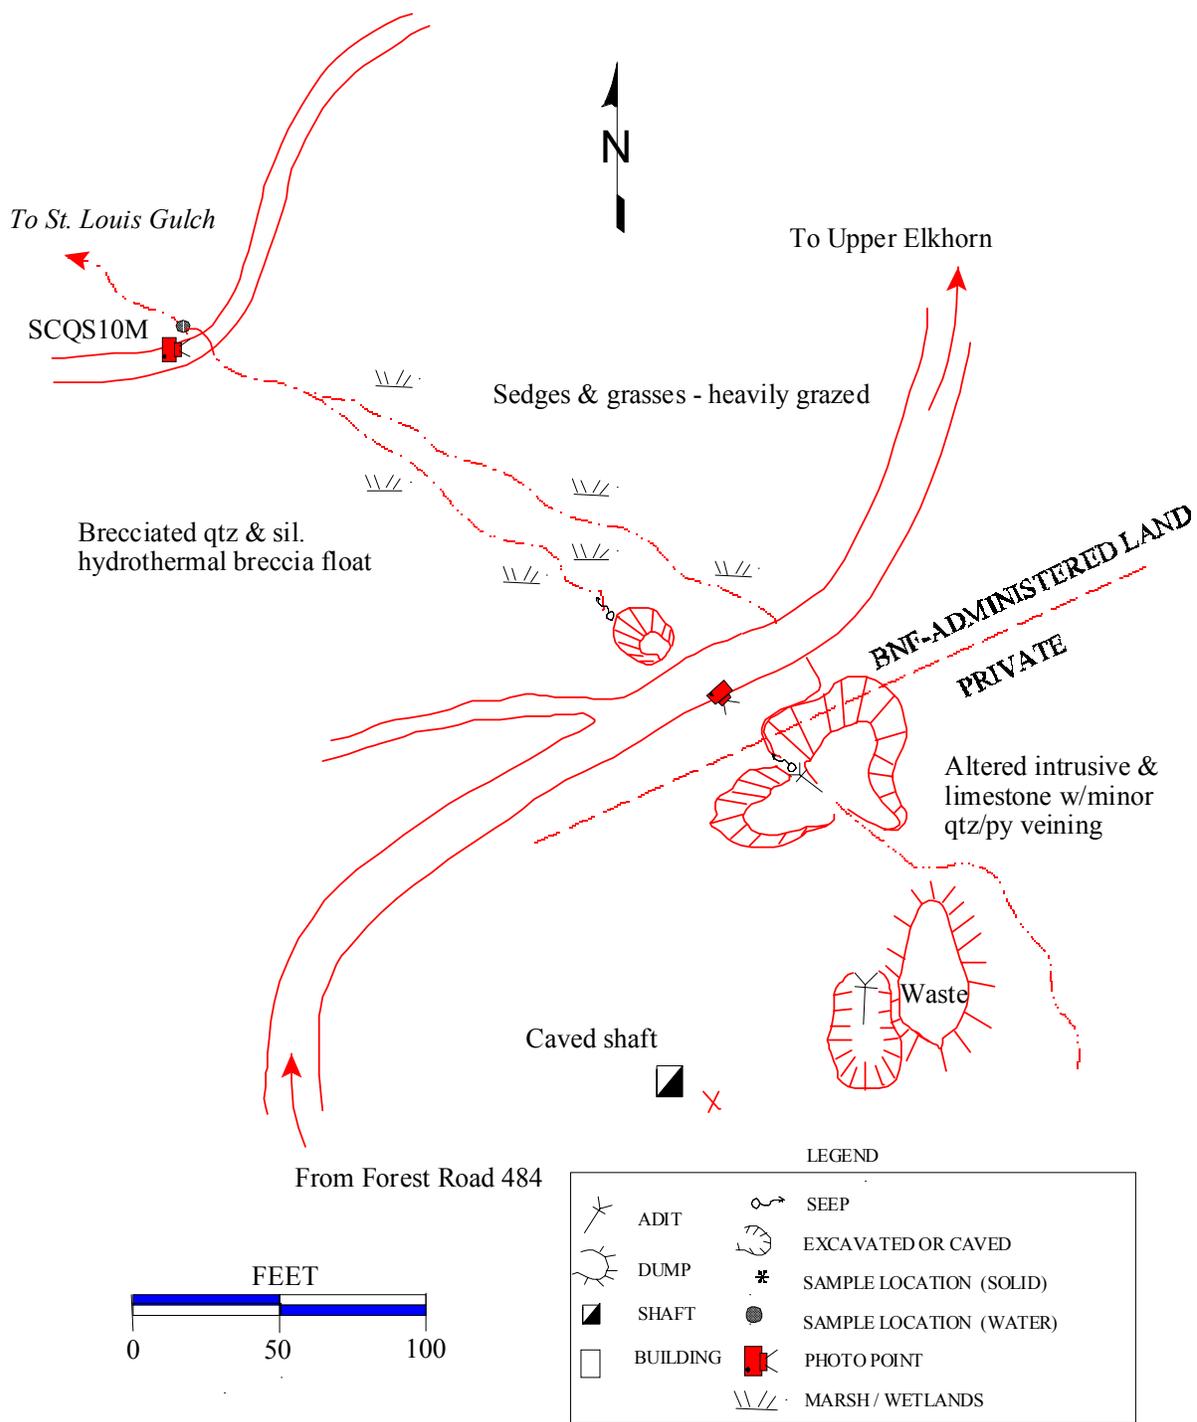
Figure 2.7 The Copper Queen patented claim had a small discharge that flowed through a culvert and down toward St. Louis Gulch, as mapped September 11, 1996.

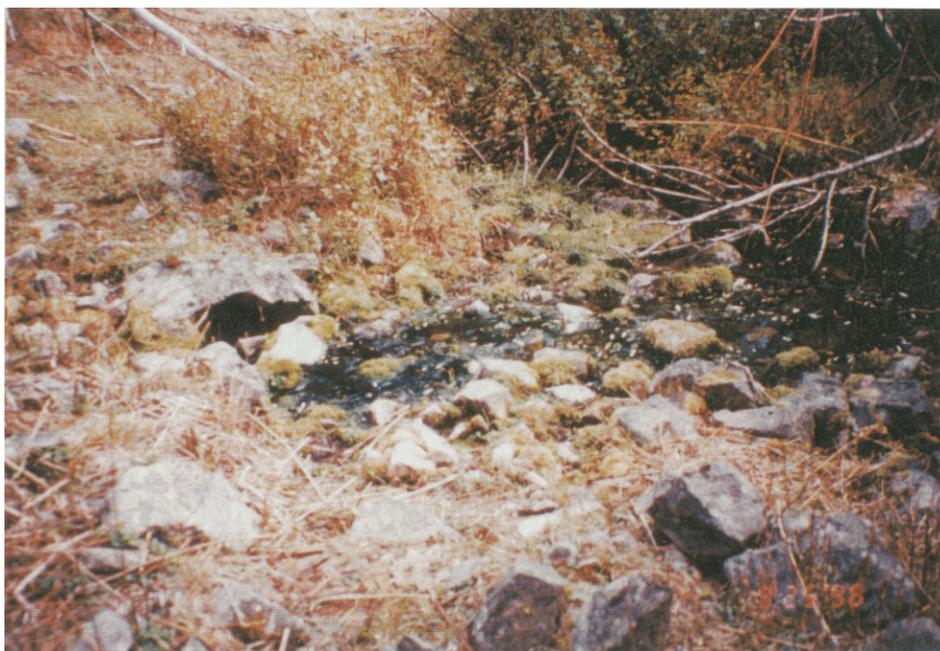
Figure 2.9 The adit discharge combined with a seep from the dump and spring area to form a small iron-stained flow near a logging road.

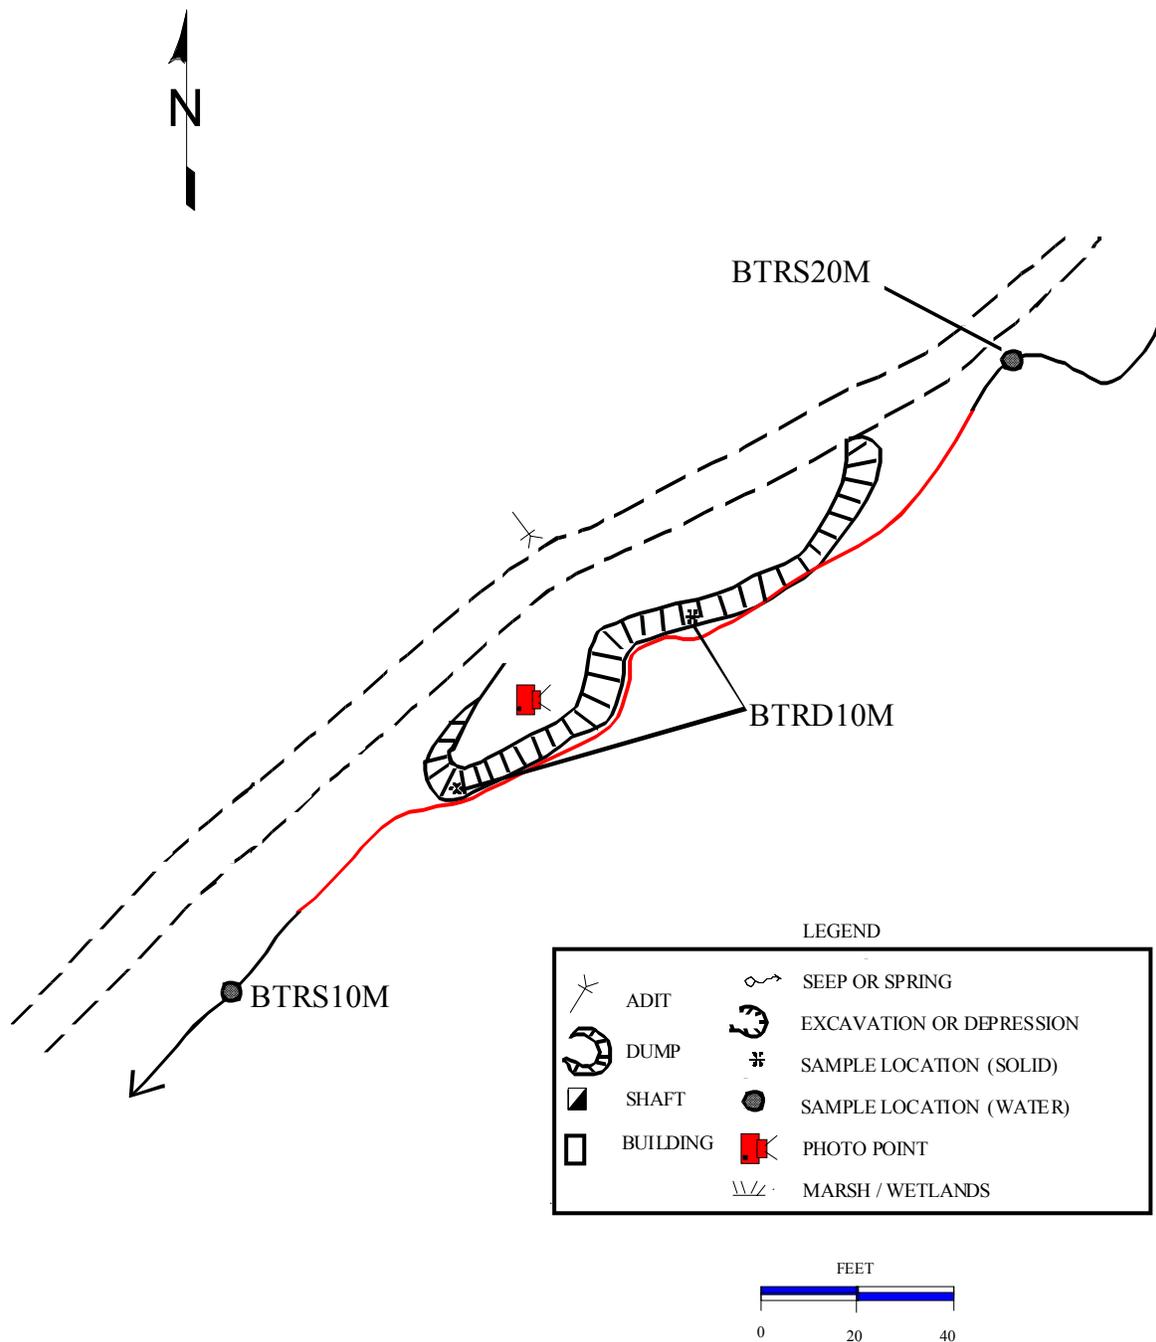
Figure 2.10 Trout Creek flows past a streamside waste-rock dump at the Paradise claim (10/8/96).

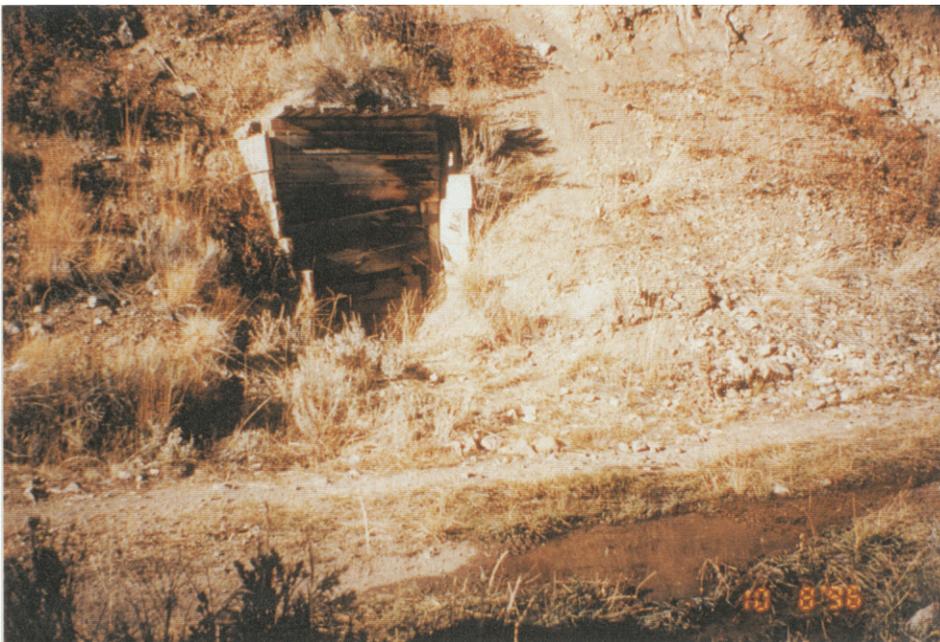
Figure 2.12 The condition of the Paradise Claim's adit is unknown because the portal is closed with a wood door that can not be opened.

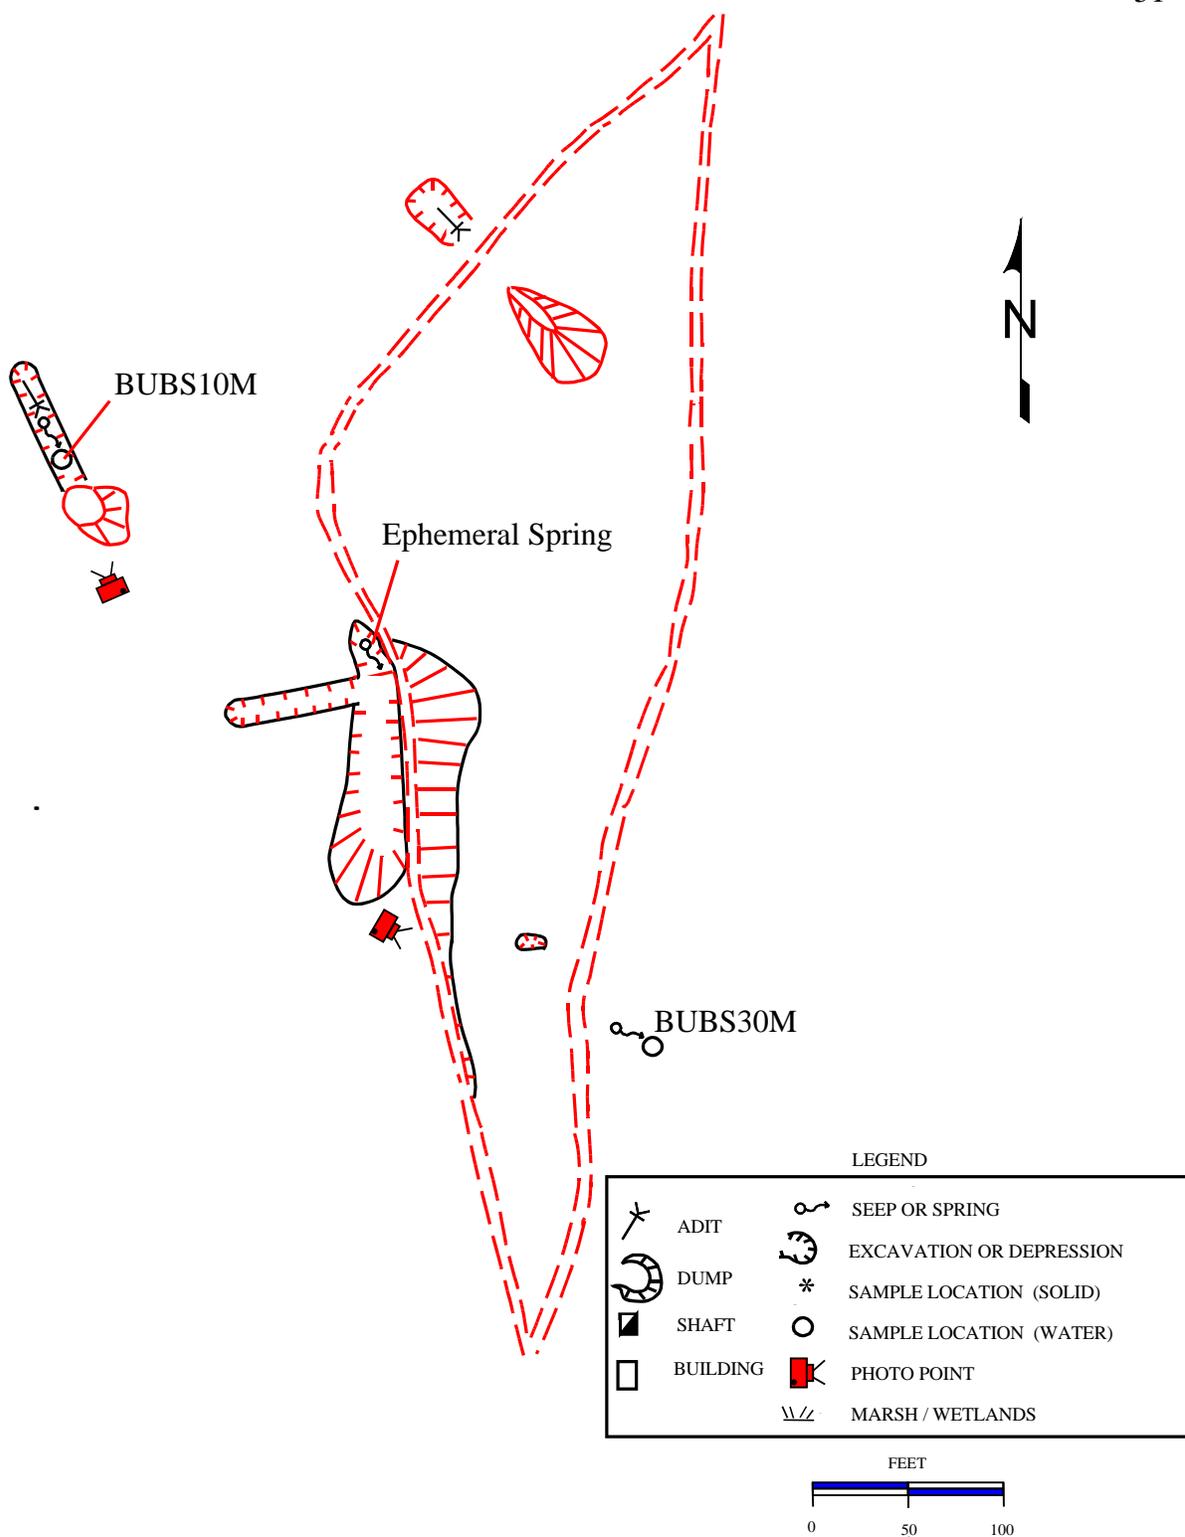
Figure 2.13 A small iron-oxyhydroxide stained spring flows from the upper adit at the Pay Day group, as mapped in September 1996.

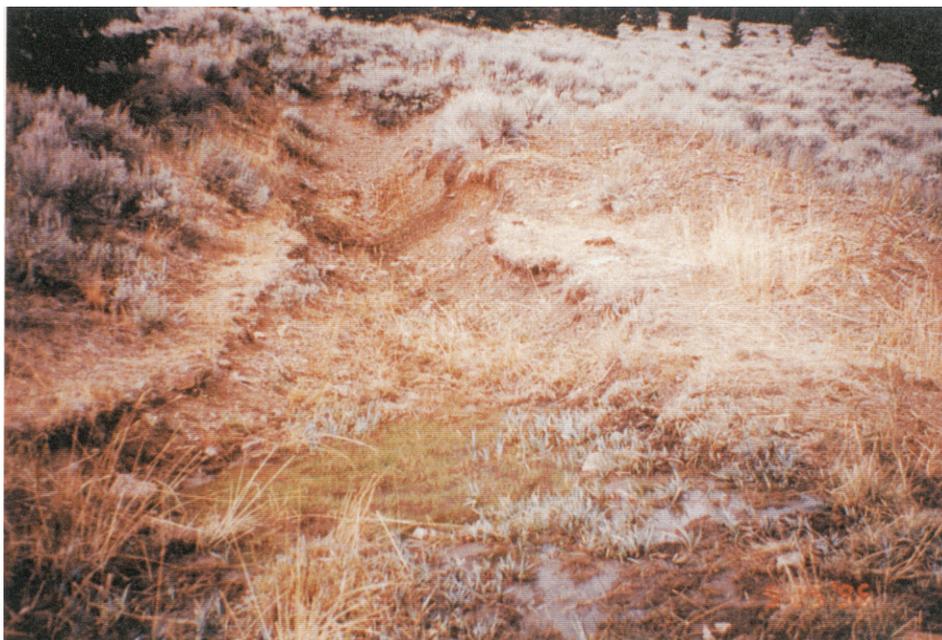
Figure 2.14 The adit discharge at the Pay Day mine contains high concentrations of aluminum, iron, and manganese.

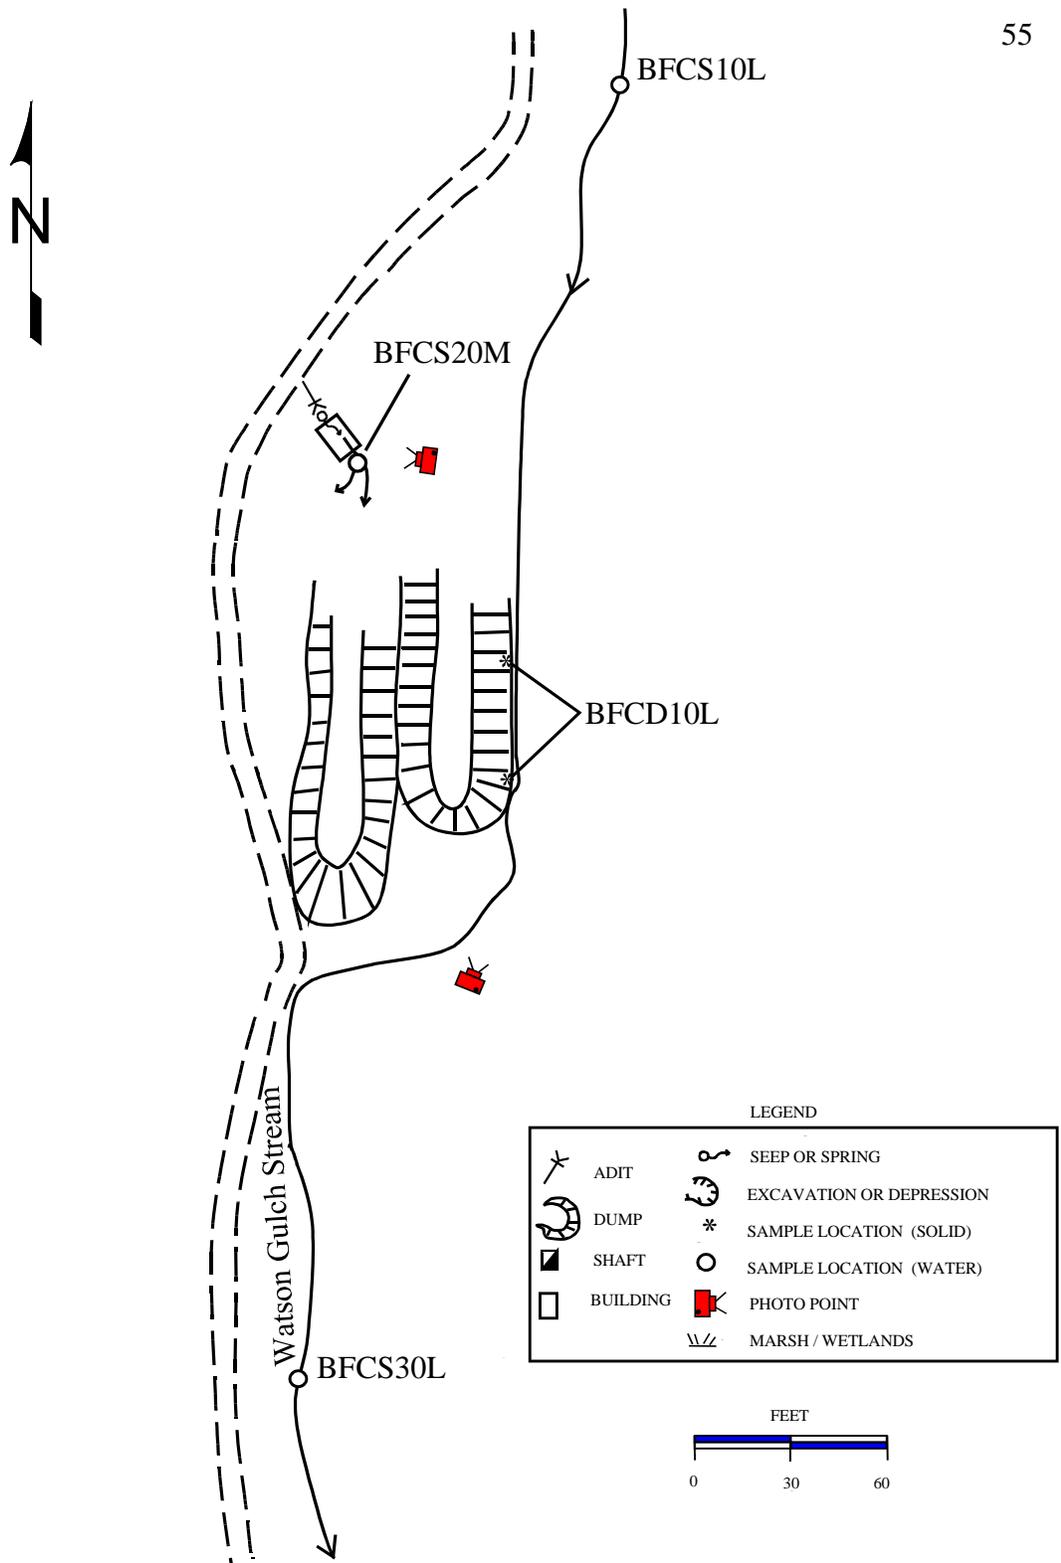
Figure 2.16 At the Watson Gulch mine, there is a small adit discharge and a streamside waste-rock dump (10/8/96).

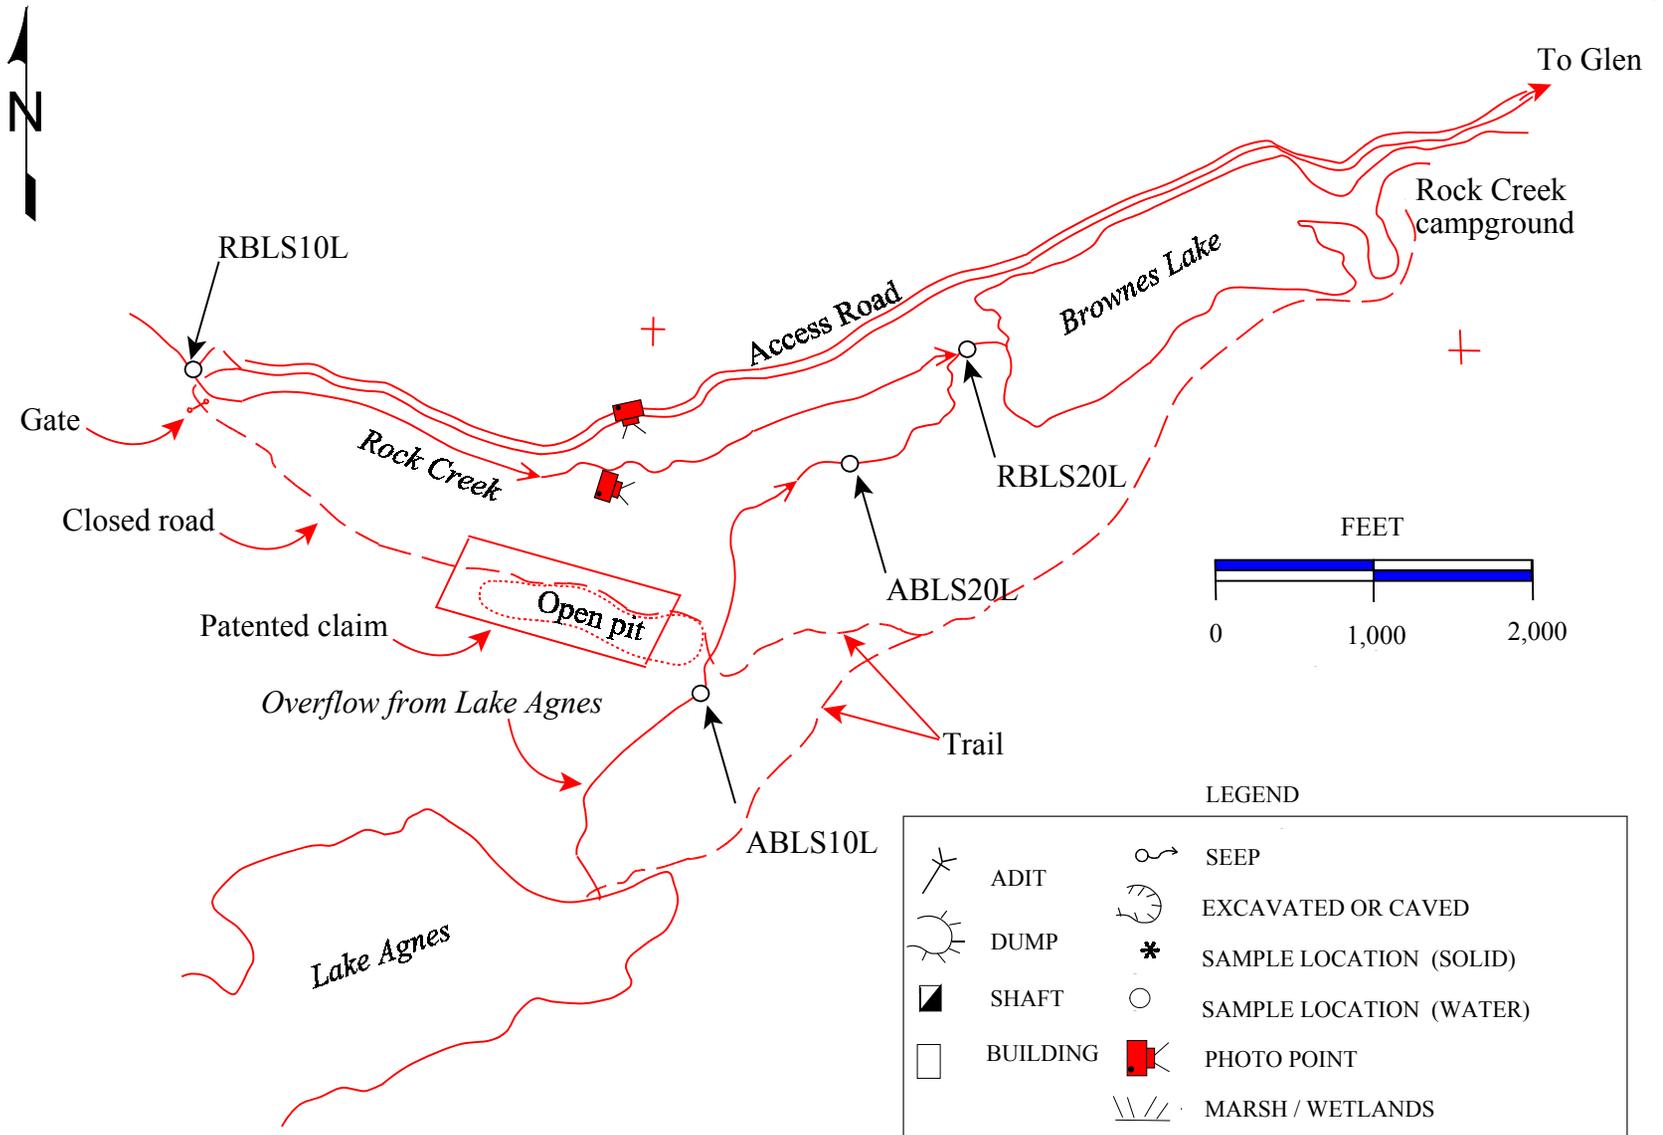
Figure 3.6 The Brownes Lake (Ivanhoe) tungsten deposit has dangerous highwalls and streamside waste, as shown in this August 29, 1996 schematic taken from the Storm Peak 7.5-min USFS ownership map.

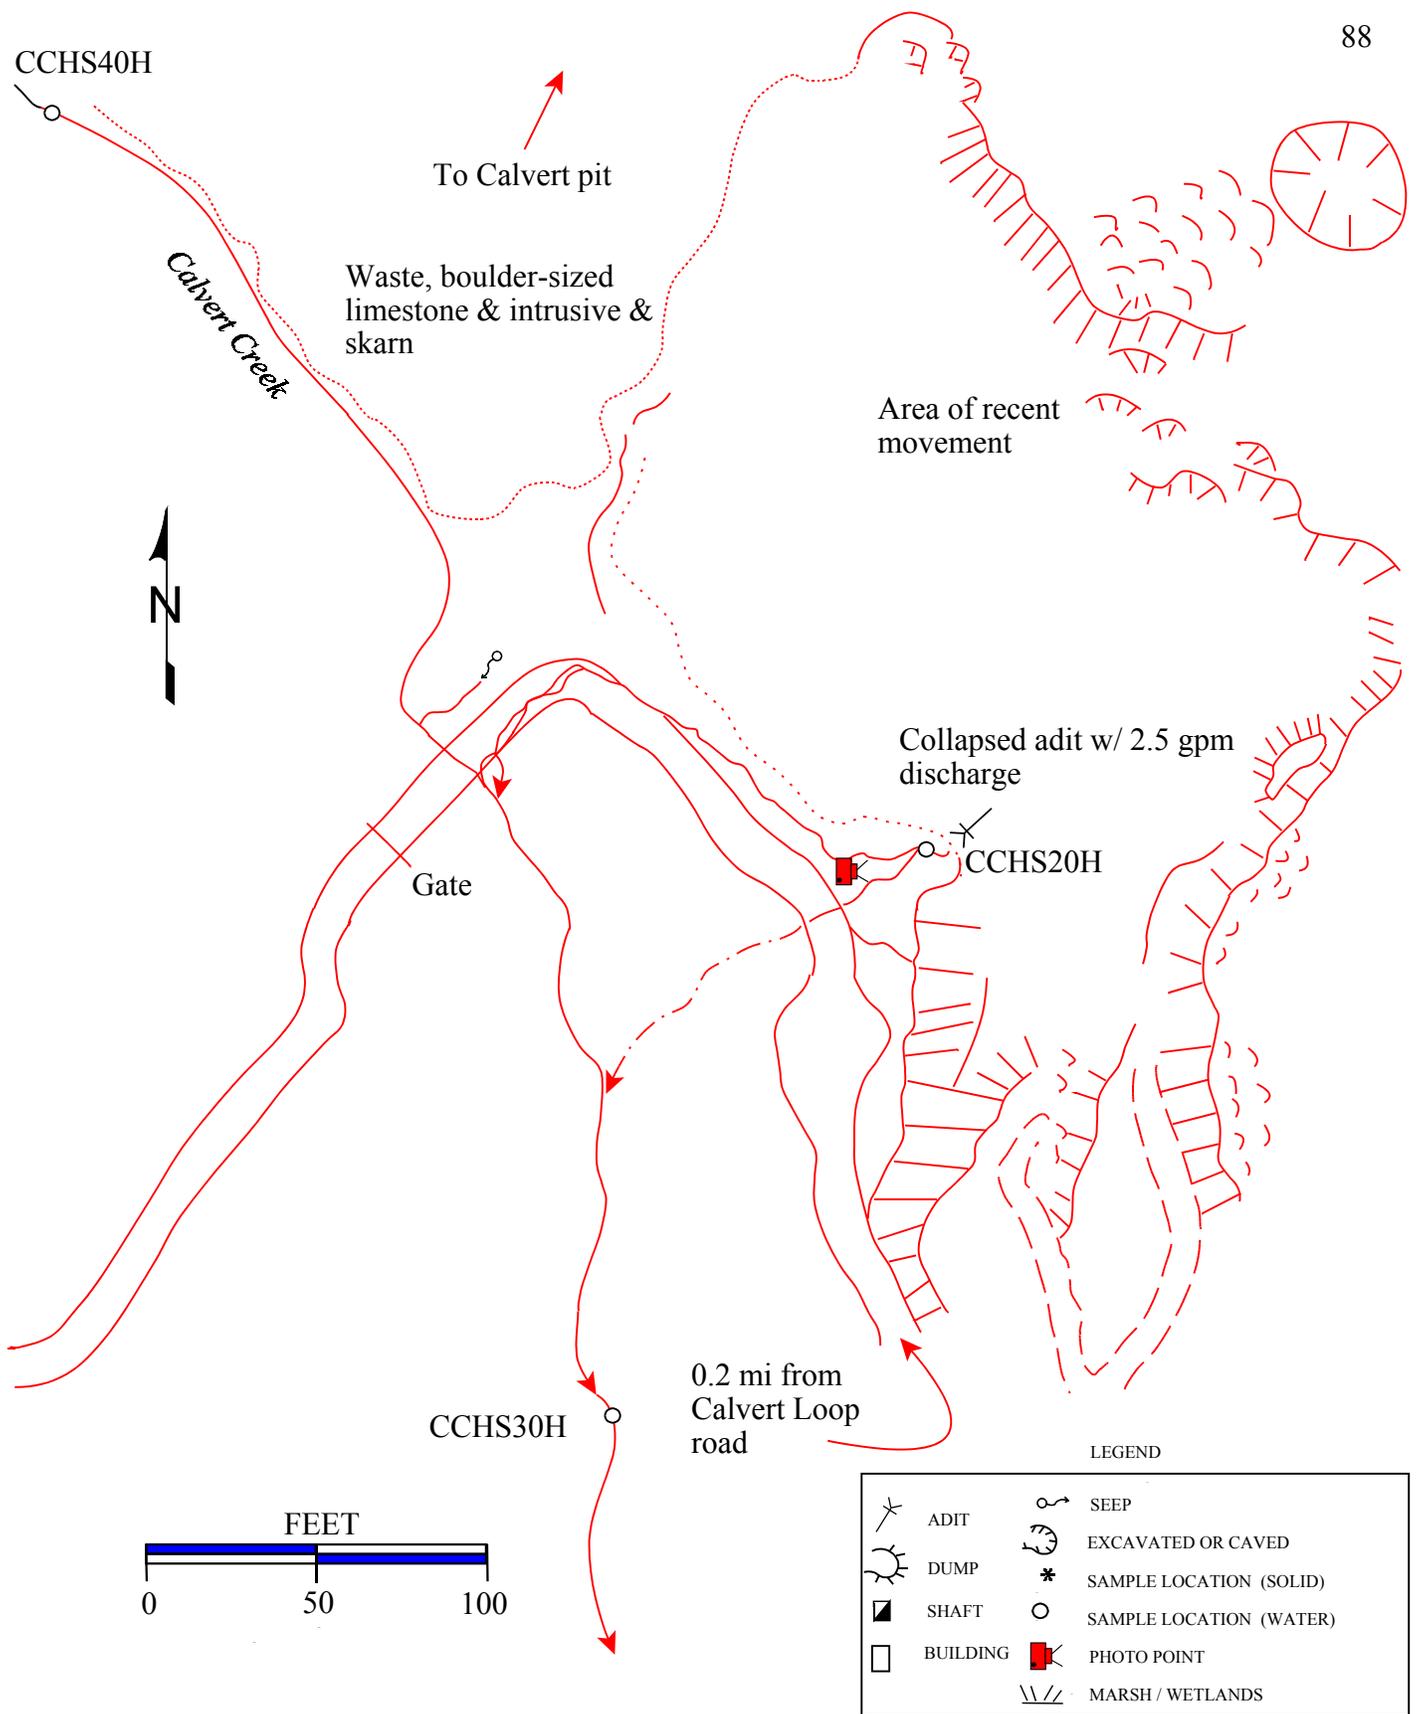
Figure 3.9 Site map of the Calvert mine area, August 1996. Slumping has occurred on the slope above the adit.

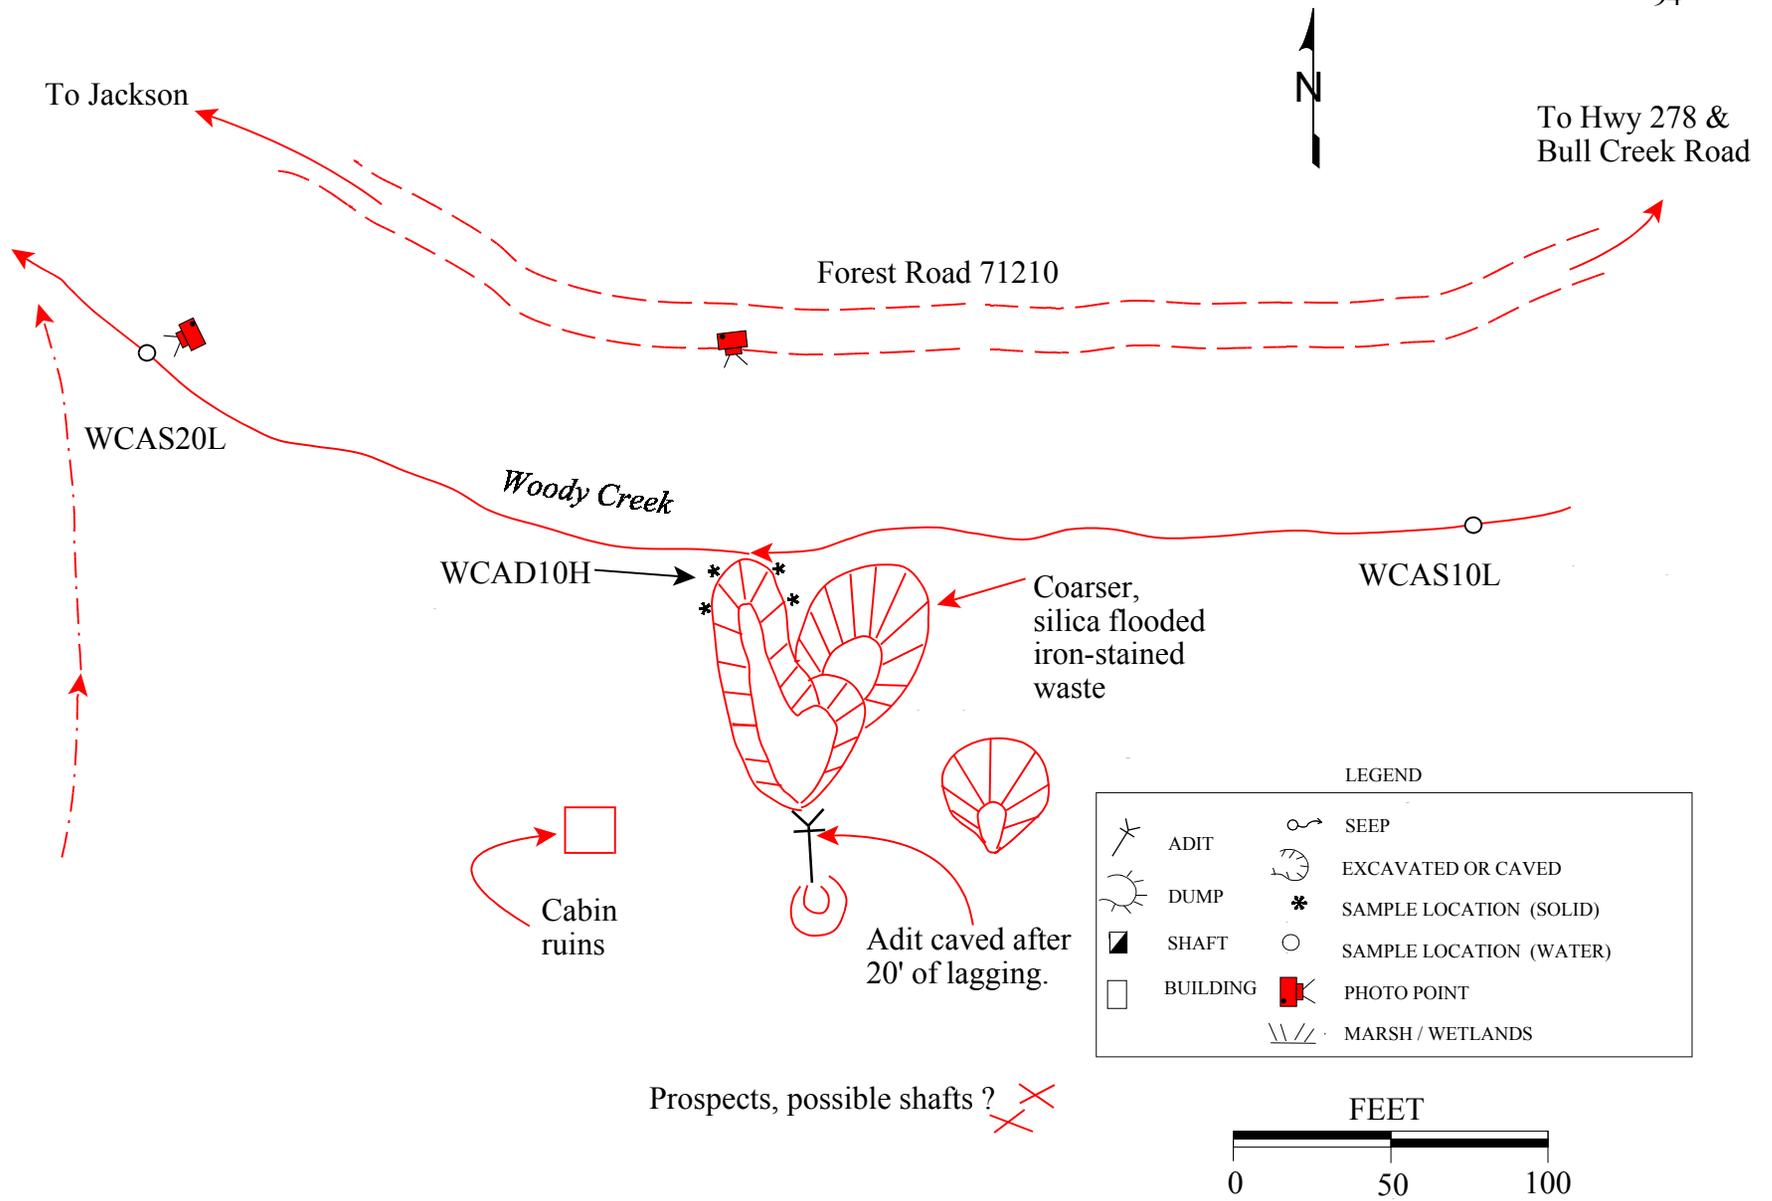
Figure 3.13 The small waste dump at the Carney mine contacted Woody Creek during times of high water but was not in contact on August 11, 1997.

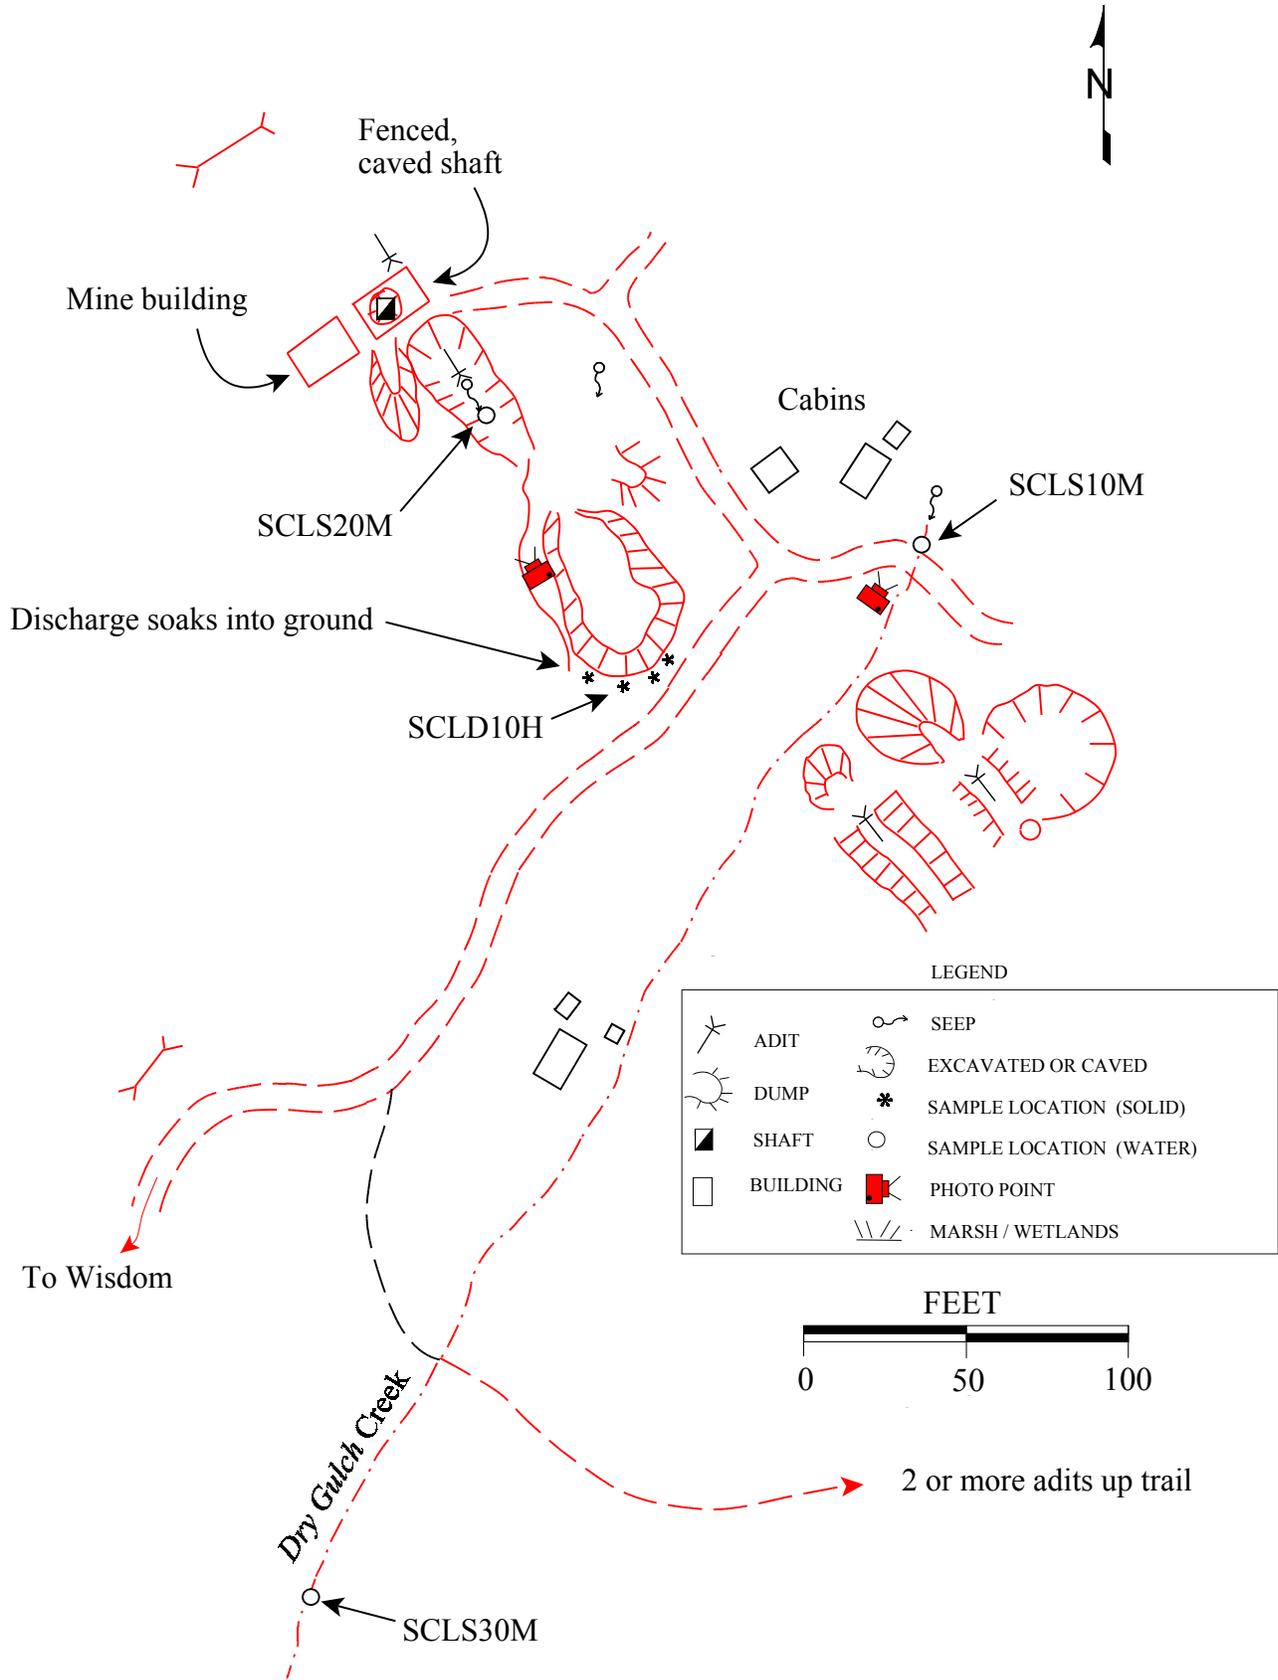
Figure 3.16 Seeps from the adit at the Clara and the surrounding hillside form Dry Gulch Creek, a small tributary to Steel Creek (August 1997).

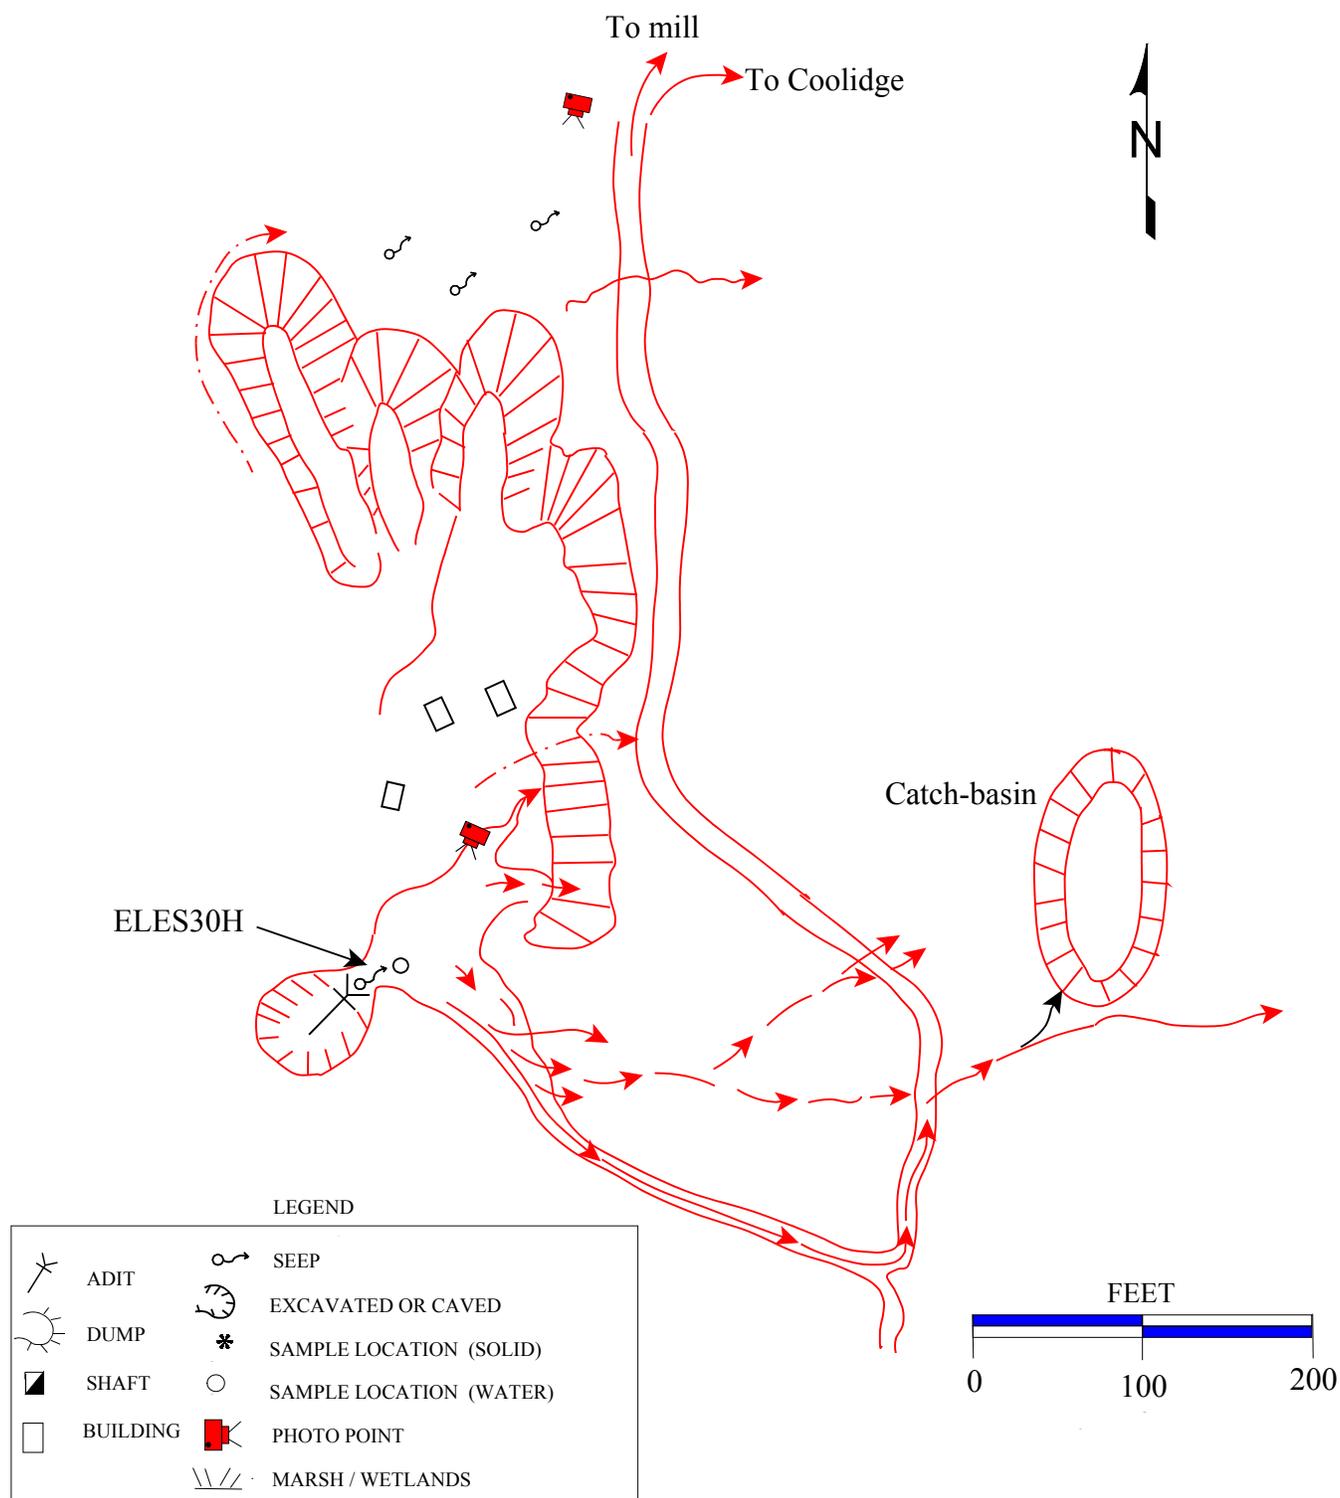
Figure 3.22 The Elkhorn mine discharges onto the waste dump and has seeps at the south end of the same dumps, as mapped September 10, 1996.
