Montana Bureau of Mines and Geology
MBMG No. 379

**Abandoned/Inactive Mines
of the
Southern Beaverhead-Deerlodge National Forest**

September 1998

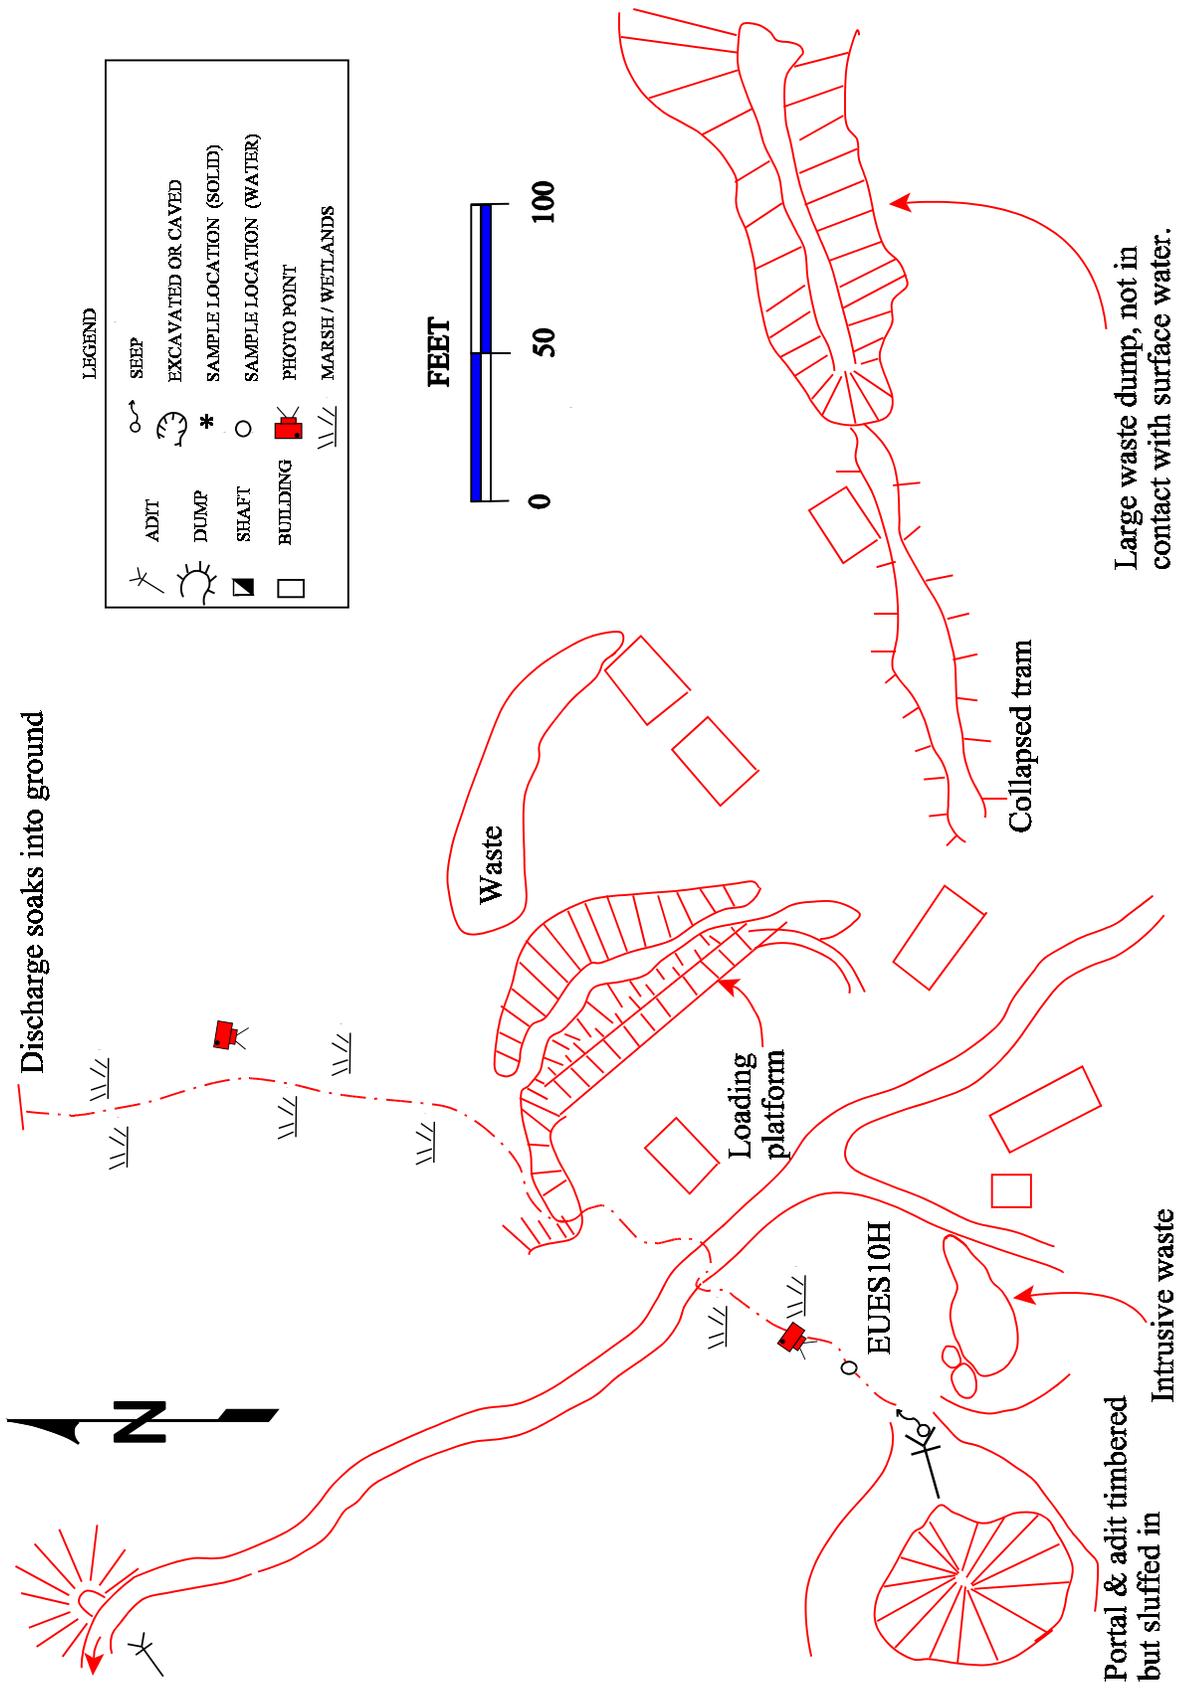
Figure 3.26 A small discharge flowed from one of the two adits at the upper camp of the Elkhorn mine, as mapped on September 12, 1996.

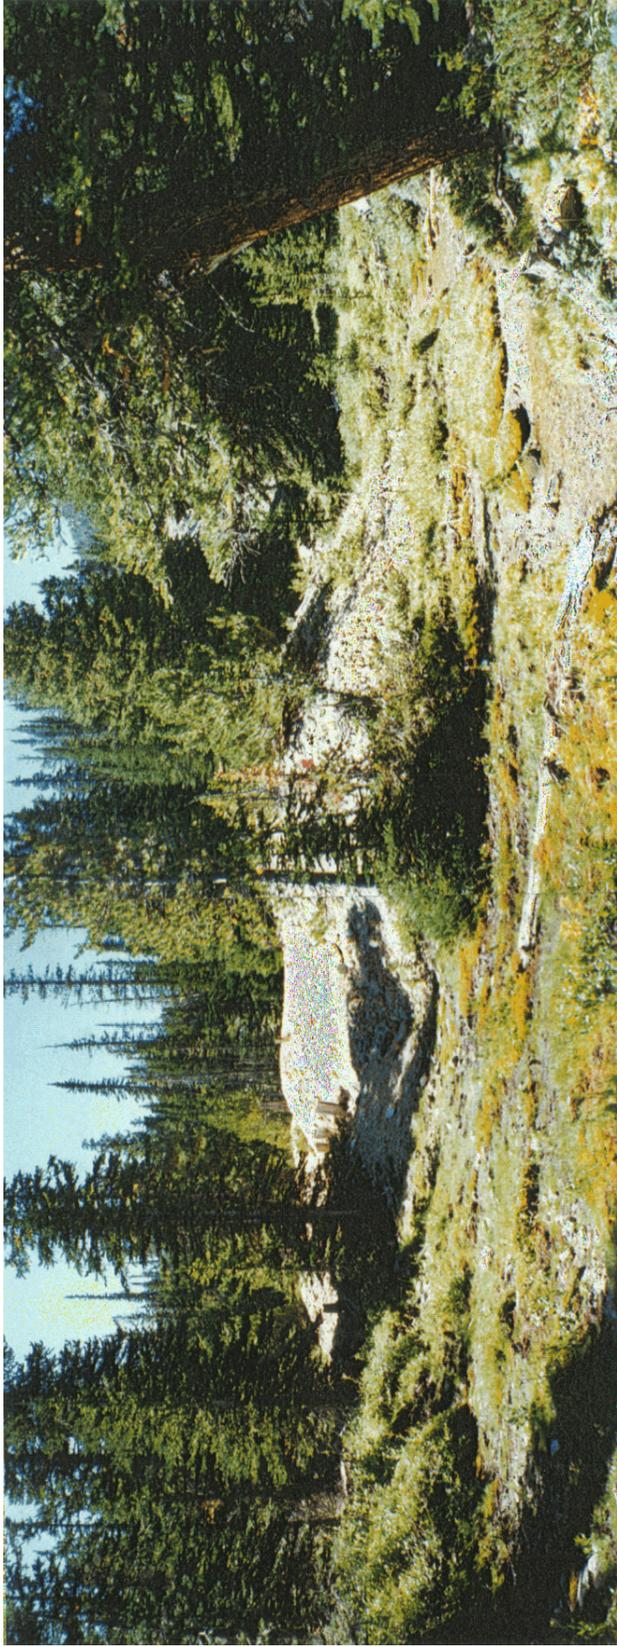
Figure 3.30 The headwater of an unnamed tributary of Sappington Creek flowed around the margin of a waste dump at

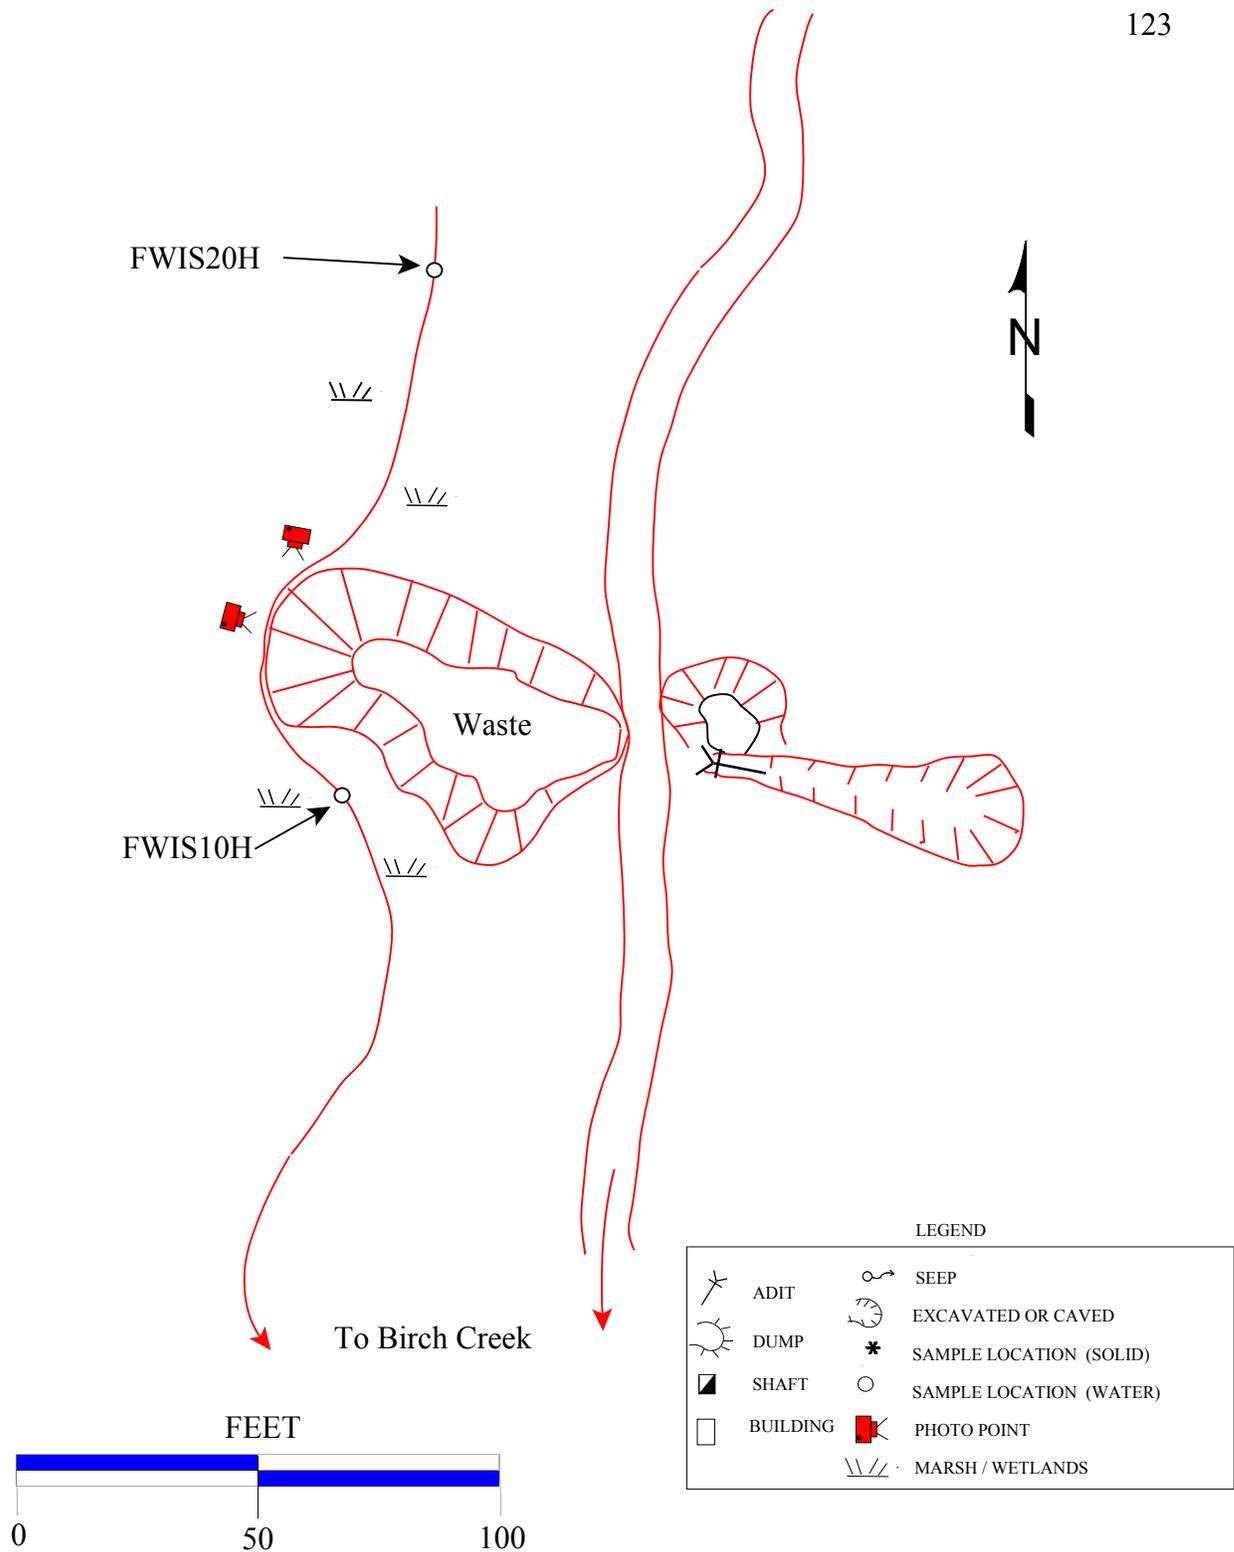
Figure 3.31 A small waste dump lies in the Farlin Gulch drainage and is actively being eroded, as mapped July 16, 1996.

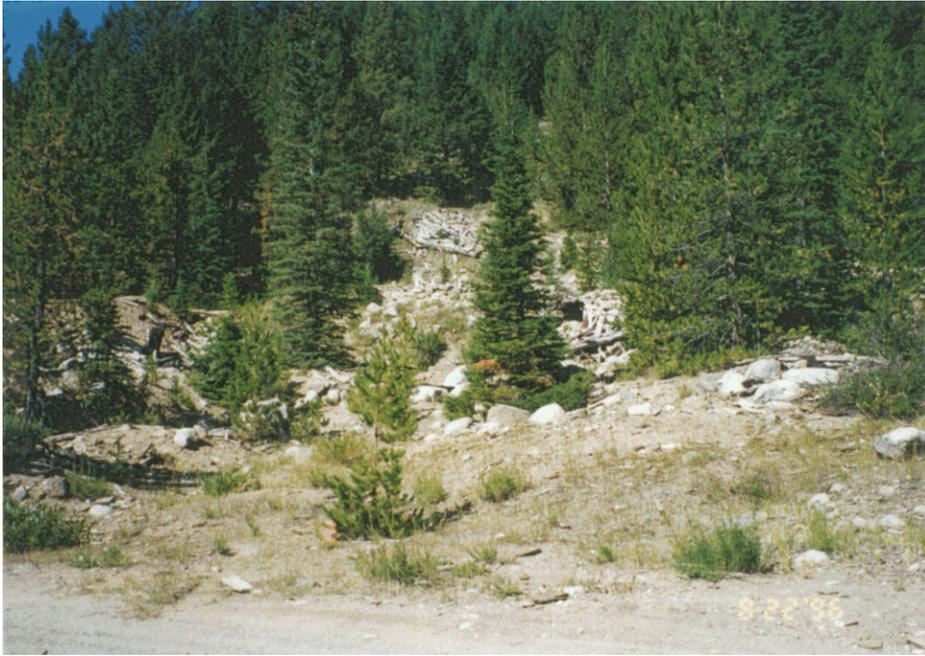
Figure 3.35 Only the foundation remains of the once massive Greenwood concentrator.

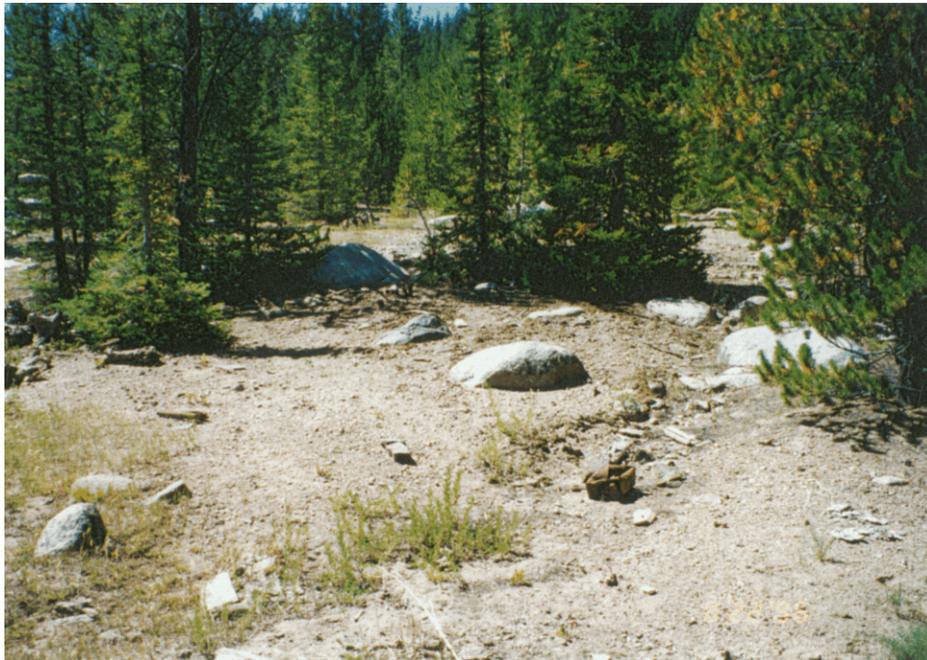
Figure 3.36 A flat area to the east of Forest Road 188 has scattered slag from the Greenwood concentrator.

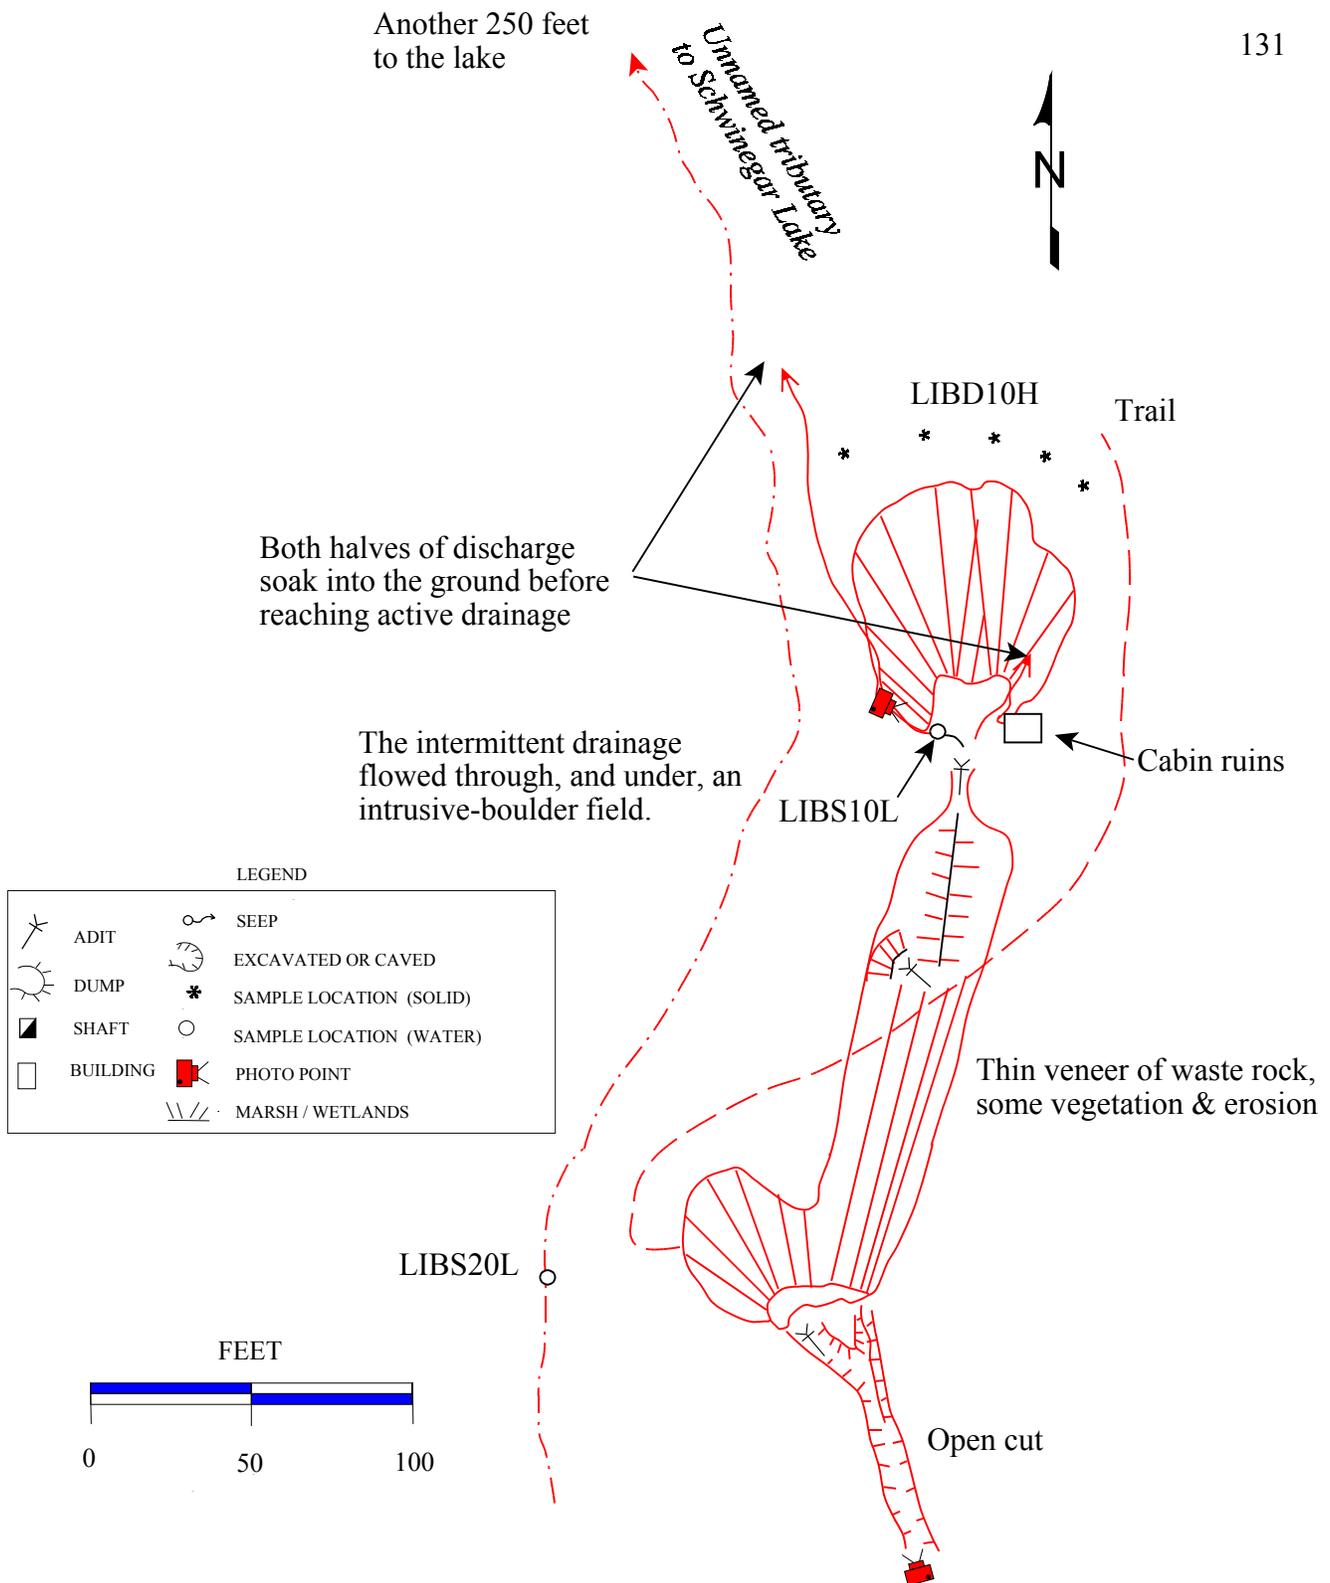
Figure 3.37 The Ibex mine consists of two or three collapsed adits, July 1997. The lowest adit has a small discharge that splits and soaks into the ground before reaching an active drainage.

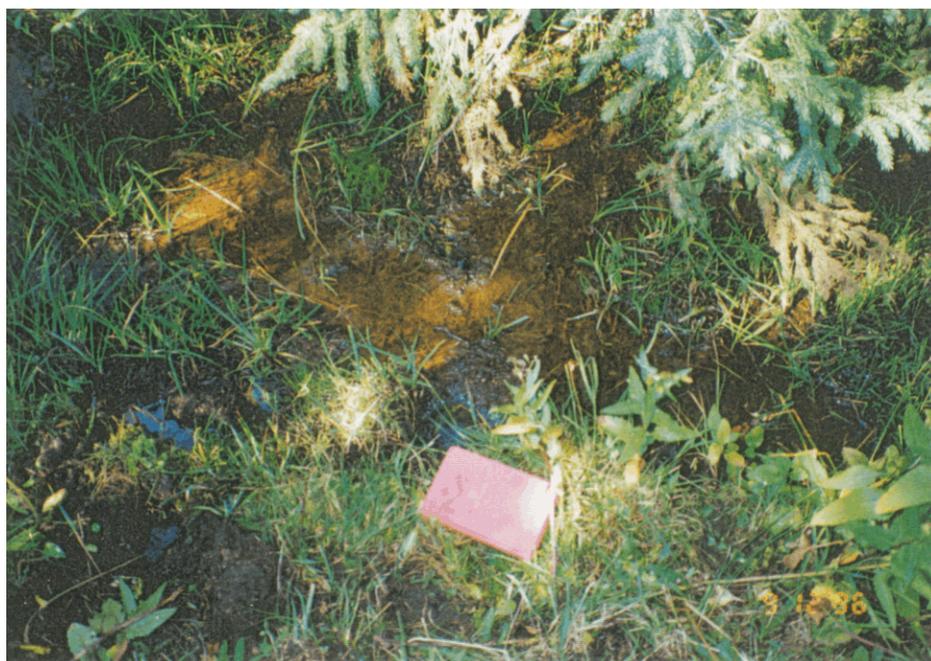
Figure 3.51 The small adit discharge was iron stained but flowed at only 2 gpm.

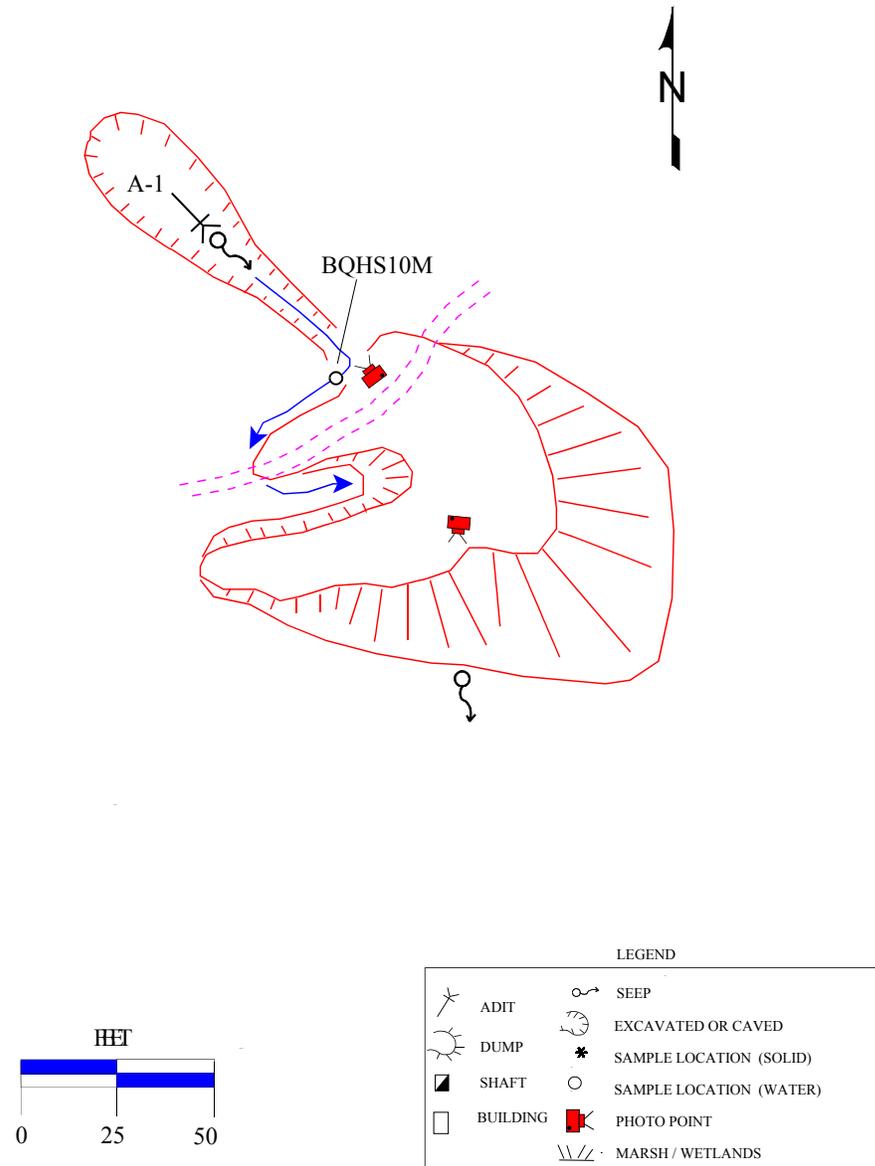
Figure 3.52 Site map of the Queen of the Hill mine, August 1996. The adit discharge sinks into the ground and re-emerges as a seep at the base of the waste-rock dump.

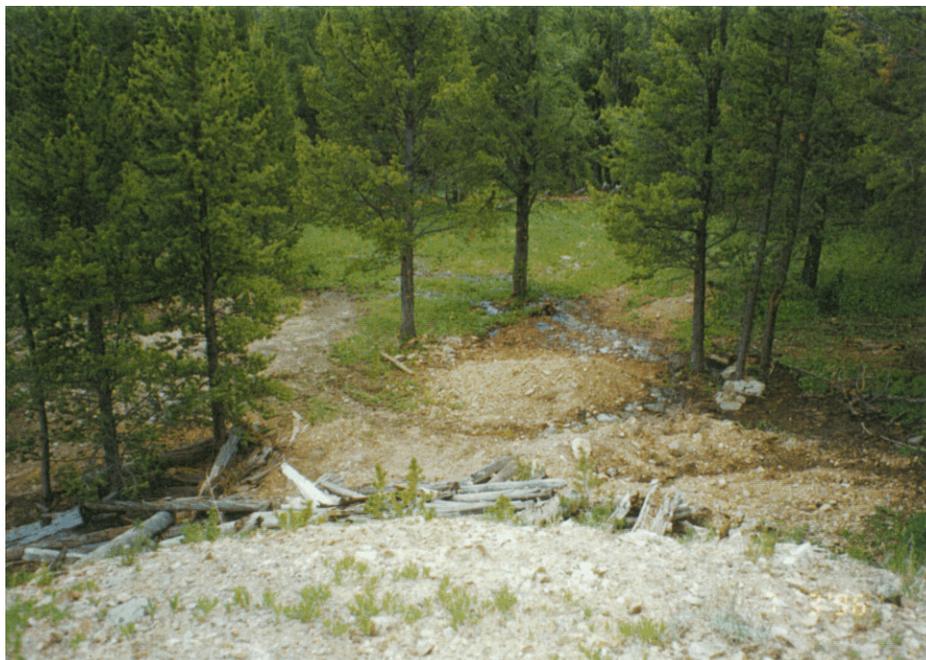
Figure 3.54 After infiltrating the ground behind the waste-rock dump, the water re-emerges as a seep at the base of the dump.

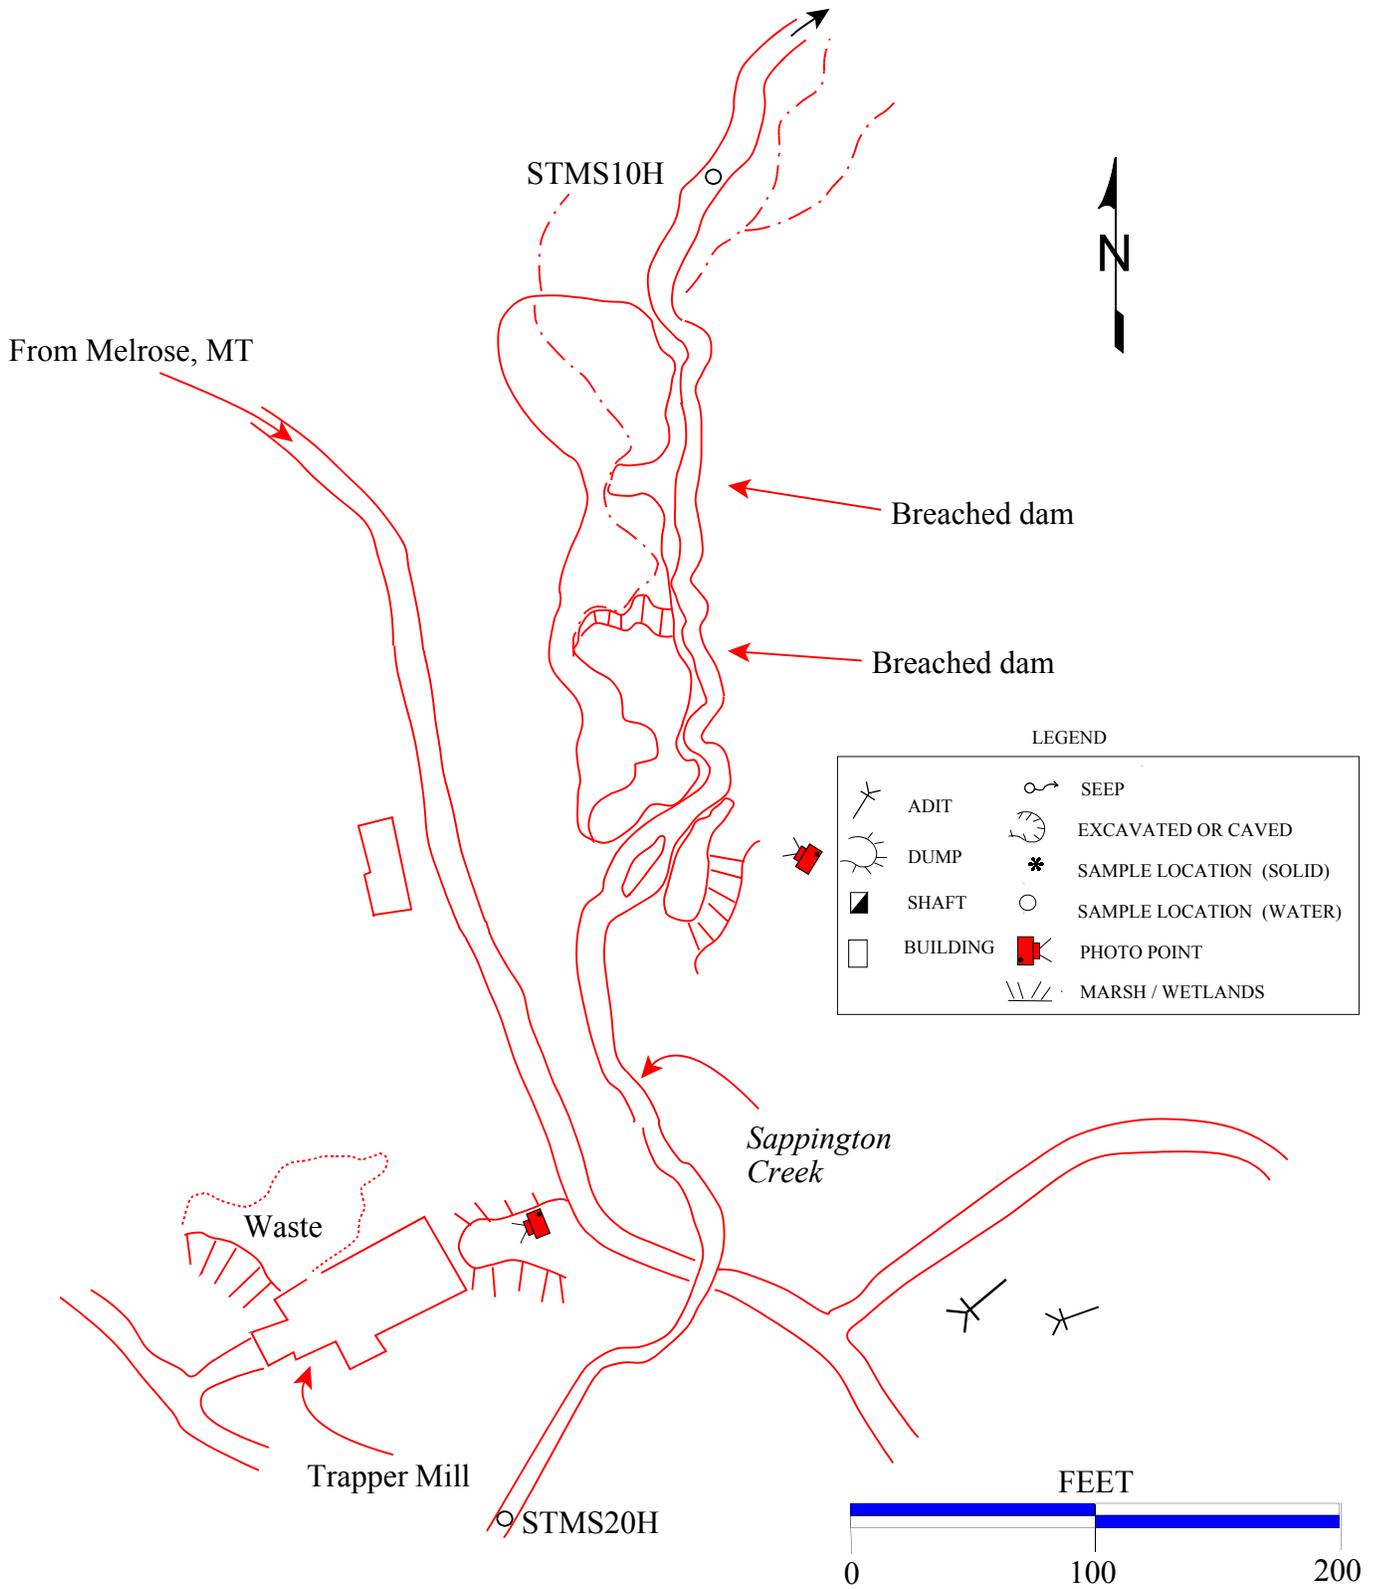
Figure 3.58 The Trapper mill tailings are adjacent to Sappington Creek, as mapped August 14, 1996.

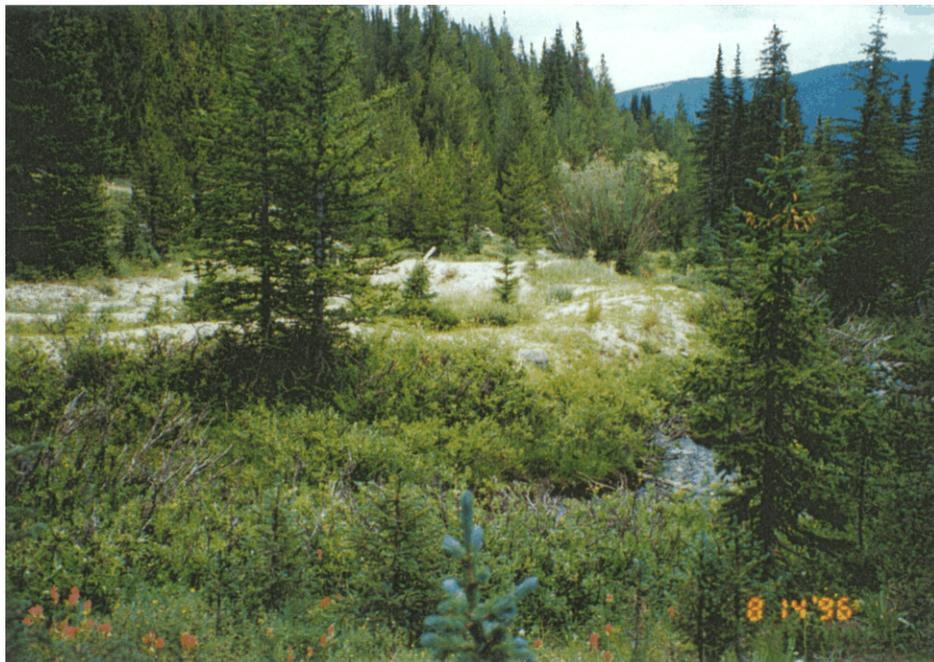
Figure 3.60 The tailings downstream of the mill are sparsely to moderately vegetated with willows, fir, and wildflowers.

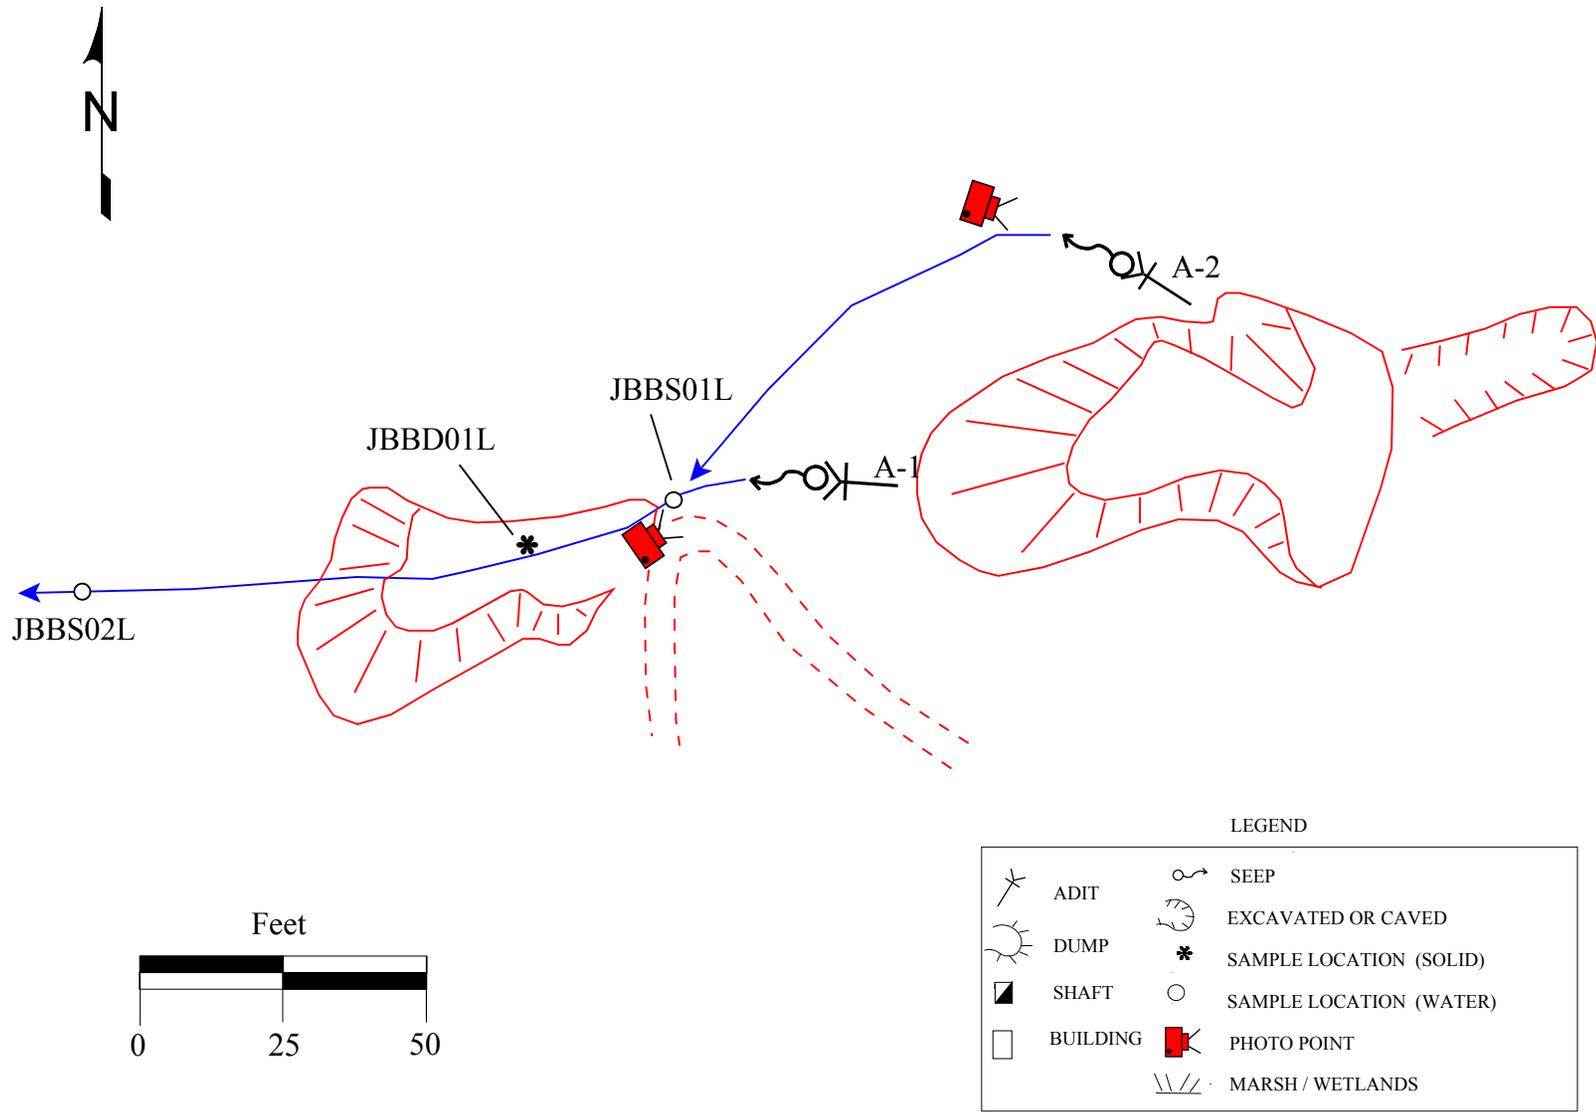
Figure 4.4 Site map of the Branham Basin mine, September 1996. The adit discharges join and flow into a marshy area.

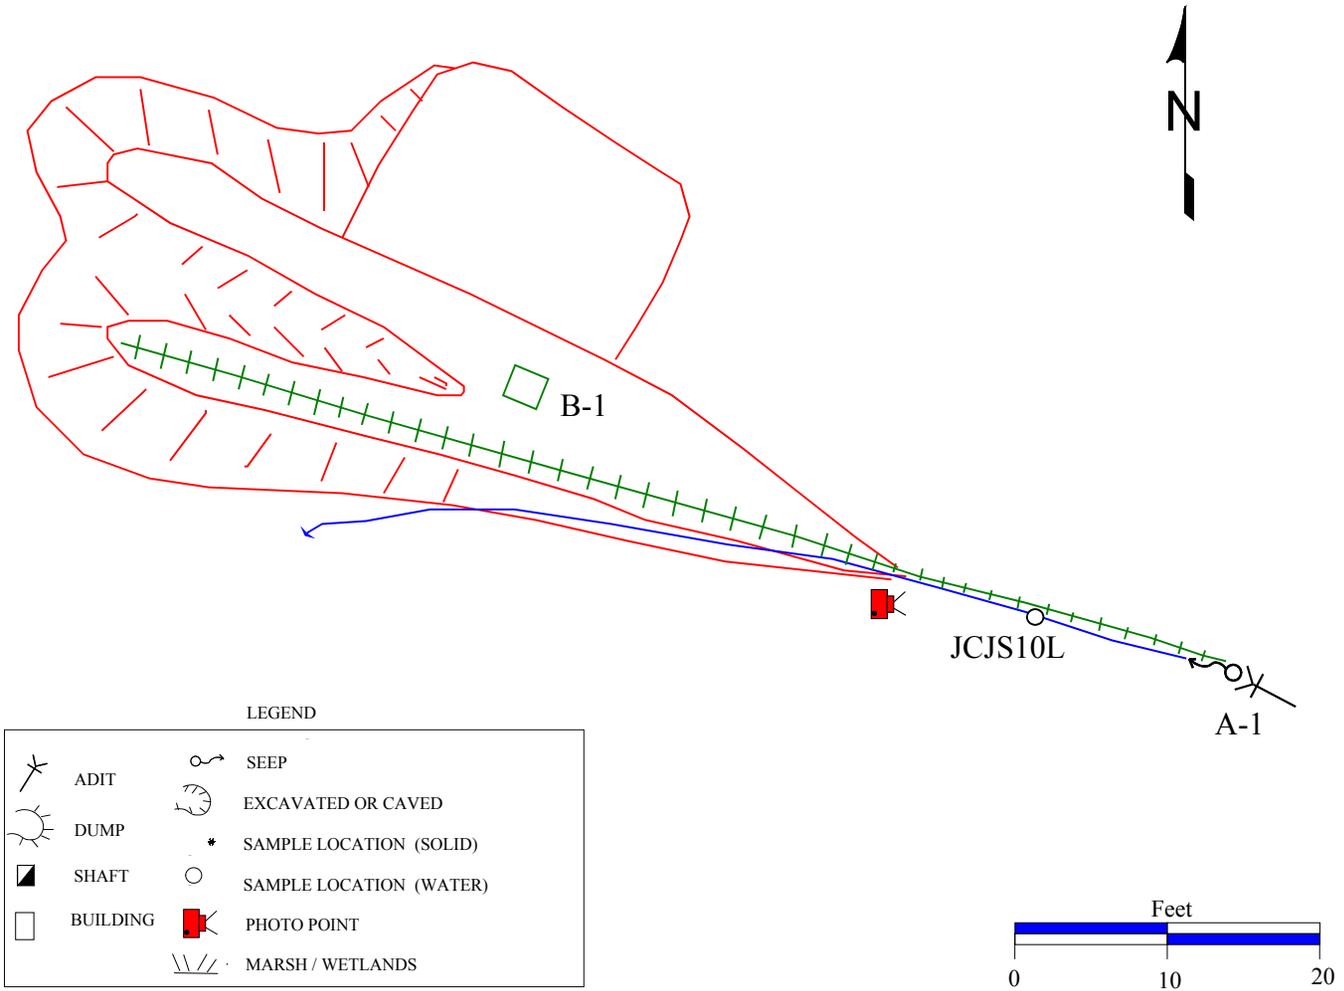
Figure 4.7 Site map of the Cousin Jack mine, September 1996. The discharge sinks into the ground about 50 feet from the adit.

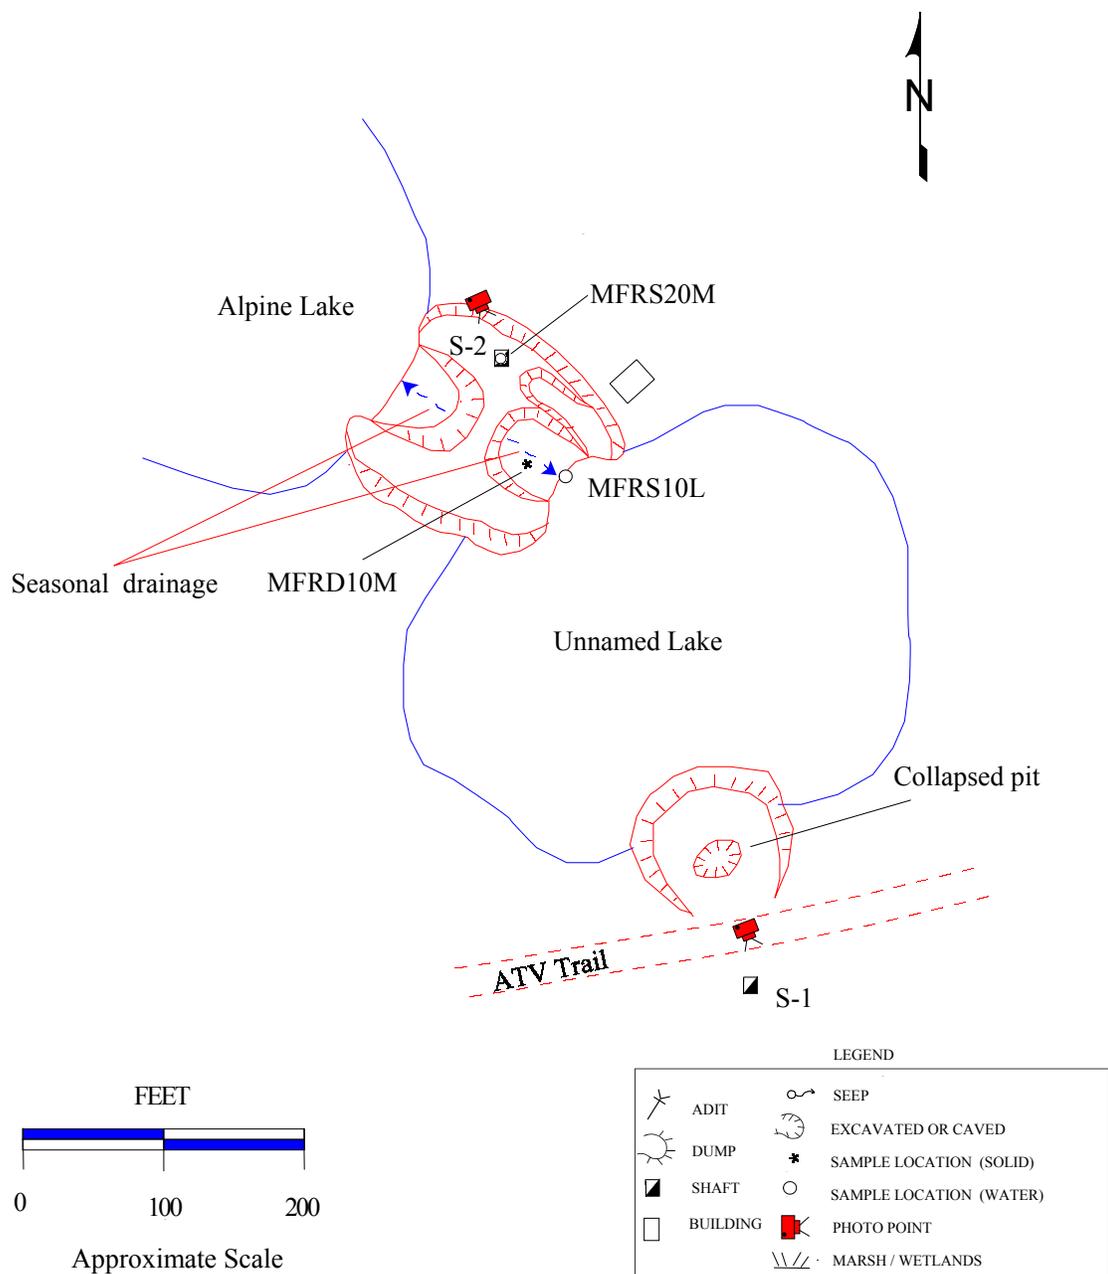
Figure 4.9 Site map of the Frisbee mine showing waste rock in contact with the lakes and the location of shafts, September 1996.

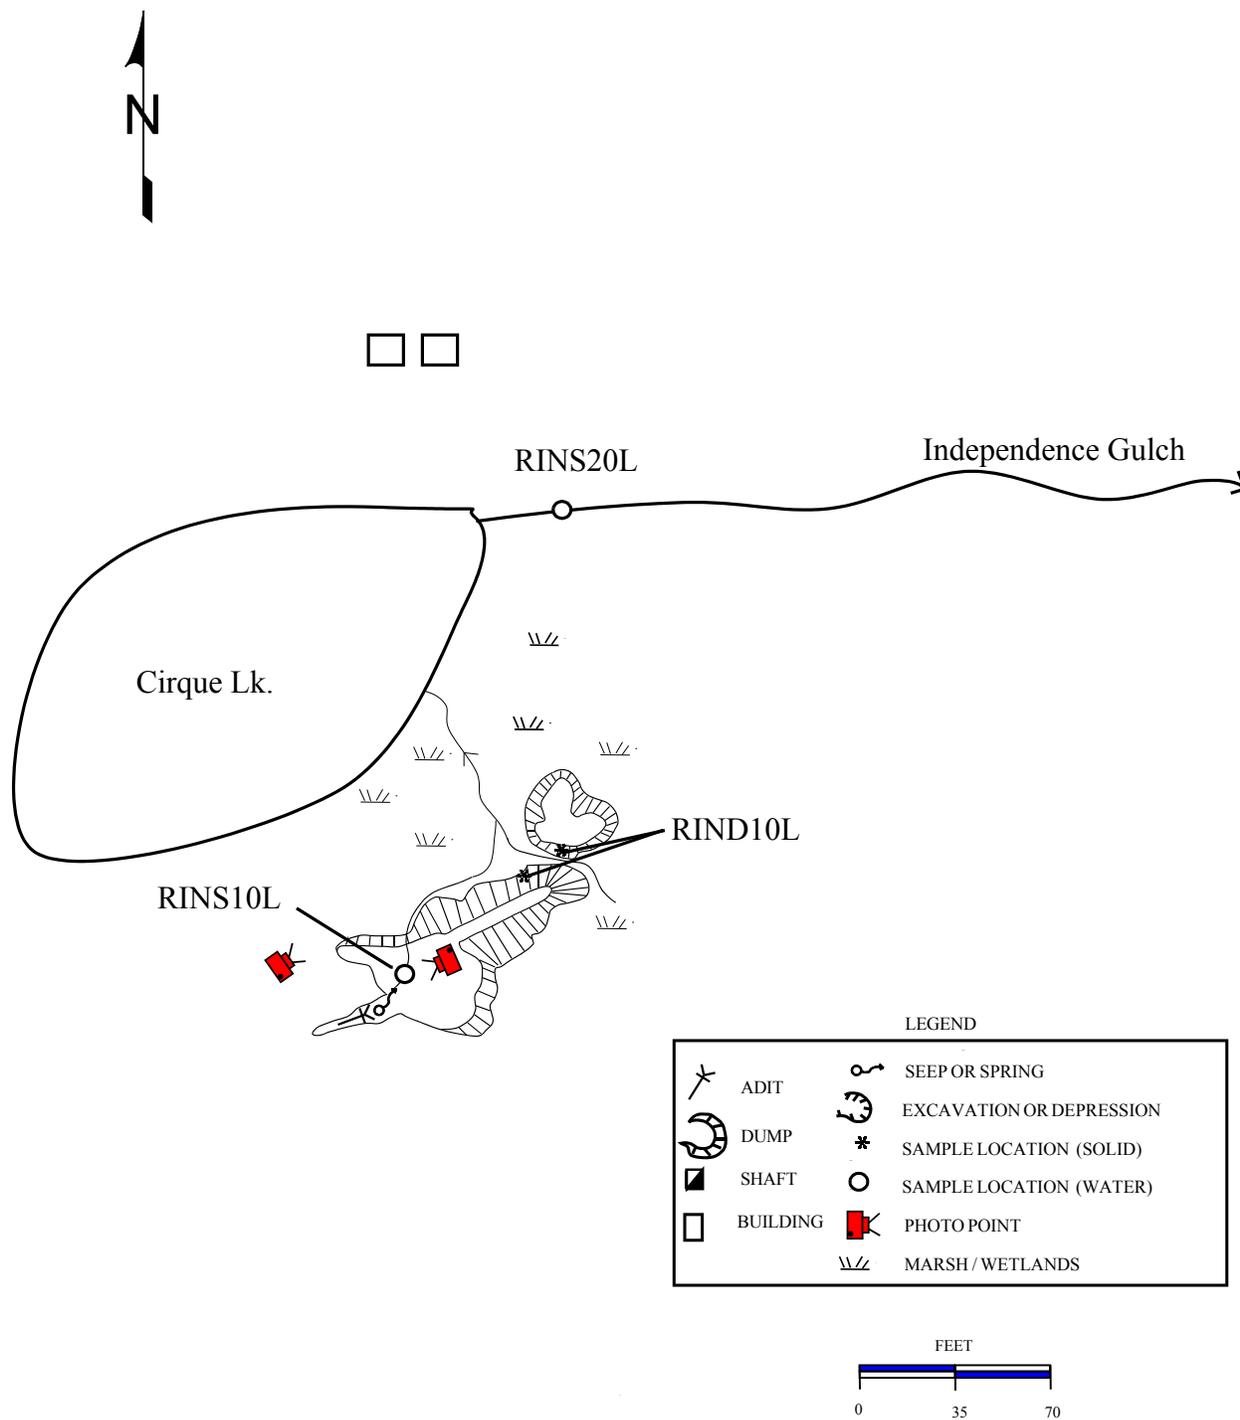
Figure 4.12 At the Independence Gulch Claim No. 1, an adit discharge flows into a marsh adjacent to a small cirque lake (8/27/96).

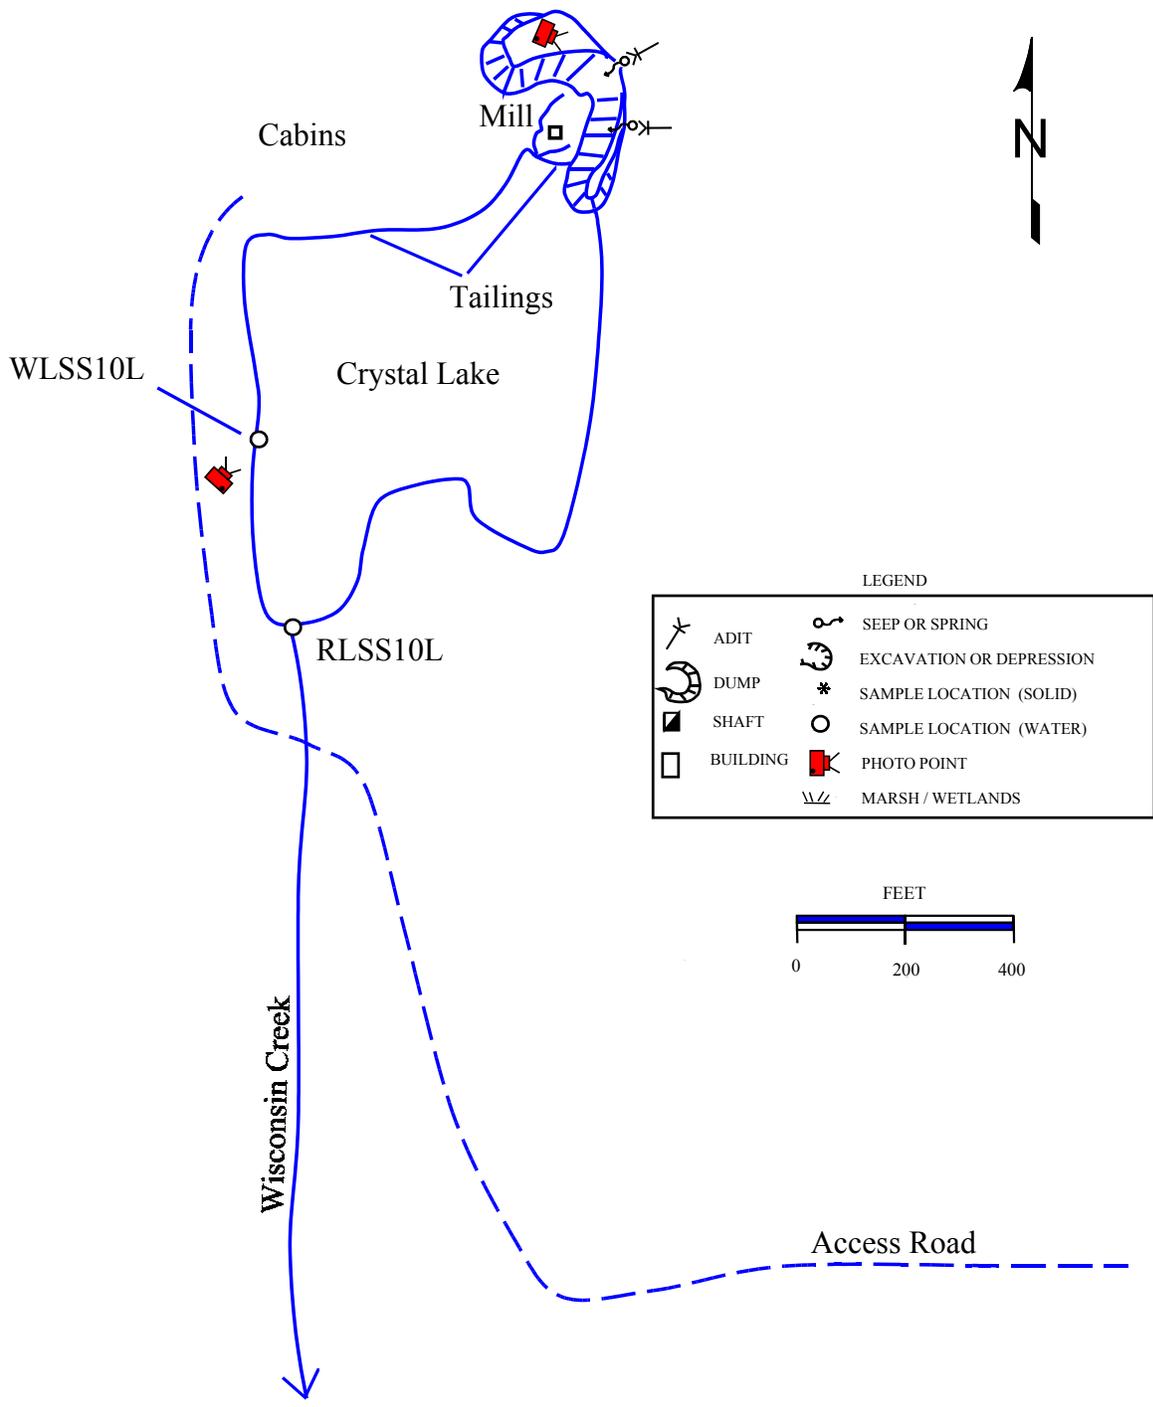
Figure 4.15 Tailings and waste rock from the Lakeshore mine and mill are located at the northeast end of Crystal Lake (8/27/96).

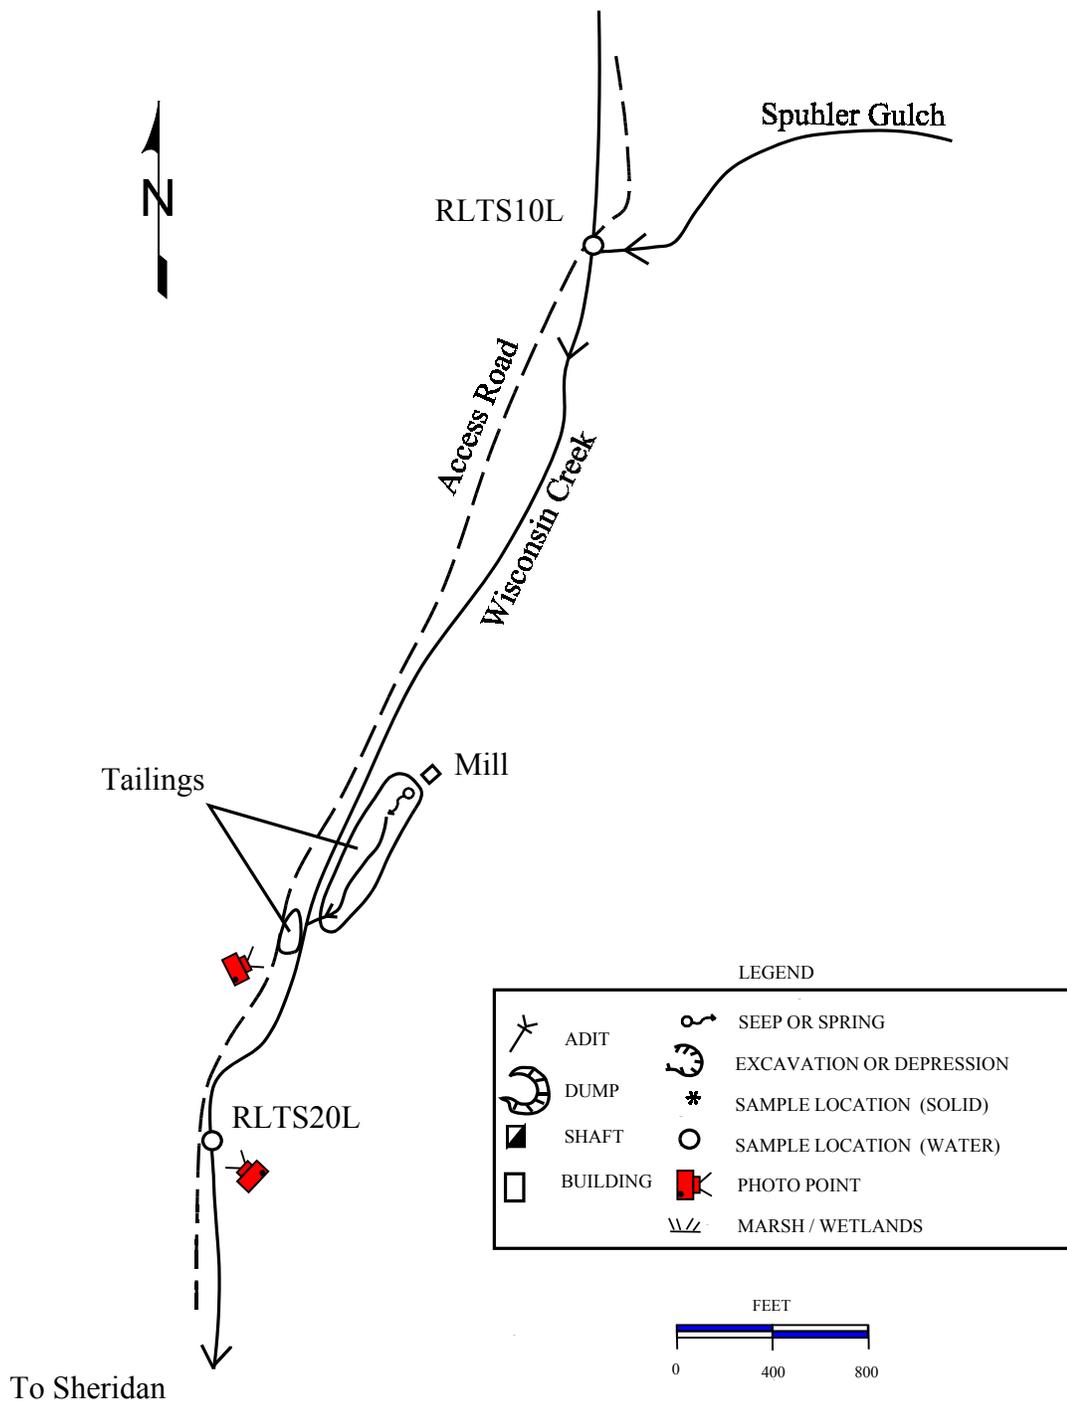
Figure 4.18 At the Leiter mill tailings site, streamside tailings on the west bank of Wisconsin Creek appear to be on both private and BNF-administered land (8/28/96).
