Montana Bureau of Mines and Geology
MBMG No. 379

**Abandoned/Inactive Mines
of the
Southern Beaverhead-Deerlodge National Forest**

September 1998

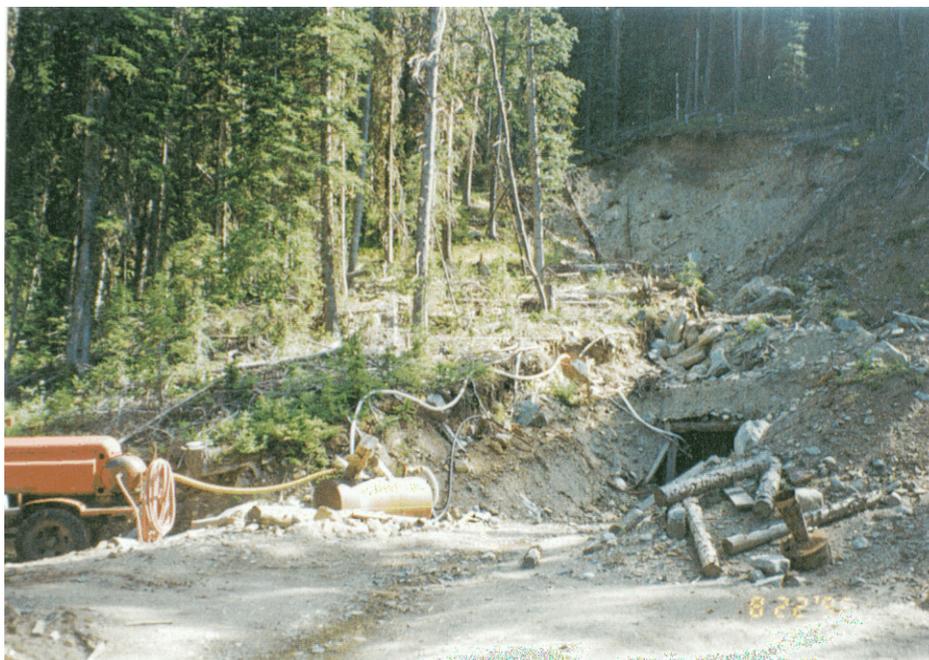
Figure 4.29 The lower adit has a small discharge that flows across the waste-rock dump before sinking into the ground. An old truck, a trailer, and some other equipment are located near the portal.

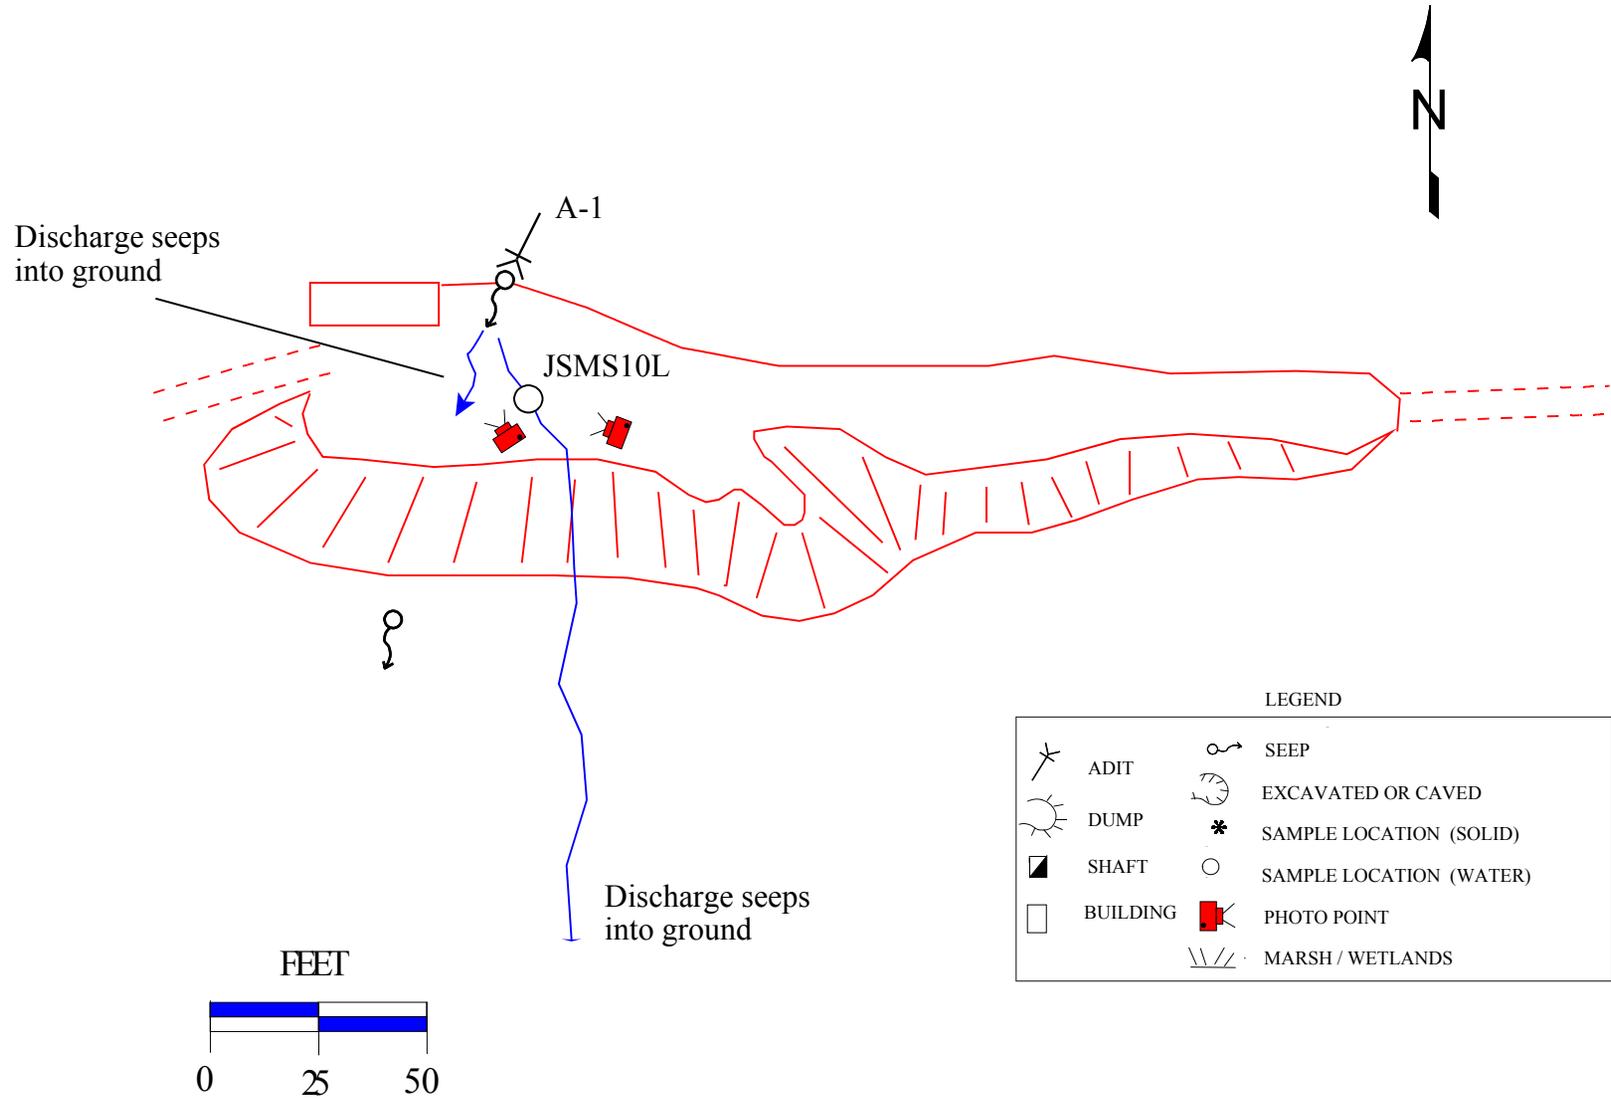
Figure 4.44 Site map for the Smuggler mine, September 1996. The adit discharge sinks into the ground about 200 to 300 feet from Mill Creek.

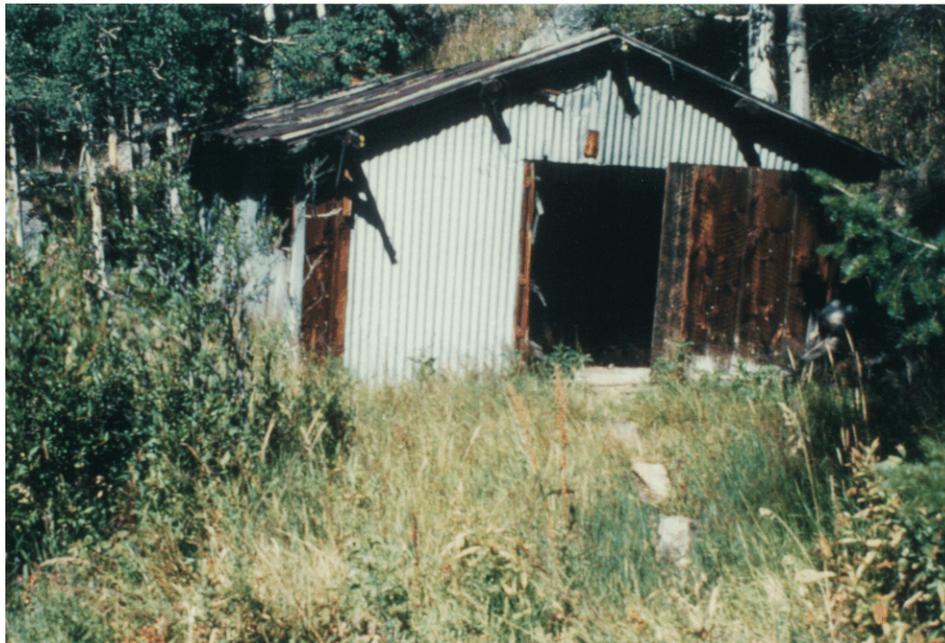
Figure 4.45 The collapsed adit portal at the Smuggler mine is located near a mine building that is in good condition.

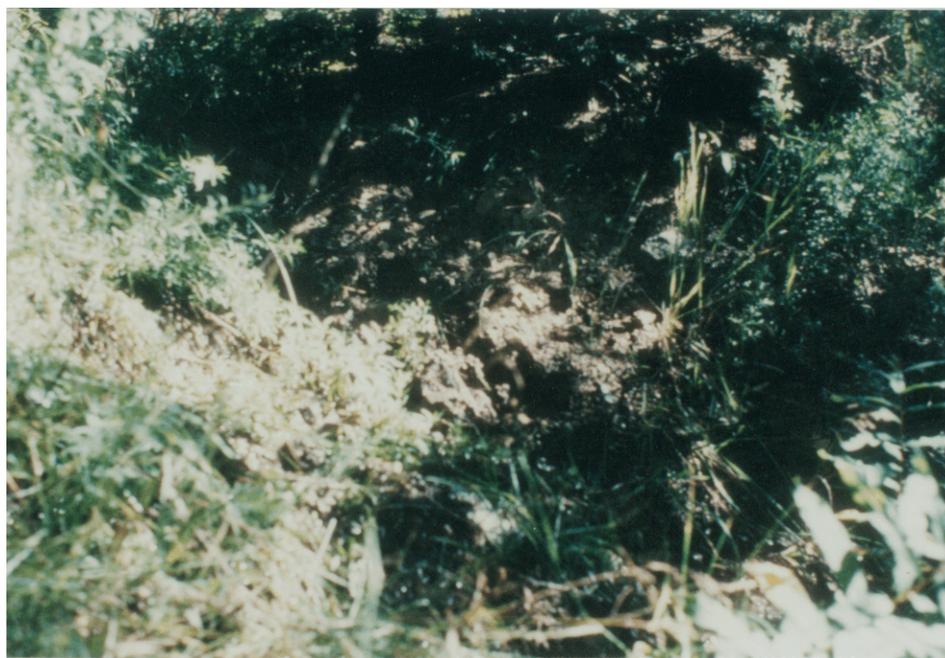
Figure 4.46 Sample JSMS10L was collected about 40 ft from the portal. The path of the discharge was well vegetated.

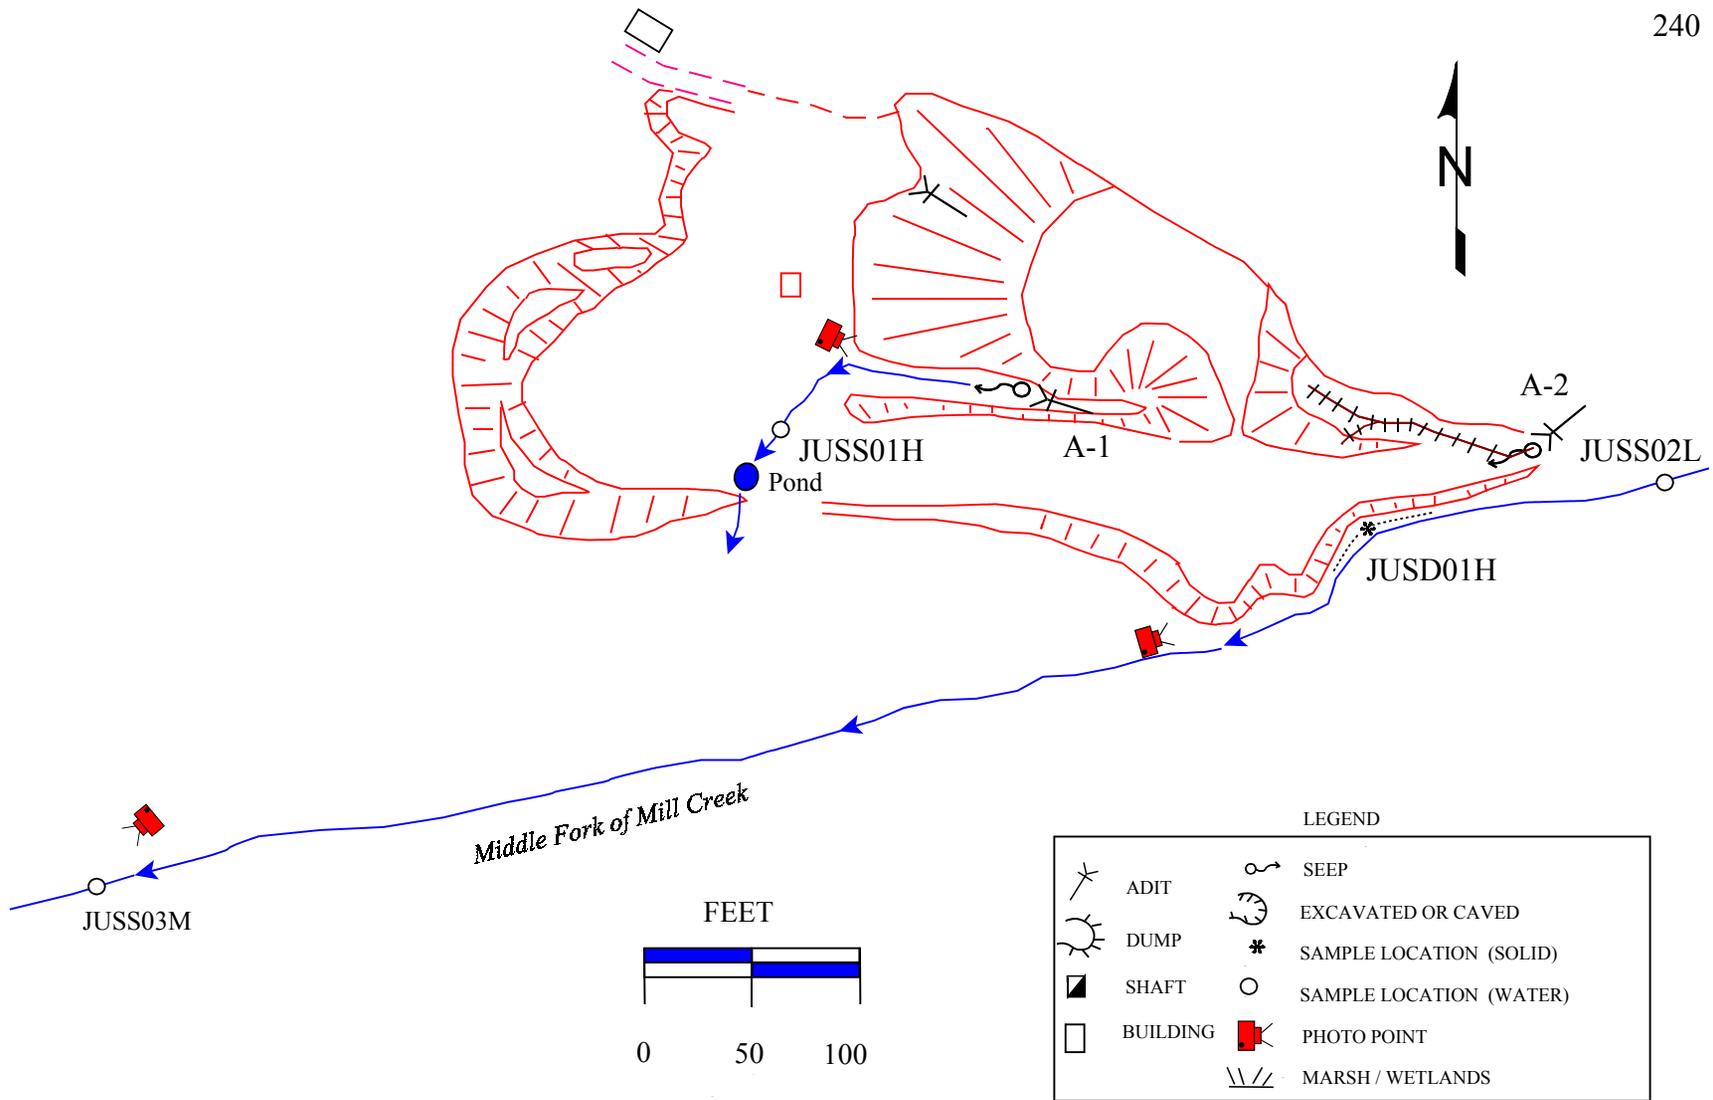
Figure 4.47 Site map of the Uncle Sam mine, September 1996. Waste rock is in contact with the Middle Fork of Mill Creek.

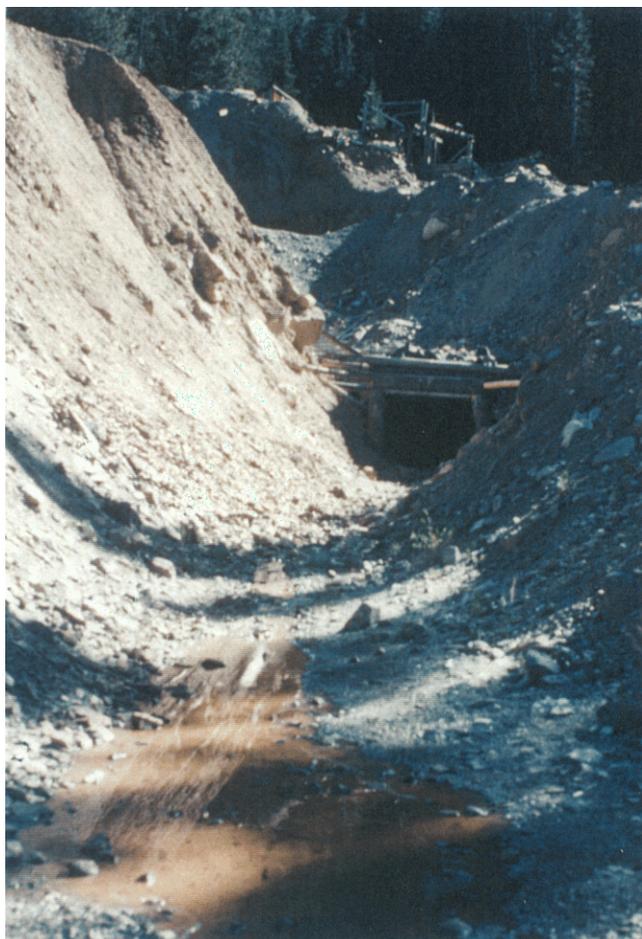
Figure 4.48 The lowermost adit at the Uncle Sam mine is open and has an iron-stained discharge.

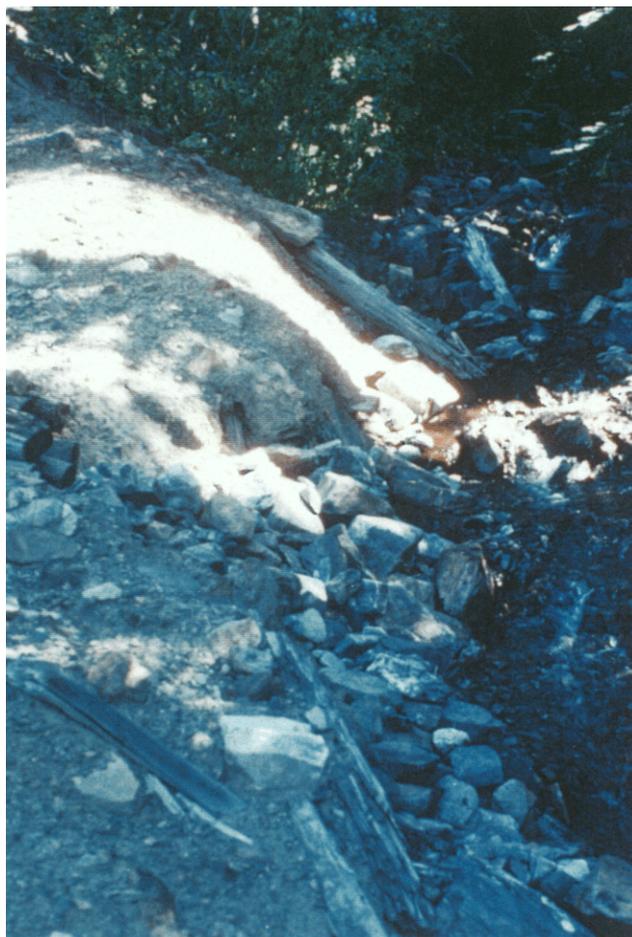
Figure 4.49 A mineralized waste-rock dump is being actively eroded by the Middle Fork of Mill Creek.
