Geologic and Hydrogeologic Investigation of the Clark Canyon Landslide, Southwestern Montana

MONTANA BUREAU OF MINES AND GEOLOGY
OPEN-FILE REPORT 442

Prepared for the
MONTANA DEPARTMENT OF TRANSPORTATION

December 2001

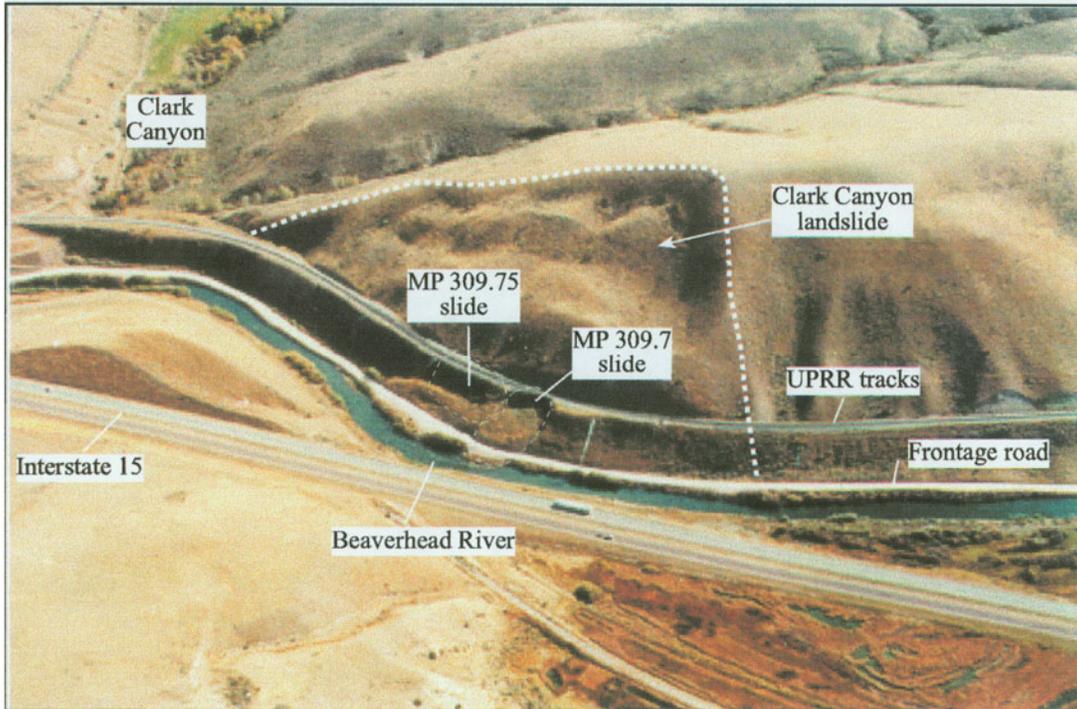
Since 1995 there have been additional stability problems associated with the active slides. In 1998, ground movement along the tracks caused vertical displacement of the tracks and damage to the surface-water drainage system installed in 1995. MBMG visited the site in 1998 and documented damage to the surface drains and ditch liner (fig. 3). New cracks were also observed on the slope above the tracks, indicating the head of the MP 309.75 slide may be migrating upslope to the east. A soldier pile retaining wall was

Figure 2. Aerial photograph of the Clark Canyon landslide. The photo was taken in October 1998. The view is toward the east.

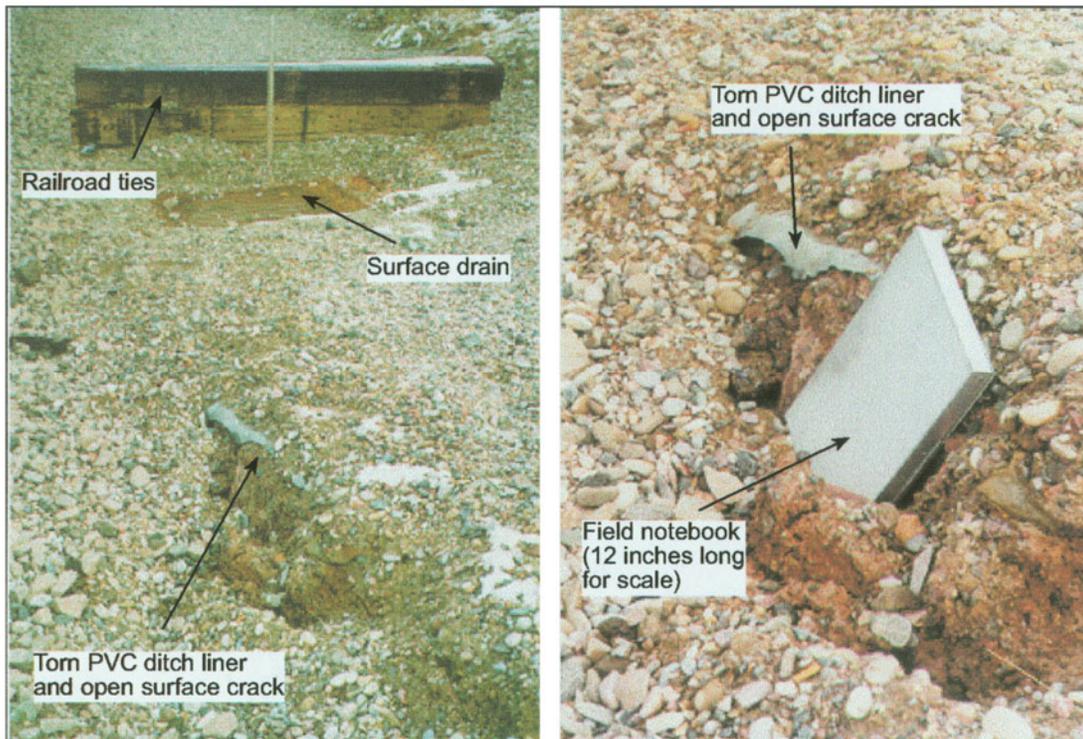
Figure 3. Open-surface cracks and the damaged PVC liner. The PVC liner was installed in 1995 in an effort to redirect surface runoff along the railroad tracks.

- 1) Inspect the integrity of the surface drainage system installed along the railroad tracks and repair any damaged areas. After it was installed, continued ground movement and surface cracking damaged the system and it no longer directs surface runoff and precipitation away from the landslides.
- 2) Fill the open cracks above the landslide at MP 309.75 with grouting or sealant to prevent run-off and precipitation from directly infiltrating into the subsurface.
- 3) Investigate the talus deposits near the head of the ancient landslide. The deposits may have accumulated along old cracks or depressions associated with the ancient landslide and may be surface-water infiltration points.

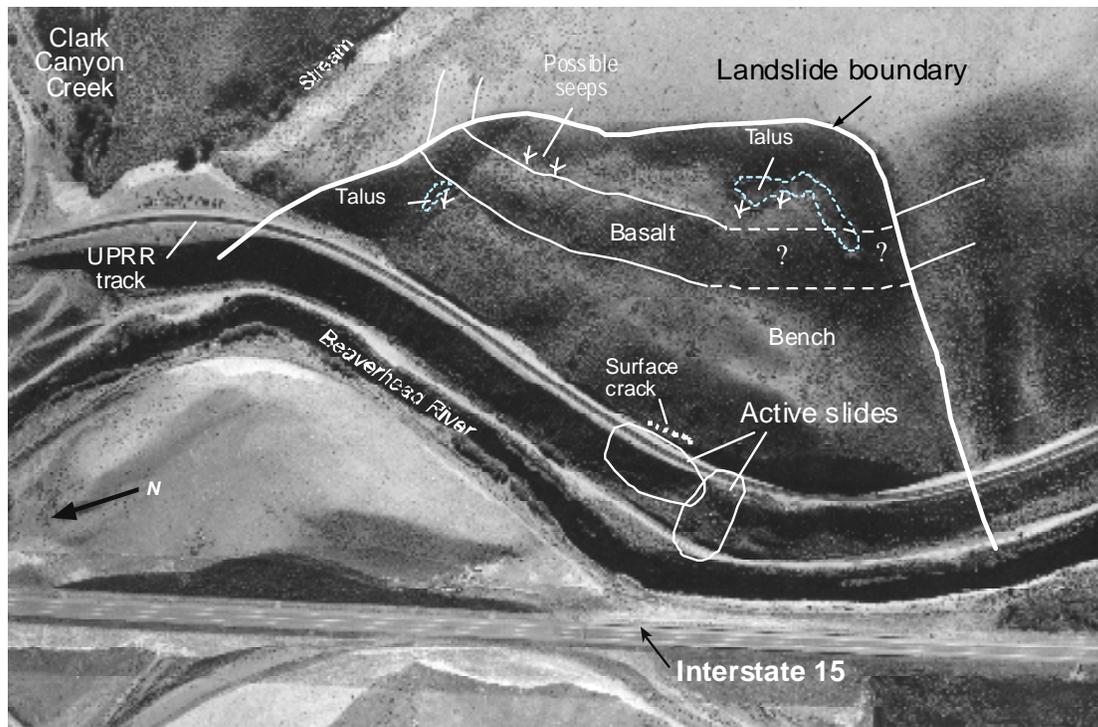
The primary surface features of the Clark Canyon landslide are shown in figure 4. The main scarp and lateral flanks of the ancient slide are well-vegetated and smooth. The topography below the head scarp is hummocky and slopes to the west. Slopes are steeper in the lower half of the landslide. The toe of the landslide is poorly defined and has probably been modified by the Beaverhead River. A number of isolated patches of serviceberry and wildrye, vegetation that can indicate moist conditions, are present

Figure 4. Aerial photograph of the Clark Canyon landslide showing the location of important surface features. The photograph, provided by MDT, was taken in 1977, prior to the slope failures along the railroad tracks.

near the base of the scarp and along the flanks of the ancient slide. Accumulations of talus near the head of the landslide and along the north flank form roughly crescent-shaped features that may have accumulated along surface depressions or cracks. A poorly-exposed outcrop of basalt is present near the head of the ancient landslide. An open surface crack crosses the slope above the head of the active slide at MP309.75.

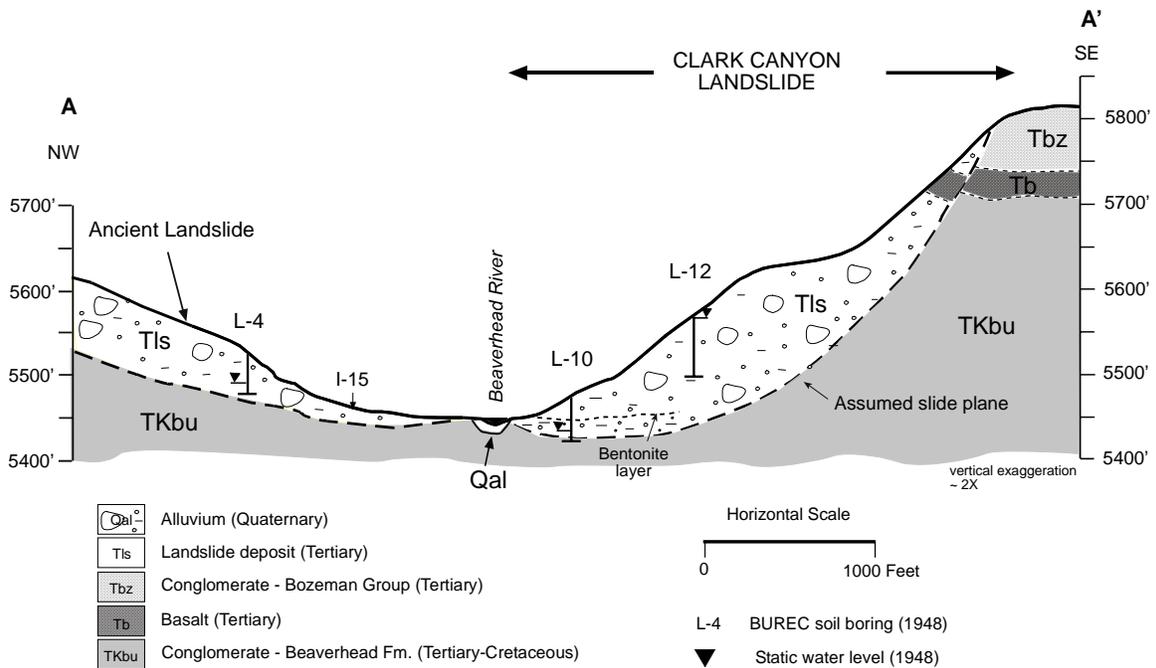
A simplified geologic cross section of the landslide is shown in figure 7. Materials in the landslide appear to be derived primarily from the unconsolidated conglomeratic beds of the Bozeman Group and, less commonly, the underlying basalt and unmapped ash beds, and the Beaverhead Formation. The thickness of the ancient landslide deposit and the location of the slide plane are based on data from the BUREC test holes drilled in 1947 and 1948. Bentonitic clay horizons, formed by alteration and weathering of volcanic ash, were identified in the borings in some places.

Figure 7. Generalized geologic cross-section through the ancient landslide. The location of the BUREC test holes and the line of the section are shown in figure 5. The active slides (post 1995) are at about the level of holes L-10 and L-12.

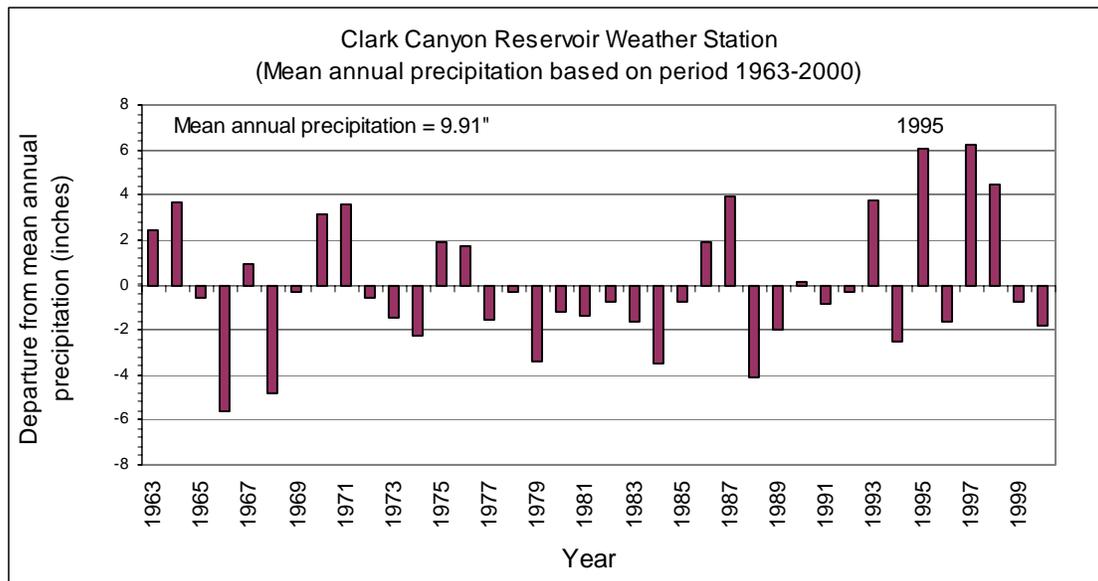
The Clark Canyon landslide and the two small landslides within the ancient complex all appear to be rotational slides. The presumed cause of the ancient landslide is over-steepened slopes, weakening of volcanic rock units by ground water, and perhaps seismic disturbances. The cause for the recent landslides is probably more complex. Ground water appears to be a key factor because the initial failures in 1995 and subsequent movement in 1997 and 1998 occurred during years with above-normal precipitation (fig. 8). Both slides originated along the grade constructed for the railroad, suggesting that modification of the original slope could be a factor. Although the landslide is in an area with considerable seismic activity (fig. 9), there were no significant seismic disturbances in 1995 that could have triggered the initial ground movement (Mike Stickney, oral commun., 2001).

Figure 8. Annual departure from mean annual precipitation at the Clark Canyon Reservoir weather station. The most active periods of slope movement were in 1995, 1997, and 1998. Data from the National Climatic Data Center (2001).

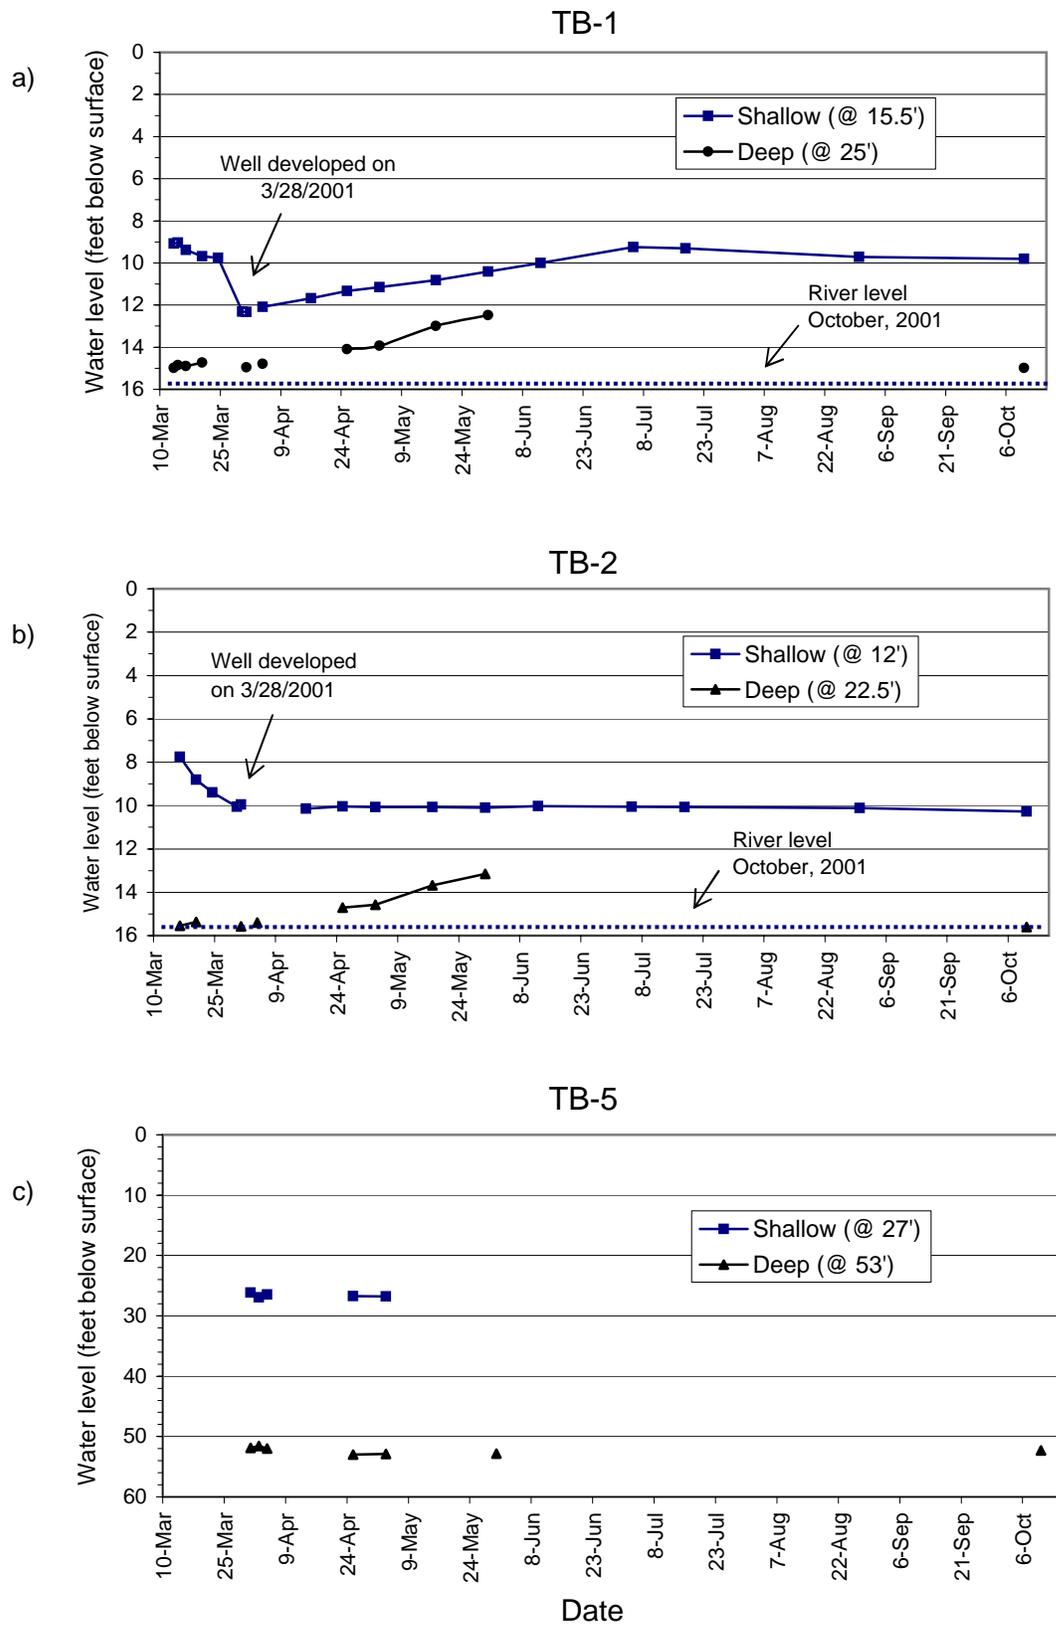
Figure 11a shows the hydrograph of hydrostatic-pressure fluctuations in TB-1 for the shallow and deep piezometers. In both cases, hydrostatic pressures increased during the spring and early summer (by approximately 2.5 feet) and then decreased after mid-July. The increase in pressure generally follows seasonal precipitation patterns (fig. 12). Hydrostatic pressures did not appear excessively high in either well, which may reflect below-normal spring and summer precipitation. The piezometers were not monitored frequently enough to determine if short-term precipitation events affected pressures.

Figures 11b and 11c show the hydrographs for test holes TB-2 and TB-5. The shallow piezometer in TB-2 showed little change in water levels from April to October, fluctuating less than 0.25 feet. Water levels in the deeper VWP showed a trend similar to the seasonal pressure changes plotted for the TB-1 piezometers. The lack of variation in the open-standpipe piezometer may indicate poor connection to the shallow saturated zone. The piezometer was developed in late March and the water level did not return to pre-development level. The hydrostatic pressures measured in the two VWP's in TB-5 were consistently low, averaging less than one foot of water above the piezometer. There

Figure 11. Hydrographs for the piezometers located in the active slides. The 53-ft deep piezometer in TB-5 is approximately 30 feet above the river level.

was no measurable water in the shallow piezometer (@ 27 ft bgs) in October, indicating dry (unsaturated) conditions. There was approximately 0.7 feet of water over the VWP at 53 feet bgs.

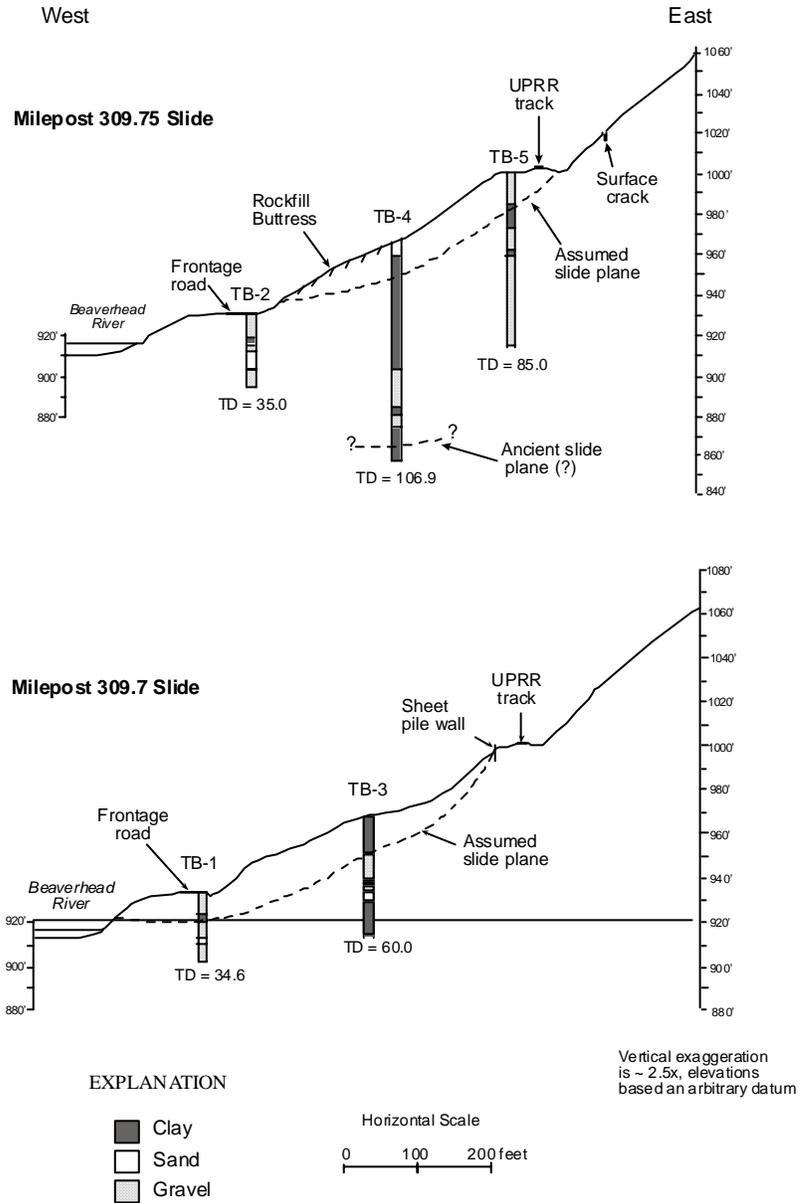
Figure 13. Generalized cross-sections through the active landslides.

Figure 13. Generalized cross-sections through the two active landslides. Assumed slide plane locations are based on interpretation of subsurface data and information collected by Shannon & Wilson (1995).

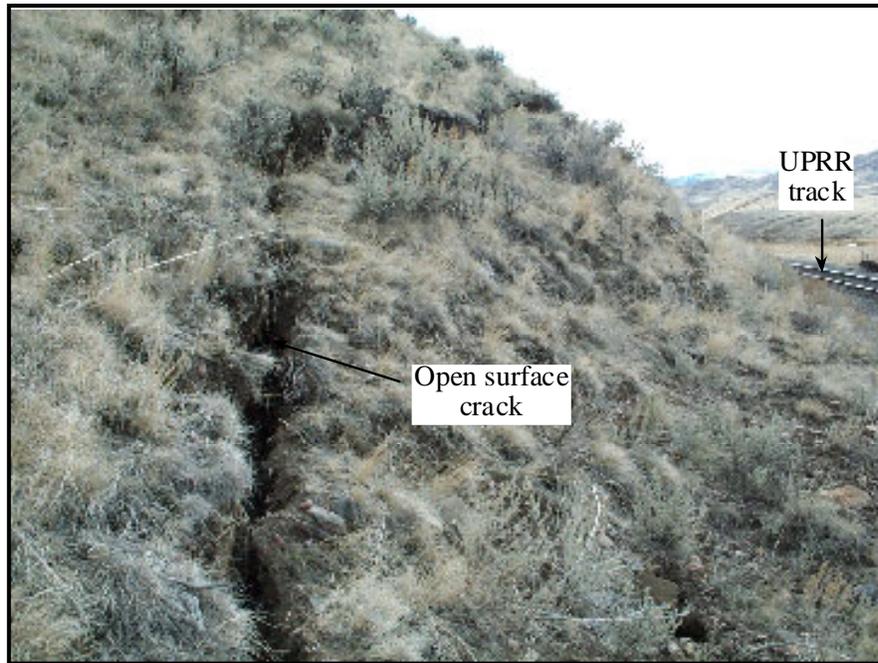
The inclinometer data for TB-4 (appendix C) showed no apparent movement, suggesting that the rockfill buttress constructed in 1995 has stabilized the slide. However, an open surface crack (approximately 170 feet long) above the slide (fig. 13 and fig. 14) indicates that additional movement is still a concern. A possible shear zone, identified as a hard clay horizon with slickensides, and a zone of potential artesian water pressure were encountered at a depth of around 104 feet bgs in this boring. Unfortunately, the interval was not fully penetrated due to difficult drilling conditions and loss of the drill bit in the boring. This interval may coincide with the failure plane of the ancient landslide.

Figure 14. Open surface crack approximately 170 feet in length in the slope above the UP track. Photograph taken in March 2001. Width of crack is approximately 8 inches.

The focus of this investigation was on the active slides that are impacting the UP track. The potential for reactivation of the larger, ancient landslide was not specifically investigated although it should be a concern. The surface cracks above the slide at

MP309.75 indicate ground movement is migrating into the steep slope above the railroad tracks. If this slope fails, the resulting slide could potentially be much larger and would likely impact the Beaverhead River and possibly Interstate 15.

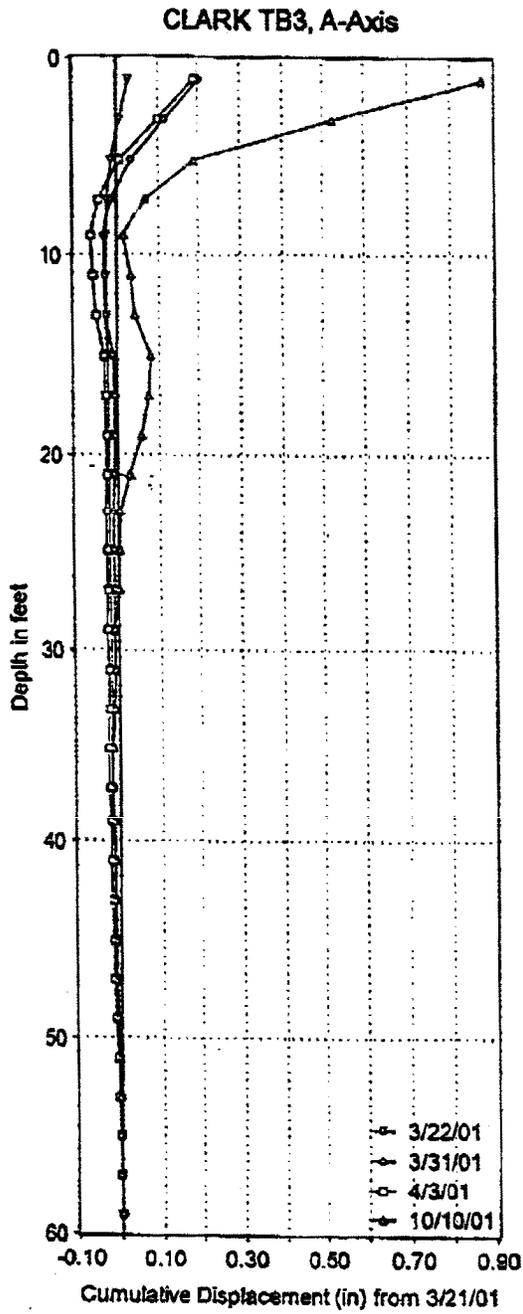
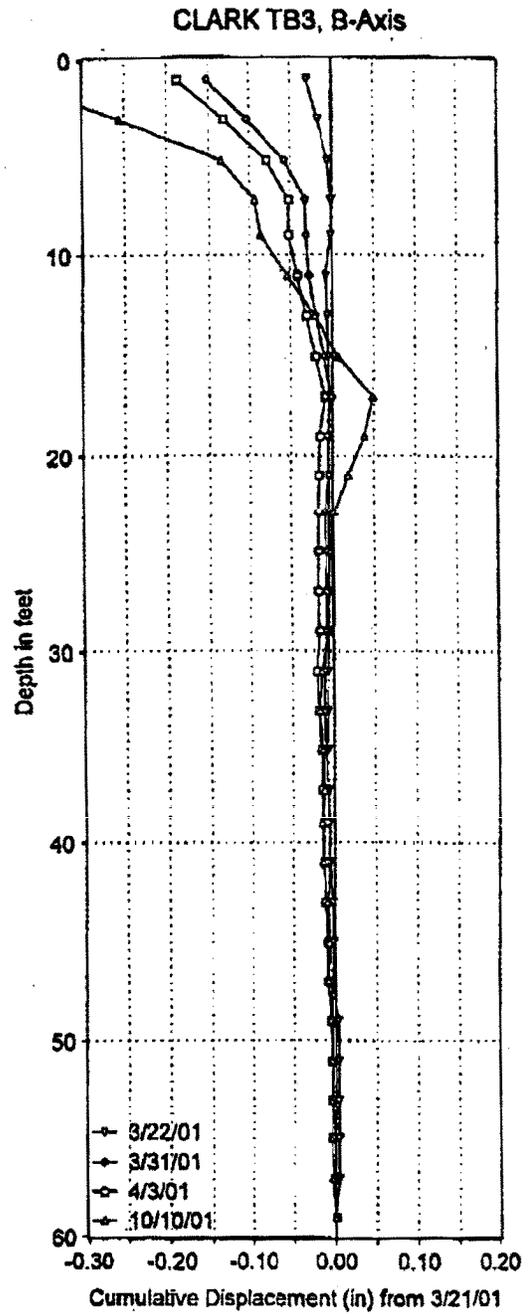
INCLINOMETER PLOT TB-3

Monitoring for slope movement was done with a borehole probe pipe and a probe inclinometer. The probe pipe was used on a monthly basis (April to October) to detect potential movement. No movement was detected with this method. A probe inclinometer that can detect very small displacements was used twice to monitor slope movement. The readings were taken in March and October, 2001. A comparison of the measurements suggests there was a very small amount of displacement (approximately 0.05 to 0.1 inch) at around 18 feet depth (see appendix C for the inclinometer plot). This depth coincides with a stiff clay layer that could represent the slide plane (fig. 13). Because the inclinometer readings were taken 6 months apart, the timing of the movement and its possible relation to seasonal changes in ground-water conditions is unknown.
