**HYDROGEOLOGIC ASSESSMENT OF HIDDEN LAKE SUBDIVISION WATER
SUPPLY
FOR
GROUND WATER UNDER THE DIRECT INFLUENCE OF SURFACE WATER**

Open File Report MBMG 401-D

**HIDDEN LAKE SUBDIVISION WATER SUPPLY
PWSID #03374
4920 Country View
Billings, MT 59105**

**by
James Rose
Montana Bureau of Mines and Geology**

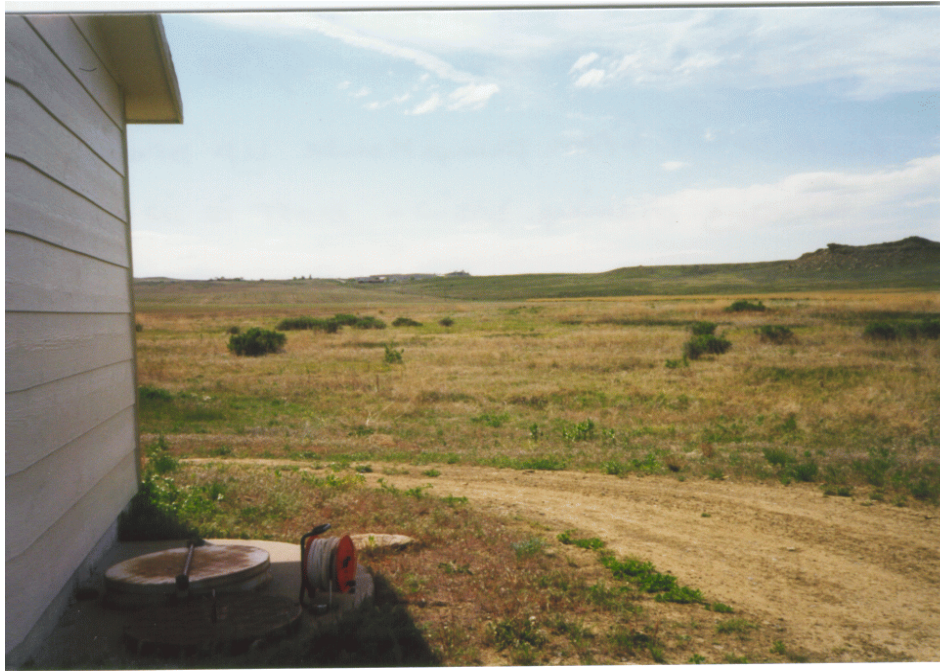
Figure C-1. Looking west alongside pump house toward headwaters of the drainage. U. S. Highway 87 is just beyond the horizon. Note the manhole cover on collection well next to pump house.

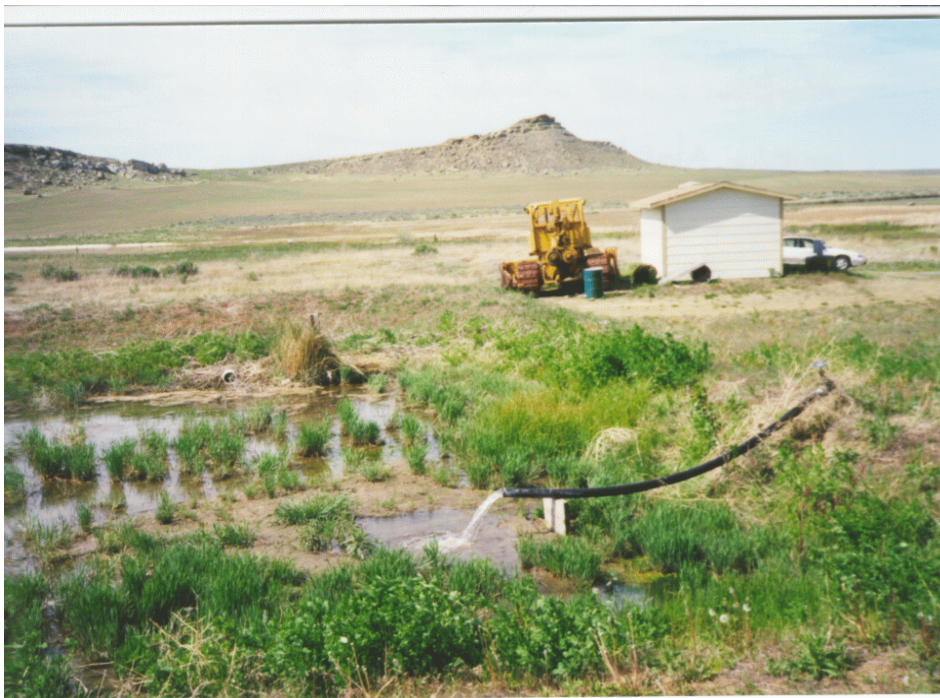
Surface water is pumped into infiltration ponds south of the infiltration galleries where the water moves downward into the shallow aquifer and flows toward the galleries. Water infiltrating from the ponds must travel through 60 ft of silty-sand to sandy-silt aquifer material from the ponds to the galleries. The time of travel required for infiltrating water to move through the aquifer between the ponds and the galleries was estimated using the average linear velocity equation (Fetter, 1994):

The calculated average linear velocity of the ground water flowing from the infiltration ponds to the infiltration galleries ranges from 2.5 ft/day to 15 ft/day. At these rates it would take surface water added to the infiltration ponds approximately 4 to 24 days to reach the infiltration

Figure C-2. View looking north. Infiltration pond in foreground with inlet pipe. Pump house and Rattlesnake Butte in the distance across the drainage. West shoreline of lake visible in upper right corner. Observation wells are located on the flat area at the drainage bottom, behind the pump house.

- It is recommended that an MPA be conducted on the system. The last MPA on record for the water system was conducted prior to or shortly after the artificial recharge system was installed. Sampling for the MPA should be conducted in the middle to late summer, after the irrigation ditch water has been pumped into the infiltration ponds for 4-6 months. The artificial recharge system is generally started around mid- to late-April each year.

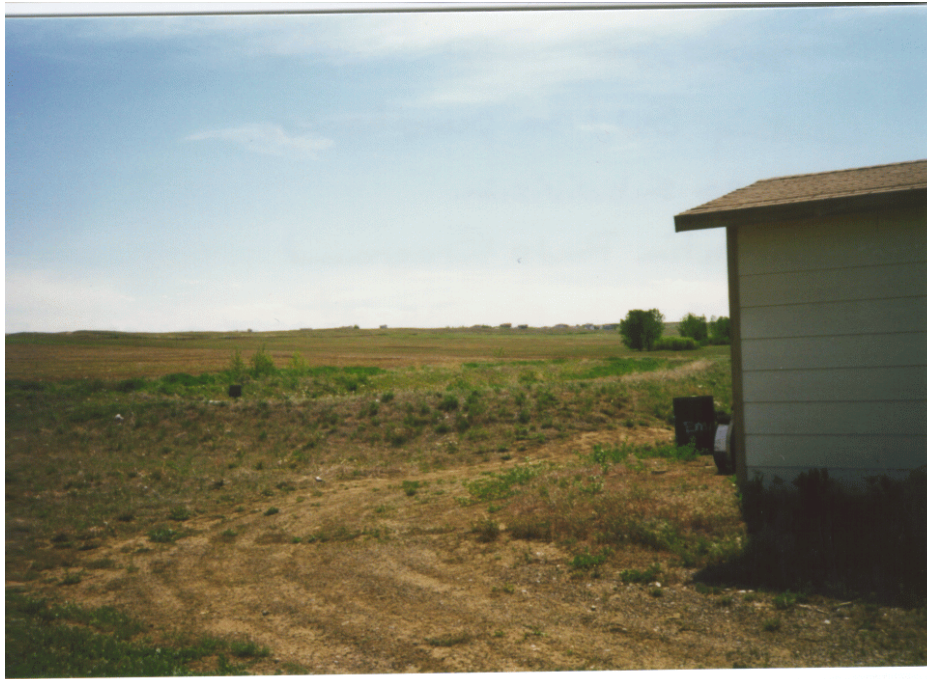
Figure C-3. Looking southwest from the pump house across the tilled field at subdivision on the horizon. One of the infiltration ponds is located in the foreground behind the vegetated rise next to the pump house.

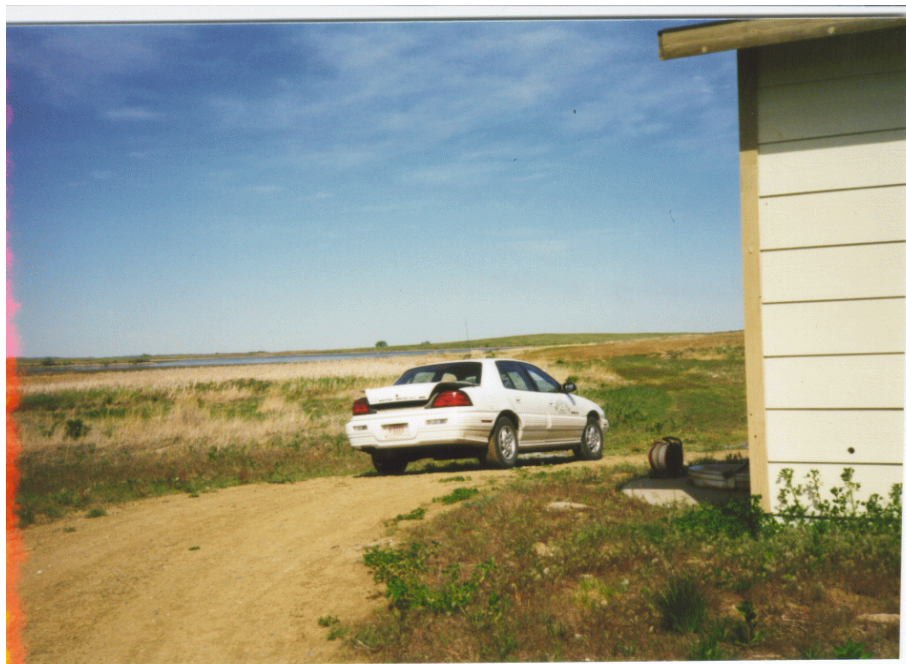
Figure C-4. Looking east at pump house toward Rattlesnake Reservoir. Collection well manhole next to pump house.

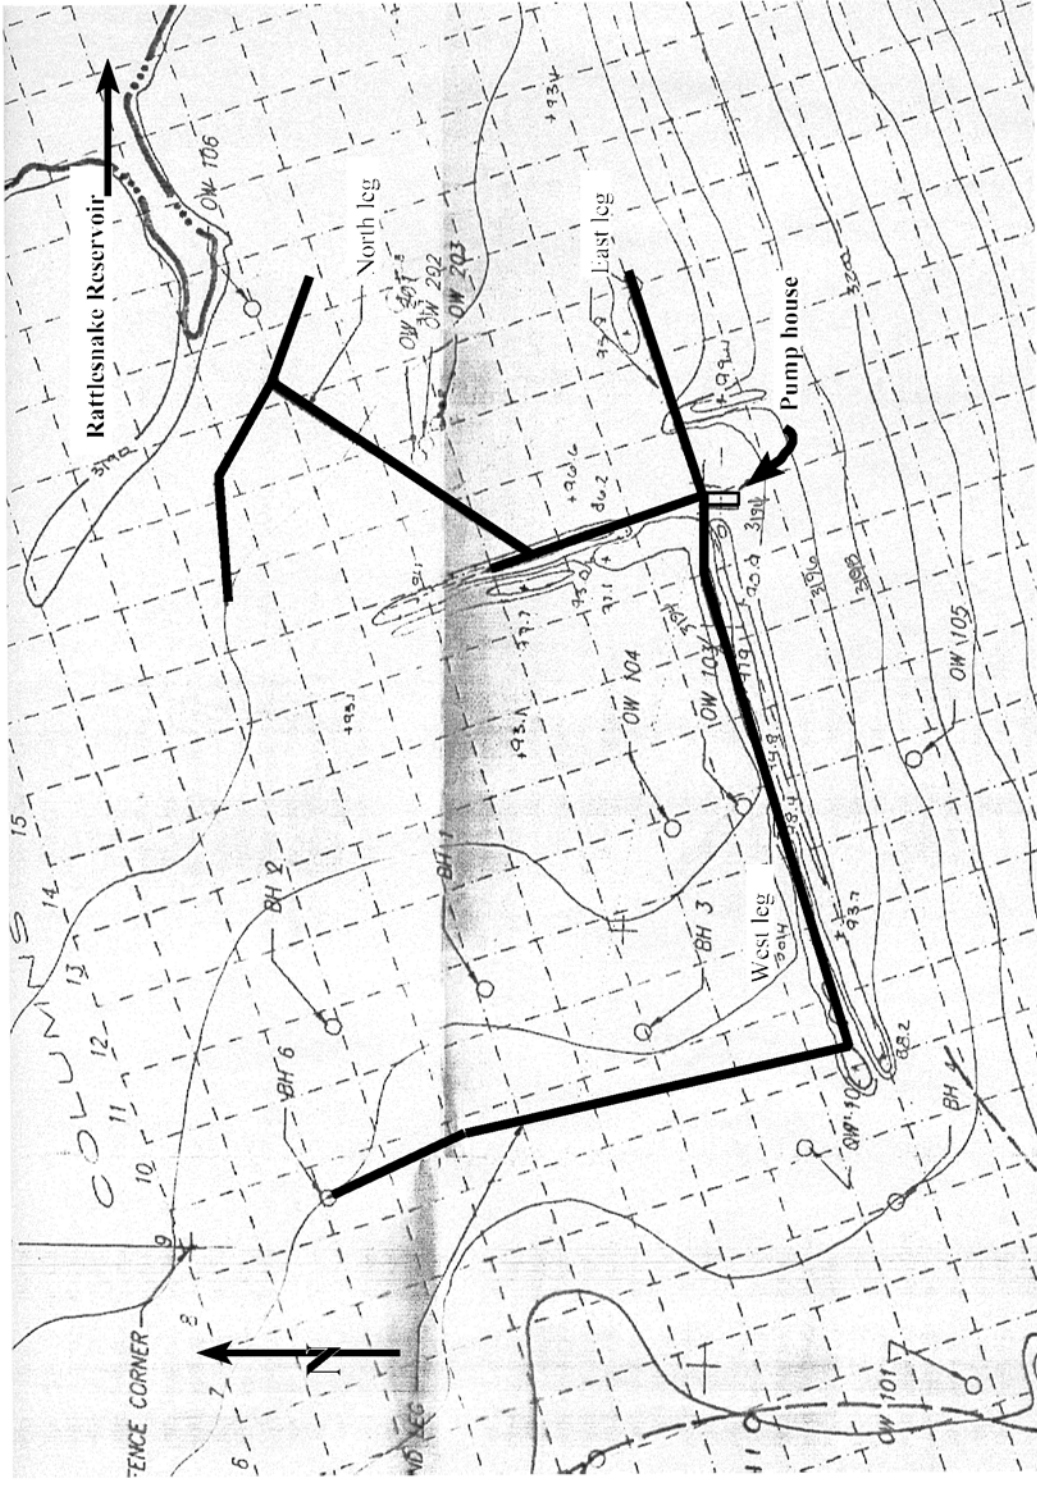
D-2. Plan view drawing showing the configuration of the infiltration galleries

- The east leg extends toward Rattlesnake Reservoir for a distance of about 160 ft from the collection well and is buried 12 ft below the top of the collection well and about 5.5 ft below the water level in the well.
- The north gallery is 135 ft long and lies 14 ft below the top of the collection well. The north gallery was extended 438 ft northeast in 1988 but was plugged off in 1989.
- The west leg was initially 388 ft long and extended to 6.5 to 7 ft below the static water level. In 1988, the west gallery was extended 371 ft to the north.

According to the ACE report (1989), the three infiltration galleries are constructed of 8-inch diameter PVC pipe perforated with 3/4-inch diameter holes spaced 4 to 6 inches apart. The gallery pipe was laid in trenches that were backfilled with coarse sand and gravel and covered by a filter fabric. The east and north infiltration galleries extend along the shoreline of the Rattlesnake Reservoir and may be recharged by water infiltrating from the reservoir. Following lengthening in 1988 the north gallery began producing turbid water and a rotten egg odor (hydrogen sulphide gas). In 1989 the extension was mechanically plugged and blocked off from the water-supply system. Also in 1989, the design of the newly added portion of the west gallery allowed unfiltered surface water to leak into the gallery, thus producing highly turbid water. The covering above the west gallery leg was resealed with filter fabric and bentonite clay and the problem was apparently solved.

D-2. Plan view drawing showing the configuration of the infiltration gallery system, pump houses, and Rattlesnake Reservoir (Aquoneering, 1989).

- The shallow water table depth below the land surface and past problems with surface water flowing into the infiltration galleries indicate that the system is potentially sensitive to surface water influences. The infiltration gallery construction should be evaluated to confirm that an adequate seal exists between the gallery inlets and the land surface.
