**HYDROGEOLOGIC ASSESSMENT OF THE TOWN OF BEARCREEK MUNICIPAL  
WATER SYSTEM  
FOR  
GROUND WATER UNDER THE DIRECT INFLUENCE OF SURFACE WATER**

**Open-File Report MBMG 401-F**

**BEARCREEK MUNICIPAL WATER SYSTEM  
PWSID #00063  
Box 1082  
Bearcreek, MT 59068**

**May, 2000**

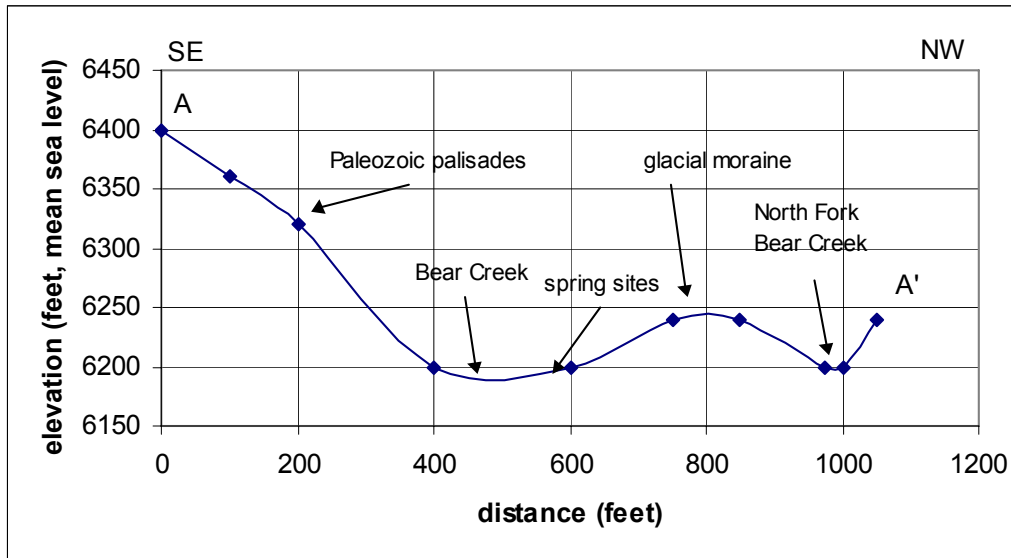
Most ground water drains from the Bear Creek valley through the coarse morainal deposits along the valley bottom or is discharged into Bear Creek (appendix C, map 1). All ground water not intercepted by evapotranspiration or public water supply discharges ultimately into Bear Creek. Ground water discharges to the land surface as springs where the land topography abruptly drops in elevation at a rate steeper than the water-table slope, causing the water-table to intersect the land surface. At the spring sites, the sides of the moraine slope steeply to the southeast (greater than 40 degrees, estimated) (appendix B, photo 1 and figure 2).

**Figure 2.** Southeast-northwest profile A-A', of the glacial moraine and the Bear Creek drainage between the spring sites, looking upstream to the southwest.

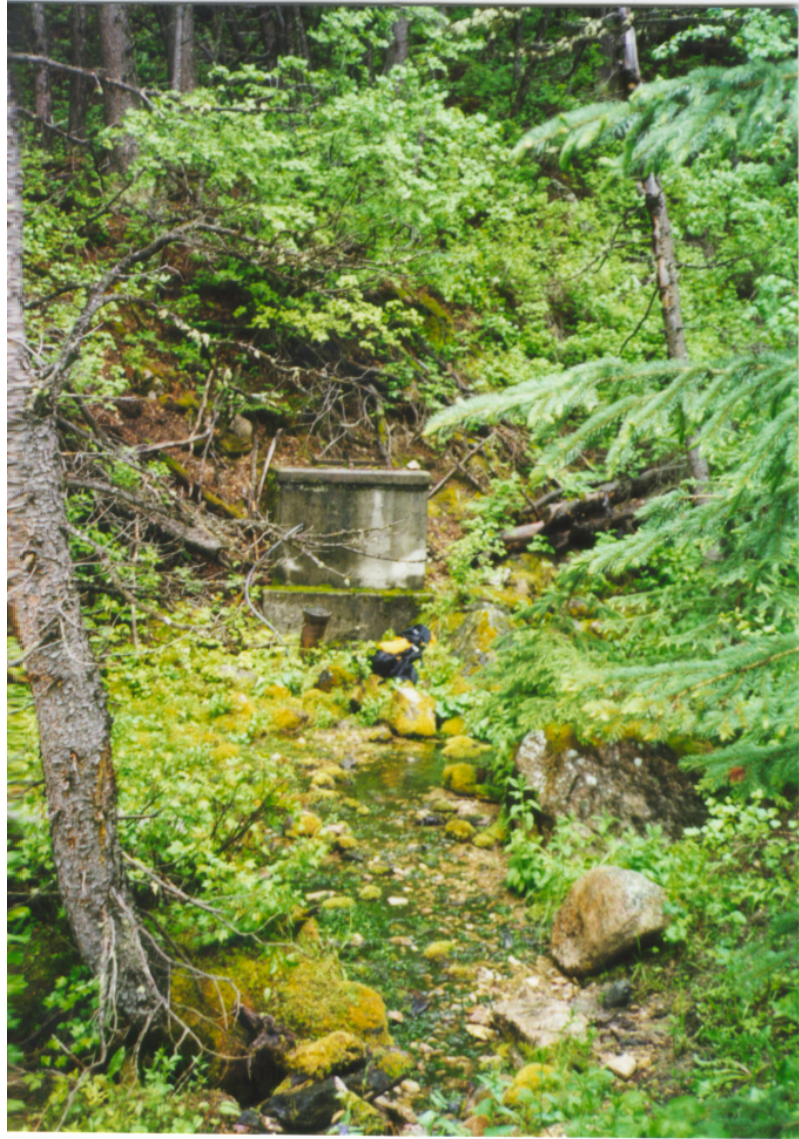
**Photo 2. Looking southeast toward the lower spring box (source #002), Bear Creek is in the foreground. Spring box is located at the southeastern edge of the glacial moraine against a slope of colluvial material ( background). Shut-off valve for spring box to water system is visible in front of box.**

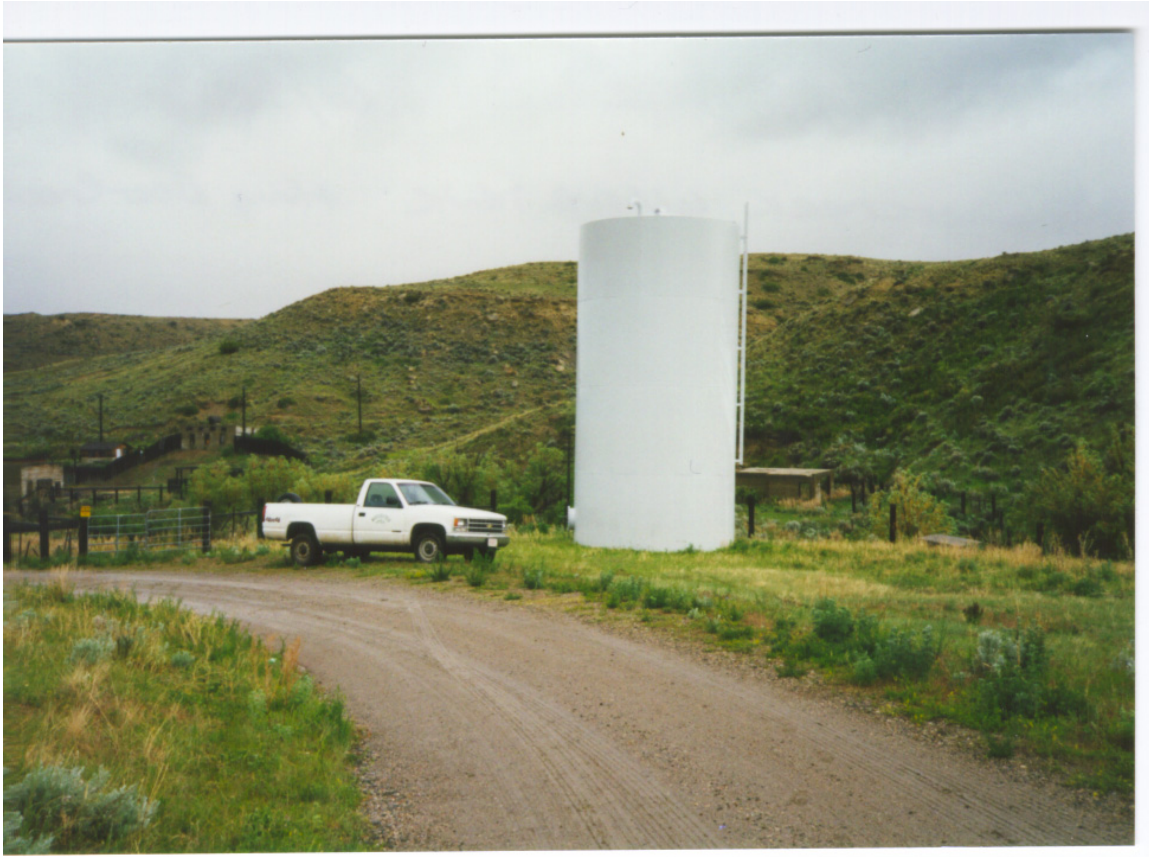
**Photo 3. Looking south at Bearcreek water system water storage tank.  
Bear Creek is just behind the water tank.**

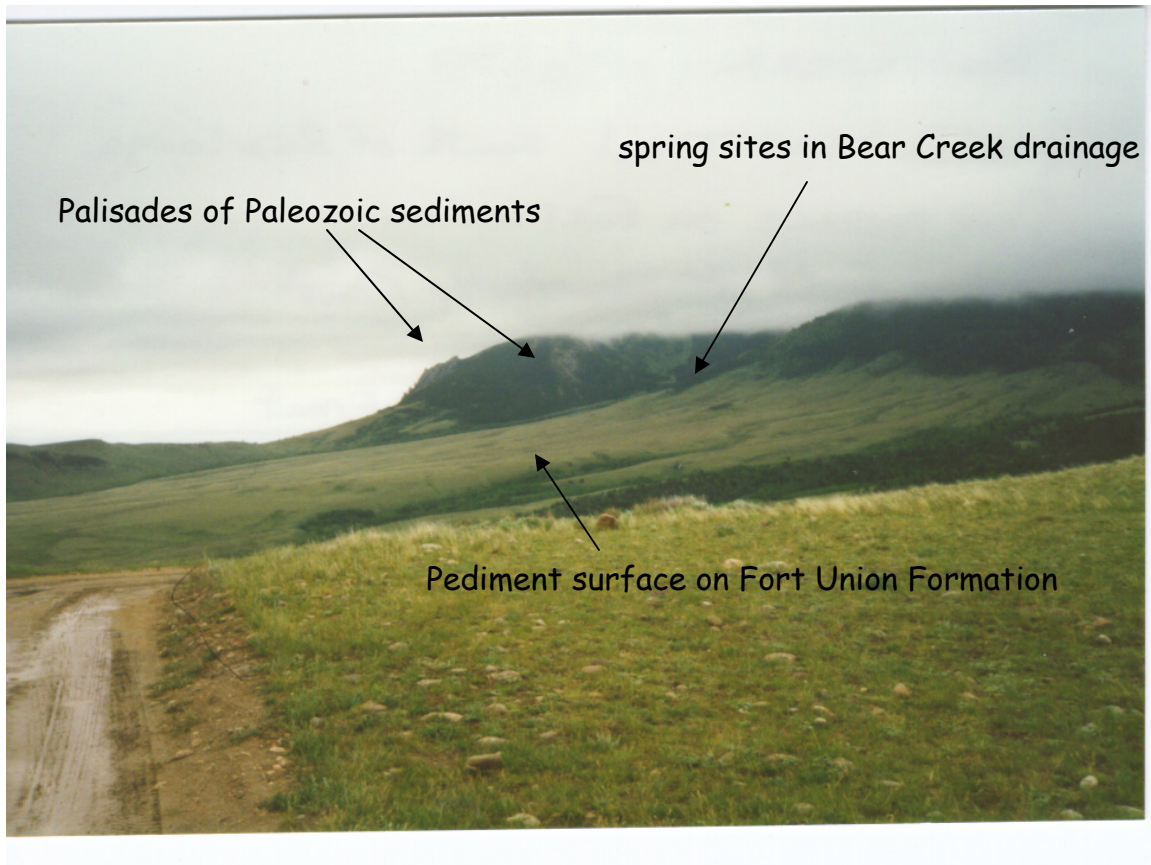
**Photo 4. View looking south along Beartooth Mountain Front from Metetsee Trail Road showing the Paleozoic palisades along the Beartooth Mountain front, the water supply spring sites along the Bear Creek drainage and the pediment surface on the Fort Union Formation. Bearcreek is to the left.**

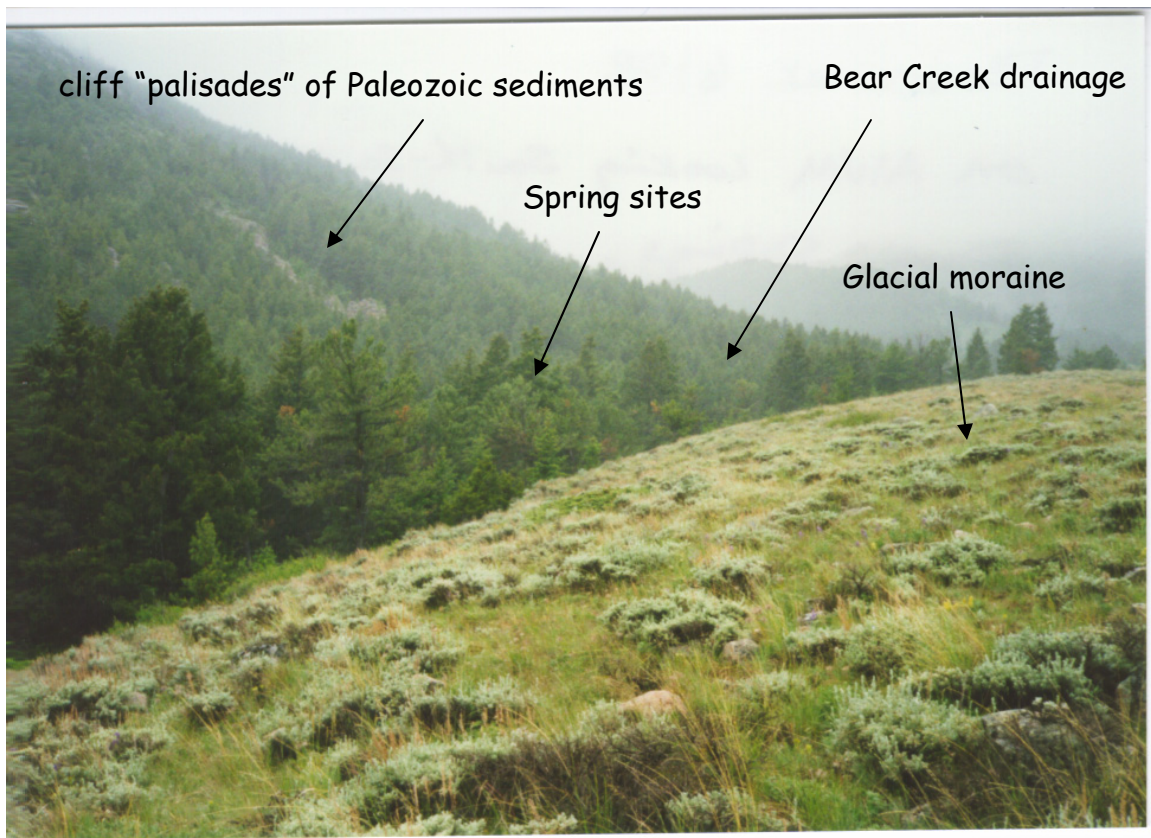
The springs discharge from Pleistocene glacial moraine and outwash deposits that form a wide longitudinal ridge of unconsolidated debris along the center of the Bear Creek drainage (appendix B, photo 5) (David Lopez, MBMG, personal communication, 1999). The moraine is composed of a thick accumulation of cobble- to boulder-size rock fragments consisting primarily of Precambrian granitic metasediments with occasional limestone, sandstone, and schist cobbles, derived from the narrow band of Paleozoic material exposed at the mountain front. Very little fine-grained material was observed in the glacial deposits. The moraine extends from the slopes of Mount Maurice, well above the spring sites, through the mountain front and onto the pediment surface of the Fort Union Formation where it blends into the outwash debris field (appendix C, map 1). The moraine overlies Precambrian, Paleozoic, and Tertiary formations along the upper Bear Creek drainage, and is estimated to be more than 60 feet thick at the spring sites.

**Photo 5. View of spring site area looking southwest along access trail towards spring sites in Bear Creek drainage showing the pediment surface of the glacial moraine, spring location along the Bear Creek drainage and the palisades formed by upturned Paleozoic sediments along the mountain front.**

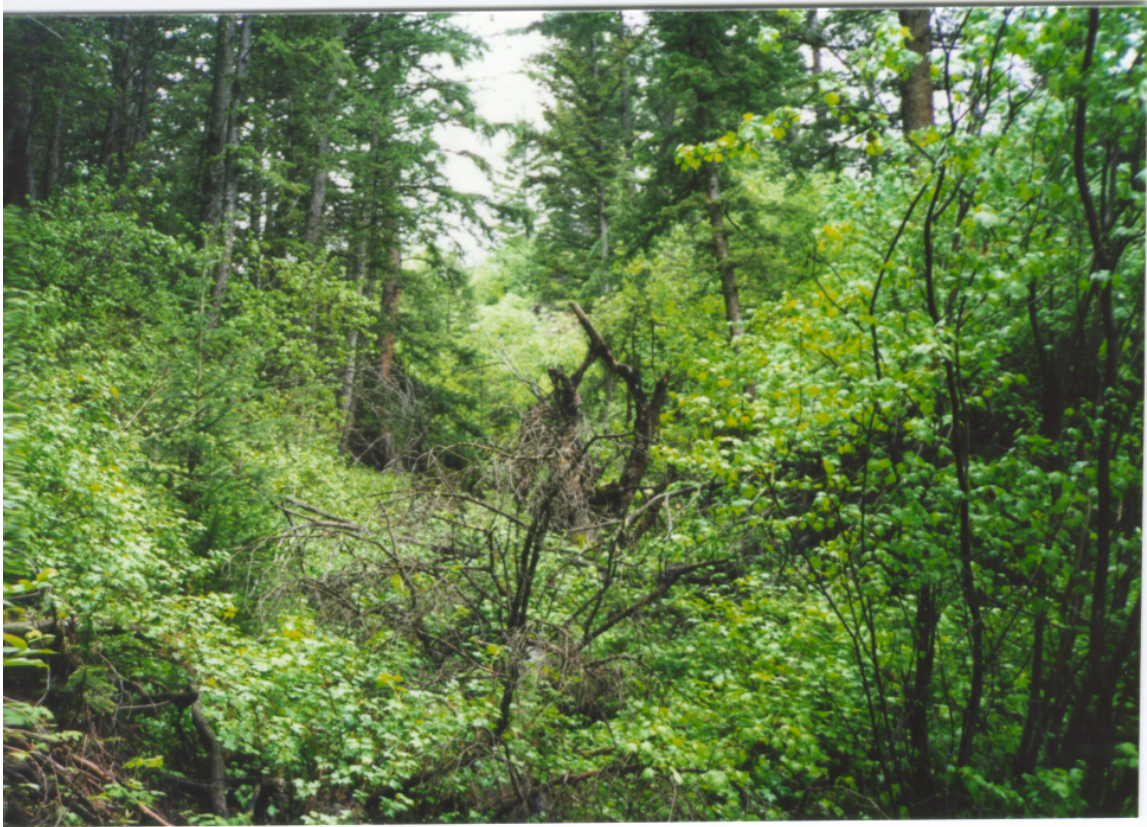
**Photo 6. Looking southwest up Bear Creek drainage between spring sites.  
The glacial moraine is to the right and the colluvial slope is to the left.**
