**HYDROGEOLOGIC ASSESSMENT OF RAPELJE WATER USERS ASSOCIATION
WATER SUPPLY
FOR
GROUND WATER UNDER THE DIRECT INFLUENCE OF SURFACE WATER**

**Open-File Report
MBMG 401-M**

**Rapelje Water Users Association
PWSID #00313
Box 46
Rapelje, Montana 59067**

**Prepared
for
Montana Department of Environmental Quality
Water Quality Division**

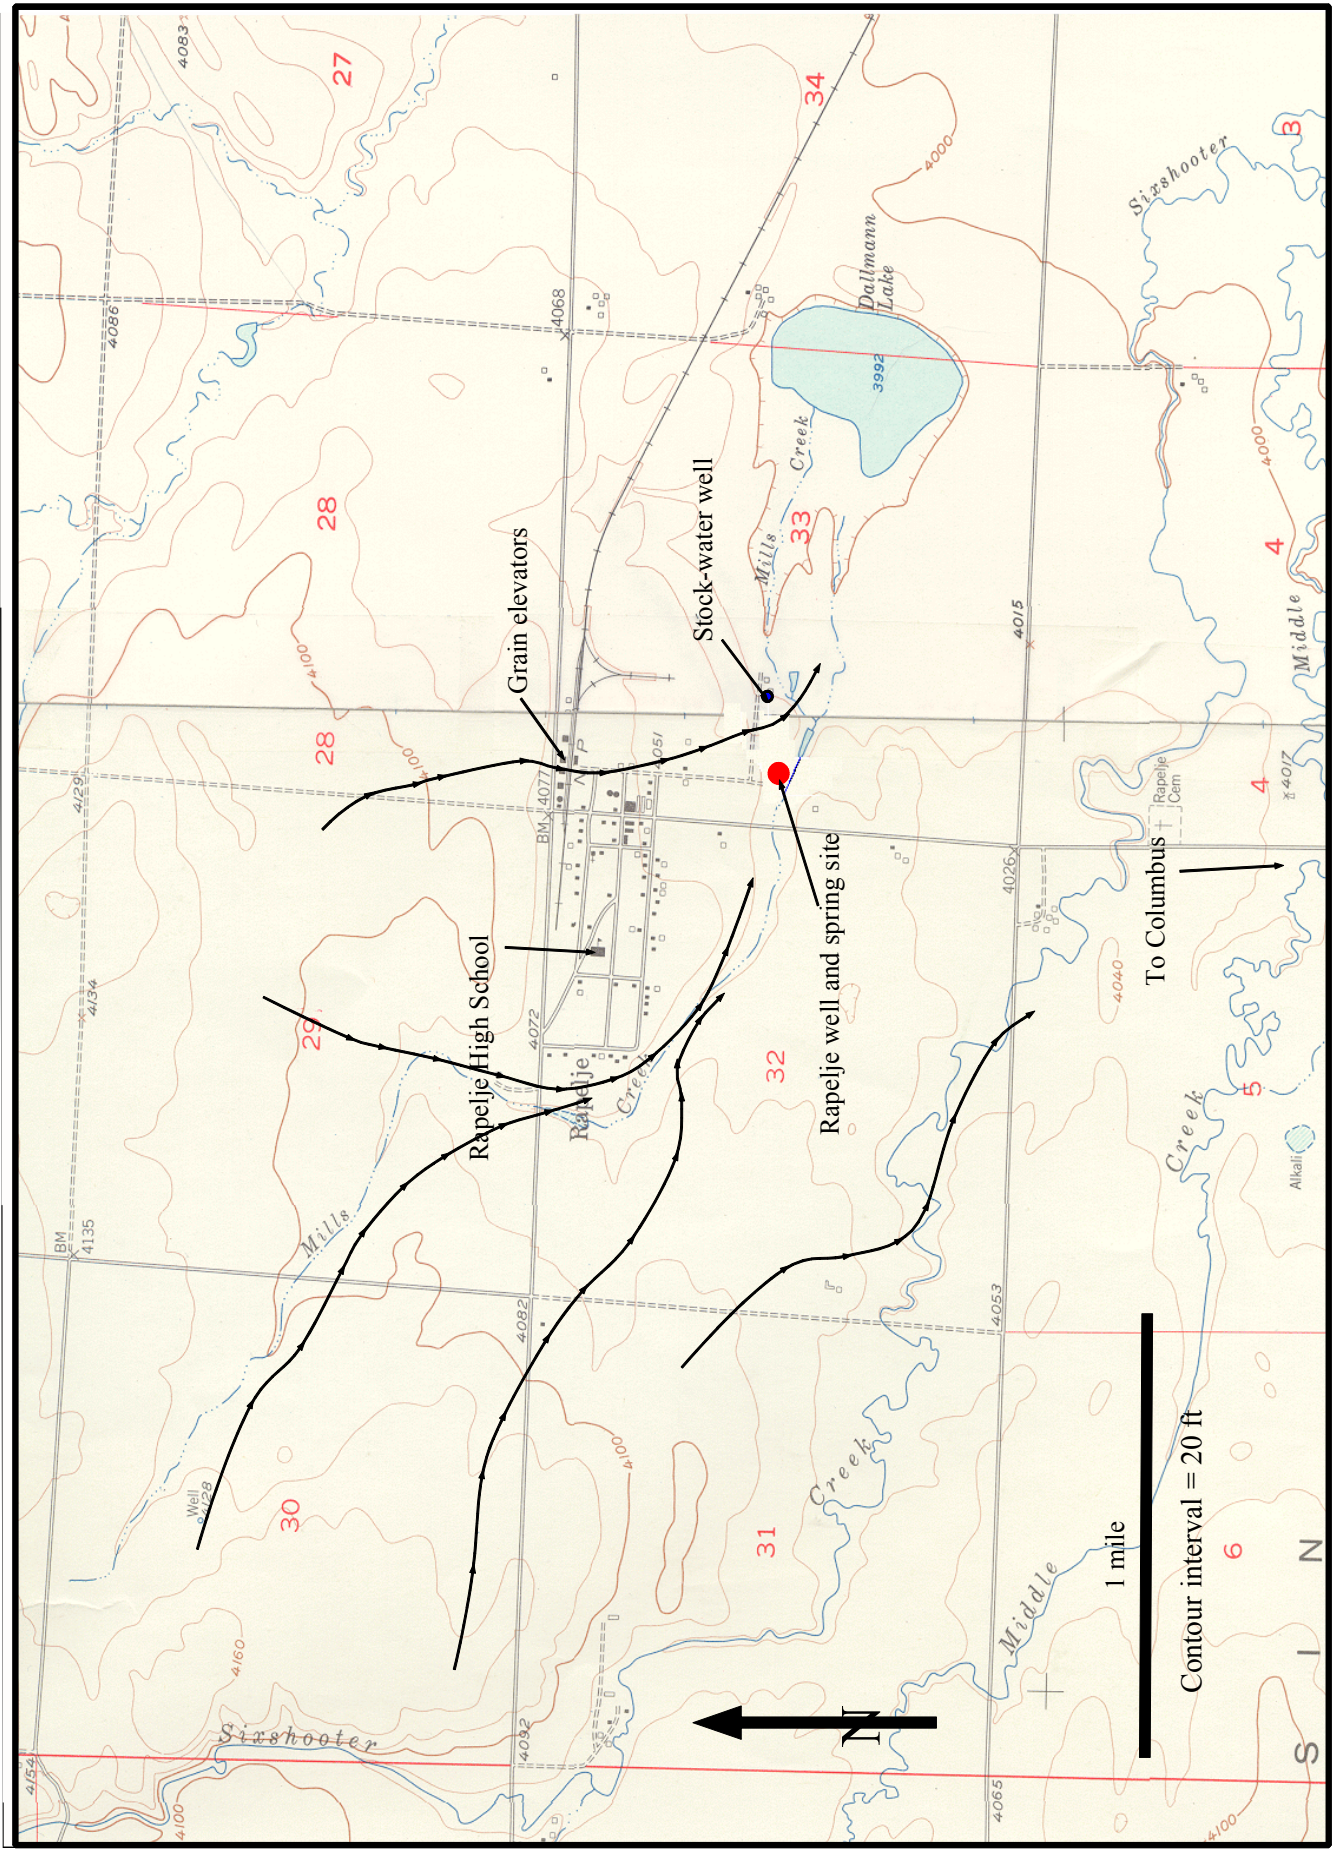
Figure B-2. Topographic contour map of Rapelje area showing the estimated direction of flow of the shallow ground water through the Fox Hills Formation (Rapelje and Battle Butte, USGS Topographic Quadrangle maps, 1956).

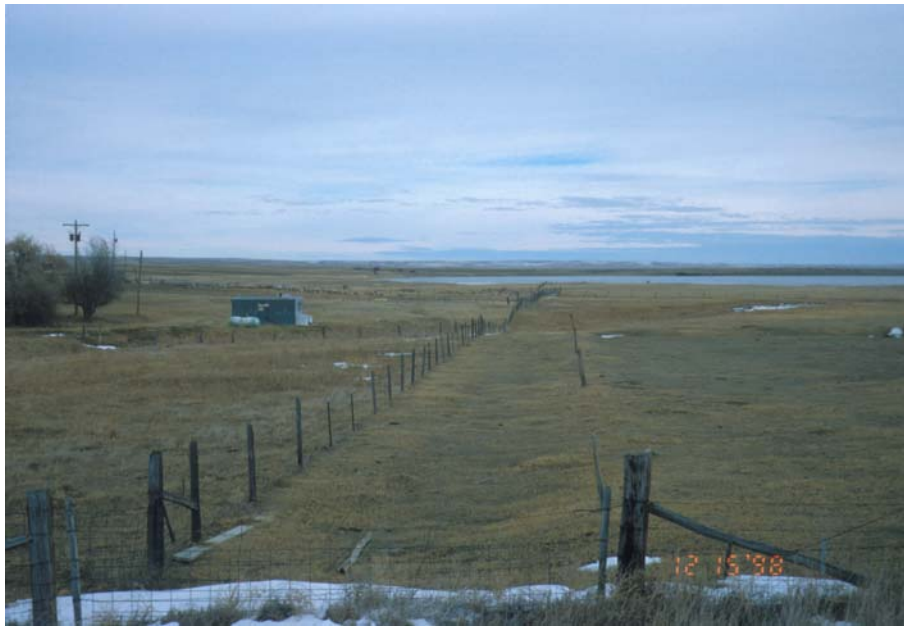
Figure C-1. View of pump house and spring site looking east from county road. Mills Creek runs past the pump house from left to right in the photo. Dallman Lake can be seen in the distance.

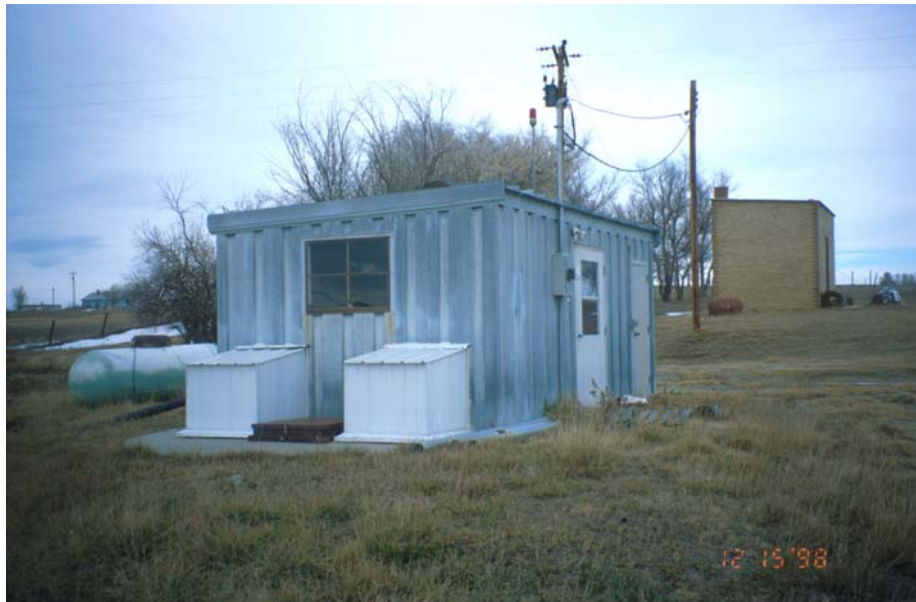
The top of the well is a 3-foot high brick and mortar ring built on top of a sandstone outcrop. A cement cap rests on top of the brick wall with a manhole opening for access. Dirt is backfilled around the well up to the top of the cement cover (Appendix C, photo C-2). The measuring point at the top of the manhole cover is 0.75 ft above the land surface. On December 15, 1998 the static water level measured in the well was 3.76 ft below the measuring point, or 2.99 ft below the land surface.

Figure C-2. Pump house in foreground. Manhole on concrete cover over the well can be seen below the two white boxes attached to the pump house. The railroad bunkhouse can be seen north of the pump house. Mark Doely's house is located northwest of the pump house and can be seen to the left in the photo. The photo was taken from the bank of Mills Creek at the spring discharge site seen in Figure C-3.

- Line the upper portion of the well to provide an adequate near-surface sanitary seal.
- Eliminate potential contaminant sources from the land near the well. In particular, do not allow livestock to graze in the pastures around the well or allow the application of pesticides or fertilizers to the land near the well.

- Remove the gasoline engine pump from the pump house to prevent potential leakage of fluids from the engine into the well.
- The shallow ground water in the Rapelje contains levels of nitrate, sulfate and TDS in concentrations above the recommended MCL for drinking water. Because there are few options for an alternate water source, it may be necessary to address the water-quality issues by developing a water-treatment system.

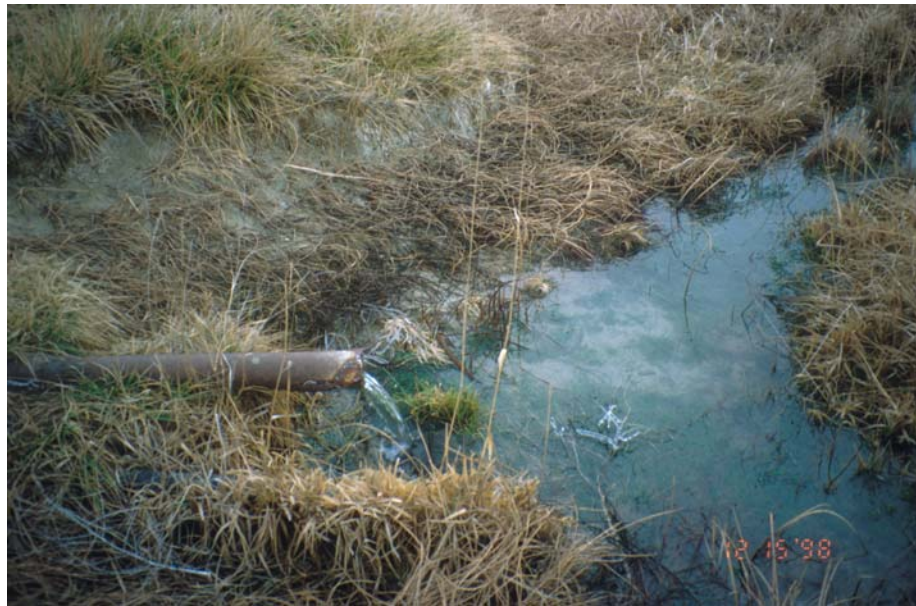
Four springs are located along the creek bottom within 100 feet of the pump house. One spring discharges from the bedrock adjacent to the well along the bank of Mills Creek and one is located to the north of the pump house. Drain tiles run from a spring located north of the pump house to the creek to drain water away from the well. No evidence of surface discharge was seen in the area north of the pump house. Bank erosion by spring discharge near the well has required the system operator to backfill dirt along the stream bank and run a pipe from the spring discharge to the creek in order to move the spring discharge water away from the city well (Appendix C, photo C-3).

Figure C-3. Mills Creek at the spring site. The pipe carries discharge water from the spring adjacent to the pump house and supplies most of the flow to Mills Creek.

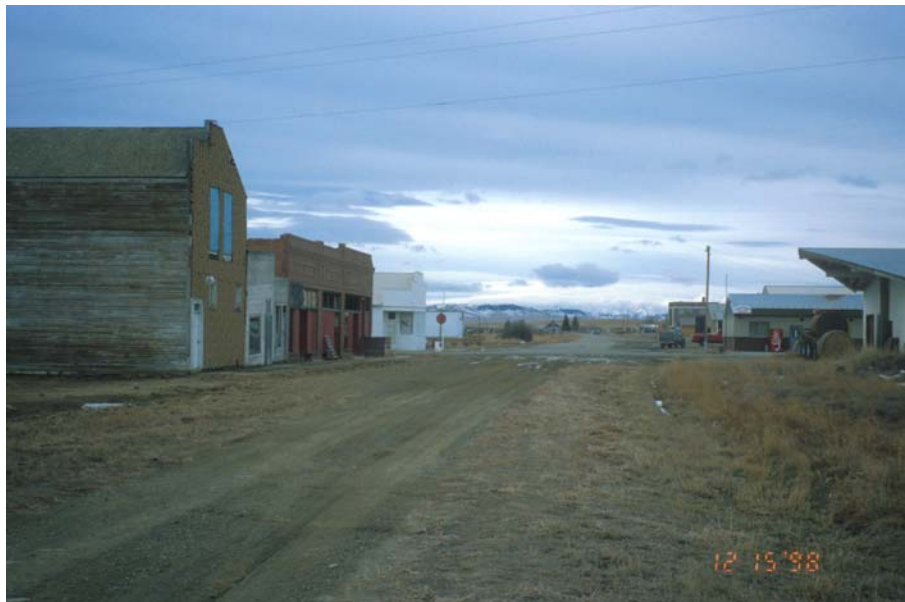
Figure C-4. View looking west across main street at the Main town intersection. The abandoned gas station is to the right, the cafe is the next building on the right and the high school can be seen in the distance behind the cafe.
