**HYDROGEOLOGIC ASSESSMENT OF THE TOWN OF LIMA  
WATER SUPPLY, ALDER SPRING,  
FOR  
GROUND WATER UNDER THE DIRECT INFLUENCE OF SURFACE WATER**

**Open-File Report  
MBMG 401-N**

**Town of Lima  
Lima Water Department  
PWSID #00276  
P. O. Box 184  
Lima, Montana 59739**

**November 2000**

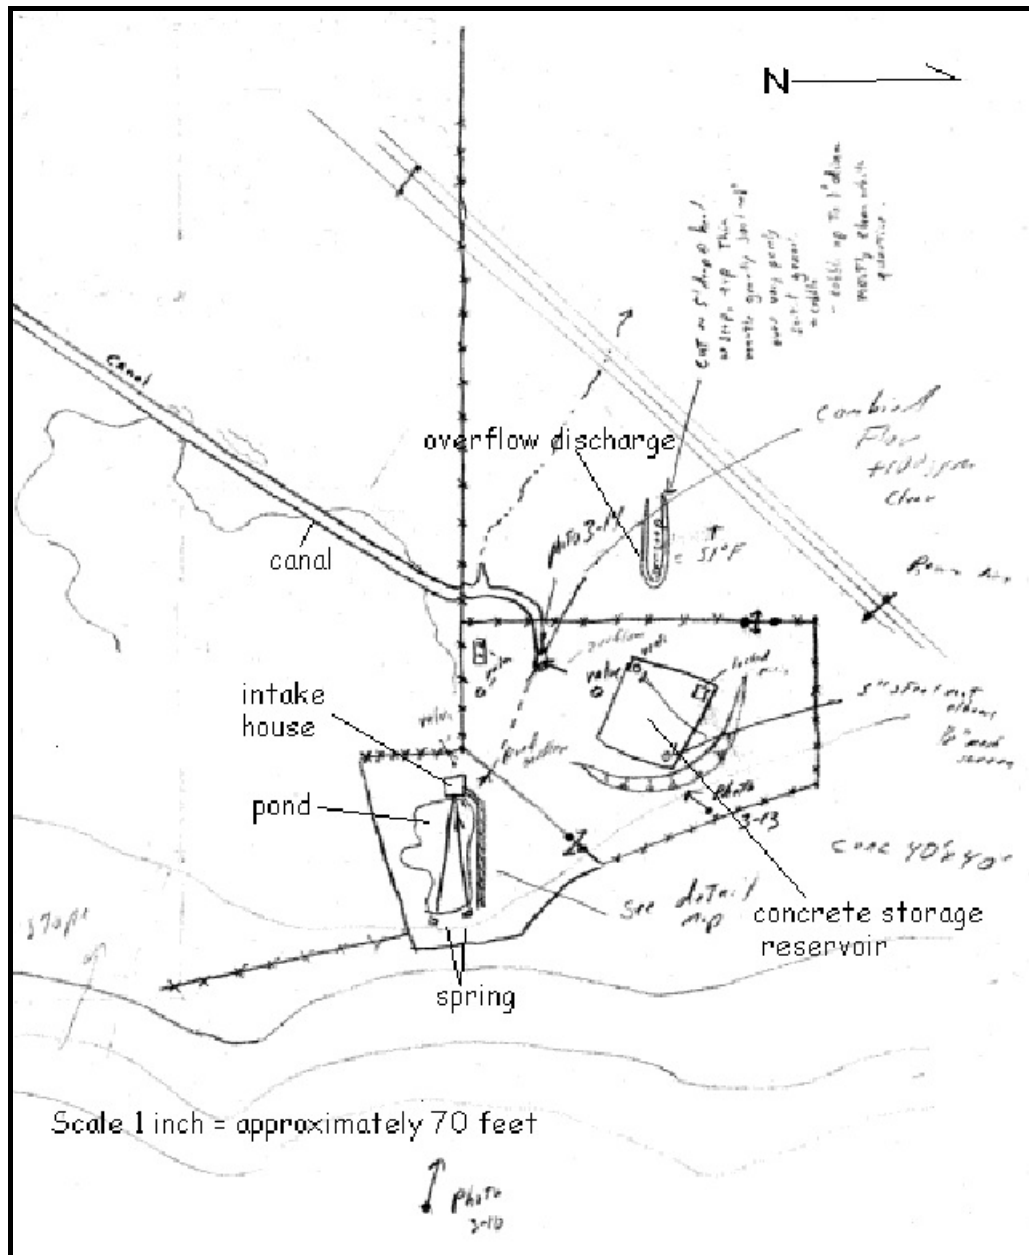
The water level of the pond at the spring site is regulated by a headgate near the intake building (Figure 3). The surface water is discharged through the headgate into a canal that carries the water across the Alder Creek fan (Appendix B, photo B-2) and (Figure 4). Ground water from the infiltration galleries buried in the hillside flows into two pipes that run along the bottom of the pond and empty into an intake house located on the west side of the pond (Figure 3). The intake house is used as a cistern and is constructed of stone block and mortar that appears to be quite old (Mike Brayton, DEQ, personal communication, 2000). Cracks in the intake house walls may allow surface water from the adjacent pond to leak through the walls into the water supply. Insects and rodents may be able to enter the water supply through gaps in the intake house structure. The water in the intake house drains into a 6-inch water line to a concrete storage reservoir (Figure 5) and (Appendix B, photo B-5). A second 6-inch line carries water from the storage reservoir to the town's main water-distribution line. The storage reservoir is located at the spring site and is a 100,000-gallon capacity rectangular, concrete box with a concrete cover. The reservoir was constructed in response to water system improvements recommended by Ellsworth Engineering and Bill Anderson, P.E., who provided the design work. According to a DEQ memo dated May 15, 1995, a recommended mainline improvement (changing 6-in to 12-in) to town was not constructed. The main water line to town is still 6-in diameter. The recommended improvements to the water system were apparently in response to a water-pressure problem to the service connections in town. A water-pressure test was conducted on the Lima water supply system at a hydrant near the school by Bill Anderson, P.E., in May 1995. The flow at the hydrant was 175 gallons per minute (gpm) at 20 pounds per square inch

**Figure 4.** Sketch map of spring site showing the pond, the canal, the spring-discharge area, the lower spring on the alluvial fan and the concrete-storage reservoir.

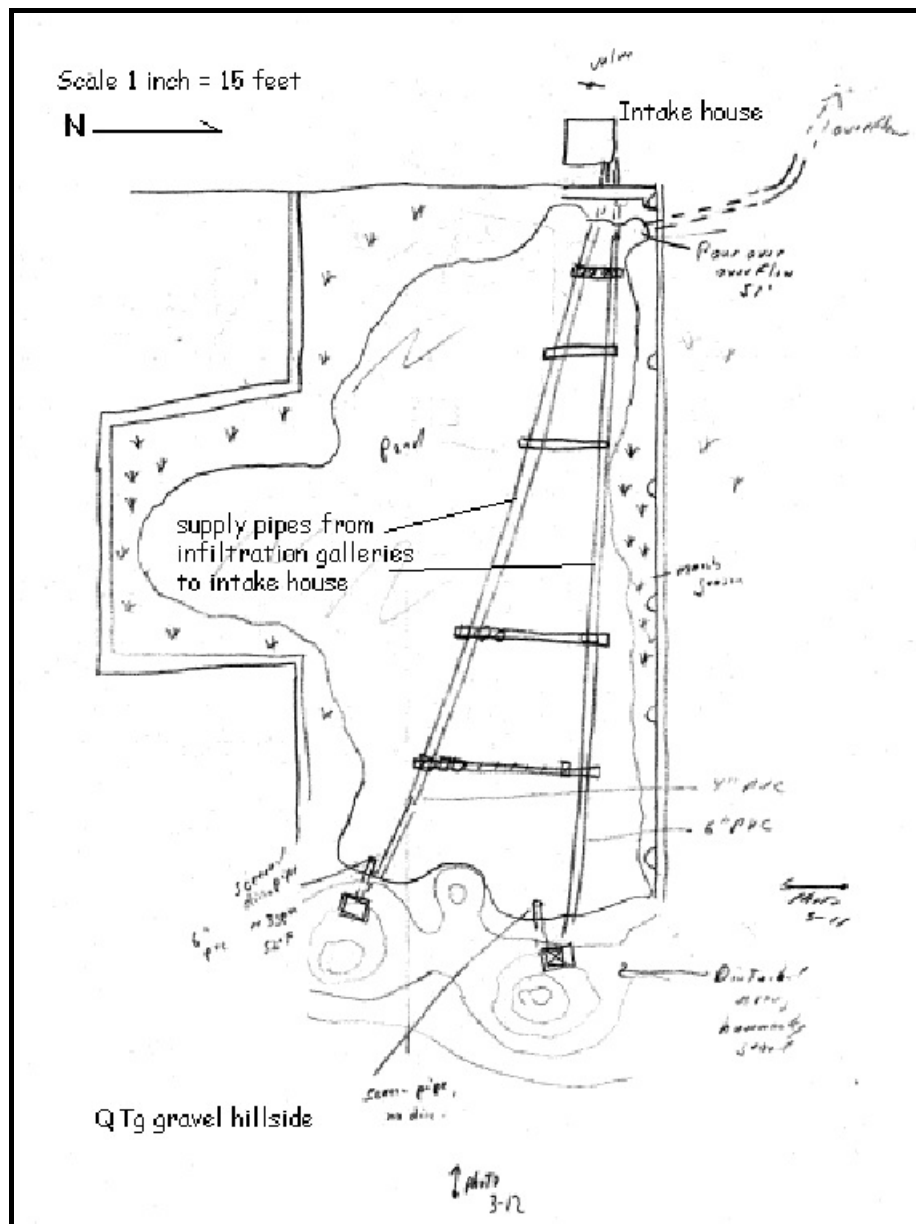
**Figure 5.** Sketch map of the spring site showing the pond, the PVC discharge pipes, the collection lines from the infiltration galleries to the intake house and the canal from the pond.

- Look at draining or relocating the pond or relocating the pipes that flow from the infiltration galleries to the intake house so that the pipes are not routed through the pond water.
- Eliminate the intake house cistern from the system. The age, construction, and location of the intake house present a potential site for the infiltration of surface water into the water supply. Running pipes from the infiltration galleries directly into the concrete storage reservoir would eliminate this potential source of surface water contact.
- Be sure all pipes, vents and openings into the water system, especially at the spring site, are sealed or screened to keep rodents and insects out of the system.

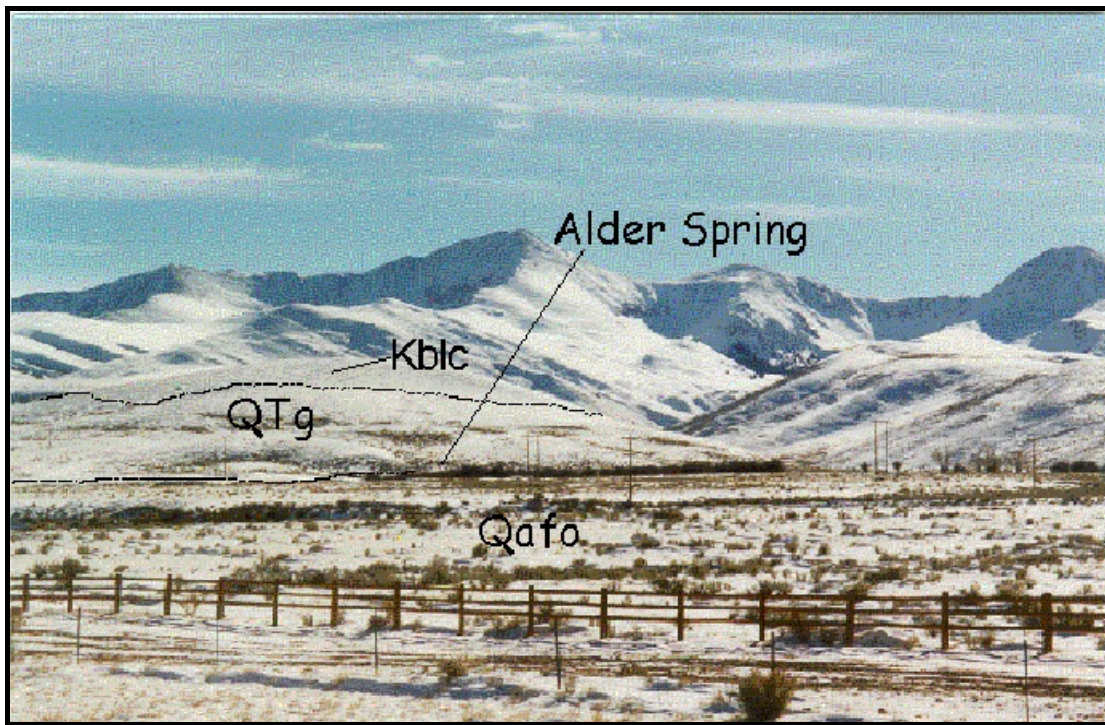
The hills south of Lima are predominantly composed of bedrock belonging to the Lima Conglomerate of the Beaverhead Group, which is estimated to be about 2,500 ft thick in the Lima area (Appendix B, photo B-1). The topography is characterized by gently rolling uplands along the base of the Tendoy Mountains (Appendix B, photo B-1).

The north end of the hills, at the Alder Spring site, are composed of unconsolidated Tertiary to Quaternary age gravel deposits (Figure 6) (Appendix B, photo B-1). Alder Spring discharges from a steep hillside composed of the QTg gravels along the east side of the Alder Creek drainage (Figure 6). Skipp (2000) described the QTg unit as gravels of uncertain affinity. The unit is similar to terrace gravels mapped in the area which consist of stream-channel deposits containing pebbles, cobbles and boulders. The clasts in the gravels are typically well rounded and are derived from erosion of the Paleozoic and Mesozoic sediments of the surrounding mountains, including rocks of the Beaverhead Group. The gravels in the QTg are unconsolidated, not cemented, and have large pore spaces that make a good water-bearing and water-transmitting aquifer. The topography developed on the gravels is hummocky, uneven terrain in contrast to the gently rolling uplands of the Lima Conglomerate located further to the south (Appendix B, photo B-1).

Alder Springs flows from a steeply sloping hillside composed of QTg gravel along the Alder Creek drainage (Figure 6). The spring occurs where the water table intercepts the more steeply sloping land surface. Alder Spring is also located along the inferred trace of a valley margin fault which may have some influence on local ground-water movement and the spring. The QTg gravels contain large pore spaces between the gravel, pebbles, cobbles, and boulders which allow for the easy and rapid movement of ground water. The ground water in the gravels is recharged by precipitation falling on the land surface, and from drainage through a hydraulic connection with the alluvium along the creek bottoms uphill from the spring site. The total surface area of the gravels exposed at the land surface is small and the area receives low annual precipitation; so the contribution to recharge from precipitation is probably small. The total thickness of the QTg gravel aquifer is not known, however, the thickness of the aquifer that lies above the spring is relatively thin because the land surface of the gravel hills rise only 160 ft above the spring site (Figure 6). This relatively shallow thickness cannot provide adequate quantities of water to continuously supply the spring. The gravel also receives very little water from the tightly cemented Lima Conglomerate that forms the hills south of the gravel deposits.

(Appendix B, photo B-1). The conglomerate would act as a barrier to ground-water movement. Therefore, most of the recharge to the gravel aquifer must come from the nearby alluvium in the Alder Creek drainage and possibly from the drainage east of the spring site. Alluvium in both drainages are recharged primarily by the infiltration of surface water from streams.

**Photo B-1.** View looking south towards Alder Spring showing hills south of spring and approximate contact between the QTg, source gravels for the spring and the Lima conglomerate (Kblc). The land in the foreground is Quaternary alluvial fan deposits (Qafo). The Alder Creek drainage is to the right of the spring and the Lima Peaks of the Tendoy Mountains are visible in the background.

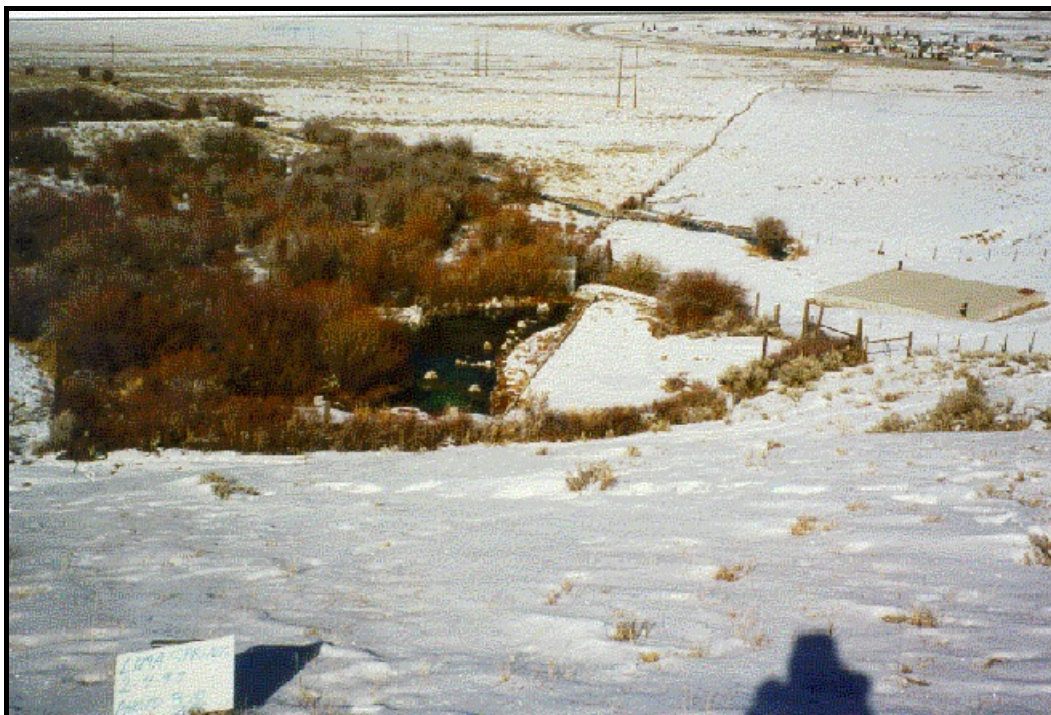
**Photo B-2.** Overview of spring site looking northwest from the gravel hillside across the Alder Creek alluvial fan. The view shows the spring, the collection pond, the storage reservoir, the lower spring, and the diversion canal. The town of Lima is visible in the background.

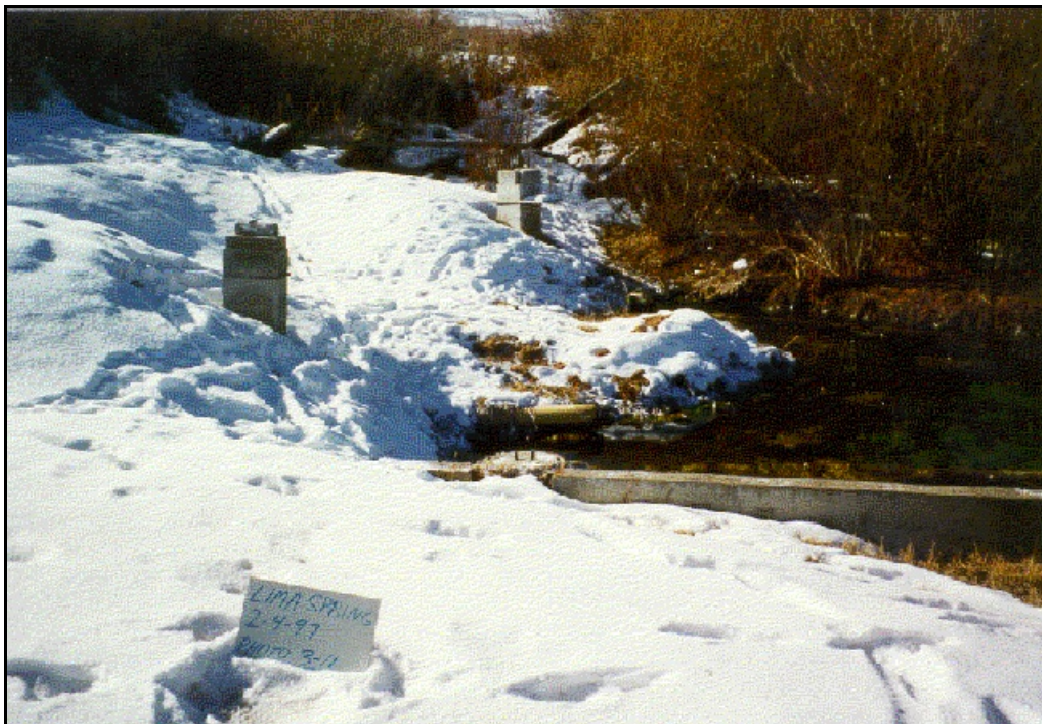
**Photo B-3.** Alder Spring discharge site. PVC drain pipes are located at the edge of the pond, the water-system collection pipes from the infiltration galleries are located below the concrete blocks.

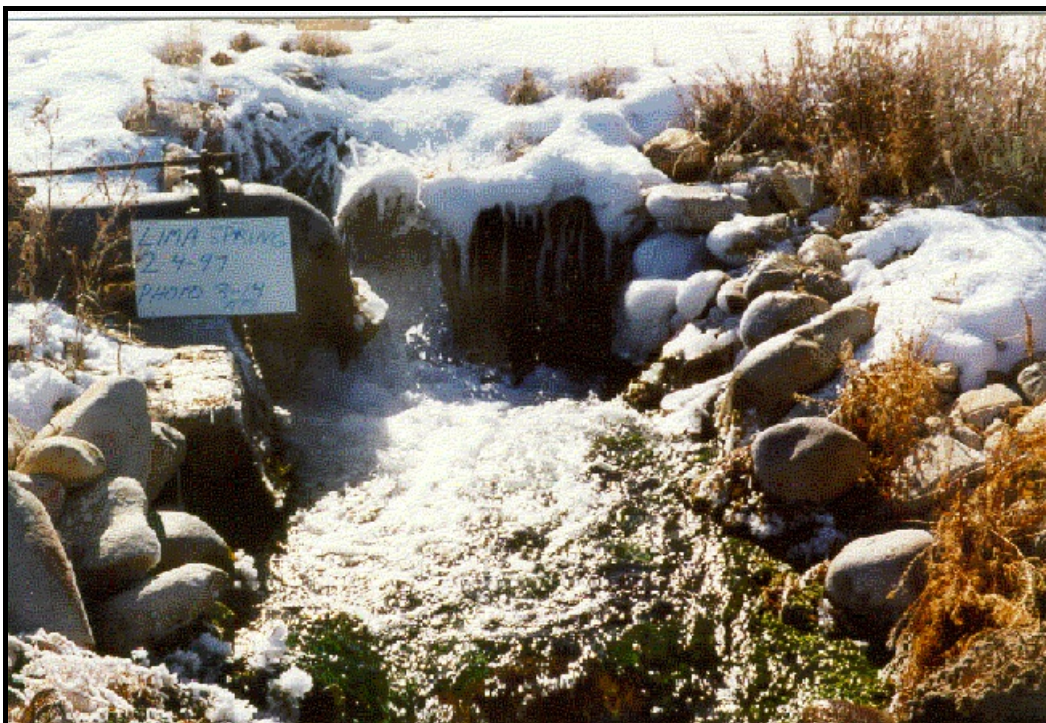
**Photo B-4.** View of overflow discharge below the storage reservoir. Note the size of the

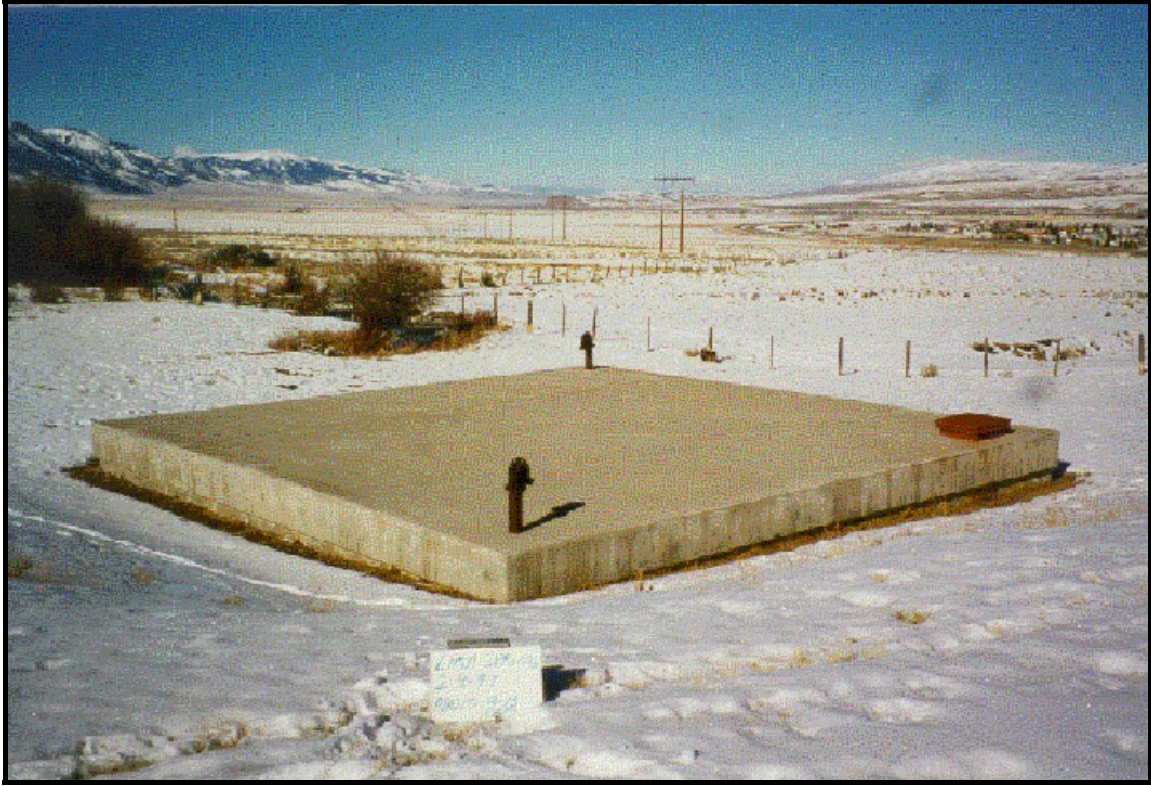
**Photo B-5.** Close-up view of the 100,000 gallon water storage reservoir. View is looking northwest across the Alder Creek alluvial fan and down the Red Rock River valley. The Tendoy Mountains are visible to the left and the Town of Lima is visible to the right.
