**Montana Bureau of Mines and Geology  
Abandoned - Inactive Mines Program  
Deerlodge National Forest**

**Volume III  
Flint Creek and Rock Creek Drainages**

**December, 1995**

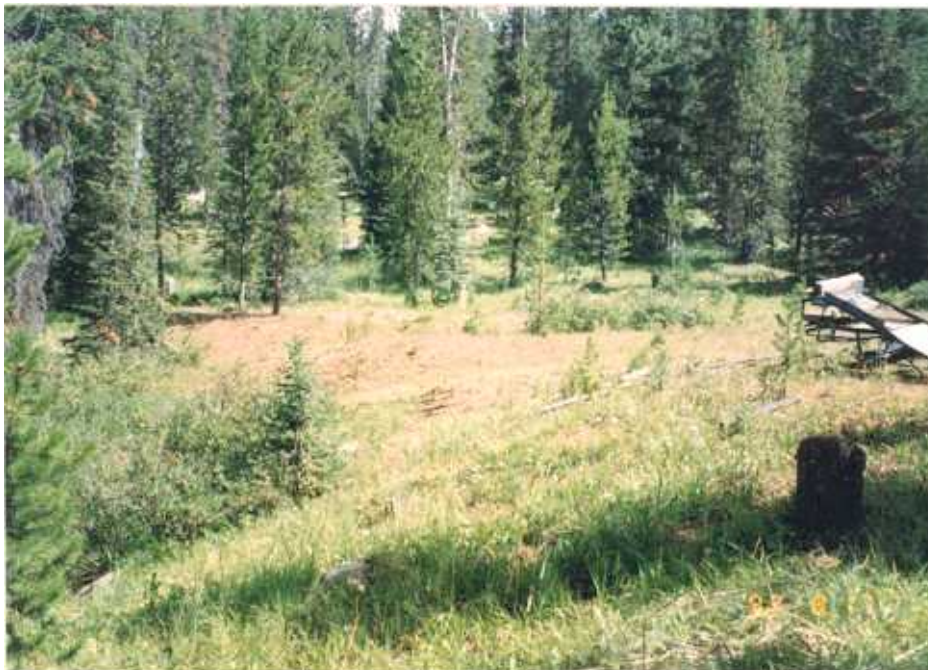
**Figure 2.4** Most of the disturbed area of the Red Lion mine is on private land. A small tailings pile is near the North Fork of Flint Creek.

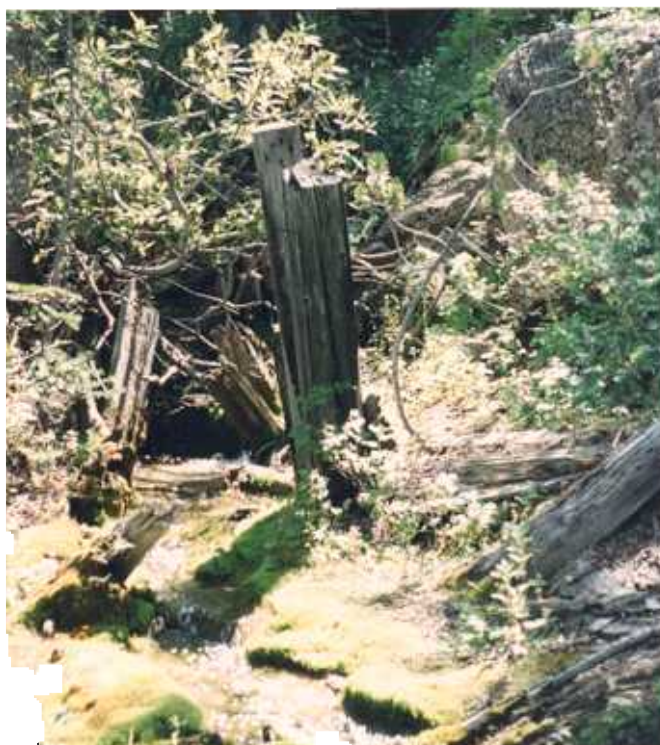
**Figure 2.5** A small discharge issues from a collapsed adit at the Red Lion mine. The adit shown is on DNF administered land.

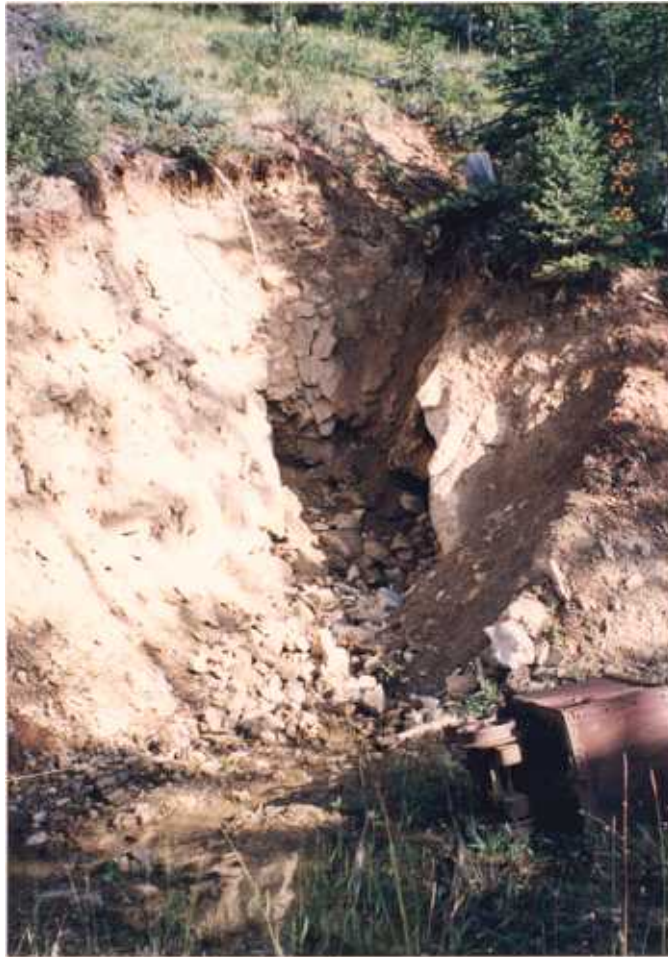
**Figure 2.6** The Garrett mine has a single adit that discharges less than one gpm. Impact to the area appears to be restricted to the adit and waste-rock dump.

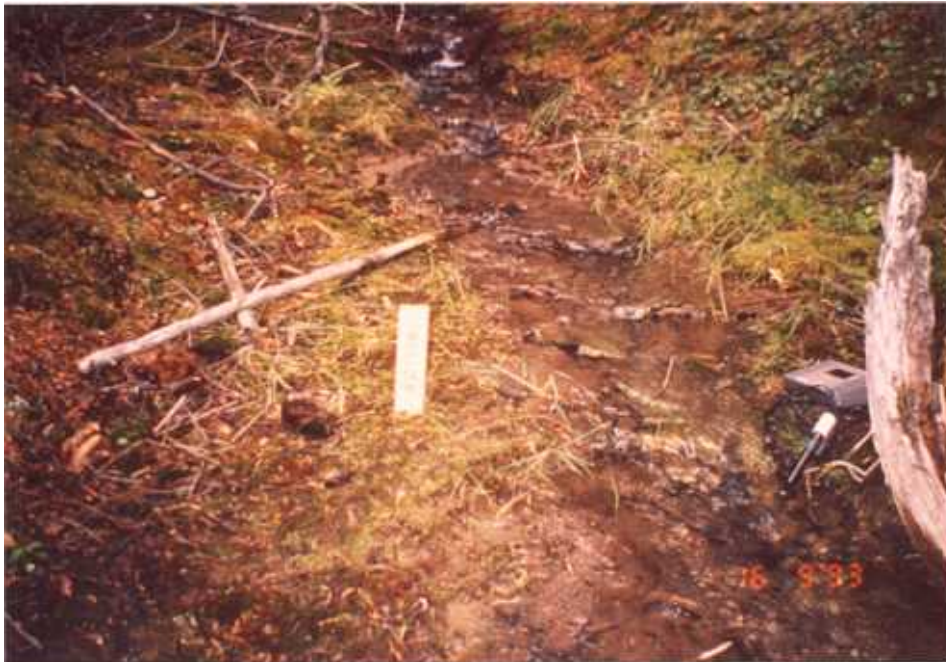
**Figure 2.8** Adit discharge flowing along ephemeral drainage below the site. Water sample CHHS10H was collected at this location.

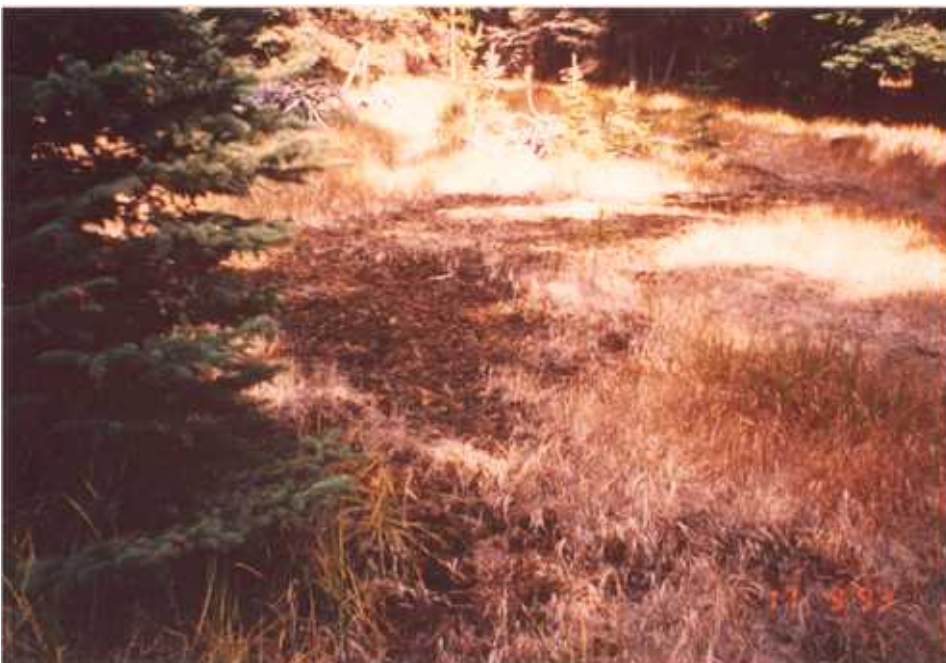
**Figure 2.9** Mossy to barren patch of ground below waste-rock dump. Soil sample CHHD20H was collected from this area.

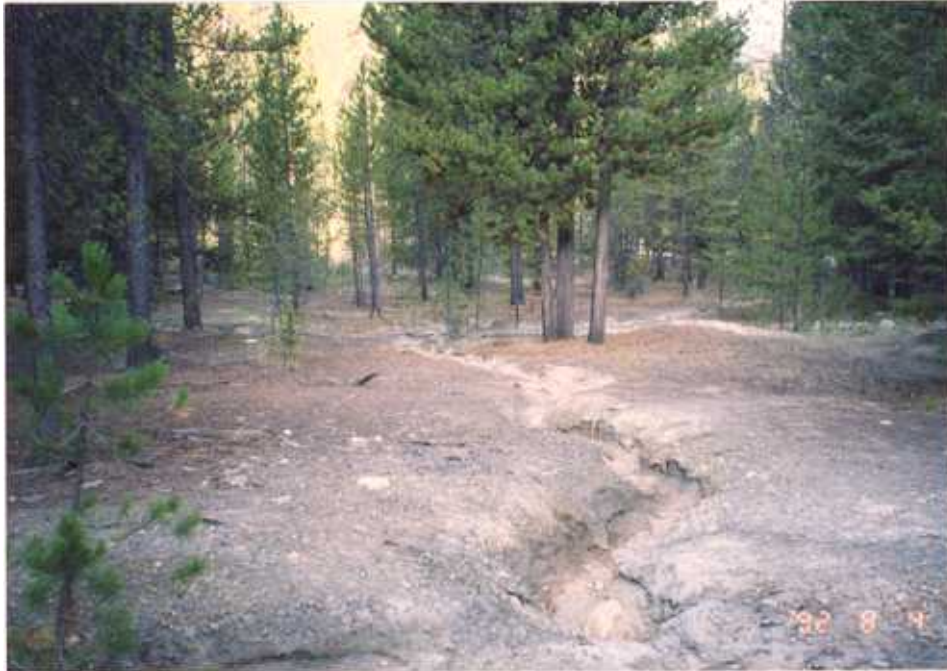
**Figure 2.11** During runoff events, mill tailings and waste rock from Brooklyn mine and mill wash downhill towards the lower portion of the site and Boulder Creek.

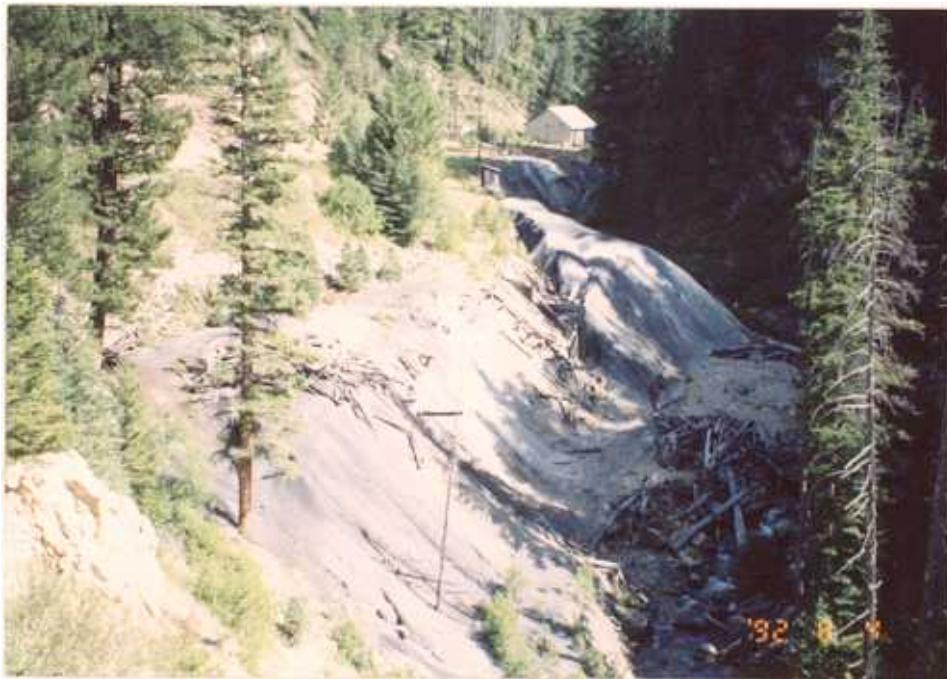
**Figure 2.12** Waste-rock dump on the banks of Boulder Creek, at the lower end of the Brooklyn site.

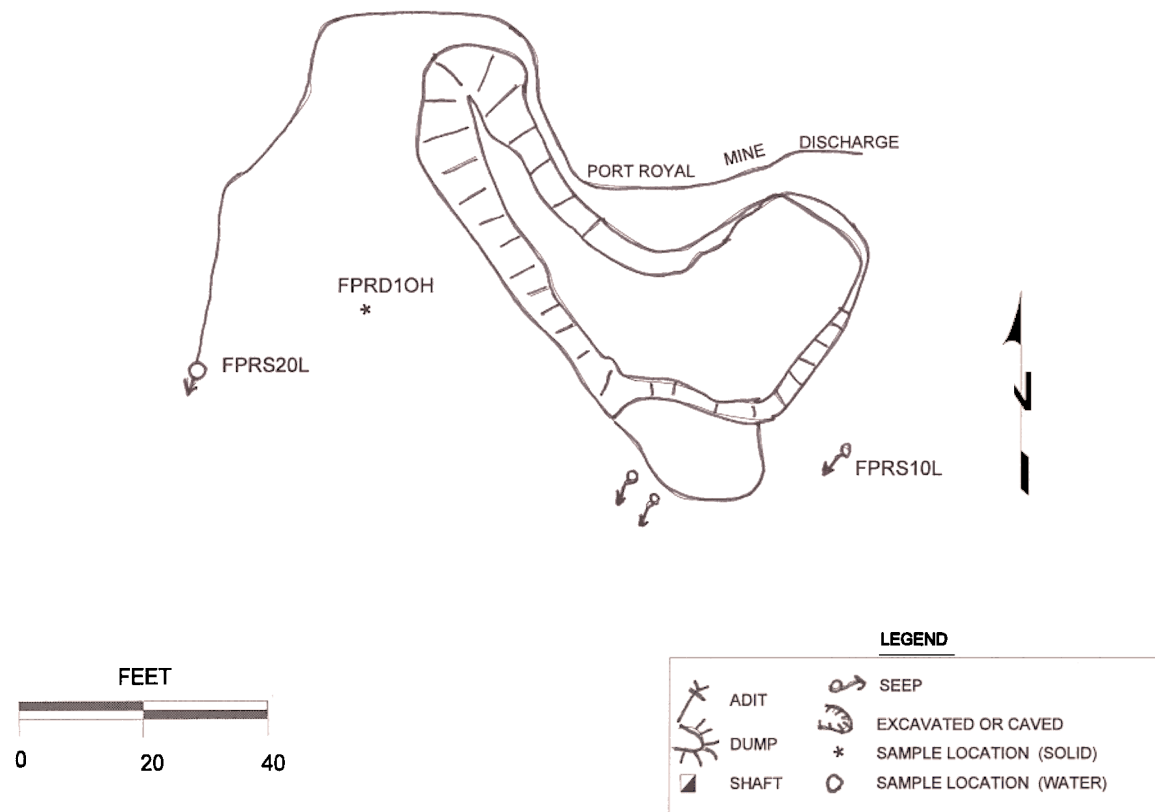
**Figure 2.13** Most of the disturbances associated with the Port Royal and Sunday mines are on private land. The investigation, therefore, focused on the tailings impoundment downhill of the Port Royal mine.

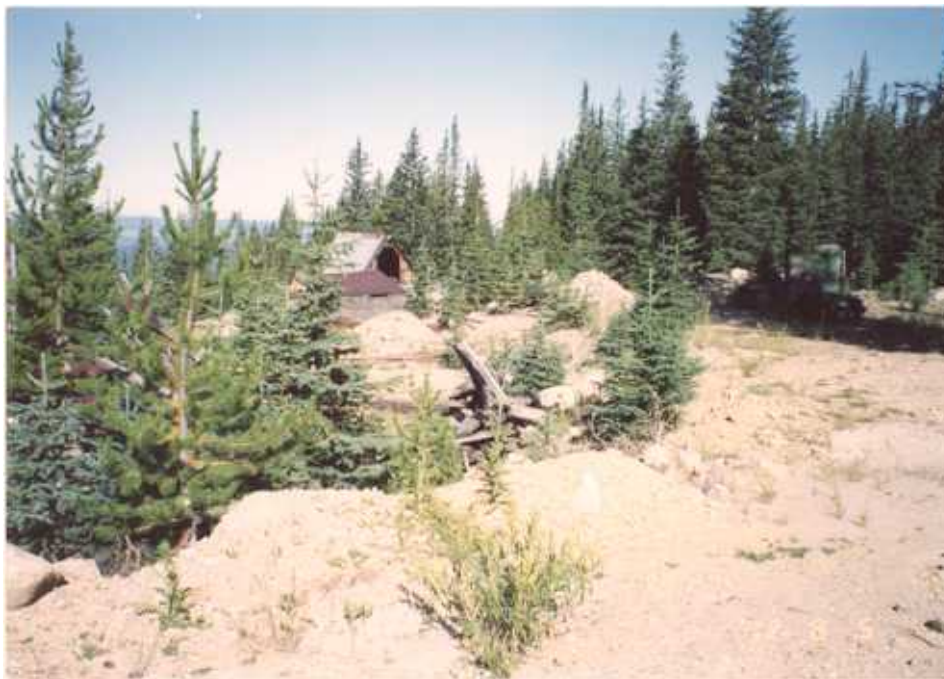
**Figure 2.15** The main development area of the Sunday mine has several acres of waste material.

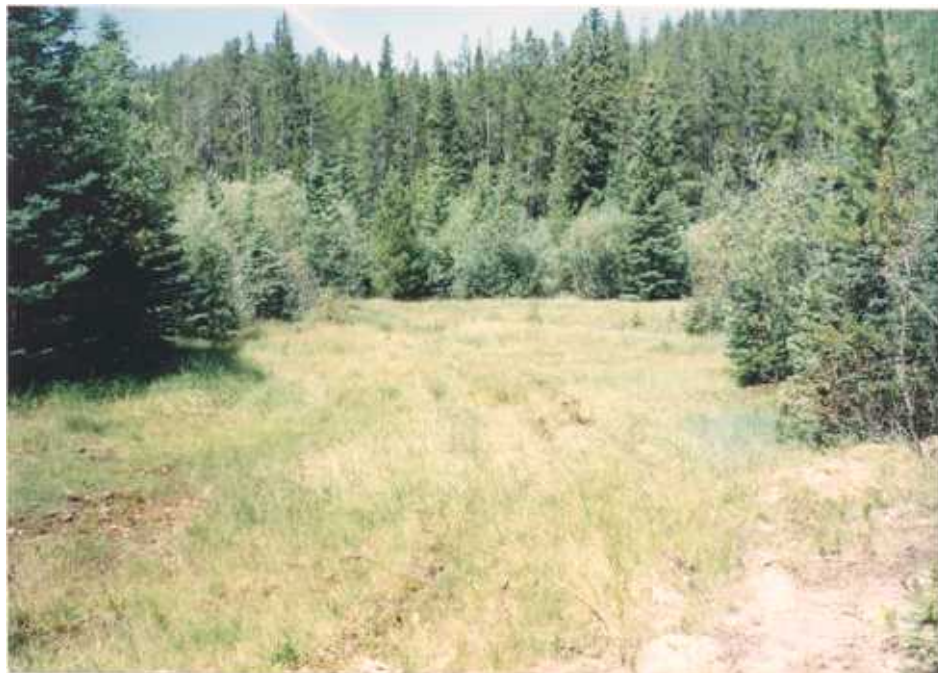
**Figure 2.17** Most of the tailings near the Royal Gold mill are covered by vegetation. Small areas devoid of vegetation were observed throughout the area.

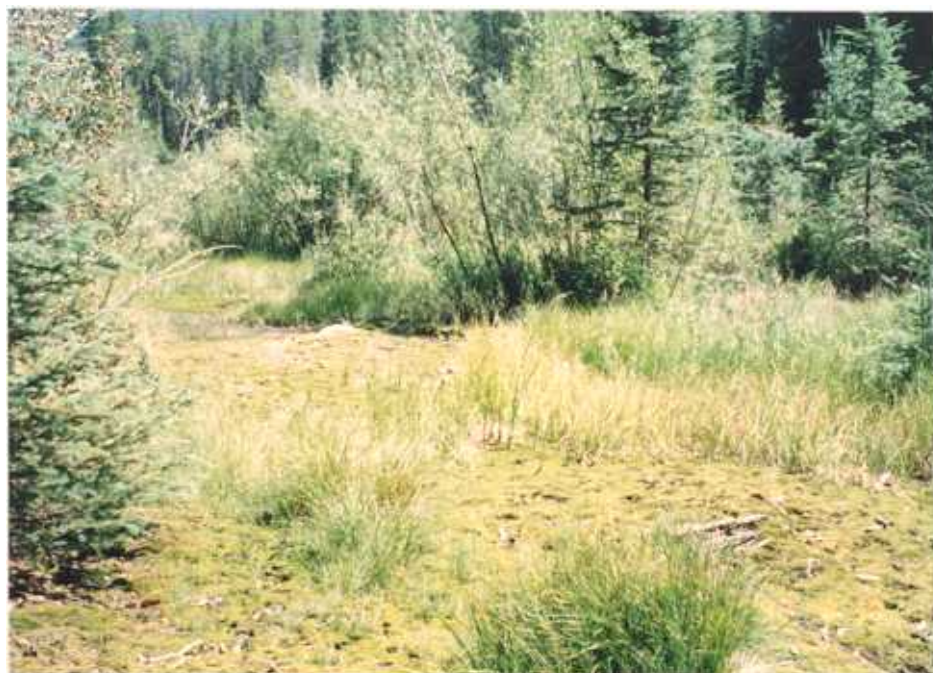
**Figure 2.18** Some portions of the Royal Gold mill tailings have been eroded and re-deposited by the creek.

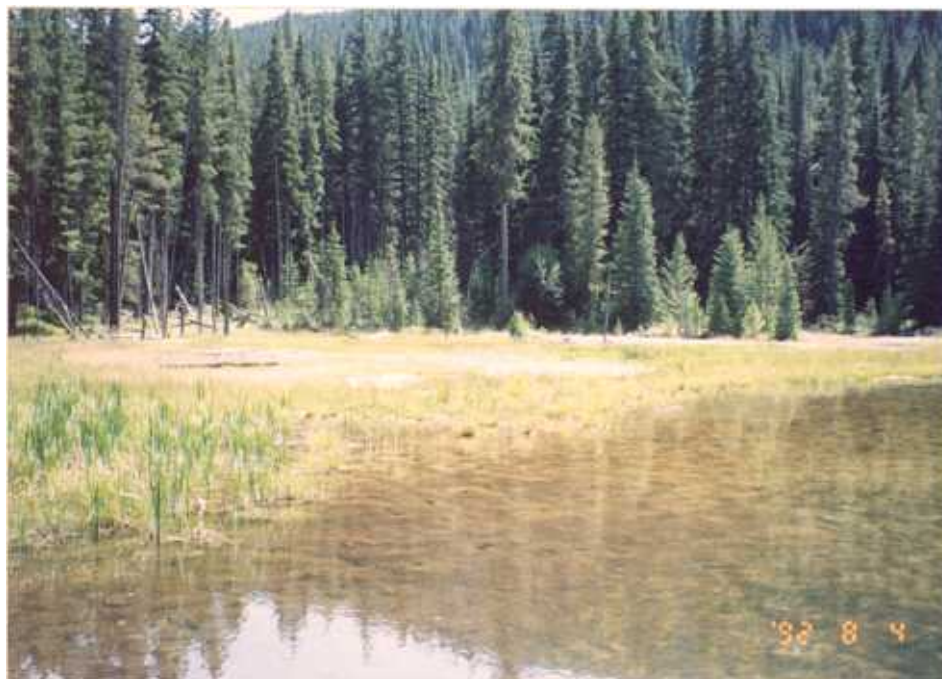
**Figure 2.21** The two largest tailings impoundments contain water. However, large areas of tailings remain exposed.

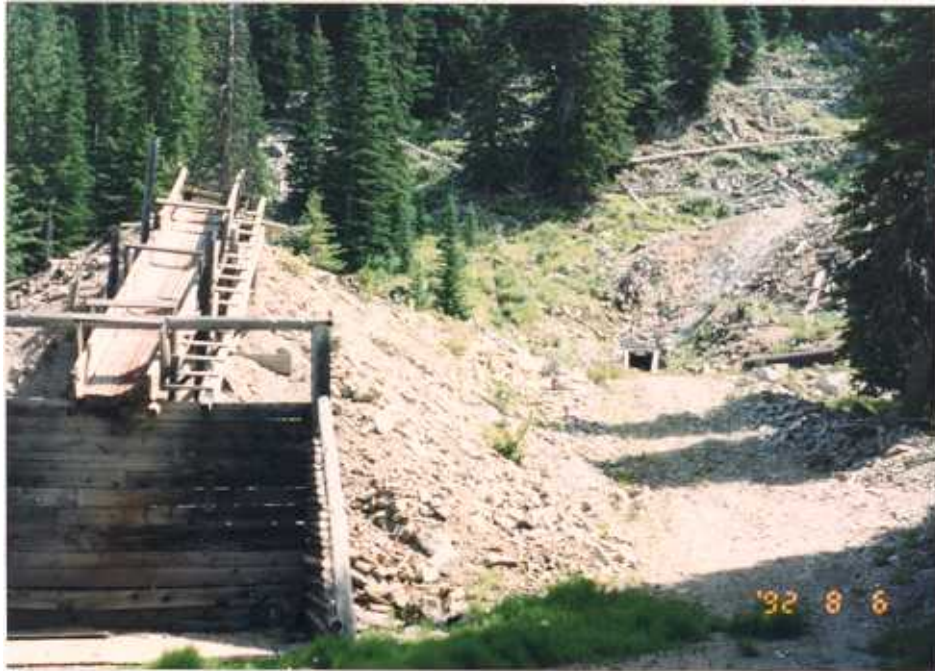
**Figure 2.23** A spring breaks from the hillside above the adit of the Blue Bird mine. The adit also discharges water.

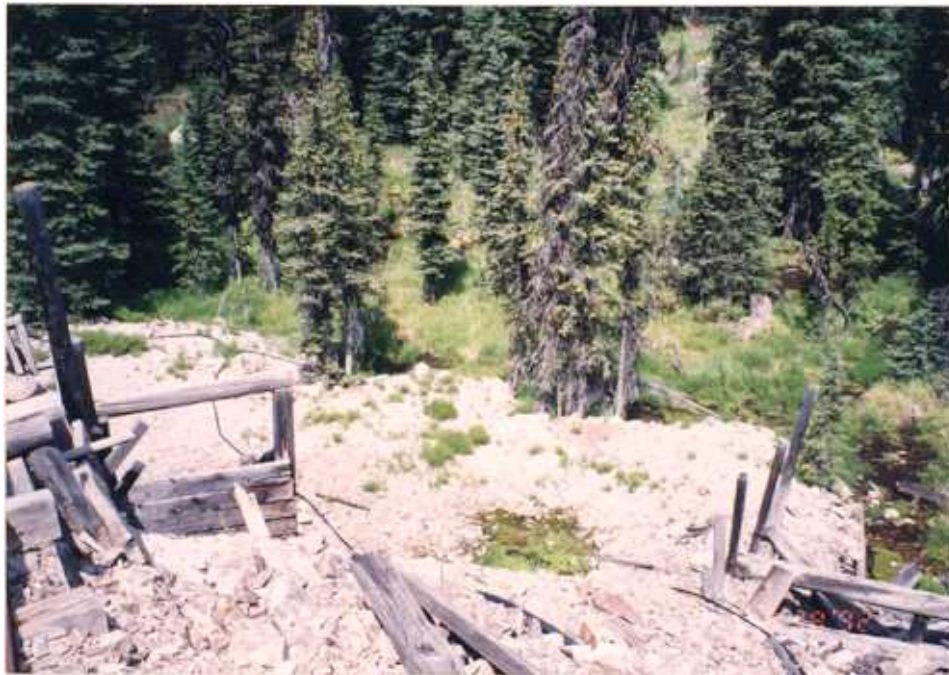
**Figure 2.24** The adit discharge and the natural spring merge below the disturbed area of the Blue Bird mine.

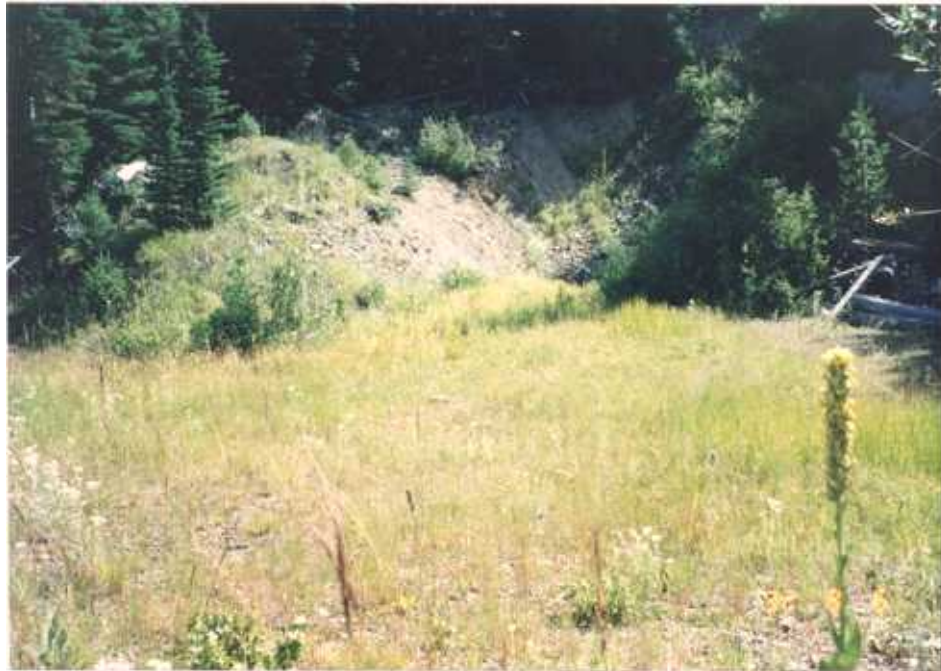
**Figure 2.26** The caved adit of the Mountain Lion has a small discharge that infiltrates the ground about 60 feet from where it emerges. Note the lush vegetation around the adit.

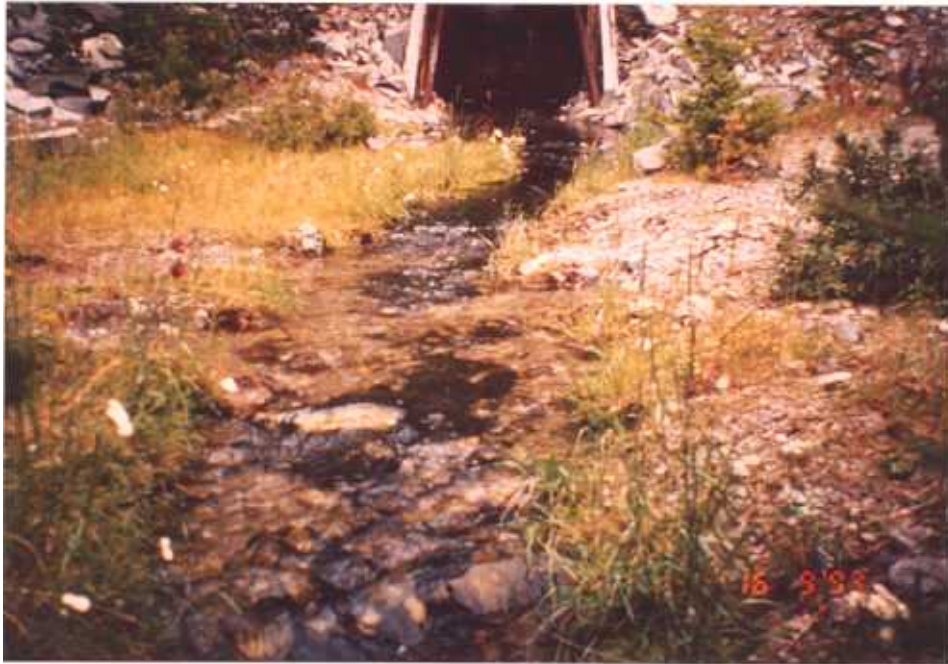
**Figure 2.28** Water flowing from the adit crosses the top of the waste-rock dump.

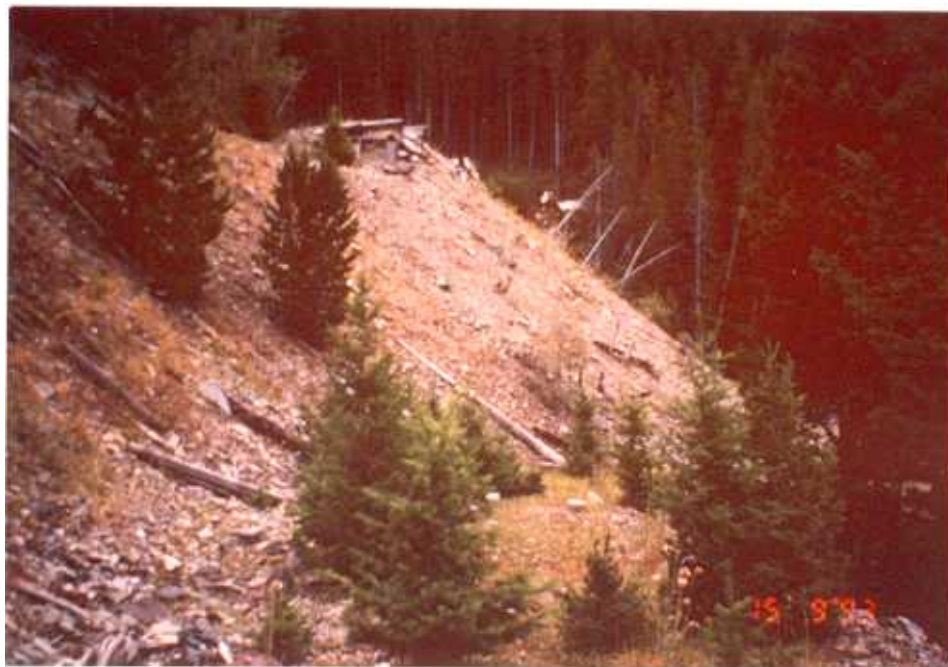
**Figure 2.29** Grasses and conifers have taken root on the steep slopes of the waste-rock dump.

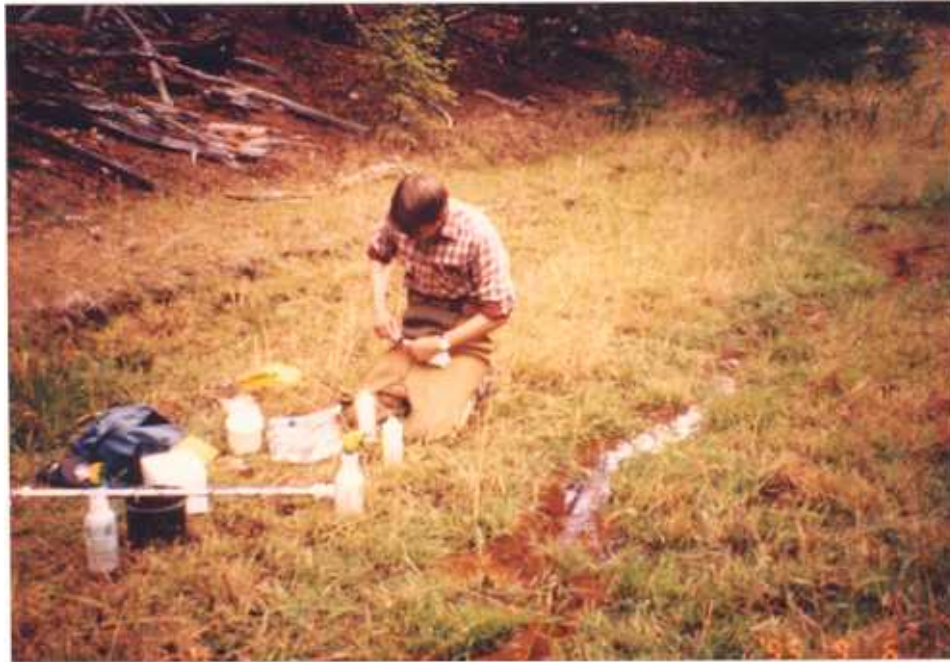
**Figure 2.31** Sample WLWS10M was collected from the seep that flowed from the main tailings impoundment.

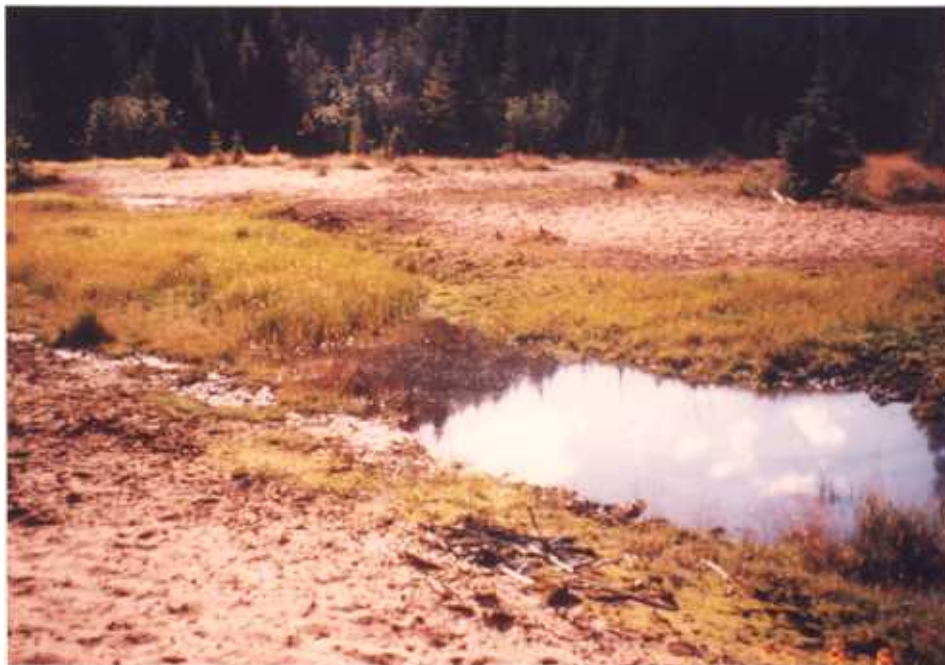
**Figure 2.32** The main tailings impoundment is generally barren; however, along the seep drainage, grasses are growing. Sample WLWD10M was collected in this area.

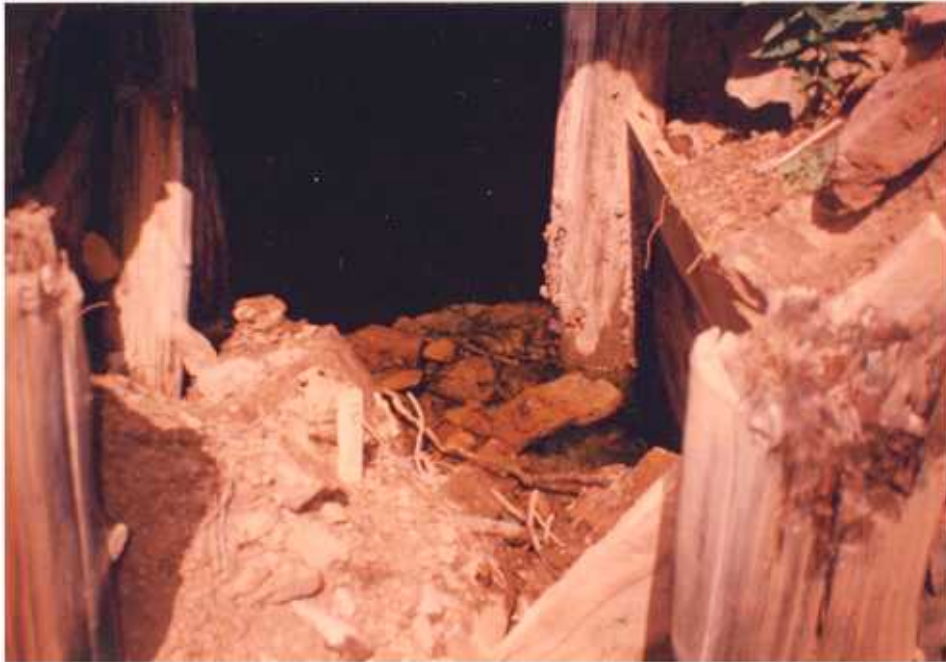
**Figure 3.5** A small, clean discharge flows from open adit A-1. The discharge infiltrates the ground before reaching the creek.

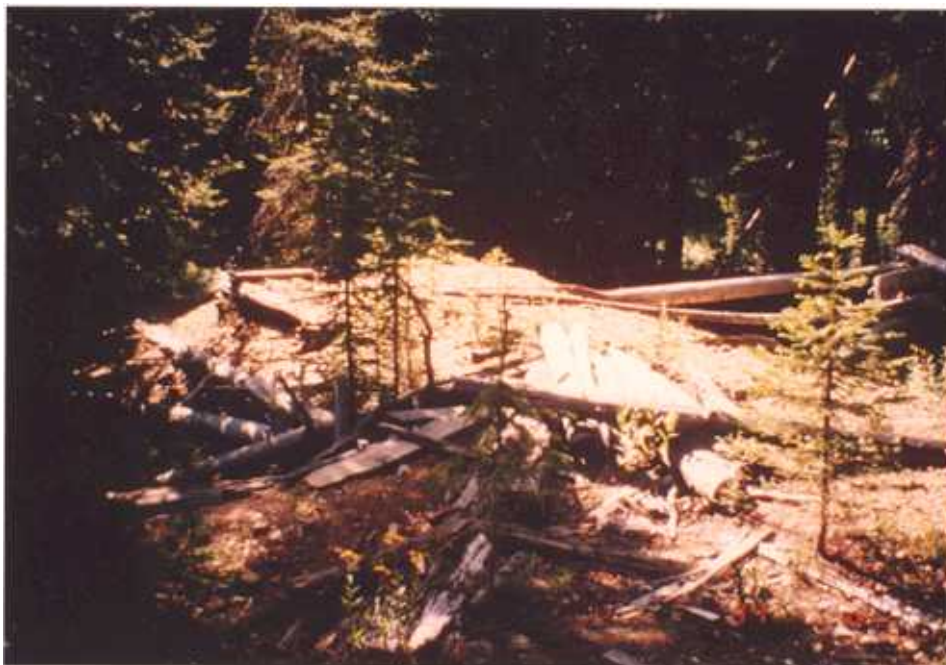
**Figure 3.6** Waste-rock dump W-2 is vegetated with grasses and small conifers. A small seep at the base of the dump does not appear to have an adverse impact.

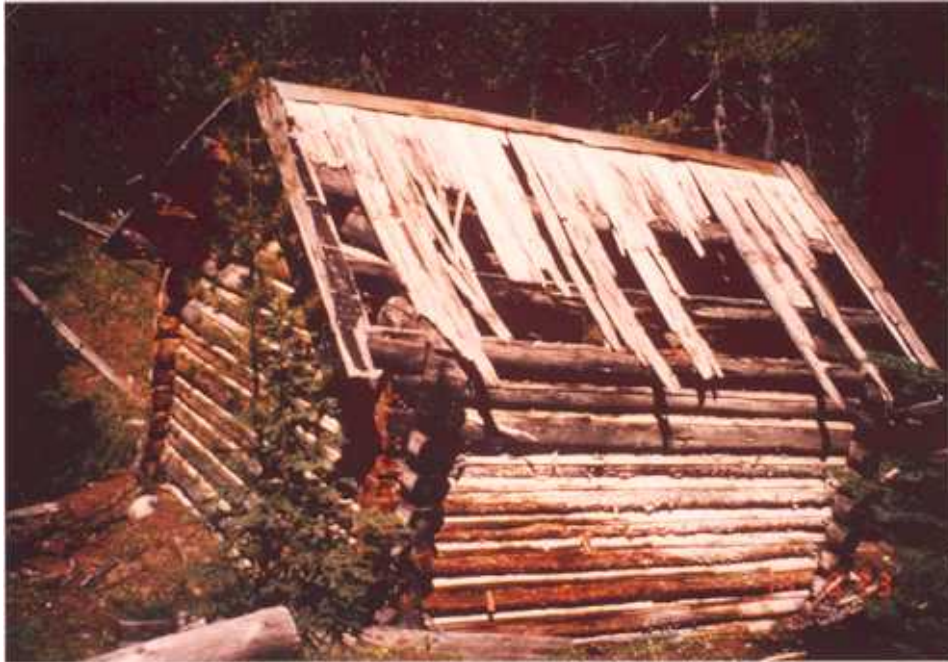
**Figure 3.7** An open shaft is enclosed within a log building below the mill.

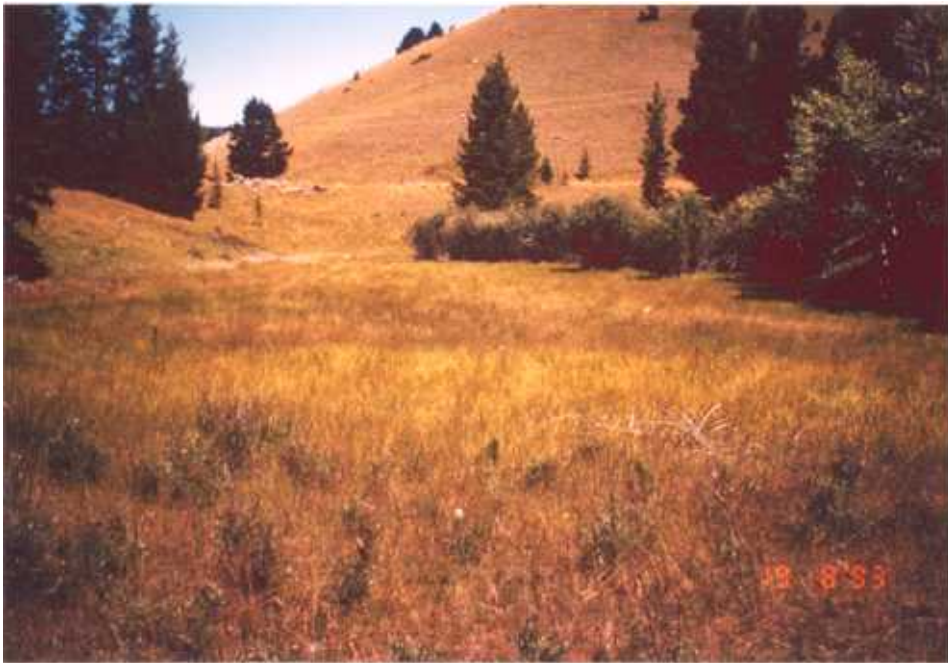
**Figure 3.8** A glacial kettle was used as a tailings impoundment. Vegetation growing on the tailings appears to be healthy.

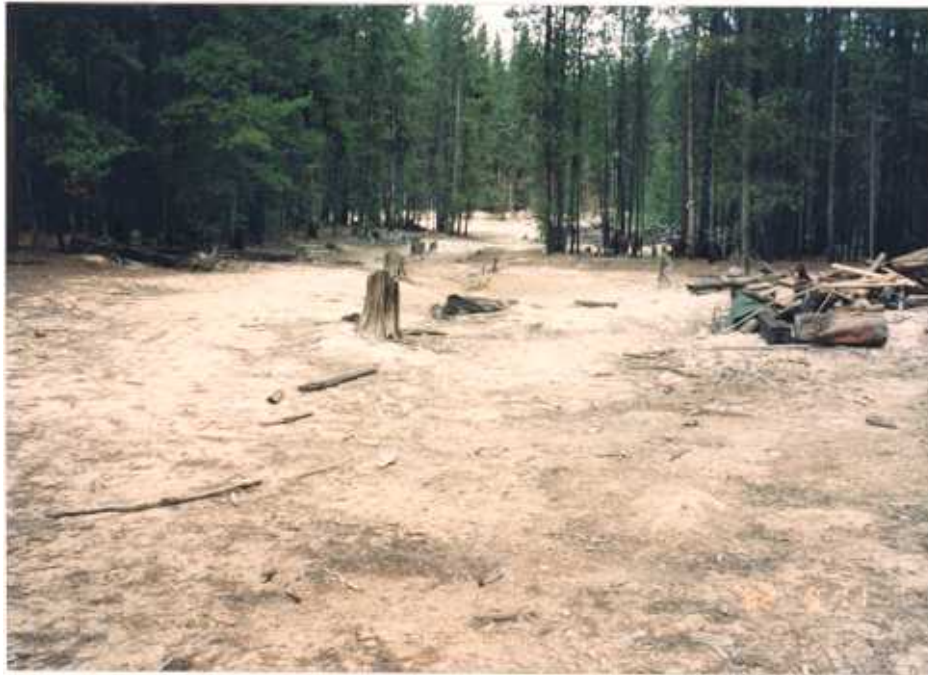
**Figure 3.10** Tailings are spread over a large area at the north end of the site.

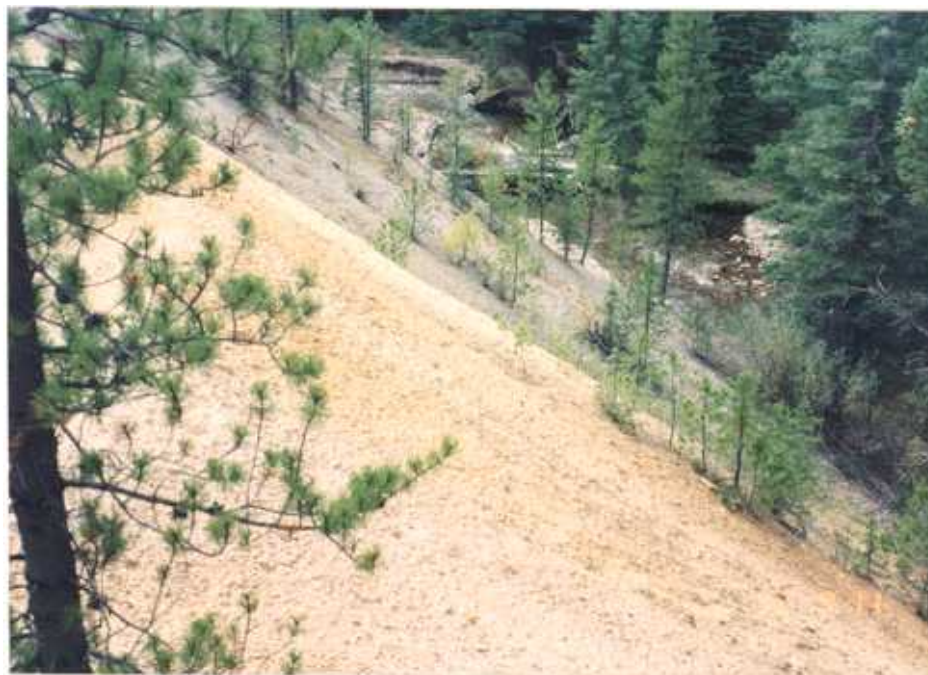
**Figure 3.11** The Middle Fork of Rock Creek (upper right corner) is undercutting and eroding the sparsely vegetated waste-rock dump.

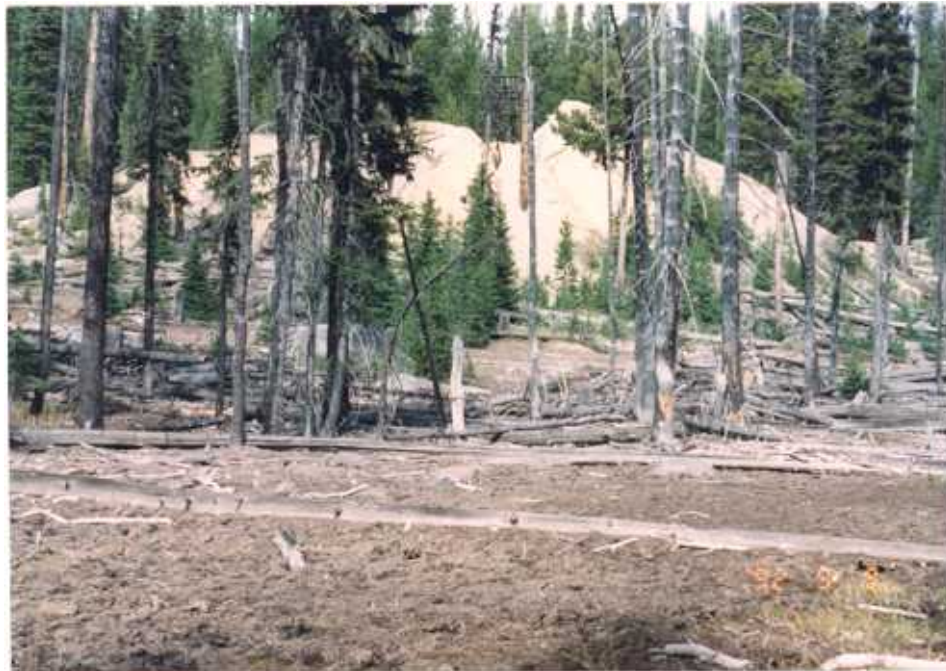
**Figure 3.13** Seeps south of waste-rock W-2 have heavily impacted soil and vegetation on DNF administered land.

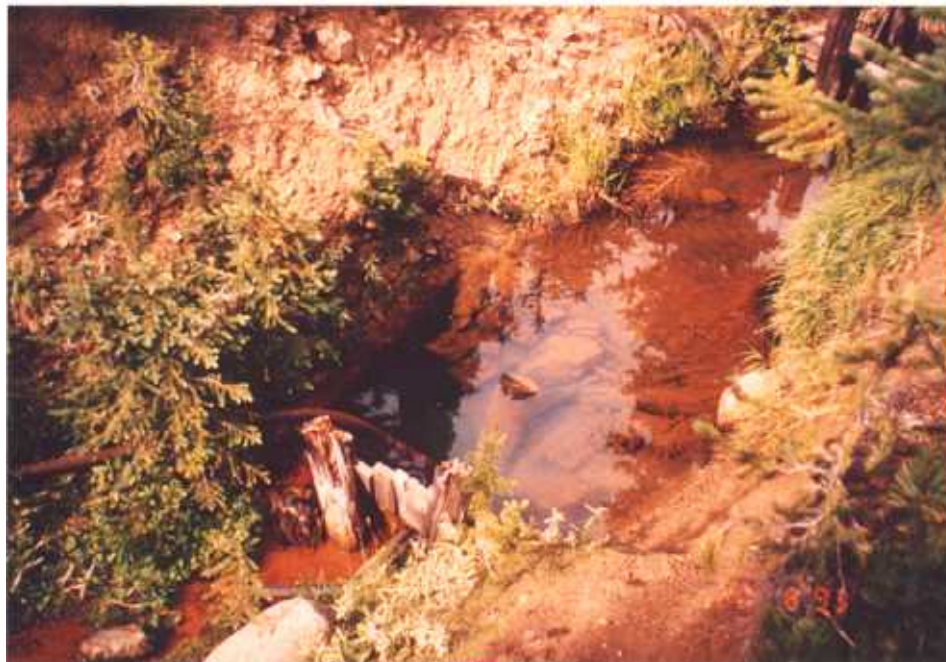
**Figure 3.14** A ferric-hydroxide stained adit discharge (lower left) mixes with water flowing from flooded shaft S-1. The combined discharge flows into a wetland to the east.

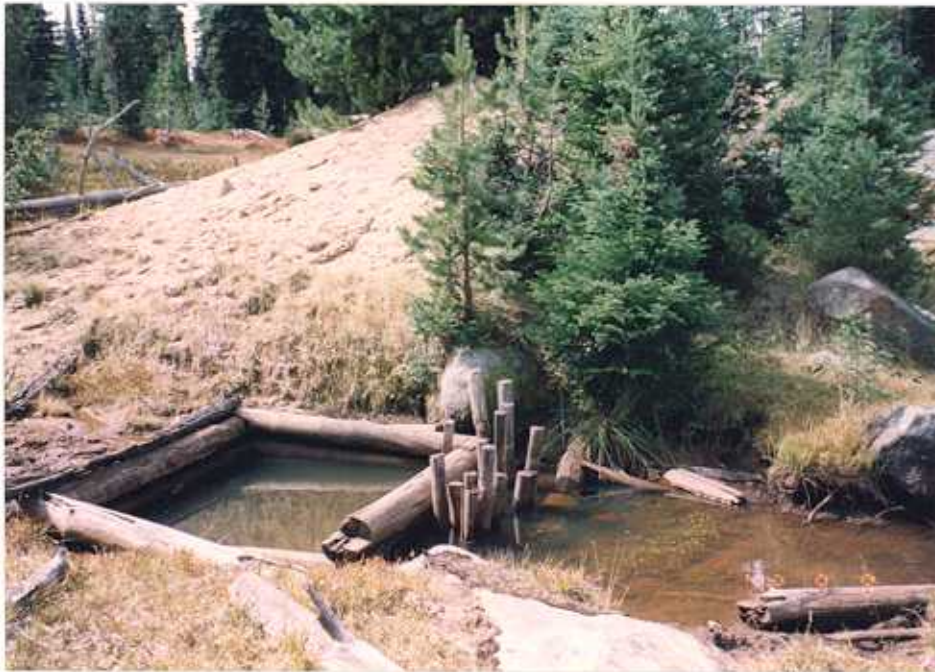
**Figure 3.15** Flooded shaft S-4 has a discharge which also flows into the wetland east of the site.

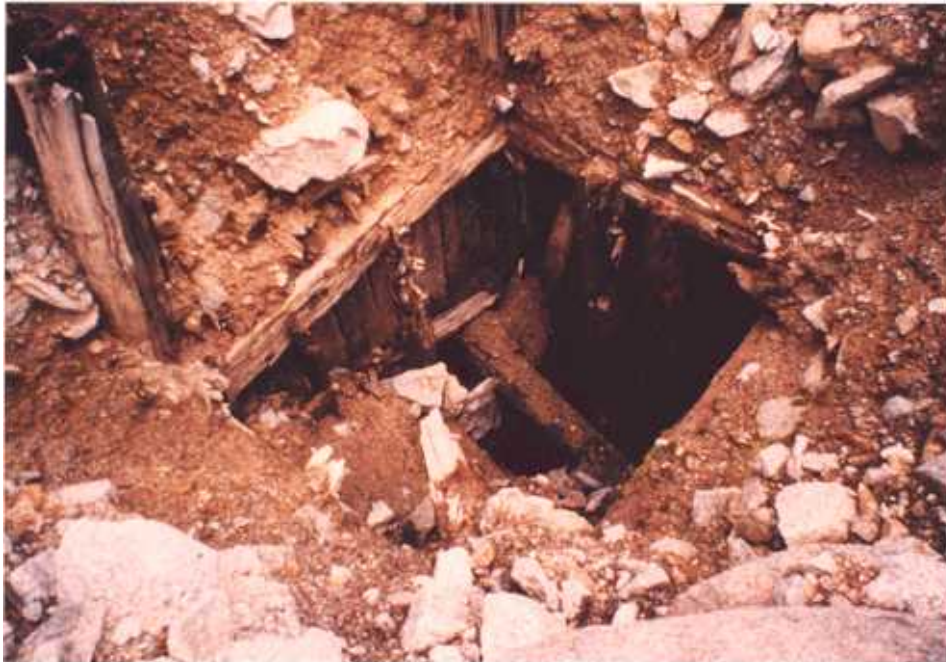
**Figure 3.18** Open, flooded shaft at the Heaney mine. Depth to water is approximately ten feet.

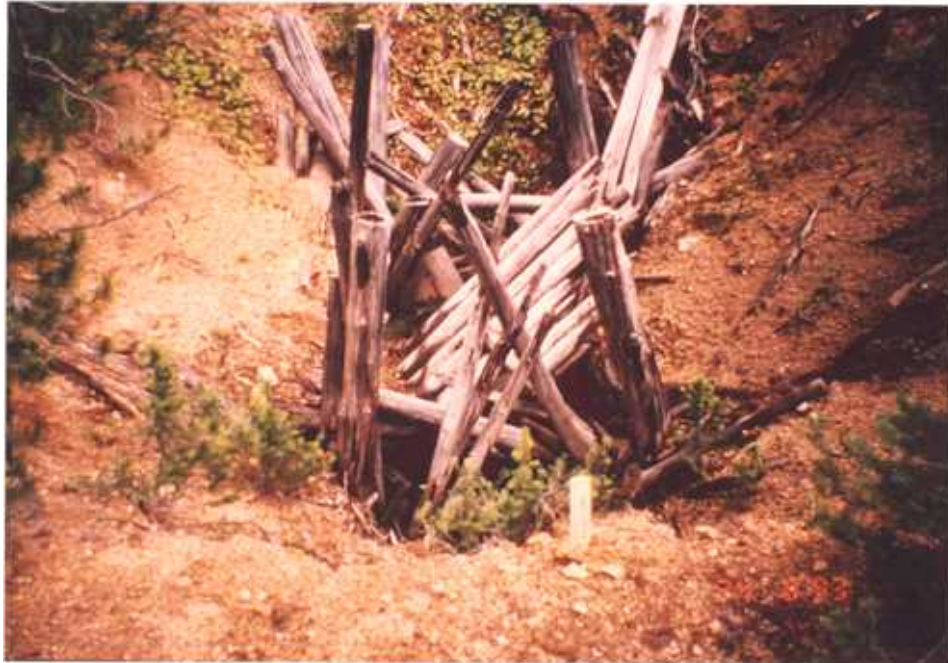
**Figure 3.21** Flooded shaft S-3 is surrounded by a small waste-rock dump.

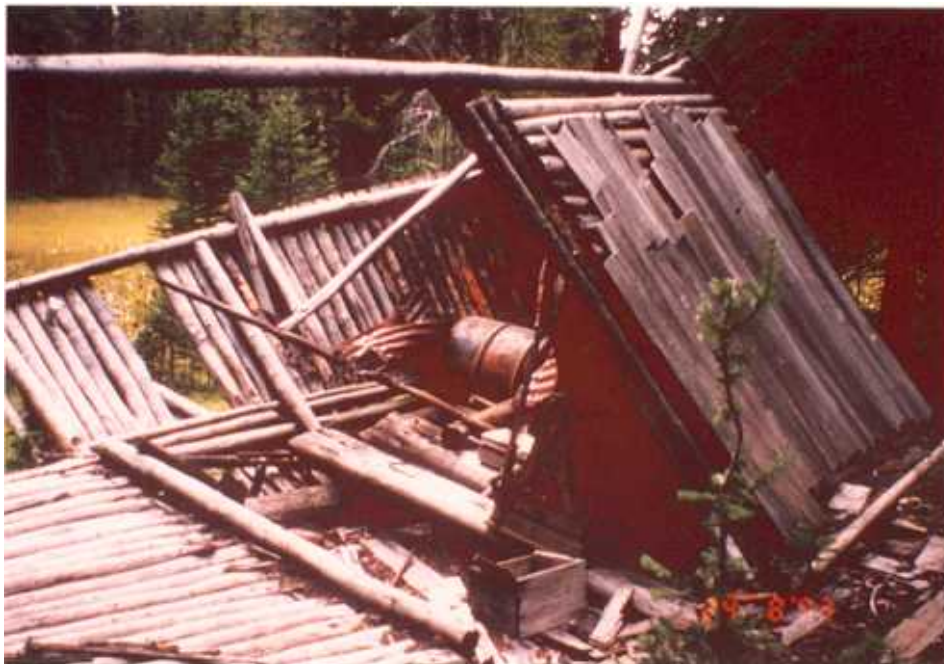
**Figure 3.22** A dilapidated mine building (B-1) with some old machinery is south of shaft S-3.

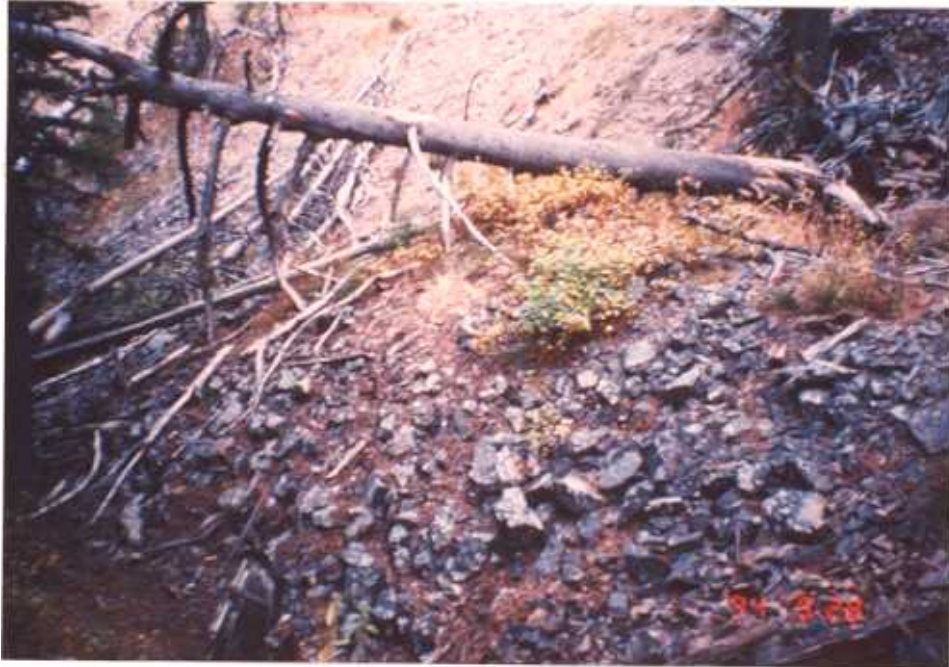
**Figure 3.27** A waste-rock dump near the McDermott mill lies in the path of McDermott Gulch.
