**Montana Bureau of Mines and Geology
Abandoned-Inactive Mines
Helena National Forest**

**Volume I
Upper Missouri River Drainage**

MBMG 352

**Prepared for the U.S. Department of Agriculture
Forest Service -Region 1**

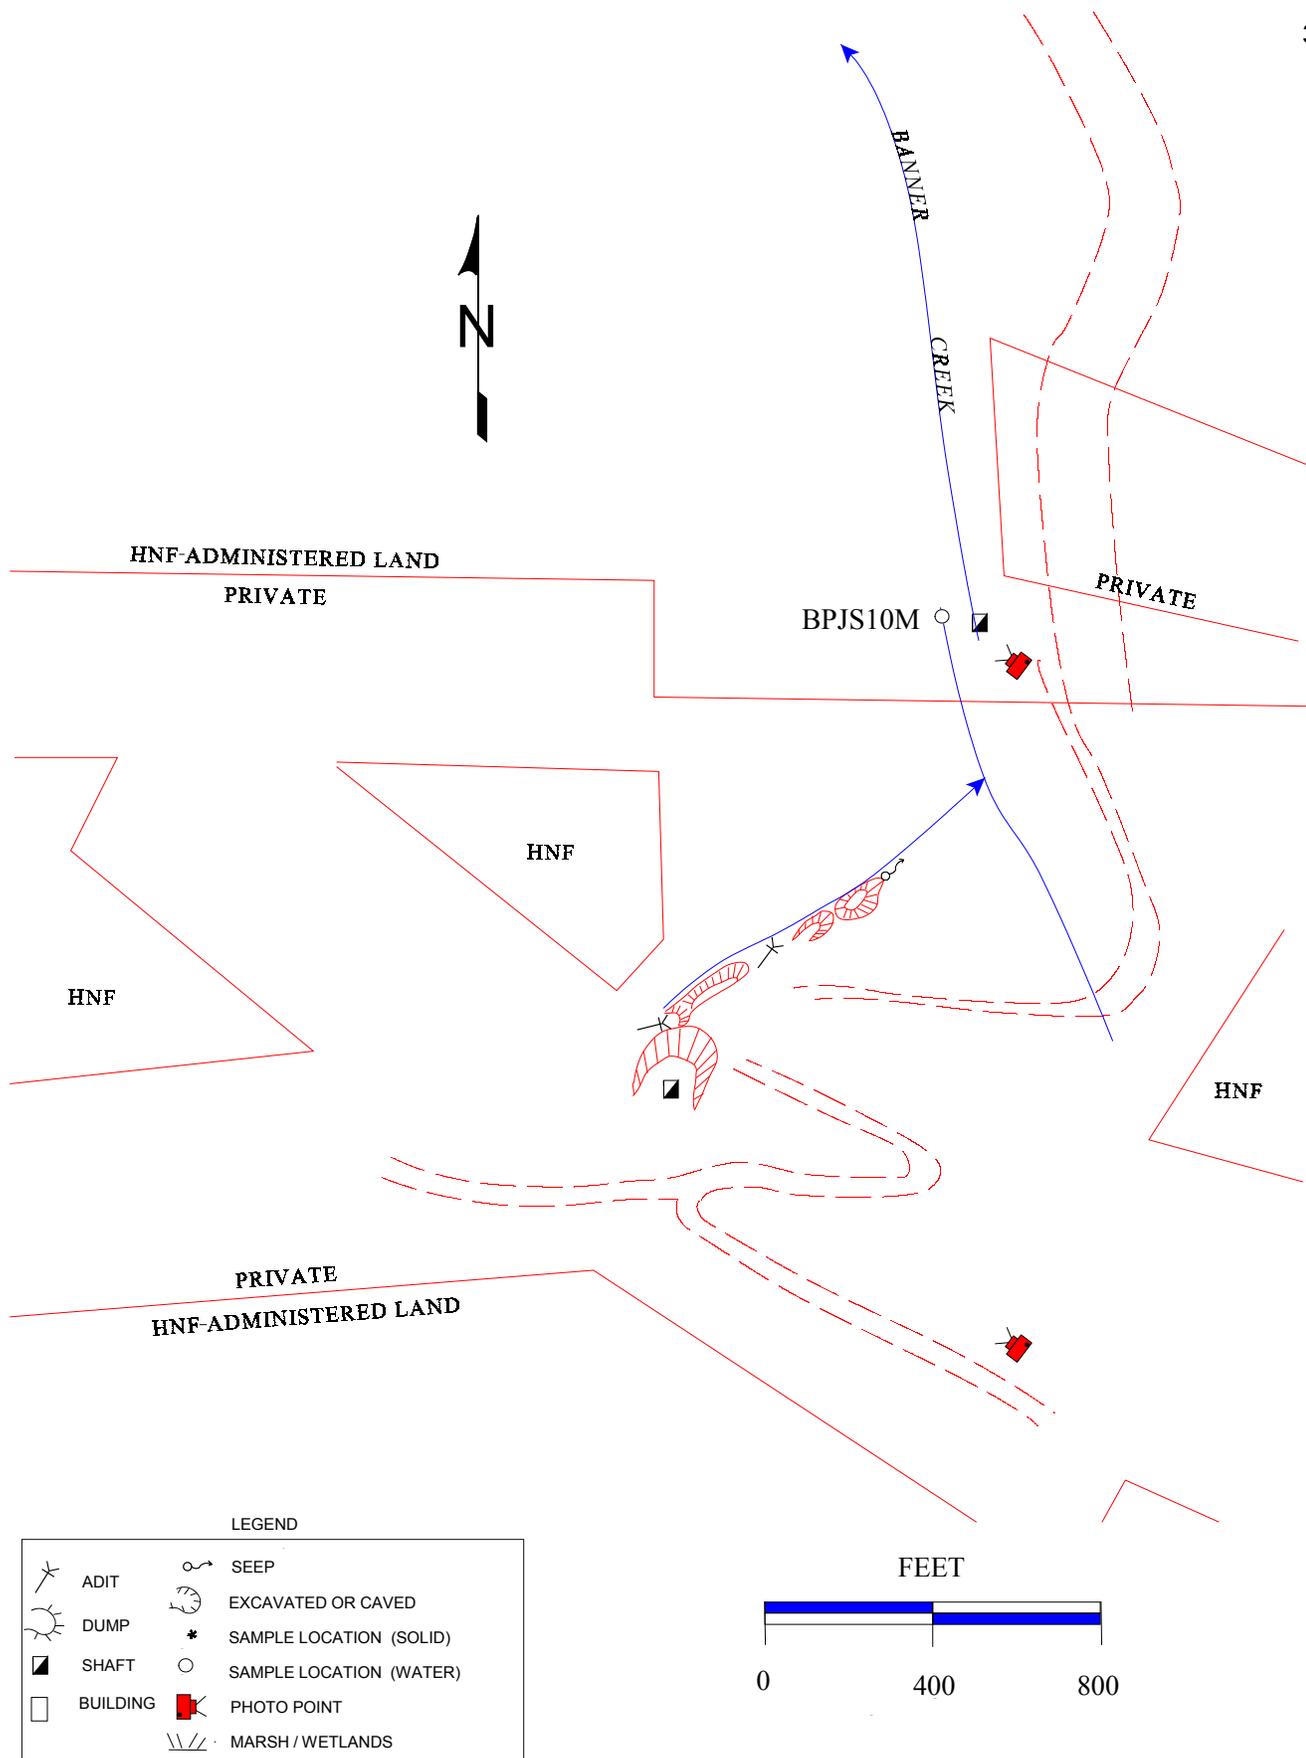
Figure 4. The Peerless Jenny mine (9/22/93) is on private land in Banner Creek. An unnamed tributary flows past the waste material and into Banner Creek below the mine

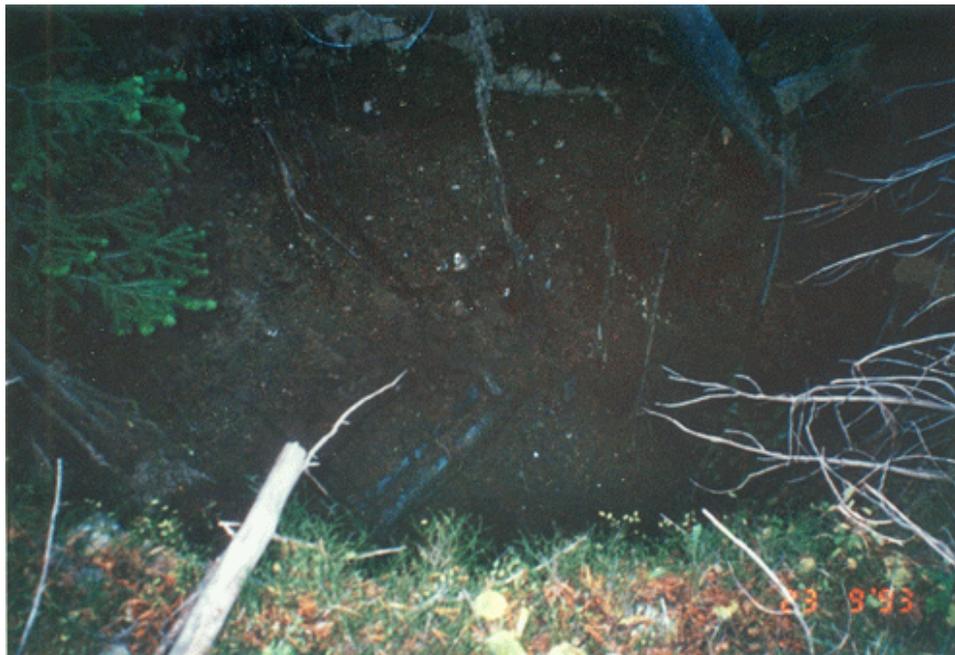
Figure 4b. The opening on the side of the hill is inconspicuous; it was uncertain if it is related to mining.

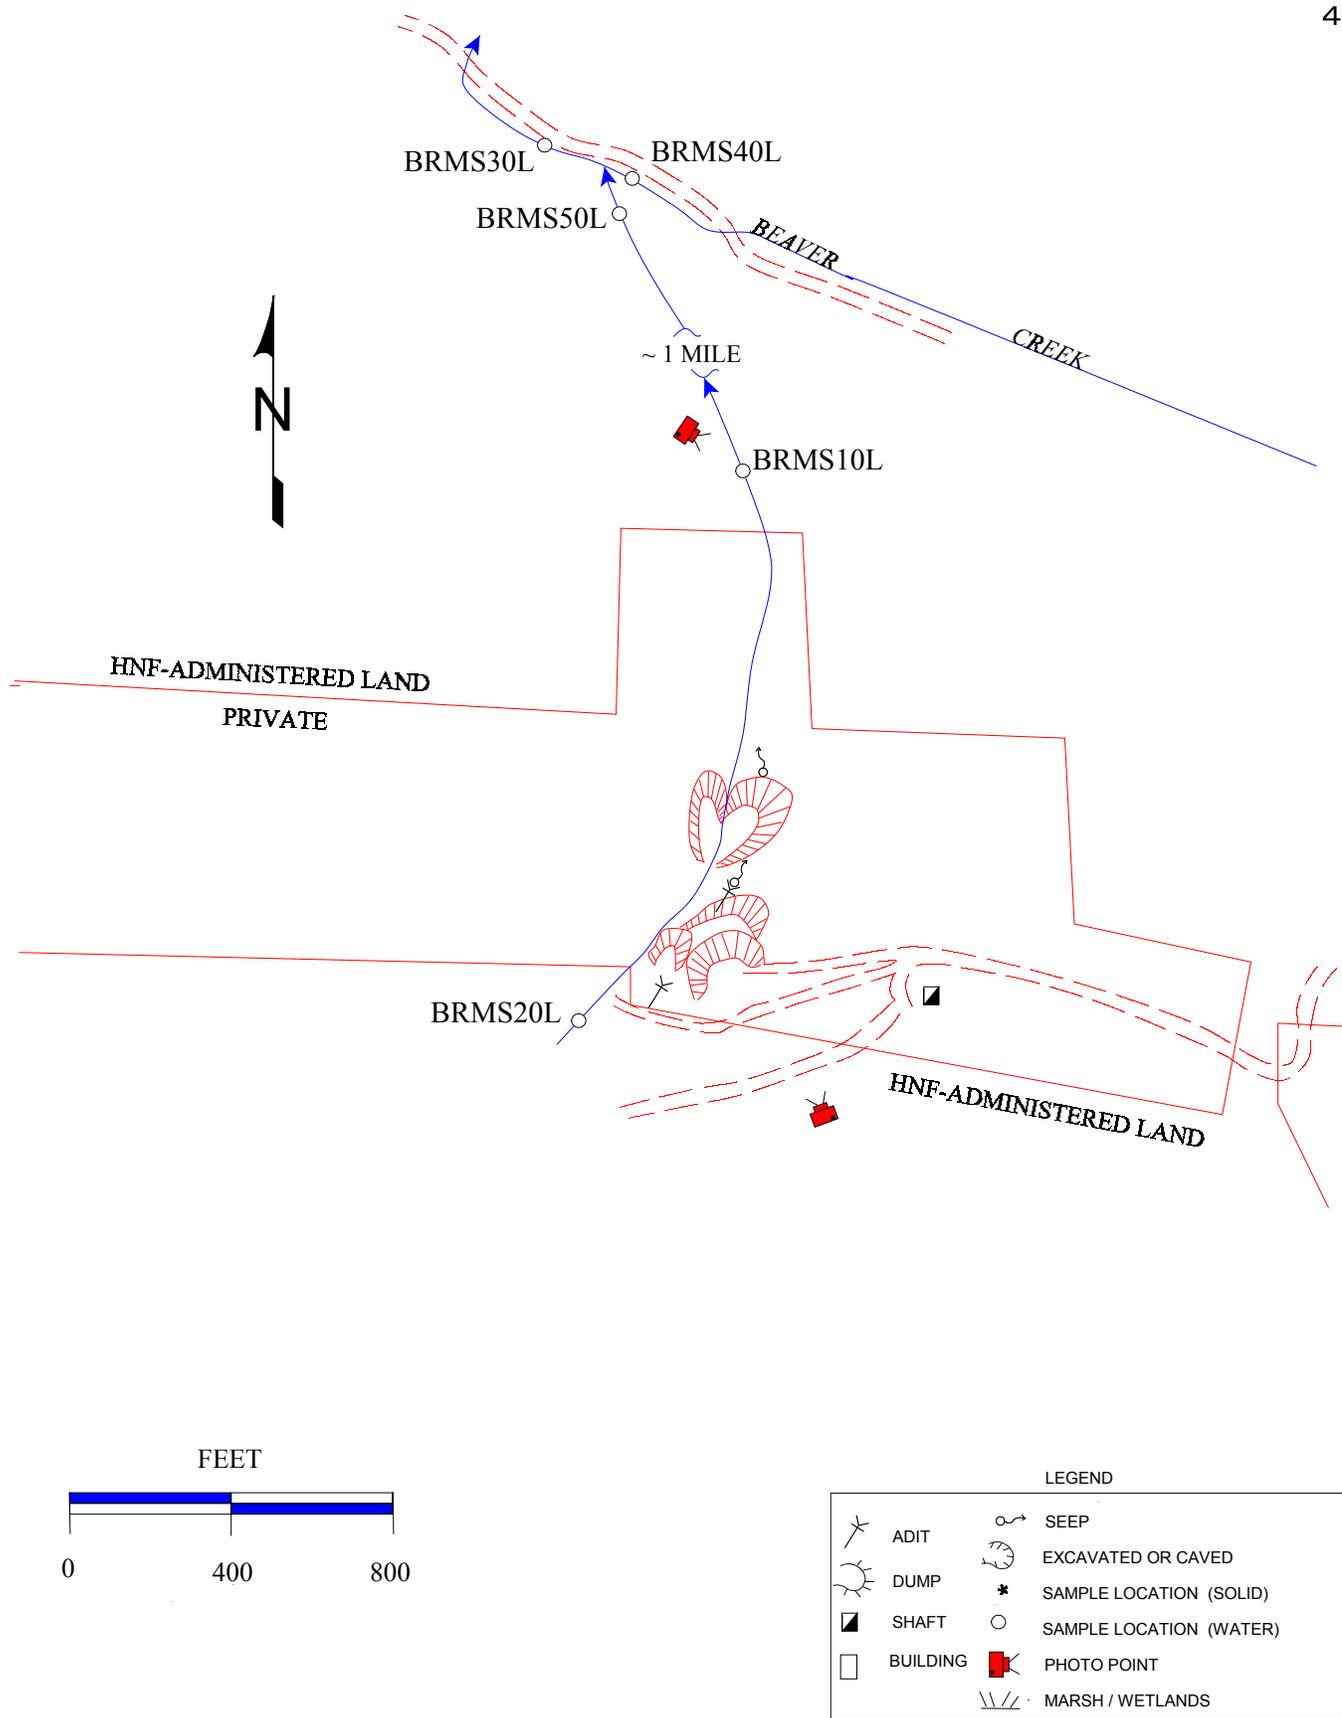
Figure 5. The Sallie Bell (Red Mountain) mine (7/21/93) is on private land in Beaver Creek. The unnamed tributary flowing past the waste-rock dumps into Beaver Creek.

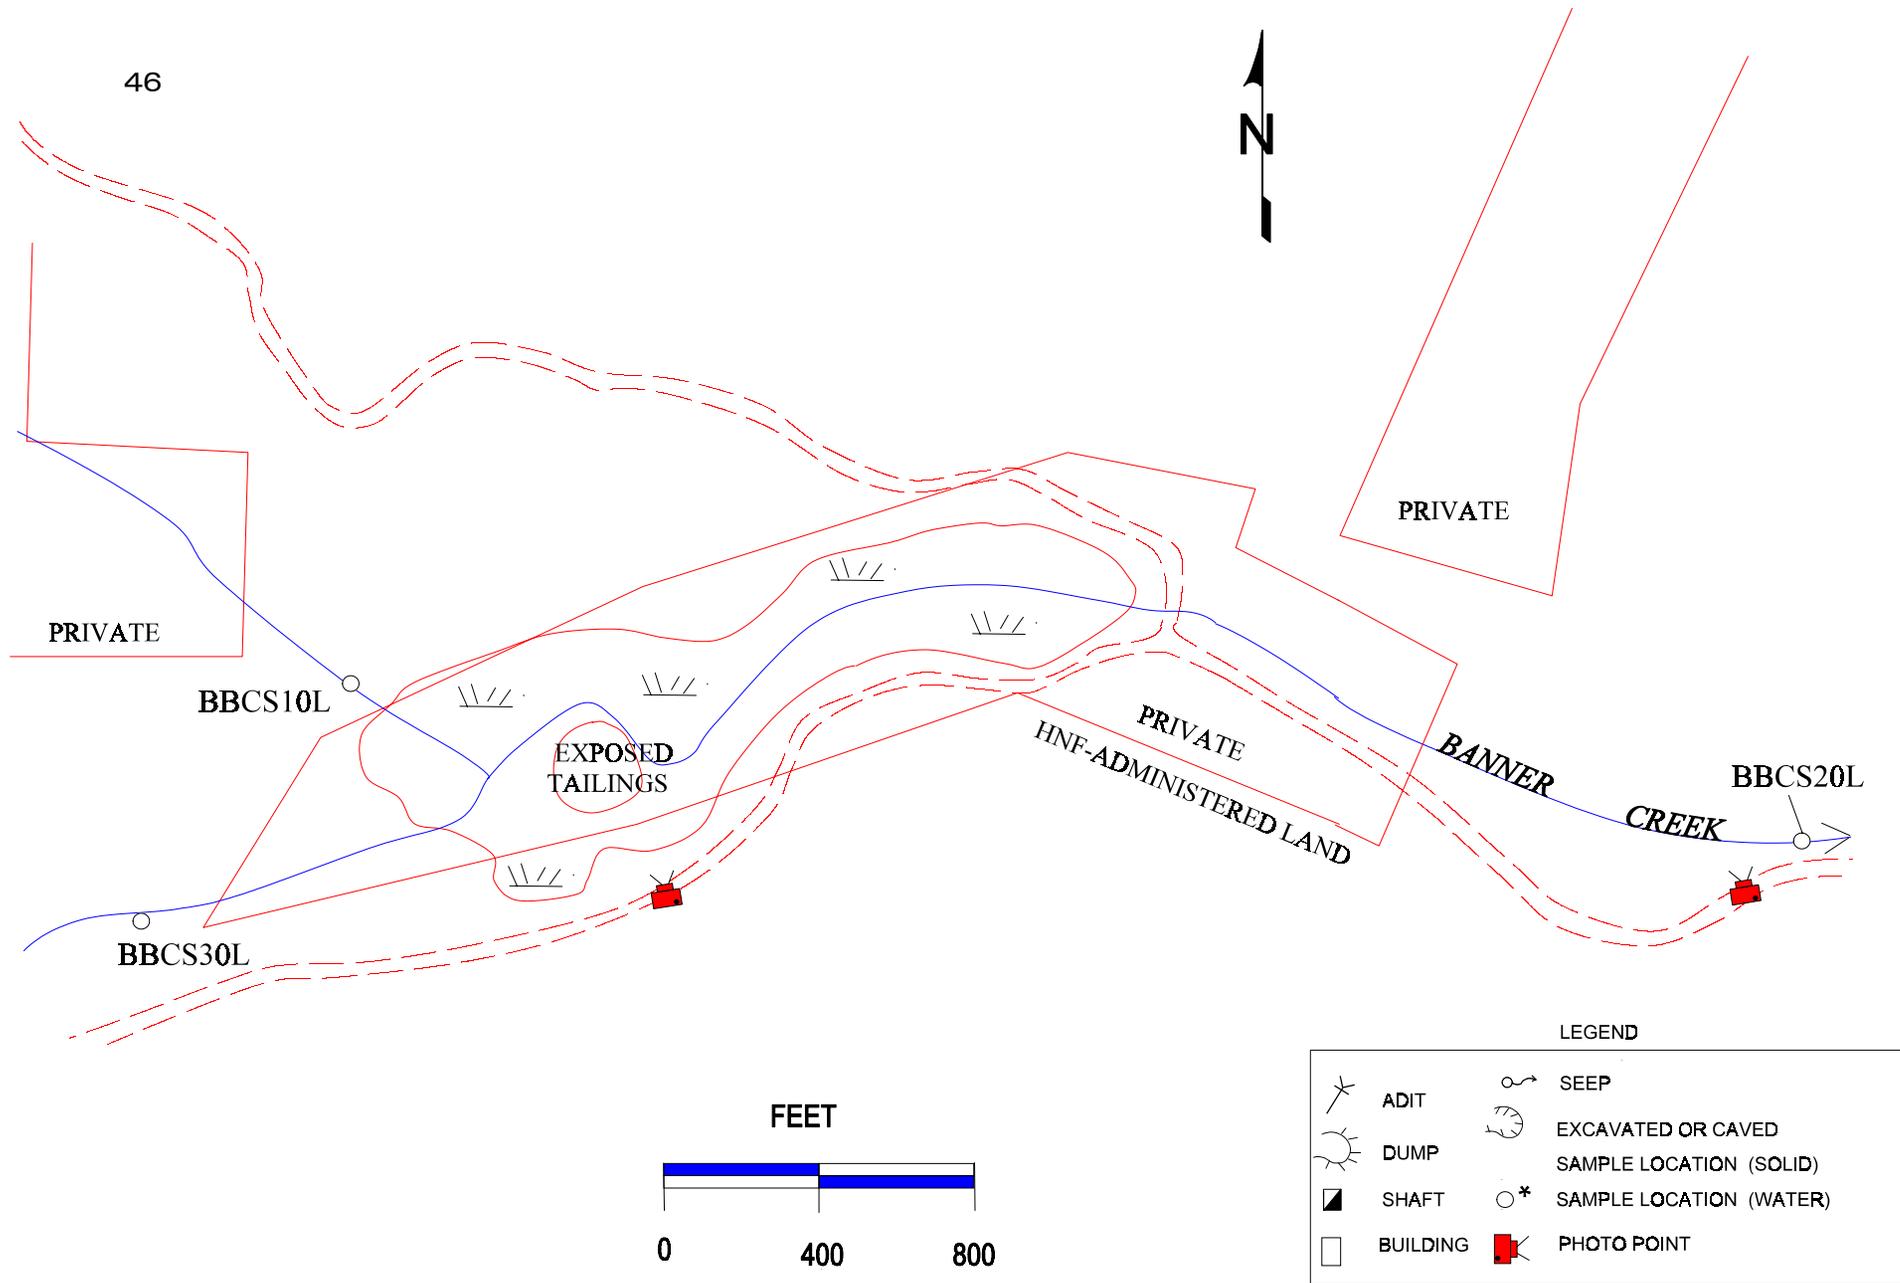
Figure 6. The Banner Creek tailings (8/25/93) are in the flood plain of Banner Creek. Most of the tailings are on private land.

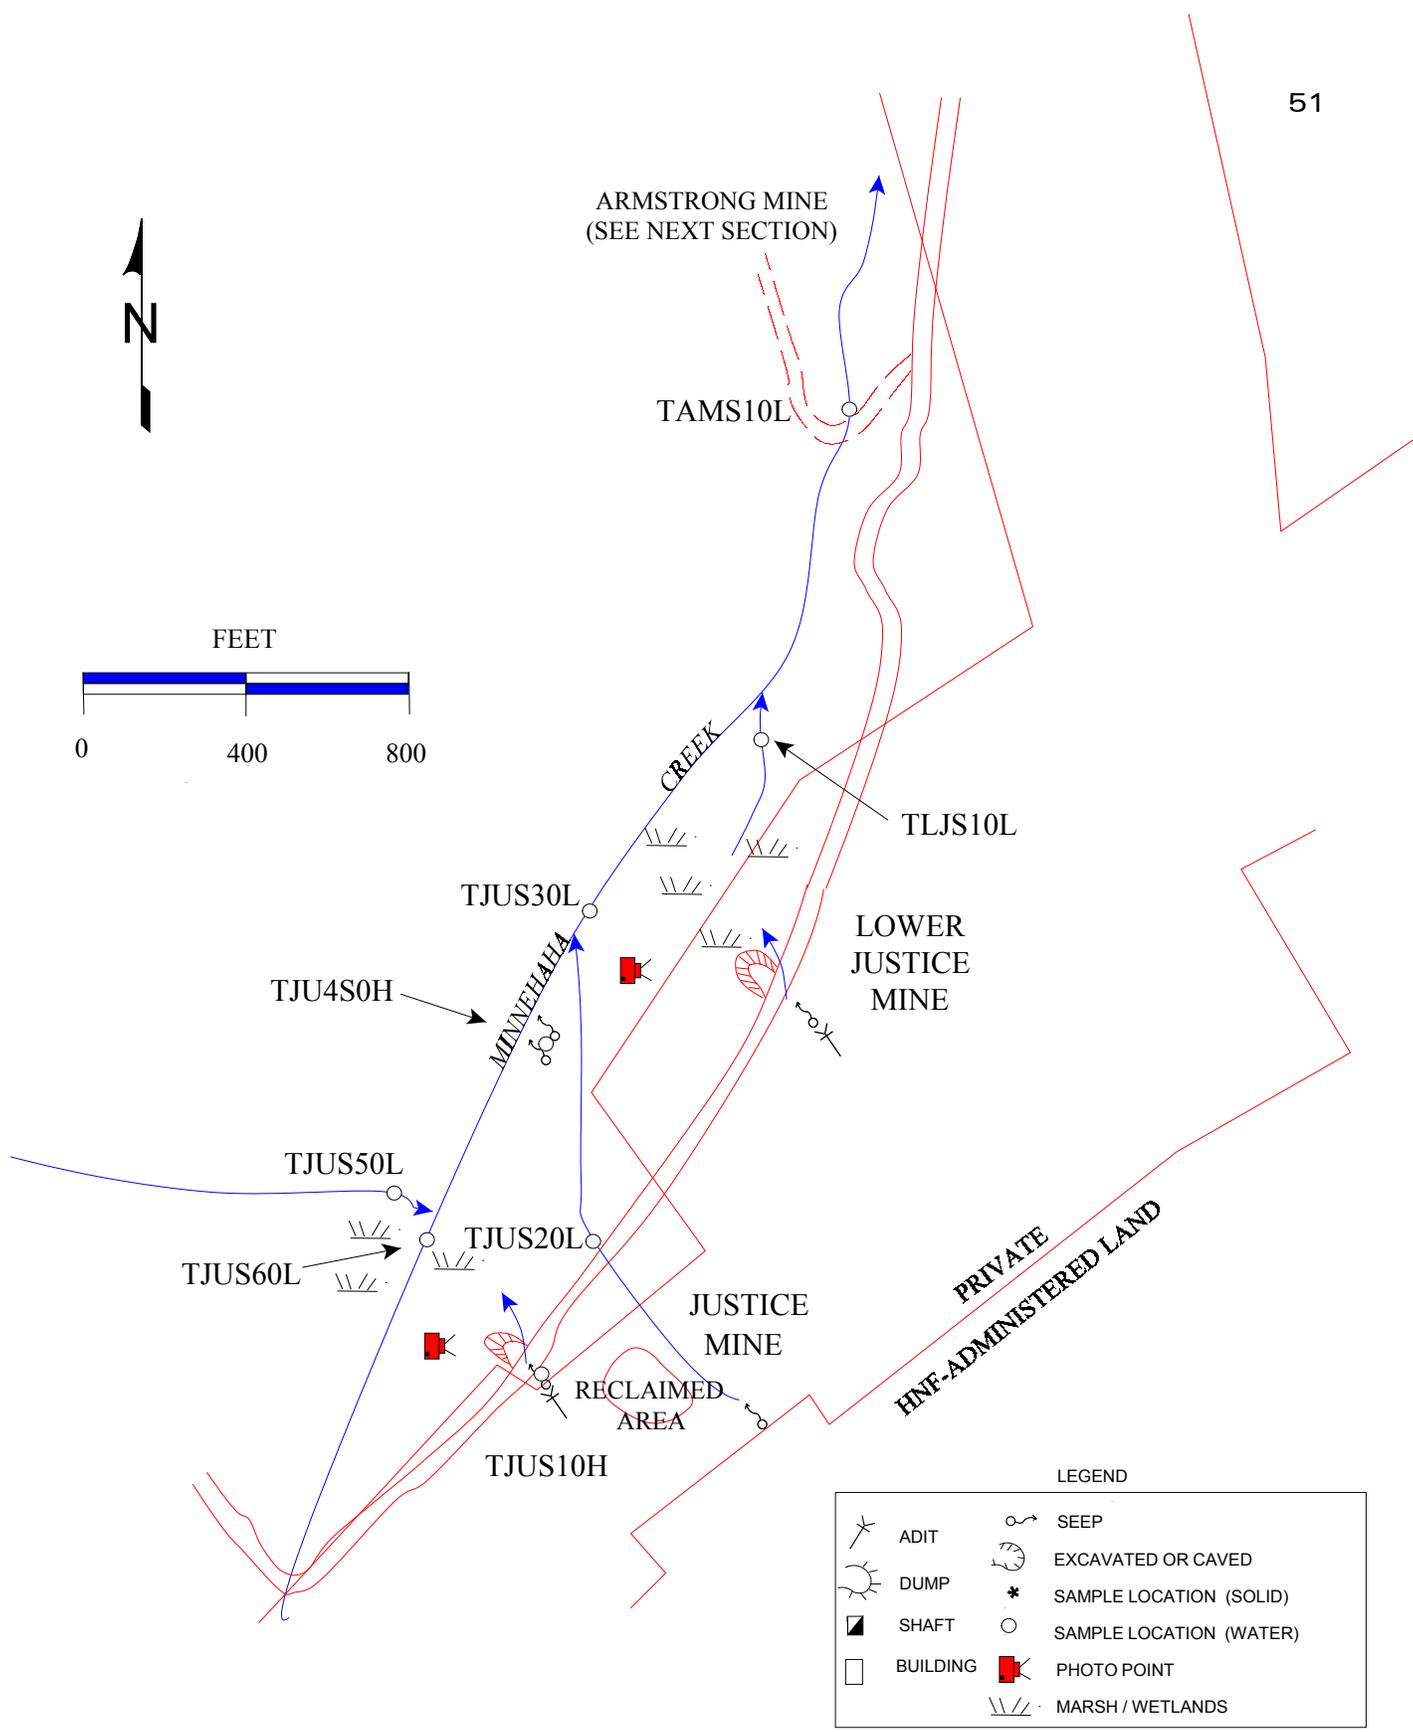
The concentrations of dissolved metals in the upper adit discharge and the seeps along Minnehaha Creek are quite high; several MCLs and ALSs were exceeded (table 11). With the exception of aluminum, the persistence of the metals dissolved in the stream was limited to a few hundred feet; the concentrations of all dissolved metals in TJUS30L were significantly lower. The concentrations of dissolved metals apparently decreased with distance downstream as indicated by the results of TAMS10L.

Figure 7. The Justice and lower Justice mines (6/9/94) are on private lands adjacent to Minnehaha Creek. Several site discharges flow into the creek, which is on HNF- administered land.

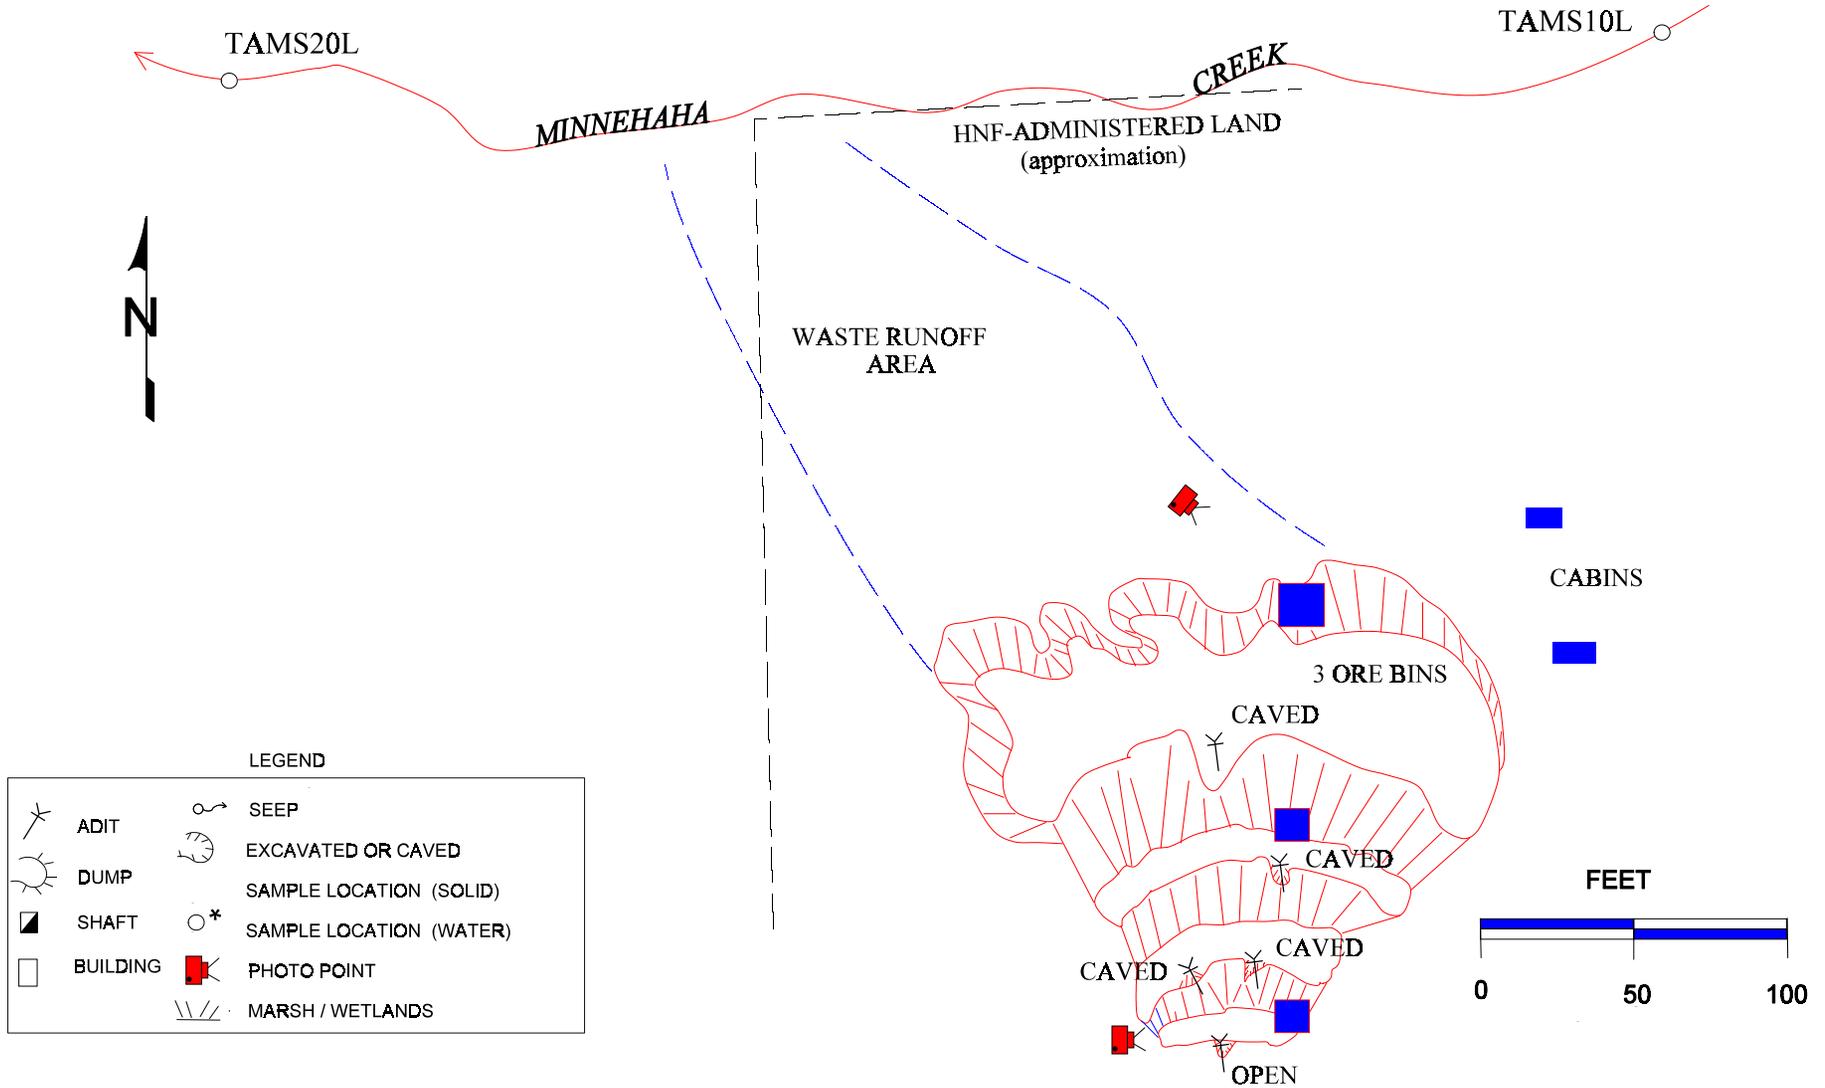
Figure 8. The Armstrong mine (8/19/93) is on HNF- administered land above Minnehaha Creek. Although dry, waste material from the dumps had been washed down toward the creek.

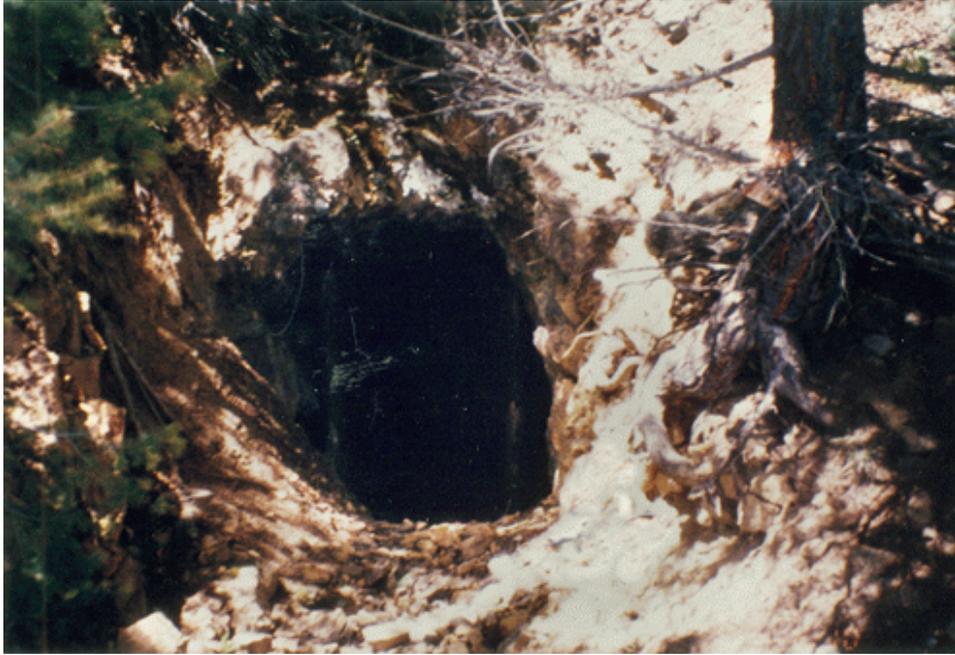
Figure 8a. The upper adit of the Armstrong mine was open at the time of the visit. There was no evidence of discharge.

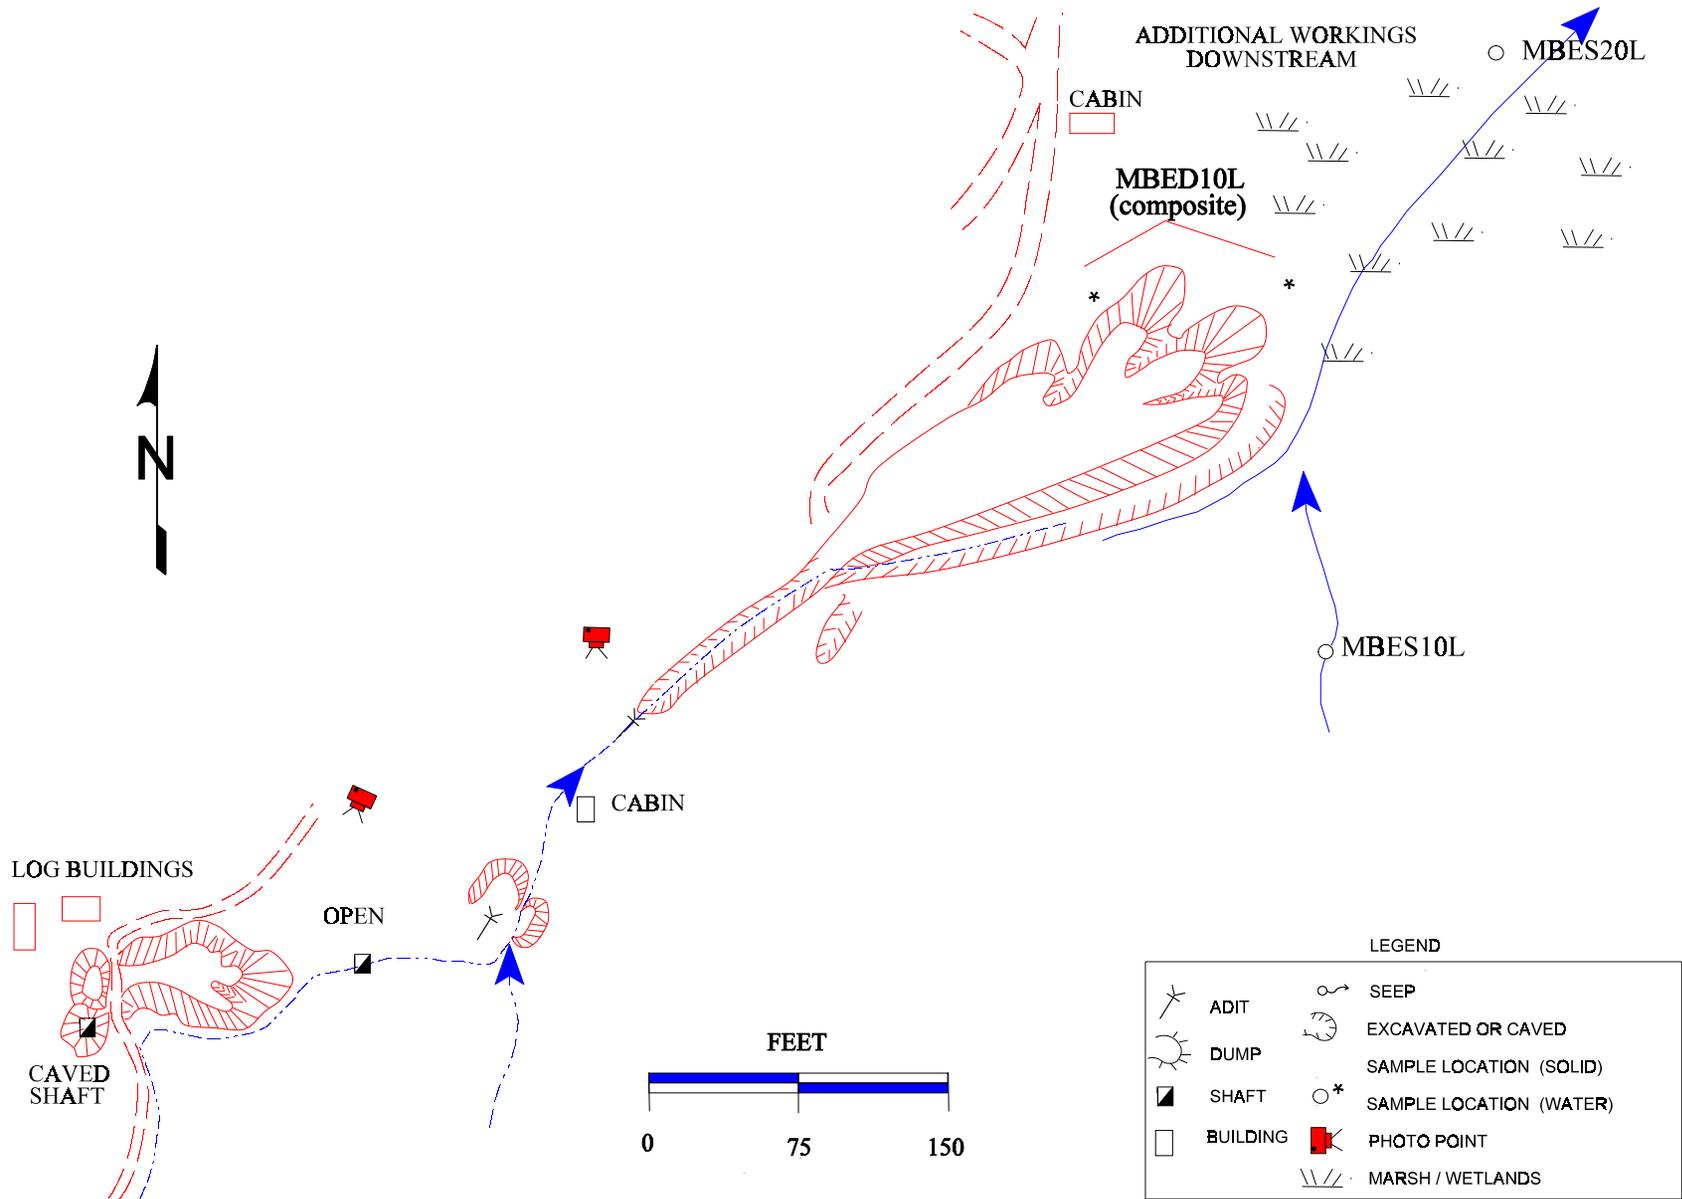
Figure 9. The Beatrice mine (8/19/93) has several large waste-rock dumps. Surface-water flowing on and near the site varies quite dramatically with the season.

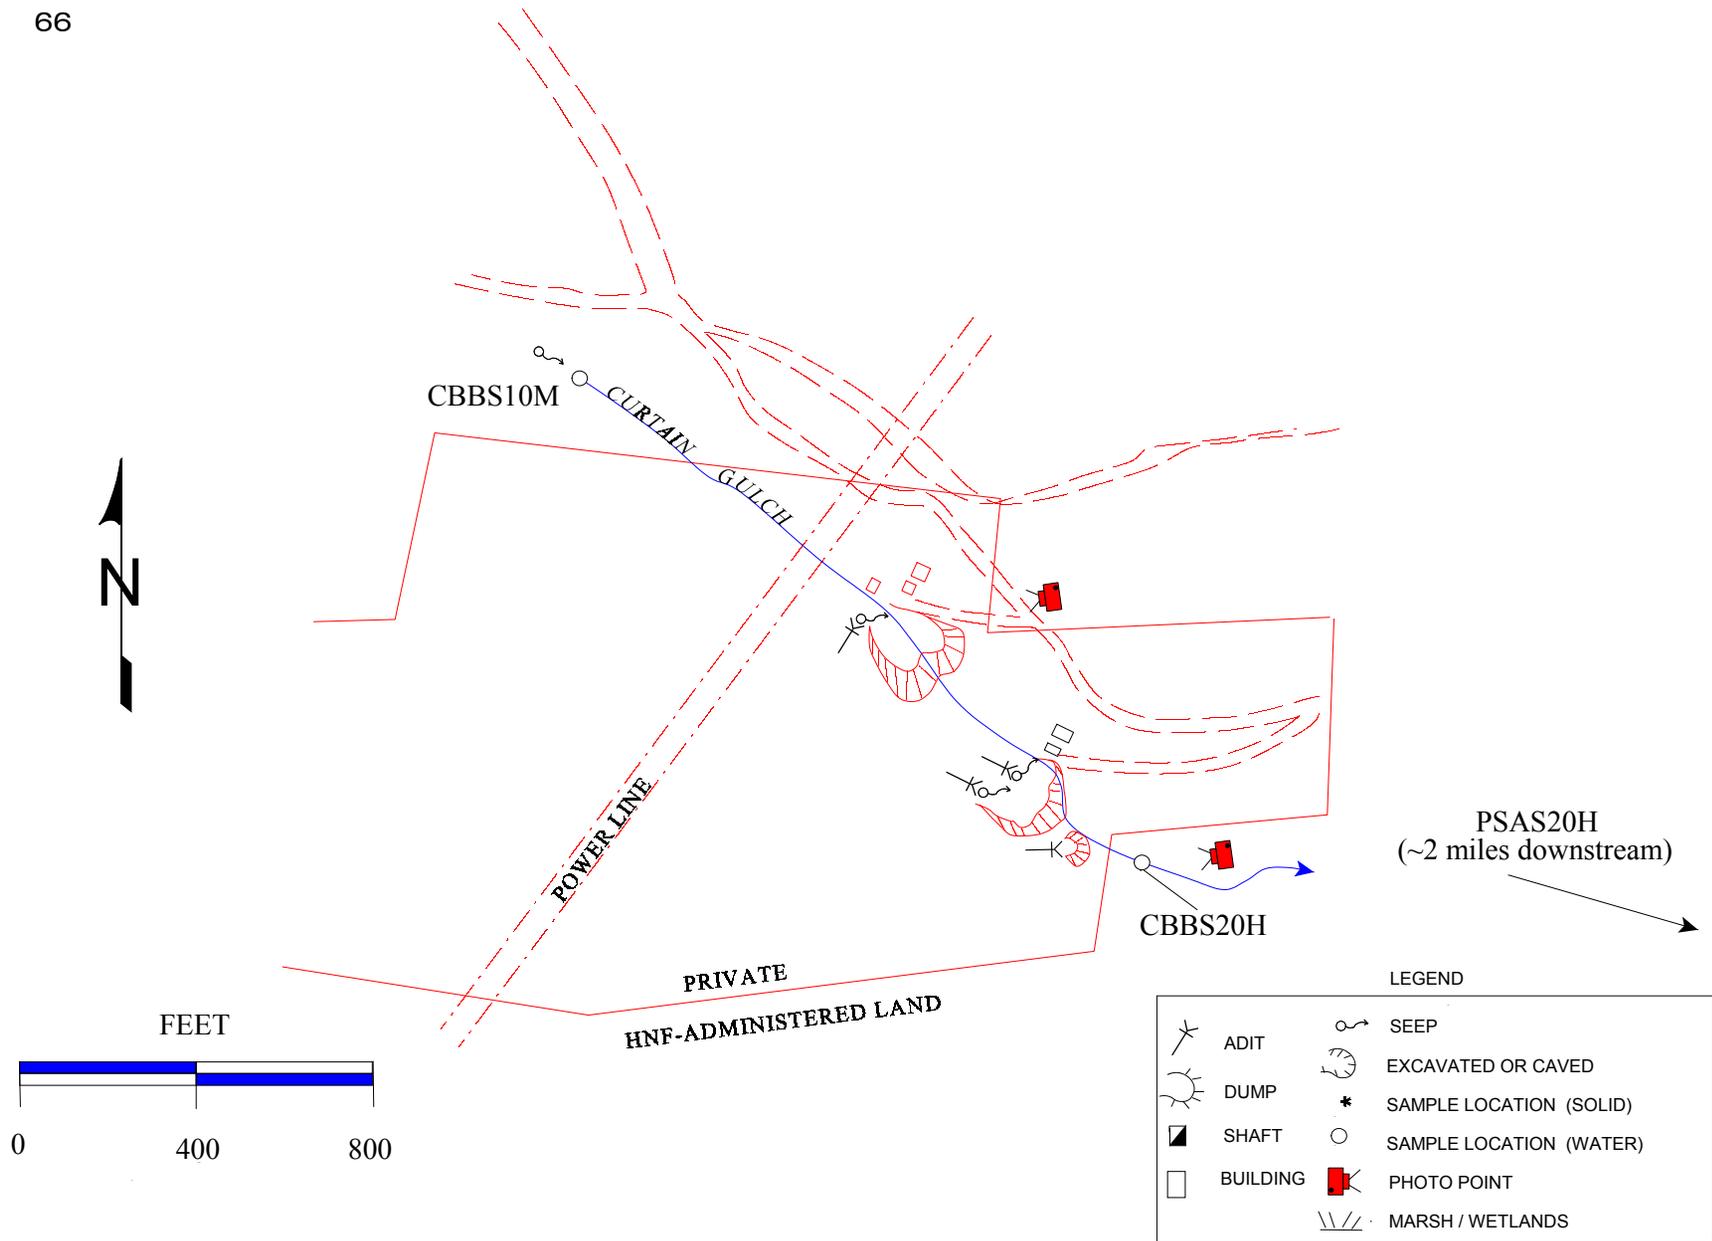
Figure 10. The Bluebird mine (10/13/93) is on private land in Curtin Gulch. Several of the adits had active discharges that flowed into the creek. Samples were collected upstream and down stream of the mine.

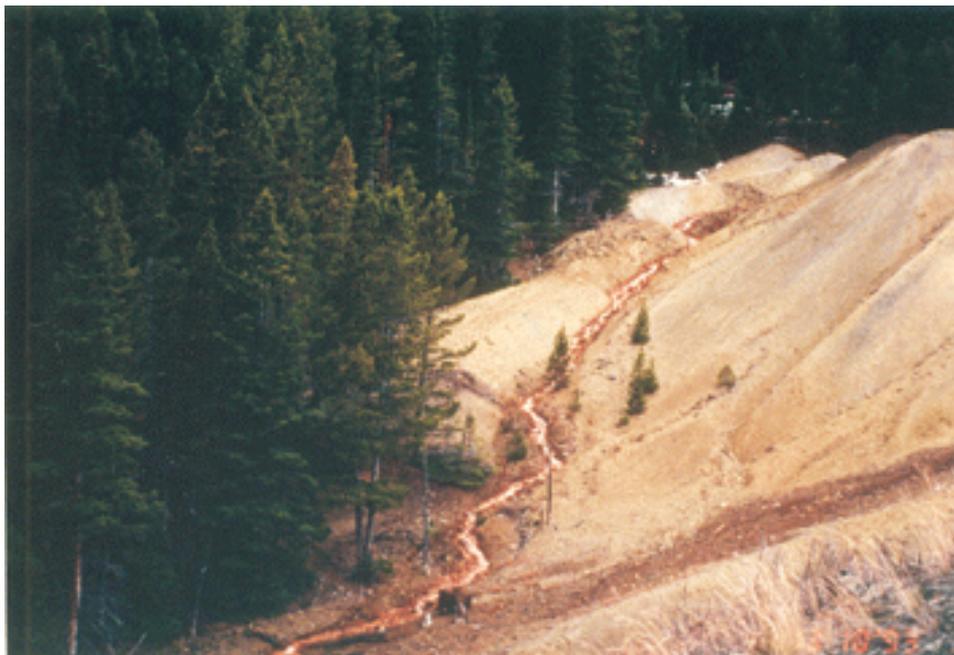
Figure 10a. Curtain Gulch flowing through the Bluebird mine was visibly impacted by the dissolution of metals from the waste material.

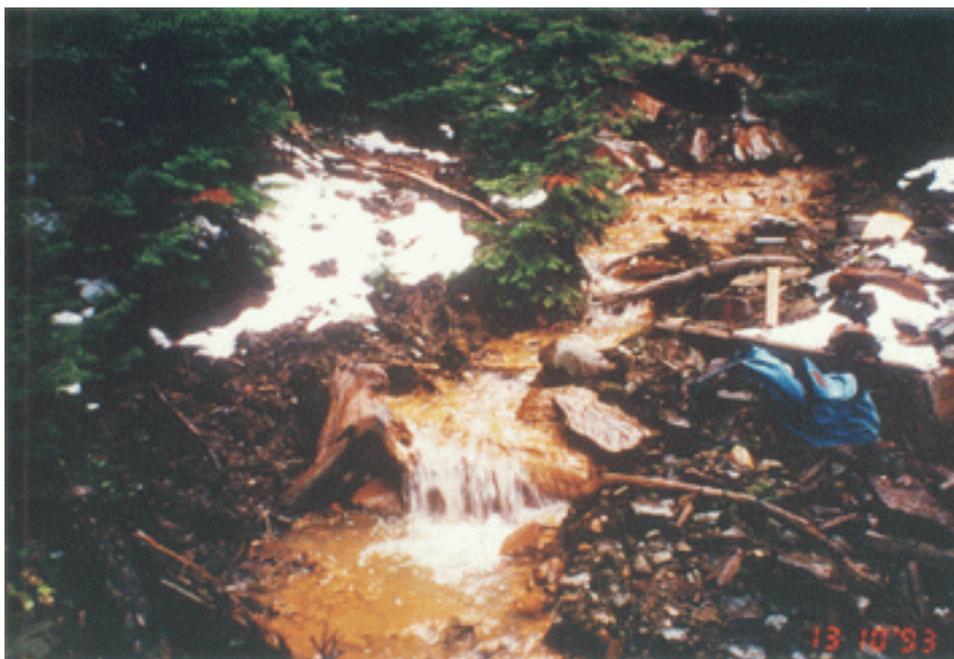
Figure 10b. Curtain Gulch below the Bluebird mine on HNF-administered land was still visibly impacted.

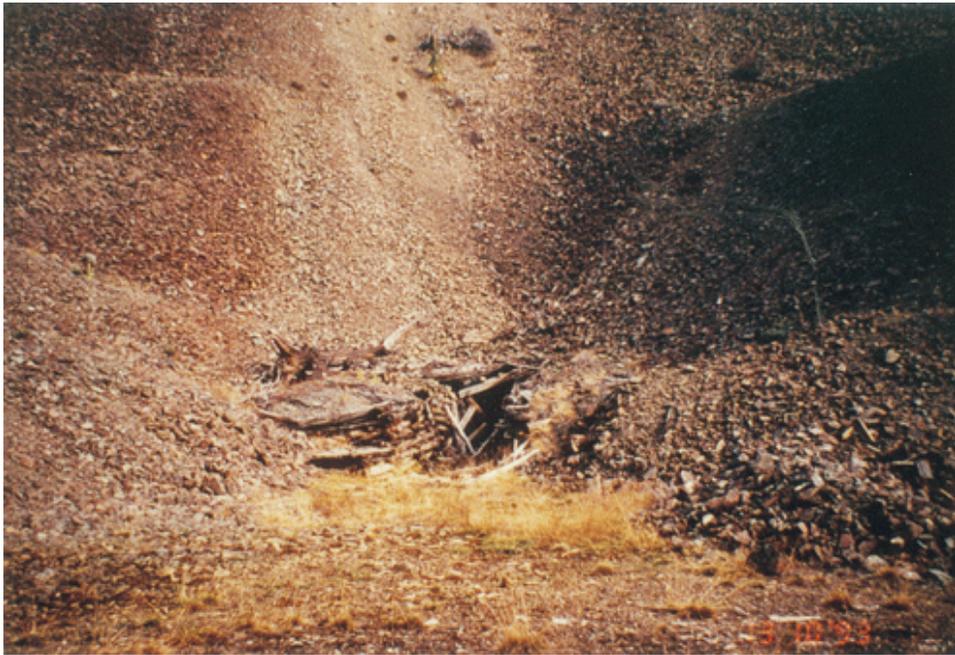
Figure 11a. The main adit of the Salvai mine was collapsed and dry. There was no evidence of past discharge.

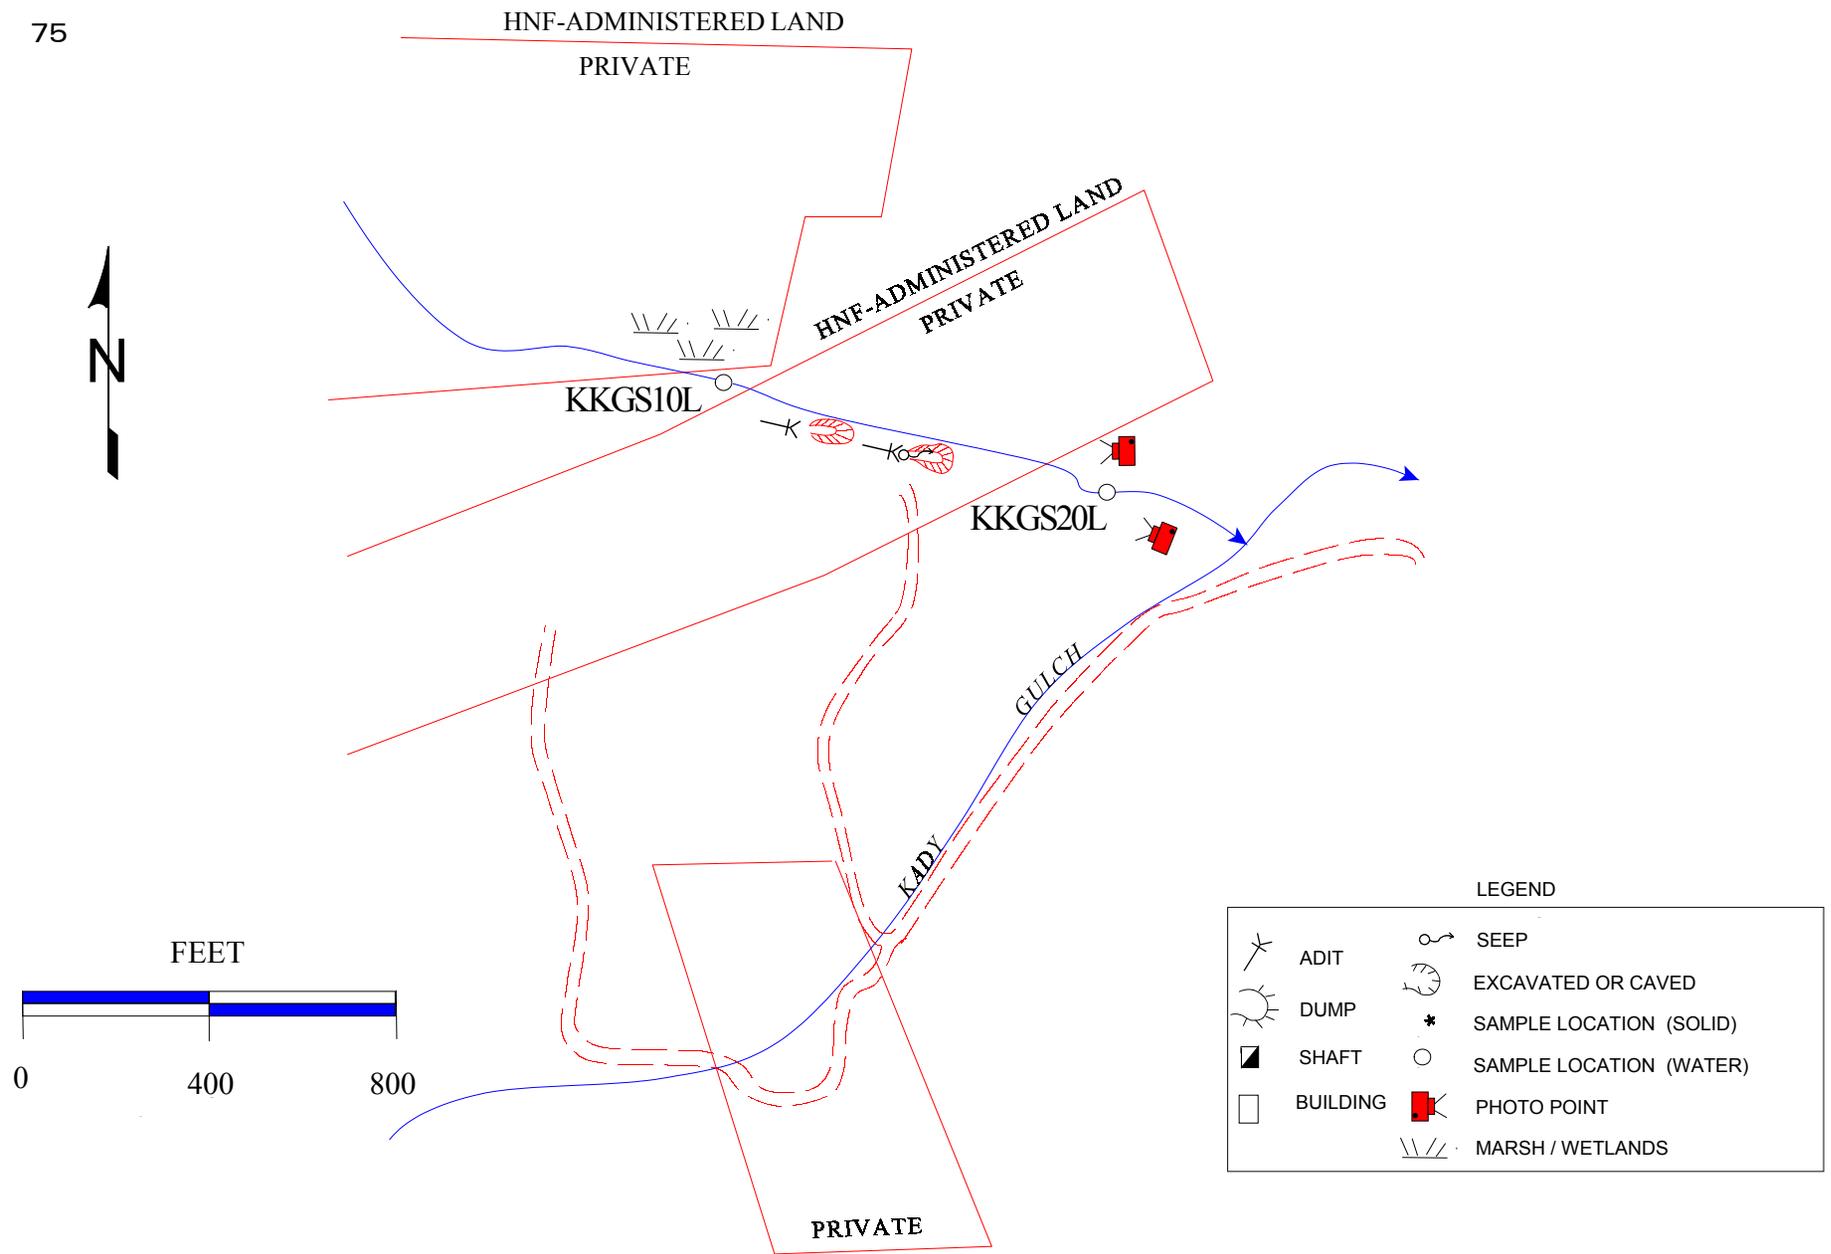
Figure 12. The Kady Gulch mine (10/27/93) is on private land on an unnamed tributary of Kady Gulch. The stream flows past the waste-rock dumps of the mine. Samples were collected upstream and downstream on HNF-administered land.

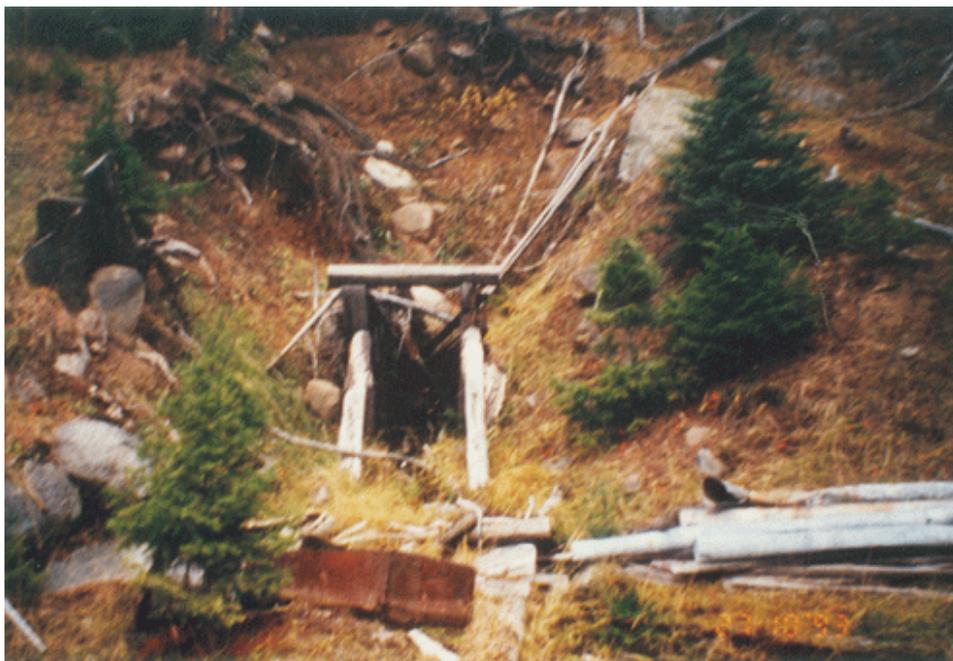
Figure 12a. The lower adit of the Kady Gulch mine was discharging to an unnamed tributary of Kady Gulch. The adits and dumps were on private land.

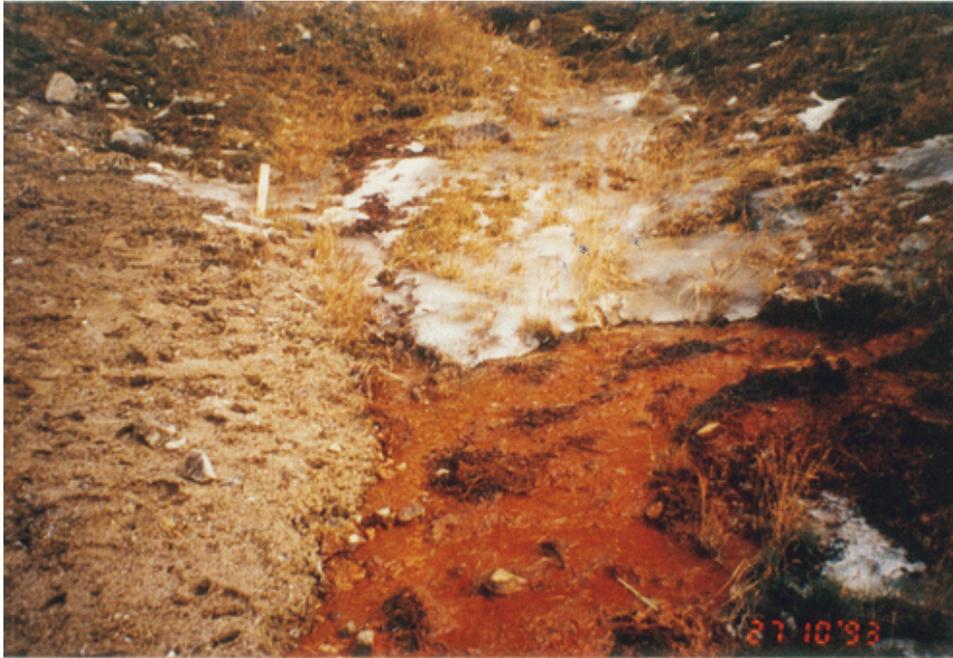
Figure 13a. The Edelweiss-Argentine pit was discharging toward South Fork Quartz Creek on HNF-administered land.
