**Montana Bureau of Mines and Geology
Abandoned-Inactive Mines
Helena National Forest**

**Volume I
Upper Missouri River Drainage**

MBMG 352

**Prepared for the U.S. Department of Agriculture
Forest Service -Region 1**

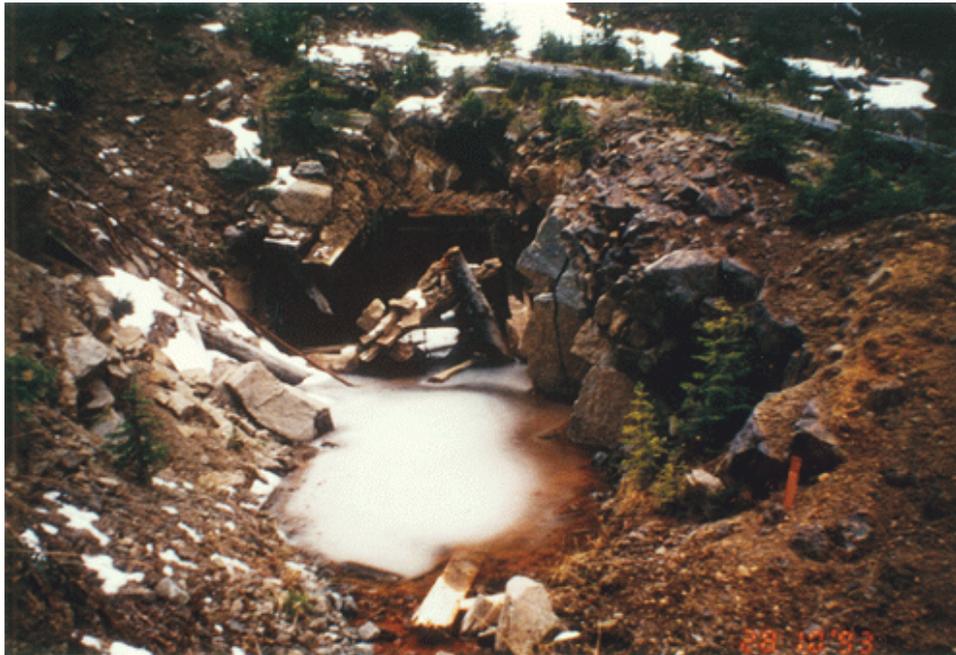
Figure 13b. The Edelweiss-Argentine adit was discharging water toward South Fork Quartz Creek.

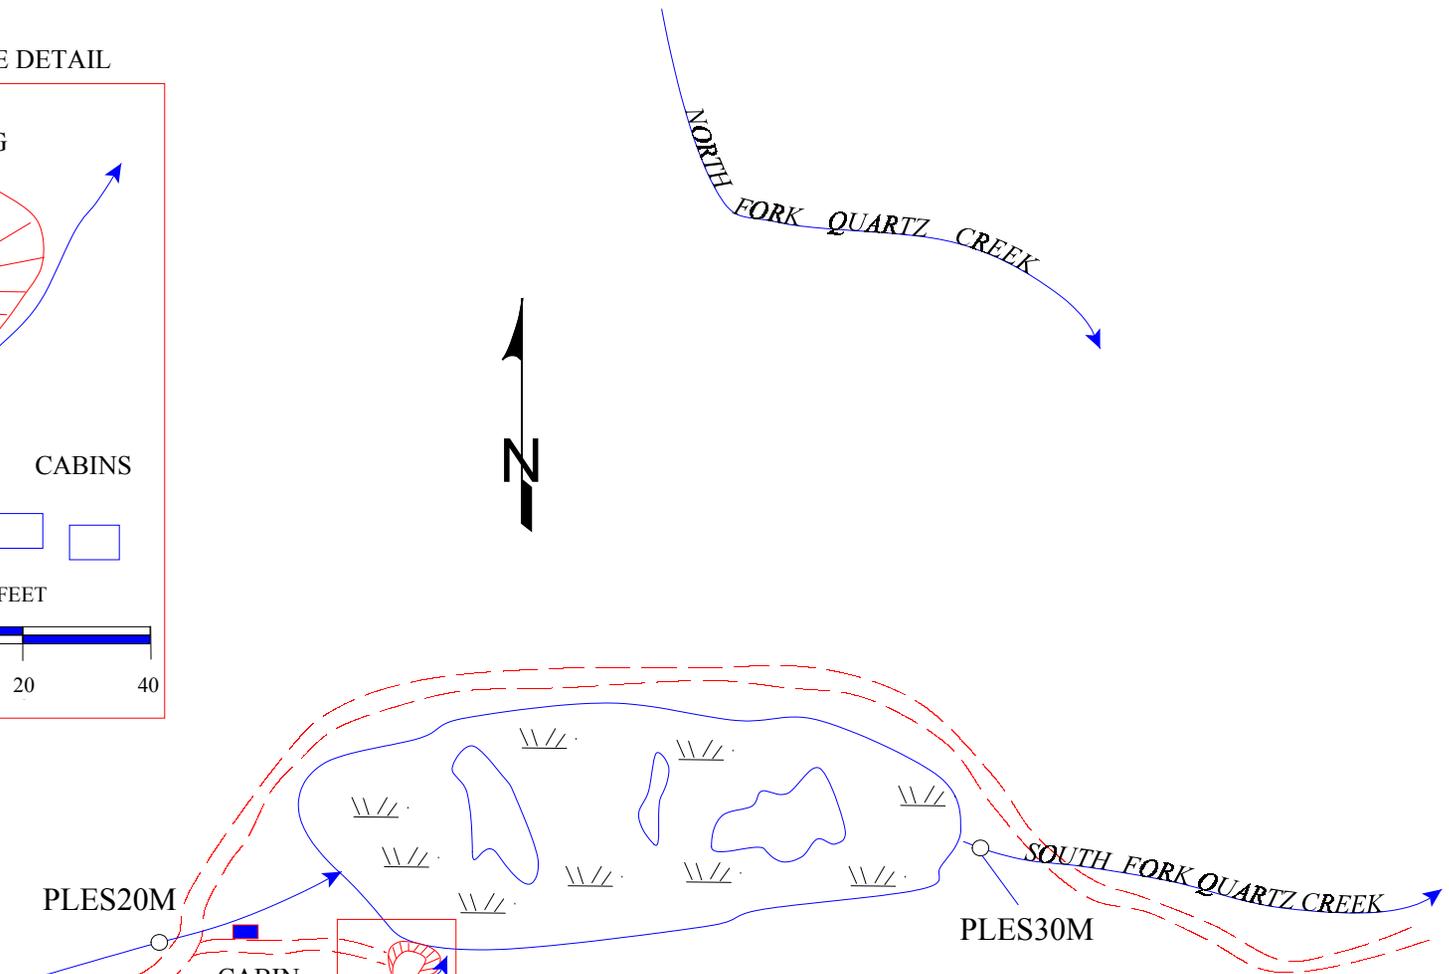
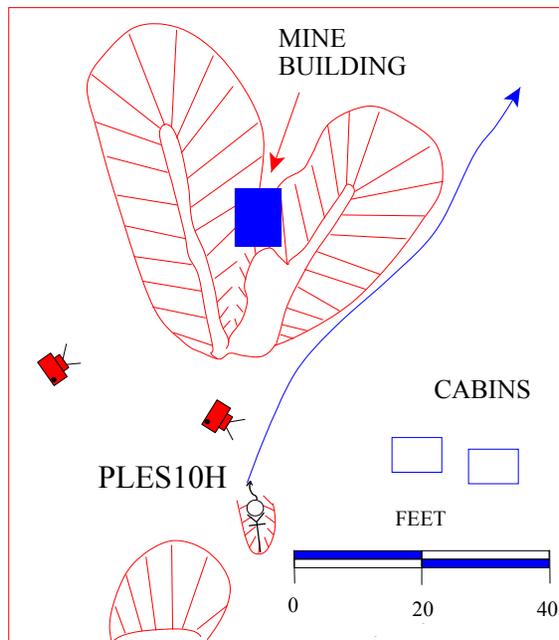
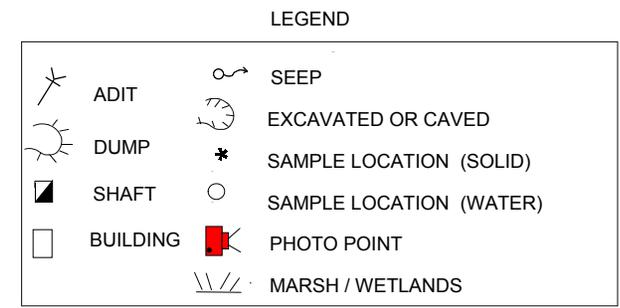
LONE EAGLE QUARTZ MINE DETAIL

Figure 14. The Lone Eagle Quartz mine (7-8/93) is on HNF-administered land in the South Fork Quartz creek drainage. A collapsed adit was discharging water into a wetlands area below the mine.

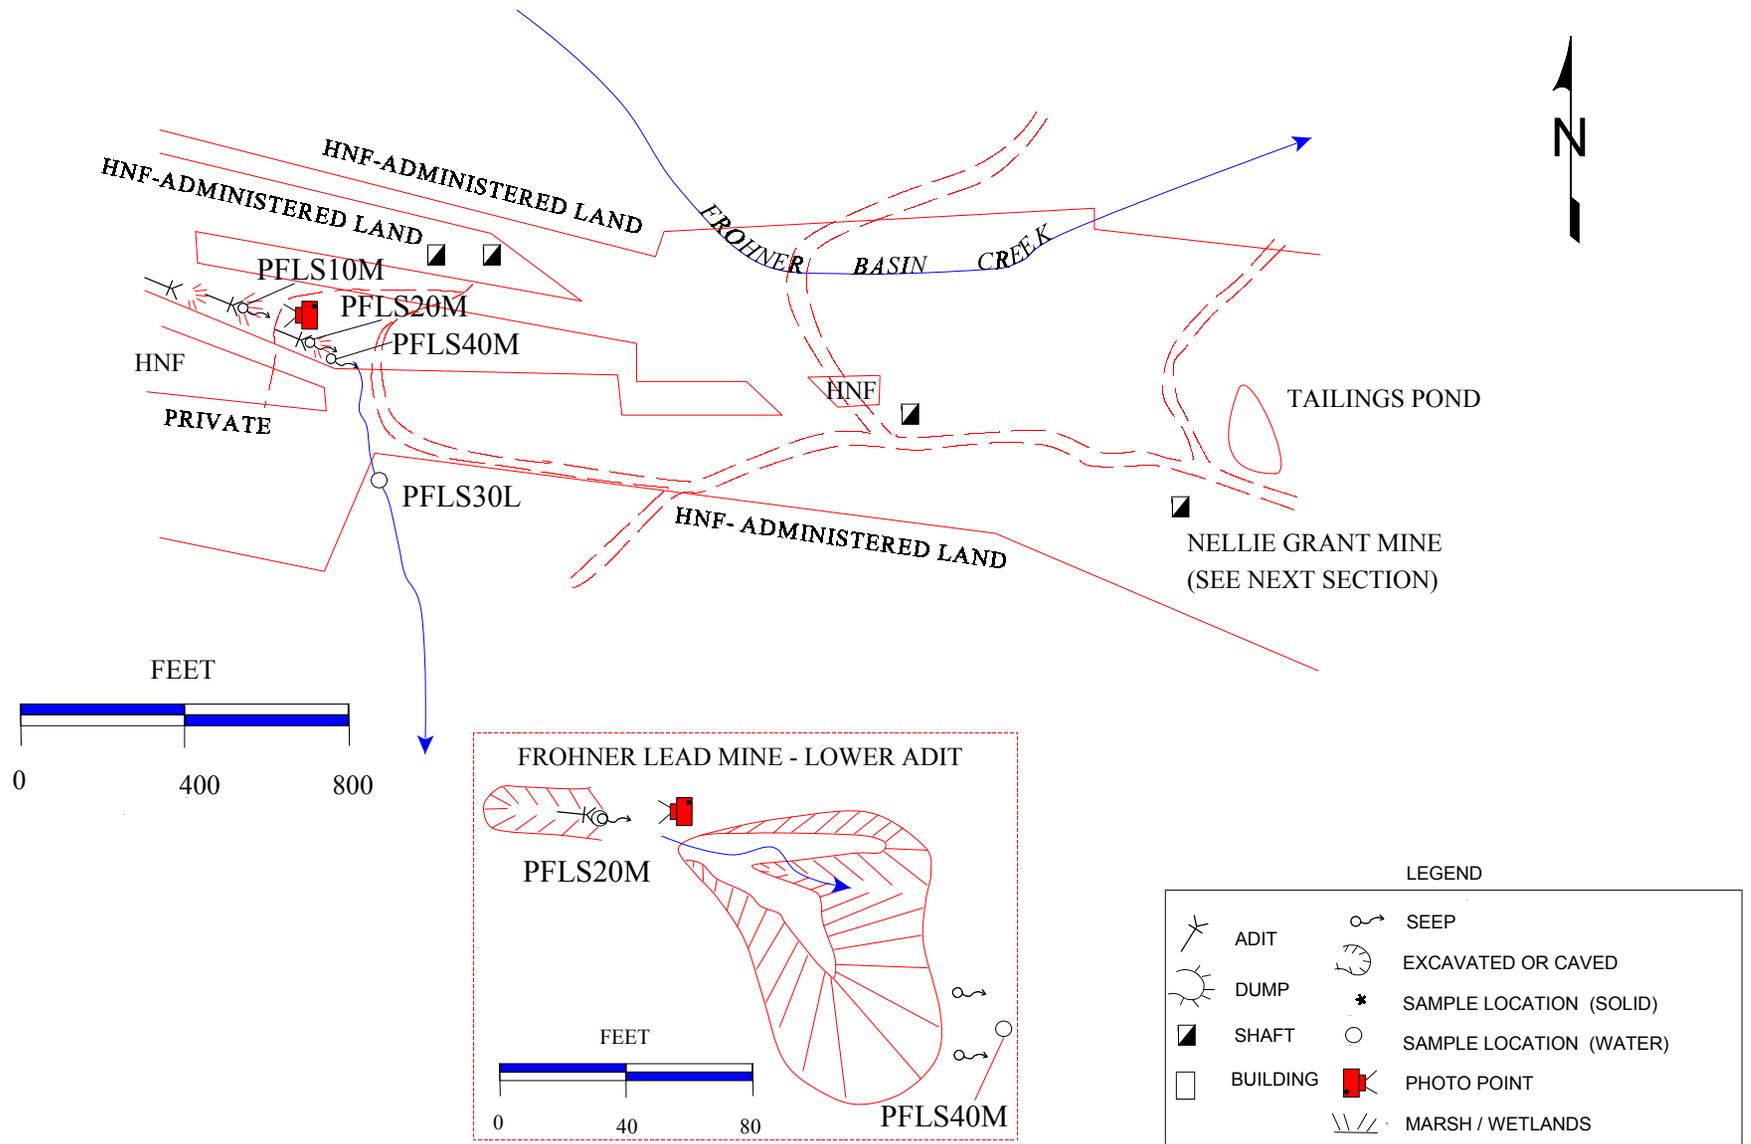
Figure 15. The Frohner Lead mine (6/29/93) is on HNF-administered land. Several adits were discharging water toward Lump Gulch.

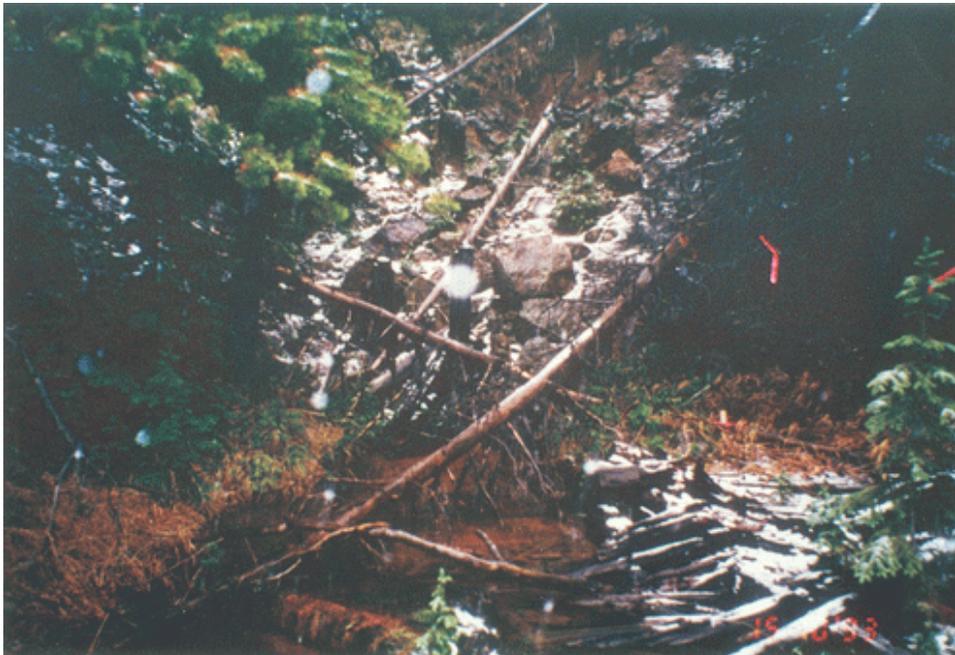
Figure 15b. The lowermost adit of the Frohner Lead mine was discharging water to an unnamed stream.

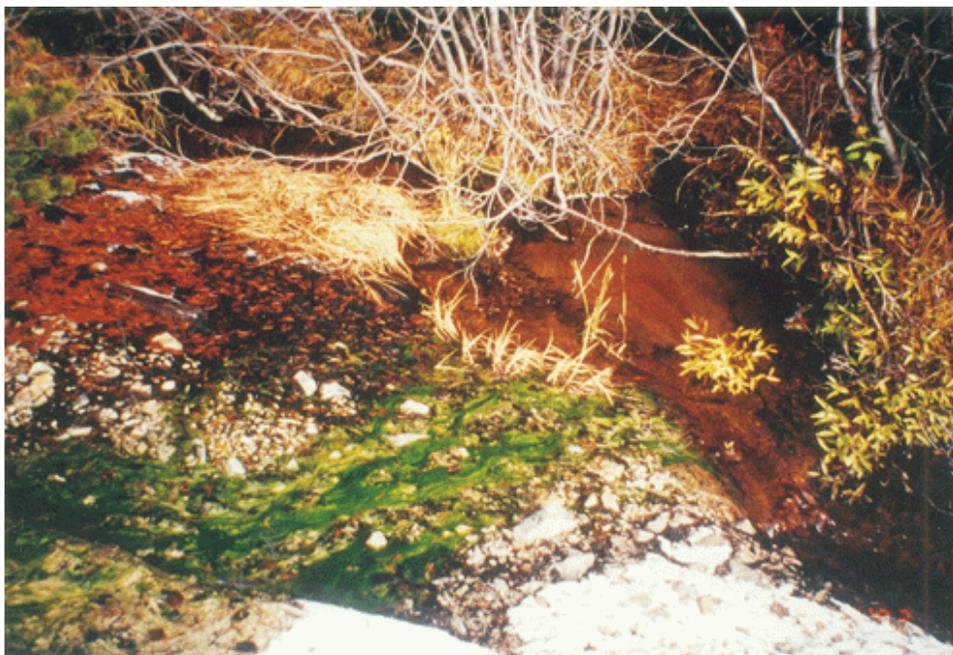
Figure 16b. The discharge from the base of Nellie Grant waste-rock dump flowed into the nearby stream.

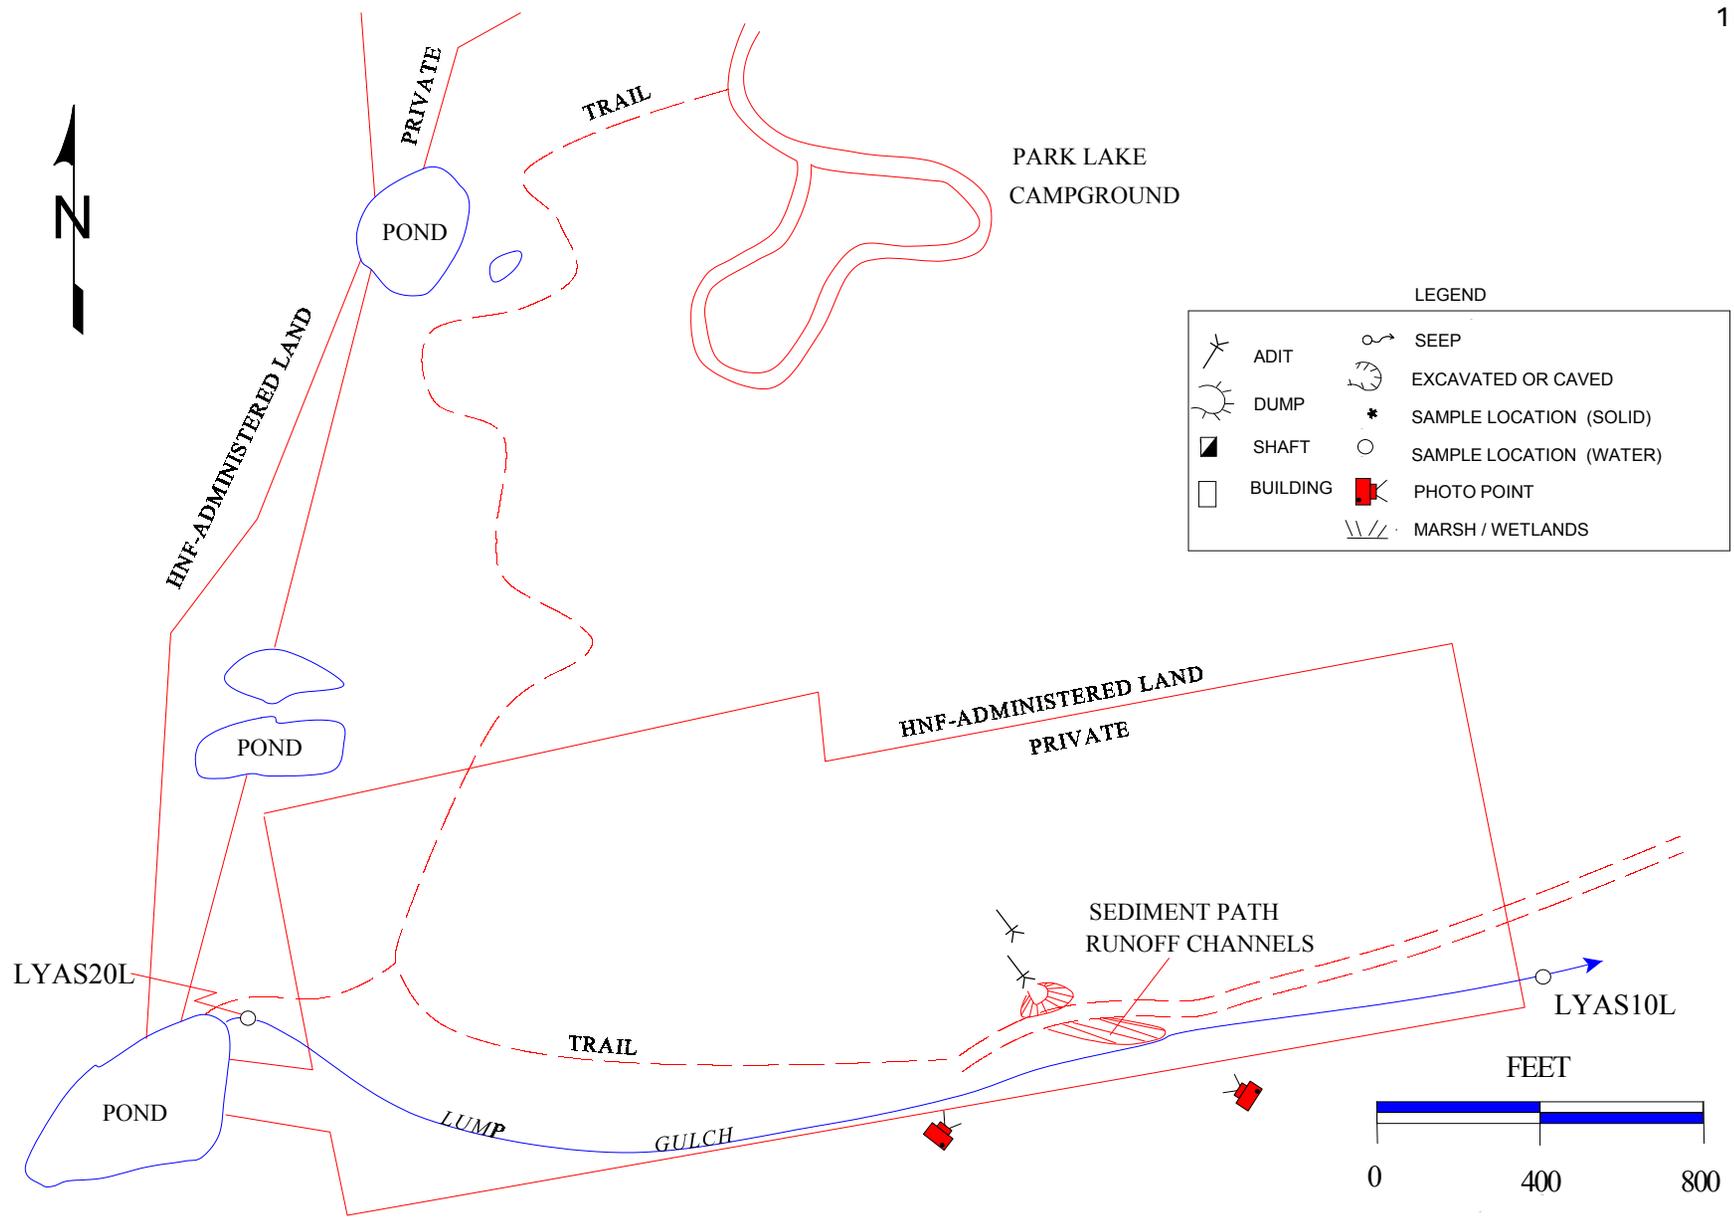
Figure 17. The Yama Group mine (10/14/93) is on private land adjacent to Lump Gulch. There were no discharges for the site, but waste material had been washed into the creek.

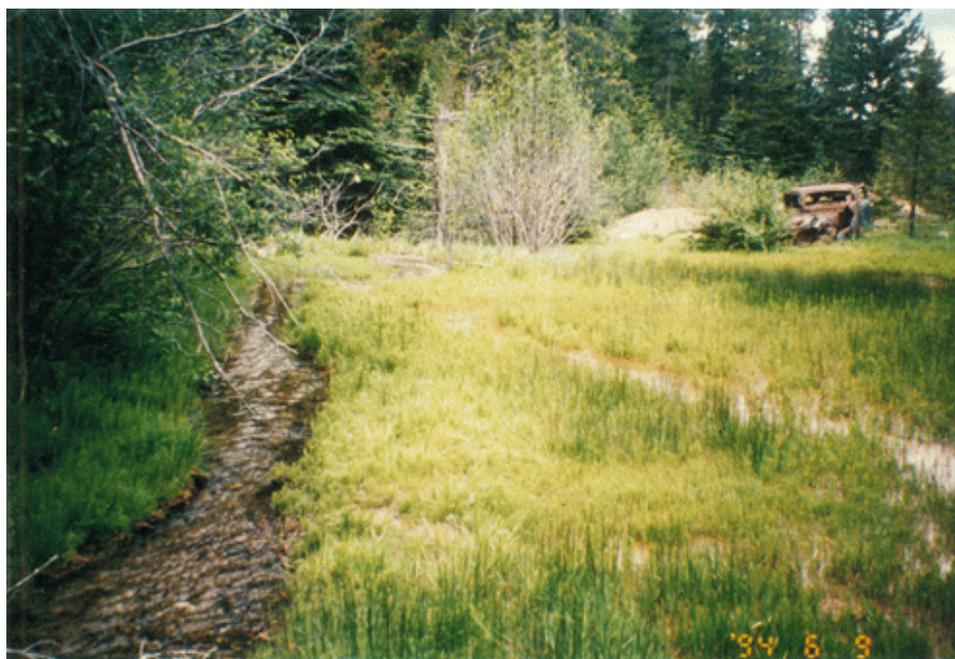
Figure 18b. The adit discharge of the Newburg mine flowed into Middle Fork Warm Springs Creek.

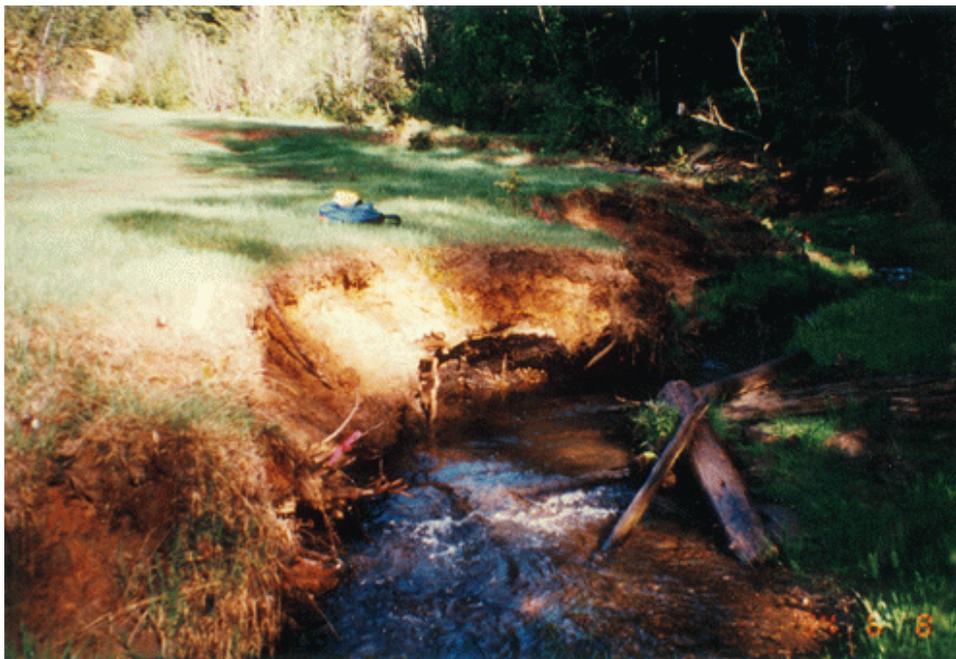
Figure 19b. Tailings along Middle Fork Warm Springs Creek were several feet thick in some areas.

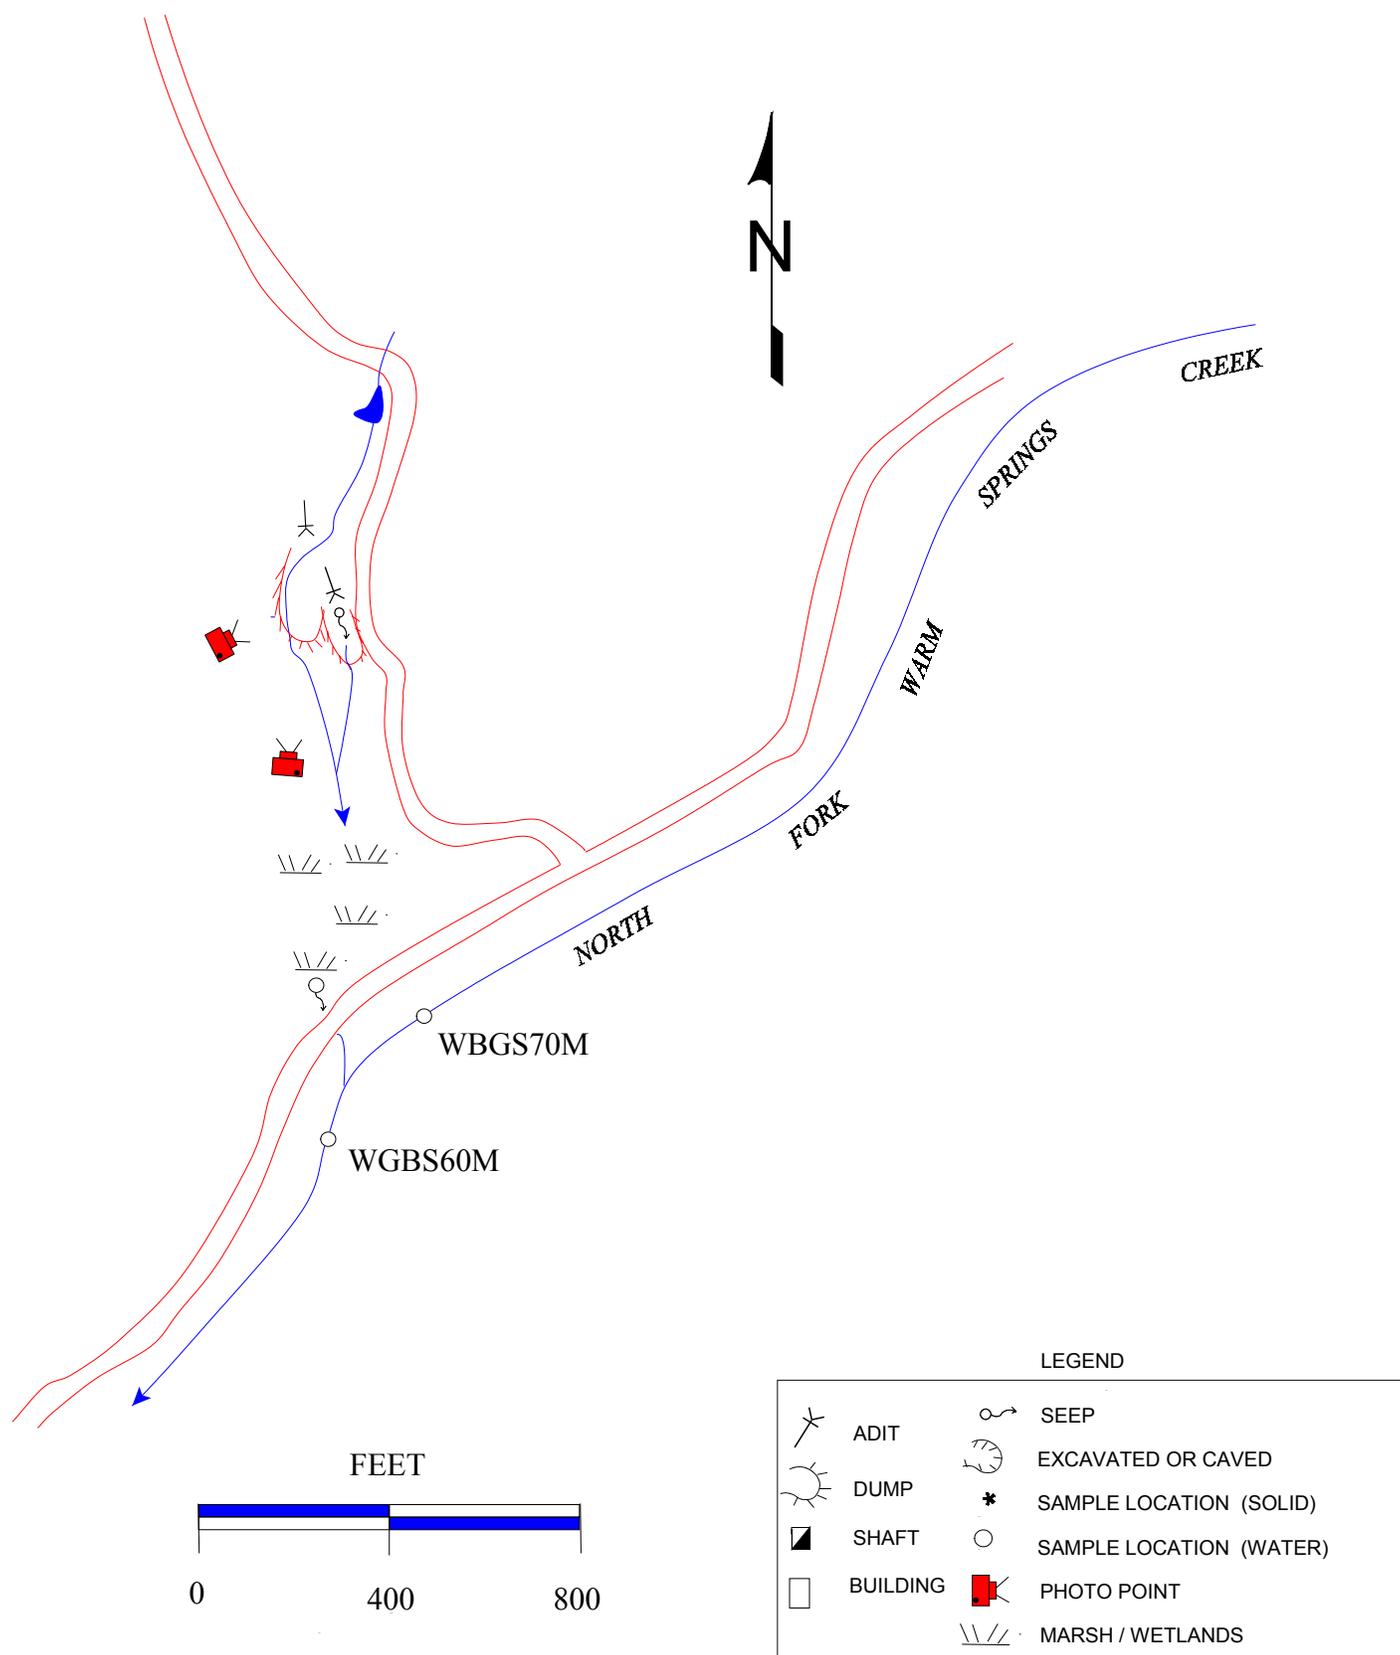
Figure 20. The Badger mine (6/7/94) lies in an unnamed tributary of North Fork Warm Springs Creek. The site was discharging water to a small wetlands below the site.

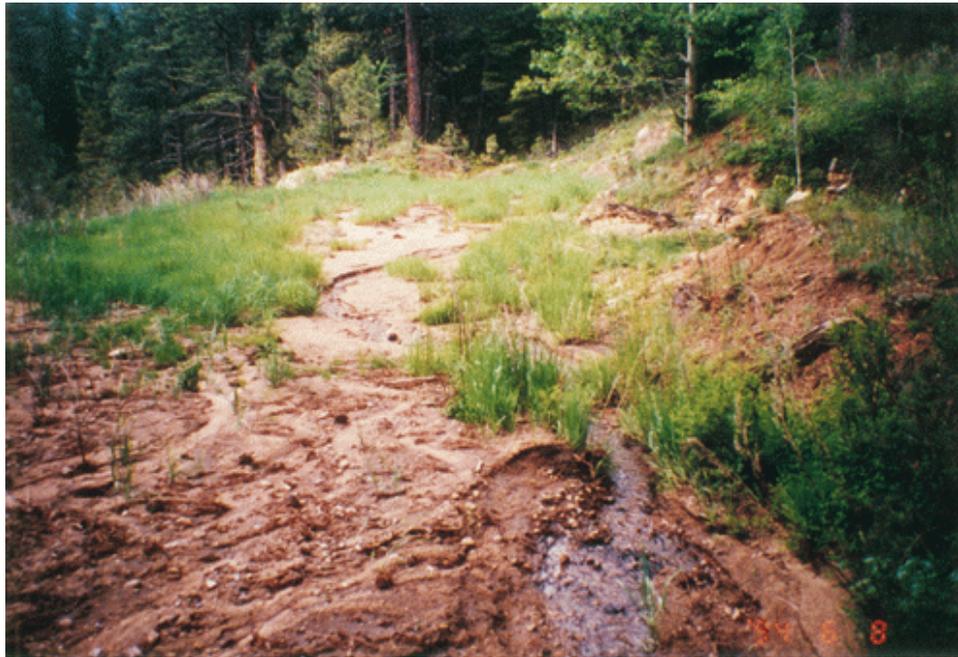
Figure 20a. The waste-rock dump of the Badger mine was being eroded by the unnamed stream flowing through the site.

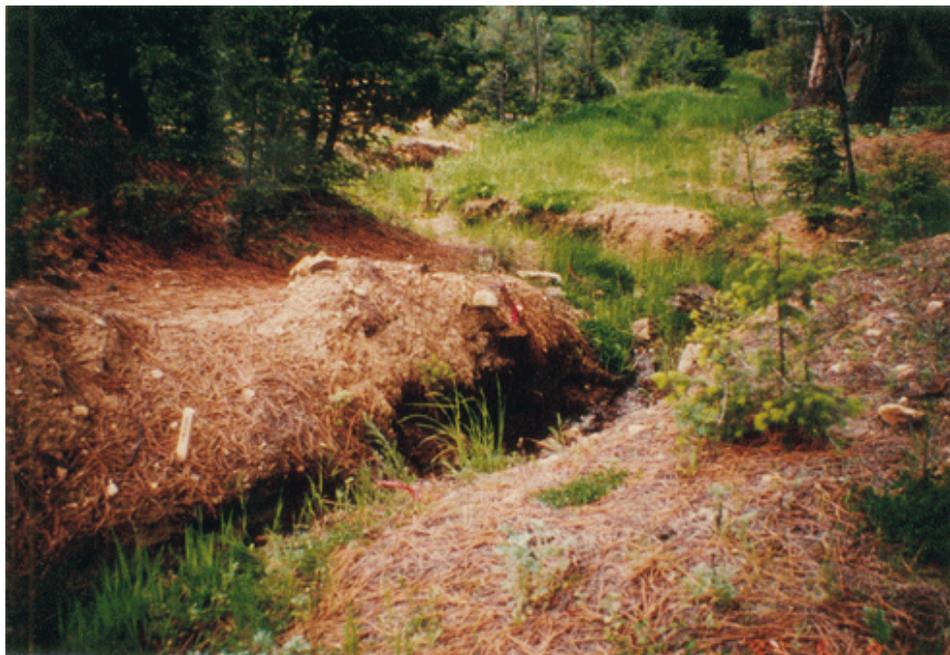
Figure 20b. Waste material from the dumps of the Badger mine had been eroded and deposited downstream of the mine.

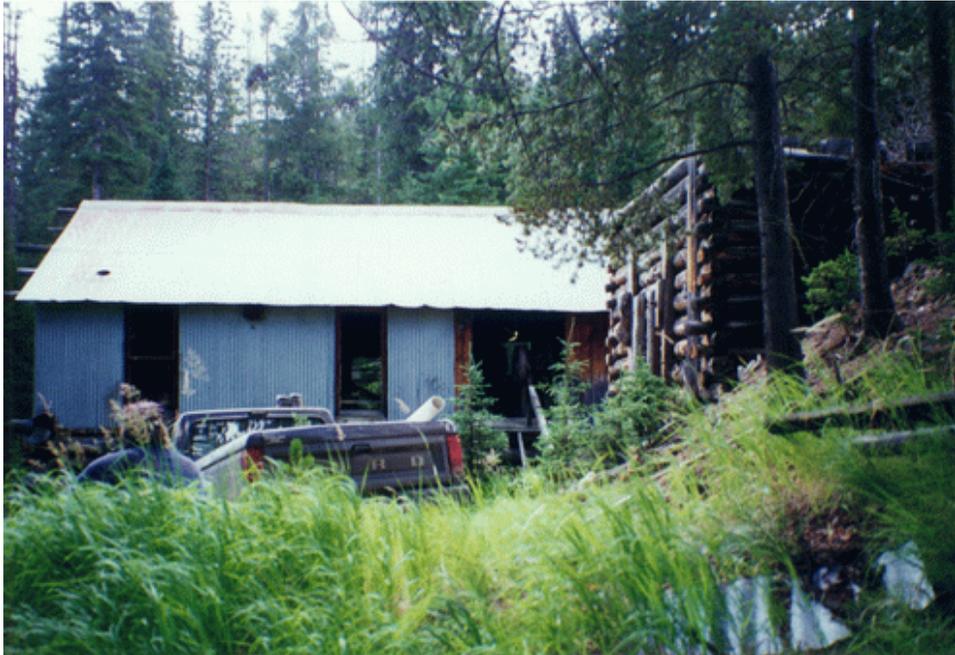
Figure 22a. The Golden Age mill had several seeps that emerged near the ore bin and mill building.

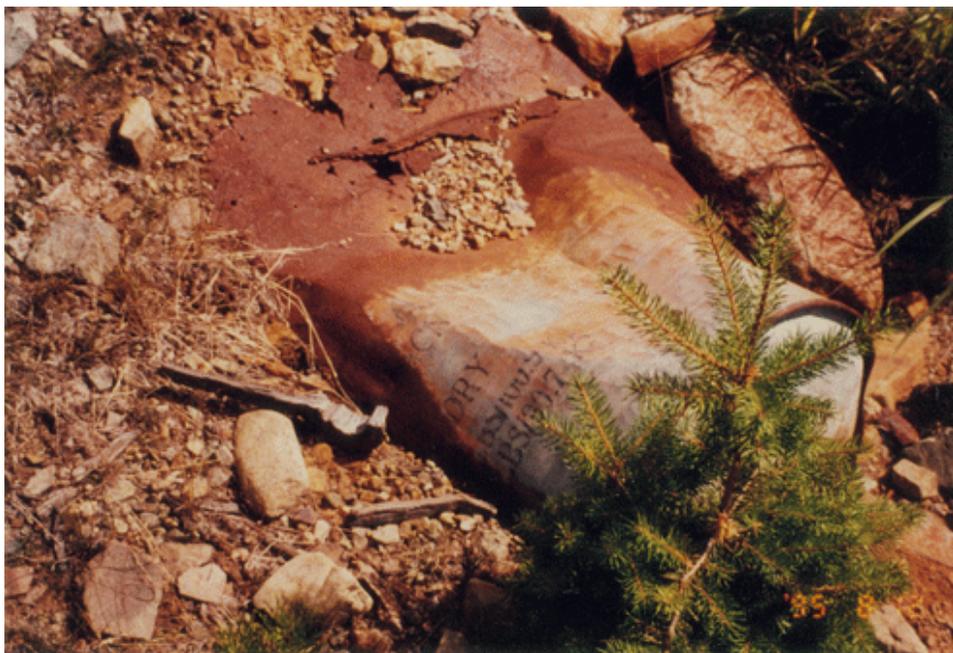
Figure 23b. An empty cyanide drum was found along one of the small drainages leading to Indian Creek.

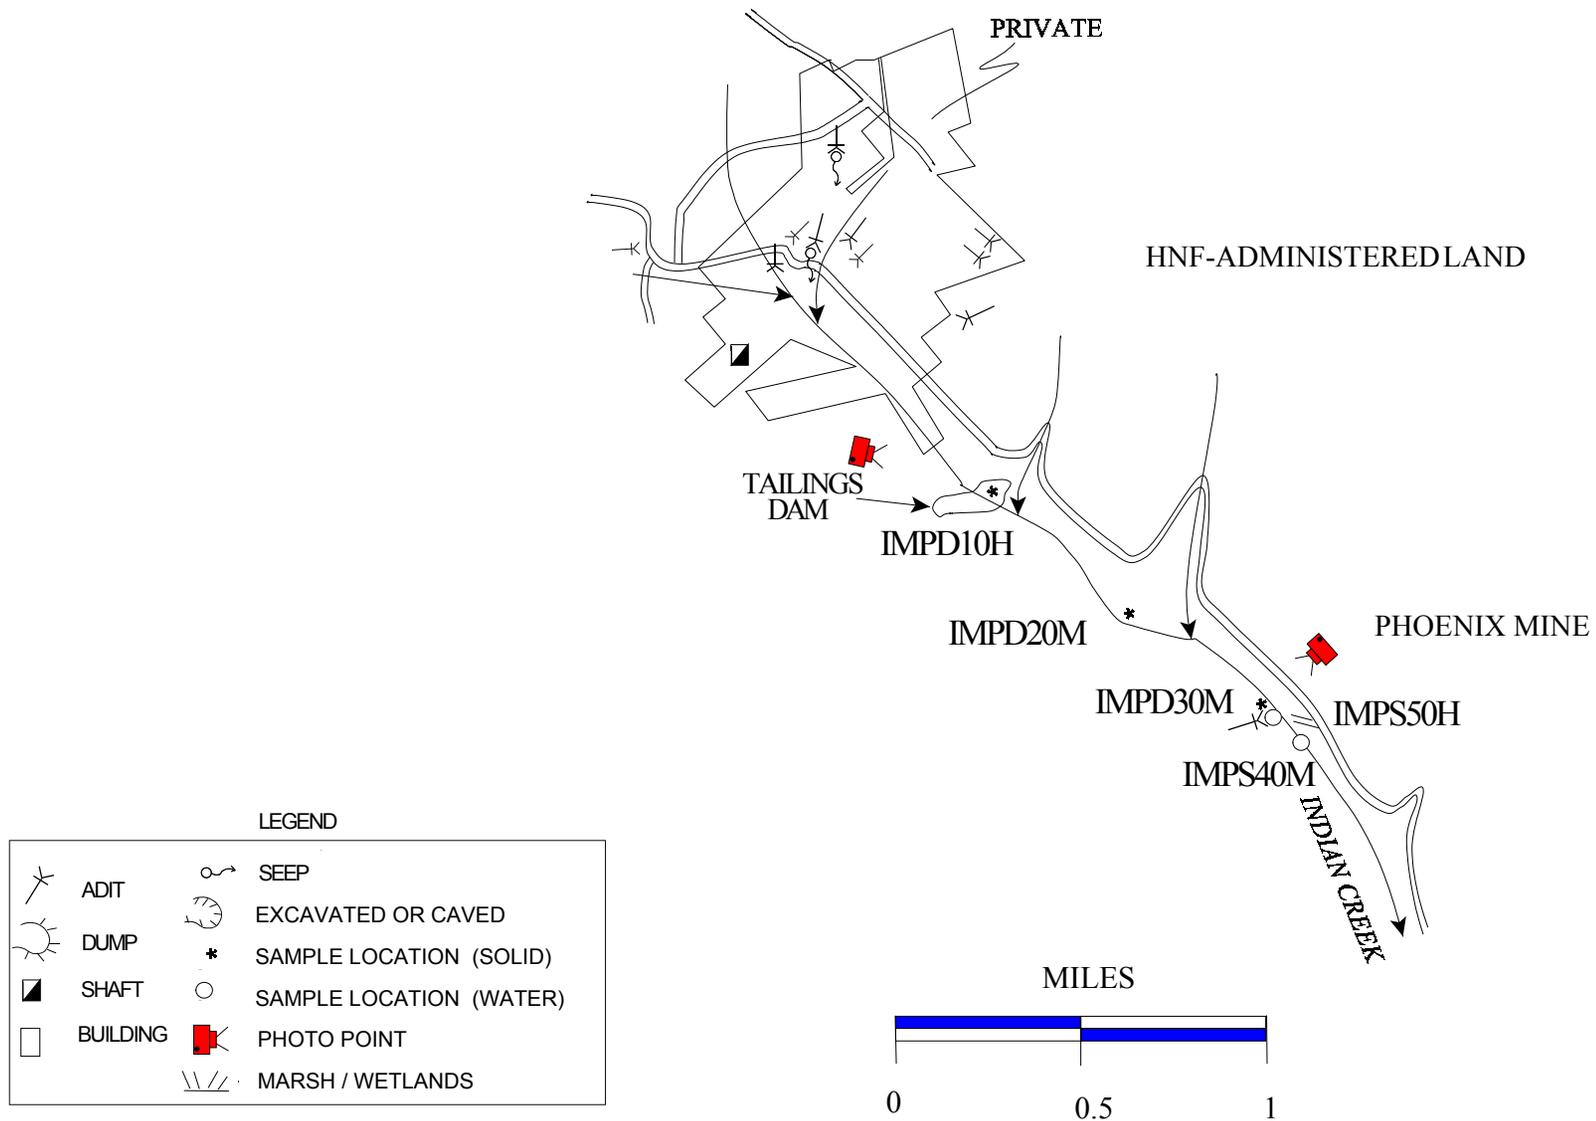
Figure 24. The Phoenix mine (1993) is on Indian Creek below the Park-Marietta mill. Tailings from the breached tailings impoundment have been deposited along the flood plain of Indian Creek.

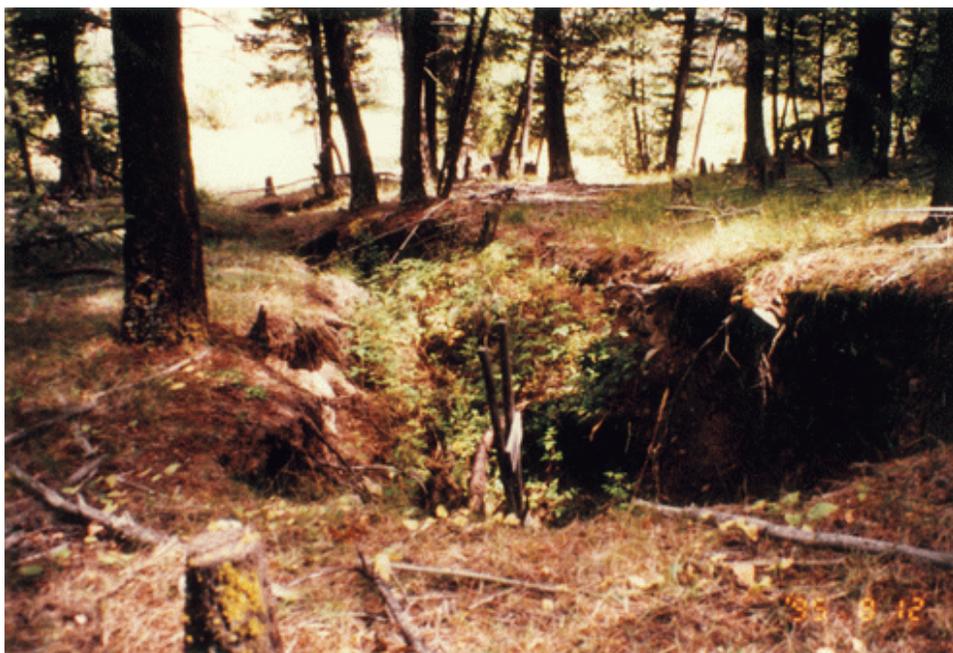
Figure 24b. Hazardous openings at the Phoenix mine were found on the hillside above the collapsed adit.

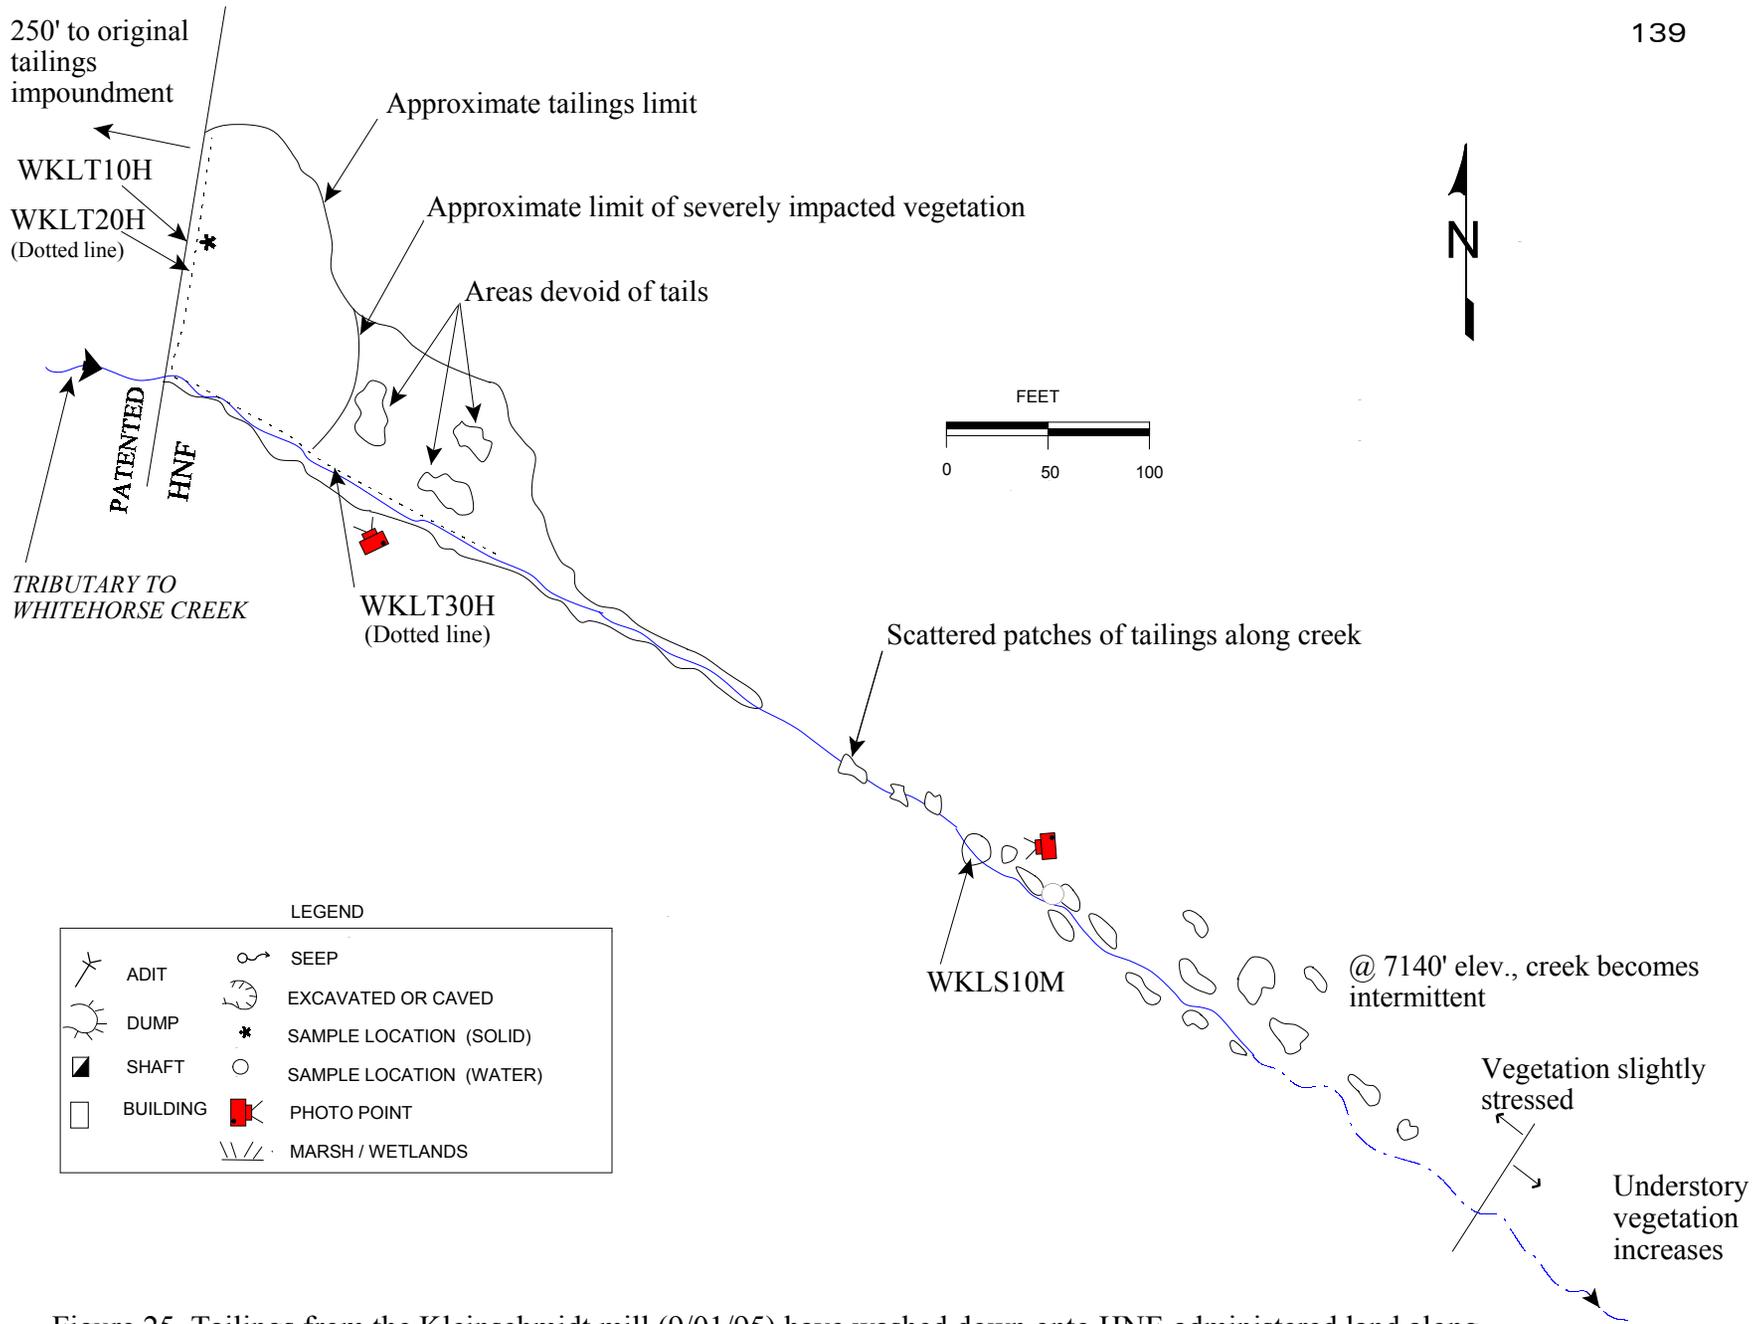
Figure 25. Tailings from the Kleinschmidt mill (9/01/95) have washed down onto HNF-administered land along an unnamed tributary of Whitehorse Creek.

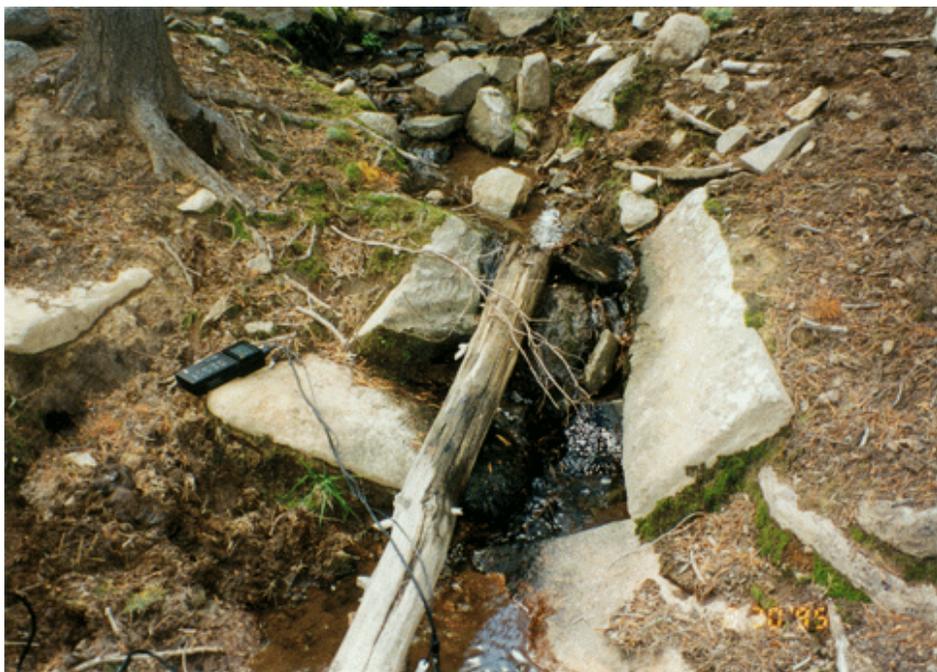
Figure 25b. A small (12 gpm) flow to a tributary of Whitehorse Creek emanated from seeps near the Kleinschmidt mine.

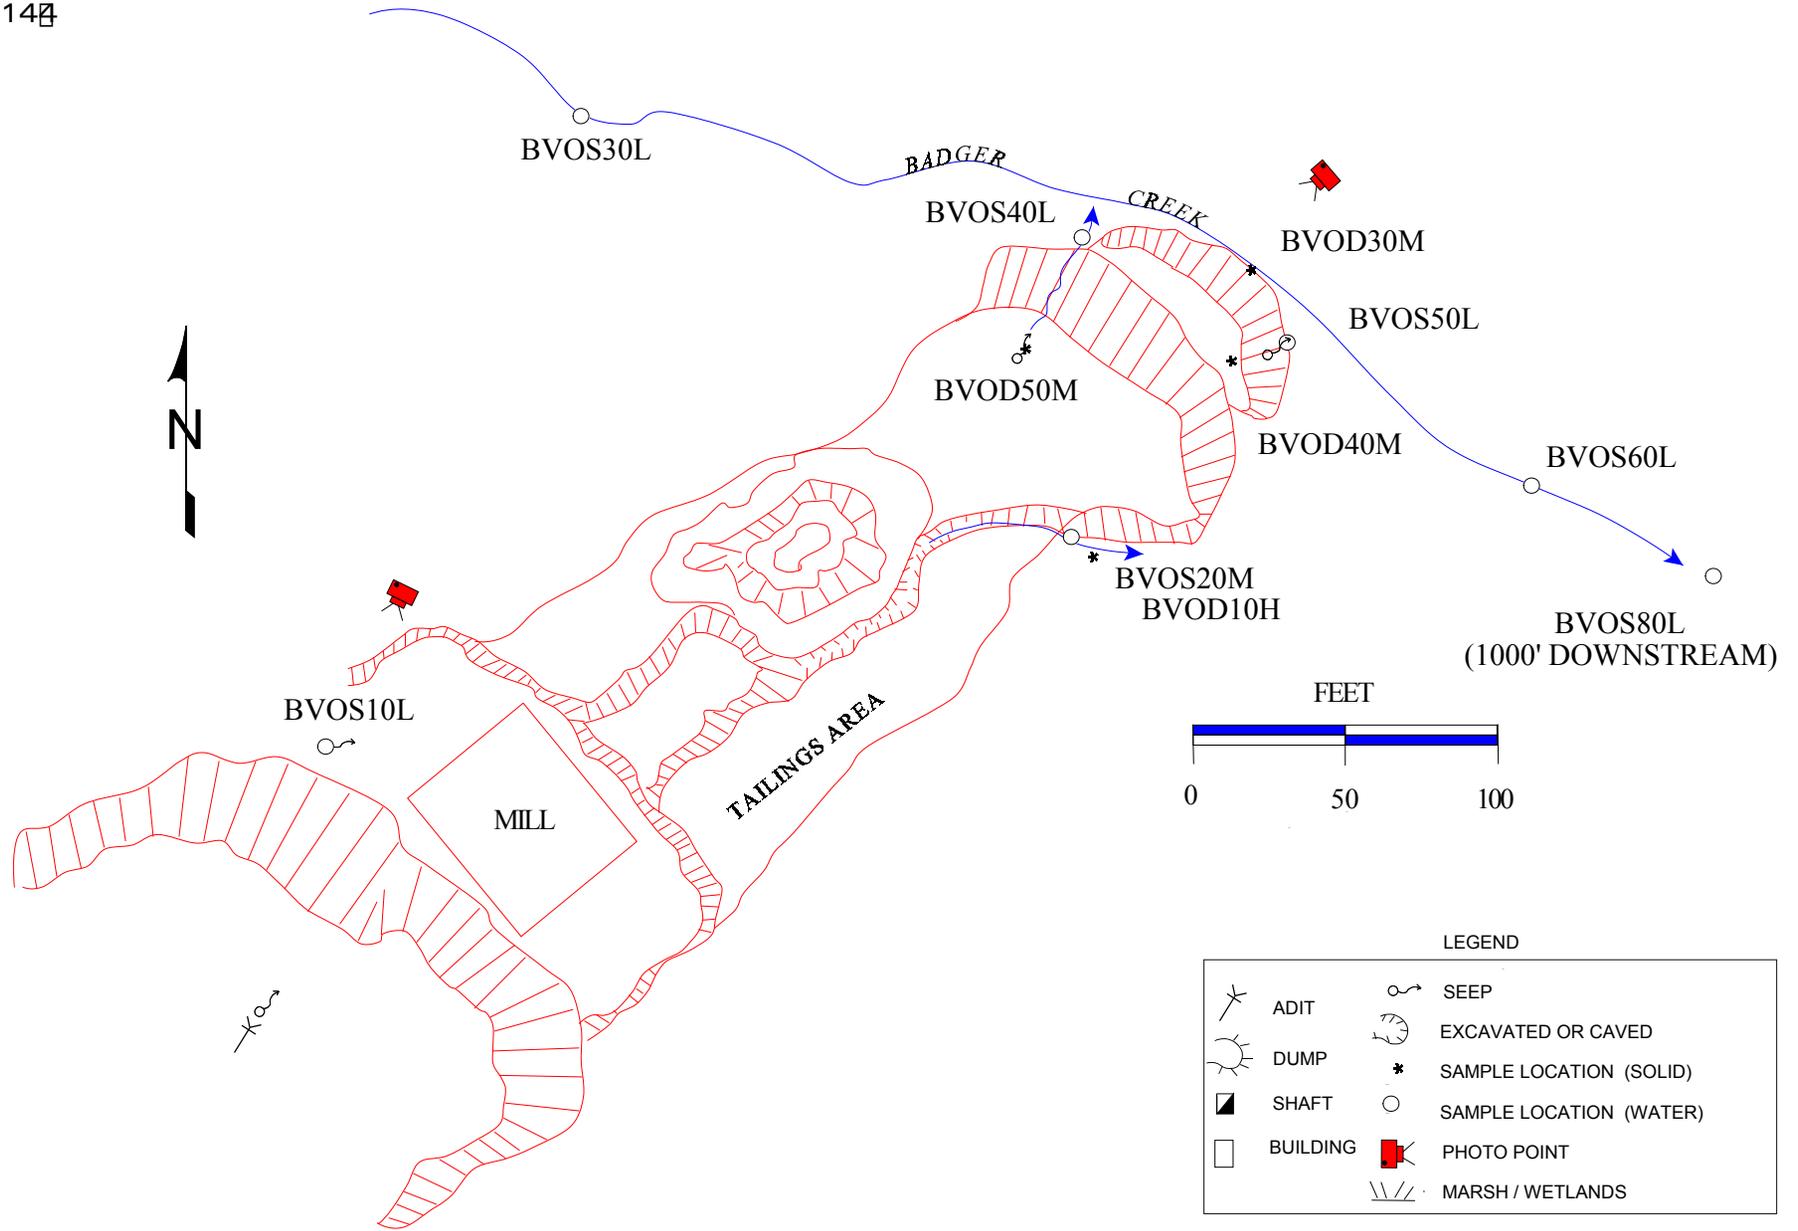
Figure 26. The Vosburg mine and Mill (1994) was the site of a large tailings release in 1994. Reclamation of the site and disposal of the tailings followed in 1995.

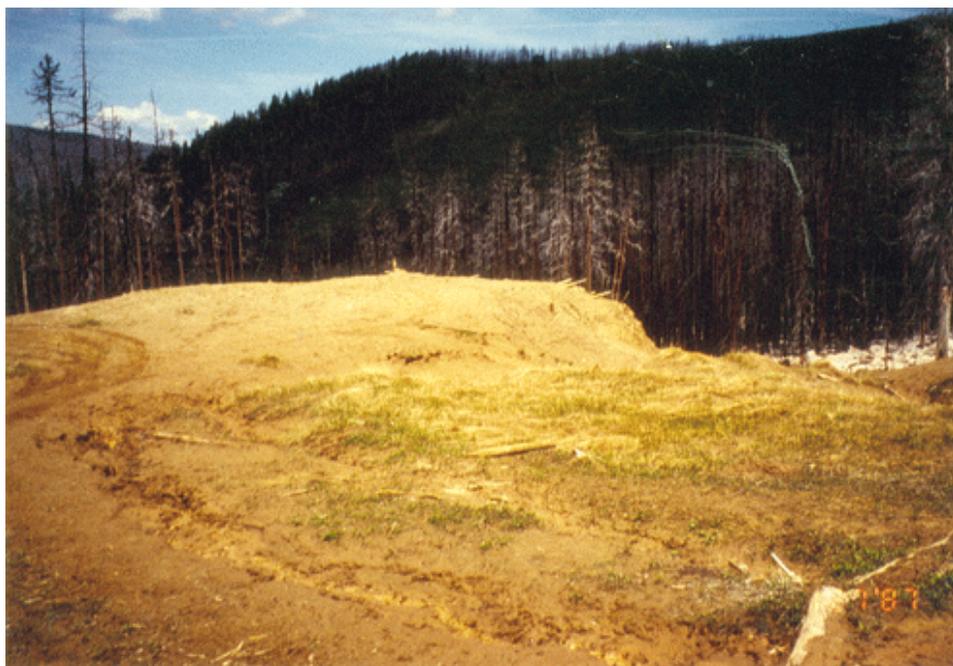
Figure 26a. The lower tailings pile of the Vosburg mill was drained by several seeps and was in the Badger Creek flood plain.
