**Montana Bureau of Mines and Geology
Abandoned-Inactive Mines
Helena National Forest**

**Volume I
Upper Missouri River Drainage**

MBMG 352

**Prepared for the U.S. Department of Agriculture
Forest Service -Region 1**

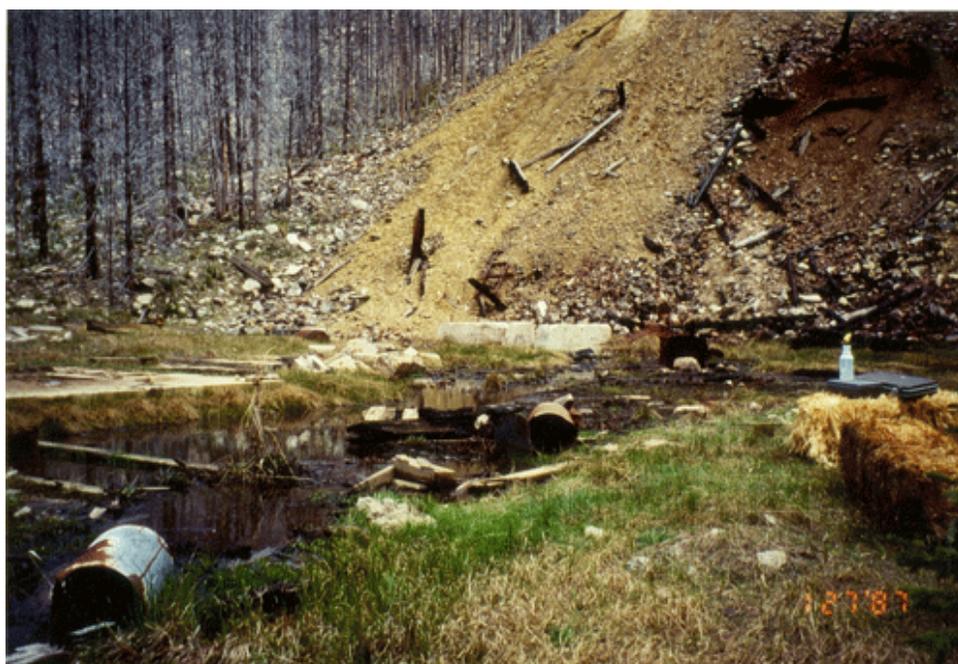
Figure 26b. The adit of the Vosburg mine discharged about six gpm. Sample BVOS10L was collected from the adit discharge after it emerged from the base of the waste-rock dump.

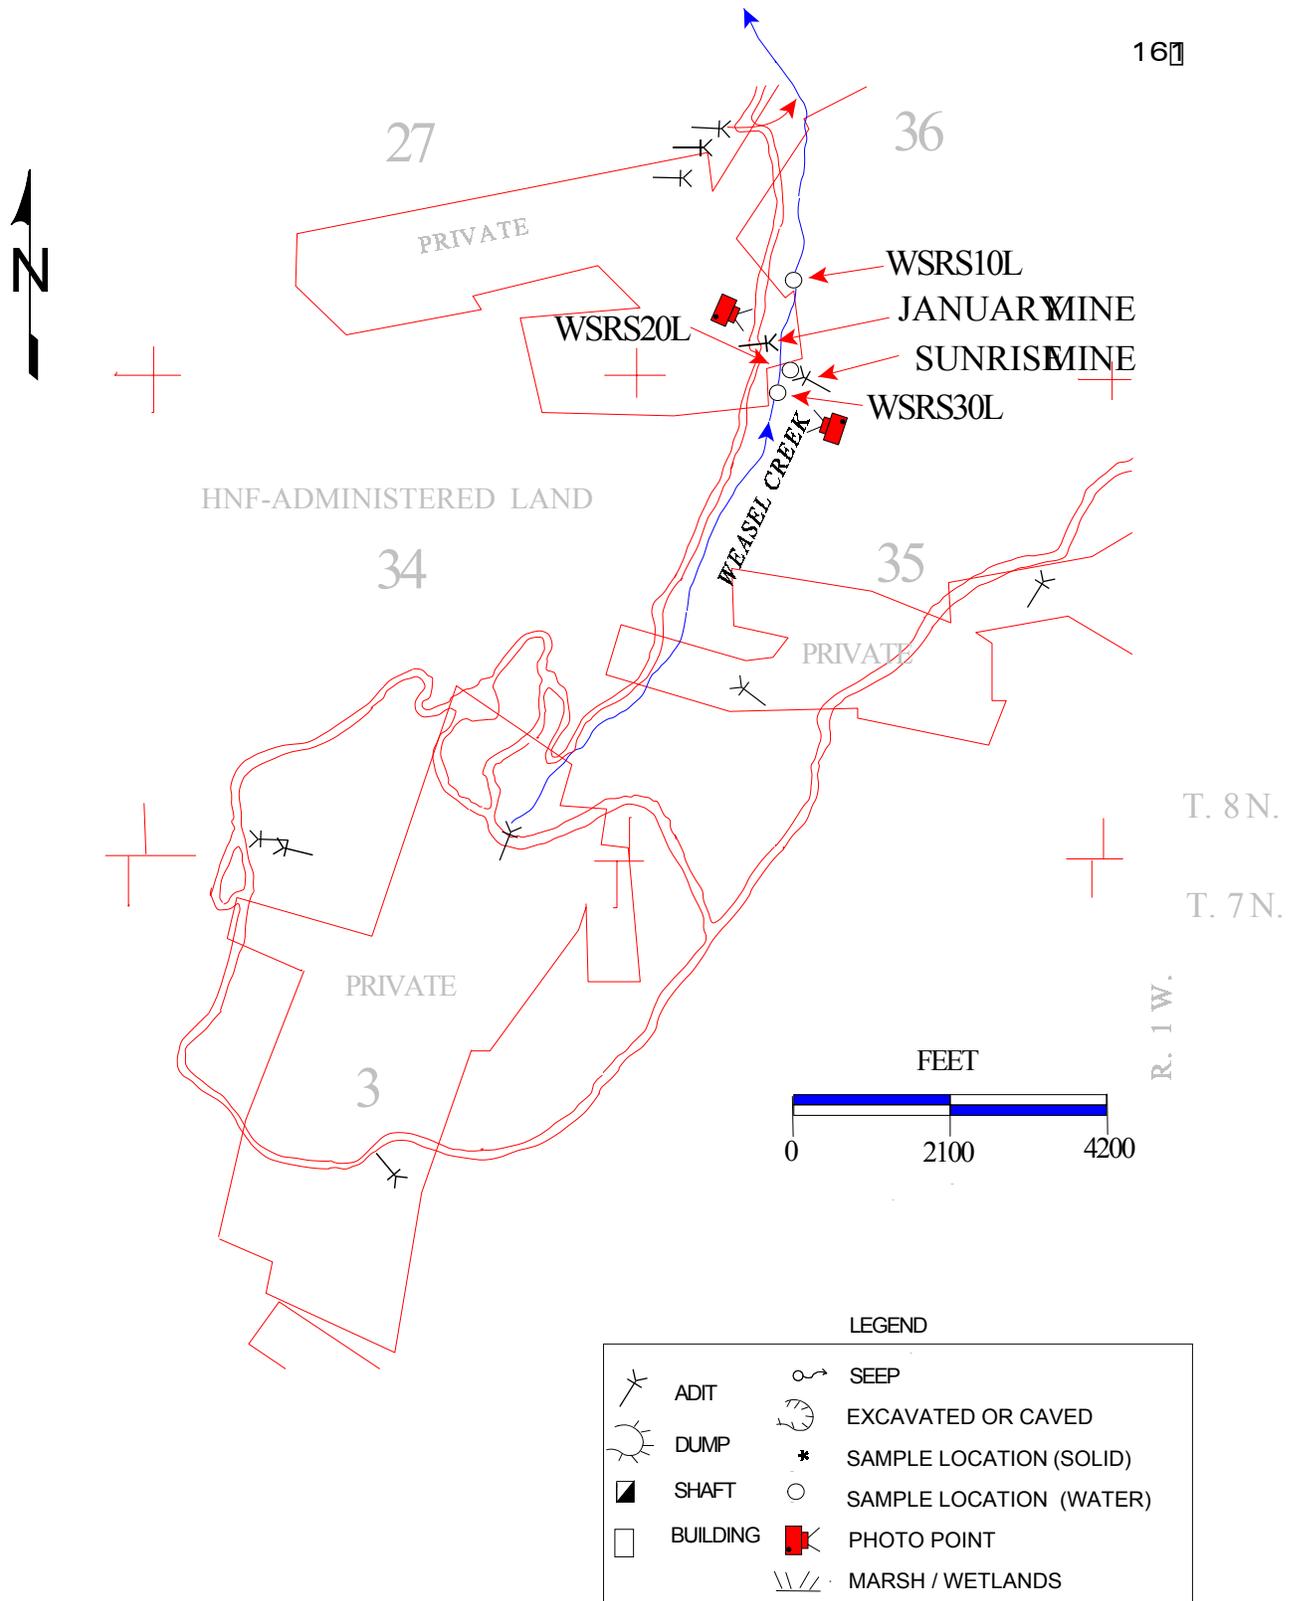
Figure 30. January and Sunrise mines (18/29/95) are adjacent to Weasel Creek. An adit discharge from the Sunrise mine flowed onto private property before flowing into Weasel Creek.

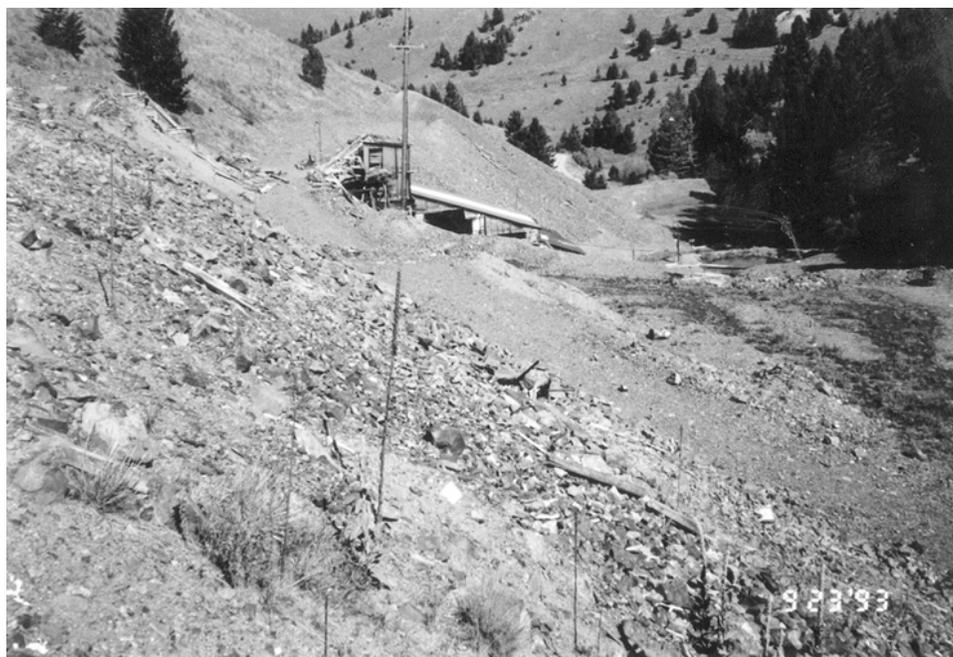
Figure 31a. The East Pacific mine and mill had several seeps and were being eroded by the stream.

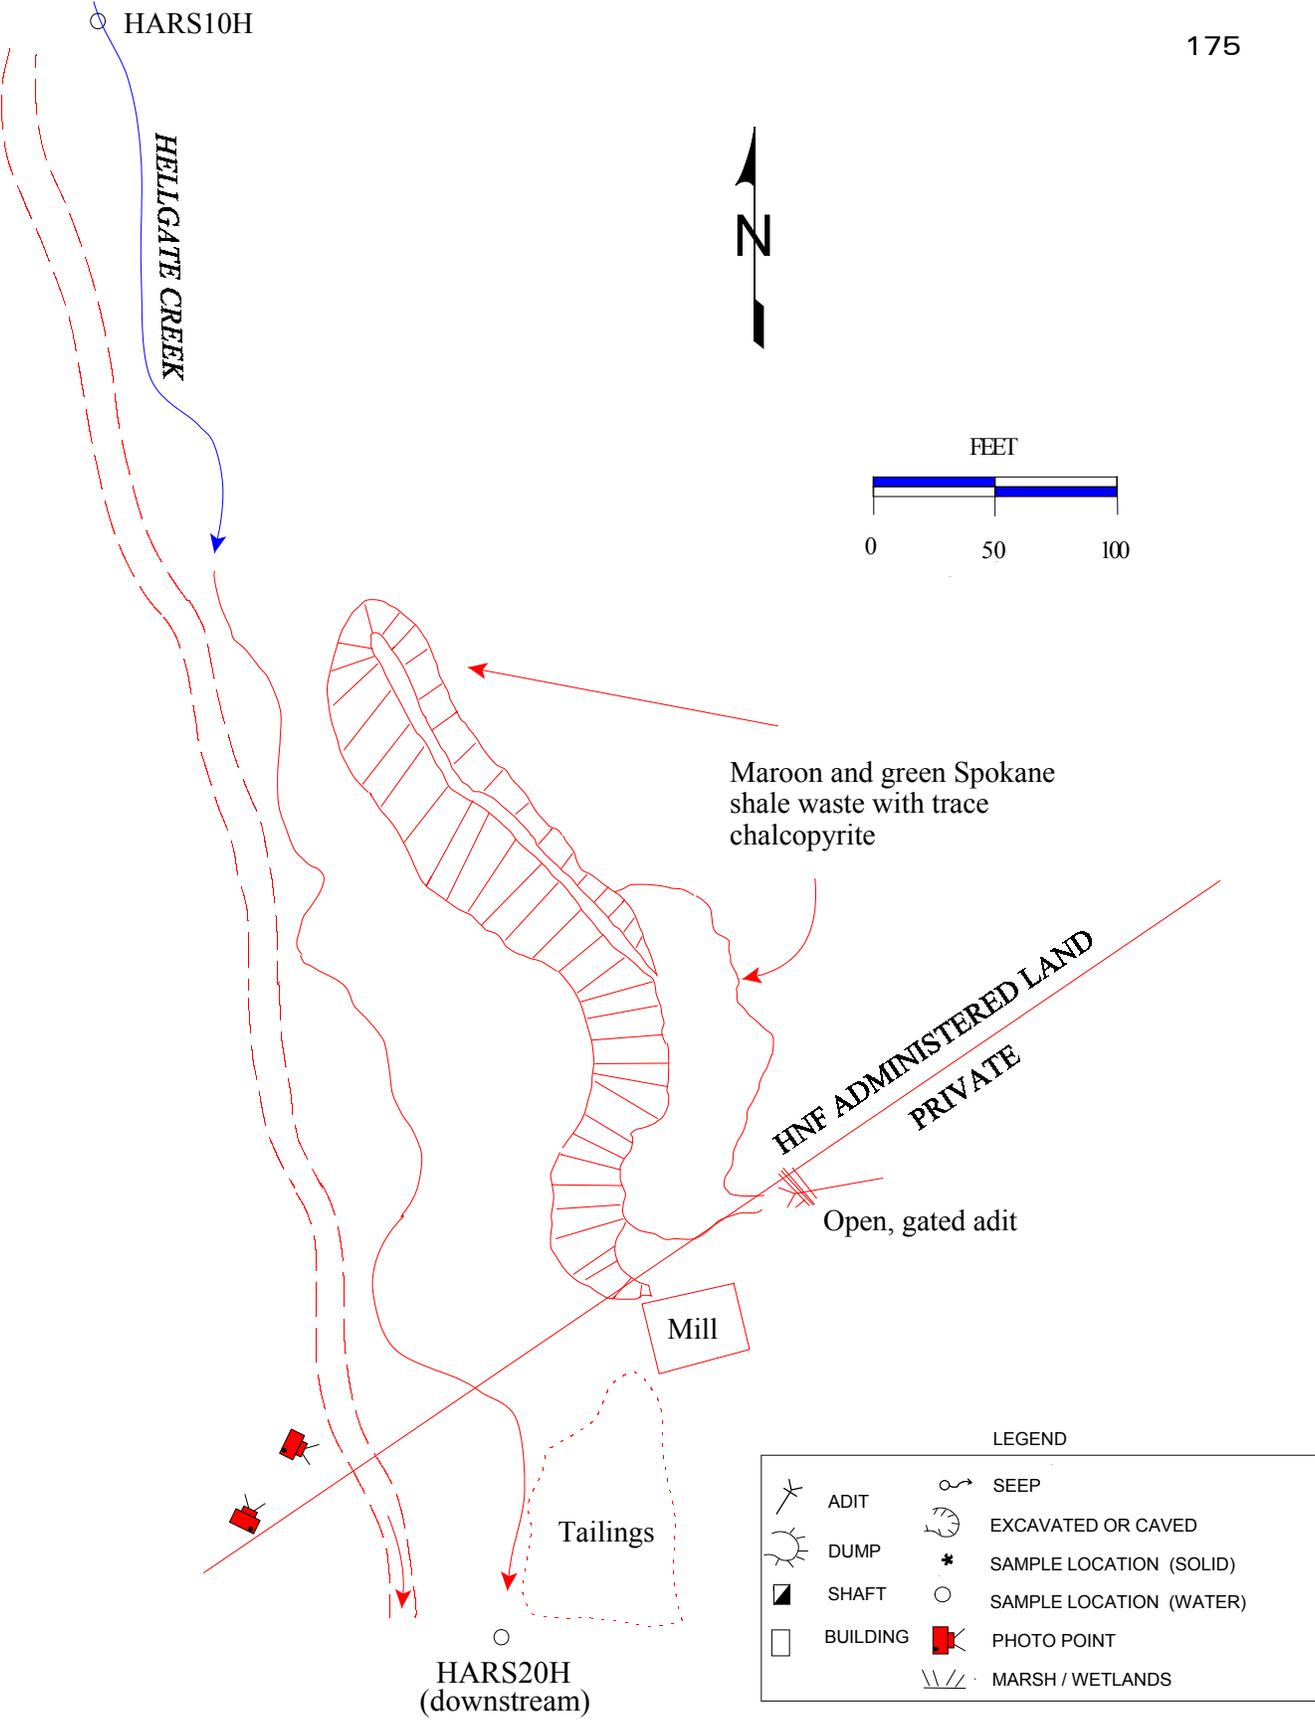
Figure 33. At the Argo mine (10/13/95), Hellgate Creek flowed past a waste-rock dump and was actively eroding tailings in the flood plain.

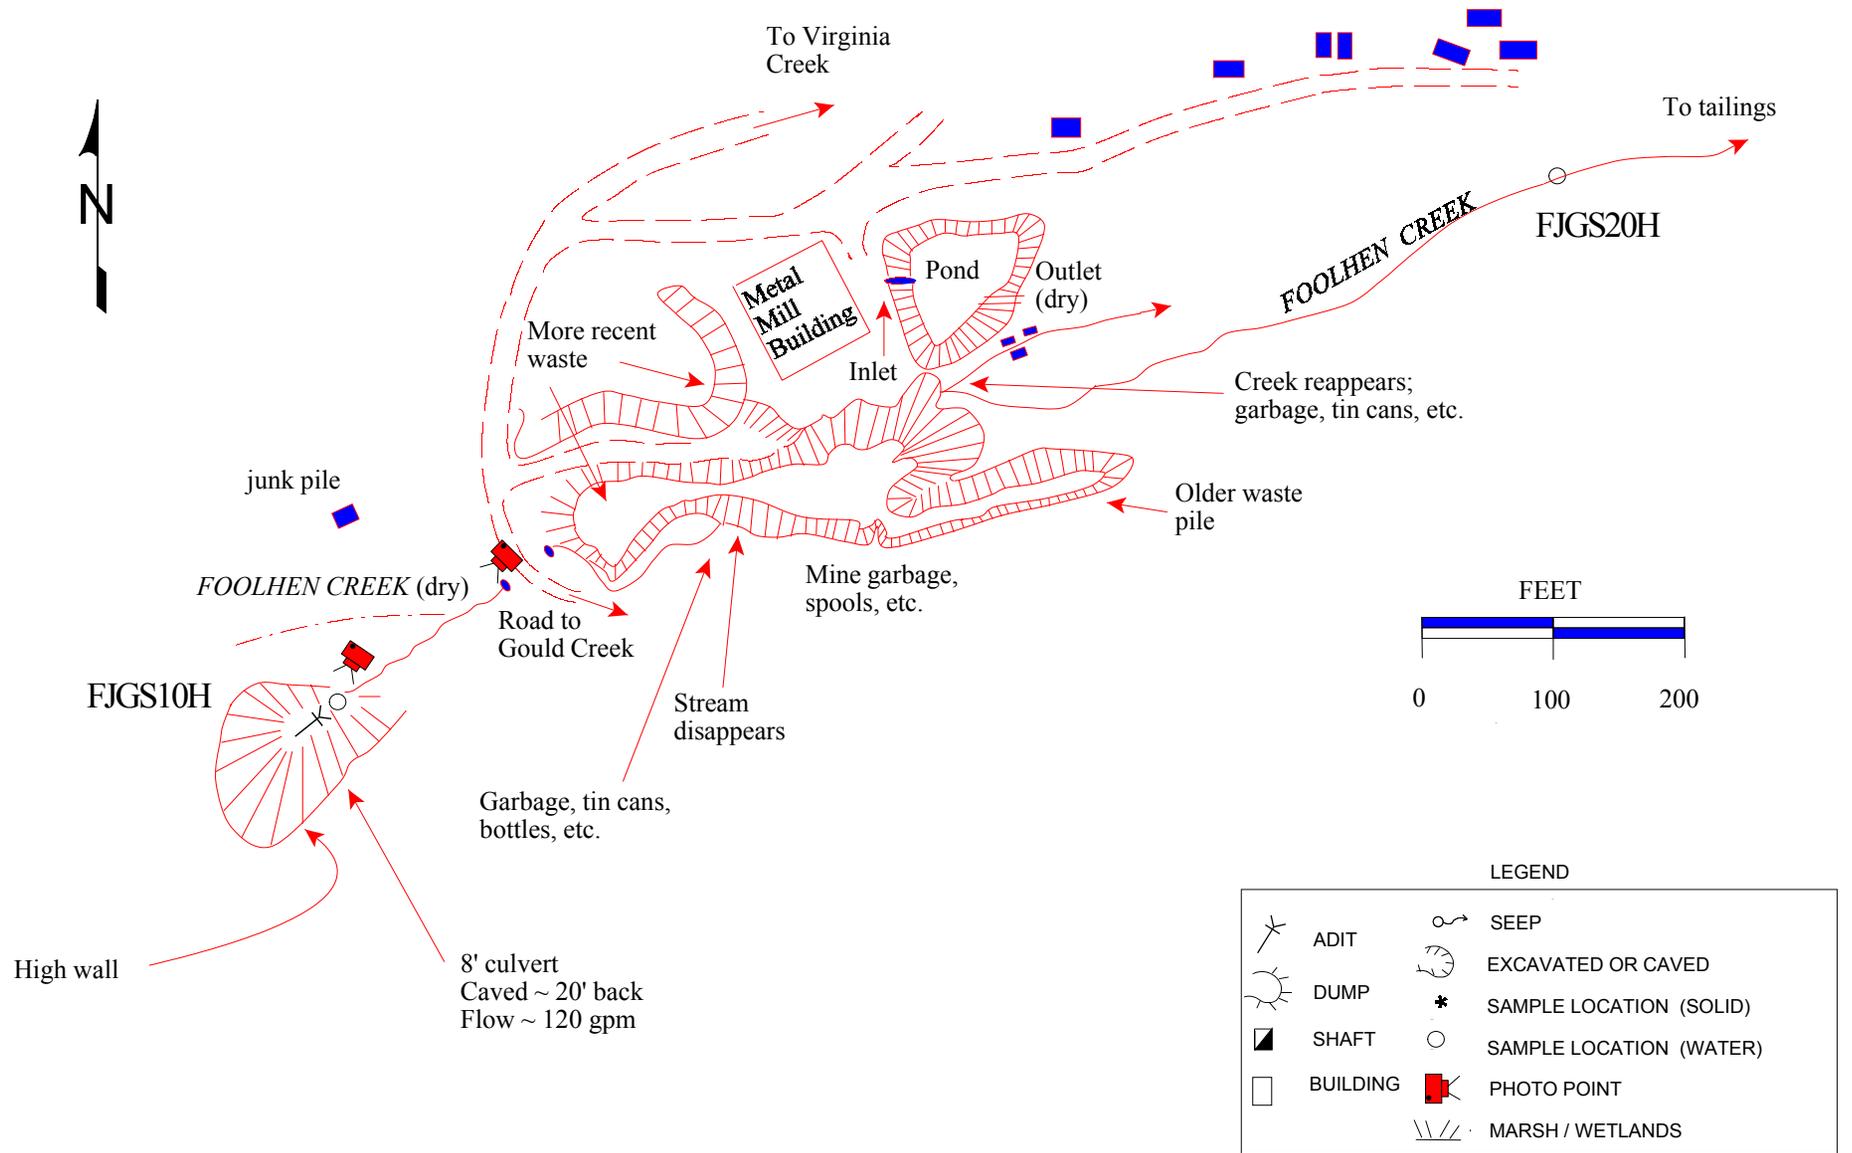
Figure 34. The workings of the Jay Gould tunnel are extensive (9/29/95). Foolhen Creek emerged from the upper adit and infiltrated the waste-rock dumps. The creek re-emerged below the lower dump.

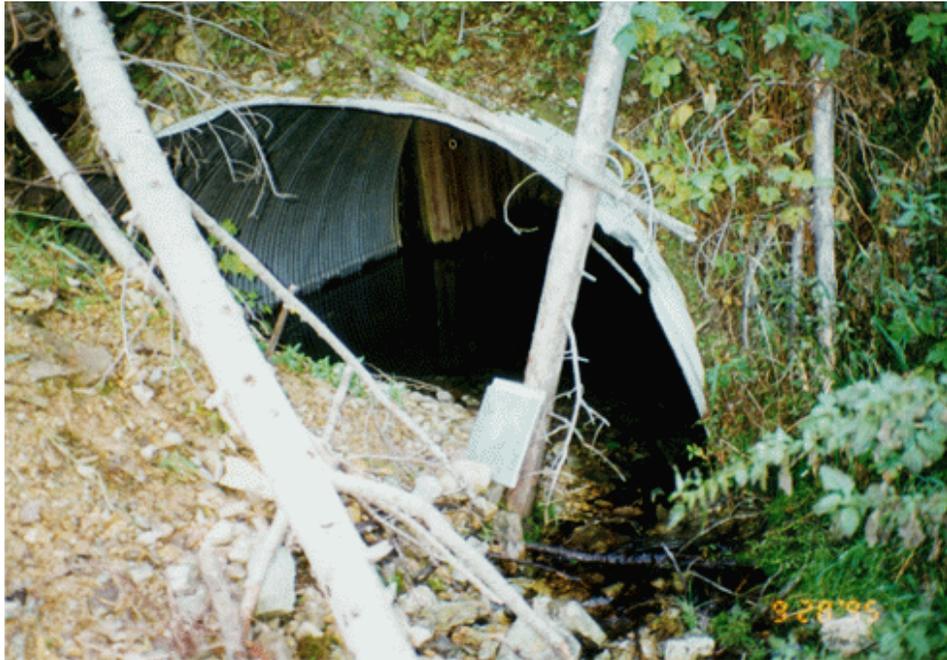
Figure 34a. Jay Gould tunnel's portal consisted of an eight foot culvert and was discharging about 120 gpm.

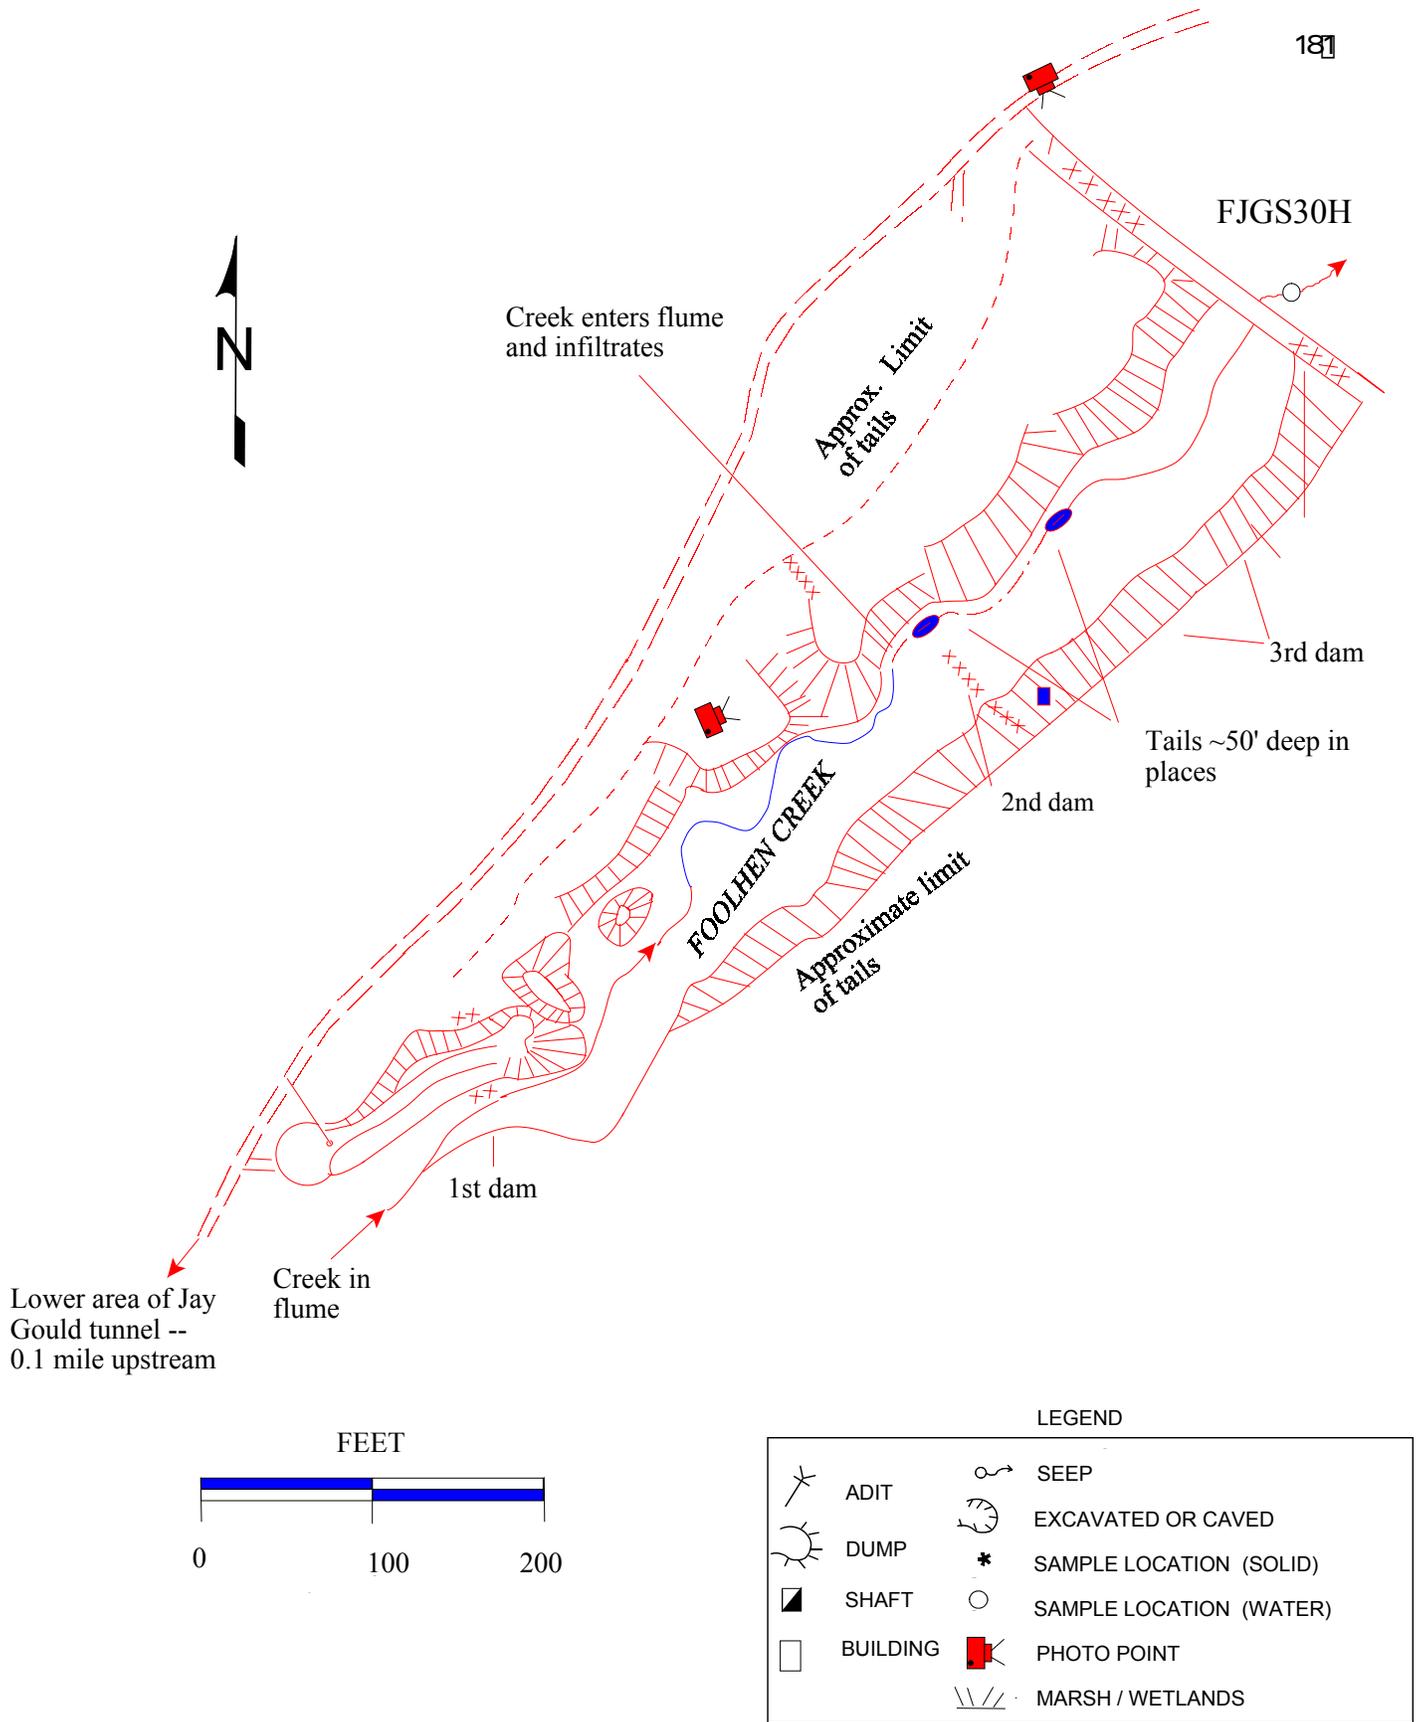
Figure 35. The Jay Gould tailings (10/19/95) consisted of tailings and alluvium eroded by Foolhen Creek.

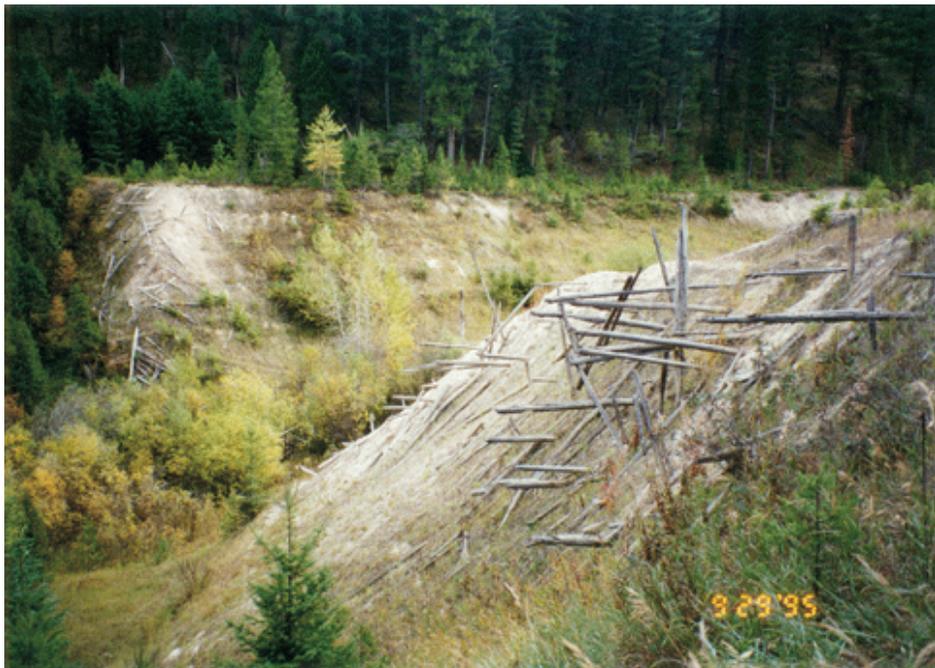
Figure 35b. The lowermost tailings dam on Foolhen Creek has been deeply eroded tailings.
