**HYDROGEOLOGIC ASSESSMENT OF THE INGOMAR WATER DISTRICT
WATER SUPPLY SYSTEM
FOR
GROUND WATER UNDER THE DIRECT INFLUENCE OF SURFACE WATER**

Open-File Report MBMG 401-K

**INGOMAR WATER DISTRICT
PWSID #03078
P. O. Box 65
Ingomar, MT 59039-0065**

April 2000

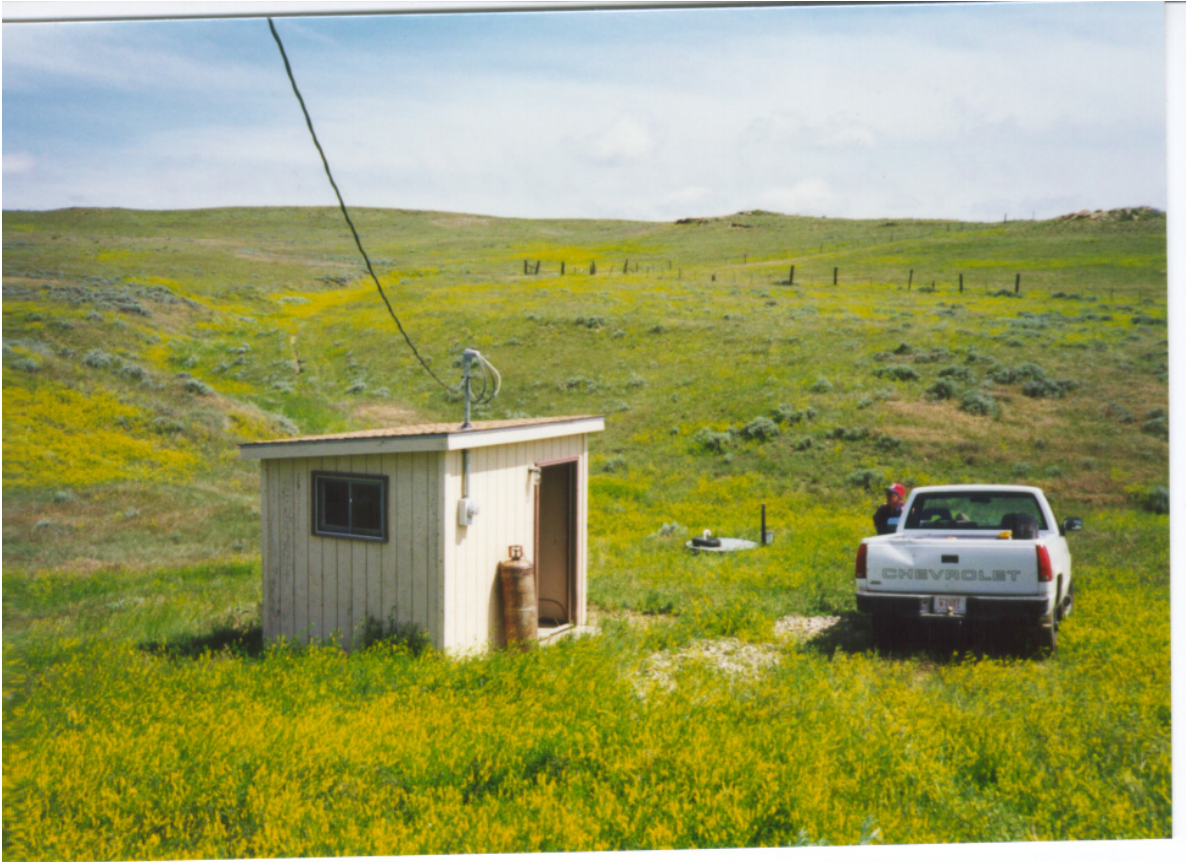
The pumped water is chlorinated by a liquid chlorination system in the pump house located at the well site (Appendix B, photo 1). From the pump house the water is pumped for a distance of about 2,000 feet to a 20,000 gallon steel storage tank located on a hilltop (Appendix B, photo 4). The operator reports that all water pumped from the well to the storage tank is chlorinated although no records have been kept of chlorine use or meter settings. The elevation rise from the well to the storage tank is approximately 115 feet. The type and size of the pipe from the pump house to the tank is unknown but is thought to be 1½-inch diameter black, flexible, PVC pipe buried along the access road. The steel storage tank is located about 2 miles from town at an elevation of 3,310 feet. Water flows by gravity from the water tank to town through a 4-inch diameter, PVC pipe (Appendix B, photo 2). Water pressure for the system is supplied by gravity flow from the water tank. The main distribution line drops 285 feet in elevation from the water tank to town (at 3,025 feet elevation).

Photo 1. View looking north across coulee showing pump house and well cover. The fence in the distance is on the north section line. A water retention dam crosses the coulee to the right, just out of view; the pond was dry. The outcrops on the hilltops are Lance Formation sandstone.

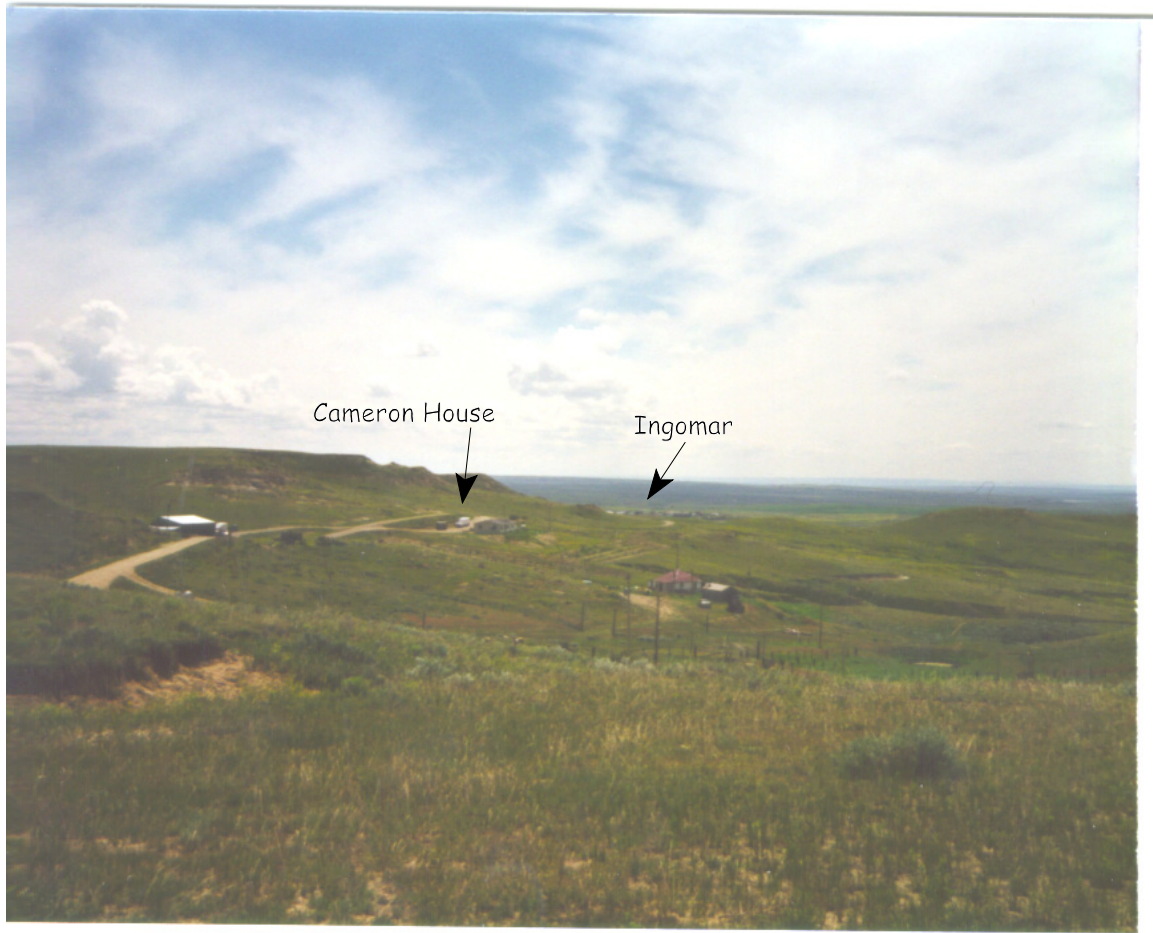
operator it appears that the leaks are getting worse, causing the water storage tank to run dry more frequently and requiring more water haulage from Forsyth. Currently water is being hauled from Forsyth 2 to 3 times per week. At the time of the HA inspection the tank was one-third to one-fourth full even though for several days the pump had been cycling as much as the well recharge would allow. This situation was reported as typical of the system by Mr. Erickson. On many occasions in the past the water tank and upper portion of the main distribution line have run dry creating a back flow from the Cameron house near the water tank into the main water line (Appendix B, photo 2). Often this is the first indication that the tank has run dry.

Repairing the breaks in the main water line would solve a lot of the water shortage problems, reduce the need for hauled water and reduce the occurrences of system back flow currently experienced. The leakage causes back flow to occur from the Cameron house near the water tank into the water system's mainline when the water level is drawn down to the house elevation. Installation of a back-flow preventer on the Cameron house would protect the water system from back flow from the house, which occurs frequently.

Photo 2. View looking south from the water-storage tank showing Ingomar in the distance and the Cameron house in the middle foreground. The Cameron house is the first house on the Ingomar water-distribution system. Hills in foreground are Lance Formation, the lower part of the hills are Fox Hills Formation bedrock. The flat terrain beyond Ingomar is typical of geomorphology developed on the Bearpaw Shale.

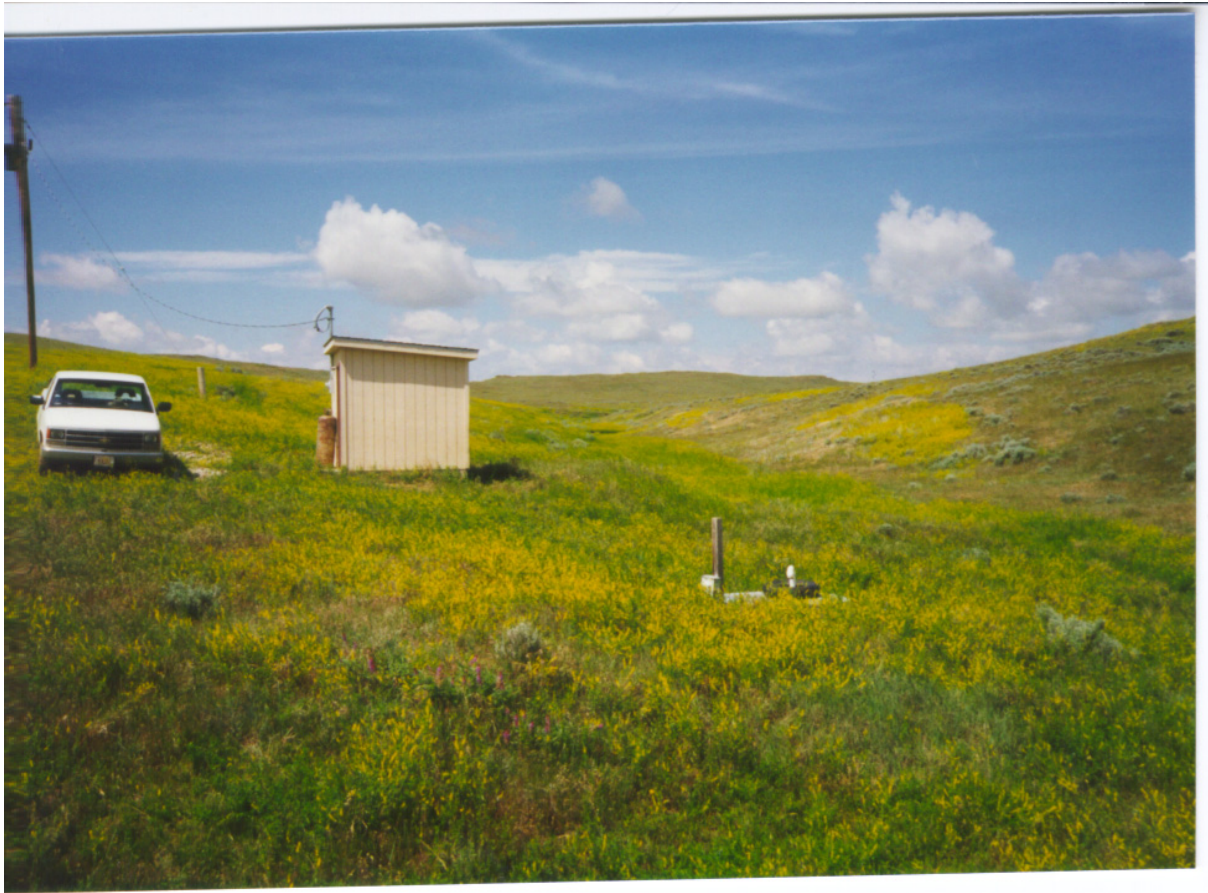
A backhoe was used to dig the present well and to install a corrugated 60-inch galvanized-steel casing vertically to a depth of 23 feet. The top of the casing is only 0.9 feet above the land surface and is covered by a heavy steel lid with a lip that covers the top of the casing. The Montana Board of Water Well Contractors Annotated Codes (1997) requires that the well casing stick up no less than 1.5 feet (18 inches) above the ground surface. The casing was placed through the colluvial material at the land surface and lowered approximately 8 feet into the Fox Hills Sandstone bedrock. The bottom of the casing is open, allowing ground water to seep into the well casing from pore spaces, fractures and partings within the sandstone formation at the bottom of the well. Sandy and silty clay dug from the well was used as backfill around the well casing. During the site inspection no cracks or gaps were seen in the backfill material.

In 1993 an infiltration gallery was connected to the well. The gallery was attached to the well 15 feet below the land surface and was laid in the colluvium on top of the underlying bedrock. The gallery is constructed from 4-inch diameter, perforated, PVC pipe laid to the west toward the center of the coulee for a distance of 150 to 200 feet (Appendix B, photo 3). The pipe was designed to capture drainage water flowing through the colluvium in the bottom of the coulee and seepage from the near-surface bedrock to supplement ground-water recharge to the well. Water draining into the infiltration gallery is probably from the same source that supplied the old spring at the well site. The system operator reported that he has not observed water flowing into the well from the infiltration gallery for the past 3 to 4 years. At the time of the HA no water

was observed flowing from the infiltration gallery and it was not determined whether the infiltration gallery contributes water to the well. The infiltration gallery may be obstructed or the gallery may have drained the available ground water from the coulee and water is no longer available to flow into the well. For the HA it was assumed that the gallery is open and functional and could contribute water to the well. The spring is recharged from drainage of the colluvium and from the bedrock below. After the well was constructed the spring did not flow at the surface. The ground water recharging the spring now flows to the well.

Photo 3. Looking west up coulee showing well in foreground and pump house. Colluvium covers the coulee bottom, the well is in the Fox Hills Sandstone, the hills in the background are Lance Formation bedrock. The infiltration gallery is buried behind the well and extends about 150 to 200 feet west, directly into the photo view.

3. Plug the infiltration gallery to ensure that shallow colluvial ground water does not flow into the well. Doing so could classify the well source as ground water.

7. Install a low water alarm system for water tank to detect low water levels before the tank runs dry.
8. Install a tighter, more secure sanitary seal on the well. Installing a rubber gasket and latch system on the present lid may be adequate to seal the top against rodents and potential surface water infiltration.

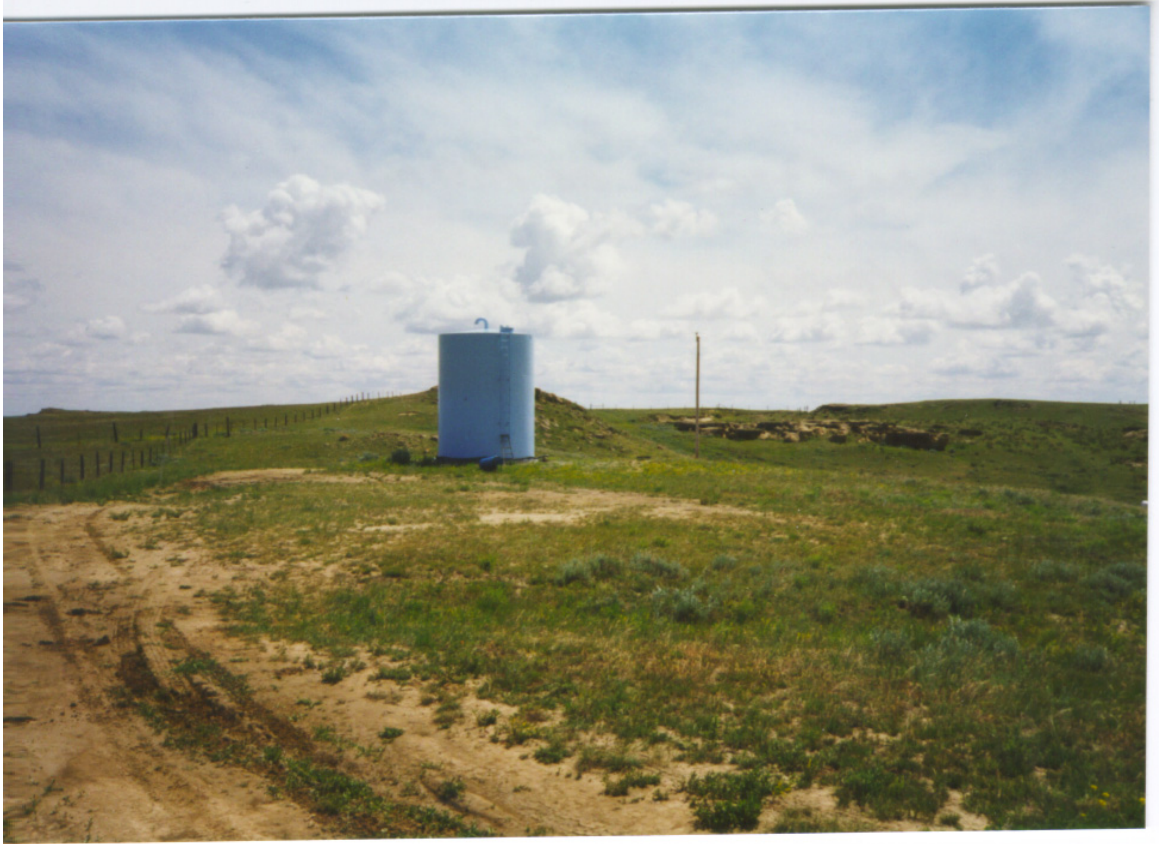
Photo 4. Looking east along a ridge showing the water-storage tank. Lance Formation sandstone forms the caprock on the hilltops. Ingomar is to the right, the well is to the left.
