MONTANA BUREAU OF MINES AND GEOLOGY
OPEN-FILE REPORT No. 321
ABANDONED-INACTIVE MINES PROGRAM
DEERLODGE NATIONAL FOREST
VOLUME 1
BASIN CREEK DRAINAGE

PREPARED FOR THE U.S. DEPARTMENT OF AGRICULTURE
FOREST SERVICE - REGION 1
APRIL 1994

**ABANDONED - INACTIVE MINE INVENTORY
FOR THE DEERLODGE NATIONAL FOREST**

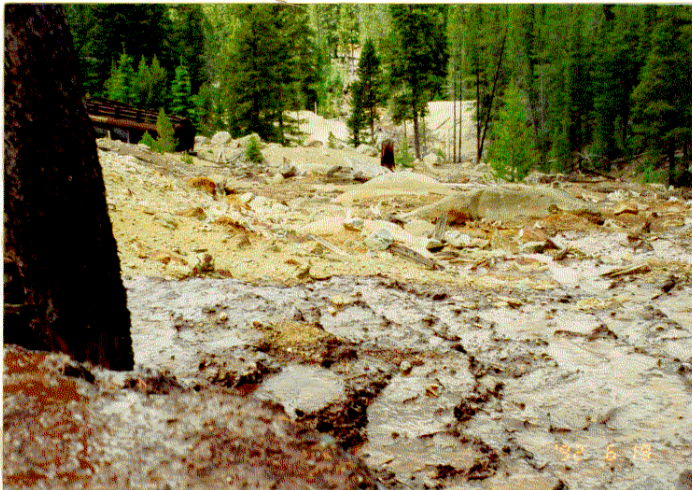
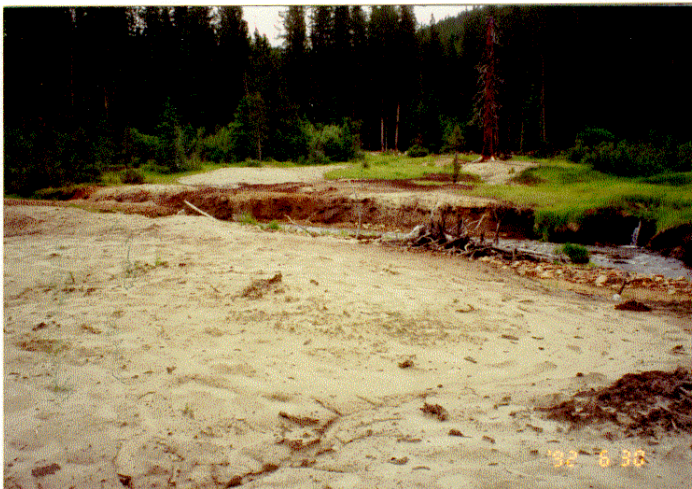
Figure 4A. Discharge streams from main development area of the Bullion mine; tailings on Jack Creek downstream of the mine.

In addition to the dissolved-metals load to the unnamed creek and Jack Creek, waste material and tailings were obviously being actively eroded and washed into the streams; stream-bed and stream-side tailings were observed in several sections of Jack Creek several thousand feet downstream.

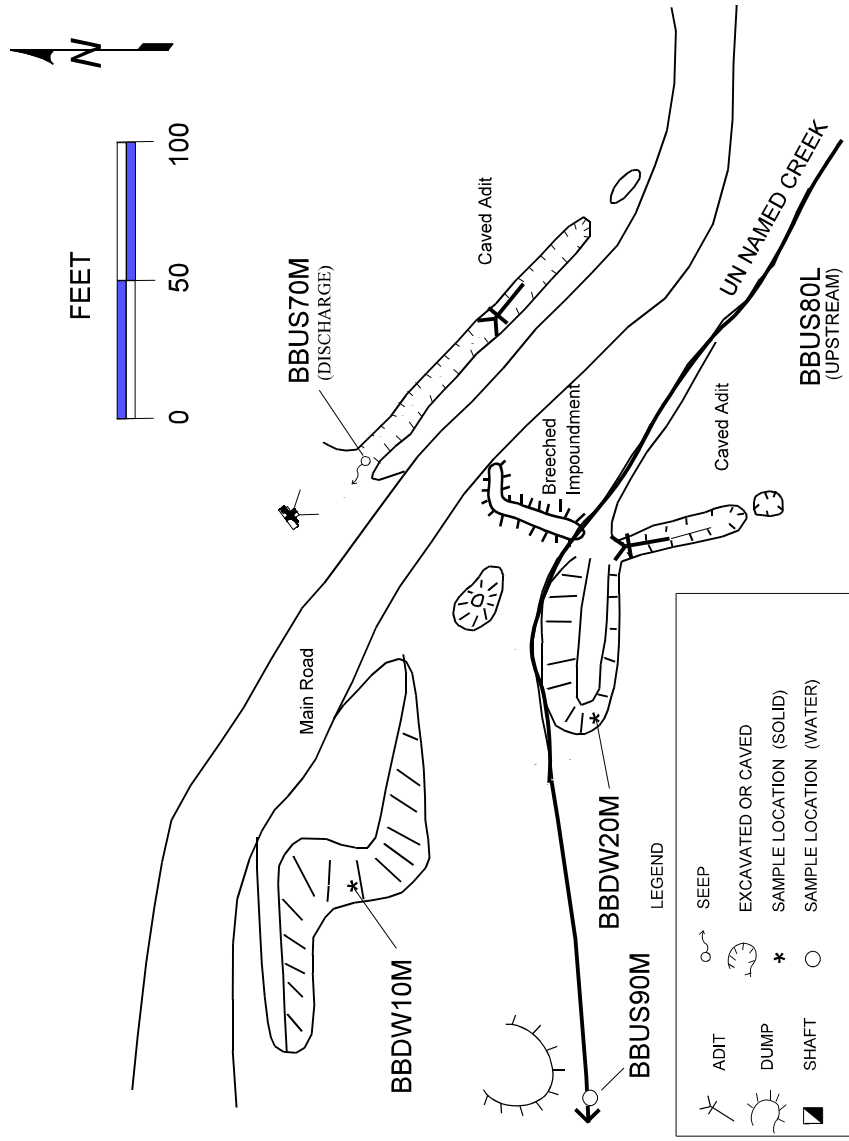
The area referred to here as the smelter area includes the smelter which has several concrete and rock foundations, slag piles, and a large collapsed mill; a group of cabins in various states of disrepair, and two adits, one of which discharges water (Figure 5).

There is a smelter and two small adits in a second tributary to Jack Creek south of the drainage that contains the development area (Figure 5). The smelter and adits are within an unnamed drainage approximately 3000 feet upstream of its confluence with Jack Creek. There was no evidence of mill tailings in the immediate area or adjacent to the unnamed creek. However, tailings in the creek were observed on private ground in Jack Creek approximately 500 feet downstream of its confluence with the unnamed creek. The source of these tailings may either be the smelter site or the tailings impoundments associated with the main development area.

Figure 5 Smelter area of the Bullion Mine. Water samples were collected upstream and downstream of the area and at the adit discharge.

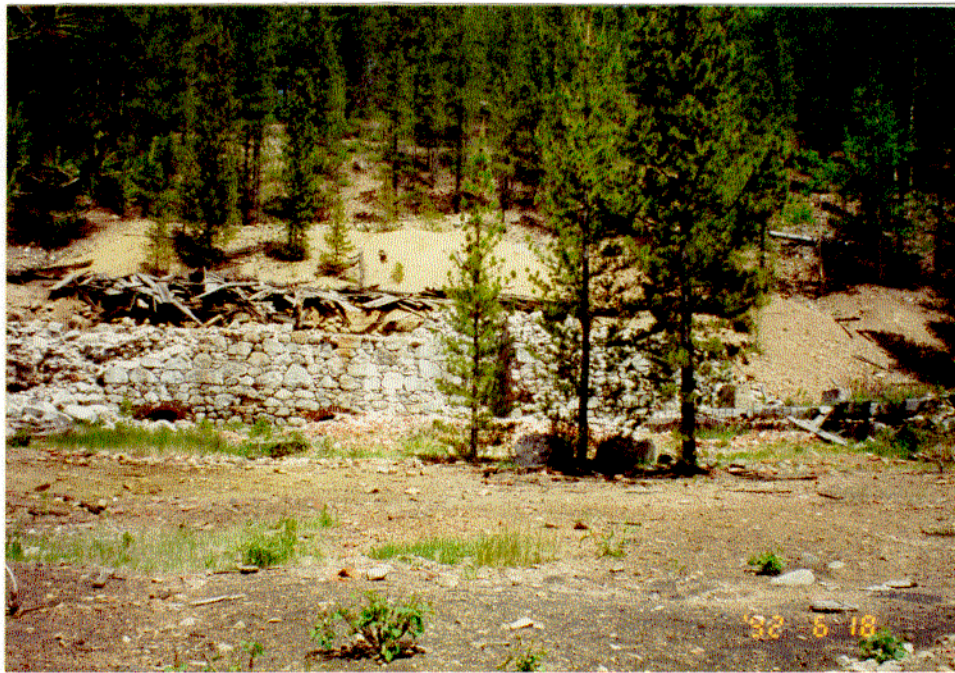
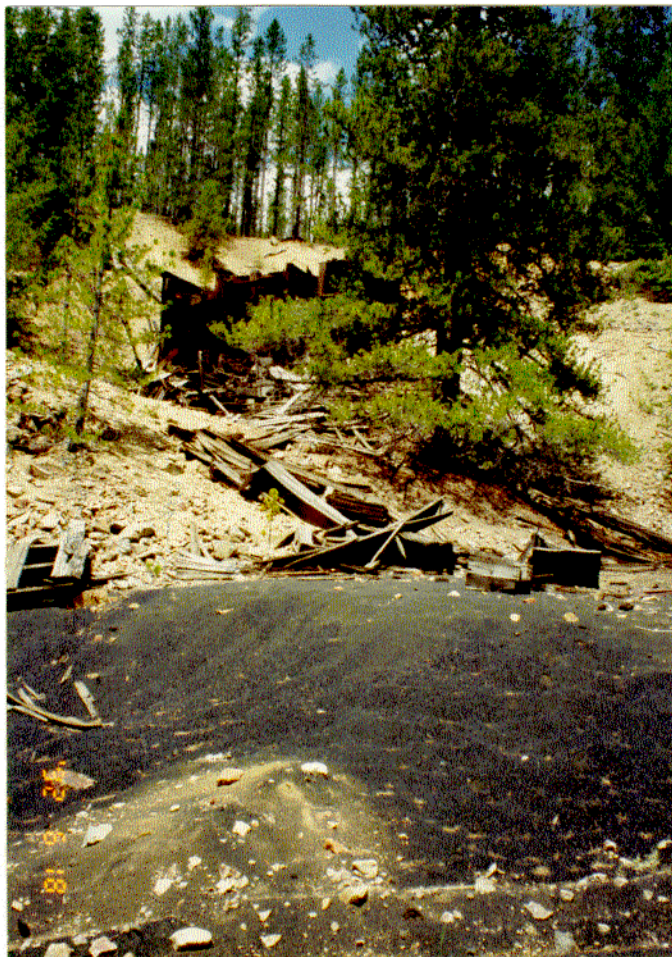
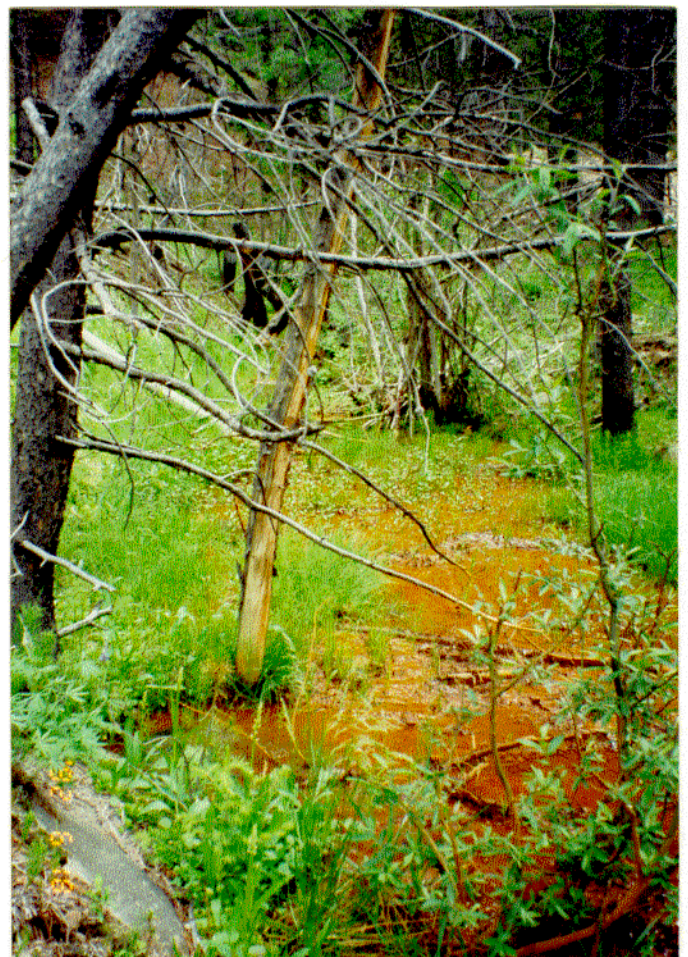
There are two adits located upstream of the smelter site. The uppermost adit was caved and was not discharging water. The lower adit was also caved, but was discharging a small amount of water which infiltrated the ground within a few feet. Ferric hydroxide and iron-bacteria were strongly evident in the adit discharge.

Figure 5A. Smelter area with slag piles and foundation material; adit discharge sample location (BBUS70M). The camera symbols in Figure 5 indicates location of photographs.

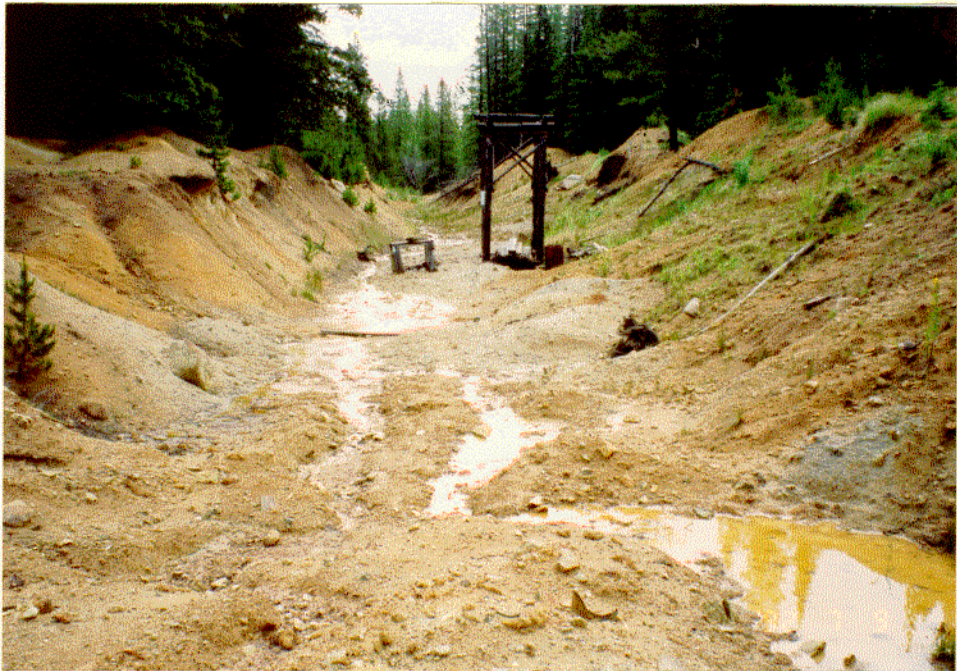
Figure 6A. The west shaft of the North Ada mine is discharging water toward the Cataract Creek drainage; the north shaft was inaccessible. The locations of the photographs are shown in Figure 6.

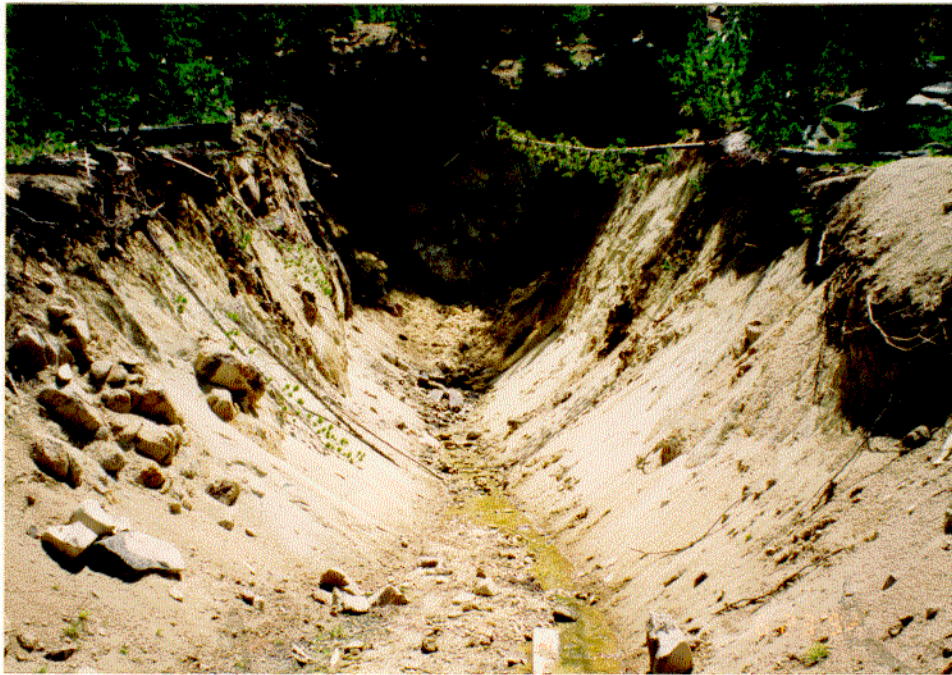
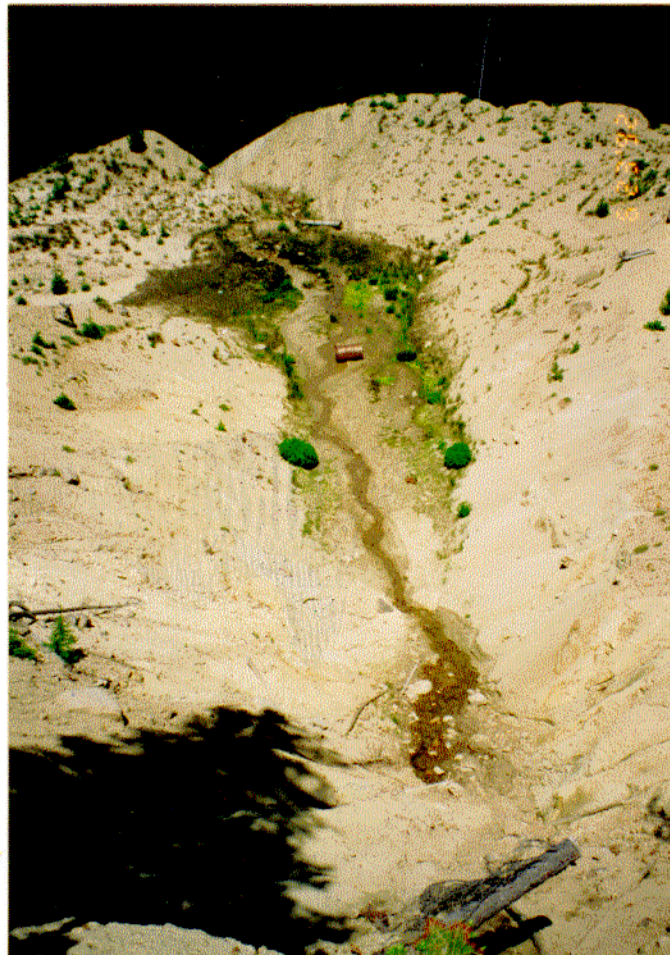
Figure 7A. Adit discharges from the Morning mine. The location of the upper photograph is shown on Figure 7, the lower adit was not mapped.

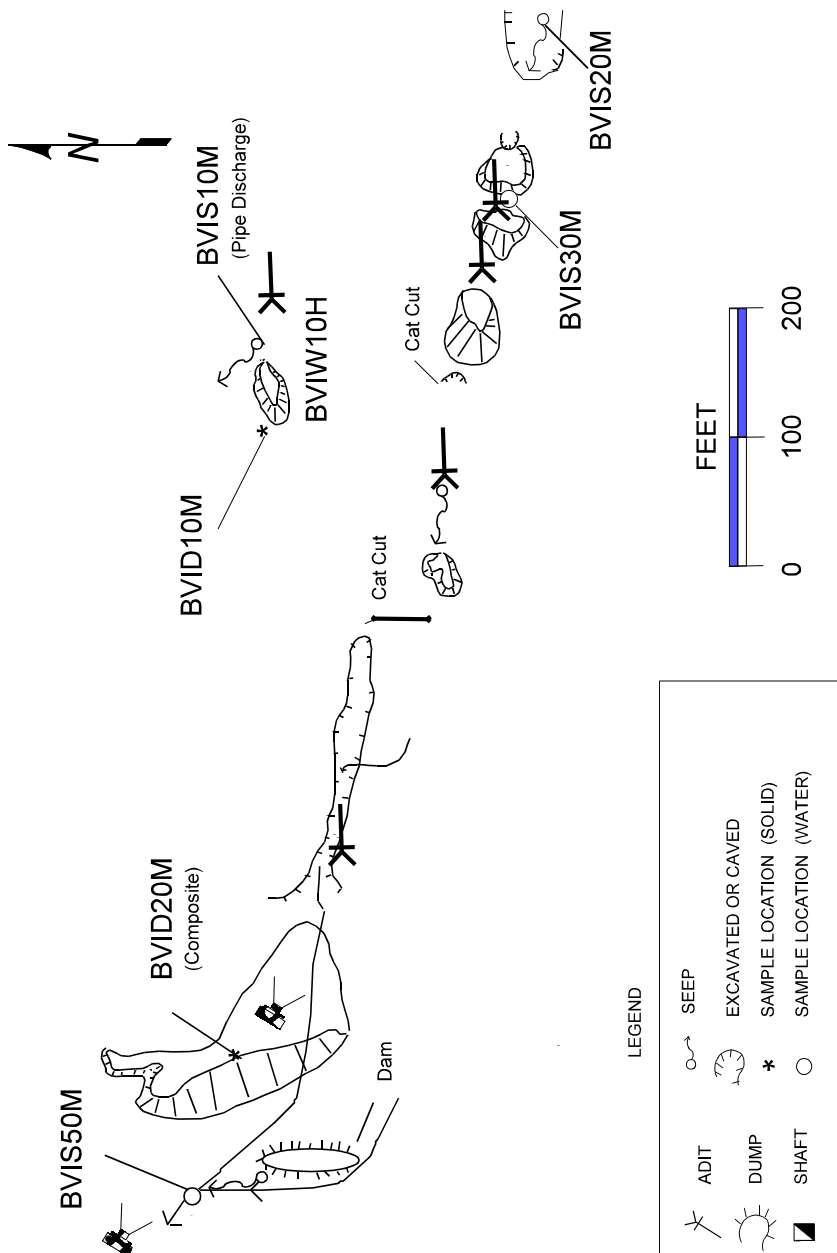
Figure 8 The main development area of the Vindicator Mine is in a wet drainage; sample locations were chosen that best represent the impact of the workings on soil and water.

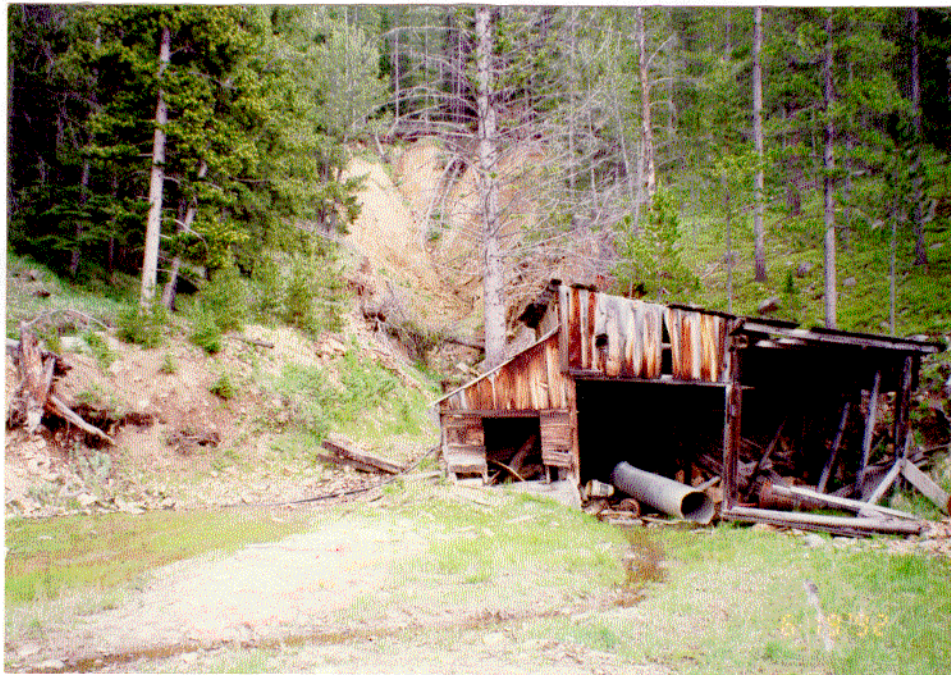
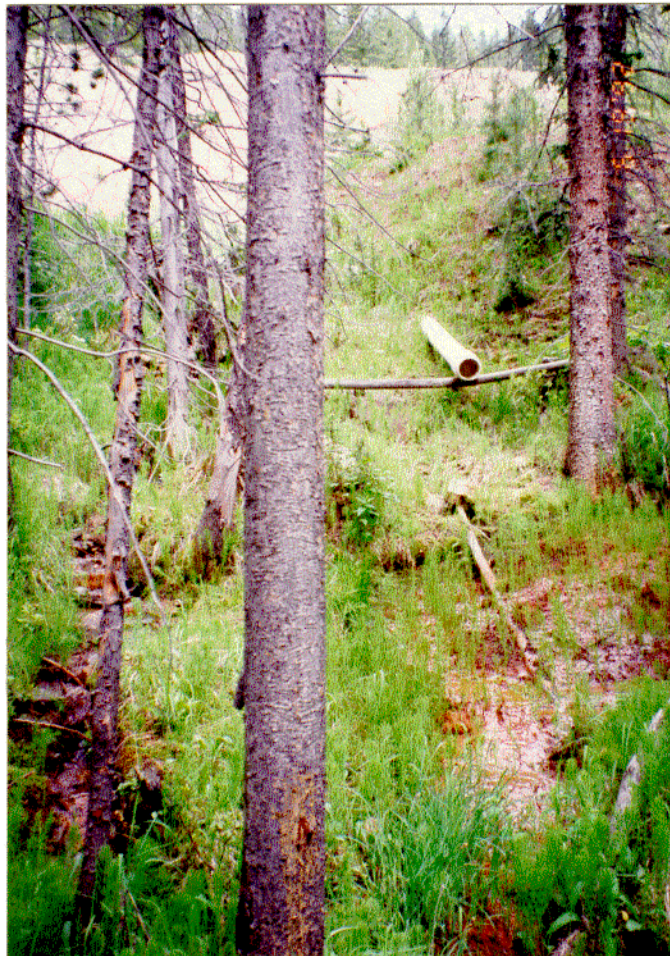
Figure 8A. Adit discharges cross the main dump (top); several discharges come together below the dam (bottom). The locations of the photographs are shown in Figure 8.

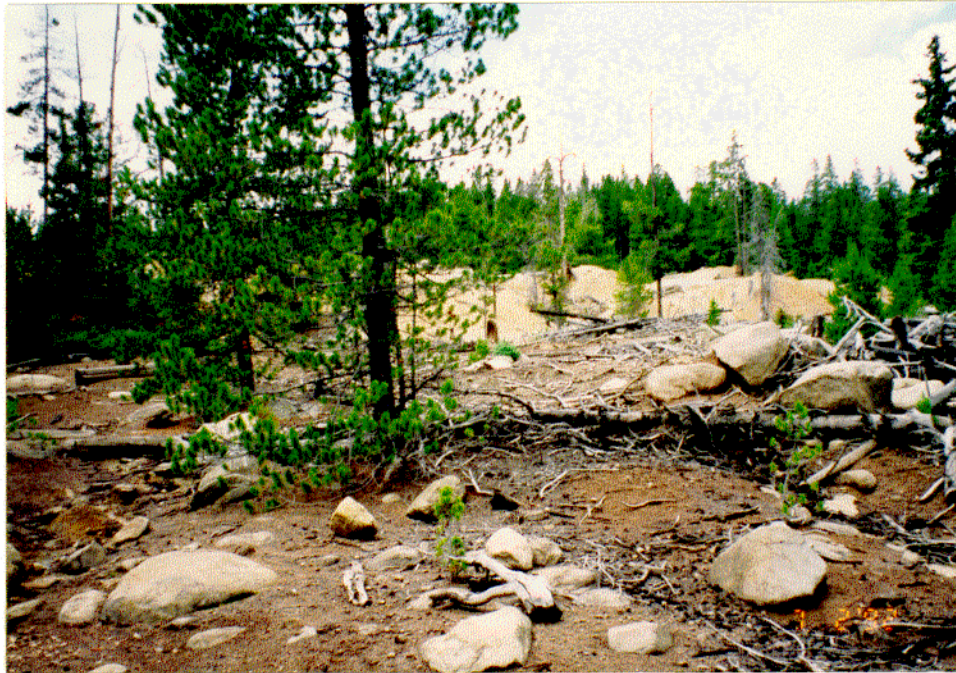
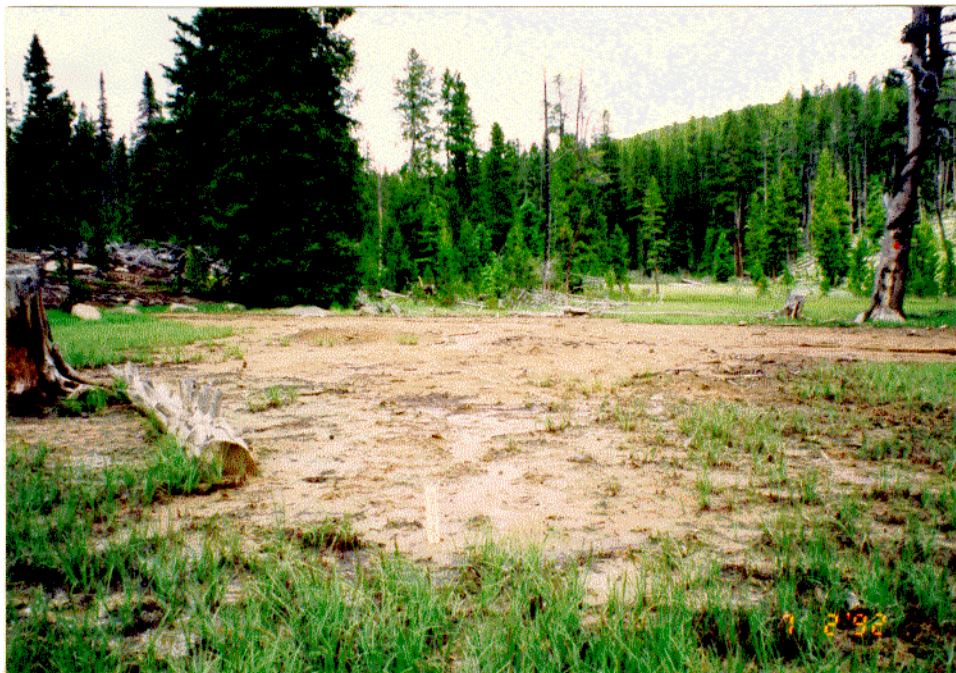
Figure 10A. Material from the mine area (top) and from the tailings impoundment (bottom) have been washed into the creek. The locations of the photographs are shown in Figure 9 and Figure 10.

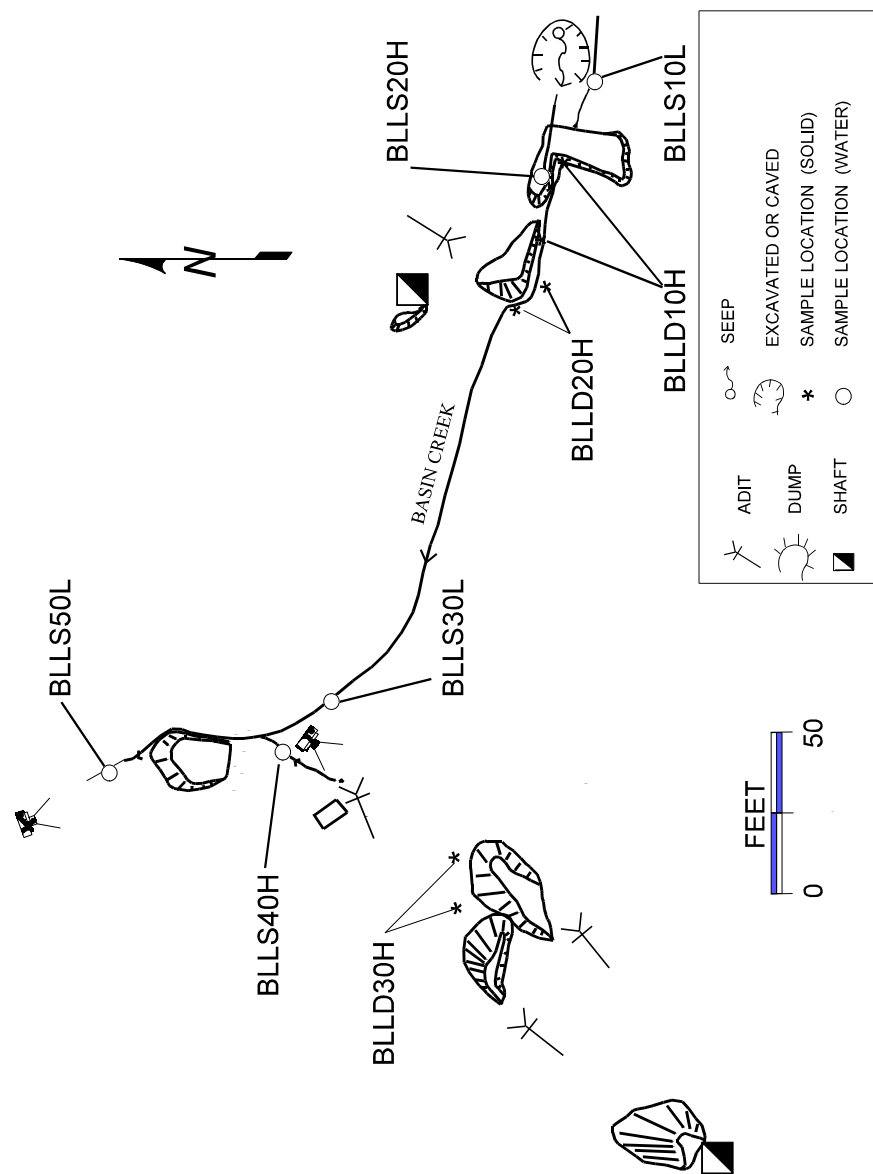
Waste rock dumps associated with the shaft and adits have been eroded and may have deposited sediments in the small stream below the site. Although field pH values were near neutral, SC values for the adit discharge water were elevated in comparison to values from Basin Creek upstream of the site. Water samples were collected upstream (BLLS10L) and downstream (BLLS50L) of the site, at each of the two discharging adits (BLLS20H and BLLS40H), and at a point on Basin Creek between the eastern and western portion of the development area (BLLS30L). Soil samples were collected near the stream where waste material appeared to be washing into the stream (BBLD10H) and at the base of two waste rock dumps (BLLD20H and BLLD30H).

Figure 11 There were two discharging adits at the Lady Lieth Mine. Water and soil samples were selected that would represent the relative impact to the stream by the western and eastern portion of the development area.

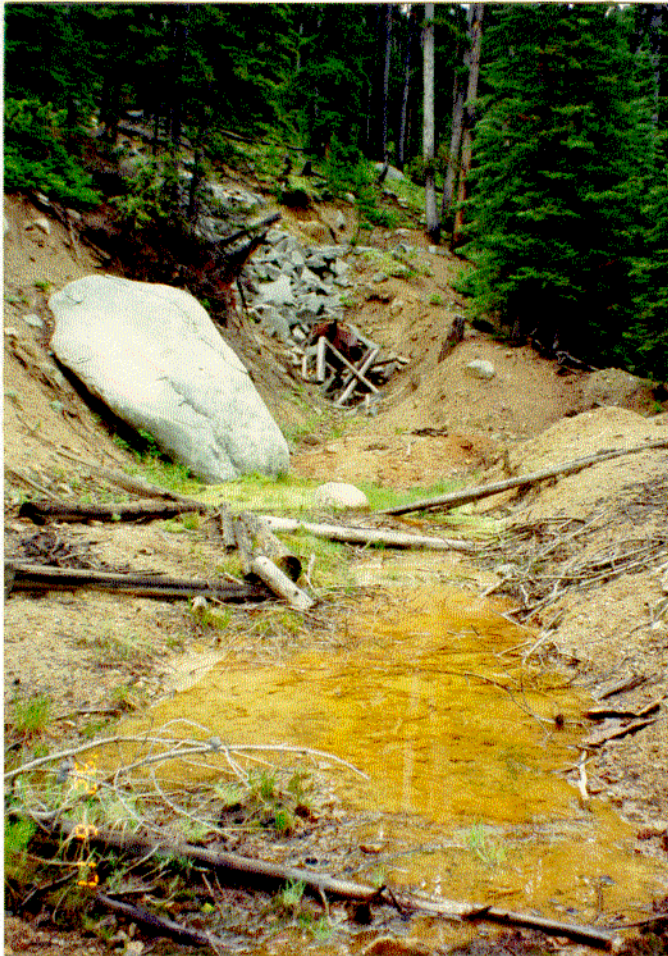
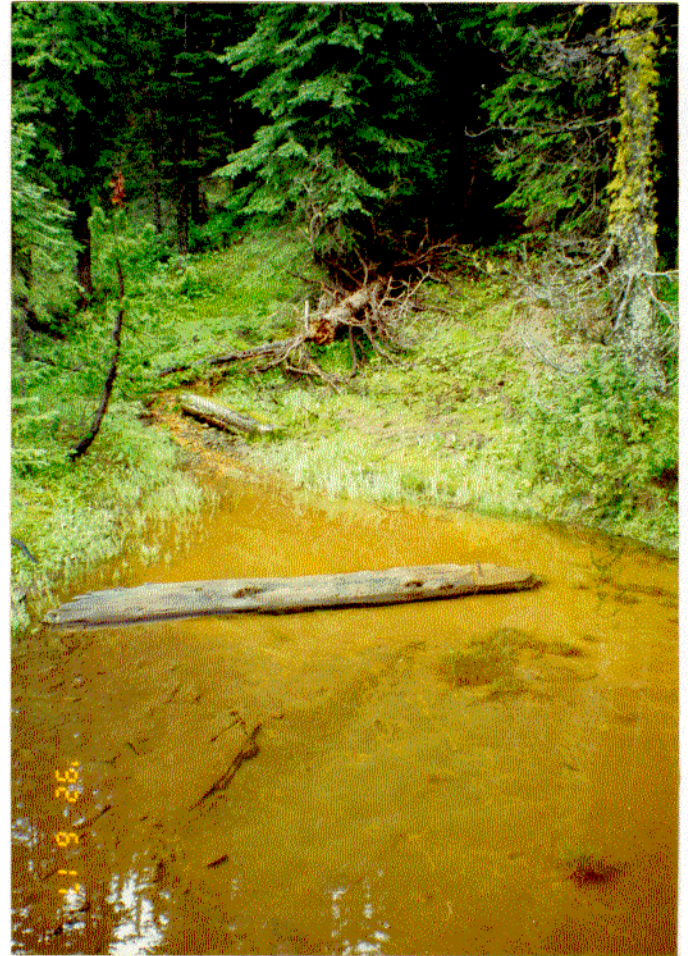
Figure 11A. The adit discharge from the lower Lady Leith (left) eventually reaches the creek (right). The locations of the photographs are shown in Figure 11.

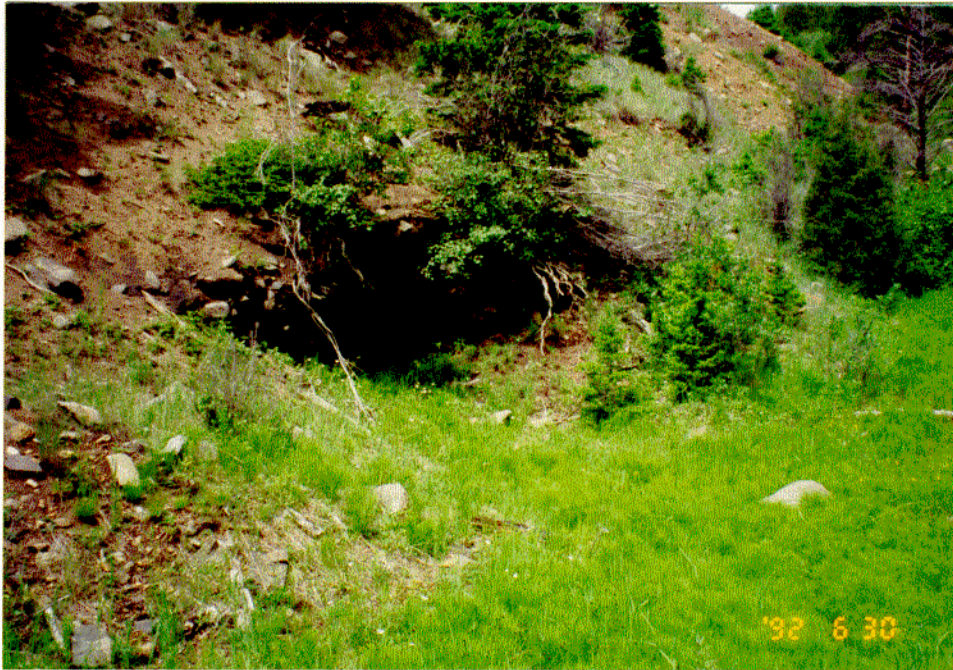
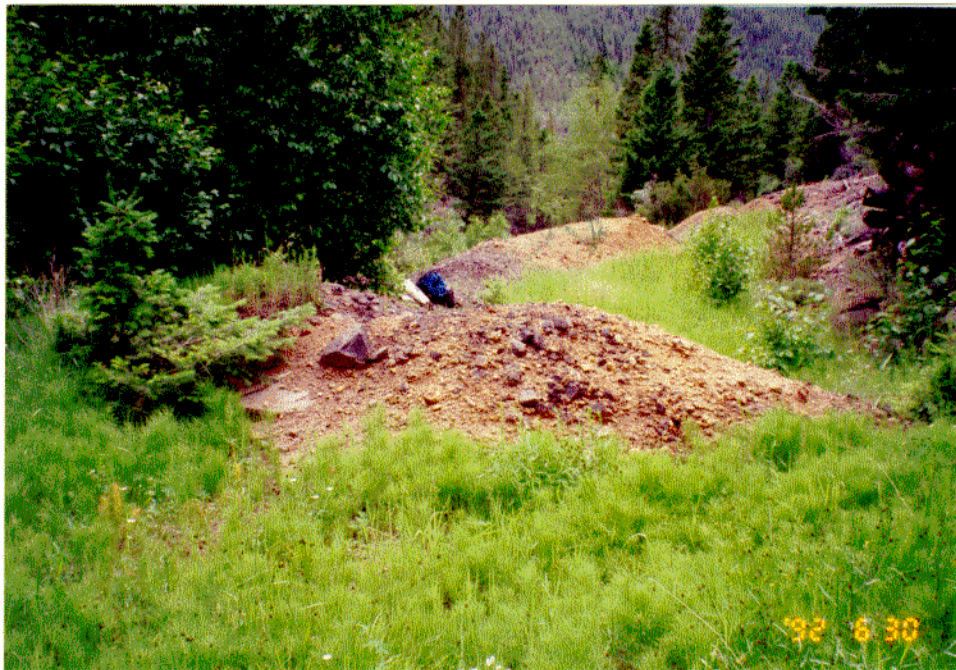
Figure 12A. The Hector mine has dry adits (top) and a stream side dump (bottom); a diversion of the stream flows over the lower dump. The locations of the photographs are shown in Figure 12.
