Abandoned-Inactive Mines on Lewis and Clark National Forest-Administered Land

Montana Bureau of Mines and Geology Abandoned-Inactive Mines Program Open-File Report MBMG 413

April 2000

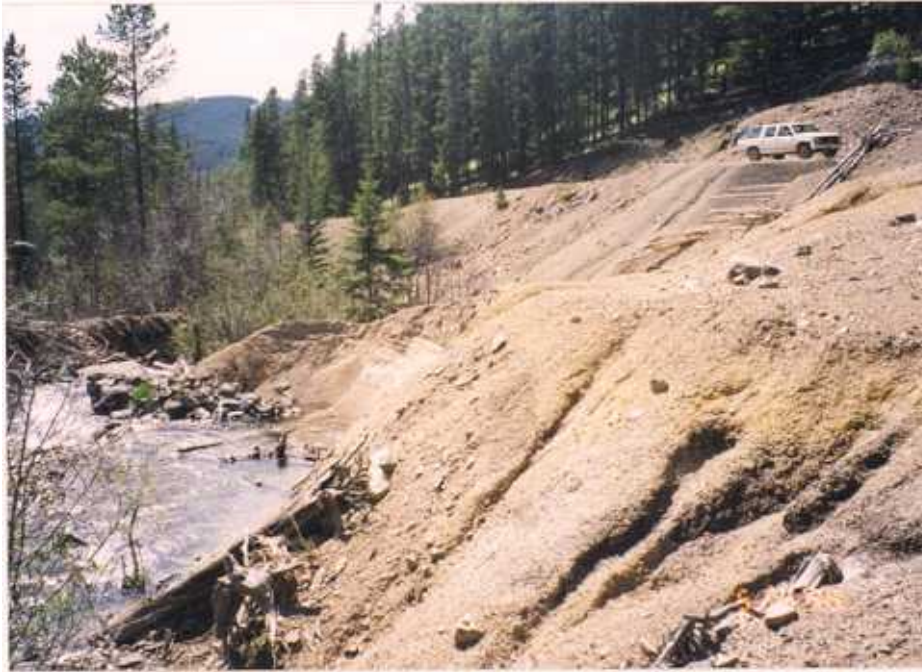
Figure 7a. Carpenter Creek actively erodes the Silver Dyke tailings and runoff has formed rills in the tailings.

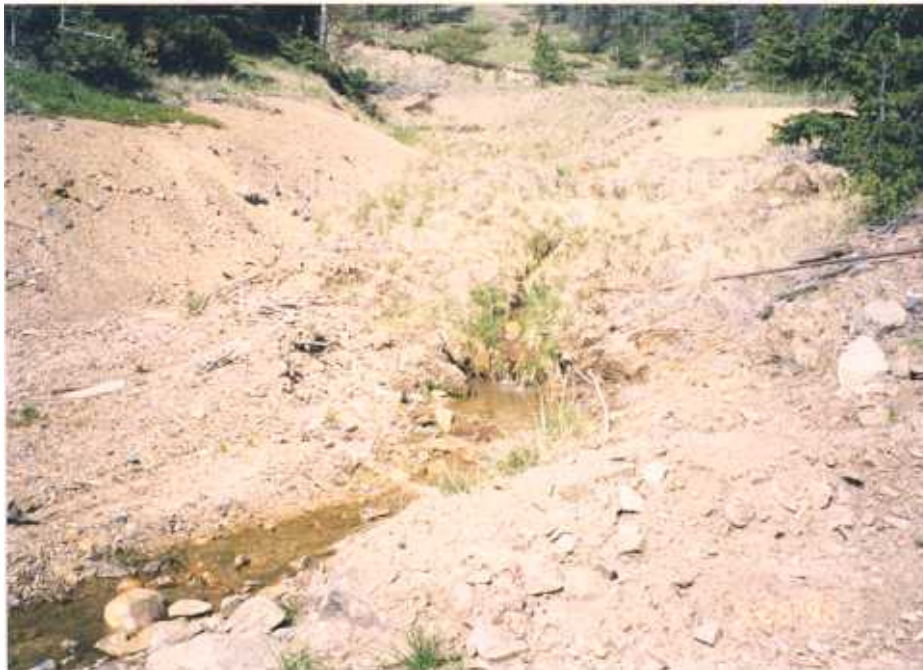
Figure 7b. The adit discharge from the Silver Dyke Mine forms the majority of the flow in Squaw Creek. Sample BSQS10H was taken here.

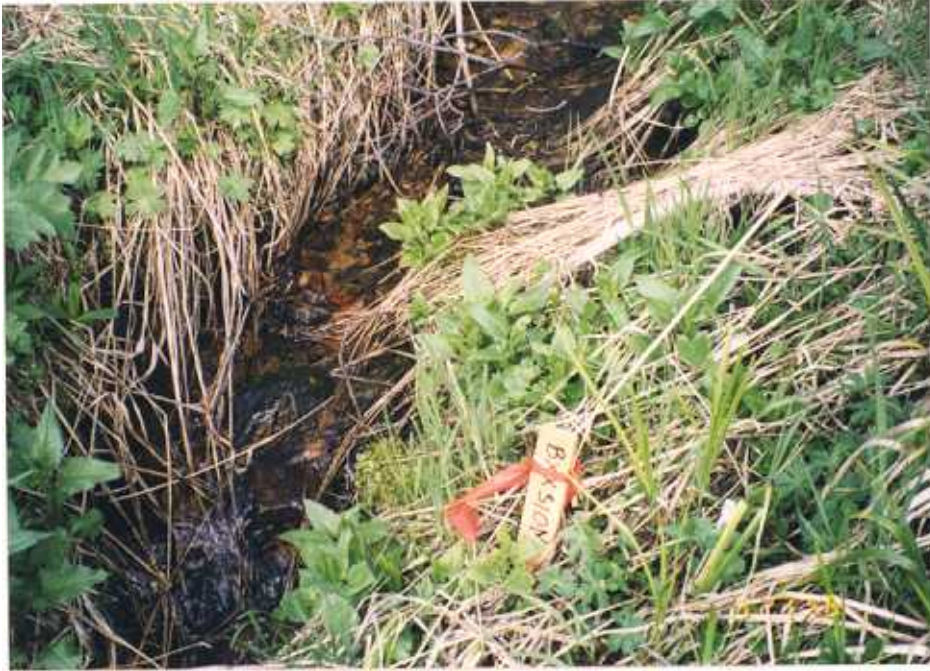
Figure 8a. At the Double X, small flow on a fraction of LCNF-administered land provided a place to sample (BXXS10M) the upper reaches of Mackay Creek.

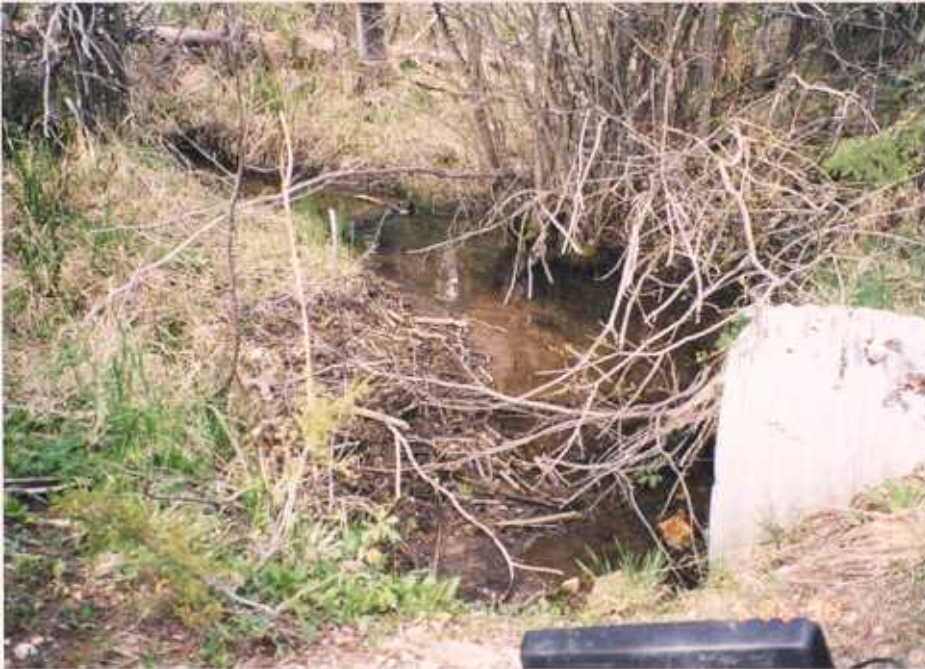
Figure 8b. The lower stretches of Mackay Creek are clear, as sampled (BXXS20M) upstream of the culvert on Forest Road 3323.

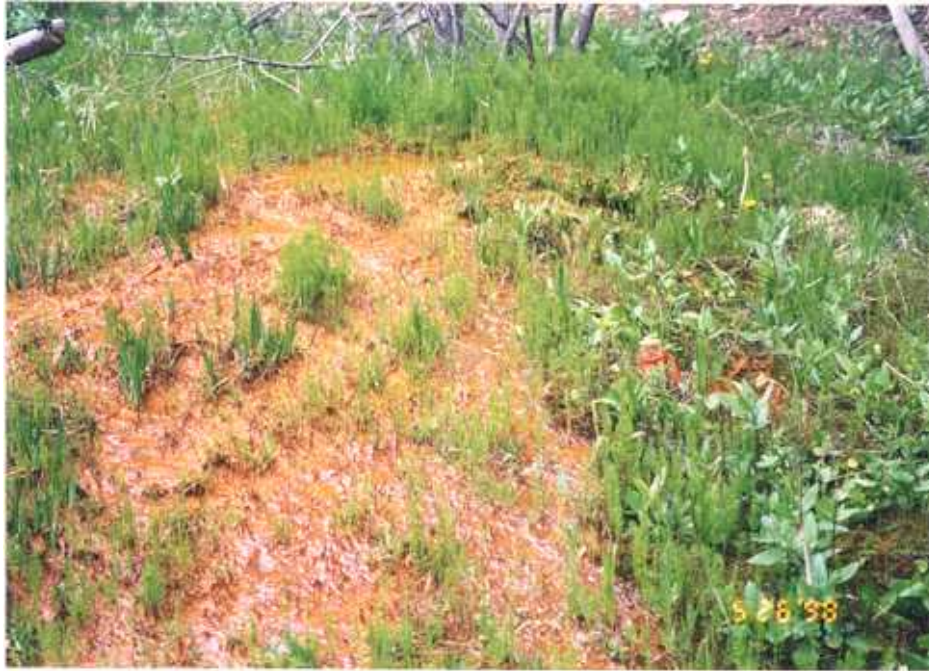
Figure 9a. The Haystack Creek Iron Spring discharged water (sample BHFS10H) that was brightly orange iron hydroxide stained but had abundant Equisetum growing in it.

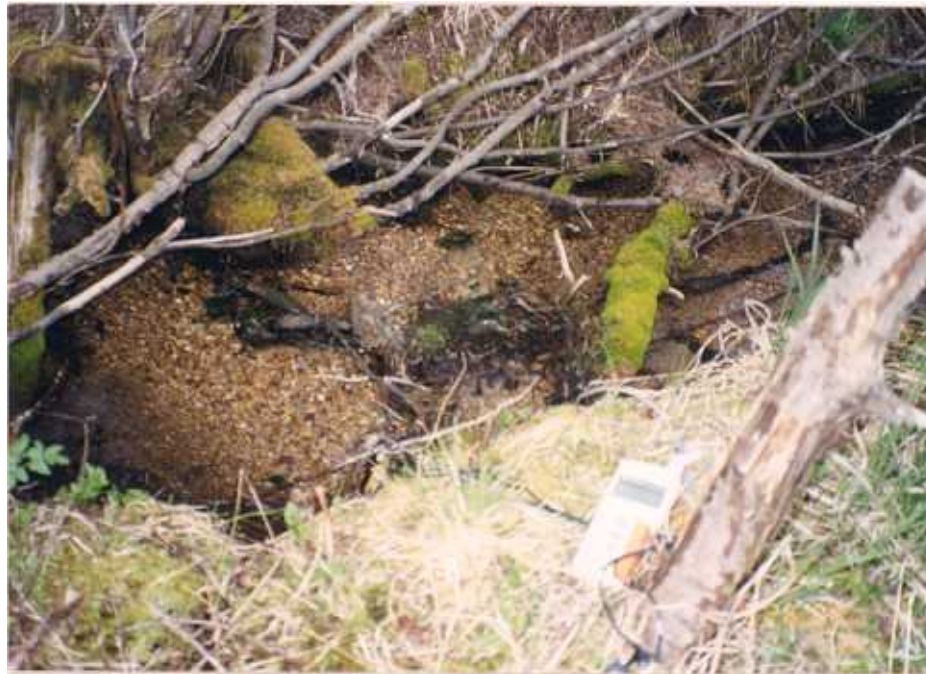
Figure 9b. Haystack Creek looked clear and clean (sample BHCS20M) but slightly exceeded the secondary MCL, and aquatic and chronic life criteria for zinc.

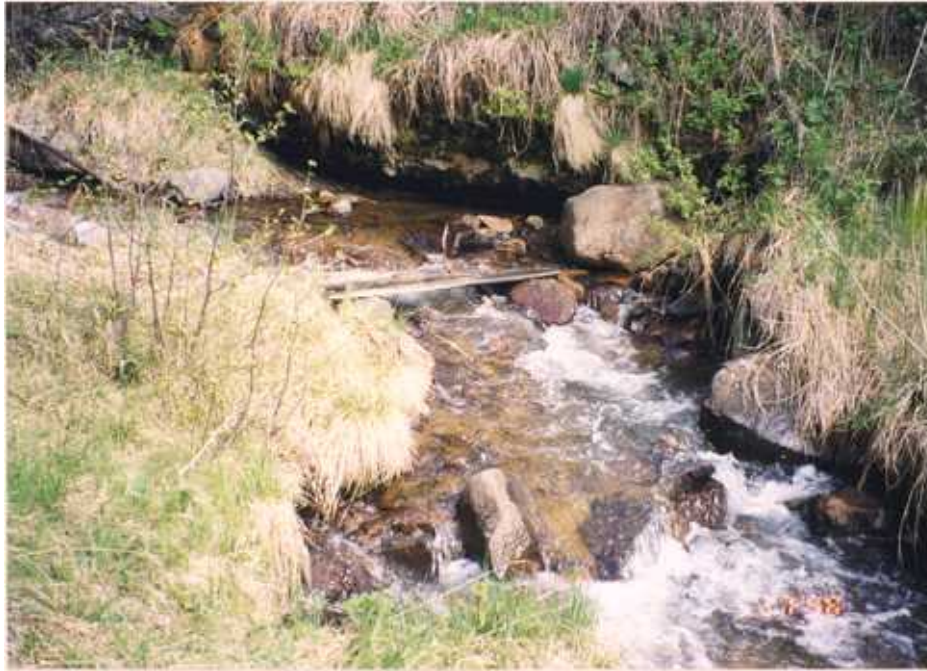
Figure 10a. Snow Creek was sampled upstream (BSNS20M) from the Snow Creek mill tailings. The bed of the creek was orange stained and had fine sediment which may be waste or tailings washed down from the Big Seven area.

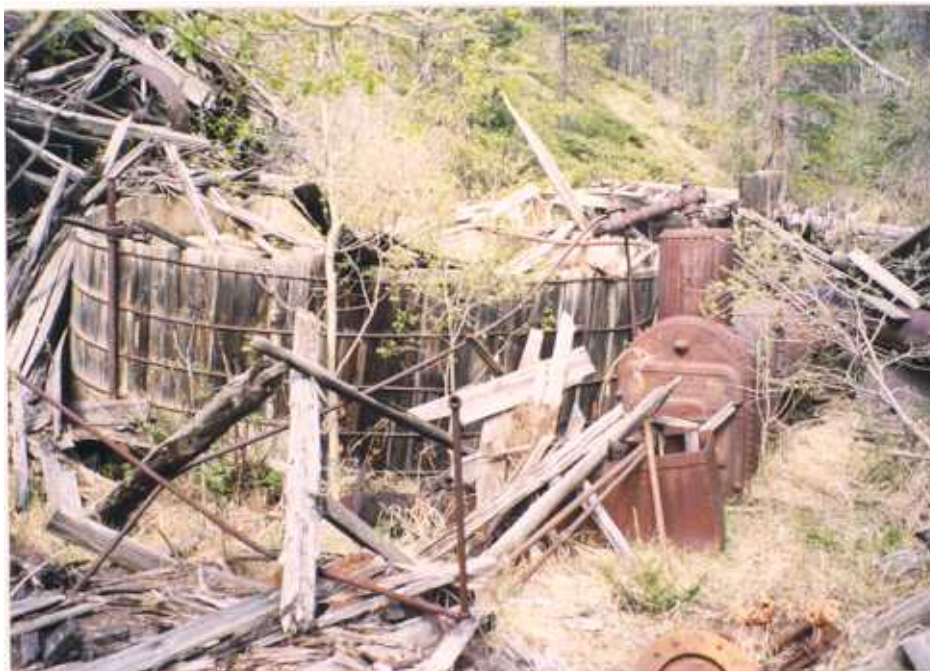
Figure 10b. The Snow Creek millsite bears remnants of its past including a vat with crushed ore and a boiler.

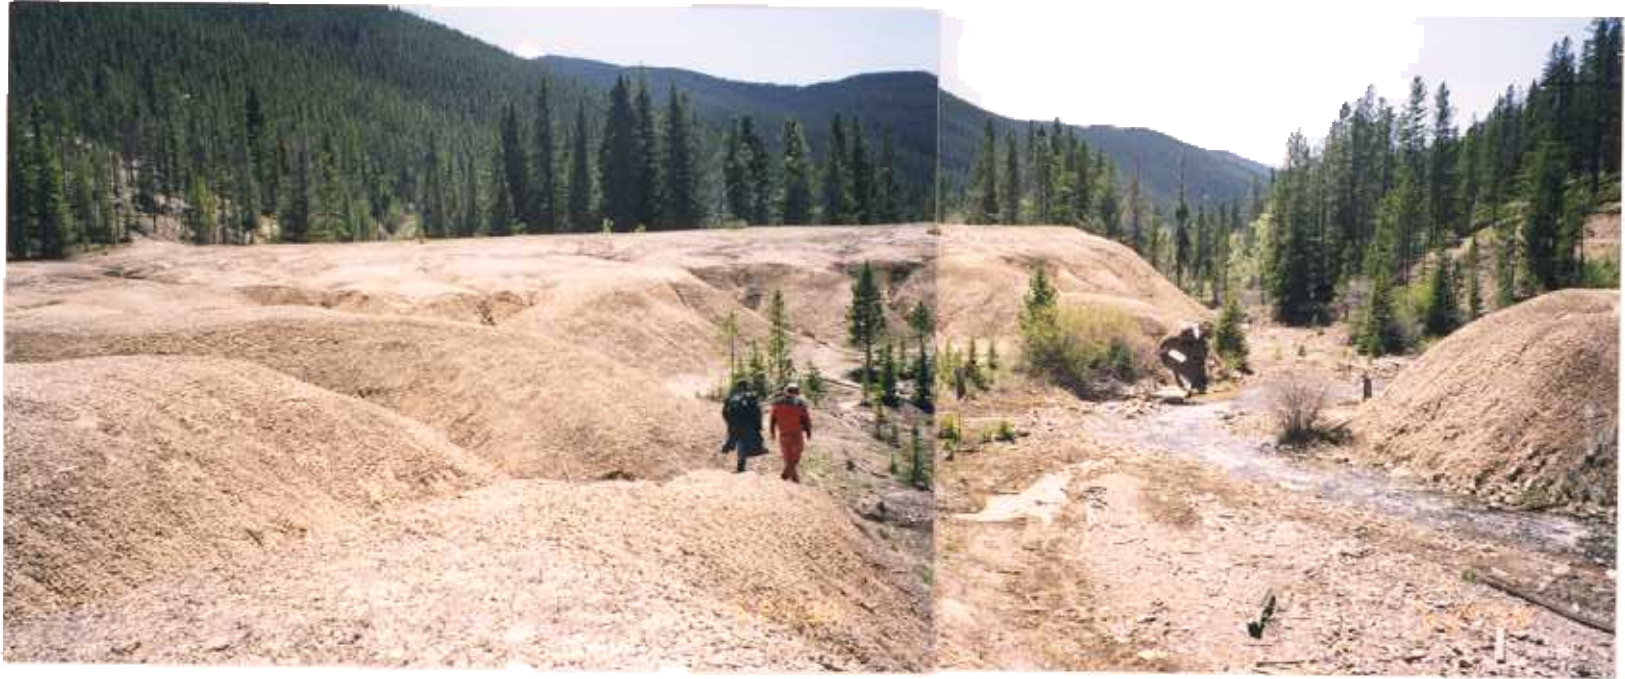
Figure 11a. Rills and gullies dissected the surface of the upper impoundment of the Carpenter Creek tailings reflecting the erosion of the tailings, as visited 05/27/98.

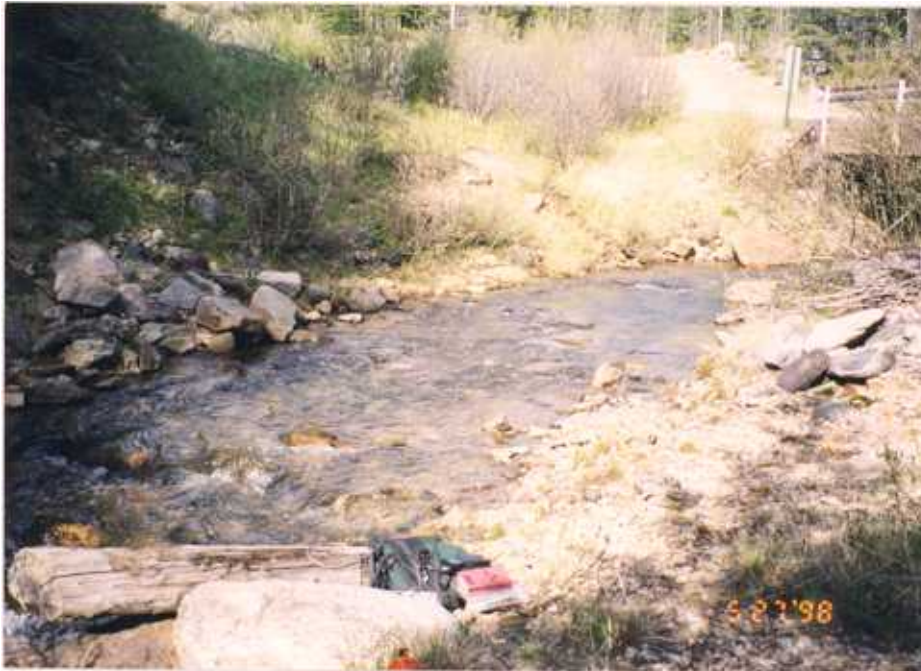
Figure 12a. Upstream of the Eighty-Eight Mine on Carpenter Creek showing sample site BEES10M.

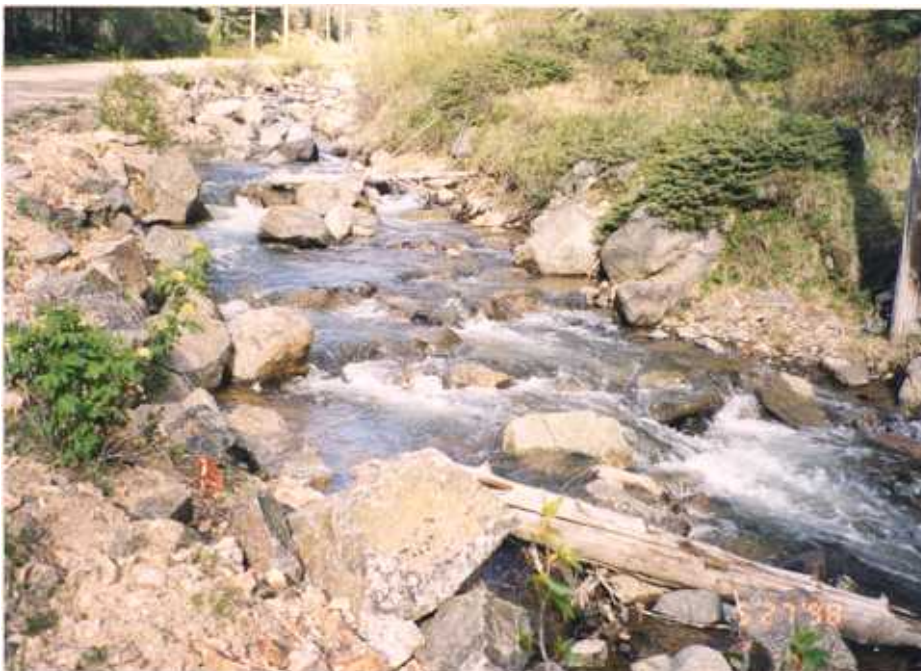
Figure 12b. Downstream of the Eighty-Eight Mine on Carpenter Creek showing sample site BEES20M.

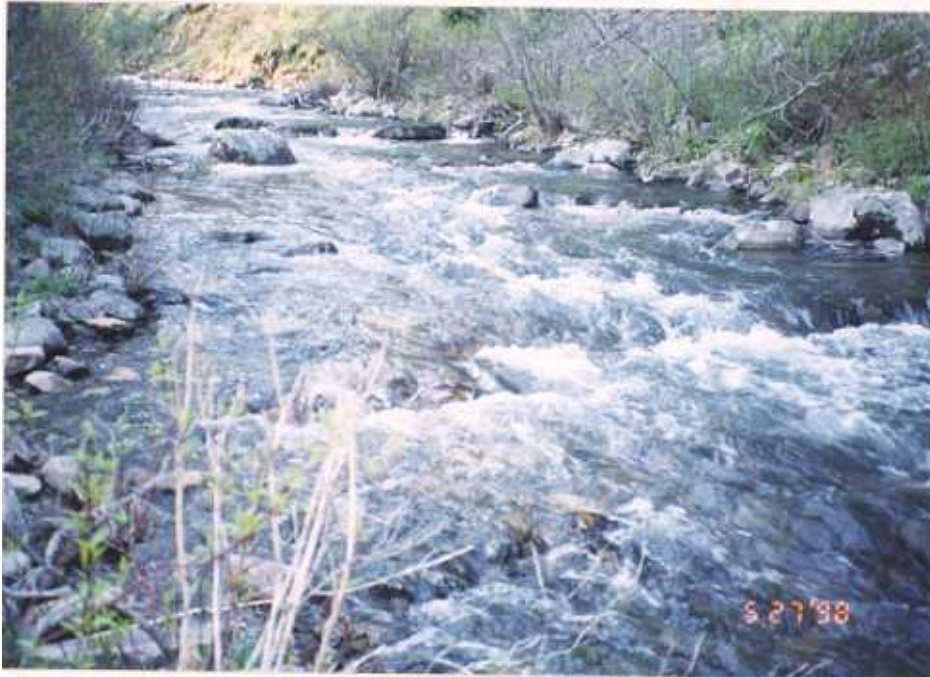
Figure 13a. The upstream sample (BBCS10M) was taken early in the morning upstream of all the mining activities in the valley.

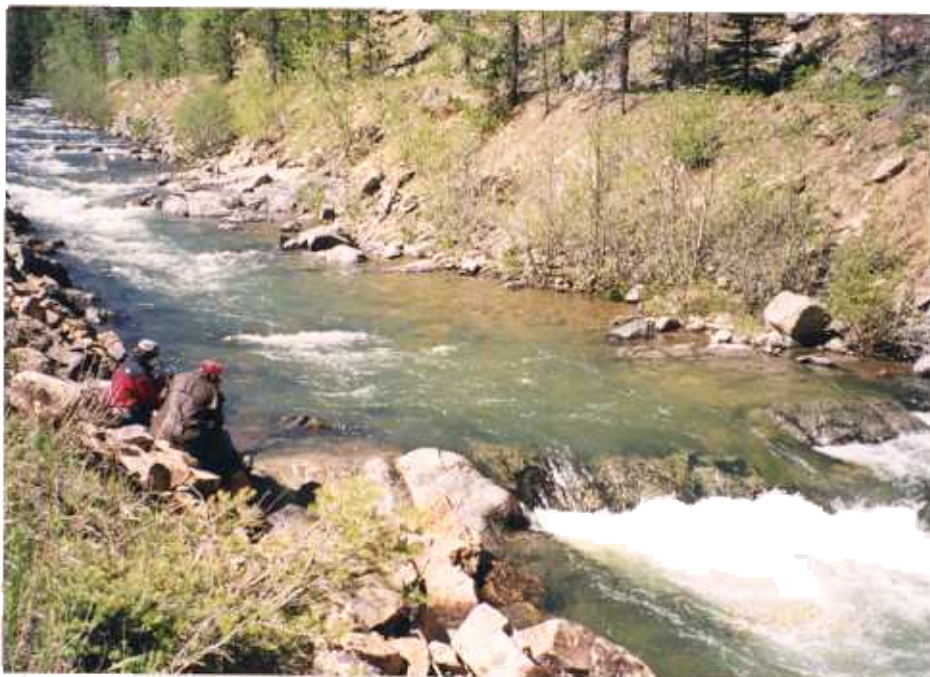
Figure 13b. The final downstream sample (BBCS50L) was taken later in the day below all the mining activity in the Neihart mining district.

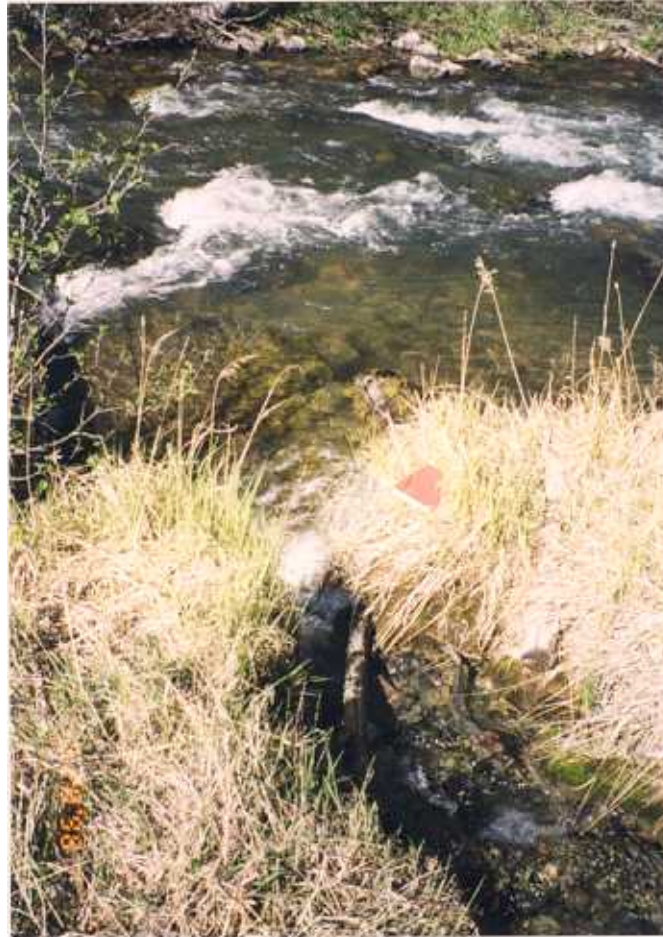
Figure 13c. Rock Creek (lower right) joins Belt Creek immediately downstream of the town of Neihart. A slight iron staining was noted at the confluence of Rock Creek and Belt Creek.

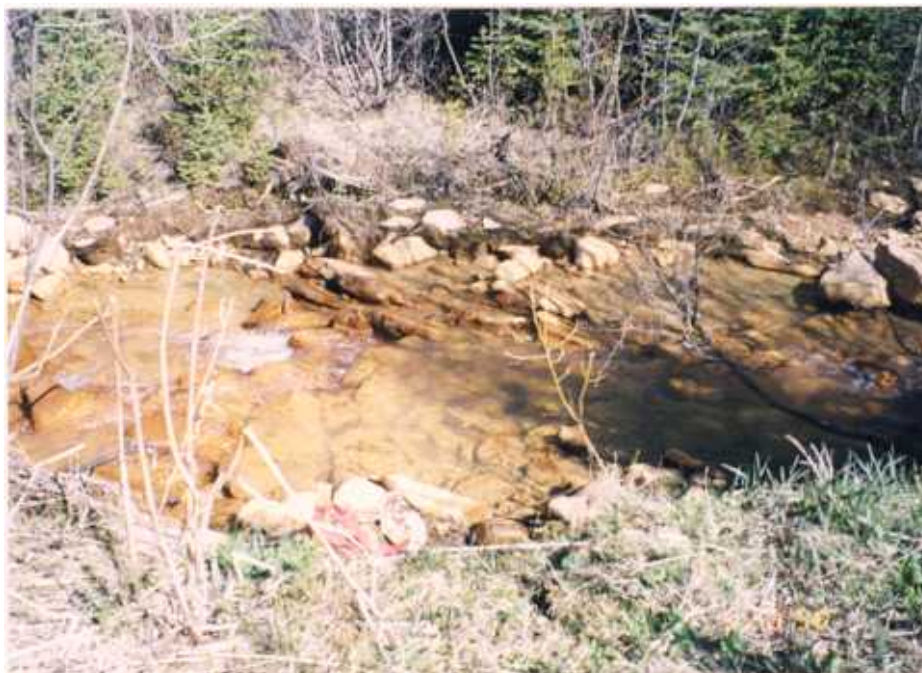
Figure 15a. The Block 'P' mill tailings upstream sample site (GPTS20H) on Galena Creek.

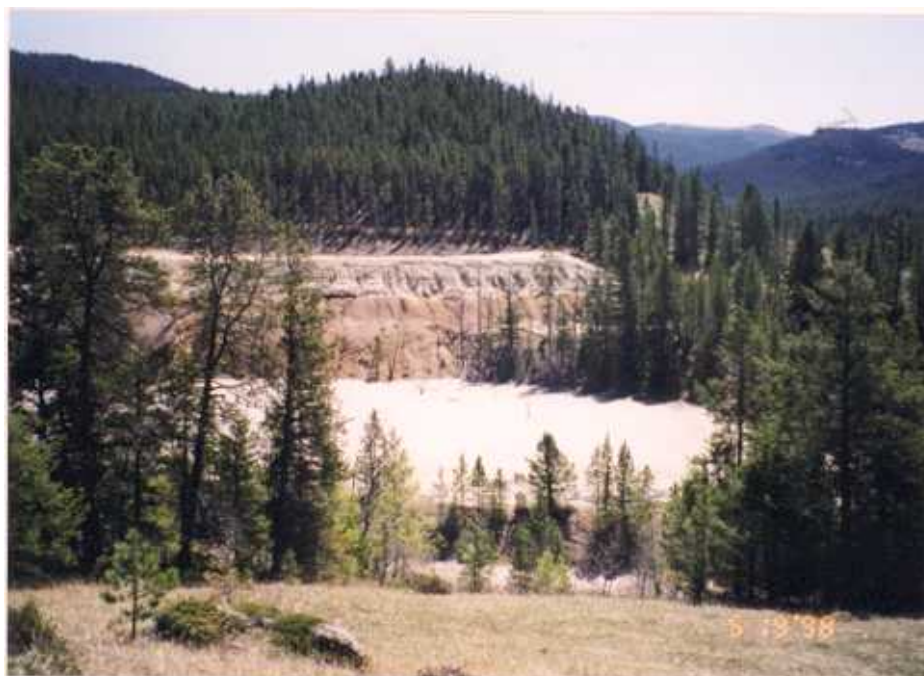
Figure 15b. The Block 'P' tailings are on private land.

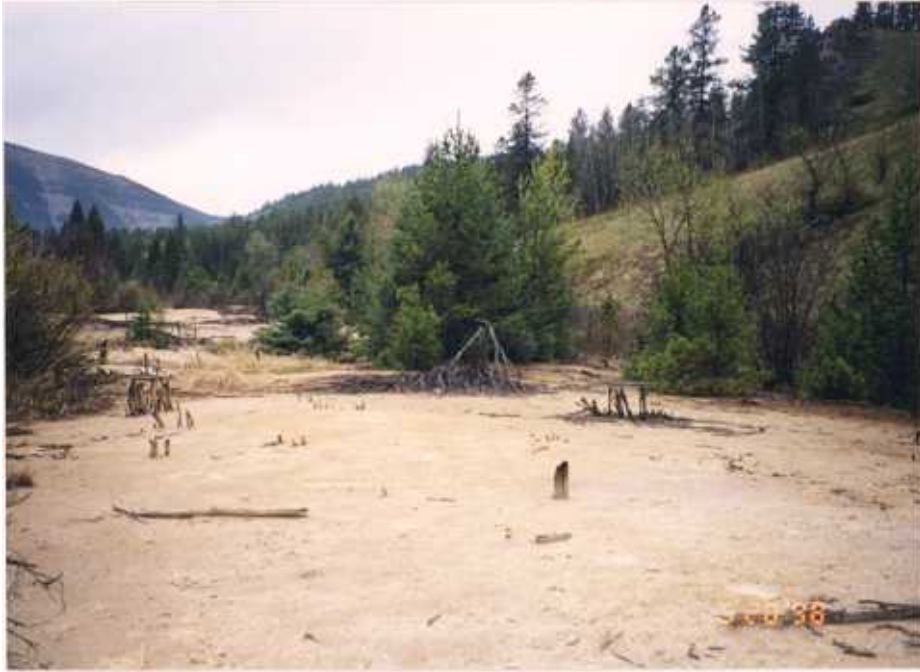
Fine-grained mill tailings with no vegetation were found for over 1,000 ft at this site along both sides of Dry Fork Belt Creek in the flood plain. Pioneer Technical Services' report (1994) estimated 10,000 cubic yards of material.

Figure 16a. The lower tailings on Dry Fork Belt Creek looking upstream.

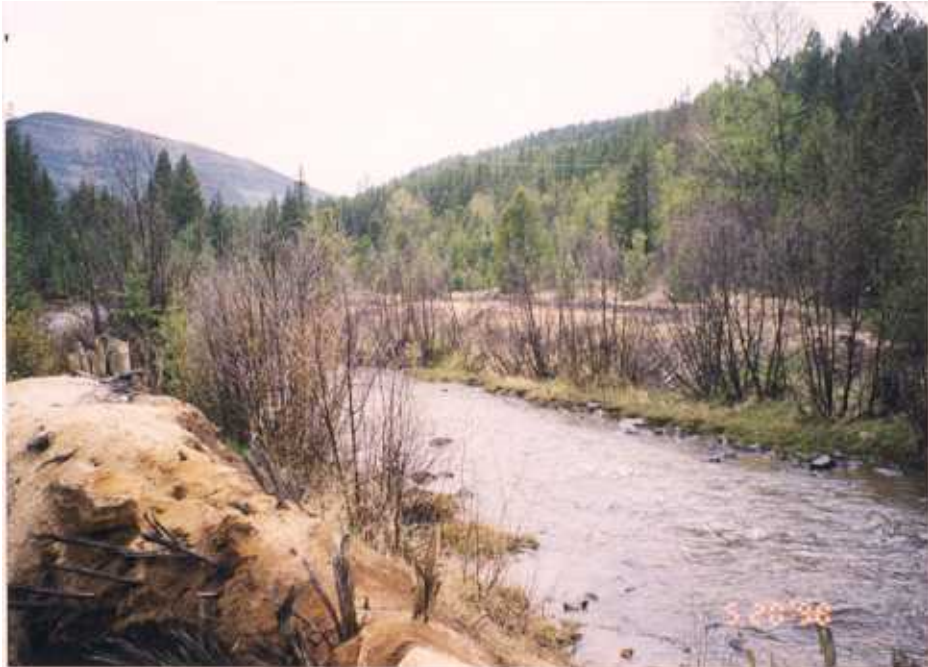
Figure 16b. Lower tailings on Dry Fork Belt Creek looking downstream.

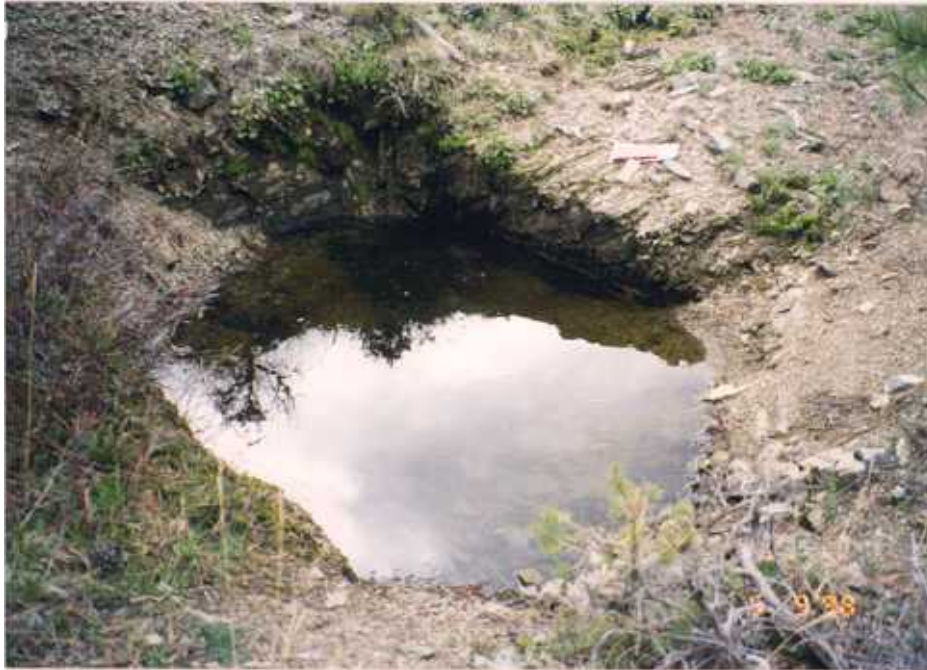
Figure 17a. A small prospect pit at the New Deal Mine filled with standing water.

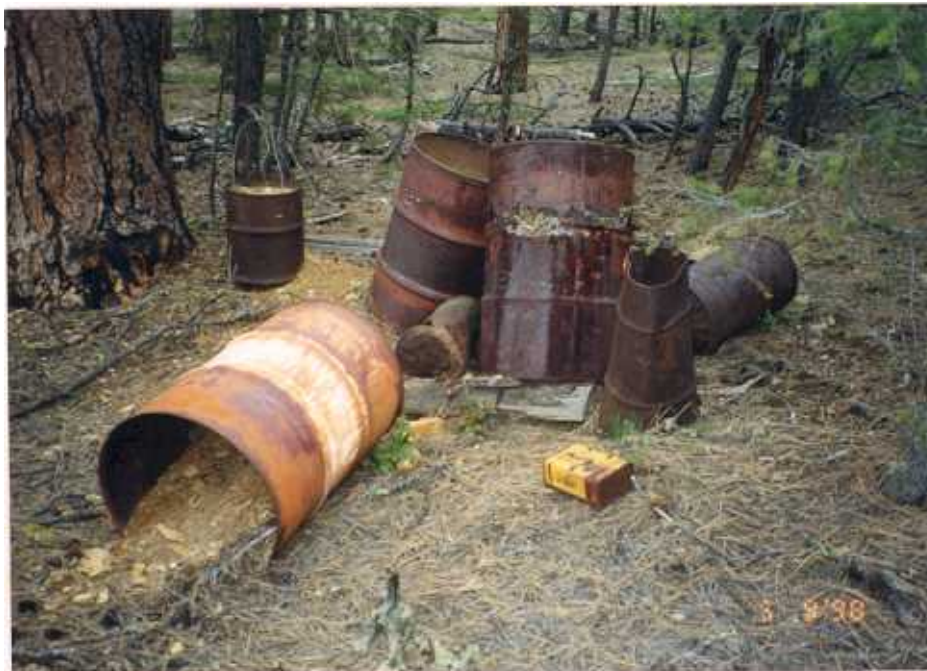
Figure 17b. Several drums at the Kid's Dream were filled with what looked like ore. This stockpile was sampled to determine its content.

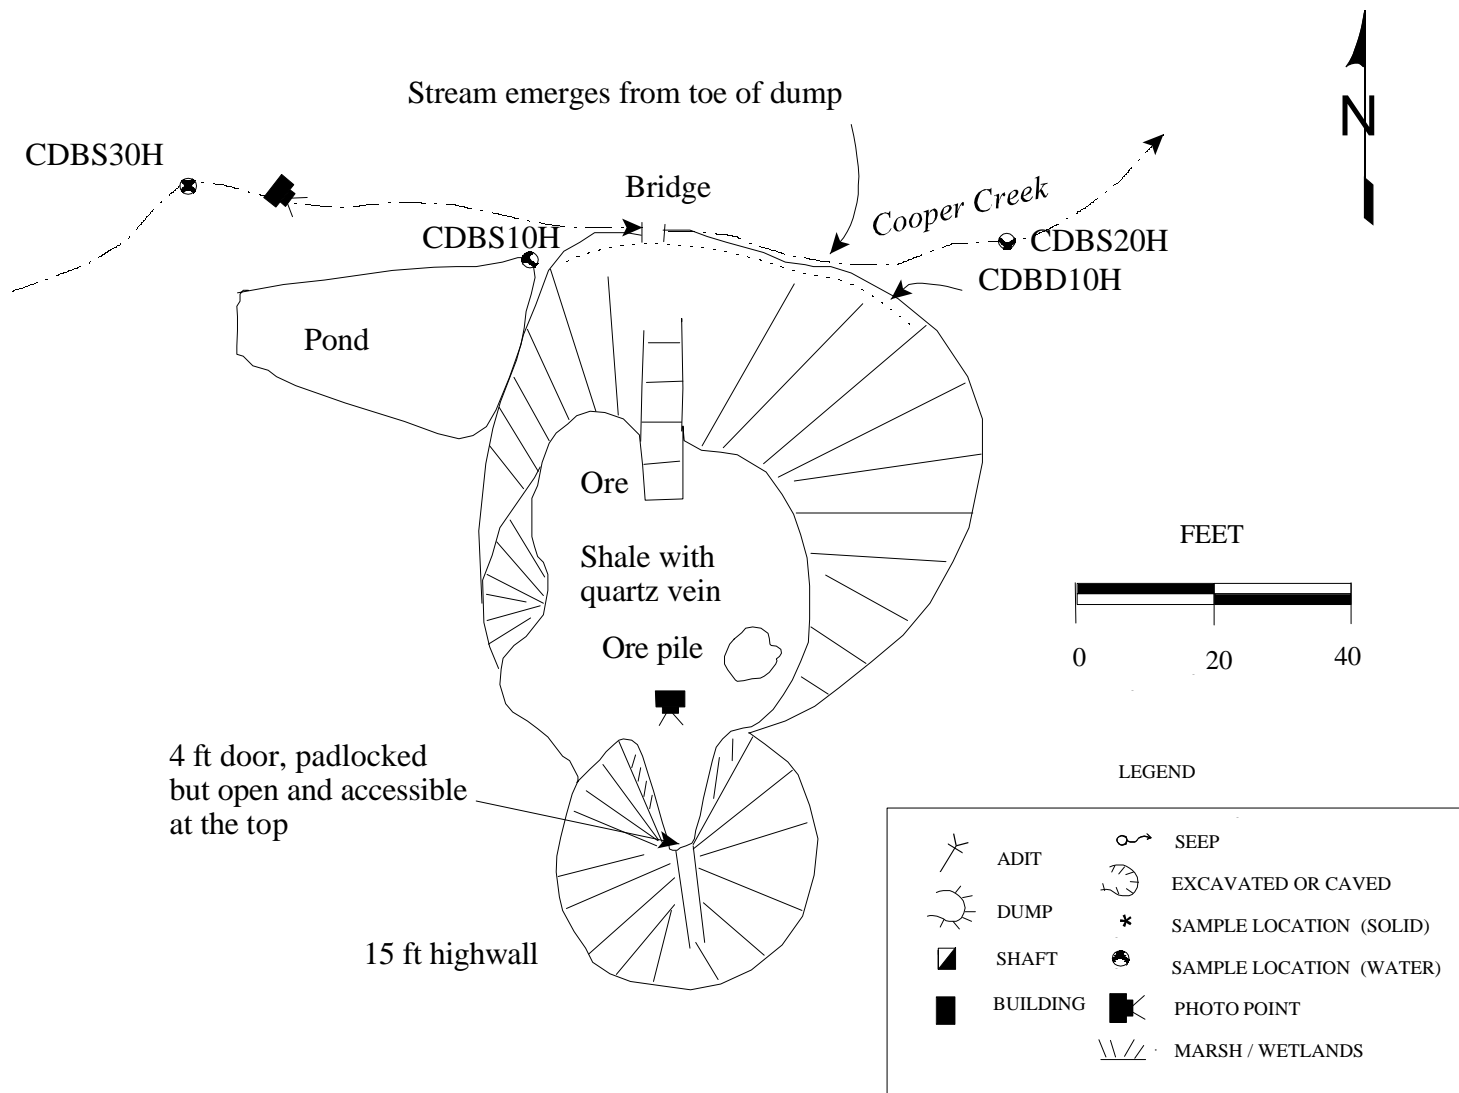
Figure 18. Dr. Barnette's mine was a small isolated working with one open adit and a waste dump that was in contact with Cooper Creek, as mapped 05/21/98.

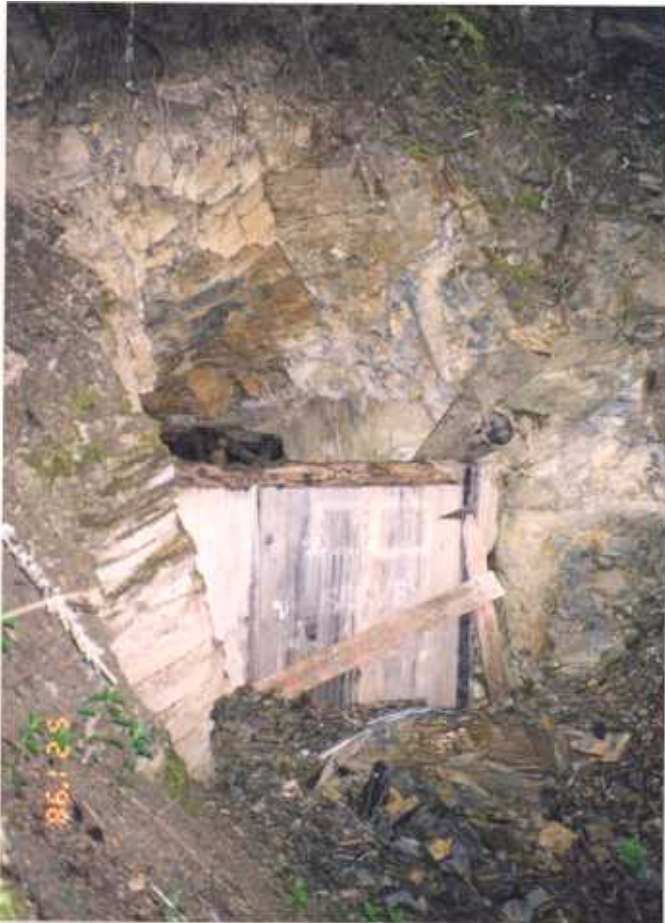
Figure 18a. The adit at Dr. Barnette's Mine had a locked portal but it could be easily circumvented. Rock on the back of the mine had recently spalled off.

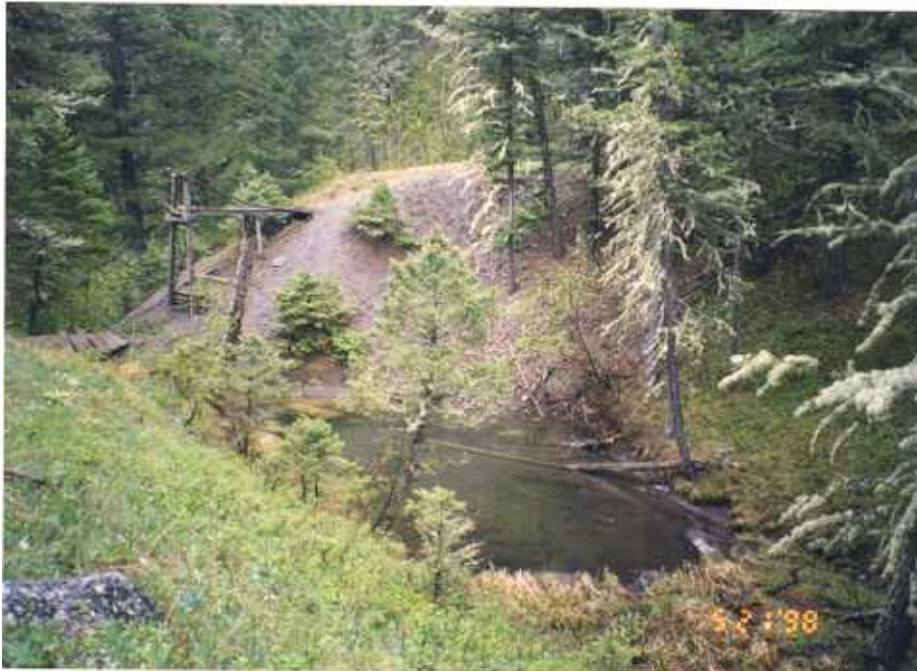
Figure 18b. The waste dump at Dr. Barnette's came into contact with Cooper Creek and blocked the drainage enough to form a small pond.

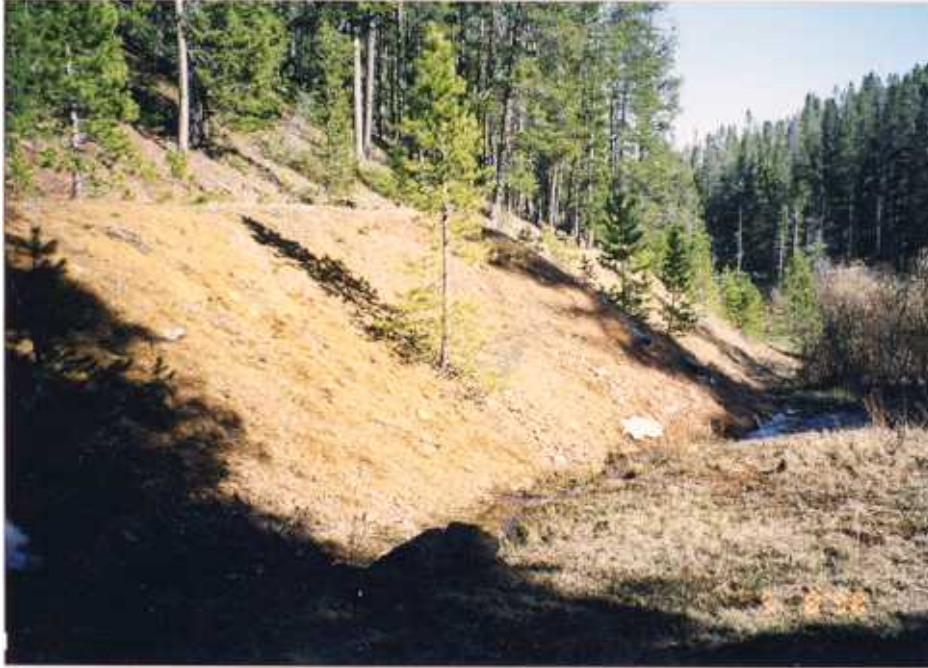
Figure 19a. Mine waste was used in building the road into the Belle of the Castle. The upper reaches of Hensley Creek and the “north fork” of the creek are in contact with the waste.

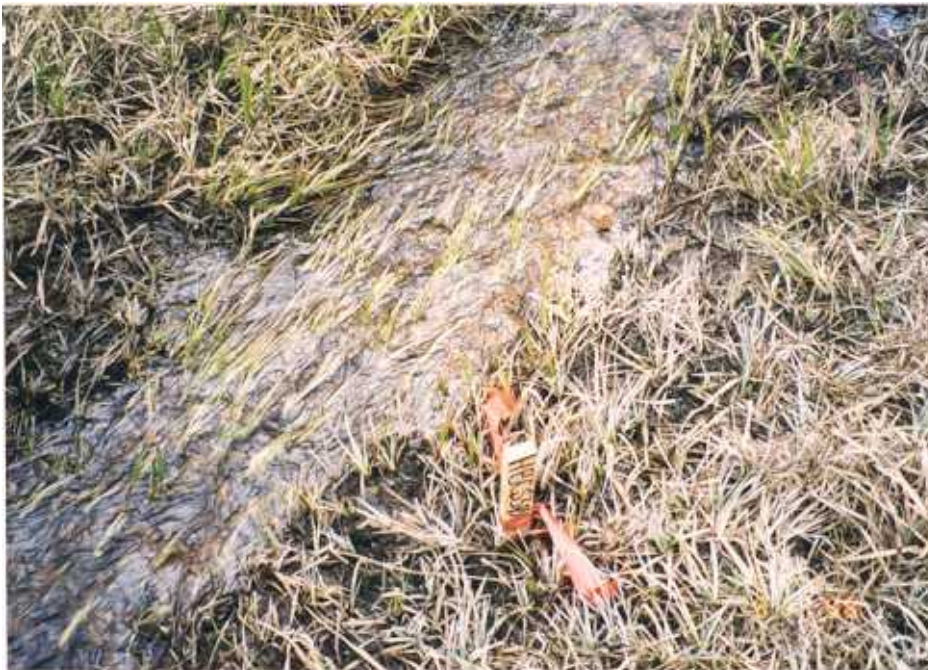
Figure 19b. Sample site HBCS30L was chosen to test the water quality of the site before it flowed onto patented land. The site is downstream from the Copper Kettle and Copper Bowl.

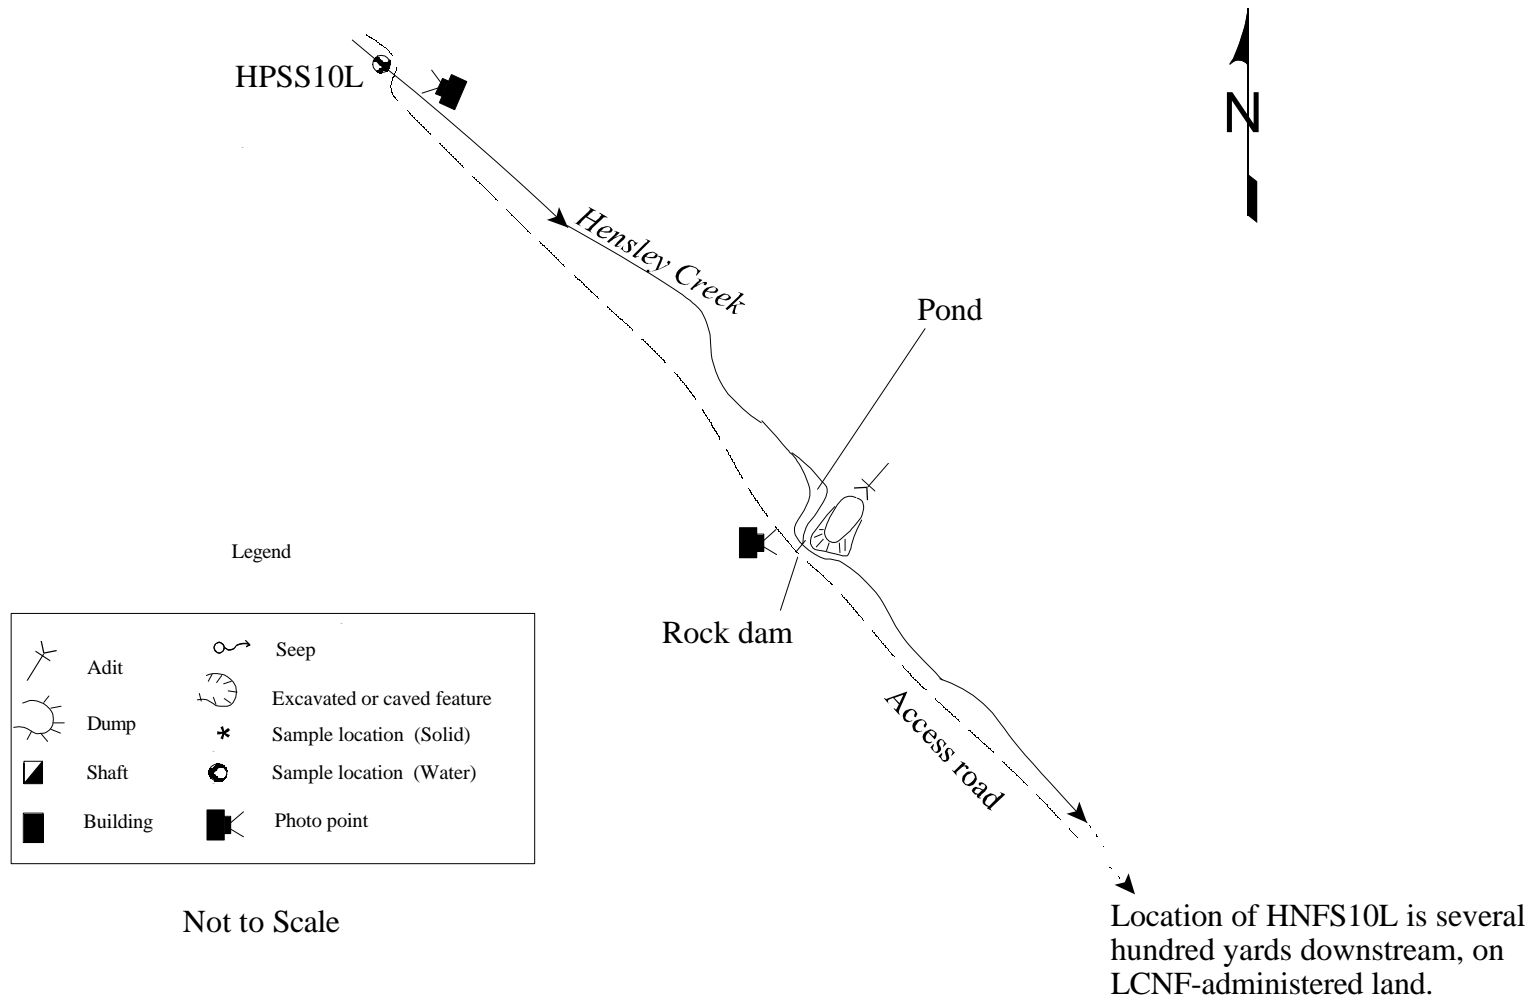
Figure 20. Sketch map of Unnamed DCAA section 2, T8N R8E mine, June 23, 1998. The waste dump is actively eroded by Hensley Creek.

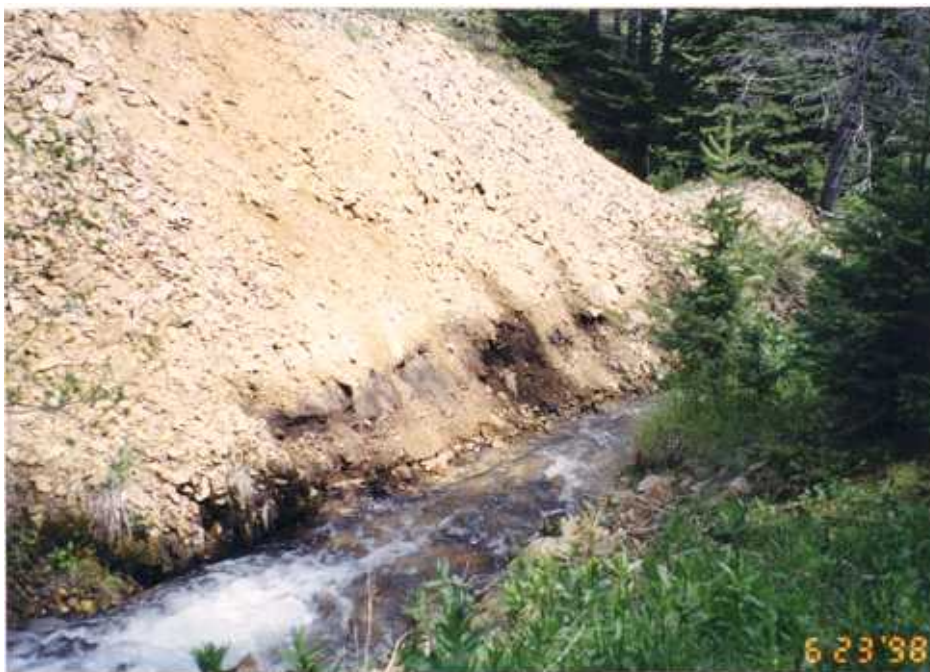
Figure 20a. Hensley Creek eroded the toe of the mine's waste-rock dump when visited 06/23/98. The site was on private land but LCNF-administered land lay both upstream and downstream.

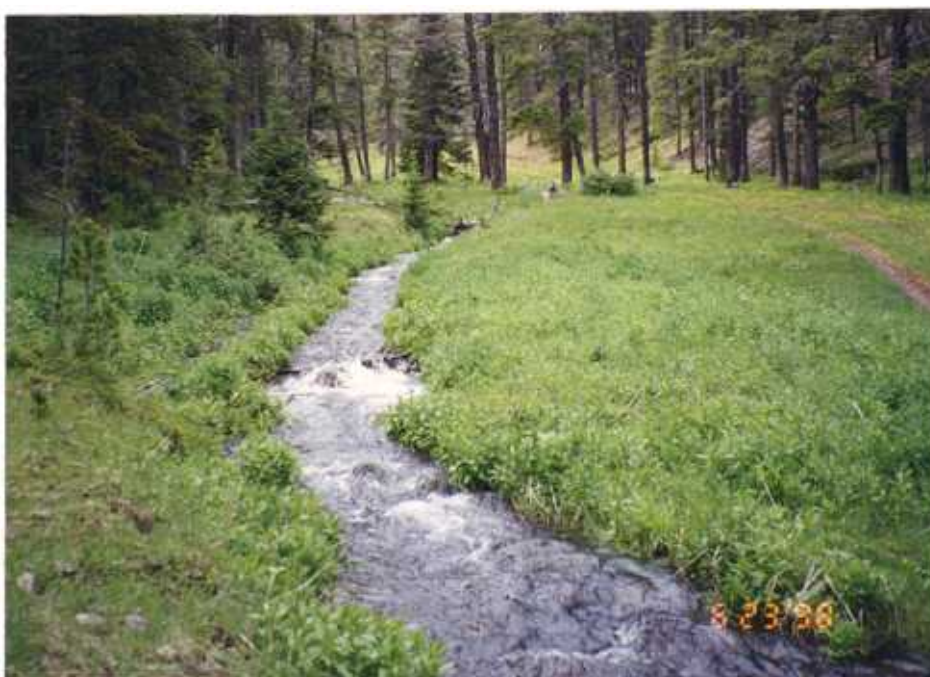
Figure 20b. Sample HPSS10L was collected from Hensley Creek, upstream of the site on LCNF-administered land. Both upstream and downstream, the creek appeared pristine.

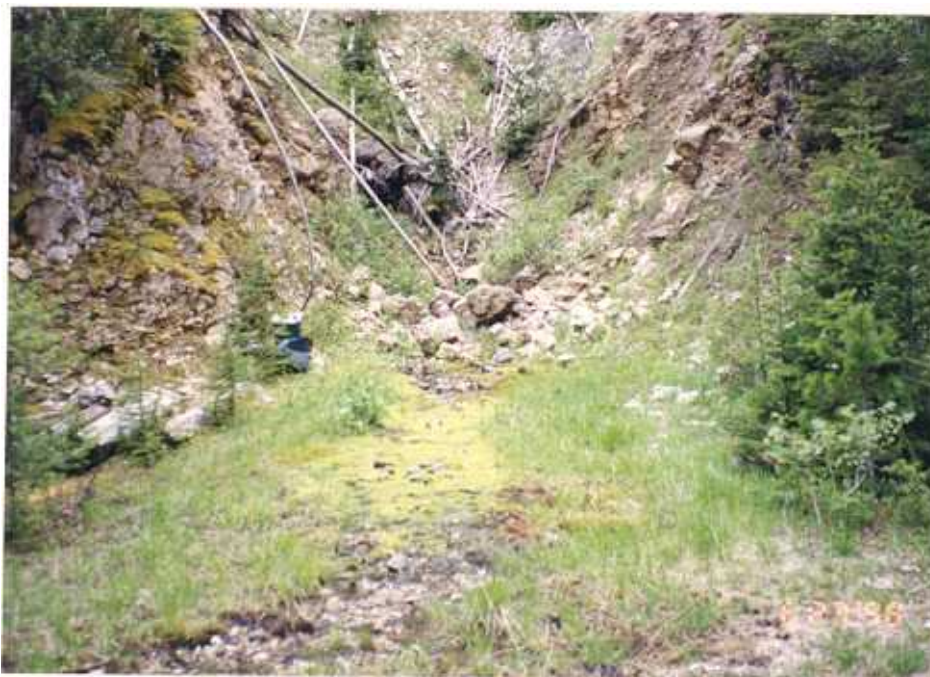
Figure 21a. Moss, grass, and algae grew along the course of the small adit discharge. No evidence of metals precipitation was noted. Sample HNFS30L was taken here.

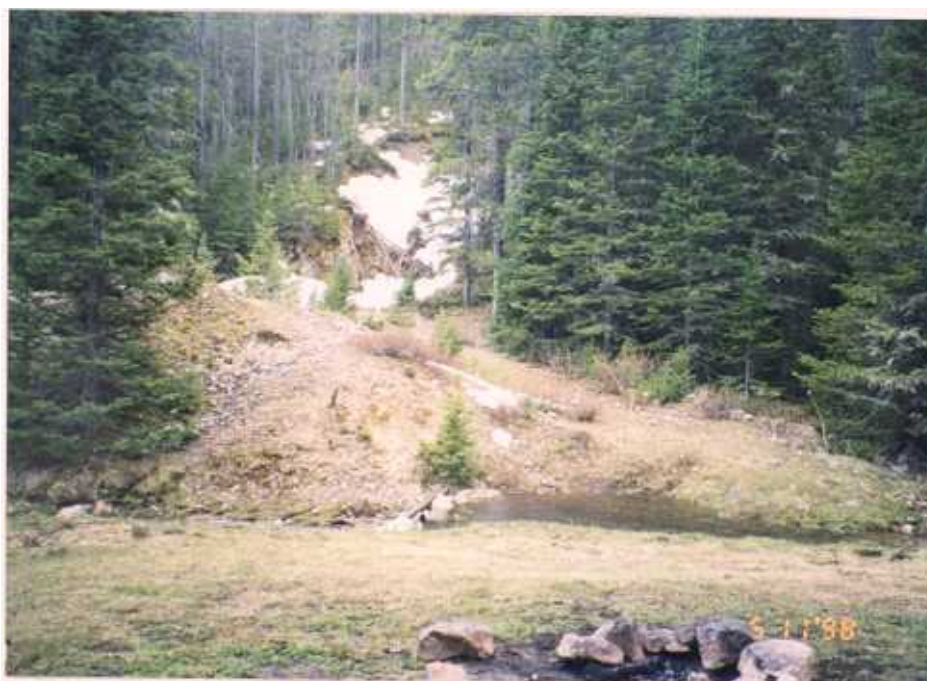
Figure 21b. The unnamed mine in sec. 11 had its waste dump in contact with Hensley Creek. The site was an unofficial, dispersed campsite.
