Abandoned-Inactive Mines on Lewis and Clark National Forest-Administered Land

Montana Bureau of Mines and Geology Abandoned-Inactive Mines Program Open-File Report MBMG 413

April 2000

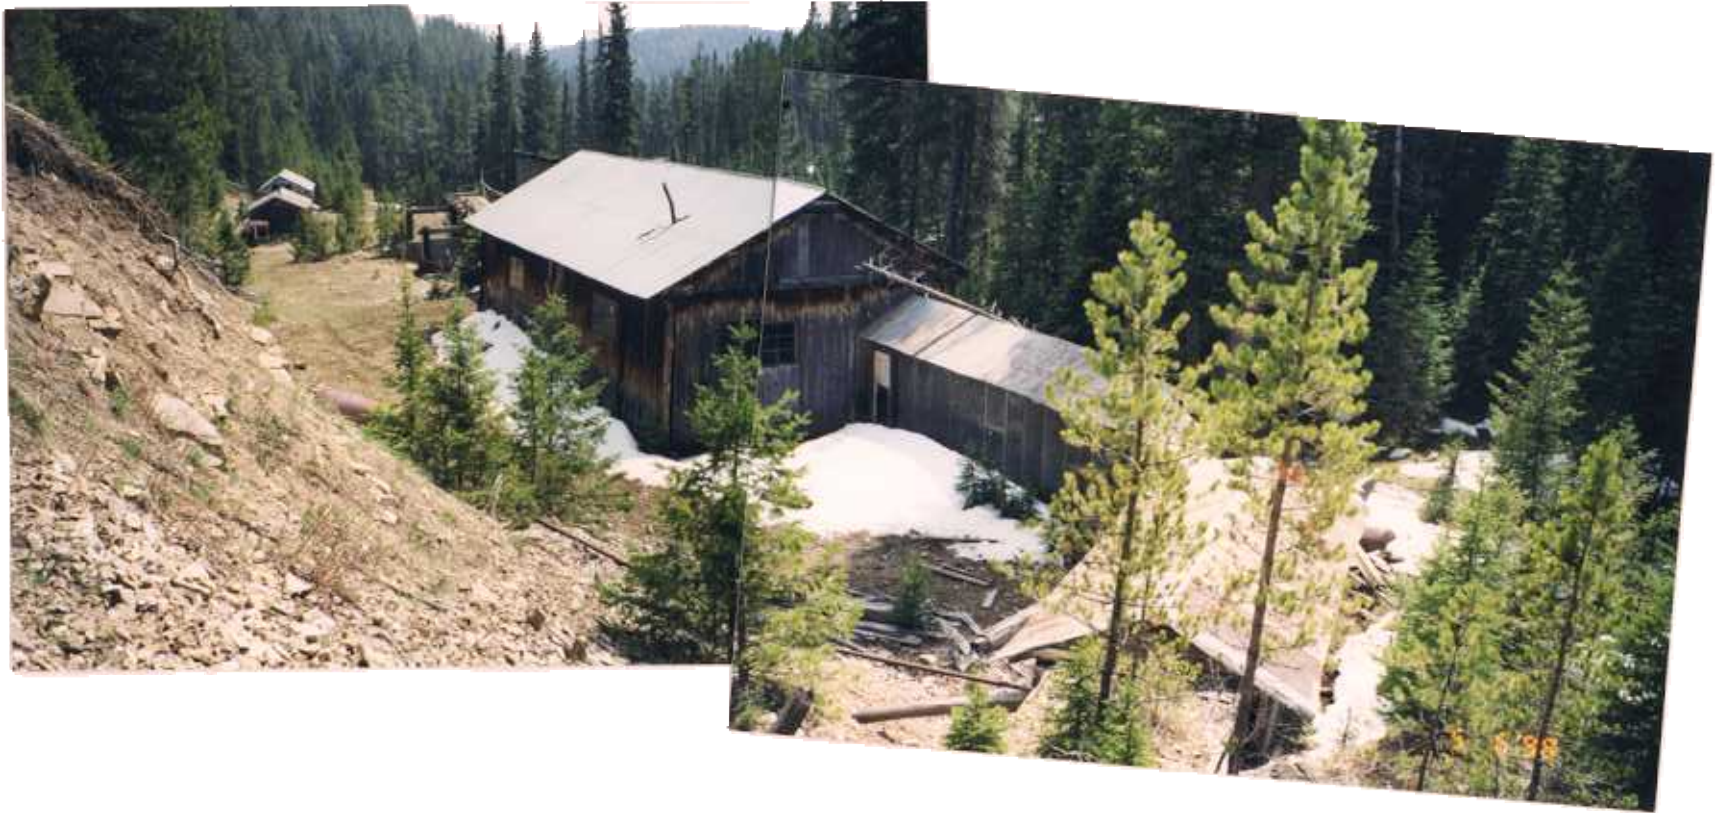
Figure 22a. The Hamilton Mine was a very complete mine site when visited on 05/06/98. Two cabins, the main mine building (shop and sawmill) and loading platform were all intact. The unique, covered tram had one wall that had collapsed but was otherwise in good condition. The adit was partially open but was secured by a locked gate.

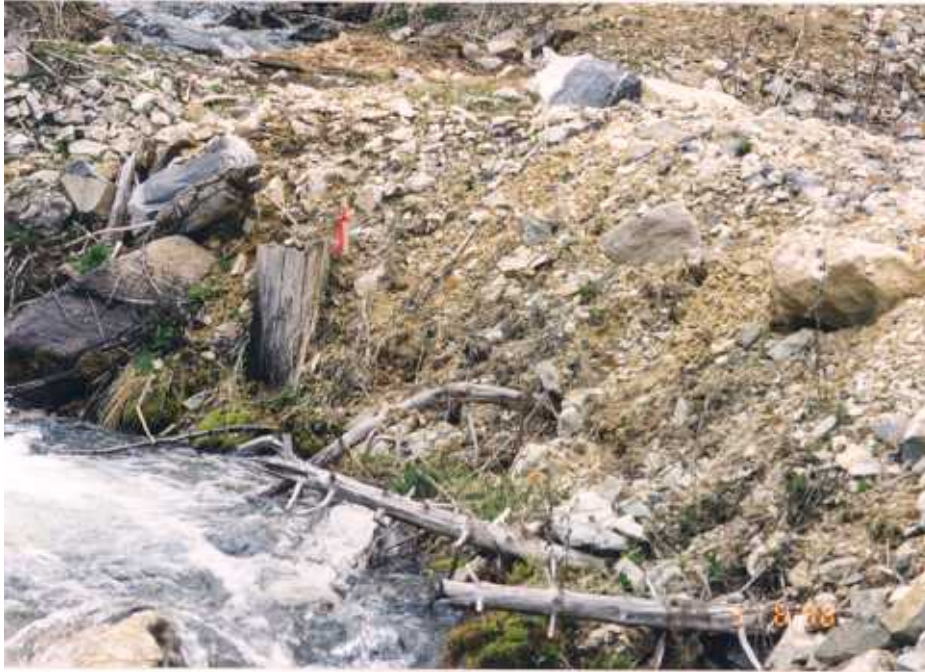
Figure 22b. The waste rock dump contacted Hamilton Creek but the rock consisted primarily of limestone and marble. Waste sample HHAW10H was composited along 50 ft of the area in contact with the creek.

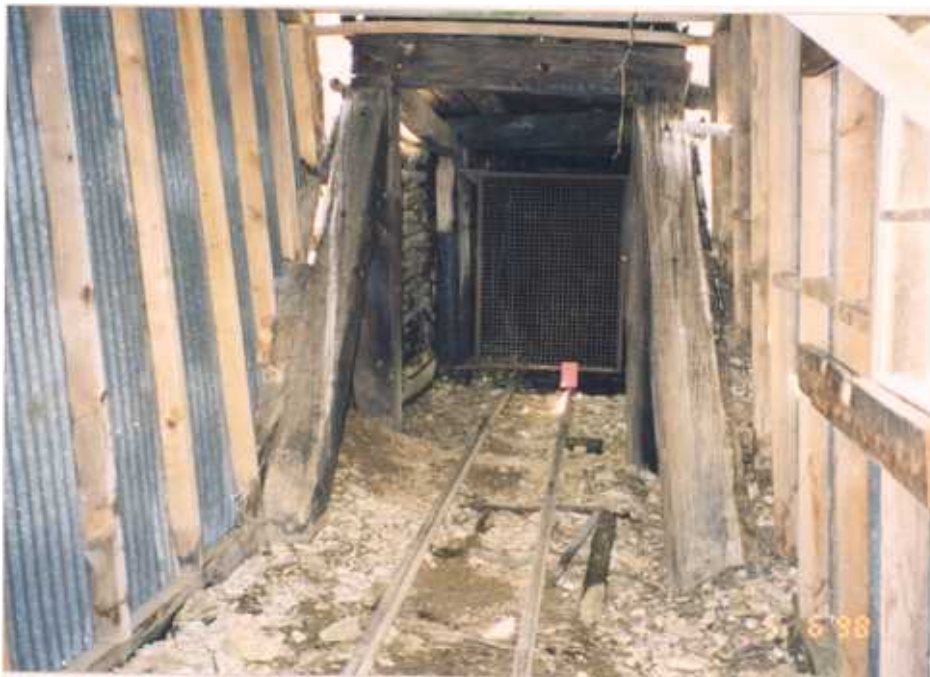
Figure 22c. The adit was open at least for 20 ft and was partially caved beyond that distance, on 05/06/98. The timbers were in good shape.

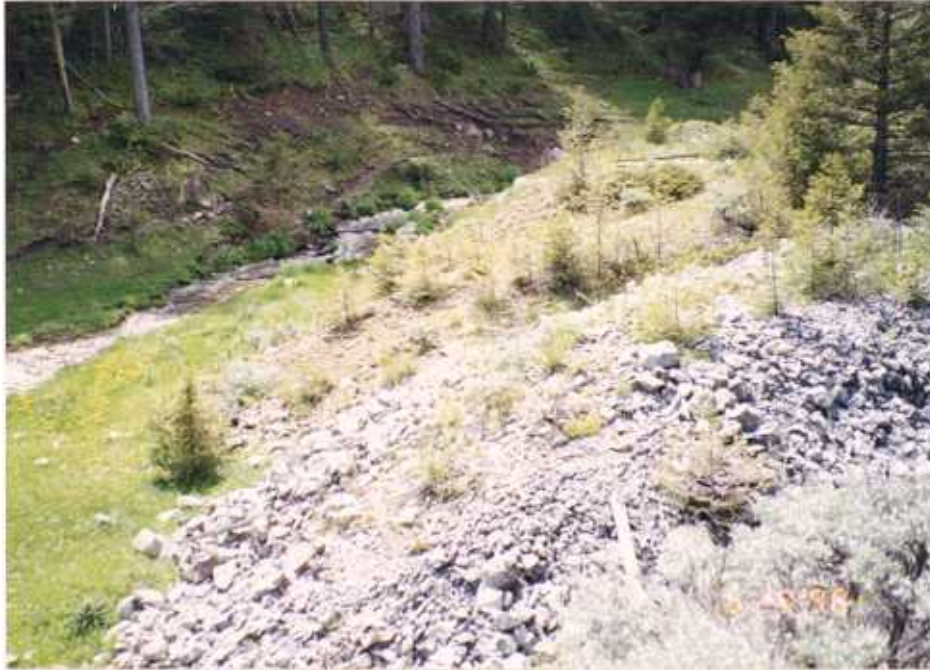
Figure 23a. Robinson Creek flows adjacent to the Powderly Mine's waste-rock dumps.

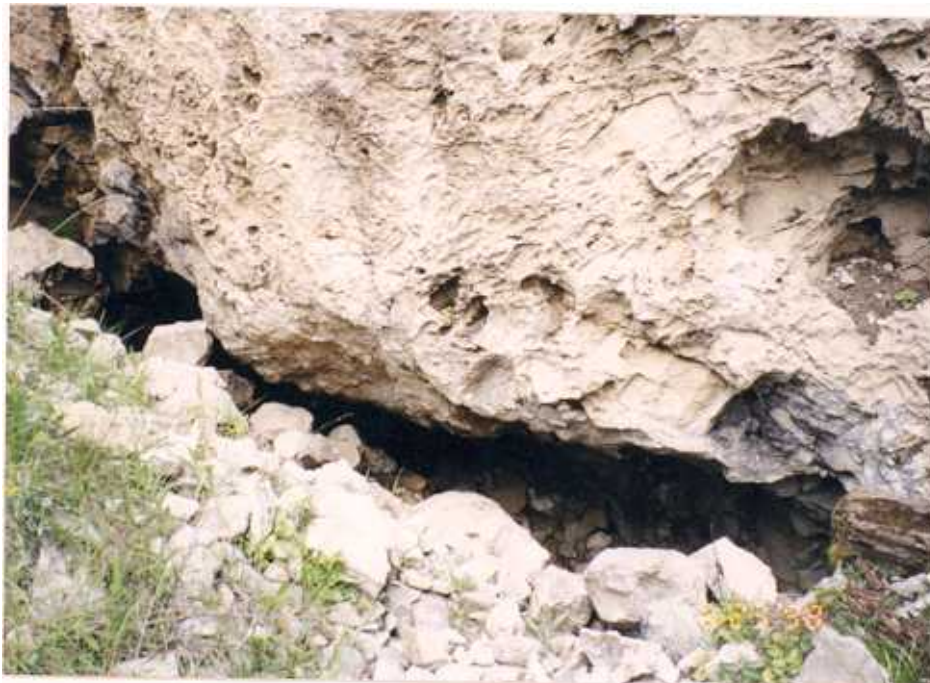
Figure 23b. The portal of the main adit at the Powderly has partially collapsed but an open crawl space still exists.

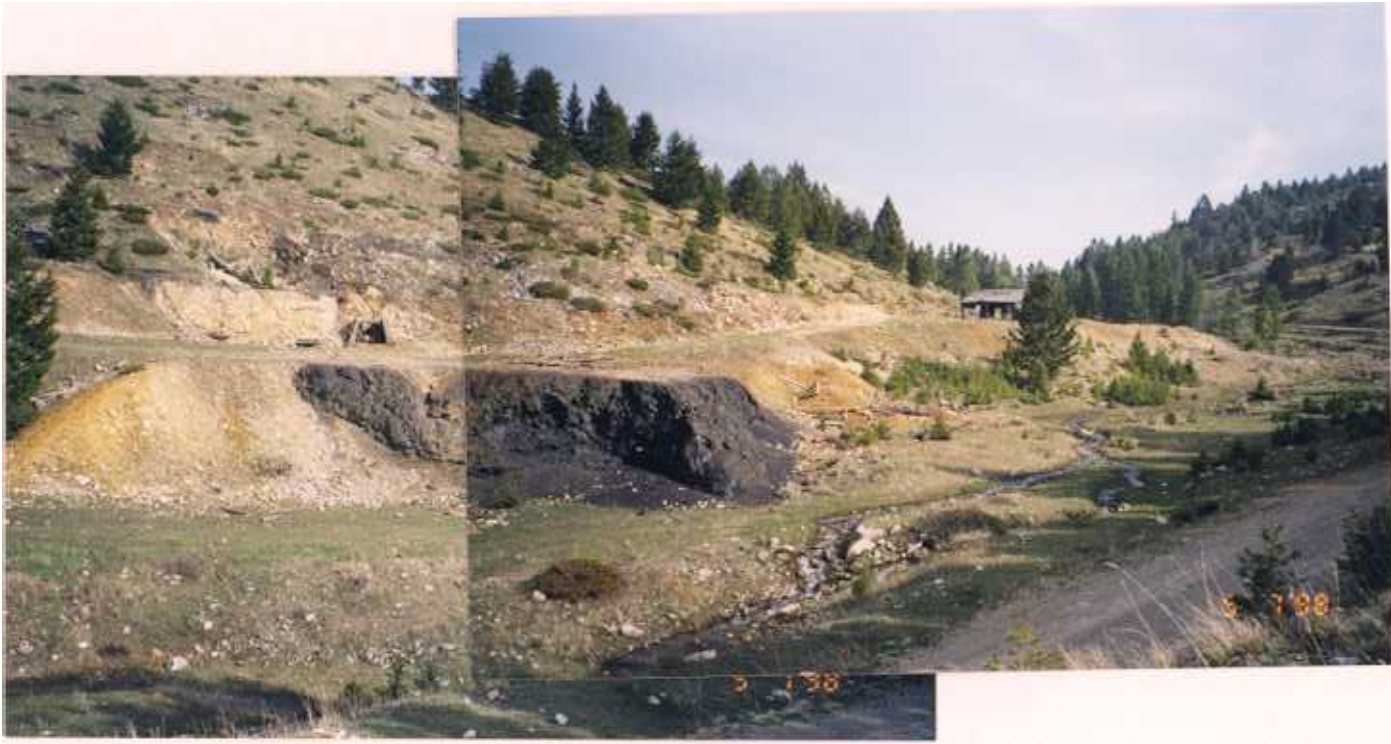
Figure 24a. The black slag on patented land did not directly contact Castle Creek, however, runoff from the slag and waste piles could possibly affect LCNF-administered land. The site is readily visible from Forest Road 581.

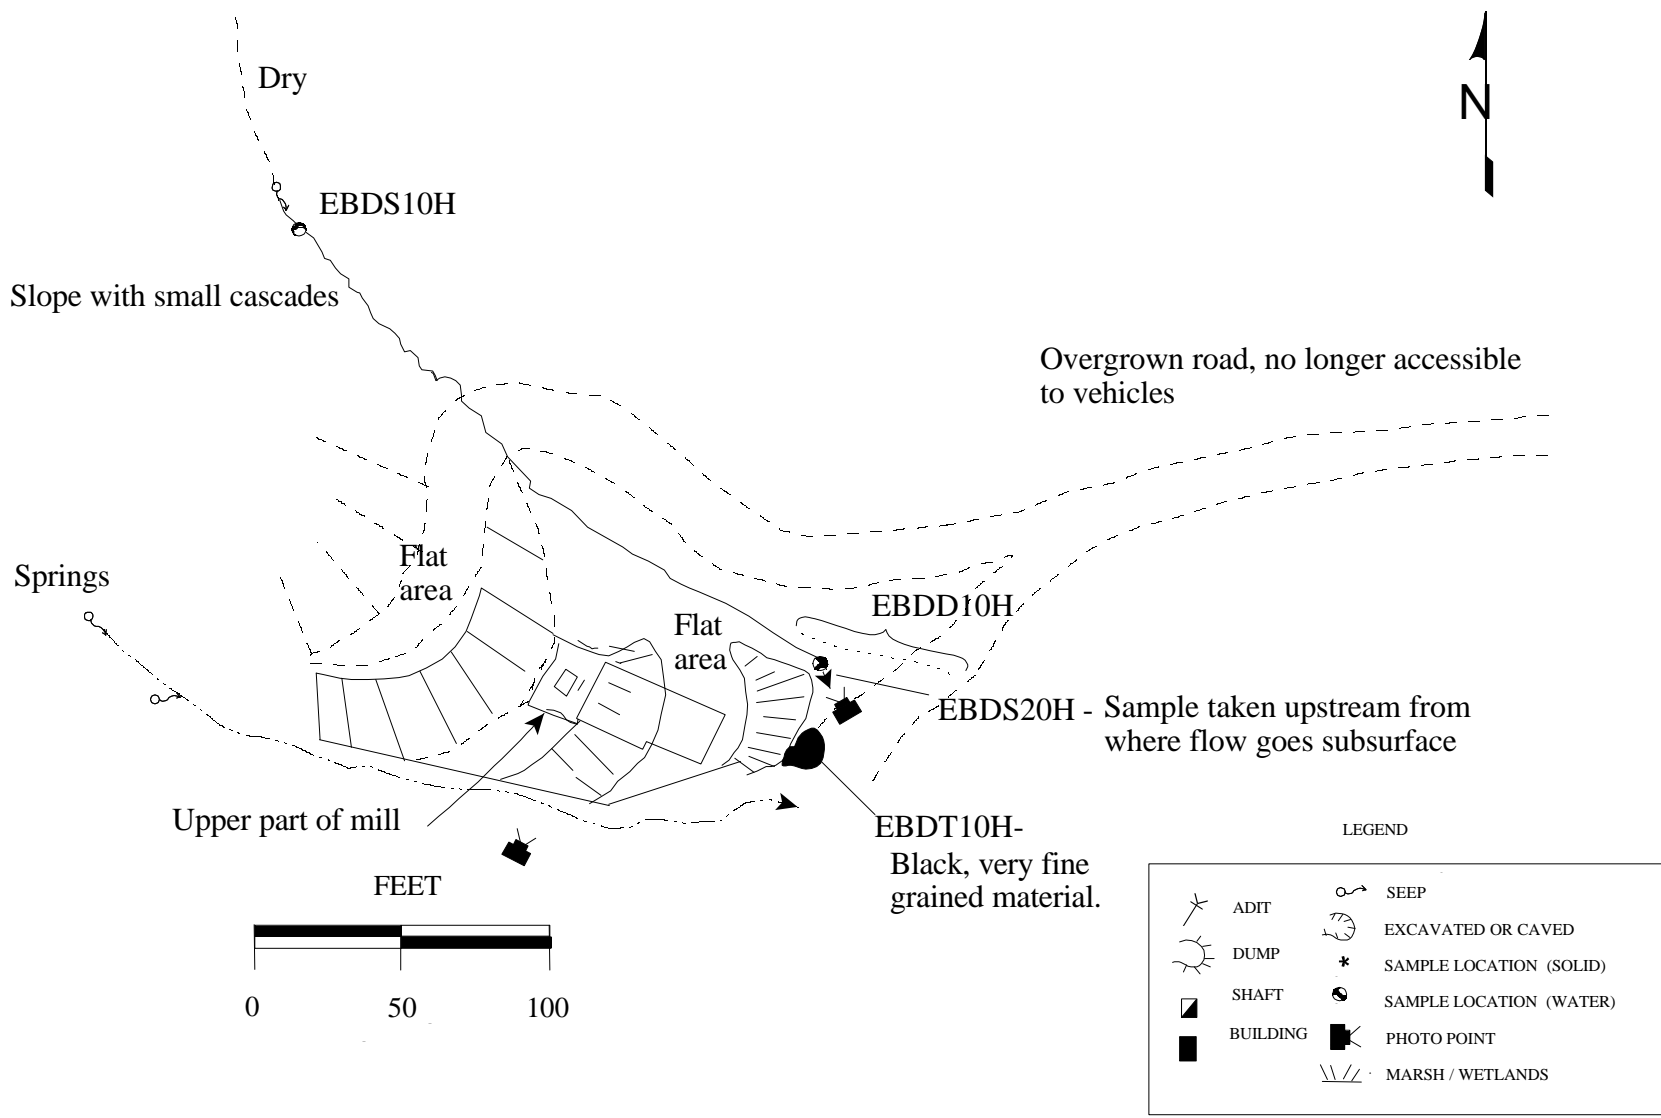
Figure 25. The Blue Dick mill laid in ruins in the small drainage formed by springs and ephemeral runoff. The drainage eventually joins Elk Creek but was not flowing at the surface when mapped on 10/13/98.

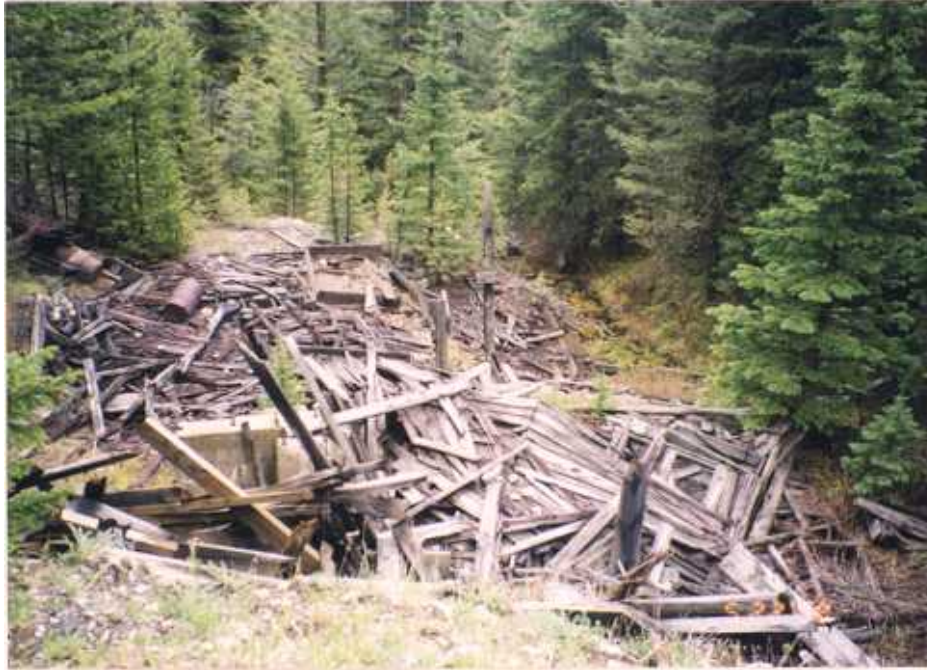
Figure 25a. Lumber, concrete foundations and some scattered junk mark the remains of the Blue Dick Mill. It lies in the drainage formed by springs in an unnamed tributary to Elk Creek.

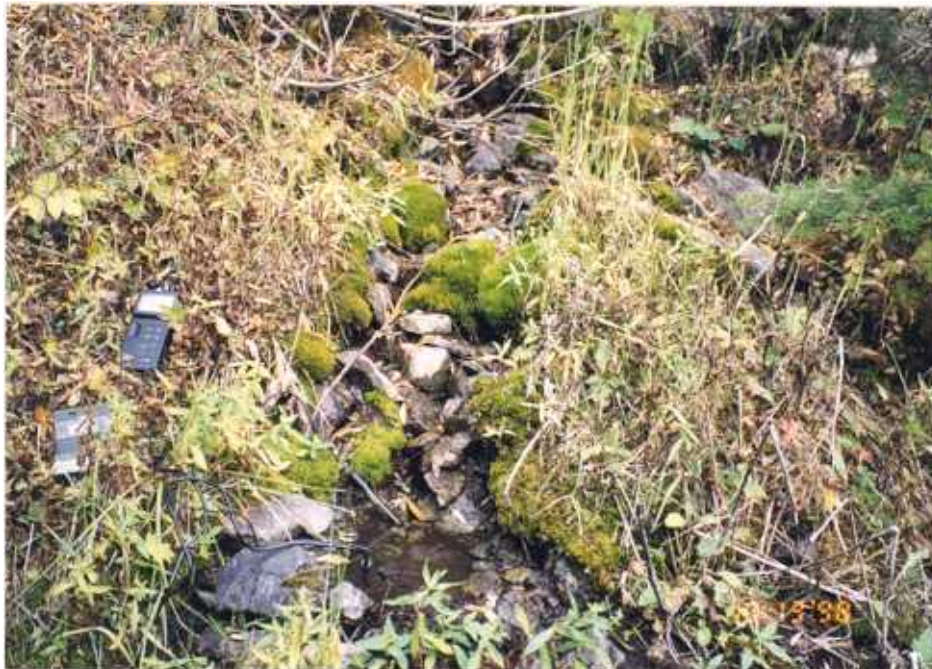
Figure 25b. At the Blue Dick, an unnamed tributary to Elk Creek was sampled just before it infiltrated into the rocky ground in the drainage. The flow probably rarely reaches Elk Creek.

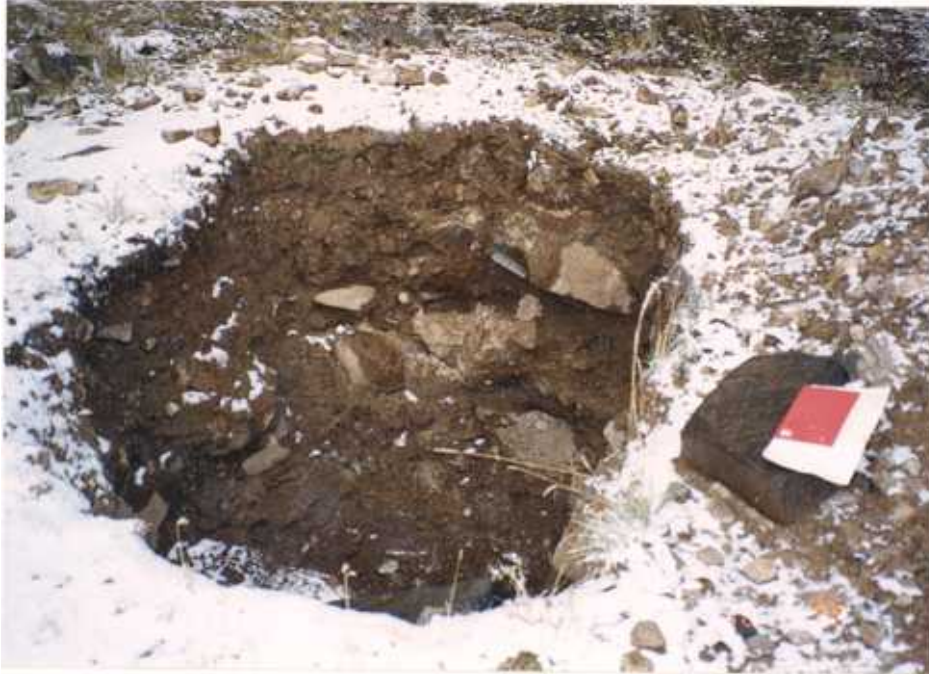
Figure 26a. The Ben Franklin Mine appeared as if recent exploration had been attempted. A small pit (5 ft by 8 ft) had been dug on top of the waste dump.

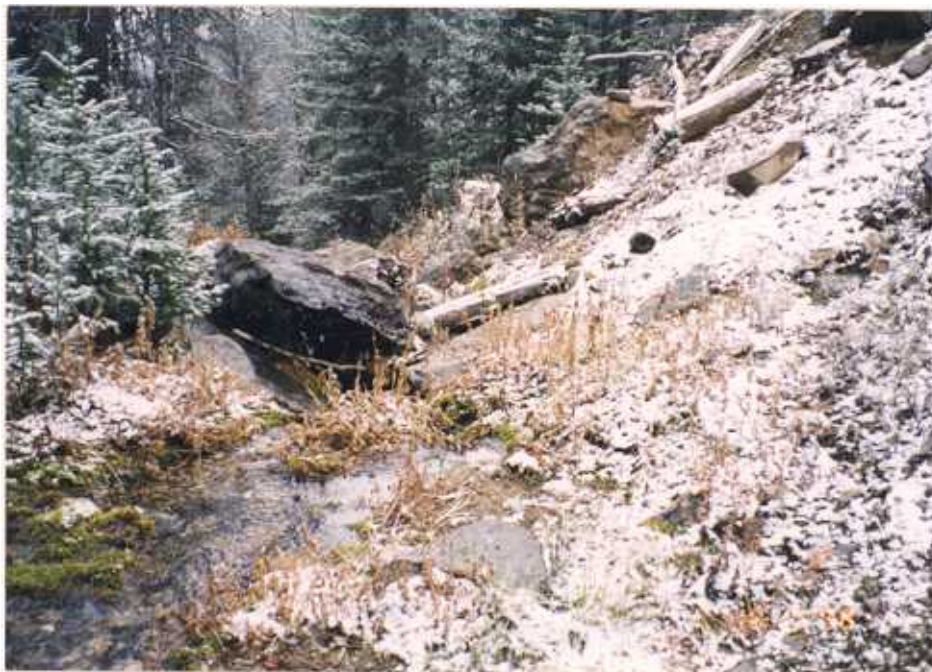
Figure 26b. At the Ben Franklin, small conifer trees grew on the waste dump (left) and Lead Gulch was in contact with the waste dump for approximately 95 ft.
