Abandoned - Inactive Mines of the
Blackfoot and Little Blackfoot River Drainages

Helena National Forest
Volume II

Open-file Report 368
MBMG

February 1998

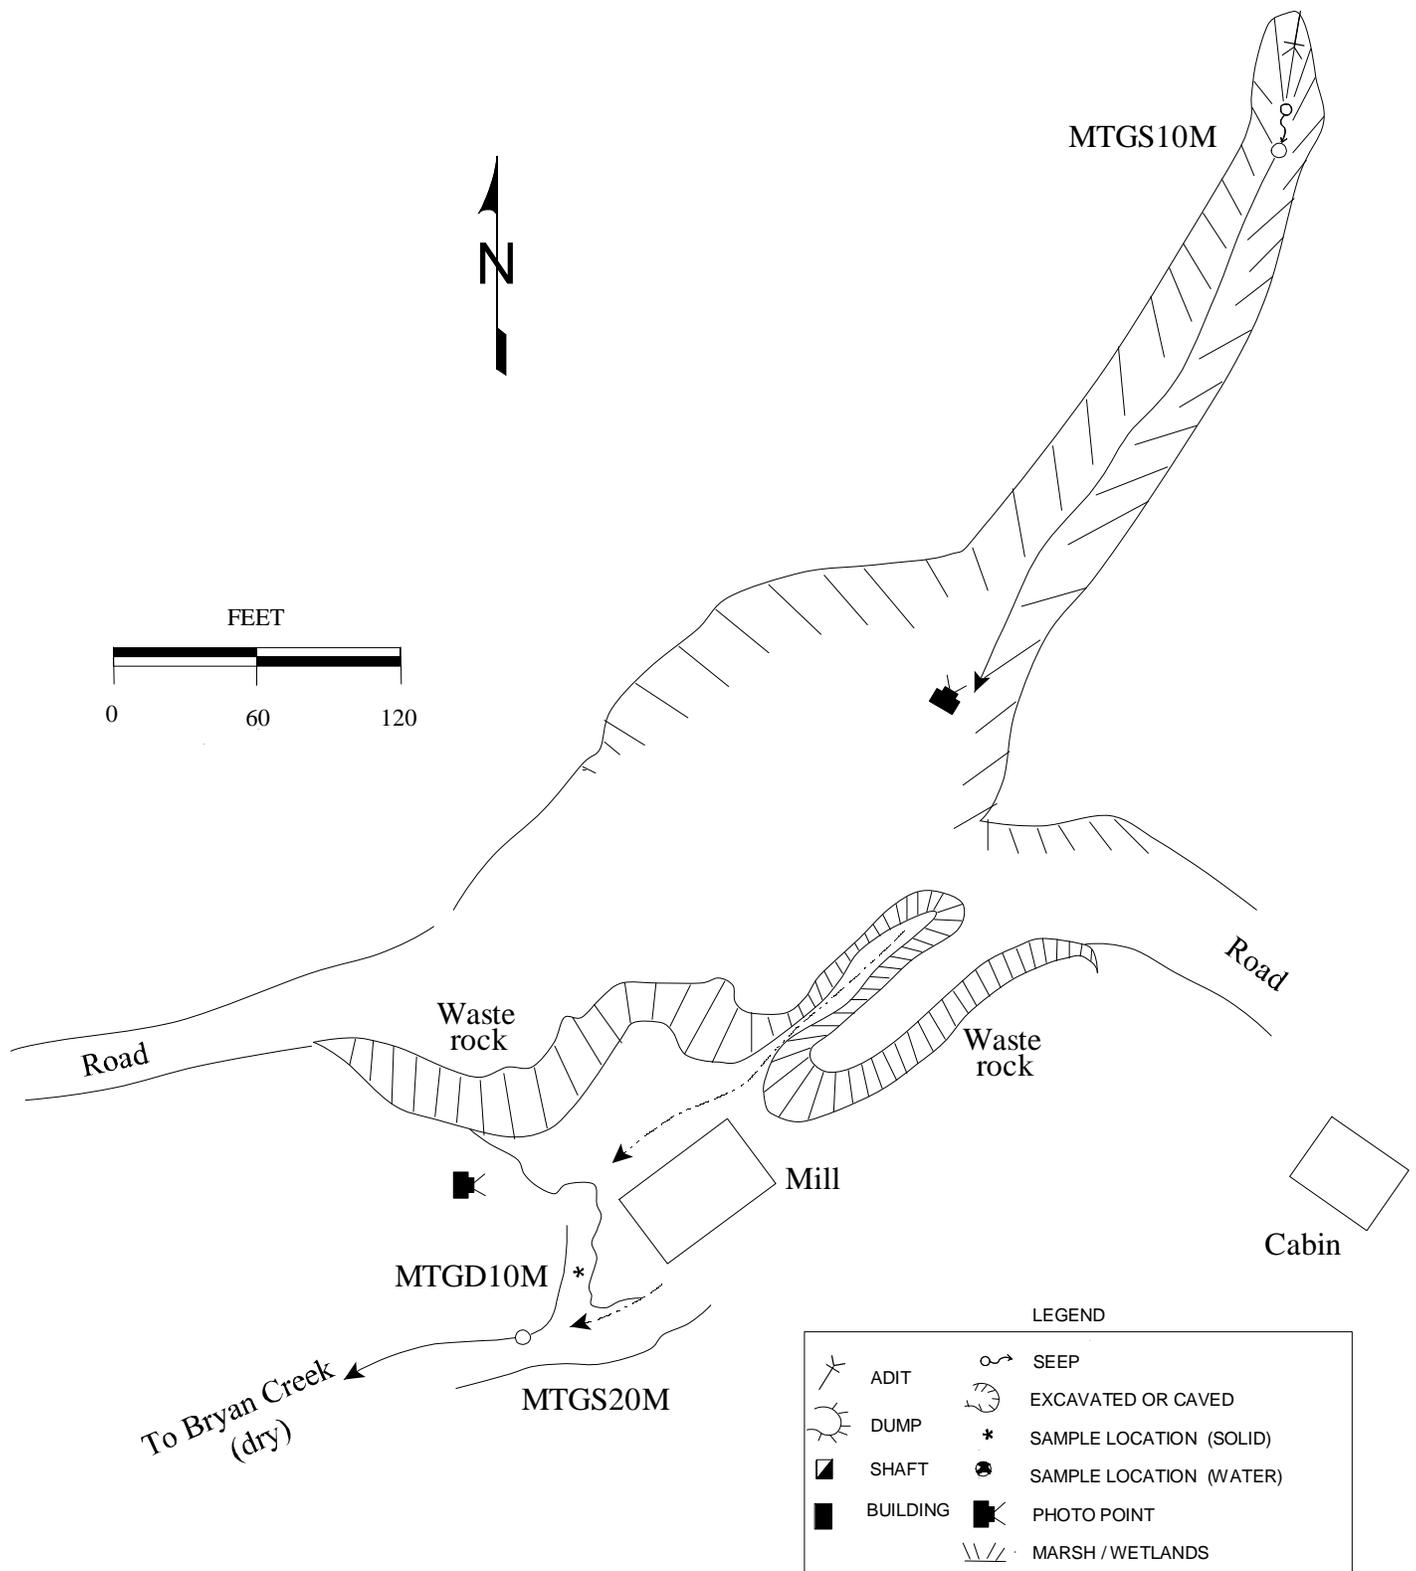
Figure 3. The Telegraph Creek mine (8/3/95) was discharging water from the adit and from springs below the mill. The site is bisected by the main road between Telegraph Creek and Tenmile Creek.

Figure 3a. The adit of Telegraph mine discharged acidic water with ferric hydroxide evident along the discharge channel.

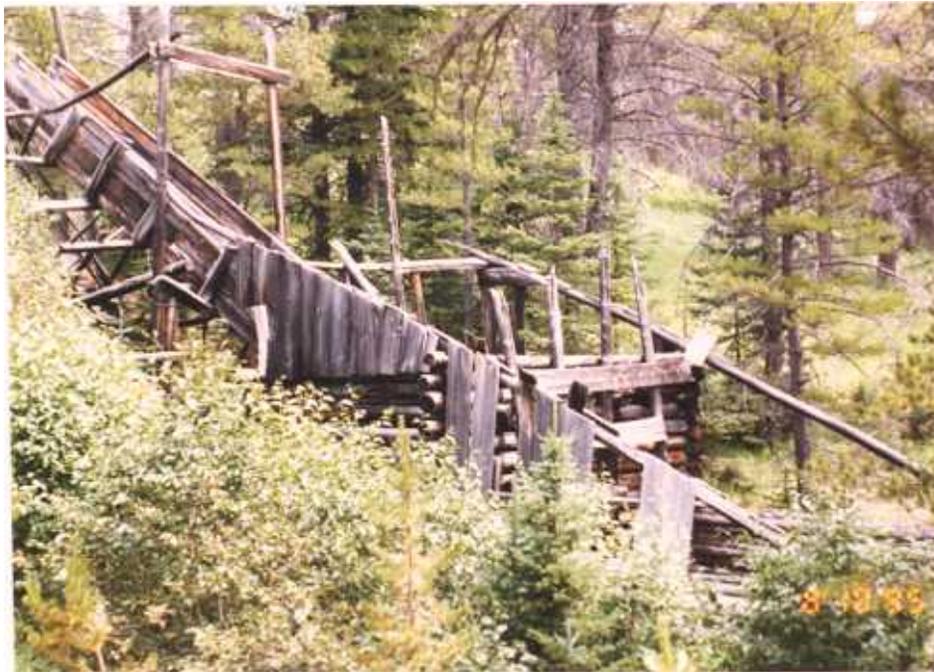
Figure 3b. The Telegraph mill was in poor condition. The area was generally overgrown by small trees and bushes.

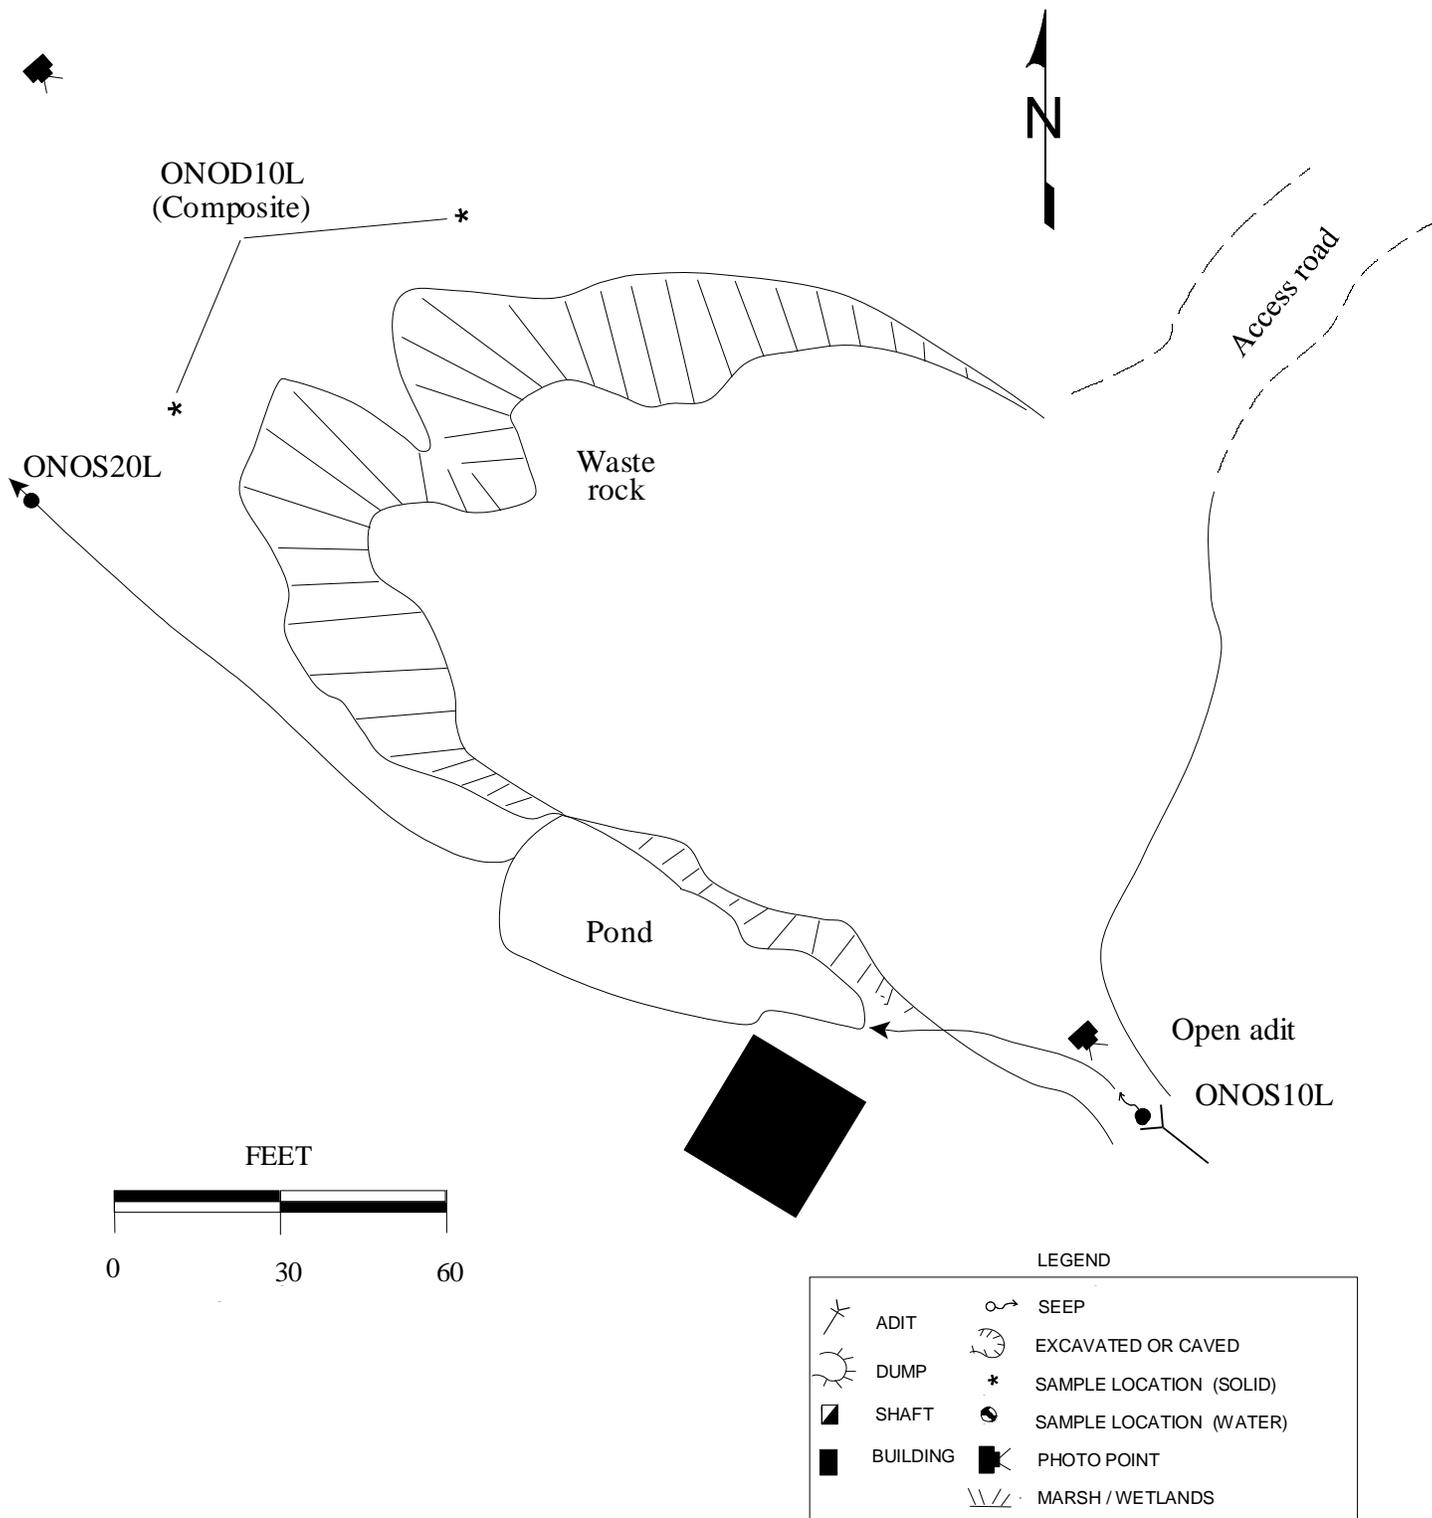
Figure 4. The North Ontario mine adit was open and discharging water to a small pond (8/9/95). The road to the site is not well marked but showed recent traffic.

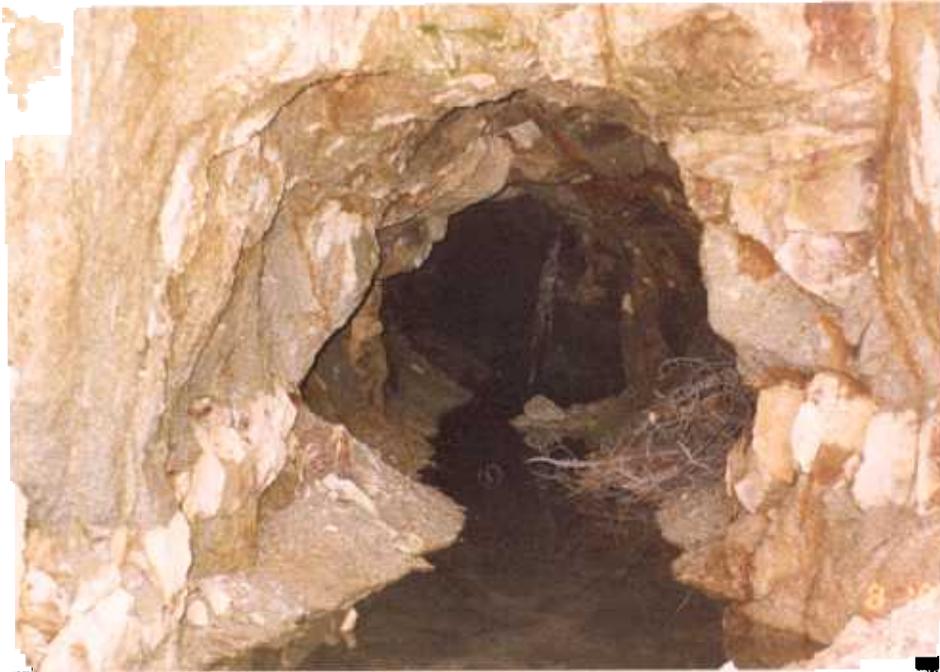
Figure 4a. The adit of the North Ontario mine remained open at least 40 feet from the surface. The tunnel was partially flooded and discharged water on to the dump.

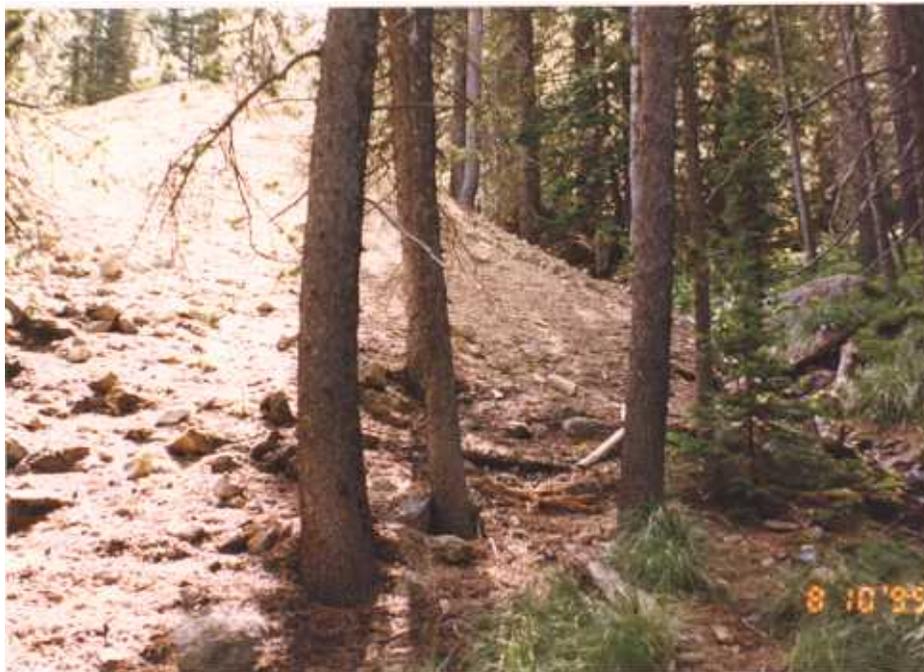
Figure 4b. The lower waste-rock dump of the North Ontario was partially vegetated near the base. A soil sample was collected where soils and waste had mixed.

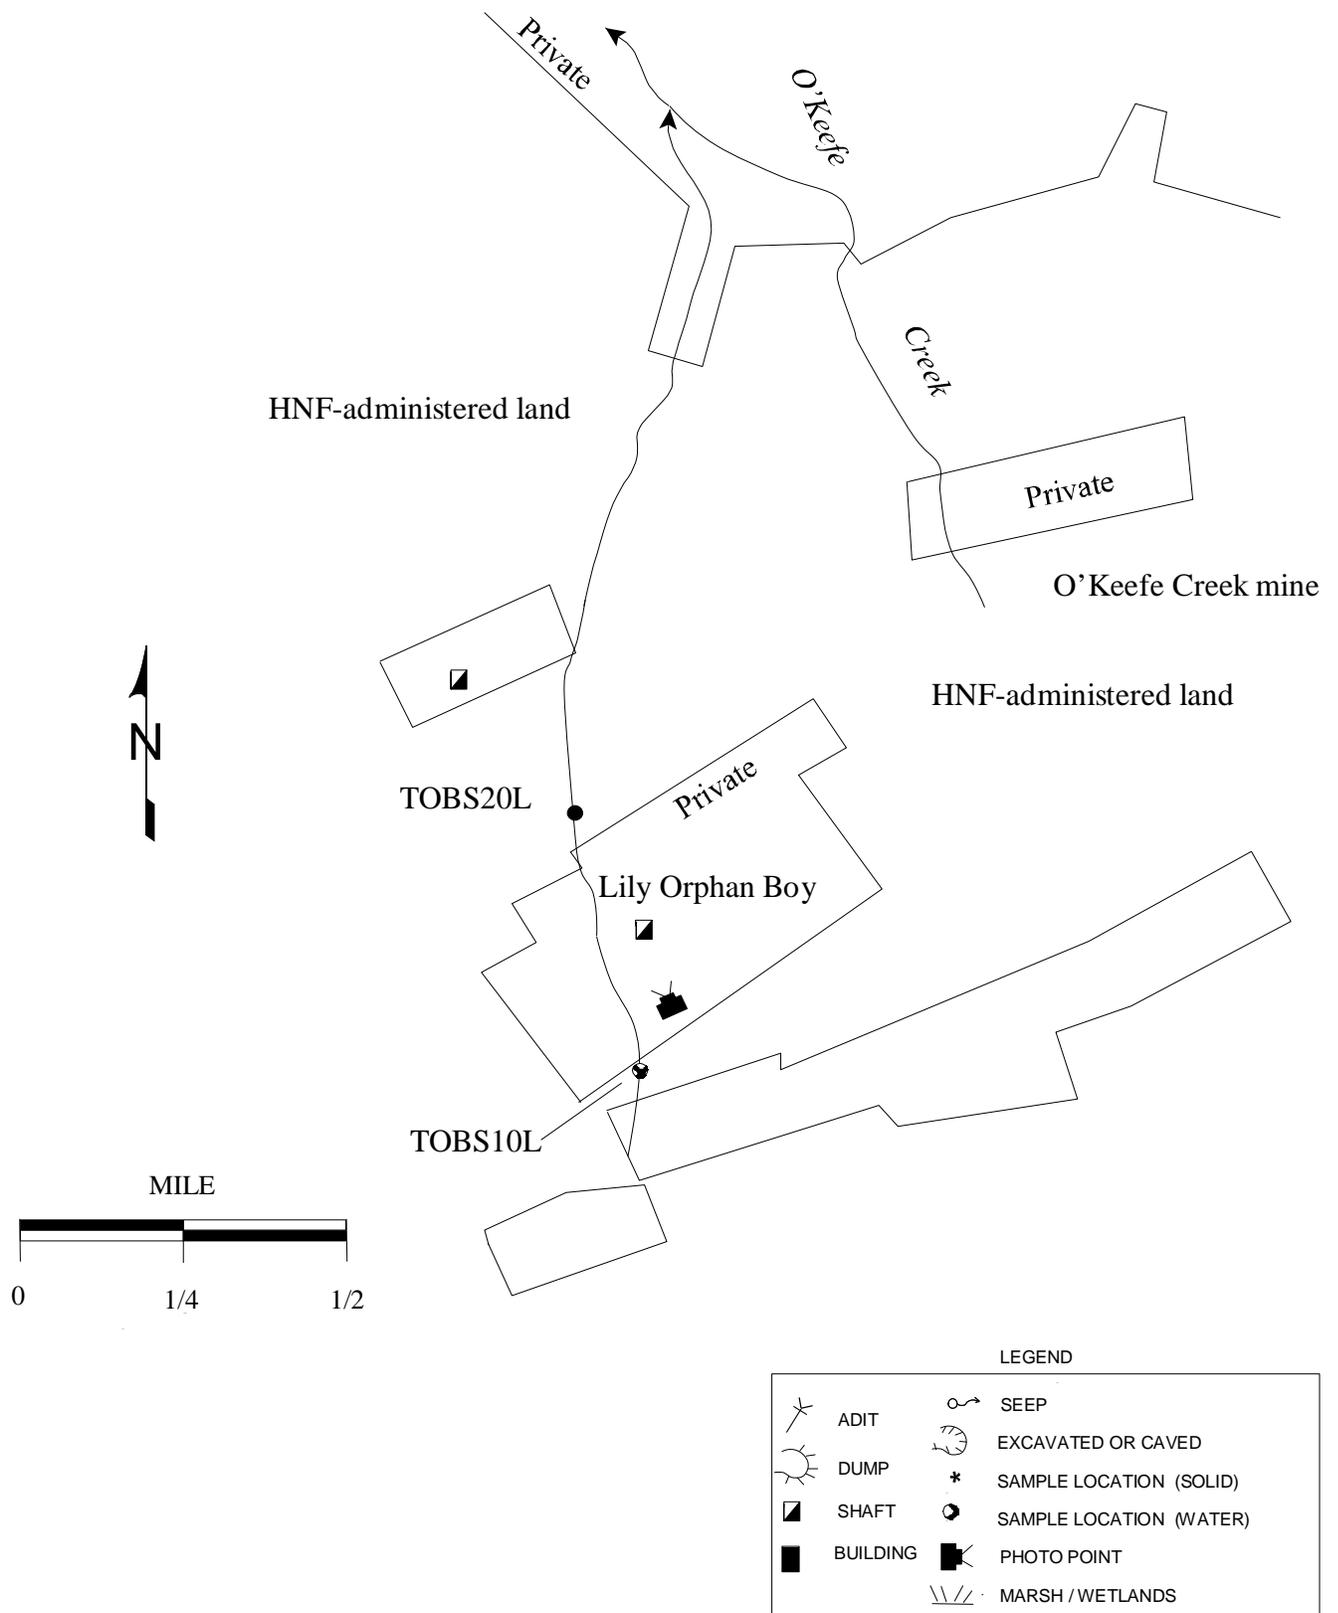
Figure 5. The Lily (Little) Orphan Boy mine is on private land (8/9/95). A sample was collected from the creek upstream and downstream of the mine on HNF-administered land.

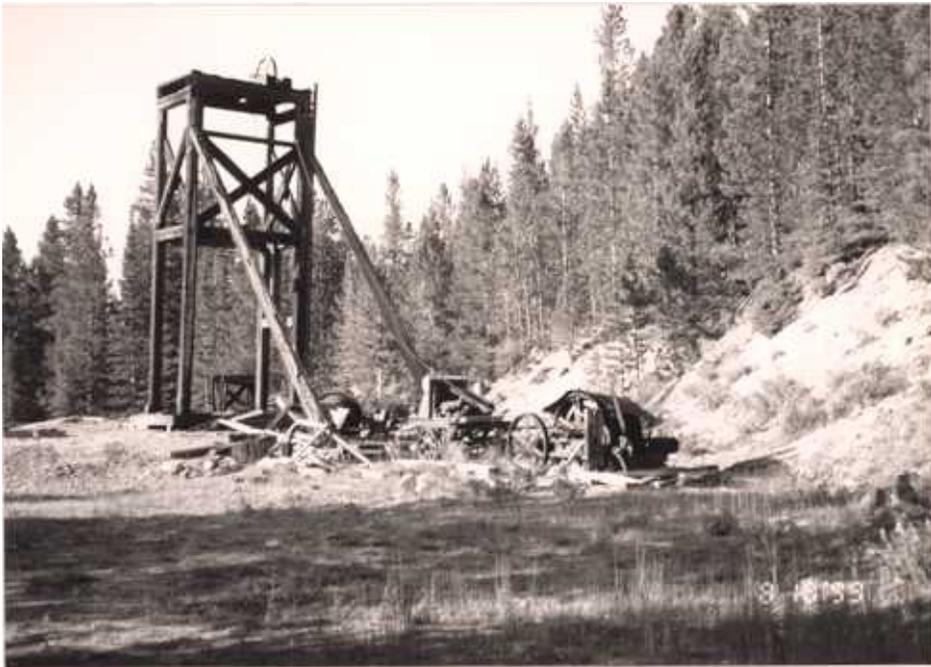
Figure 5a. The Lily (Little) Orphan Boy shaft and the development area occurred on private land within HNF-administered land.

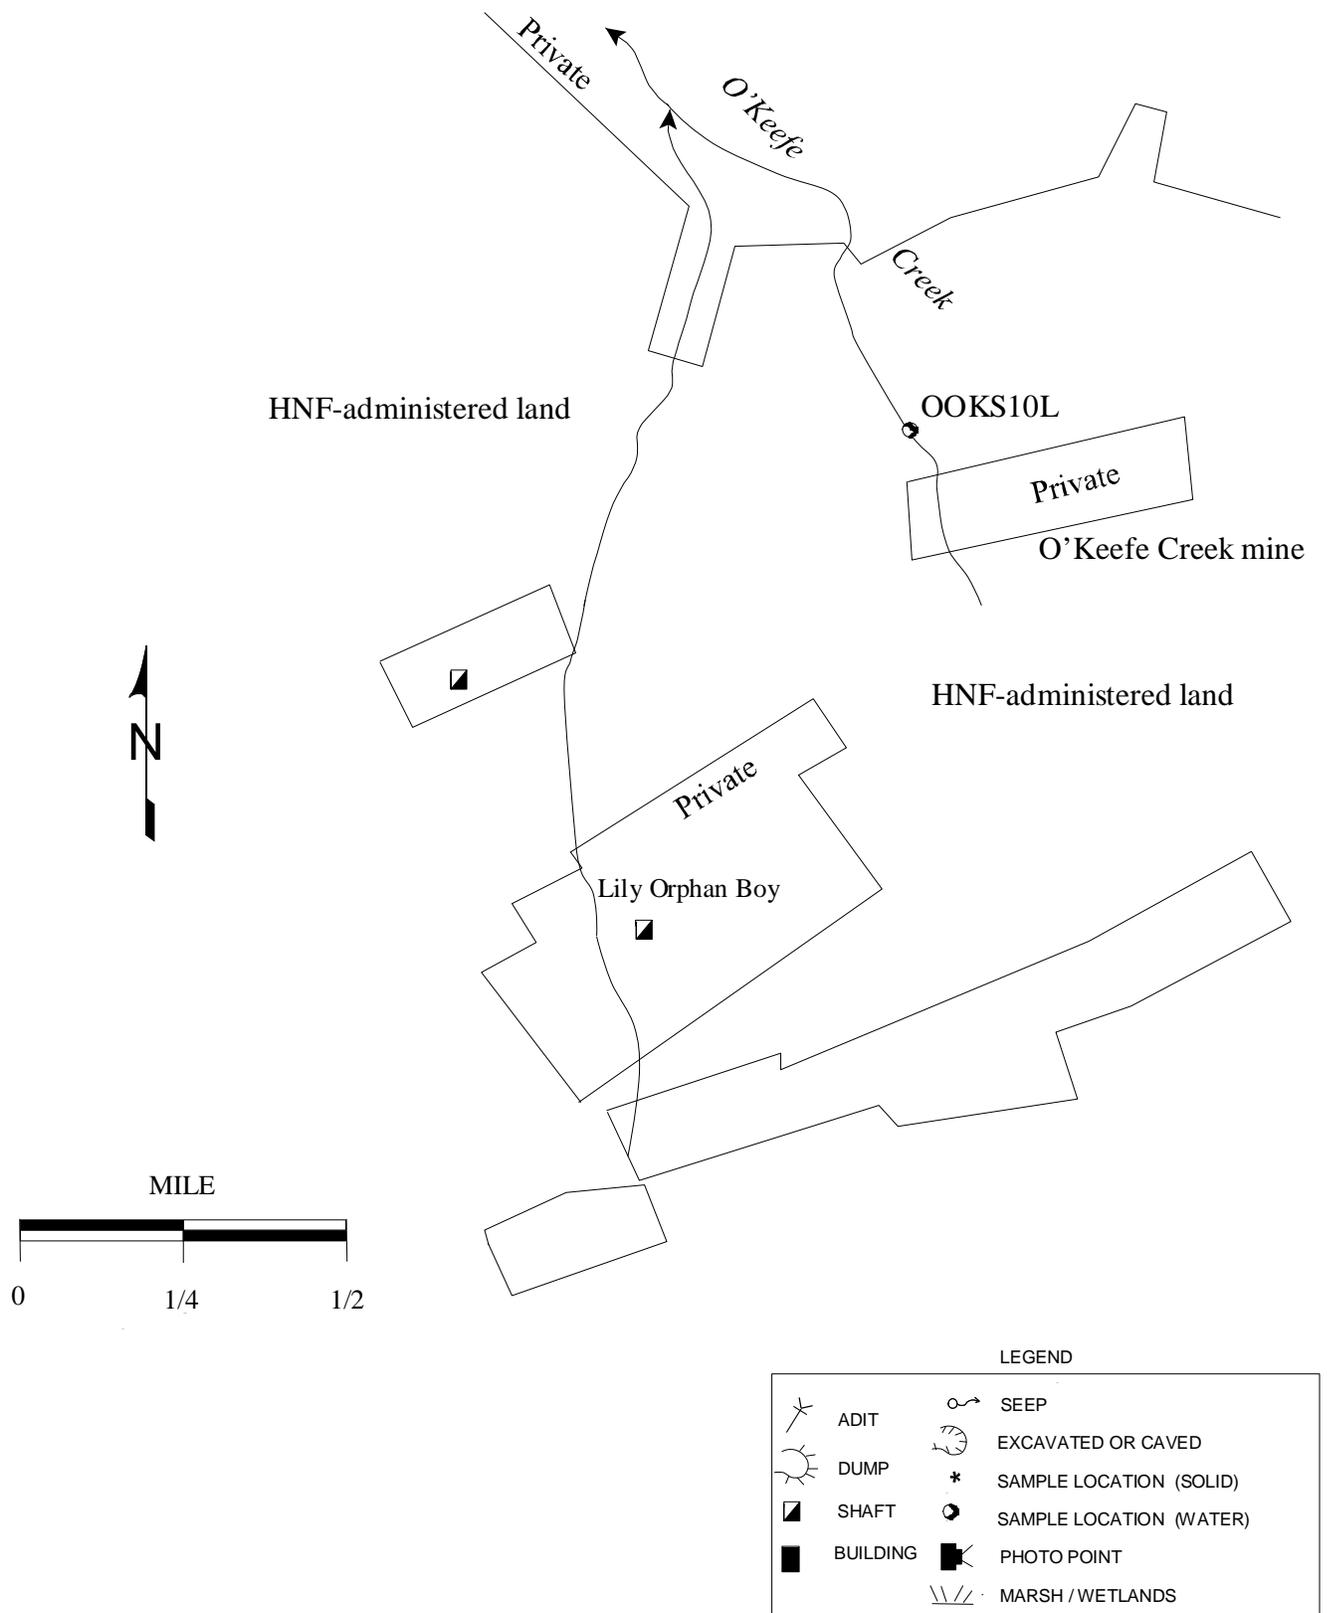
Figure 6. The O'Keefe Creek mine is on private land (8/9/95). A sample was collected from the stream downstream of the mine.

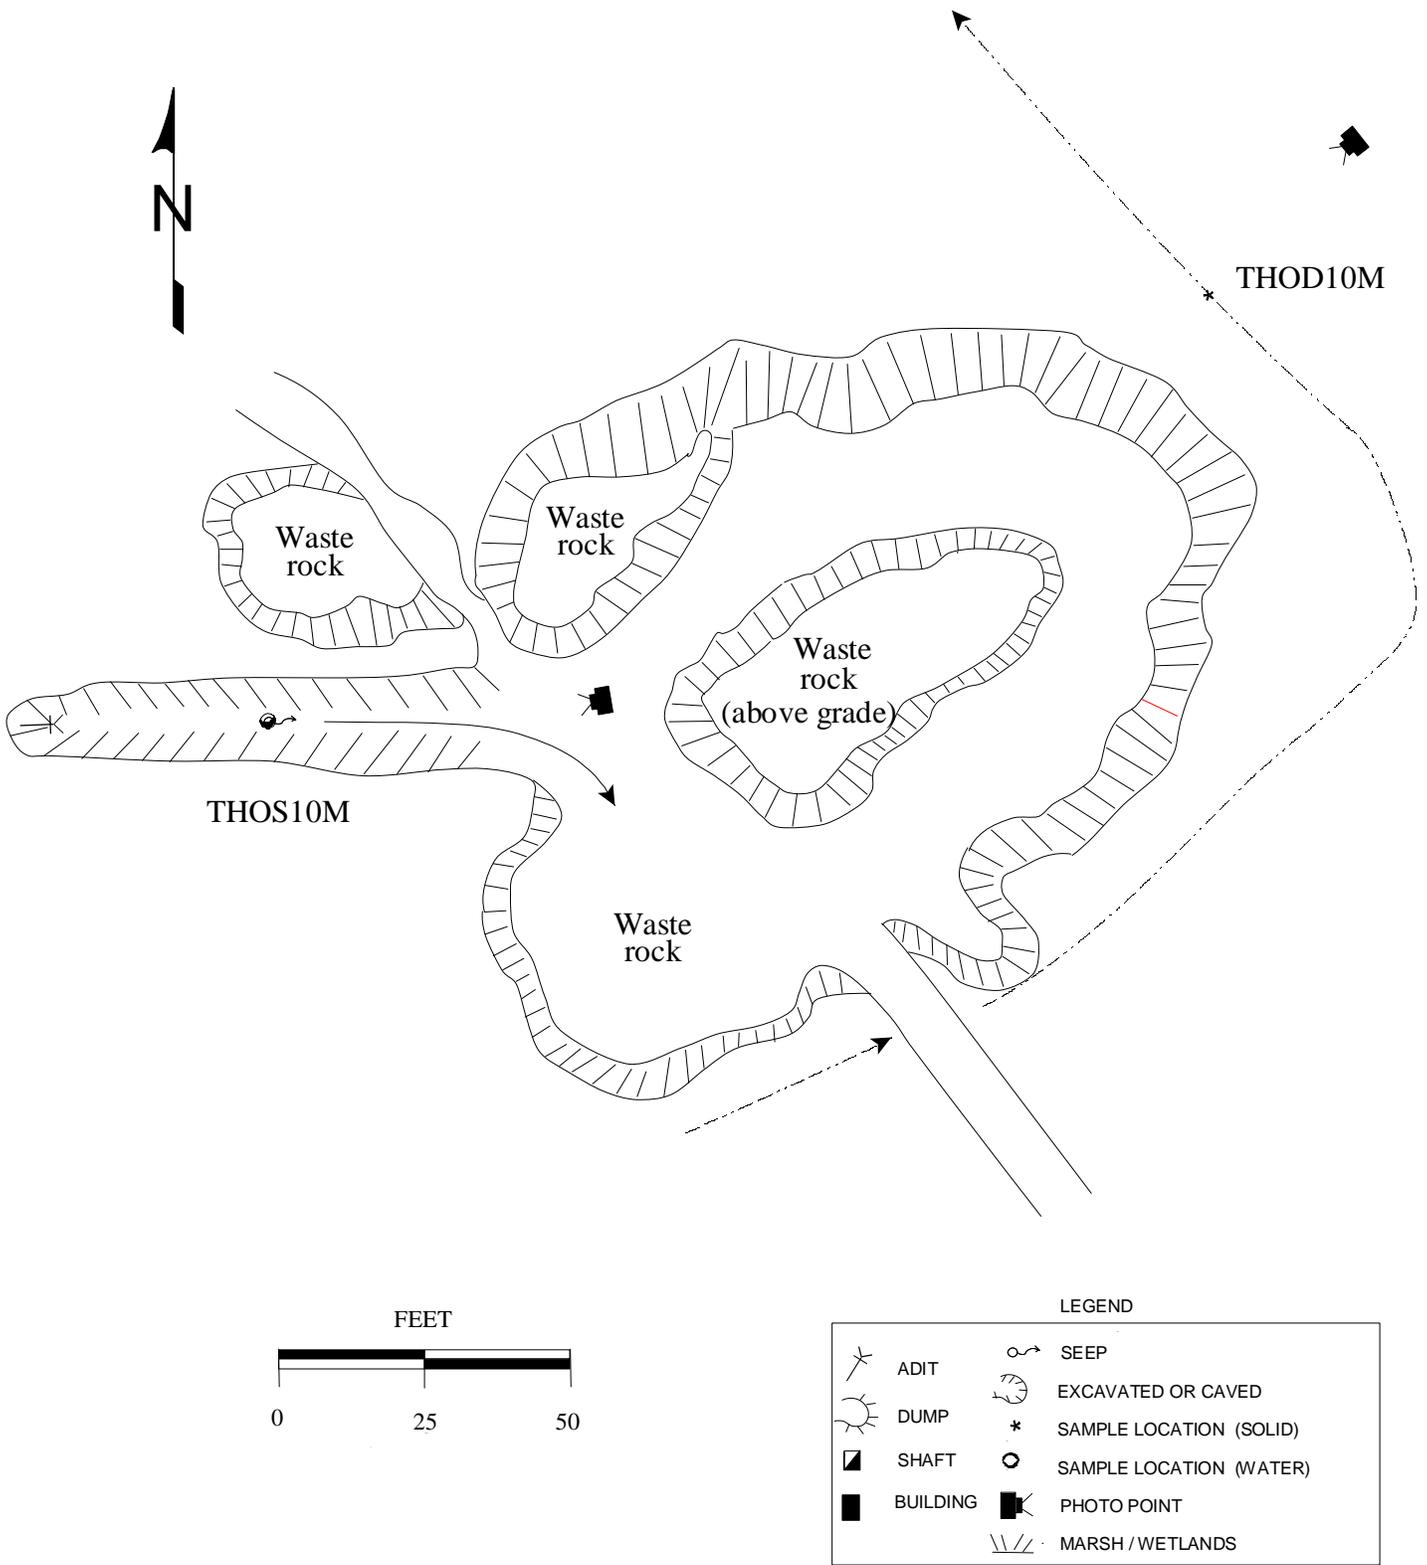
Figure 7. The Hope mine (8/9/95) was discharging water from a caved adit. There were several dry stream beds that probably flow during snowmelt and large storms.

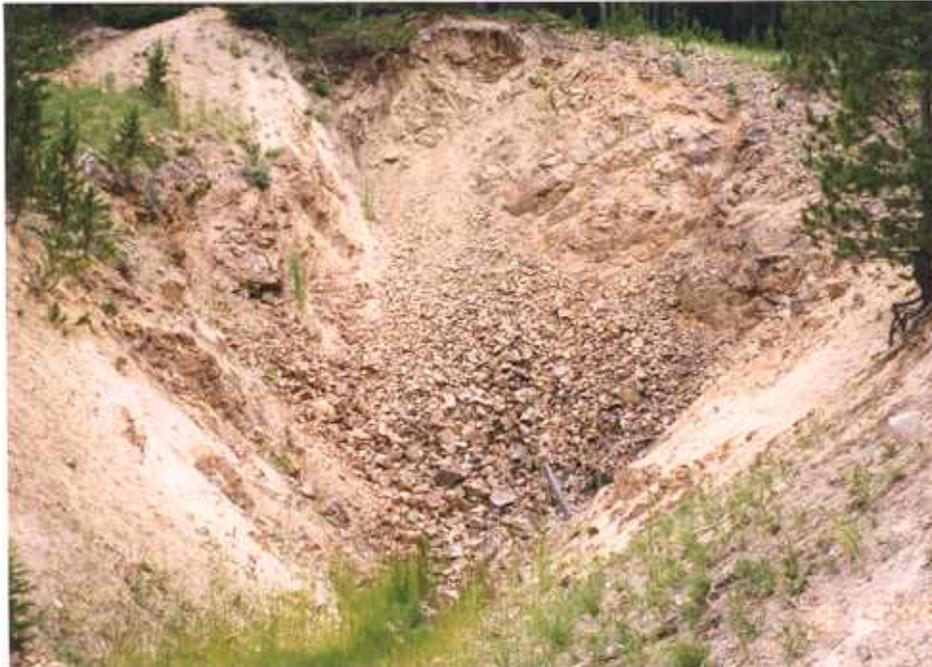
Figure 7a. The collapsed adit at the Hope mine discharged about 1 gpm. The highwall was steep but generally stable.

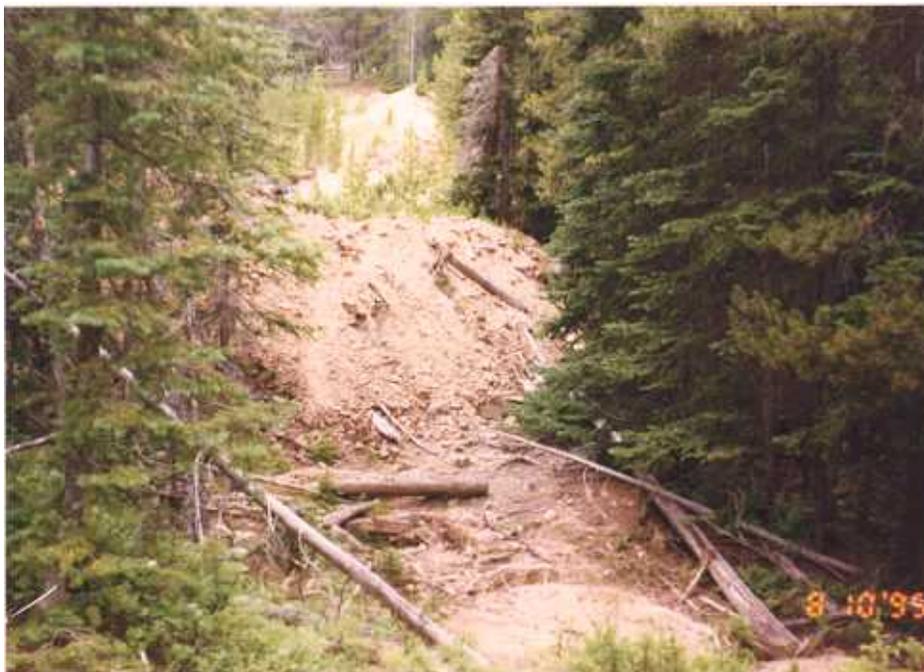
Figure 7b. The lower waste-rock dump of the Hope mine was barren of vegetation. MBMG staff collected a soil sample from the dry stream bed at the base of the dump.

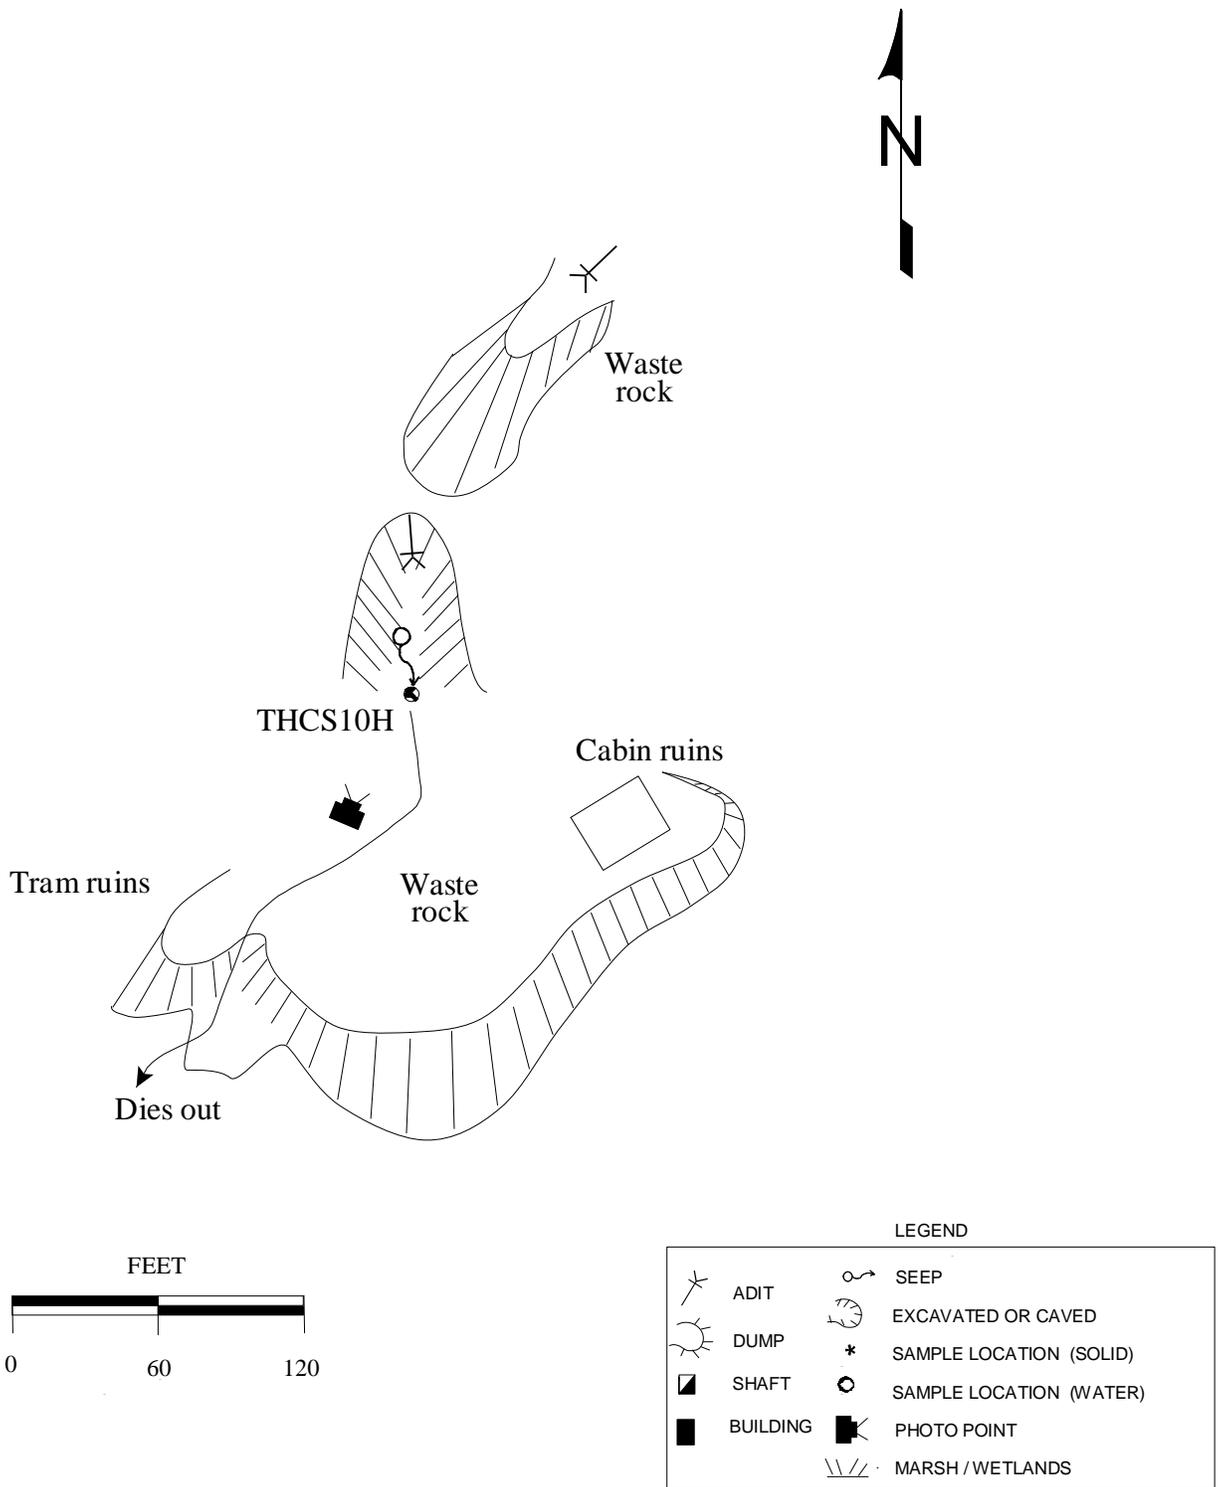
Figure 8. The Hub Camp mine (8/3/95) consisted of two caved adits; the lower adit was discharging a small amount of water. The stream infiltrated the ground within a short distance from the base of the dump.

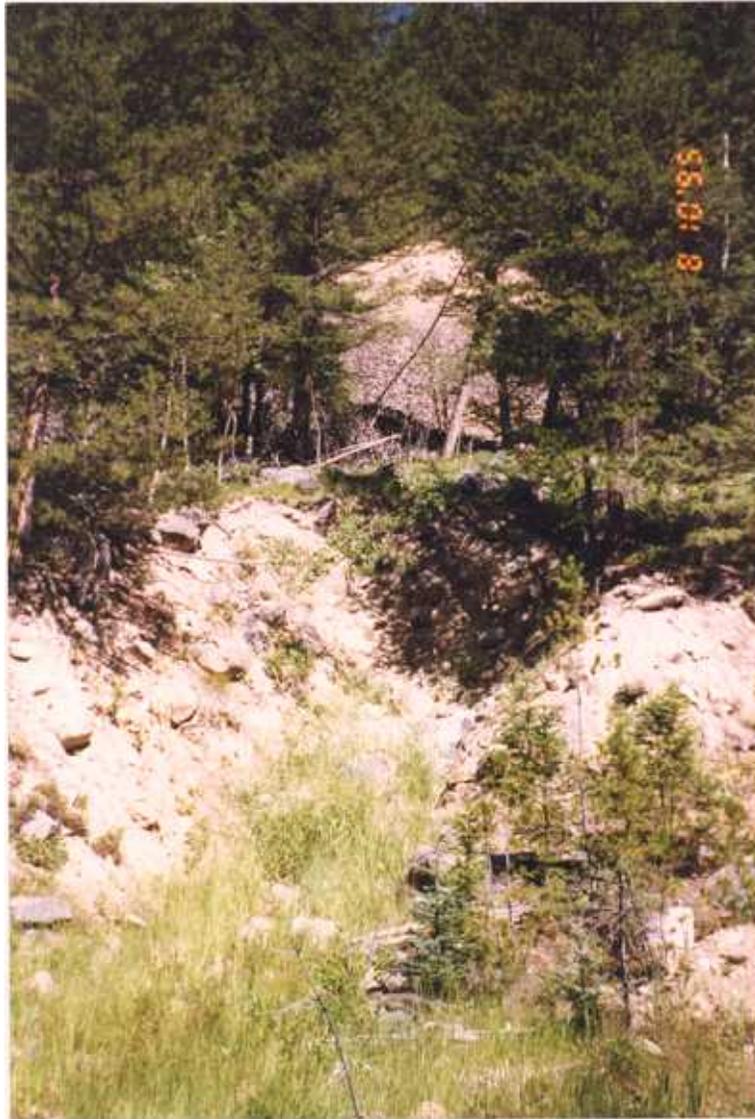
Figure 8a. The collapsed adit of the Hub Camp mine discharged about 1.5 gpm, which infiltrated the ground within 100 feet of its origin.

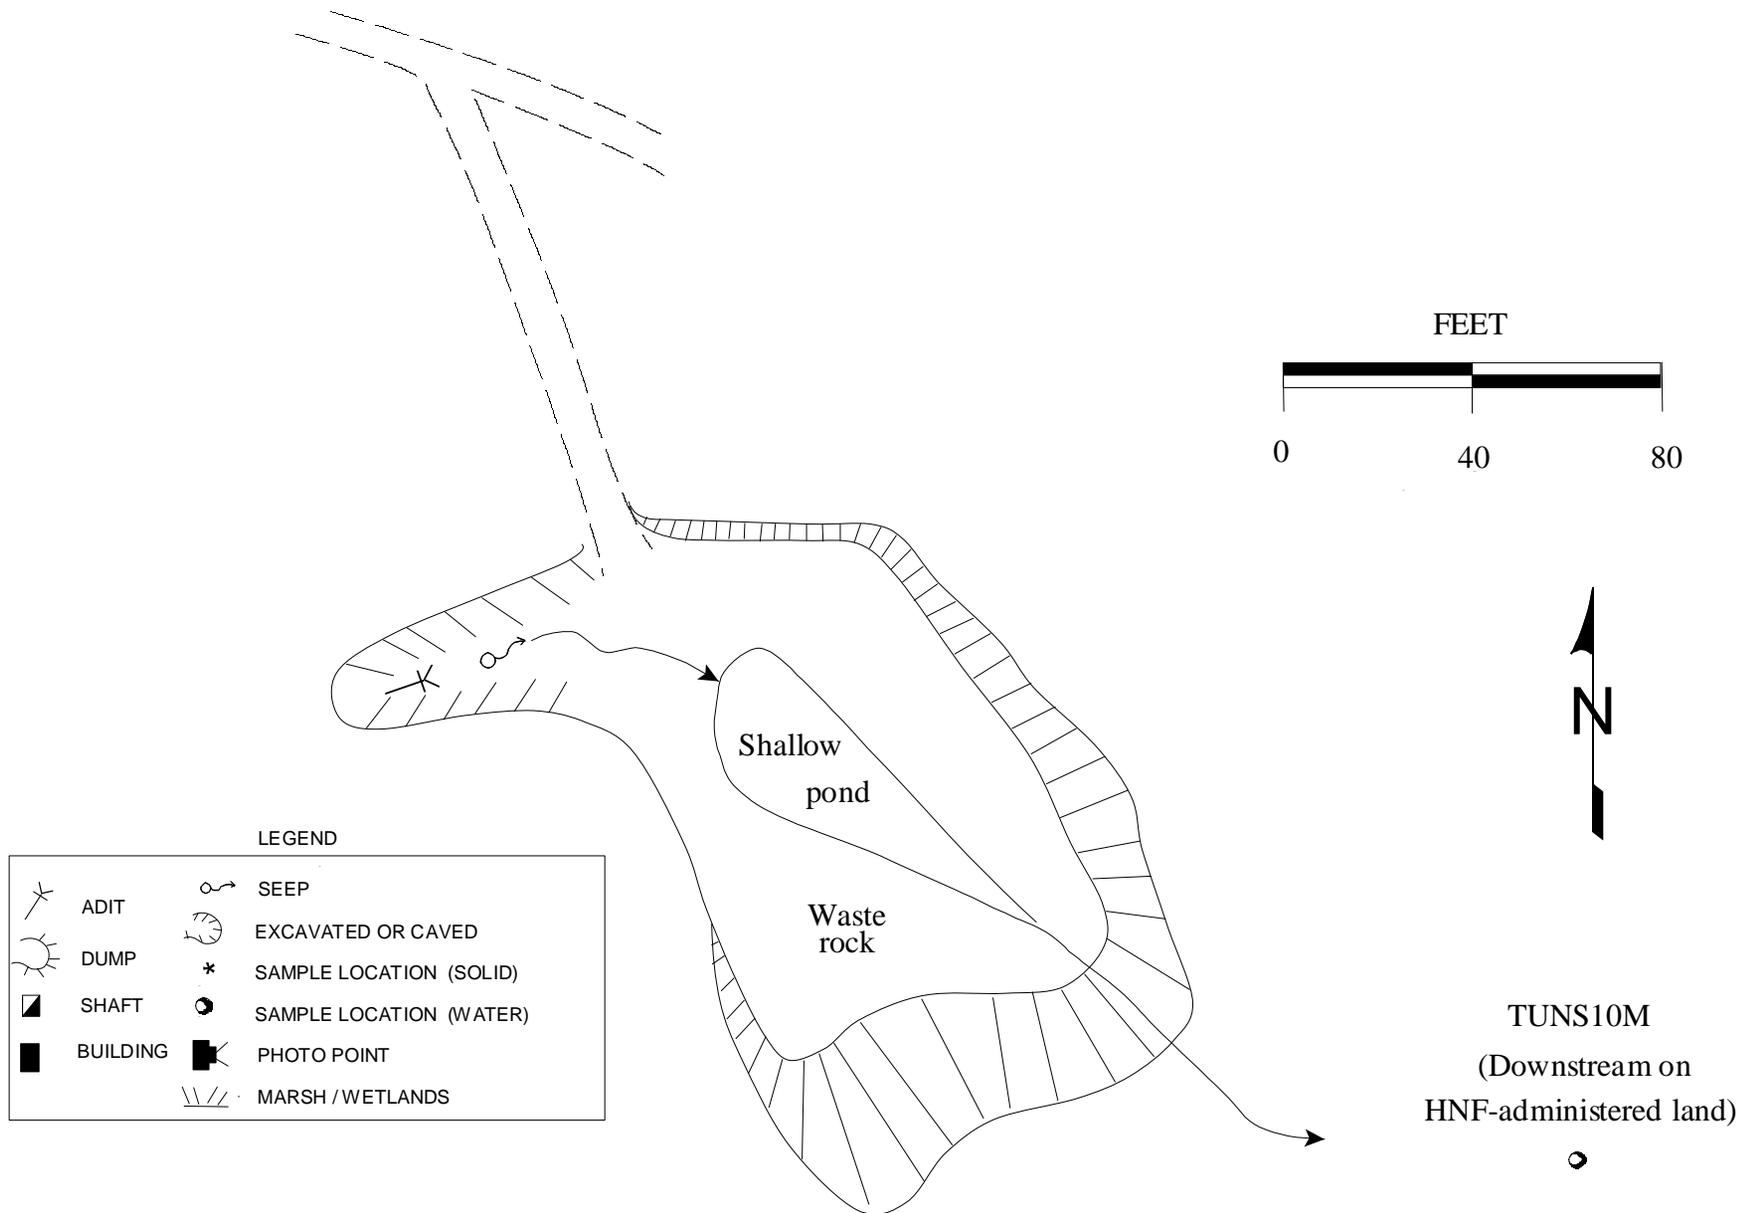
Figure 9. The Unnamed mine in Moose Gulch is on private land (9/26/95). The adit discharge flowed onto HNF-administered land below the site.

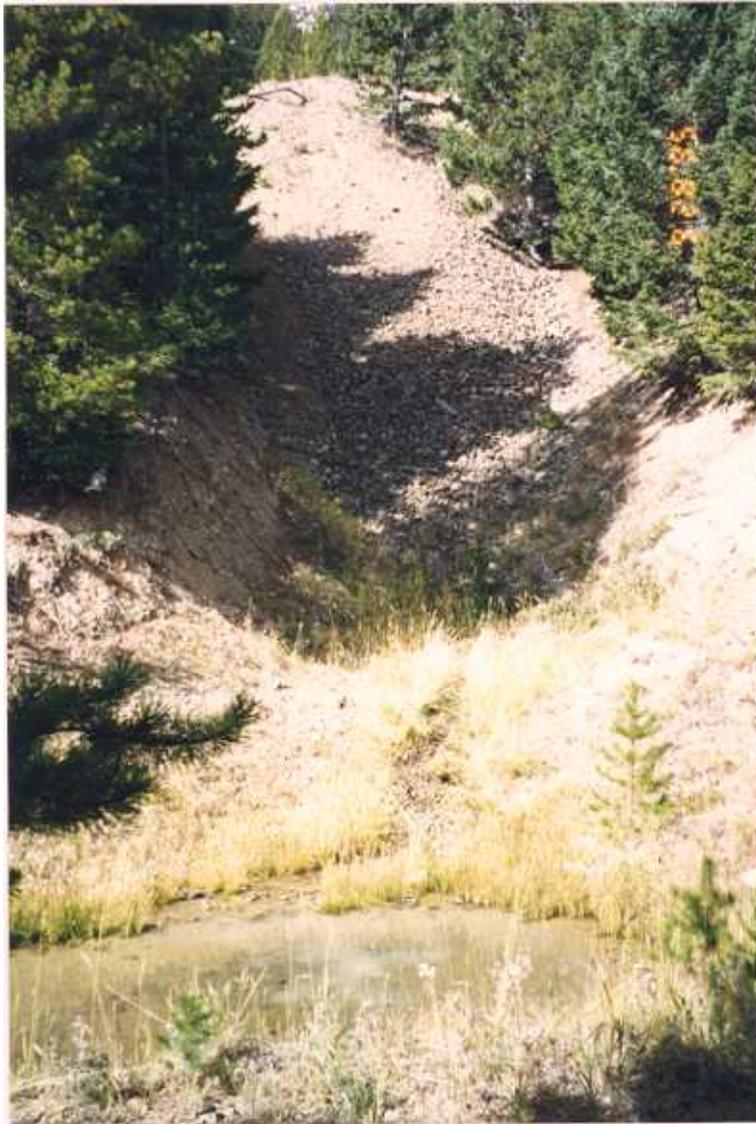
Figure 9a. The adit of the Unnamed mine in Moose Gulch is on private land upstream of HNF-administered land.

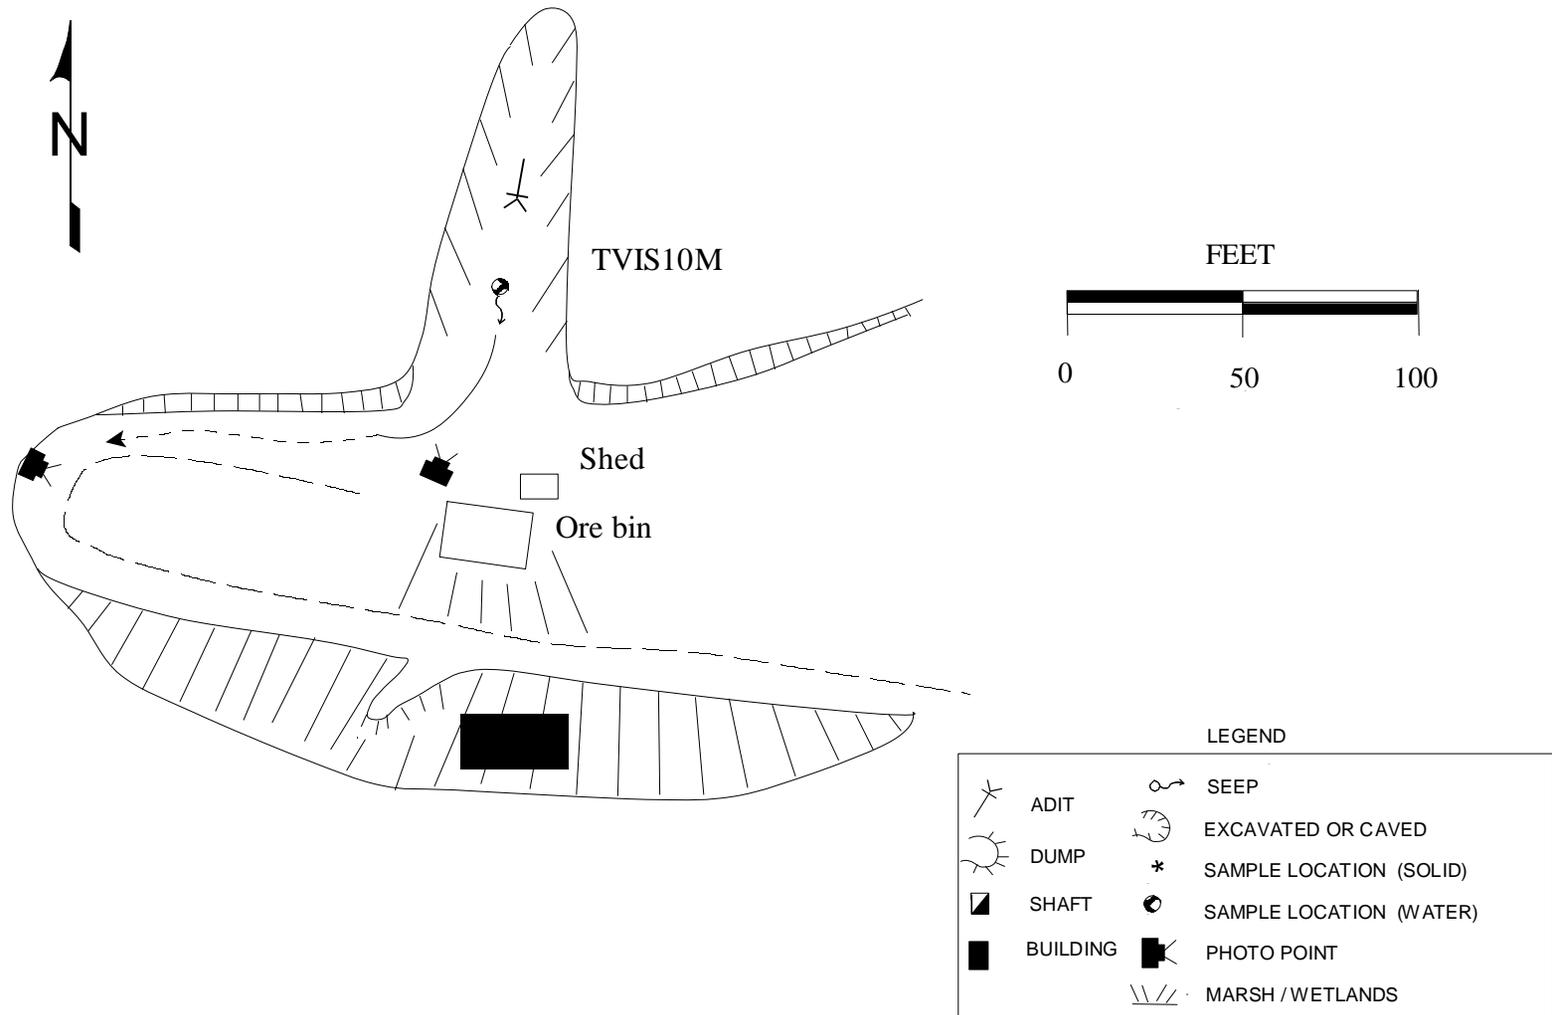
Figure 10. The Viking mine adit was discharging a small amount of water that flowed part way down the road (9/28/95). The road to the site had been blocked off at Moose Gulch.

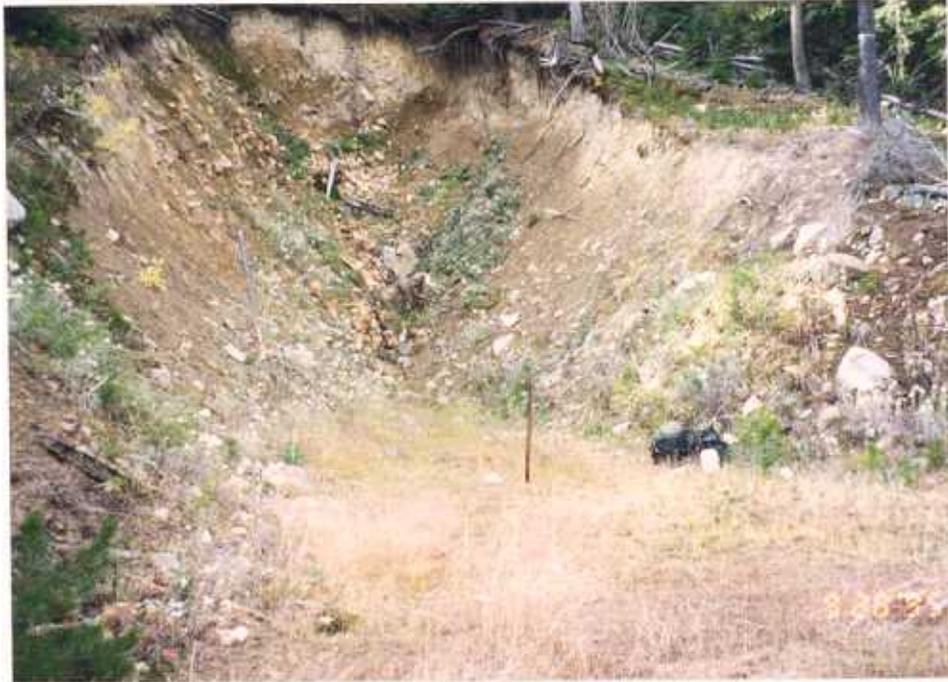
Figure 10a. The collapsed adit of the Viking mine discharged about 0.5 gpm. No other discharges were observed on or near the site.
