Abandoned - Inactive Mines of the
Blackfoot and Little Blackfoot River Drainages

Helena National Forest
Volume II

Open-file Report 368
MBMG

February 1998

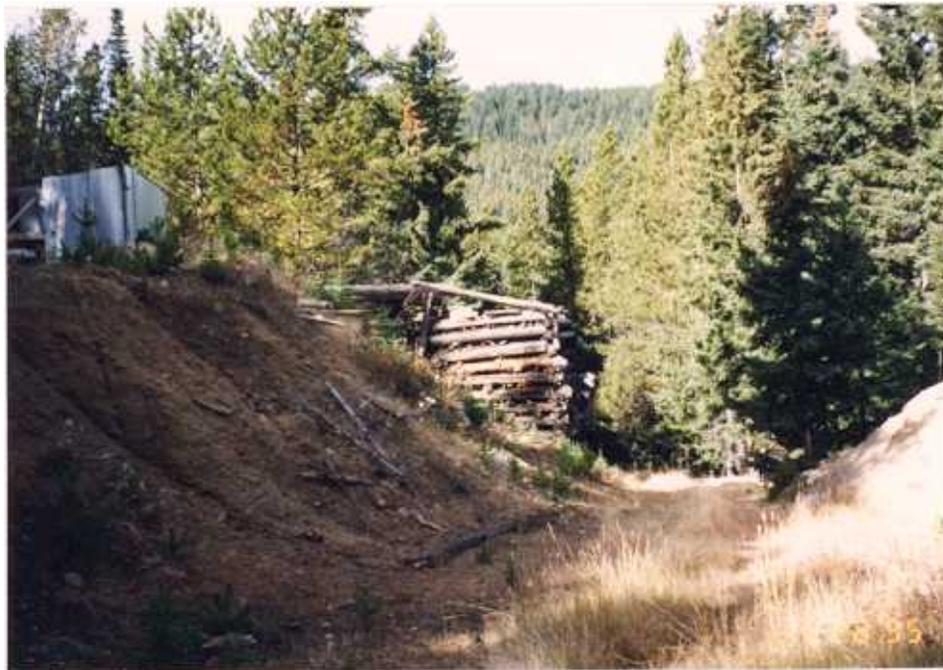
Figure 10b. An ore bin lies near the base and a metal shed sits at the top of the waste-rock dump of the Viking mine. Part of the dump has been reworked.

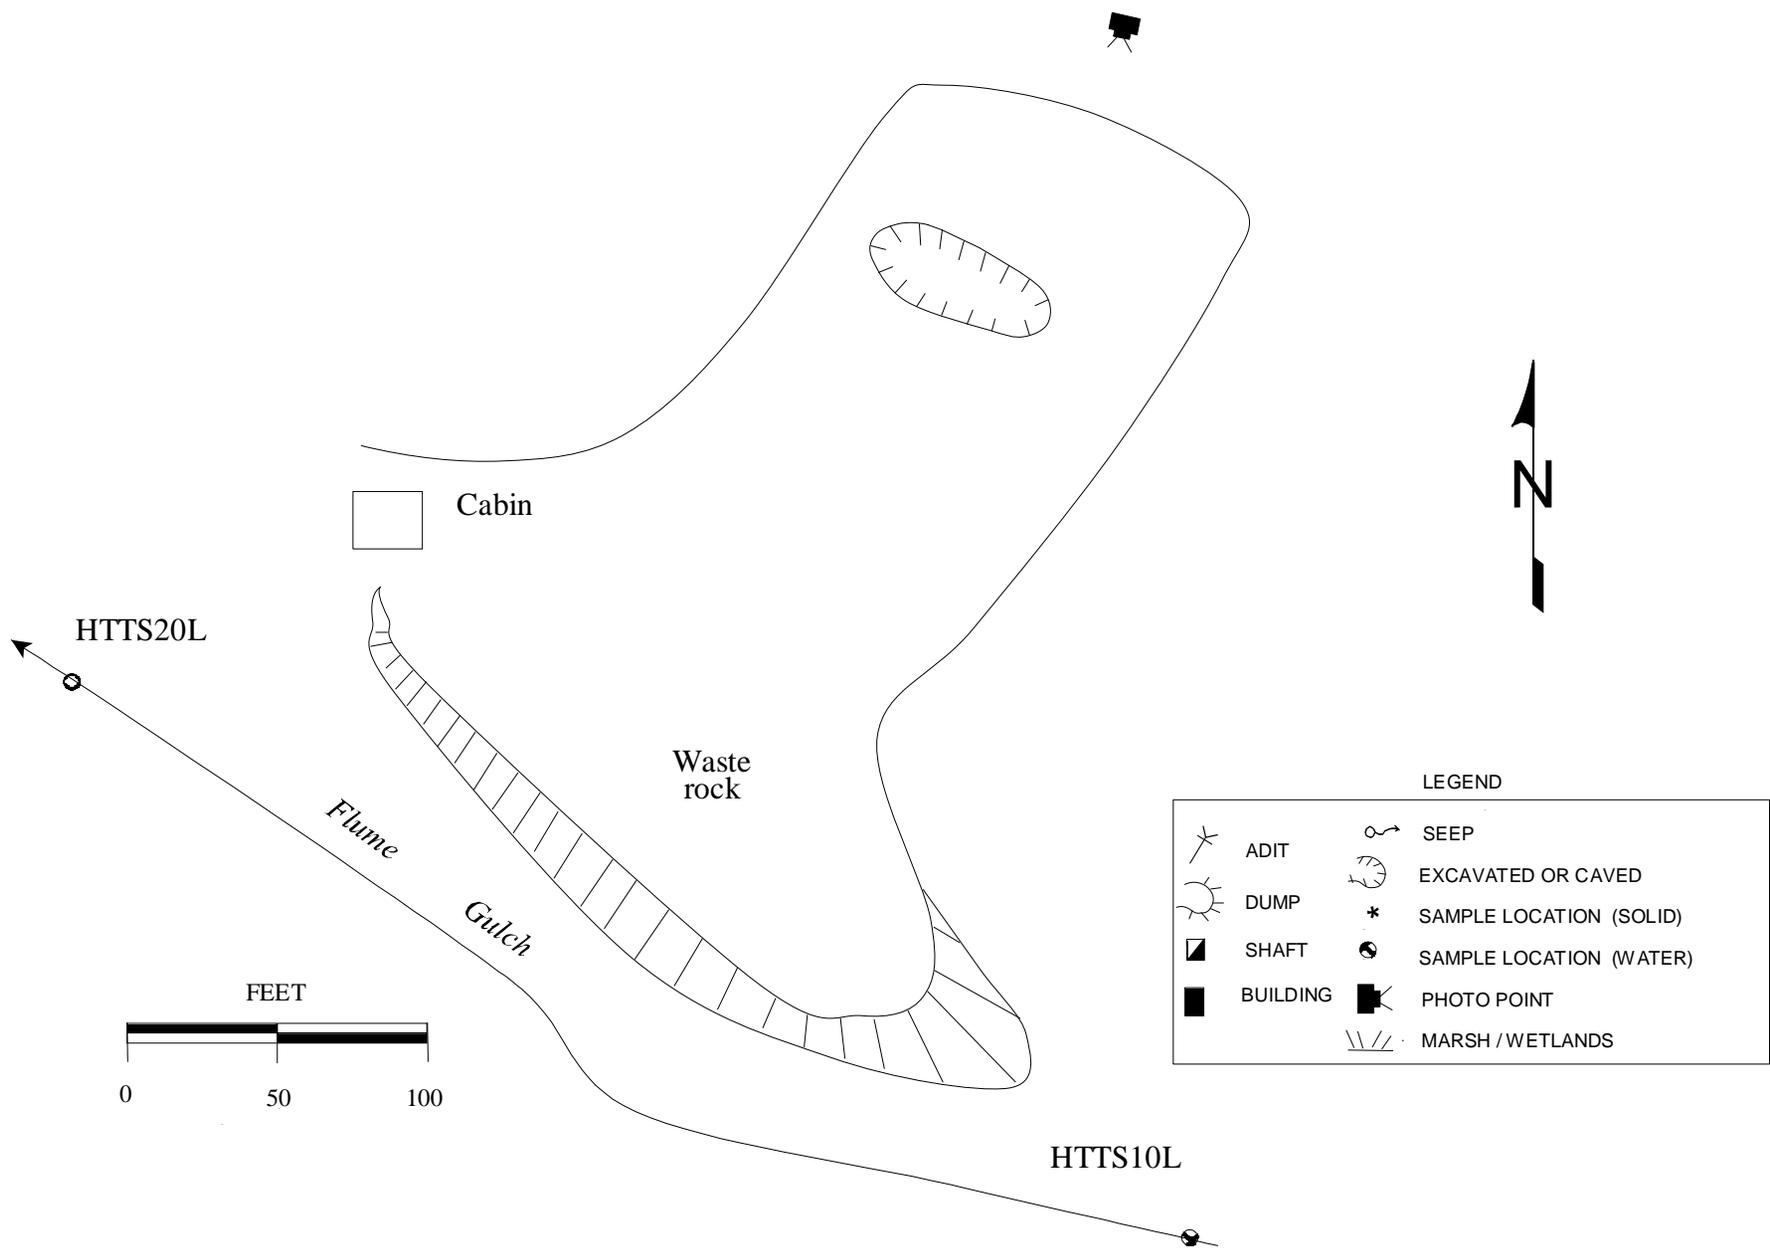
Figure 11. The Third Term mine had been reclaimed at the time of the visit (9/26/95). On an earlier visit by the geologist, water was seeping from the collapsed adit.

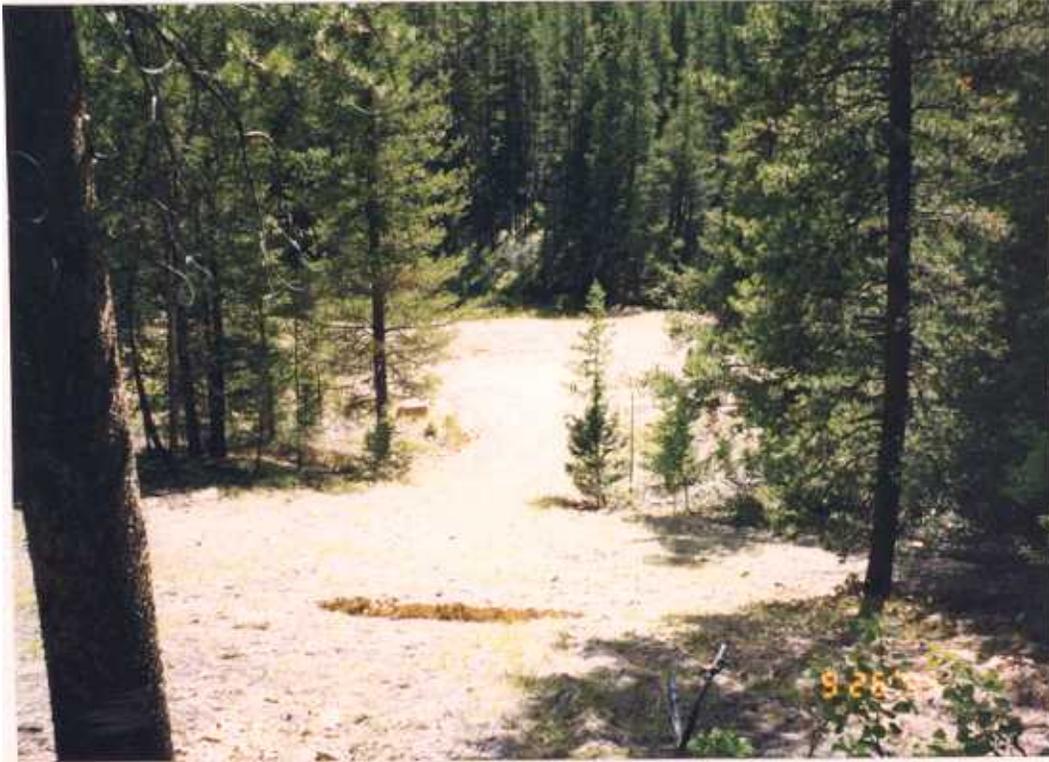
Figure 11a. The Third Term mine has been reclaimed; however, a part of the adit subsided after reclamation (shadow in center of picture).

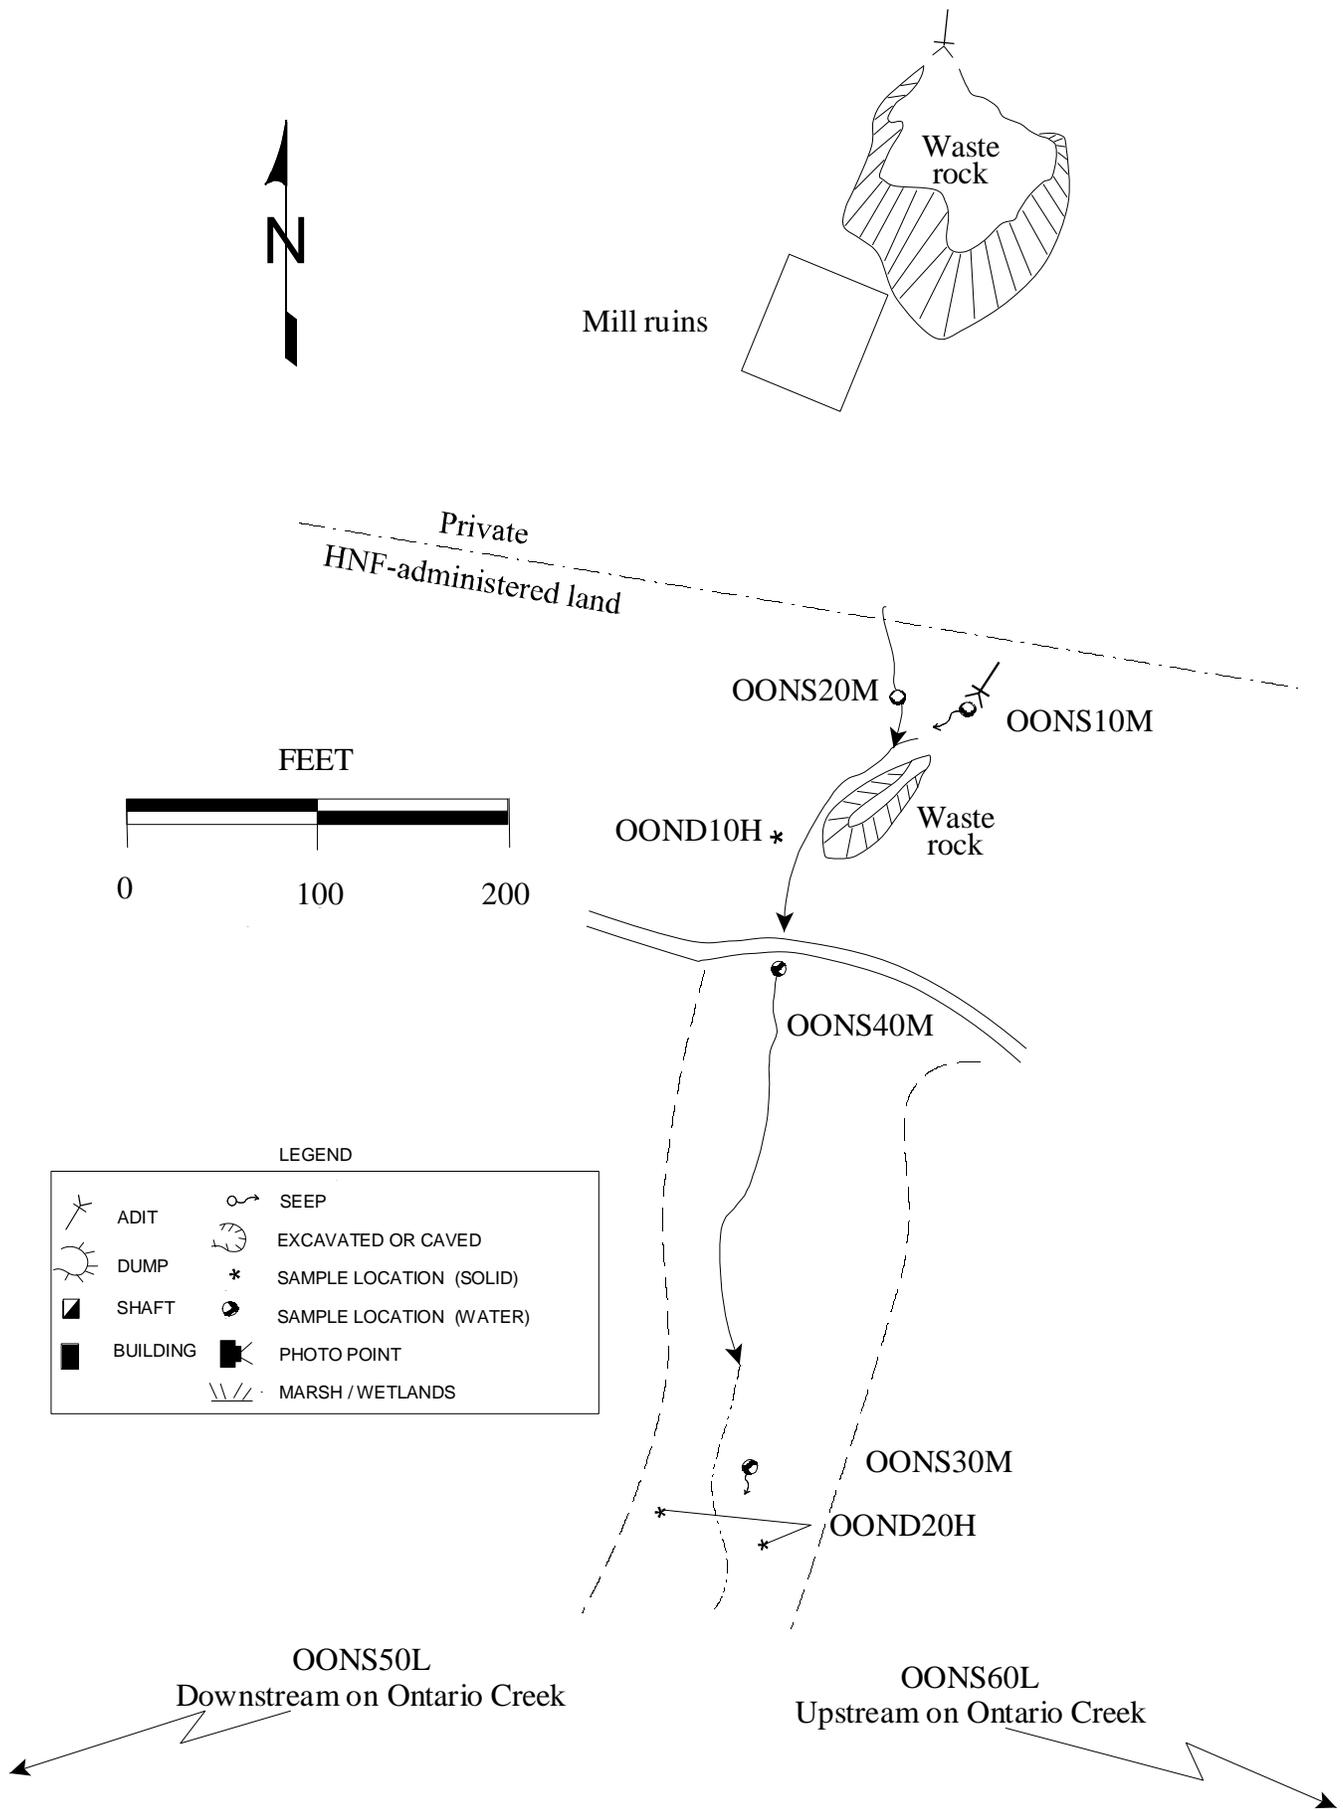
Figure 12. The Ontario mine and mill (8/3/95) have had an extensive impact on the drainage. The tailings extend at least 1,500 feet downstream on Ontario Creek (not shown).

Figure 12a. The lower waste-rock dump of the Ontario mine channels the discharge from the workings toward a wet area above the road.

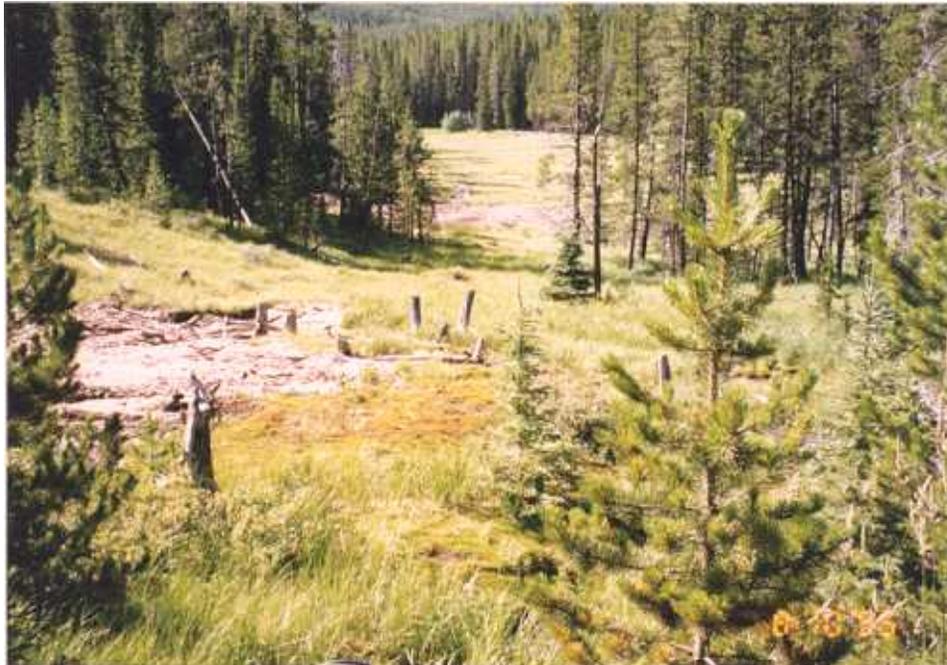
Figure 12b. The Ontario mill tailings extend from the road about 3,400 feet downhill (tree line) and then at least 1,500 feet down Ontario Creek.

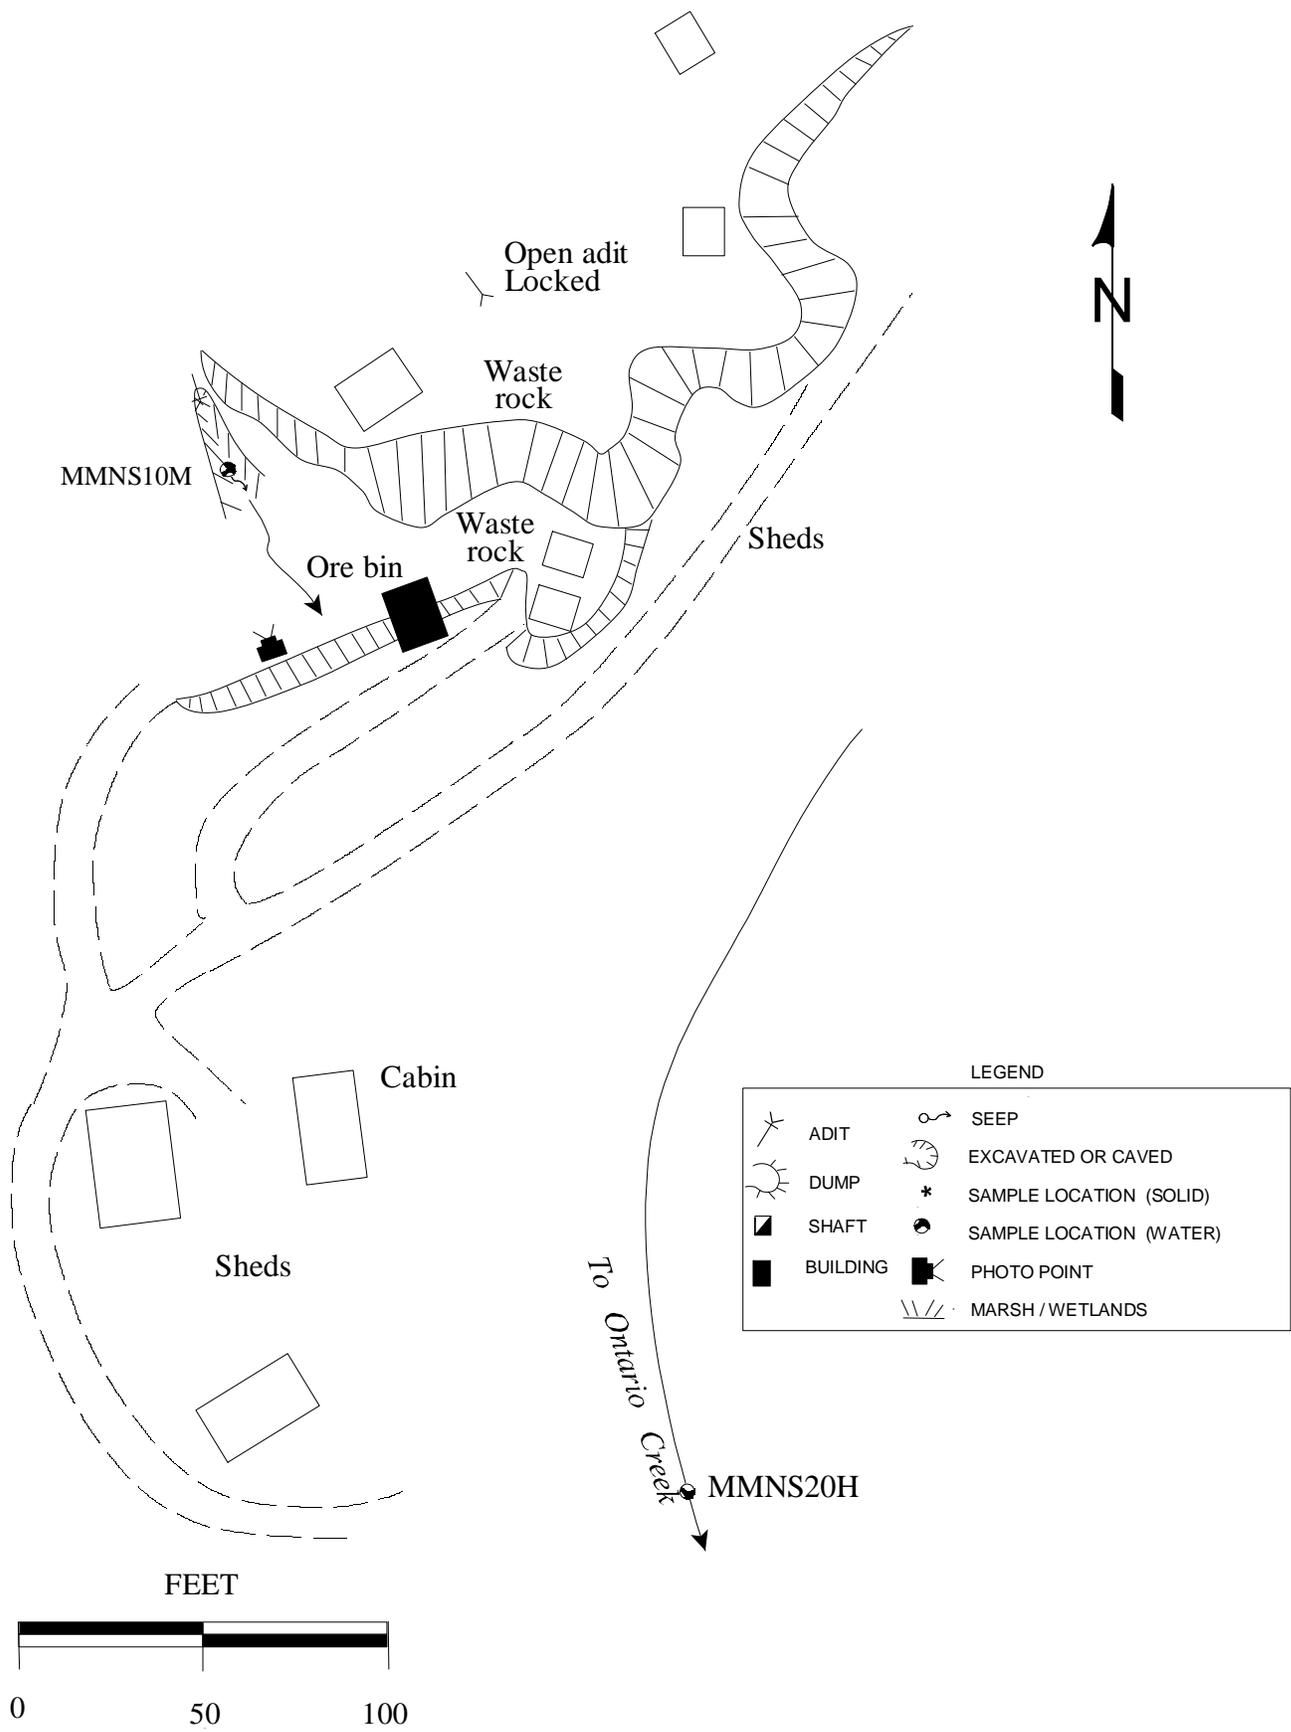
Figure 13. The Monarch mine was apparently active (9/27/95); the upper adit had recently been repaired. The lower adit was discharging about 0.3 gpm.

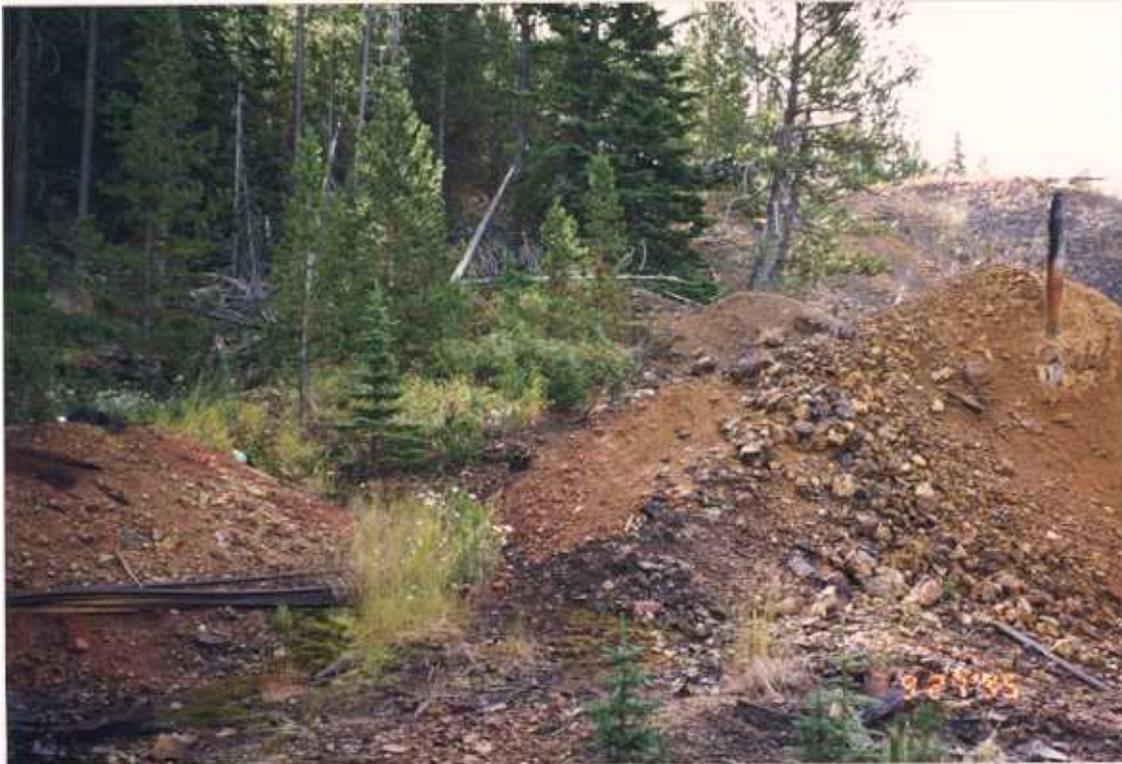
Figure 13a. The lower, caved adit of the Monarch mine was discharging a small amount of water on to the lower waste-rock dump. The adit lies in the trees just left of center.

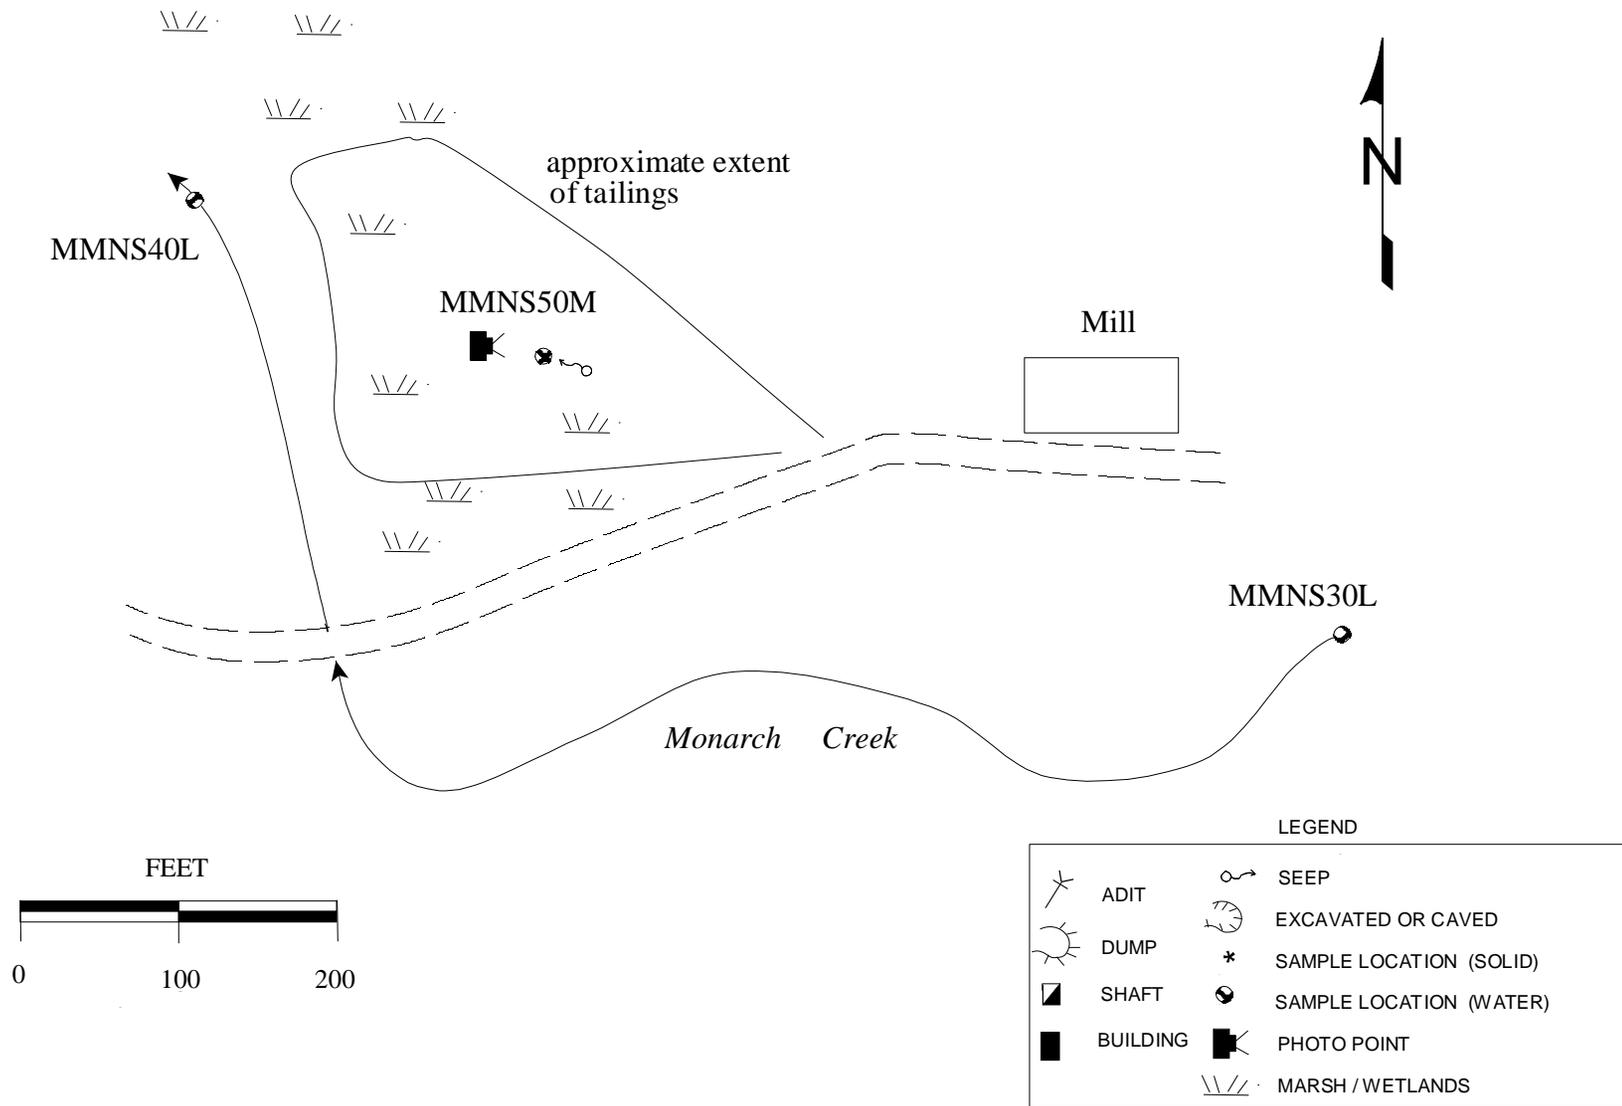
Figure 14. The tailings of the Monarch mill were buried and well vegetated (9/27/95). Small springs with ferric-hydroxide staining gave evidence of their presence.

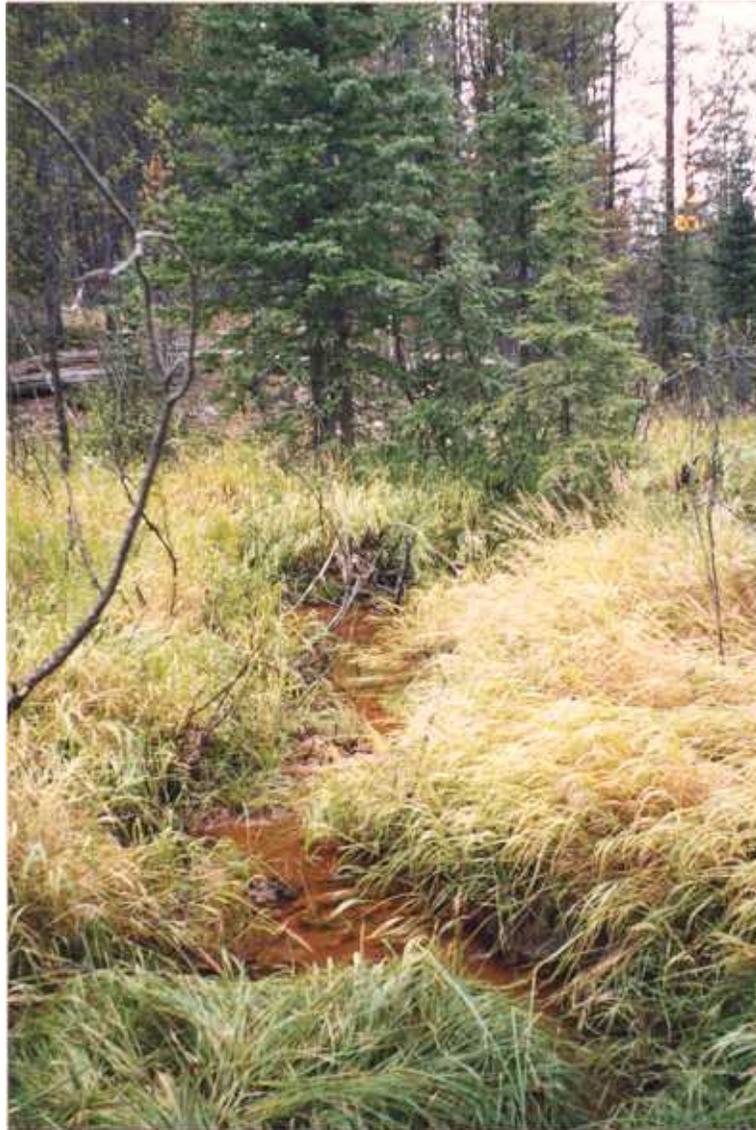
Figure 14a. The tailings of the Monarch mill were buried; however, there were several telltale ferric-hydroxide-stained springs.

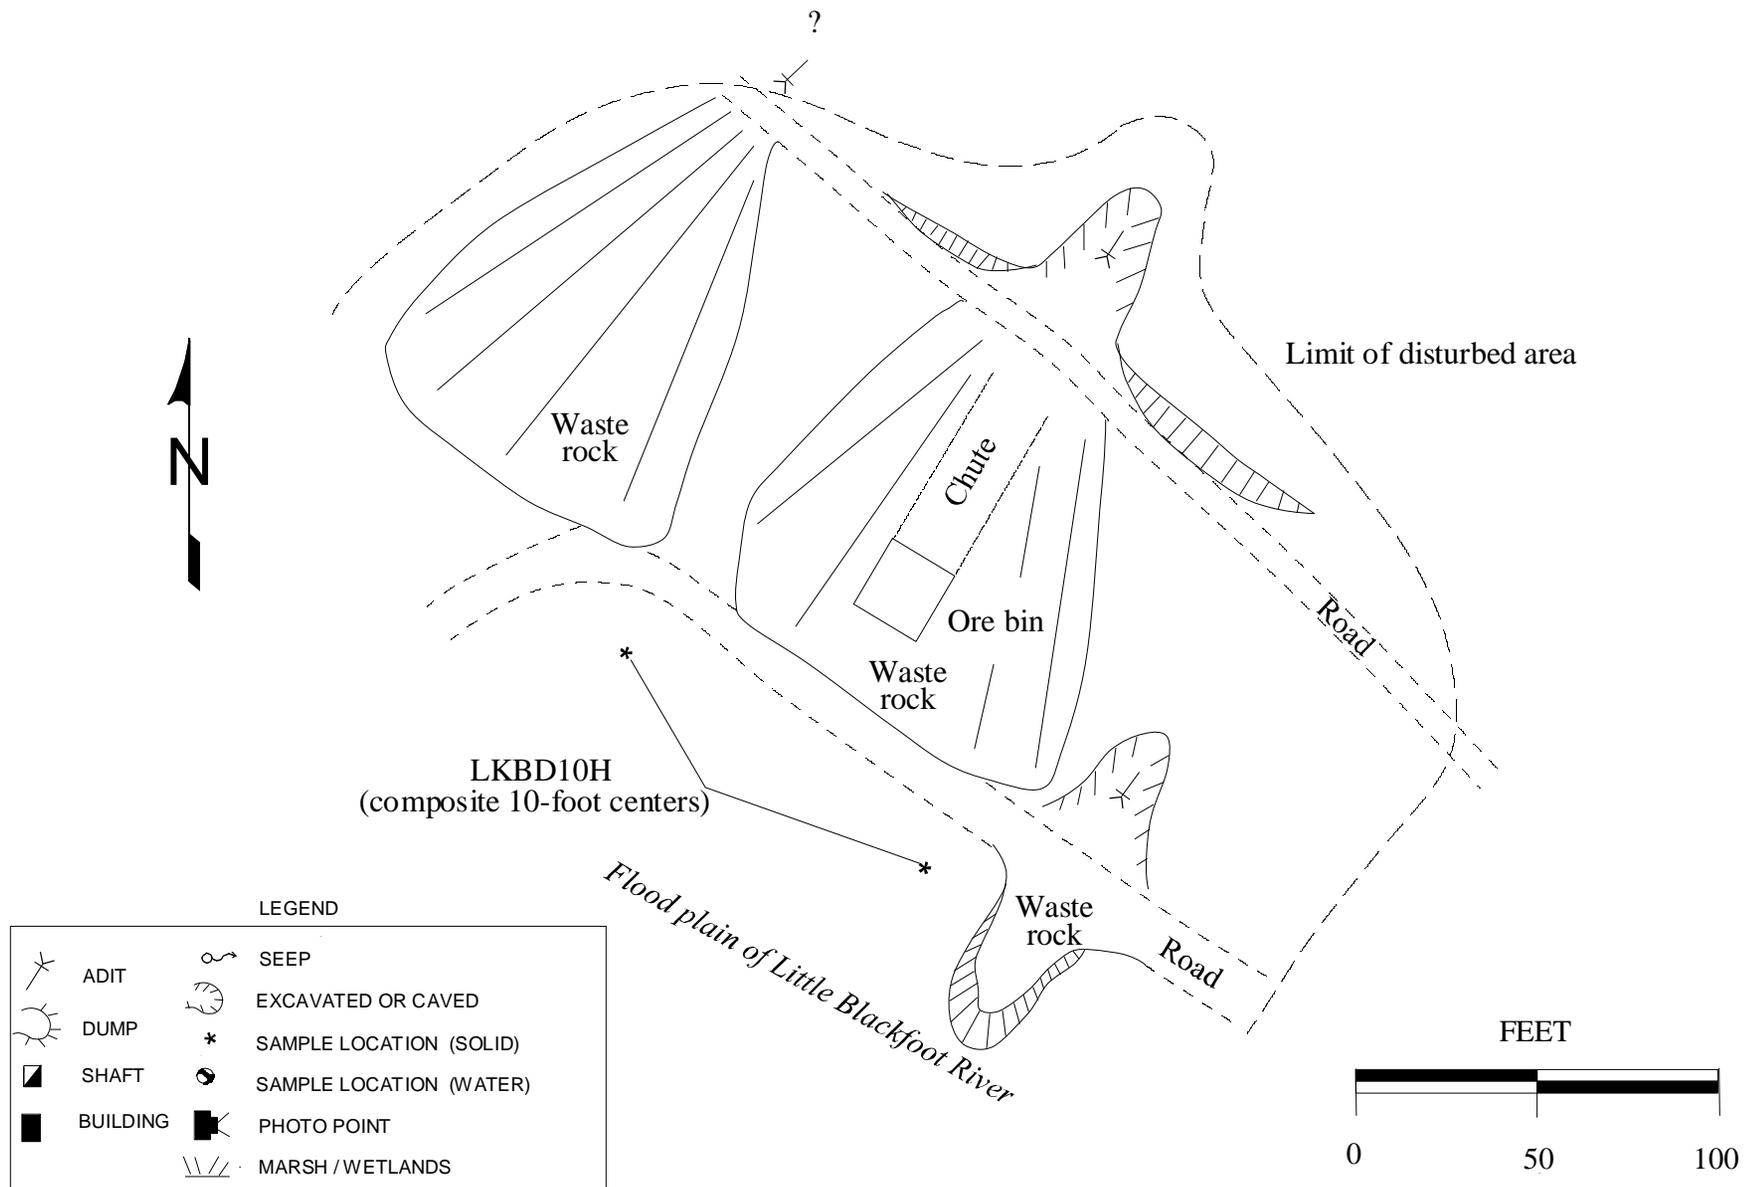
Figure 15. The Kimball mine had no site discharges at the time of the visit (10/6/95); however, waste material had been eroded and deposited in the flood plain of the Little Blackfoot River.

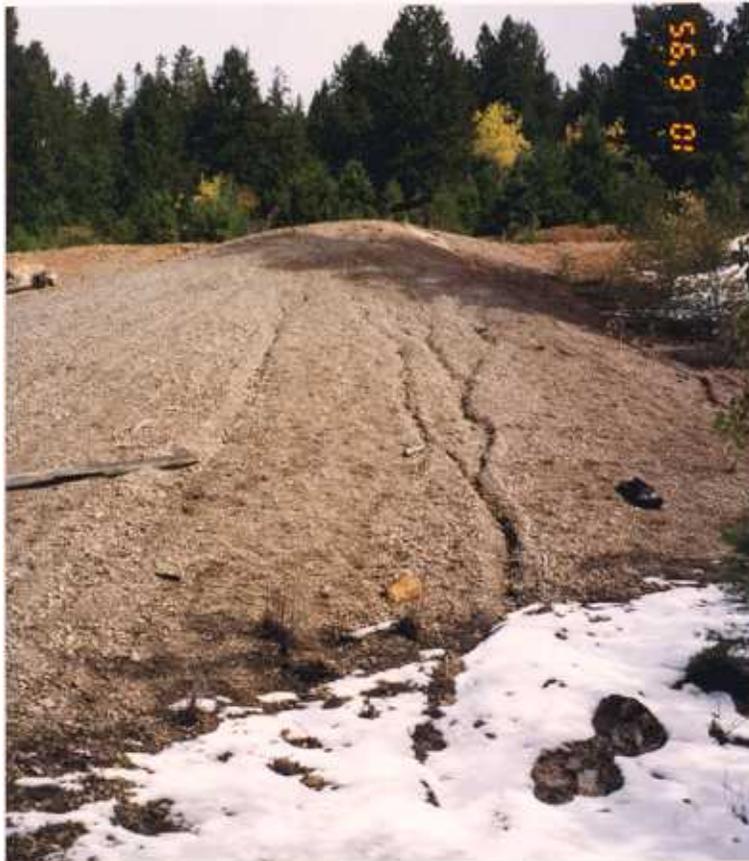
Figure 15a. Erosional rills marked several large waste-rock dumps on a steep hillside at the Kimball mine.

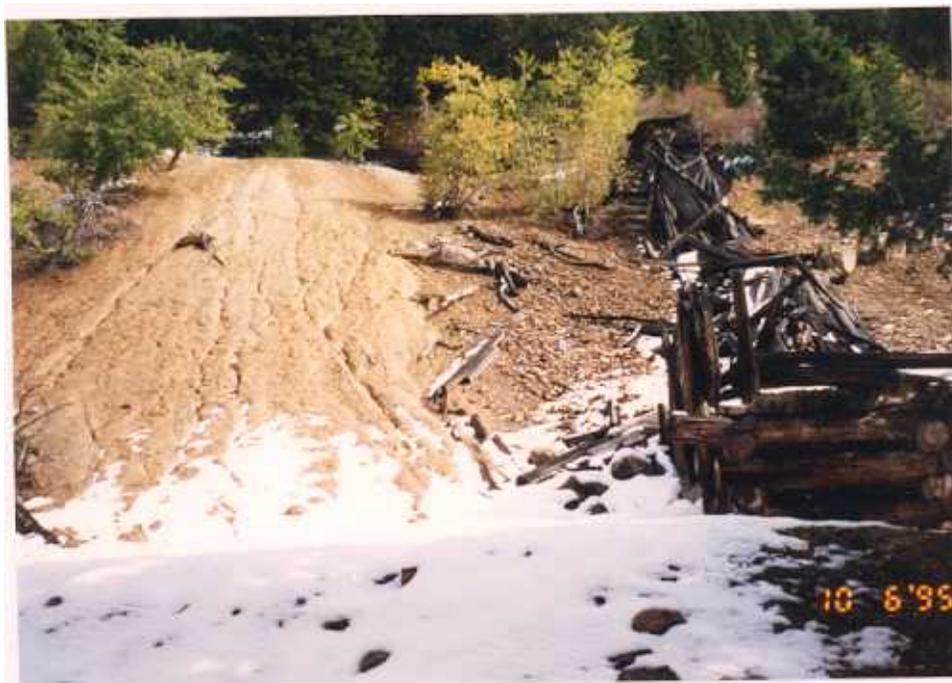
Figure 15b. The ore bin remaining on the Kimball mine sat near the base of the dumps.

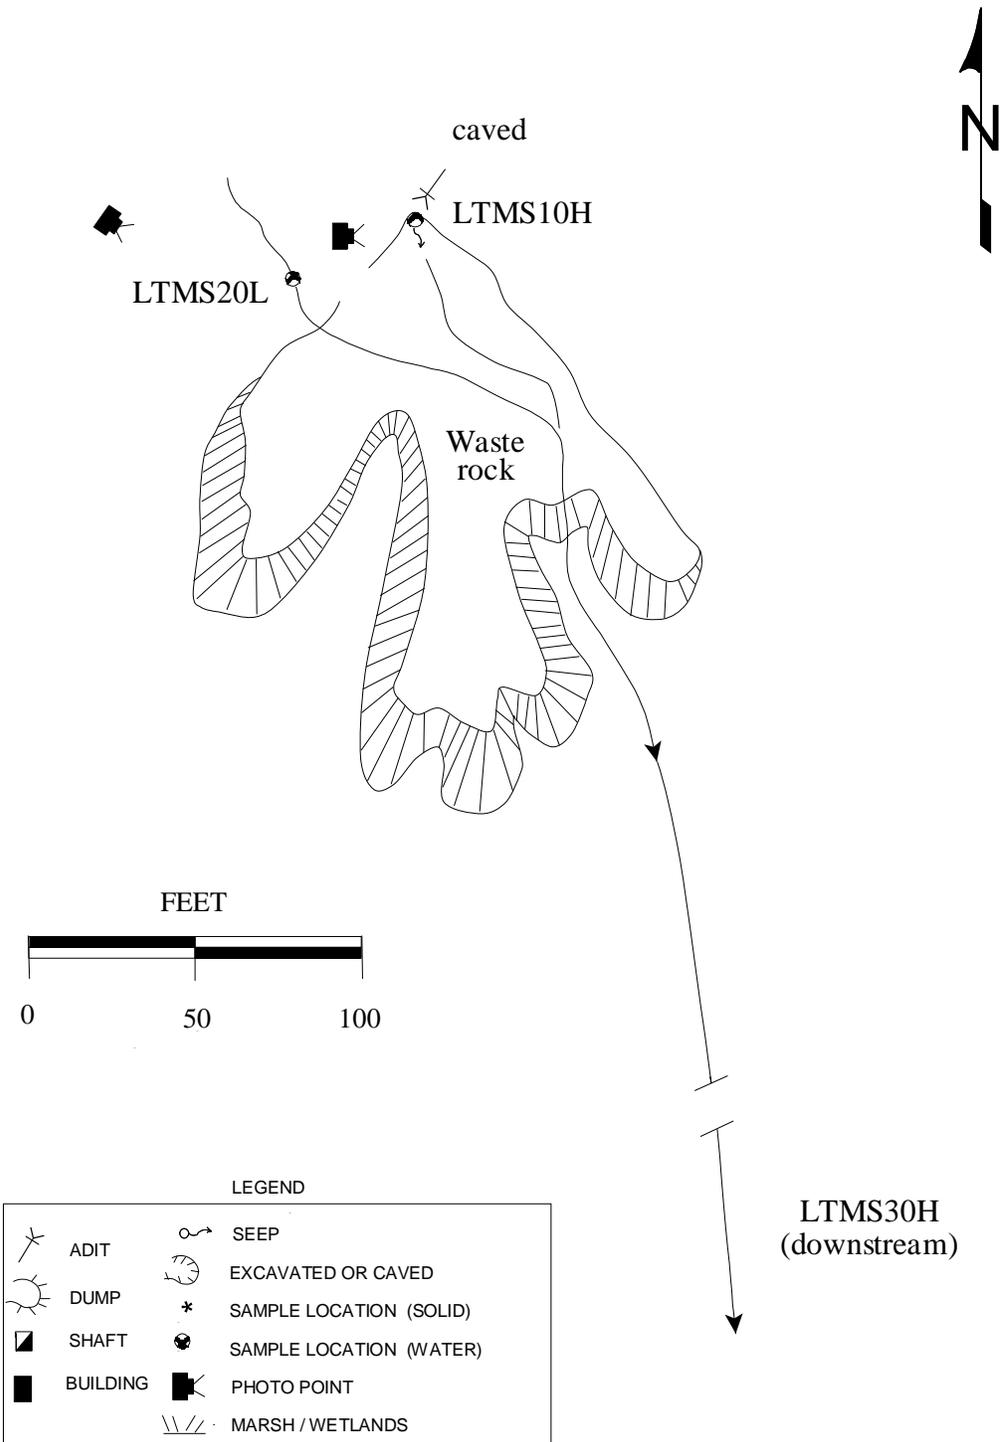
Figure 16. The Treasure Mountain mine adit was discharging about 6 gpm. There was evidence that the adit has greater flows at other times of the year. The lower waste-rock dump is not shown.

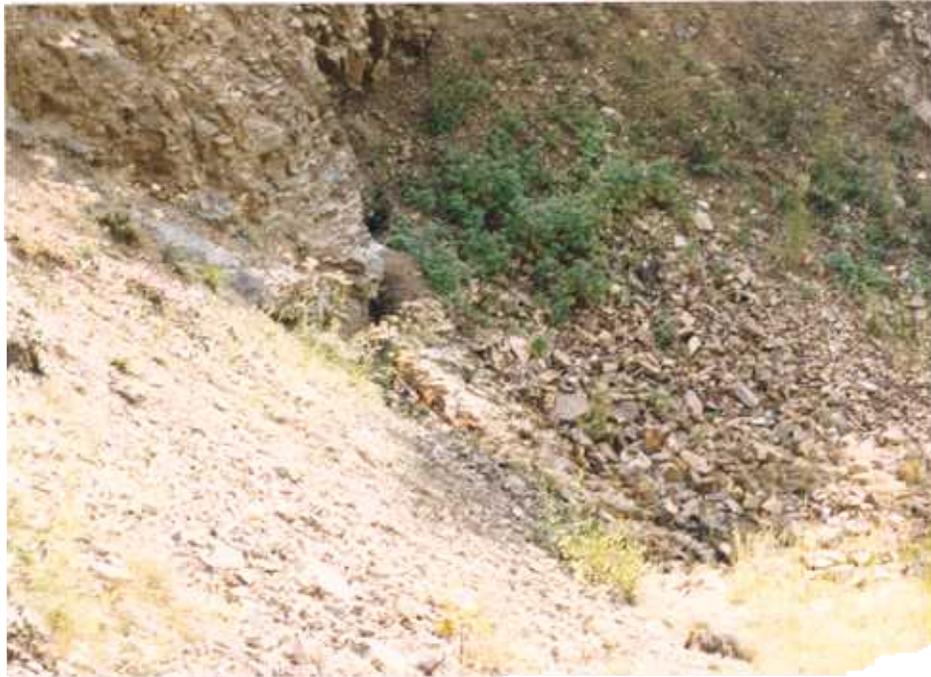
Figure 16a. The Treasure Mountain adit discharged water into a small stream that originated above the mine.

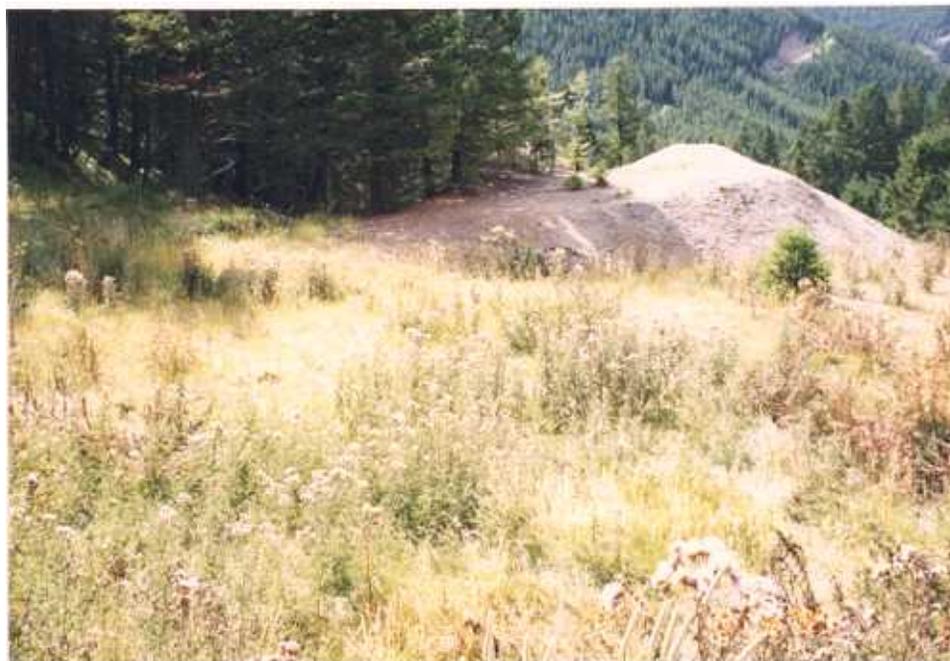
Figure 16b. The waste-rock dump of the Treasure Mountain mine was well vegetated in some areas, barren in other areas.

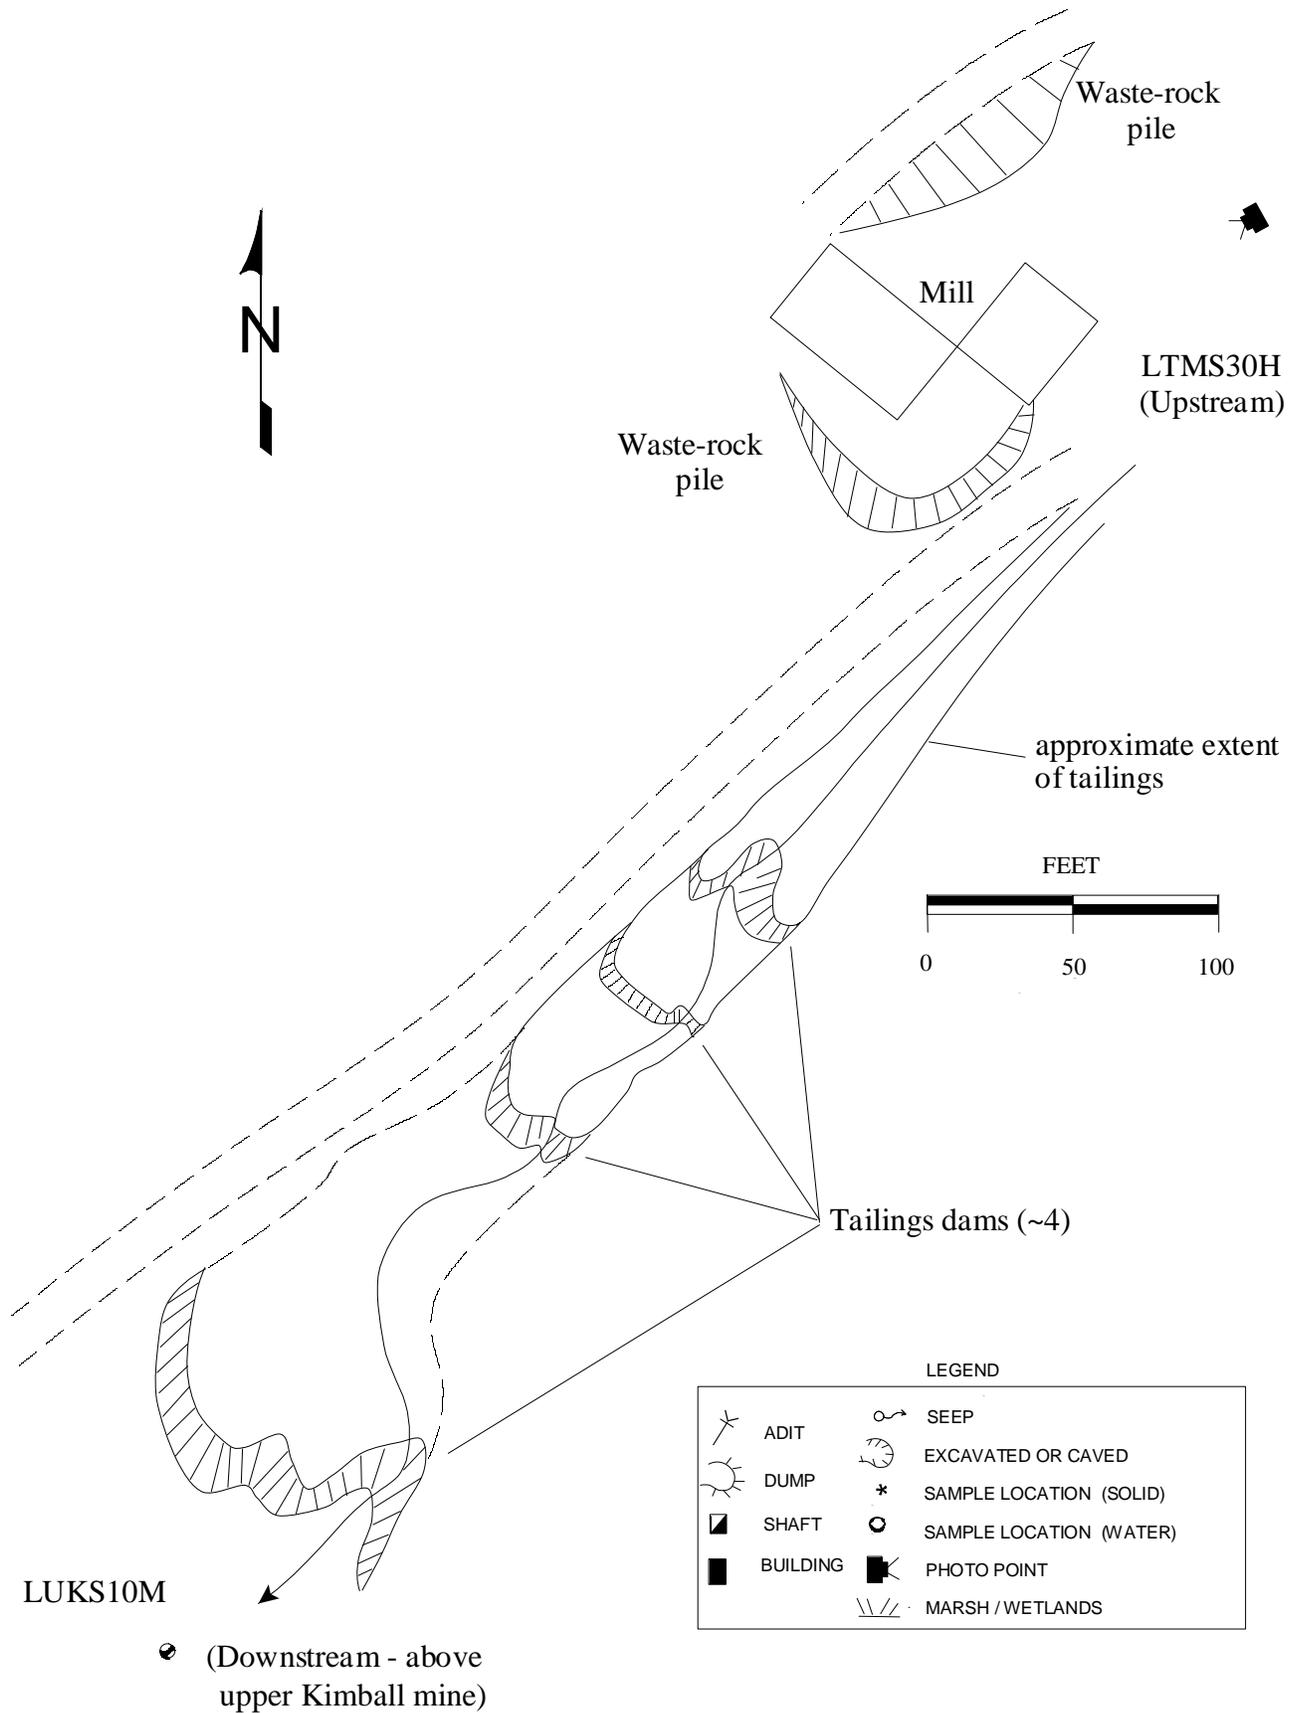
Figure 17. The Big Dick mill tailings extended about 500 feet downstream of the mill (9/28/95). The lateral extent was difficult to distinguish in some areas.

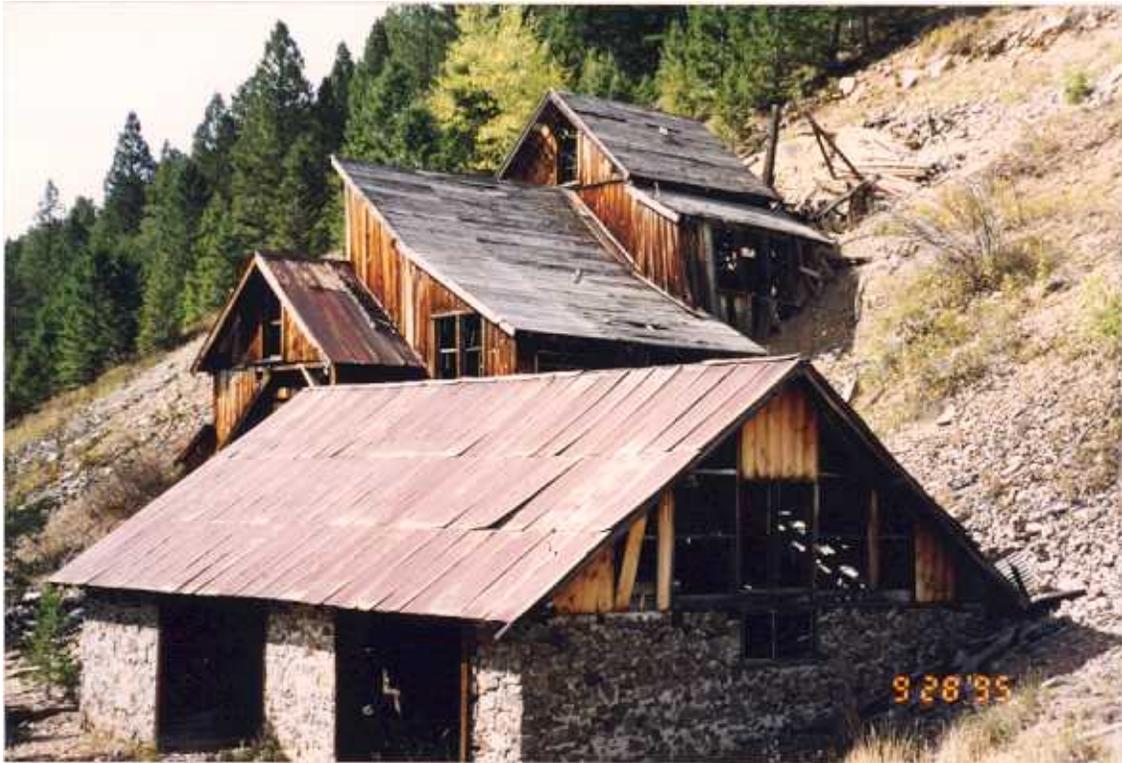
Figure 17a. The mill building of the Big Dick mill lies immediately adjacent to the road. The stream flows on the opposite site of the road.
