Abandoned - Inactive Mines of the
Blackfoot and Little Blackfoot River Drainages

Helena National Forest
Volume II

Open-file Report 368
MBMG

February 1998

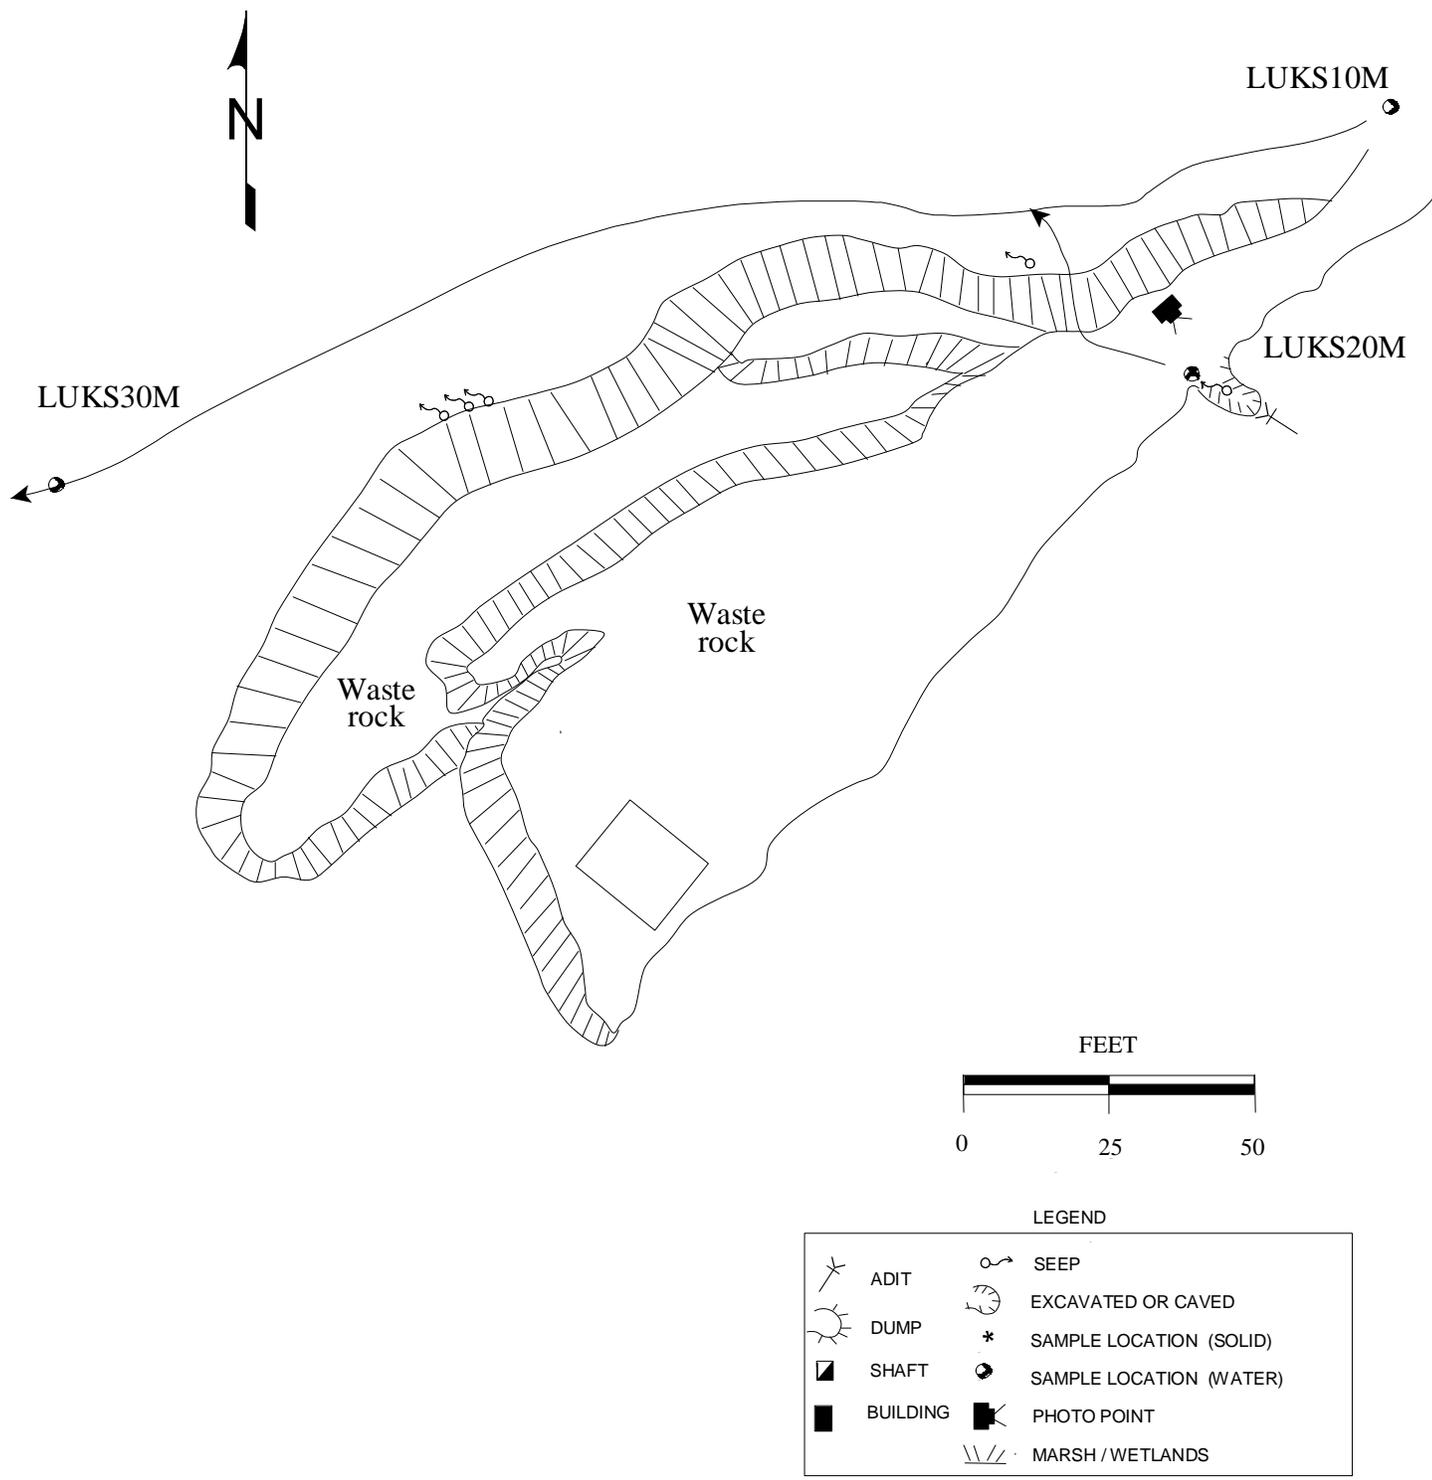
Figure 18. The upper Kimball mine is below the Big Dick mill, the Treasure Mountain mine, and several other mines and mills. The adit was caved and was discharging water to an unnamed tributary of the Little Blackfoot River (9/28/95).

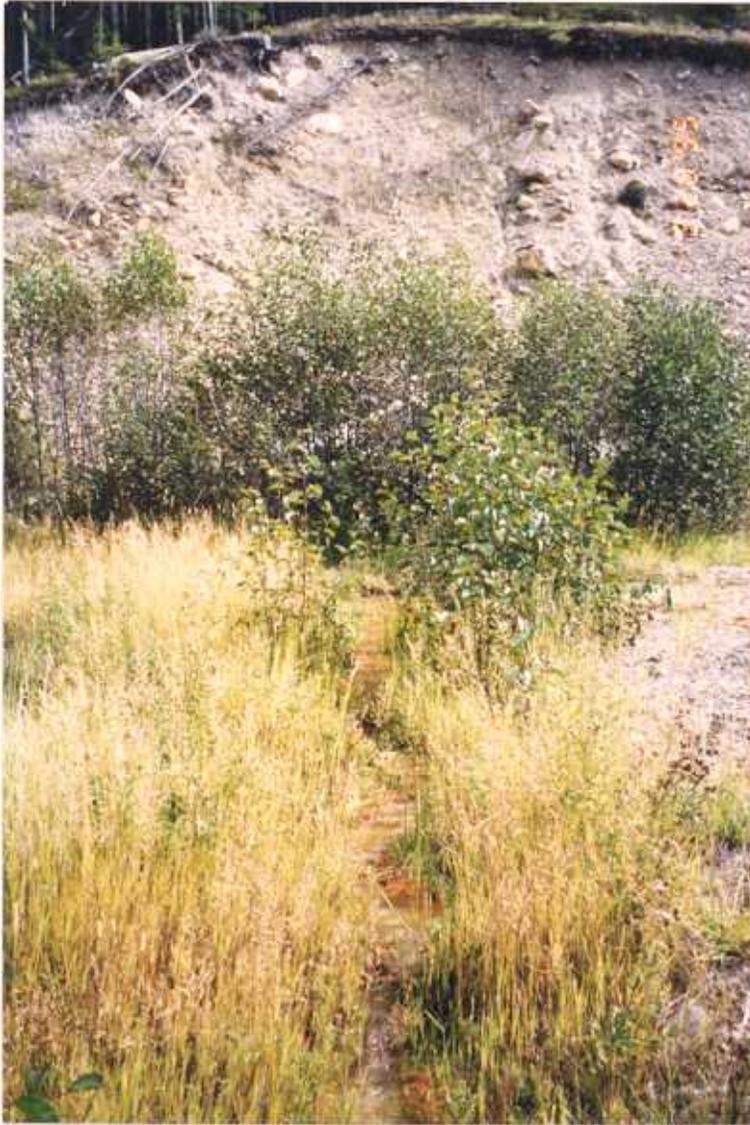
Figure 18a. The upper Kimball mine adit discharged water from an adit heavily covered by vegetation.

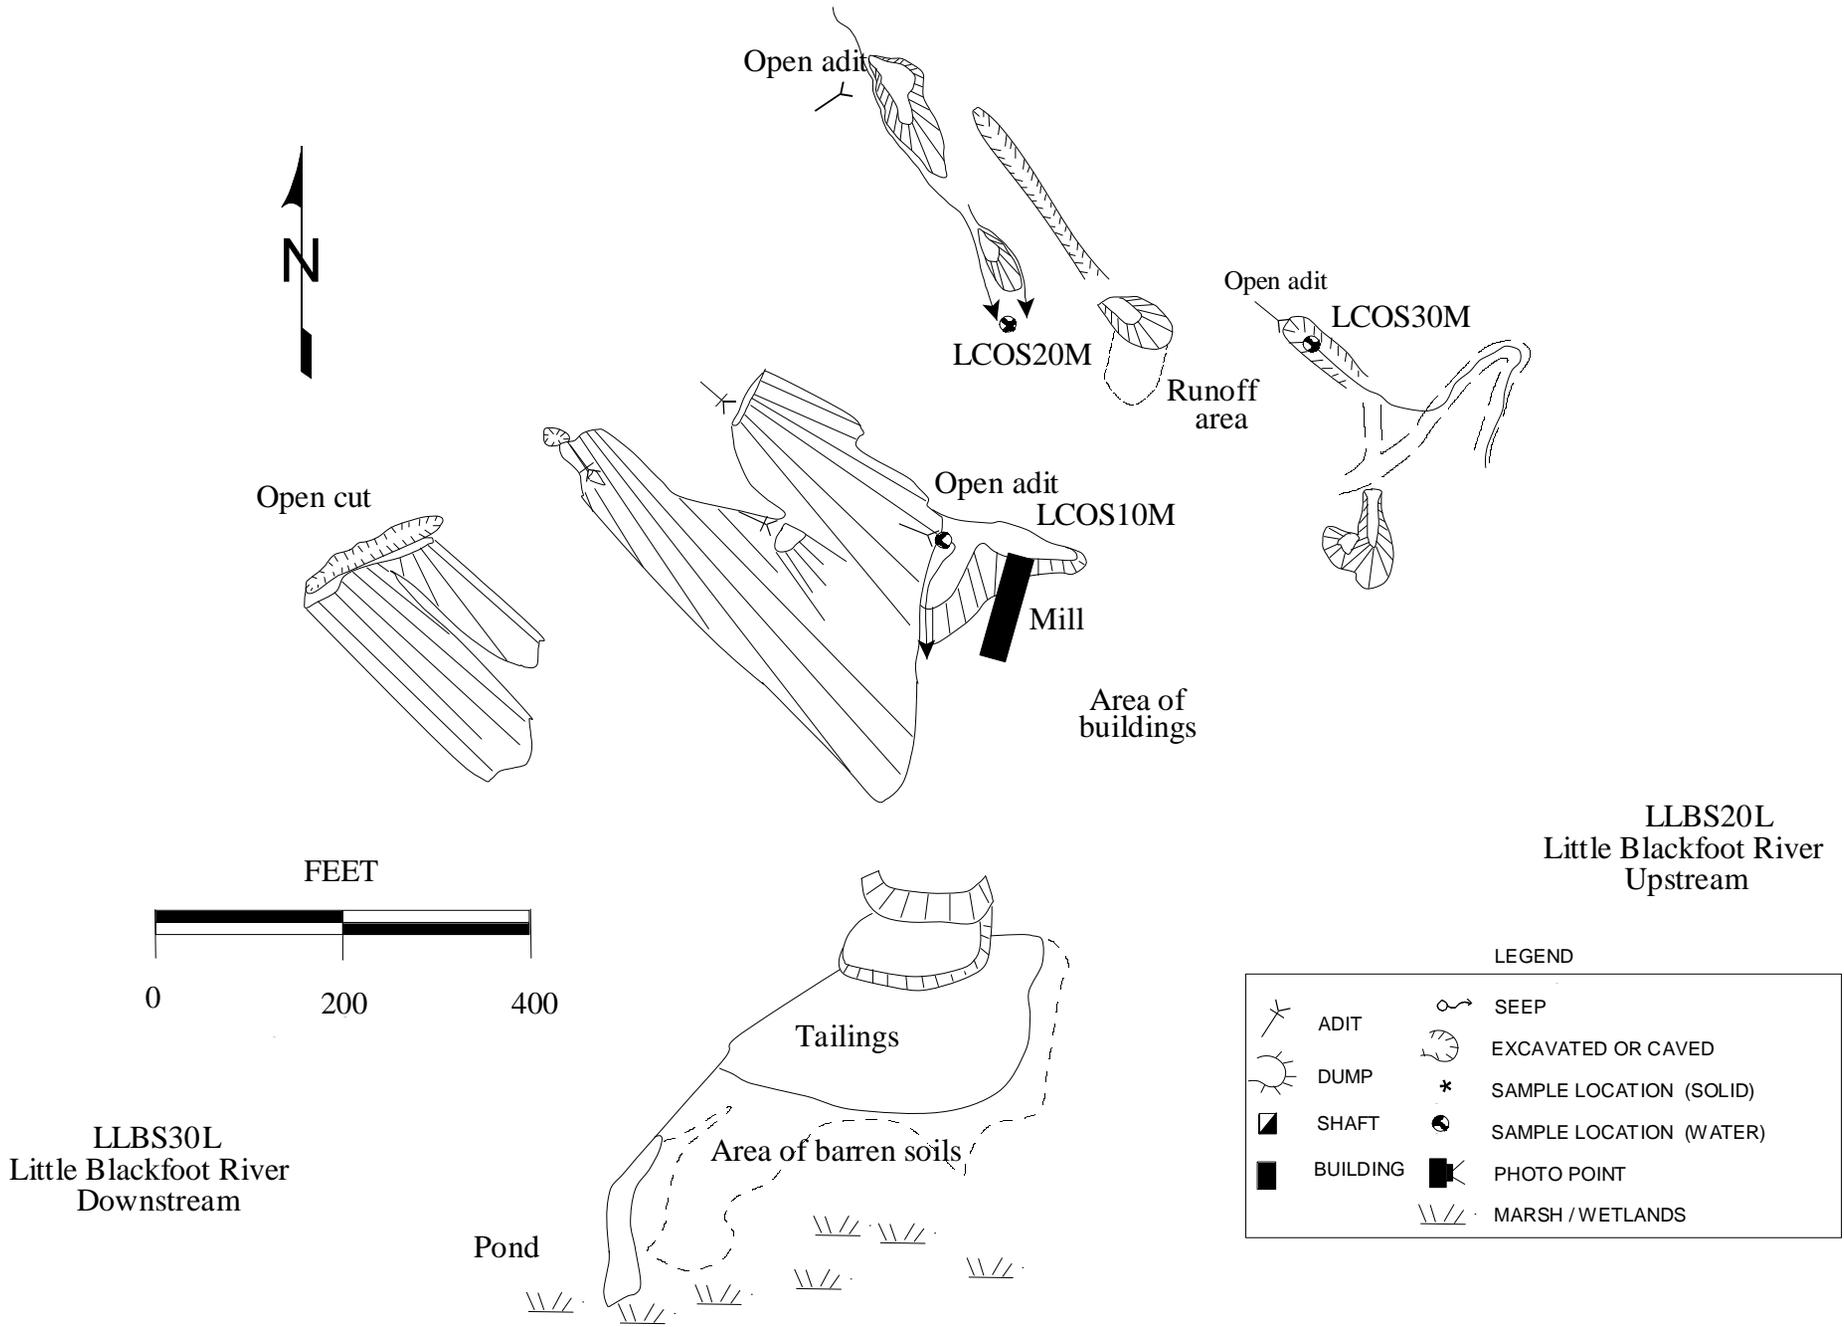
Figure 19. The Charter Oak mine and mill covered a large area next to the Little Blackfoot River (10/6/95). The tailings are in the flood plain of the river.

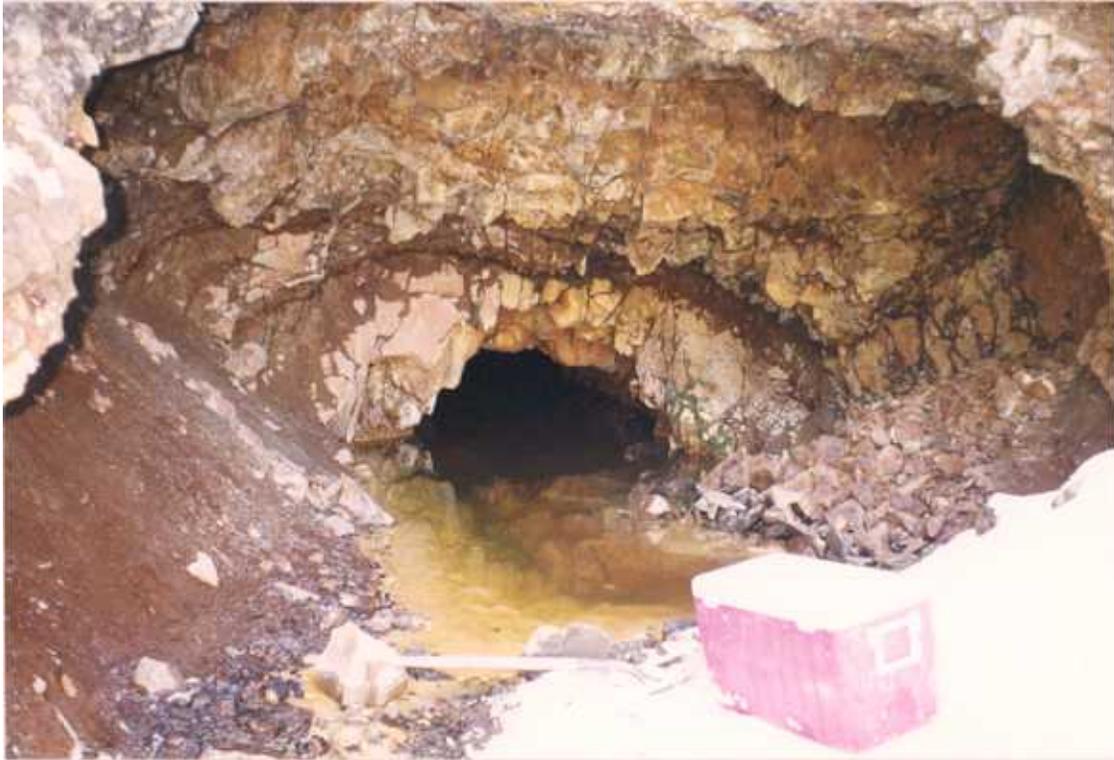
Figure 19a. The lower adit of the Charter Oak mine was open, and water flowed toward the nearby Little Blackfoot River.

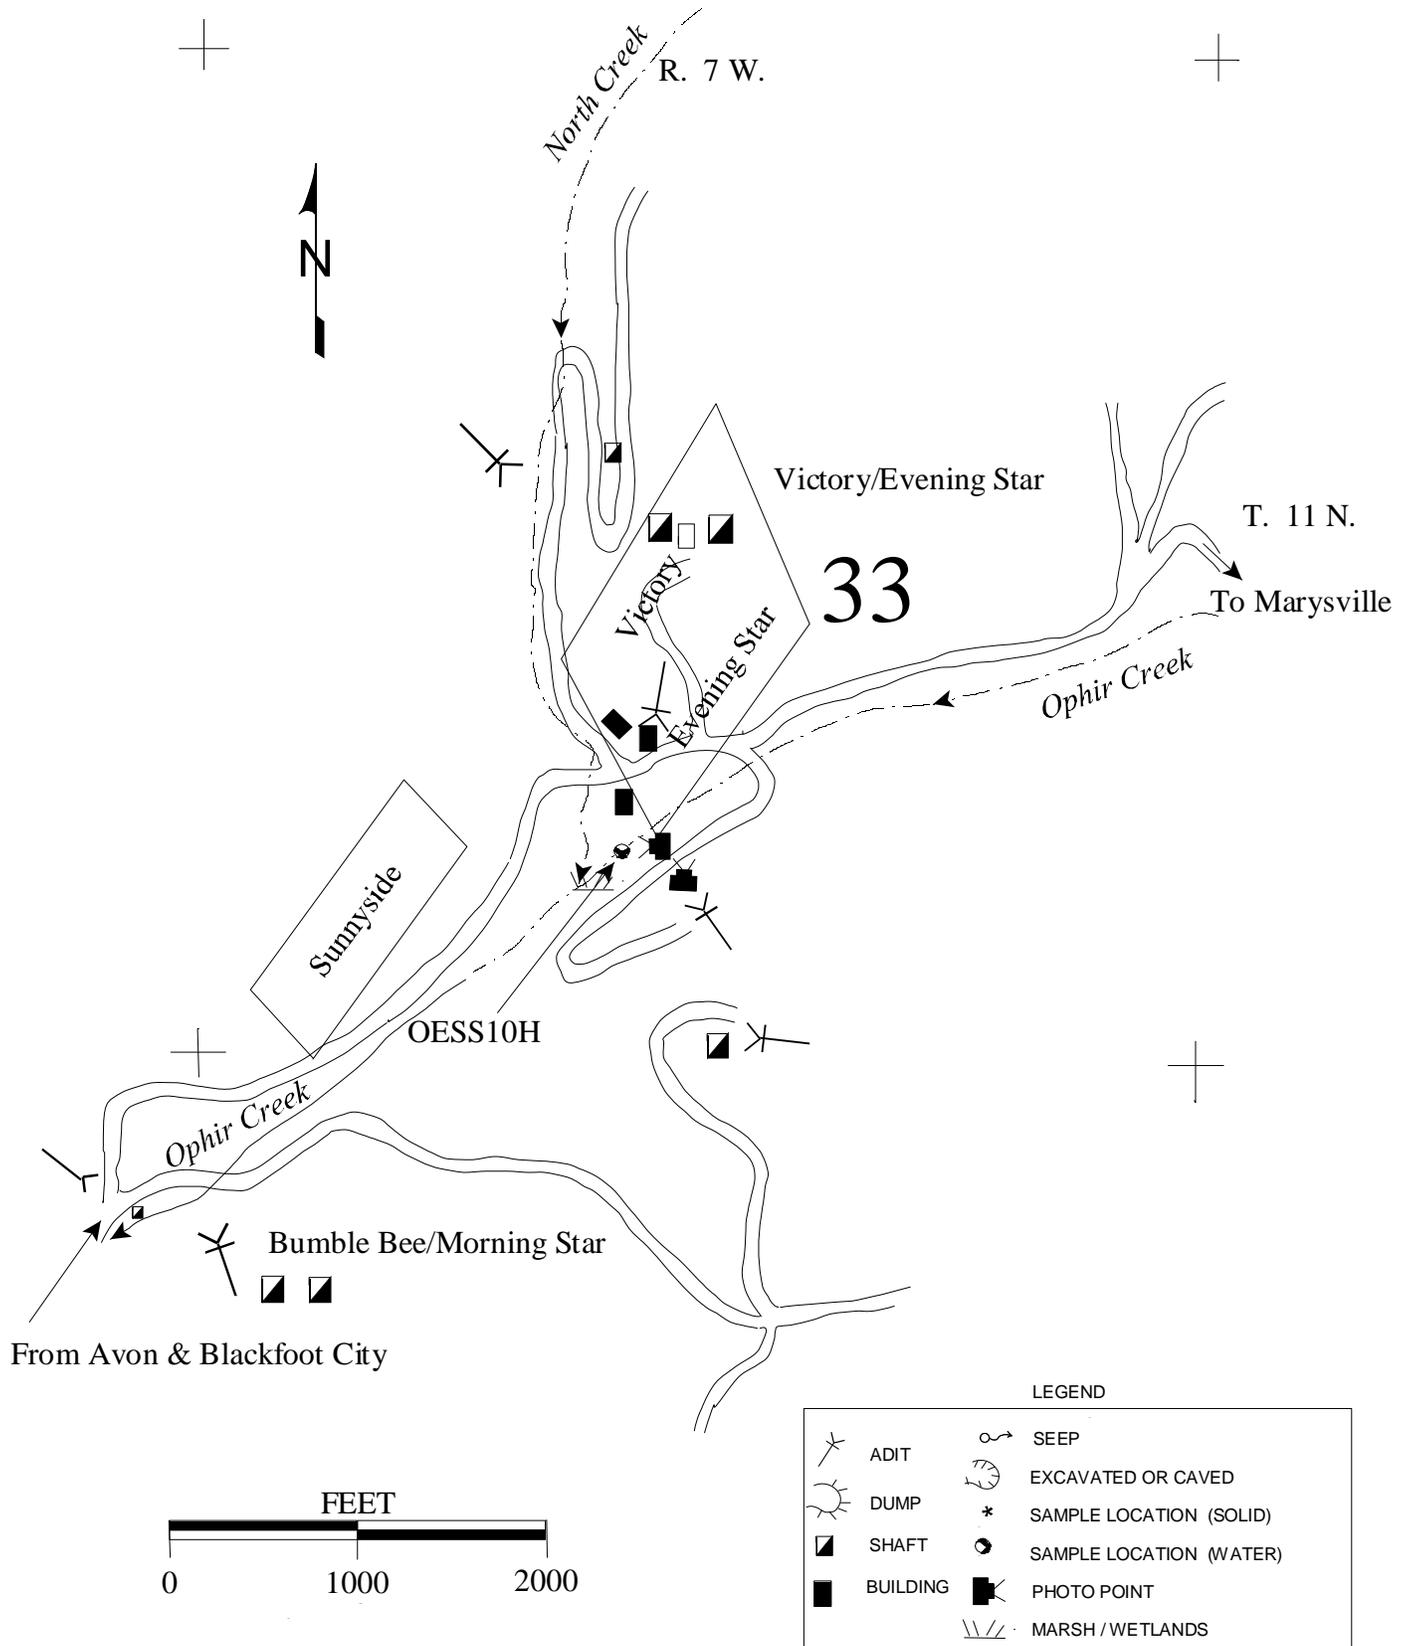
Figure 20. Schematic map of the Victory/Evening Star area showing sample location, taken from USFS ownership map.

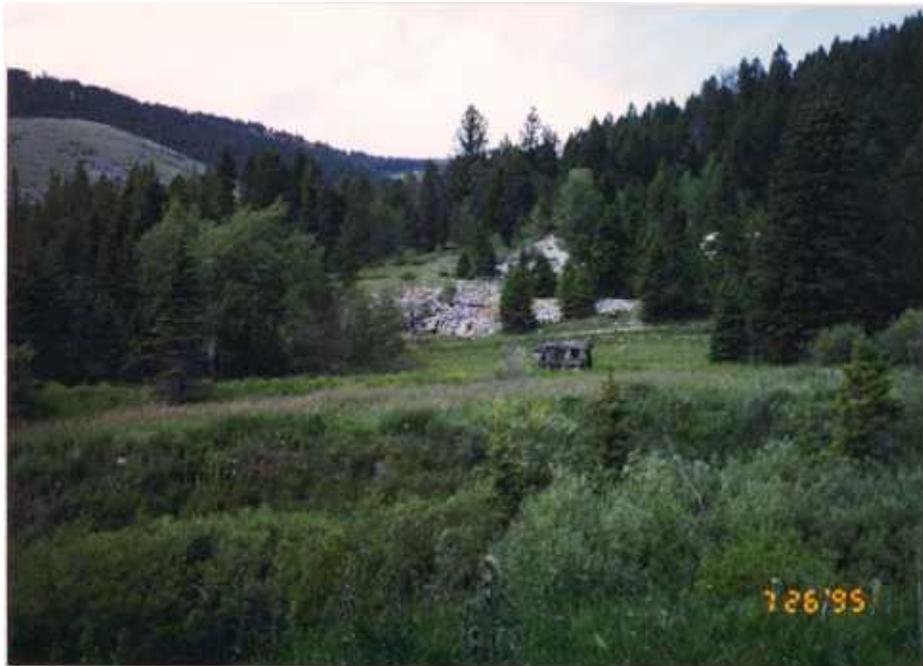
Figure 20a. Victory/Evening Star looking north from Ophir Creek toward patented land, the collapsed mill and the underground workings.

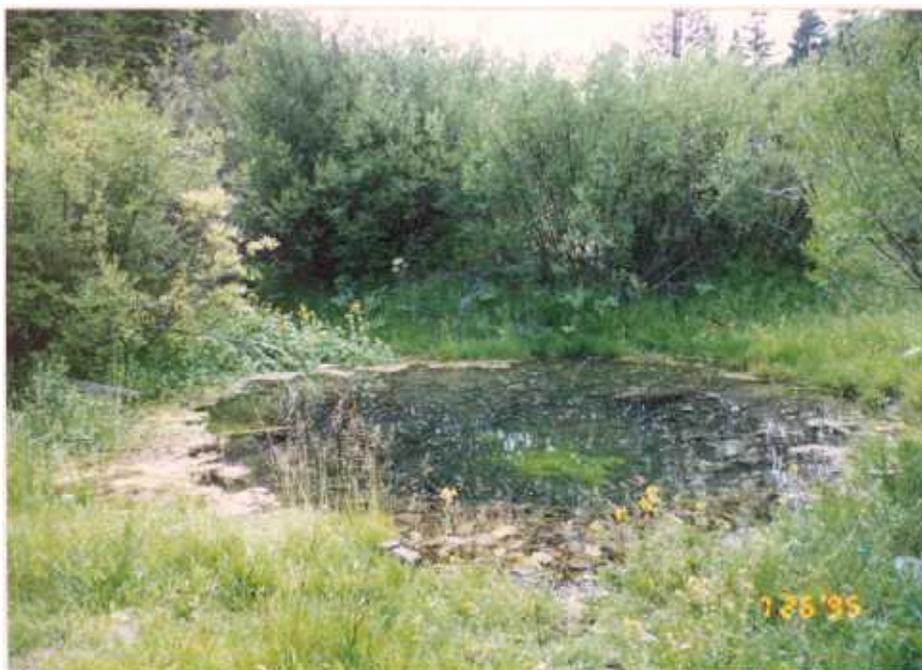
Figure 20b. Ophir Creek re-emerged from the subsurface in a small pond immediately upstream from where OESS10H was taken.

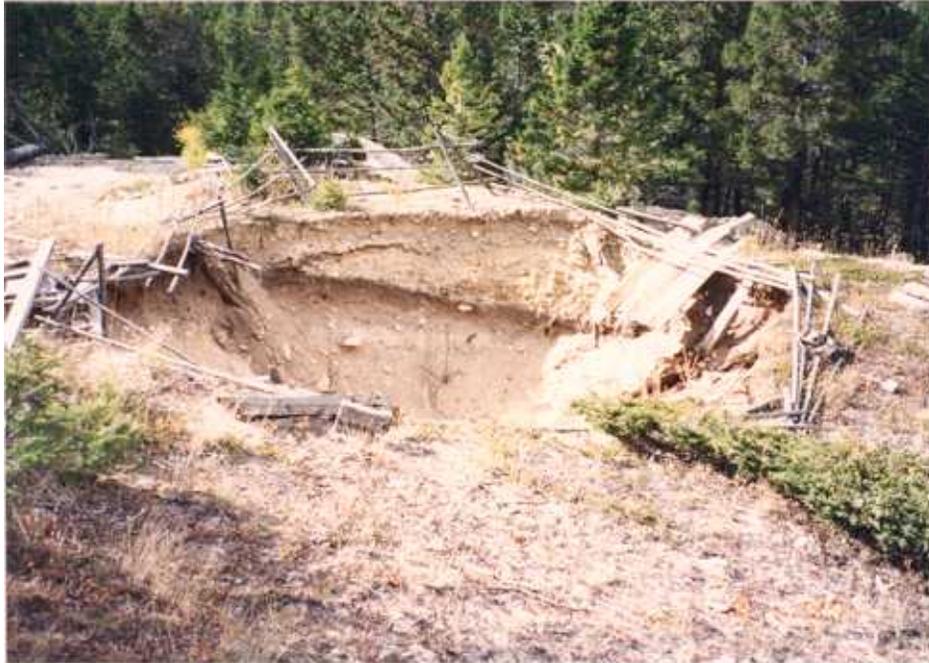
Figure 21a. One of two dry, collapsed shafts found at the Bumble Bee/Morning Star.

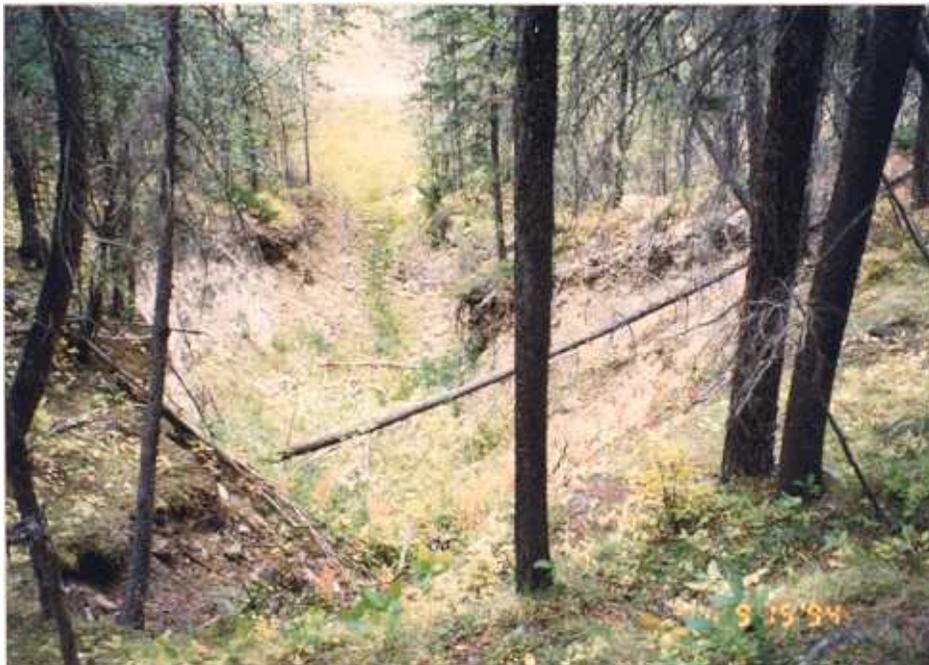
Figure 21b. Looking NW along the collapsed adit at the Bumble Bee with the small greenish discharge channel visible in the center of the photo.

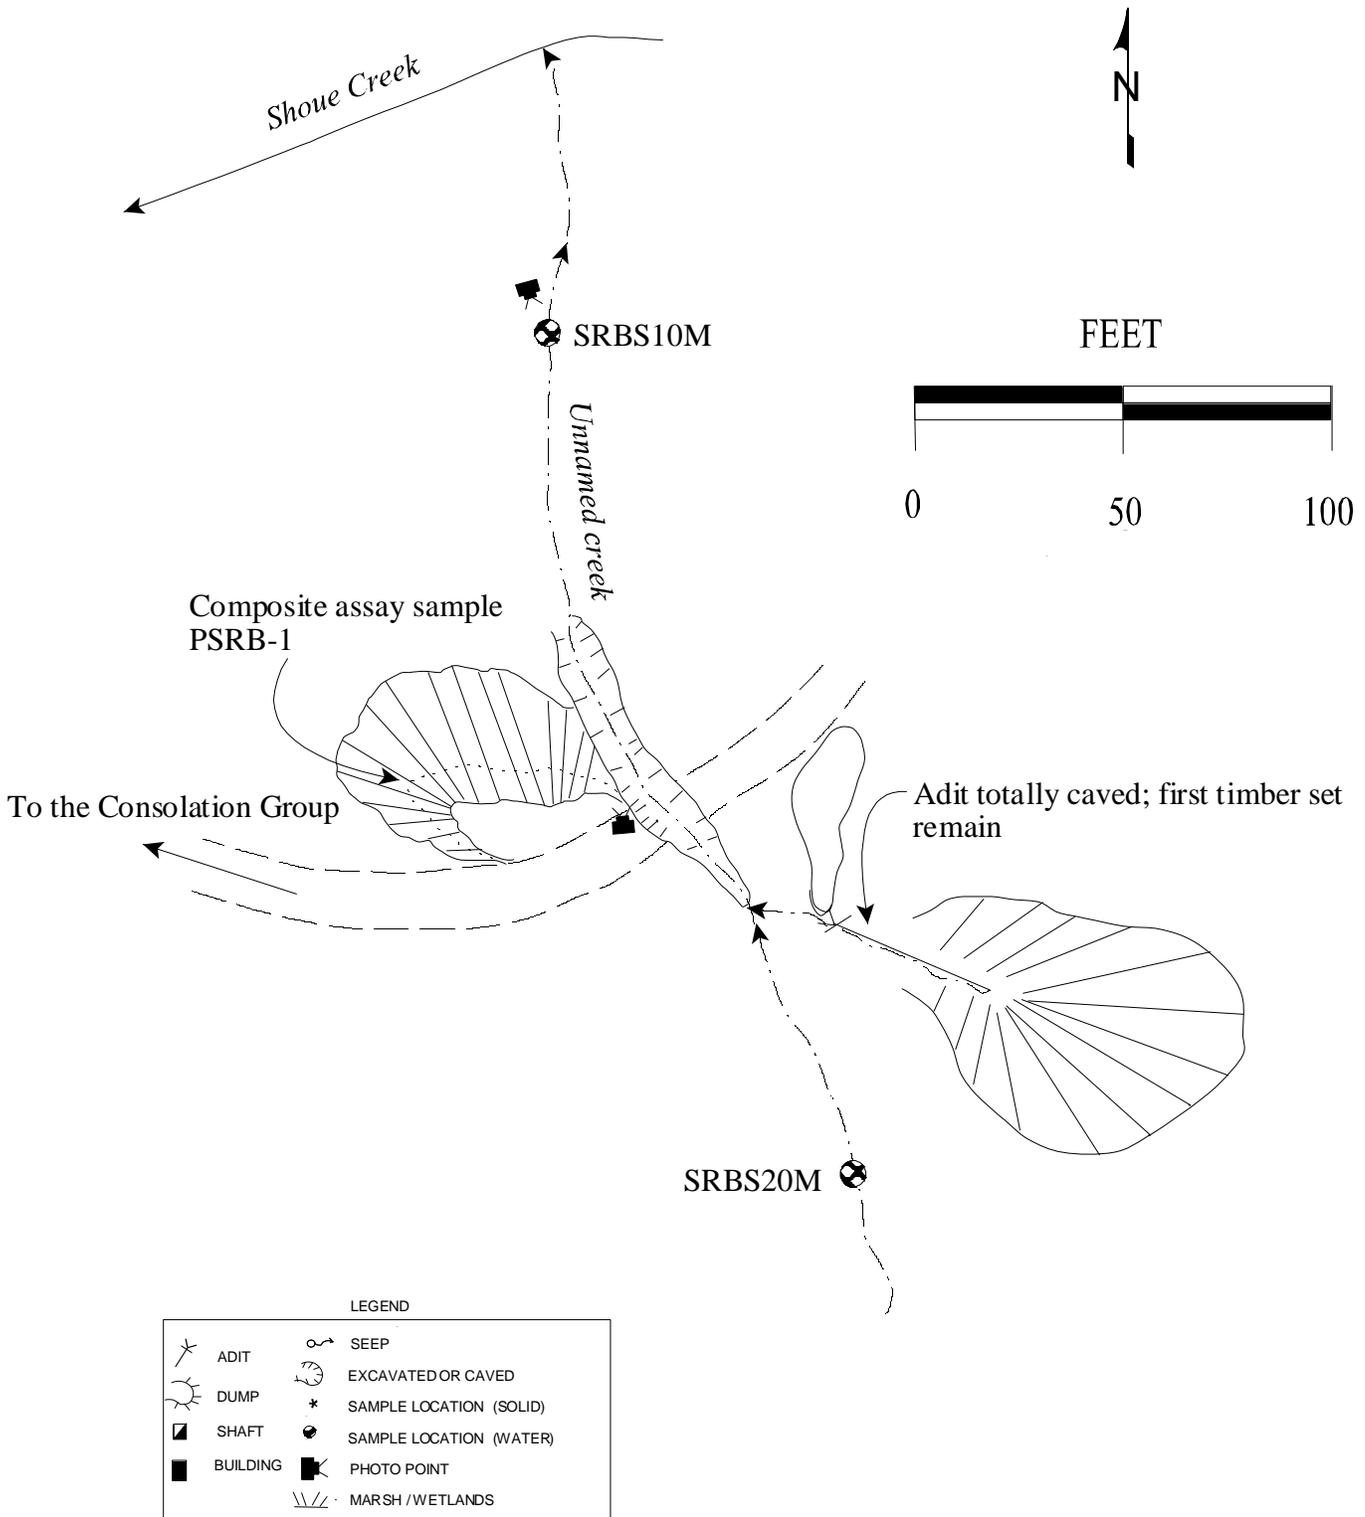
Figure 22. Rex Beach's discharge joins with the flow in an unnamed creek, as mapped 10/12/94.

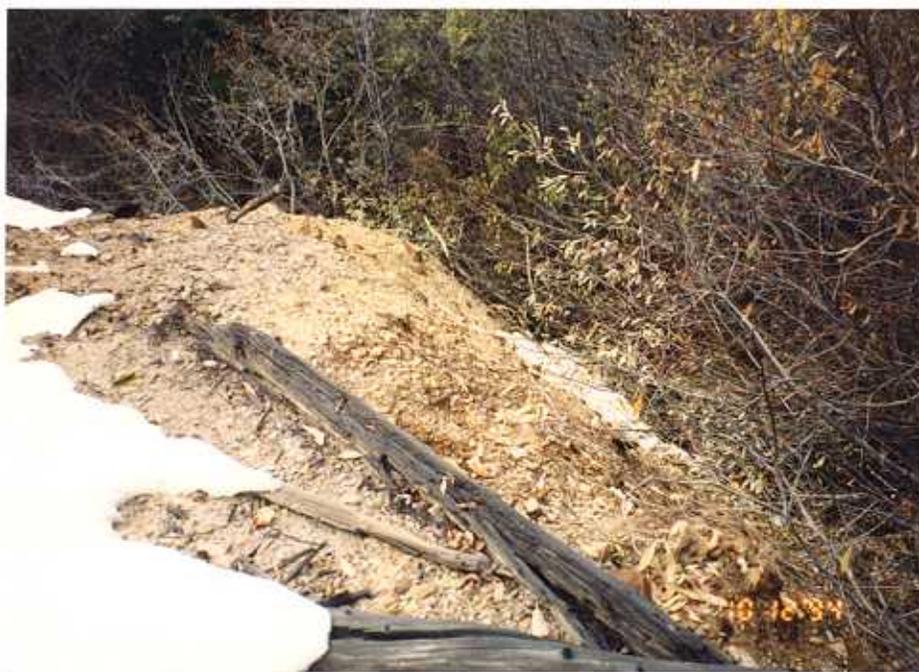
Figure 22a. Unnamed creek, tributary of Shoue Creek, flowed on the east (right) side of the waste-rock dump.

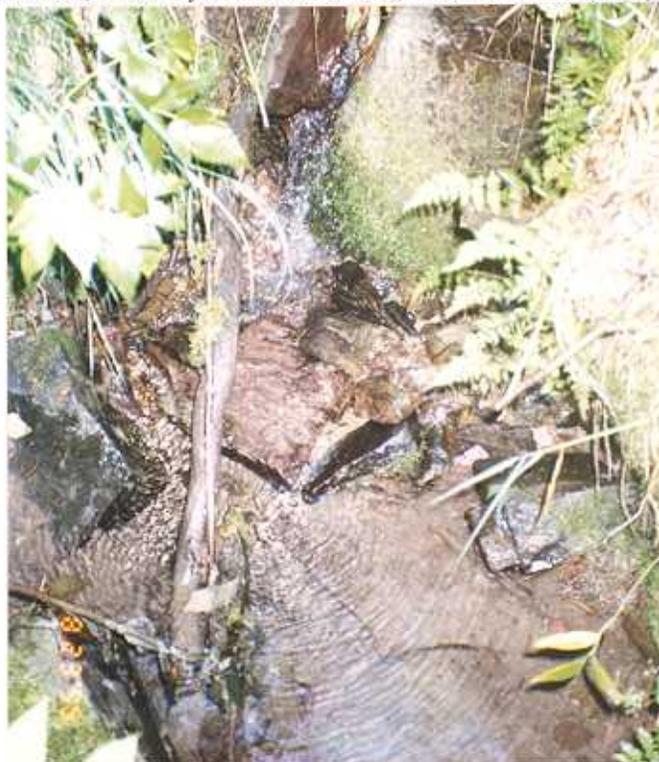
Figure 22b. Sample site SRBS10M on the unnamed tributary to Shoue Creek flowed clear and cold.

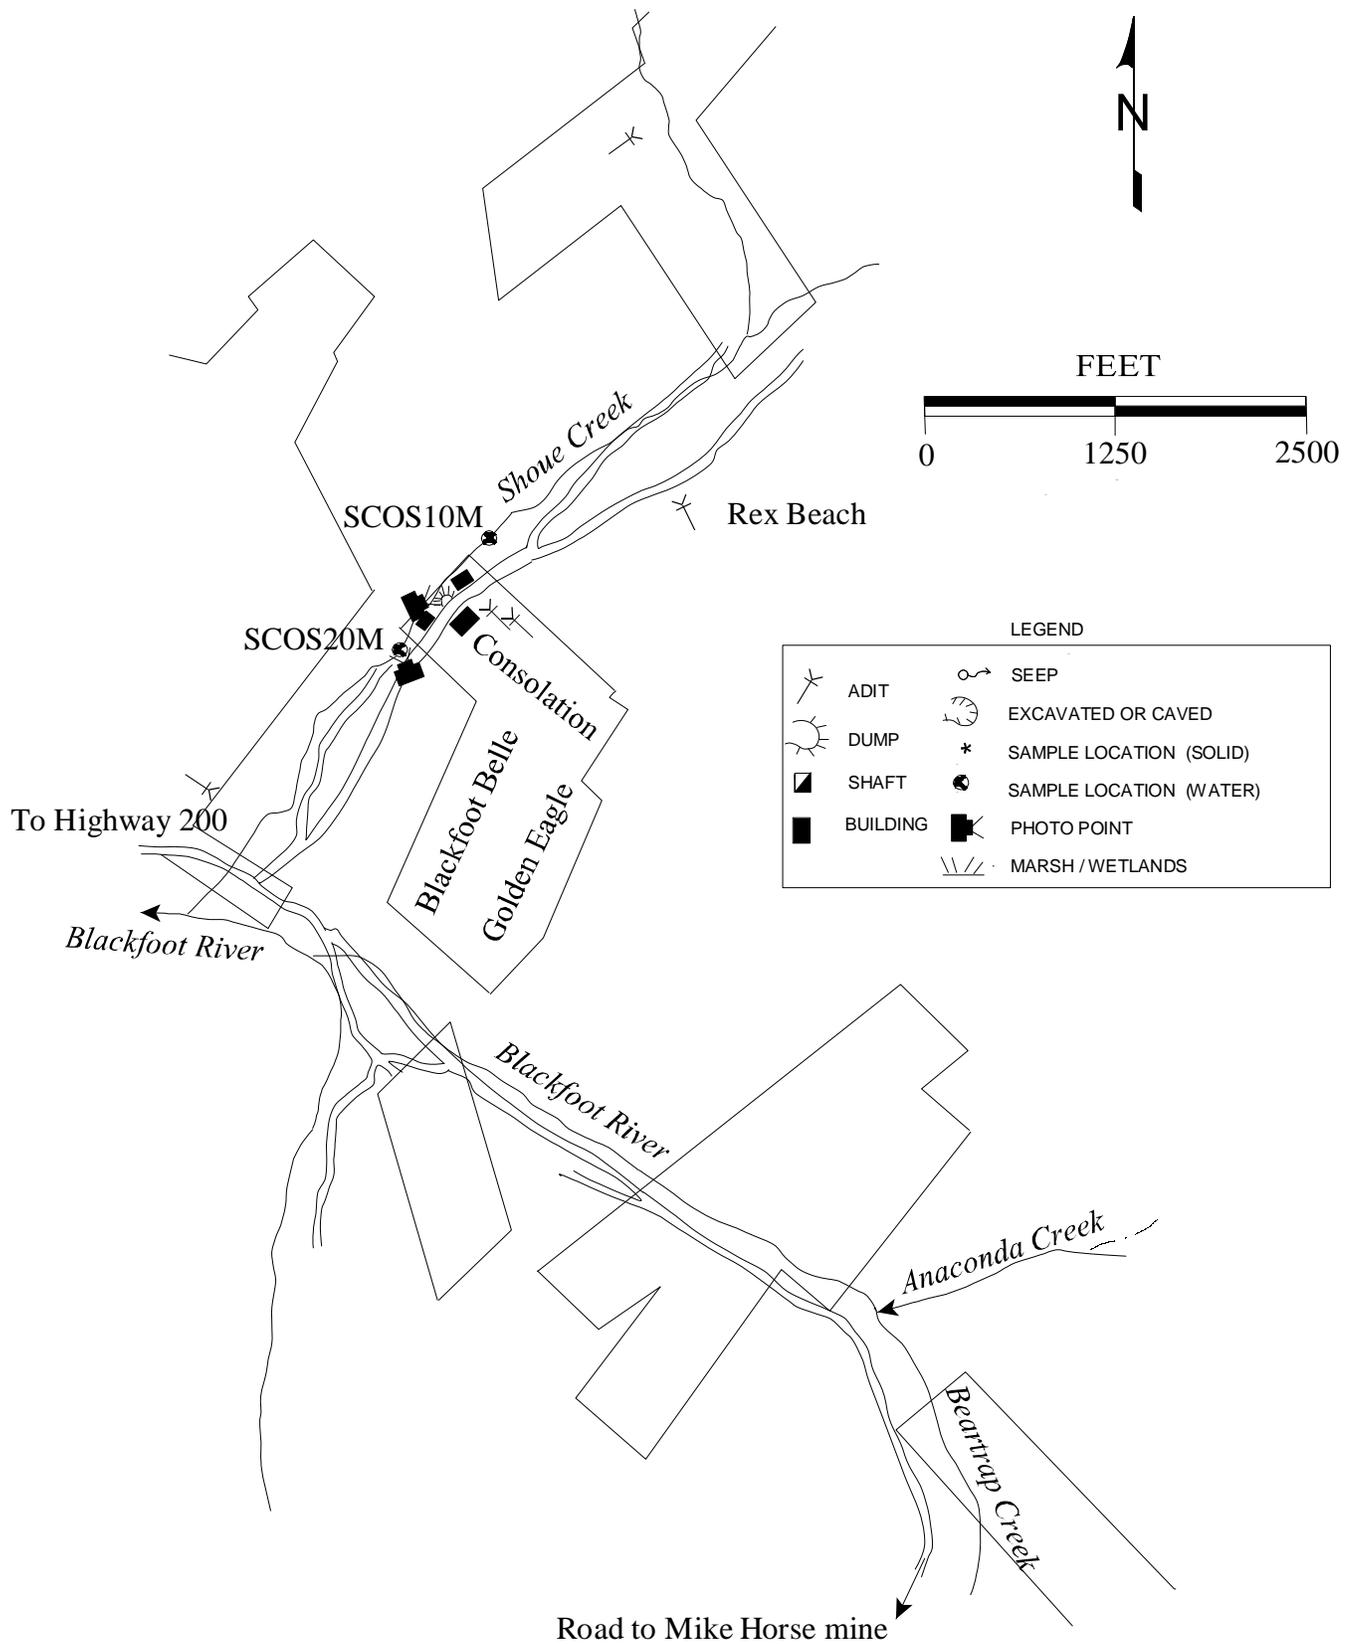
Figure 23. Schematic of the Consolation Group and surrounding area showing upstream/downstream sample sites; taken from a USFS ownership map of the Rogers Pass 7.5-min. quadrangle.

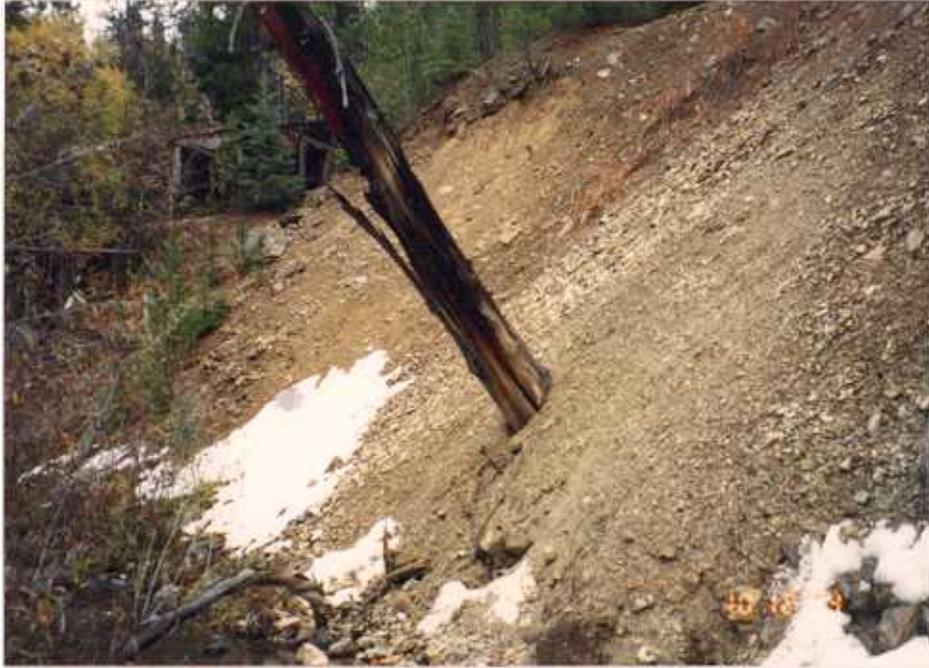
Figure 23a. Shoue Creek flowed by the Consolation mine and its waste, eroding the waste slightly.

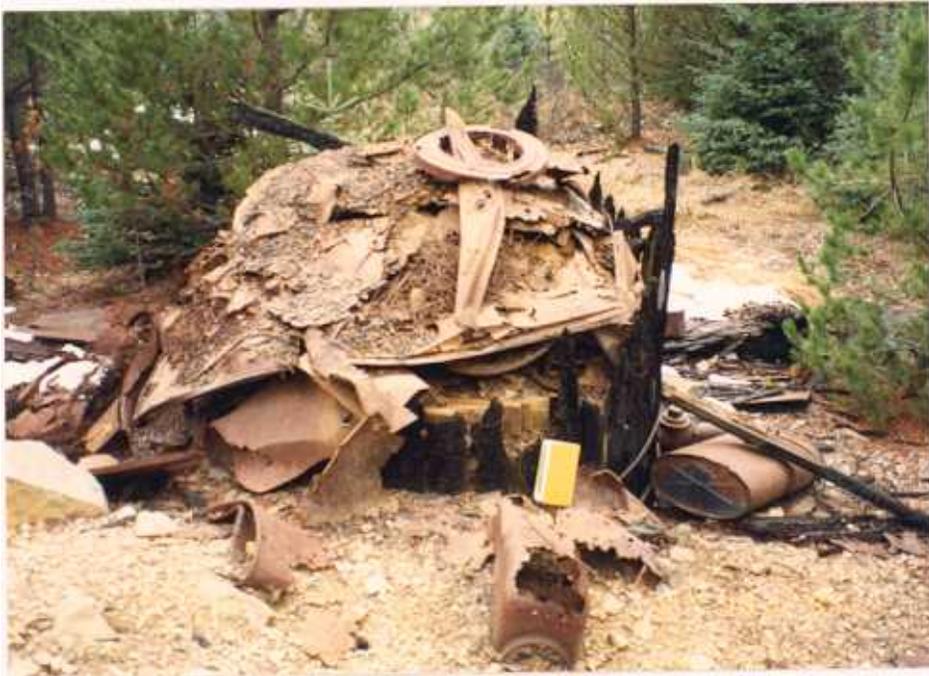
Figure 23b. Burned vat and junk clutter the Consolation mine, primarily on patented land.

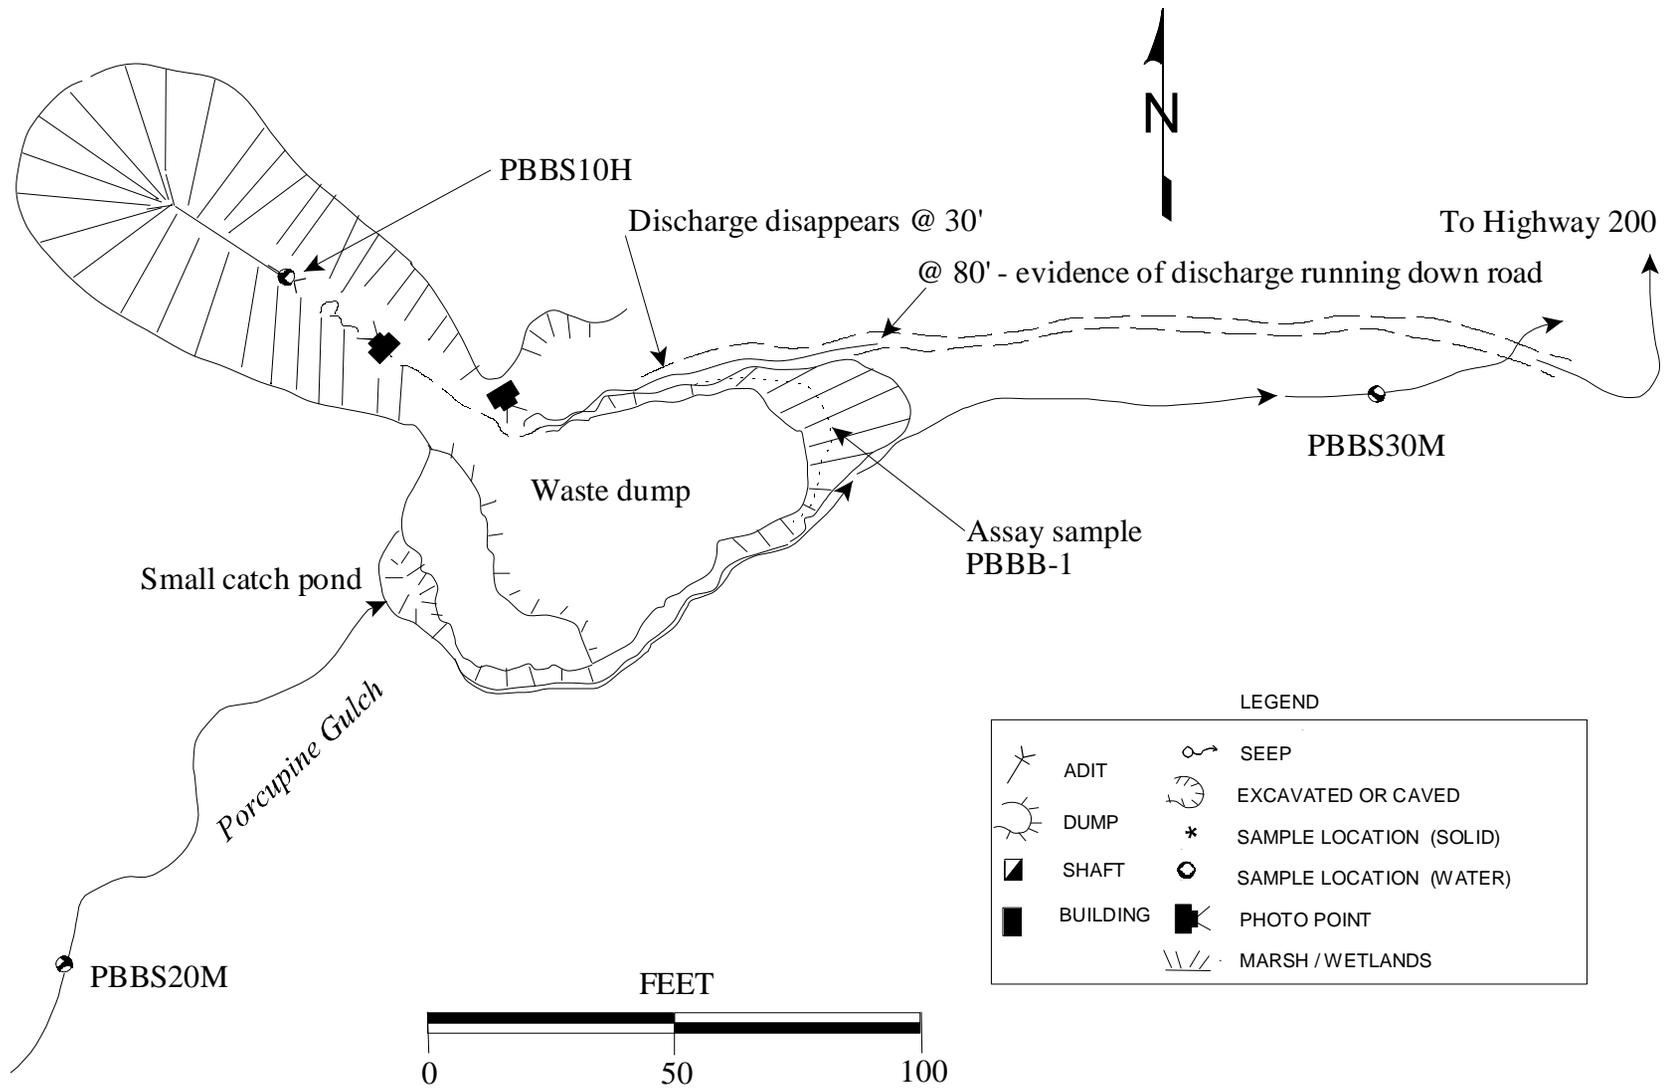
Figure 24. Bobby Boy mine on Porcupine Gulch discharges less than one gpm as mapped 09/08/94.

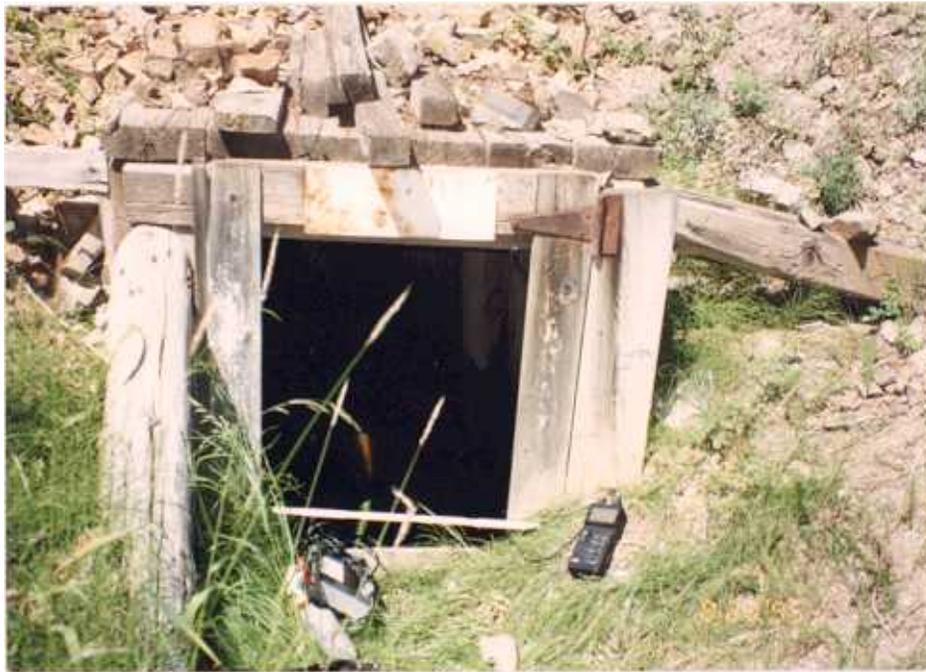
Figure 24a. Water stands in the open, timbered, and lagged adit at the Bobby Boy with a <0.5 -gpm discharge.

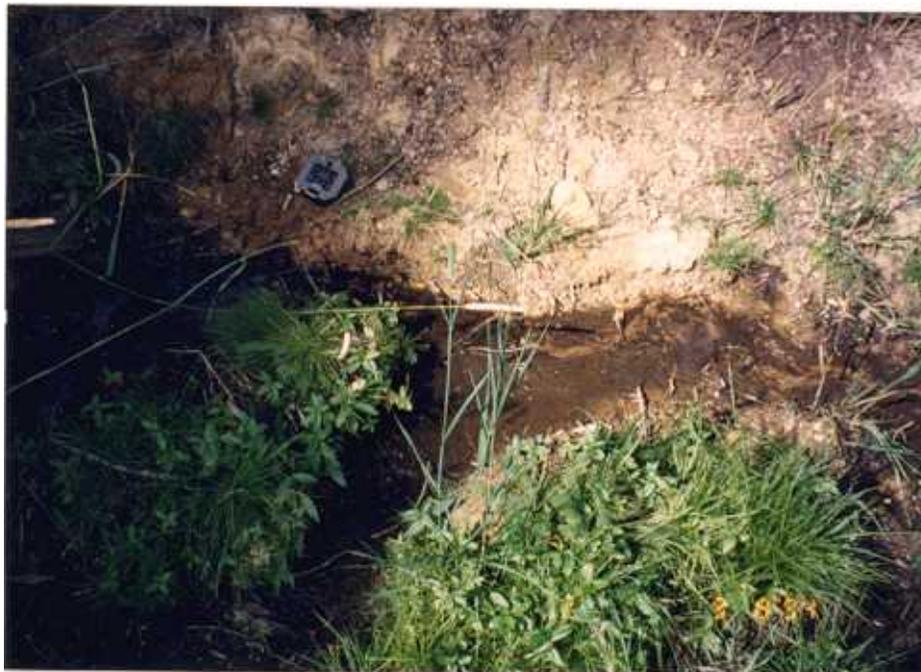
Figure 24b. A small discharge (<0.5 gpm) flows from the adit at the Bobby Boy.

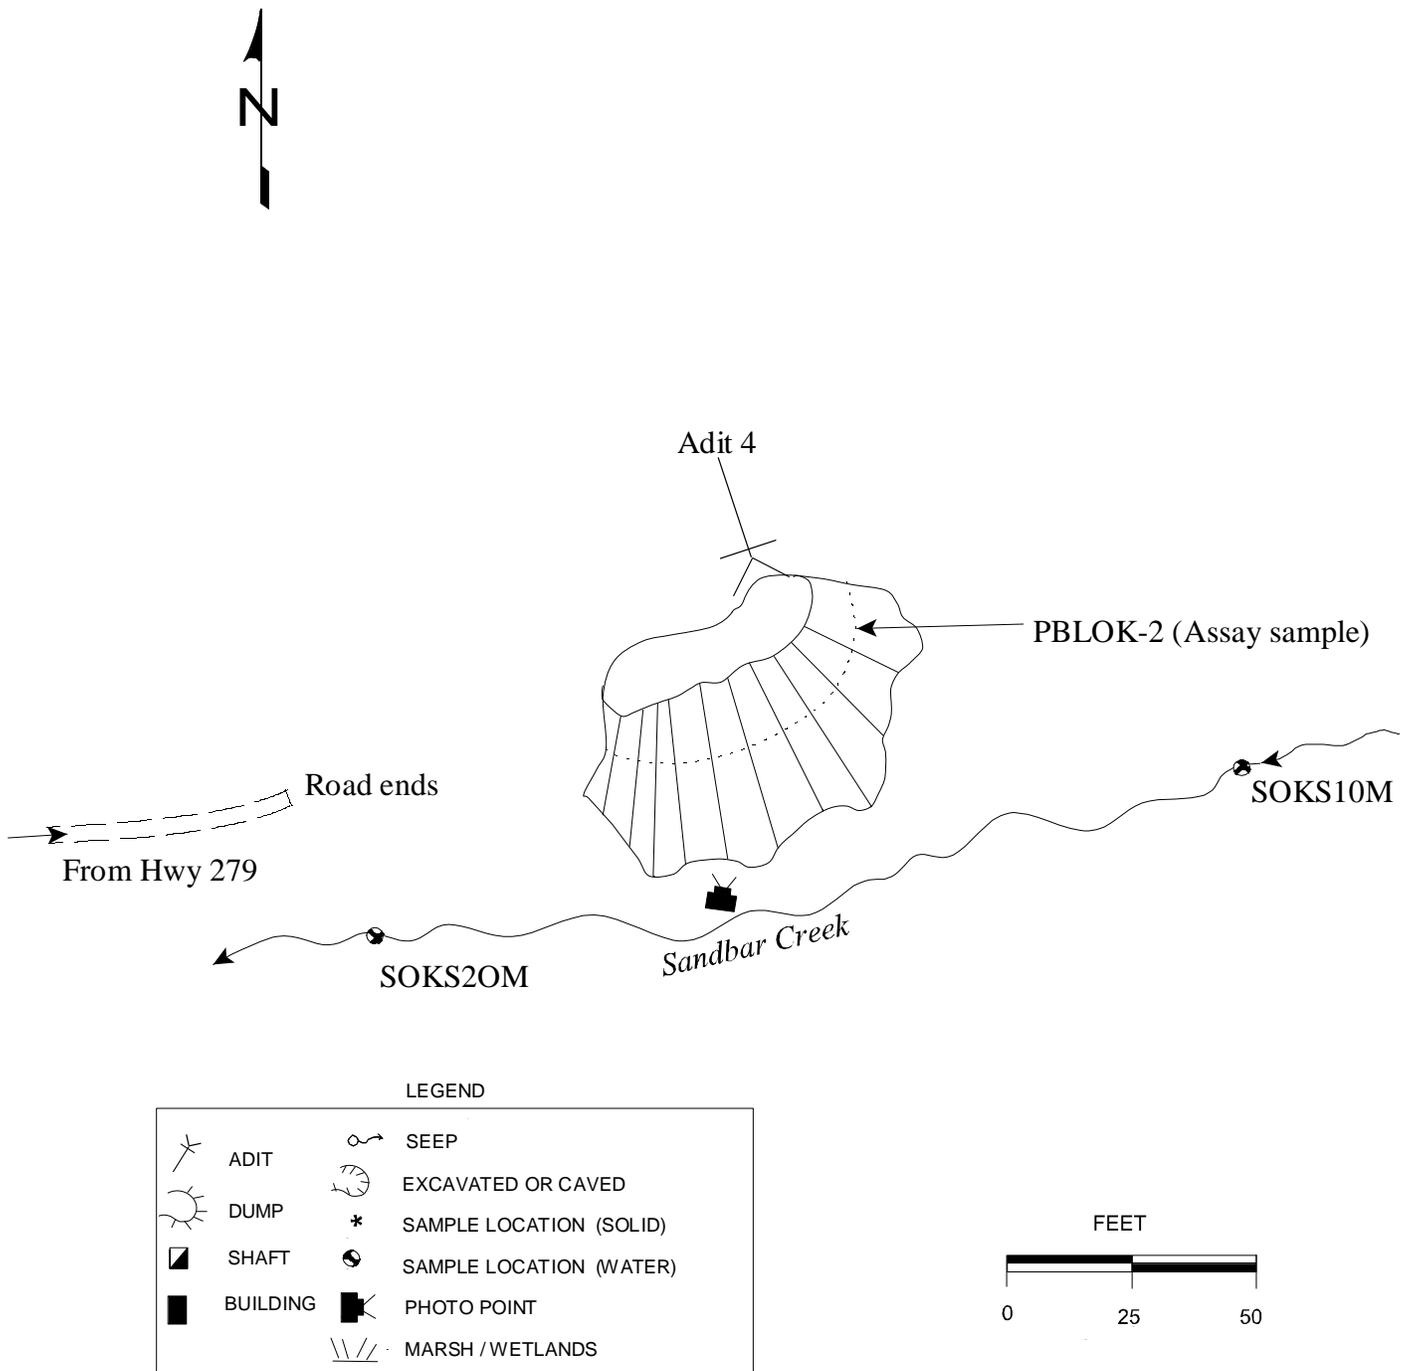
Figure 25. Easternmost adit; Oker mine, sulfide-rich dump, as mapped 09/07/94.
