Abandoned - Inactive Mines of the
Blackfoot and Little Blackfoot River Drainages

Helena National Forest
Volume II

Open-file Report 368
MBMG

February 1998

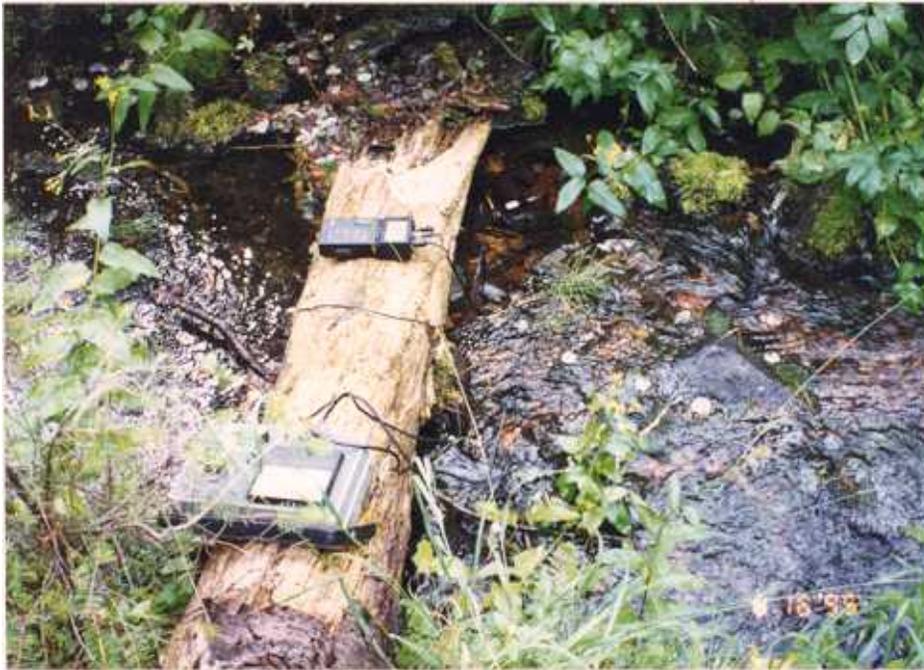
Figure 25a. Shoue Creek flows clear and cold upstream from the easternmost adit.

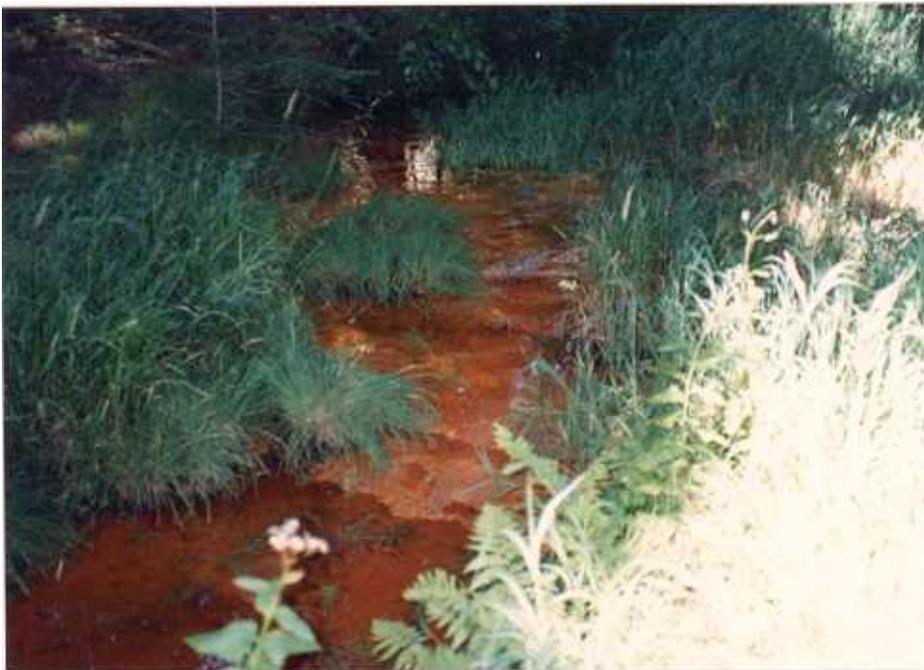
Figure 25b. Shoue Creek was iron stained as it flowed in front of the fourth and westernmost adit.

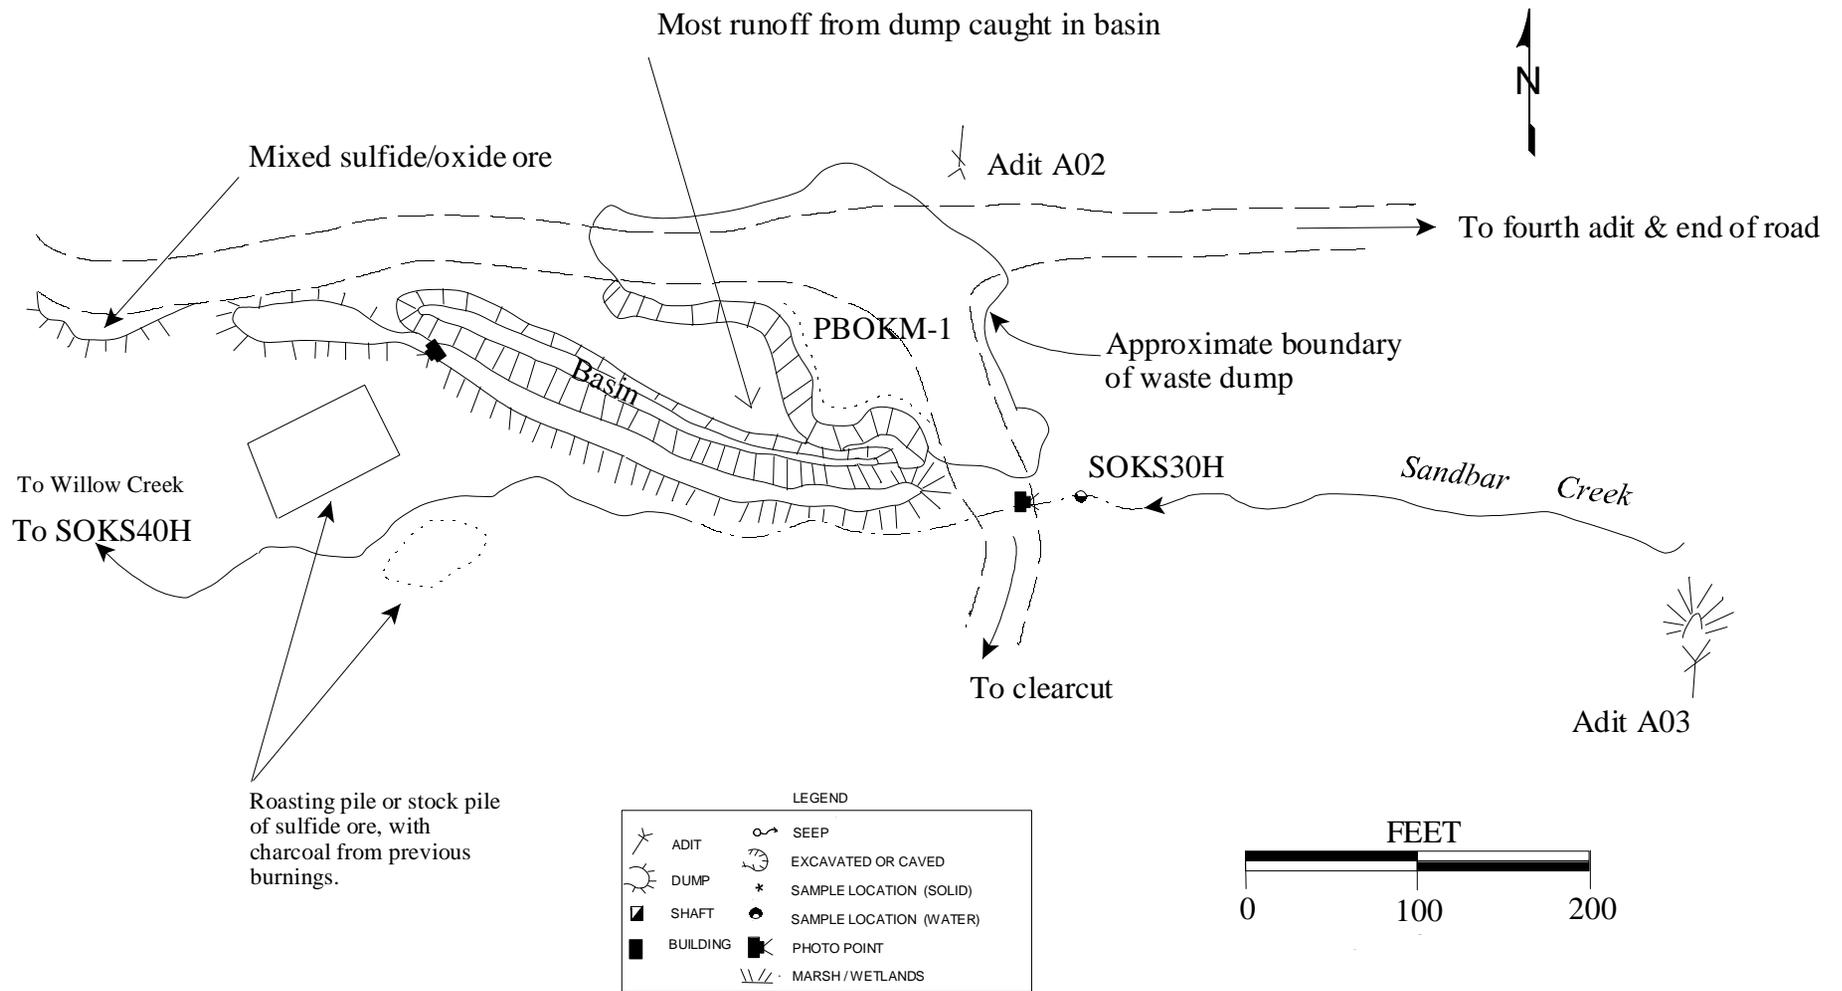
Figure 26. The samples upstream and downstream of the middle adits on Sandbar Creek have no exceedences, as mapped 09/13/94.

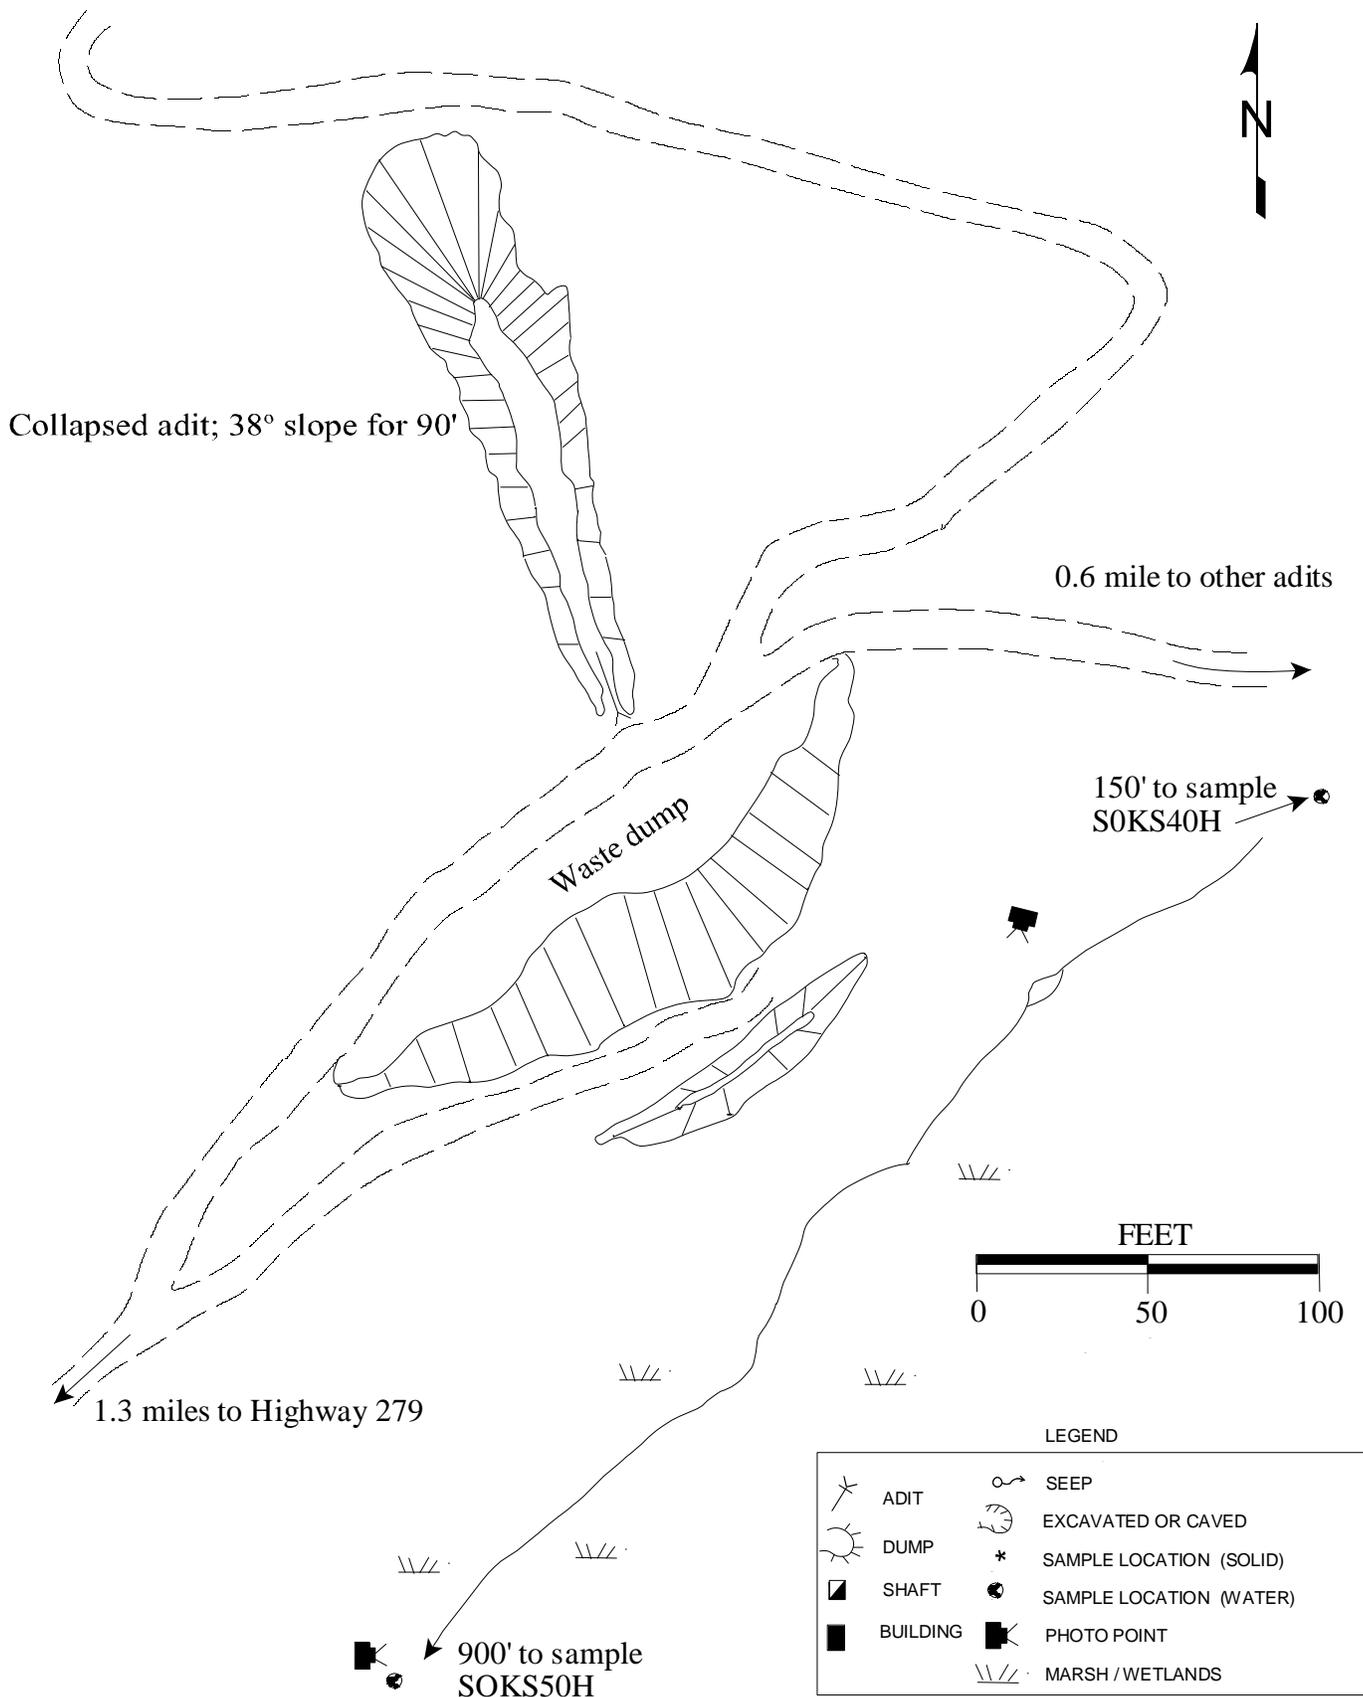
Figure 27. The water of Sandbar Creek was strongly iron stained as it flowed by the westernmost adit, as mapped 09/13/94.

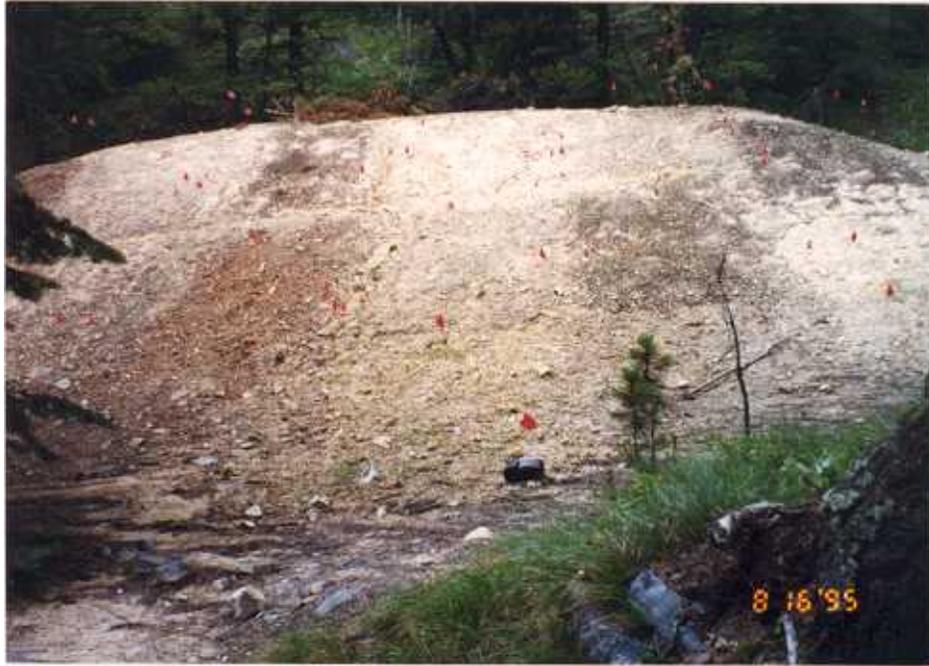
Figure 27a. Waste dump of the easternmost Oker adit with surveyors' flags was a probably a part of an unidentified study.

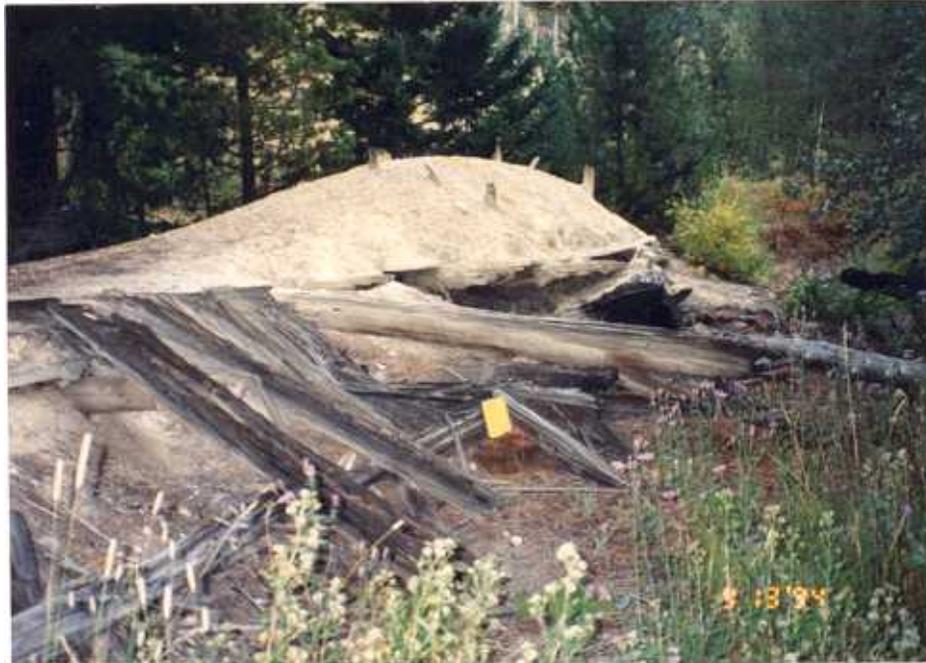
Figure 27b. A possible roasting pile with charcoal and sulfides lies near the third Oker adit.

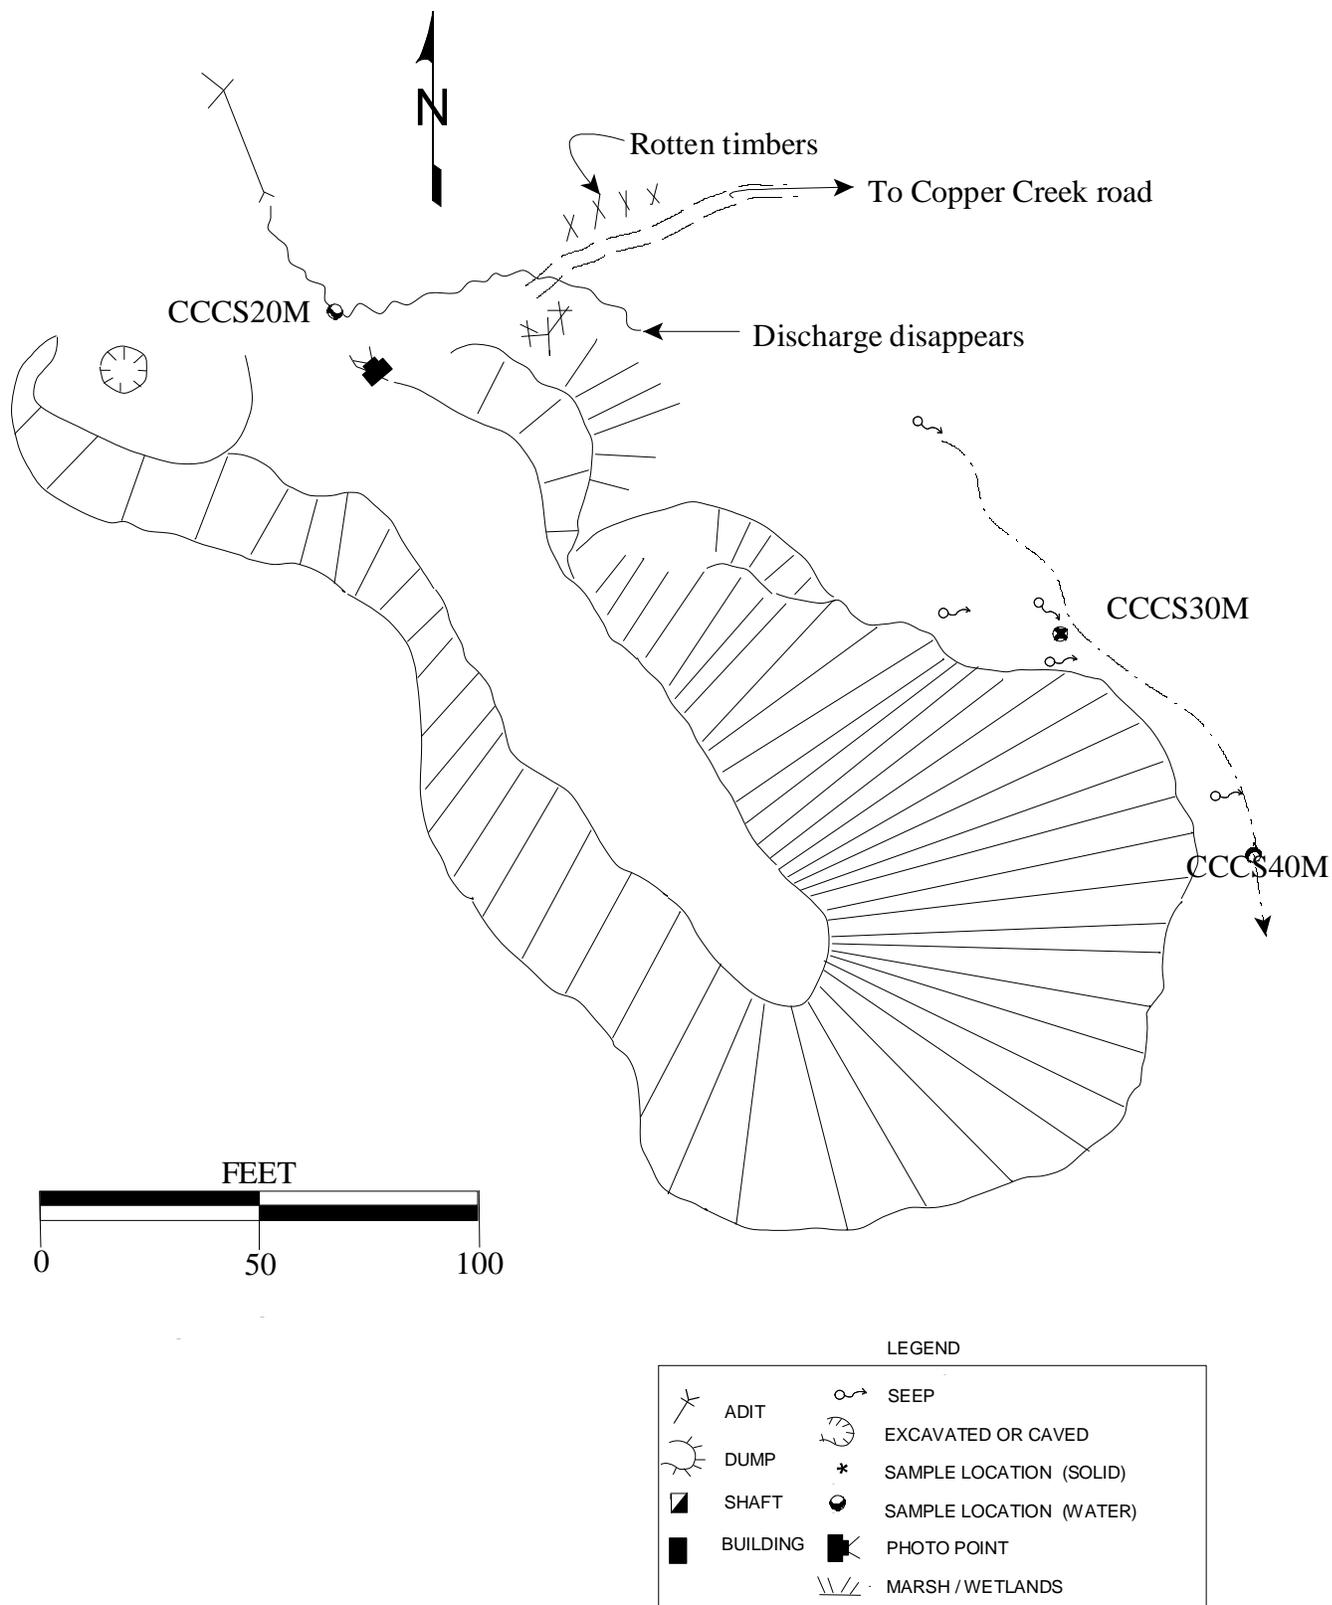
Figure 28. Several springs and an adit discharge emerge from the lower workings of the Copper Camp site, 08/22/94.

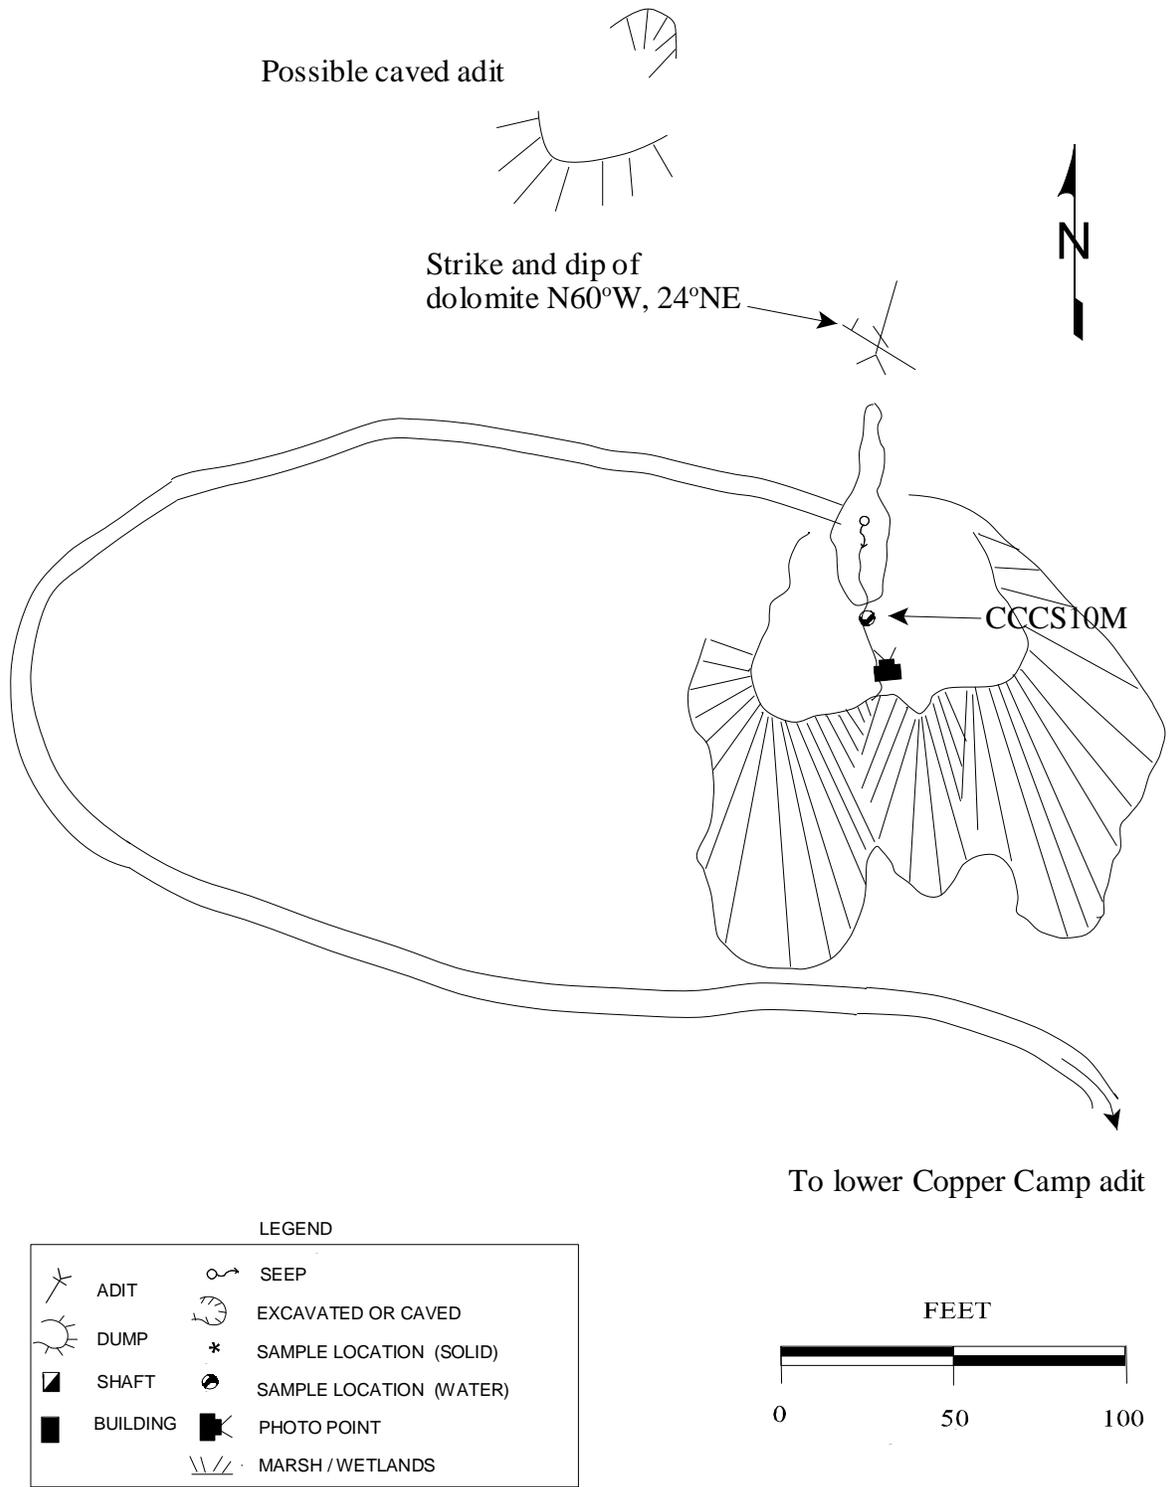
Figure 29. Upper Copper Camp adits, small discharge issues from one, as mapped 08/22/94.

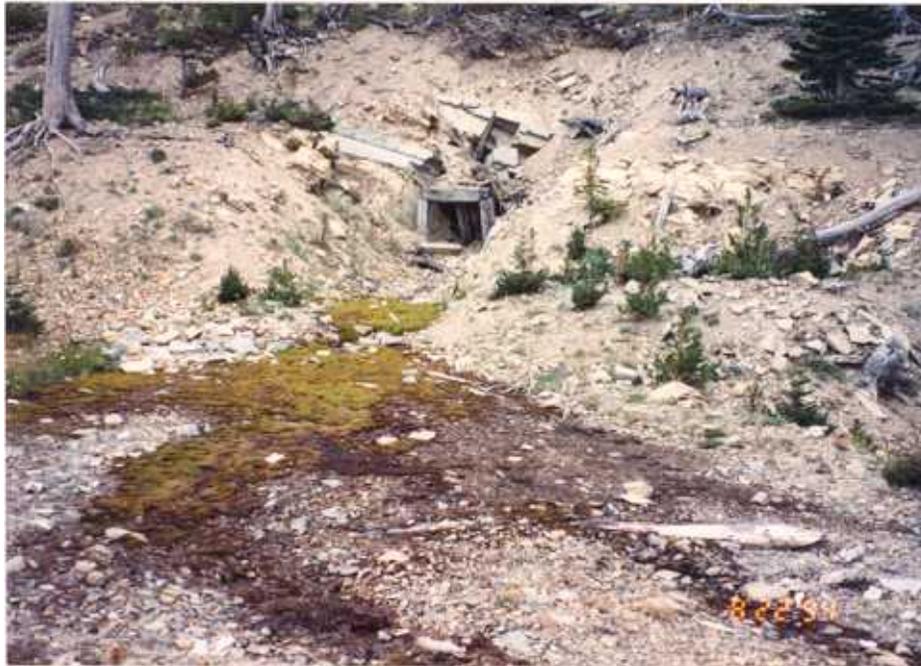
Figure 29a. Upper Copper Camp adit, trended N15°E, with <five-gpm discharge that infiltrated into dump.

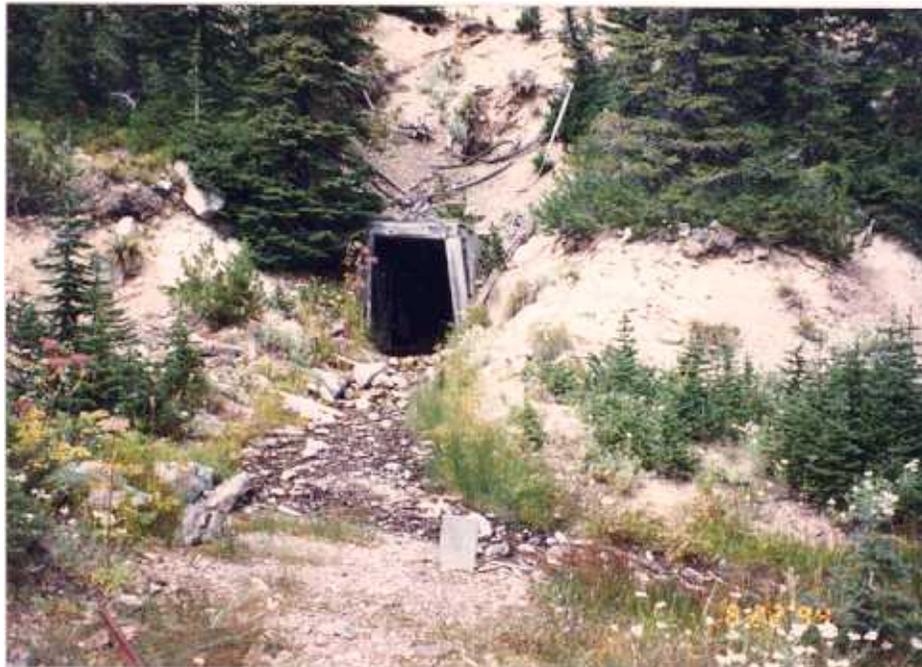
Figure 29b. Five-gpm discharge emerged from the lower Copper Camp adit that was caved beyond the lagging.

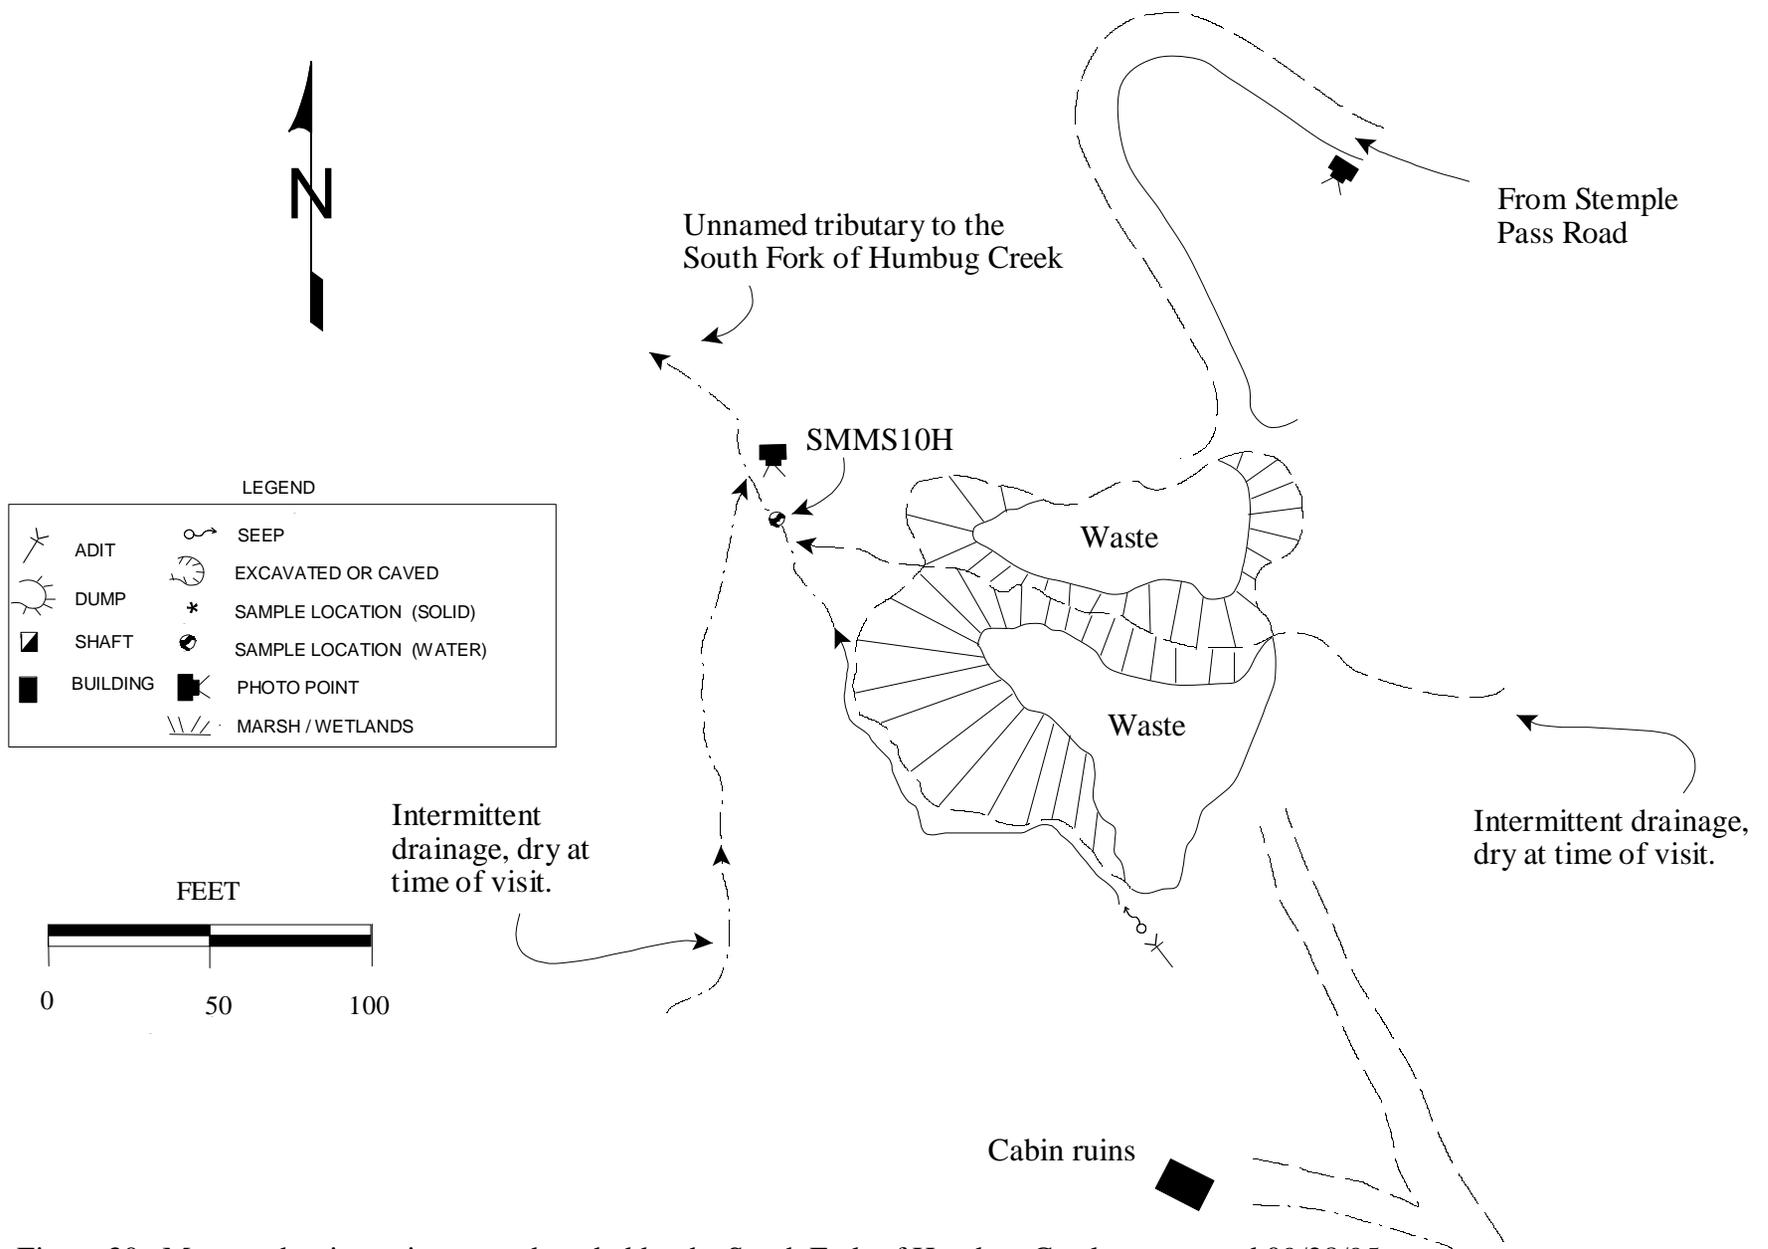
Figure 30. Mammoth mine - site cut and eroded by the South Fork of Humbug Creek, as mapped 09/28/95.

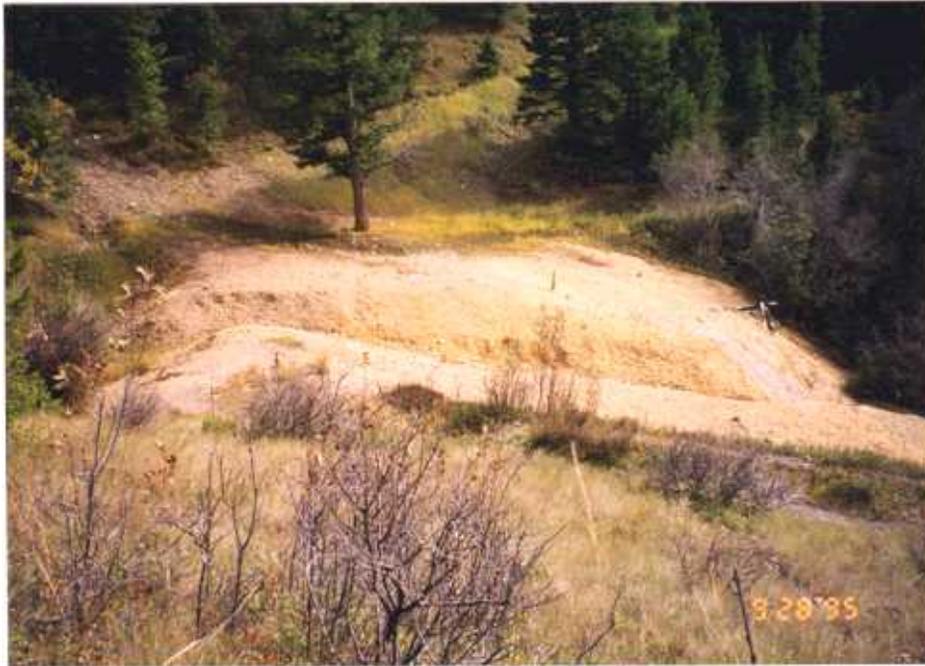
Figure 30a. A channel cut through the waste of the Mammoth mine; an adit discharge/seep appears in the upper left of photo and flows to the right at the edge of the waste dump.

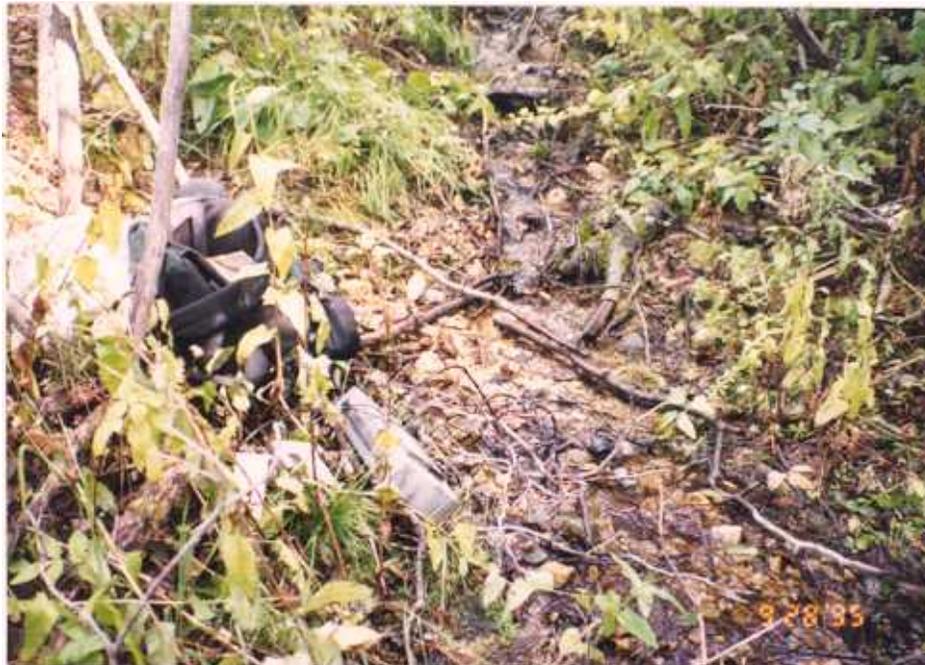
Figure 30b. Sample site SMMS10H below the Mammoth mine where the headwaters of the South Fork of Humbug Creek flow clear and cold.

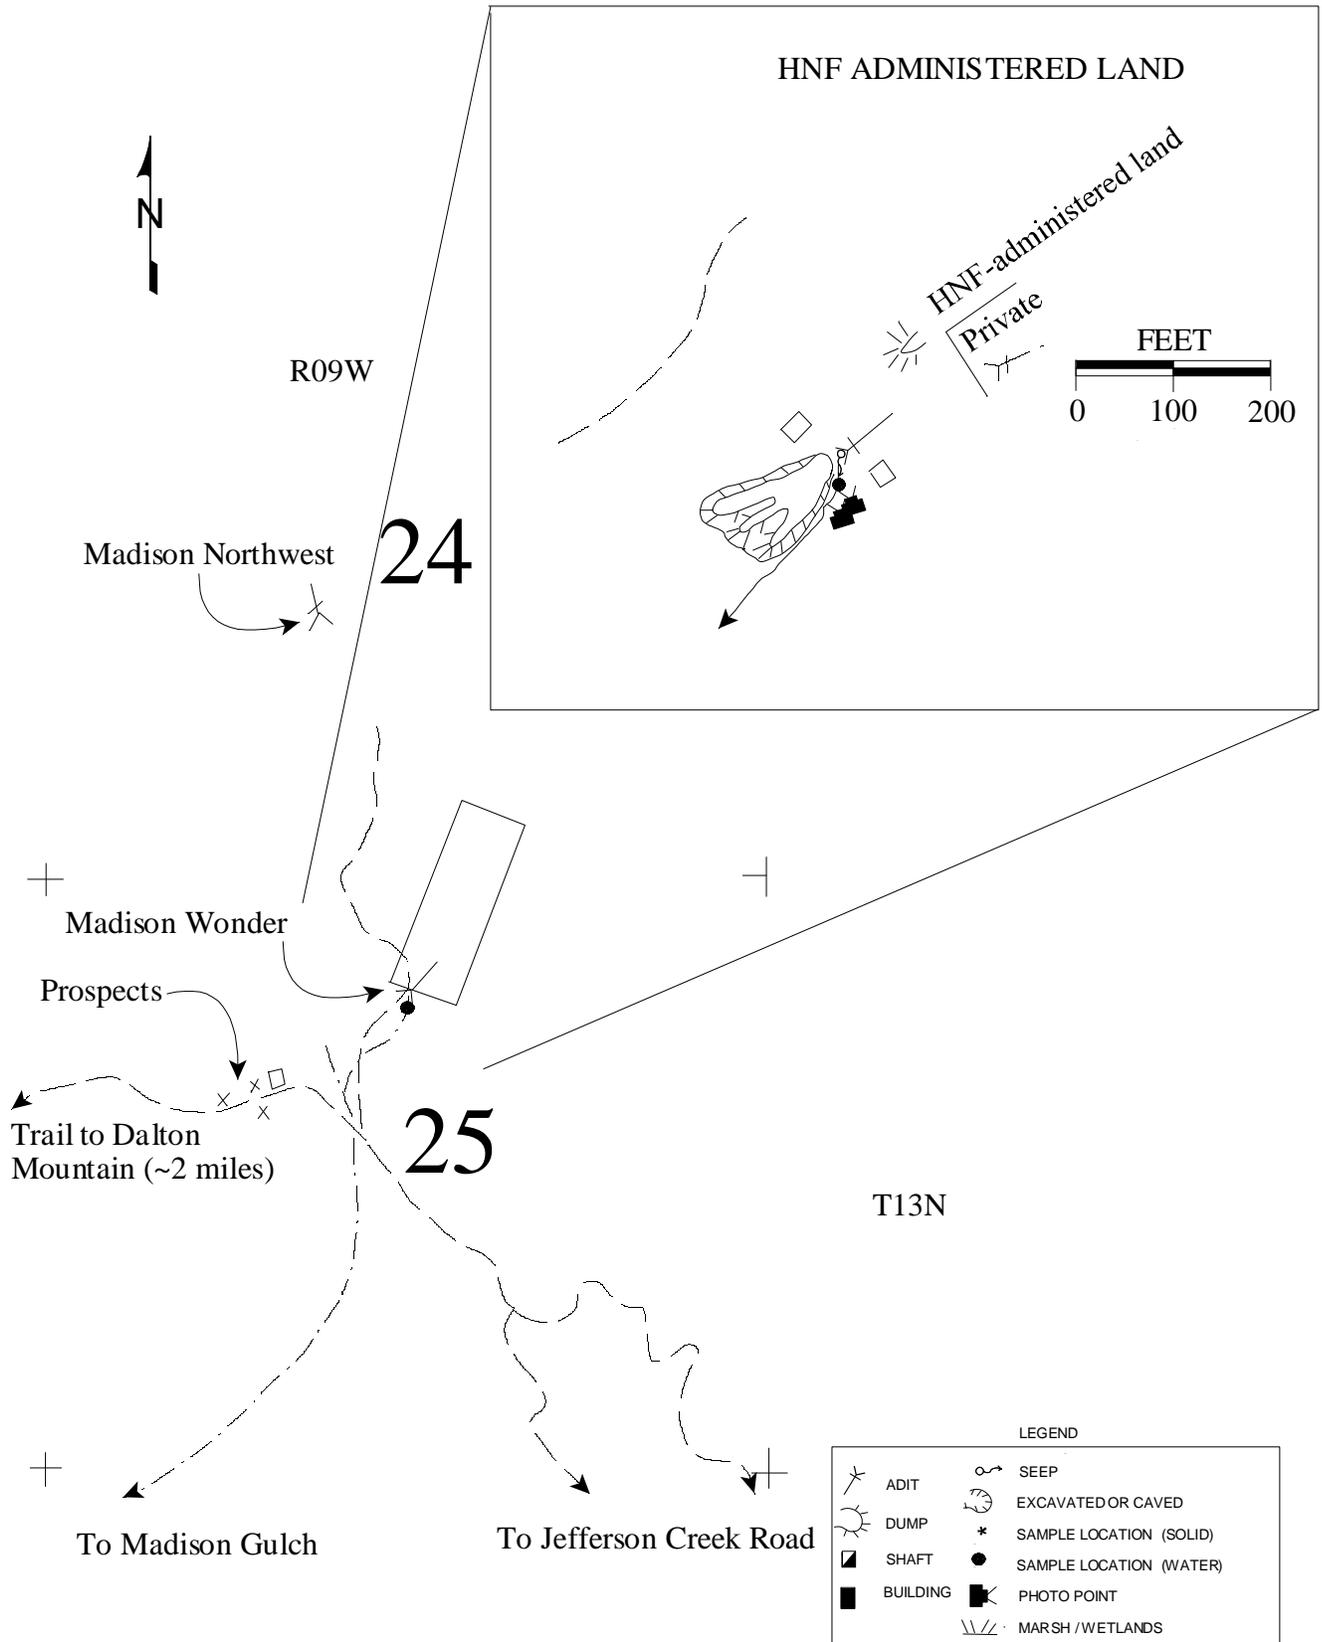
Figure 31. Madison Wonder discharges 2–3 gpm, as mapped 09/08/94. Location is a schematic from USFS ownership map of the Finn 7.5-min. quadrangle.

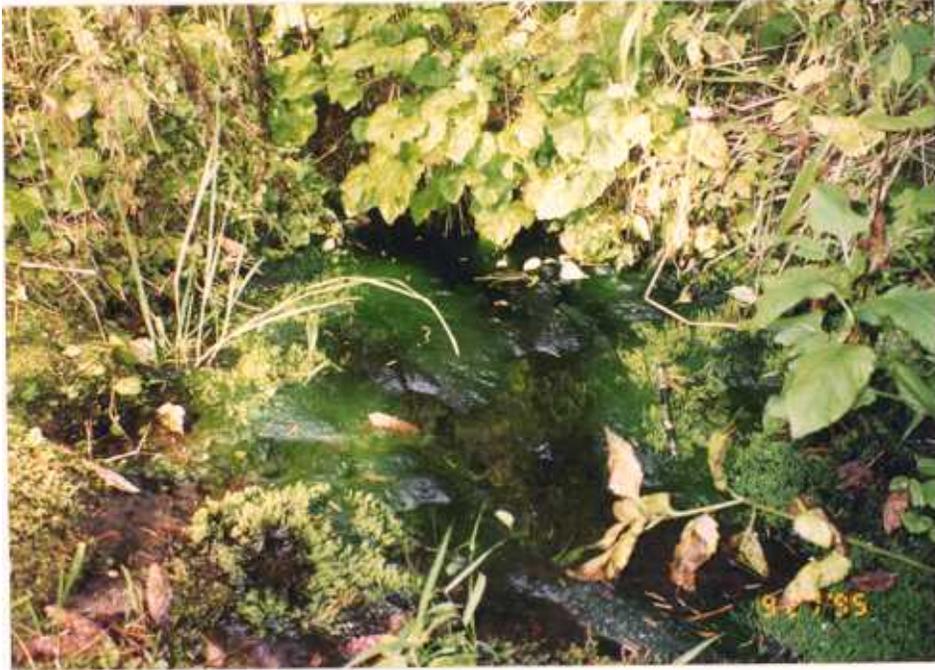
Figure 31a. A discharge from the adit at the Madison Wonder flowed around the margin of the waste dump.

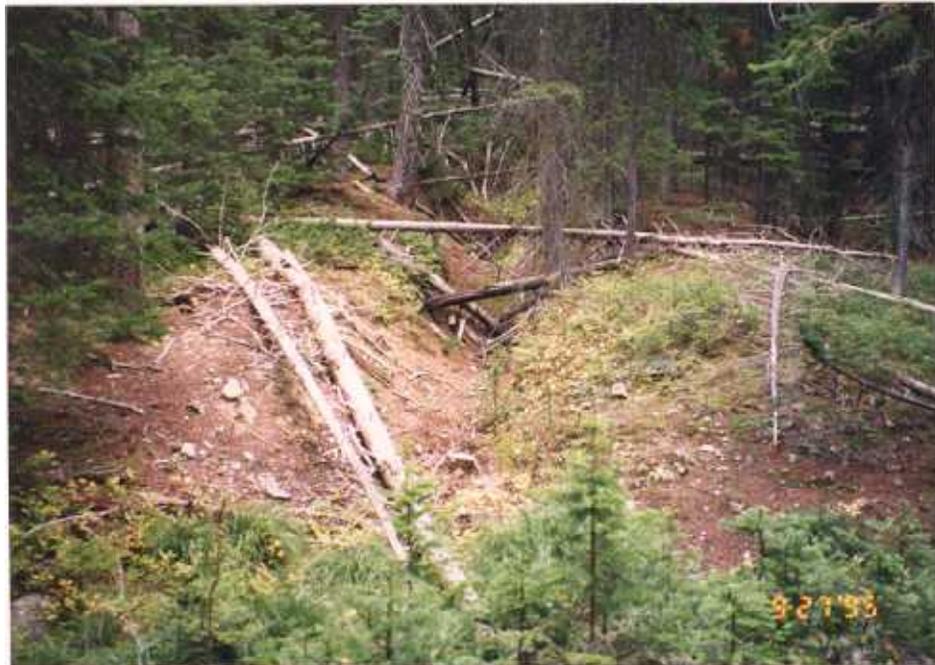
Figure 31b. A collapsed adit at the Madison Wonder occurred on patented land.
