Plate 3: Longitudinal cross-section of the West Crane Aquifer

This cross-section displays major geologic units associated with the West Crane aquifer. The line of this longitudinal profile and cross section is shown on plate 1.

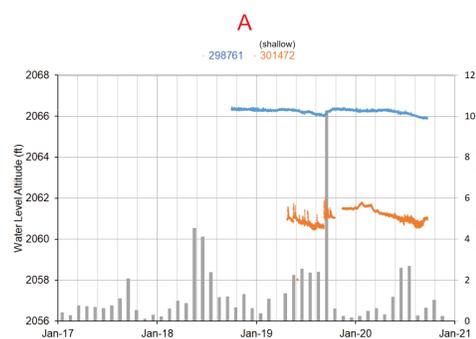
Hydrograph (A) is from wells located on the valley slope above Burns Creek in the southern part of the Garden-Burns upland. The water levels at both sites rise in response to recharge from direct precipitation and snowmelt. Declines are primarily in response to evapotranspiration. No detectable response to pumping is apparent.

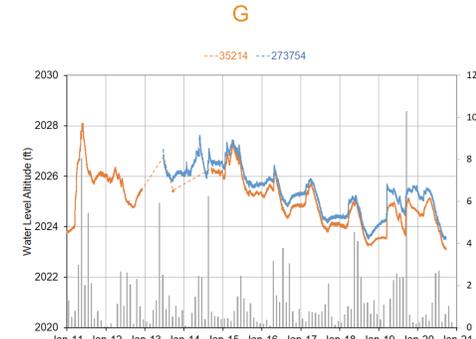
Hydrograph (G) is from a pair of wells located in the Crane Creek valley. Water-level fluctuations at these wells are nearly identical, with the deeper well (273754) having slightly higher heads, indicating an upward flow gradient. Water levels at 35214 rose about 4 ft during the major recharge event during the spring of 2011. Variable annual spring recharge dominates the hydrograph. Evapotranspiration is the main cause of discharges causing water-level declines.

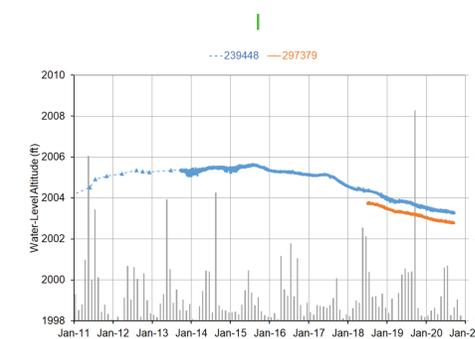
Hydrograph (I) is from wells located near the middle of the Fox-Crane upland. Similar to other sites in the aquifer, water levels rose during the spring 2011 recharge event and declined starting in 2015. Unlike other sites where water levels stabilized and recovered in 2019, declines continued in this area. With the closest irrigation well 1 mile away, no drawdown related to pumping is observed at this site.

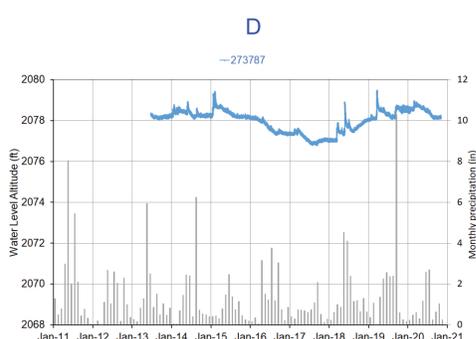
Hydrograph (D) is from a well located in the Dunlap Creek Valley adjacent to the dry streambed. Water levels at this site are very sensitive to climatic factors. This sensitivity is demonstrated by a 2.5 ft decline in water level from 2015 to 2017, 3 years with little aquifer recharge. Water levels recovered to 2013 levels with increased recharge in 2018 and 2019.

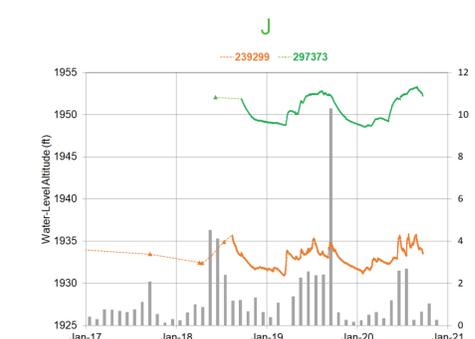
Hydrograph (J) is from well 293299, which is located in the Fox Creek Valley where it joins the Yellowstone River Valley. The Lower Yellowstone Irrigation Project (LWIP) main canal is about 1,300 ft south and upgradient of this well. Hydrograph (J) also includes 297373, which is located at the north edge of the Fox-Crane upland 65 ft above the LWIP canal. The LWIP main canal is about 280 ft north of this well. Water-level fluctuations are very similar, with both wells directly responding to the annual filling and draining of the LWIP main canal. Water-level elevations are about 18 ft higher in well 297379 than in well 239448.
