TEMPERATURE AND SITE DATA FOR GROUNDWATER SEEPS, TRIBUTARIES, AND TAILWATER RETURNS TO THE BIG HOLE RIVER NEAR GLEN, MONTANA

**Montana Bureau of Mines and Geology
Ground Water Investigation Program**

Montana Bureau of Mines and Geology Open-File Report 775

June 2025

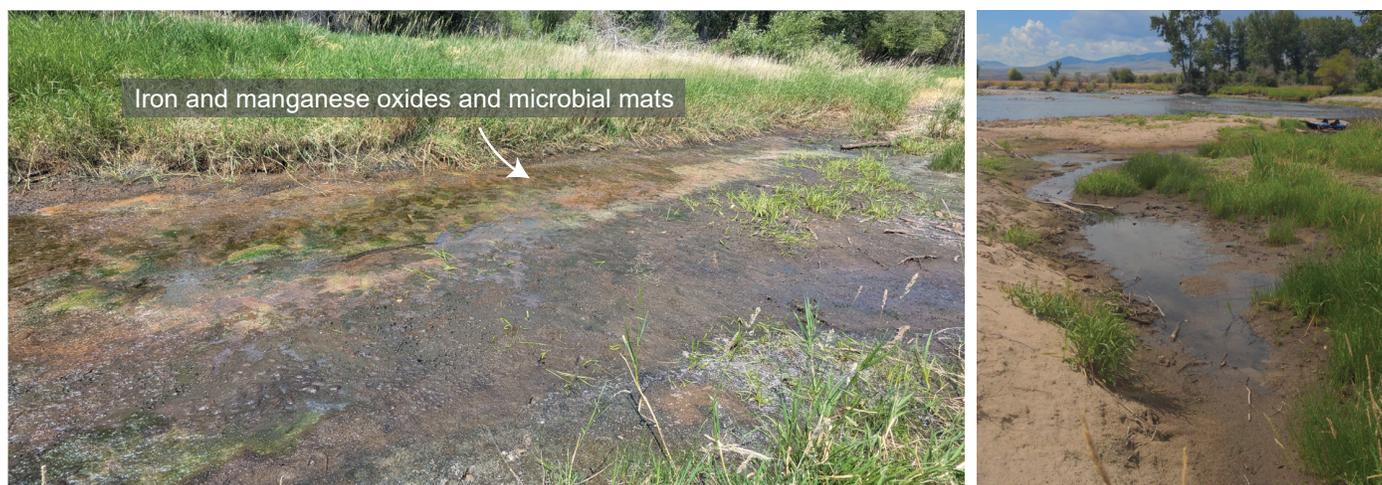
Figure A3.2. Backwater with groundwater seeping (left) and the hyporheic seep (right). Both sites had iron- and manganese-oxide deposition.

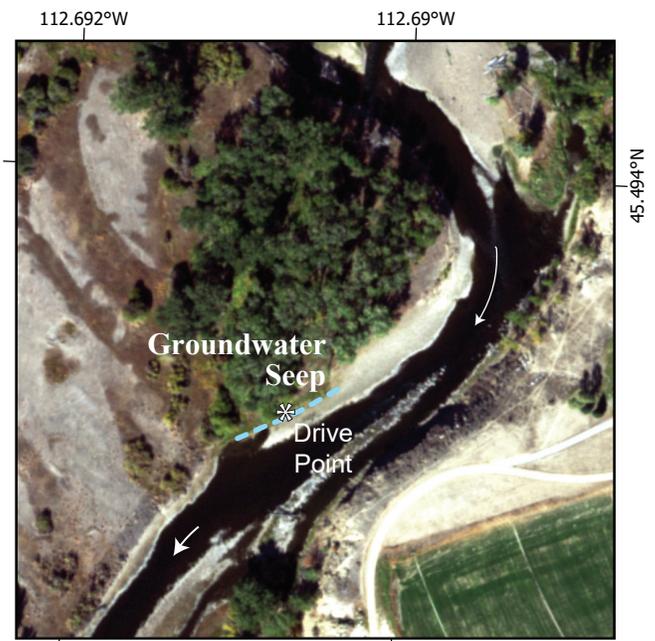
Figure A4.1. Aerial map of Site 4 showing the location of the groundwater seep (dashed blue line).

Description: Site 4 had groundwater discharging along a cobble riverbank for ~180 ft (fig. A4.1). The pH, DO, and ORP of the groundwater seep were less than those measured for the river; groundwater SC was within 13% of river SC (table A4.1). Iron-oxide deposition, iron-encrusted algae mats, and biofilm were present between the cobbles (fig. A4.2). The thermal infrared showed obvious cool temperatures on the riverbank from a distance (fig. A4.3); subsurface temperatures ranged from 10.9°C to 12.5°C. Cool groundwater temperatures appeared to move outward from the riverbank at lower river stages. Groundwater temperatures in the drive point showed minimal diel fluctuations. When stage decreased, the groundwater was warmer and showed greater diel fluctuations (fig. A4.4).

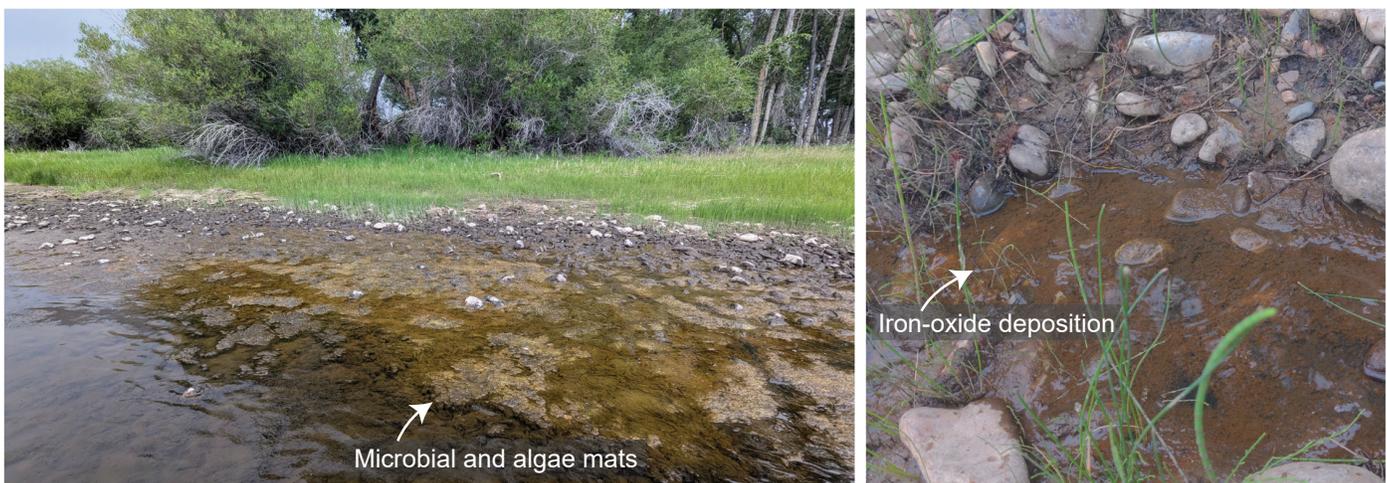
Figure A4.2. Saturated cobble riverbank (left) with iron-oxide deposition (right). Iron-encrusted algae and microbial mats were more prevalent at this site in 2024 when stage was lower.

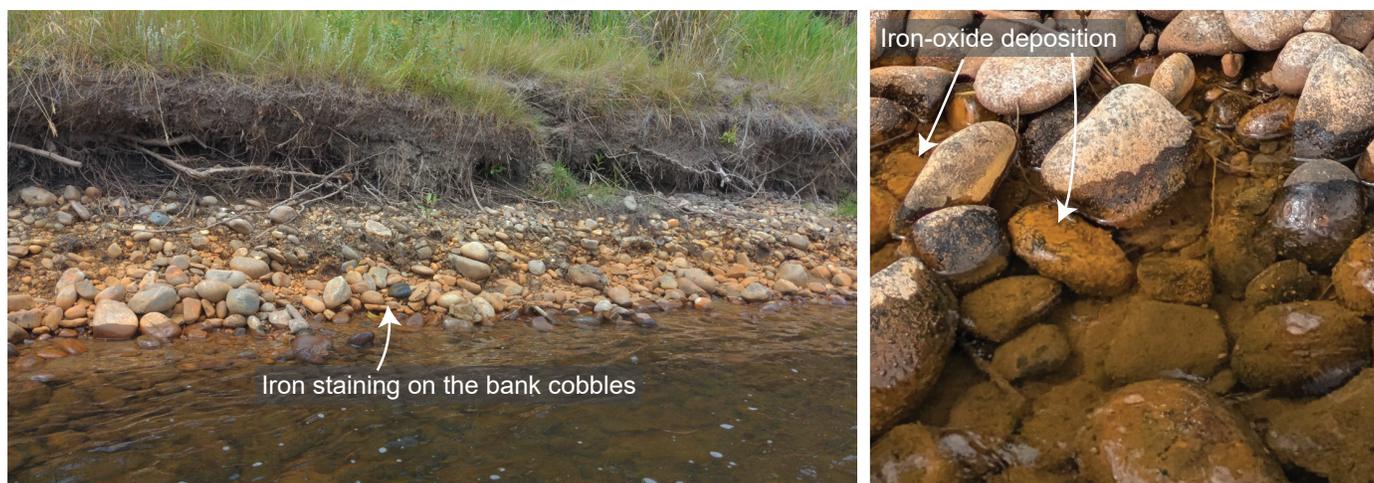
Figure A5.2. Iron staining on the cobbles (left) and iron-oxide deposition below the water surface (right) where groundwater was seeping into the river.

Description: Site 5 had groundwater discharging along a cobble riverbank for ~290 ft (fig. A5.1). The groundwater seep was visually identified by the iron-stained cobbles (fig. A5.2). Cool groundwater was observed flowing from the riverbank using thermal infrared (fig. A5.3). Subsurface temperatures ranged from 9.7°C to 11.4°C. The pH, DO, and ORP of the groundwater seep were generally less than those measured for the river; groundwater SC was within 5% of river SC (table A5.1); however, it was hard to isolate the groundwater from the river using the YSI probe at this site. Logged groundwater temperatures were consistent around 12°C with greater diel temperature fluctuations when river stage was lower (fig. A5.4).

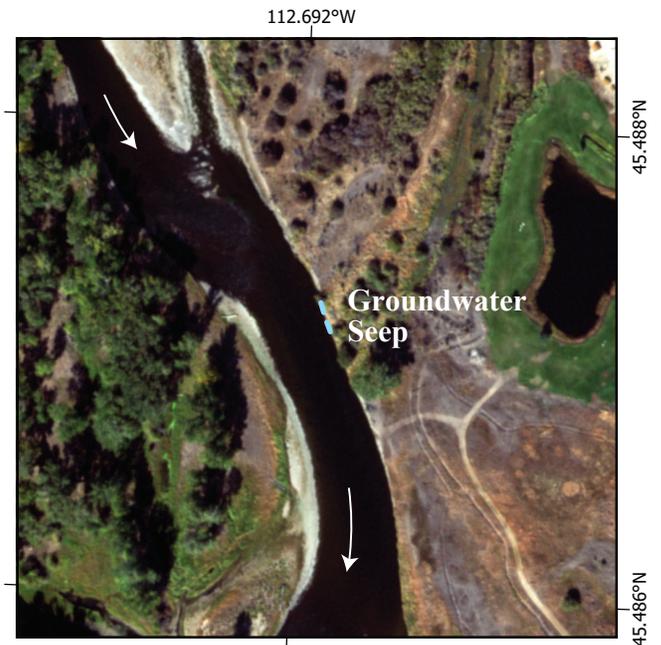
Figure A6.1. Aerial map of Site 6 showing the location of the groundwater seep (dashed blue line).

Description: Site 6 had discrete areas of groundwater discharging along a cobble riverbank for ~60 ft (fig. A6.1). Iron-encrusted algae/iron-stained cobbles (fig. A6.2) and cooler thermal infrared temperatures (~11-15°C; fig. A6.3) were observed at this groundwater seep. Subsurface temperatures ranged from 9.5°C to 11.4°C. The pH, DO, and ORP of the groundwater were less than those measured for the river; groundwater SC was within 5% of river SC (table A6.1). The logged groundwater temperatures were steady around 11°C with <0.5°C diel variations (fig. A6.4).

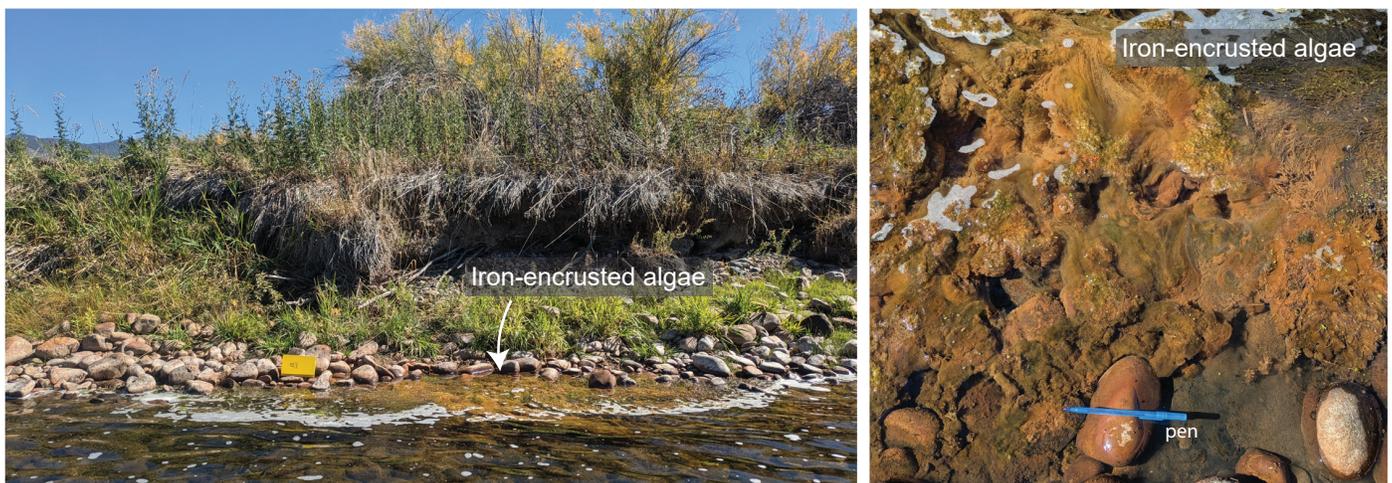
Figure A6.2. A patch of iron-encrusted algae at the Site 6 groundwater seep (left). A close-up of the iron-encrusted algae (right).

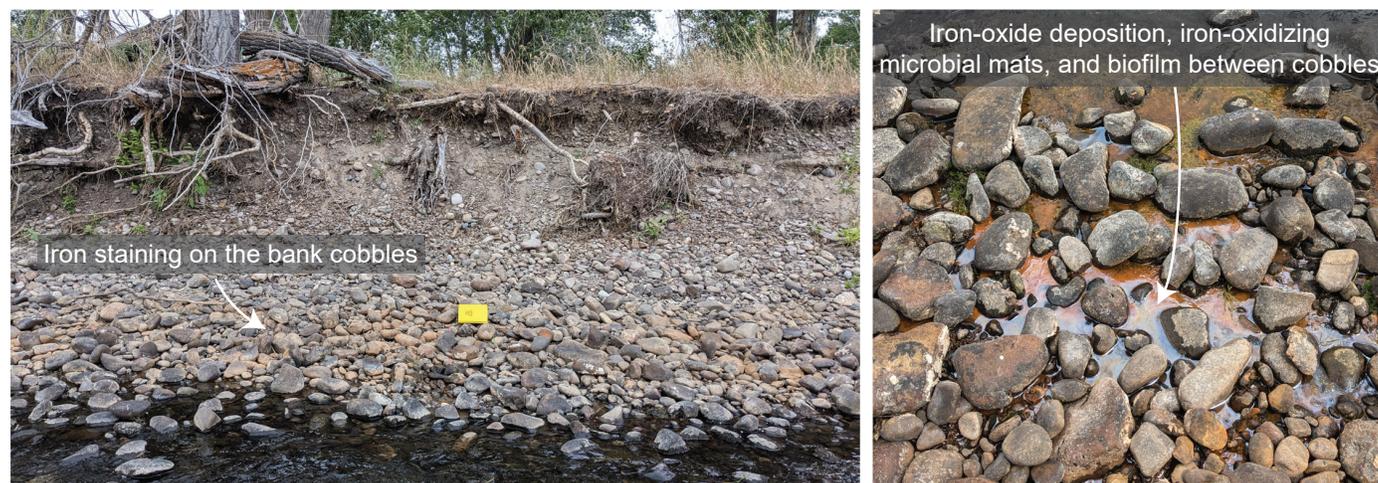
Figure A7.2. Iron-stained cobbles (left). Iron-oxide deposition on algae, iron-oxidizing microbial mats, and biofilm were found at this site (right).

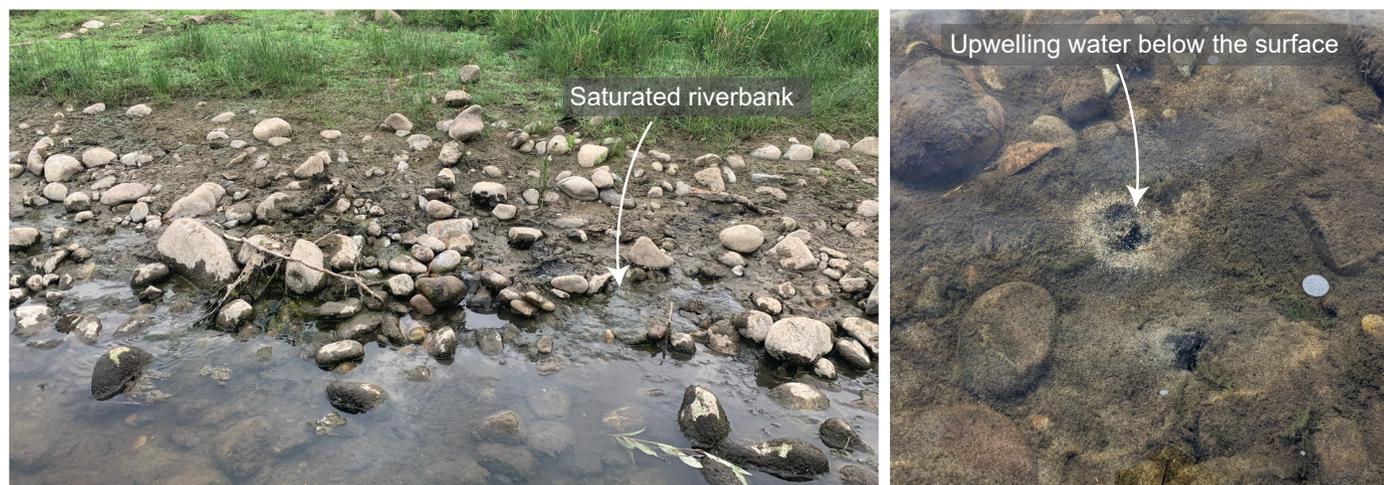
Figure A8.2. Saturated riverbank from hyporheic water (left). Often water was observed upwelling from the sand below the surface (right).

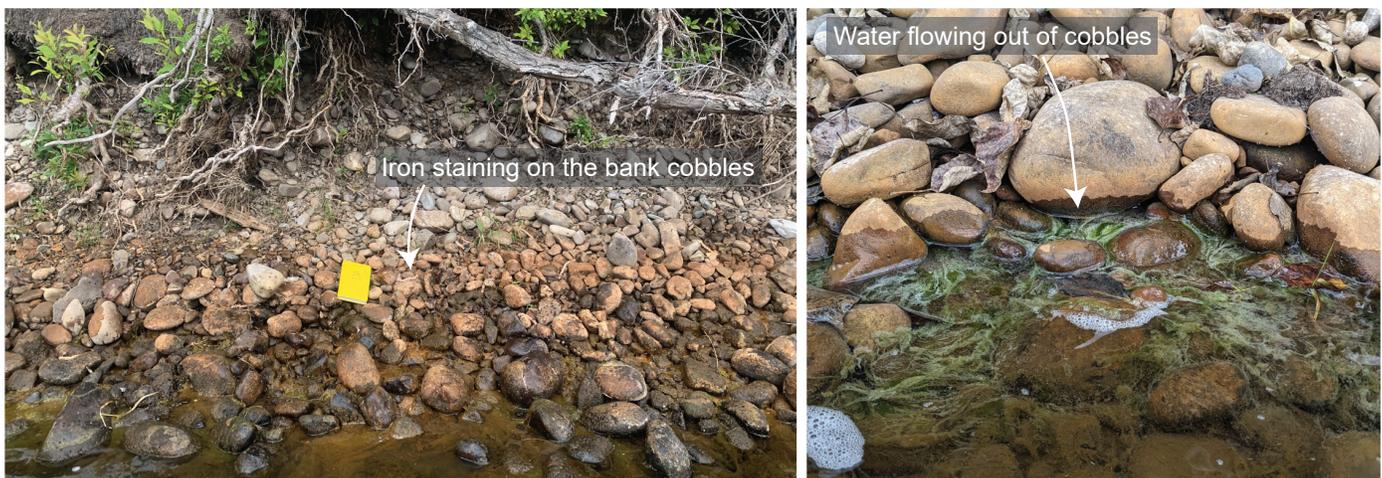
Figure A9.2. Iron staining on the cobbles (left) and water flowing out from the riverbank cobbles (right). Algae and iron-encrusted microbial mats were commonly observed at this site.

Description: Site 9 had groundwater discharging along a continuous section of a cobble riverbank for ~280 ft (fig. A9.1). The groundwater seep was visually recognized by the iron-stained cobbles and water flowing out from the cobbles (fig. A9.2). Cool thermal infrared temperatures were also observed along the entire riverbank (fig. A9.3). Subsurface temperatures ranged from 10.9°C to 12.1°C. The pH, SC, ORP, and DO of the groundwater were generally less than the river (table A9.1). Logged groundwater temperatures were around 12-15°C with diel temperature fluctuations <2°C (fig. A9.4); groundwater temperatures were cooler than the river temperatures in late summer and warmer than river temperatures in fall and winter (fig. A9.4).

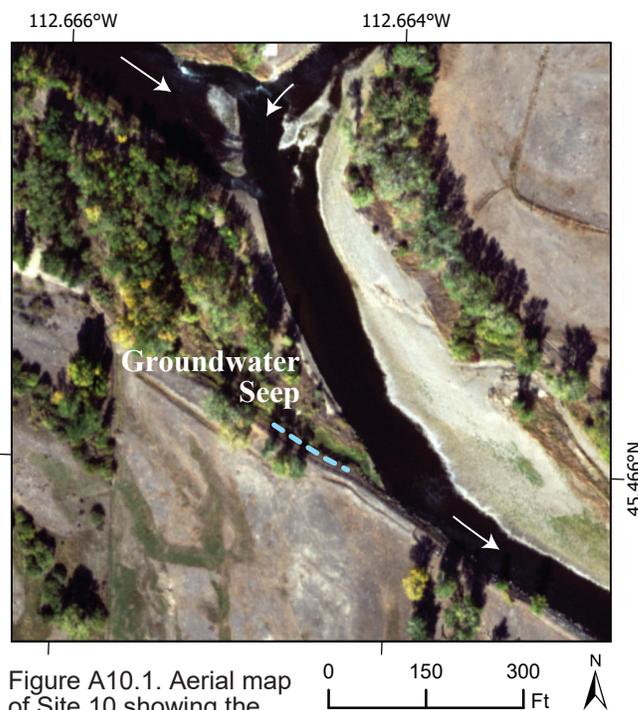
Figure A10.1. Aerial map of Site 10 showing the location of the groundwater seep (dashed blue line).

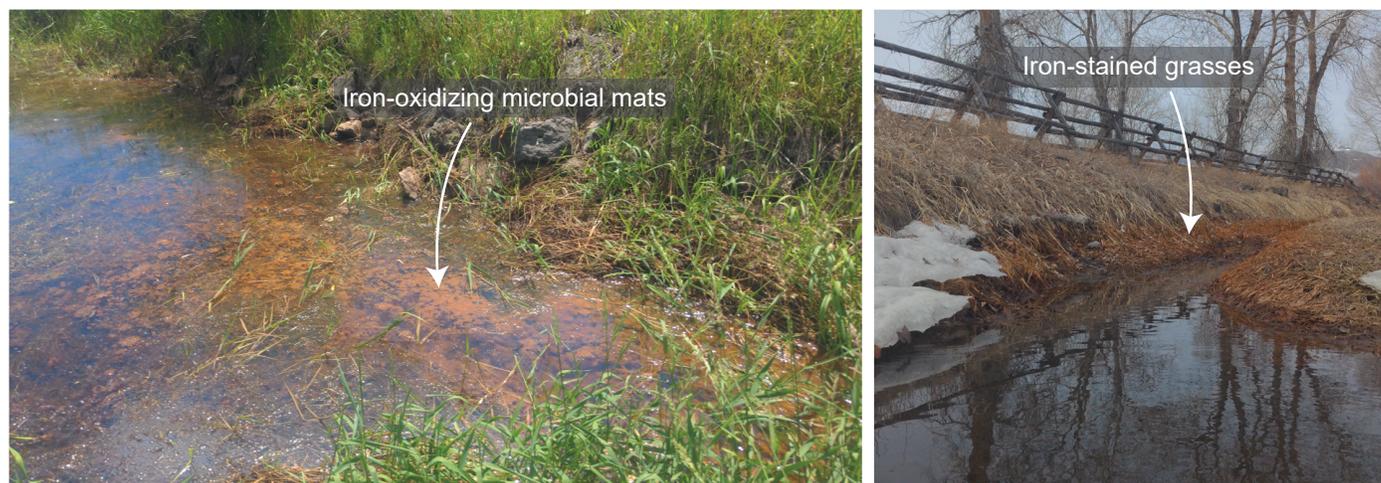
Figure A10.2. Iron-oxidizing microbial mats were commonly observed in the backwater with groundwater seeping into it (left). Early in the spring, the grasses were stained red from the iron oxides (right).

Subsurface temperatures were as cold as 11.9°C. The pH, DO, and ORP of the groundwater seep were generally less than those measured for the river; SC was higher in the groundwater than the river (table A10.1). Iron-oxide staining/deposition and iron-oxide microbial mats were common throughout the backwater (fig. A10.2).

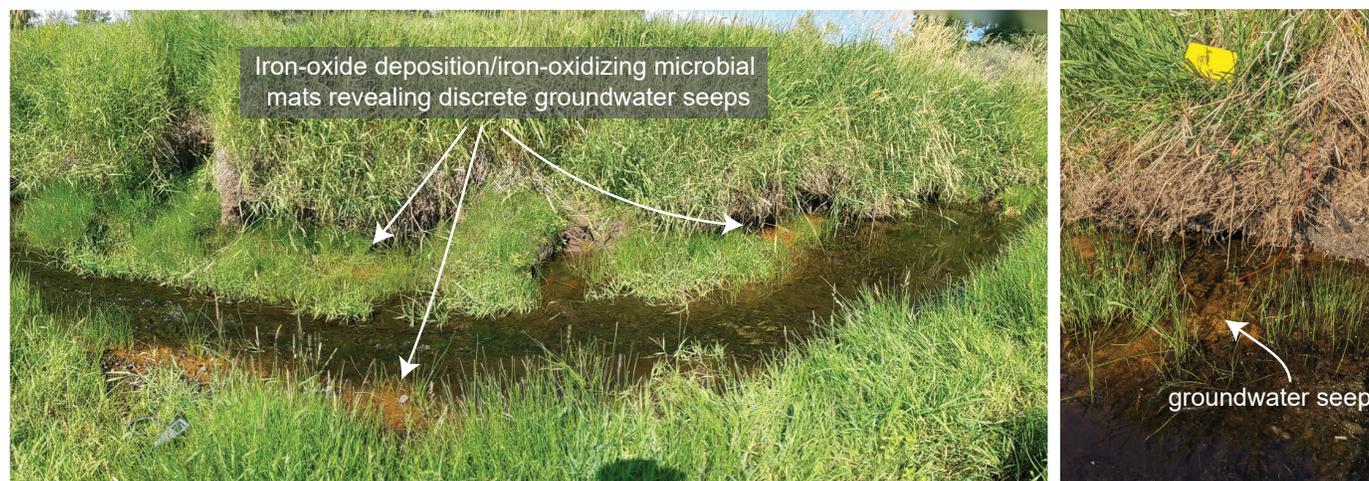
Figure A11.2. Discrete areas of groundwater seeping can be seen visually by the iron-oxide deposition and iron-oxidizing microbial mats.

Description: Site 11 had discrete areas of groundwater discharging for ~200 ft along a small river chute that was cross-cutting a point bar (fig. A11.1). Groundwater discharge was observed where iron-oxide depositions/iron-oxidizing microbial mats (fig. A11.2) and cooler thermal infrared temperatures (~14°C) occurred (fig. A11.3). Subsurface temperatures ranged from 10.2°C to 14.3°C. The pH, DO, and ORP of the groundwater seep were less than those measured for the river; groundwater SC could be higher or lower than the river (table A11.1). The logged groundwater temperatures were steady with minimal to no diel variation in Summer 2023; the diel groundwater temperatures varied in Summer 2024 up to 1.5°C (fig. A11.4).

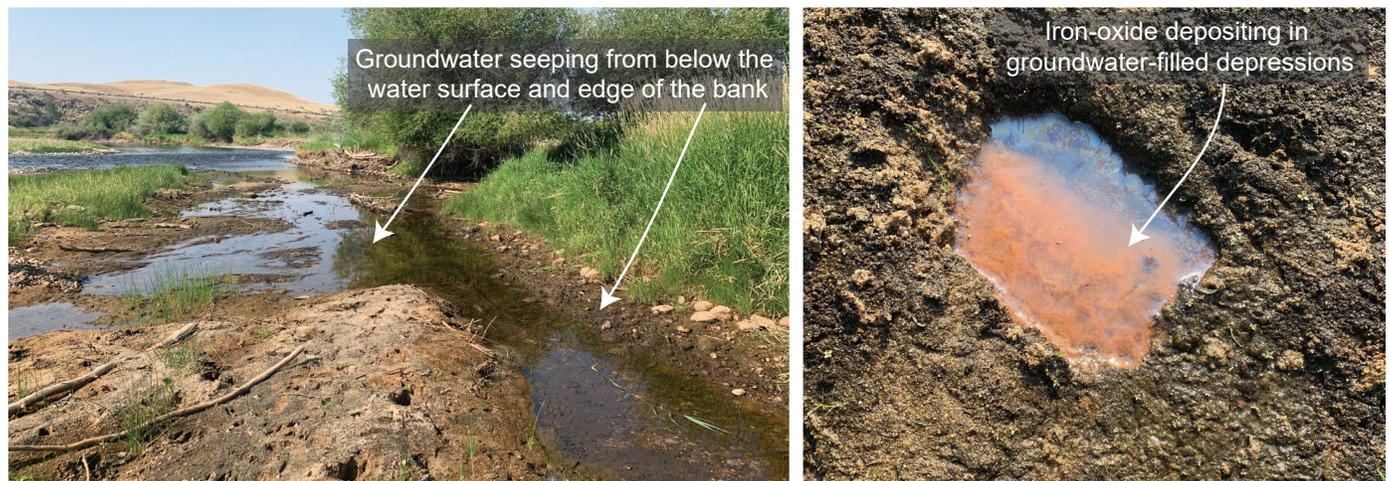
Figure A12.2. Ponded groundwater seep at Site 12 (left). Iron-oxide deposition was common at this site filling depressions (right) and the bottom of the ponded water.

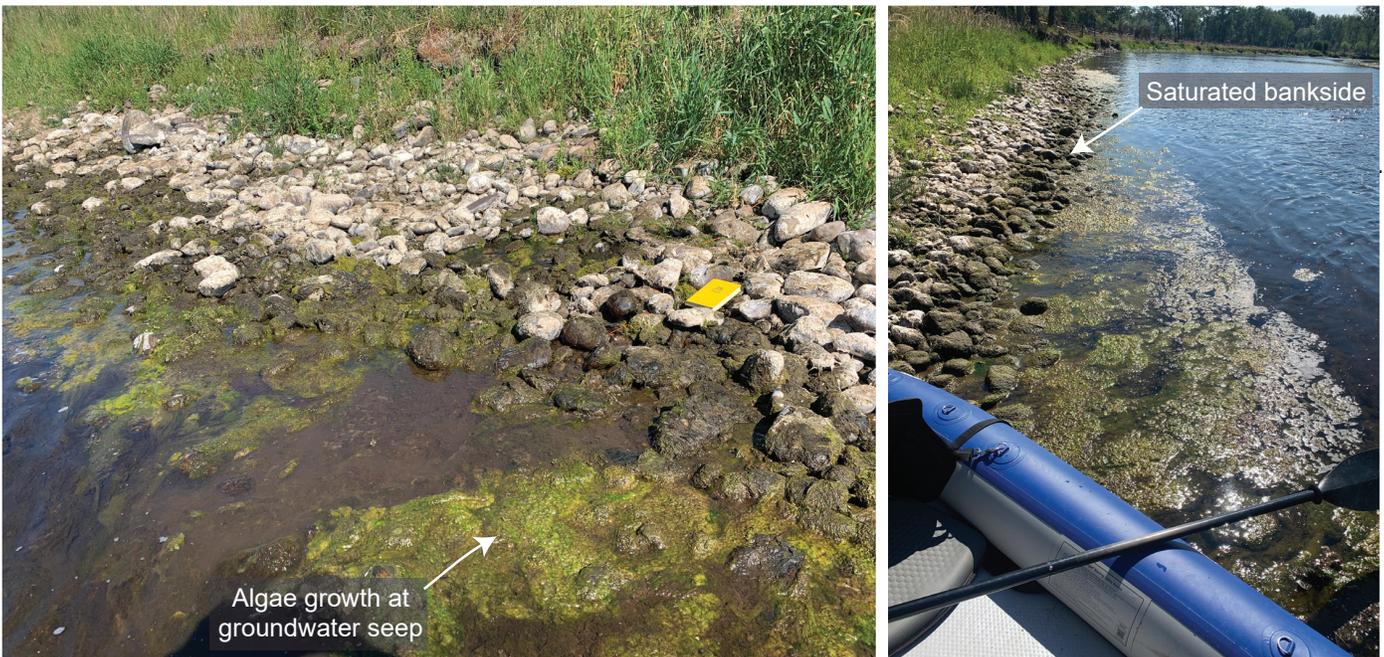
Figure A13.2. Visible signs of the groundwater seep at Site 13 included algae growth along the edge and a saturated riverbank above the river elevation.

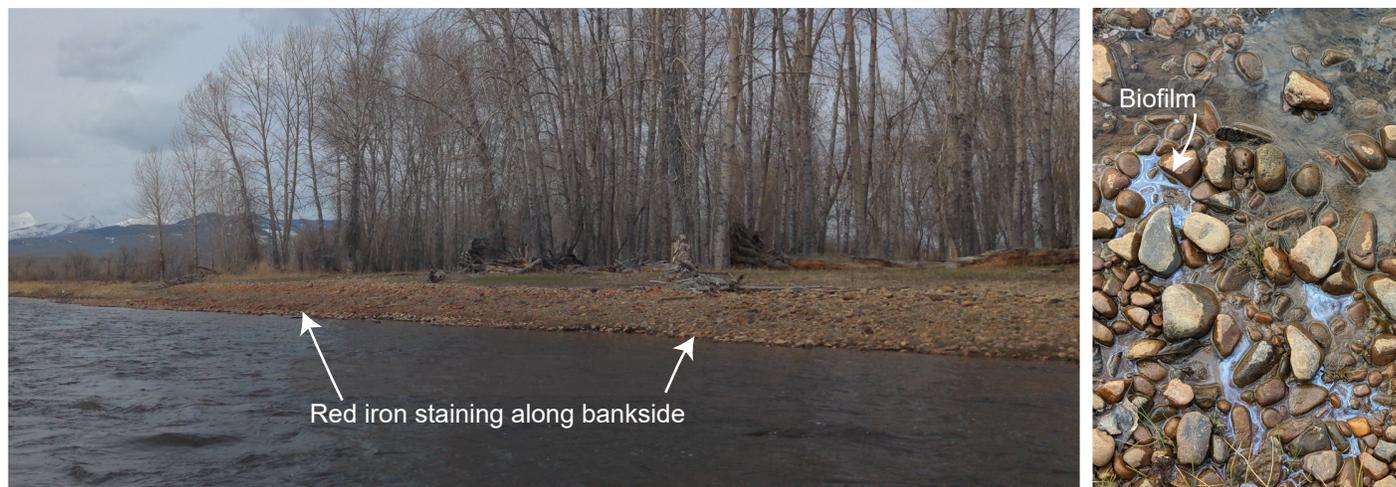
Figure A14.2. Iron-stained riverbank (left) and the biofilm between the cobbles (right).

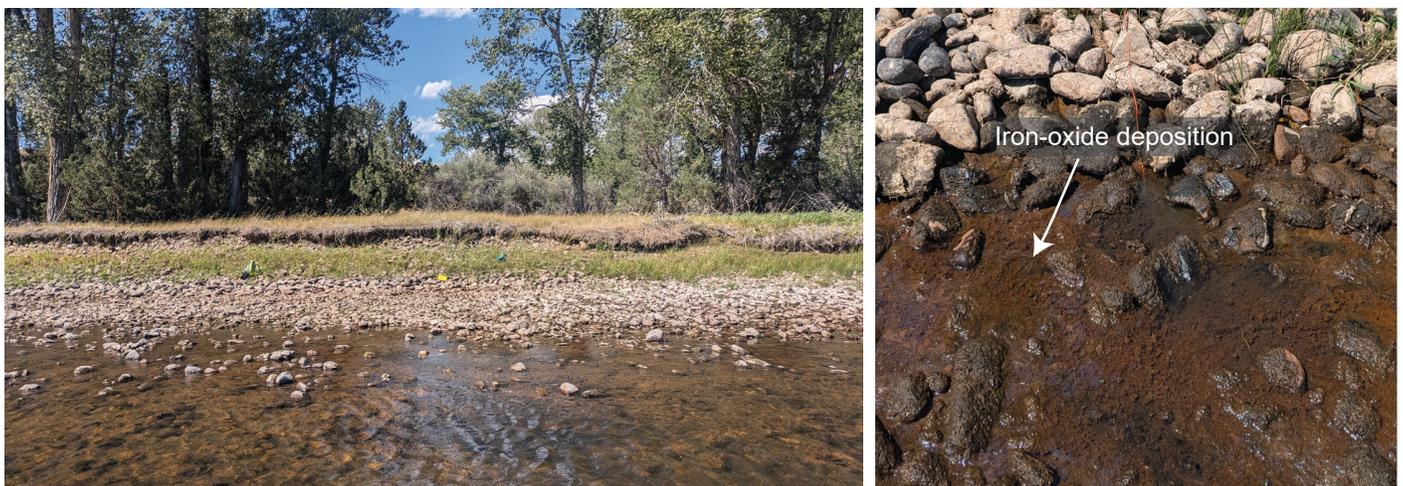
Figure A15.2. The groundwater seep (left) with a close-up showing iron-oxide deposition (right).

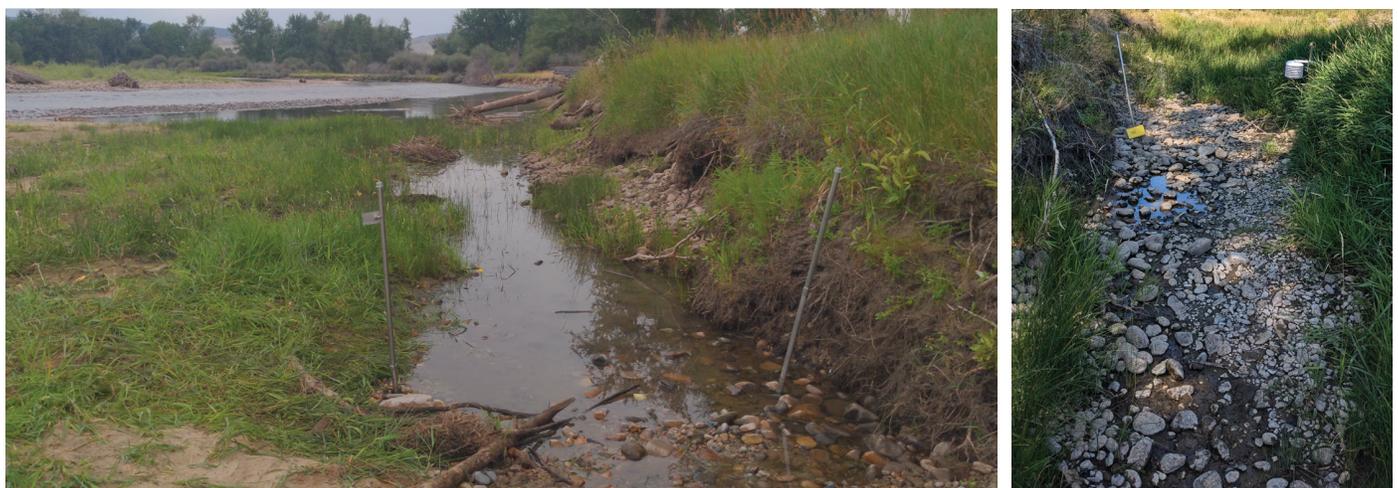
Figure A16.2. The groundwater seep had more ponded water in 2023 (right) than in 2024 (left).

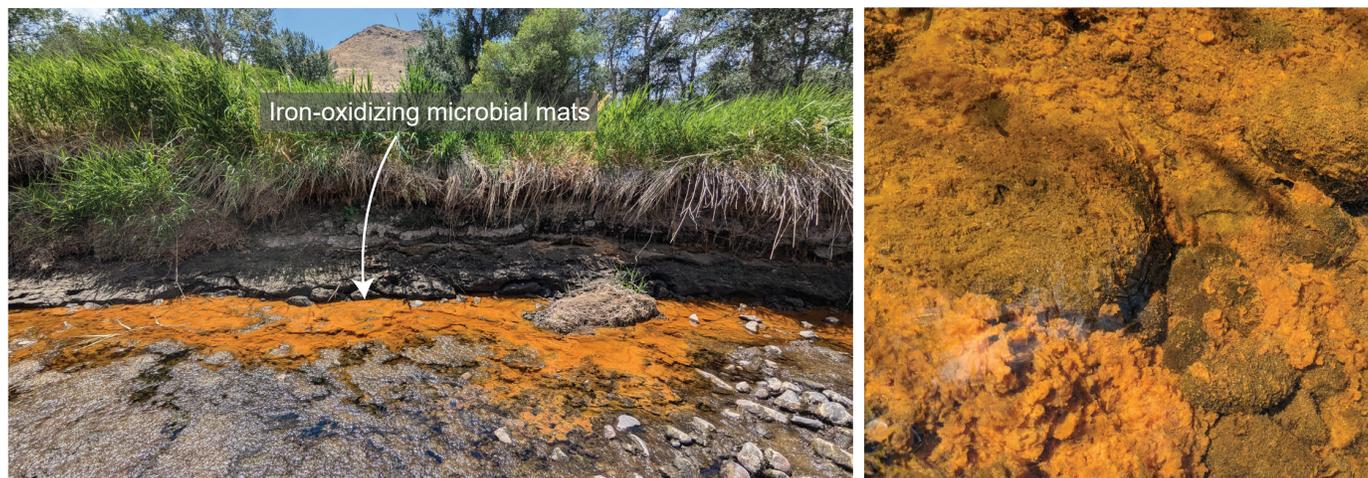
Figure A18.2. Bright orange iron-oxidizing microbial mats at the groundwater seep (left) and a close-up of the iron-oxidizing microbial mats (right).

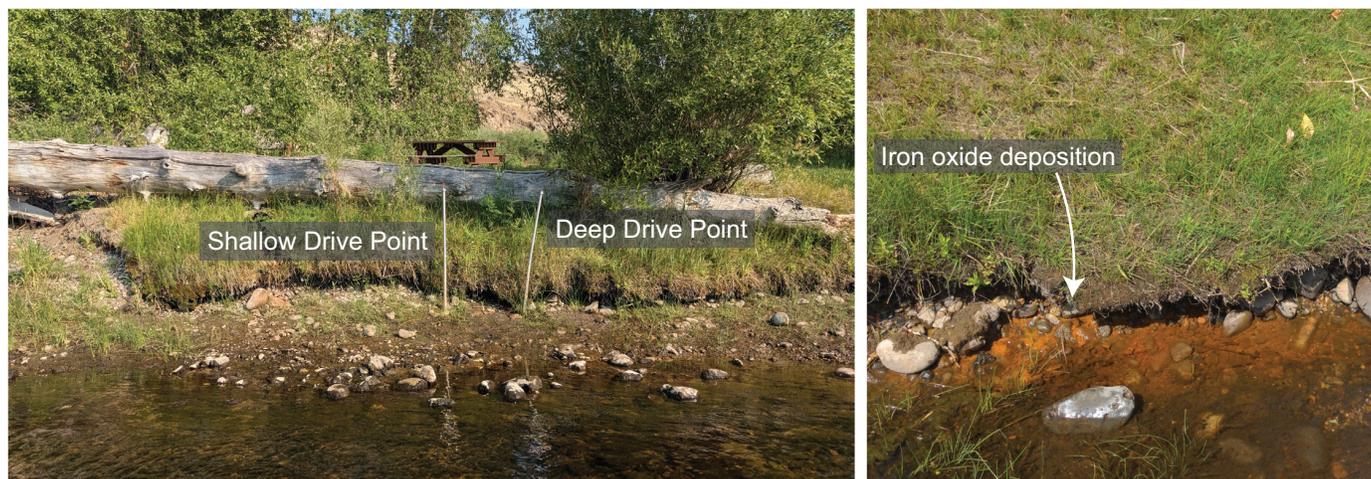
Figure A20.2. The shallow (~1.96 ft deep) and deep (~5.06 ft deep) drive points in the saturated riverbank of the groundwater seep (left). Iron-oxide deposition was commonly seen along the riverbank (right).

Continuous temperature measurements were obtained from all 20 seep sites by burying temperature loggers (HOBO Pendant MX2201, set to record every 15 min) approximately 10 cm deep within the coldest identified area of the seep (tables 1, 2). Drive-point piezometers (Solonist model 615N) were installed at four sites (seeps 2, 4, 16, and 20; fig. 1; table 2) to monitor temperatures and water levels at depths between 1.5 and 5 ft. Pressure transducers (In-Situ

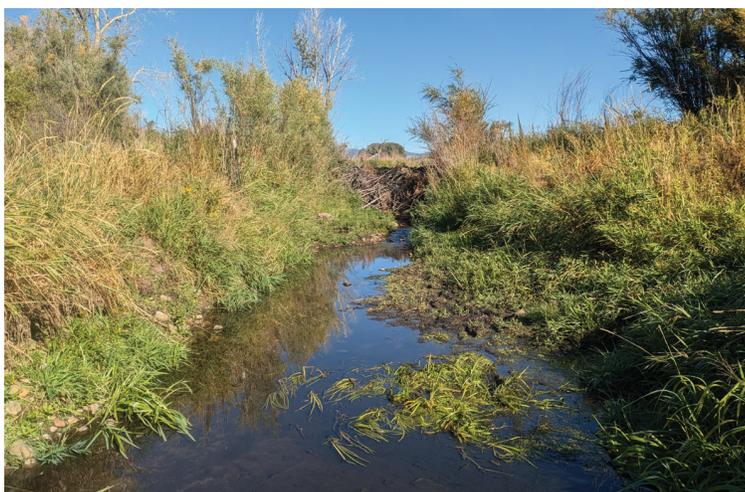
Figure B1.1. The northern tailwater return is ponded behind a stick dam.

Description: The northern tailwater return is a surface-water discharge (0.29–0.55 cfs) to the Big Hole River (see study map in fig. 1). An artificial stick dam backs up water in a large pond (fig. B1.1) that was deepened to allow groundwater to mix with the tailwater before being released into the river. The tailwater return has lower pH, DO, and ORP and higher SC compared to the river (table B1.1). Continuous temperatures showed the water from the tailwater return could be up to 7°C cooler than the river (fig. B1.2).

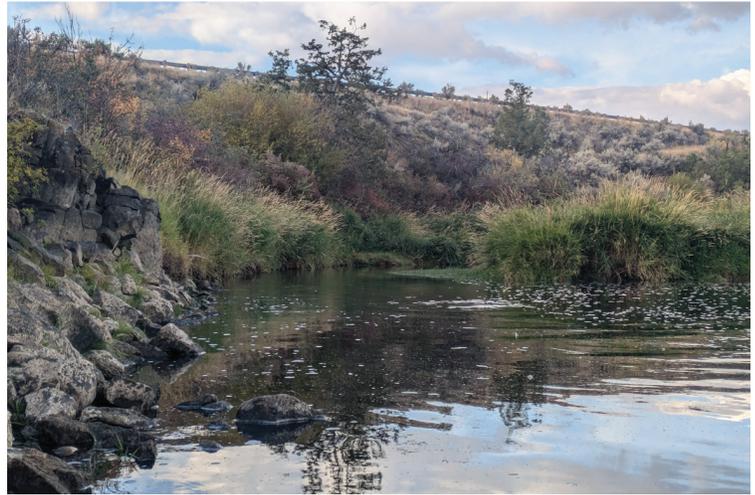
Figure B2.1. The confluence of Willow Creek with the Big Hole River.

Description: Willow Creek is a tributary (9.5–13 cfs) of the Big Hole River (see study map in fig. 1; fig. B2.1). Willow Creek generally had slightly lower pH, DO, and ORP and higher SC compared to the river. However, DO and ORP were higher in Willow Creek compared to the river during some site visits (table B2.1). Willow Creek was consistently cooler than the river during the summer, having temperatures up to 5°C cooler than the river (fig. B2.2).

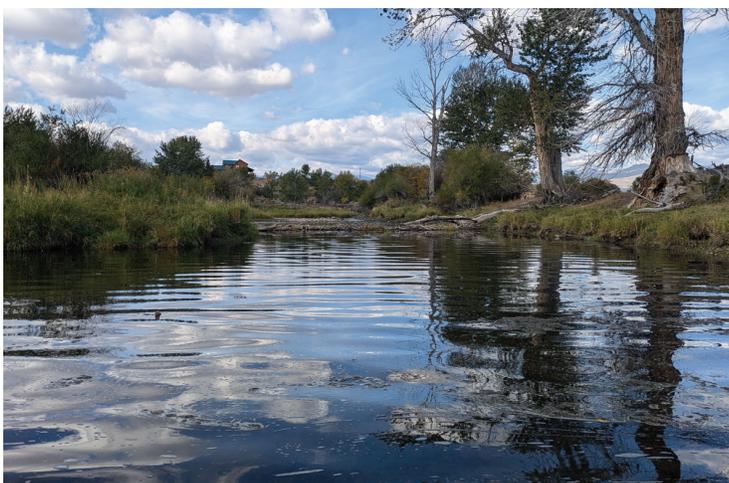
Figure B3.1. The confluence of Birch Creek and the Big Hole River.

Description: Birch Creek is a tributary of the Big Hole River (see study map in fig. 1; fig. B3.1). Prior to joining the Big Hole River, Birch Creek mixes with canal water and/or groundwater (1.76–1.99 cfs). The pH and DO of Birch Creek were lower than the river; ORP could be higher or lower than the river; SC was generally higher in Birch Creek than the river (table B3.1). Birch Creek commonly had warmer temperatures during the late afternoon and cooler temperatures during the early morning compared to the river (fig. B3.2).

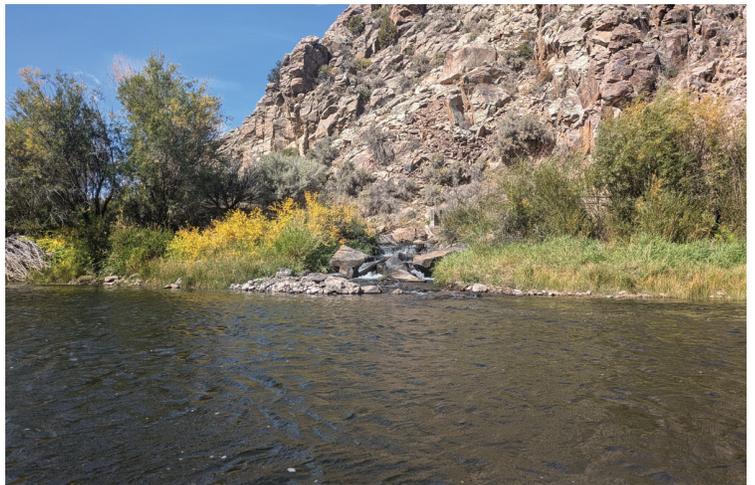
Figure B4.1. Tailwater is ponded and flows over a spillway to the river.

Description: The southern tailwater return is a surface-water discharge (1.05–4.35 cfs) to the Big Hole River (see study map in fig. 1). Tailwater is ponded and flows over a spillway down a series of boulders to the river (fig. B4.1). The tailwater return generally had lower pH and DO, similar ORP, and higher SC compared to the river (table B4.1). The tailwater return had similar temperatures to the river, but did not reach as high of maximums (fig. B4.2).
