**WEST CRANE AQUIFER TEST SUMMARIES,
RICHLAND COUNTY, MONTANA**

**Montana Bureau of Mines and Geology
Ground Water Investigation Program**

February 2021

Montana Bureau of Mines and Geology Open-File Report 737

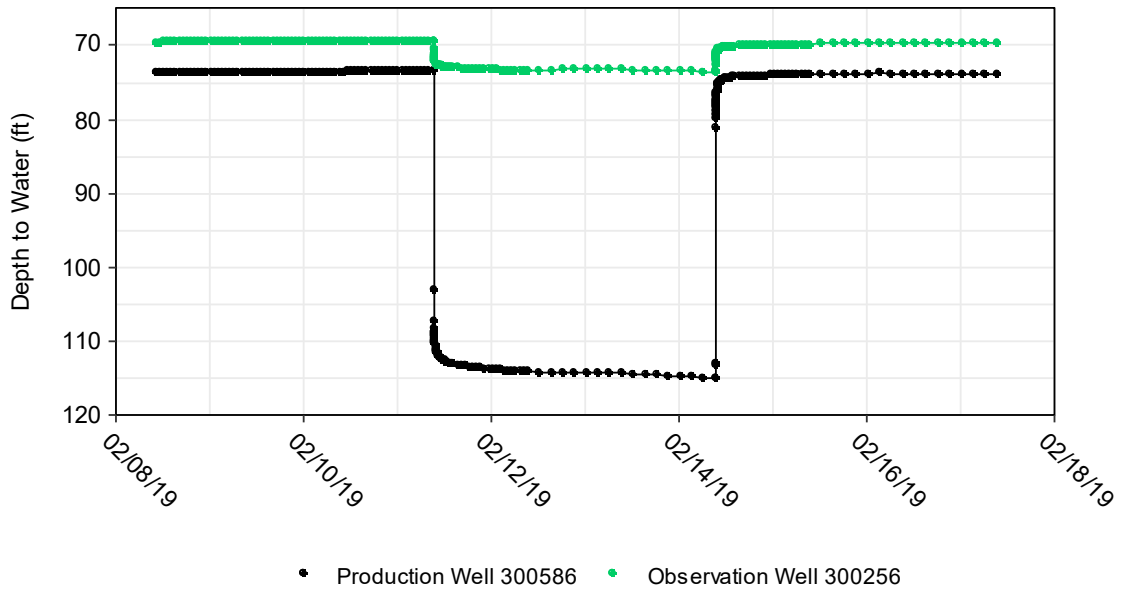
Figure A11. Lange 2 aquifer test background through recovery water levels. Pumping rate appears to have fluctuated in the last part of the test.

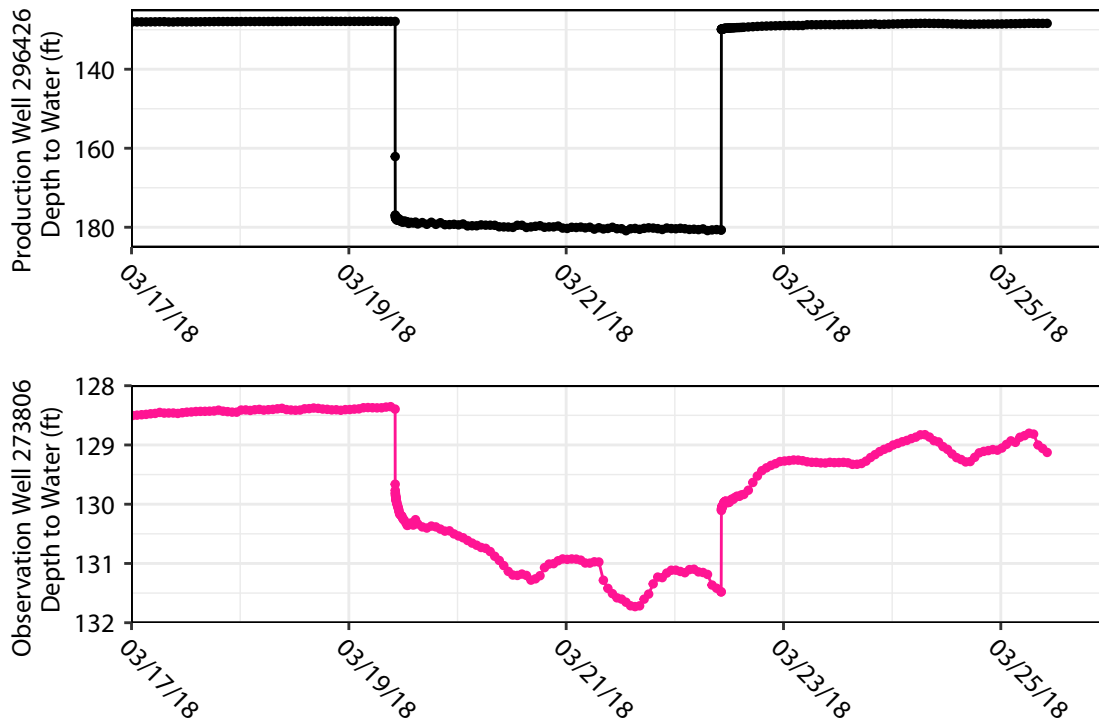
Figure A14. Lange 2 aquifer test background through recovery water levels. Pumping rate appears to have fluctuated in the last part of the test.

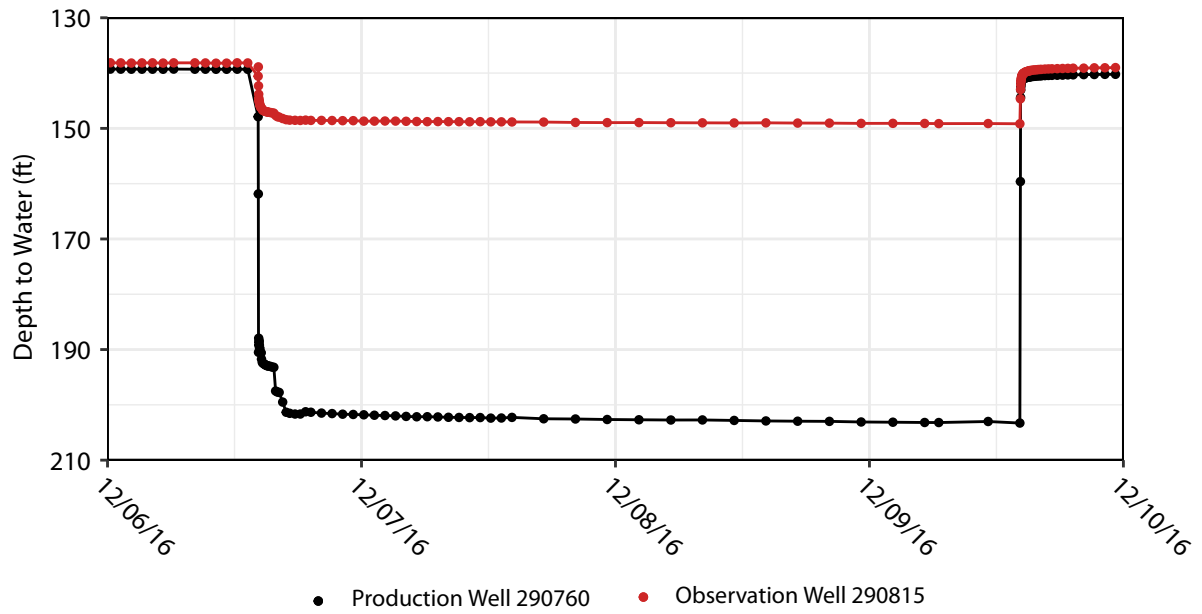
Figure A19. D. Jorgenson 1 aquifer test background through recovery water levels.

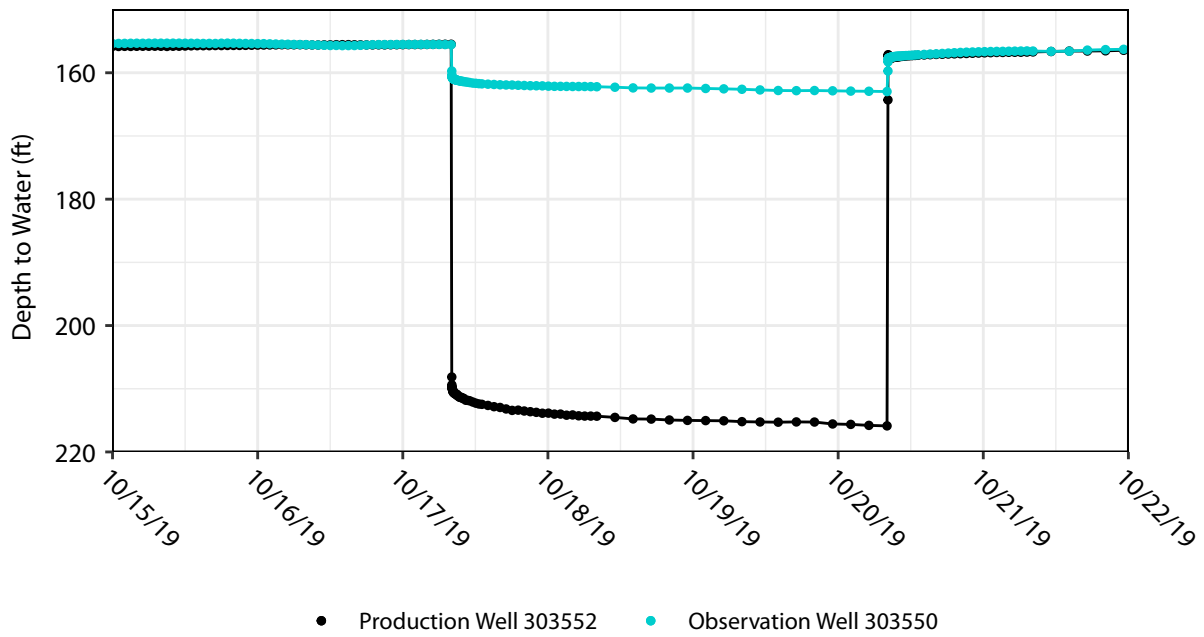
Figure A28. J. Jorgenson 1 aquifer test background through recovery water levels.

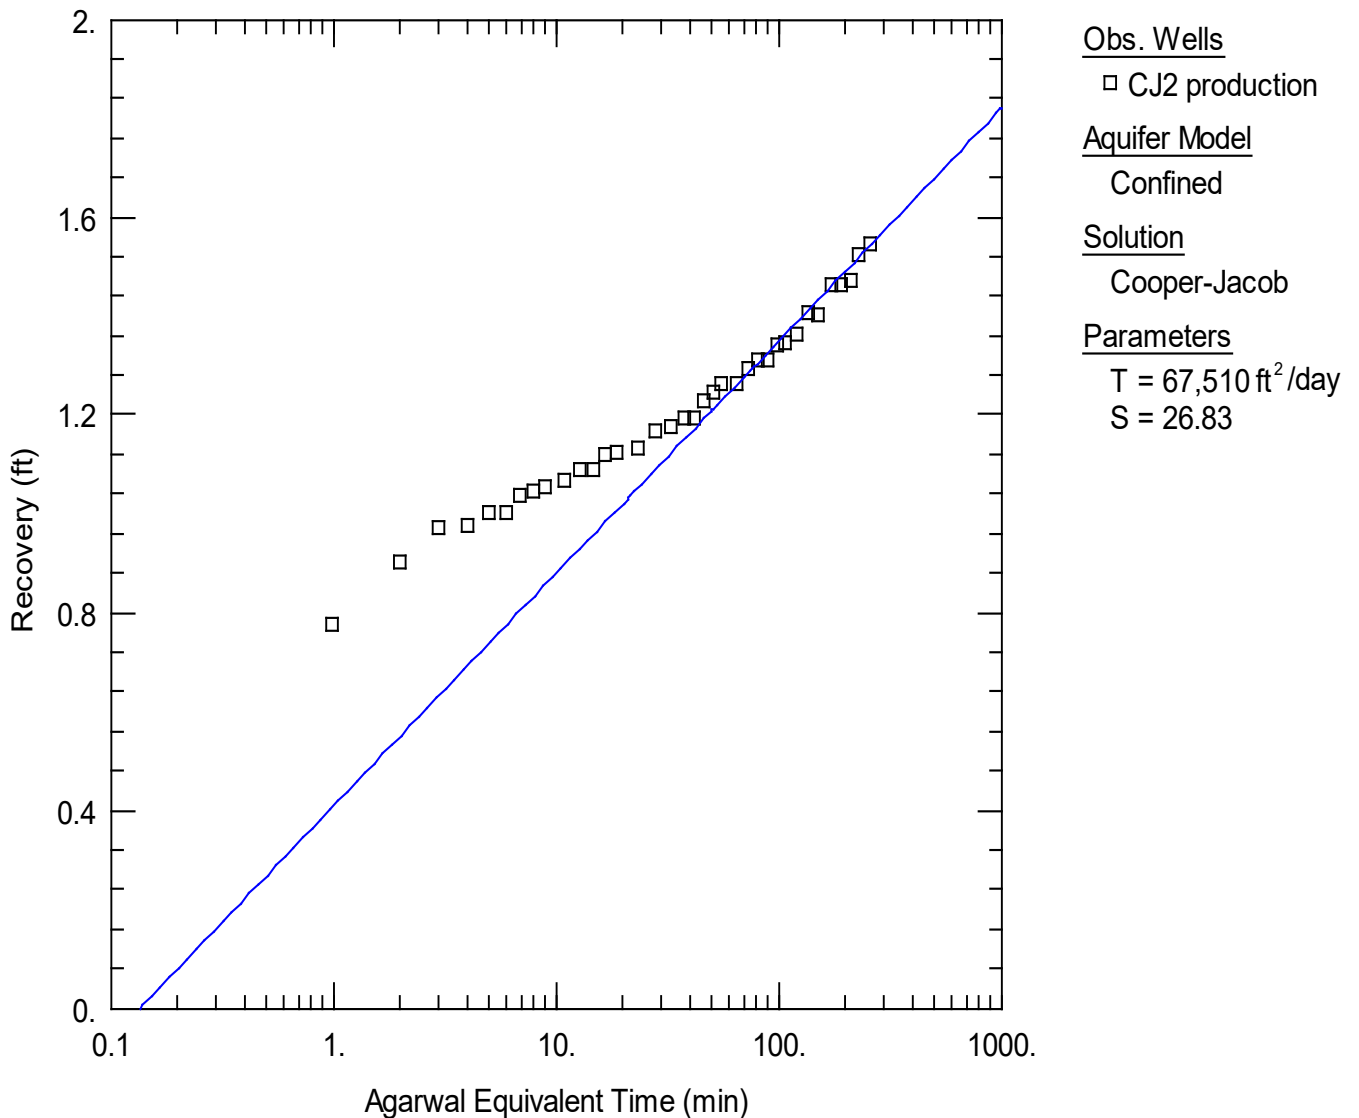
Figure A65. C. Johnson 2 aquifer test showing Cooper–Jacob confined aquifer recovery solution.
