**MONTANA BUREAU OF MINES AND GEOLOGY
OPEN-FILE REPORT
MBMG 401-J**

**HYDROGEOLOGIC ASSESSMENT OF THE
STOCKETT, MONTANA PUBLIC WATER SUPPLY
FOR GROUND WATER UNDER THE DIRECT
INFLUENCE OF SURFACE WATER**

**Prepared
for
Montana Department of Environmental Quality
Water Quality Division
by
Kirth Erickson & John R. Wheaton
Montana Bureau of Mines and Geology
May, 2000**

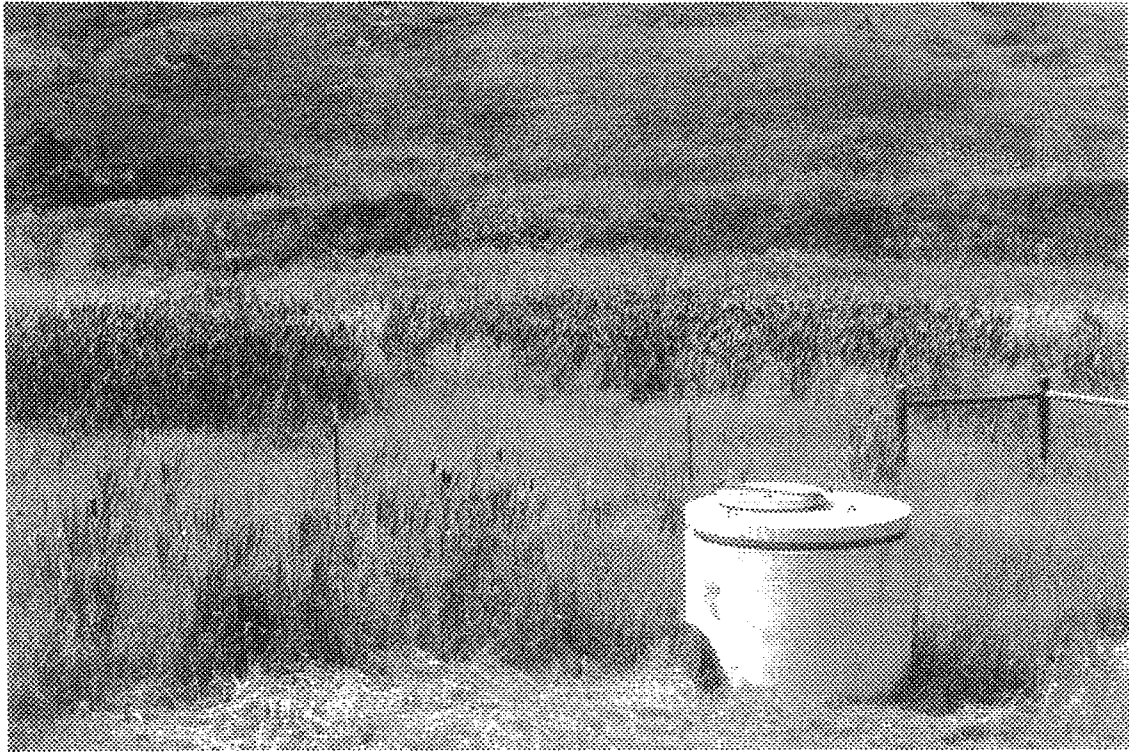
Stilling well for Stockett city water supply infiltration gallery.

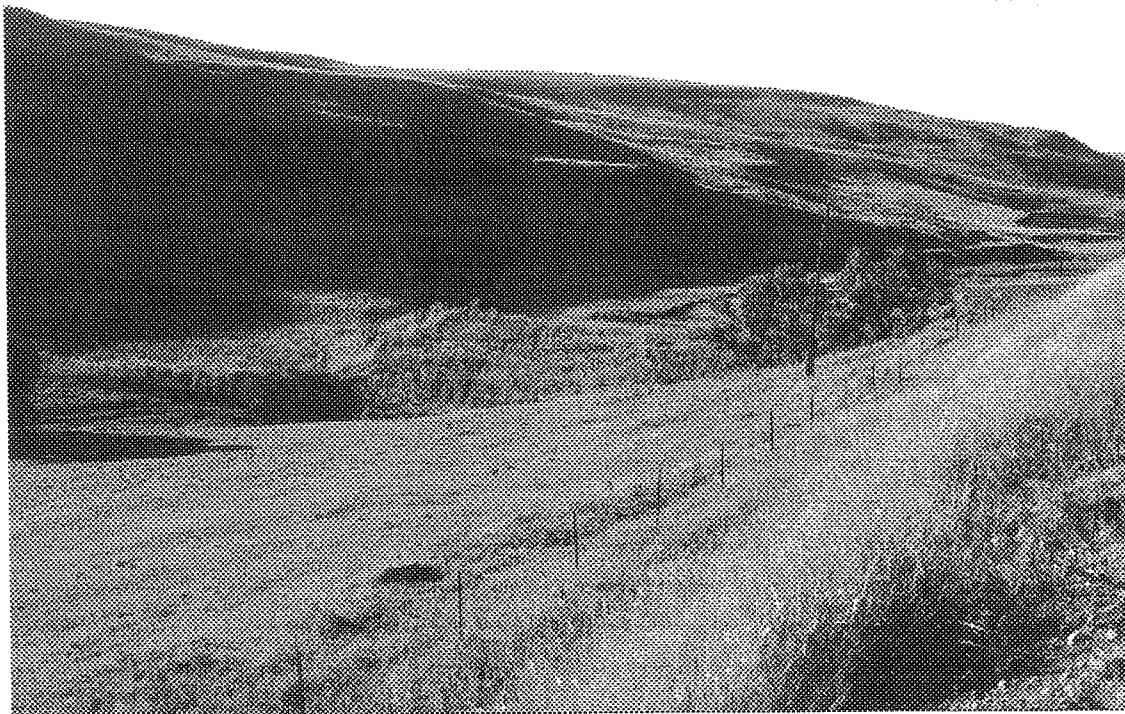
View of Cottonwood Creek looking northwest. Stockett city water supply collection gallery is just right of center of the picture, near the valley bottom.
