**HYDROGEOLOGIC ASSESSMENT OF THE SURPRISE CREEK RANCH COLONY
WATER SUPPLY
FOR
GROUND WATER UNDER THE DIRECT INFLUENCE OF SURFACE WATER**

**Open-File Report
MBMG 401-O**

**Surprise Creek Ranch Colony
PWSID #00391
Box 310
Stanford, Montana 59479**

**by
James Rose
Montana Bureau of Mines and Geology**

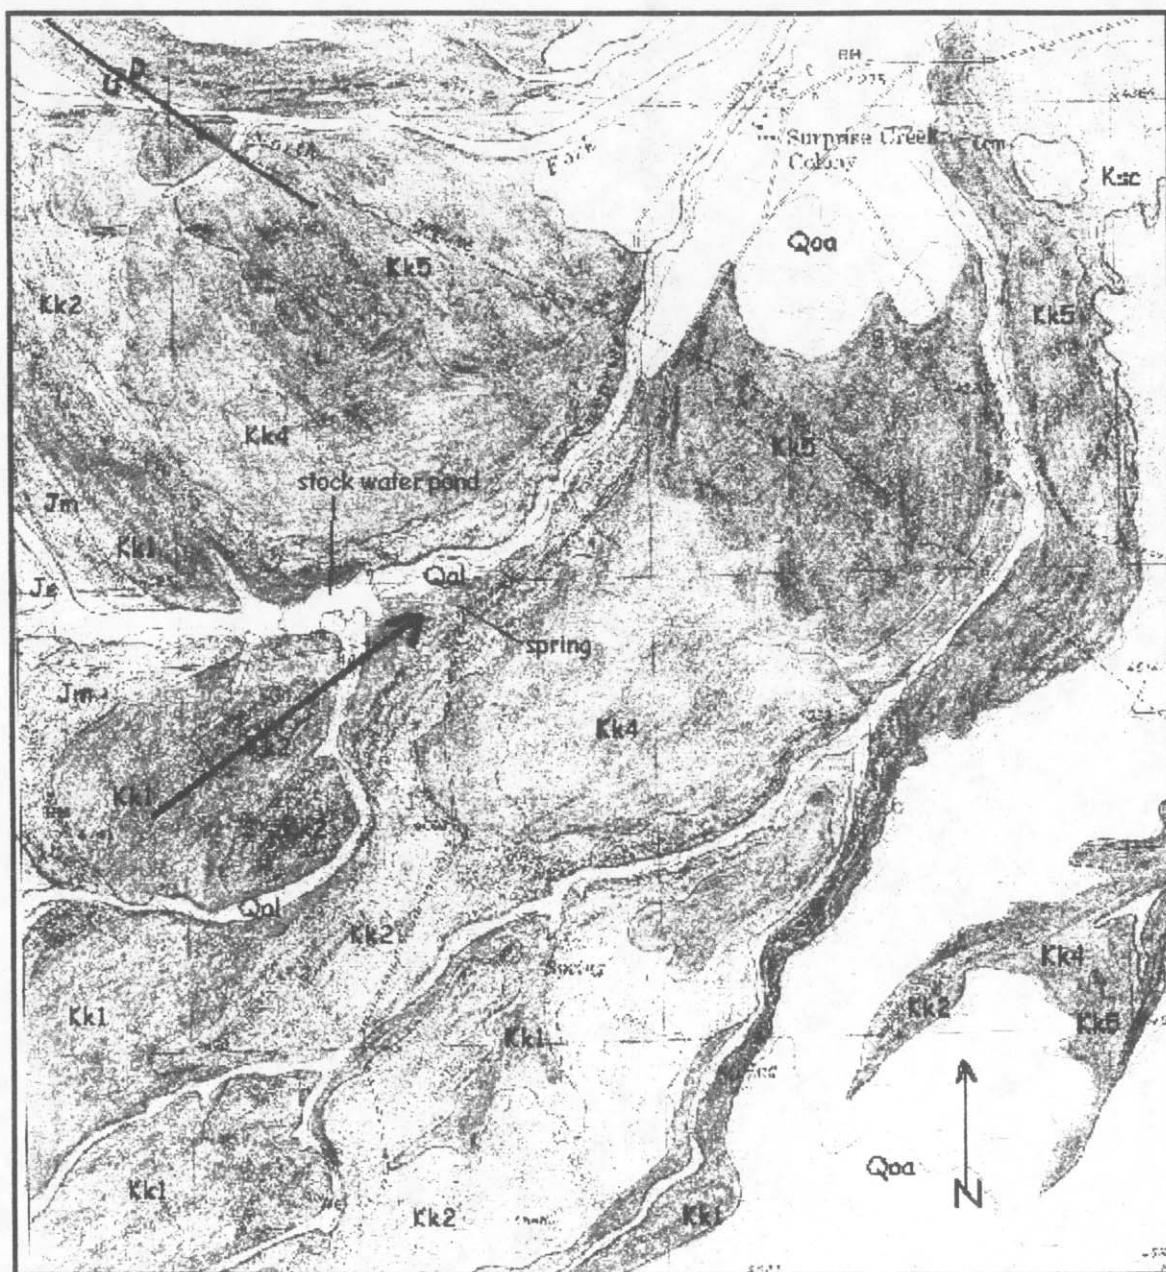
The hills on the Surprise Creek Ranch are composed of outcrops of Kootenai Formation sandstones and mudstones (figure 4 and appendix B, photos B-1, B-2 and B-3). The bedrock layers dip gently, 5-10° to the northeast, toward the Judith Basin, and are covered locally by remnants of the older fan- and stream-deposited alluvium (Qoa) (Susan Vuke, MBMG, unpublished maps, 2000). Along the drainage bottoms the bedrock is covered by a thin layer of Quaternary alluvium (figure 4 and appendix B, photo B-3). The ranch buildings are situated on the older Quaternary age alluvial fan and stream channel deposits (terrace gravels) (figure 4).

Figure 4. Geologic map of the Surprise Creek Ranch Colony area. The arrow shows the approximate direction of ground-water flow to the spring. The geologic formations mapped include 1) Jurassic Ellis Group (Je), 2) Jurassic Morrison Formation (Jm), 3) the Cretaceous Thermopolis Shale, 4) four members of the Cretaceous Kootenai Formation: the Cutbank Sandstone Member (Kk₁), the Second Member (Kk₂), the Fourth Member (Kk₄), and the Fifth Member (Kk₅), 5) Quaternary alluvium (Qal), and 6) old Quaternary alluvium (Qoa). From Susan Vuke (MBMG, unpublished maps, 2000) and USGS, 1978.

Recharge to the Cutbank Sandstone in the area of the spring is limited to the outcrops of sandstone between the Morrison Formation (Jm) and the Second Member mudstone (Kk₂) (figure 4). The portions of the recharge area most vulnerable to contamination from surface sources are the area immediately around the spring, the hillside of mudstone south of the spring that directs overland flow toward the well, the outcrops of the Cutbank Sandstone (Kk₁), including the exposures at the stock pond, and the Quaternary alluvium along the drainages above the spring to the south and west.

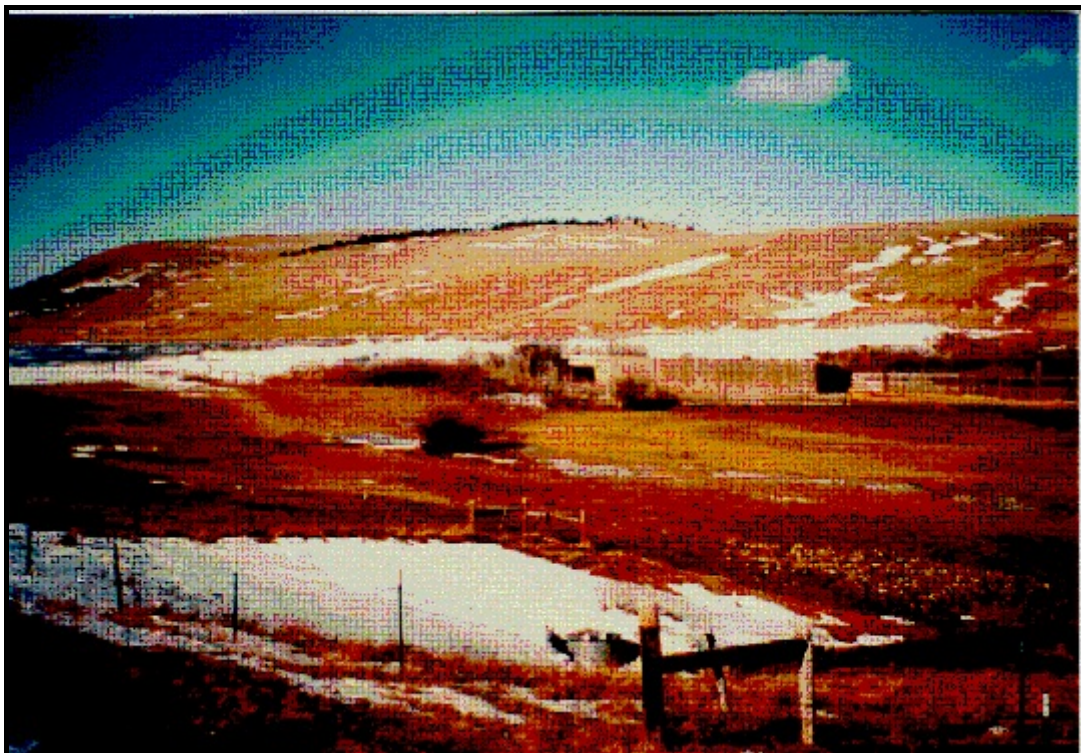
- Short grass and sheep droppings are evidence of frequent sheep grazing around the spring, outside of the fenced area (appendix B, photos B-2 and B-3). The immediate area around the spring site is fenced off to keep animals out.

Figure B-2. Overview of spring site and the Surprise Creek drainage. The spring is located in an incised side drainage along the south side of the Surprise Creek drainage. The ranch's stock pond is visible in the left background.

- Livestock should be restricted from areas west and south of spring, especially on the alluvium in the drainage west and south of the spring, from the Cutbank Sandstone outcrops west and south of the spring and from the hillside south of the spring. Maintain the existing fence around the spring.

- The long term historic use of the stock pond has no doubt created a large amount of animal waste around the pond and could produce a long-term source of potential ground water contamination. This may require the spring site to be abandoned as a water source as no clear solution could be identified. Draining the pond may reduce the amount of infiltration of surface water into the spring system.

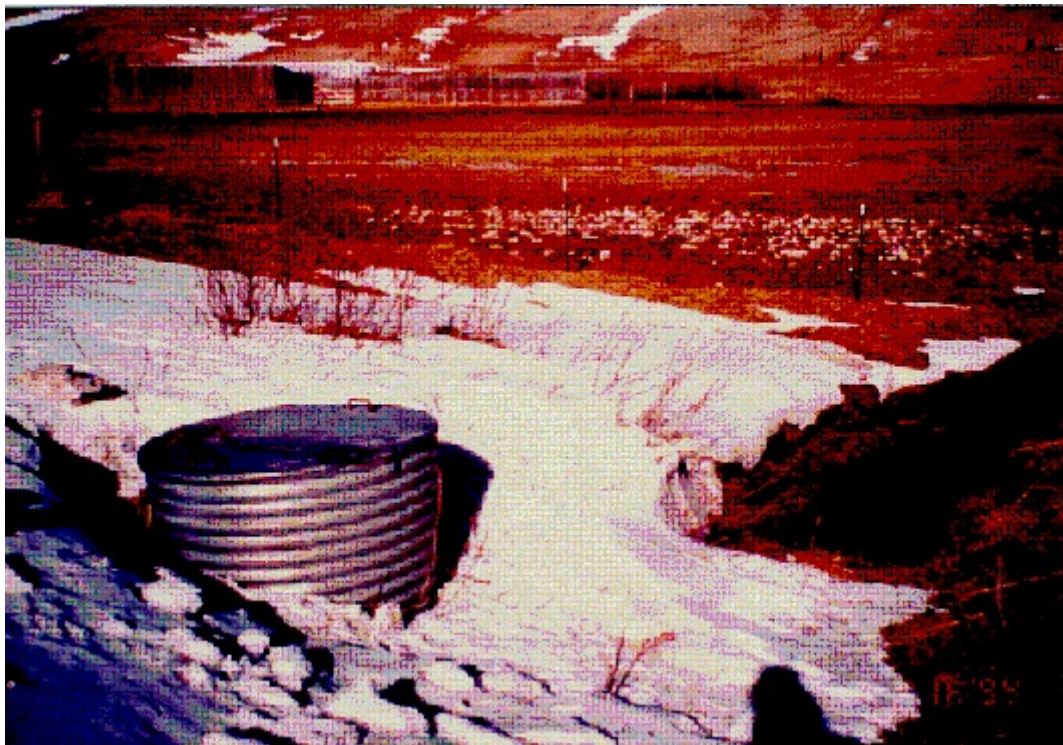
Recommendations from previous DHES inspections suggested a tighter, locked cover should be placed on the spring culvert for security and to keep rodents and insects out (DHES memo, 1983). At the time of the HA inspection, a metal cover was in place but it did not form a tight seal over the culvert pipe and the lid was not locked (appendix B, photo B-4).

The construction of the culvert casing around the spring may allow infiltration of rainfall and snowmelt into the ground water through openings between the culvert and the ground. The area around the spring is fenced to keep animals from the area immediately around the well, but the

Figure B-4. Close-up view of culvert over spring discharge area. As the drifted snow melts, the water probably infiltrates into the ground around the culvert.

- providing a tight seal on the culvert-pipe lid over the spring, and placing screen covers over the overflow pipe and vents on the water supply system to prevent rodents and insects from entering the system.

- Inspecting the grout seal around the culvert for cracks and adding bentonite grout to improve the seal between the culvert and the land surface. The grout should be built-up around the culvert to allow surface water to drain away from the culvert pipe.
- Mound dirt in the drainage above the culvert to divert surface drainage away from the spring.
- Extra precautions should be taken when handling or transporting materials on the access road above the spring to ensure nothing is spilled near the spring that could contaminate the well.

- The entire system should be inspected for potential leaks or openings that might allow rodents and insects to enter the water system. A tight seal should be made for the culvert lid over the spring.

- The grout seal between the ground and the culvert pipe over the spring should be inspected to ensure that the seal is adequate to prevent the infiltration of surface water into the spring. The grout should be built up around the culvert to direct the drainage of surface water away from the culvert. Build up a dirt mound above the culvert to divert surface runoff water away from the spring from the drainage depression above the spring.
