MONTANA BUREAU OF MINES AND GEOLOGY

ABANDONED - INACTIVE MINES PROGRAM

DEERLODGE NATIONAL FOREST

VOLUME II
CATARACT CREEK DRAINAGE

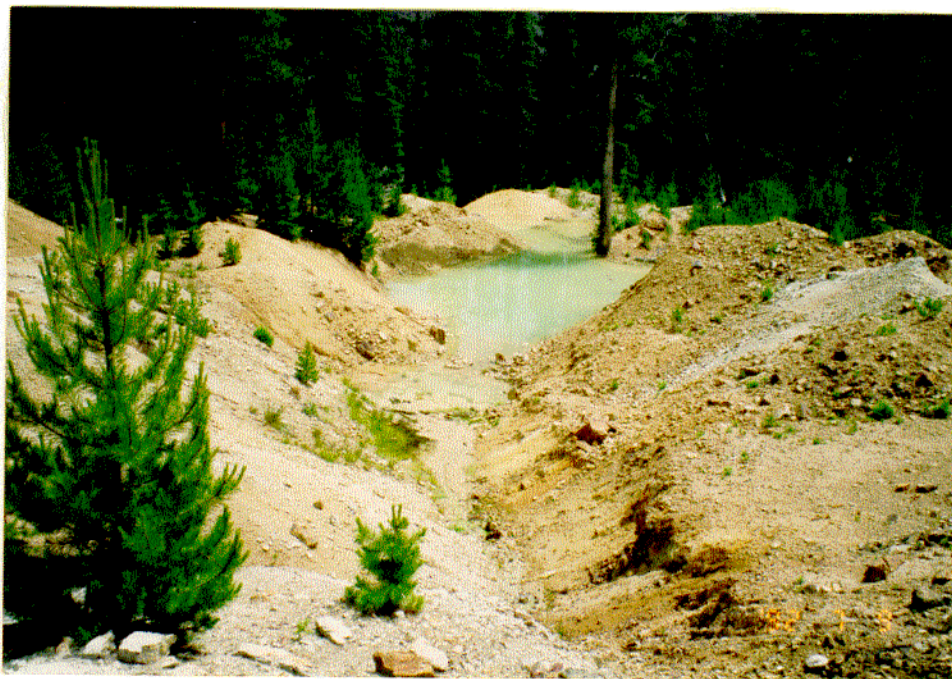
Figure 4A. After spring runoff and precipitation events, water ponds in the lower end of the cat cut.

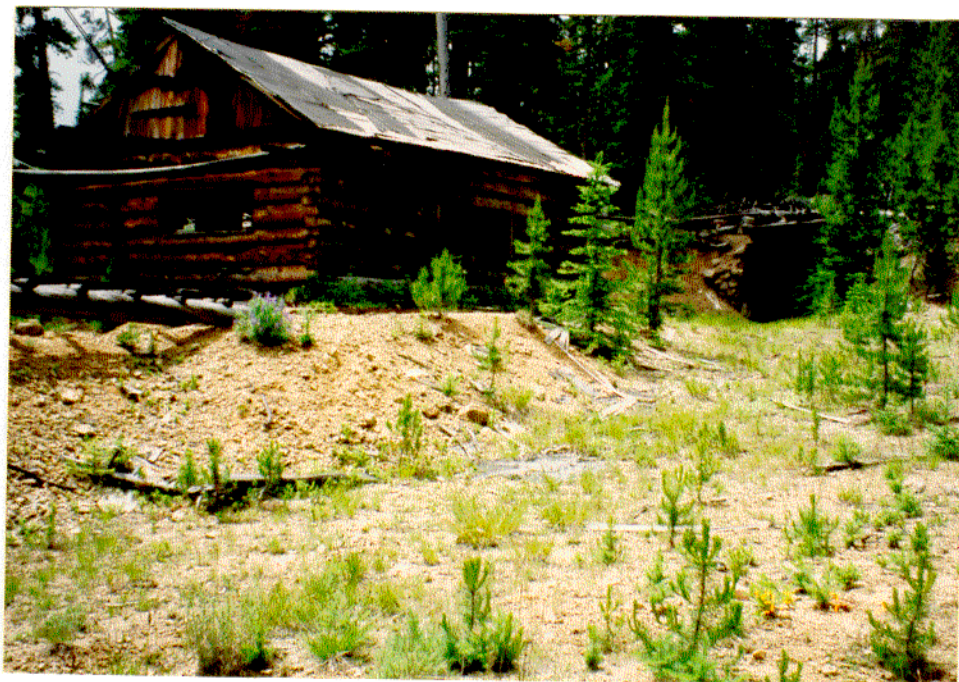
Figure 4B. The adit (right of the building) was dry, but a seep broke out just below the building and flowed toward the wetlands area.

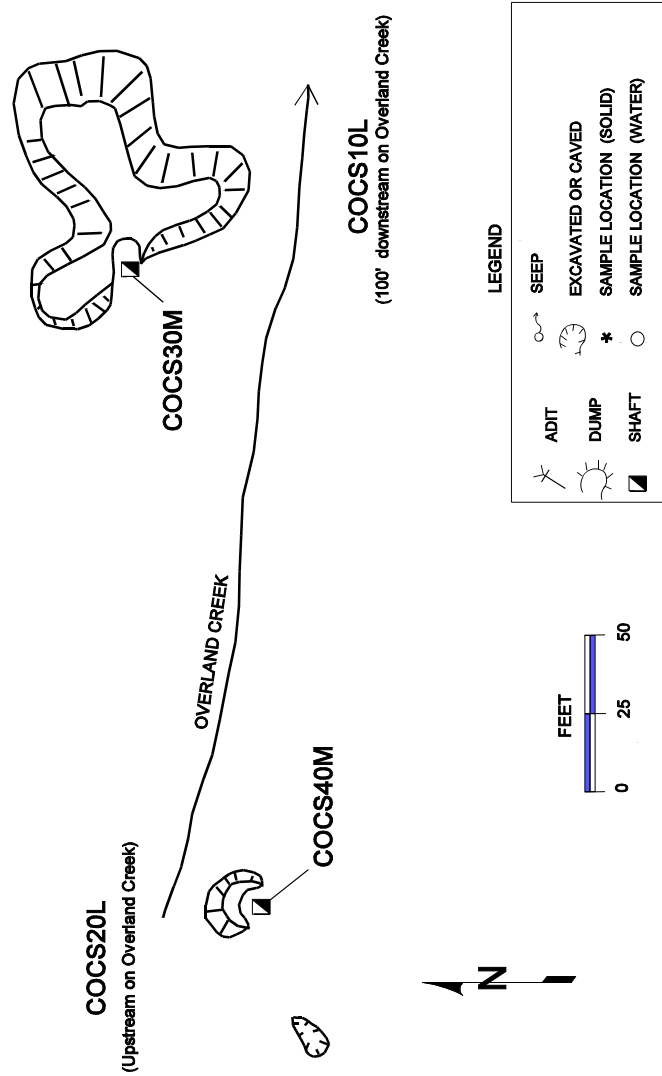
Figure 5 The Overland Creek mine is adjacent to Overland Creek and consists of two shafts and associated dumps. Overland Creek has been placer mined in this area.

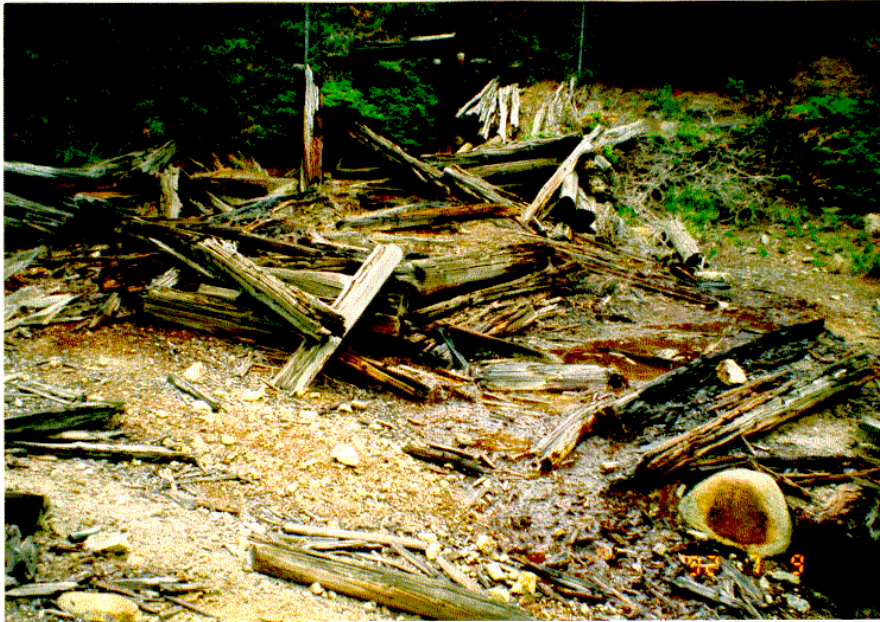
Figure 6A. A spring emanated from the hillside next to the main adit. This spring infiltrated the ground below the dump.

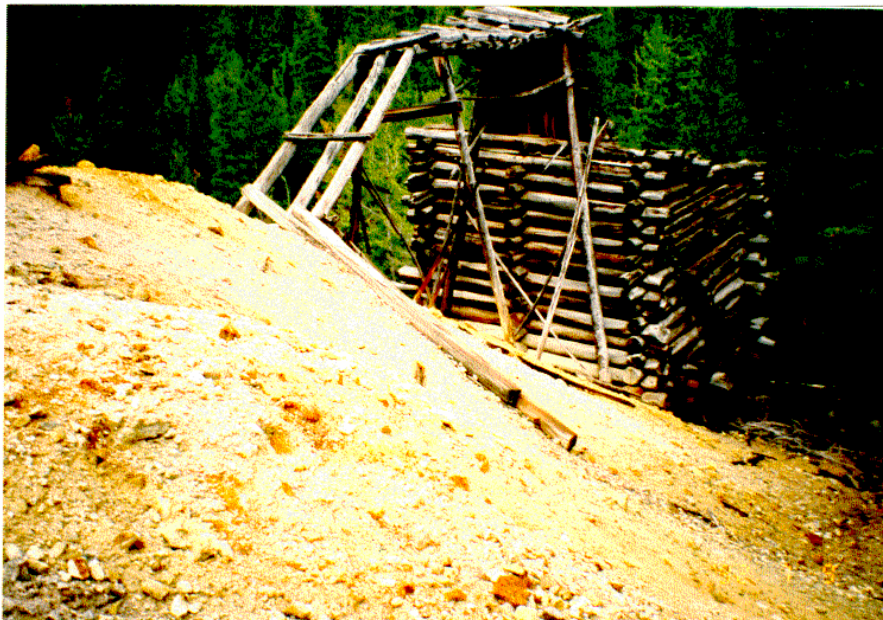
Figure 6B. Material from the waste-rock dump has been eroded and deposited on native soils below the dump. Some of this material is probably washed into the creek during runoff or precipitation.

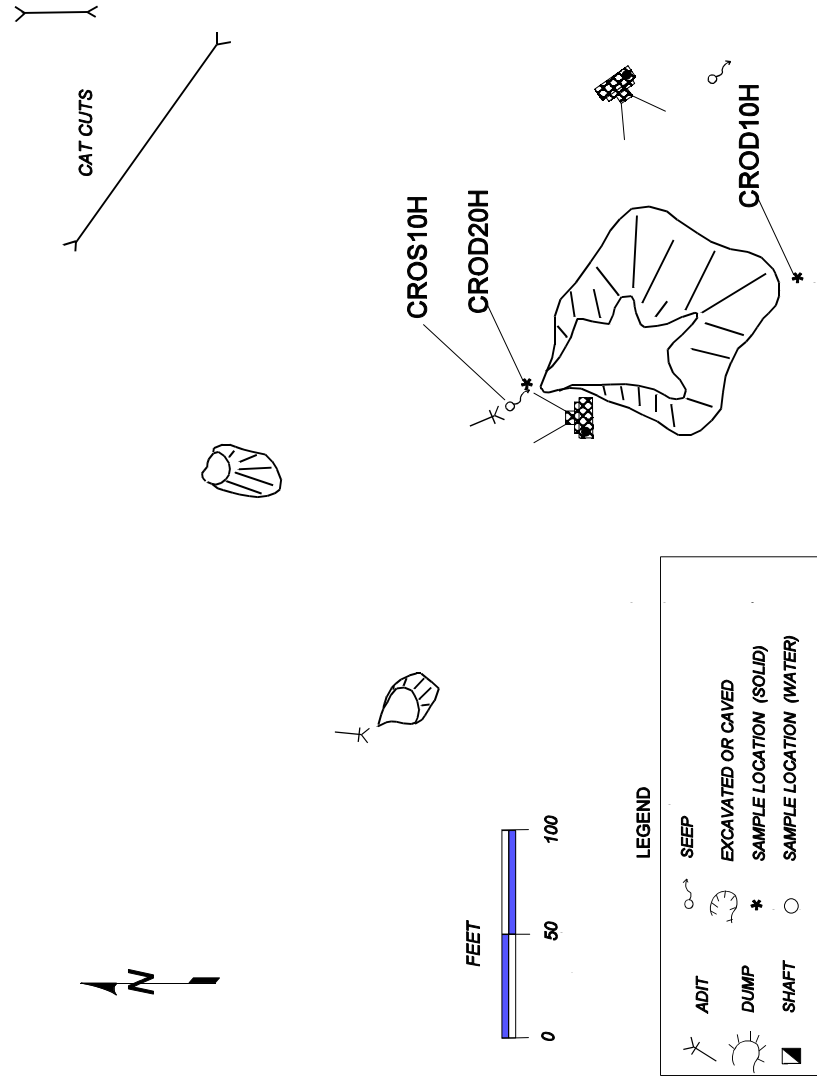
Figure 7 The Rocker mine is up slope from Rocker Creek. Although there were several small workings, only one adit discharged water. Soil down slope of the waste-rock dump appeared to have been impacted.

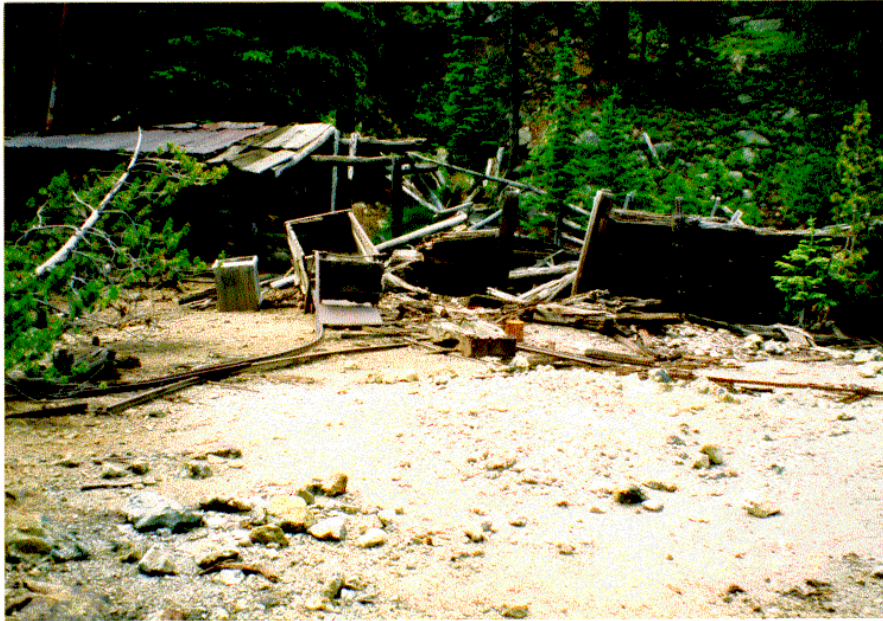
Figure 7A. The adit issued a small discharge that infiltrated the ground before reaching Rocker Creek. There were several structures in poor repair near the caved adit.

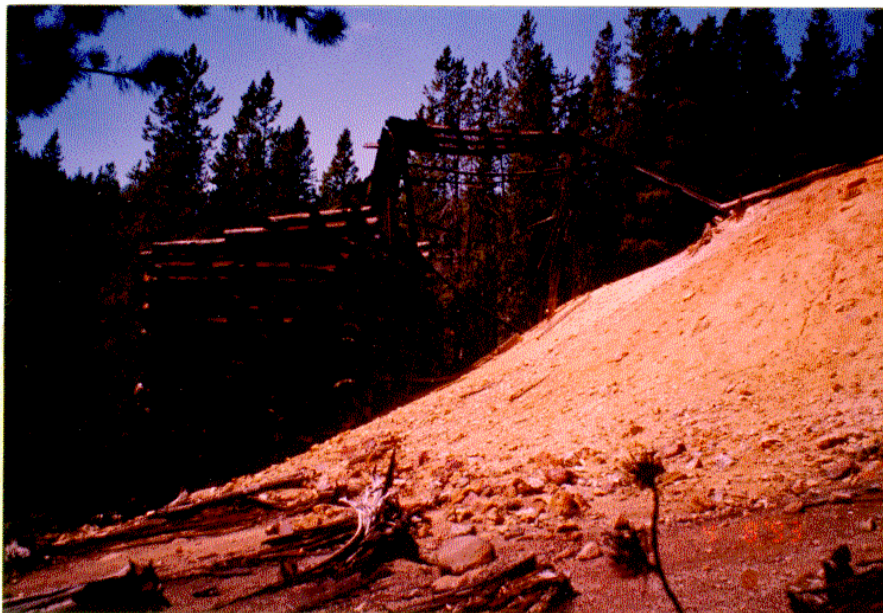
Figure 7B. Material from the waste-rock dump has been eroded and washed onto native soils below the dump.

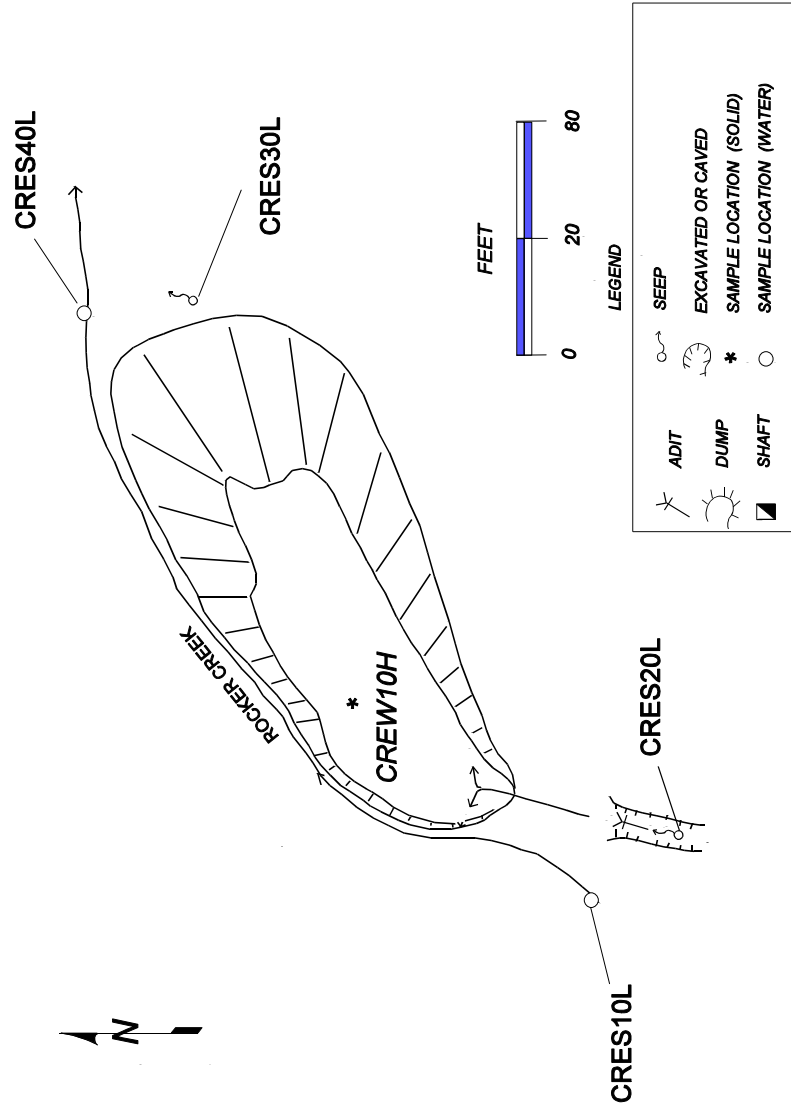
Figure 8 At the Rocker Extension mine, the adit discharge and the springs at the base of the waste-rock dump discharge directly to Rocker Creek.

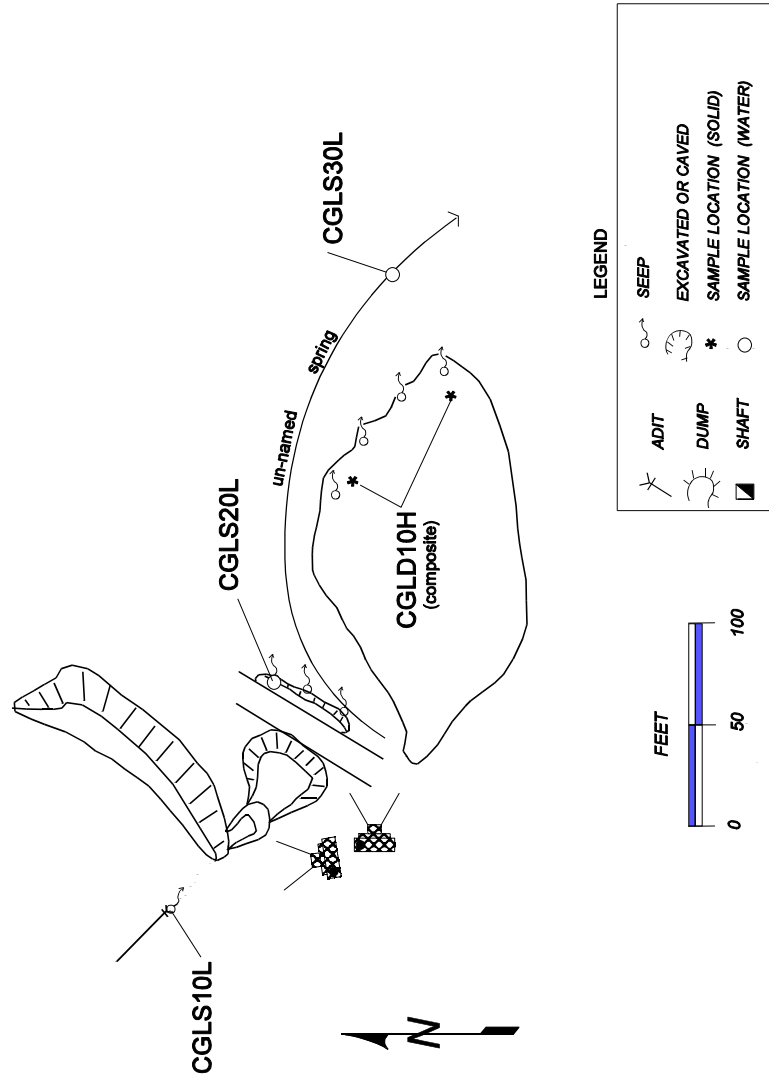
Figure 9 The Gray Lead mine adit discharges water. The greatest impact at this site, however, is the seeps and tailings wash down slope of the tailings impoundment.

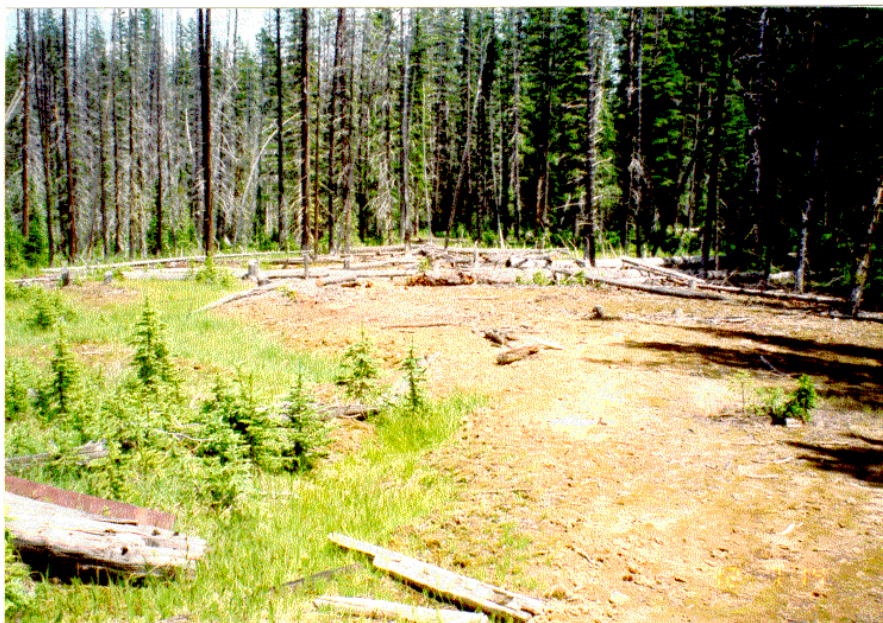
Figure 9A. Tailings from the Gray Lead mill have been washed toward the small stream. Several seeps break at the lower end of the tailings.

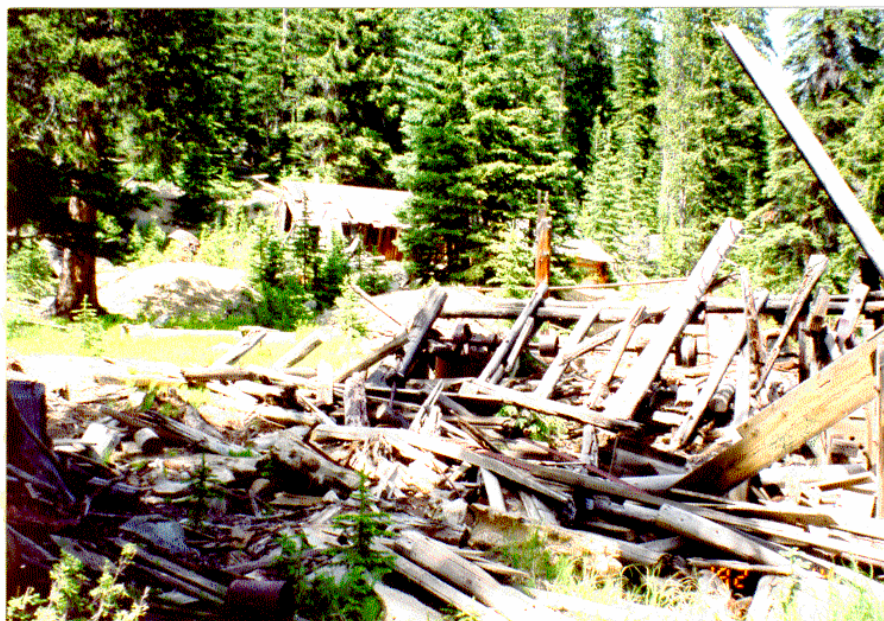
Figure 9B. The mill has been partially dismantled or has collapsed (foreground). The waste-rock dumps and adit were near the cabin (background).

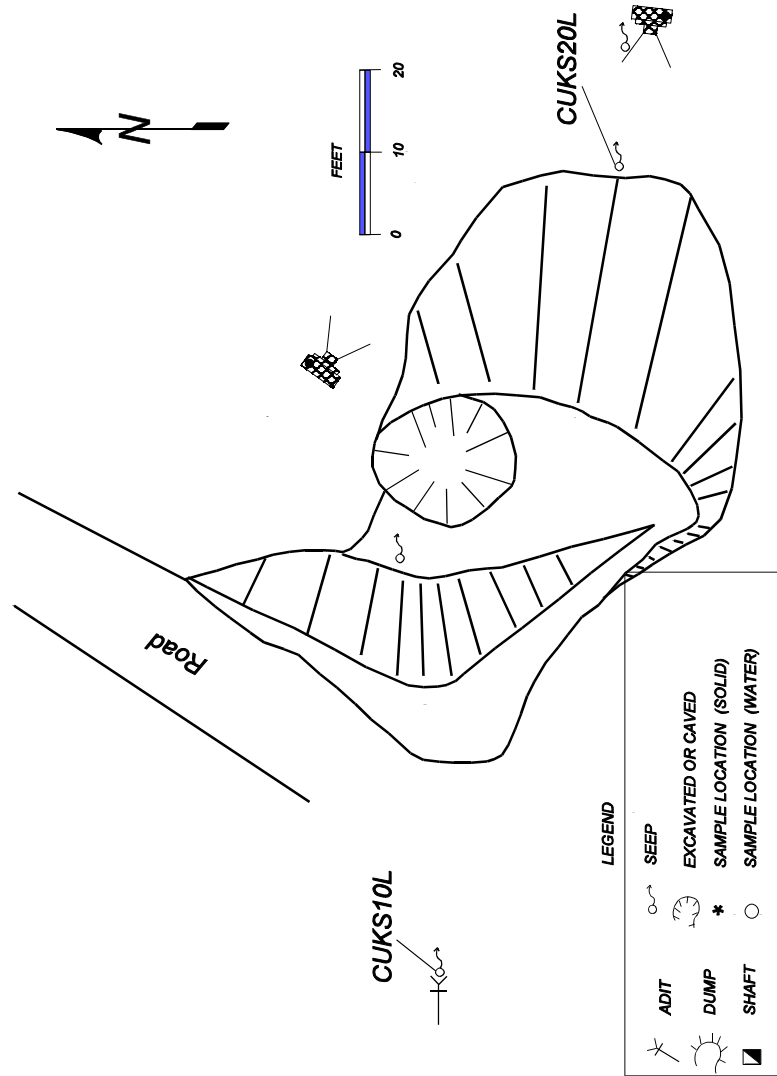
Figure 10 The Unnamed #2 mine discharges water from the caved adit and from the base of the waste-rock dump. Closed depressions in the dump may act as local recharge areas for the seeps.

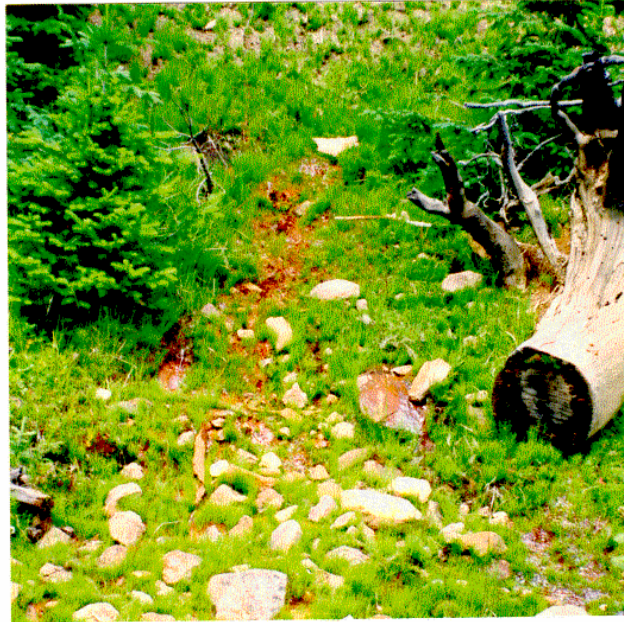
Figure 10A. There were at least two seeps at the base of the waste-rock dump. Ferric-hydroxide staining was evident in the seep closest to the dump.

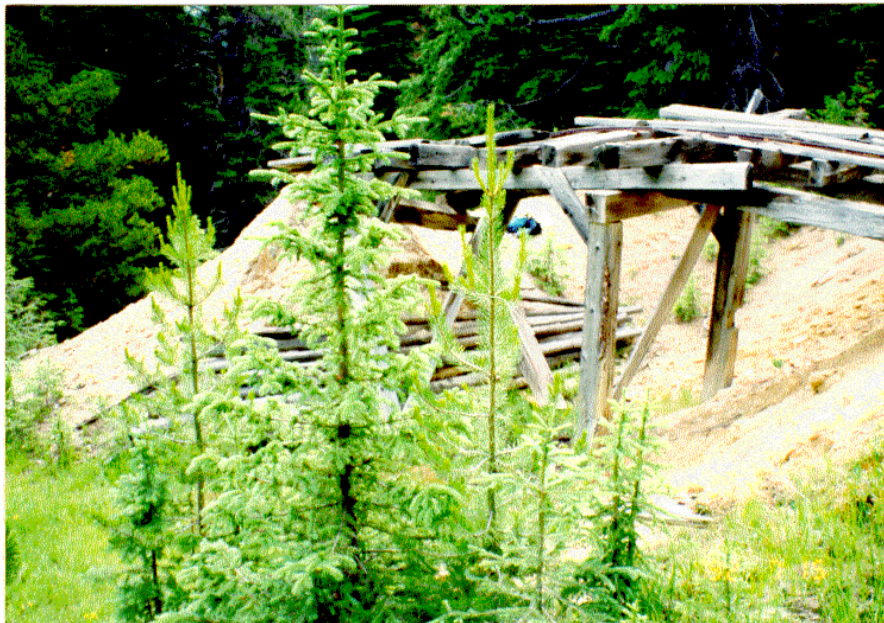
Figure 10B. The base of the waste-rock dump was generally well vegetated. Vegetation on the dump was sparse.

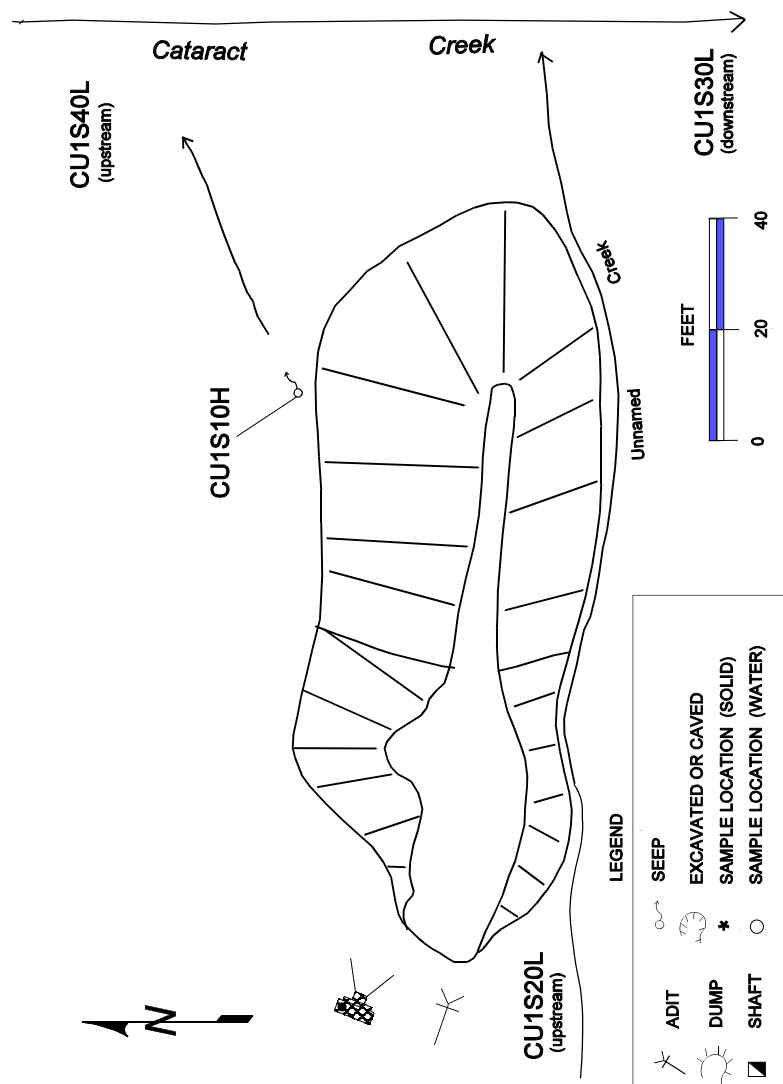
Figure 11 The waste-rock dump of the Unnamed #1 mine contained large amounts of pyrite. Despite this, there was little evidence of acid mine drainage or impact to soils.

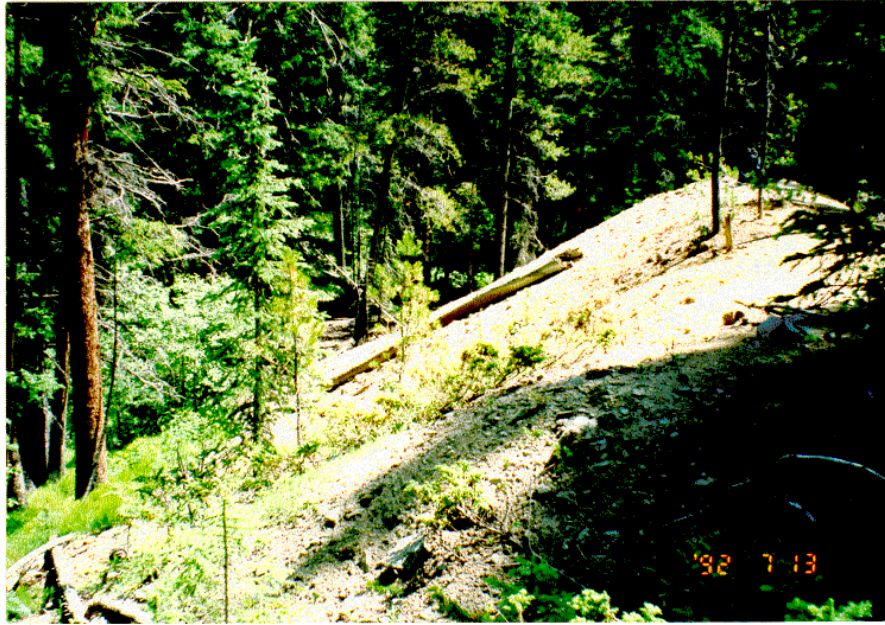
Figure 11A. Despite the large percentage of pyrite, the waste-rock dump of the Unnamed #1 mine was well vegetated. Several small trees were growing on the crown of the dump.

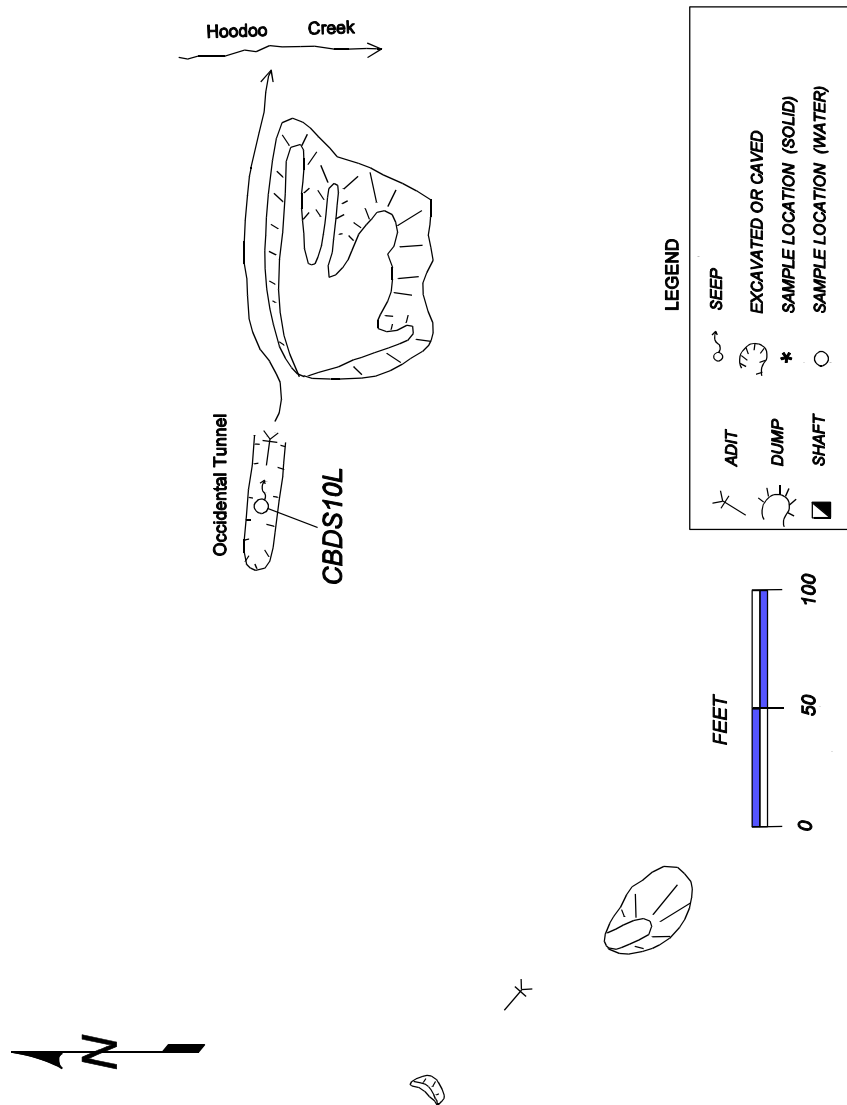
Figure 13 The Occidental tunnel discharges to Hoodoo Creek. The Blue Diamond tunnel (Figure 12) is downstream.

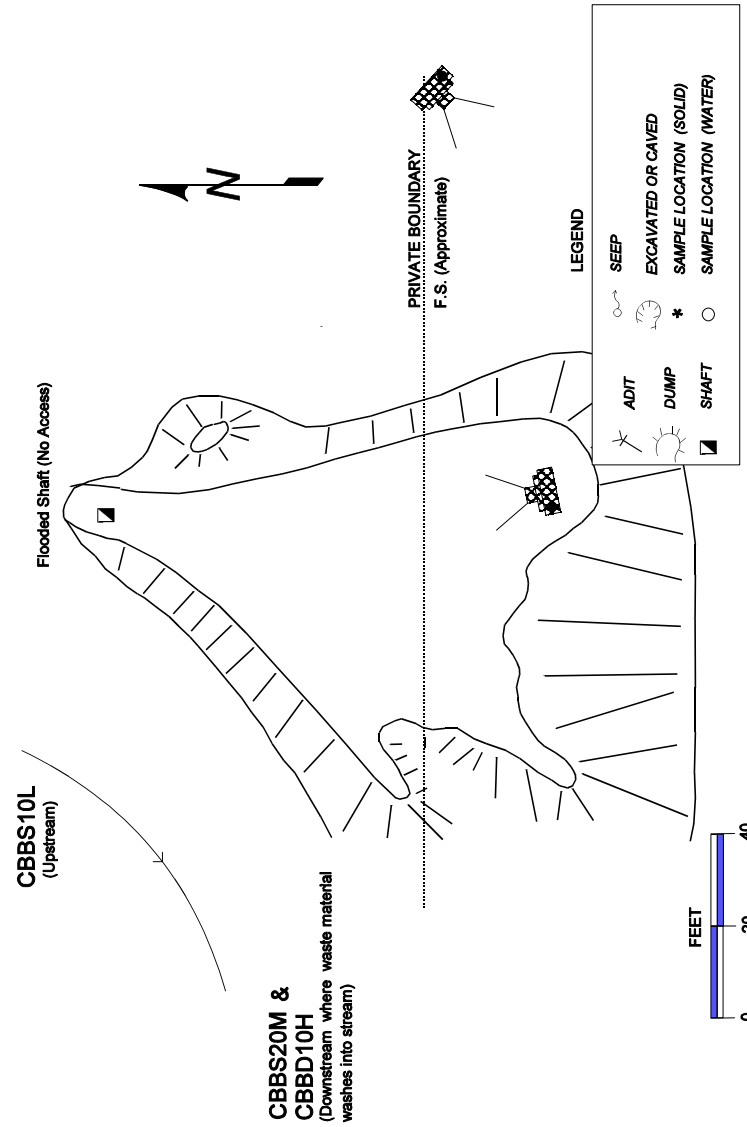
Figure 14 Waste material from the dump of the Black Bear shaft has contaminated soils down slope to the unnamed stream. The shaft and most of the waste-rock dump is on private land while part of the dump and the soil wash area are on DNF administered land.

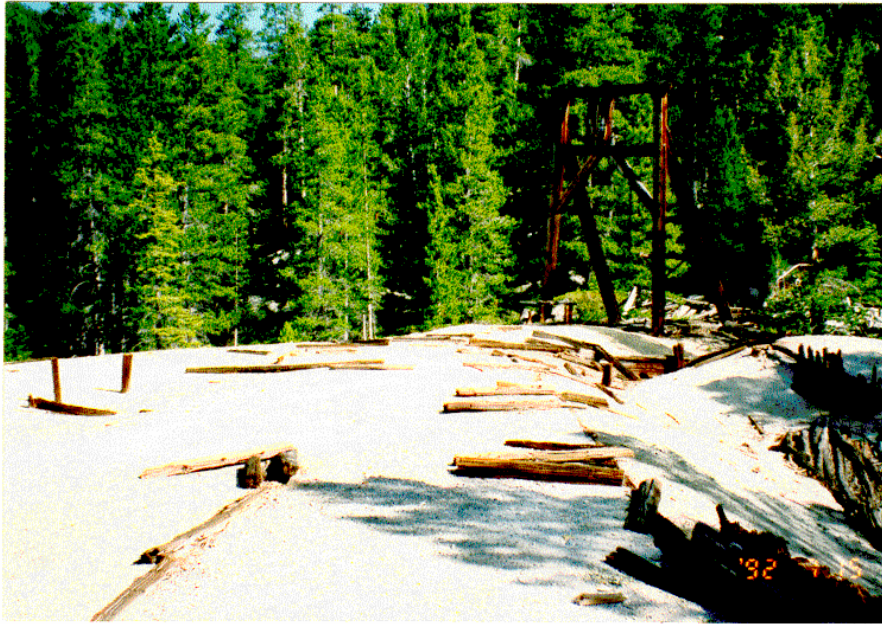
Figure 14A. The main development area of the Black Bear mine consisted of a shaft on private land and a large waste-rock dump on private and DNF land.

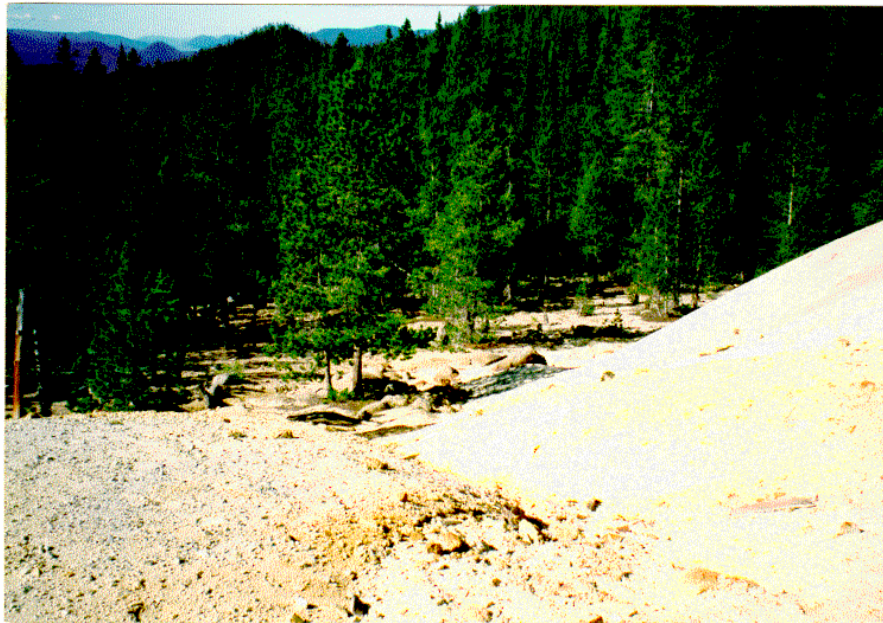
Figure 14B. Fined-grained material from the waste-rock dump has been washed several hundred feet downhill toward a small stream. The area was generally devoid of vegetation.

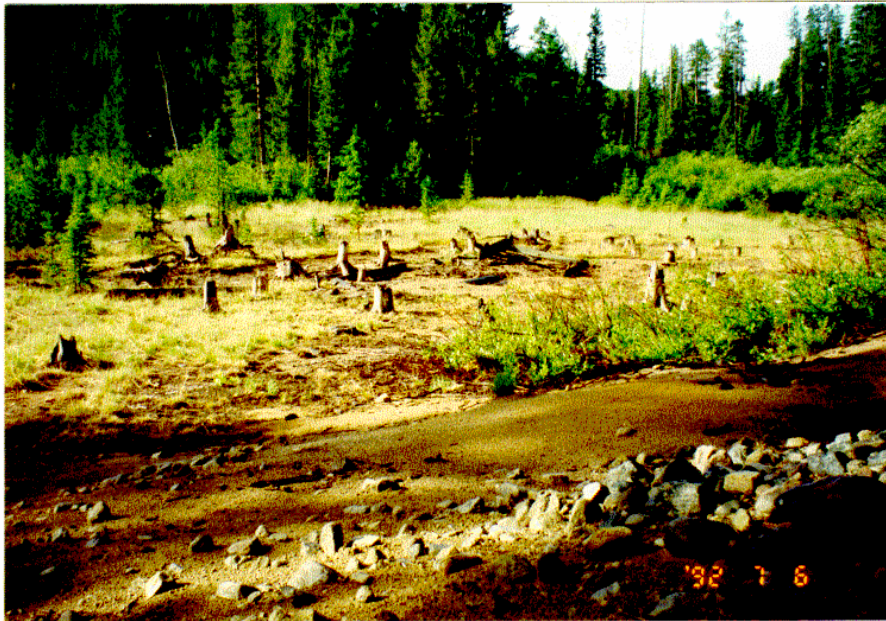
Figure 15A. The vegetation cover on the Cataract Creek tailings ranges from sparse to none. Cataract Creek is to the left of the photograph.

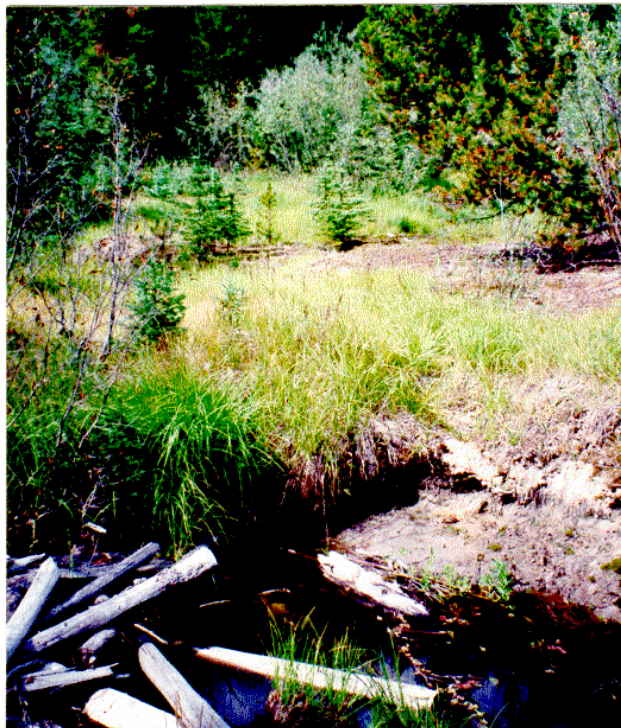
Figure 15B. Tailings and soil have been washed into Cataract Creek. Cattle are common in the area and have trampled the stream banks.

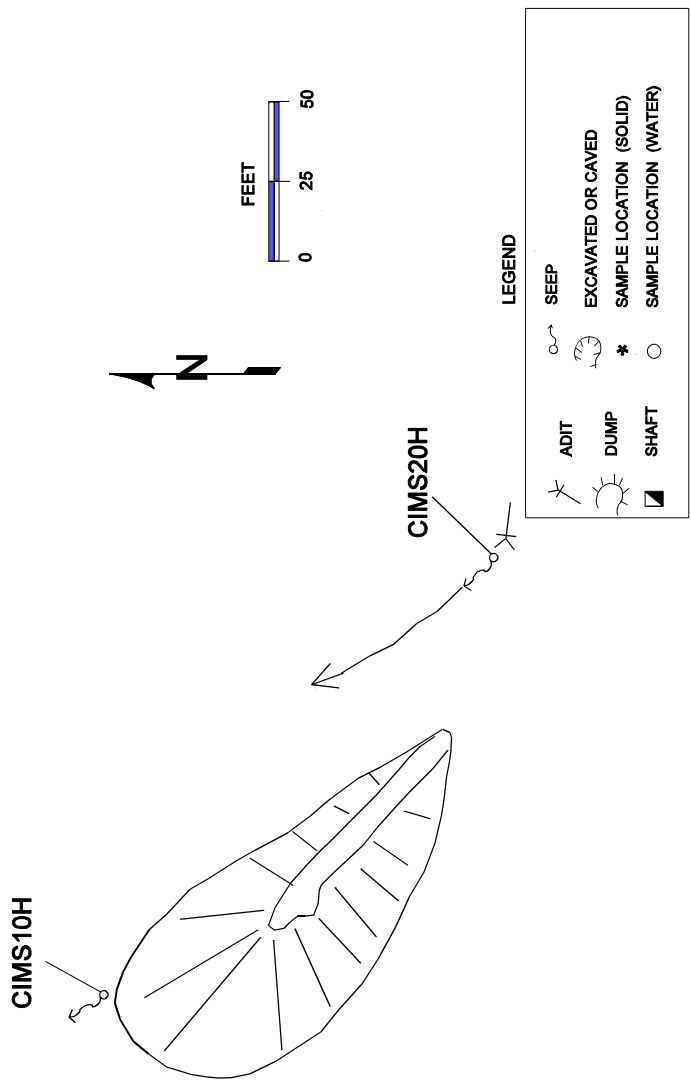
Figure 17 The discharge stream from the adit and the seeps at the base of the waste-rock dump merge in a wetlands area down slope of the development area. Impacts to soils are restricted to the disturbed areas.

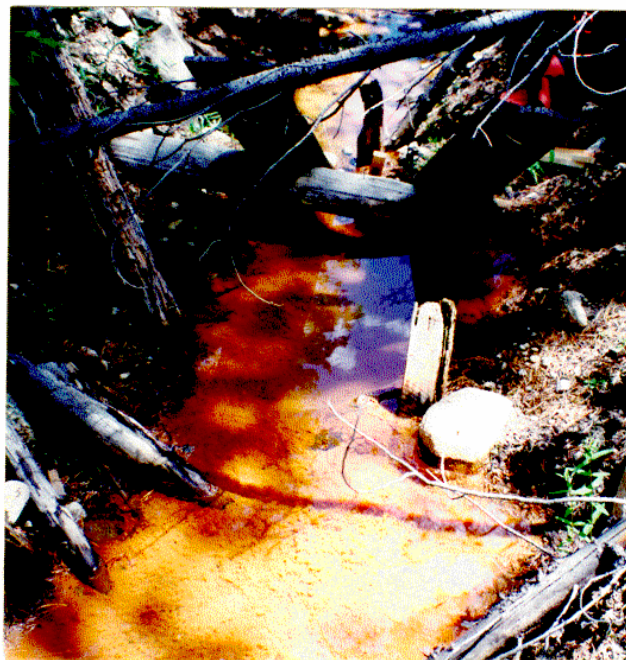
Figure 18A. The collapsed adit of the lower Hattie Ferguson mine was discharging a small amount of water. The discharge did not extend across the road.

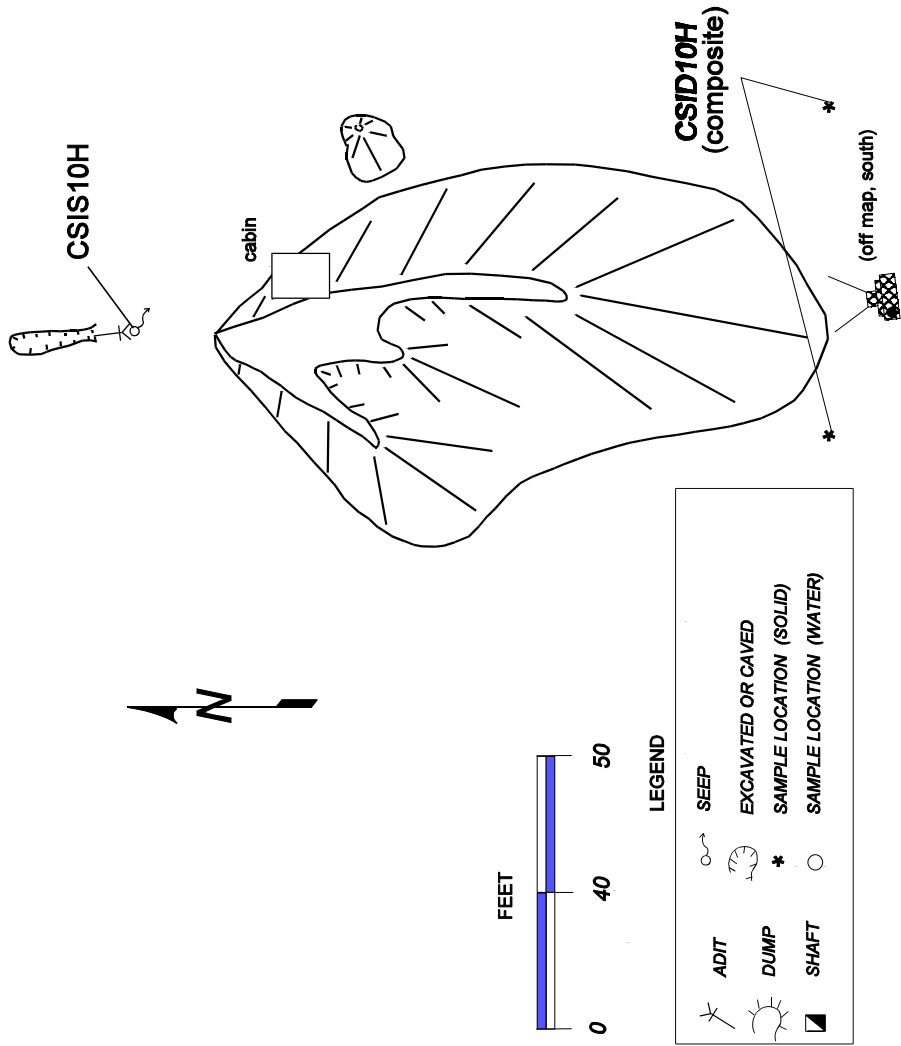
Figure 20 The adit discharge stream from the Sirius mine infiltrated the ground before reaching the edge of the waste-rock dump. Ferric hydroxide stains indicated a much longer discharge stream under wetter conditions. Soils down slope of the waste-rock dump have been significantly impacted for several hundred feet.

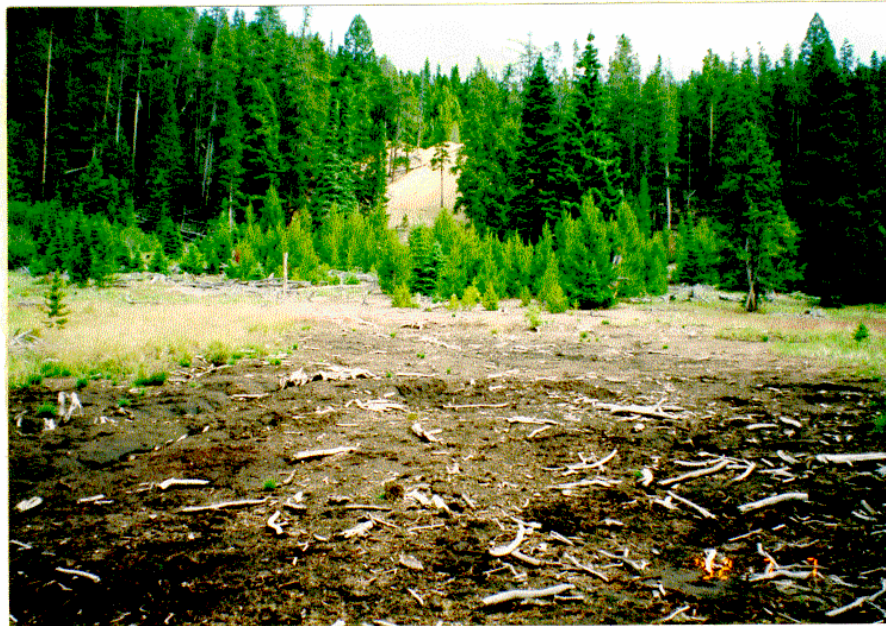
Figure 20A. Material from the waste rock of the Sirius mine has been eroded and mixed with native material for several hundred feet down slope. Some areas were devoid of vegetation.

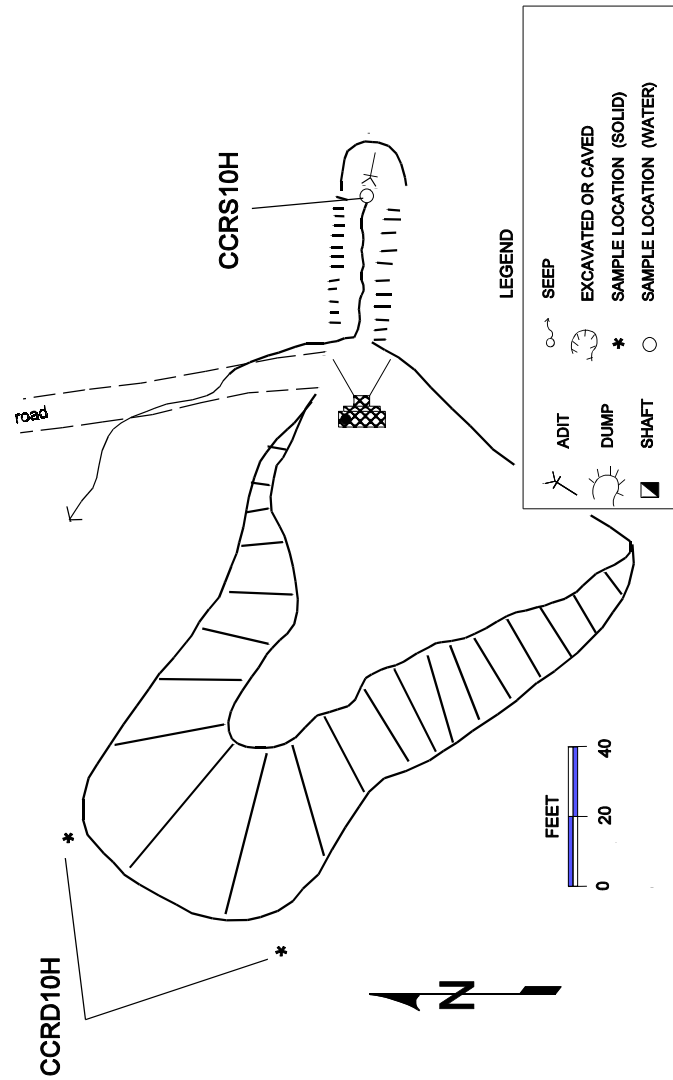
Figure 21 The adit of the Cracker mine discharged water toward Cataract Creek. Waste material has been washed onto and has mixed with soils down slope of the waste-rock dump.

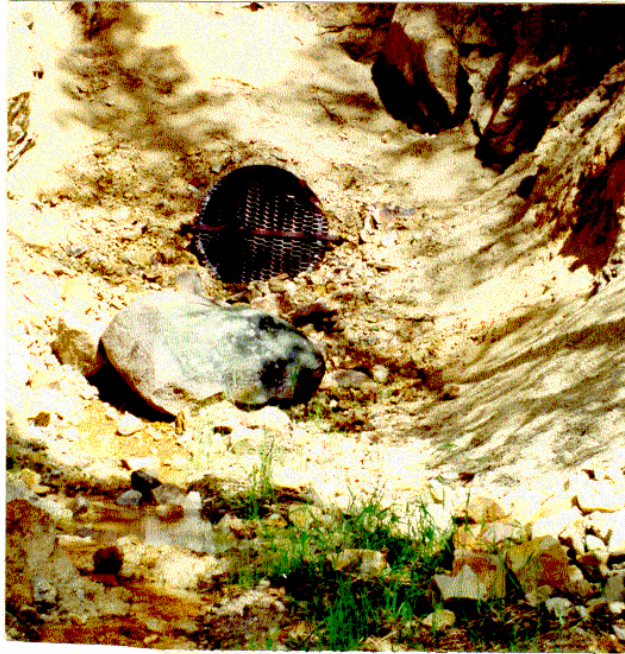
Figure 21A. The adit of the Cracker mine was open, but secure. A small discharge issued from the adit and flowed toward Cataract Creek. Ferric-hydroxide precipitate was evident along its entire length.

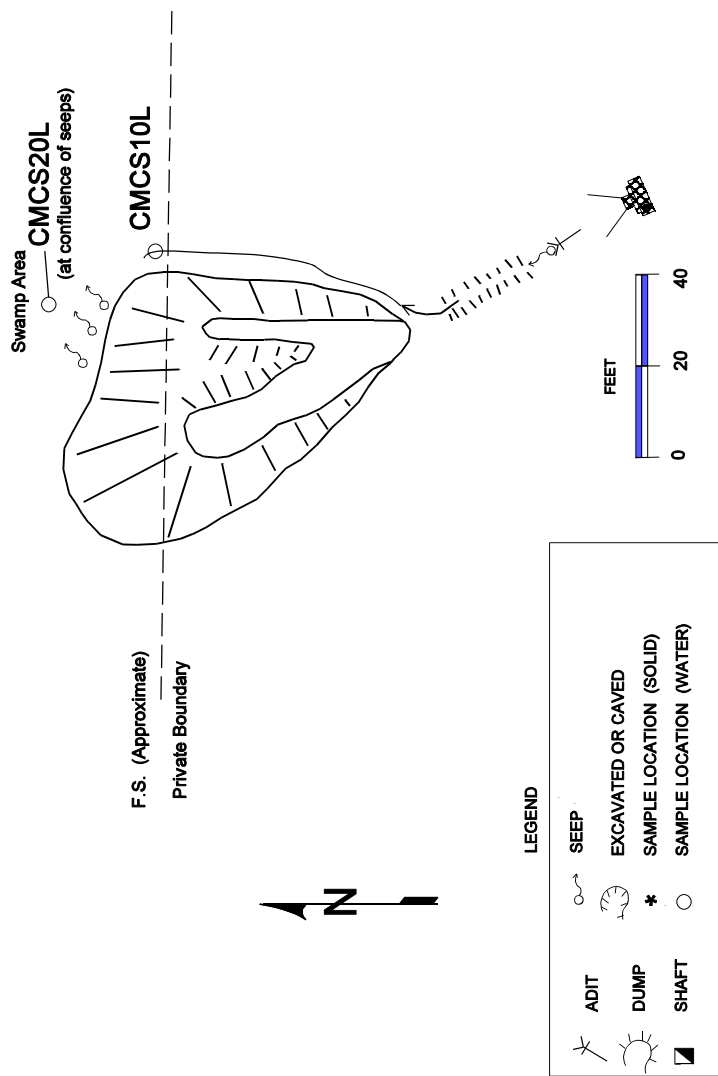
Figure 22 The adit and part of the waste-rock dump of the Mountain Chief mine are on private land; the lower portion of the dump and the seeps are on DNF administered land.

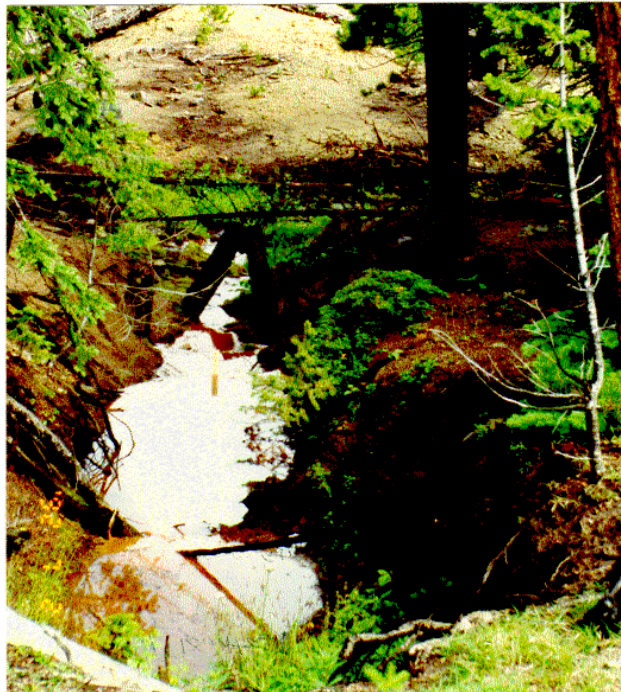
Figure 22A. The collapsed adit and part of the waste-rock dump of the Mountain Chief mine are on private ground. The lower part of the dump and the area downhill are on DNF administered land.

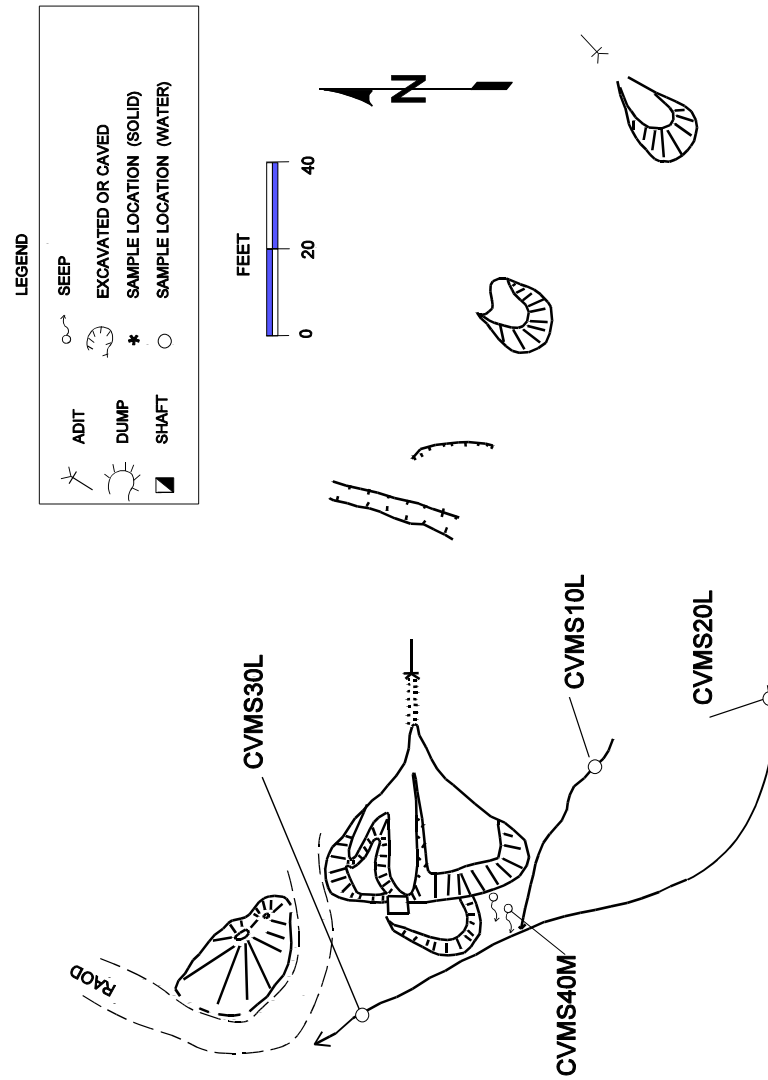
Figure 23 The ownership of the Vera and Marie development area is uncertain. Sampling focused on areas outside of the disturbed area and potential impacts to Cataract Creek.

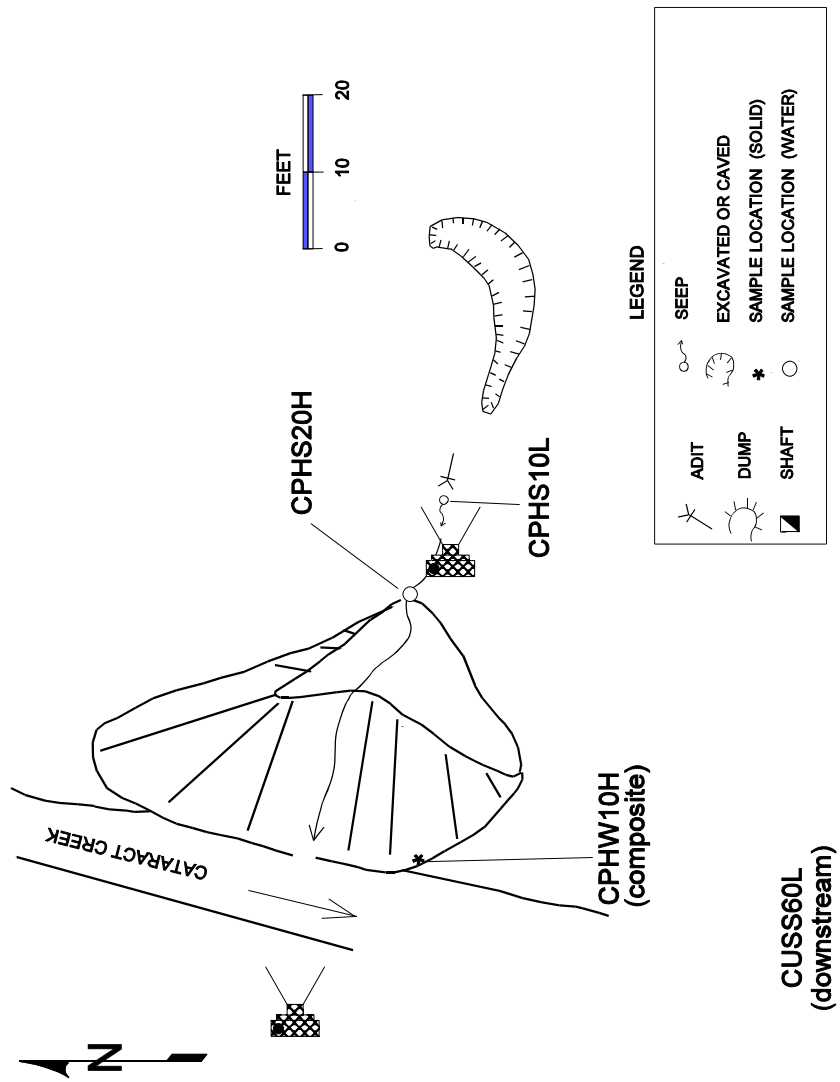
Figure 25 The adit of the Phantom mine was discharging water directly into Cataract Creek. The base of the waste-rock dump has been eroded by the creek.
