MONTANA BUREAU OF MINES AND GEOLOGY

ABANDONED - INACTIVE MINES PROGRAM

DEERLODGE NATIONAL FOREST

VOLUME II
CATARACT CREEK DRAINAGE

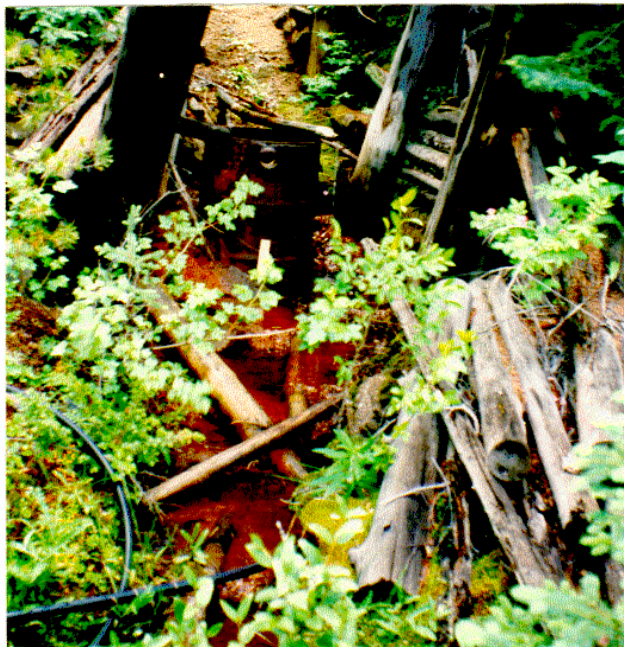
Figure 25A. The collapsed adit of the Phantom mine discharged water to Cataract Creek. Ferric hydroxide precipitate was evident for most of its length.

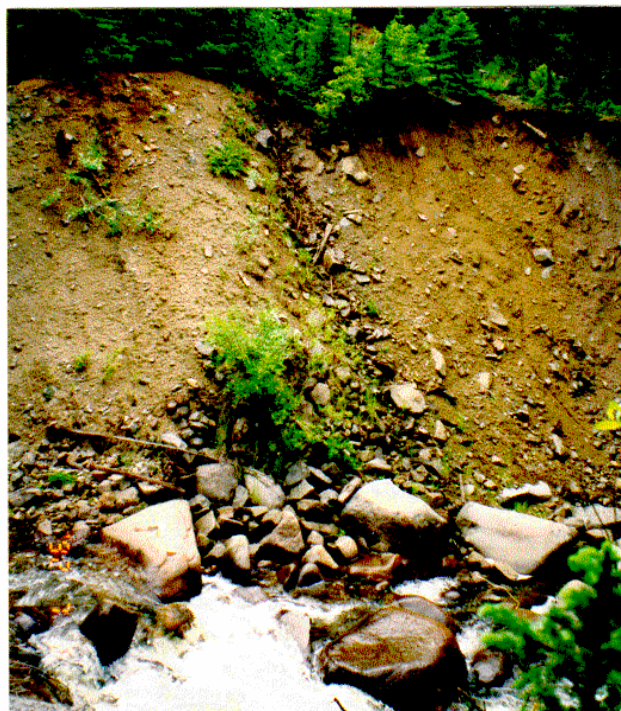
Figure 25B. The discharge from the adit was flowing into Cataract Creek. Material from the waste-rock dump had been washed into the creek as well.

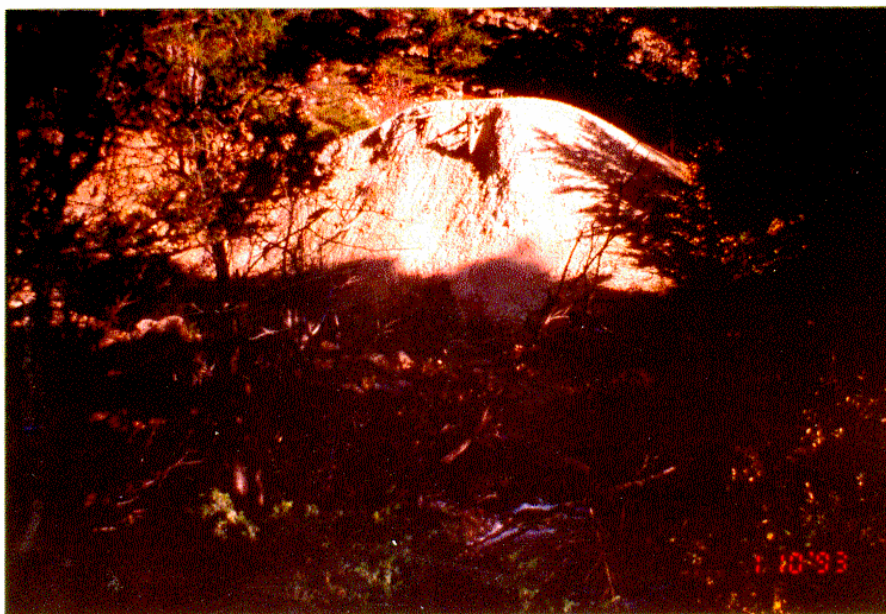
Figure 26A. The development area of the South Mantle mine is on private land; although a detailed assessment was not conducted, waste material has probably made its way into Cataract Creek.

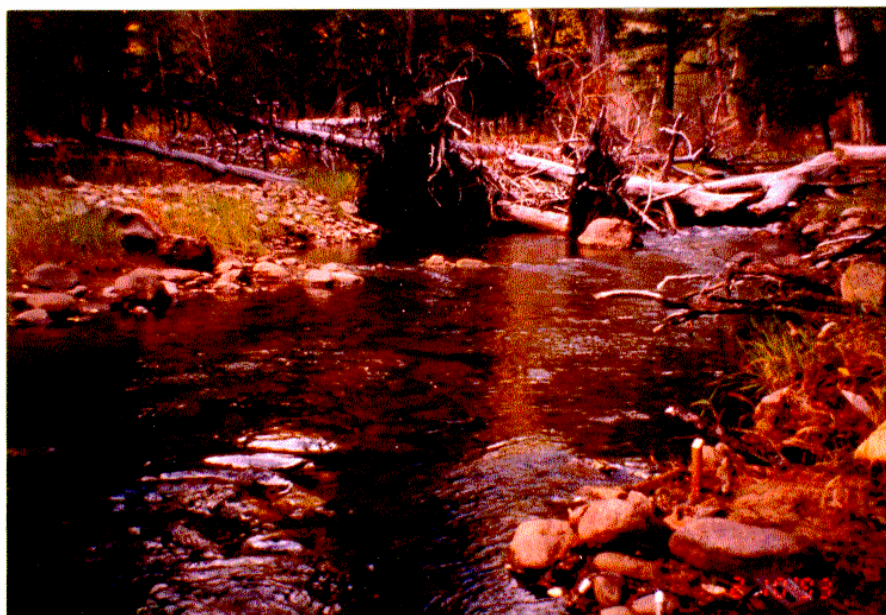
Figure 26B. Cataract Creek was sampled at a small section of DNF administered land downstream of the South Mantle mine.
