Montana Bureau of Mines and Geology
MBMG No. 379

**Abandoned/Inactive Mines
of the
Southern Beaverhead-Deerlodge National Forest**

September 1998

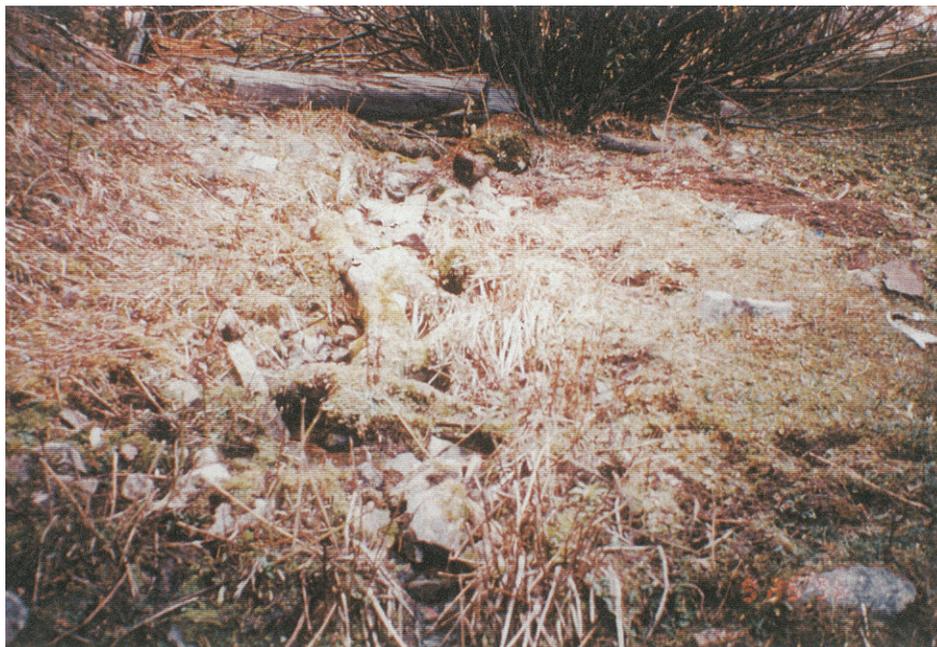
A small, clear seep emerges near the base of the lowermost waste-rock dump (figure 2.5). The water from the seep flows across the access road and into a boggy area adjacent to the Cave Gulch stream.

Figure 2.5 A seep emerges at the base of the Capitol mine's lowermost dump. Sample BCAS10L was collected here.

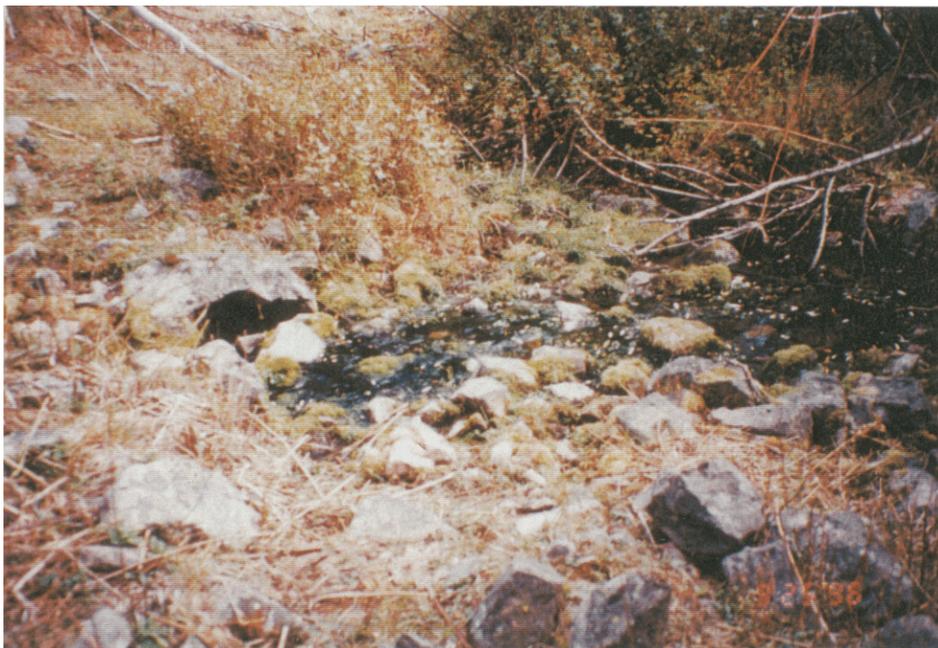
Figure 2.6 Sample BCAS20L was collected from Cave Gulch Spring to provide an indication of background water quality.

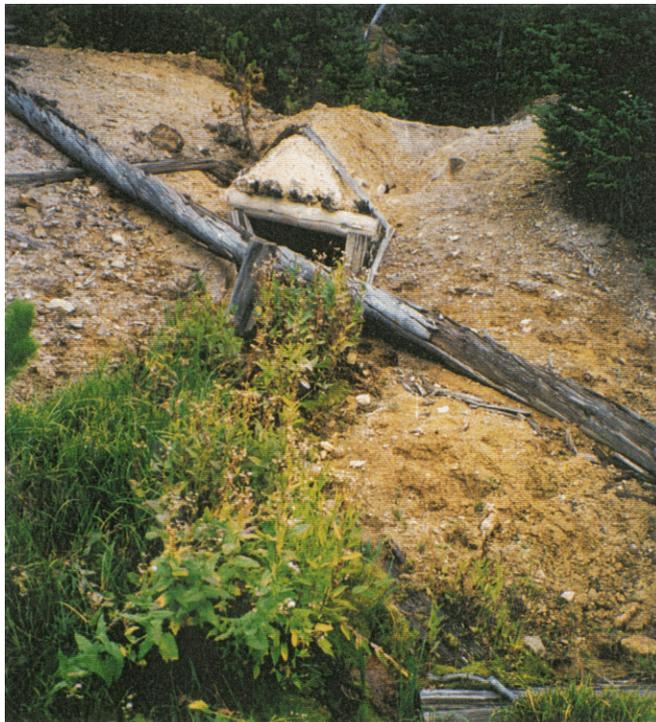
Figure 2.8 The collapsed adit with a discharge at the Copper Queen mine was sampled downstream.

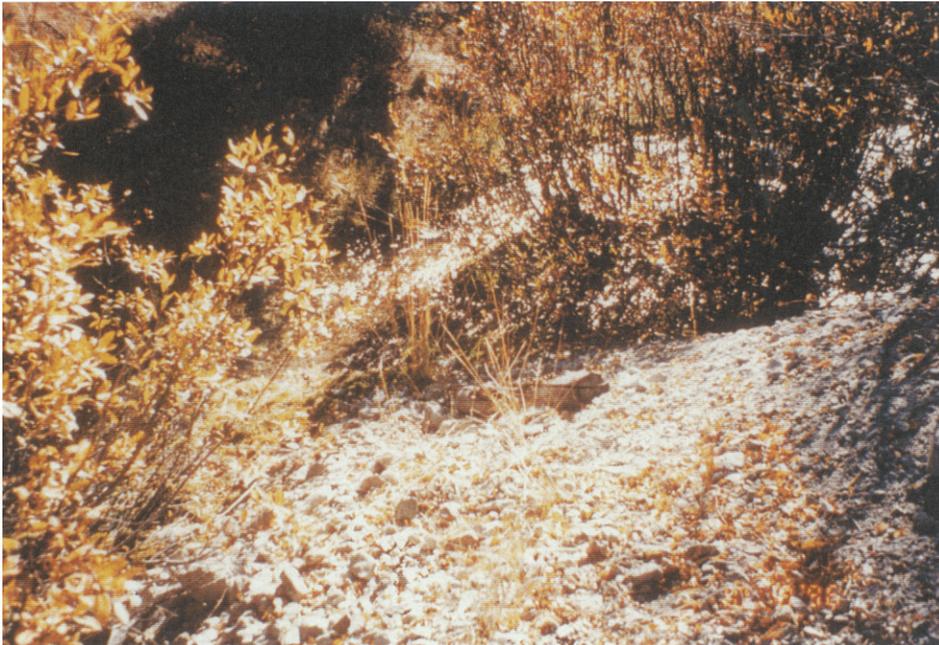
Figure 2.11 A small waste-rock dump is located on the bank of Trout Creek.

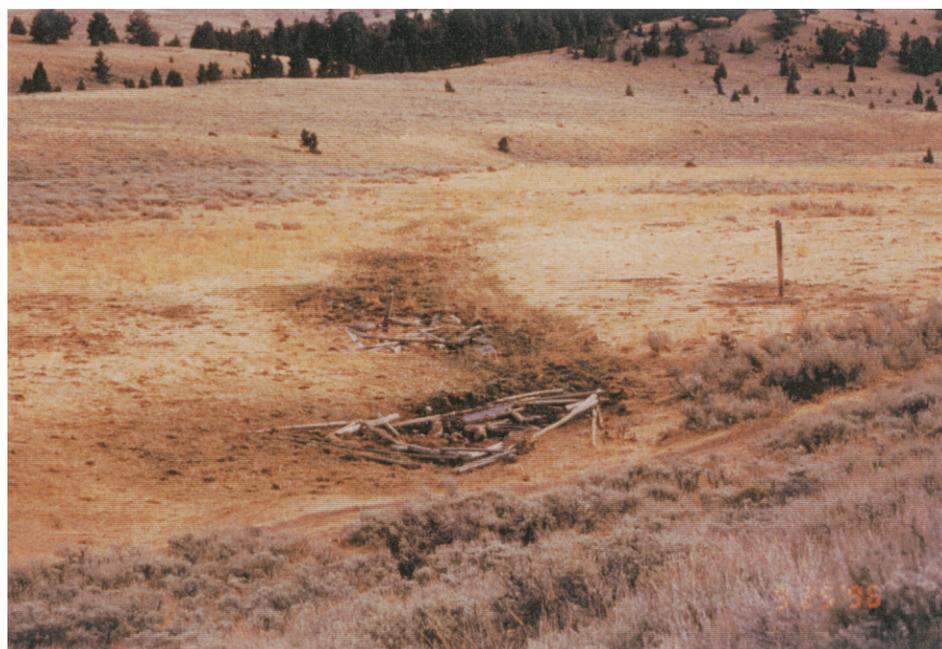
Figure 2.15 A spring several hundred feet downhill from the mine is used for watering livestock. The water quality here is good.

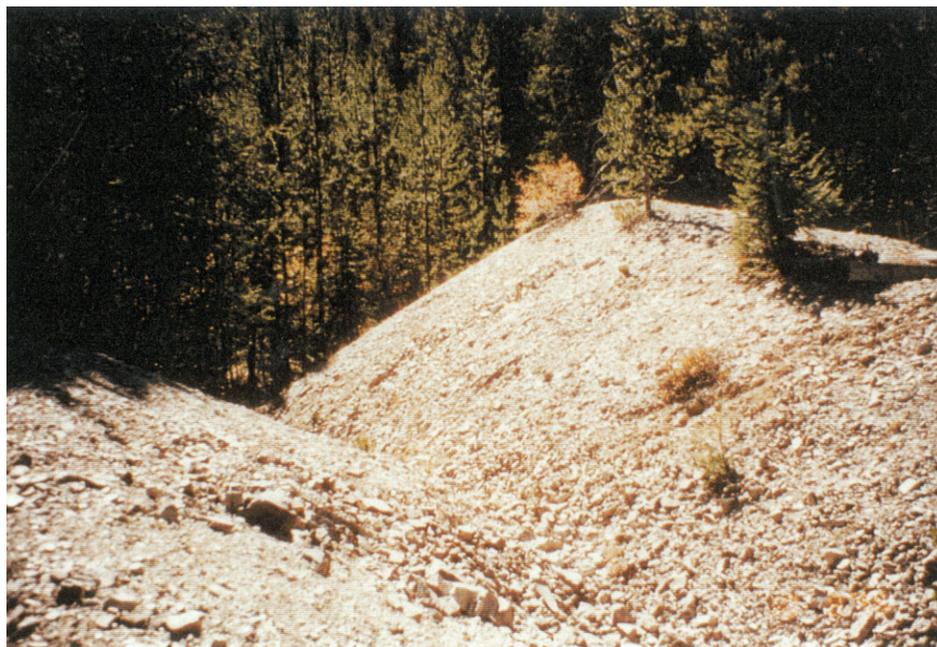
Figure 2.17 A large waste-rock dump is located on the bank of the Watson Gulch stream.

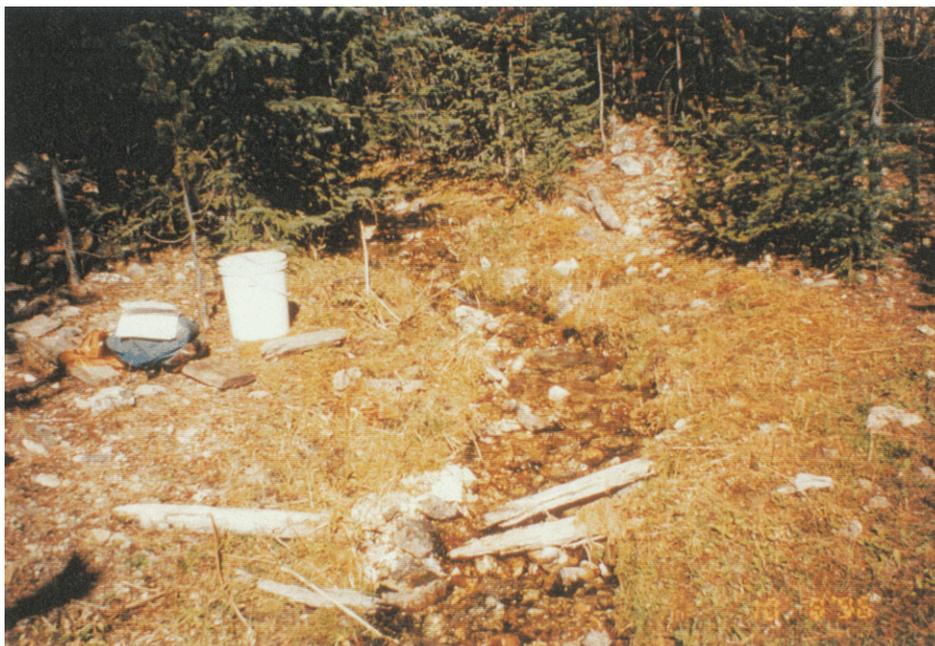
Figure 2.18 Sample BFCS30L was collected from the Watson Gulch stream below the mine.

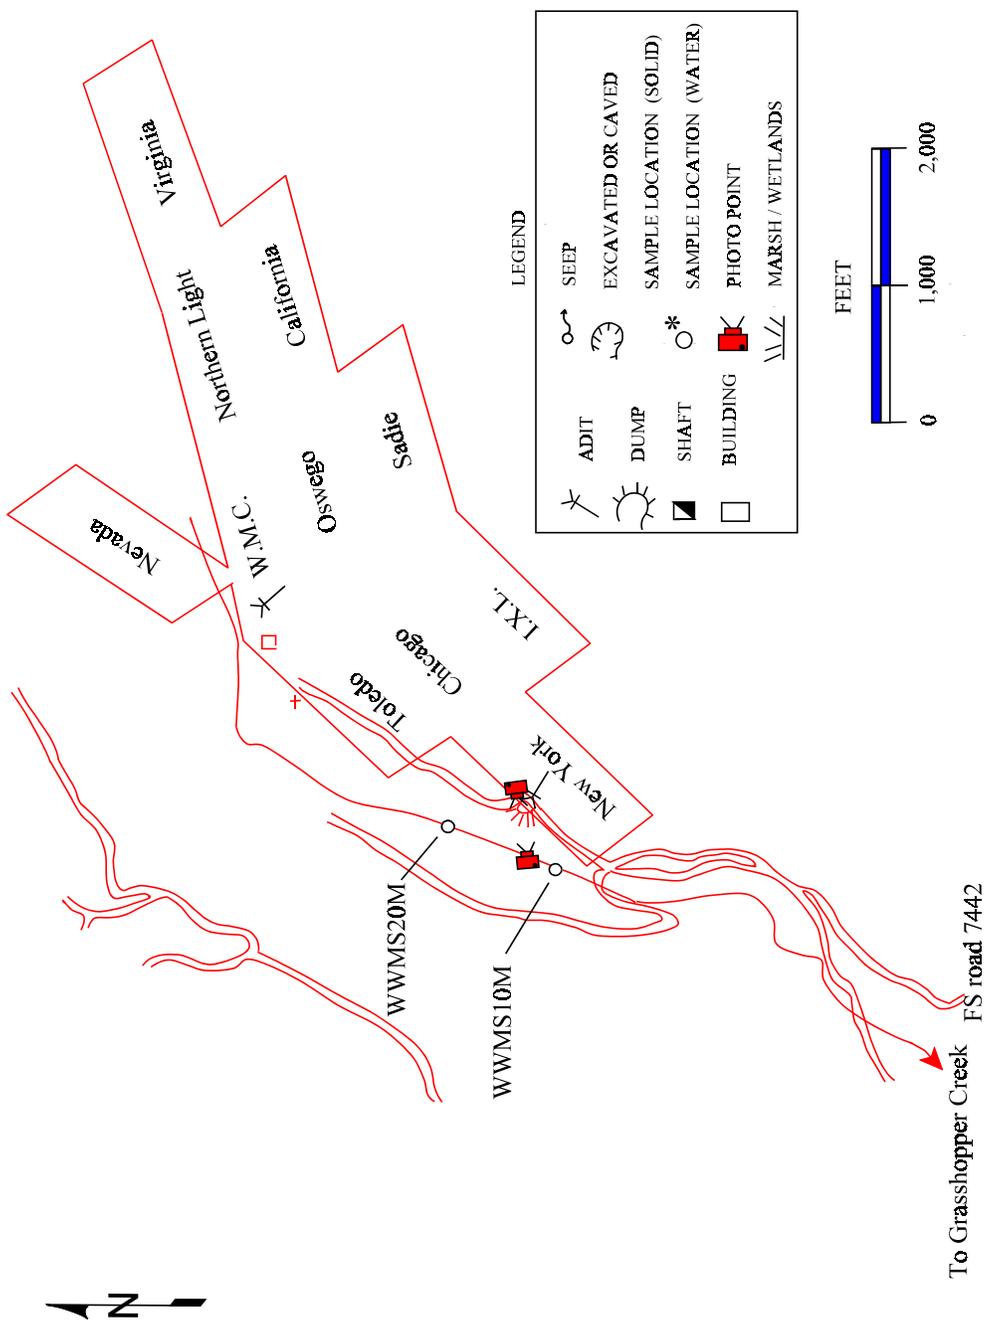
Figure 2.19 Schematic of the Wellman group taken from the Elkhorn Hot Springs 7.5-min. USFS ownership map (11/1/96).

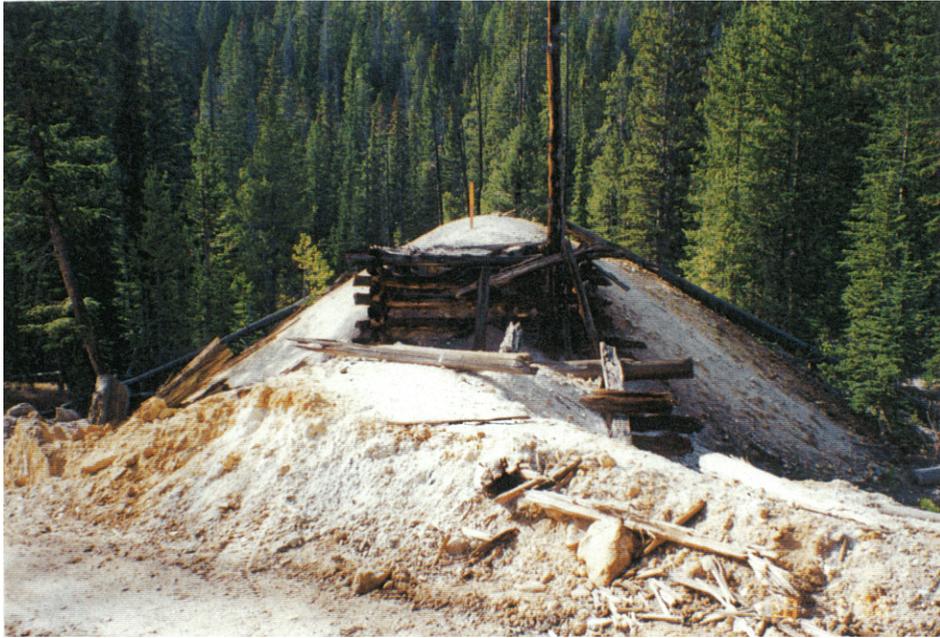
Figure 2.20 A survey marker shows the private/BNF-administered land boundary. The high sulfide waste dump is primarily on patented land.

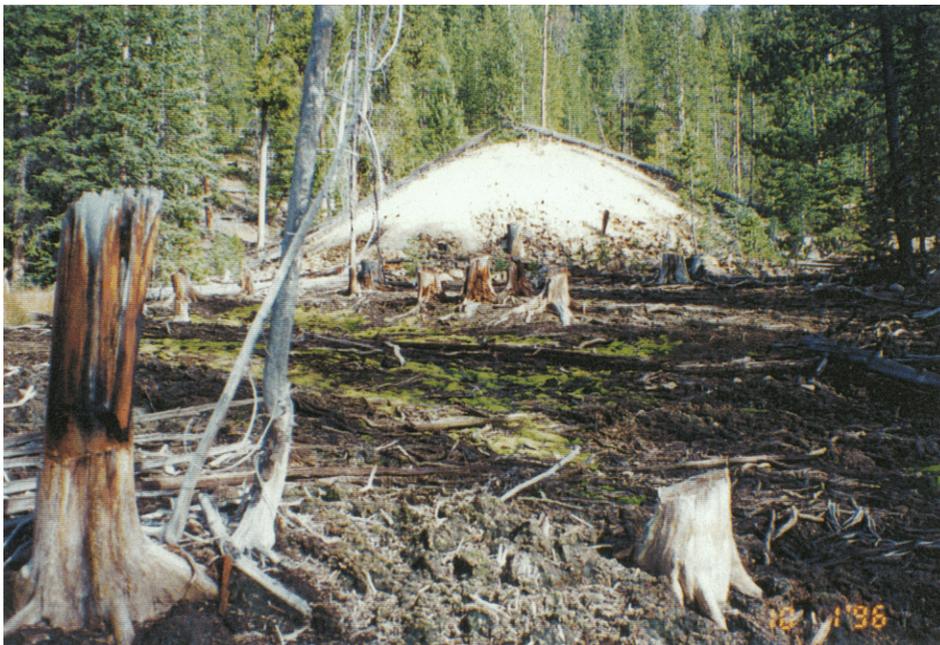
Figure 2.21 Downhill from the waste dump, the vegetation has died.

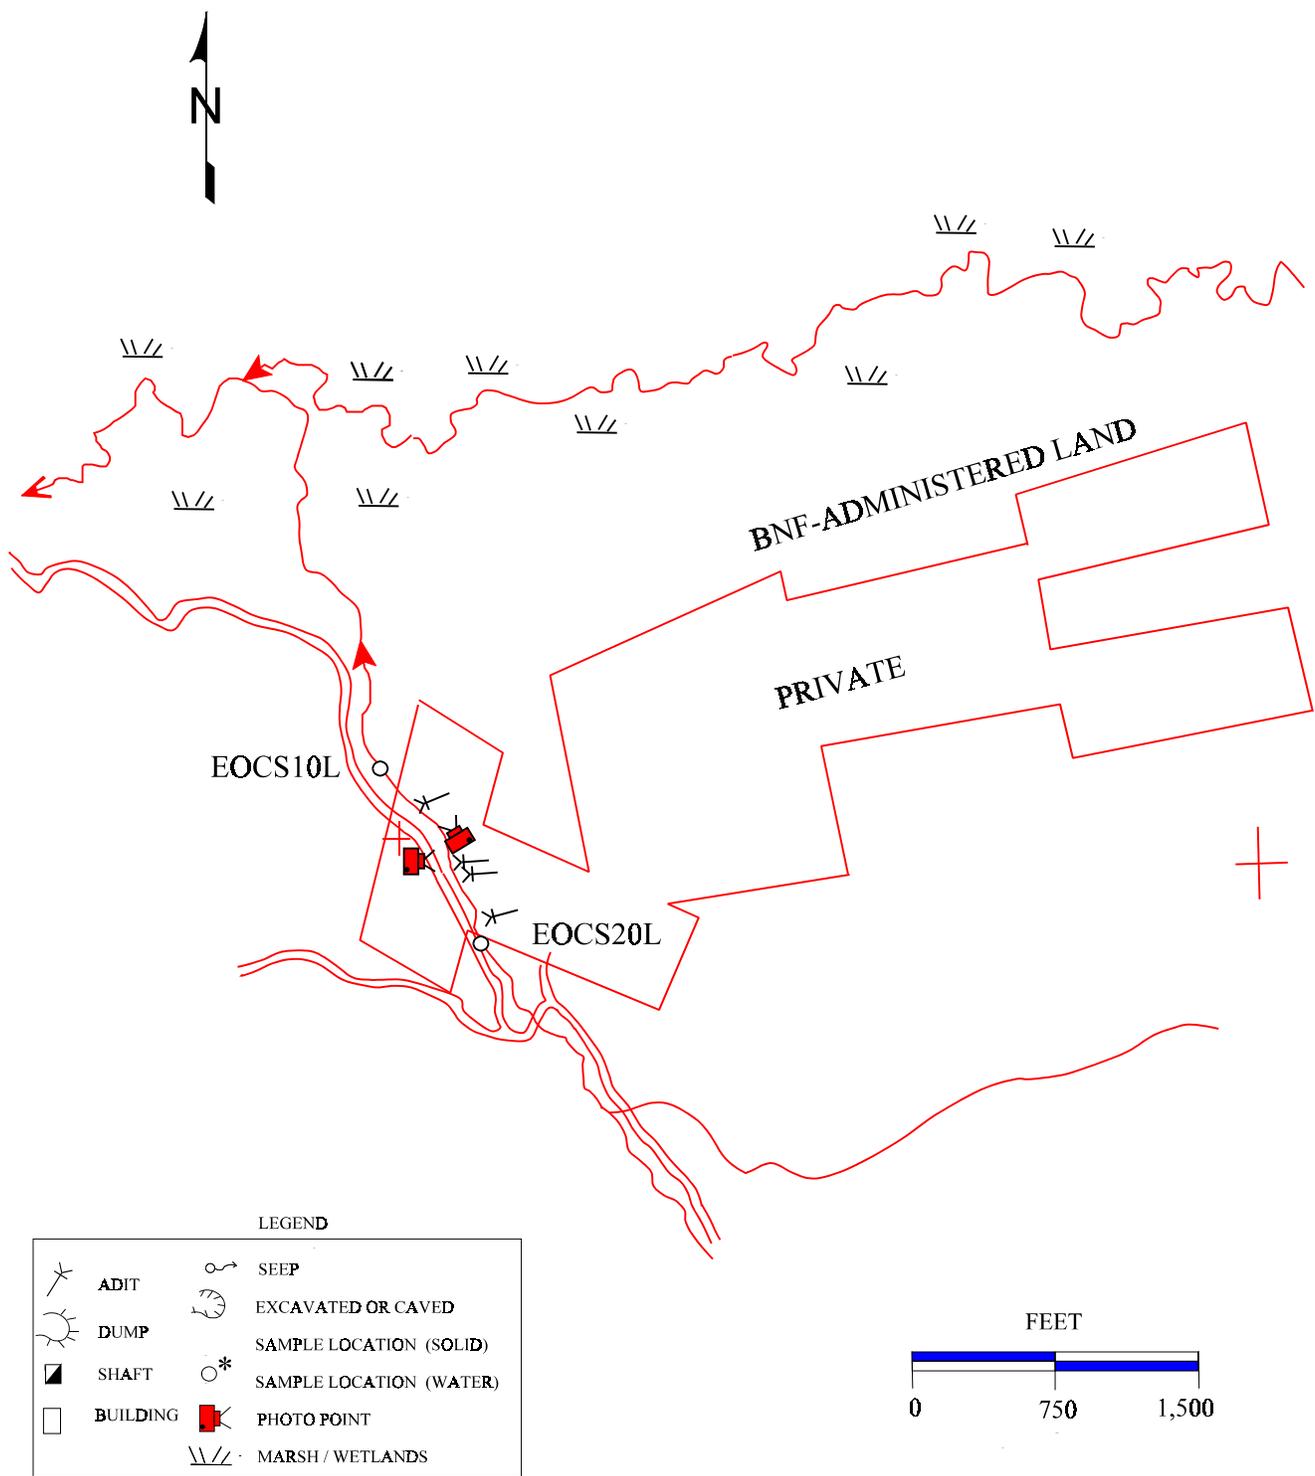
Figure 3.3 Schematic map of the Bobsled and OCJ claims as taken from the Maurice Meadows 7.5 min USFS ownership map (10/96).

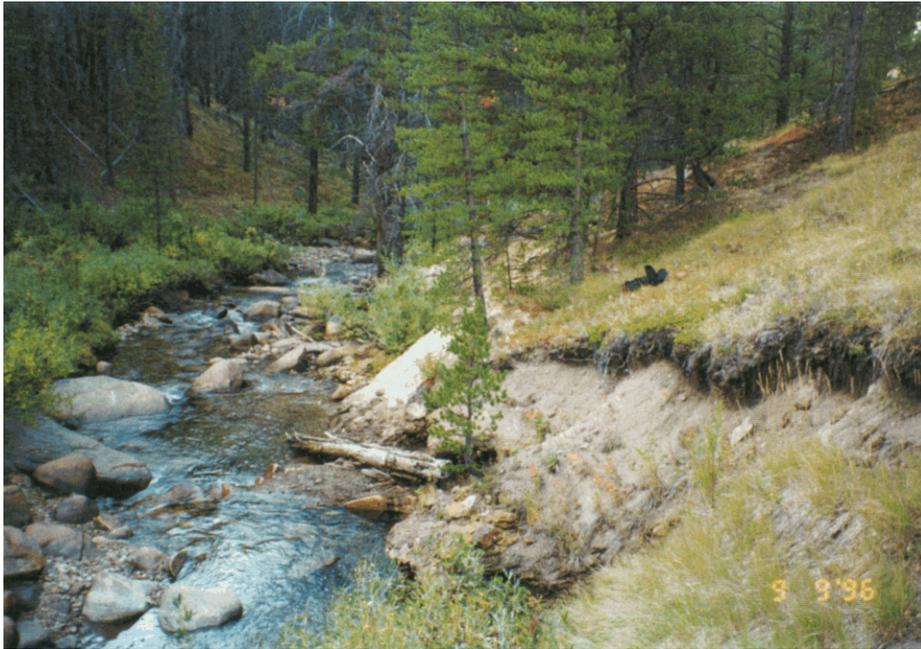
Figure 3.4 A small waste-rock dump at the Bobsled and OCJ claims (light streak to the left of the dark backpack) was in contact with Elkhorn Creek.

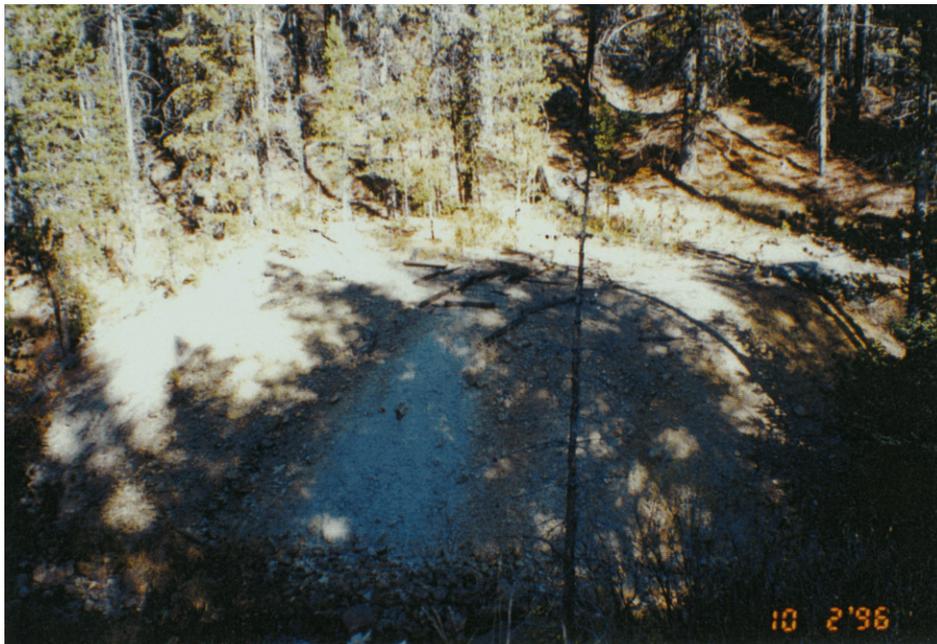
Figure 3.5 The toe of the larger waste-rock dump is in contact with Elkhorn Creek.

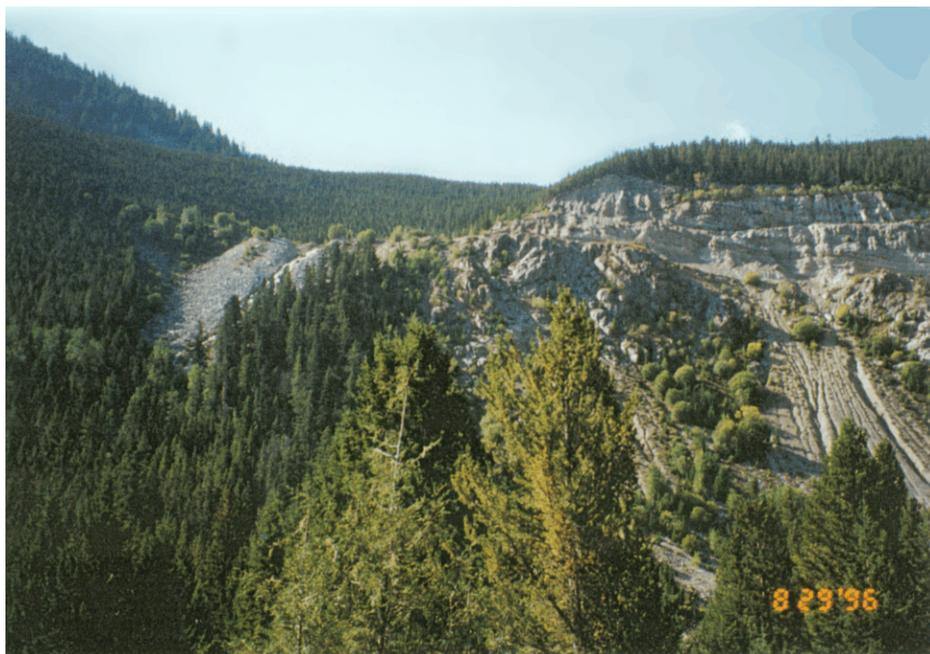
Figure 3.7 The Brownes Lake tungsten deposit is perched on the mountainside above Rock Creek.

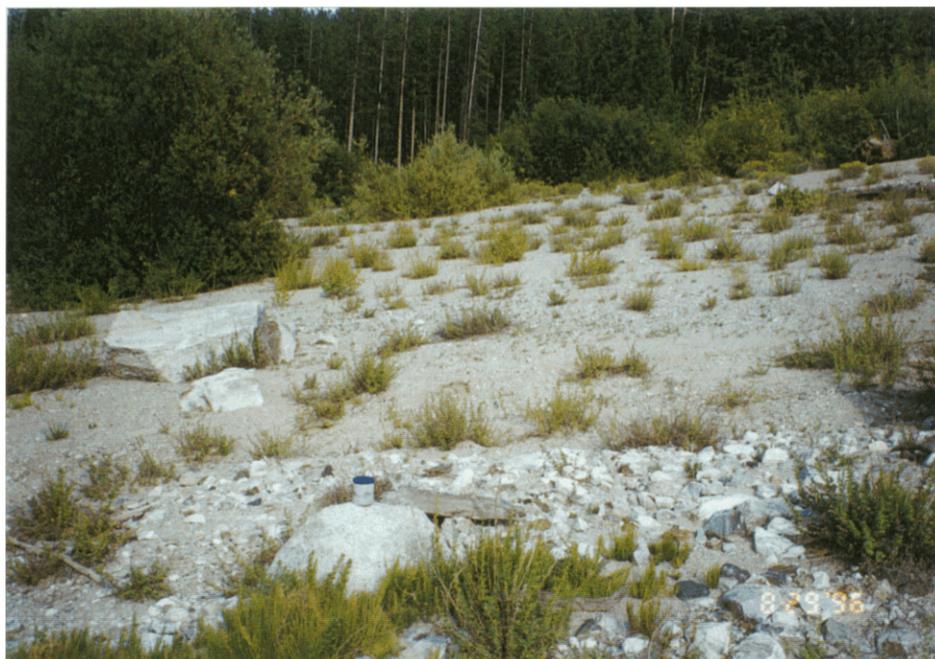
Figure 3.8 Gravel to boulder-sized waste rock is deposited along the bank of Rock Creek.

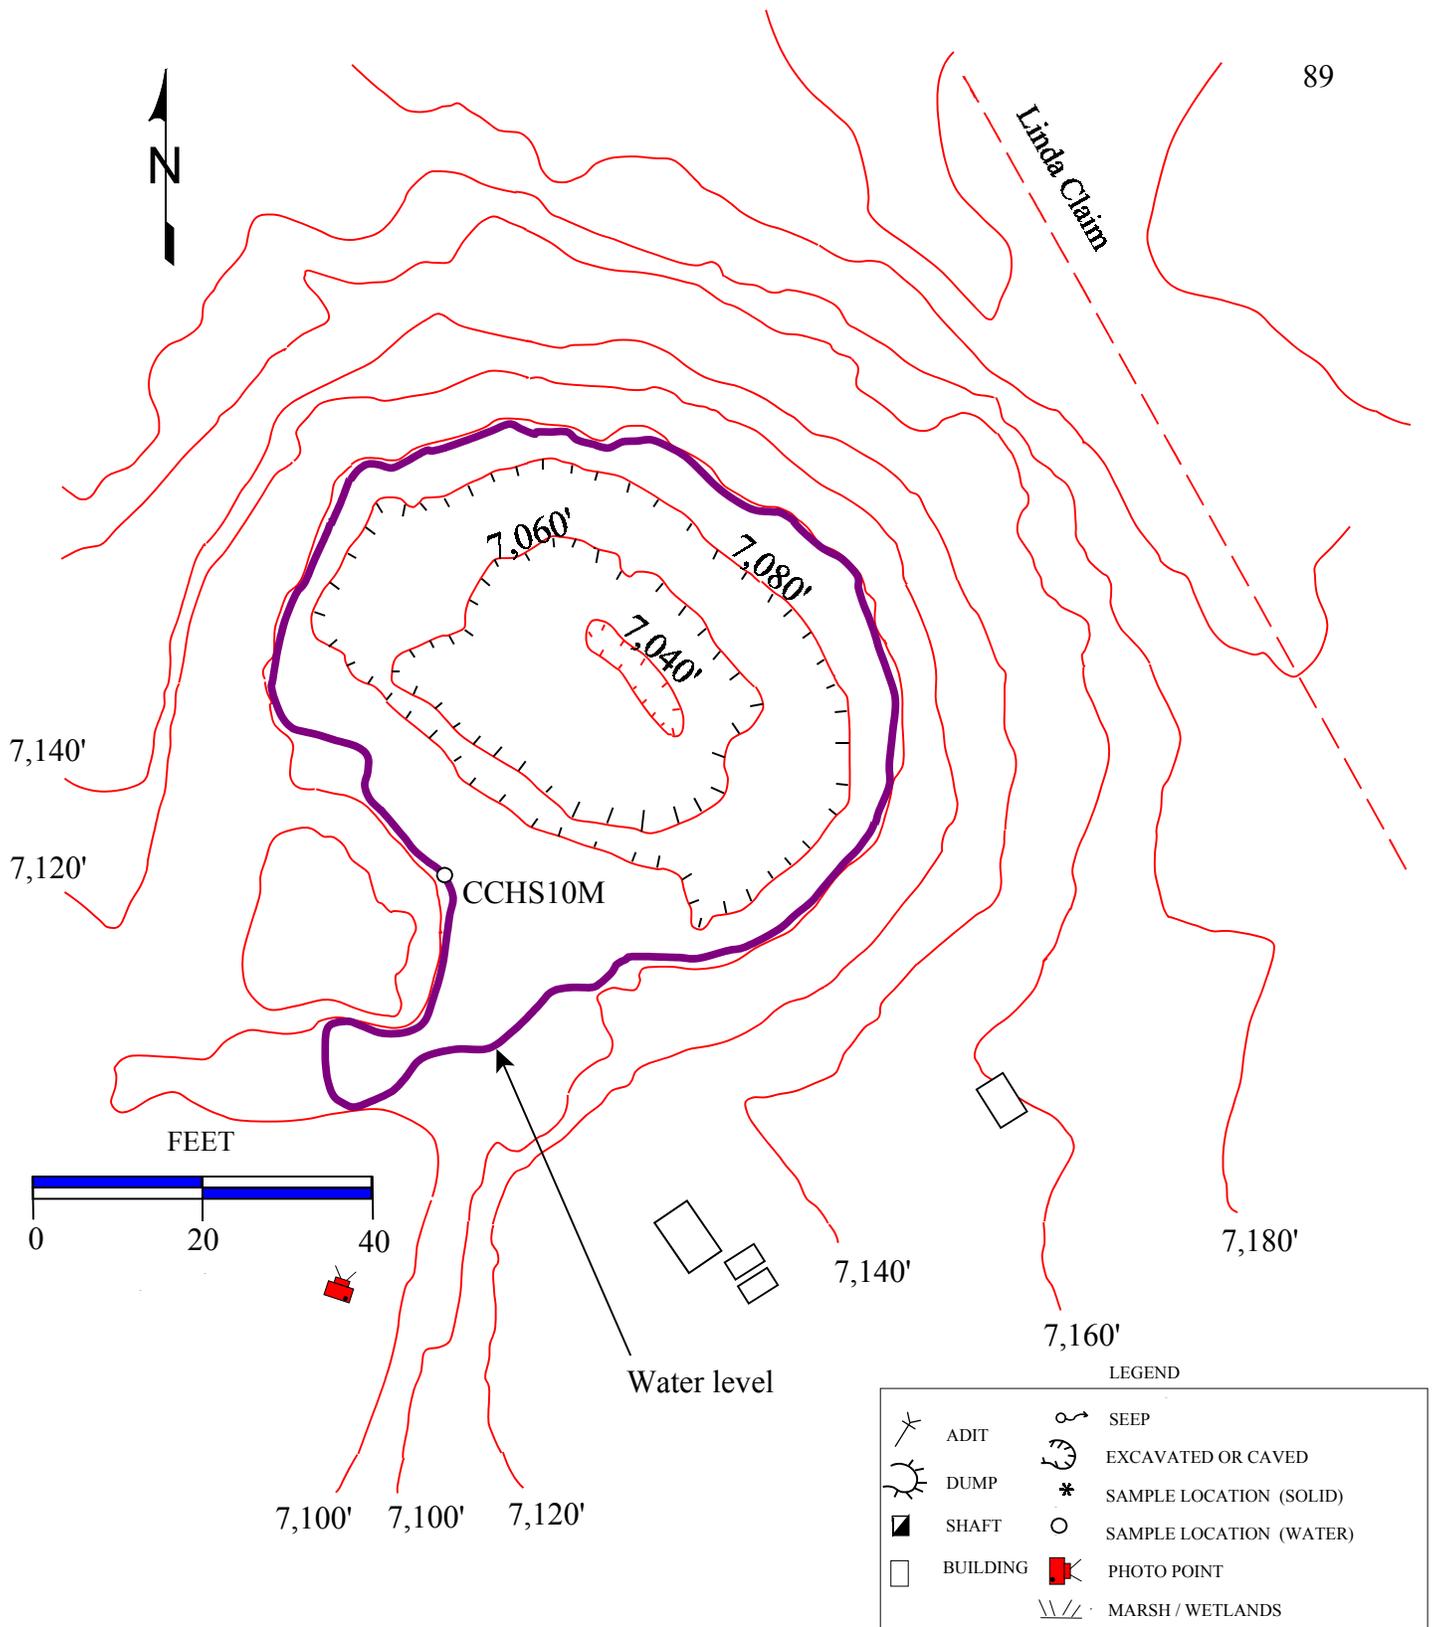
Figure 3.10 The Calvert pit showing water level as mapped October 31, 1961 by Anaconda Company geologists. Water sample location CCHS10M from the MBMG study is shown also.

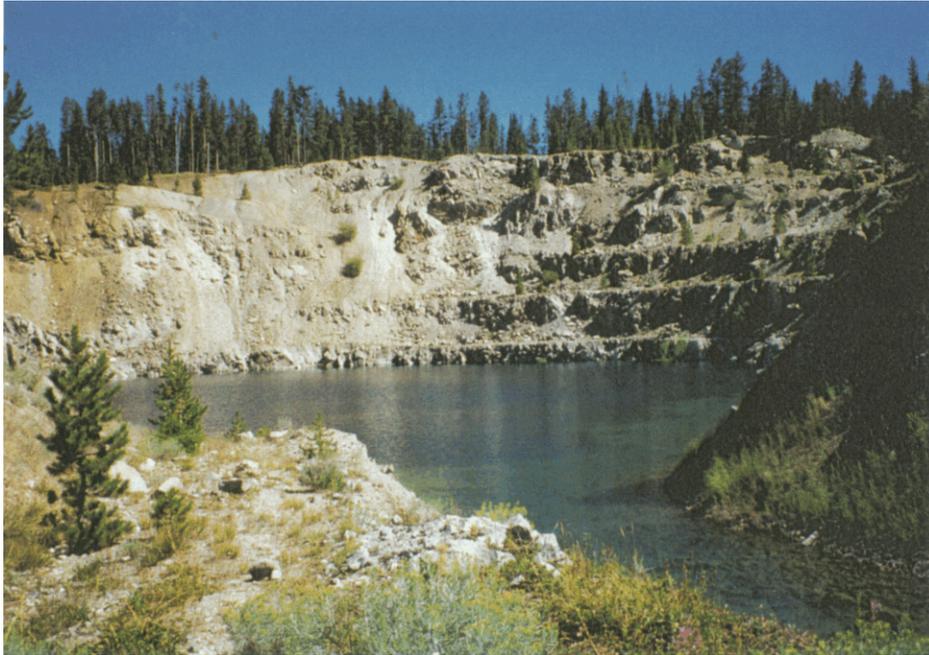
Figure 3.11 The water in the flooded pit is approximately 45 ft deep; the dimensions of the pit are roughly 250 ft x 300 ft x 85 ft.

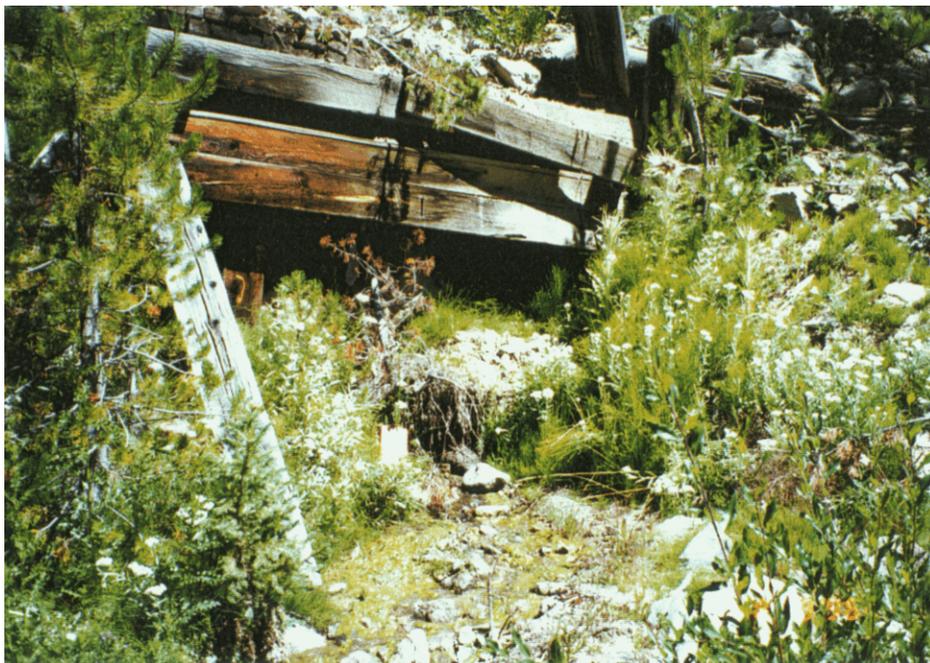
Figure 3.12 A slight mass movement of earth has occurred upslope from the collapsed adit south of the open pit.

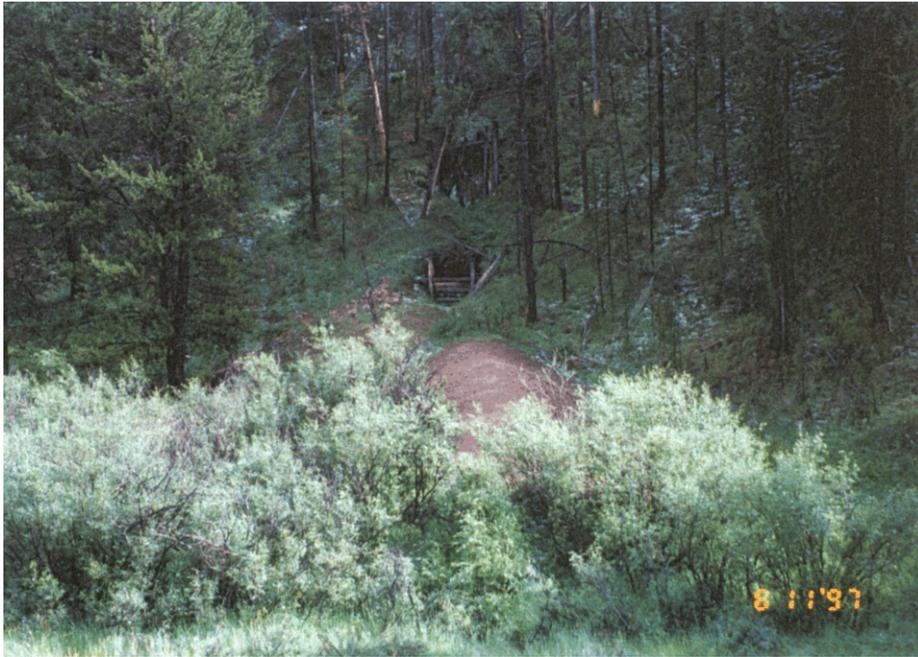
Figure 3.14 Woody Creek flows through willows where the creek is in contact with the toe of the waste dump.

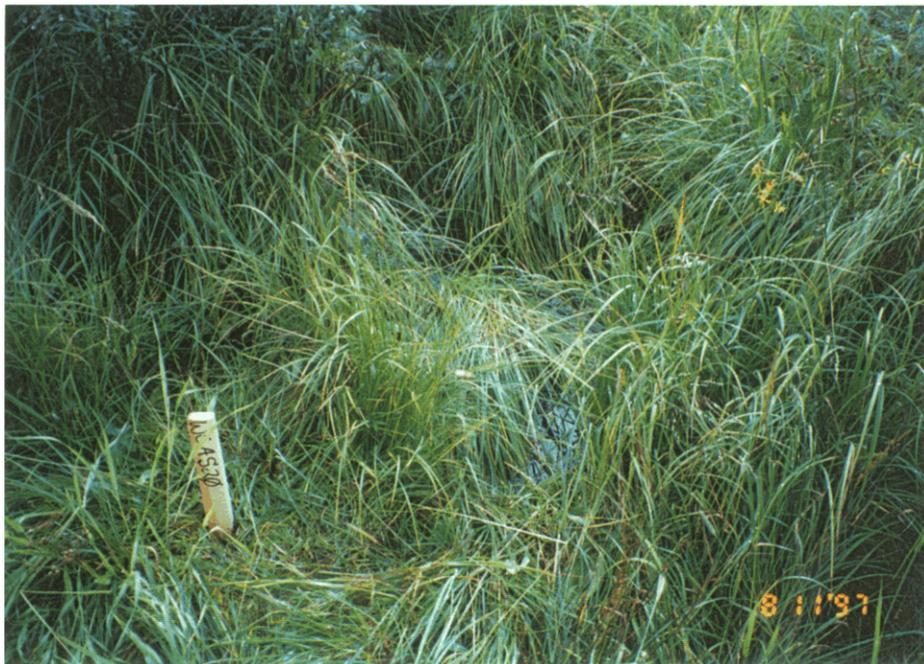
Figure 3.15 Lush vegetation and a small volume flow characterize Woody Creek downstream from the mine.

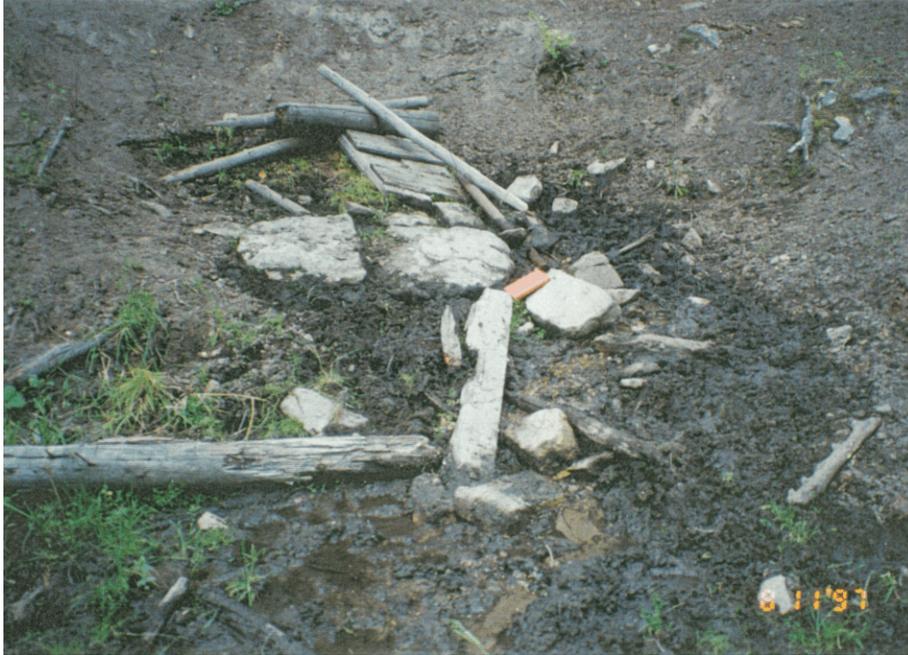
Figure 3.17 Upstream from the Clara mine, a small spring marks the beginning of Dry Gulch Creek, a small tributary to Steel Creek.

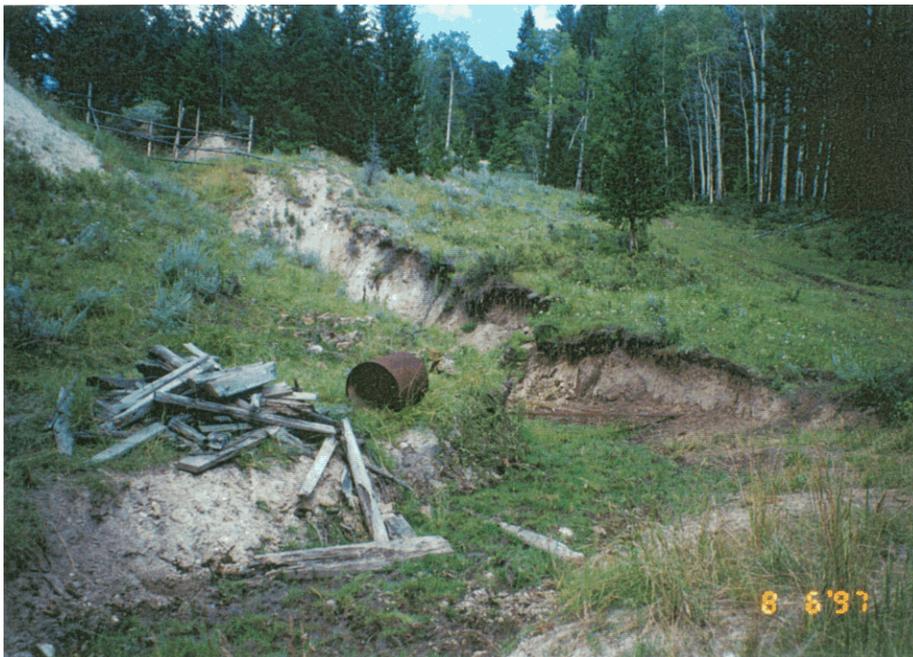
Figure 3.18 The collapsed adit has a small, probably seasonal discharge, that flows across a flat area and soaks into the ground.

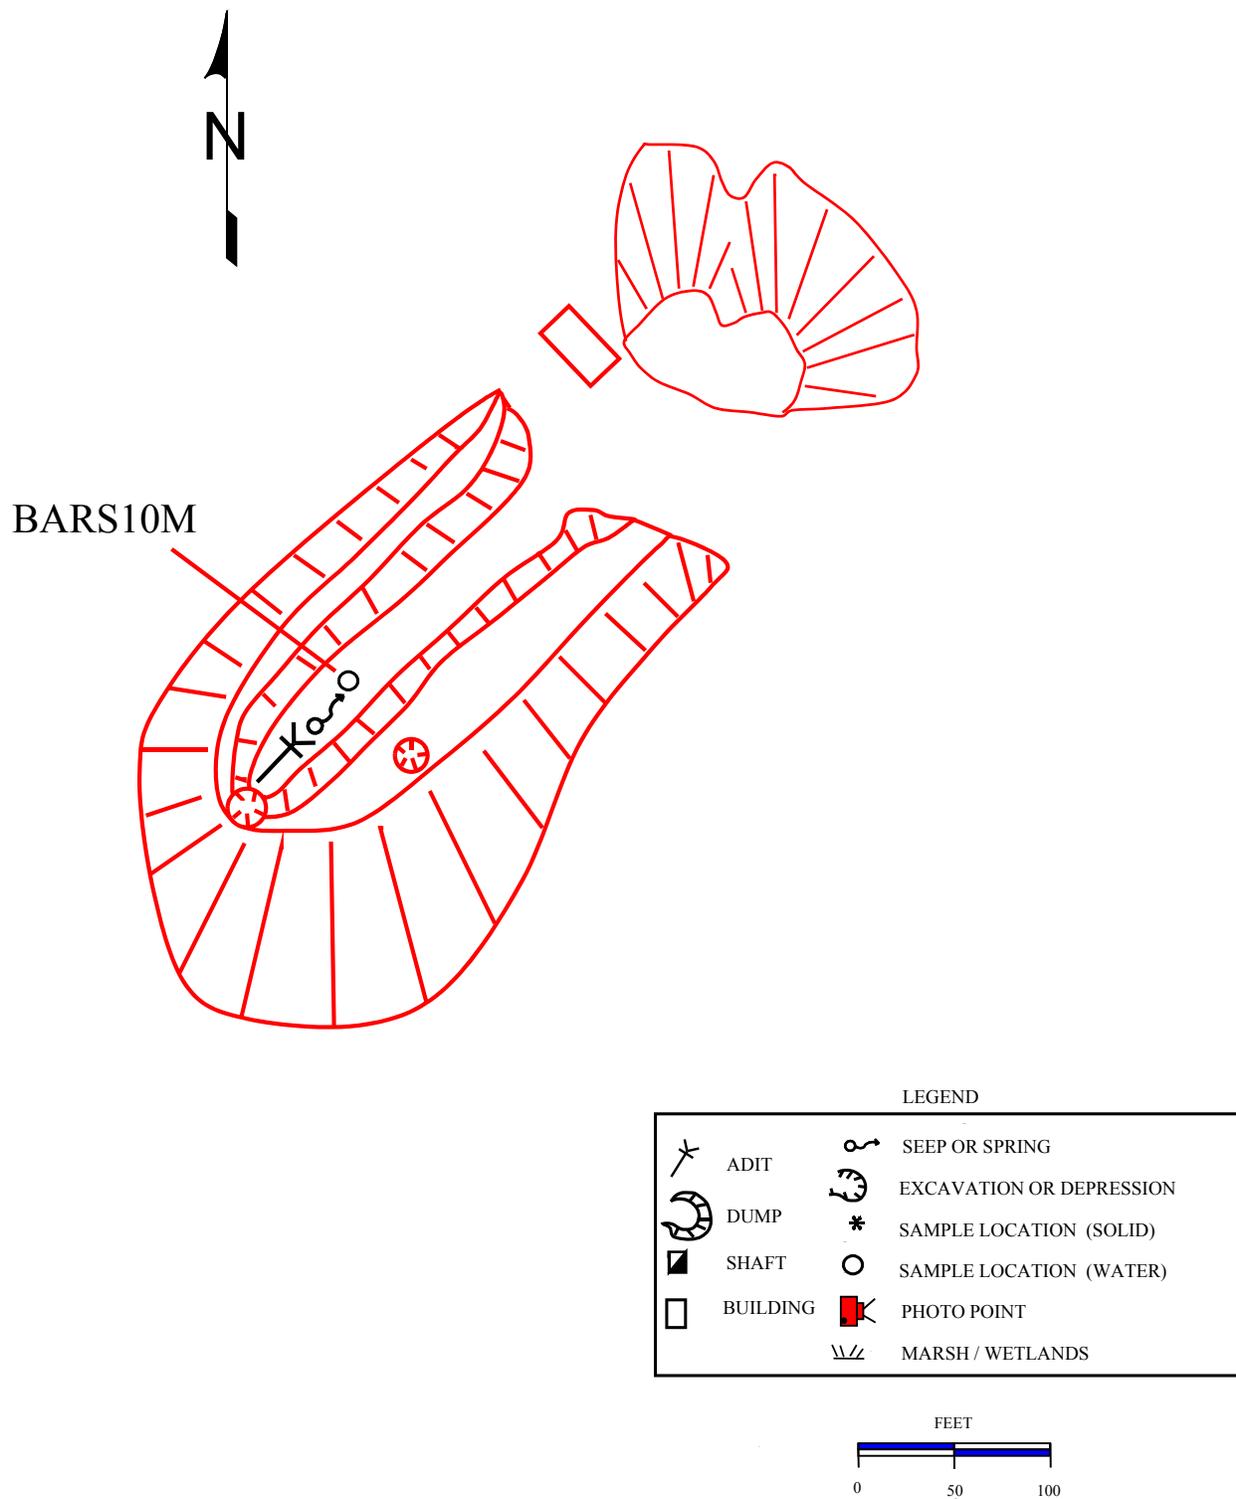
Iron and manganese concentrations in the adit discharge exceeded the secondary MCLs (table 3.8). As noted previously, the discharge infiltrates the ground before reaching any surface-water receptor; however, it may impact ground-water quality near the site.

Figure 3.19 Site map of the Arnold (Diadem Group) mine, October 1996.

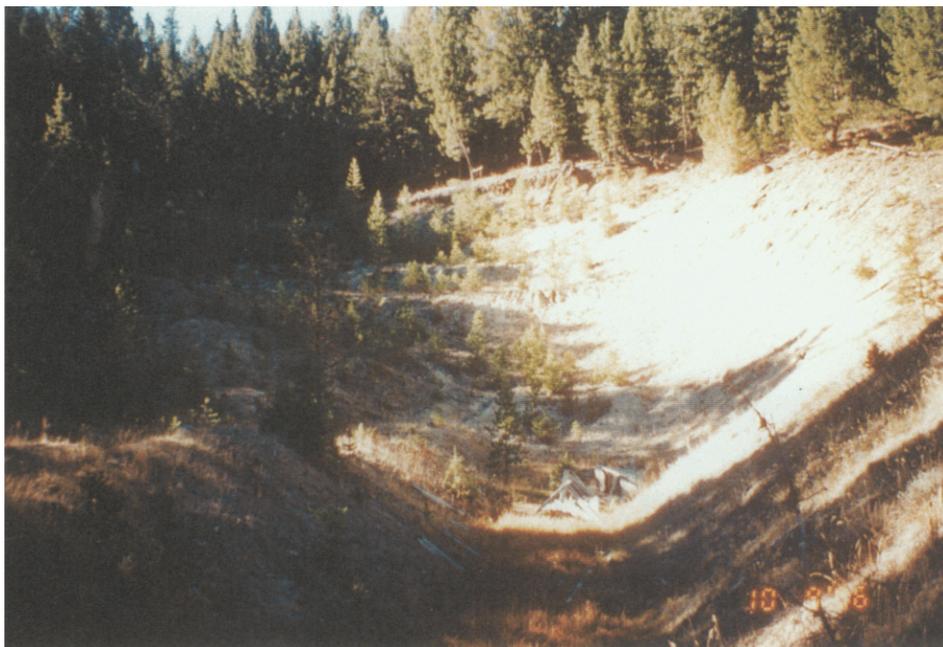
Figure 3.20 A small discharge flows from a collapsed adit at the Diadem Group (Arnold) mine.

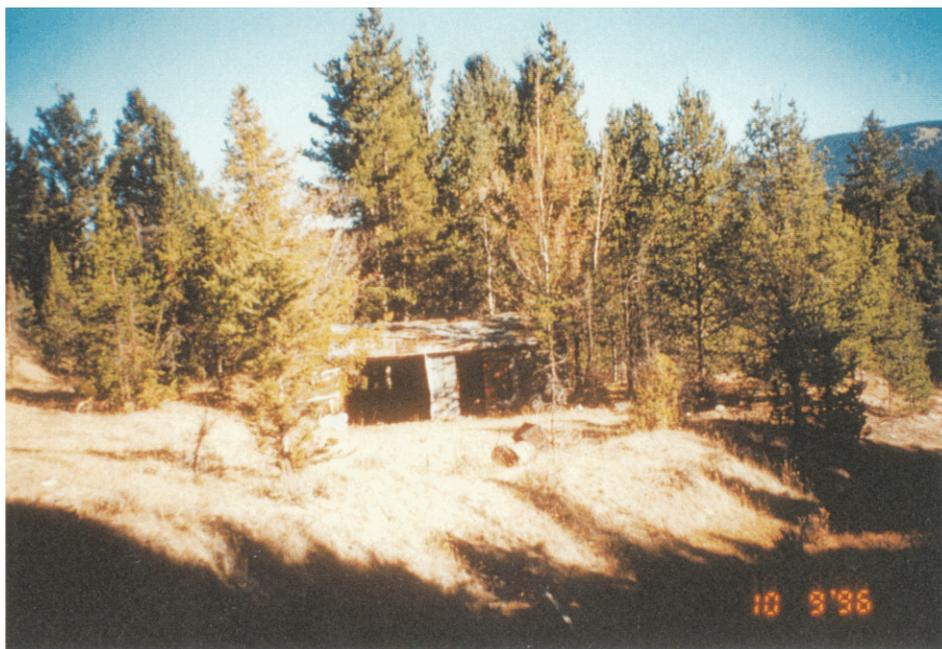
Figure 3.21 An empty mine building is located near the adit.

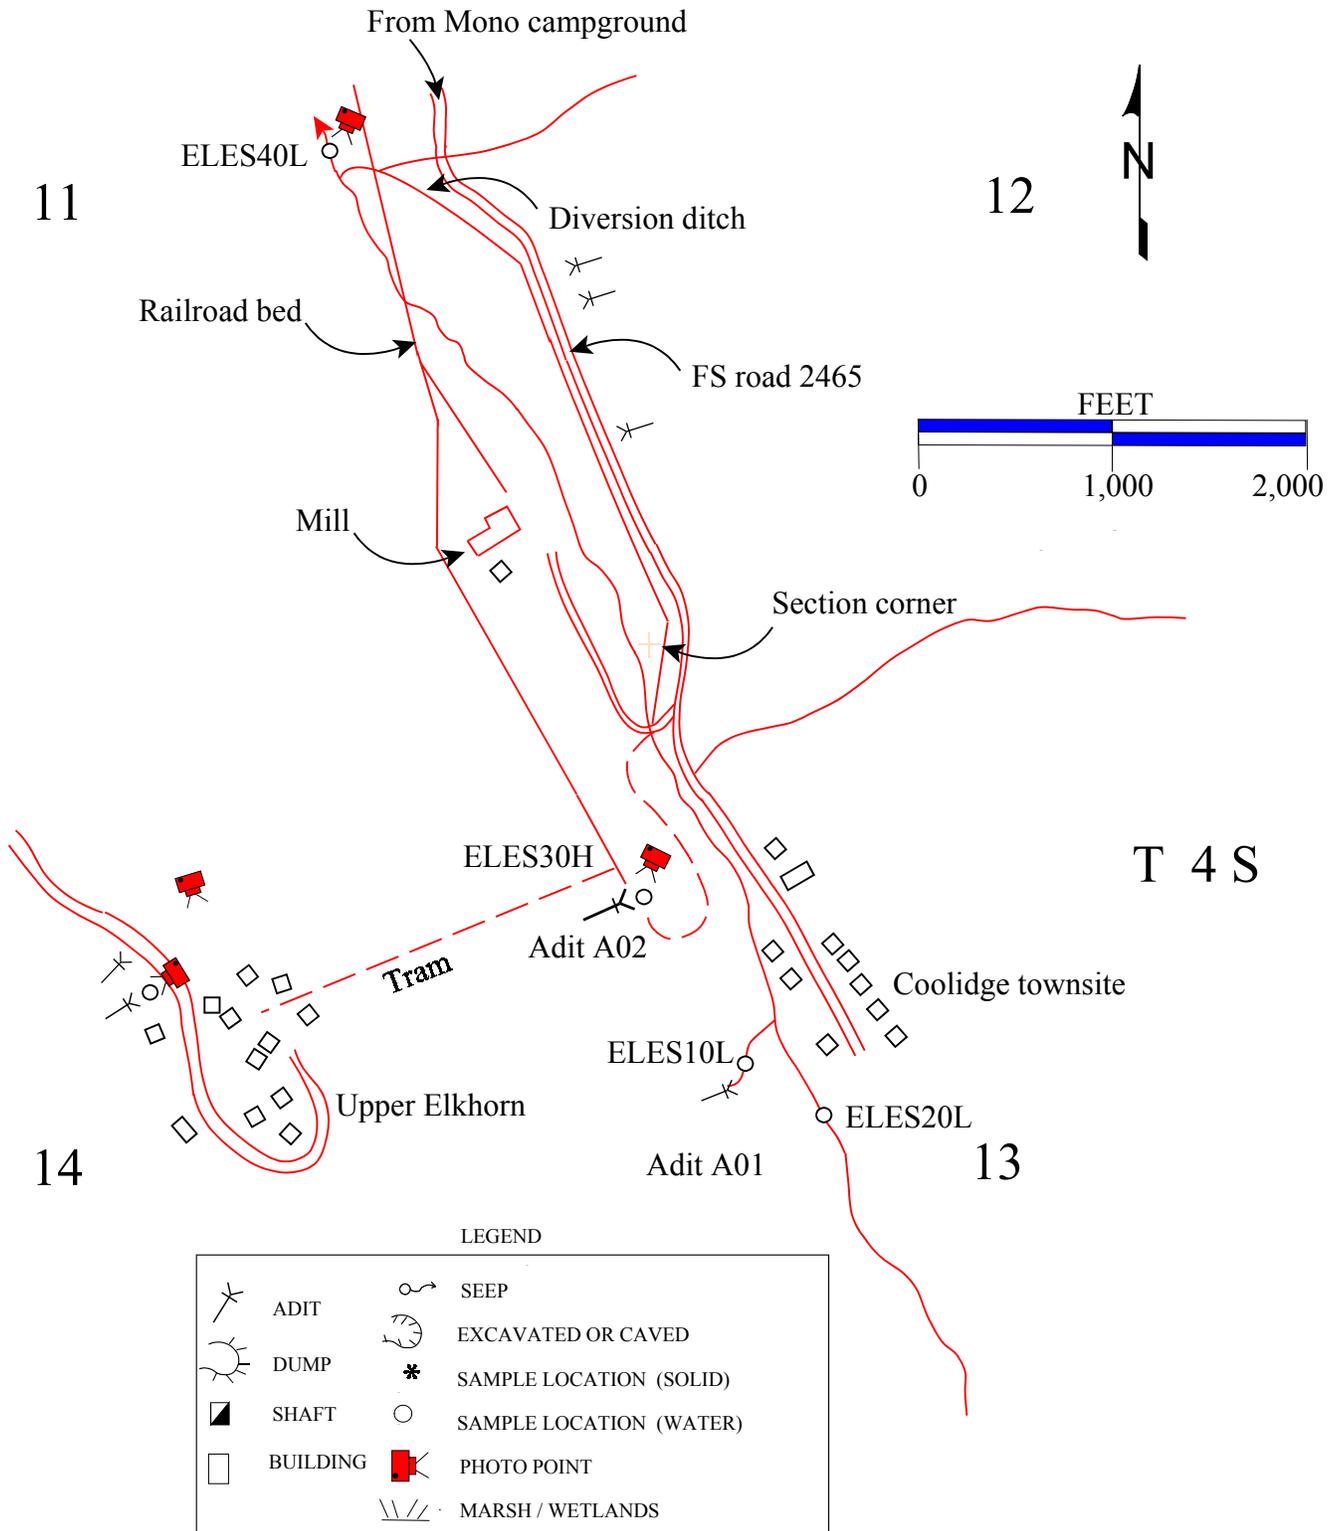
Figure 3.23 Schematic of the Elkhorn mine and mill on Elkhorn Creek taken from the Elkhorn Hot Springs 7.5-min. topographic map. The Upper Camp Elkhorn mine also is shown.
