Montana Bureau of Mines and Geology
MBMG No. 379

**Abandoned/Inactive Mines
of the
Southern Beaverhead-Deerlodge National Forest**

September 1998

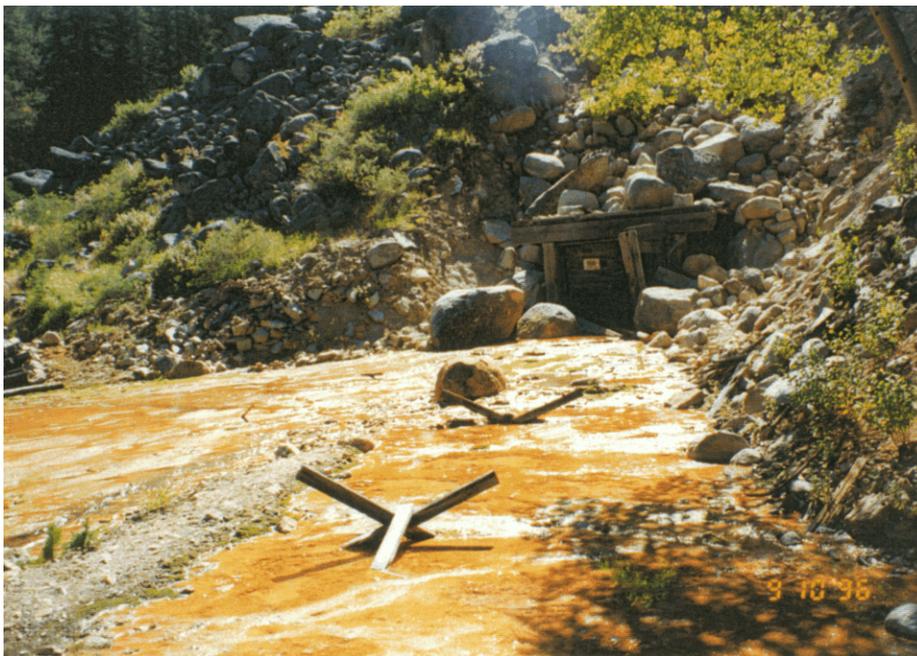
Figure 3.24 The discharge from the Elkhorn mine main adit splits into two channels; when the site was visited in September 1996, the flow was estimated at 150 gpm.

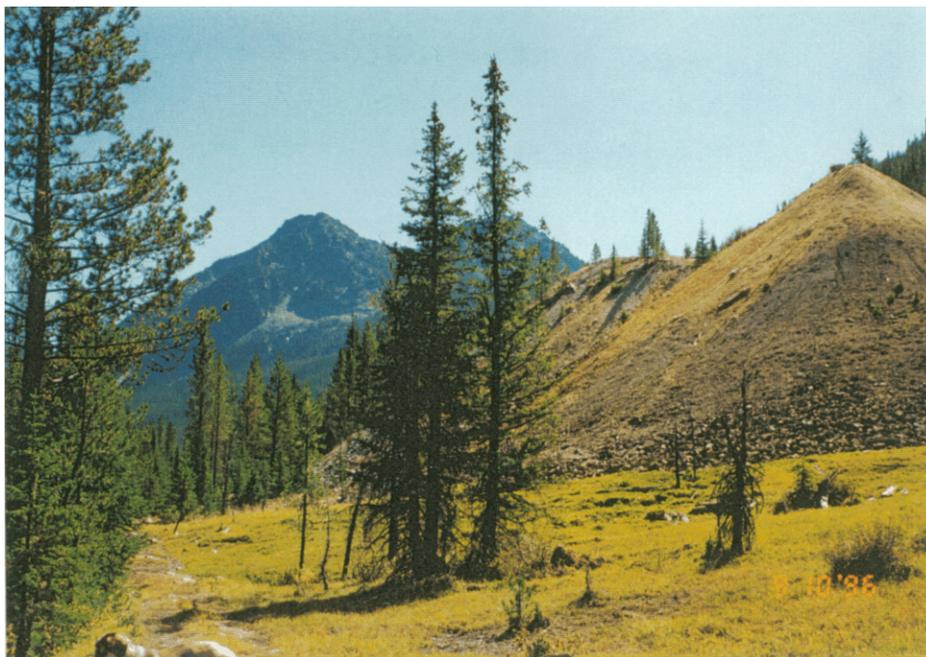
Figure 3.25 Seeps emerge from the toe of the Elkhorn mine's waste dumps.

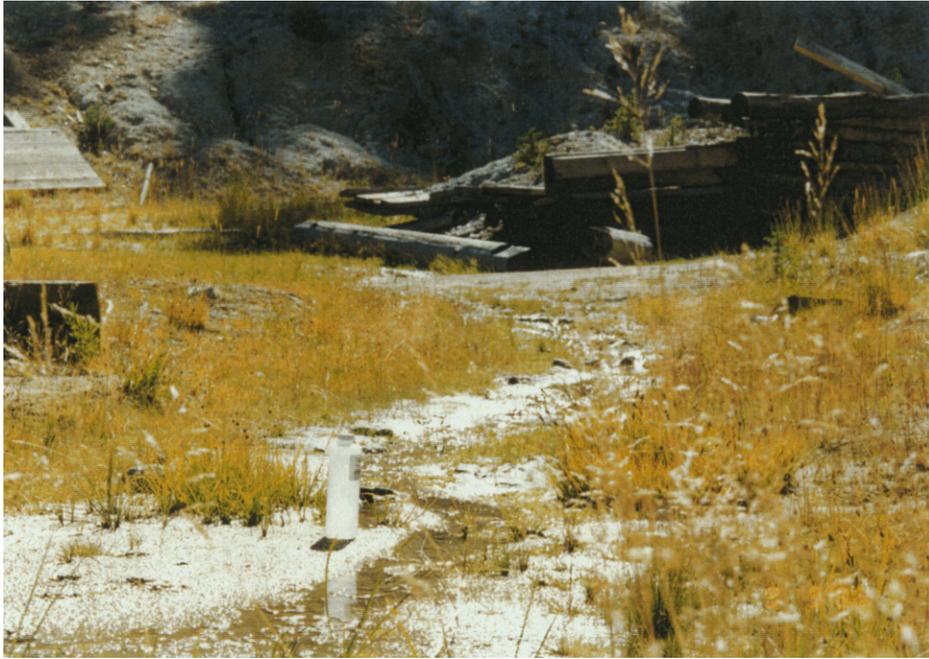
Figure 3.27 A small discharge flowed from the collapsed adit and soaked into the ground.

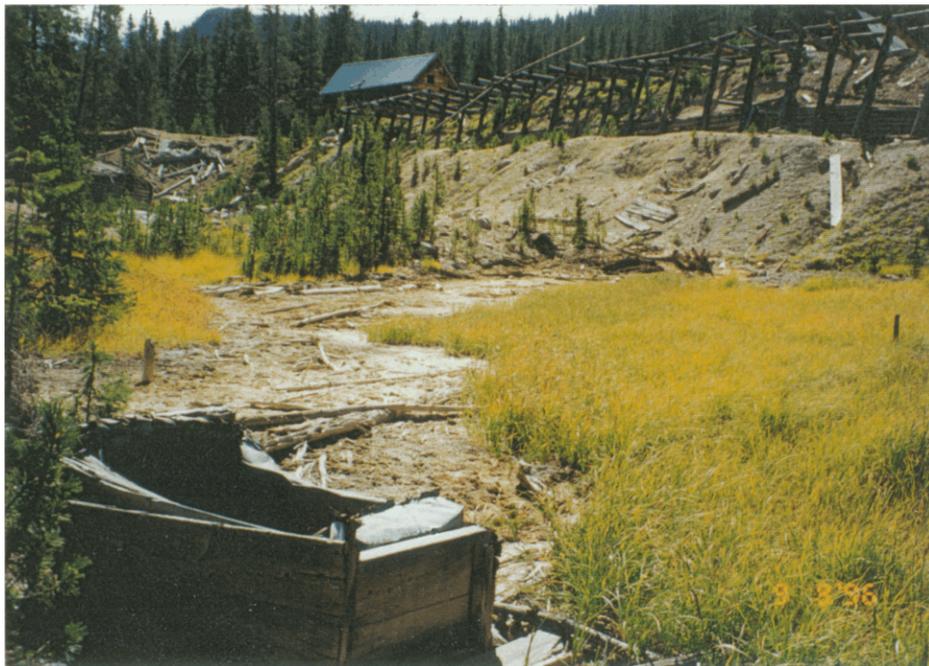
Figure 3.28 A flat area northeast of the adit was densely vegetated with sedges and grasses except for a barren swath that cut through the center of it. The barren area evidently is related to run off from the mine.

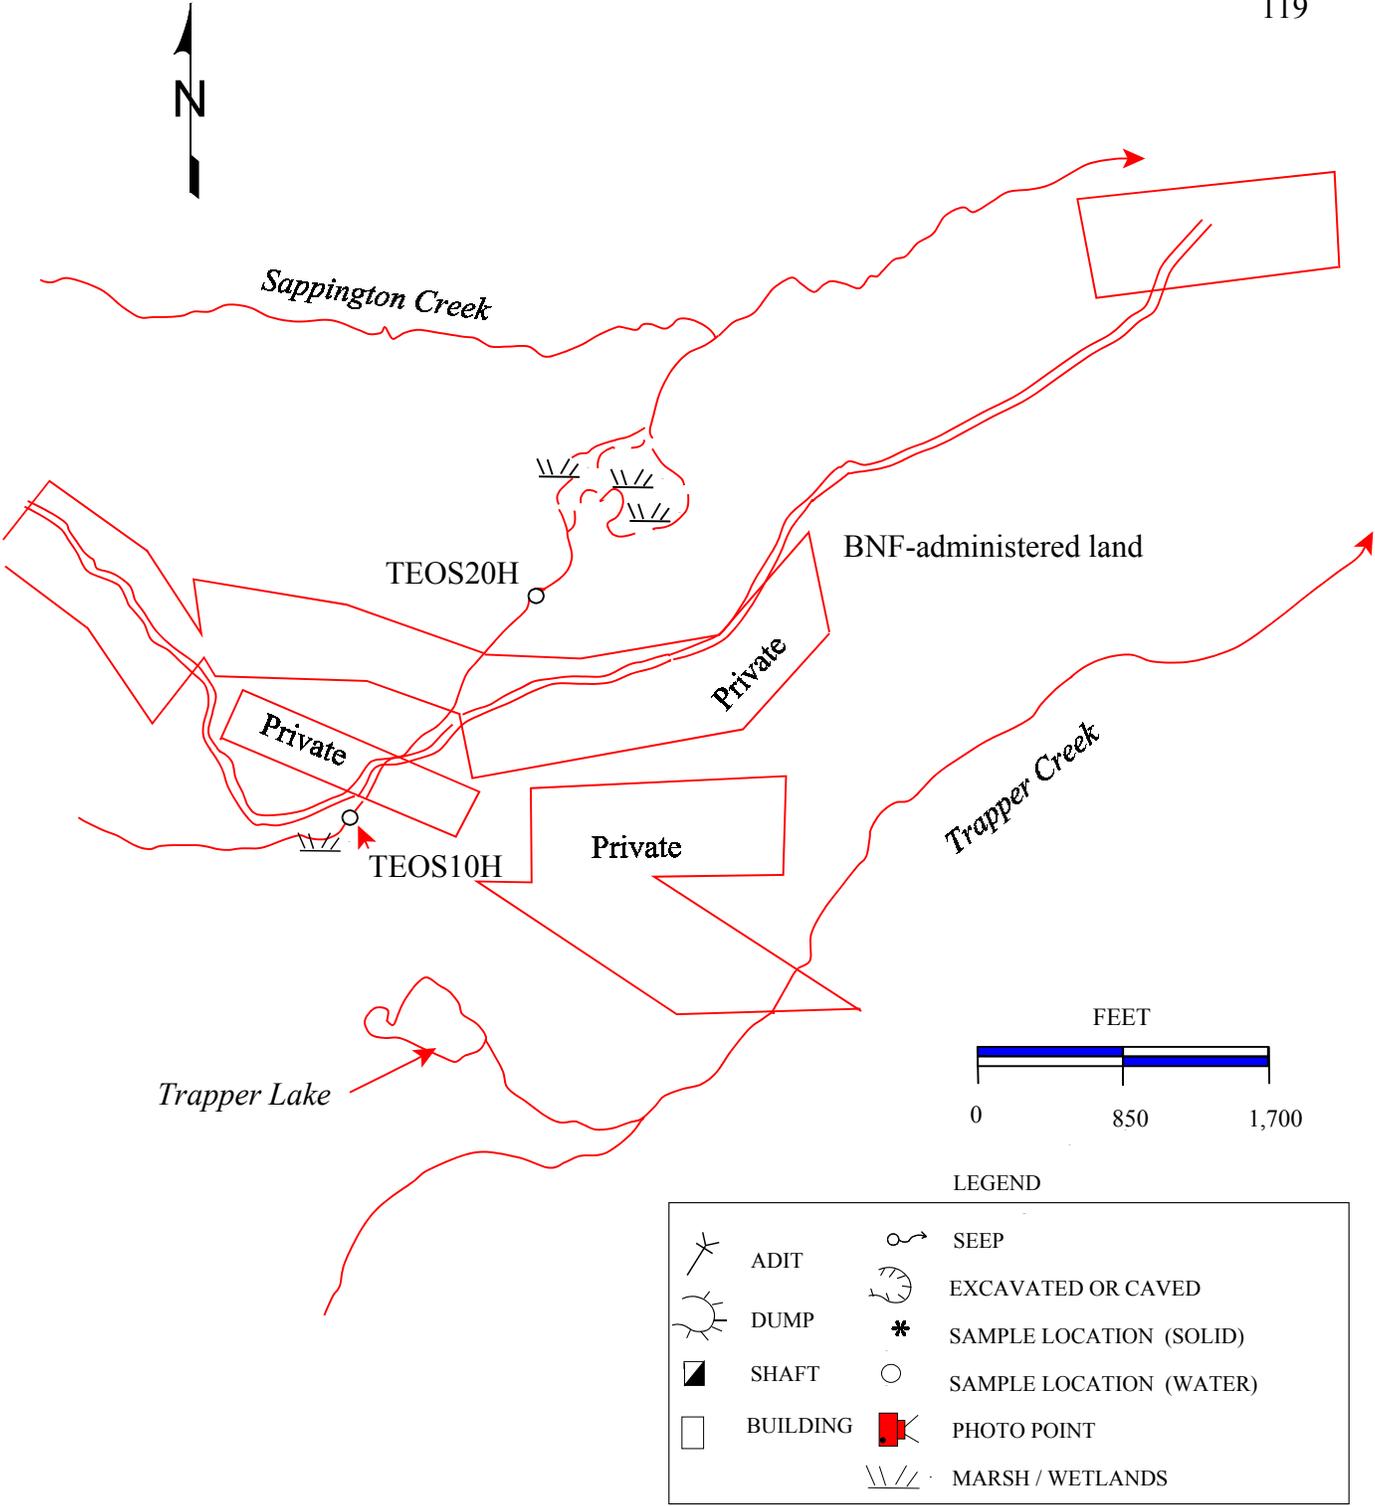
Figure 3.29 Samples for the Elm Orlu were taken upstream and downstream of the patented claims on August 29, 1996, as shown in this schematic drawing from the 7.5 min USFS ownership map.

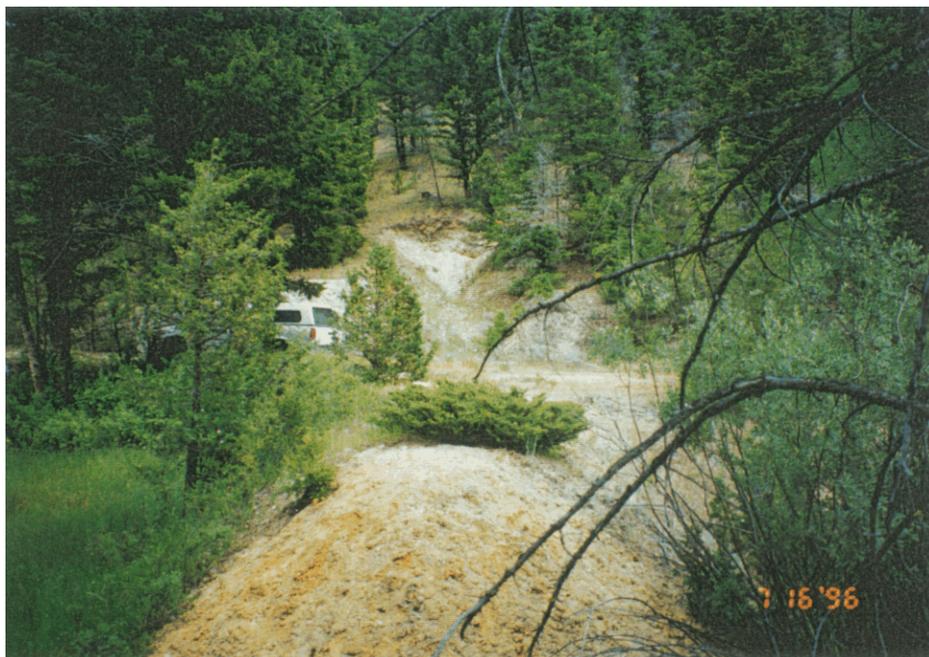
Figure 3.32 Workings at the Farlin Gulch site include a collapsed adit and a small waste dump.

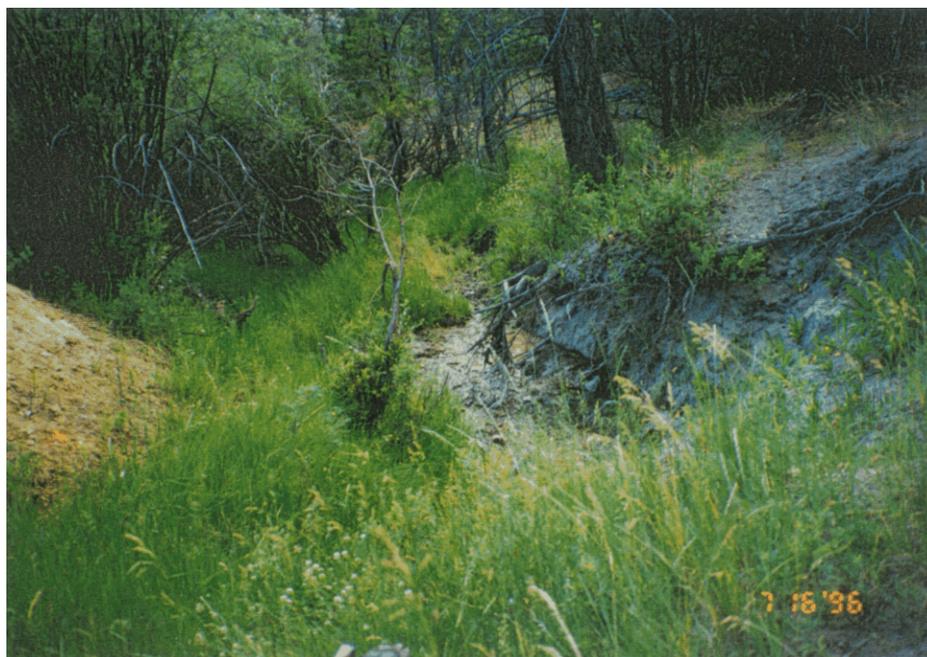
Figure 3.33 The small creek in Farlin Gulch cuts across and erodes the toe of the waste dump.

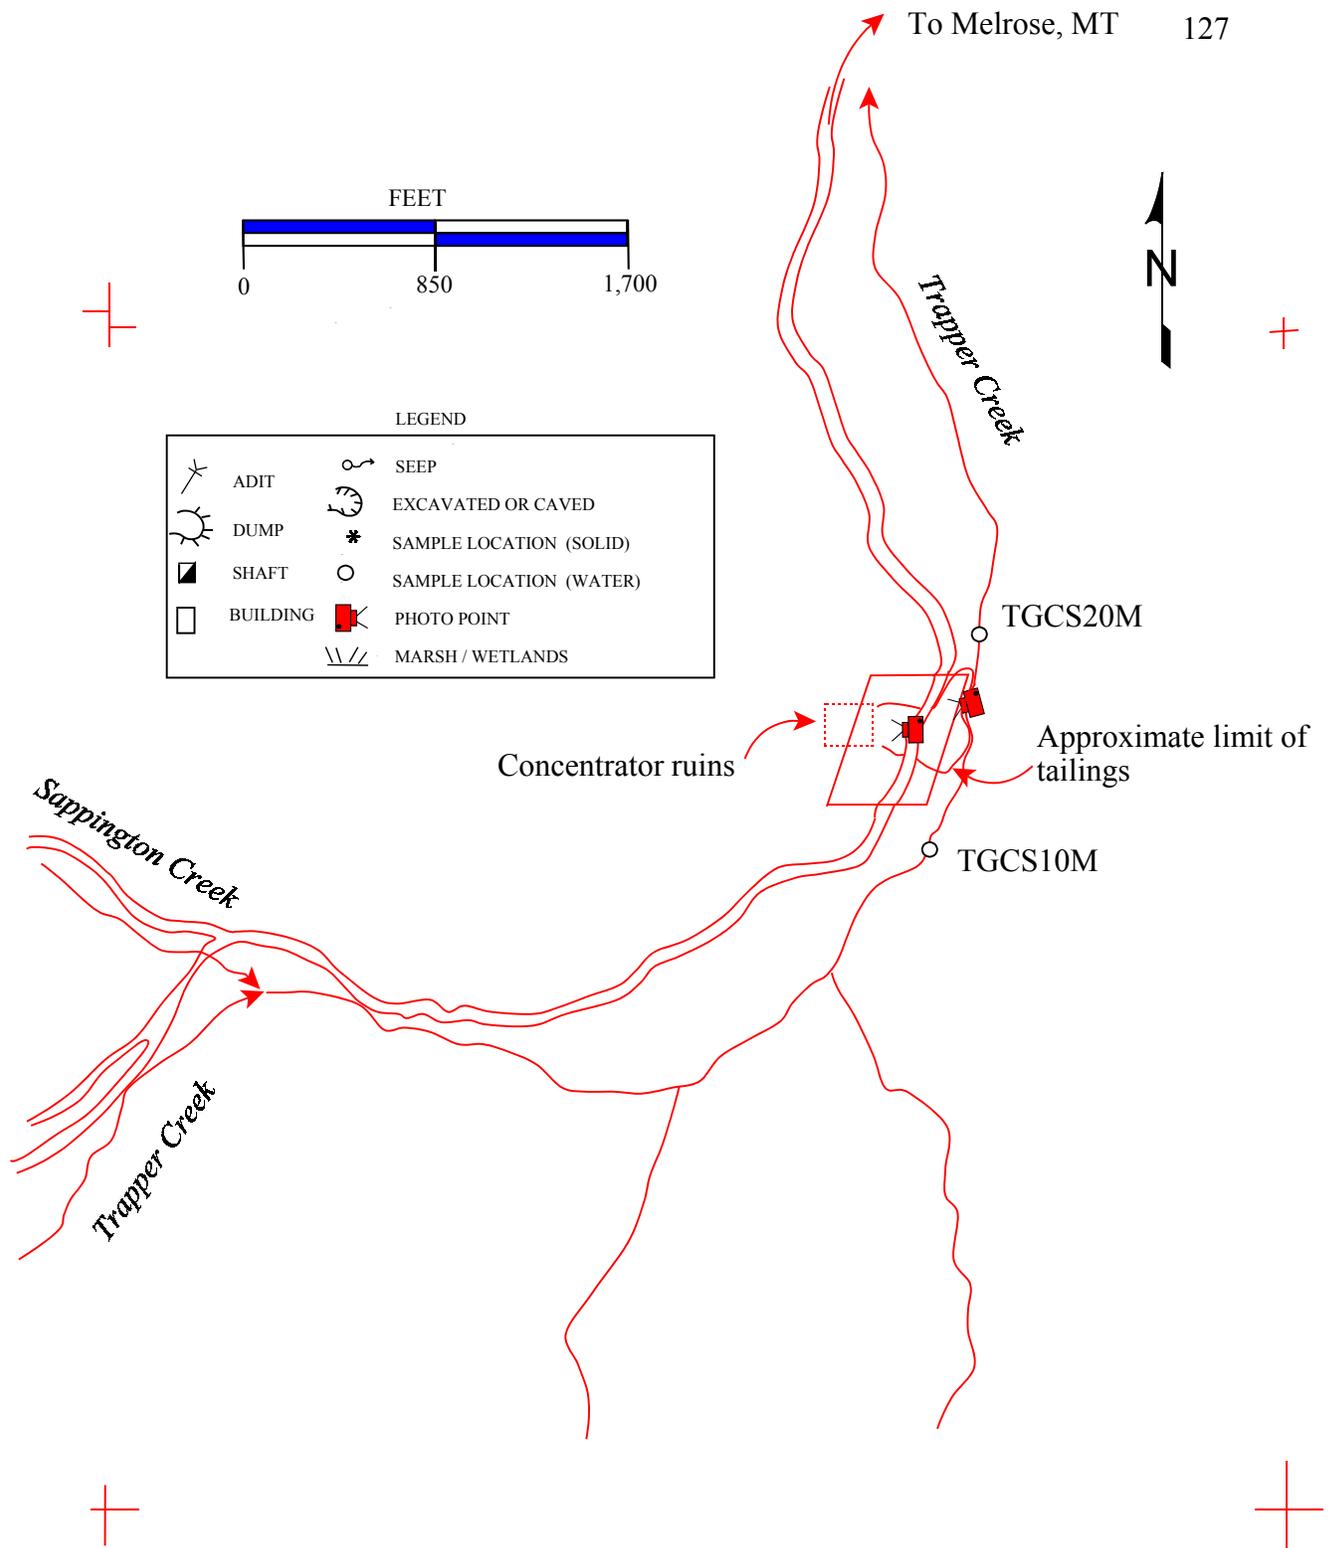
An apron of tailings is spread from the east of the concentrator ruins to Trapper Creek. Some of the tailings are in contact with the creek. Two samples were taken from the creek on August 22, 1996: one upstream (TGCS10M) and one downstream (TGCS20M). Most of the tailings are on private, patented land (a 400-foot by 600-foot mill site?). Site features and sample locations are shown on figure 3.34; photographs of the site are shown in figures 3.35 and 3.36.

Figure 3.34 Samples for the Greenwood Concentrator were taken upstream and downstream of the patented claim on August 22, 1996, as shown in this schematic drawing from the Mount Tahepia 7.5 min USFS ownership map.

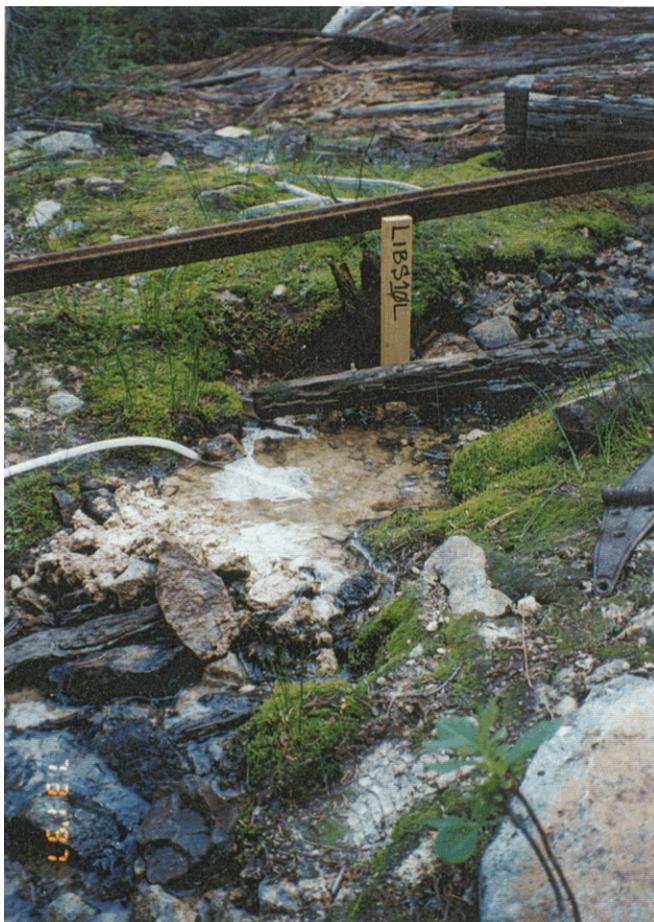
The pH of the adit discharge (field=6.52, lab = 6.32) and the unnamed drainage (field=6.48, lab = 6.1) was slightly acidic and fell outside the acceptable secondary MCL range of 6.5 to 8.5 (table 3.12). The acidity may be caused by the water being in contact with the intrusive host rock or by organic acids released by the spruce and pine vegetation. Locally, there are no carbonate rocks to act as a buffer. Copper, iron, manganese, and zinc concentrations were higher in the adit discharge than in the background sample from the unnamed stream; however, no water-quality standards were exceeded.

Figure 3.38 The Ibex mine had an adit discharge that flowed at 5 gpm; no signs of AMD were evident.

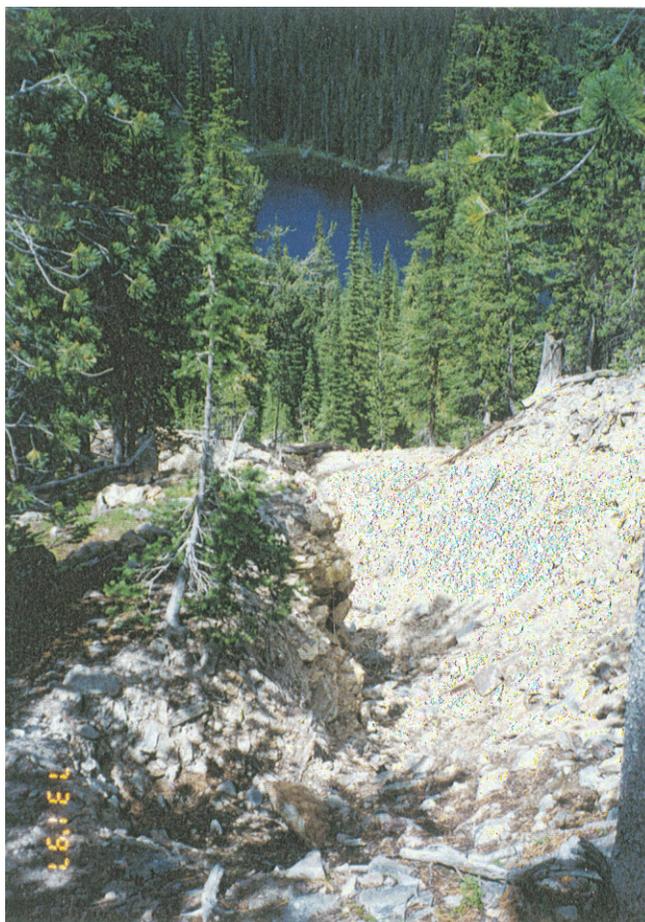
Figure 3.39 The upper adits of the Ibex were collapsed; Schwinegar Lake appears in the background.

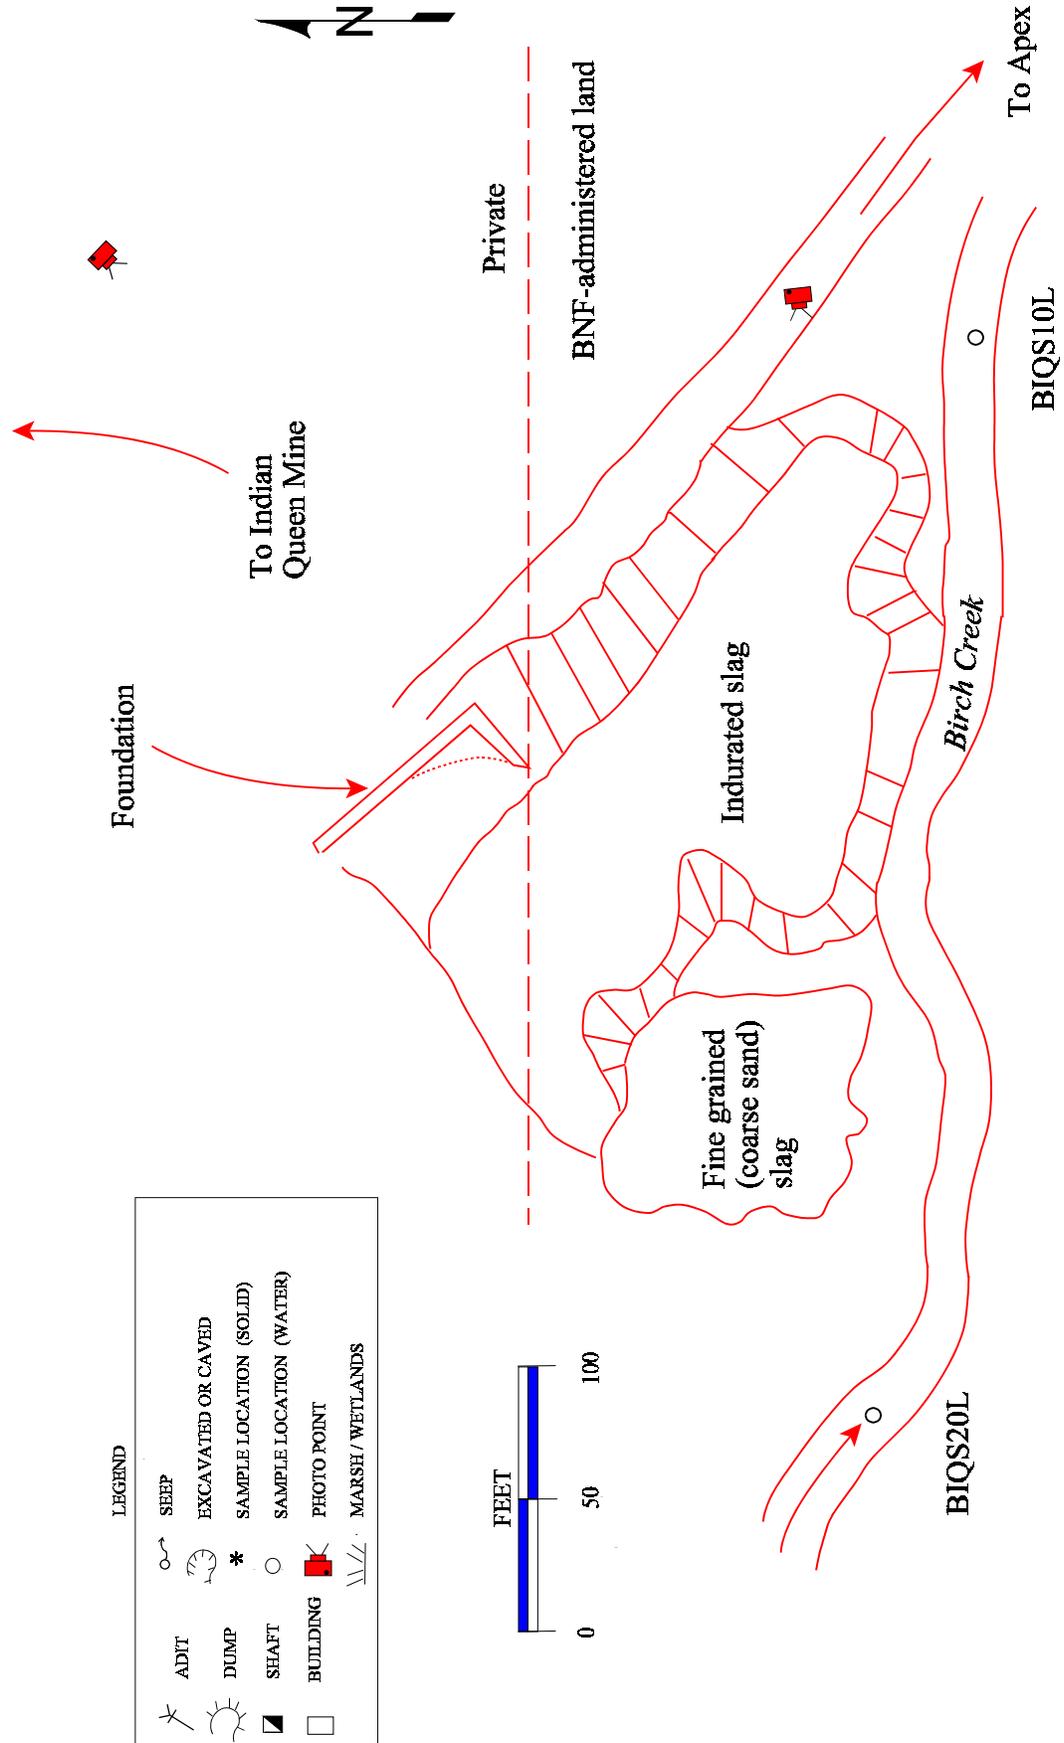
No differences in the water quality were noted between the upstream and downstream samples. The slag largely occurred in competent blocks and did not appear to be rapidly eroding even though Birch Creek was immediately adjacent to the slag pile. The metals in the slag may be silica encapsulated.

Figure 3.40 Birch Creek flows adjacent to the Indian Queen smelter slag, as mapped May 3, 1996.

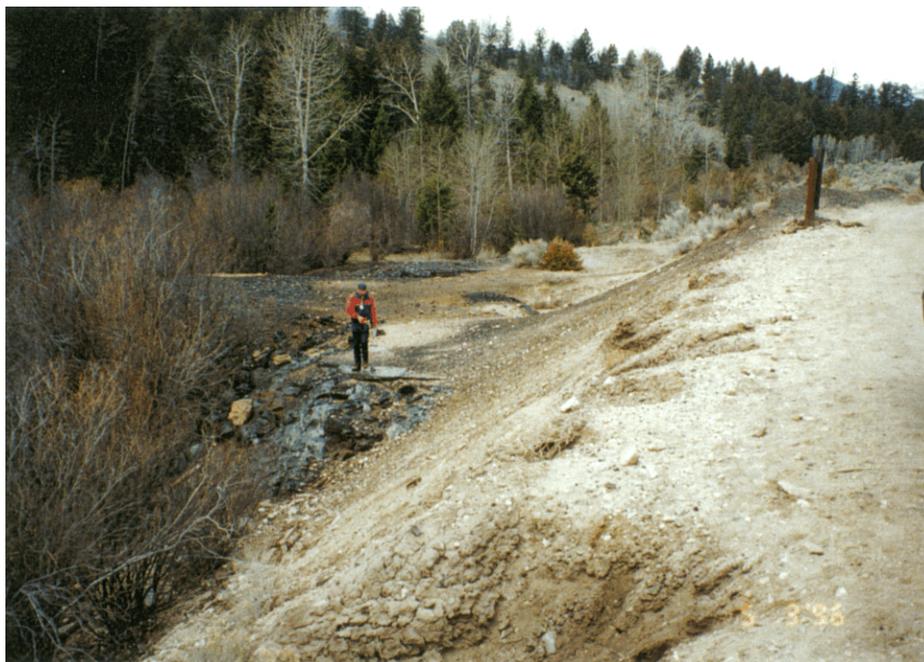
Figure 3.41 Birch Creek flows by the smelter waste at the Indian Queen mine.

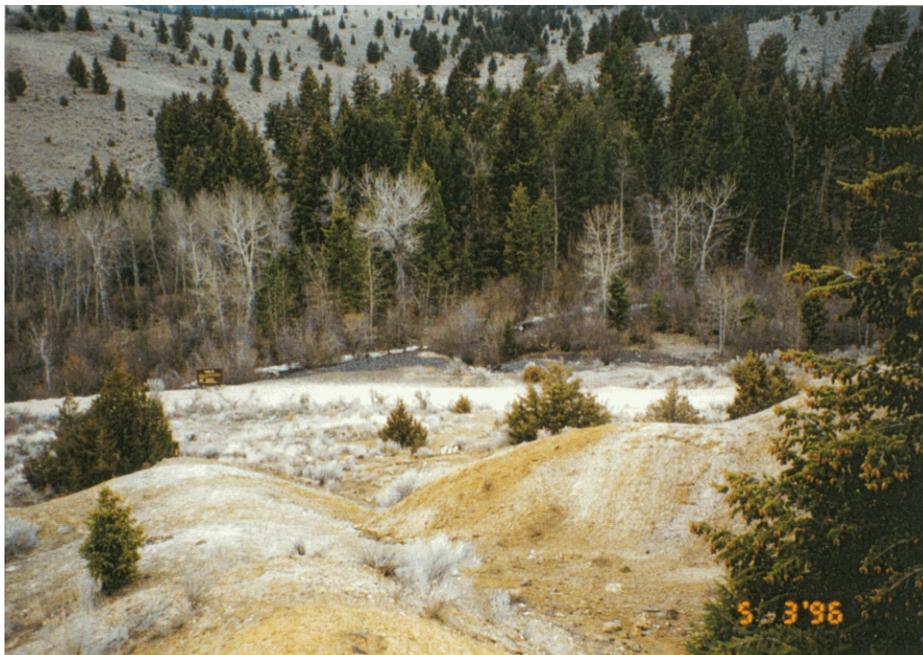
Figure 3.42 The waste rock from the Indian Queen lies on dry ground up slope from the smelter site.

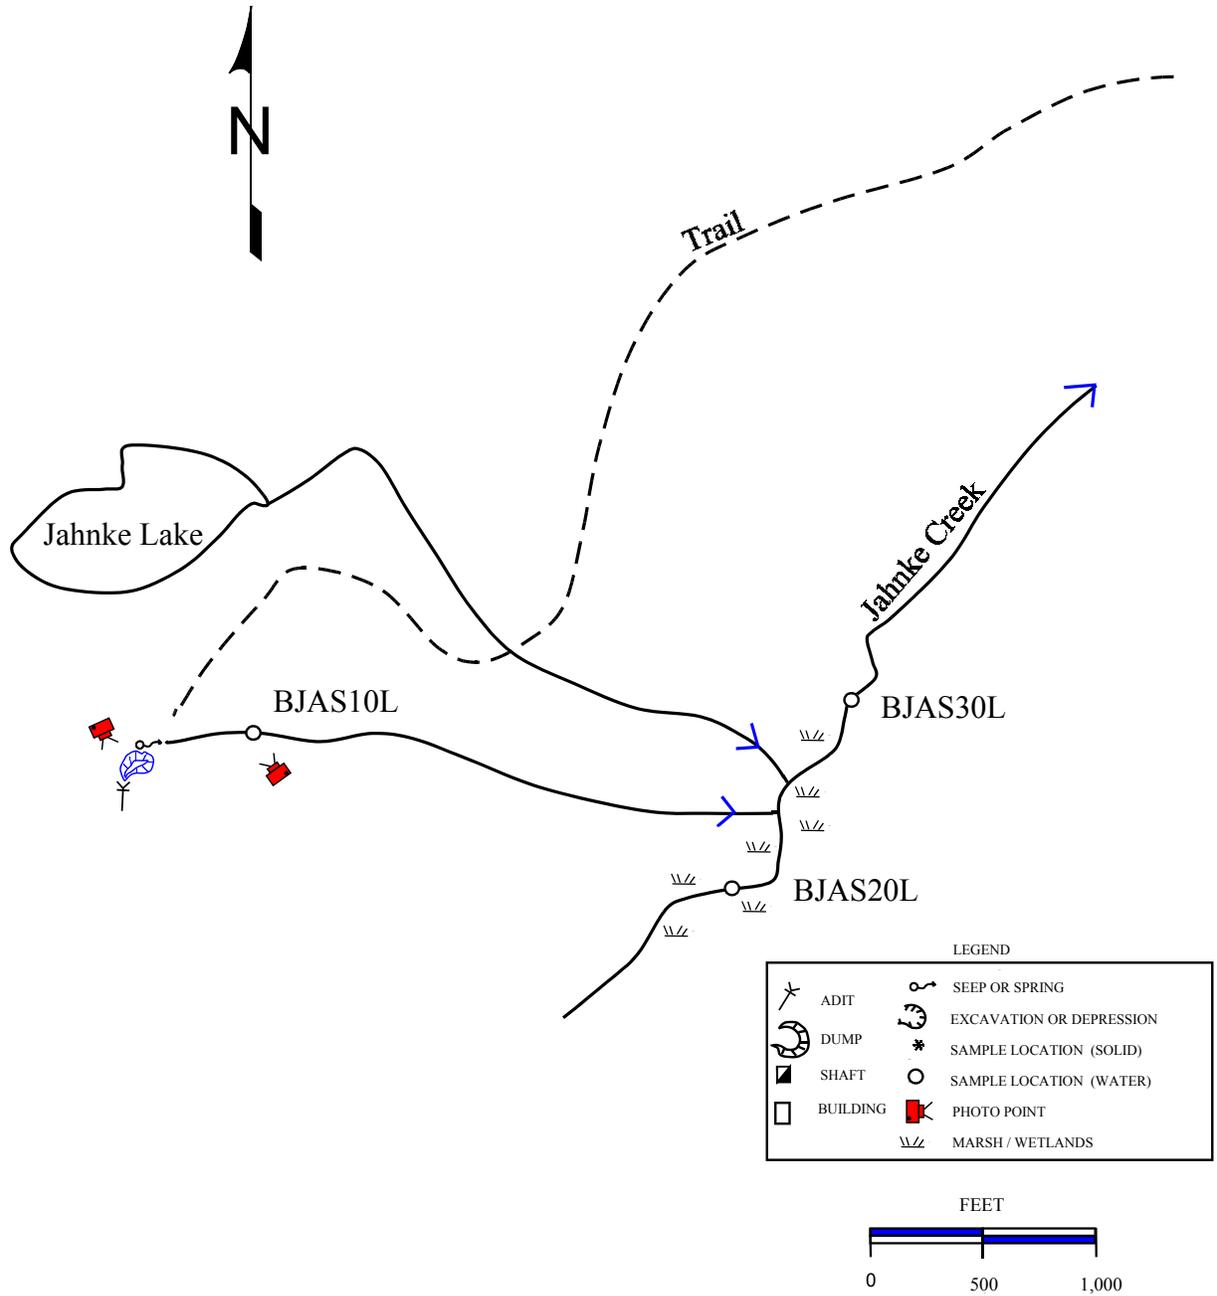
Although the adit discharge is in contact with waste rock at the site, erosion of the waste is a minor problem. No waste rock deposits were observed on BNF-administered land; hence, no soil samples were collected at the site.

Figure 3.43 Site map of the Jahnke mine, September 1996.

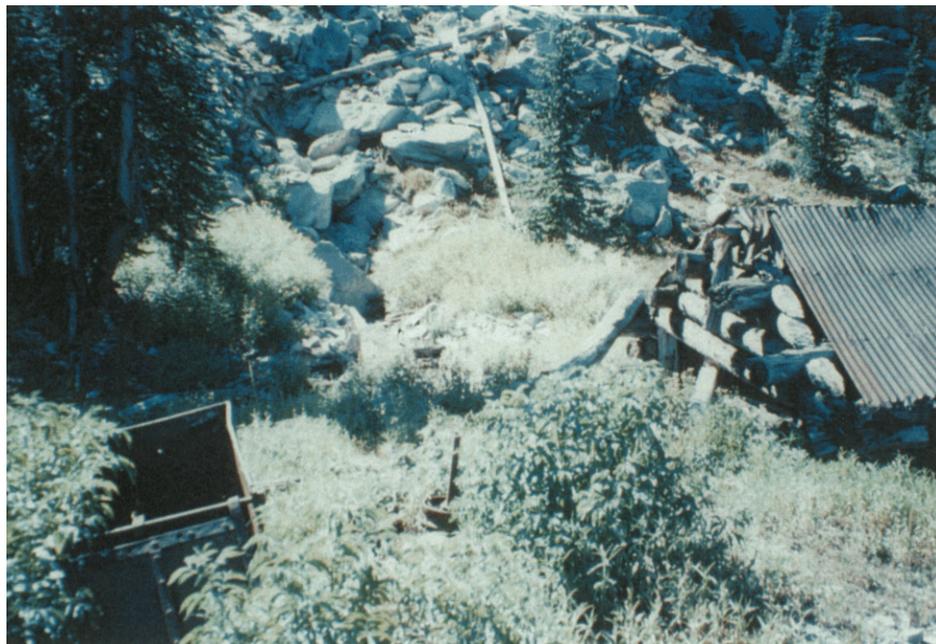
Figure 3.44 The partially collapsed adit at the Jahnke mine has a large, clear discharge.

Although the adit apparently has been closed by blasting, entry still is possible by crawling through a hole between the boulders. The adit is on private land. No hazards were observed on BNF-administered land.

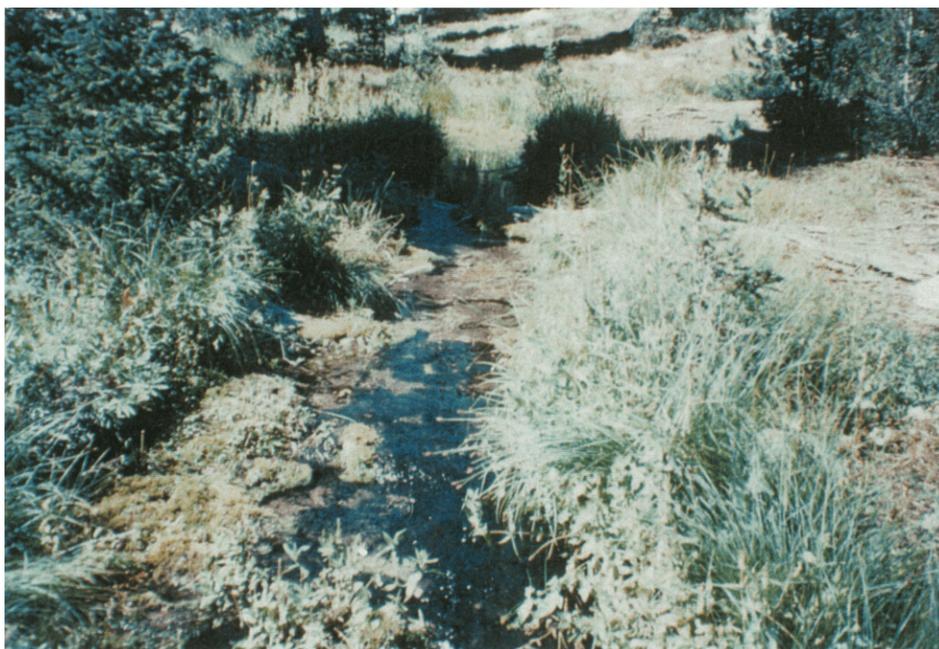
Figure 3.45 The adit discharge flows onto BNF-administered land a short distance below the mine. Sample BJAS10L was collected at this location.

The silver concentration in the adit discharge exceeded the chronic aquatic life standard, but similar concentrations were found in a background sample collected from a tributary to Jahnke Creek. Therefore, silver may naturally occur at elevated concentrations in the vicinity of the mine. No other environmental problems were noted at the site.

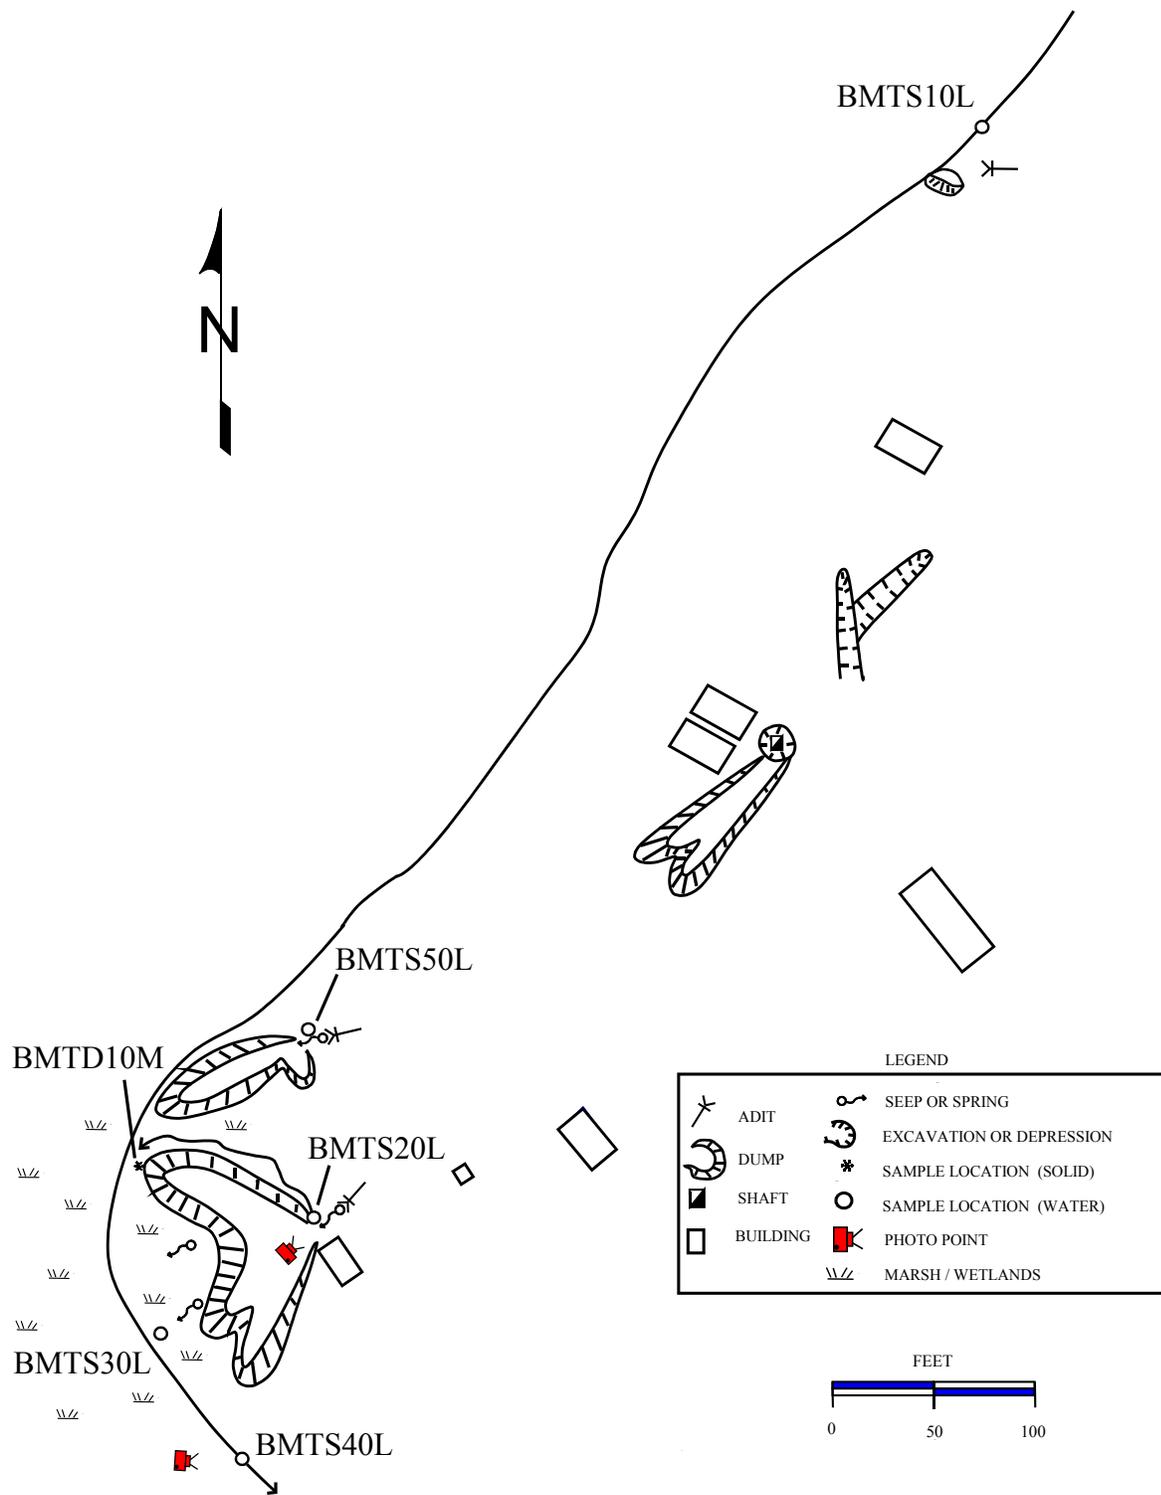
Soil and water-quality samples were collected at the site on September 11, 1996. Water samples BMTS20L and BMTS50L were collected from the two adit discharges (see figure 3.46). The discharge from the north adit had a pH of 6.4 and a flow rate of less than 1 gpm. The discharge from the south adit had a pH of 7.4 and a flow rate of 2 gpm. Sample BMTS30L was collected from one of the iron-stained seeps below the southernmost dump. The seep had a flow rate of 1 gpm and a pH of 5.7. Soil sample (BMTD10M) was collected from the barren slope of the dump where it closely bordered the creek. To evaluate the site's environmental impact on the East Fork of Warm Springs Creek, samples were collected upstream (BMTS10L) and downstream (BMTS40L) of the workings. The flow rate of the creek at the upstream sample location was 18 gpm; at the downstream location, the flow rate was 5 gpm.

Soil around the streamside waste-rock dump has concentrations of copper, lead and zinc that are well above phytotoxic levels (table 3.14). Arsenic was found to be slightly above the phytotoxic concentration.

Figure 3.46 Site map of the Martin mine, September 1996.

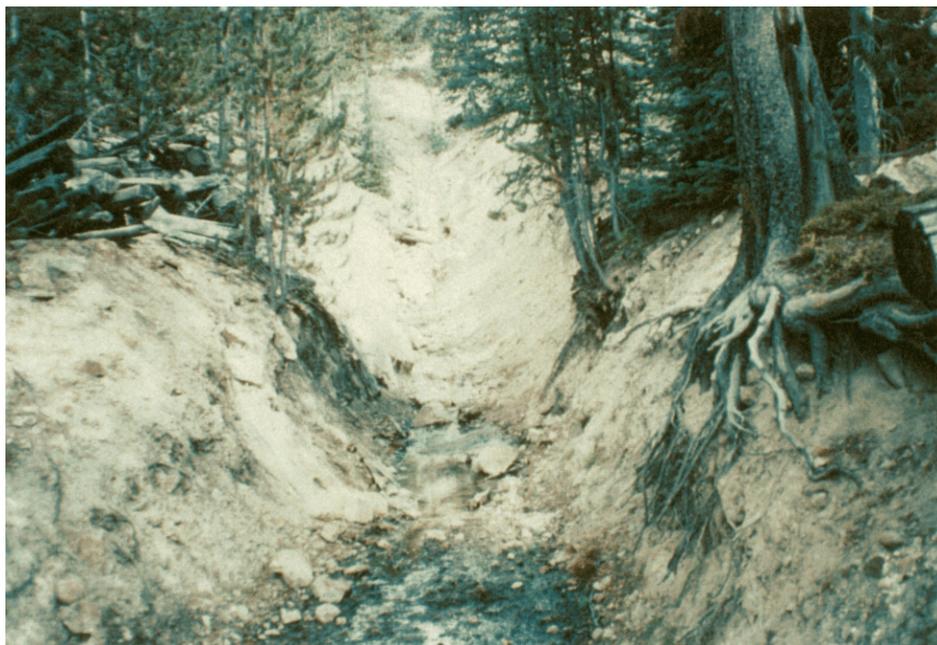
Figure 3.47 A small discharge flows from the collapsed portal of the main lower adit.

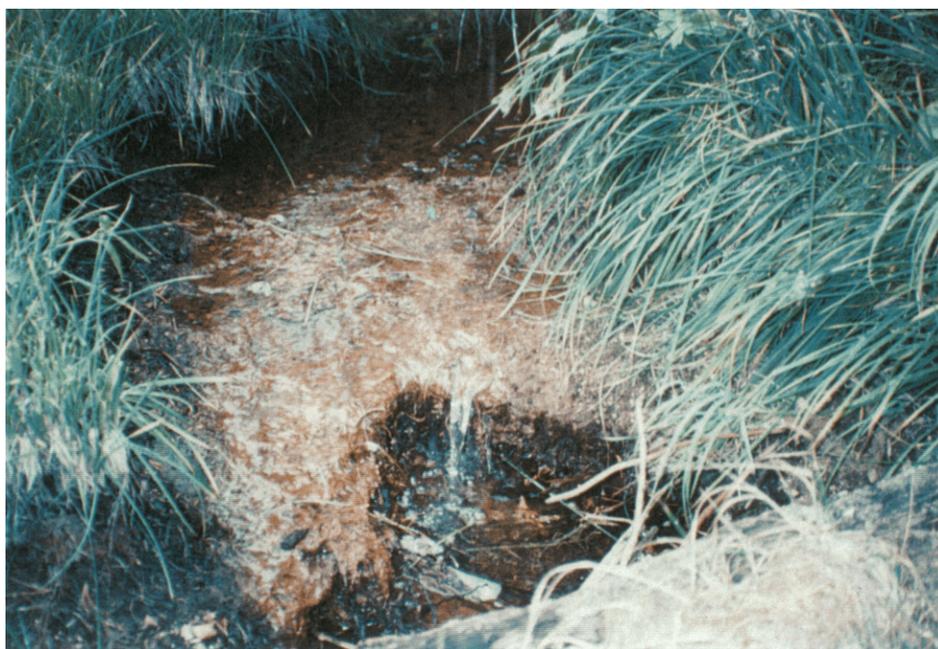
At the lower end of the site, two adits discharge a small volume of water into a wetland adjacent to Warm Springs Creek. The waste-rock dumps associated with the adits are within the floodplain of the creek. At the base of one of the dumps, several iron-oxyhydroxide stained seeps are present. The East Fork of Warm Springs Creek is stained with iron-oxyhydroxides downstream of the site.

Figure 3.48 An iron-oxyhydroxide precipitate coats the bottom of the East Fork of Warm Springs Creek a short distance downstream of the site.

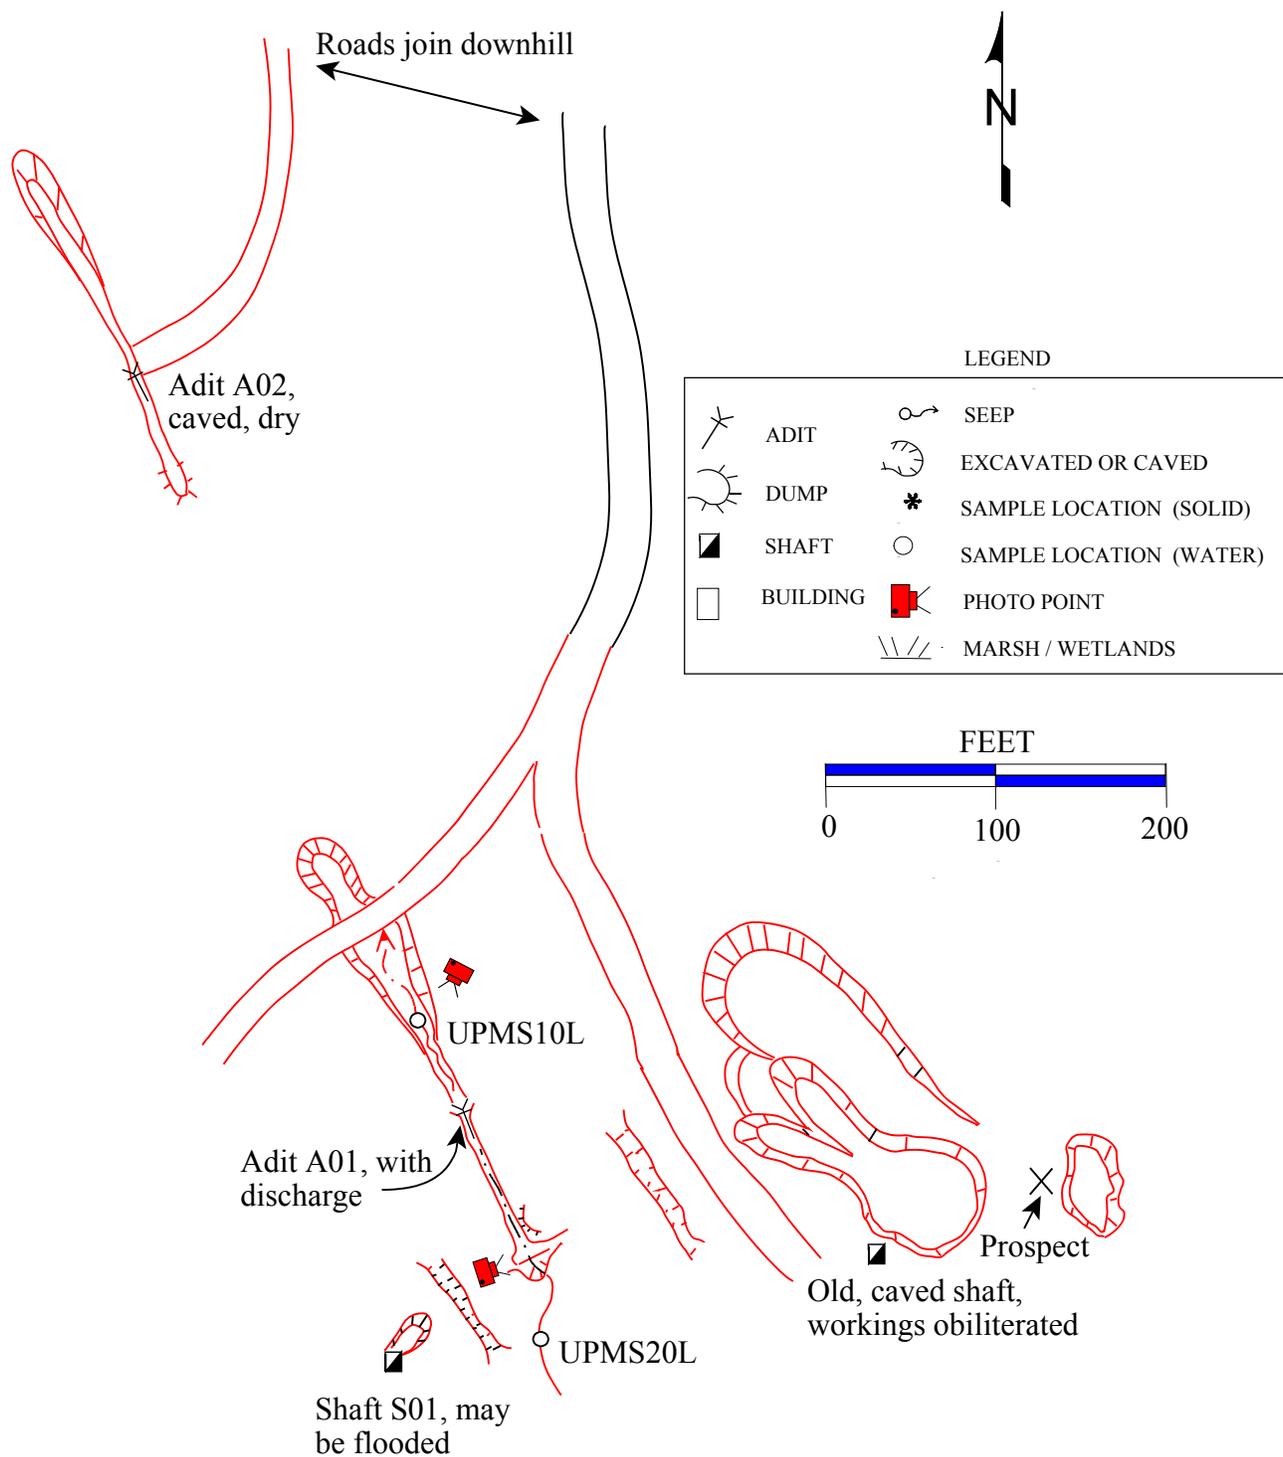
Figure 3.49 The Park mine taken from Geach (1972).

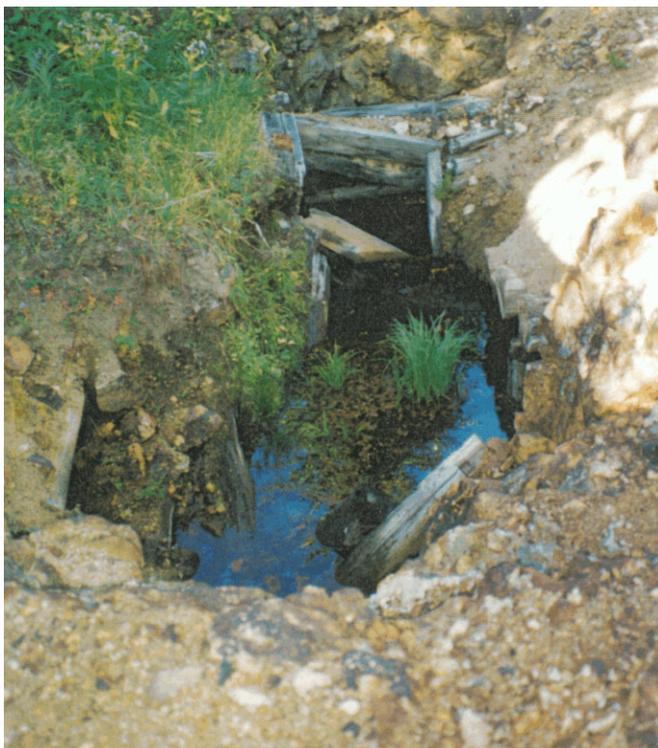
Copper, iron, lead, manganese, mercury, silver, and zinc concentrations in the small adit discharge exceeded one or more water-quality standards (table 3.16). Also, the pH of the discharge (6.4) was outside the acceptable secondary MCL range of 6.5 to 8.5. The water collected from the spring upgradient of the site also had a low pH, but concentrations of dissolved metals did not exceed any standards.

Figure 3.50 A shaft at the Park mine is flooded and has a small discharge at the north end.

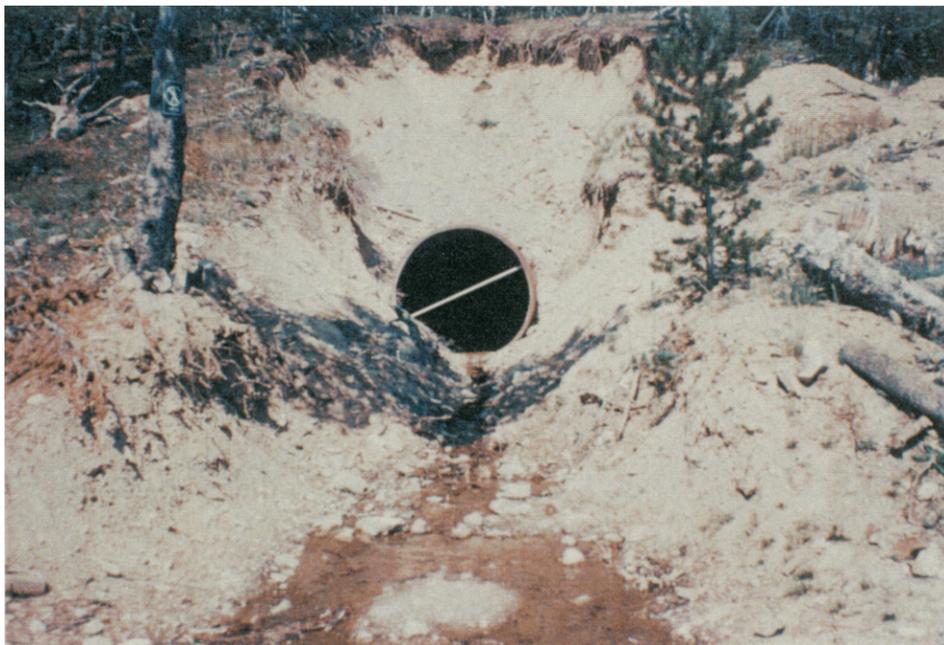
Figure 3.53 A 5-gpm discharge flows from the collapsed adit at the Queen of the Hills mine.
