Montana Bureau of Mines and Geology
MBMG No. 379

**Abandoned/Inactive Mines
of the
Southern Beaverhead-Deerlodge National Forest**

September 1998

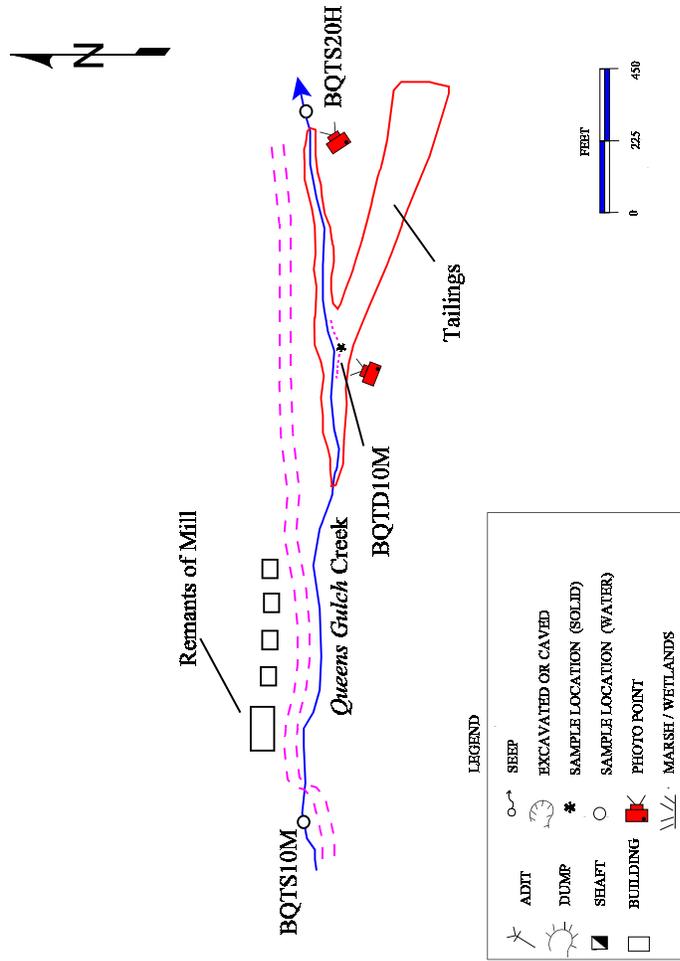
The results from the analysis of the streamside tailings (BQTS10M) show that arsenic, cadmium, copper, lead, and zinc exceed one or more of the Clark Fork Superfund background levels (table 3.18). Cadmium excluded, these constituents also exceed phytotoxic levels.

Figure 3.55 Site map of the Queen of the Hills tailings, August 1996.

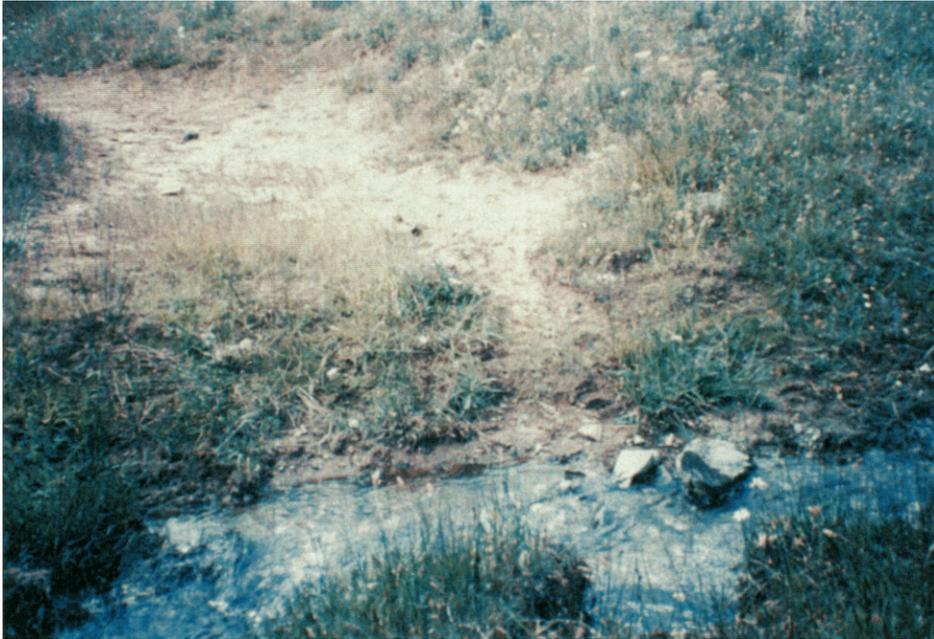
Figure 3.56 Barren patches of tailings can be seen intermittently along the banks of Queens Gulch Creek.

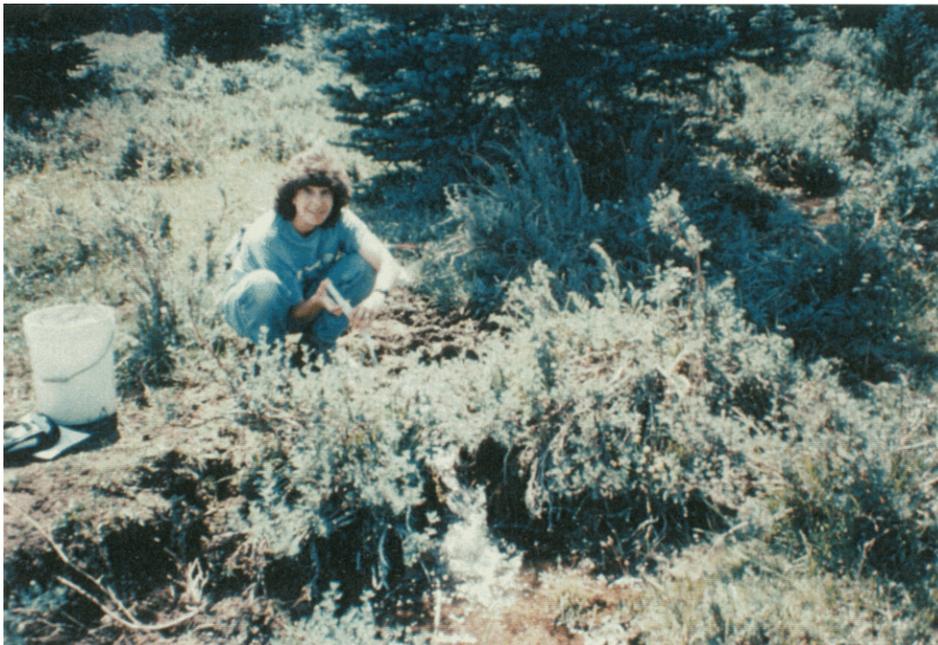
Figure 3.57 Hydrogeologist Ginette Abdo collected water-quality sample BQTS20H downstream of the tailings deposits.

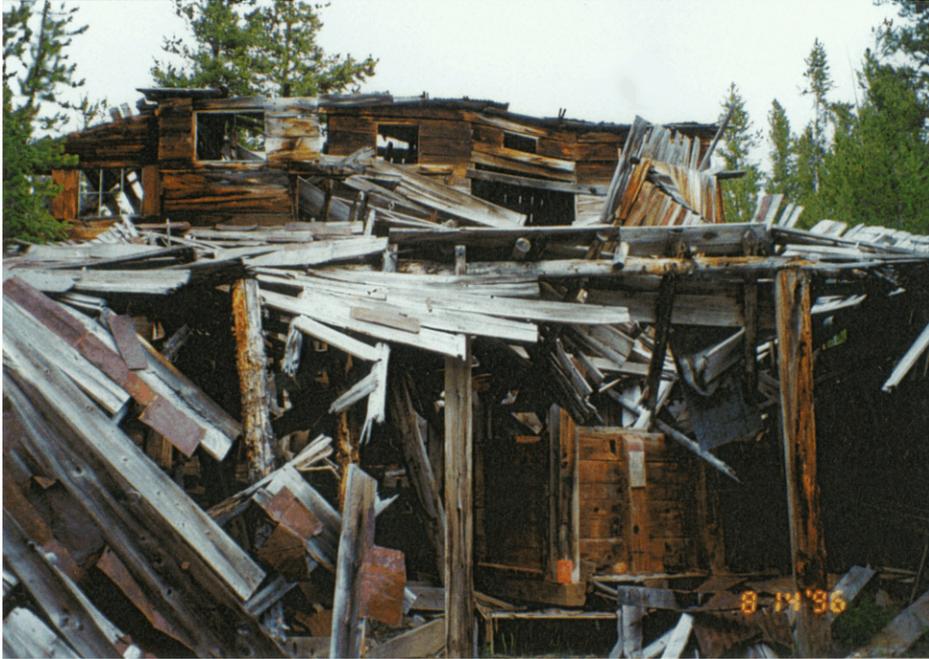
Figure 3.59 The Trapper mill was still partially standing in August 1996. Because the structure is unstable, it poses a safety risk.

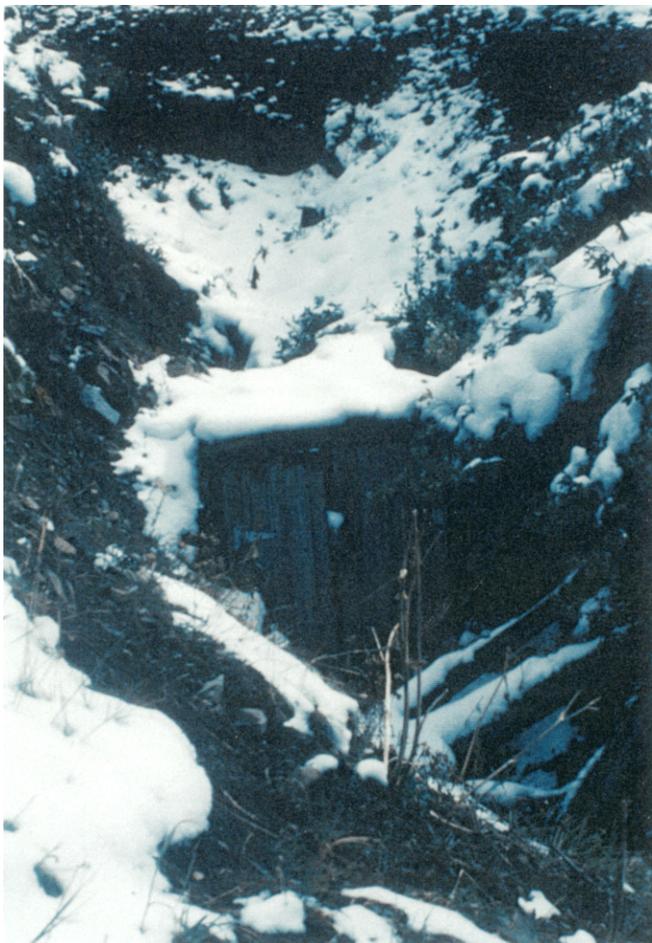
Figure 4.5 A small discharge flows from the portal of the collapsed upper adit.

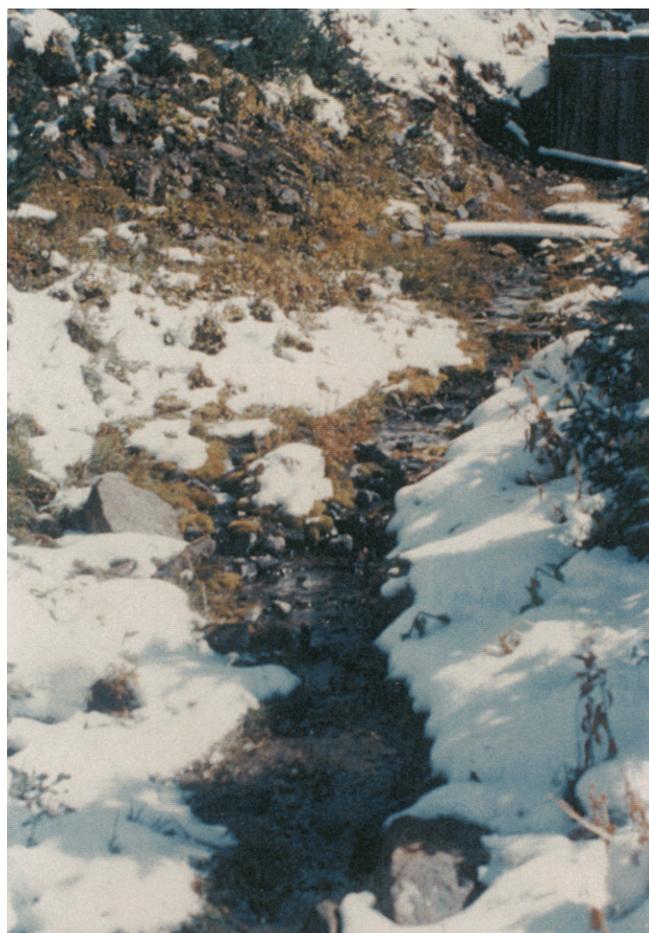
Figure 4.6 The discharge from the lower adit eventually joins the discharge from upper adit. The combined flow rate of the discharges is about 5 gpm.

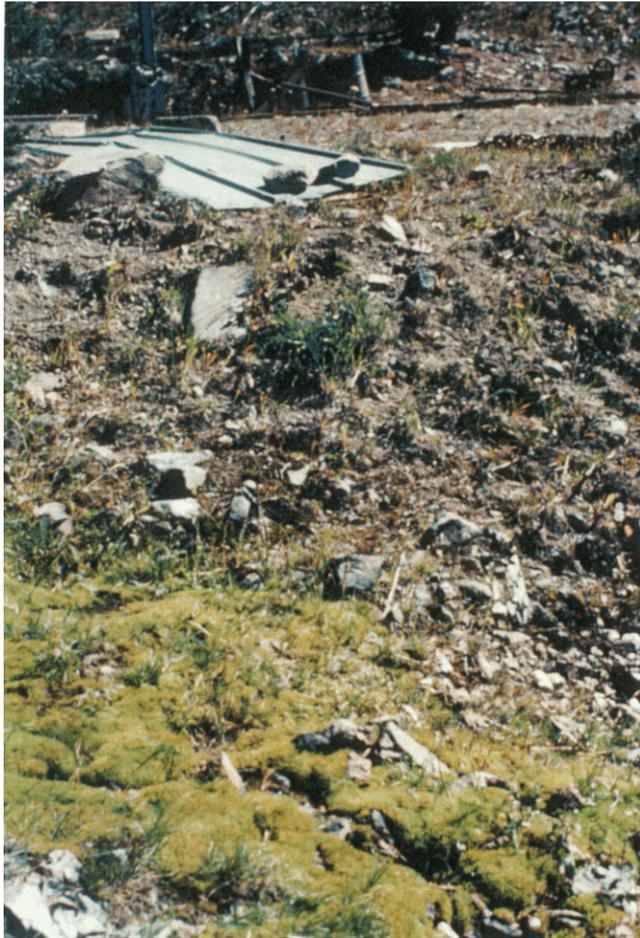
Figure 4.8 A small discharge from the adit at the Cousin Jack mine flows over some waste rock before sinking into the ground.

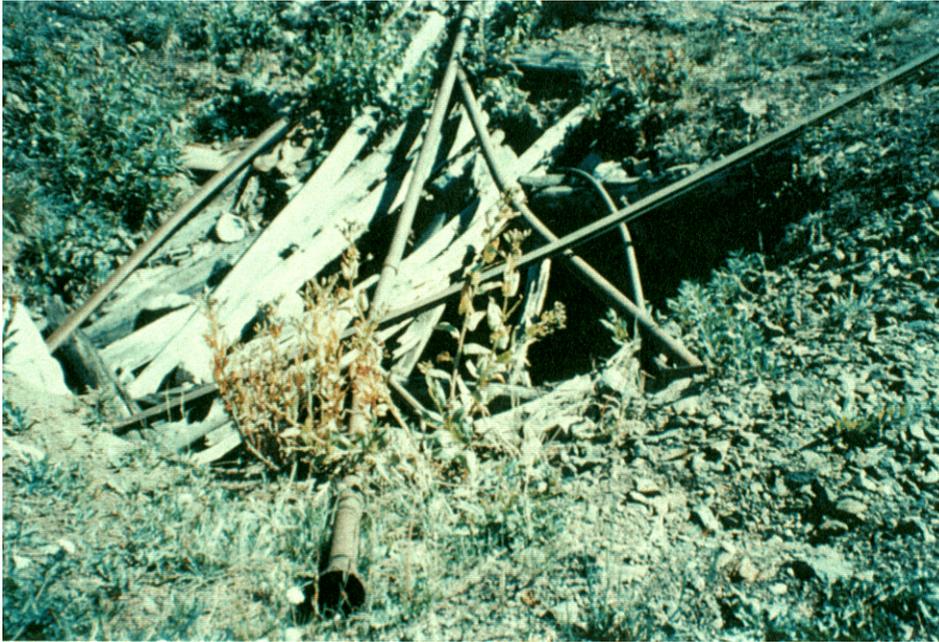
Figure 4.10 The poorly marked S-1 shaft is a safety concern because it is located next to a heavily used ATV trail.

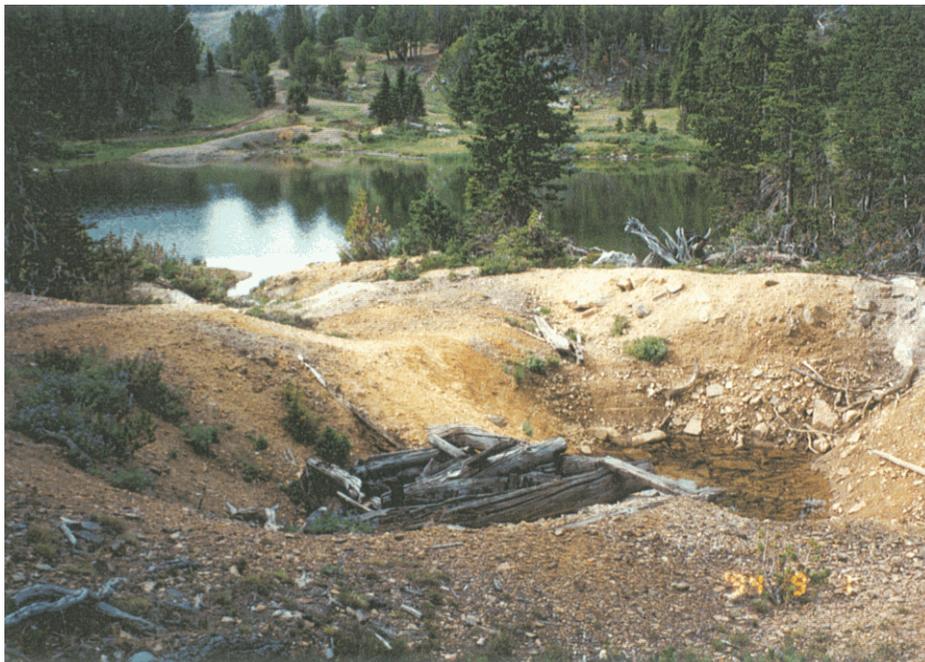
Figure 4.11 Soil sample MFRD10M was collected from the waste rock along the shore of the unnamed lake south of shaft S-2.

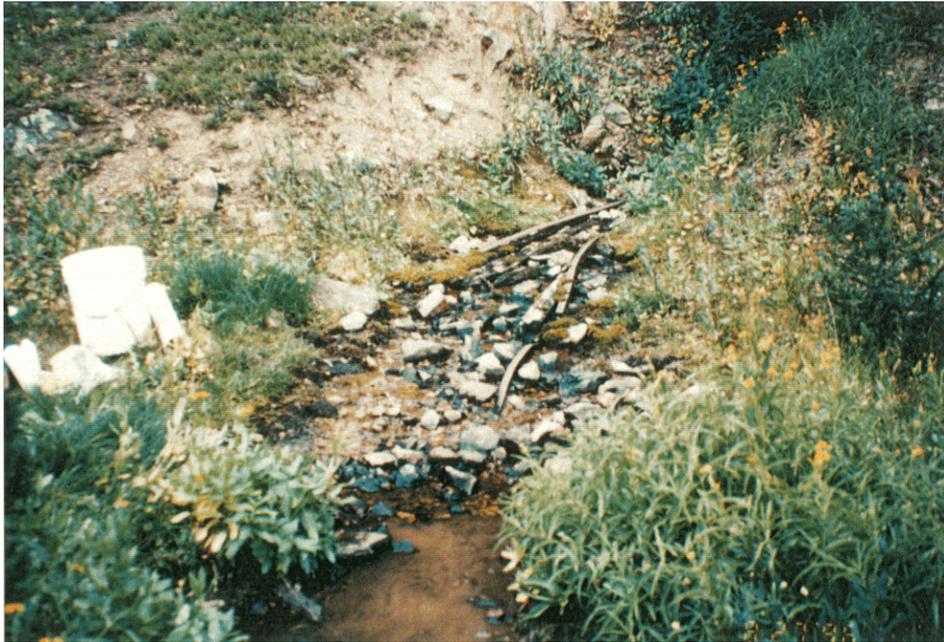
The site was sampled on August 27, 1996. Water-quality sample RINS10L was collected from the adit discharge. The flow rate of the discharge was 2.5 gpm. Sample RINS20L was collected from Independence Gulch at the outlet of the cirque lake. The flow rate of the stream was 12.4 gpm. Soil sample RIND10L was collected around the edge of the waste-rock dump that was in contact with the marsh. Site features and sample locations are shown on figure 4.12; figures 4.13 and 4.14 are photographs of the site.

Figure 4.13 Sample RINS10L was collected from the adit discharge.

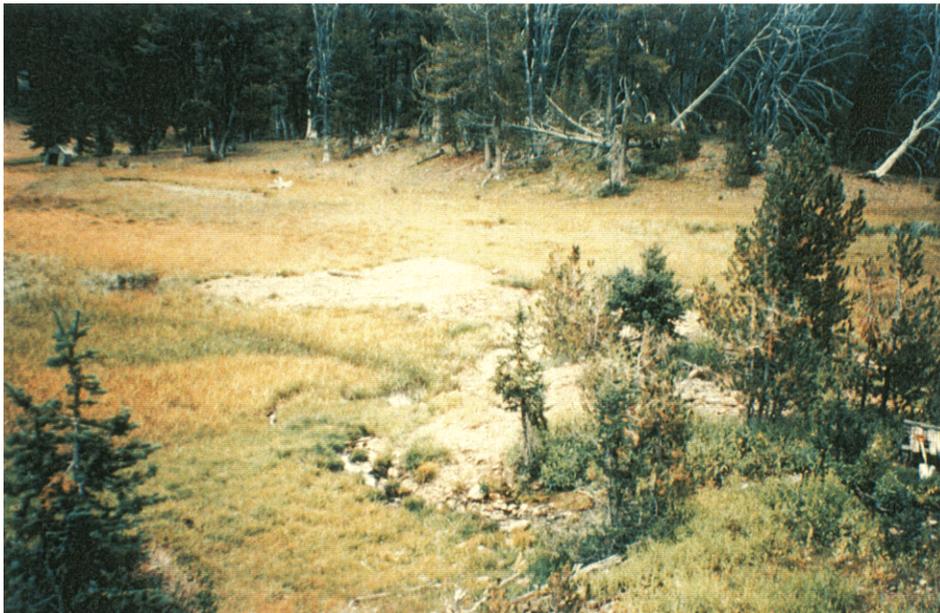
Figure 4.14 A waste-rock dump extends into a marsh adjacent to a small cirque lake.

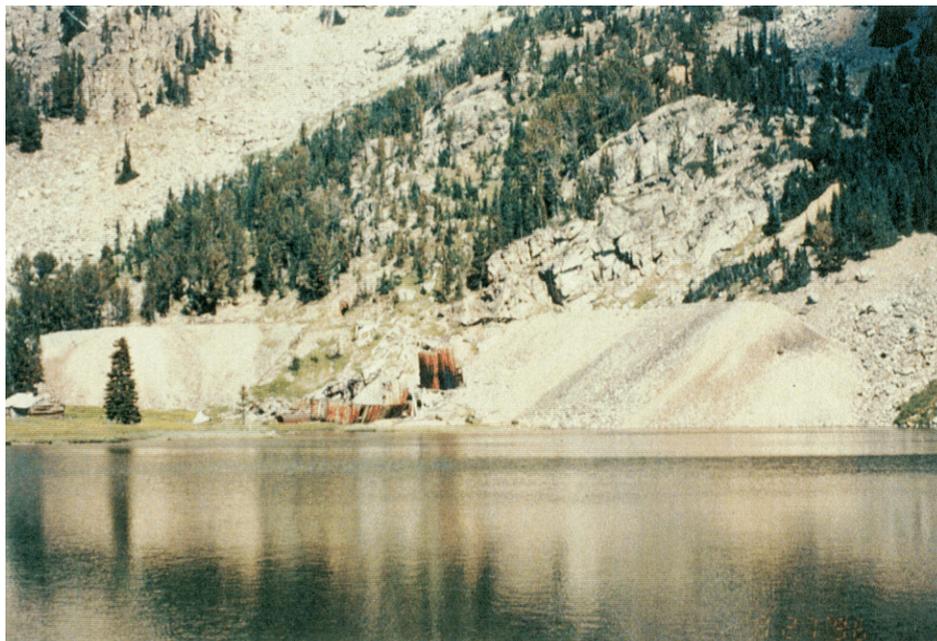
Figure 4.16 A large waste-rock dump and mill ruins are located at the northeast end of Crystal Lake.

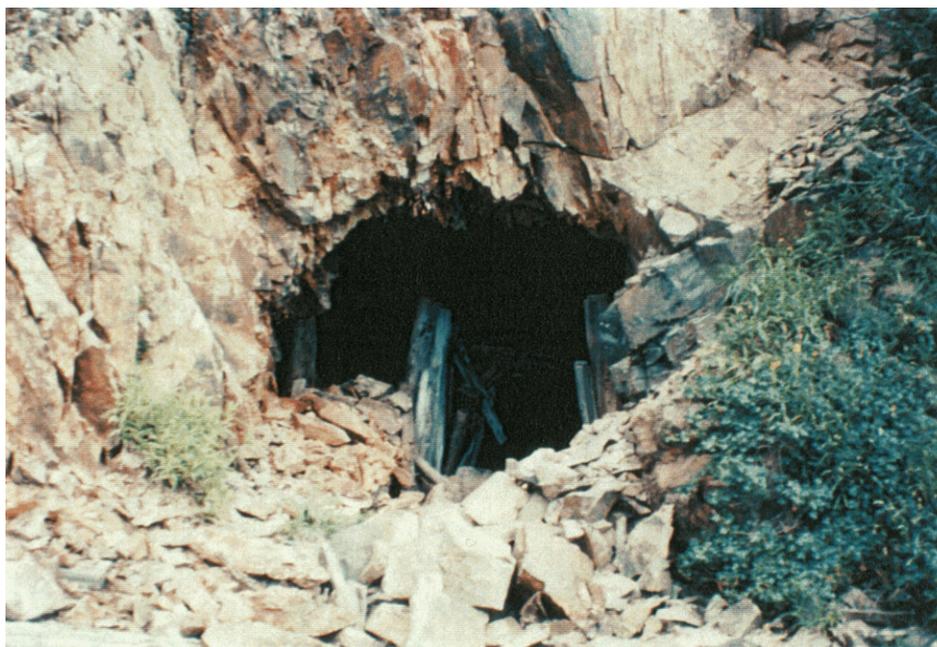
Figure 4.17 The northern adit at the Lakeshore mine is open and has a substantial discharge.

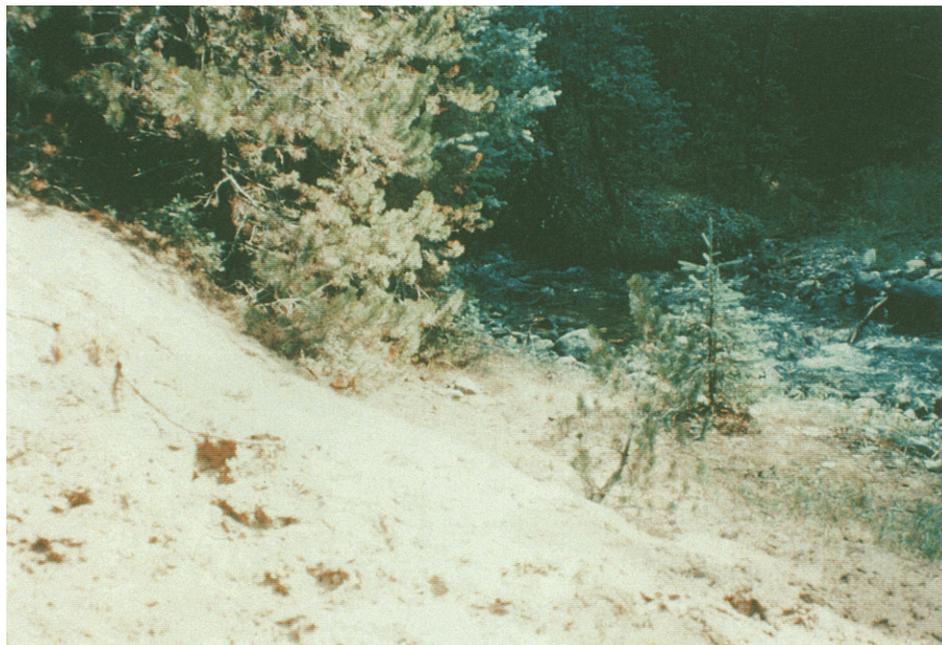
Figure 4.19 Sample RLTD10M was collected from streamside tailings deposits on the west side of Wisconsin Creek.

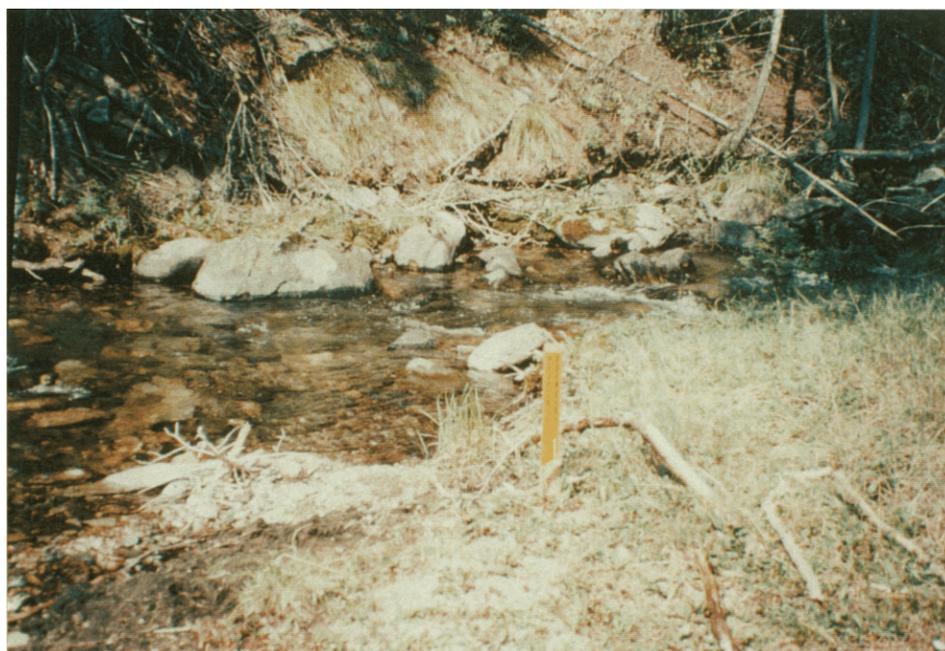
Figure 4.20 Sample RLTS20L was collected downstream of the site where Wisconsin Creek crosses back onto BNF-administered land.

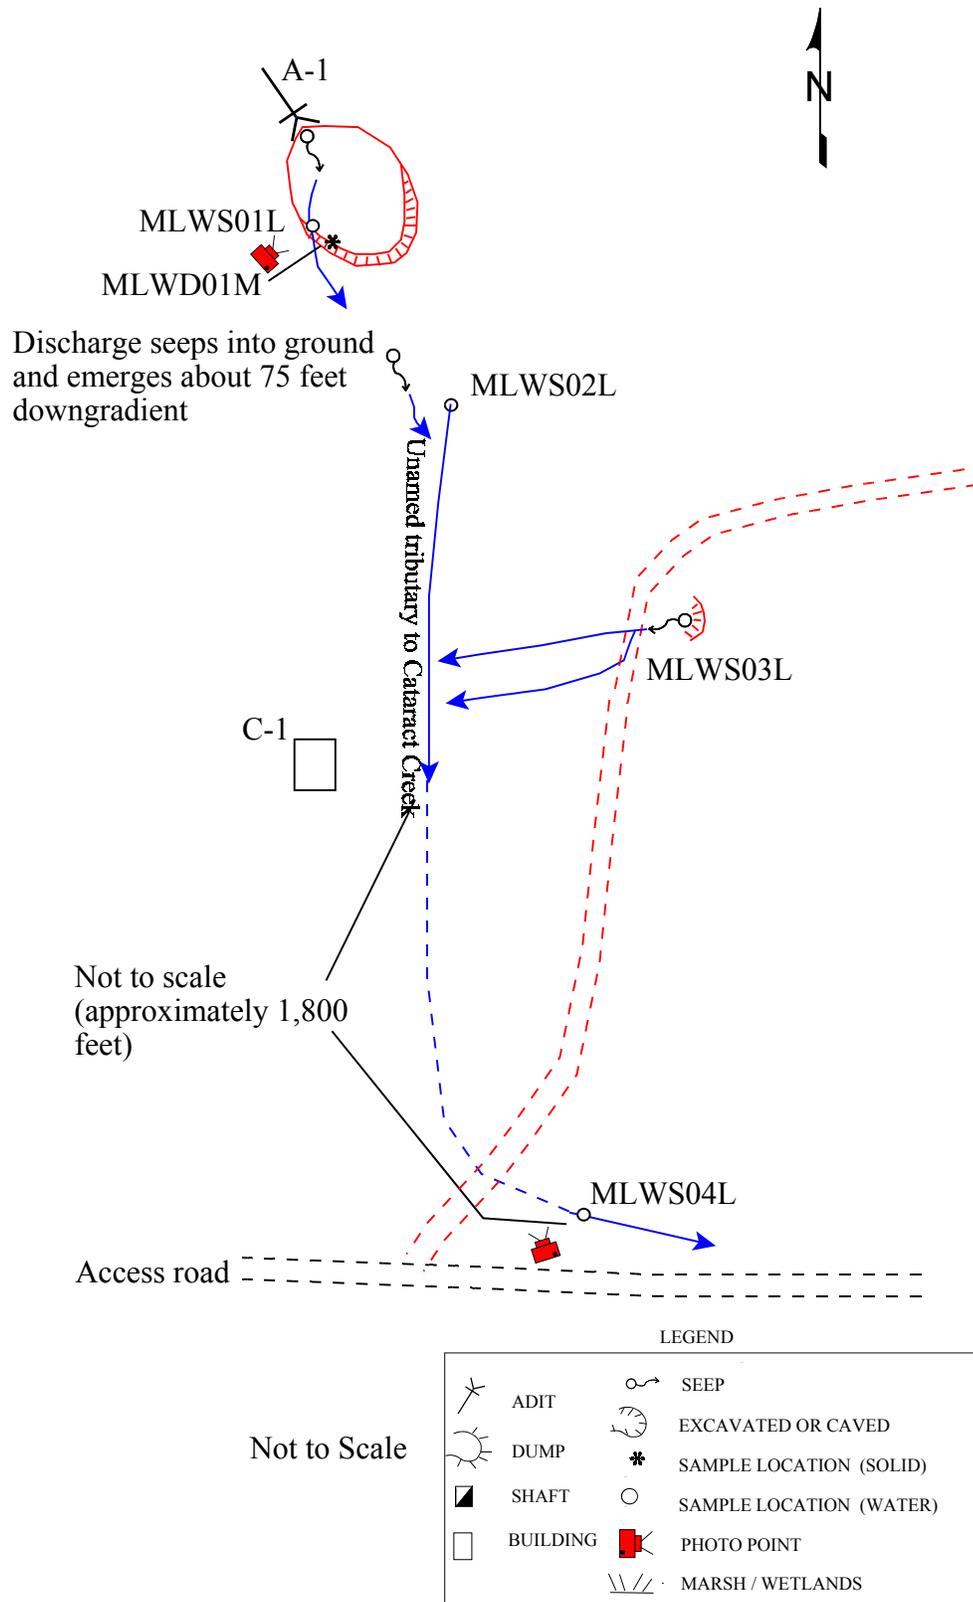
Features at the Lone Wolf mine include a caved adit and small waste-rock dump. The dump does not contain any material that would be classified as ore. Many small prospects are scattered across the mountainside near the site. A sketch map of the area is presented as figure 4.21.

Figure 4.21 Site map of the Lone Wolf mine, September 1996.

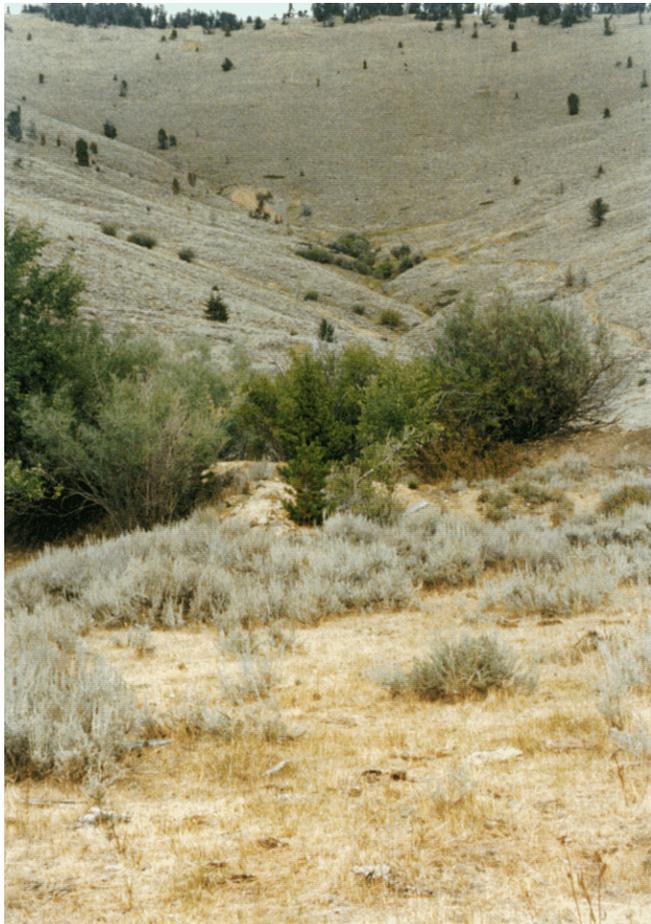
Figure 4.22 The Lone Wolf mine is located near the headwater of an unnamed tributary to Cataract Creek. The site is shown in the upper center of the photograph.

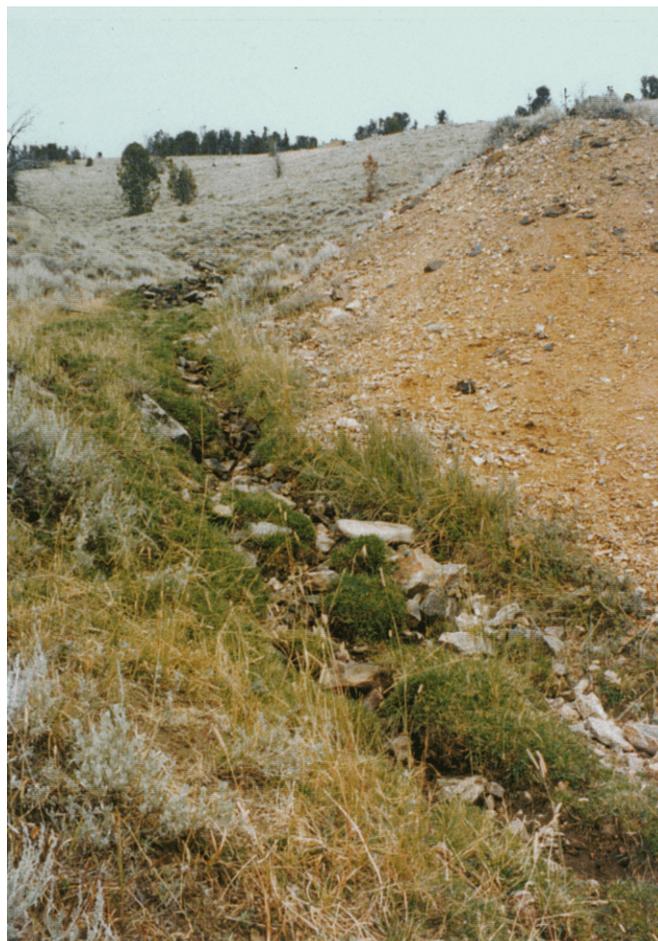
The soil sample results show that the arsenic concentration exceeds both Clark Fork Superfund background and phytotoxic levels (table 4.10). Cadmium, lead and zinc exceeded one or more Clark Fork Superfund background levels.

Figure 4.23 Soil sample MLWD01M was collected where the waste-rock dump is in contact with the adit discharge.

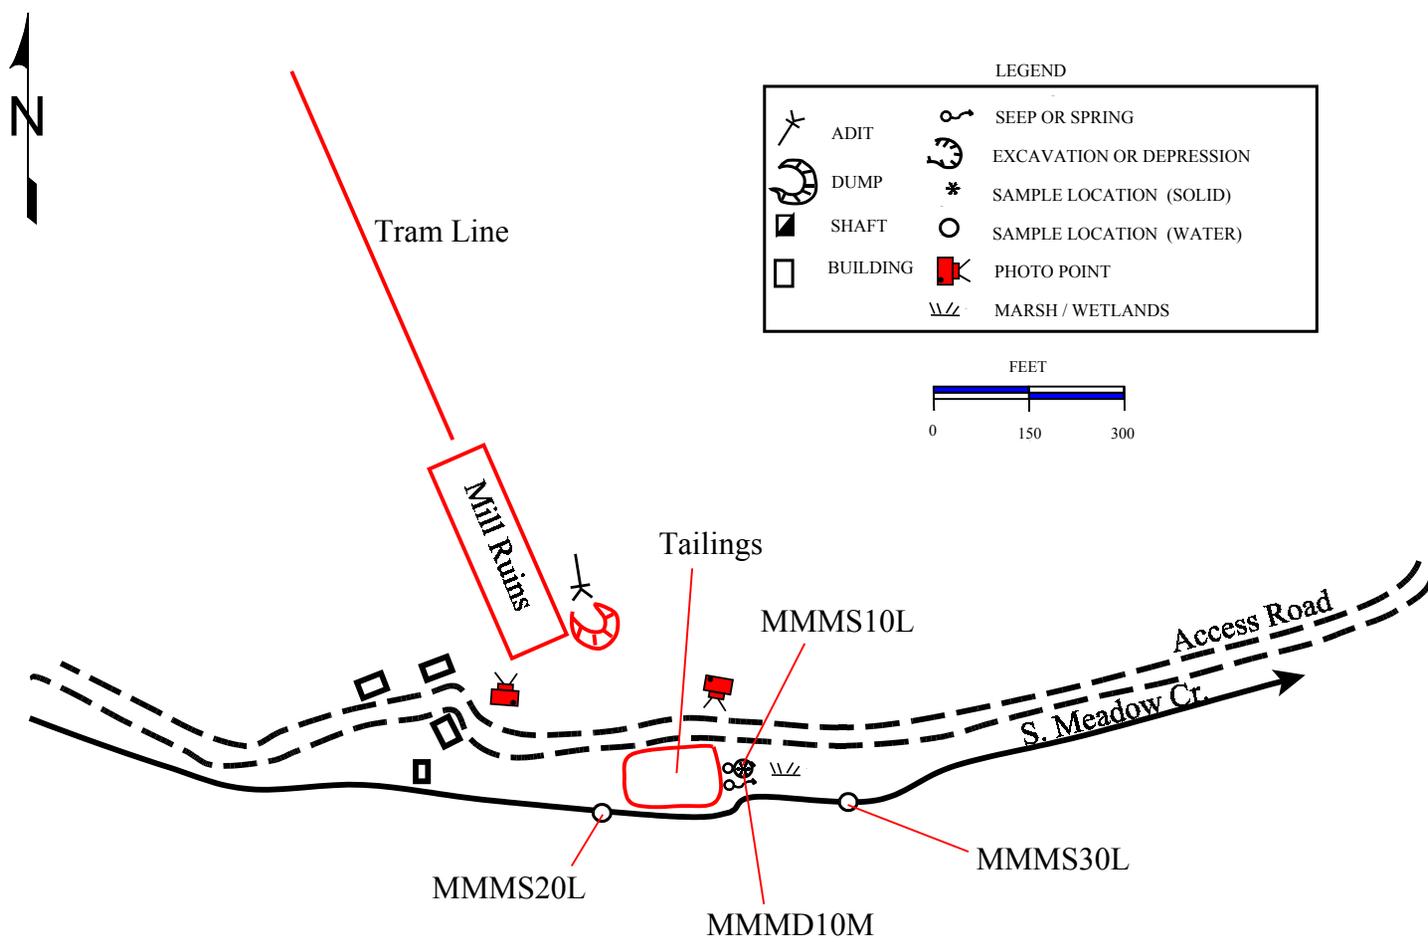
Several seeps emerge at the base of a tailings pile located close to South Meadow Creek (figure 4.24). Tailings have been transported down the seep channels and released into the creek. A small clear discharge flows from the partially collapsed adit portal just east of the mill ruins. The discharge sinks into the ground within a short distance and does not appear to have any adverse environmental impact.

Figure 4.24 Site map of the Missouri-McKee mine and mill, May 1998.

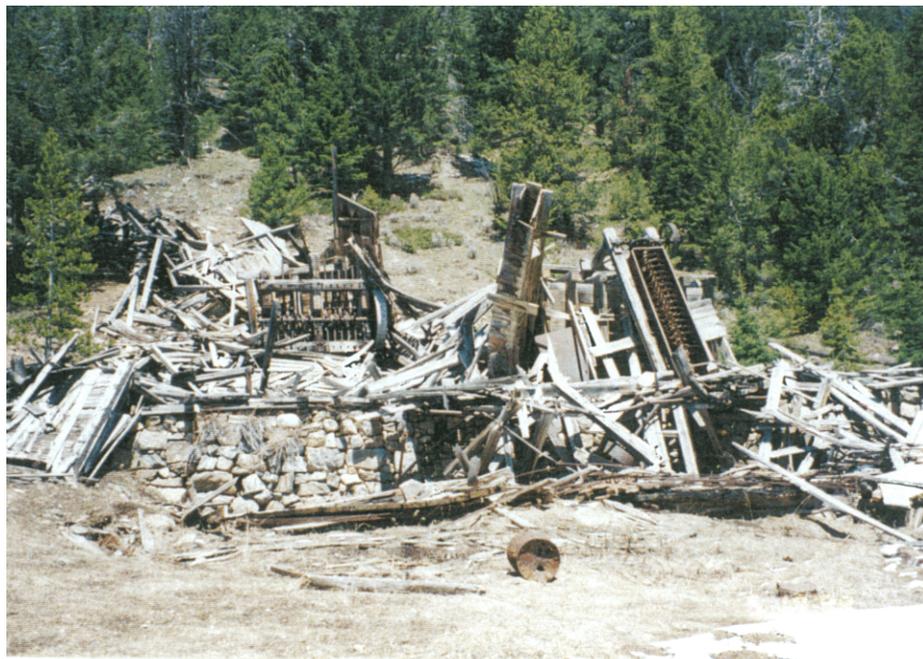
Figure 4.25 The ruins of the Missouri-McKee/Snowslide mill are spread down the mountainside just east of the open adit.

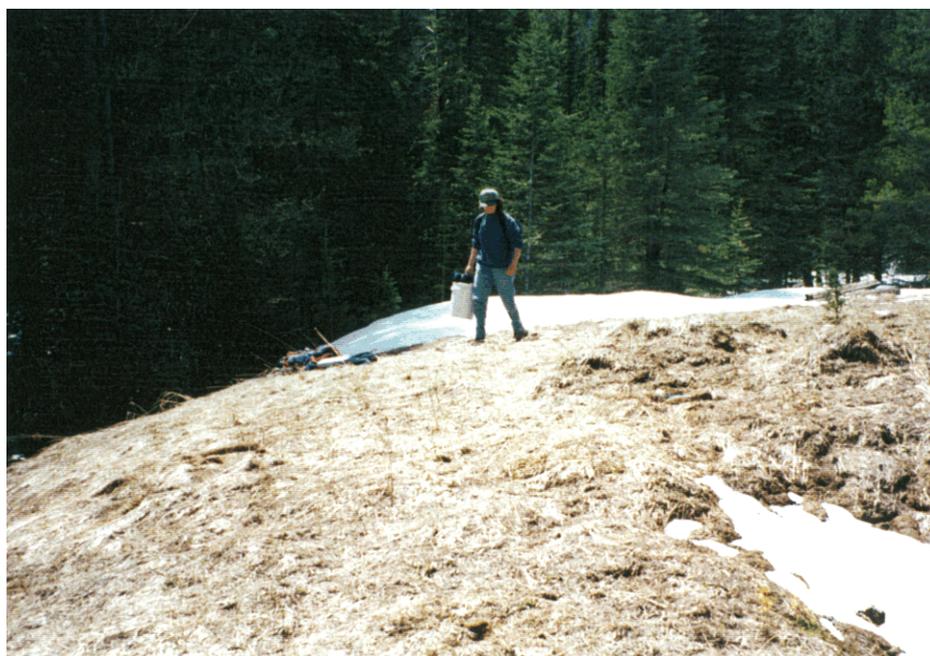
Figure 4.26 The tailings pile at the Missouri-McKee/Snowslide site is partially vegetated with grasses.

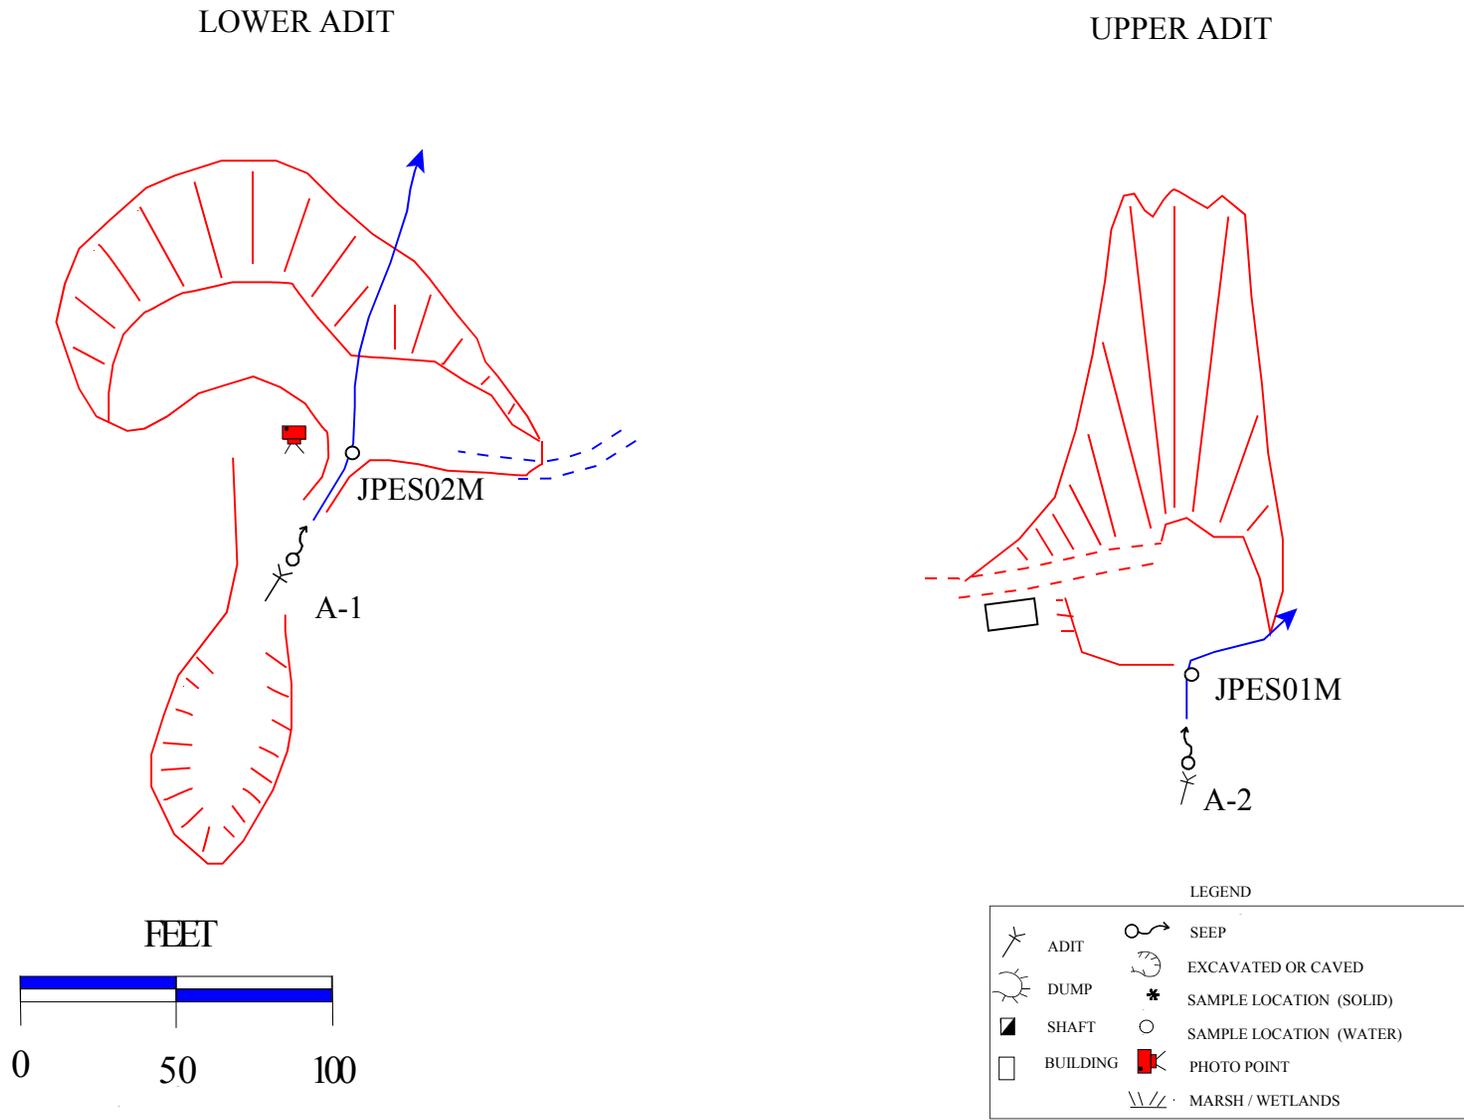
Figure 4.27 Site map showing adits of the Pedro (Pot Rustler) and Pedro Middle mines, September 1996.

The site consists of a lower, middle and upper adit (figure 4.27). The lower adit (A-1) is open and has a discharge that flows at about 1.6 gpm. The discharge runs across a waste-rock dump and sinks into the ground about 200 feet from the adit. A 5-gallon drum that may contain motor oil is present near the portal.

The site was sampled on August 21, 1996 and September 23, 1996. Sample JPES02M was collected from the lower adit discharge, about 50 feet from the portal. Sample JPES01M was collected from the middle adit discharge. Site features and sample locations are shown on figure 4.27; figures 4.28 and 4.29 are photographs of the site.

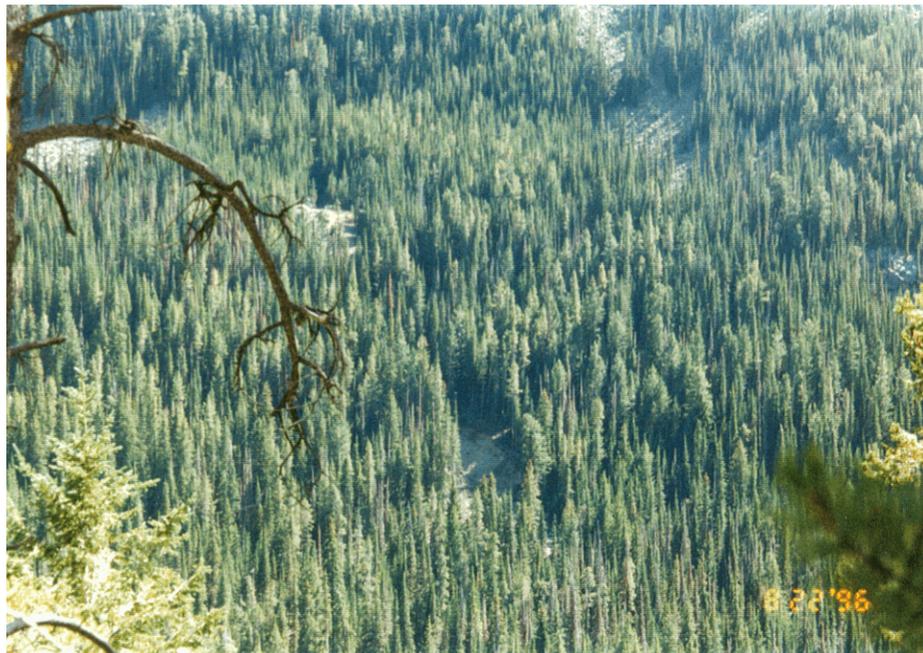
Figure 4.28 The Pedro (Pot Rustler) and Pedro Middle mines are located on a thickly wooded mountainside along the South Fork of Mill Creek.

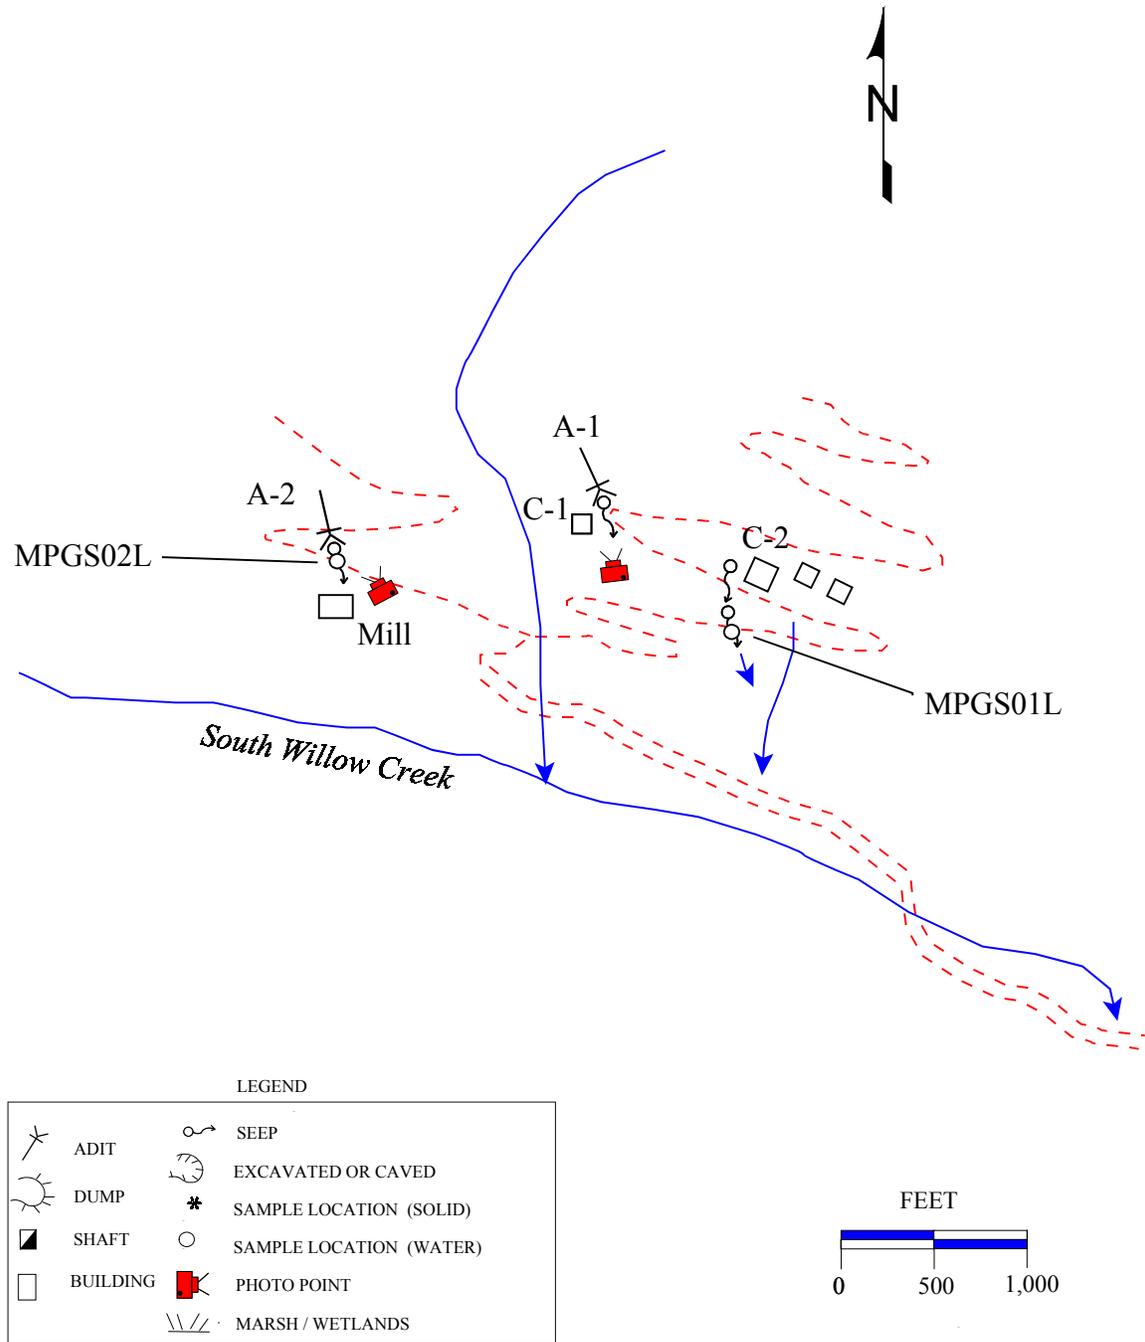
Figure 4.30 Site map of the Presidential-Demos Group, October 1997.

Environmental concerns at this site focus on two collapsed adits (A-1 and A-2, figure 4.30) with small discharges. The discharge from the A-1 adit seeps into the ground approximately 200 feet from the portal. A discharge from a PVC pipe near a new cabin on site also was noted, but since the pipe is on private land, the source of the discharge was not investigated. Downgradient of the A-1 adit, a spring issues from a road cut. The flow rate of this spring was about 6.4 gpm.

Site features and sample locations are shown on figure 4.30; figures 4.31 and 4.32 are photographs of the site.

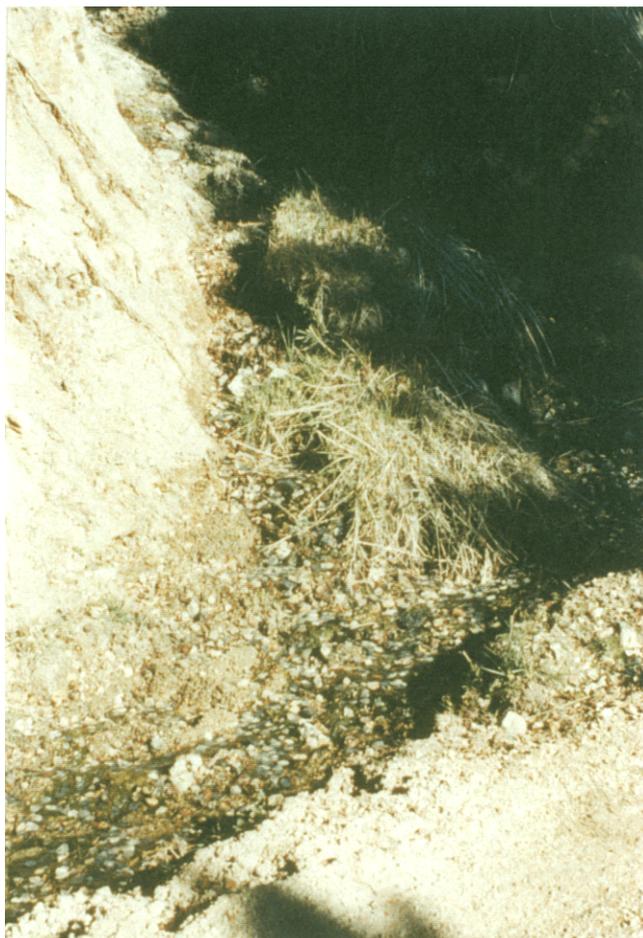
Figure 4.32 The discharge from the A-2 adit was sampled where it crosses onto BNF-administered land.

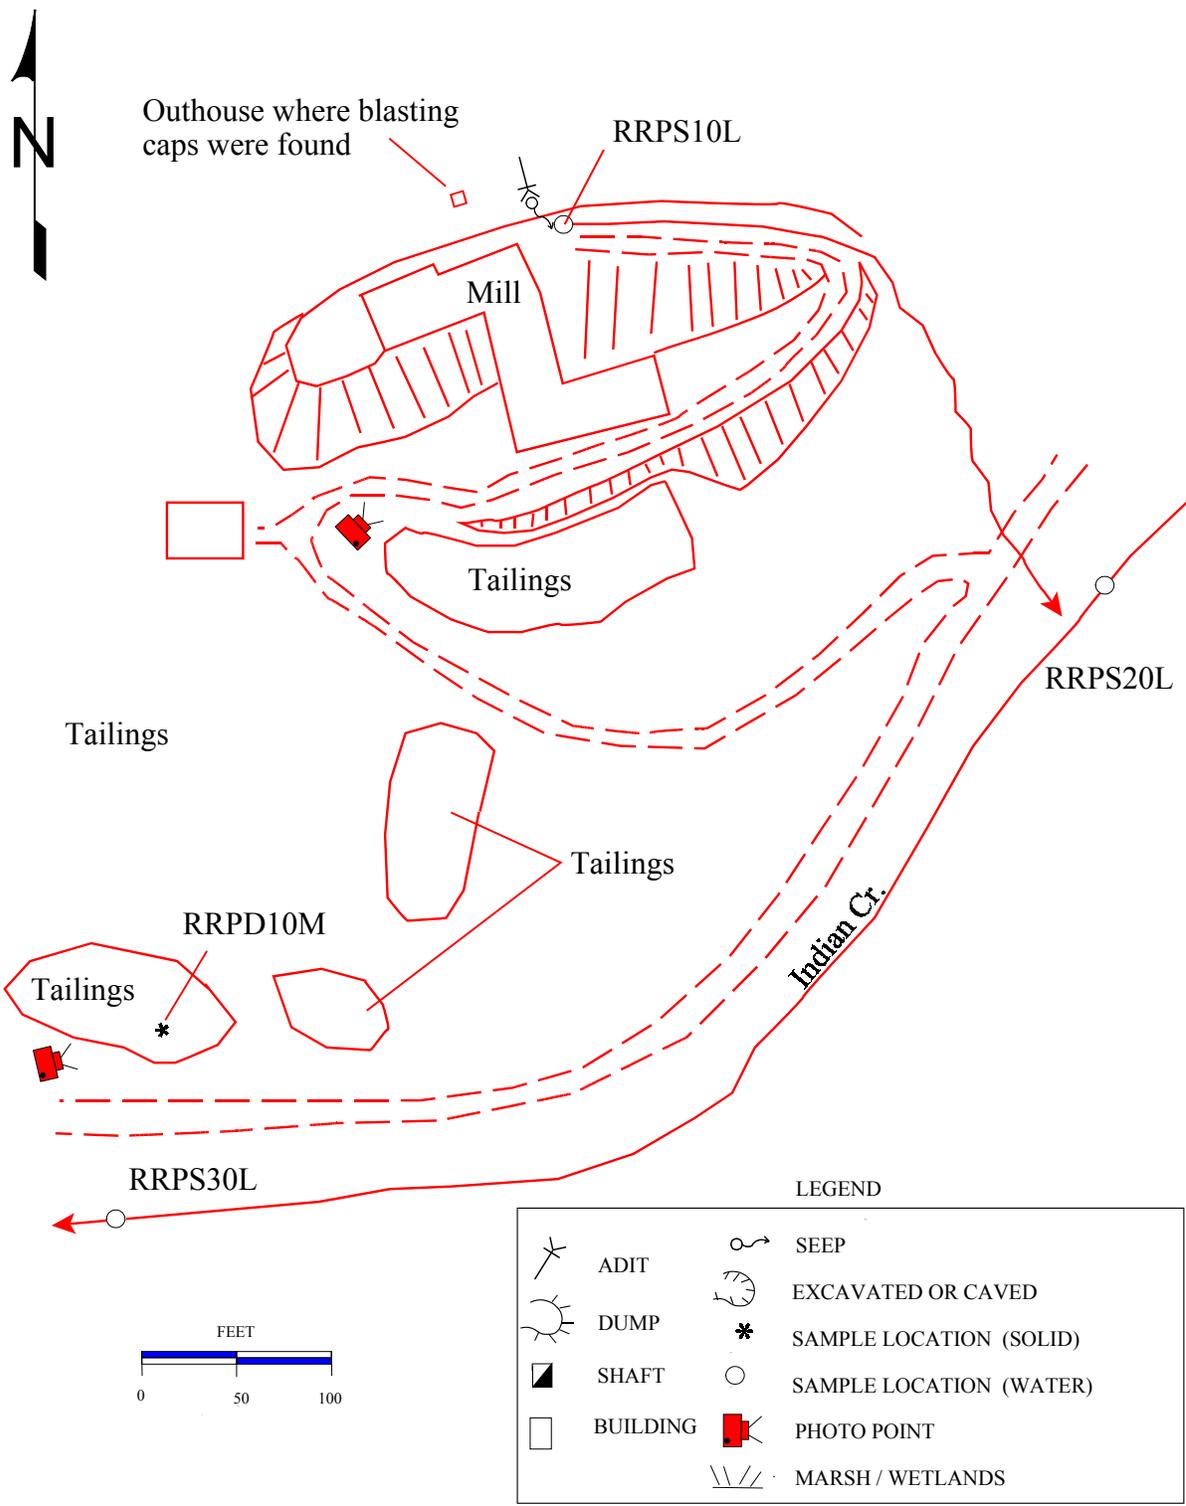
Figure 4.33 Site map of the Red Pine mine and mill, August 1997.

The site was sampled on August 29, 1997. Water-quality sample RRPS10L was collected from the adit discharge. The discharge was flowing at approximately 400 gpm and had a pH of 8.0 and an SC of 97 μ mhos/cm. Samples RRPS20L and RRPS30L were collected from Indian Creek upstream and downstream of the site, respectively. The flow rate of the creek was estimated to be 10 cfs. The pH of the creek was 8.0, and the SC was approximately 110 μ mhos/cm. Soil sample RRPD10M was collected from the muddy tailings in the lowermost impoundment. Site features and sample locations are shown on figure 4.33; figures 4.34 and 4.35 are photographs of the site.

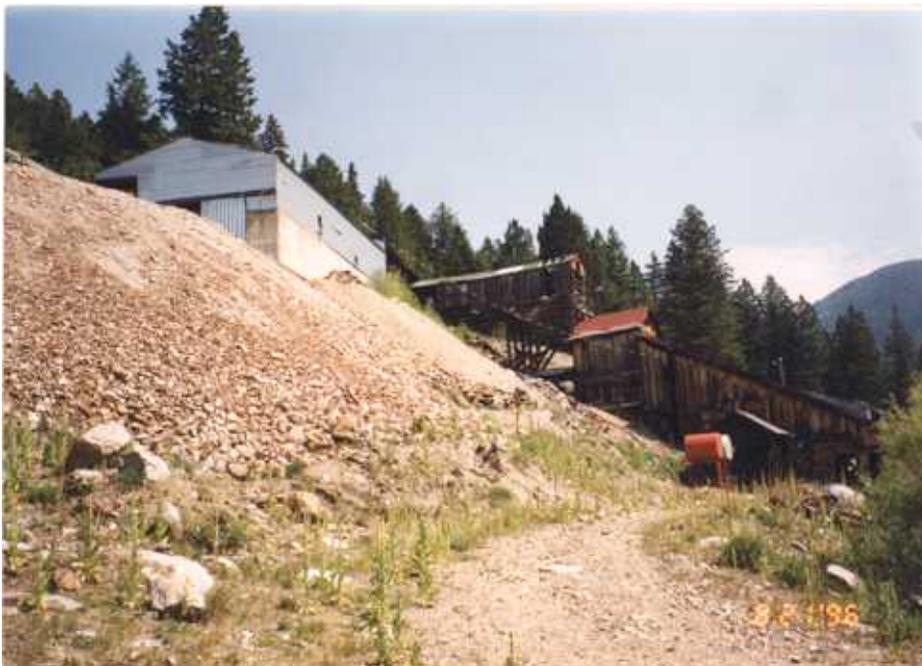
A large, clear discharge flows from an open adit above the mill (figure 4.34). The water runs down the mountainside and into Indian Creek. Tailings from the mill are located in several impoundments and are generally dry. The lowermost impoundment is 100 to 200 feet from Indian Creek and has been breached. When the site was visited in August 1997, the bottom of the impoundment contained a puddle of standing water. No streamside tailings were observed along Indian Creek.

Figure 4.34 The Red Pine mine and mill are located on a southeast-facing mountain slope above Indian Creek near Sheridan.
