Montana Bureau of Mines and Geology
MBMG No. 379

**Abandoned/Inactive Mines
of the
Southern Beaverhead-Deerlodge National Forest**

September 1998

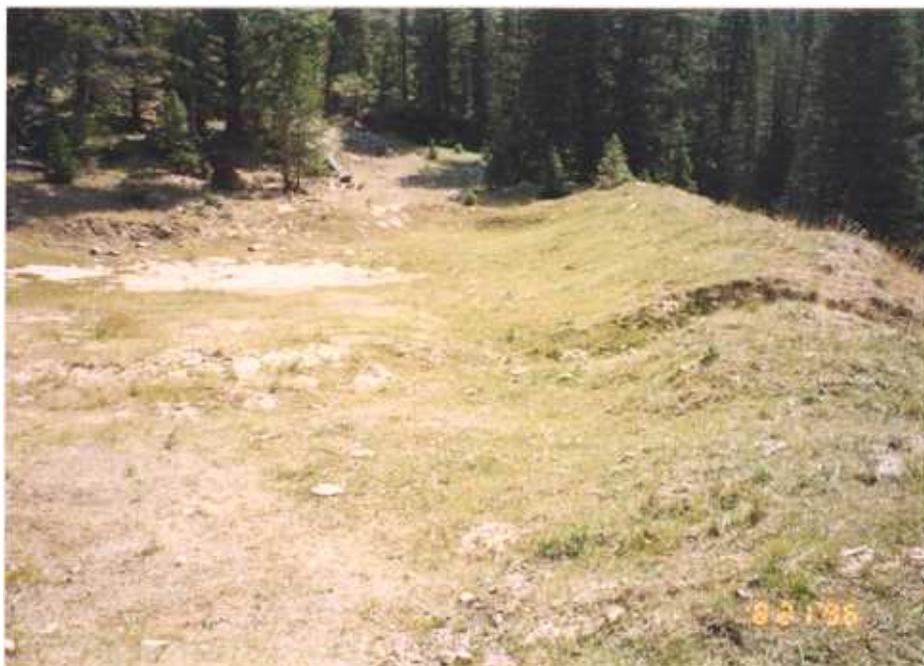
Figure 4.35 Soil sample RRPD10M was collected from a breached impoundment that contains some muddy tailings.

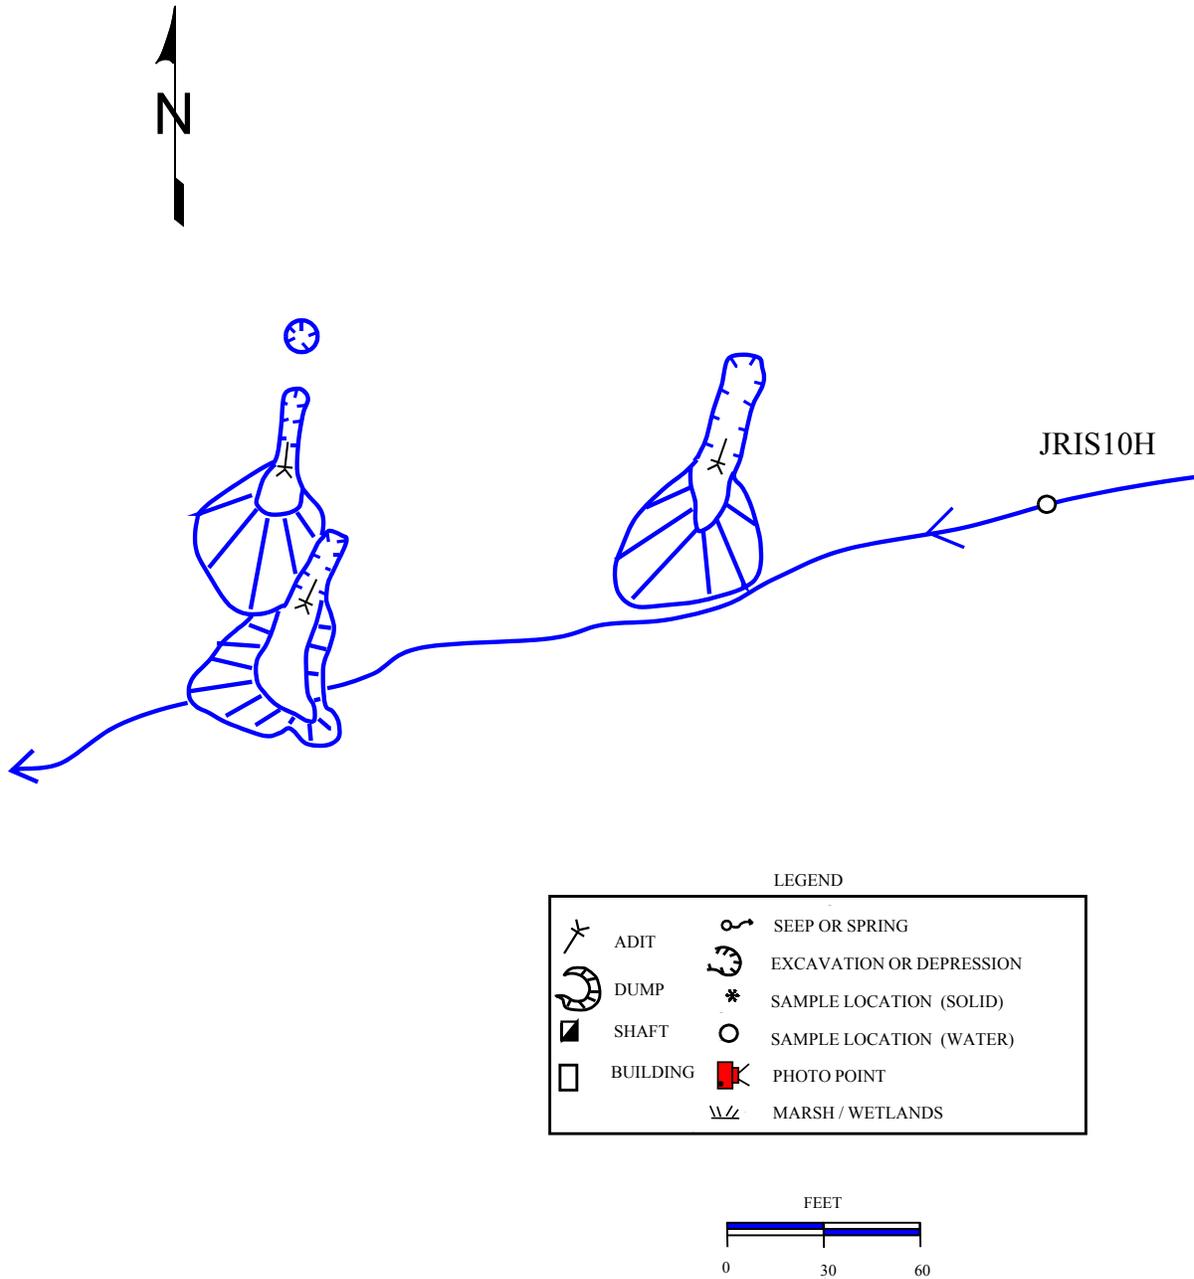
Figure 4.36 Site map of the Richmond Group mine, August 1996.

At each site, waste rock is present in the flood plain of the small tributary to Goodrich Gulch (figures 4.36, 4.37, and 4.38). The waste is not highly mineralized, and is not eroding appreciably.

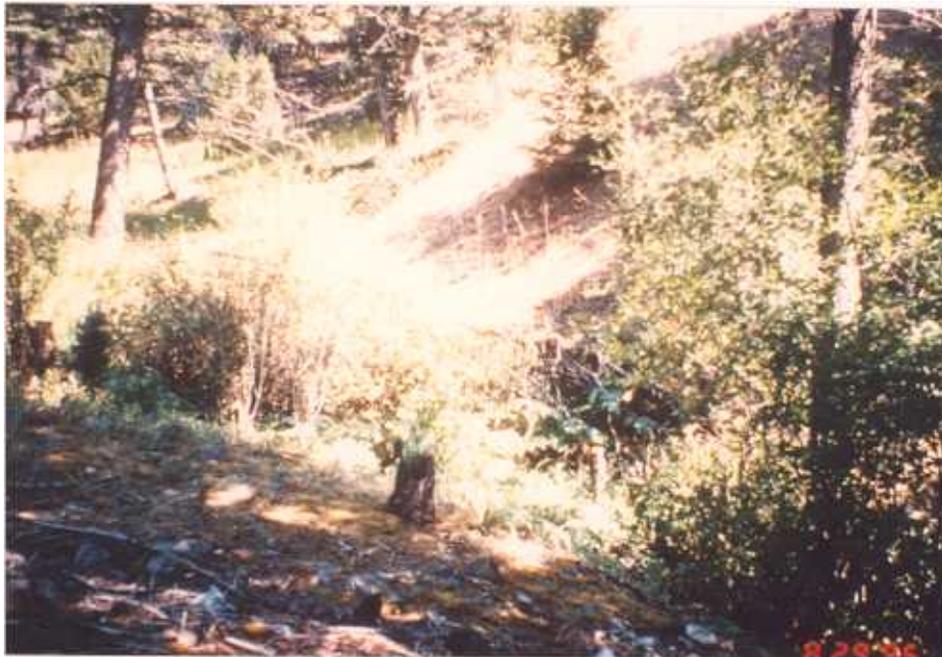
Figure 4.39 At the Bismuth prospect, a small tributary to Goodrich Gulch flows past a mid-sized waste-rock dump.

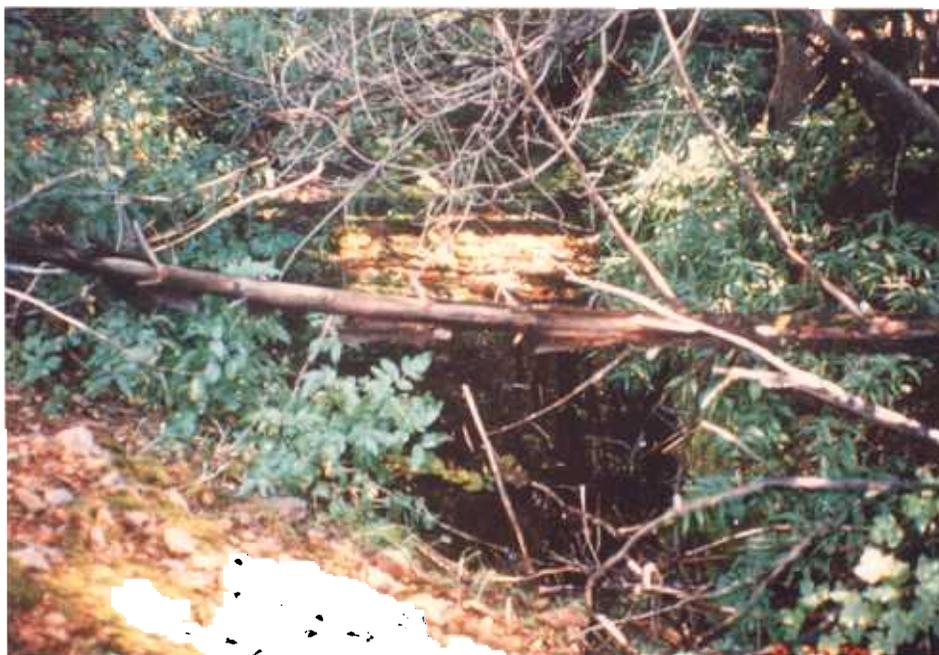
Figure 4.40 Water collects in a small pond behind a waste-rock dump at the Urbane mine.

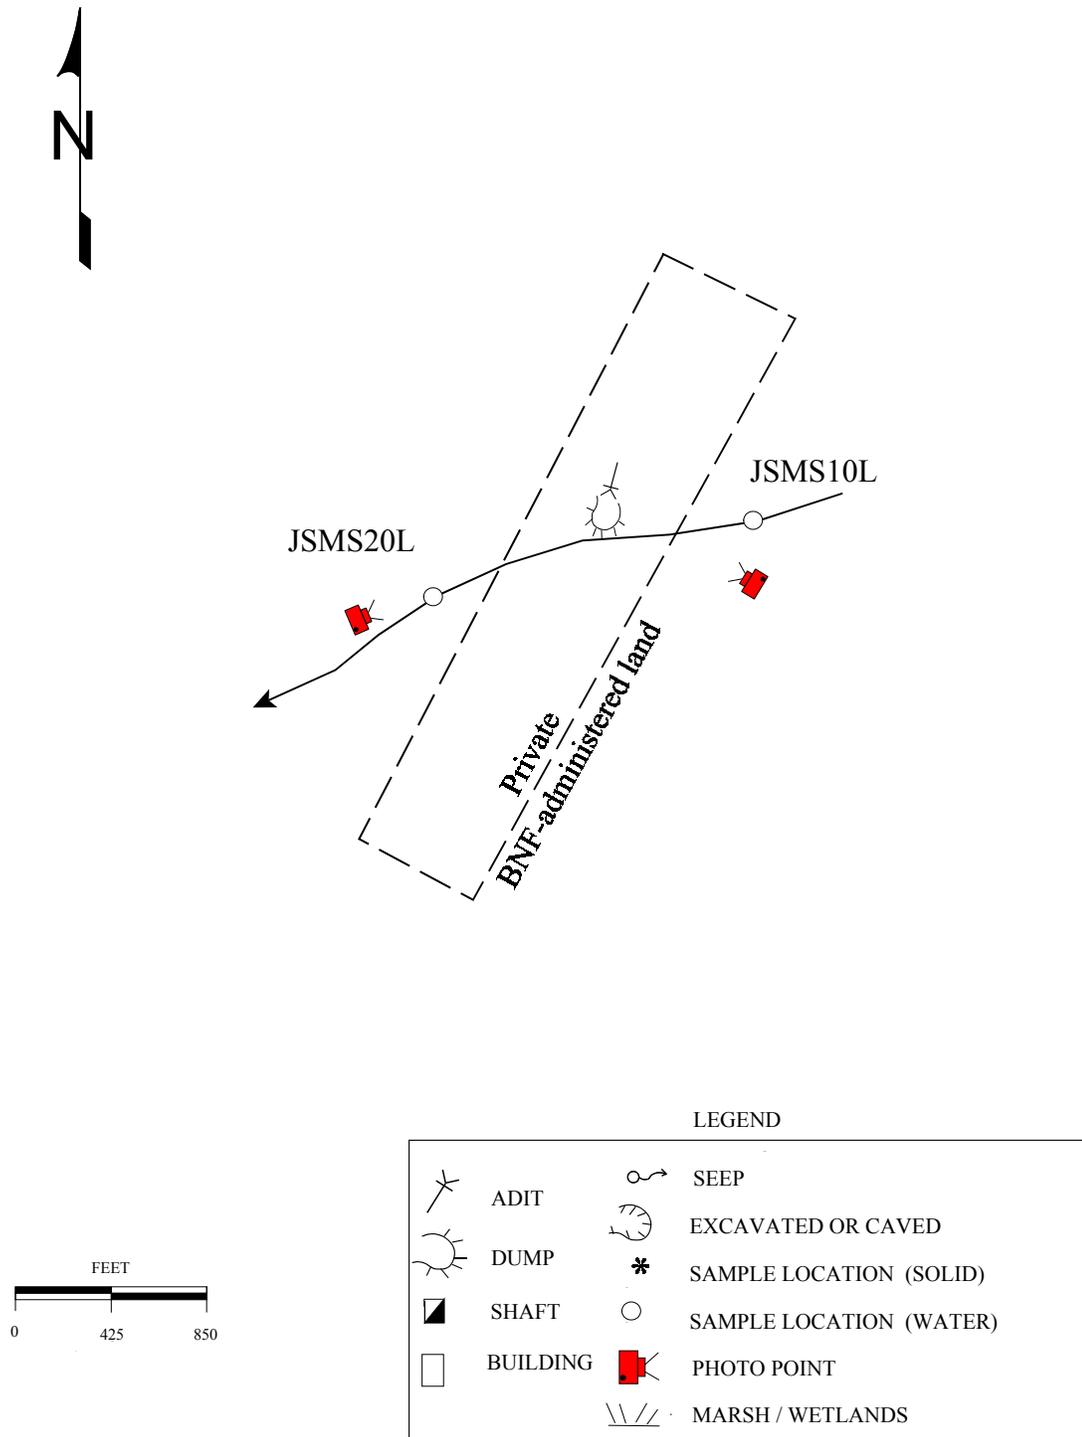
Figure 4.41 Site map of the Schmidt North prospect, August 1996.

Water-quality samples were collected several hundred yards upstream (JSMS10L) and downstream (JSMS20L) of the site on August 29, 1996. The flow rate of the creek was estimated to be 0.2 cfs at both sample locations. Site features and sample locations are shown on figure 4.41; figures 4.42 and 4.43 are photographs of the site.

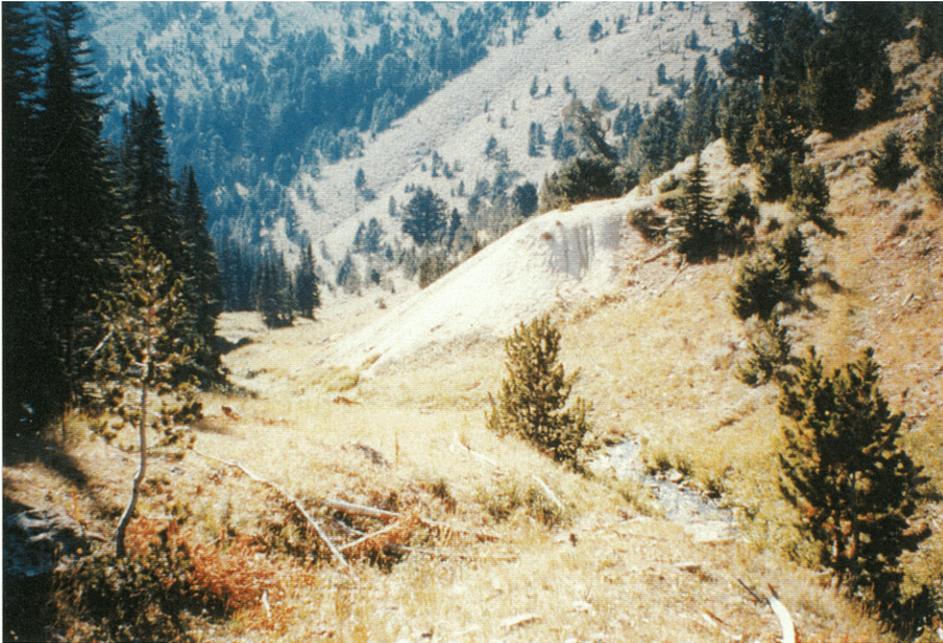
Figure 4.42 The Schmidt prospect's lowermost waste-rock dump is in contact with the watercourse in Goodrich Gulch.

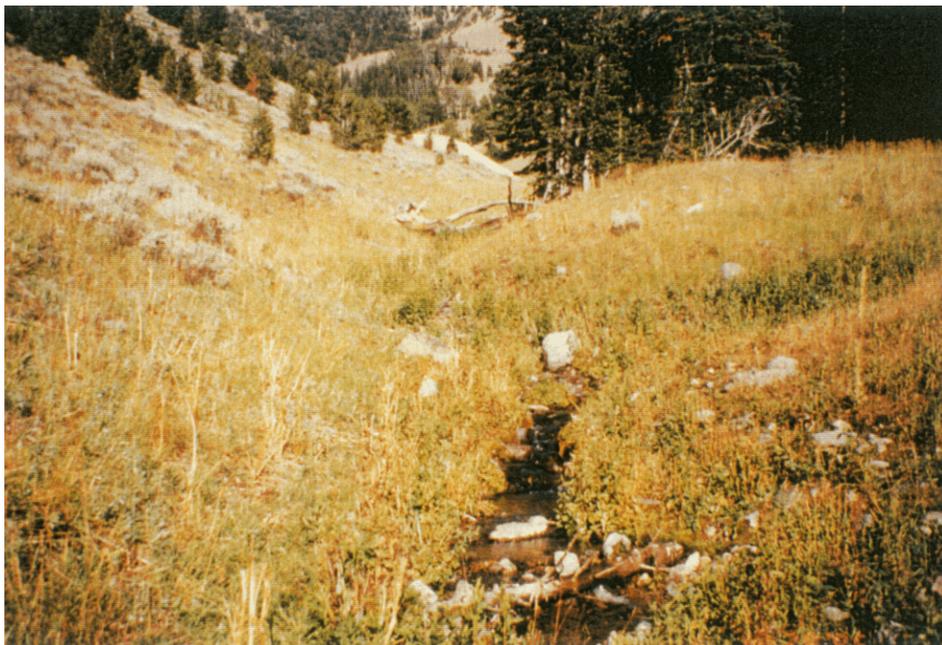
Figure 4.43 Sample JSMS20L was collected downstream of the mine to determine if streamside waste rock had impacted water quality.

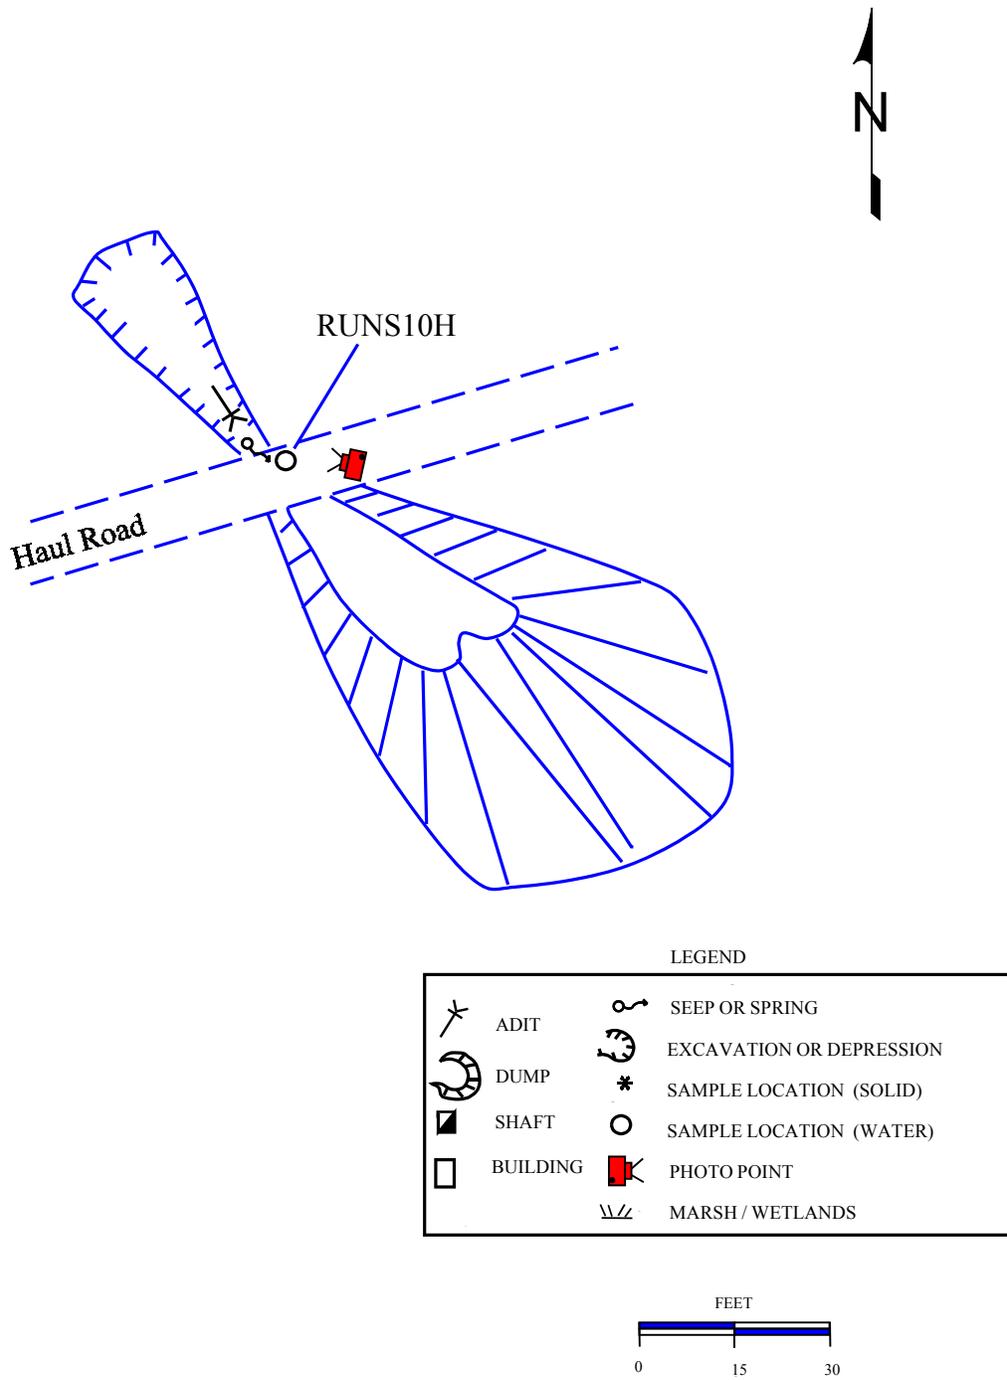
Figure 4.50 Site map of the Unnamed 03S05W26DBAC mine, August 1996.

A small clear discharge flows from the collapsed adit that is located on a steep slope several hundred feet above Wet Georgia Gulch (figure 4.50). The discharge sinks into the ground less than 20 feet from the portal.

A water-quality sample (RUNS10H) was collected from the adit discharge on August 28, 1996. The flow rate of the discharge was less than 0.1 gpm. Site features and the sample location are shown on figure 4.50; figures 4.51 and 4.52 are photographs of the site.

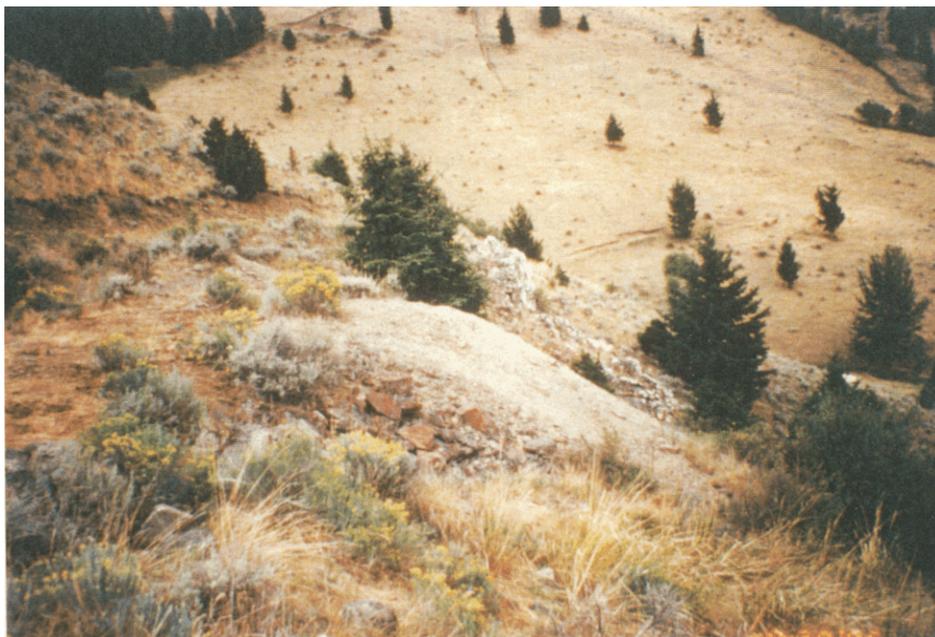
Figure 4.51 The Unnamed 03S05W26DBAC mine is located on a steep slope above Wet Georgia Gulch.

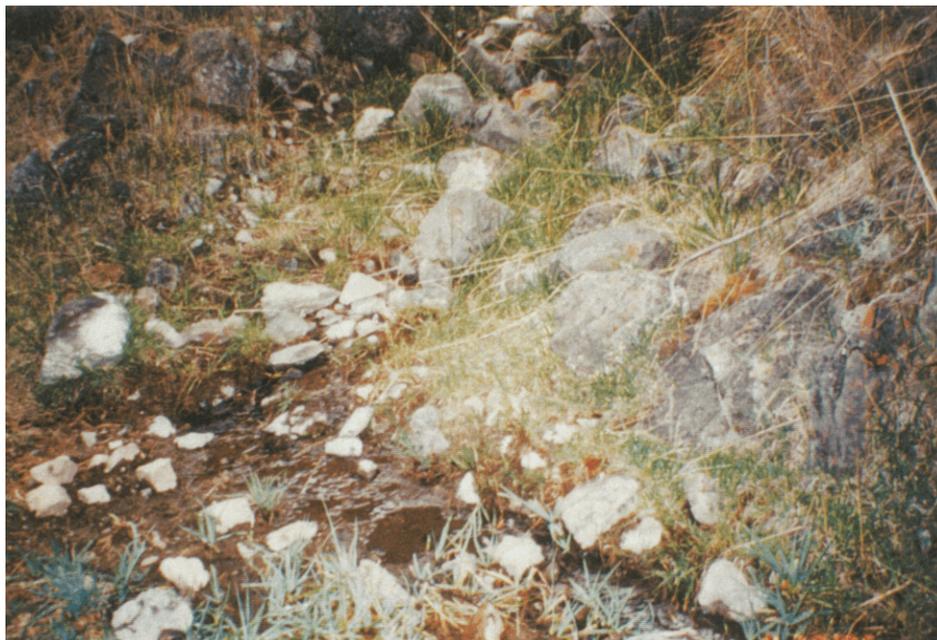
Figure 4.52 Sample RUNS10H was collected from the adit discharge at the site.
