Geologic and Hydrogeologic Investigation of the Clark Canyon Landslide, Southwestern Montana

MONTANA BUREAU OF MINES AND GEOLOGY
OPEN-FILE REPORT 442

Prepared for the
MONTANA DEPARTMENT OF TRANSPORTATION

December 2001

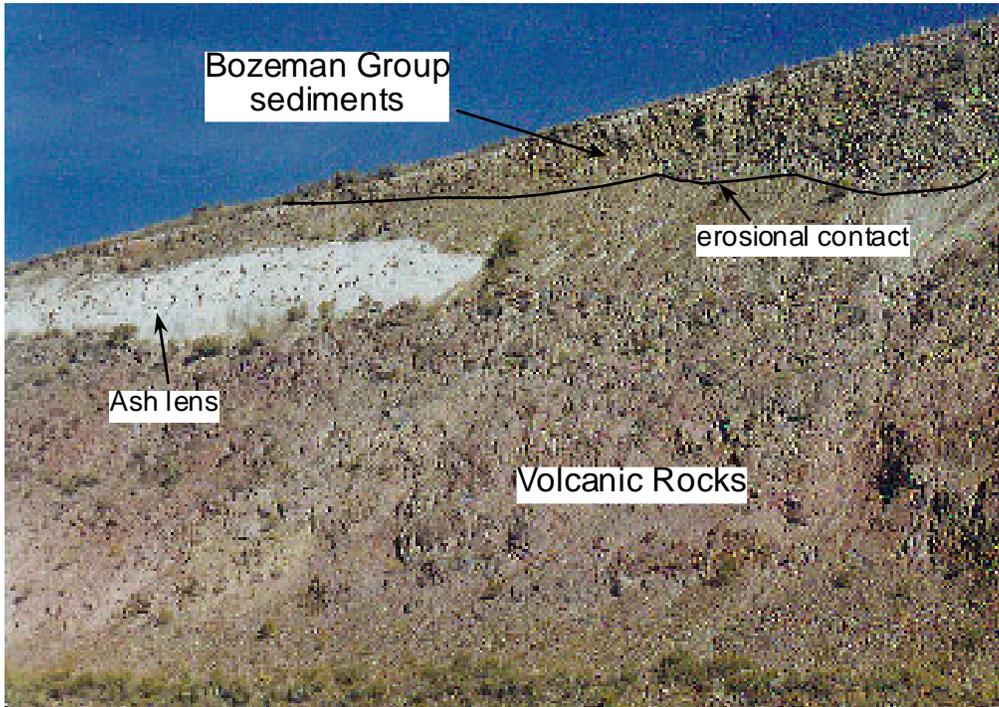
Figure 6. Cutslope exposure showing general stratigraphy of the volcanic and overlying sedimentary bedrock in the area near the Clark Canyon landslide.

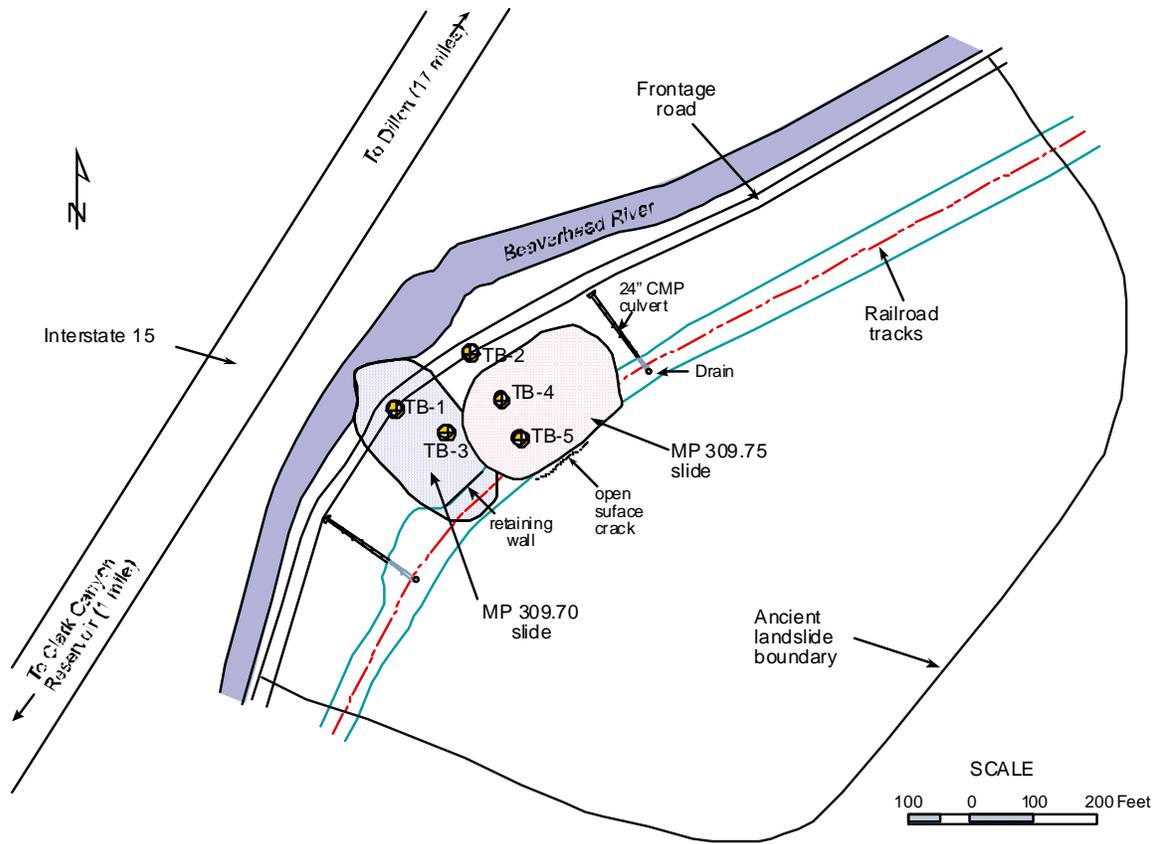
Figure 10. Site map of the Clark Canyon landslide identifying test holes (TB-1 – TB-5) drilled during the 2001 investigation.

The MP309.70 landslide extends from the barrow pit adjacent to the railroad track to the Beaverhead River (fig. 10). Test holes TB-1 and TB-3 were completed in this slide. TB-1 was drilled along the frontage road near the toe of the slide and was instrumented to monitor ground-water fluctuations. A 3.9-ft thick clay layer was encountered during drilling; therefore two piezometers were installed in the test hole to measure hydrostatic pressures above and below this potential confining unit. Test hole TB-3 was drilled near the center of the slide to monitor slope movement.

The MP309.75 slide extends from the railroad track to approximately 20 feet above the frontage road based on data collected soon after the slide occurred (Shannon & Wilson, 1995). Two borings, TB-4 and TB-5, are located within the slide; boring TB-2 is below the slide (fig. 10).
