**HYDROGEOLOGIC ASSESSMENT OF THE TOWN OF BEARCREEK MUNICIPAL  
WATER SYSTEM  
FOR  
GROUND WATER UNDER THE DIRECT INFLUENCE OF SURFACE WATER**

**Open-File Report MBMG 401-F**

**BEARCREEK MUNICIPAL WATER SYSTEM  
PWSID #00063  
Box 1082  
Bearcreek, MT 59068**

**May, 2000**

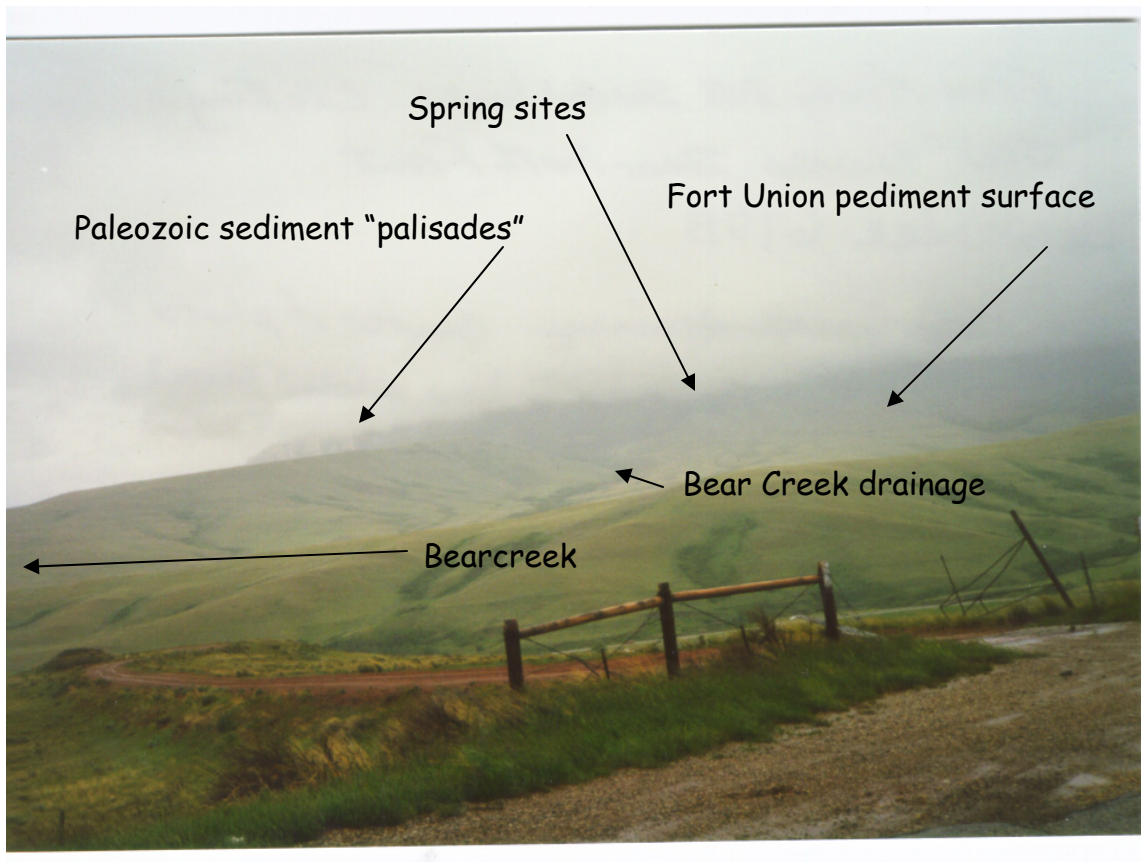
**Photo**

**. Looking south from Highway 308 , 4-miles west of Bearcreek, looking towards spring sites and Beartooth Mountain Front**
