**HYDROGEOLOGIC ASSESSMENT OF RAPELJE WATER USERS ASSOCIATION
WATER SUPPLY
FOR
GROUND WATER UNDER THE DIRECT INFLUENCE OF SURFACE WATER**

**Open-File Report
MBMG 401-M**

**Rapelje Water Users Association
PWSID #00313
Box 46
Rapelje, Montana 59067**

**Prepared
for
Montana Department of Environmental Quality
Water Quality Division**

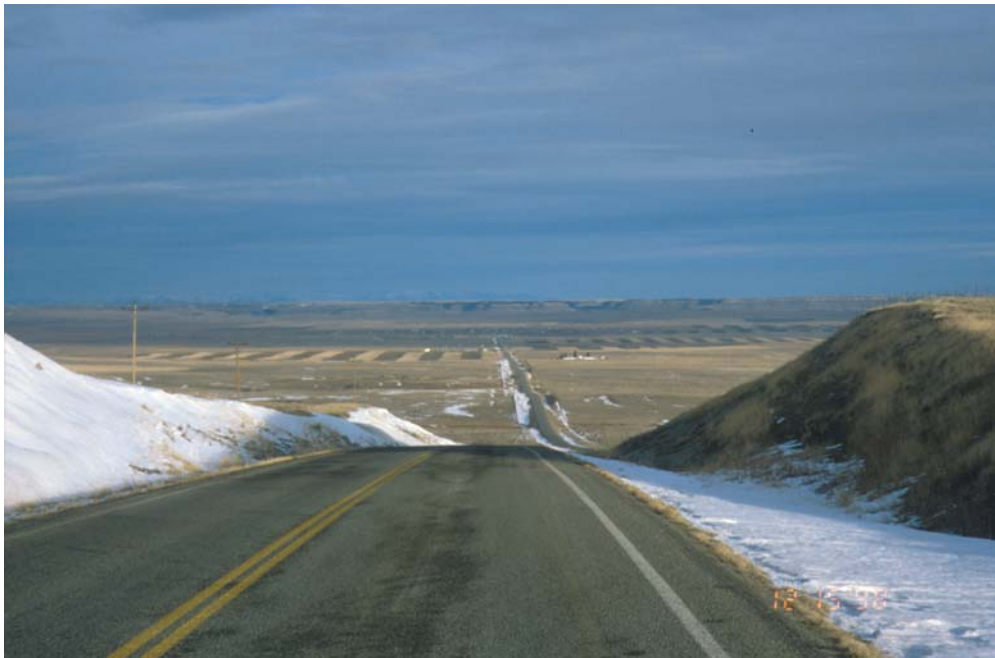
Figure C-5. Photo looking north toward Rapelje on county road from Columbus showing the basin in which Rapelje is located. Rapelje is along the paved road near the center of the picture, crop-fallow fields can be seen around town. The ridge in the background is Eagle sandstone along the Lake Basin Fault zone.

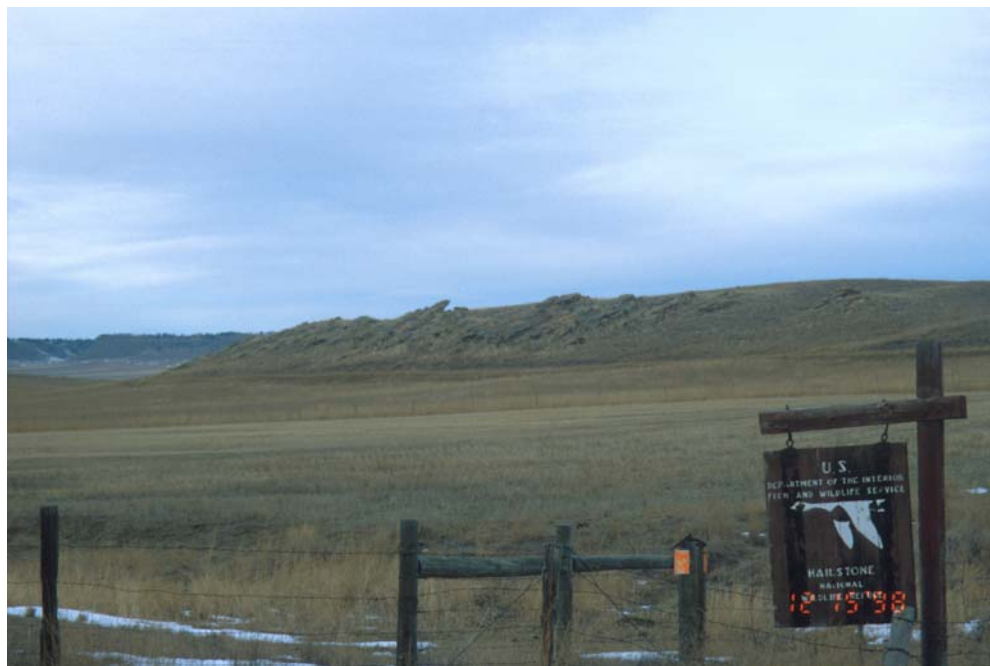
Figure C-6. Fault tilted outcrops of Judith River Formation bedrock (??) along the Lake Basin Fault zone at Hailstone National Wildlife Refuge located 4 miles northeast of Rapelje (Figure B-2).
