**HYDROGEOLOGIC ASSESSMENT OF THE TOWN OF LIMA  
WATER SUPPLY, ALDER SPRING,  
FOR  
GROUND WATER UNDER THE DIRECT INFLUENCE OF SURFACE WATER**

**Open-File Report  
MBMG 401-N**

**Town of Lima  
Lima Water Department  
PWSID #00276  
P. O. Box 184  
Lima, Montana 59739**

**November 2000**

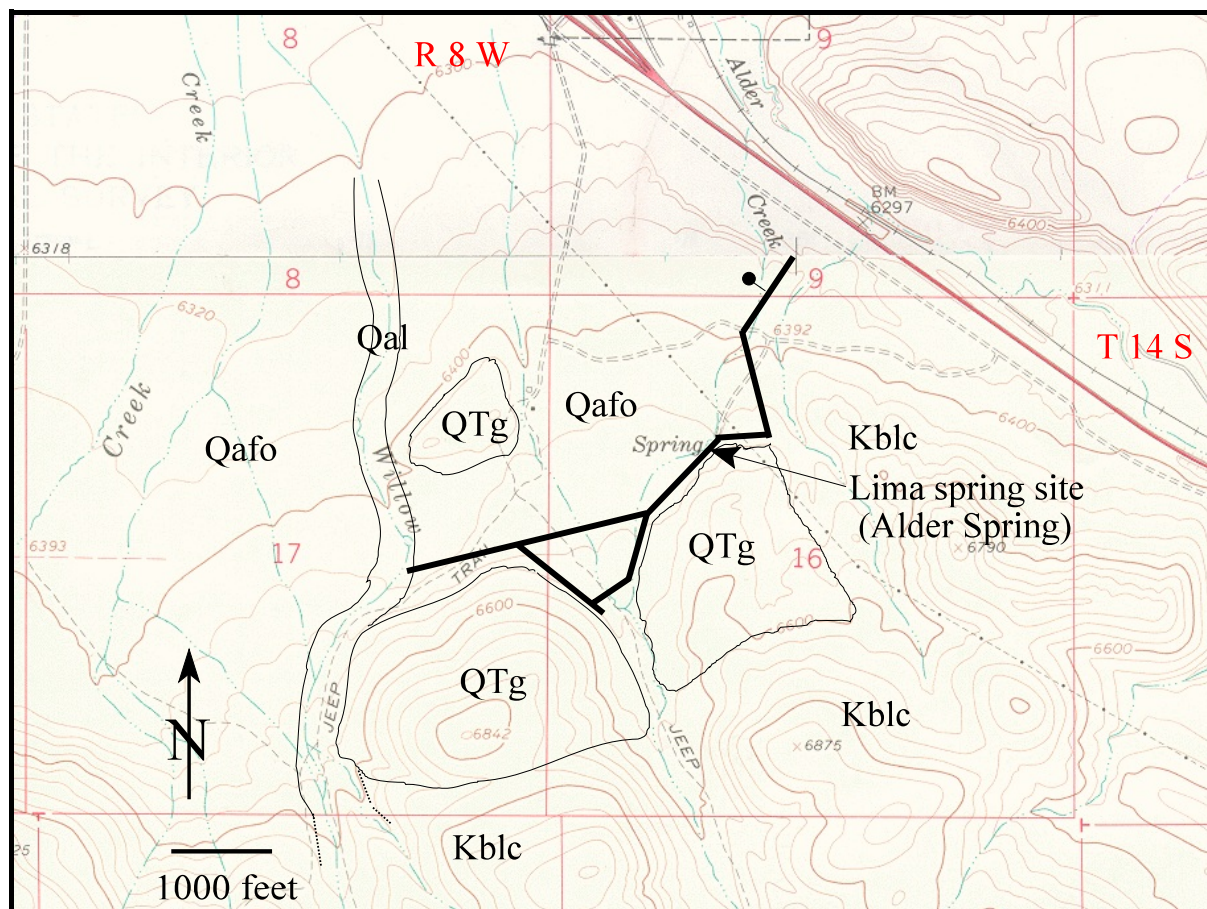
The north end of the hills, at the Alder Spring site, are composed of unconsolidated Tertiary to Quaternary age gravel deposits (Figure 6) (Appendix B, photo B-1). Alder Spring discharges from a steep hillside composed of the QTg gravels along the east side of the Alder Creek drainage (Figure 6). Skipp (2000) described the QTg unit as gravels of uncertain affinity. The unit is similar to terrace gravels mapped in the area which consist of stream-channel deposits containing pebbles, cobbles and boulders. The clasts in the gravels are typically well rounded and are derived from erosion of the Paleozoic and Mesozoic sediments of the surrounding mountains, including rocks of the Beaverhead Group. The gravels in the QTg are unconsolidated, not cemented, and have large pore spaces that make a good water-bearing and water-transmitting aquifer. The topography developed on the gravels is hummocky, uneven terrain in contrast to the gently rolling uplands of the Lima Conglomerate located further to the south (Appendix B, photo B-1).

**Figure 6.** Geologic map of the Alder spring site (modified from Skipp, 2000) on the Lima Peaks topographic quadrangle map (USGS, 1965). The map shows the late-Tertiary to possibly Quaternary age, unconsolidated gravels (QTg) southeast of the spring, which are the source of ground water for the spring. Kblc is the Lima Conglomerate of the Beaverhead Group (Cretaceous age), Qafo are older alluvial fan deposits of Quaternary age, and the Qal is more recent alluvium deposited by the creeks. The heavy lines are faults mapped by Skipp (2000). Most of the faults show normal movement, with the north side dropped relative to the south side. Many similar faults in the area show signs of recent movement and displacement of recent alluvial sediments.

Alder Springs flows from a steeply sloping hillside composed of QTg gravel along the Alder Creek drainage (Figure 6). The spring occurs where the water table intercepts the more steeply sloping land surface. Alder Spring is also located along the inferred trace of a valley margin fault which may have some influence on local ground-water movement and the spring. The QTg gravels contain large pore spaces between the gravel, pebbles, cobbles, and boulders which allow for the easy and rapid movement of ground water. The ground water in the gravels is recharged by precipitation falling on the land surface, and from drainage through a hydraulic connection with the alluvium along the creek bottoms uphill from the spring site. The total surface area of the gravels exposed at the land surface is small and the area receives low annual precipitation; so the contribution to recharge from precipitation is probably small. The total thickness of the QTg gravel aquifer is not known, however, the thickness of the aquifer that lies above the spring is relatively thin because the land surface of the gravel hills rise only 160 ft above the spring site (Figure 6). This relatively shallow thickness cannot provide adequate quantities of water to continuously supply the spring. The gravel also receives very little water from the tightly cemented Lima Conglomerate that forms the hills south of the gravel deposits.
