**Montana Bureau of Mines and Geology  
Abandoned - Inactive Mines Program  
Deerlodge National Forest**

**Volume III  
Flint Creek and Rock Creek Drainages**

**December, 1995**

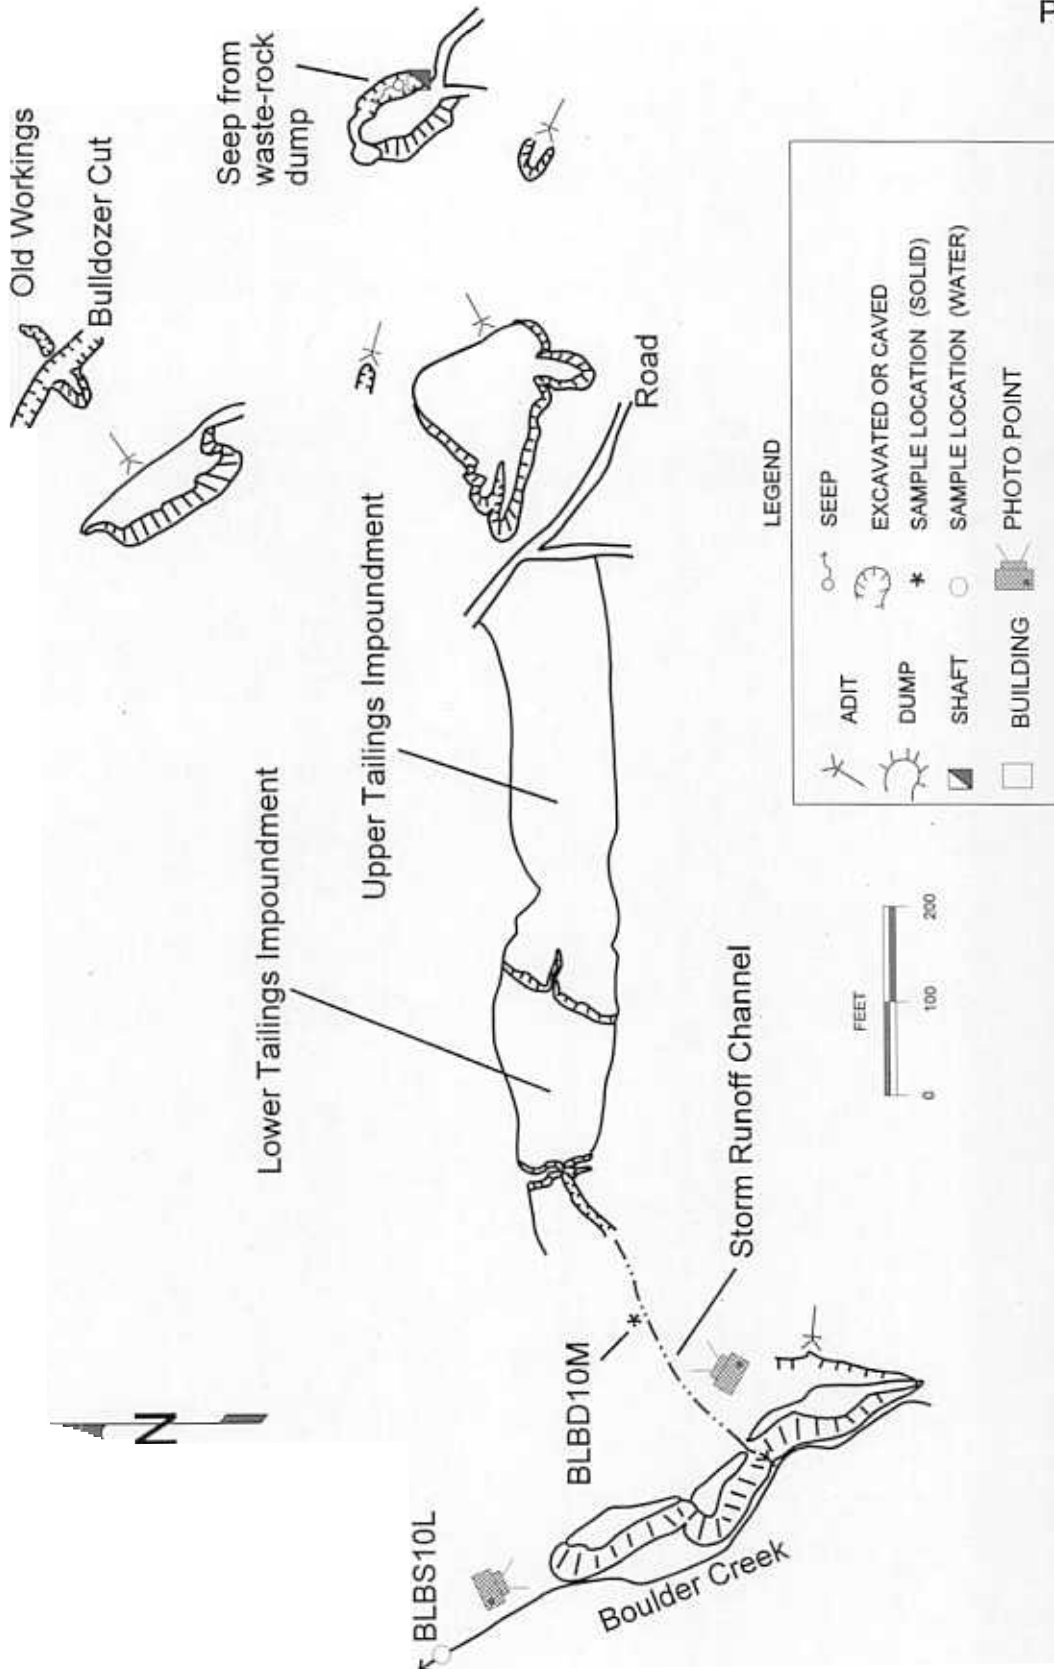
Figure 2.10 Site map of th Brooklyn mine and mill

The site consists of one open and four caved adits, a caved shaft, mill tailings and waste-rock dumps (Figure 2.10). Mill tailings and waste material from upper portions of the site are washed onto lower portions of the site and into Boulder Creek by storm-water runoff. During high flows, Boulder Creek undercuts the waste material along its banks. Iron-oxyhydroxide stains are present along a discharge channel leading away from the lowest adit. The stains suggest that water is discharged from this adit, but at the time of the site visit, there was no discharge.

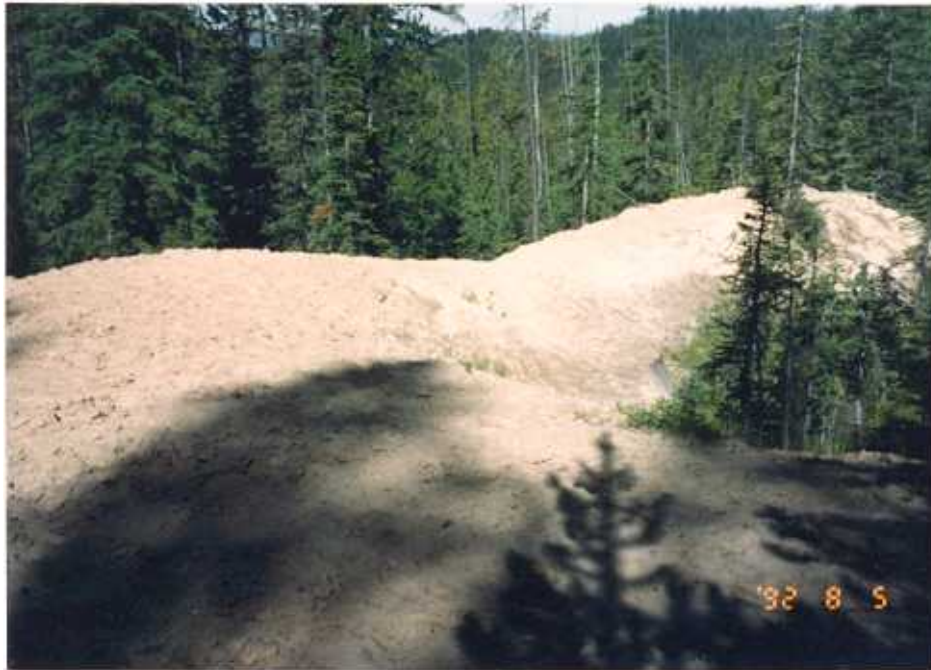
**Figure 2.14** The Port Royal tailings are on private land, uphill from DNF administered land.

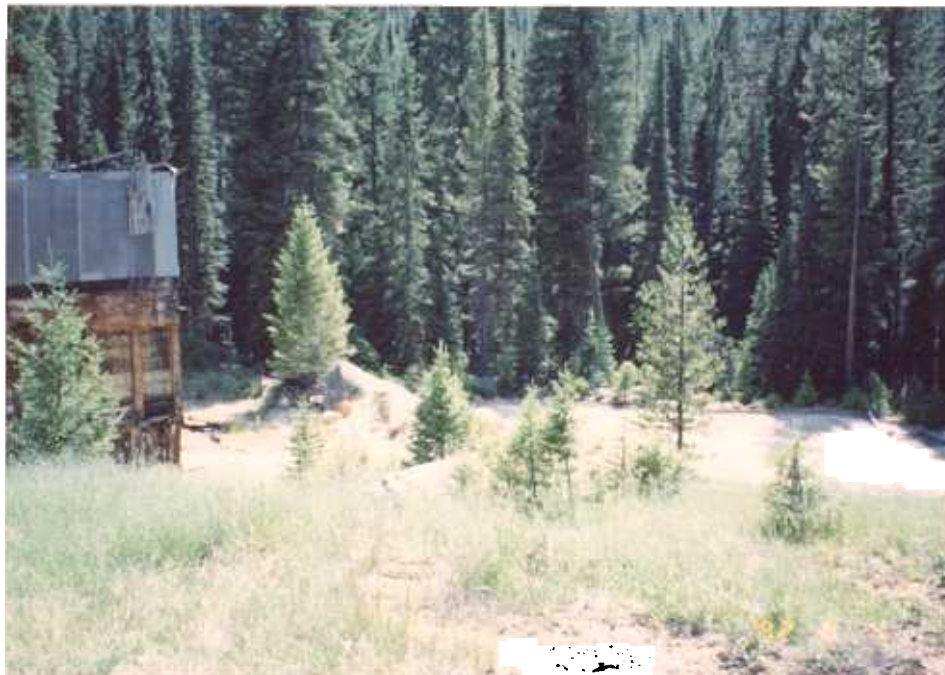
**Figure 2.20** The mill site of the Non Pareil mill is adjacent to the main Boulder Creek Road, approximately 2 miles upstream of the town of Princeton.

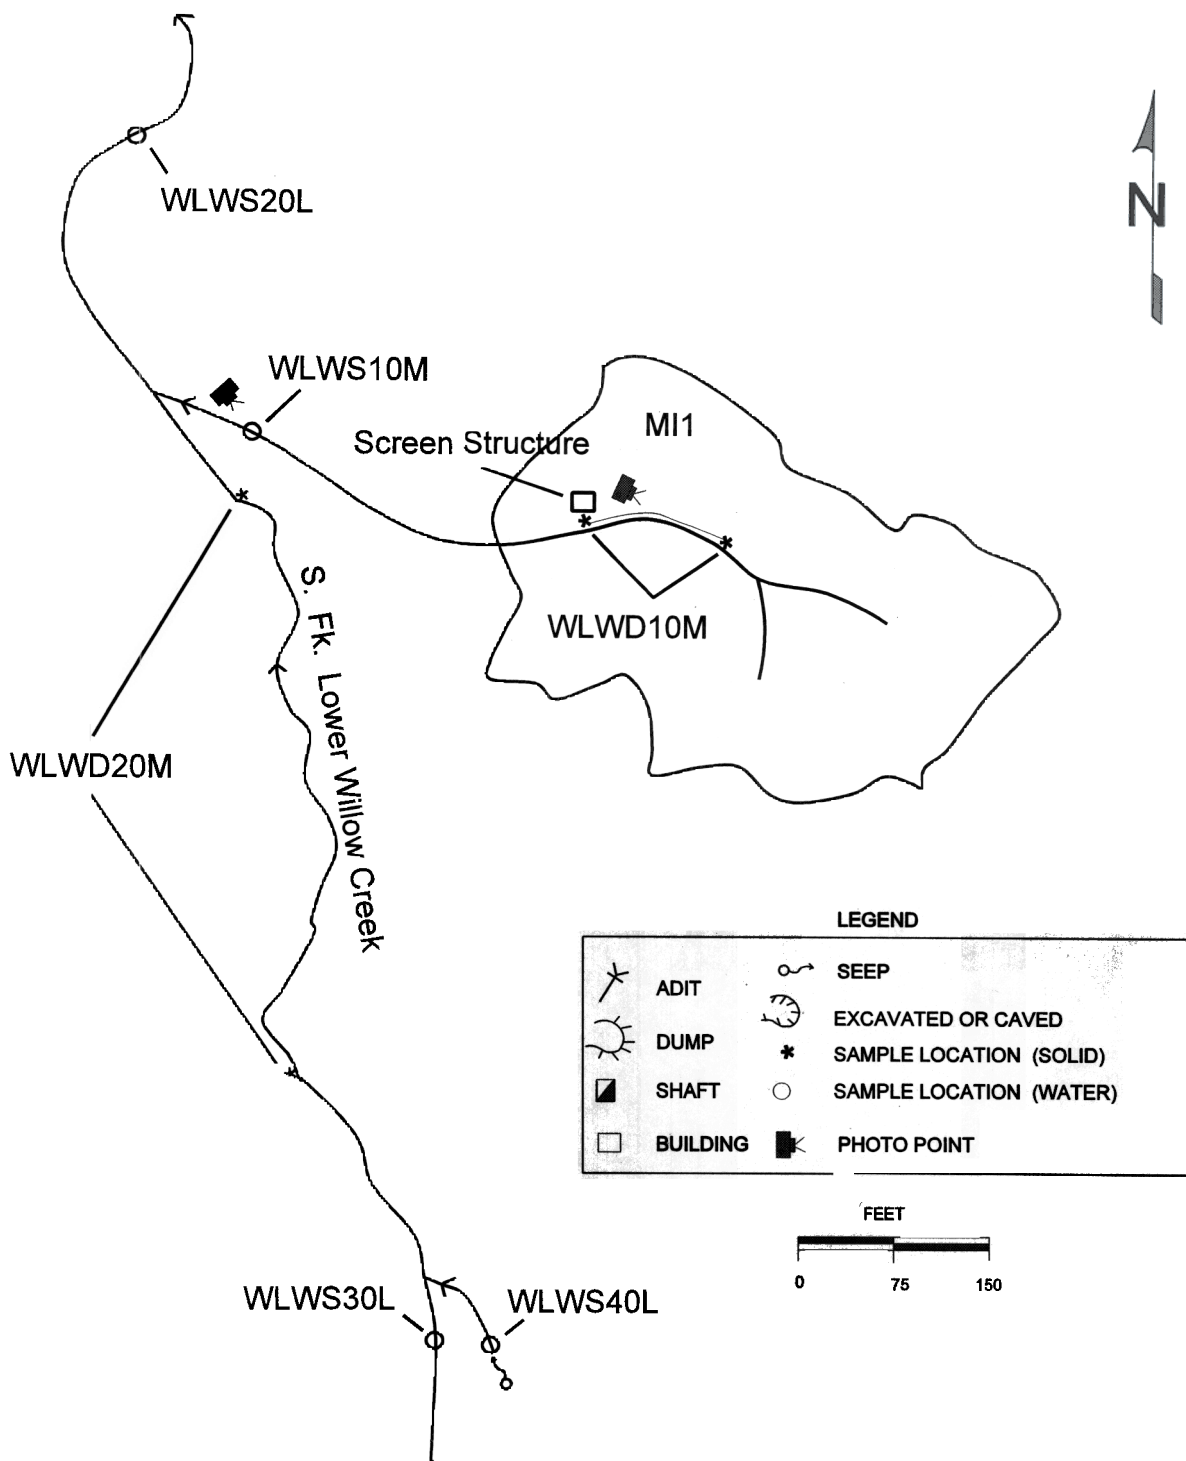
Figure 2.30 Site map of the Lower Willow Creek tailings

The tailings impoundment (M11, see Figure 2.30) and streamside tailings cover an area of more than 10 acres. Seeps flow from the impoundment and the streamside tailings into the South Fork of Lower Willow Creek. Also, streamside tailings are washed into the creek during high-flow events.

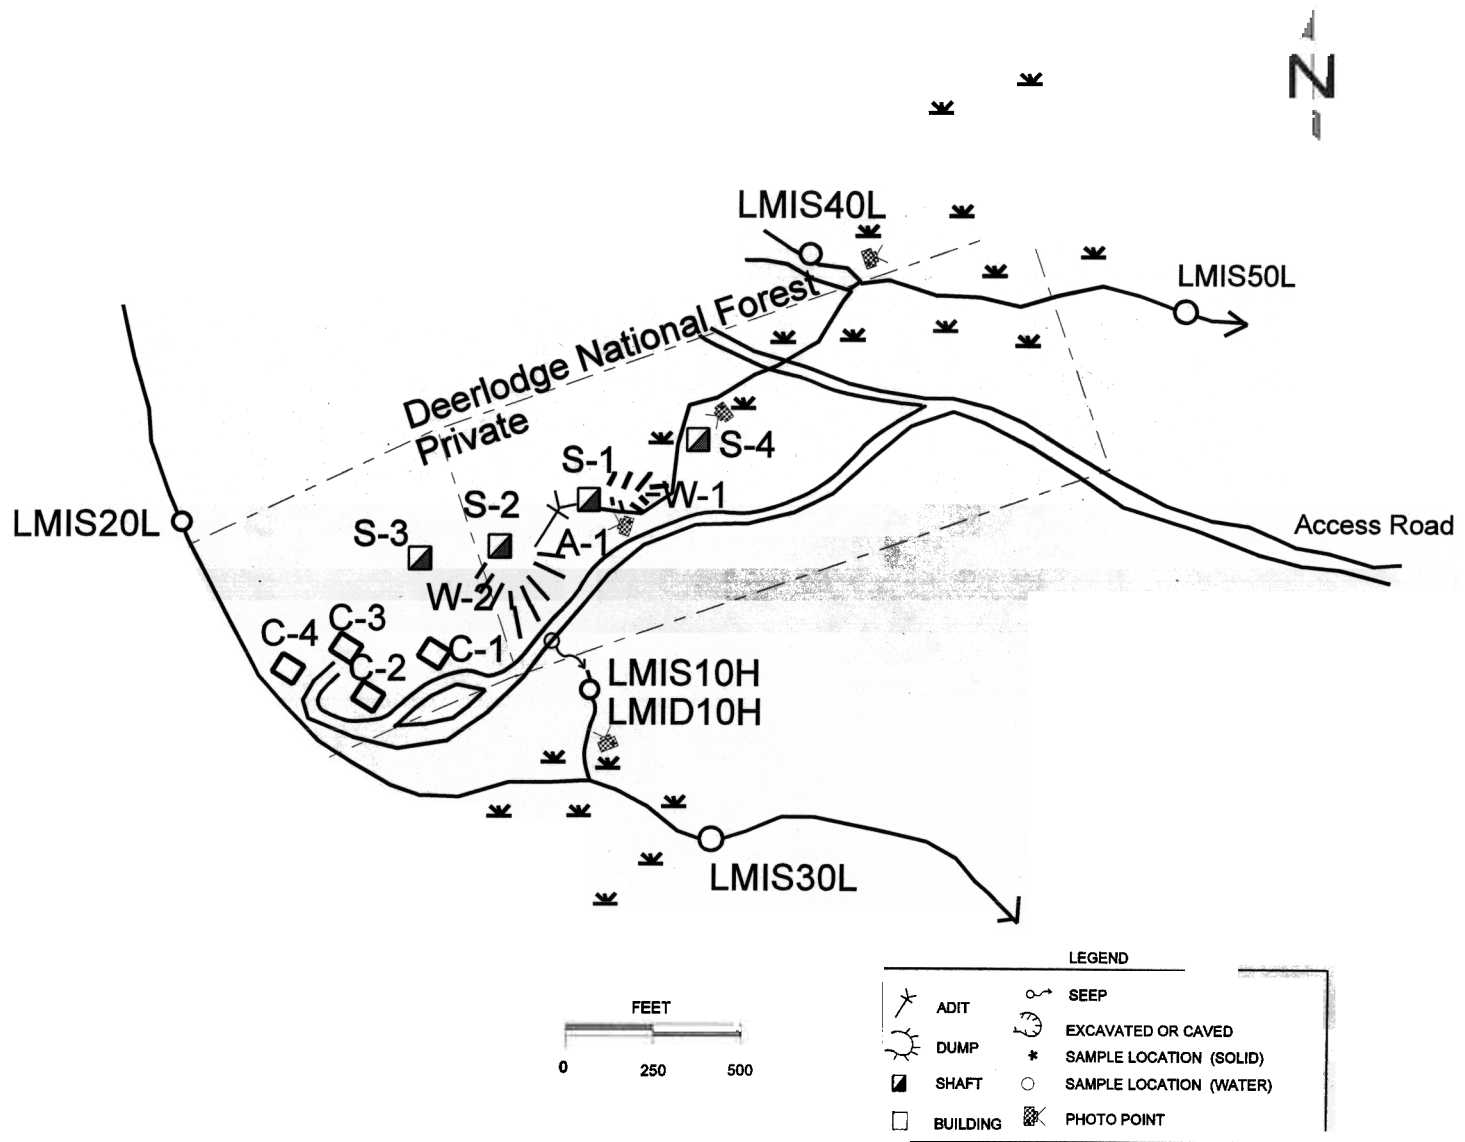
Figure 3.12 Site map of Miller's mine

The MBMG inventoried four shafts (S-1 through S-4, see Figure 3.12), and adit (A-1), and two large waste-rock dumps (W-1 and W-2) at the site. The two easternmost shafts (S-1 and S-4) are flooded to the surface and discharge water. Shaft S-2 has a headframe and is flooded to within 20 to 30 feet of land surface. The adit has a small iron-oxyhydroxide stained discharge that joins with the S-1 discharge. A large, unvegetated seep area occurs south of dump W-2.

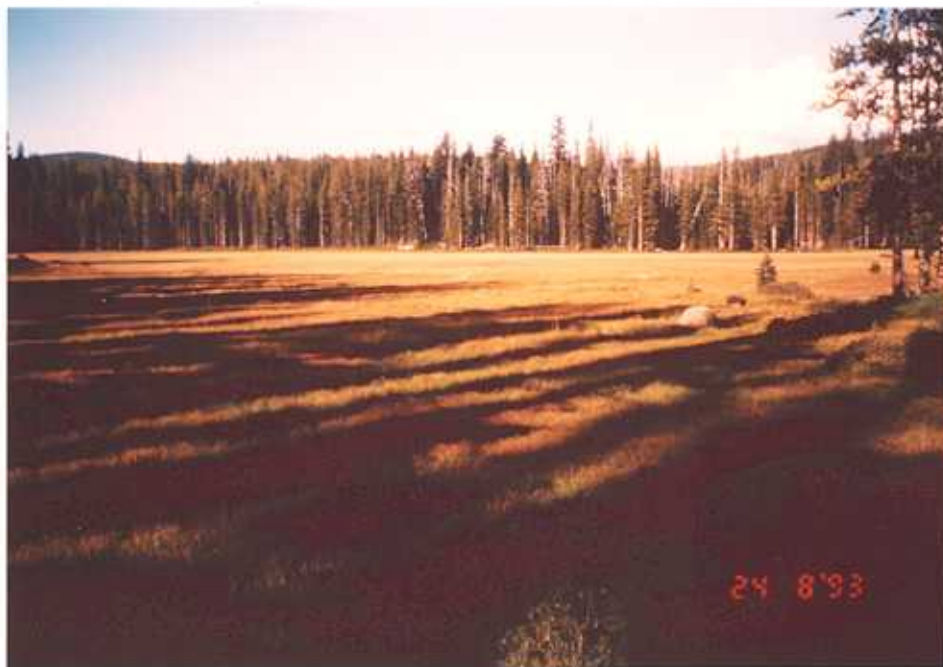
**Figure 3.16** Wetland east of Miller's mine.

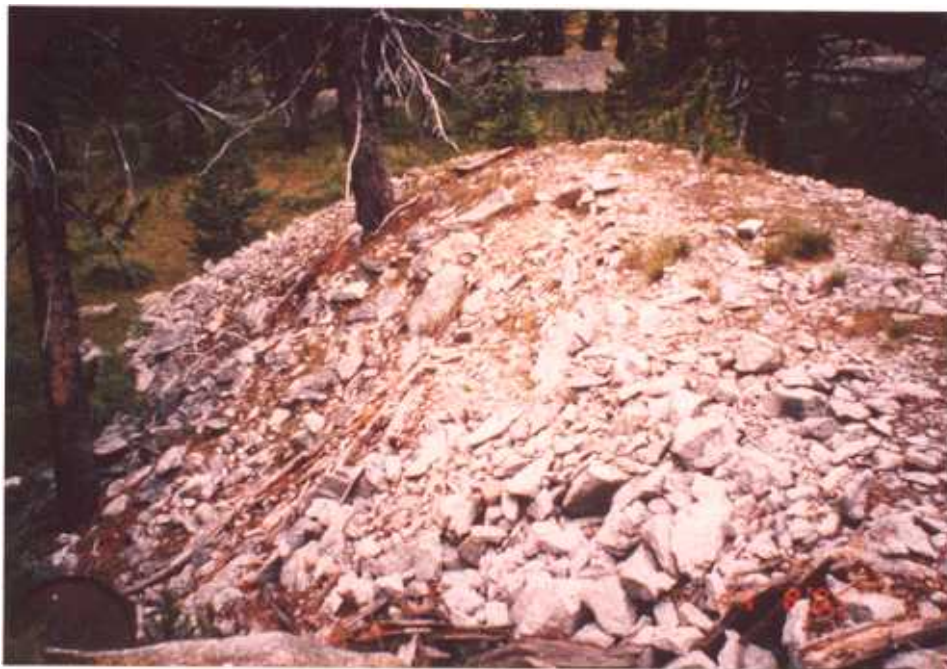
**Figure 3.19** The waste-rock dump is comprised of unaltered granodiorite.

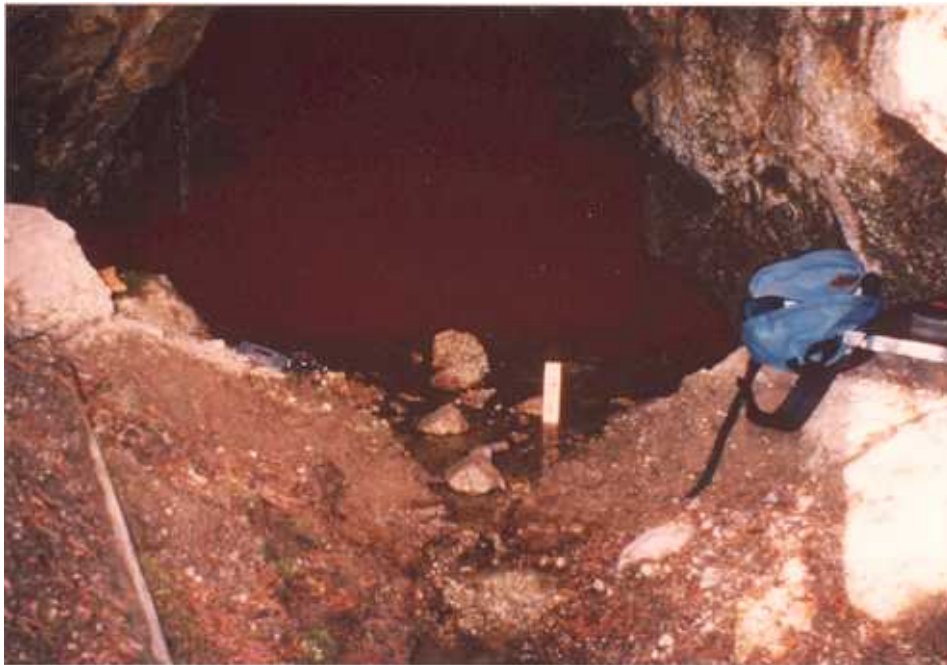
On 9/7/93, surface water samples were collected from the adit discharge (RKES10L), the seeps at the base of the dump (RKES30L), and from one of the springs downhill of the mine (RKES20L). The adit discharge flowed at about 4

**Figure 3.24** Water sample RKES10L was collected from the discharge flowing from the open adit.

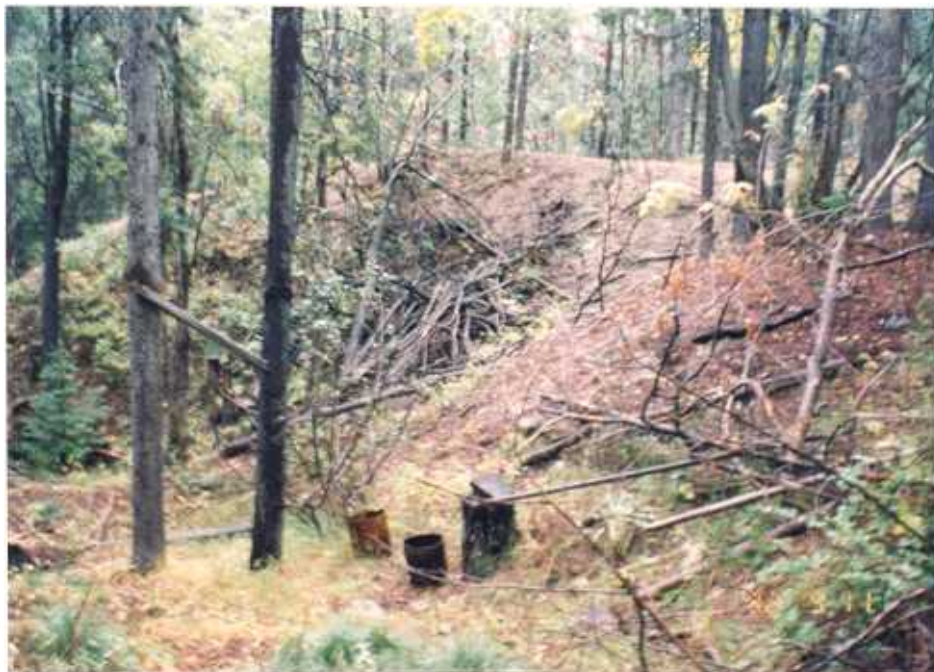
**Figure 3.25** The waste-rock dump at the Kent mine is vegetated with grasses, brush, large conifers.

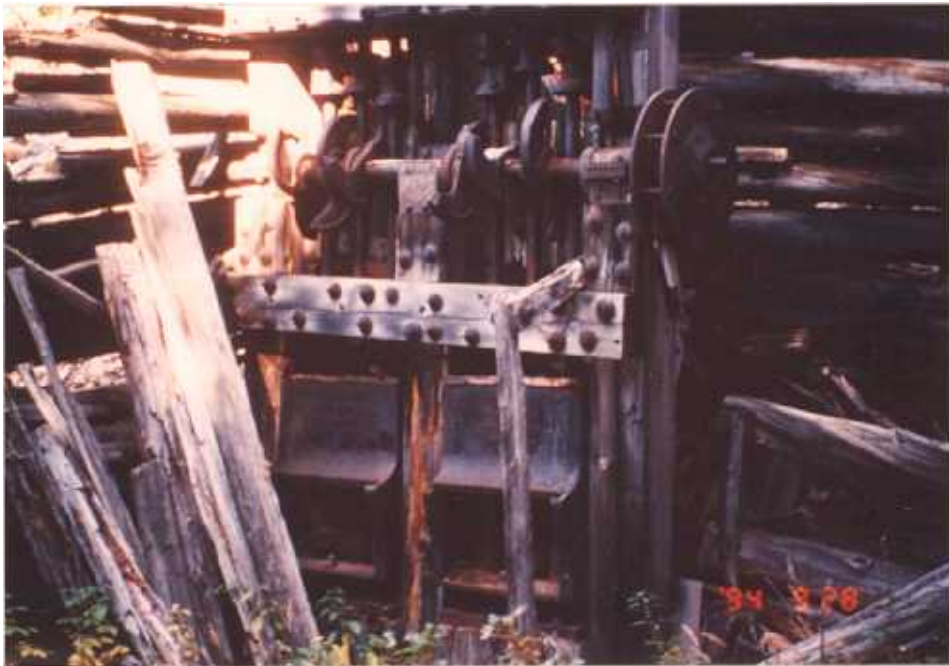
**Figure 3.28** Stamp mill forged at the Philipsburg Iron Works.
