**Montana Bureau of Mines and Geology
Abandoned-Inactive Mines
Helena National Forest**

**Volume I
Upper Missouri River Drainage**

MBMG 352

**Prepared for the U.S. Department of Agriculture
Forest Service -Region 1**

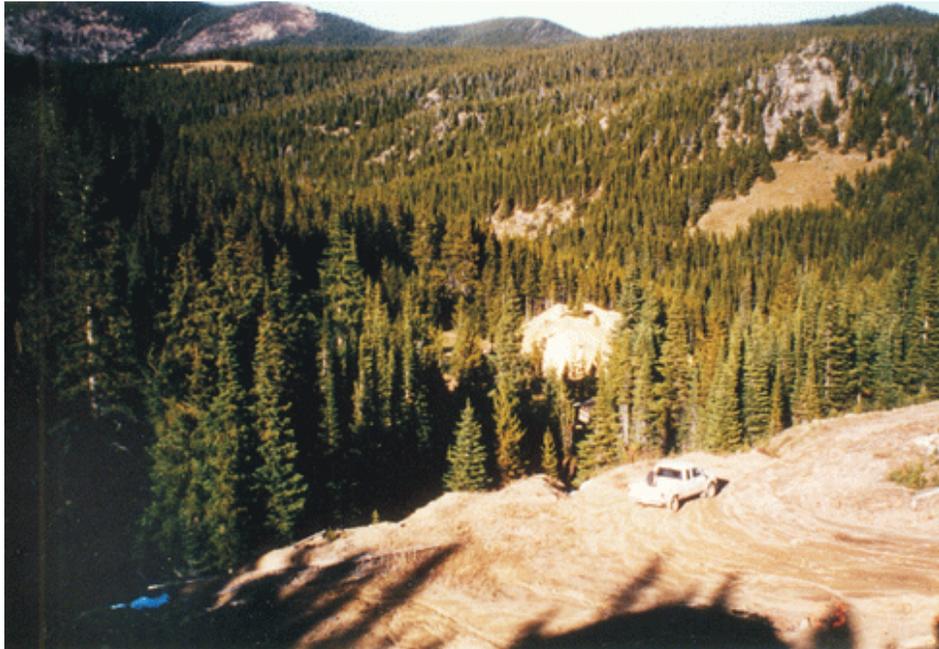
Figure 4a. The Peerless Jenny mine is in a small tributary of Banner Creek. The waste-rock dump can be seen from the access road.

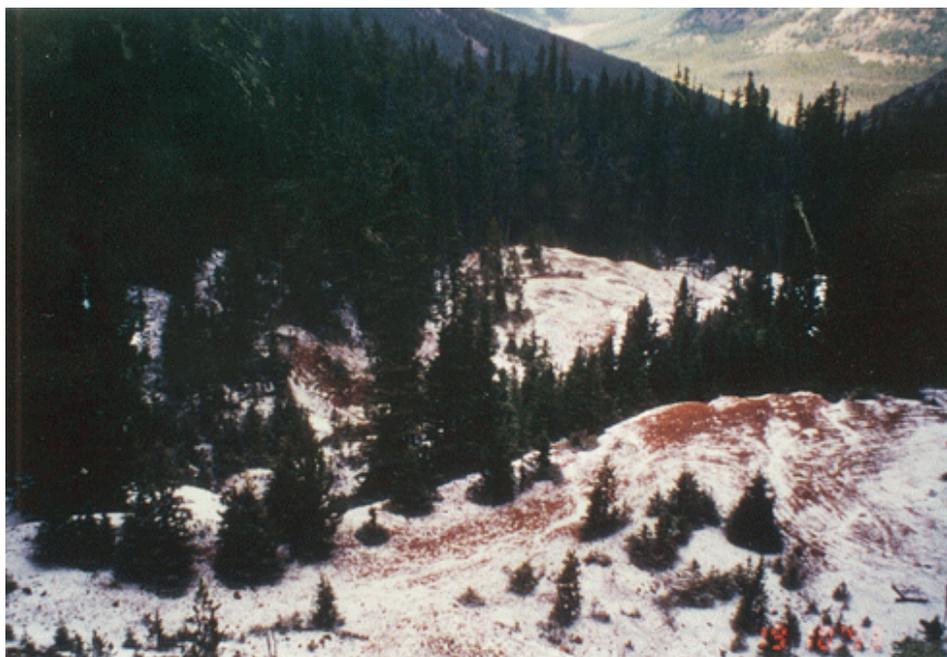
Figure 5a. The Sallie Bell (Red Mountain) mine has several waste-rock dumps on either side of the small stream.

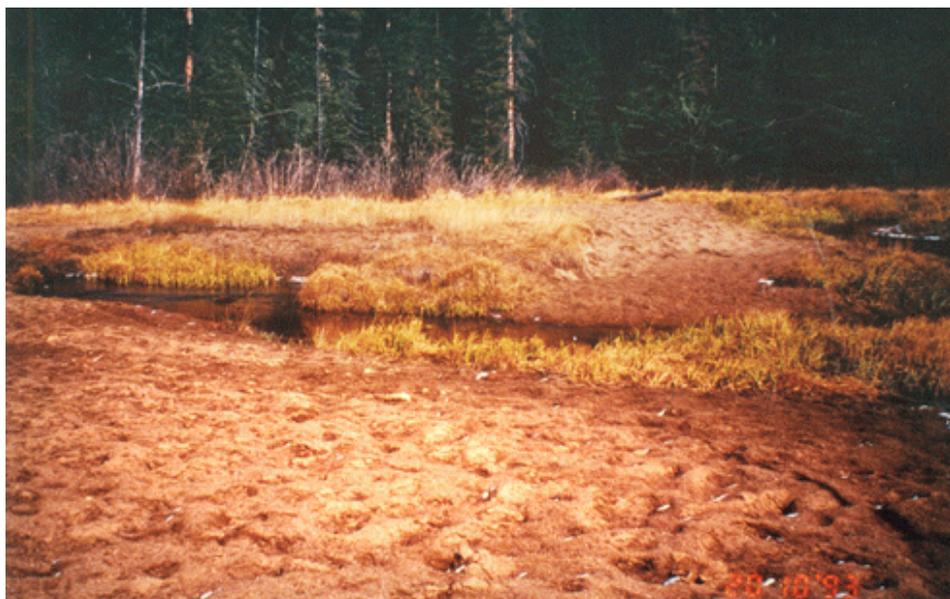
Figure 6a. Barren ground where tailings are exposed indicate the phytotoxicity of the soils associated with the Banner Creek tailings.

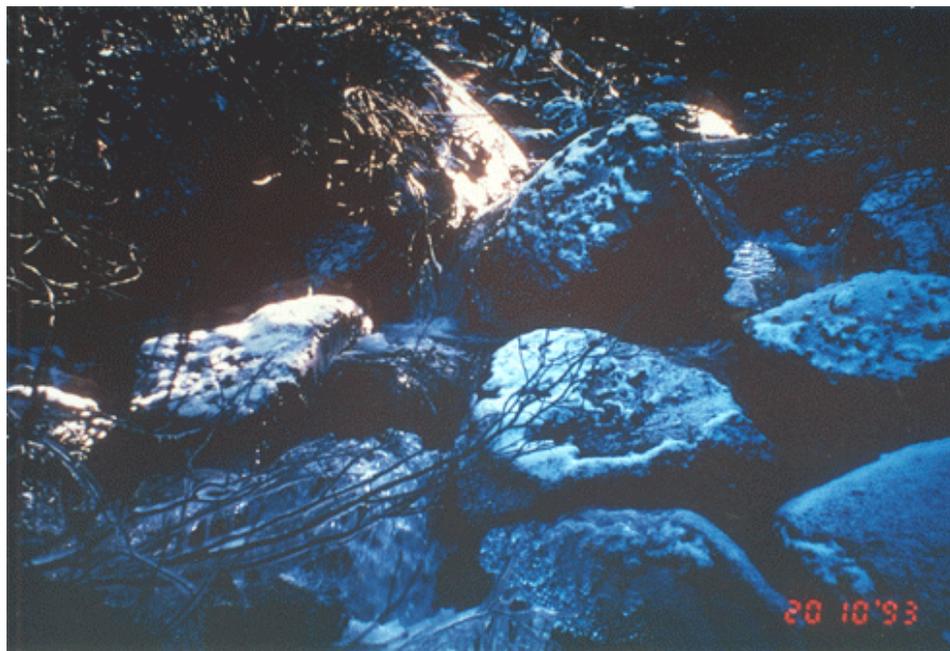
Figure 6b. Banner Creek below the tailings had higher concentrations of iron and mercury.

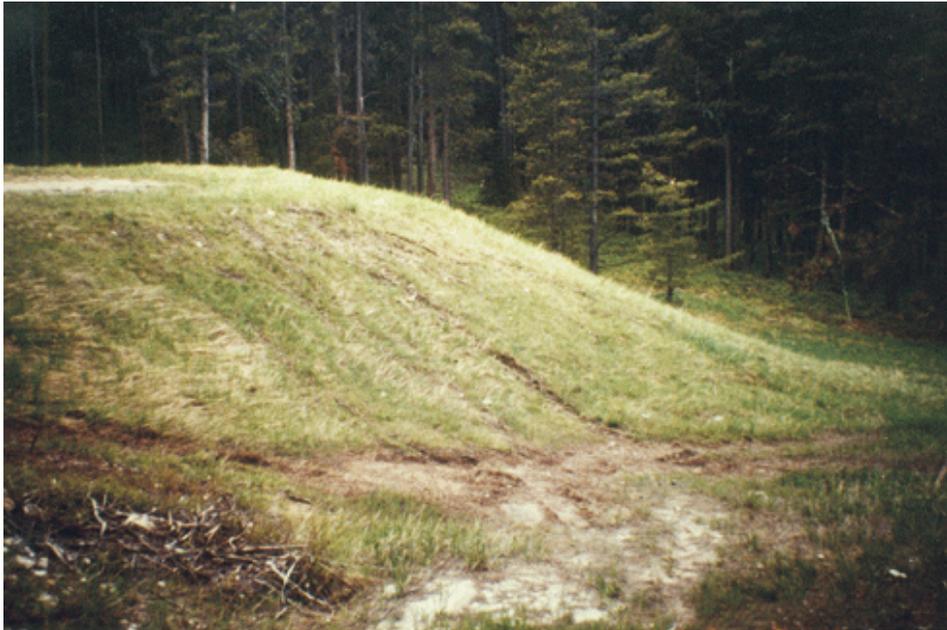
Figure 7a. The main waste-rock dump of the Justice mine has been reclaimed. The adit still discharges to Minnehaha Creek.

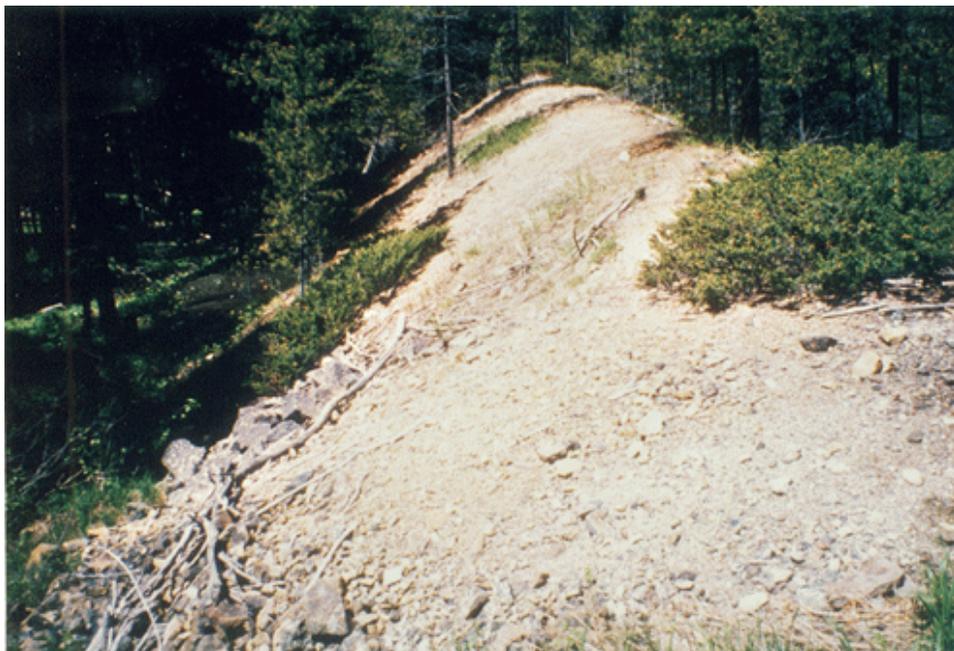
Figure 7b. The waste rock dump of the Lower Justice mine is on private land. The collapsed adit discharges toward the creek.

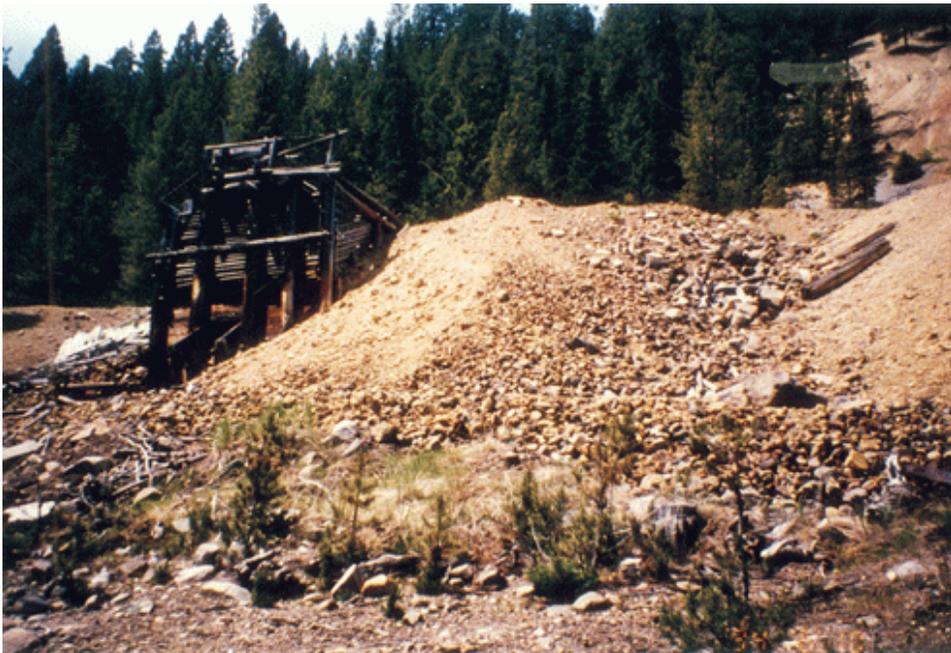
Figure 8b. The lower waste-rock dump of the Armstrong mine was barren. The area below the dump also was barren of vegetation.

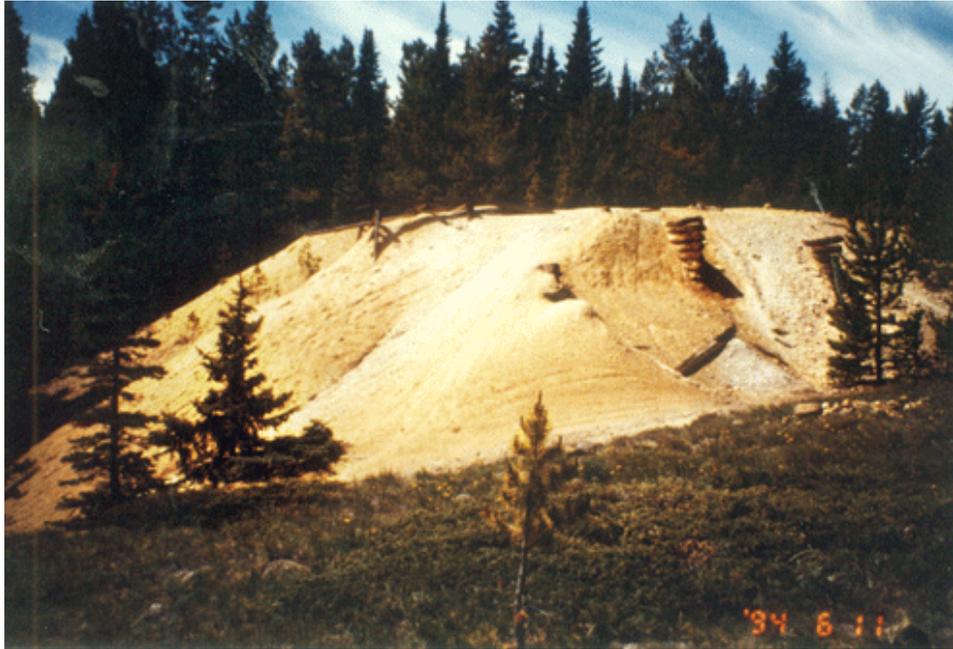
Figure 9a. The upper waste-rock dump of the Beatrice mine is large and provides sediment to the intermittent stream.

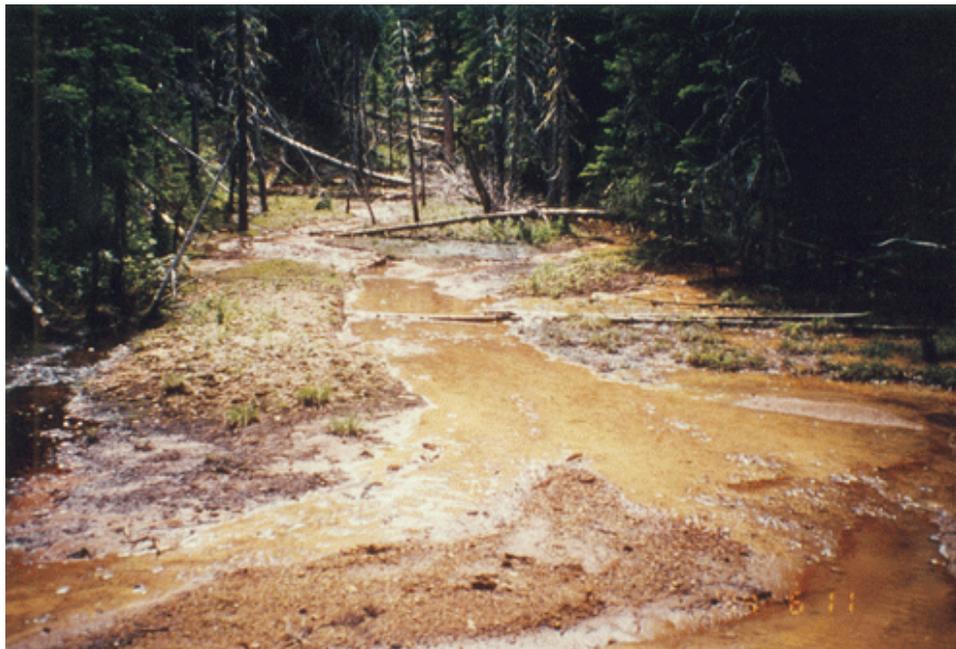
Figure 9b. Waste material below the upper dumps has washed down the drainage during runoff events.

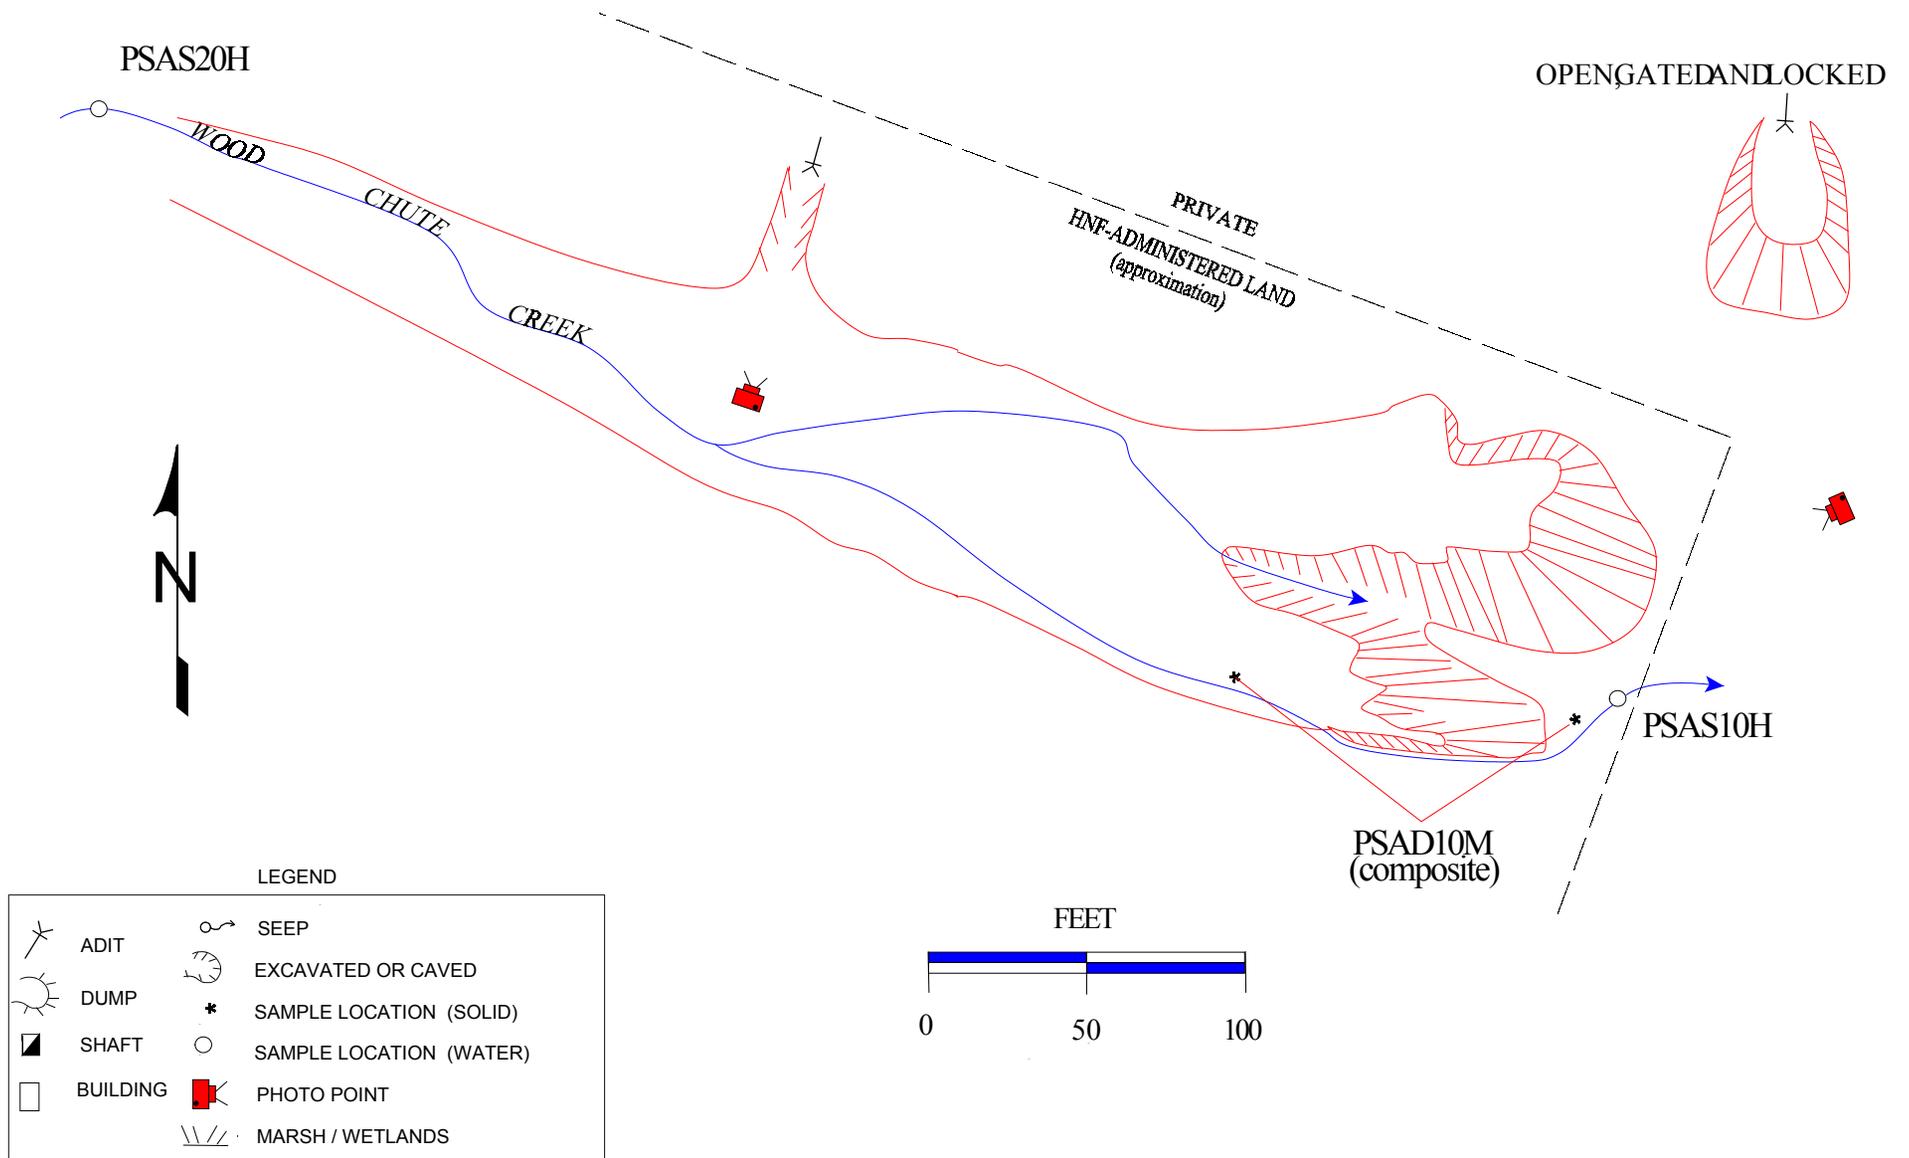
Figure 11. The disturbed area of the Salvai mine (5/24/93) is on private and HNF-administered land. Wood Chute Creek flows through the main development area.

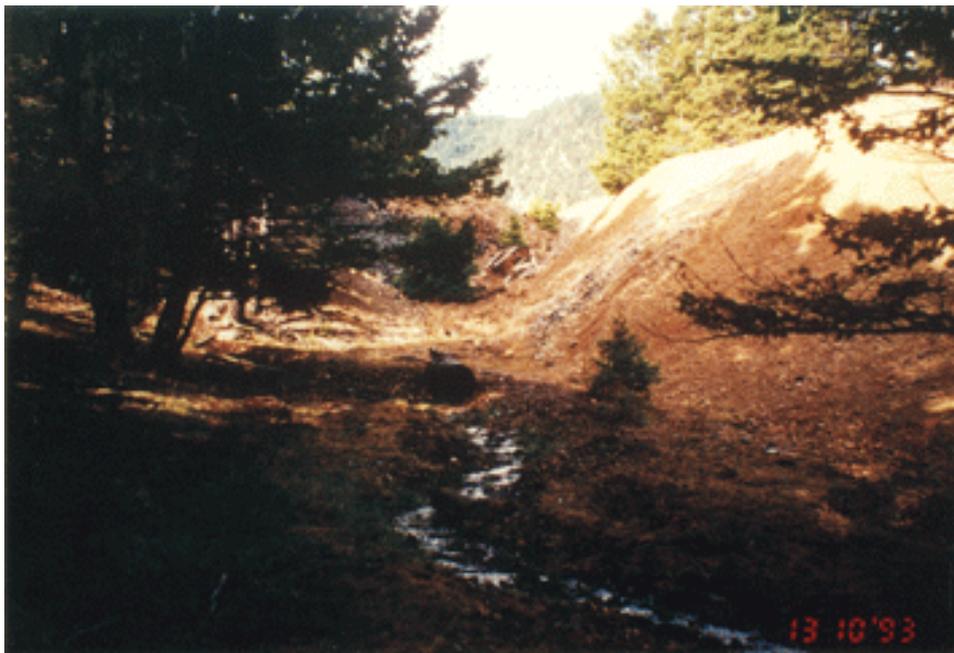
Although the water quality of Wood Chute Gulch downstream of the Salvai mine is somewhat poor, the quality of water above the mine is only slightly better (table 17). The Bluebird mine, about two miles upstream, probably contributes to the total metals loading in the stream. In general, the concentrations of metals near the Salvai mine are relatively low. However, during spring runoff and storm events, there is likely to be a large amount of metals dissolved from the waste-rock dump.

Figure 11b. Wood Chute Creek below the Salvai mine was impacted by the Salvai mine (shown) and the Bluebird mine upstream.

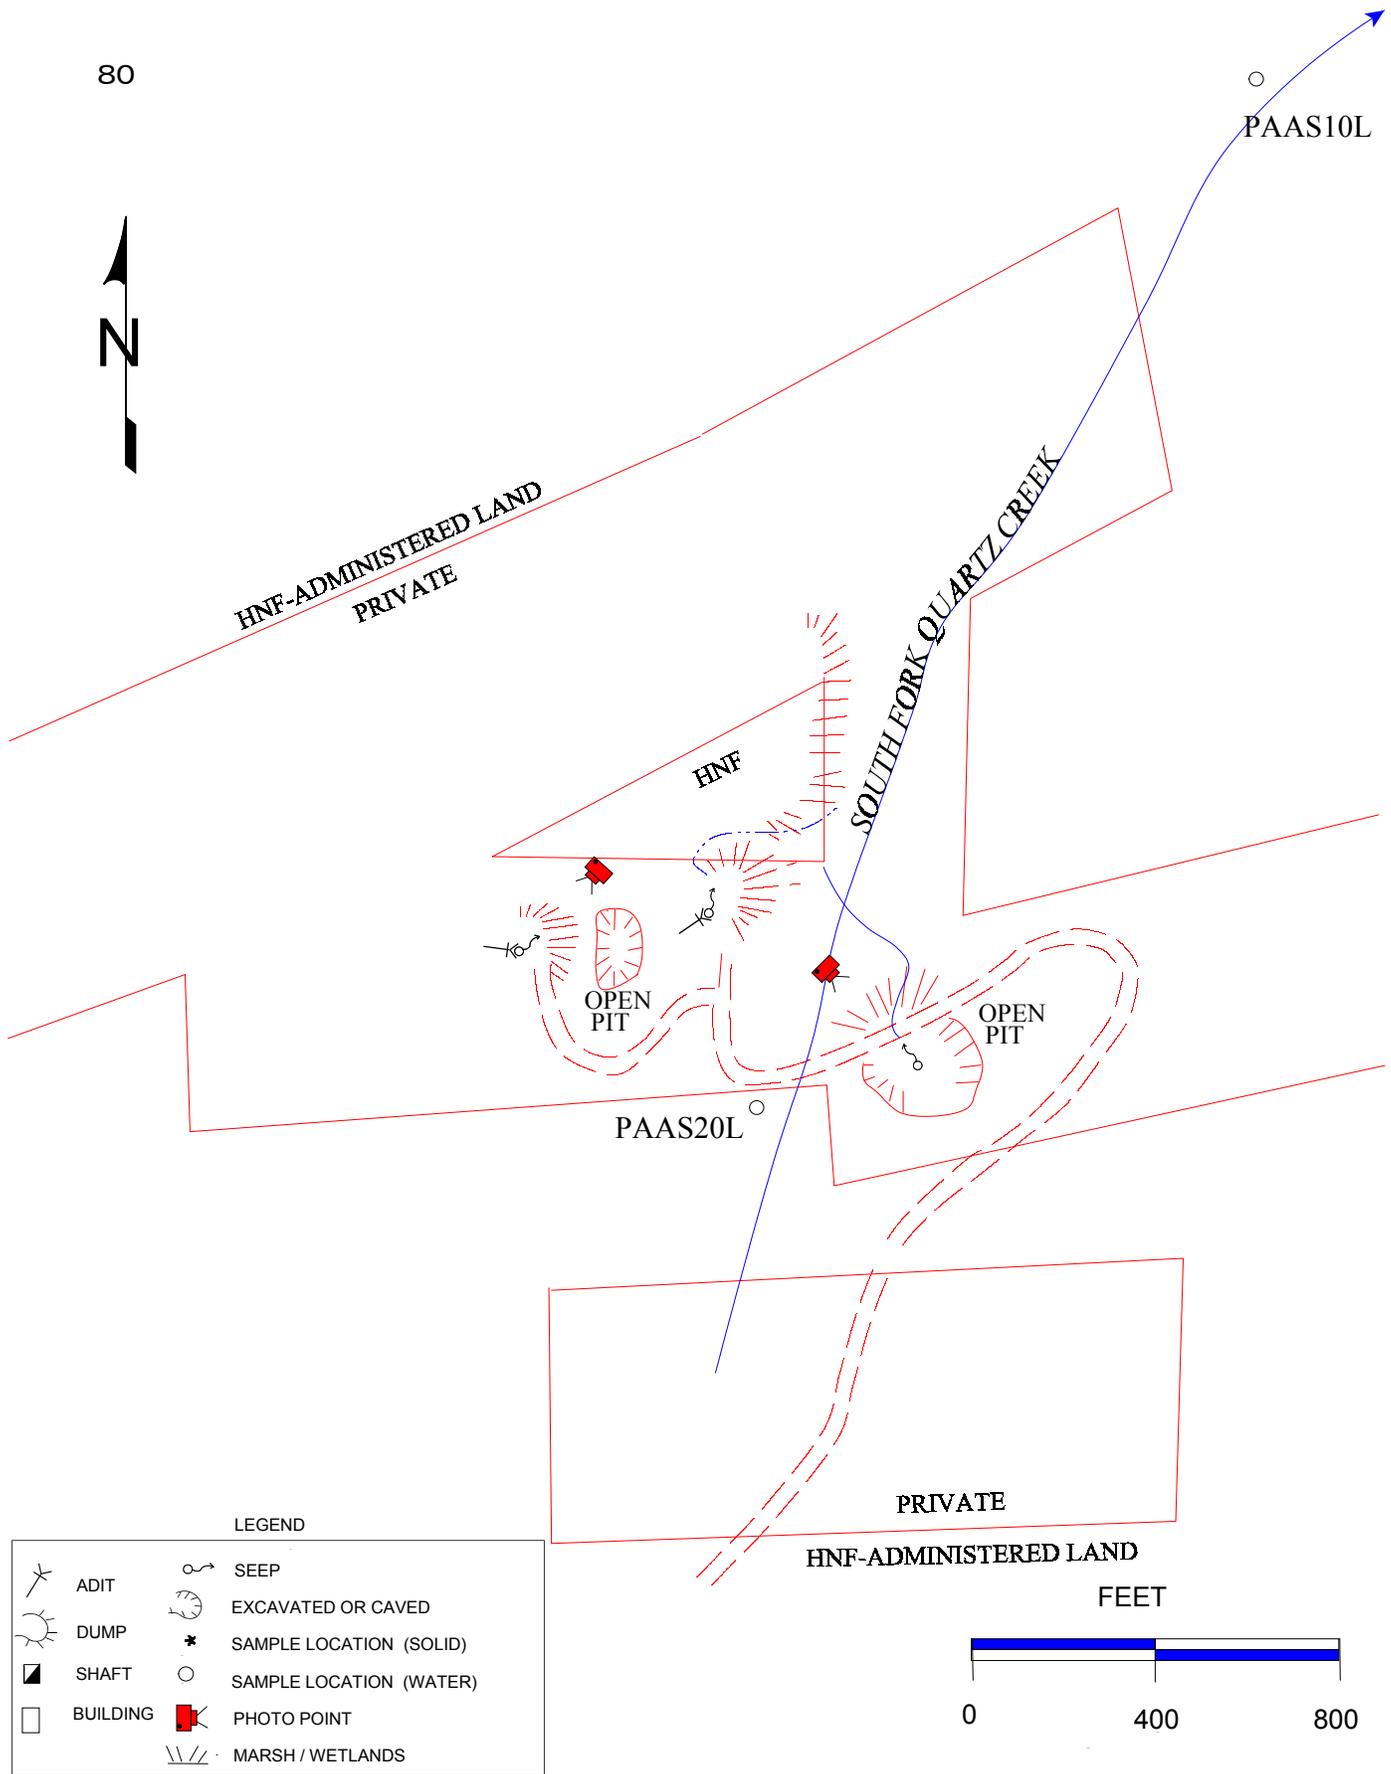
Local undisturbed vegetation at the Edelweiss-Argentine mine consisted of weeds, grasses, and coniferous trees. In the waste-rock dump areas, the ground was generally barren. Many of the trees along the mine-discharge drainages were dead or stressed.

Figure 13. The Edelweiss-Argentine mine (10/27/93) is on either side of South Fork Quartz Creek on private land. Samples were collected upstream and downstream of the mine.

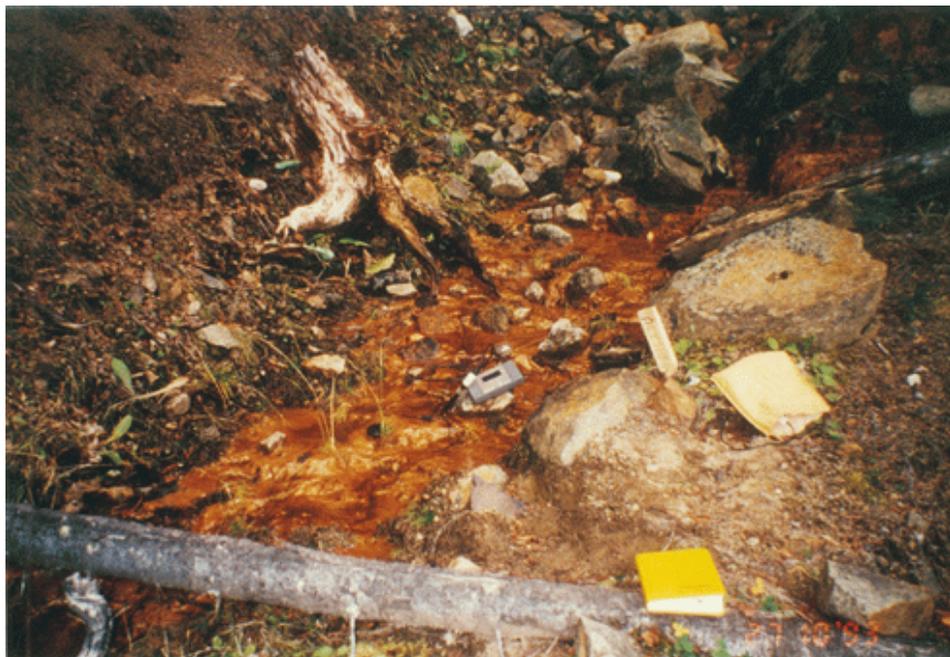
Figure 14a. The Lone Eagle Quartz lower adit was discharging water into a wetlands below the mine.

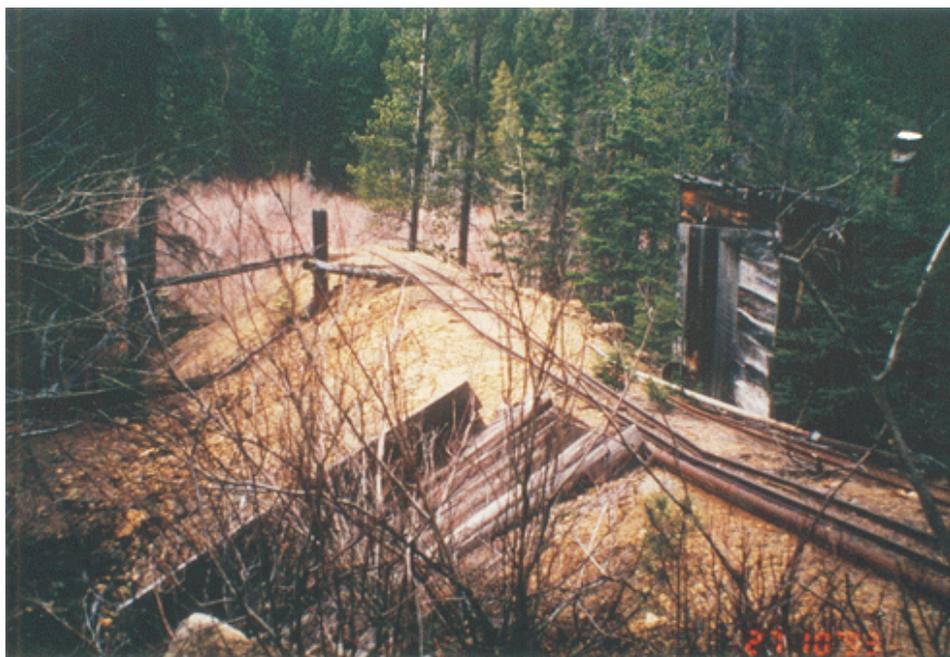
Figure 14b. The lower waste-rock dump of the Lone Eagle Quartz mine was barren, but the area below the dump was generally well vegetated.

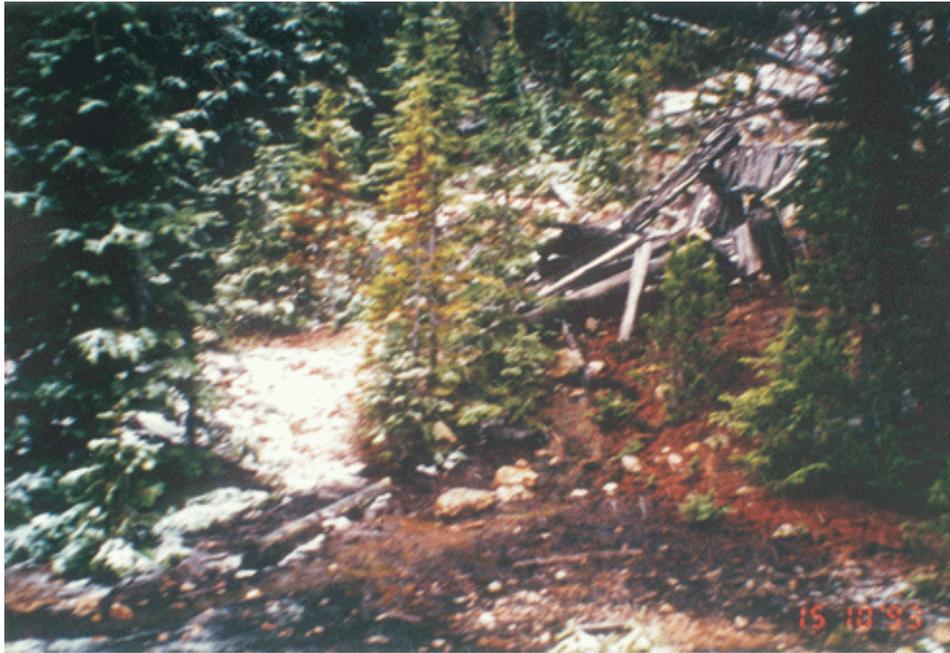
Figure 15a. The middle adit of the Frohner Lead mine was discharging water toward the lowermost adit.

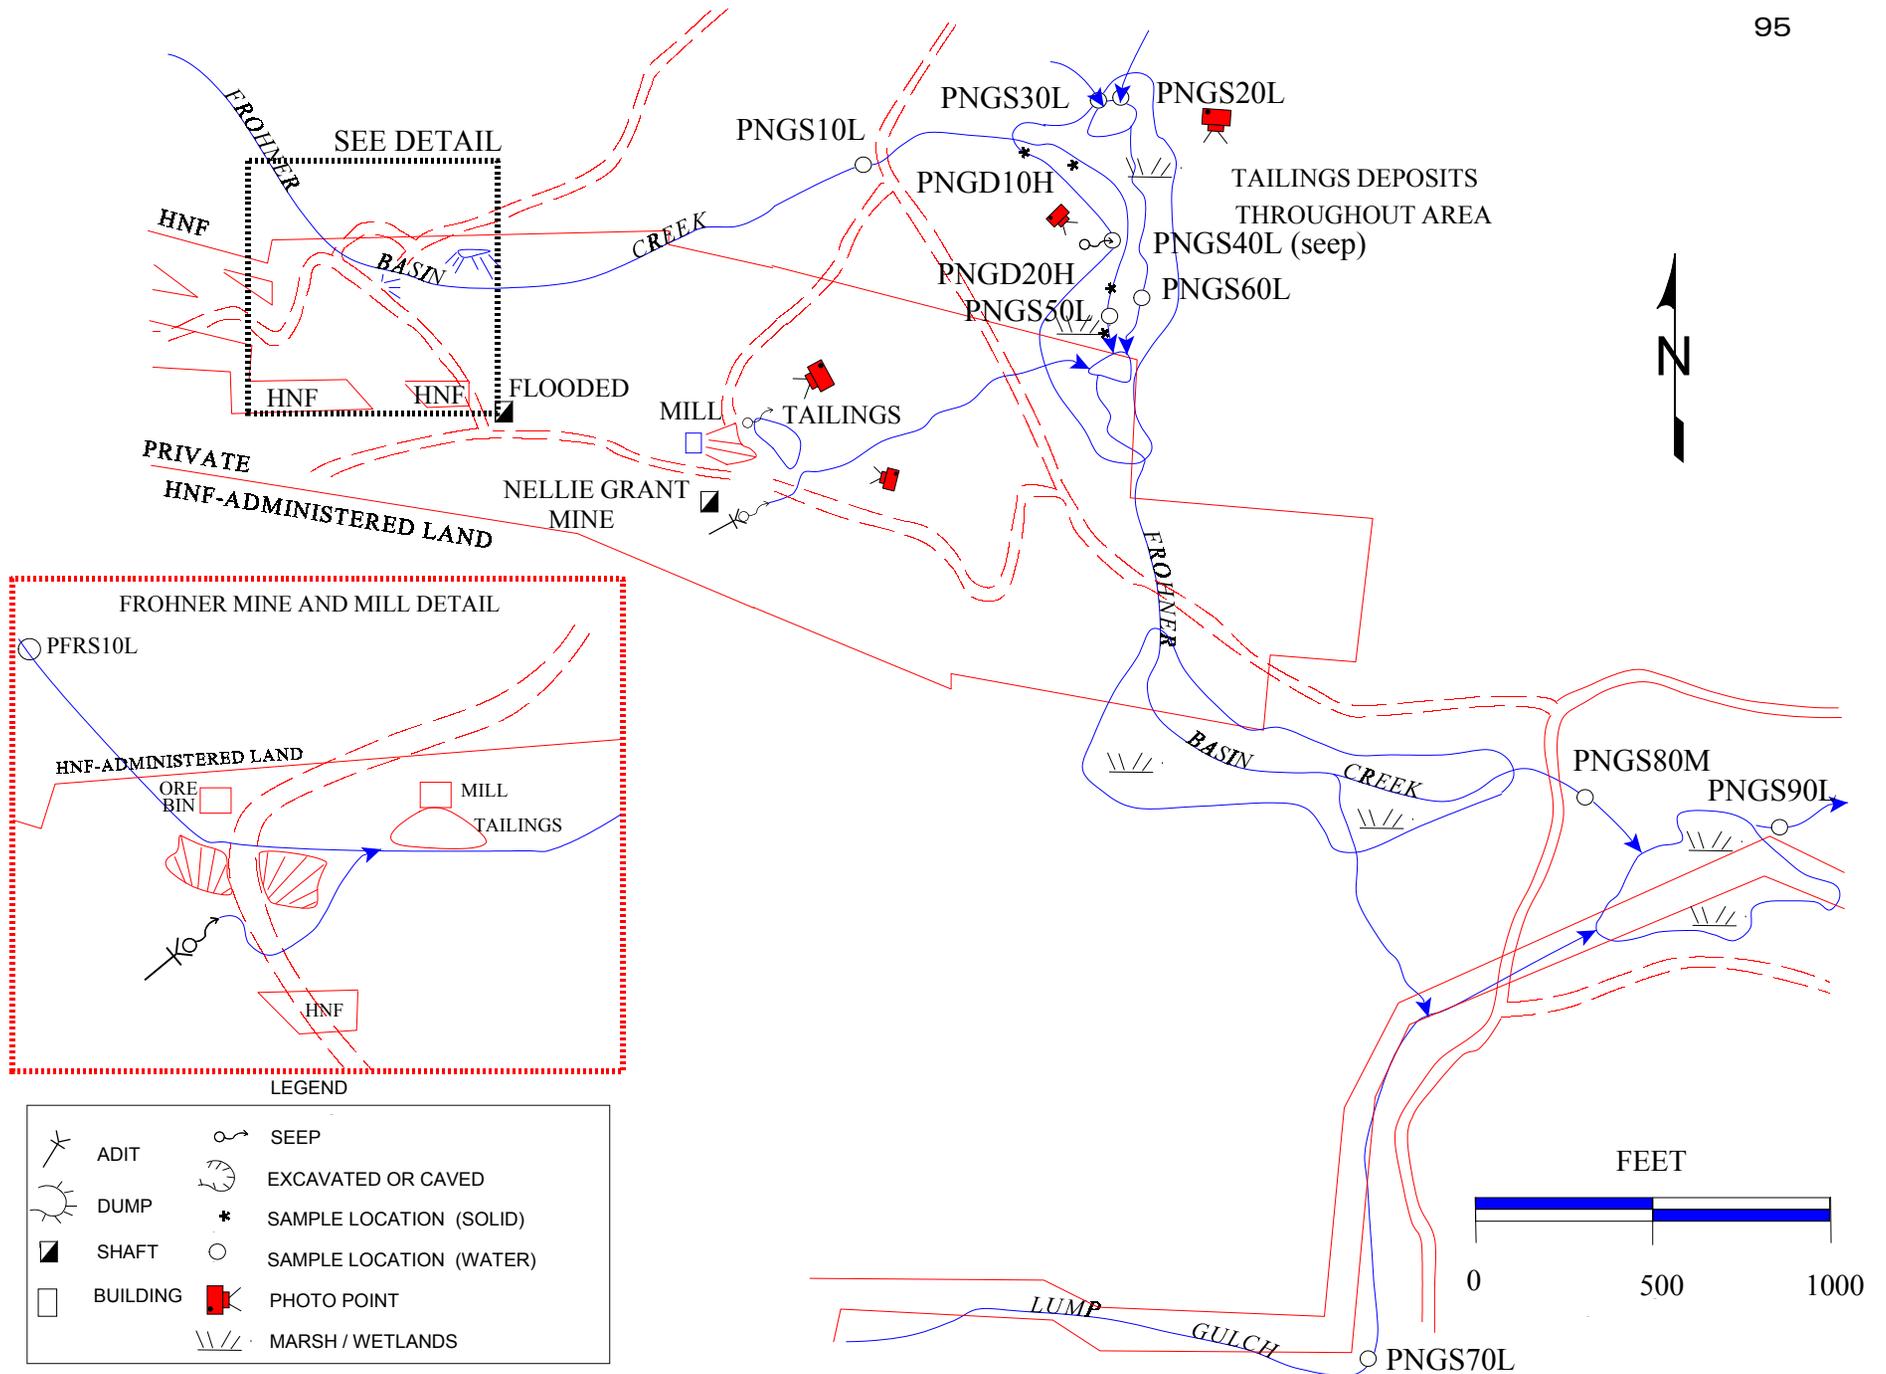
Figure16. The Frohner mine/mill and the Nellie Grant mine are on private land (10/15/93). Samples were collected on HNF-administered land.

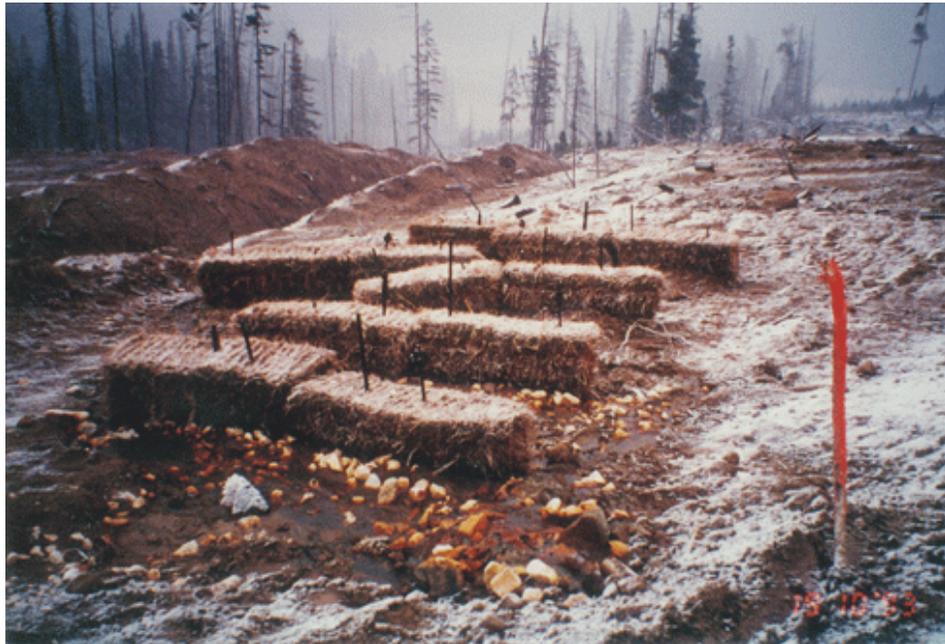
Figure 16a. Reclamation of the Nellie Grant mine included sediment control and adit discharge control.

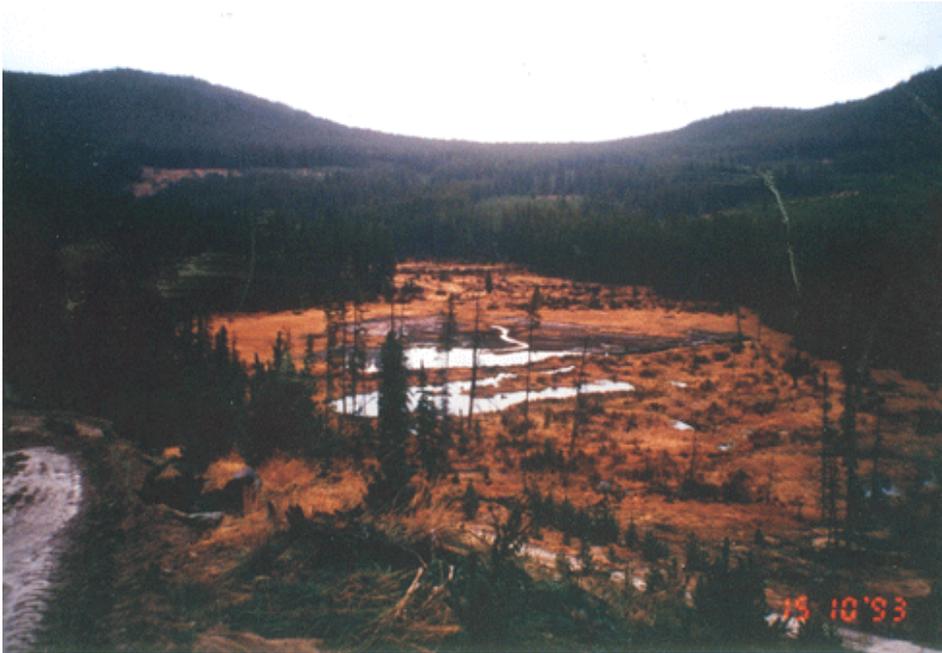
Figure 16c. Frohner Basin Meadows has been visibly impacted by sediment and poor quality water from upstream mines (right).

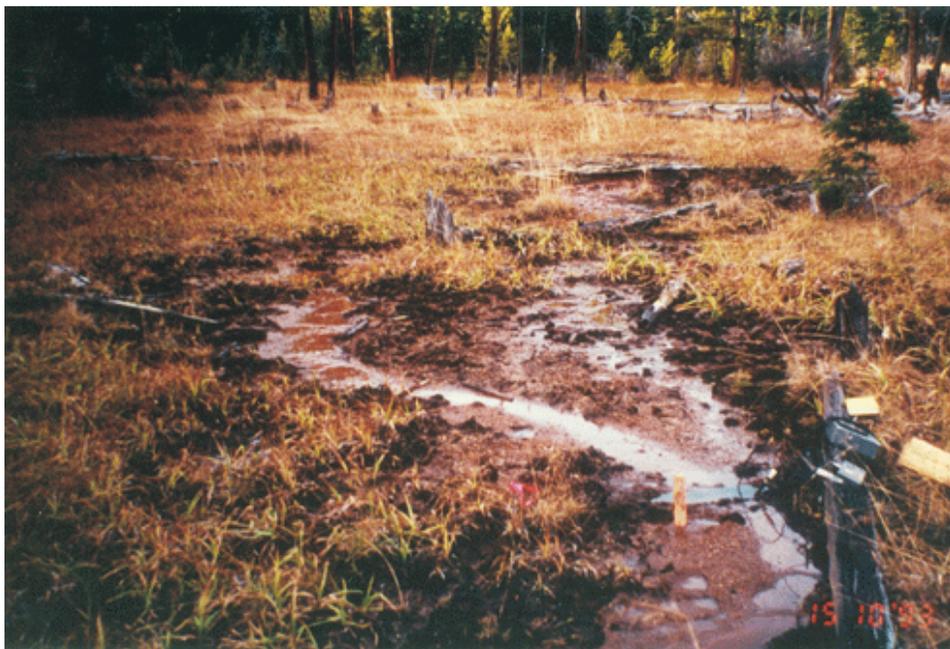
The high concentration of metals in the tailings/soils is well reflected in the water quality and exceedences of MCLs and ALSs throughout Frohner basin (table 23). Of particular note is the seep flowing into the wetlands (PNGS40L). This seep probably represents ground-water conditions in much of the wetlands. The field-Eh at this location was much lower than those measured at other sample sites and suggested reducing conditions. The reducing nature of the water from the seep is further evidence by a relatively low sulfate concentration. The poor quality of the water downstream of the wetlands indicates the limitations of the wetlands to ameliorate the metals loading to Frohner Basin Creek.

Figure 16d. Metals-laden seeps in Frohner Basin Meadows were flowing into the creek.

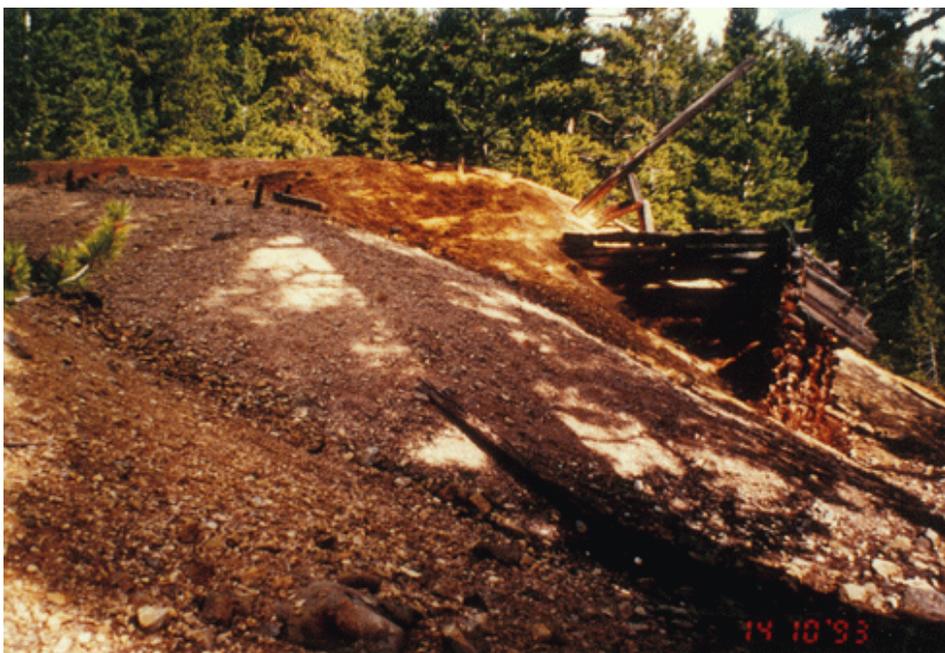
Figure 17a. The Yama Group mine waste-rock dump was on private land adjacent to Lump Gulch above the Park Lake Campground.

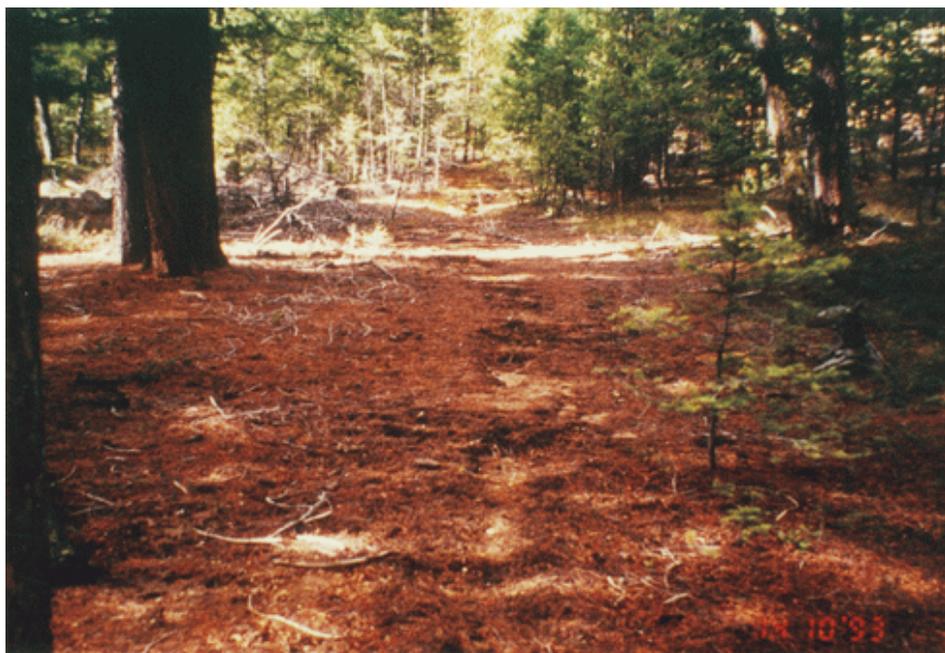
Figure 17b. The sediment path below the Yama Group mine extended from the base of the dump to Lump Gulch.

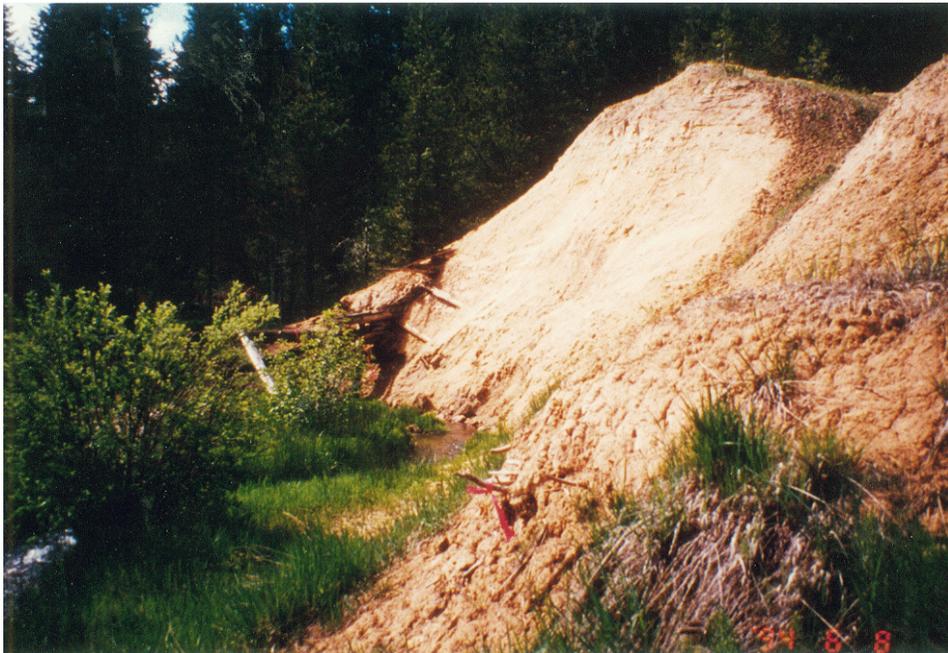
Figure 19a. The second tailings dam of the Warm Springs tailings was the largest. The dam had been breached by the stream.

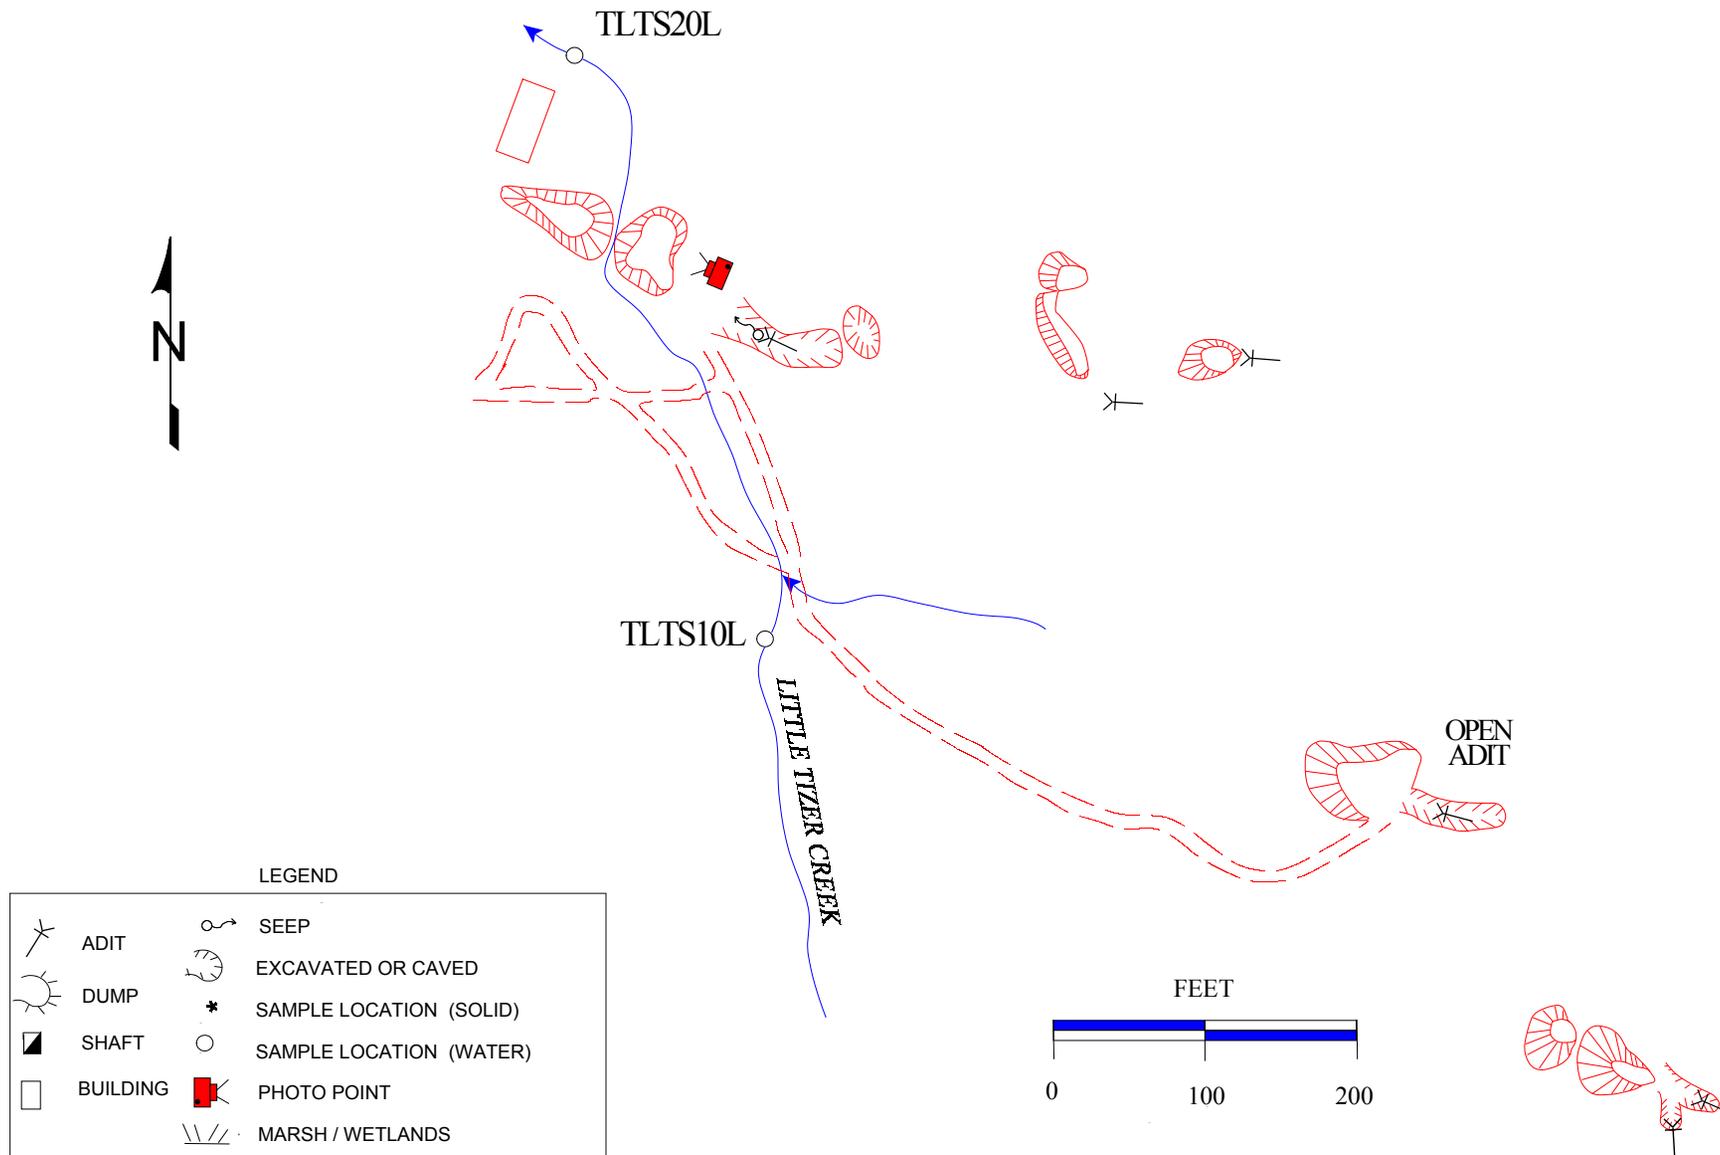
Figure 21. Little Tizer Wildcat mine (8/12/93) lies adjacent to Little Tizer Creek. The lower (north) adit was not discharging at the time samples were collected.

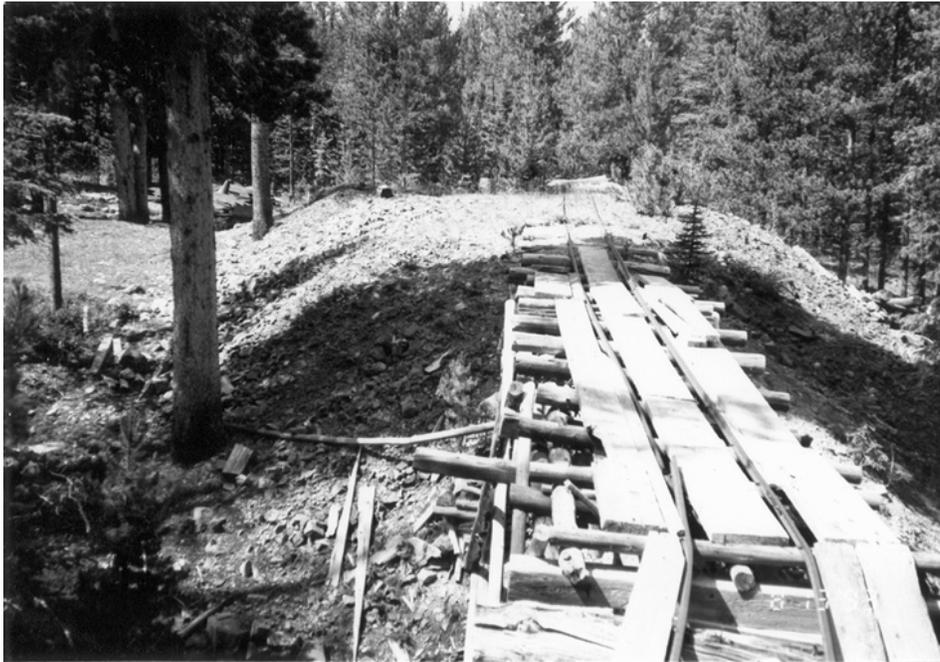
Figure 21a. The lower waste-rock dump of the Little Tizer Wildcat mine was deposited on both sides of Little Tizer Creek.
