**Montana Bureau of Mines and Geology
Abandoned-Inactive Mines
Helena National Forest**

**Volume I
Upper Missouri River Drainage**

MBMG 352

**Prepared for the U.S. Department of Agriculture
Forest Service -Region 1**

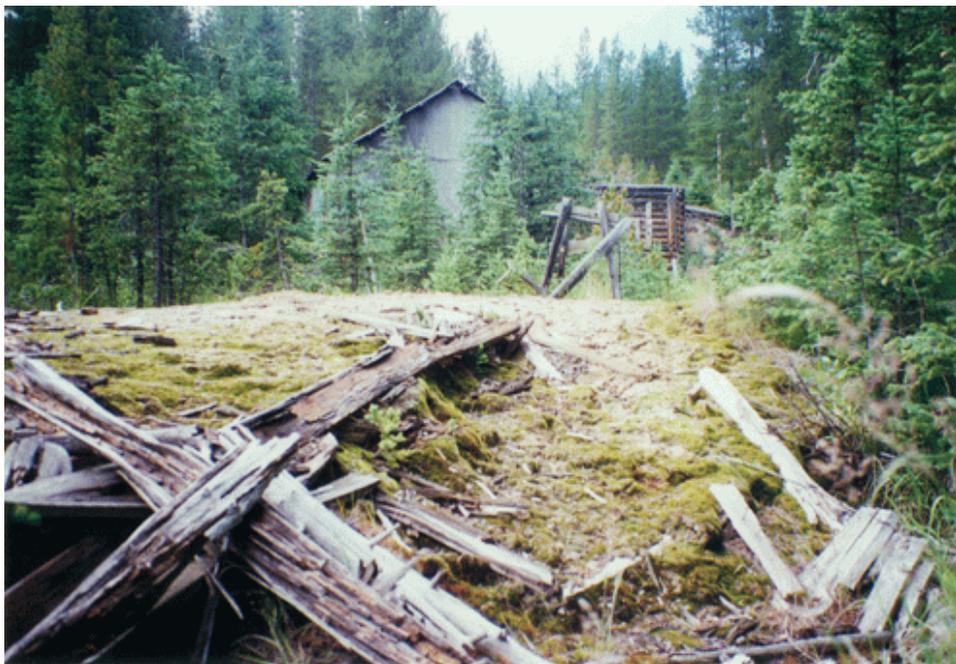
Figure 22b. The tailings impoundment of the Golden Age mill were adjacent to Wilson Creek. The mill and ore bin are in the background.

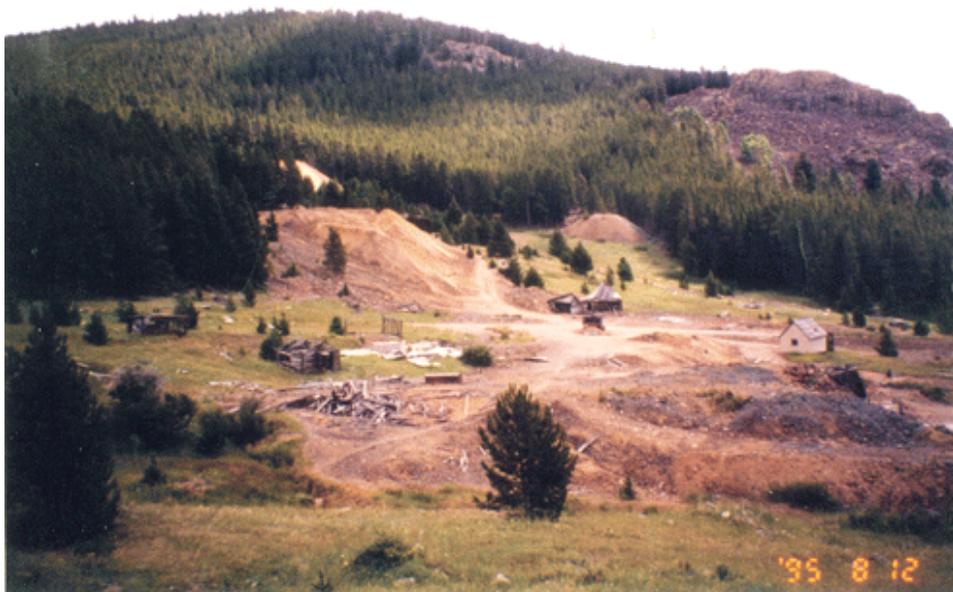
Figure 23a. The Park–New Era Group covered approximately 150–200 acres of privately owned land.

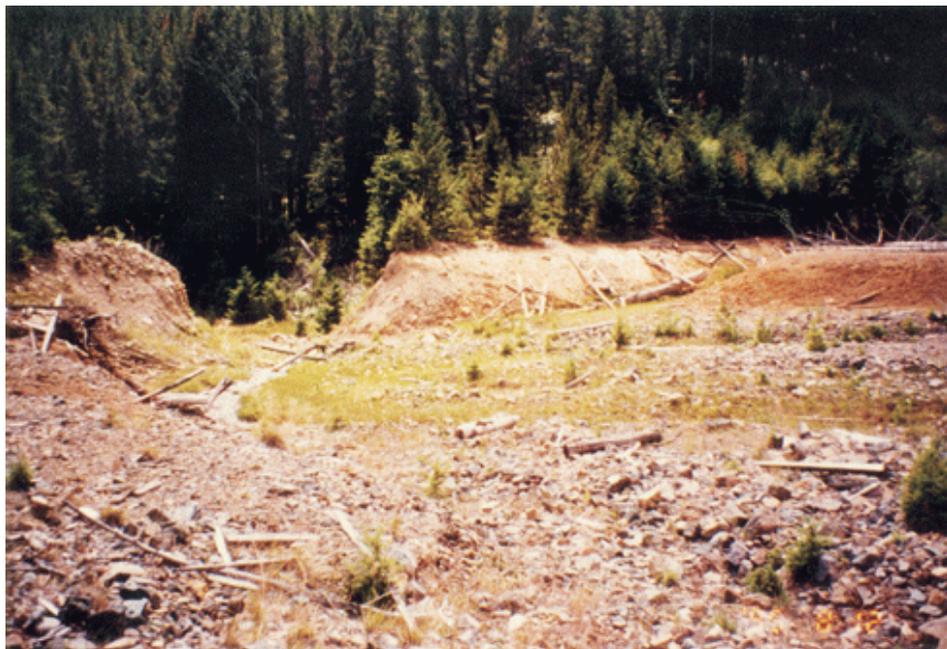
A large tailings impoundment had been breached, and waste material had washed down the Indian Creek drainage for many miles. Close to the impoundment, the streamside tailings deposits were generally several inches to several feet thick. Proceeding downstream, the deposits became thinner and discontinuous. At several locations, iron-stained seeps flowed from the tailings into the creek.

Figure 24a. The breached tailings impoundment had eroded and mixed with soils. A soil sample (IMPD10H) was collected from the impoundment.

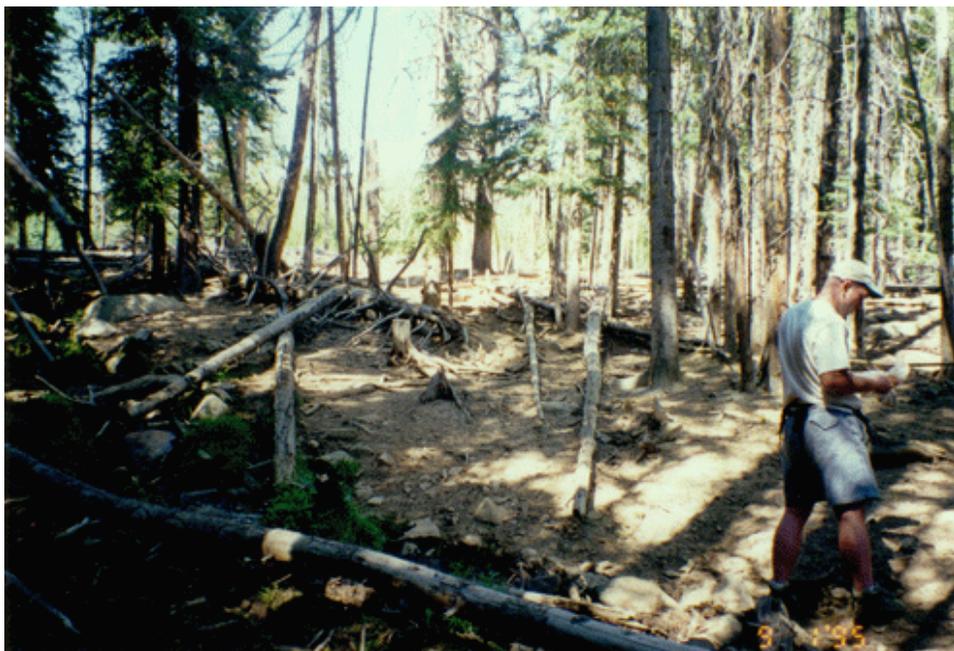
Figure 25a. The understory vegetation at Kleinschmidt has been affected by tailings washing down through the forest.

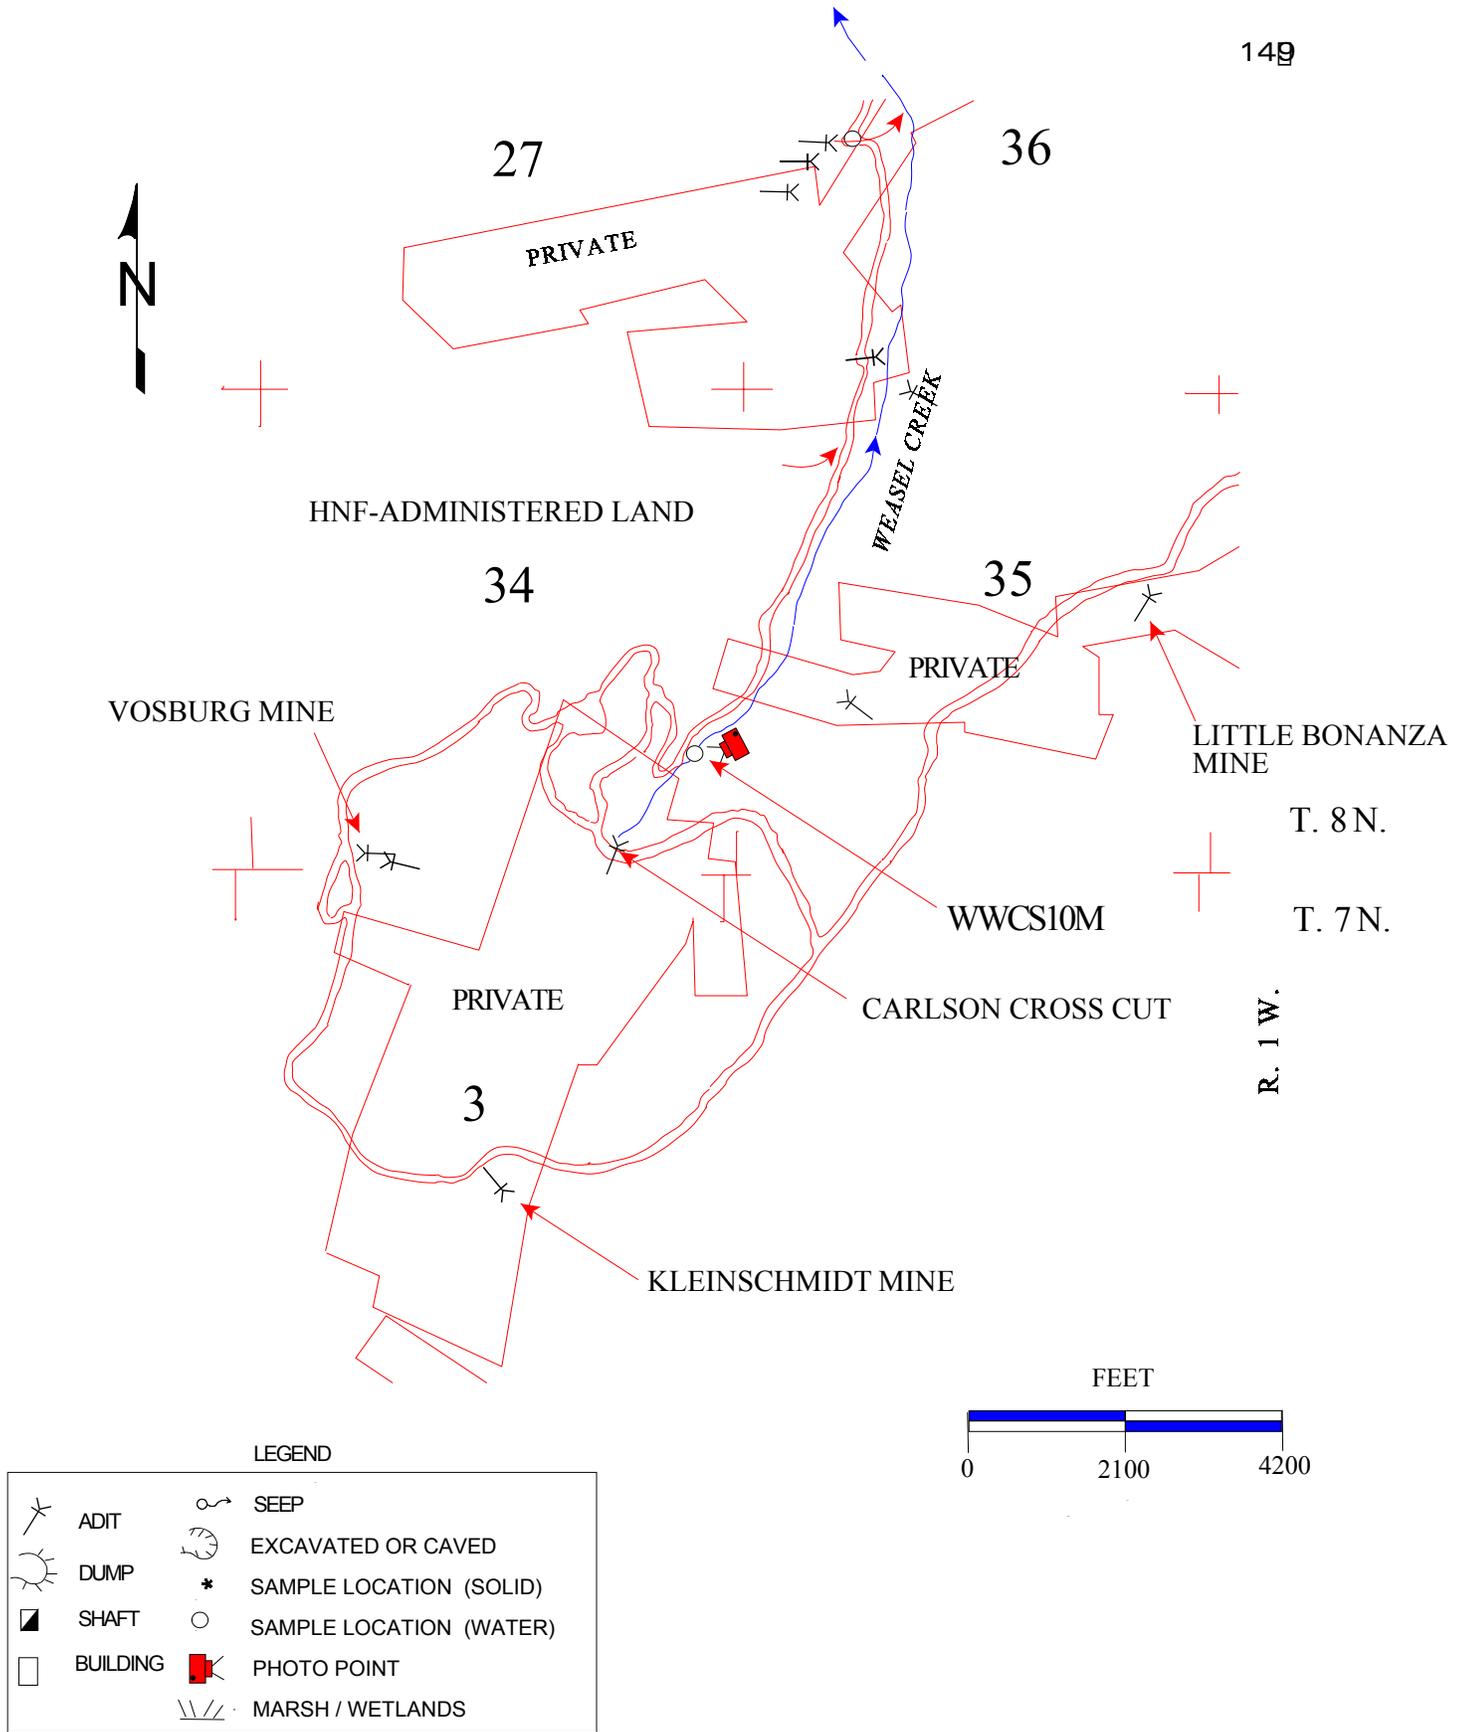
Figure 27. The area along Weasel Creek (8/30/95) has been previously mined. A sample was collected from the creek below the Vosburg mine and mill, the Kleinschmidt mine and mill, and the Carlson Crosscut.

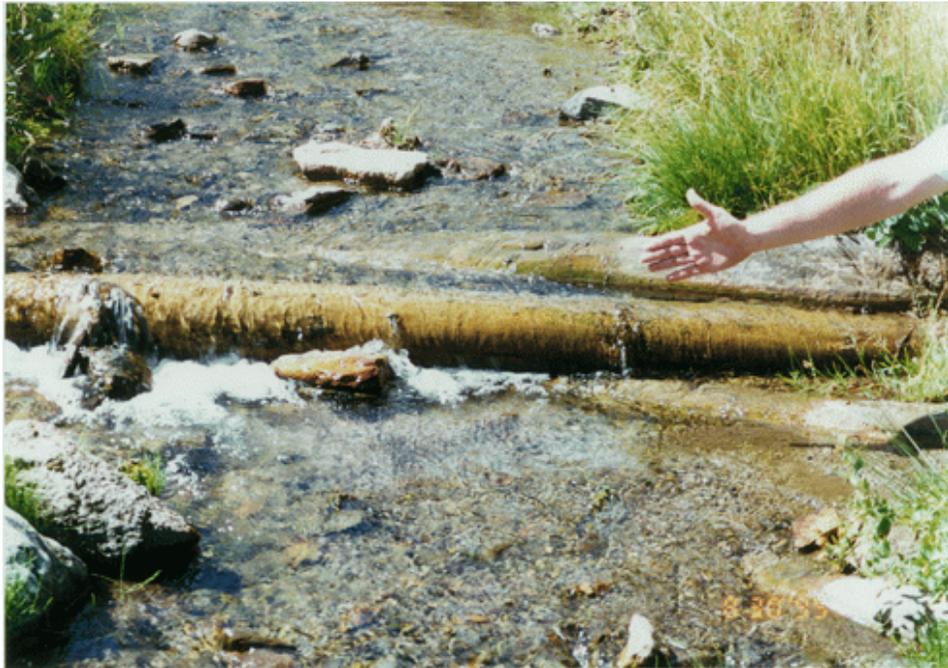
Figure 27a. A surface-water sample (WWCS10M) was collected from Weasel Creek on HNF-administered land below several mines on private land.

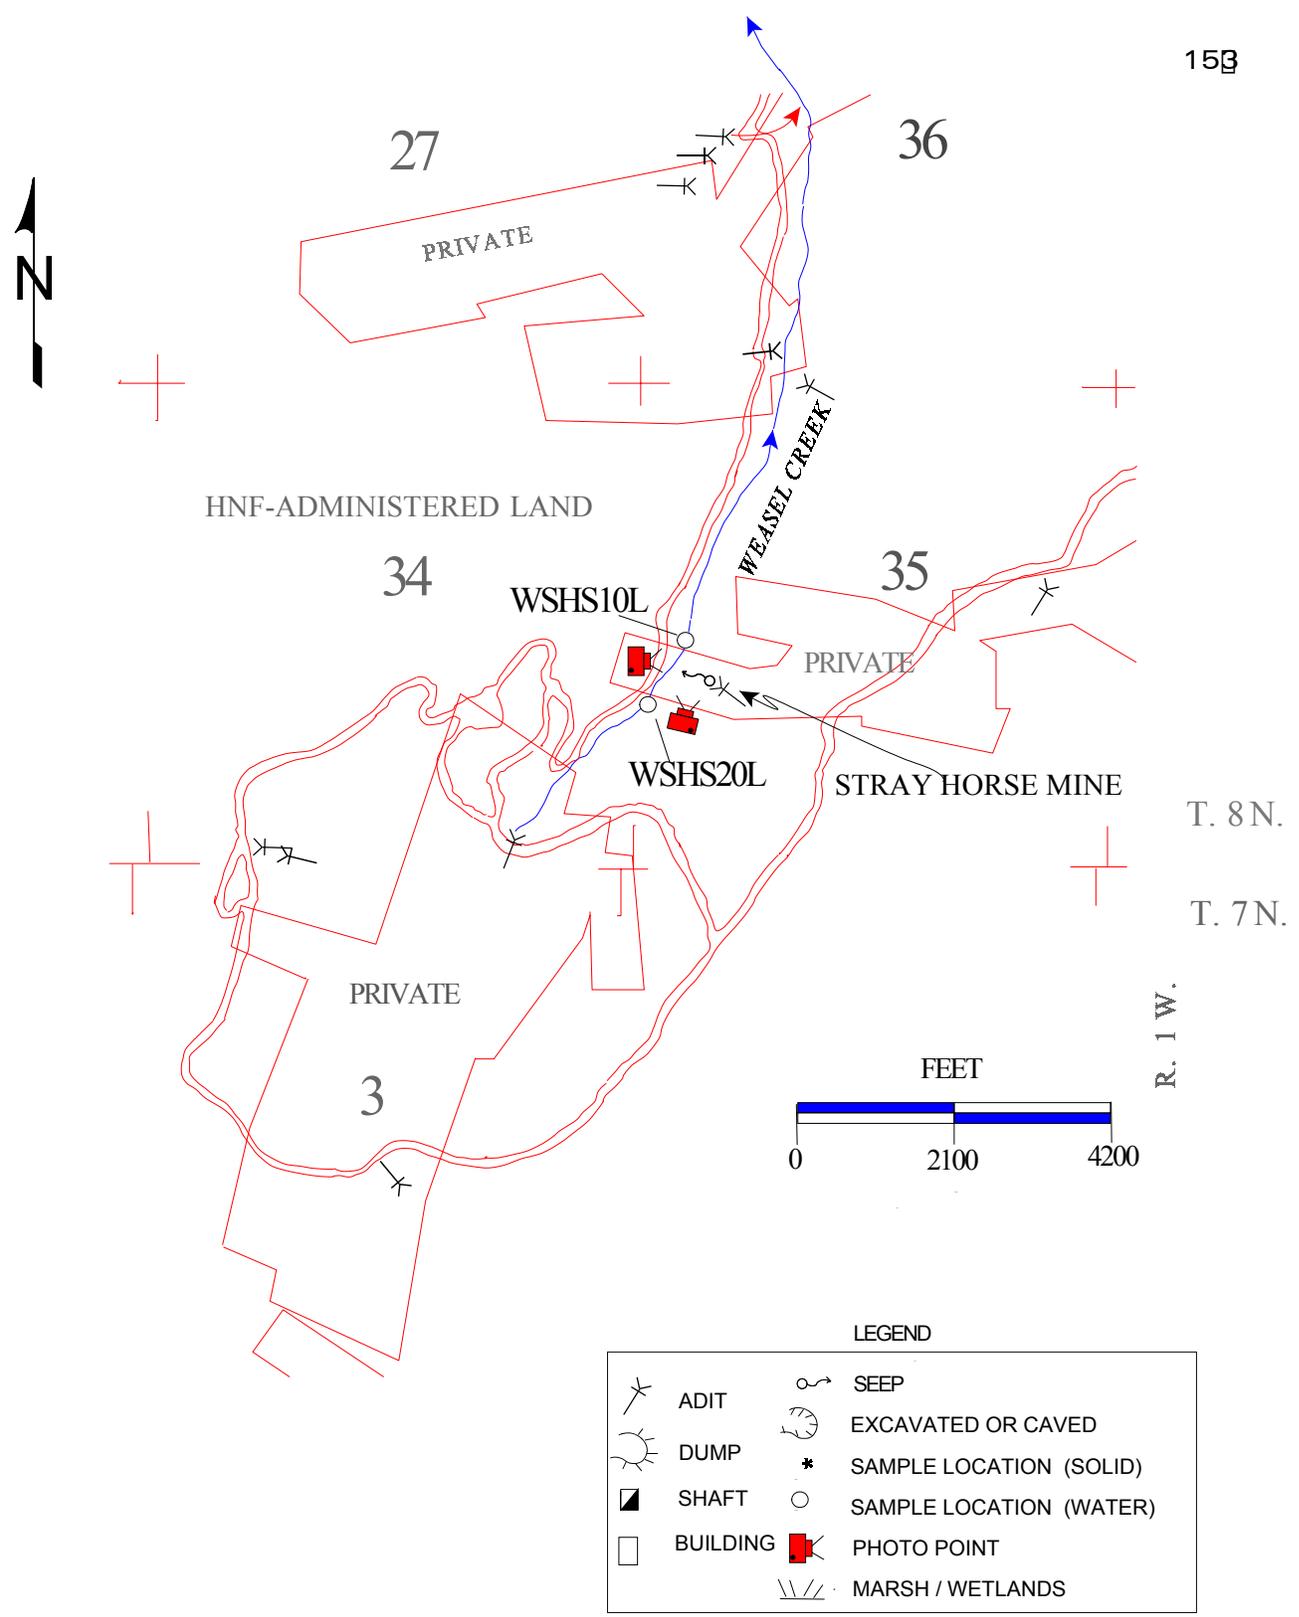
Figure 28. Surface-water samples were collected upstream and downstream of the Stray Horse mine (8/28/95). The boundaries shown are based on 7.5-min. USFS ownership maps.

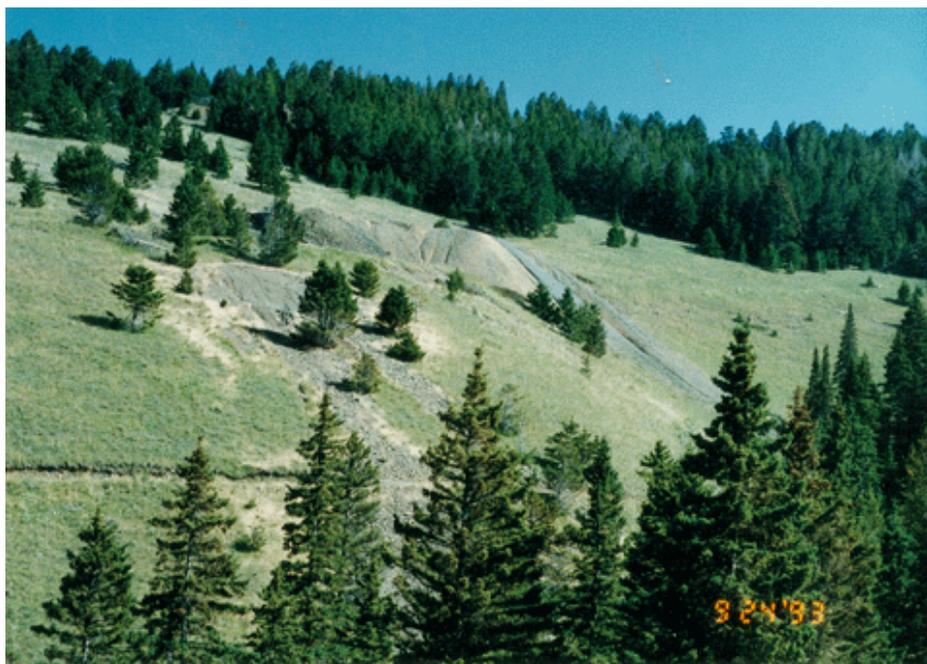
Figure 28a. The upper waste-rock dumps of the Stray Horse mine are well above the flood plain of Weasel Creek.

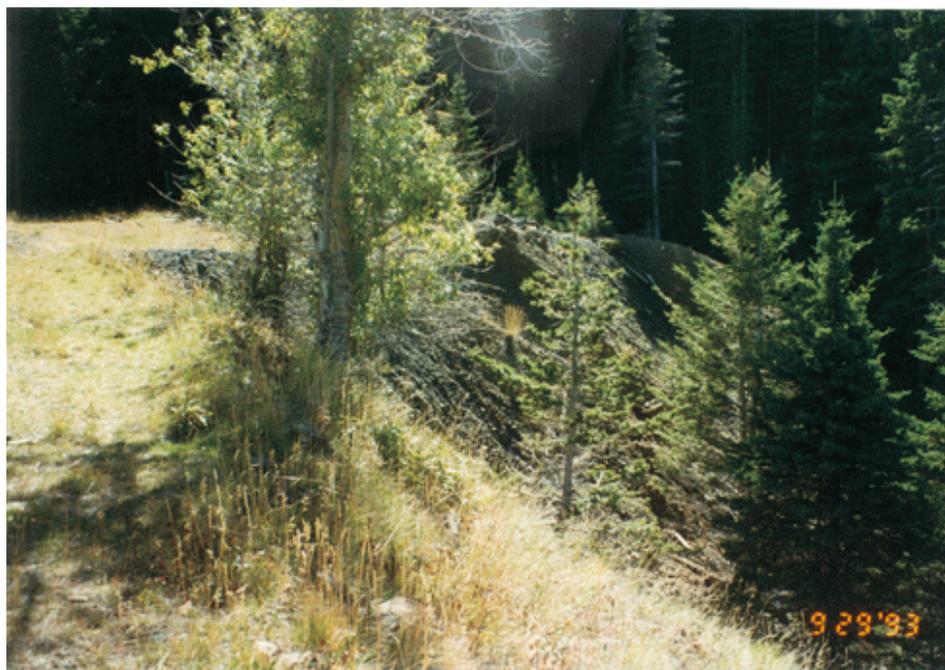
Figure 28b. The lower waste-rock dump at the Stray Horse mine is adjacent to Weasel Creek.

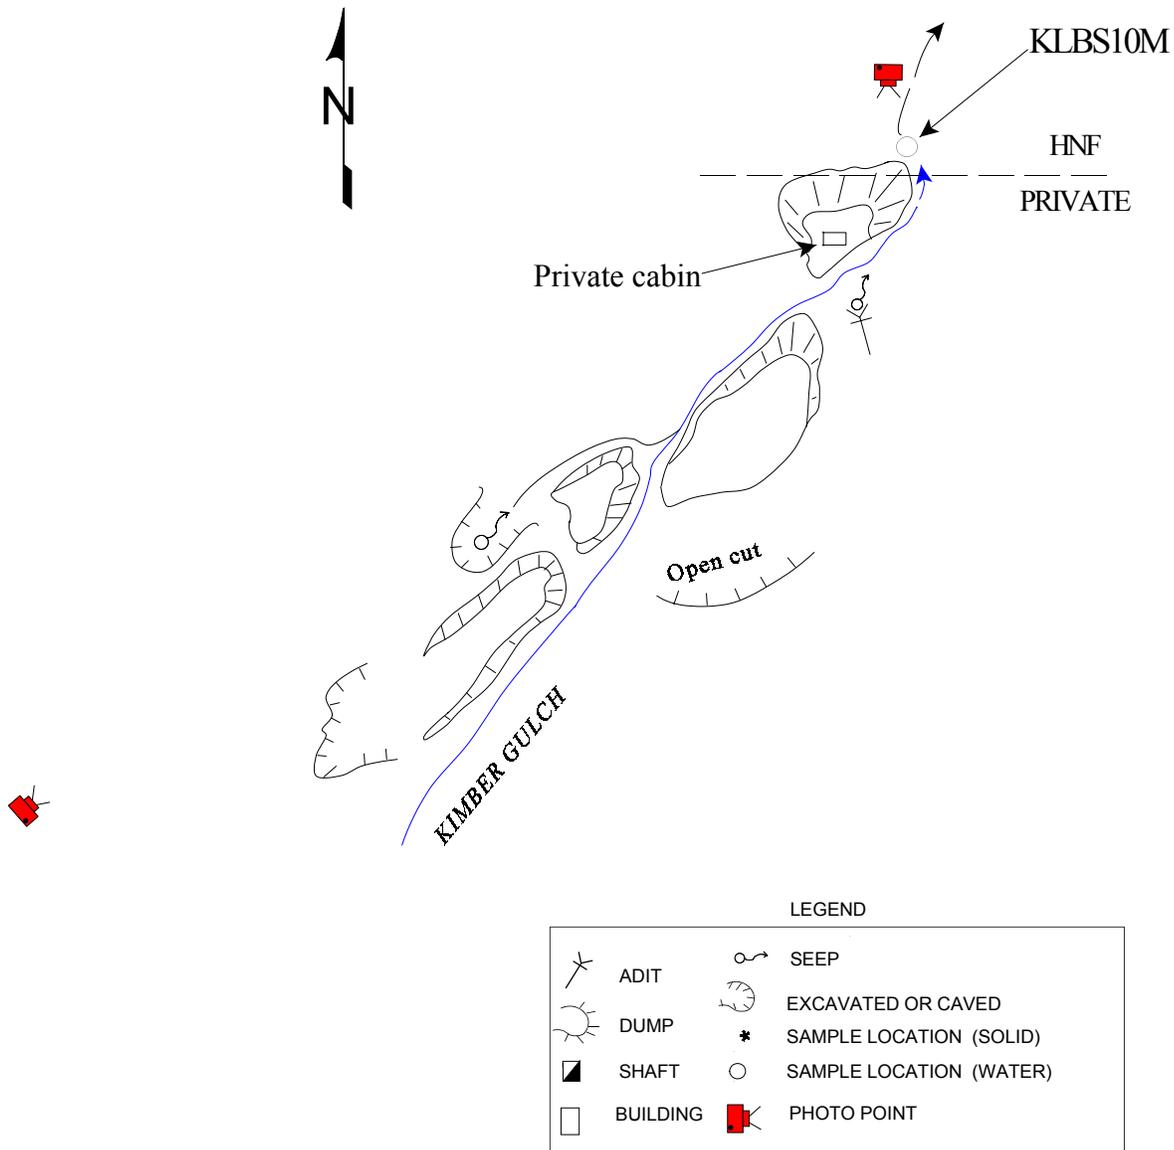
Figure 29. The Little Bonanza mine's discharges and waste dump were adjacent to HNF-administered land (9/18/93). A sample of Kimber Gulch was collected downstream.

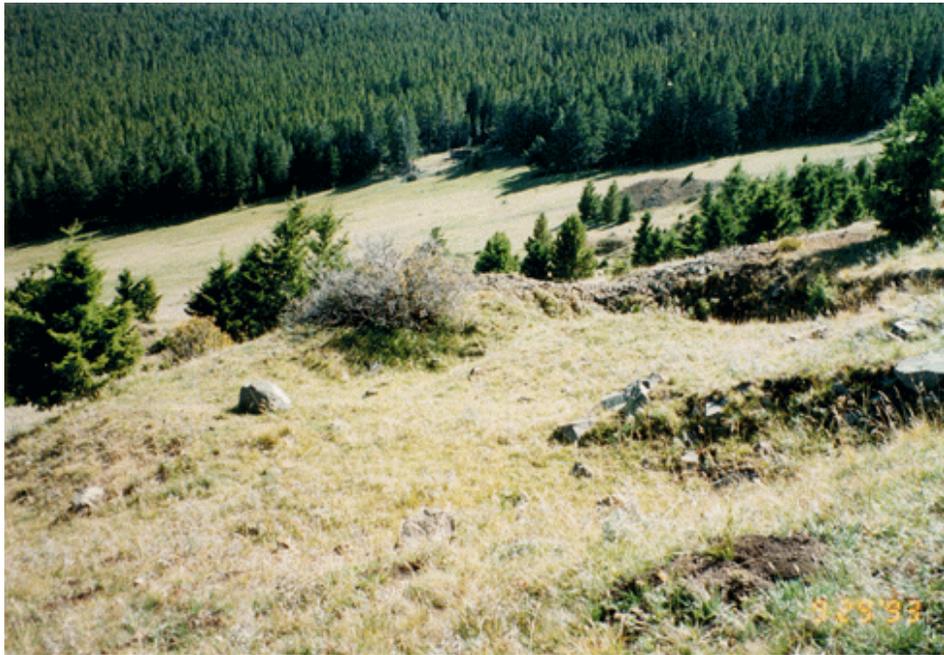
Figure 29a. The Little Bonanza mine lies mostly on private land in Kimber Gulch.

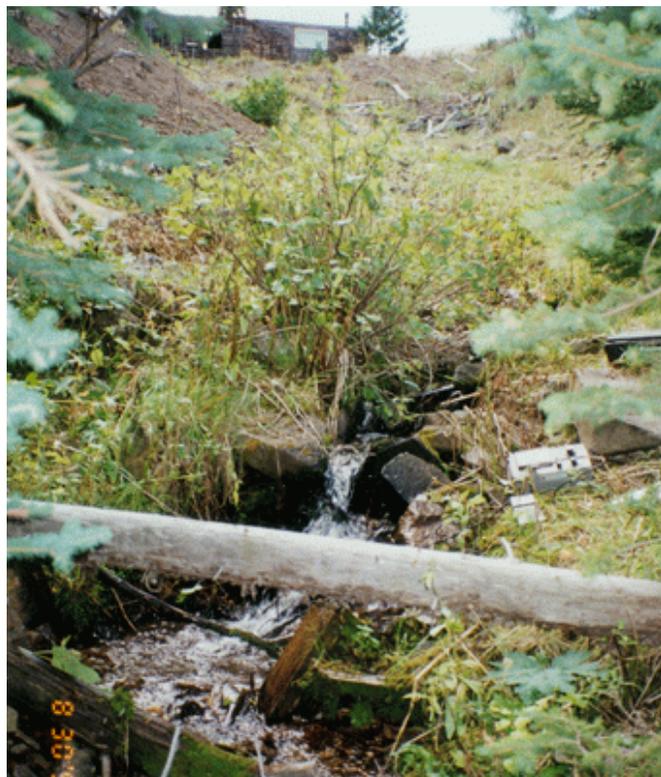
Figure 29b. A surface-water sample was collected from Kimber Gulch below the Little Bonanza mine on HNF-administered land.

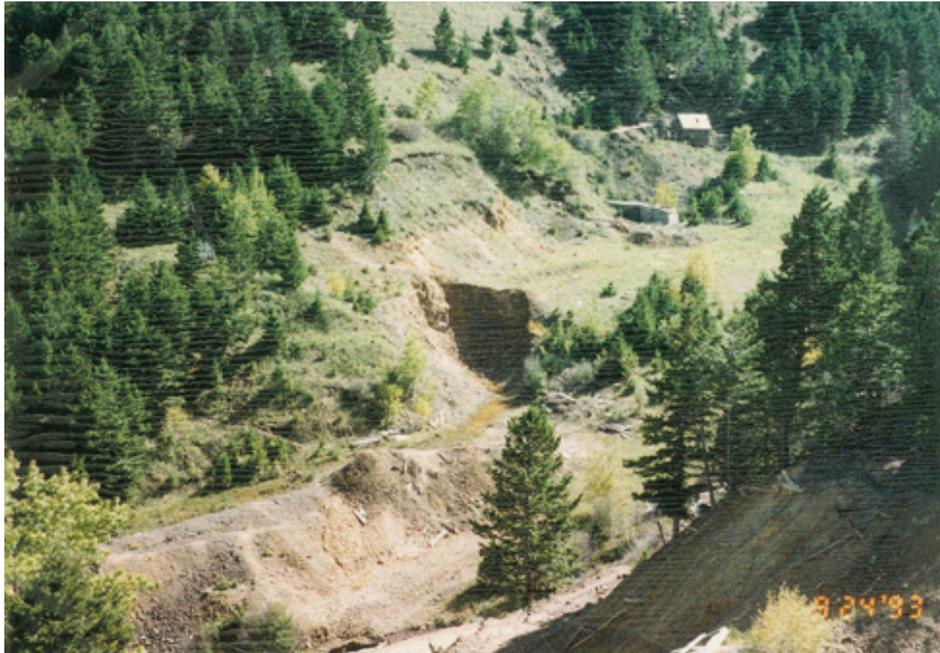
Figure 30a. Water from the caved adit and waste-rock dump at the Sunrise mine flowed to the north and joined Weasel Creek on private property.

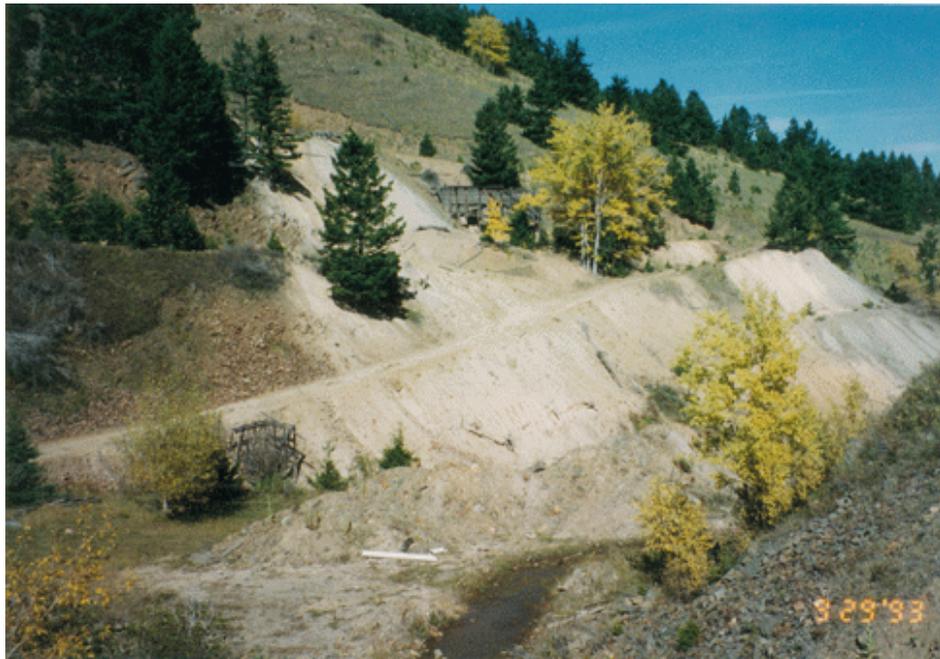
Figure 30b. The waste-rock dump of the January mine is across Weasel Creek from the Sunrise mine. Adit discharge from the Sunrise mine is shown in the bottom of the photograph.

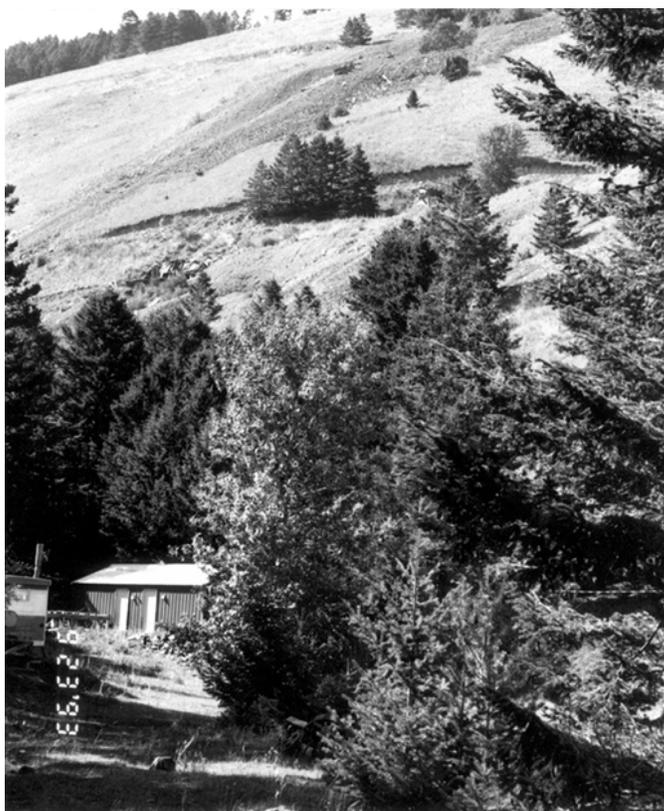
Figure 31b. The upper workings at the East Pacific mine and mill are on a steep hillside. Springs emerged at several points within the disturbed area.

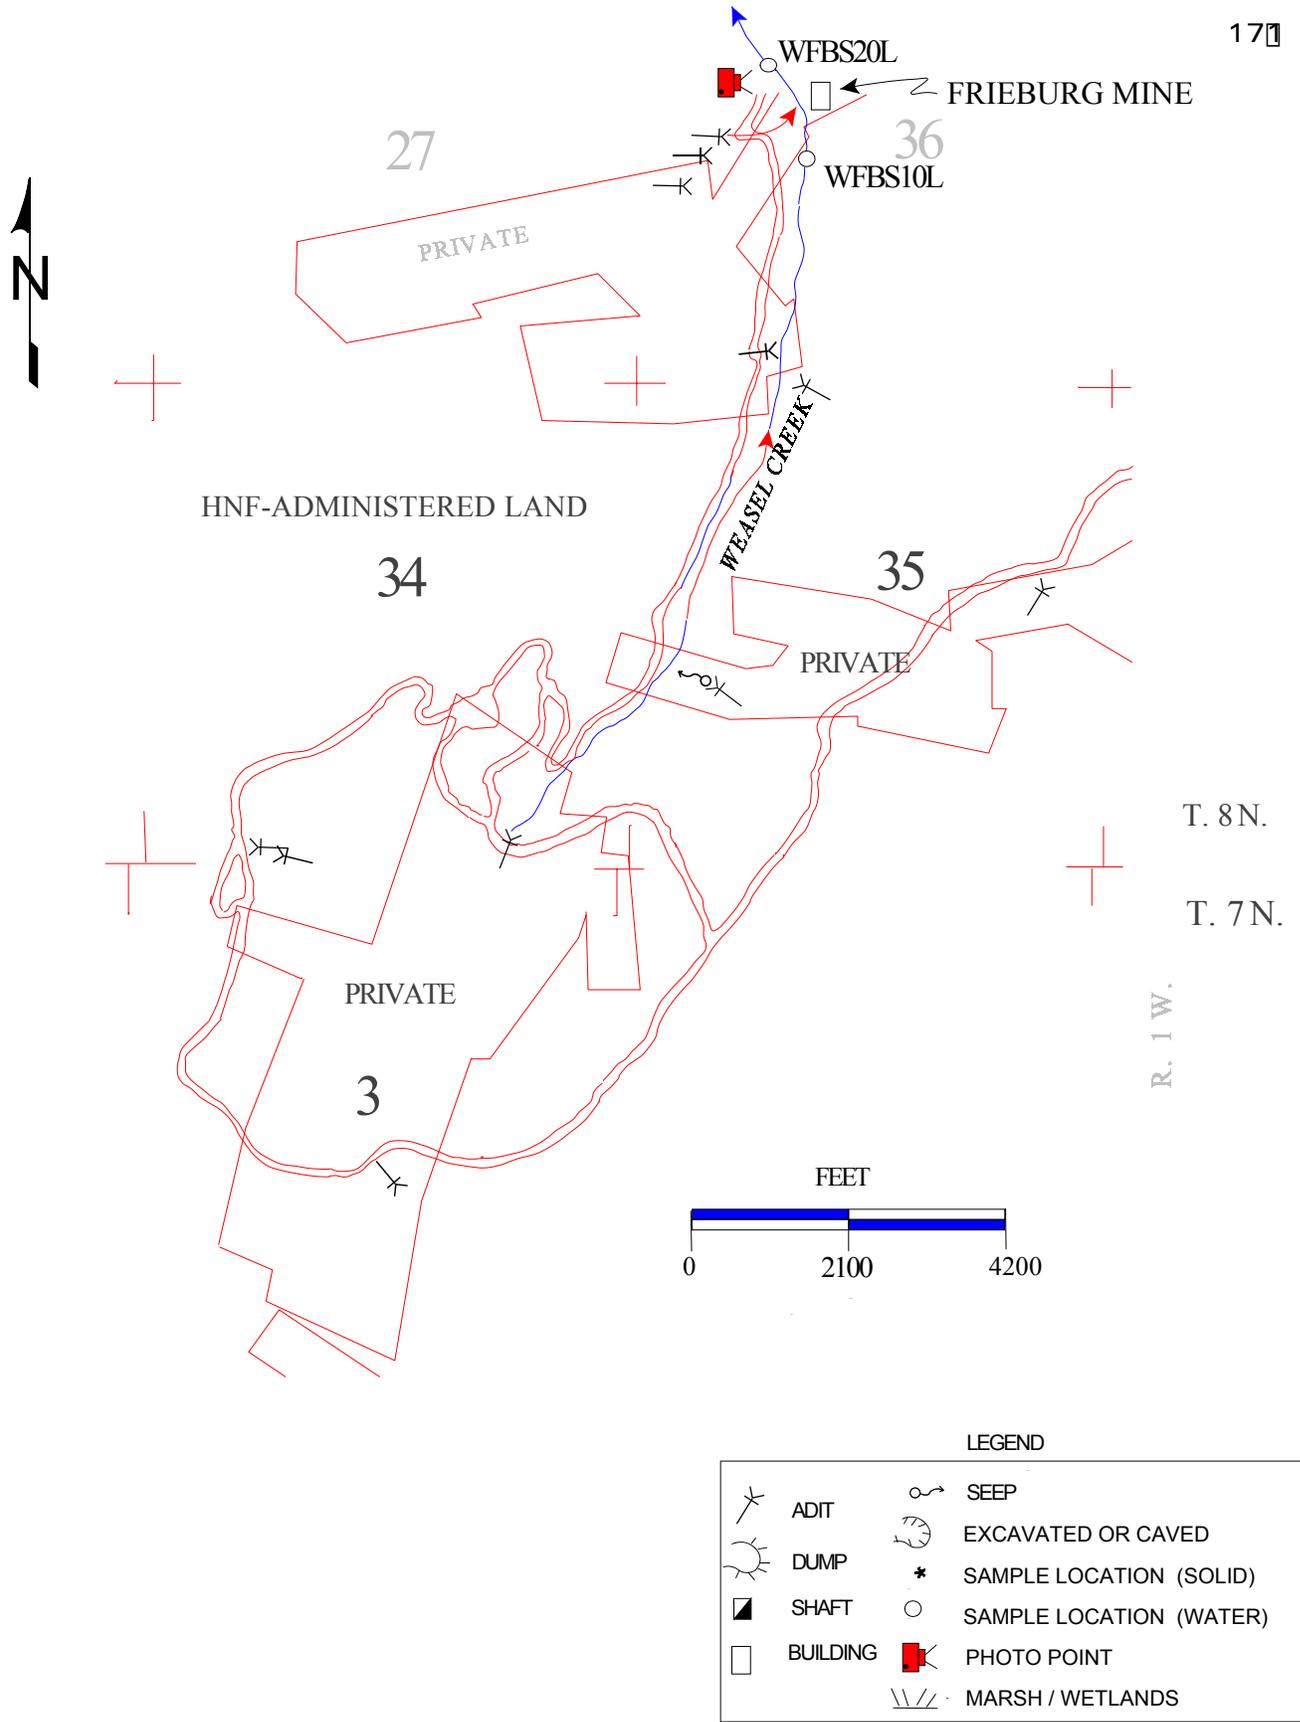
Figure 32. The Frieburg mine (8/28/95) is downstream of several other mines on Weasel Creek. Samples were collected upstream and downstream on HNF-administered land.

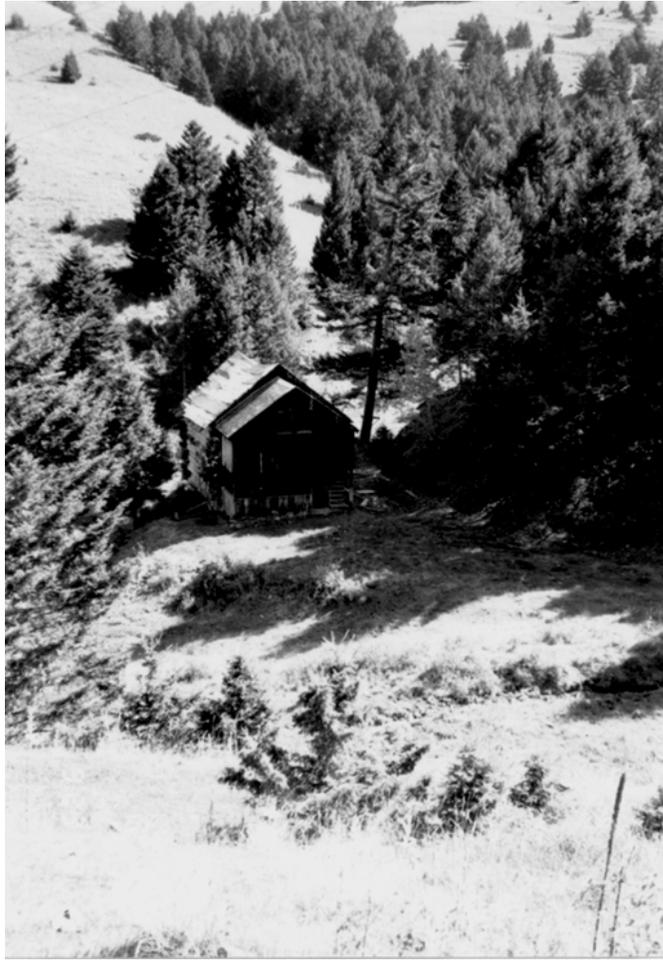
Figure 32a. The Freiburg mine site is on private land. Weasel Creek, which flowed onto HNF-administered land, is the foreground.

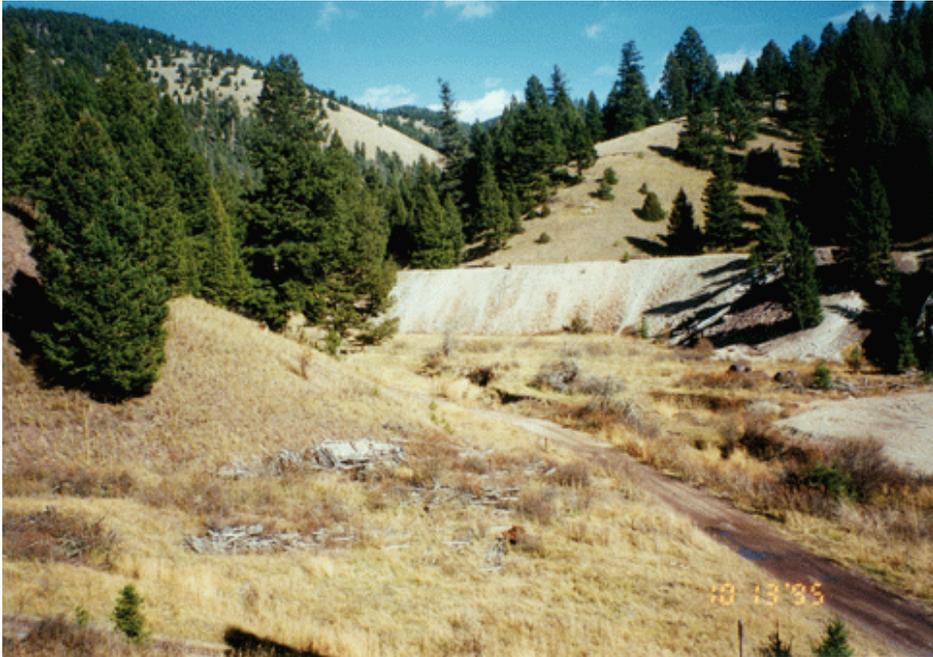
Figure 33a. The waste-rock dump of the Argo mine is on HNF-administered land in Hellgate Creek. The tailings are on private land (lower right of photo). Also pictured are flattened buildings on private land.

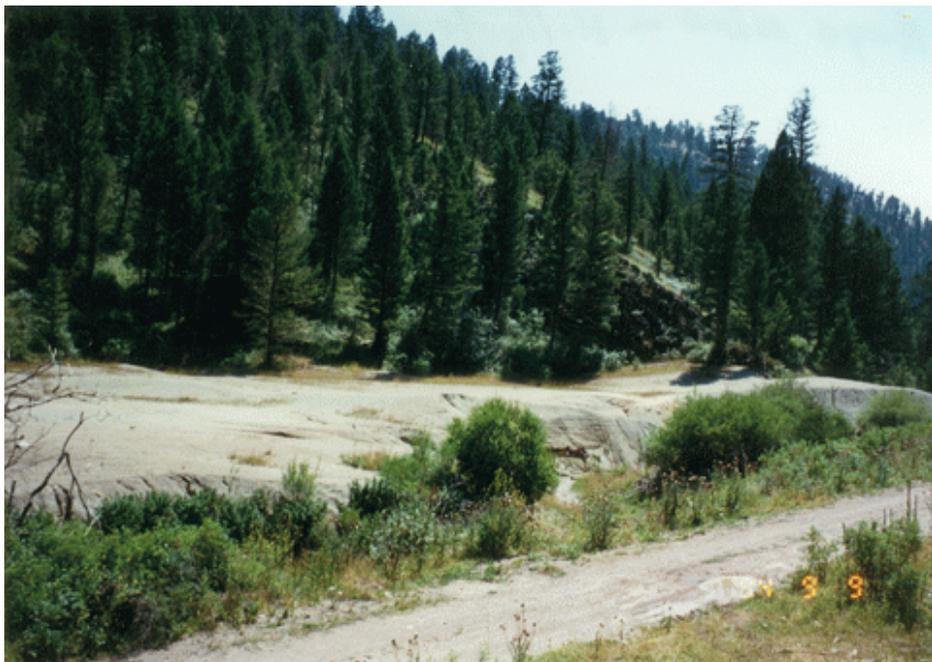
Figure 33b. The layered tailings on private land were being actively eroded by Hellgate Creek. The extent of the tailings is marked by sparse vegetation.

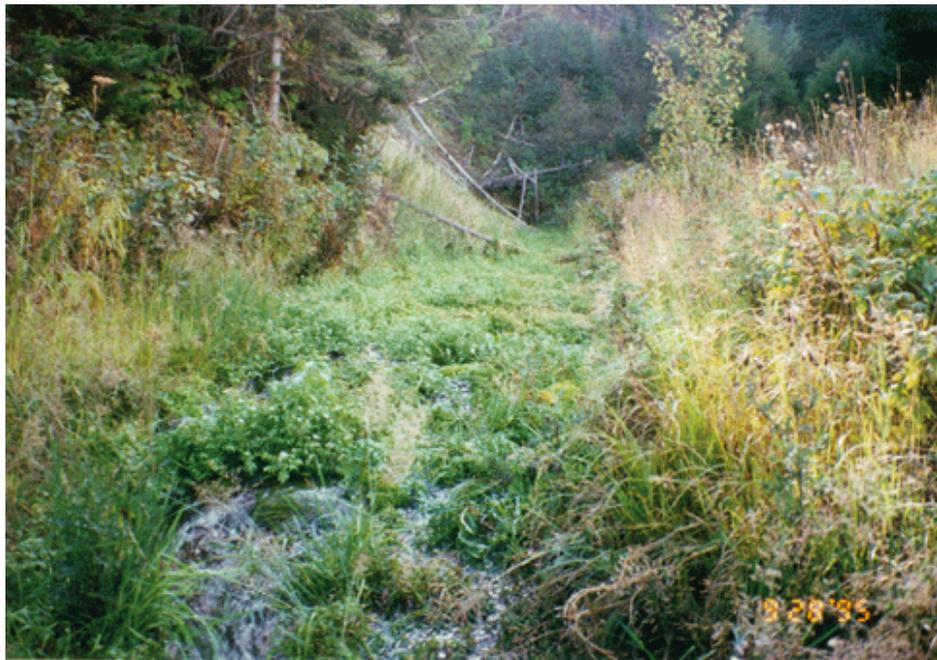
Figure 34b. Water plants were growing in the discharge from the tunnel (upper center of photo).

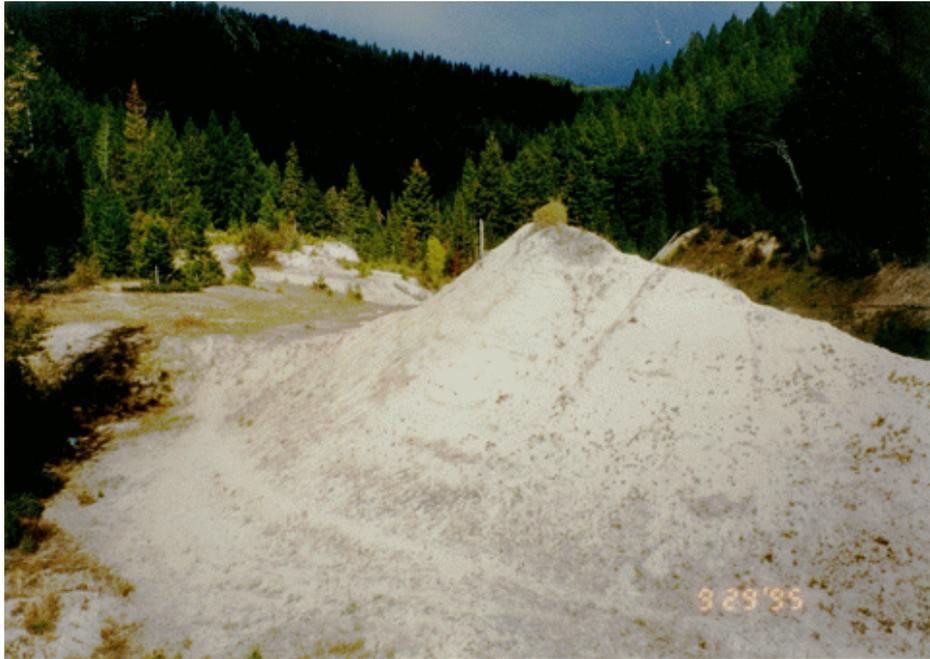
Figure 35a. Jay Gould tailings were deeply incised and generally barren to sparsely vegetated.

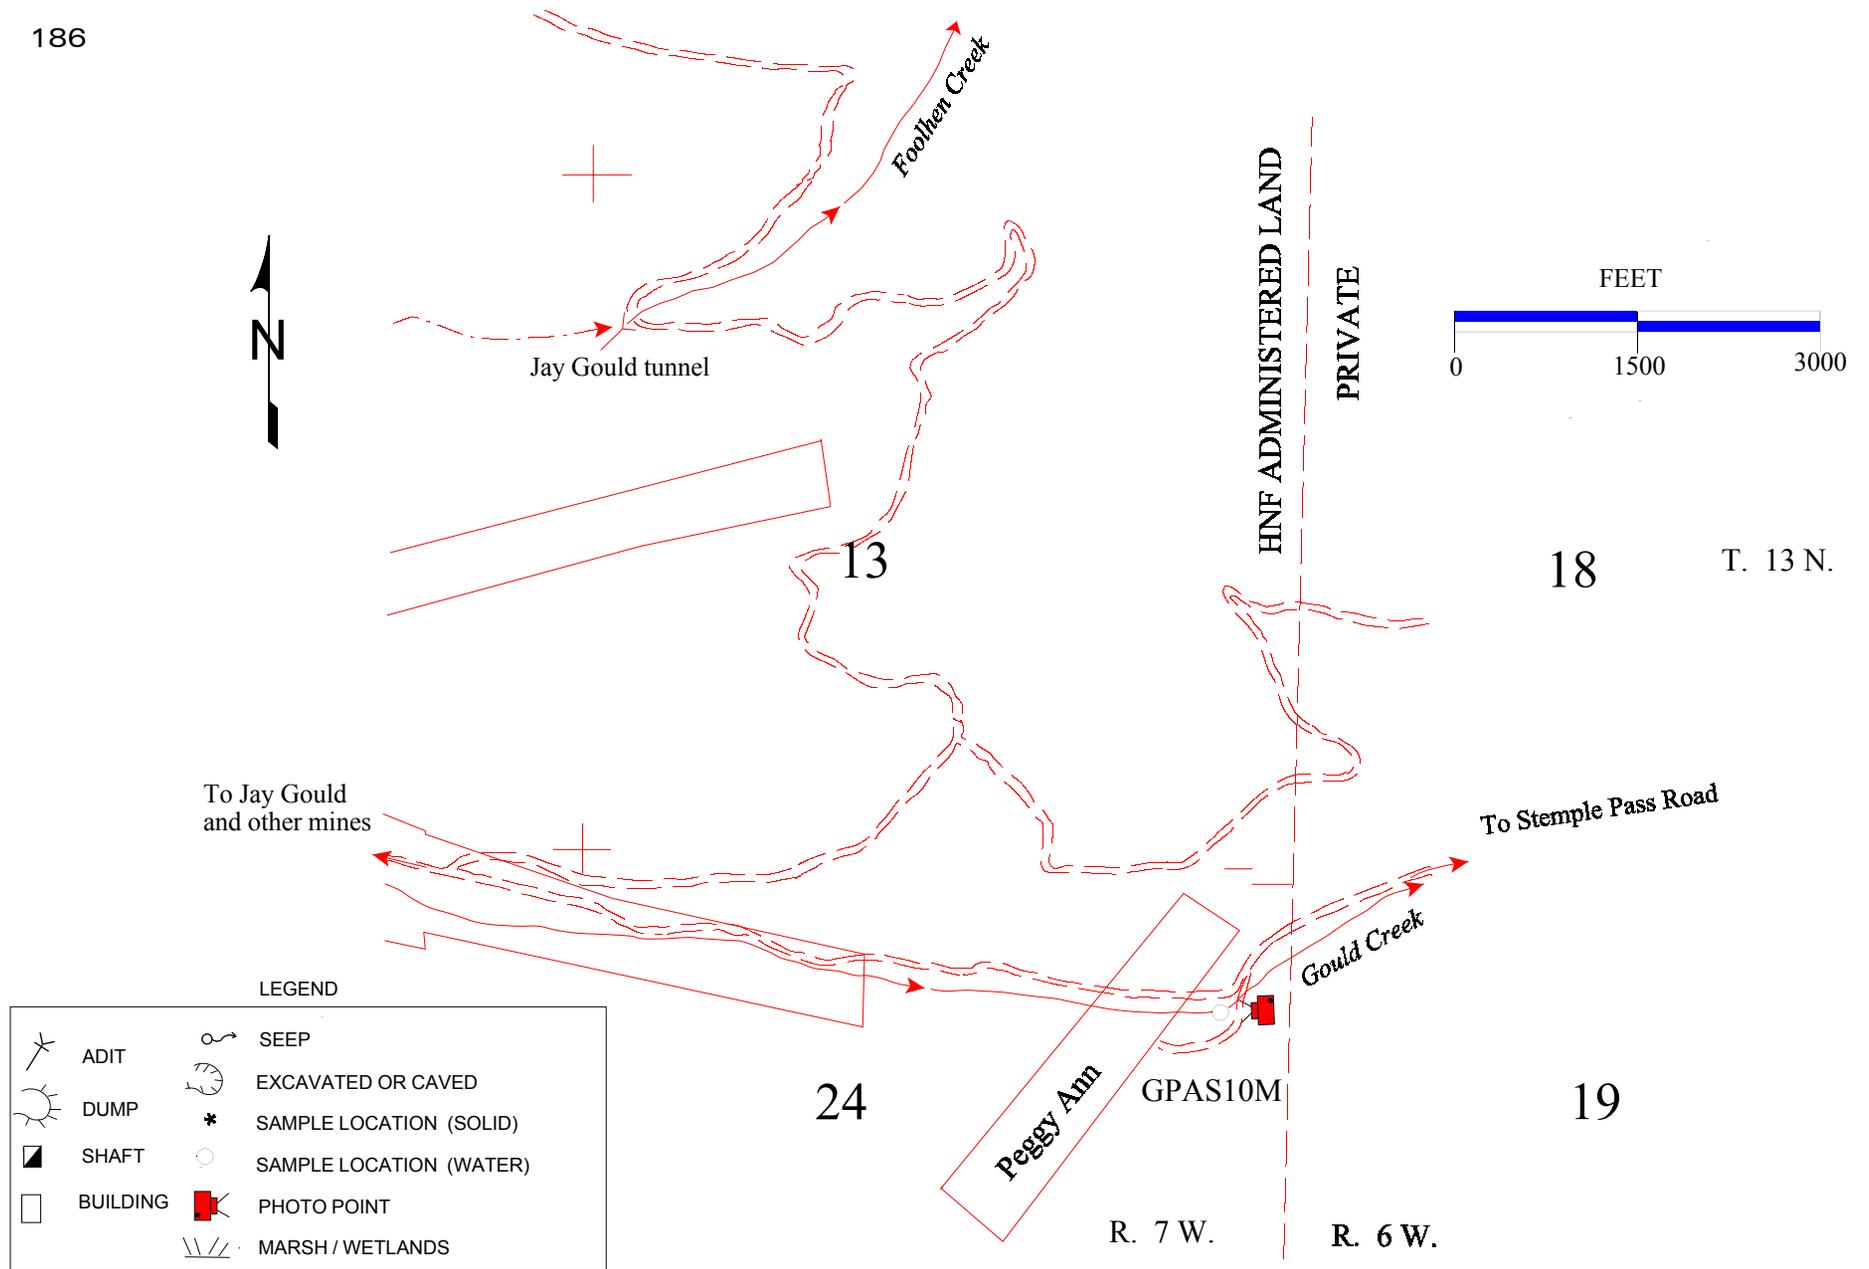
Figure 36. The area near the Peggy Ann mine in Gould Creek was mined intermittently from the 1880's to the 1970's. The boundaries shown are based on 7.5-minute USFS ownership maps.

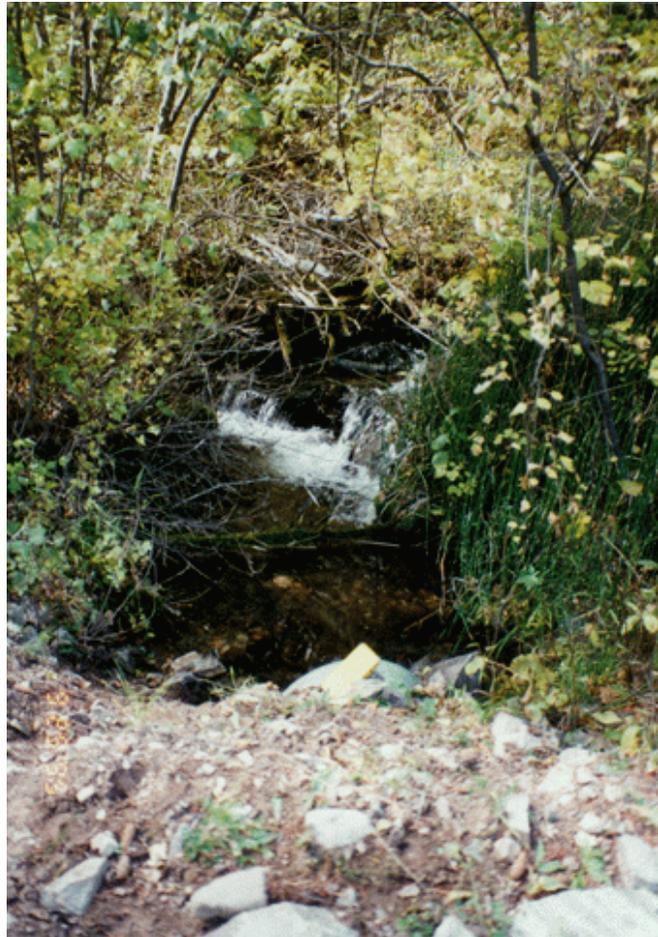
Figure 36a. A sample (GPAS10M) was collected from Gould Creek below the Gould and Peggy Ann mines.
