**HYDROGEOLOGIC ASSESSMENT OF THE INGOMAR WATER DISTRICT
WATER SUPPLY SYSTEM
FOR
GROUND WATER UNDER THE DIRECT INFLUENCE OF SURFACE WATER**

Open-File Report MBMG 401-K

**INGOMAR WATER DISTRICT
PWSID #03078
P. O. Box 65
Ingomar, MT 59039-0065**

April 2000

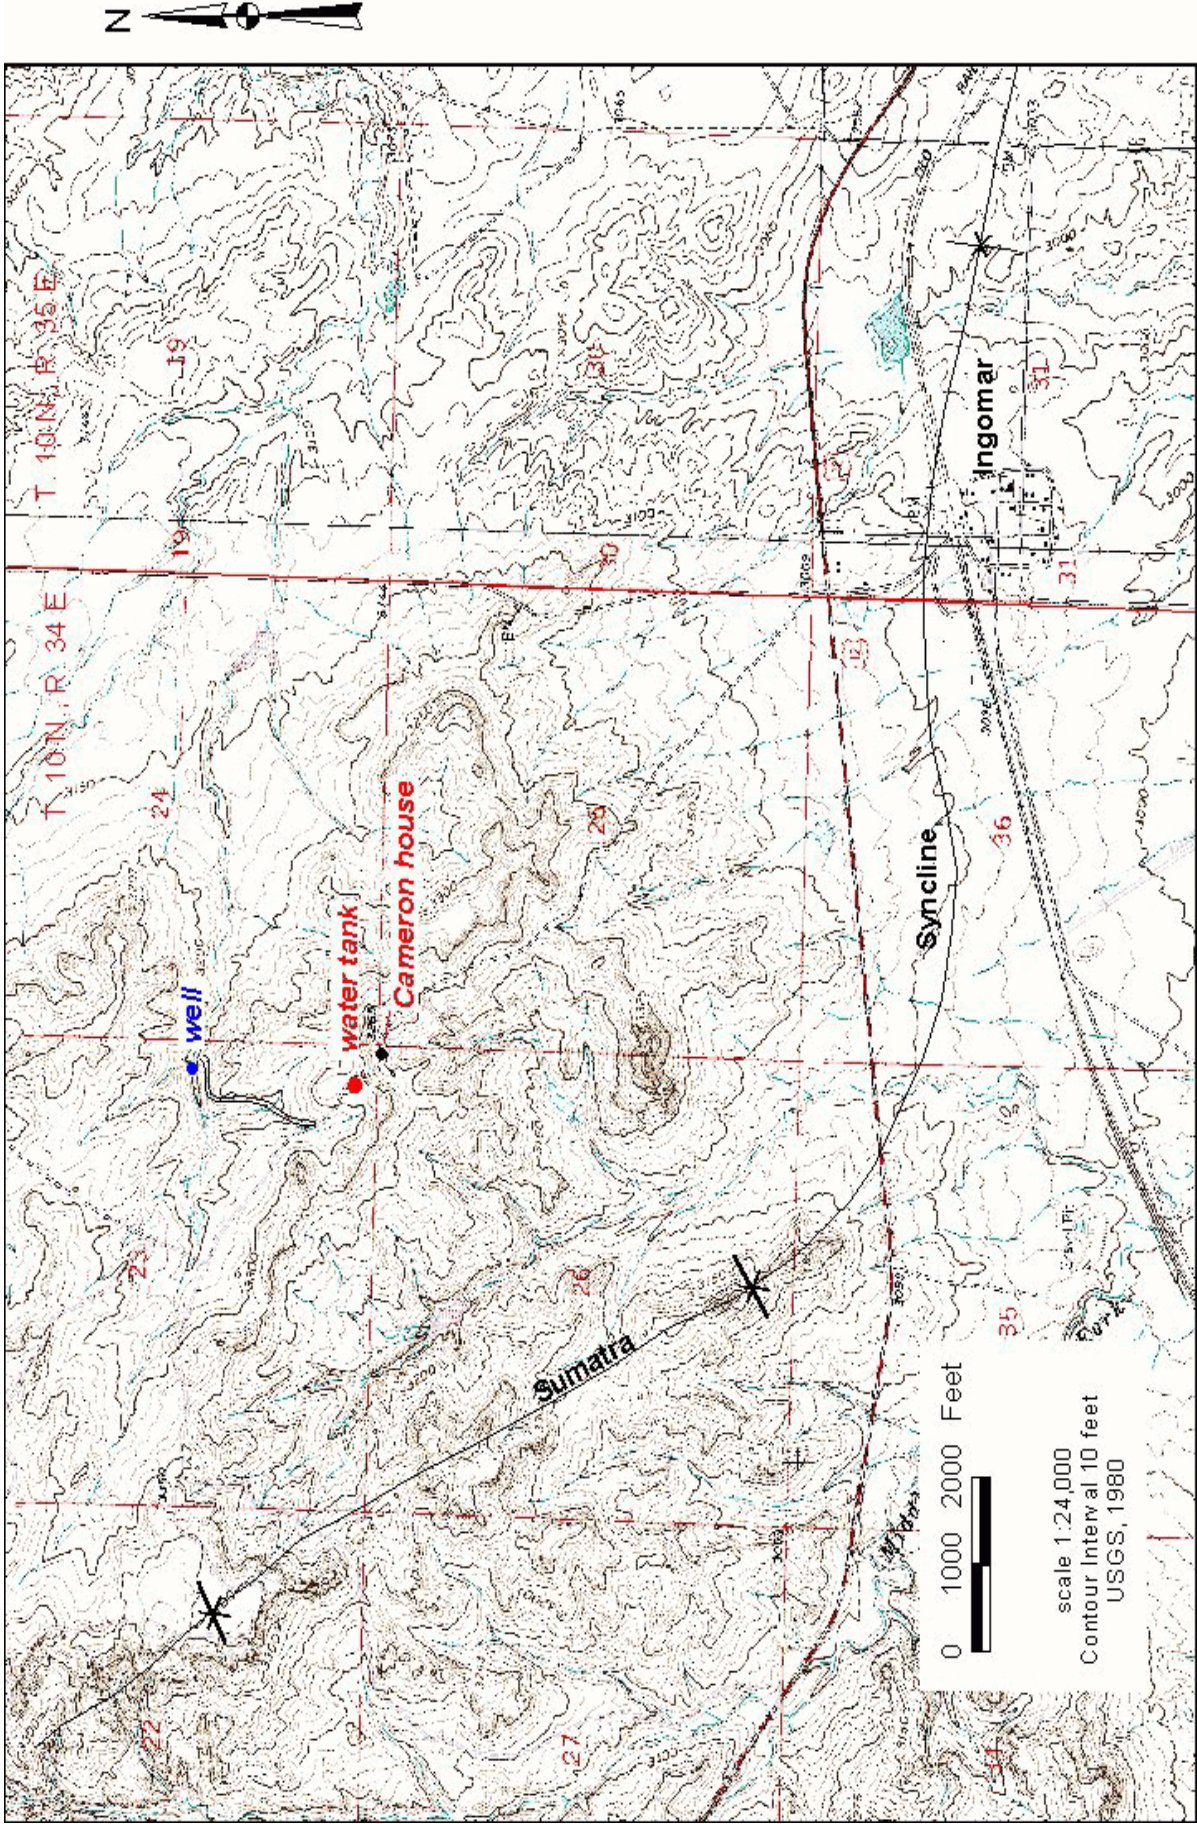
Map 1. Location and topographic map of water supply site

The spring/well site is located at 3,250 feet elevation along the south slope of a shallow coulee in hills about 2½ miles northwest of Ingomar (Appendix D, map 1). The land surface at the well is covered by colluvium, which overlies bedrock of the Fox Hills Formation (Appendix B, photo 1). The well is accessed by using the Sun Coulee Ranch manager's driveway. Donald John Cameron is the ranch manager; the Cameron house is located about one-quarter mile below the water-system storage tank and is the first house connected to the water-supply system (Appendix D, map 1) (Appendix B, photo 2).

Map 1. Topographic map of Ingomar area showing the location of the water supply well, water storage tank, Cameron house and Ingomar (Ingomar East and Ingomar West, USGS Topographic Quadrangle maps, 1980).
