**Montana Bureau of Mines and Geology
Open File Report No. 435**

**The Flooding of Butte's Underground Mines and Berkeley Pit
Butte Mine Flooding Operable Unit
Annual Water-Level Update, 2000**

**Terence E. Duaine
and
John J. Metesh**

**Prepared for
The Montana Department of Environmental Quality
Remediation Division
and
U.S. Environmental Protection Agency
Region VIII**

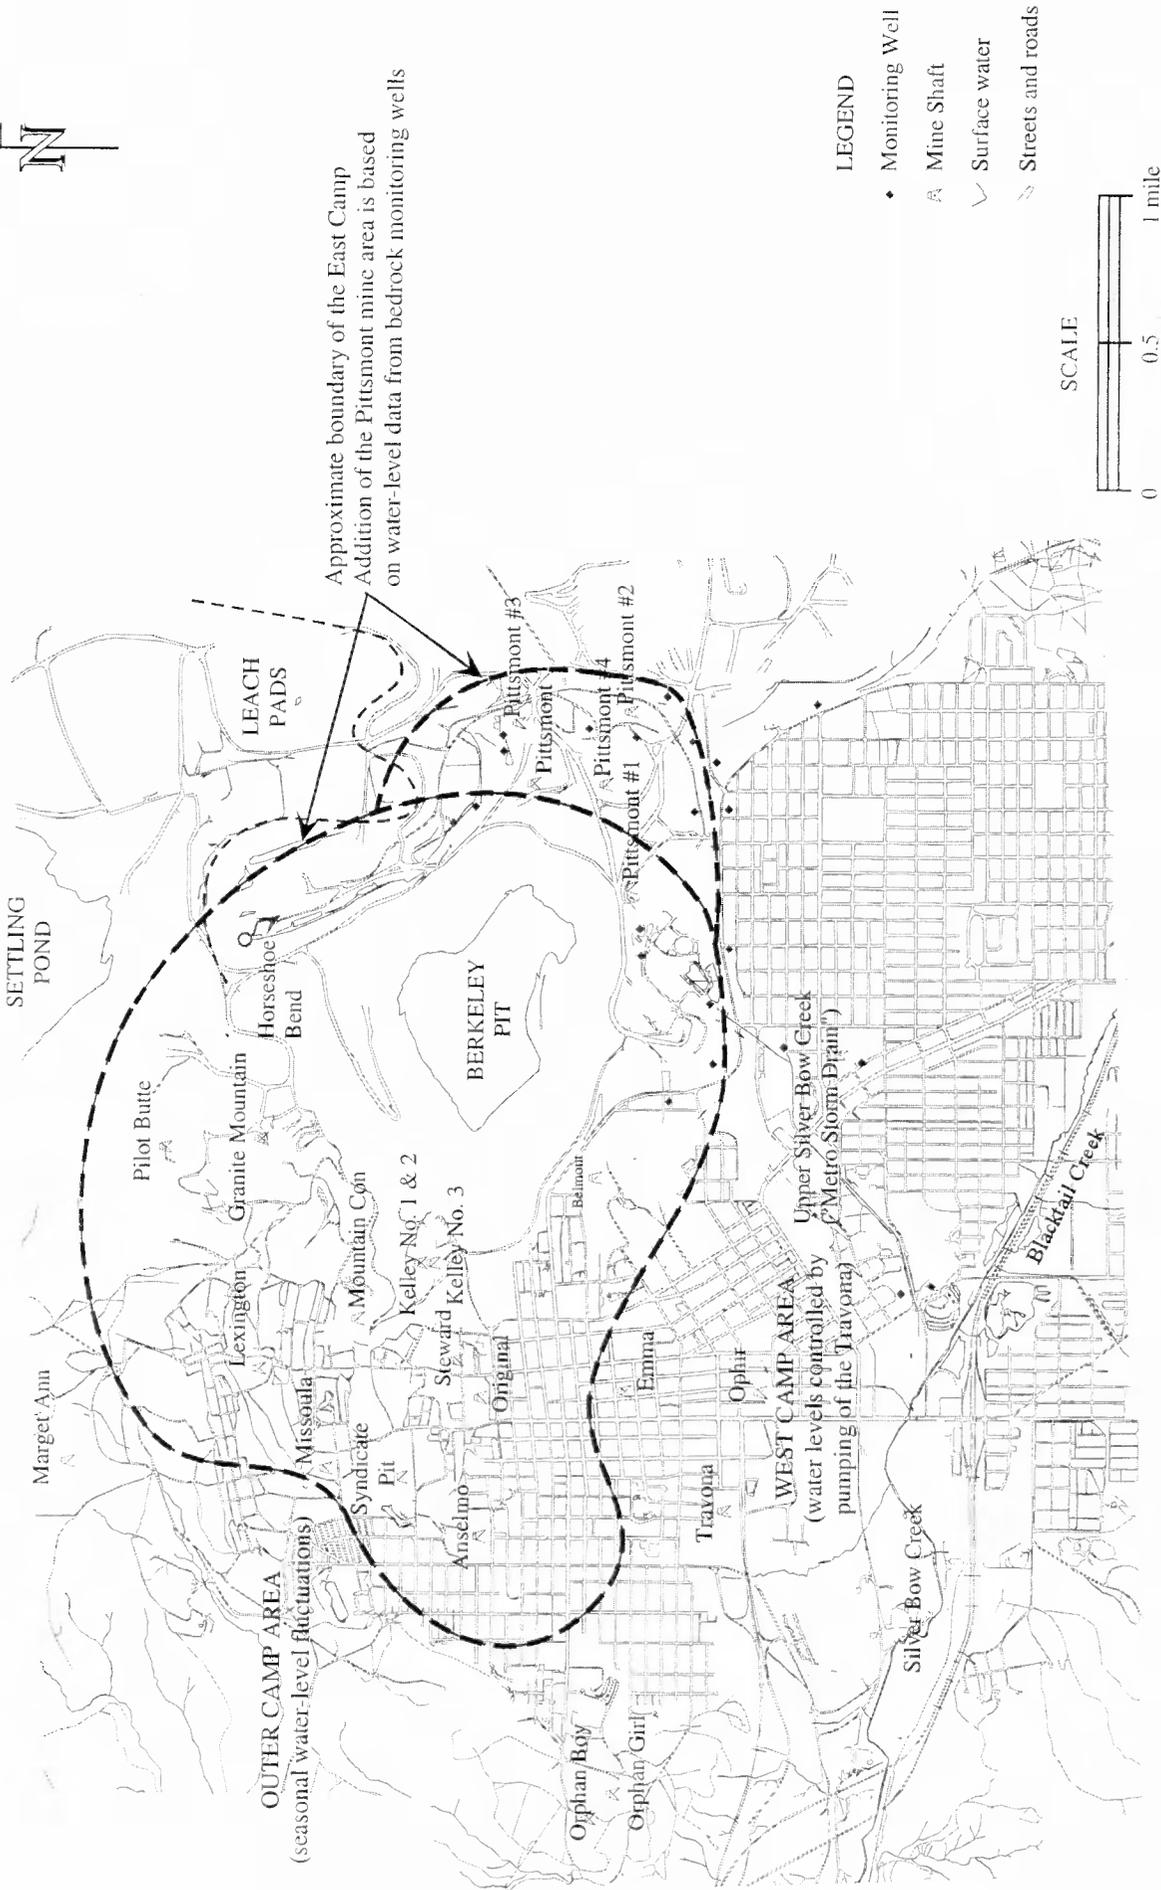
Figure 1-1. East Camp, West Camp, and Outer Camp boundaries.

Monitoring activities continued in 2000 in the East Camp, West Camp and Outer Camp systems (figure 1-1). The East Camp System includes mines and mine workings draining to the Kelley Mine pump station when mining and dewatering were suspended in 1982. The West Camp System includes workings that historically drained to the East Camp from the southwest portion of the Butte Mining District but were hydraulically isolated by the placement of bulkheads in interconnected mine workings to separate the West Camp from the East Camp. The Outer Camp System consists of the western and northern extents of mine workings that were interconnected to the East Camp at some time, but have been isolated with water levels returning to, or near, pre-mining conditions.

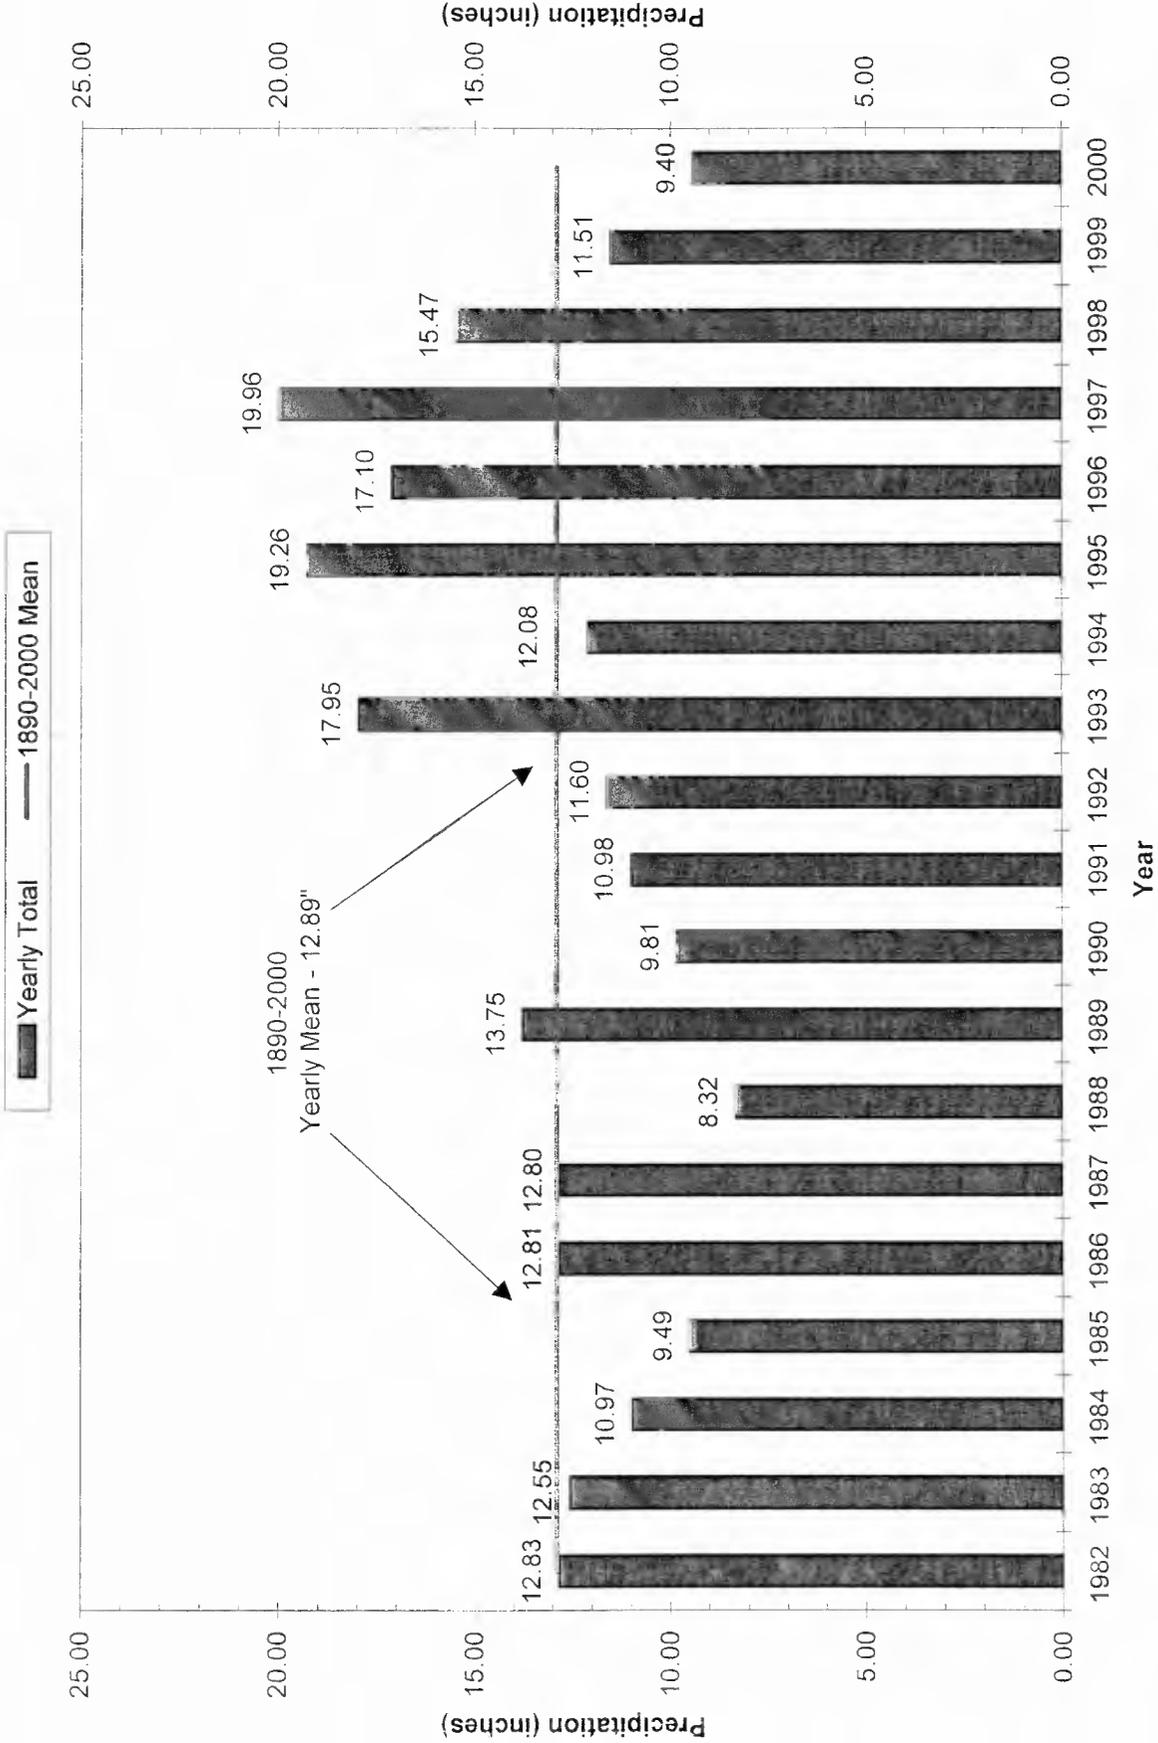
Figure 1-2. Yearly precipitation totals, 1982-2000, showing 1890-2000 yearly mean precipitation total.

Precipitation during 2000 was well below average. Total precipitation was 9.4 inches compared to the long-term average of 12.89 inches. This is a decline of twenty-eight percent and is the second consecutive year of below-average moisture. Table 1.2.1 contains monthly precipitation totals from 1982 through 2000, while figure 1-2 shows this information graphically in comparison to the long-term yearly average. Figure 1-3 shows departure from normal for precipitation from 1895 through 2000.

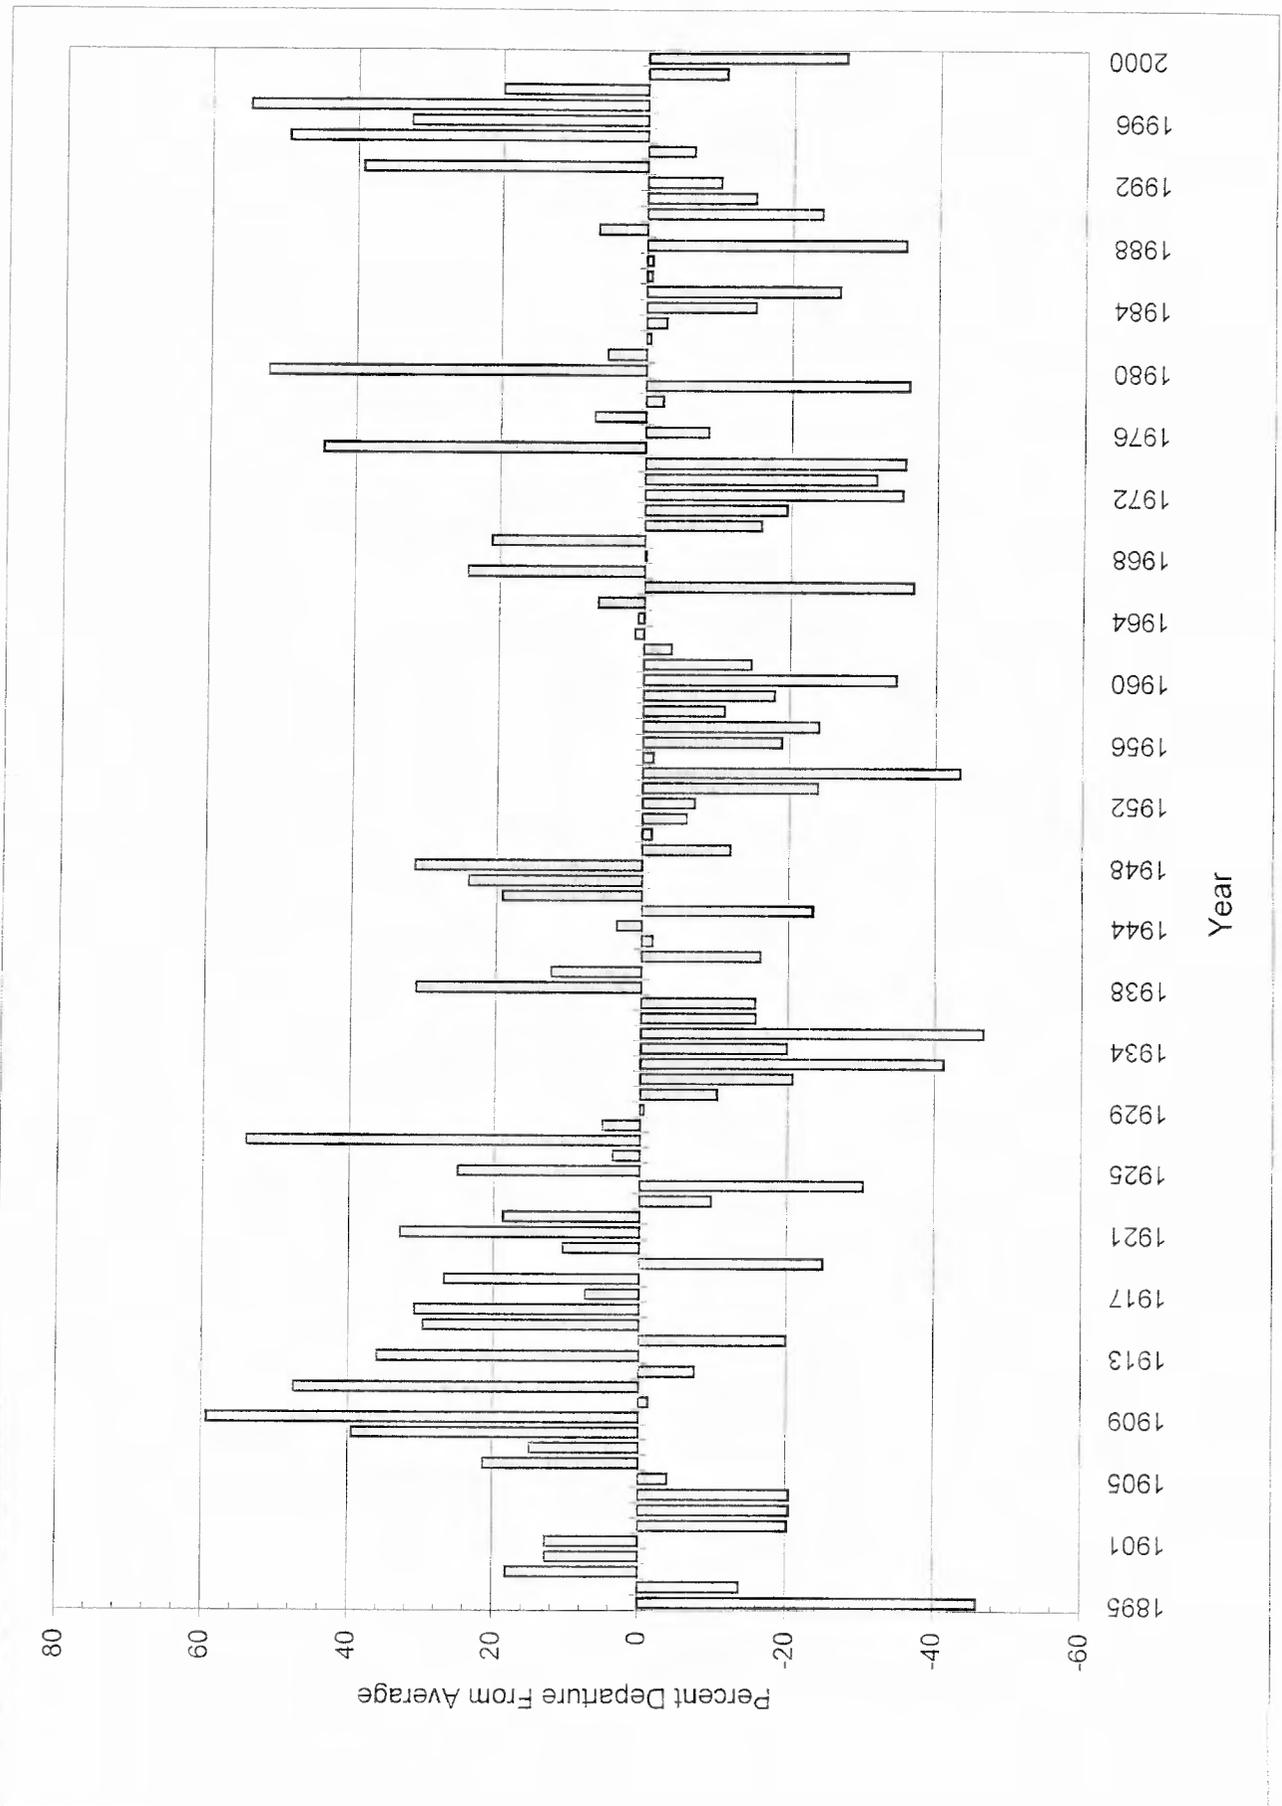
Figure 1-3. Percent precipitation departure from average, 1890-2000.

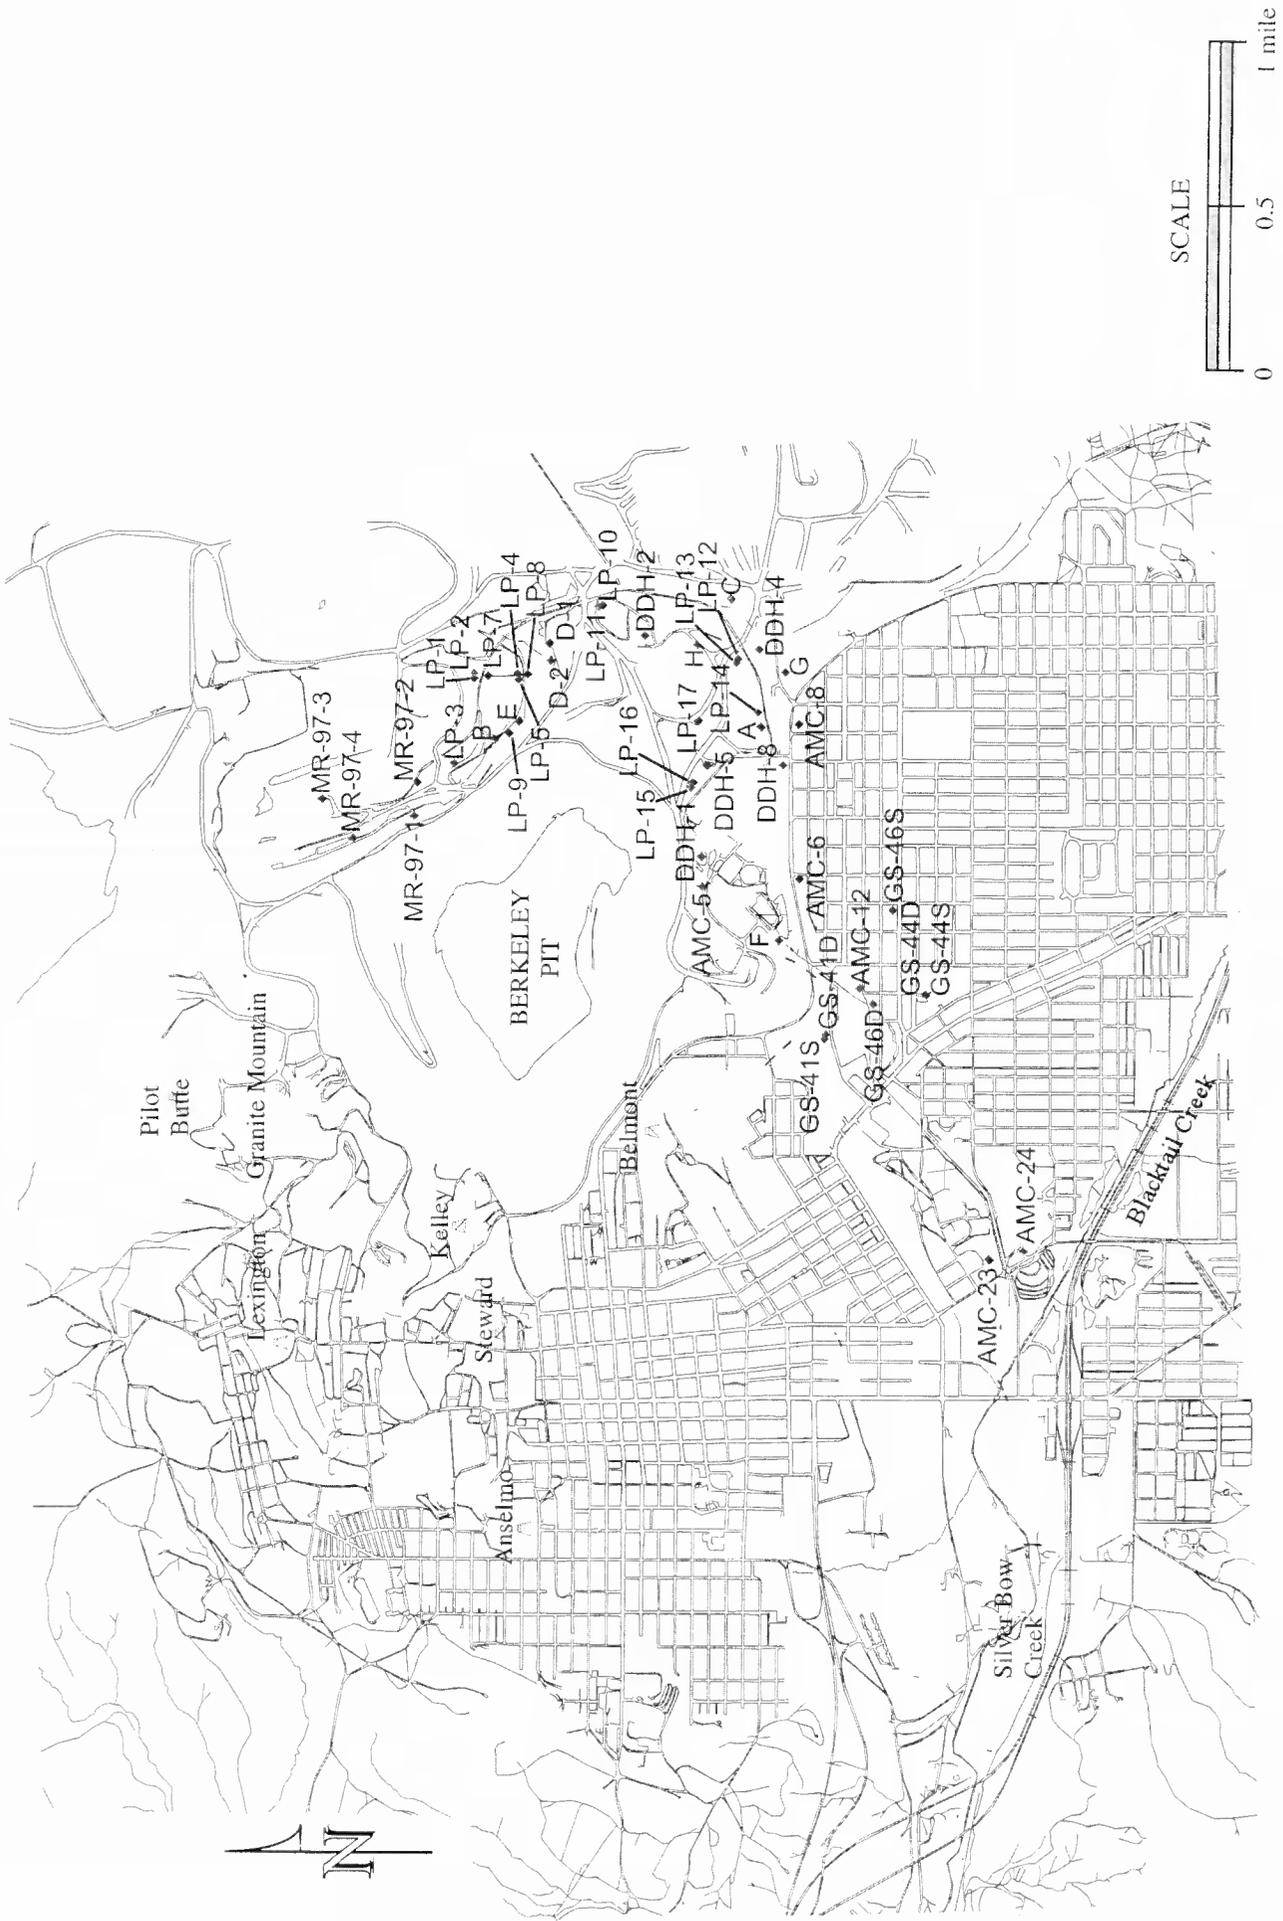
Figure 2-1. East Camp Monitoring Sites.

The East Camp System consists of the Anselmo, Belmont, Granite Mountain, Kelley, Steward, Lexington and Pilot Butte Mines, the Berkeley Pit and the mine workings associated with those sites. It also includes the East Camp bedrock system adjacent to the East Camp mines not affected by mine water pumping and the shallow East Camp alluvial system (figure-2-1). The East Camp alluvial system is discussed first, followed by the East Camp bedrock system.

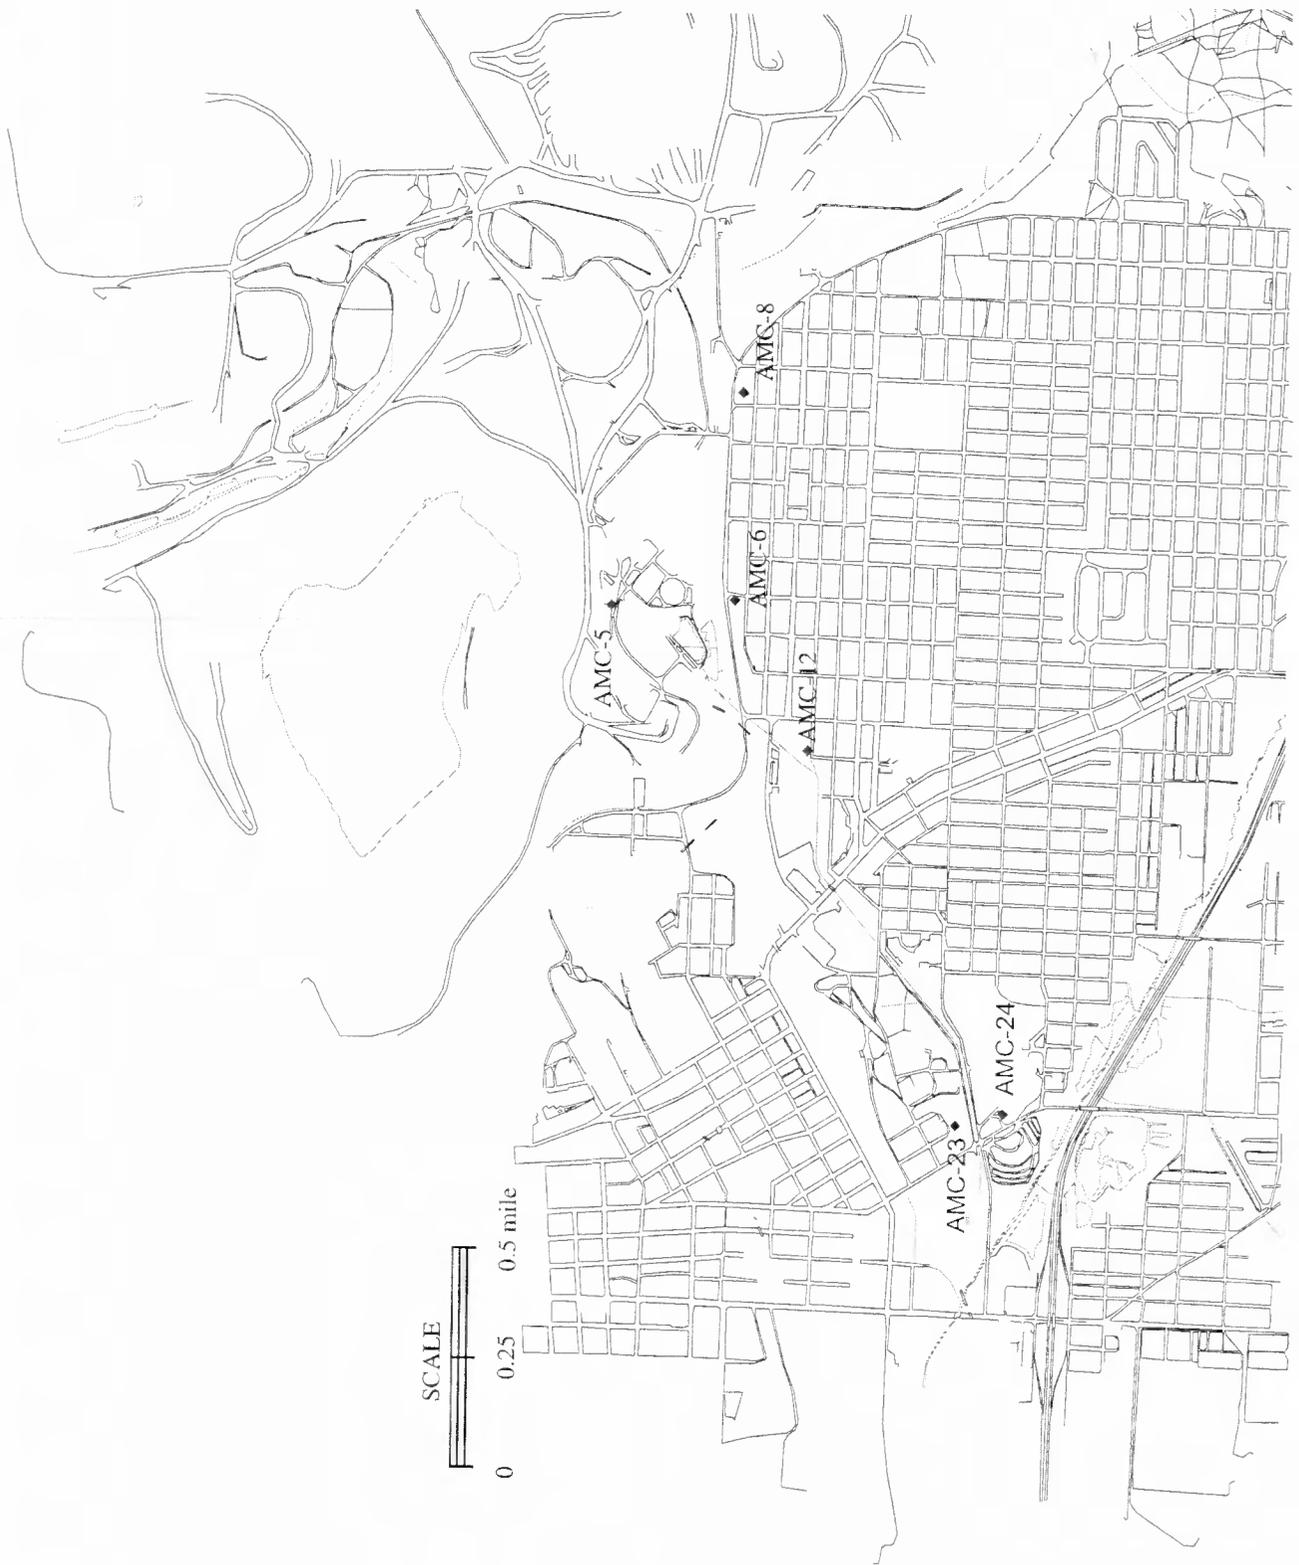
Figure 2-2. AMC well location map.

The locations of the Anaconda Mining Company (AMC) wells are shown on figure 2-2; table 2.1.1.1 lists the annual water level changes for these sites. Water levels declined in 8 of the 10 wells during 2000. Wells 10 and 11 remained dry. Net water level changes from 1983 are rises in 2 wells; declines in 6 wells and 2 wells remain unchanged (dry).

Wells AMC-5, AMC-6, and AMC-8 are located to the south of the active mine area and the Butte Concentrator facility (figure 2-2). Well AMC-12 is located west of these wells. Hydrographs for wells AMC-5 and AMC-12 (figure 2-3) and AMC-6 and AMC-8 (figure 2-4) show the long-term trends in the shallow alluvial ground water system south of the pit. Monthly precipitation amounts are shown as bars and are plotted on the right-hand y-axis.

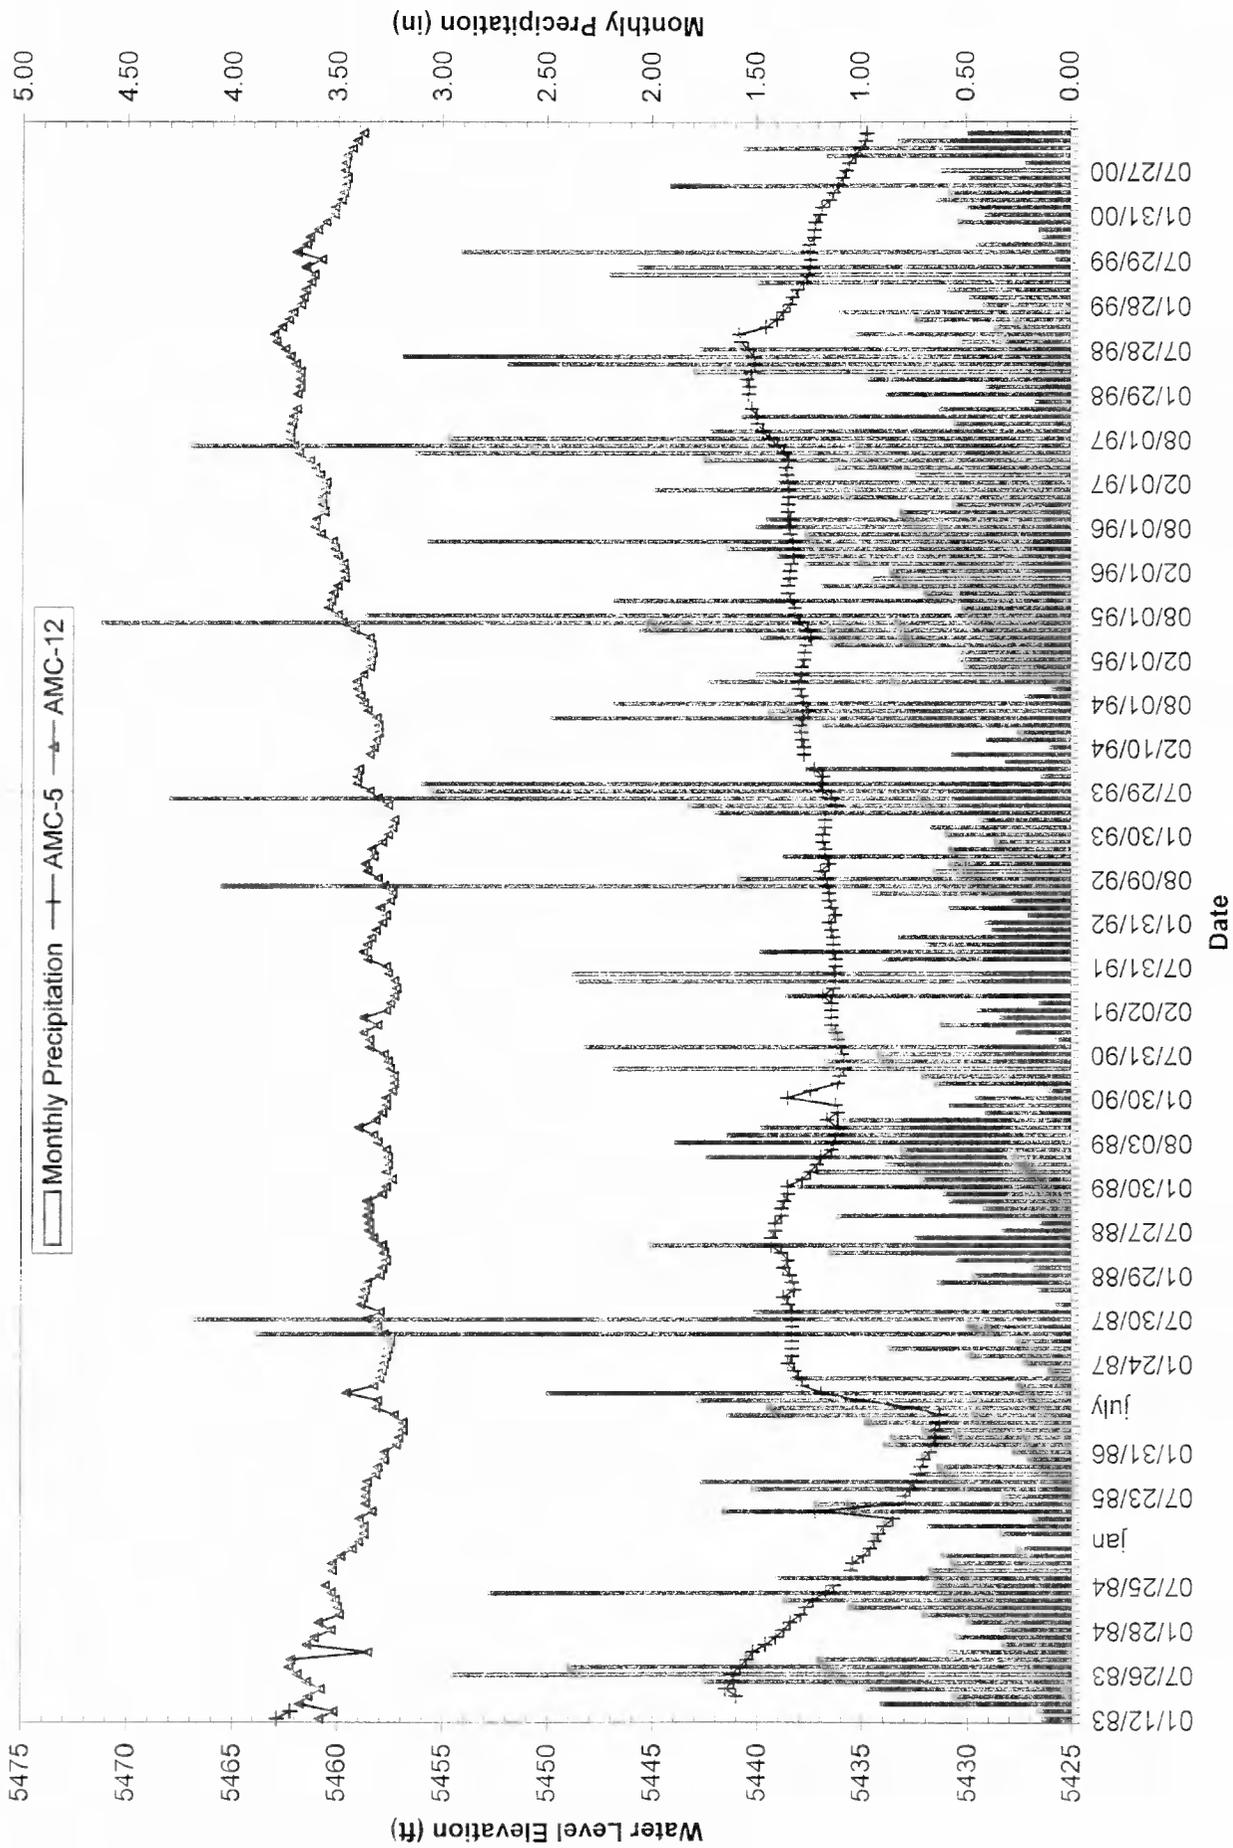
Figure 2-3. Water-level hydrograph for wells AMC-5 and AMC-12.

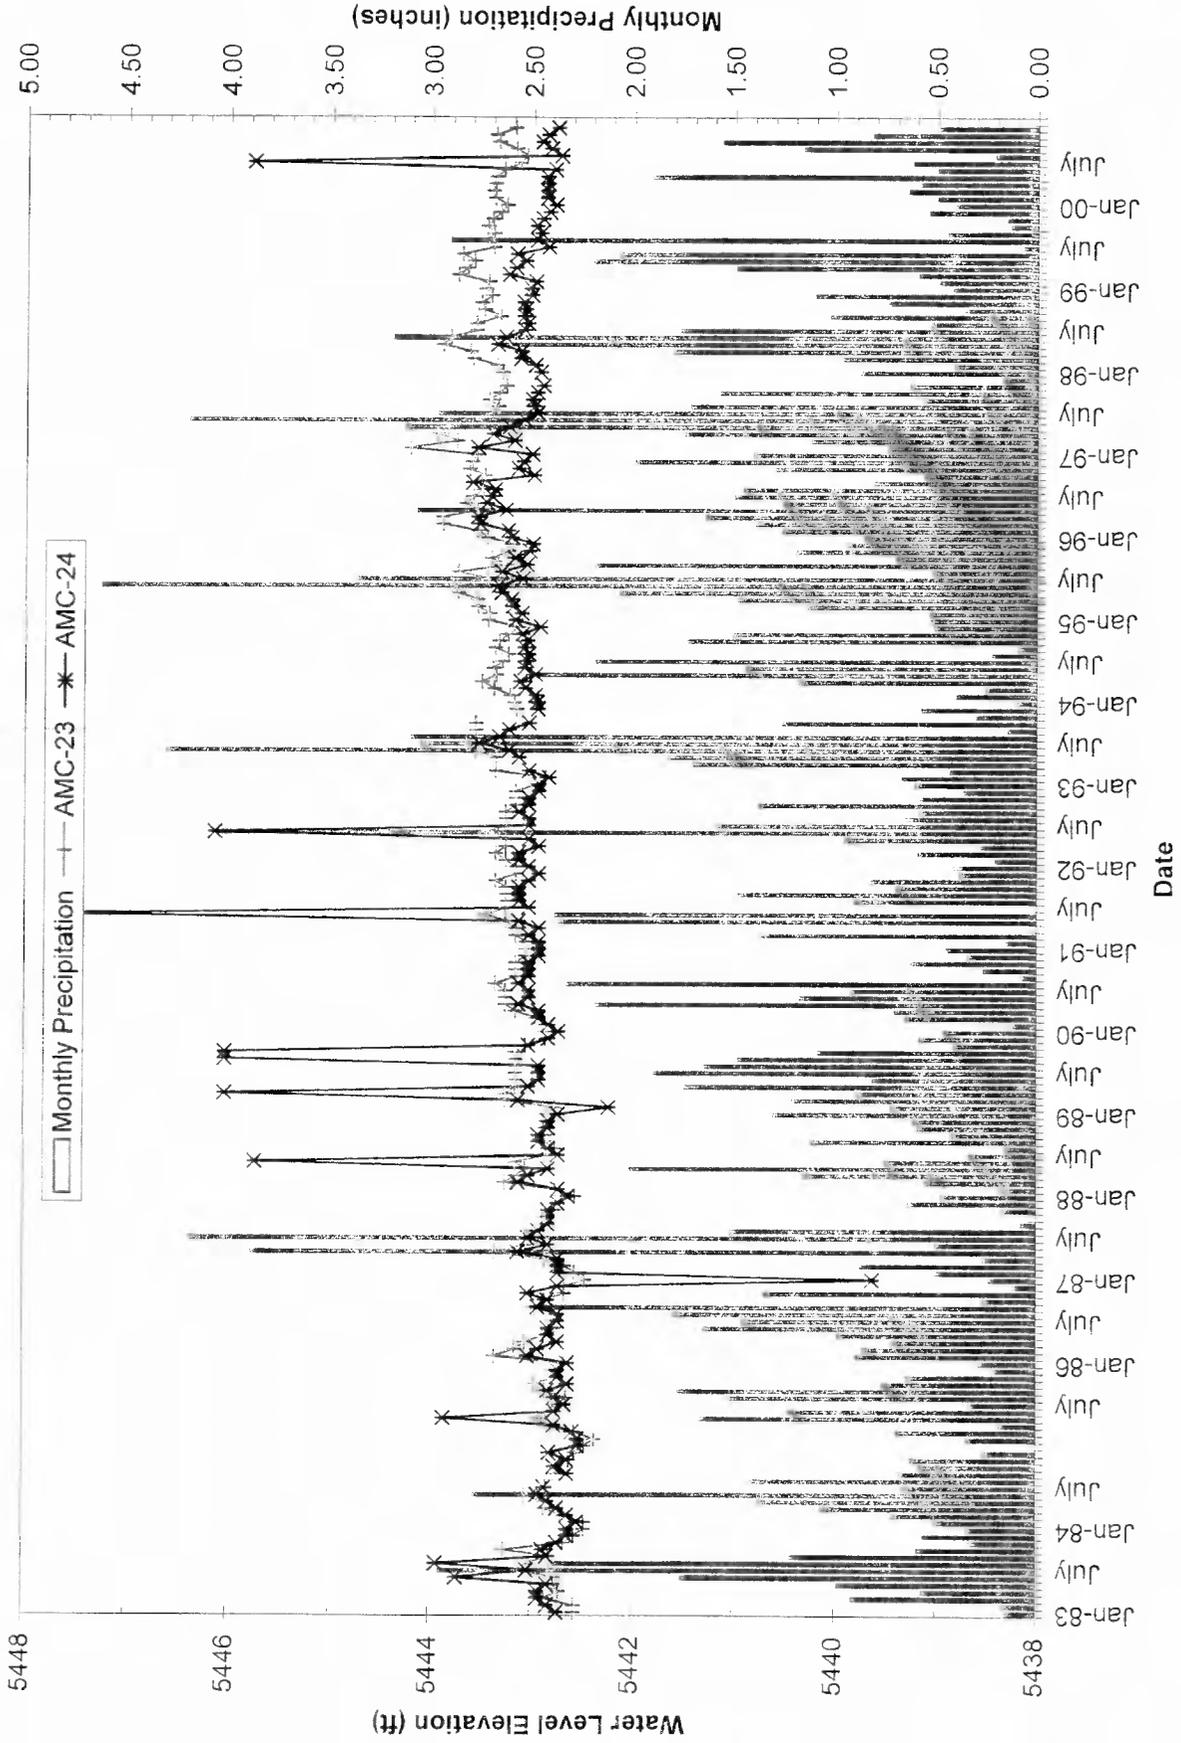
Figure 2-5. Water-level hydrograph for wells AMC-23 and AMC-24.

Figure 2-5 shows hydrographs of wells AMC-23 and AMC-24 with monthly precipitation amounts. The hydrographs for these two wells are much different than those four previously discussed wells. Both of these wells show an almost immediate rise in water levels after increased precipitation, followed by a decline in water levels by the next month. These events are more pronounced in well AMC-24 because of its location between Blacktail Creek and Silver Bow Creek (SBC). Well AMC-23 lies north of SBC so it receives recharge from SBC only.

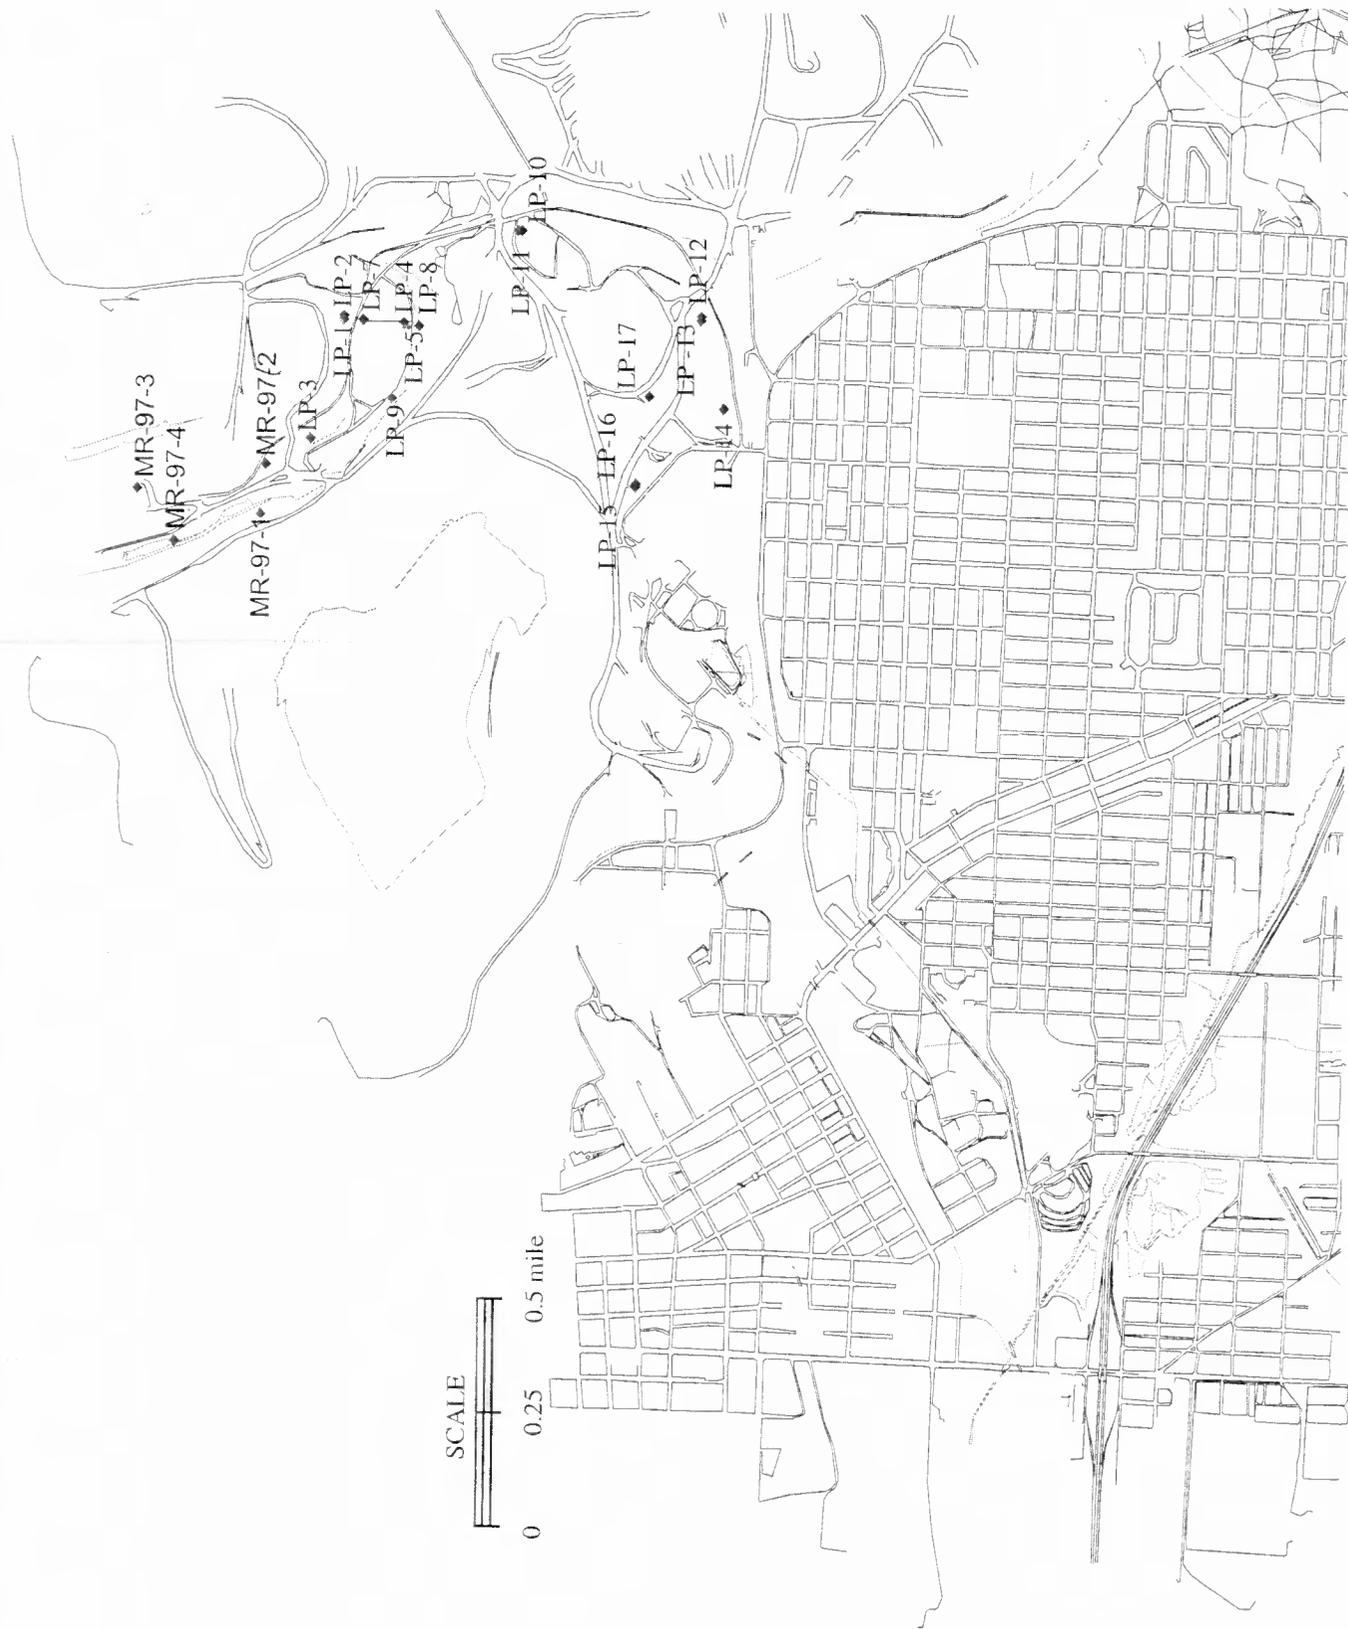
Figure 2-6. LP series and MR97 wells location map.

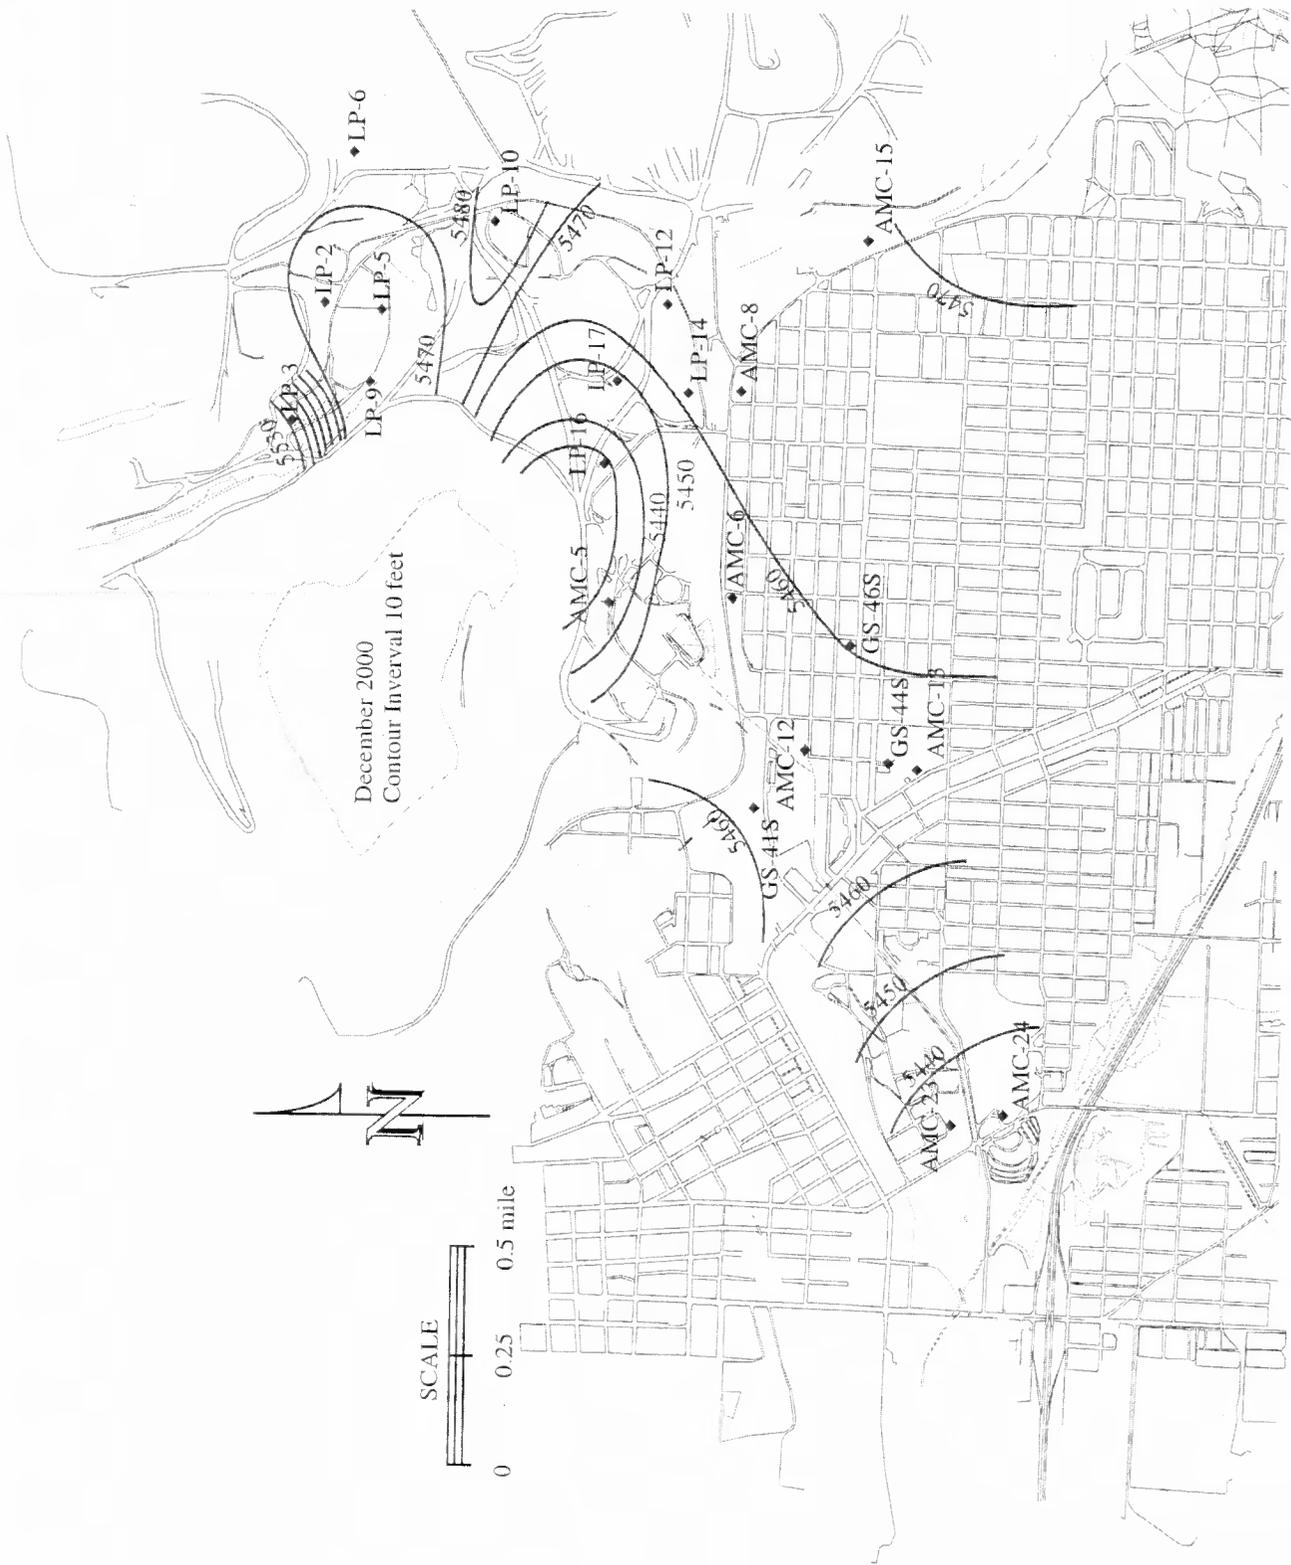
Figure 2-10. Alluvial aquifer potentiometric map for December, 2000

Figure 2-10 is an alluvial aquifer potentiometric map constructed using December 2000 water levels. It shows how alluvial water levels are flowing towards the Berkeley Pit from the north, east and south. Water contaminated by historic mining activities (Metesh, 2000) is flowing towards and into the Berkeley Pit, ensuring that there is no outward migration of contaminated water into the alluvial aquifer outside the mine boundary.

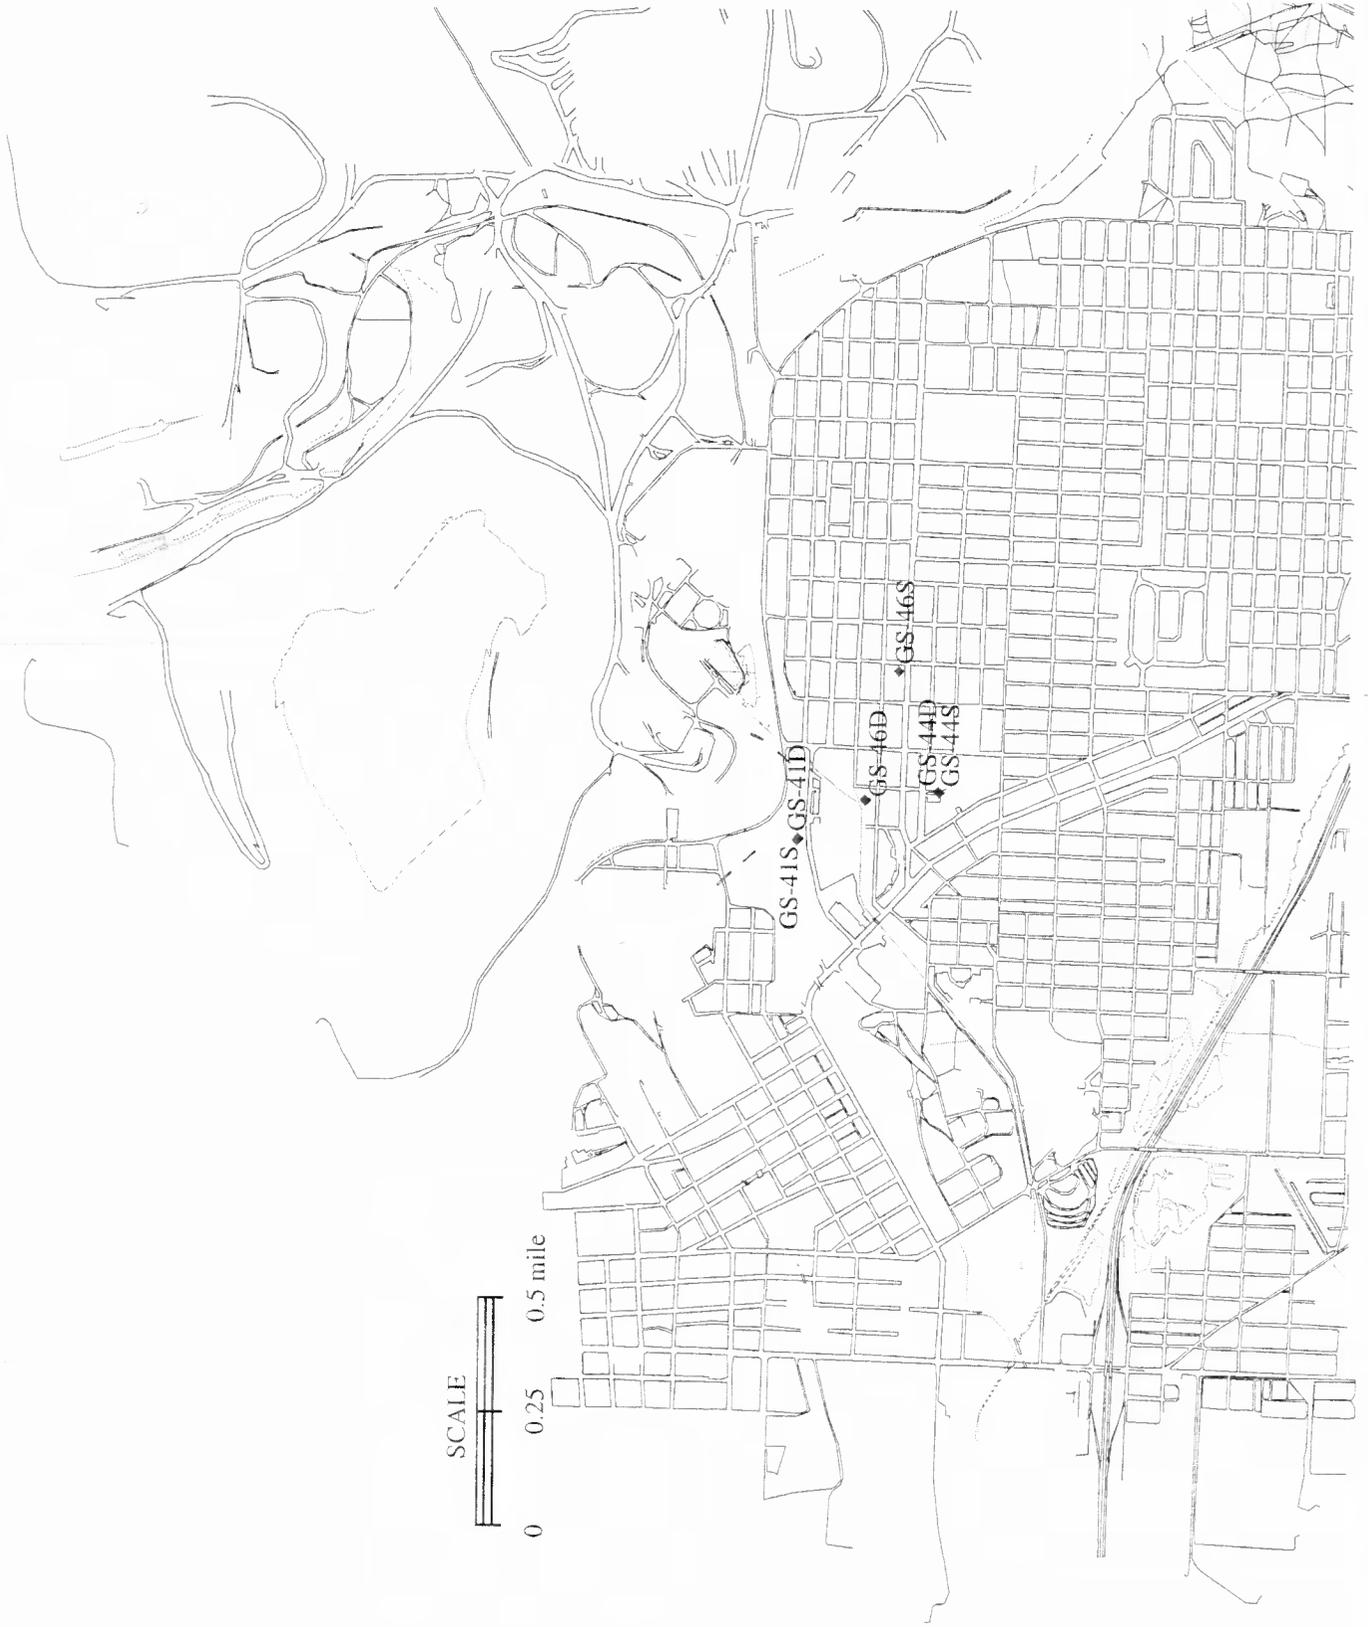
Figure 2-14 GS wells location map

Continuous and monthly water level monitoring of the 6 GS wells continued throughout 2000. The location of these wells is shown on figure 2-14. Table 2.1.4.1 contains annual water level changes for these wells. The S and D identify the shallow and deep wells in each nested well pair. Wells GS-41 and GS-44 are paired, while wells GS-46S and GS-46D are 1000 ft apart; however, they are considered to be a nested pair.
