**Montana Bureau of Mines and Geology
Open File Report No. 435**

**The Flooding of Butte's Underground Mines and Berkeley Pit
Butte Mine Flooding Operable Unit
Annual Water-Level Update, 2000**

**Terence E. Duaine
and
John J. Metesh**

**Prepared for
The Montana Department of Environmental Quality
Remediation Division
and
U.S. Environmental Protection Agency
Region VIII**

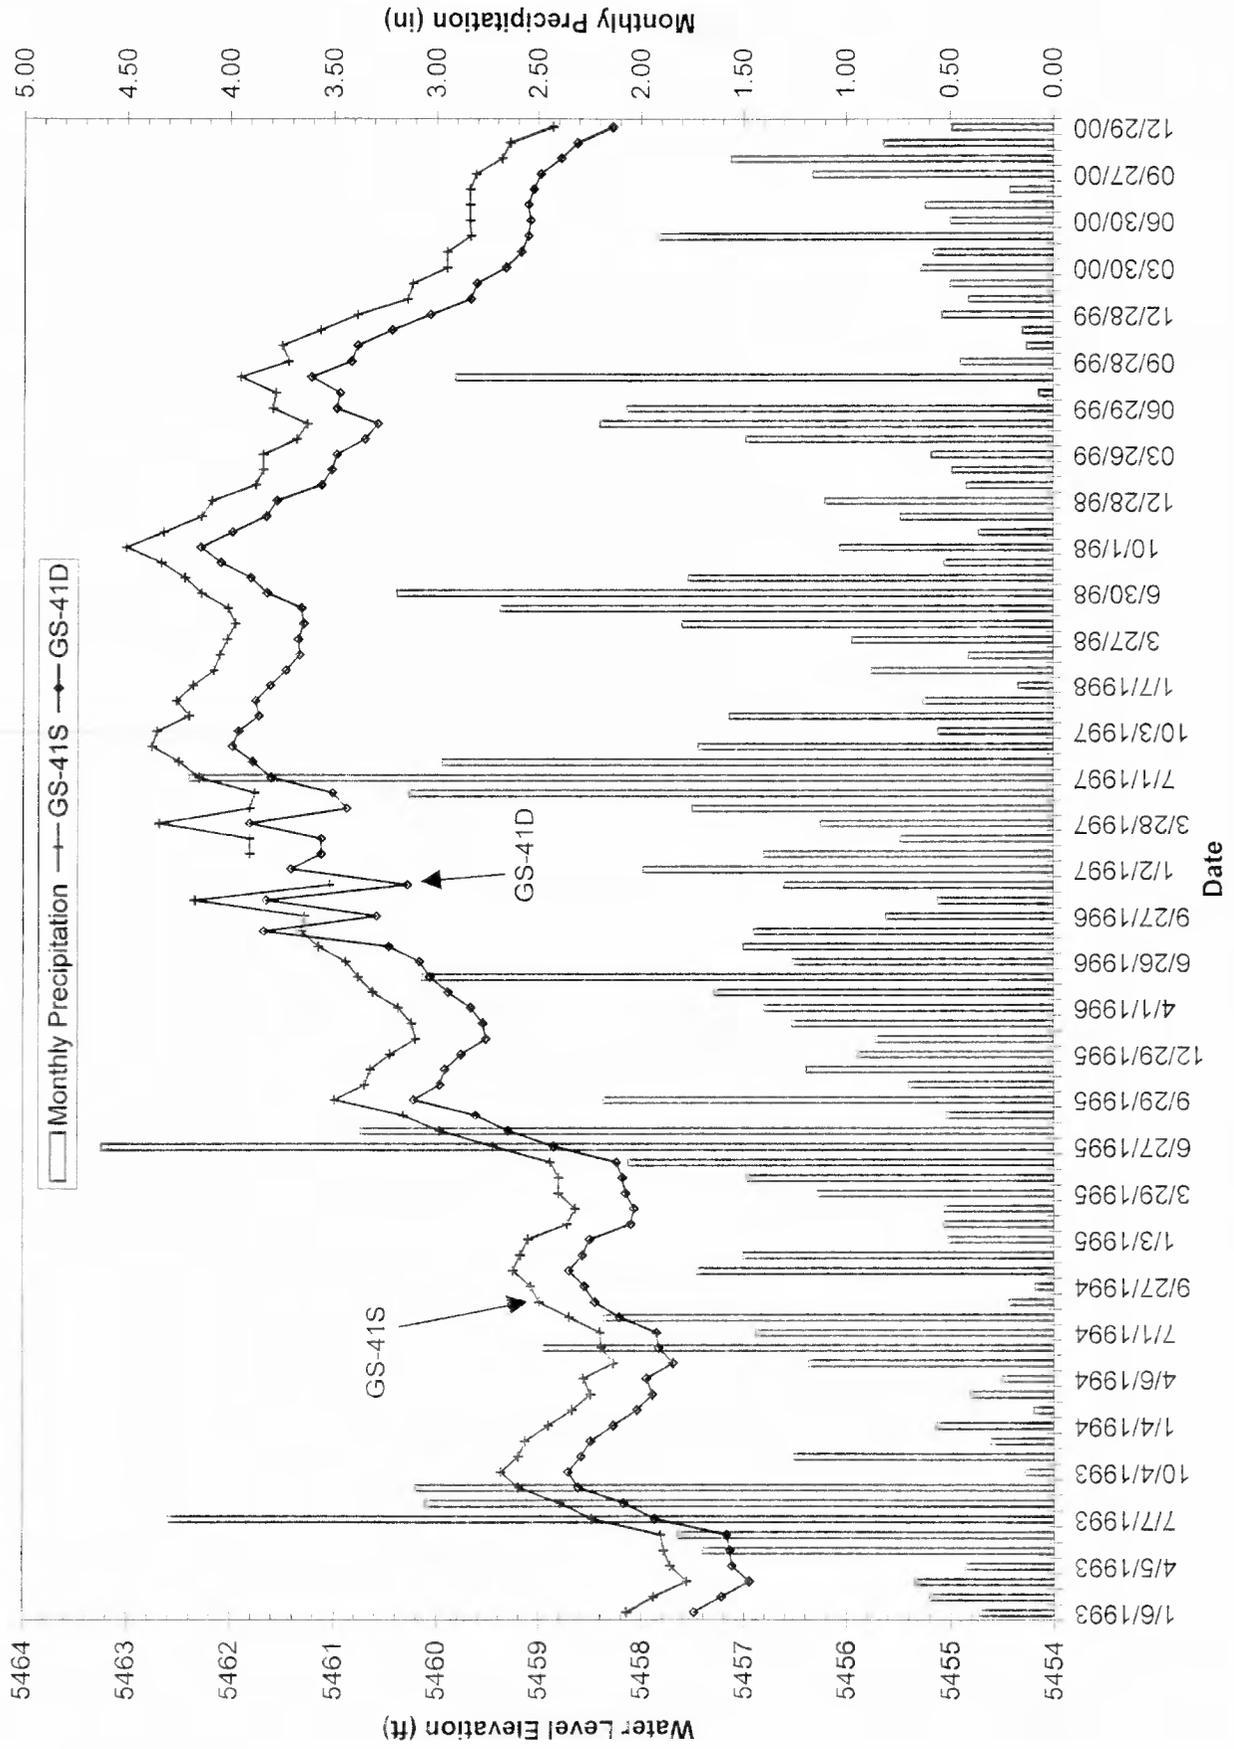
Figure 2-15. Water-level hydrograph for wells GS-41S and GS-41D.

Figures 2-15 through 2-17 are well hydrographs with monthly precipitation totals shown for the well series GS-41, GS-44, and GS-46. The seasonal rise and fall in water levels closely follow monthly precipitation trends. Water levels begin a gradual increase in the spring as precipitation increases. There is a 2 to 3 month lag (delay) between peak rainfall and peak water levels.

Water-level changes in wells GS-41S and GS-41D were similar once again during 2000. Water levels continued their steep decline that began following the September 1998 Berkeley Pit landslide (figure 2-15). The influence of precipitation was limited. Water levels declined over 1.75 ft in these two wells during 2000.

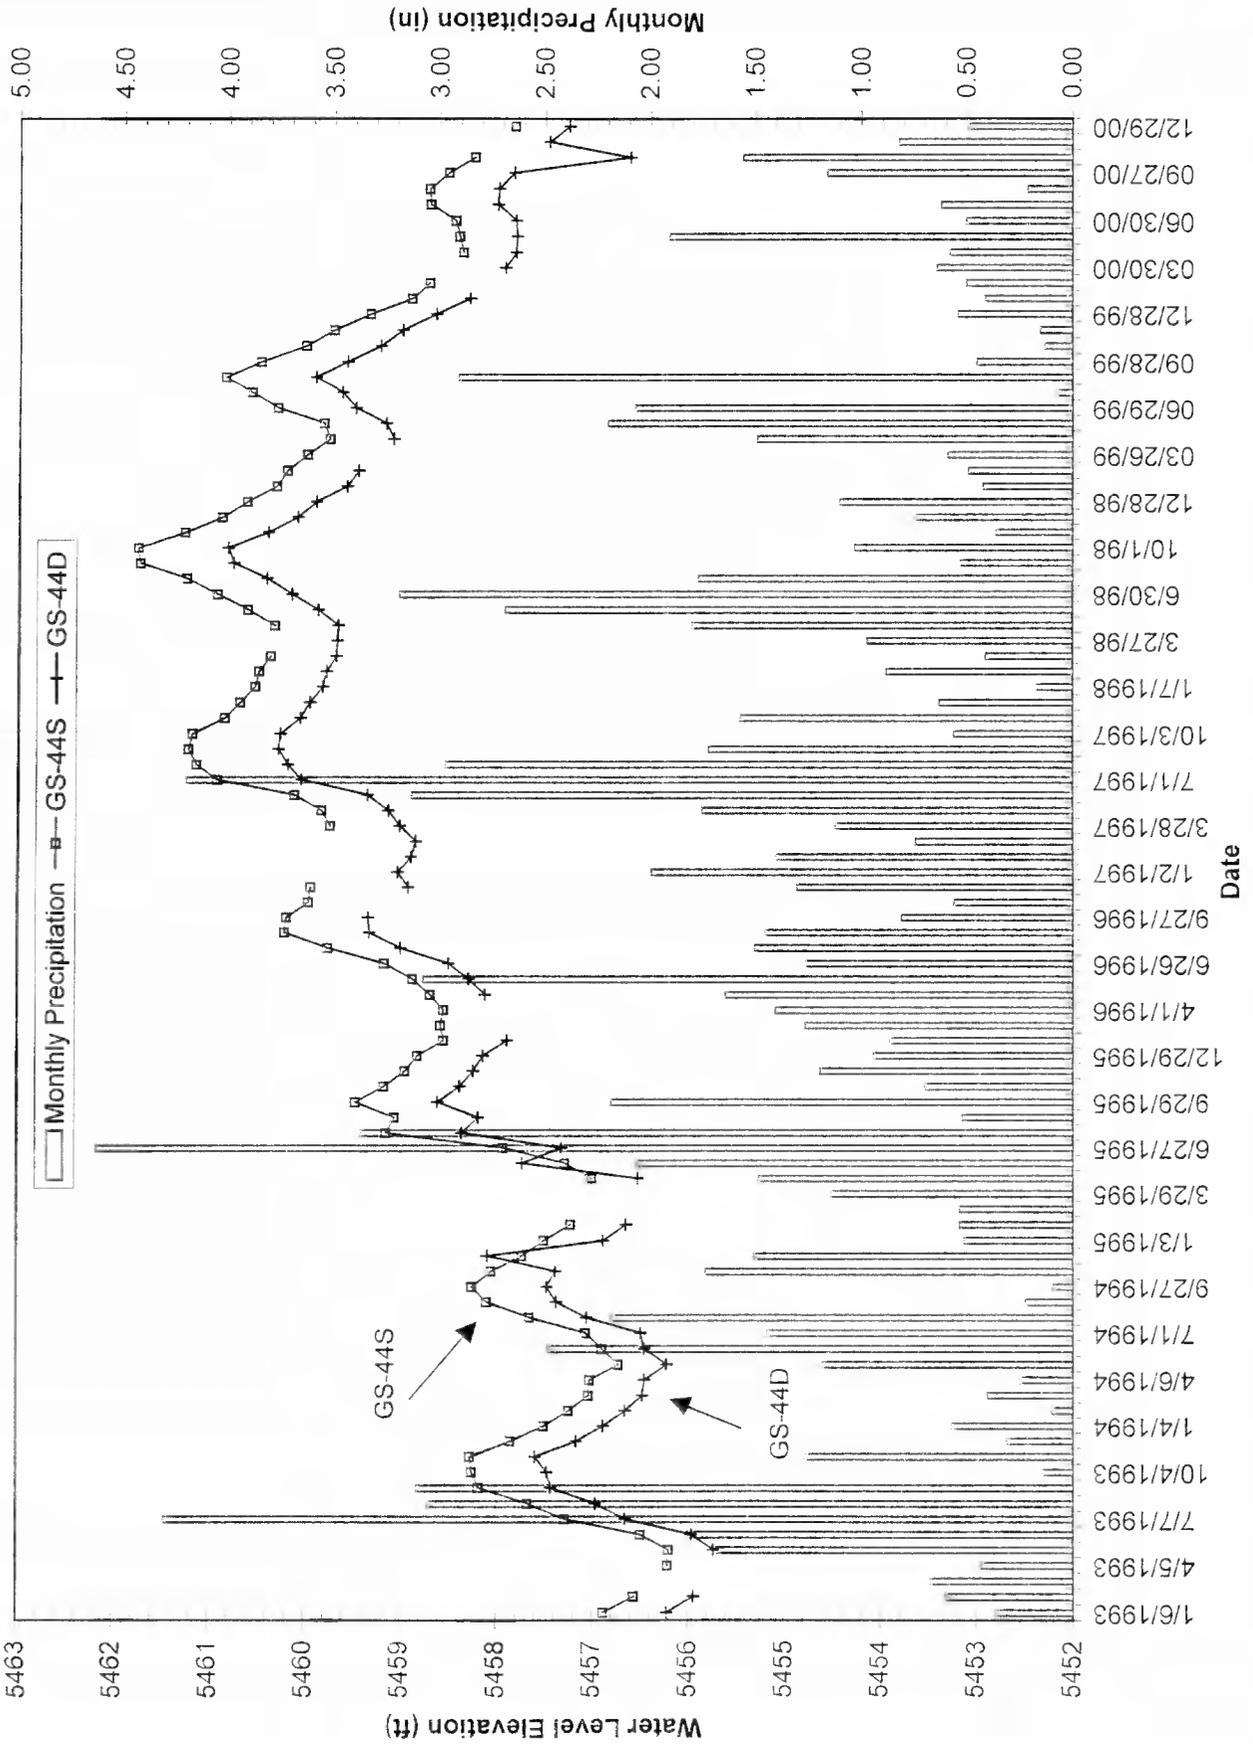
Figure 2-16. Water-level hydrograph for wells GS-44S and GS-44D.

Wells GS-44S and GS-44D had similar water level changes throughout 2000, (figure 2-16). The rise and fall of seasonal water levels are similar to that described for wells GS-41S and 41D. However, these wells showed a greater response to spring precipitation events than the GS-41 series wells. The trend noted above for the GS-41 wells from October 1998 through 2000 was observed in these wells also. The water level decline for 2000 was greater than 1.3 ft.

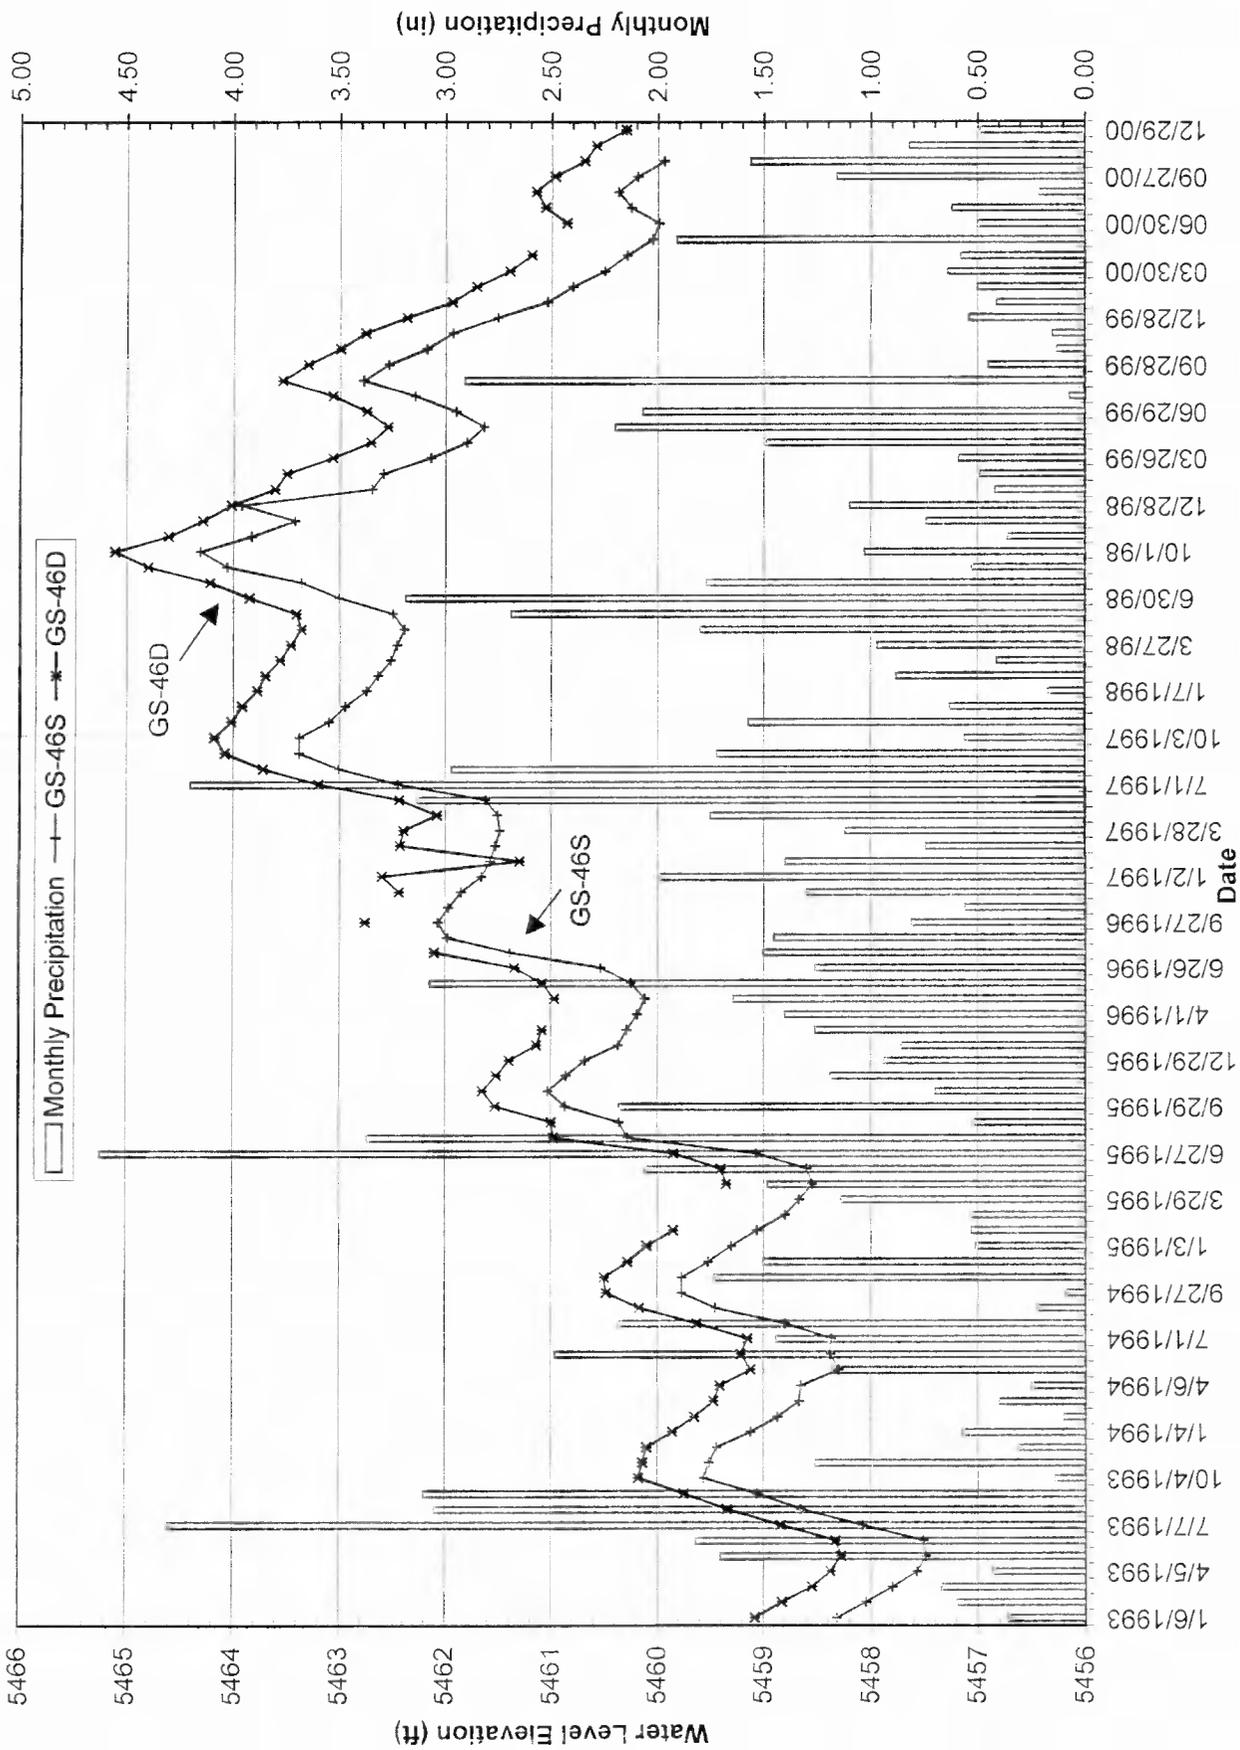
Figure 2-17. Water-level hydrograph for wells GS-46S and GS-46D.

Overall, water-level trends were similar during 2000 in wells GS-46S and GS-46D (figure 2-17), and followed the trends discussed previously for well series GS-41 and GS-44. Water levels declined from 1.21 ft in well GS-46S to 2.07 ft in well GS-46D during 2000. Total water-level increases in these two wells since 1993 are less than 2 ft. The seasonal trends are the same as those in the other GS series wells.

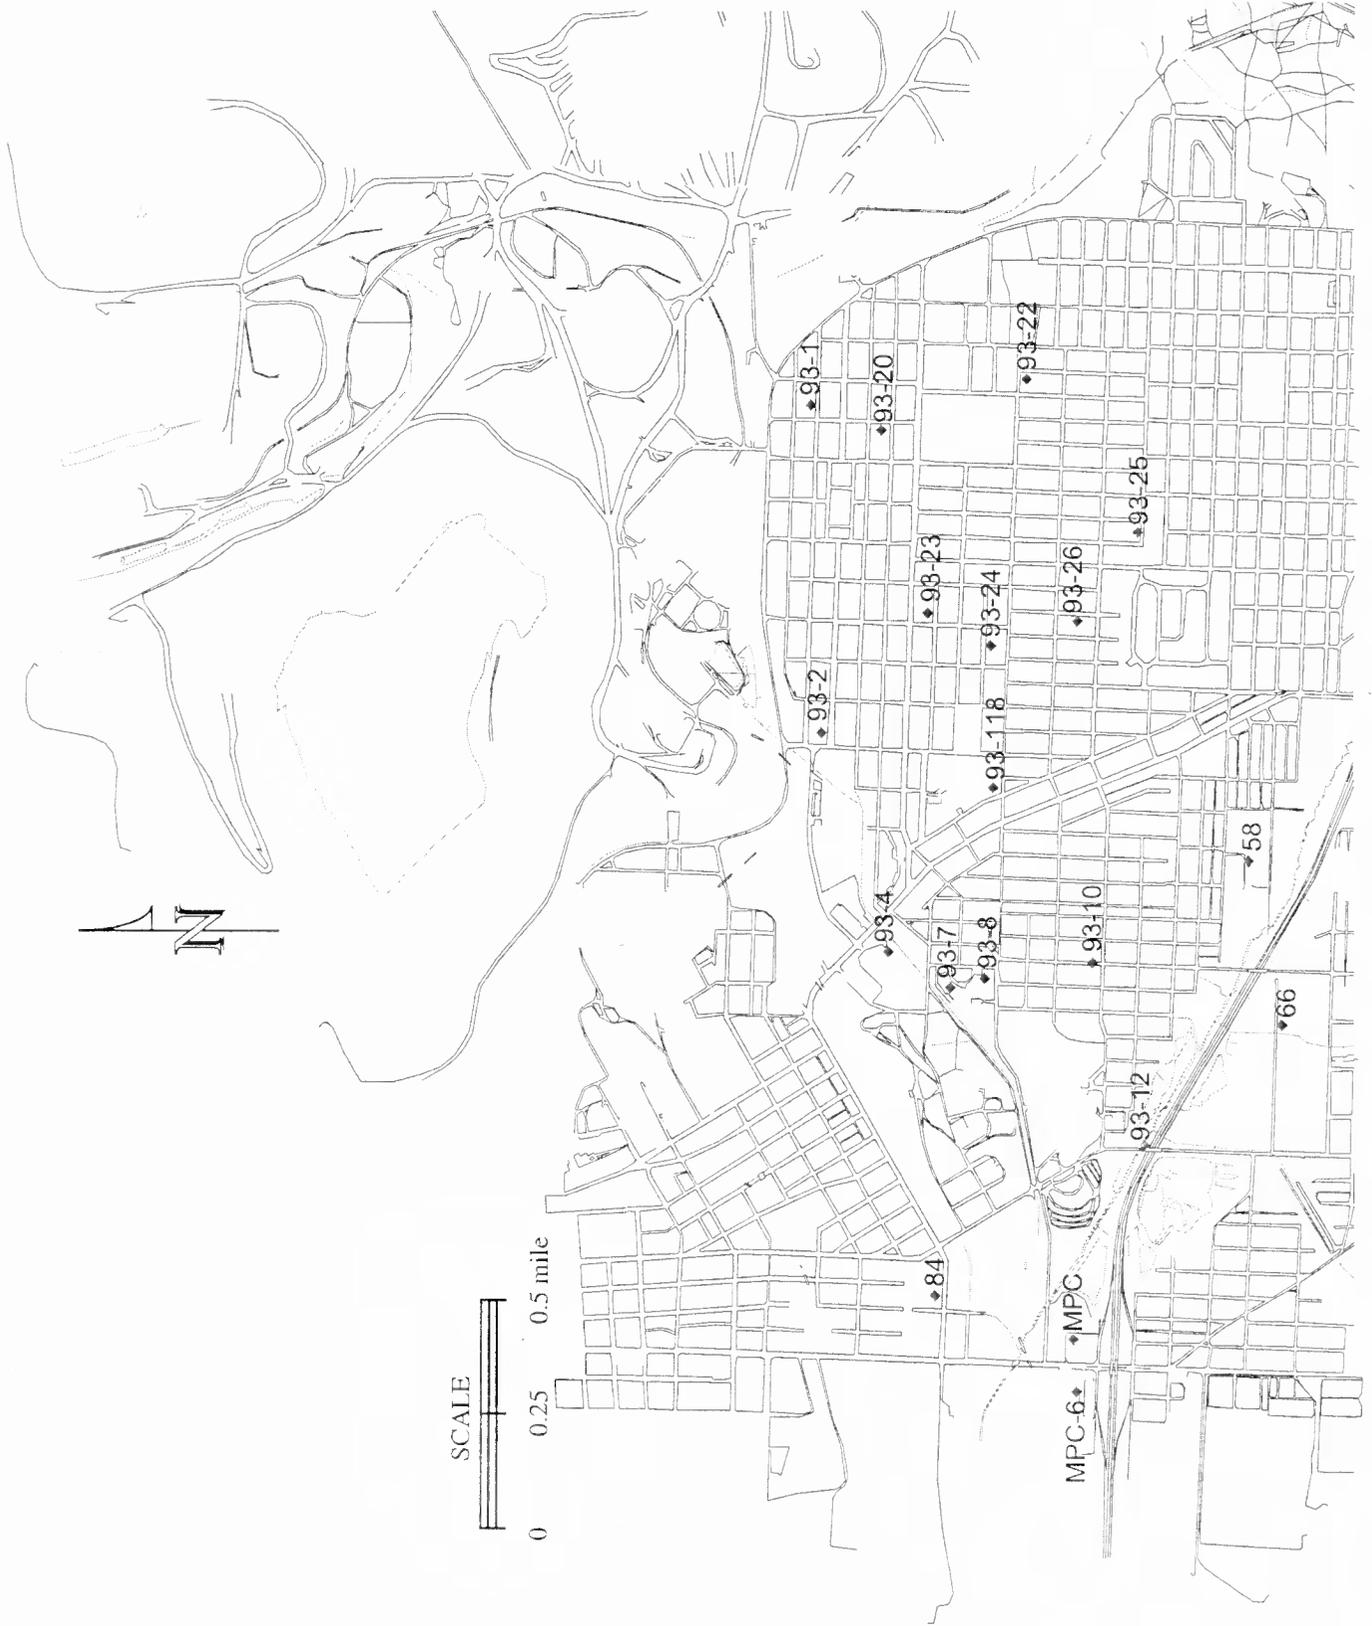
Figure 2-18. Domestic well location map.

Monitoring continued in the 14 domestic wells for the fourth year. The locations of these wells are shown on figure 2-18. Table 2.1.5.1 contains water-level summary data for these wells.

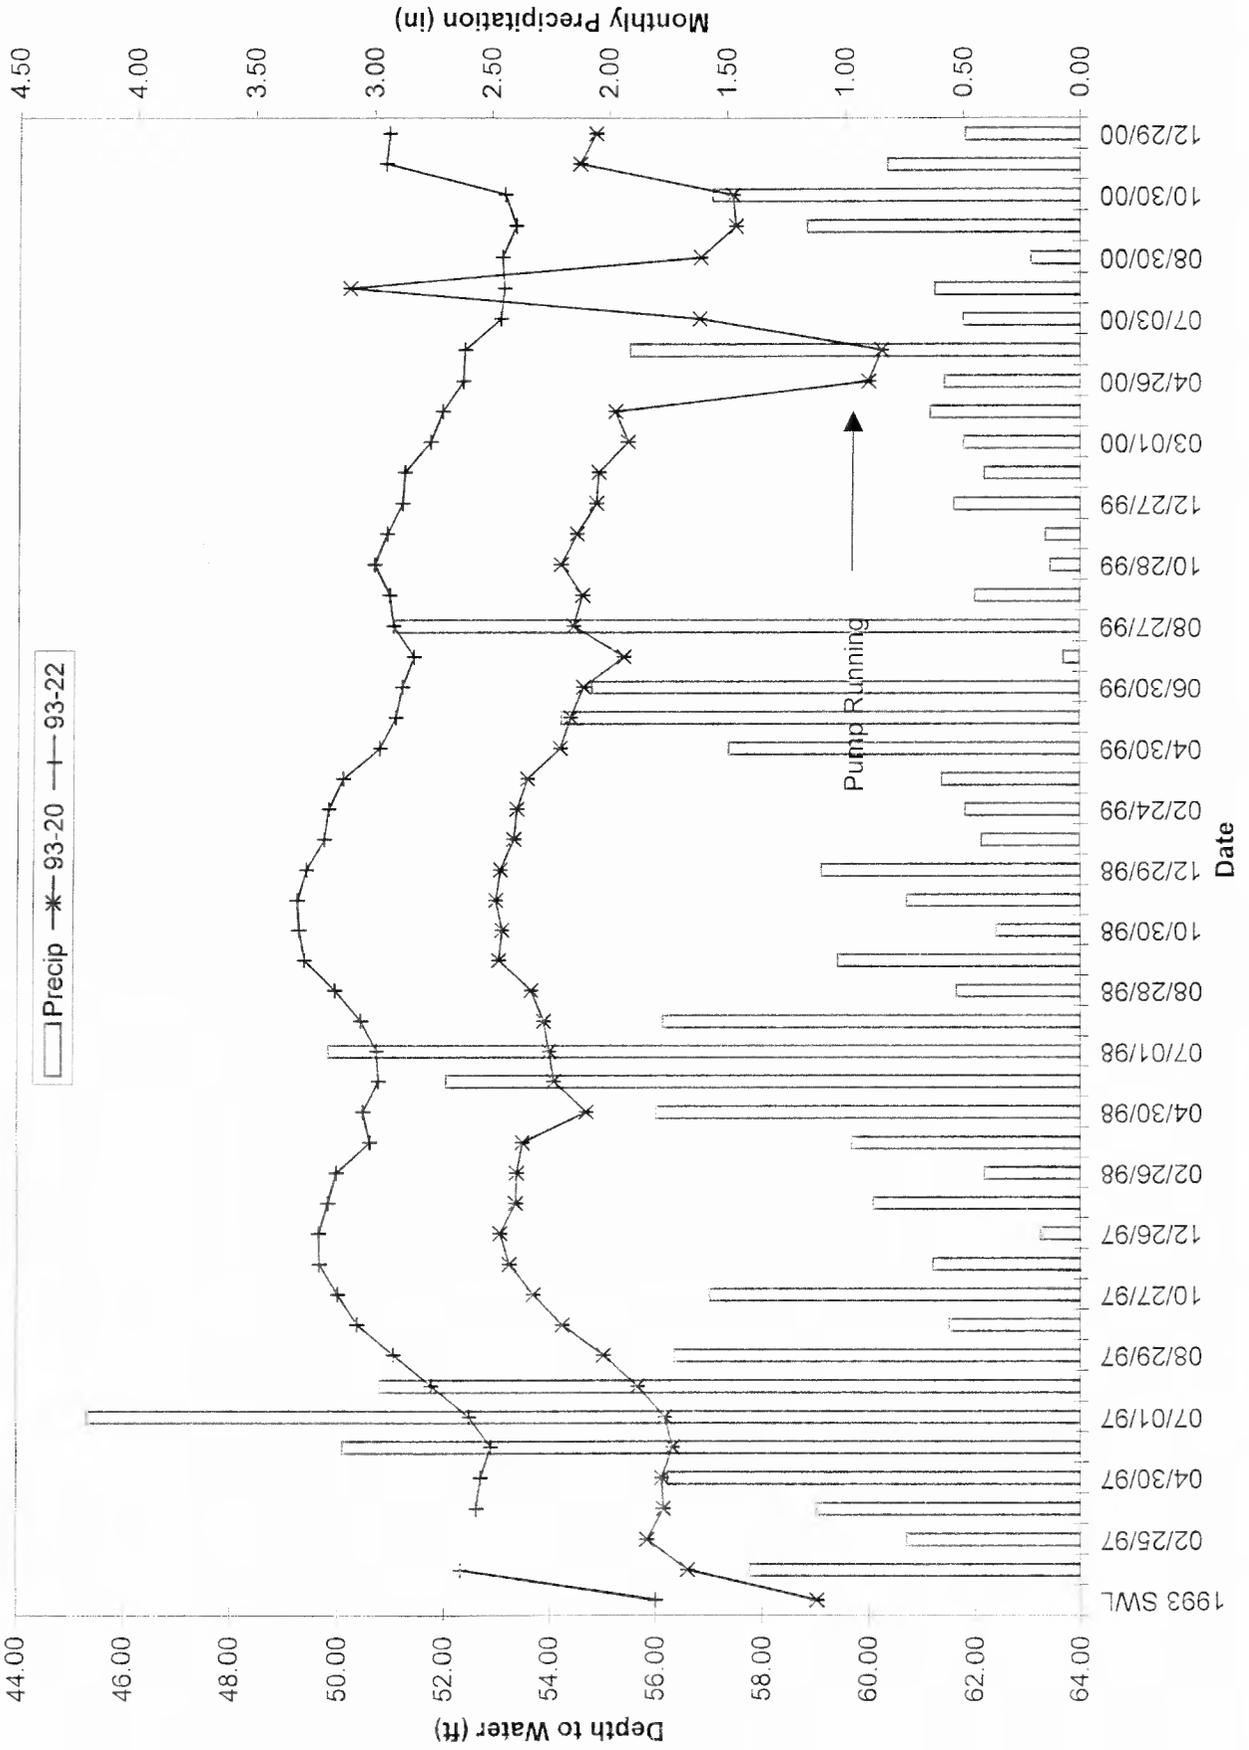
Figure 2-19. Water-level hydrograph for domestic wells 93-20 and 93-22.

The effects of precipitation are noticeable in wells 93-20, 22, 25, and 26 (figures 2-19 and 2-20). Water levels began to rise in the spring, one to two months after precipitation increased. They continued to rise through the fall before leveling off and falling during the winter. Water-level trends are very similar in each of these figures.

Total water-level changes vary from a decline of 1.92 ft to a rise of 5.06 ft, at wells 93-12 and 93-22 (excluding well 93-24). Similar to previous years, water levels have a net increase in wells to the east of Harrison Avenue and a decrease in areas west of Harrison Avenue. Figures 2-19 and 2-20 are hydrographs of domestic monitoring wells to the east of Harrison Avenue. The seasonal water-level changes are remarkably similar to those seen in other alluvial monitoring wells. Minimum water levels occur in early spring and maximum water levels occur in the late summer or early fall. No effects of the September 1998, Berkeley Pit landslide were seen in any of the domestic wells.

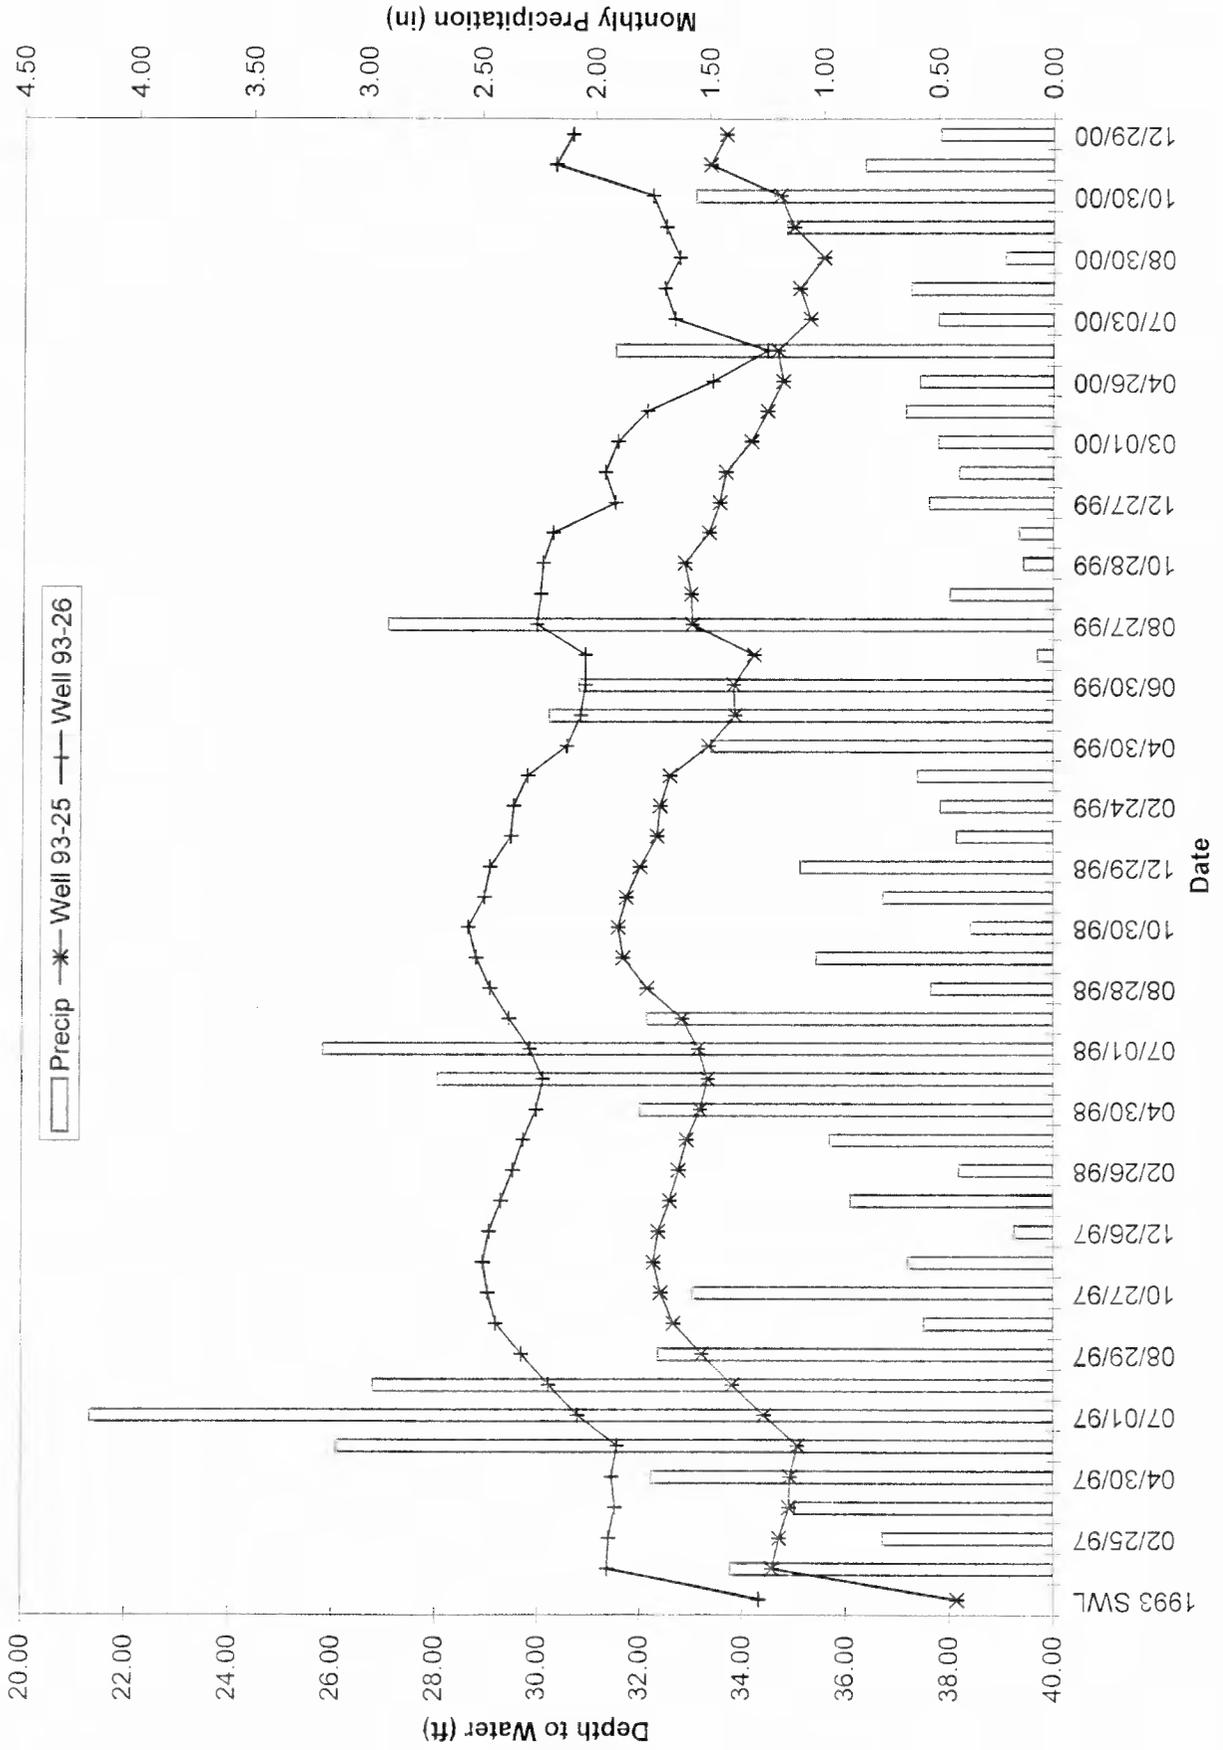
Figure 2-20. Water-level hydrograph for domestic wells 93-25 and 93-26.

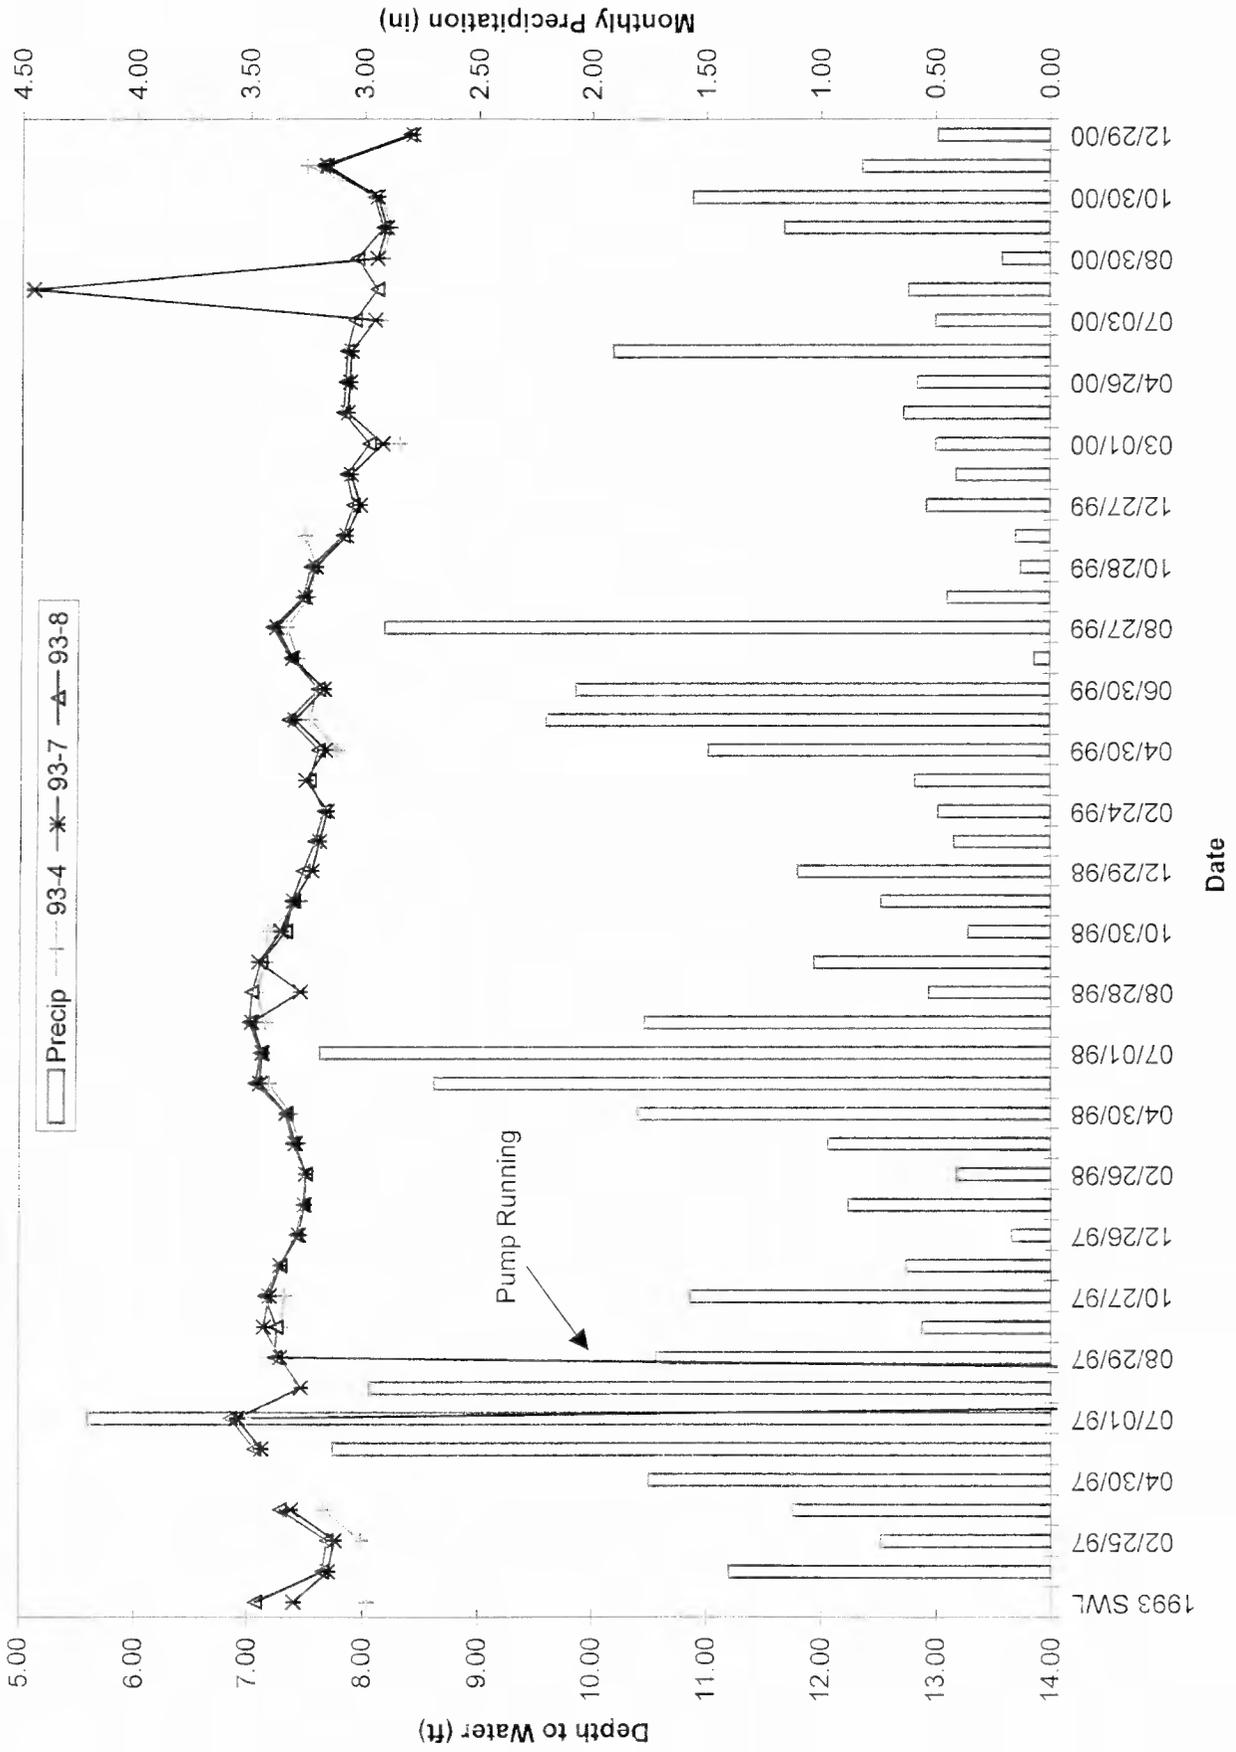
Figure 2-21. Water-level hydrograph for domestic wells 93-4, 93-7 and 93-8.

Figures 2-21 and 2-22 are hydrographs of selected domestic monitoring wells west of Harrison Avenue. One change was seen in these wells during 2000, that being at well 93-9 which had a water-level increase for 2000. The water level had declined in this well during the three previous years. The seasonal trends are similar to the other alluvial water levels, however, just not as pronounced.

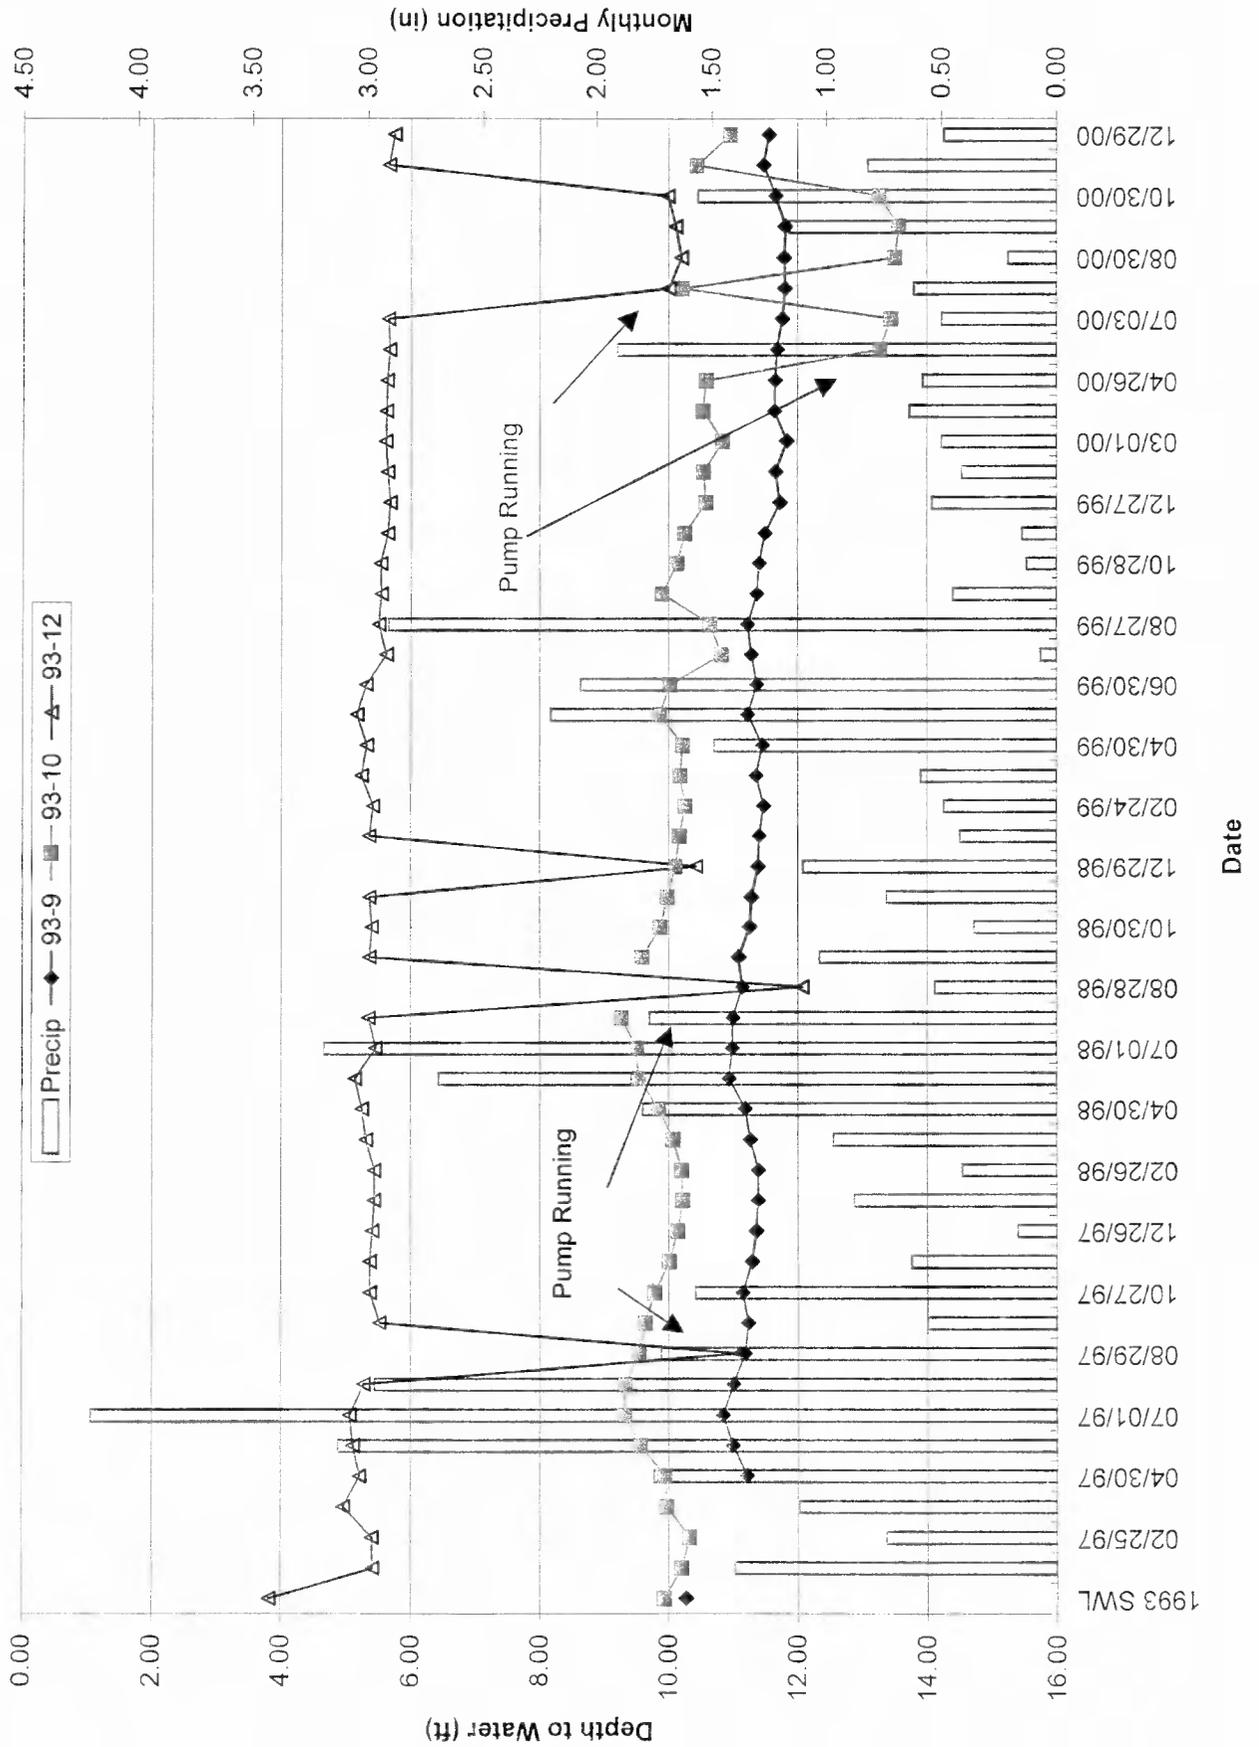
Figure 2-22. Water-level hydrograph for domestic wells 93-9, 93-10, and 93-12.

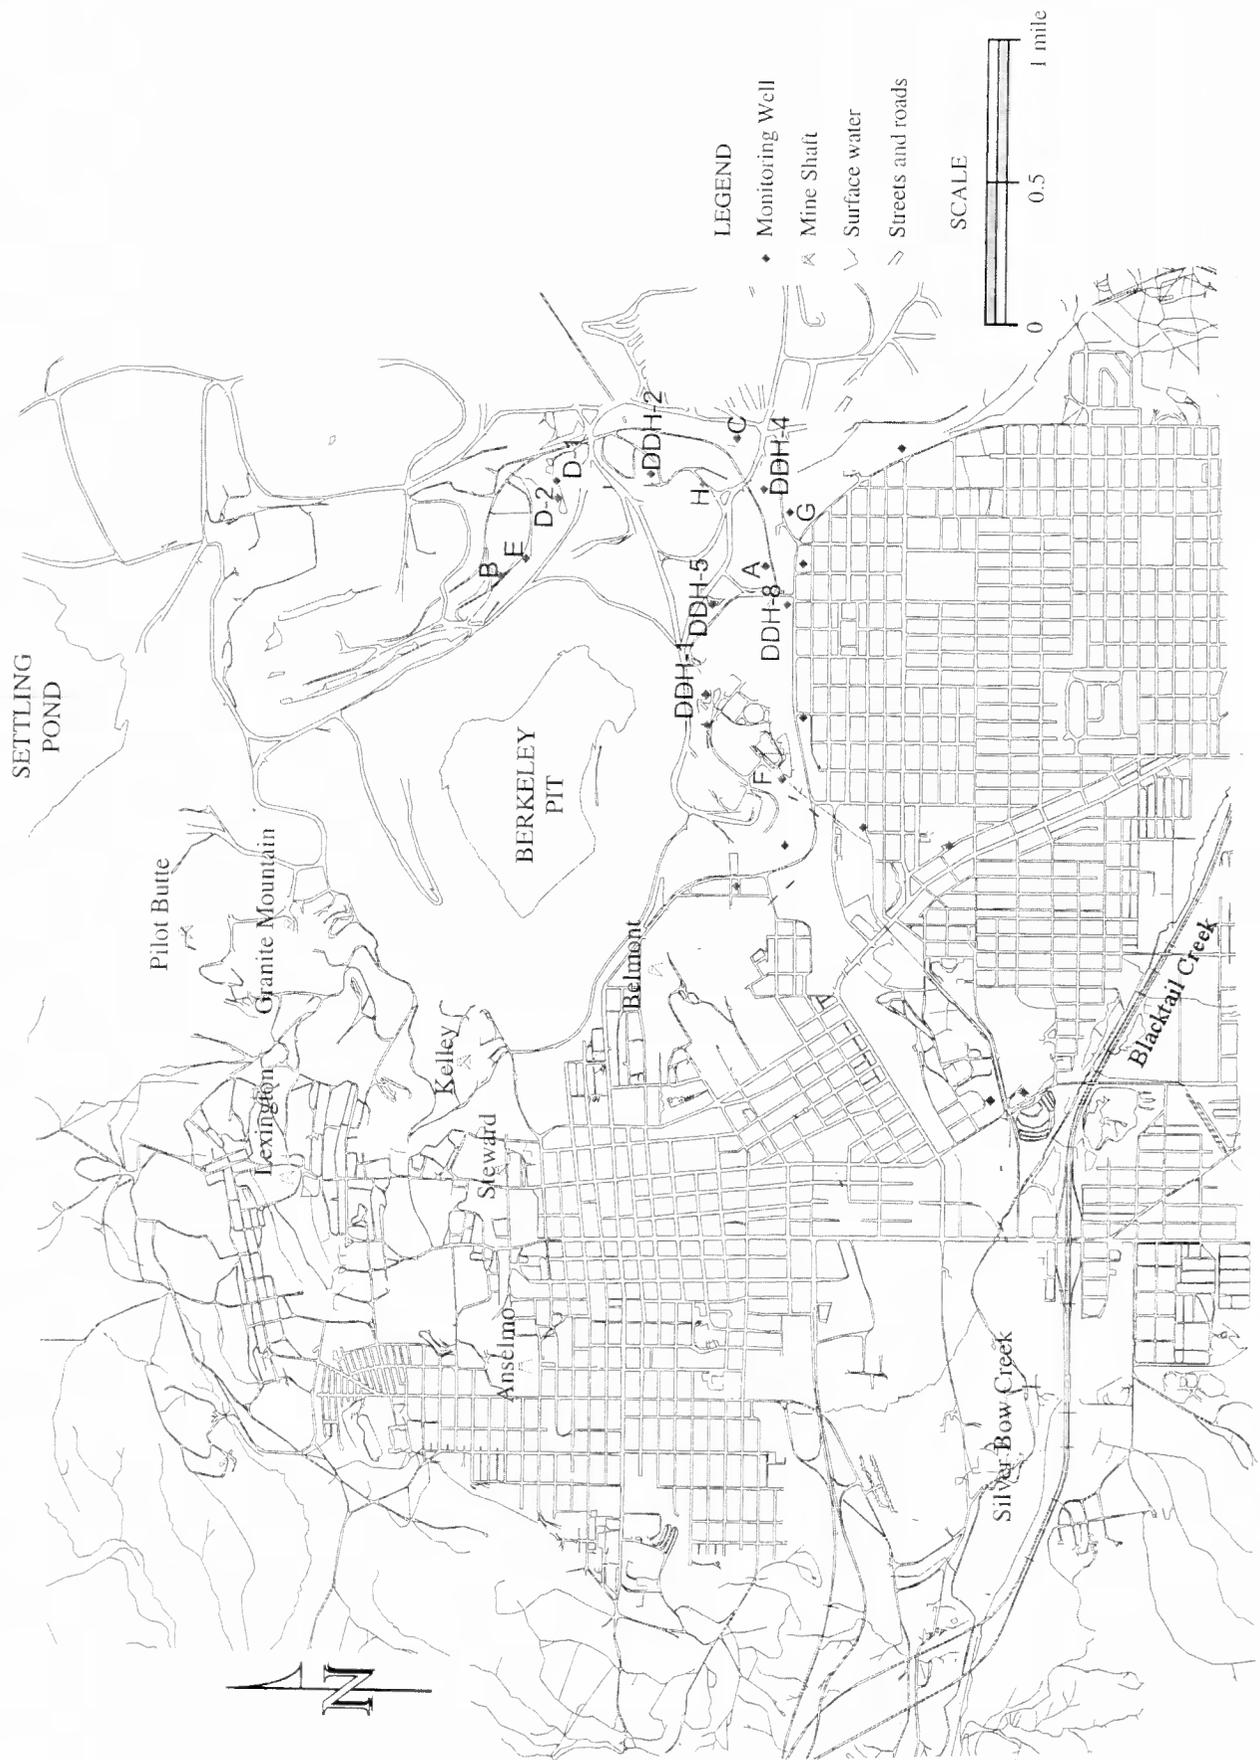
Figure 2-23. East Camp mines and RI/FS bedrock wells location map.

Monitoring of water levels in the seven East Camp underground mines continued. Their locations are shown on figure 2-23. During the year 2000, water levels rose between 14 and 16 ft in the mines, while the Berkeley Pit water level raised 16.97-ft, Table 2.2.1. Figure 2-24 shows the annual water level changes graphically.

Activities then shifted to cleaning and redevelopment of well D-2. This well is located near well D-1, figure 2-23. Wells D-1 and D-2 had been drilled as a nested pair, with D-2 being the deeper well. Initial cleaning of this well followed the same methods used for wells A and D-1 blowing with air, followed by pumping. Since this well was drilled deeper than D-1 a different design was used from that of the other wells. The stainless steel casing suspended from the suspension ring (540-ft) reduces to a smaller diameter casing at a depth of 660-ft below ground surface. The tremie pipe was too large to fit below this reduction in casing at 660-ft; therefore, no redevelopment took place in the screen interval of this well. Follow-up work with the downhole
