**Montana Bureau of Mines and Geology
Open File Report No. 435**

**The Flooding of Butte's Underground Mines and Berkeley Pit
Butte Mine Flooding Operable Unit
Annual Water-Level Update, 2000**

**Terence E. Duaine
and
John J. Metesh**

**Prepared for
The Montana Department of Environmental Quality
Remediation Division
and
U.S. Environmental Protection Agency
Region VIII**

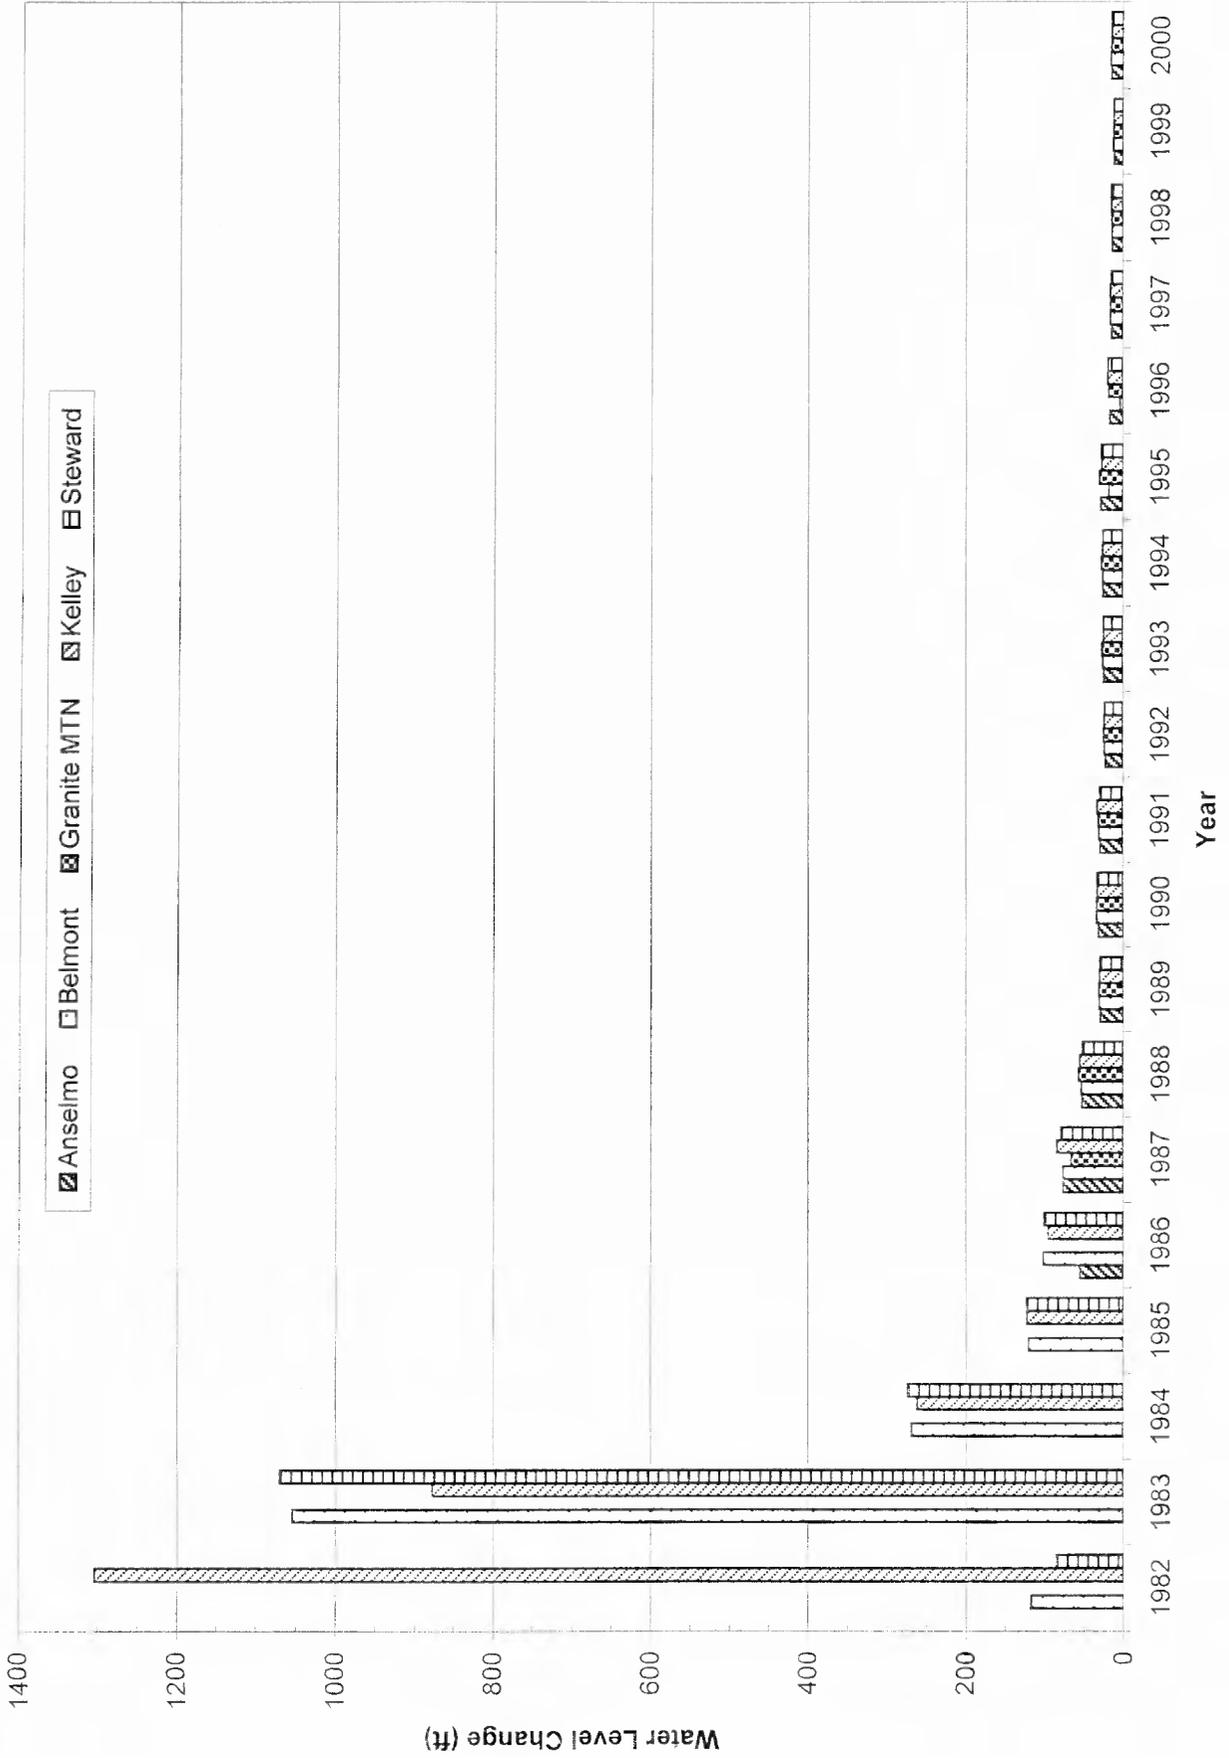
Figure 2-24. East Camp mines annual water-level changes.

Monitoring of water levels in the seven East Camp underground mines continued. Their locations are shown on figure 2-23. During the year 2000, water levels rose between 14 and 16 ft in the mines, while the Berkeley Pit water level raised 16.97-ft, Table 2.2.1. Figure 2-24 shows the annual water level changes graphically.

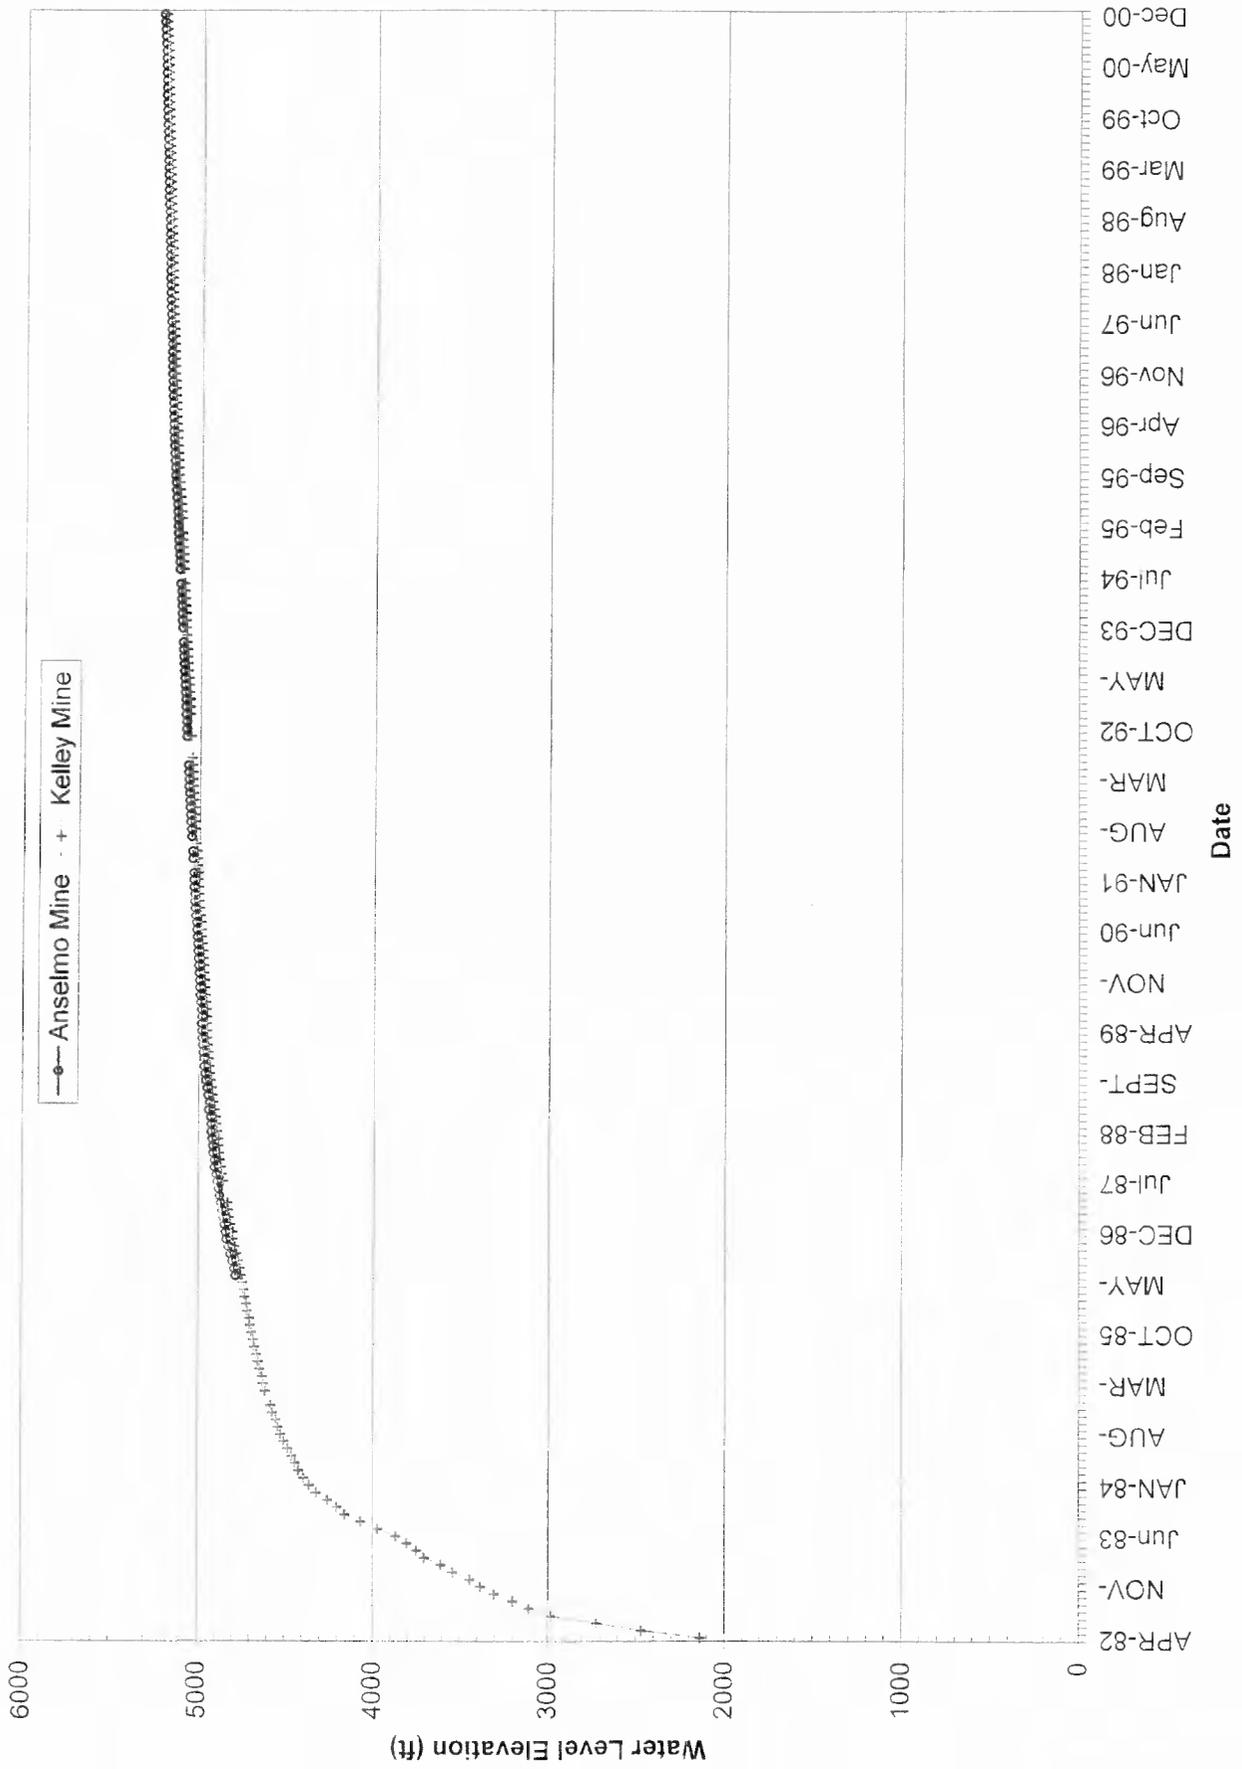
Figure 2-25. Water-level hydrographs for the Anselmo Mine and Kelley Mine.

Figure 2-25 is a hydrograph based upon water levels for the Anselmo Mine and Kelley Mine. There is no obvious change in water levels on this figure; however, changes are noticeable during the last 6 months of 2000 on a hydrograph based on water levels from 1995 through 2000 (figure 2-26). The addition of HSB drainage water into the pit is responsible for this change. Figure 2-27 shows monthly water-level changes in the Berkeley Pit during 2000. Water-level changes the last 6 months of 2000 were twice those of the first 6 months. A similar trend was seen in all the East Camp underground mines. Water levels remain the highest in the sites farthest from the Berkeley Pit. This continues to confirm that water is flowing towards the pit, thus keeping the pit the low point in this system.

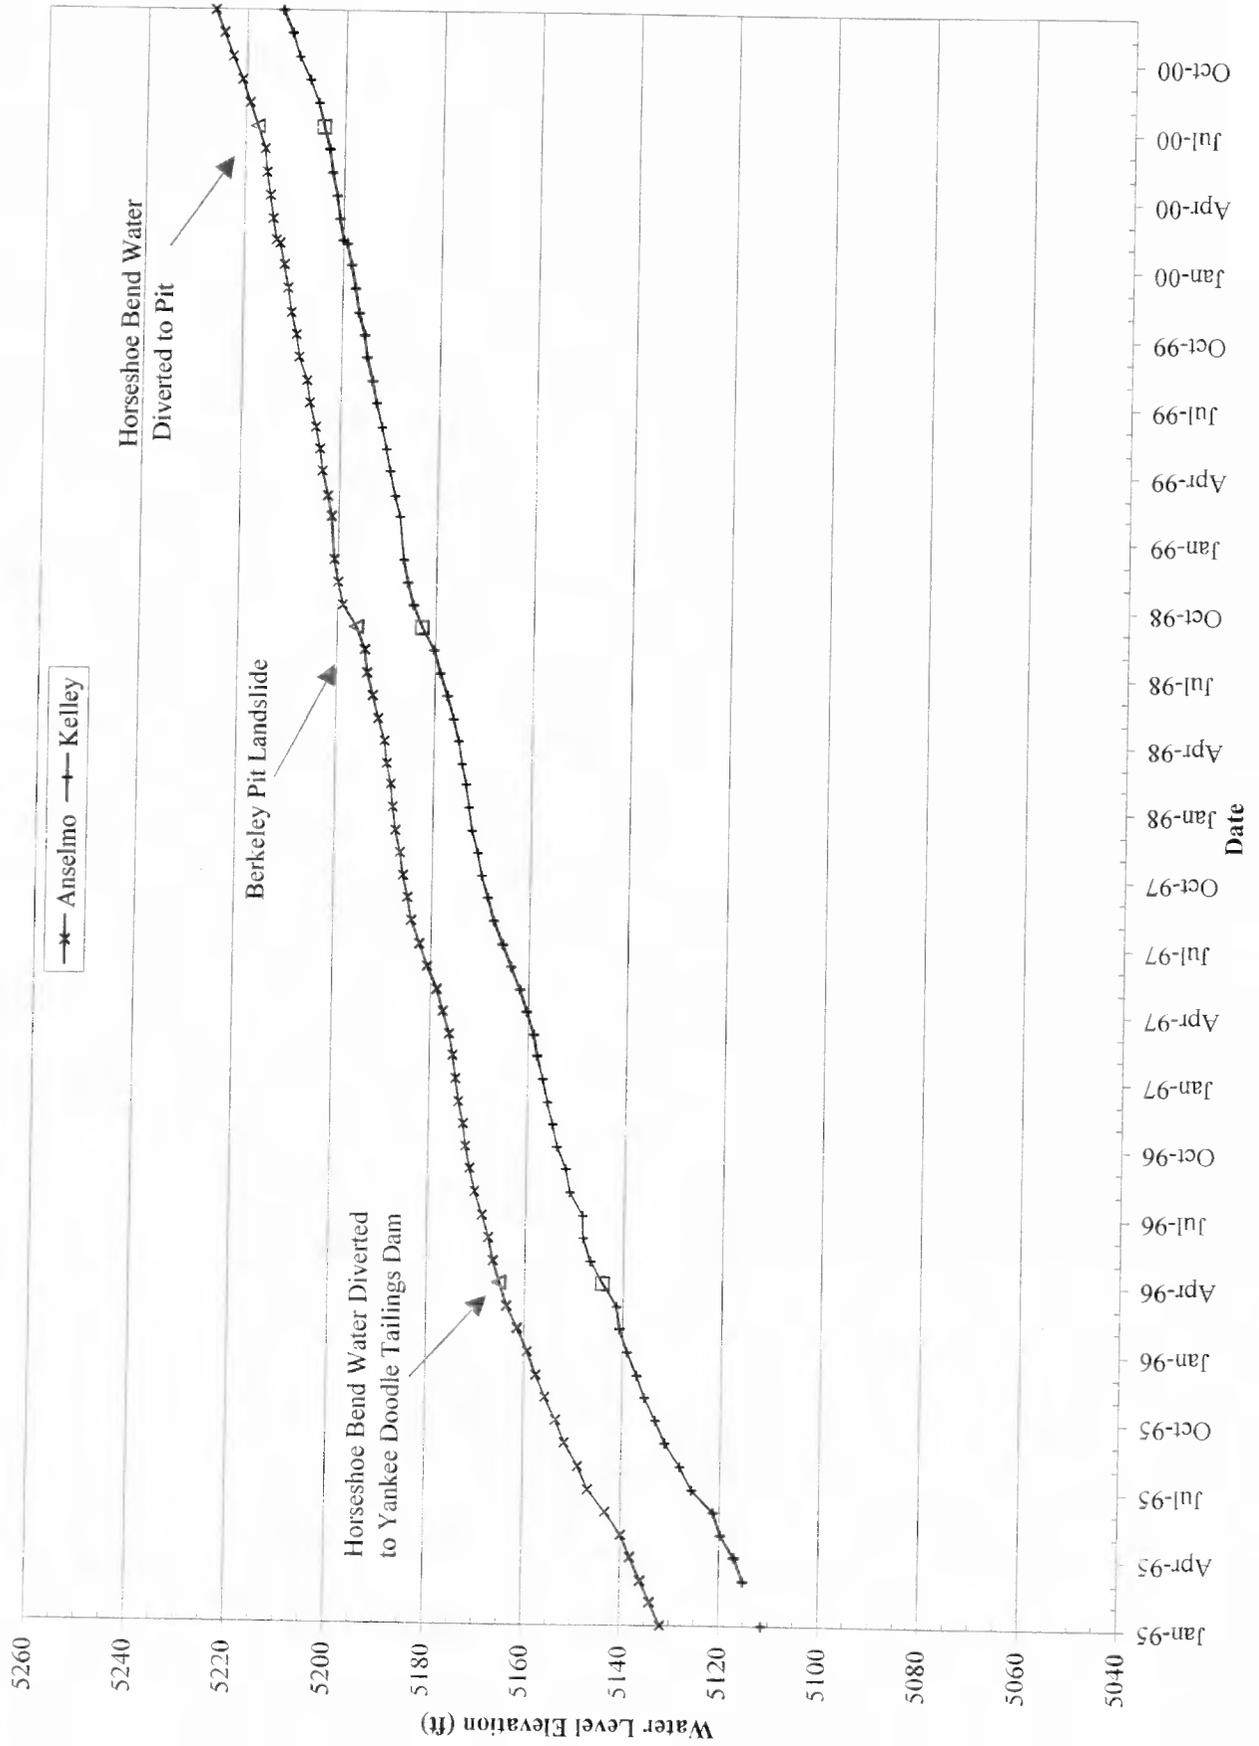
Figure 2-26. Water-level hydrograph, 1995-2000, Anselmo Mine and Kelley Mine.

Water levels appear to have continued to rise in a similar trend. However, a hydrograph prepared using water levels from 1995 through 2000 shows both the 1996 and 2000 HSB operational changes (figure 2-26). The April 1996 diversion of HSB water is responsible for the flattening of the rise, while the 2000 addition of HSB is responsible for the increased rate of rise. This same trend is seen in the Berkeley Pit water-level rise (figure 2-27). The 1998 Berkeley Pit landslide is also noticeable on this figure.

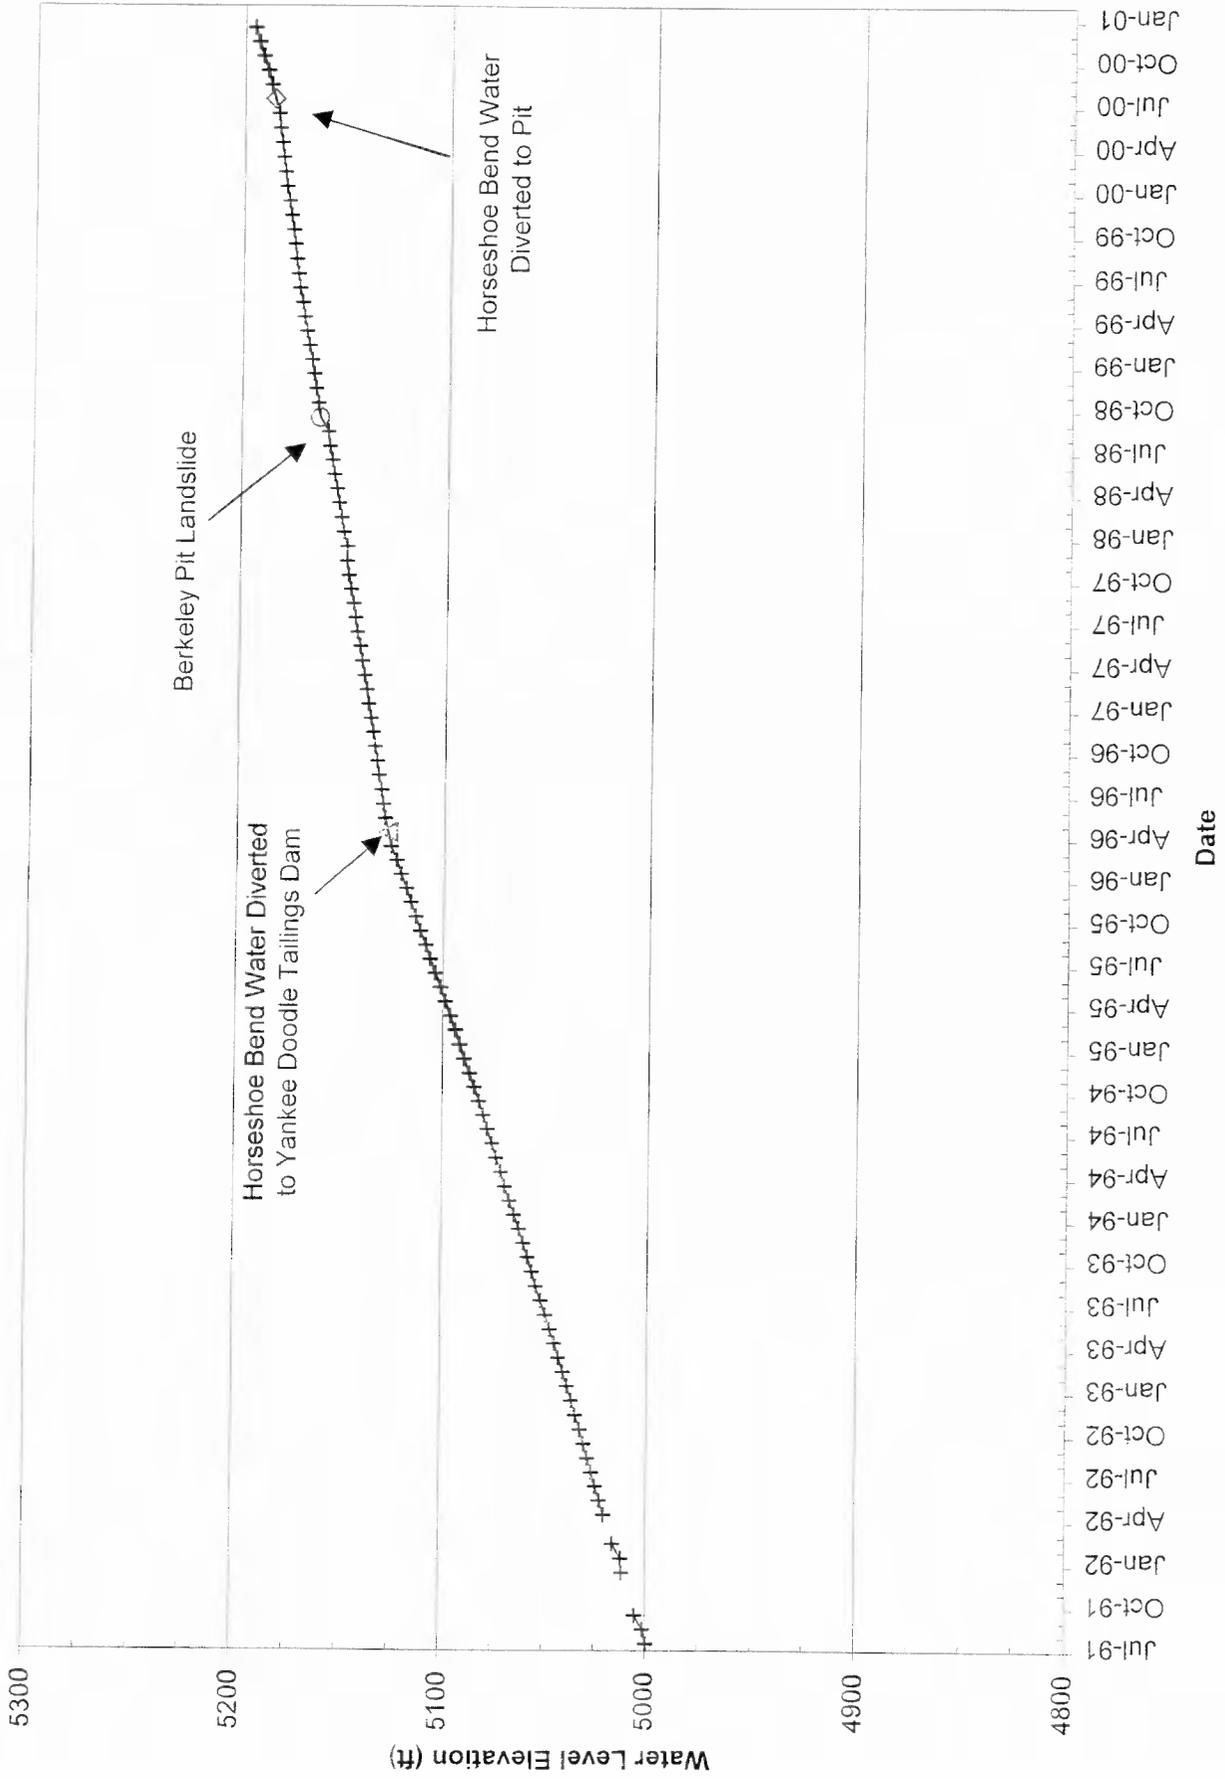
Figure 2-27. Water-level hydrograph for the Berkeley Pit.

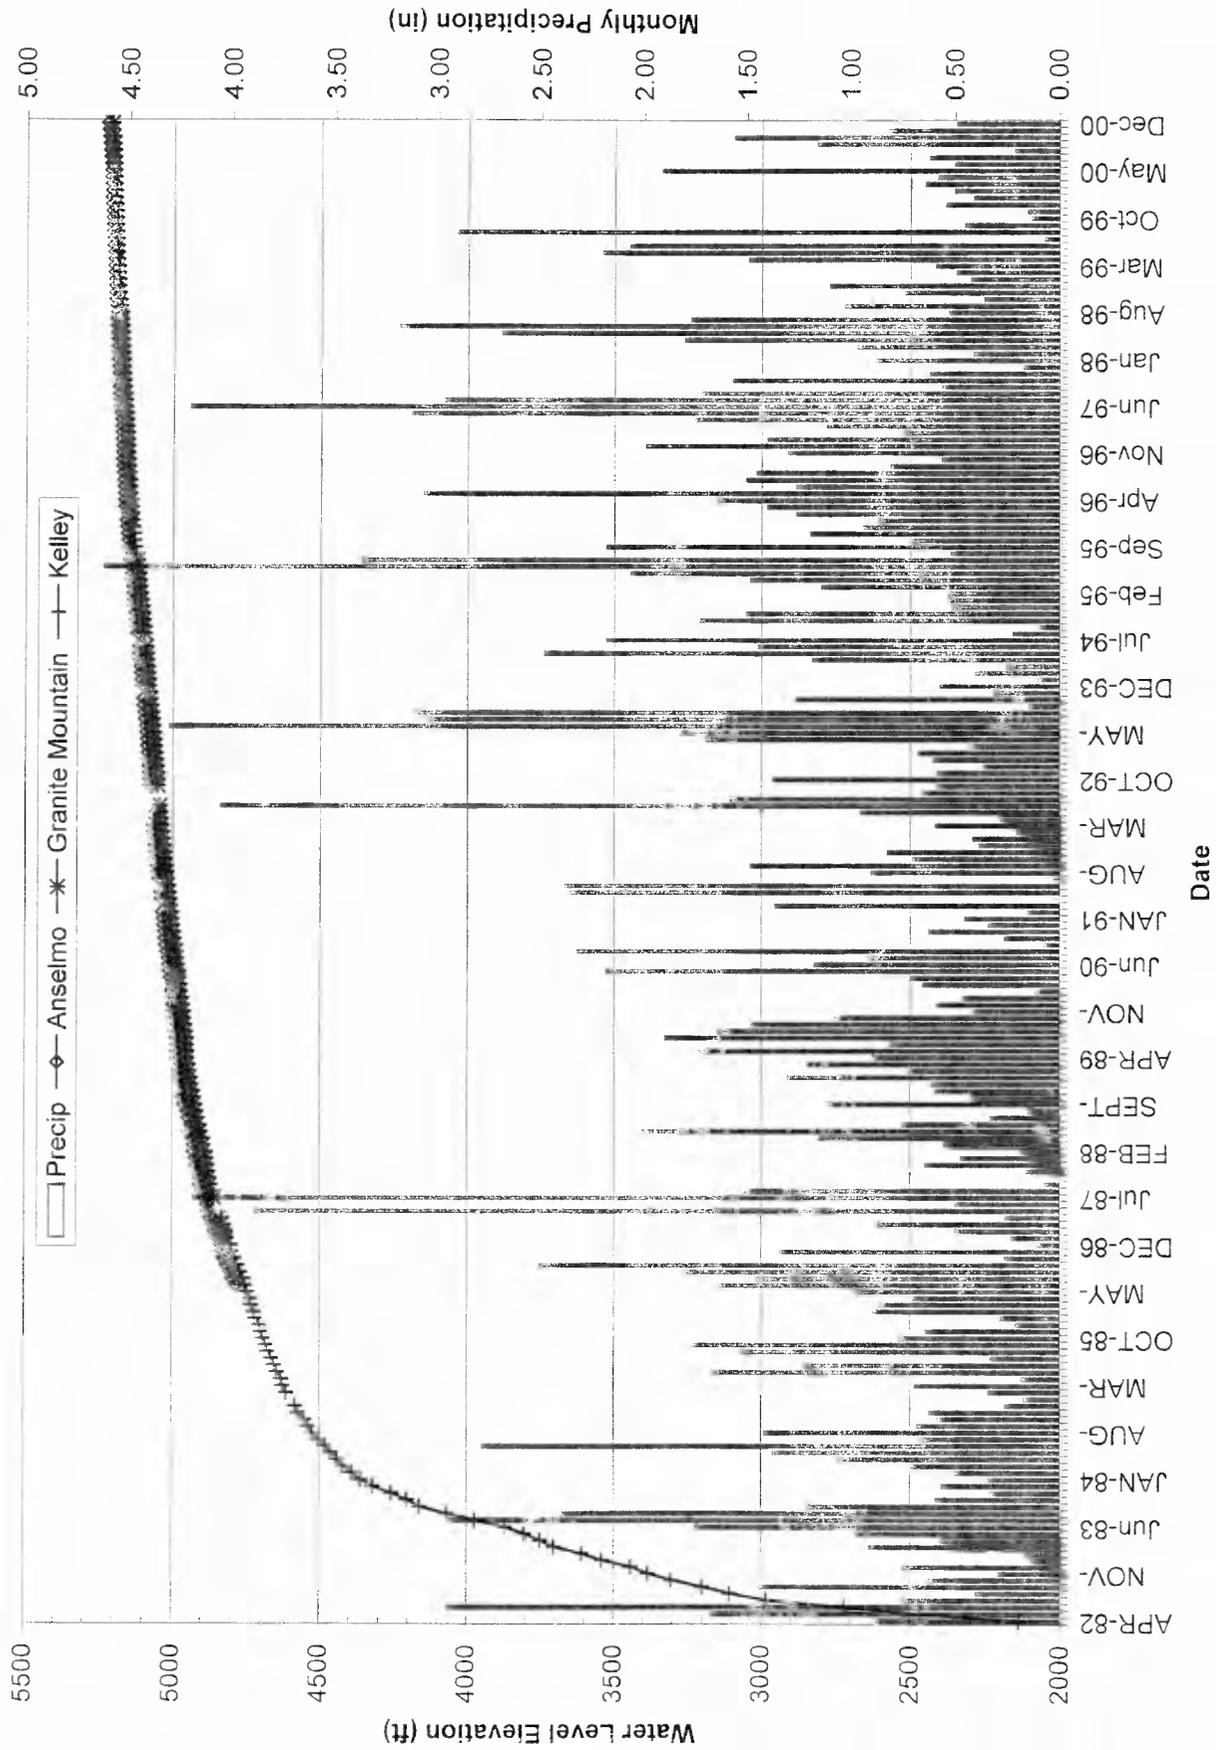
Figure 2-28. Water-level hydrographs for selected East Camp mine shafts, with precipitation.

Figure 2-28 is a plot of selected mine-shaft water levels versus precipitation. There is no apparent influence on water levels in the underground mines from monthly precipitation. It is obvious that the rise in water levels is a function of historic mine-dewatering activities and the void areas in the underground mines and Berkeley Pit, and is not a function of precipitation.

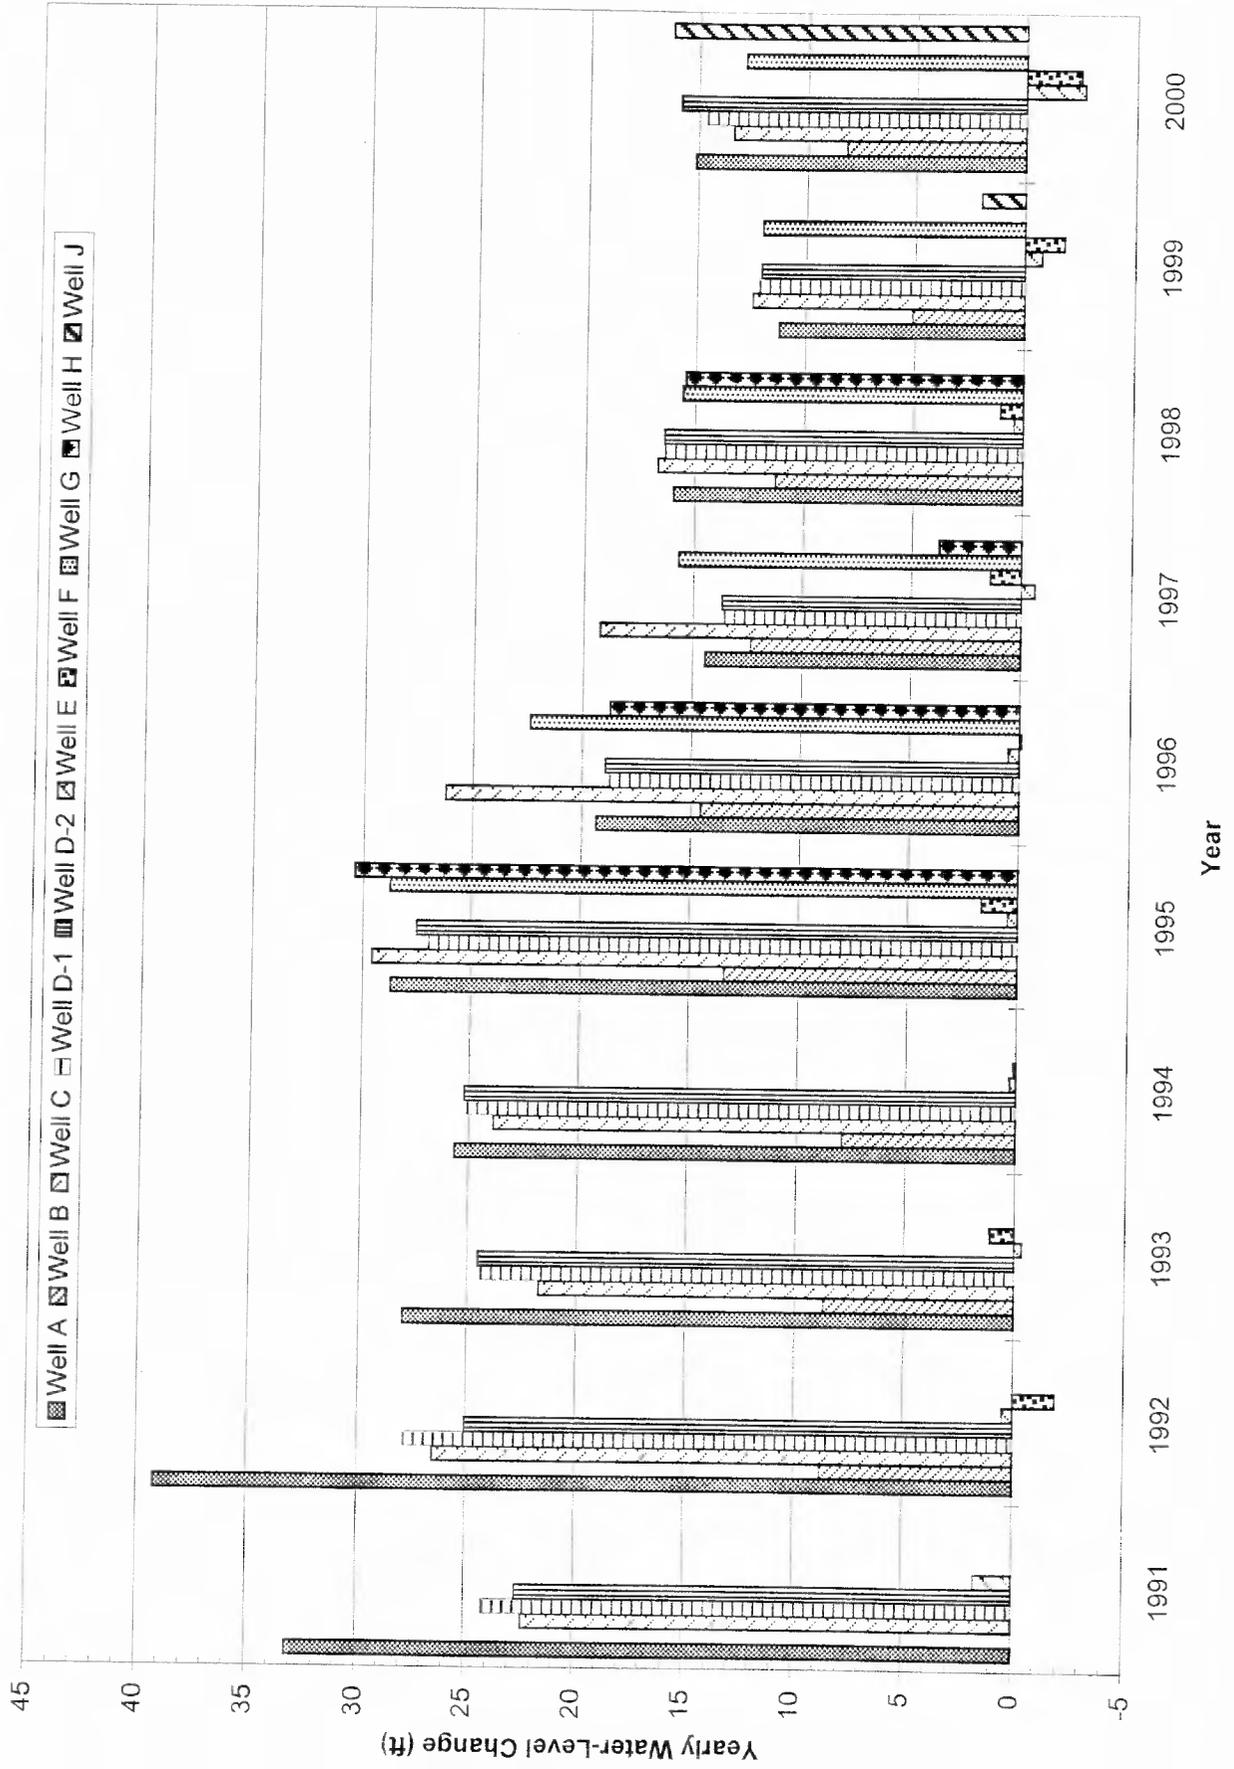
Figure 2-29. RI/FS bedrock wells annual water-level change.
