**Use of Aeration to Control Copper Corrosion  
in a Small Public Water System, in  
Florence, Montana**

*MBMG 400A*

Prepared for the Drinking Water Assistance Program  
Montanan State University  
October 2000

# Use of Aeration to Control Copper Corrosion in a Small Montana System

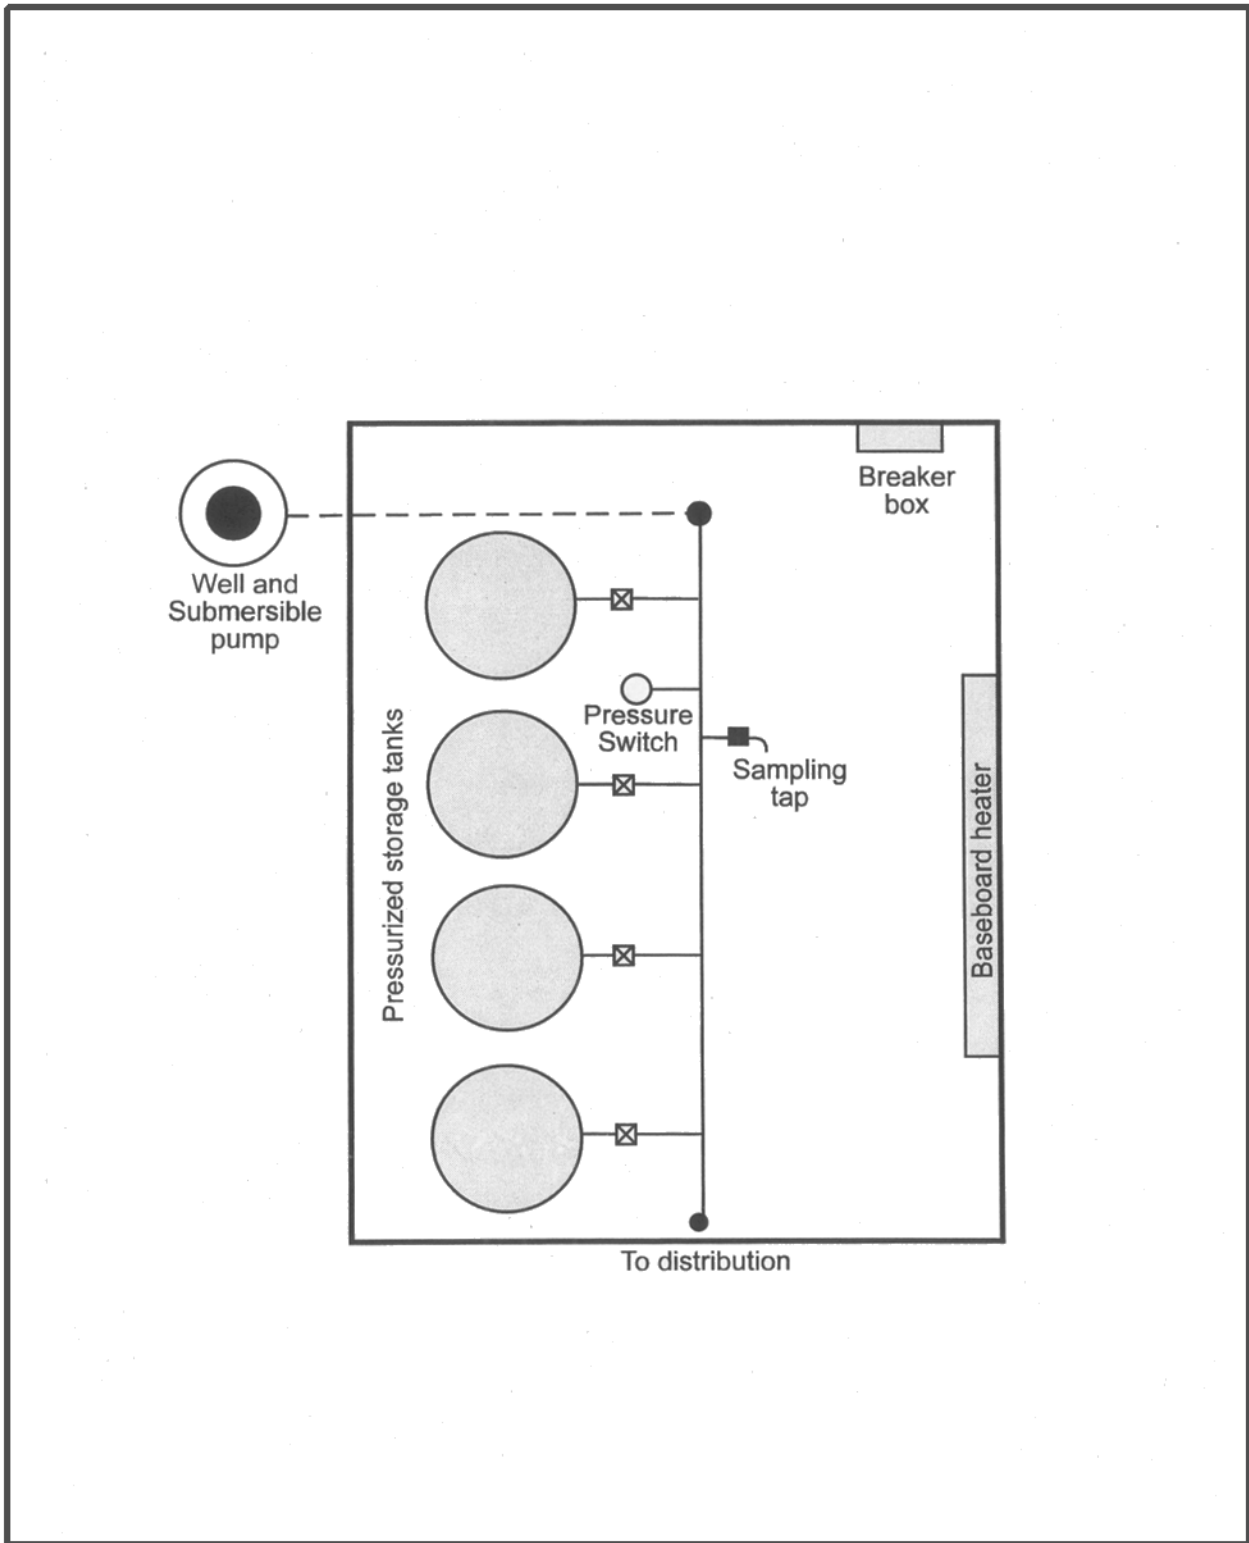
**Figure 2.** Schematic of the Forest View Homeowners Association pumphouse prior to expansion to accommodate the aeration system.

**Installation of the treatment system.** The pumphouse was enlarged to twice its original size in December 1997; much of the labor was contributed by the homeowners. Figure 4 is a schematic of the pumphouse after the installation (compare to figure 2, which is a schematic prior to the installation). System installation was completed in February 1998 and treatment of the ground water began on February 16, 1998.
