SELECTED HYDROGRAPHS OF THE COLSTRIP AREA

by
 Wayne A. Van Voast and Jon C. Reiten
 1988

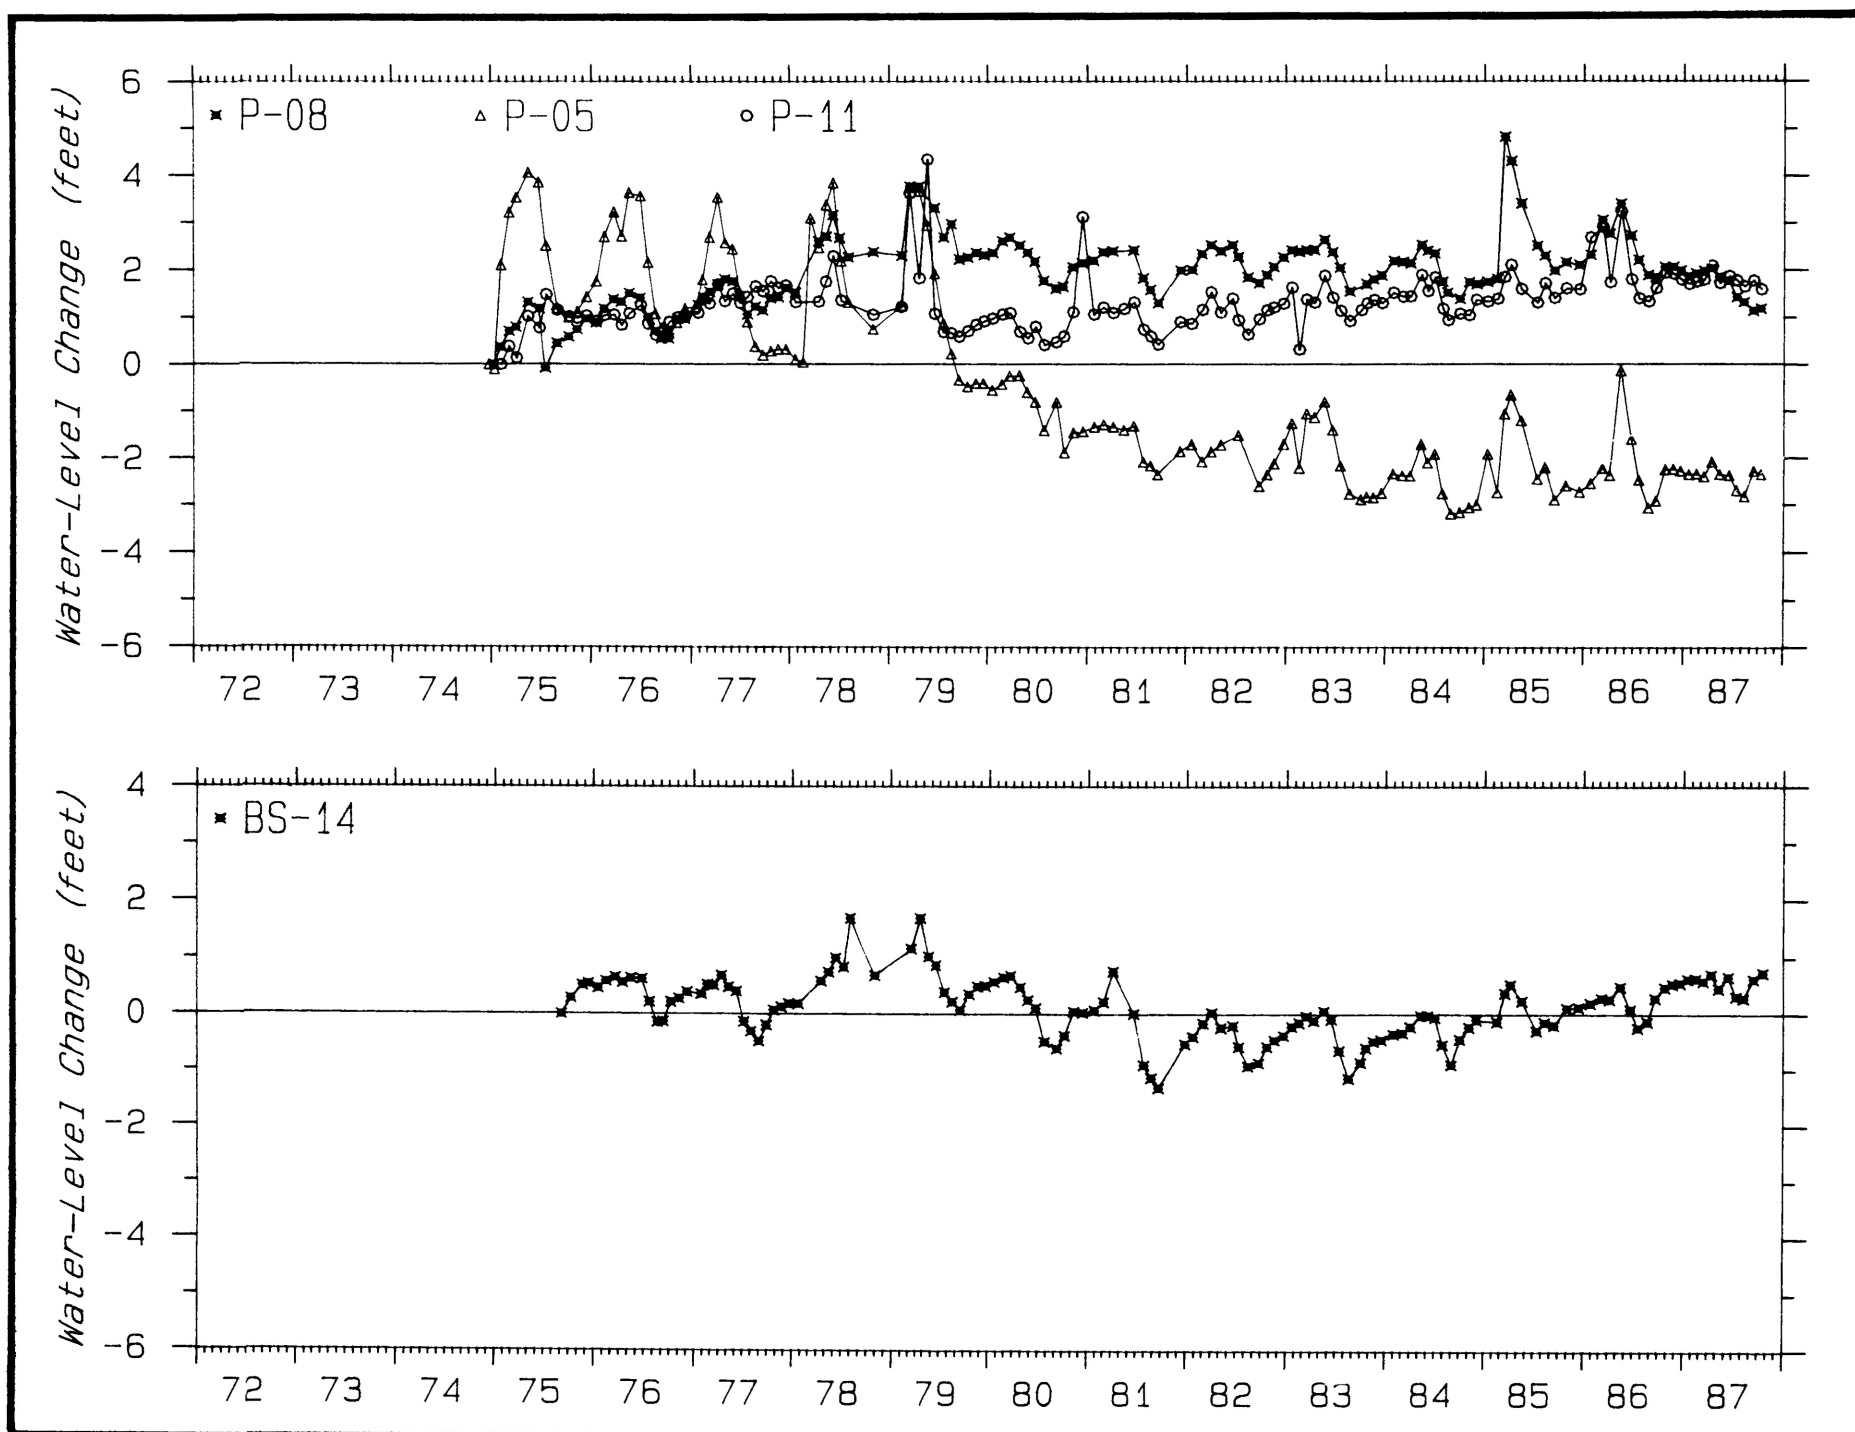
HYDROGRAPH 1 Along East Fork Armells Creek, the water table upstream (P-08) and downstream (P-11) from mining activities has not been affected, near the mines (P-05), the water table has dropped about 3 feet. The water table near the Big Sky mine (BS-14) has not significantly changed.

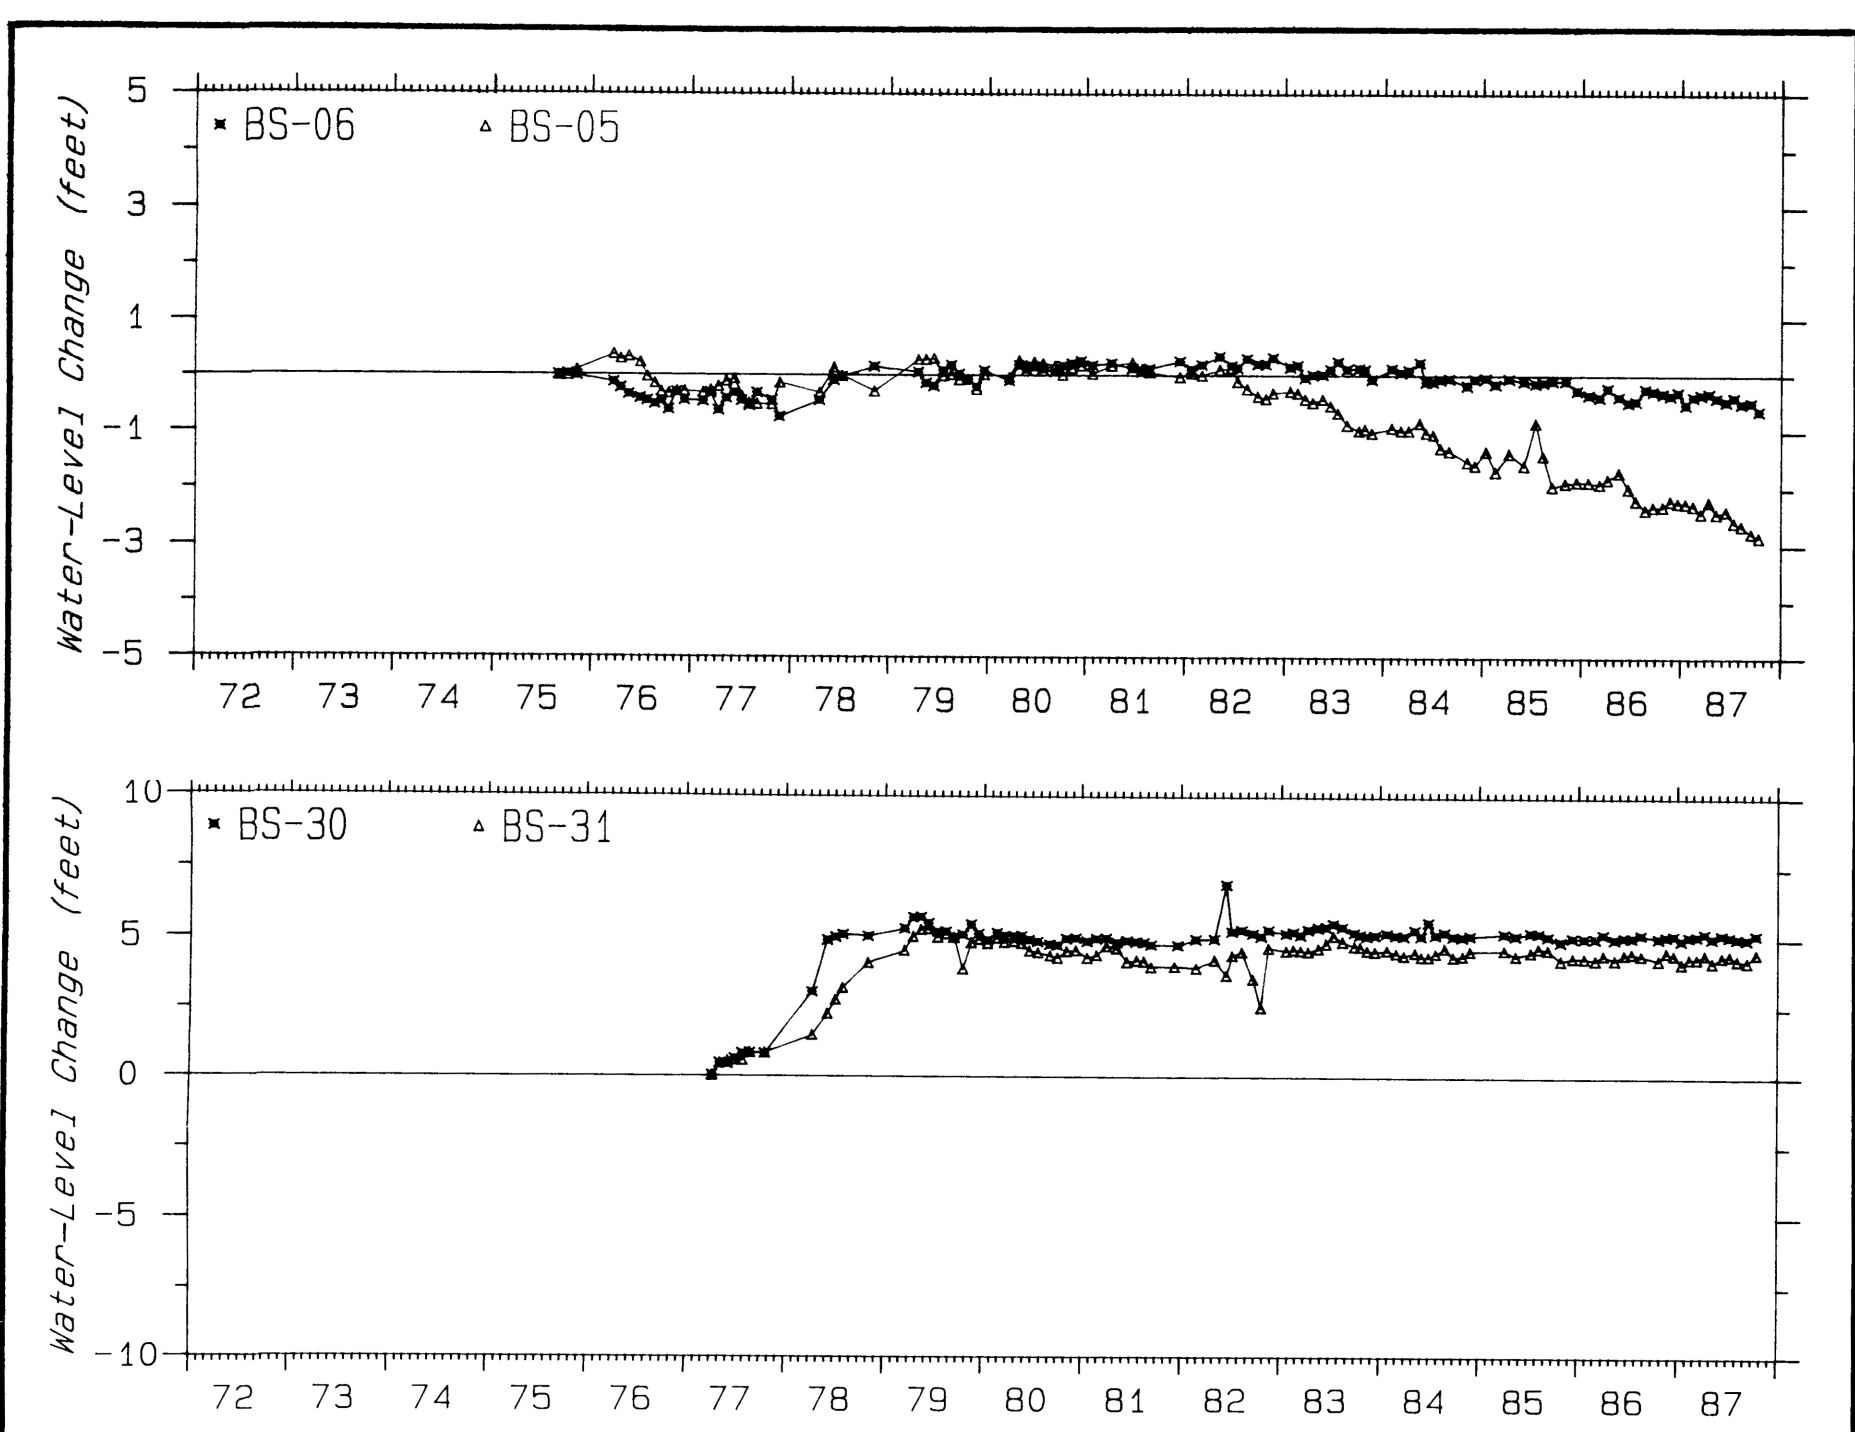
HYDROGRAPH 3 At the Big Sky mine, the Rosebud and McKay beds are being mined, and water levels for both beds are declining, effects on the McKay coal bed (BS-05) are greater. Where the mine pits have been back-filled, nearby water levels in the Rosebud coal bed (BS-30, BS-31) have recovered, perhaps to pre-mining levels.
