# Abandoned-Inactive Mines on Lolo National Forest-Administered Land

## Open-File Report MBMG 476 April 2003

Prepared for the U.S. Department of Agriculture  
Forest Service-Region 1

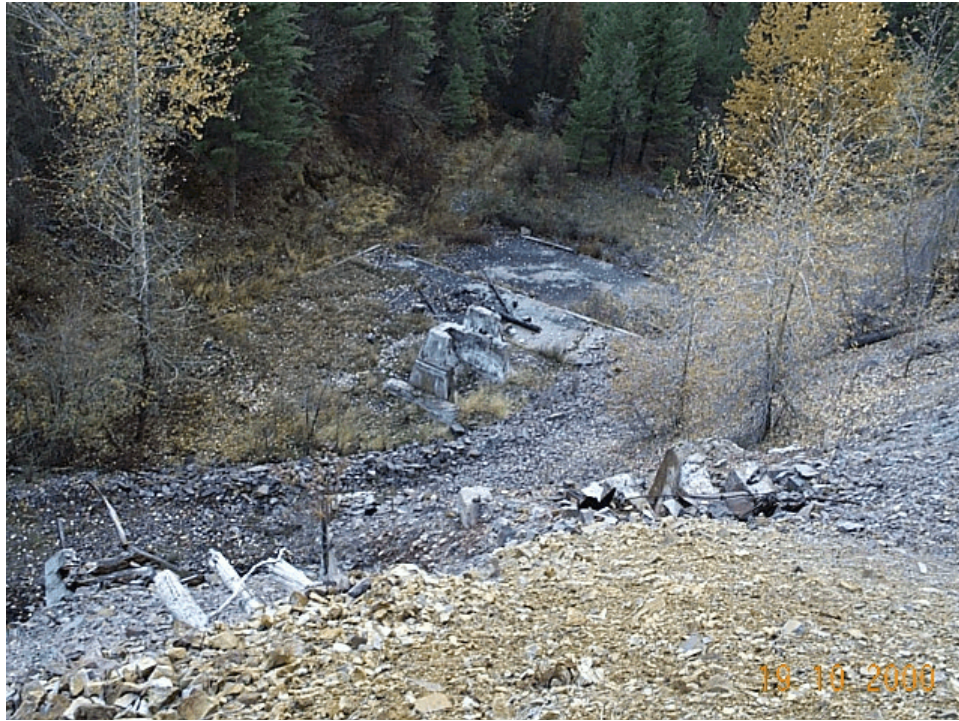
**Figure 7a.** East Fork of Brewster Creek mill site looking to the west, as mapped on 10/20/00. Only the concrete foundations remain. The creek flows from left to right in the upper portion of the photo.

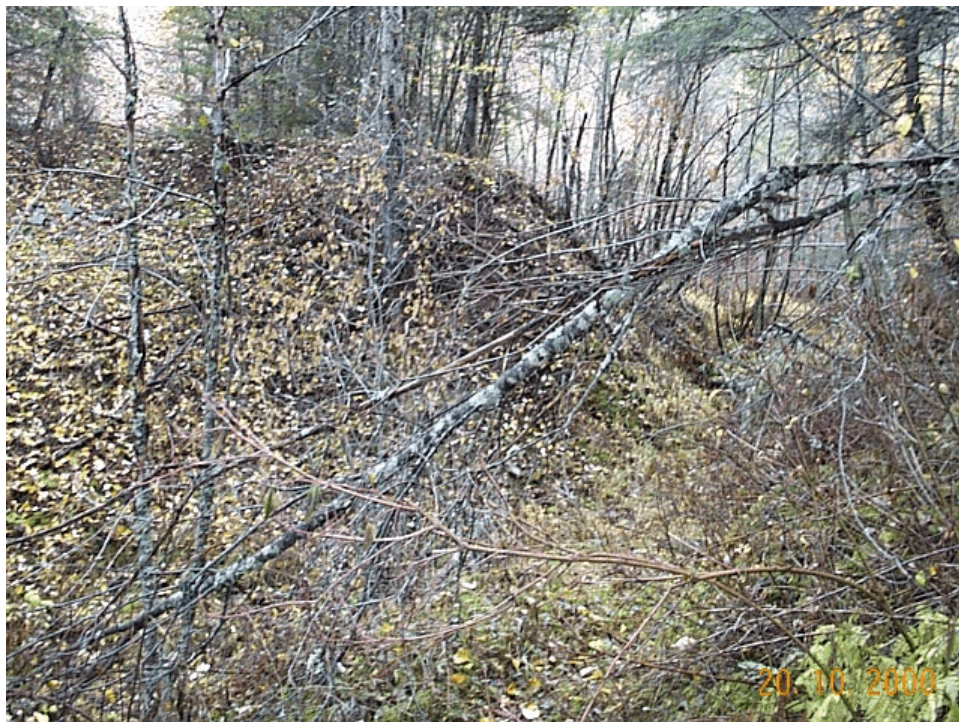
**Figure 7b.** The tailings-pond dam at the East Fork of Brewster Creek mill site was breached, as mapped on 10/20/00.

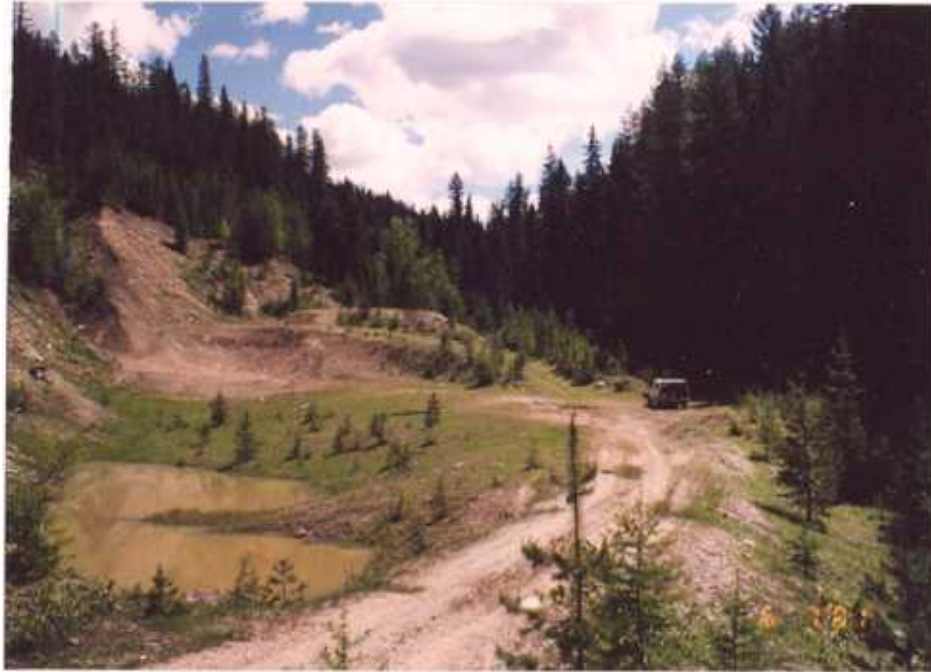
**Figure 9a.** An overview of the Frances Copper Mine shows the open cut and the small pond (in the left foreground). The waste-rock dumps are off the photo to the right.

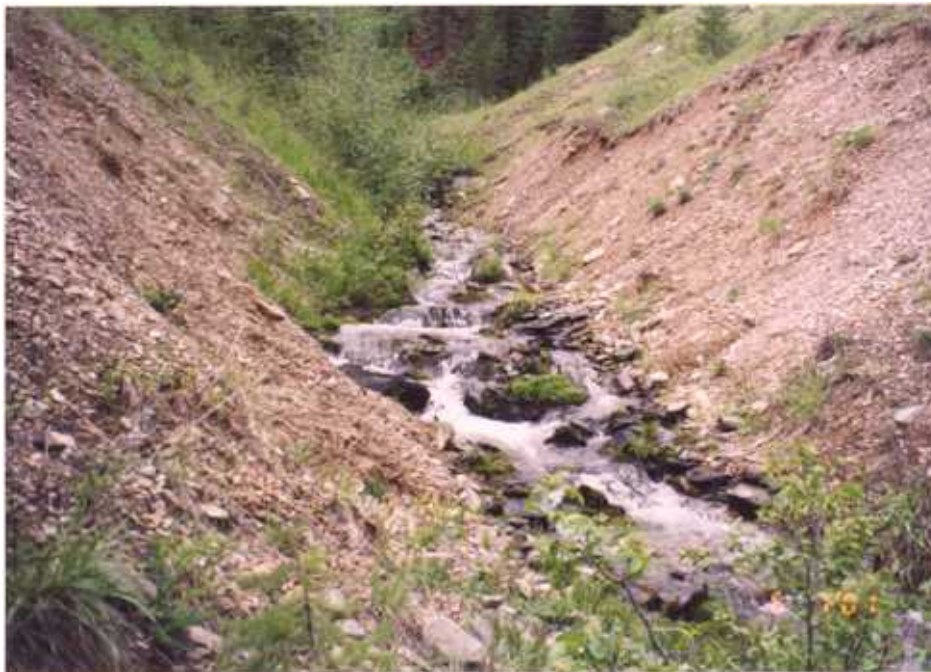
**Figure 9b.** The East Fork of St. Louis Creek actively erodes the waste-rock dumps along both sides.

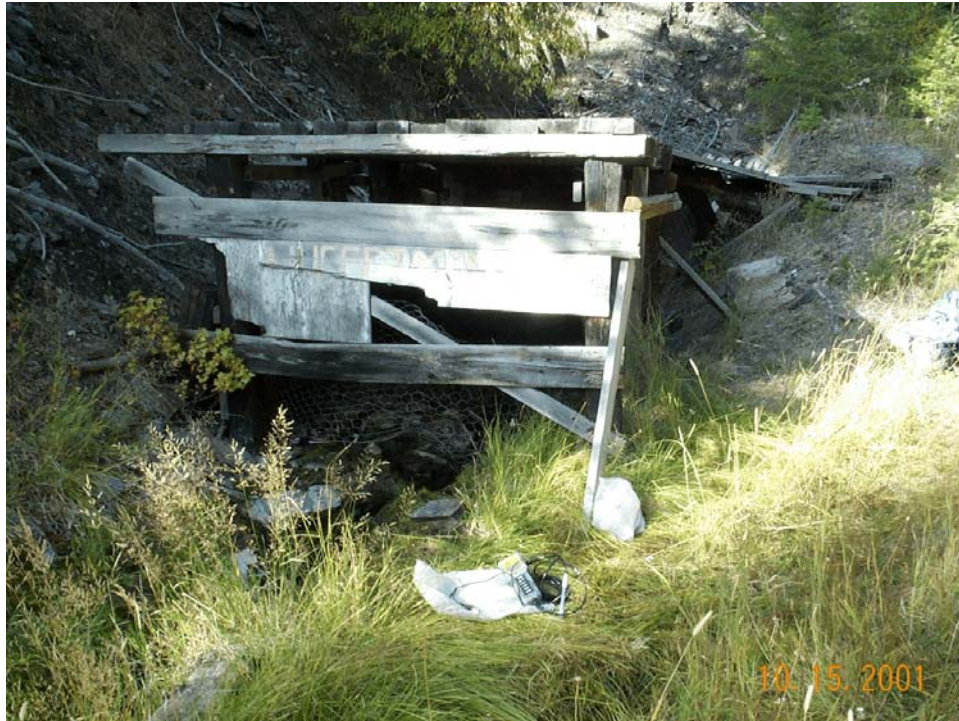
**Figure 10a.** The Nugget Mine adit where the discharge was sampled (KNGS10H).

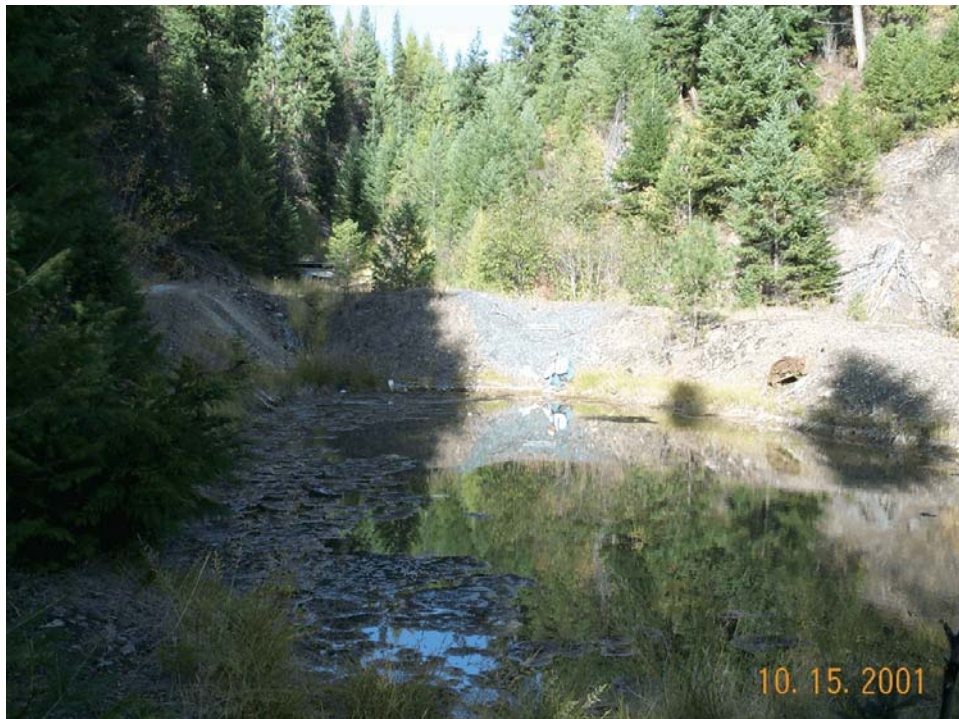
**Figure 10b.** The Nugget Mine waste rock surrounds a settling pond located downgradient from the discharging adit. Discharge from the pond flows into Kennedy Creek.

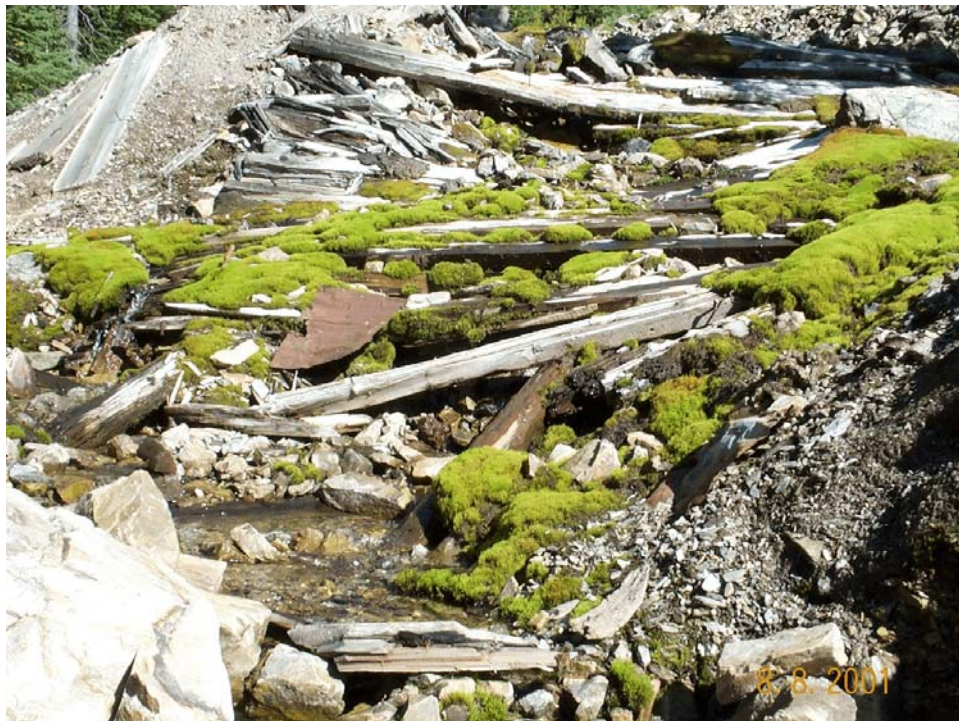
**Figure 12a.** The Silver Cable Mine's waste rock was being eroded into the roadbed, but the road was on the patented claim.

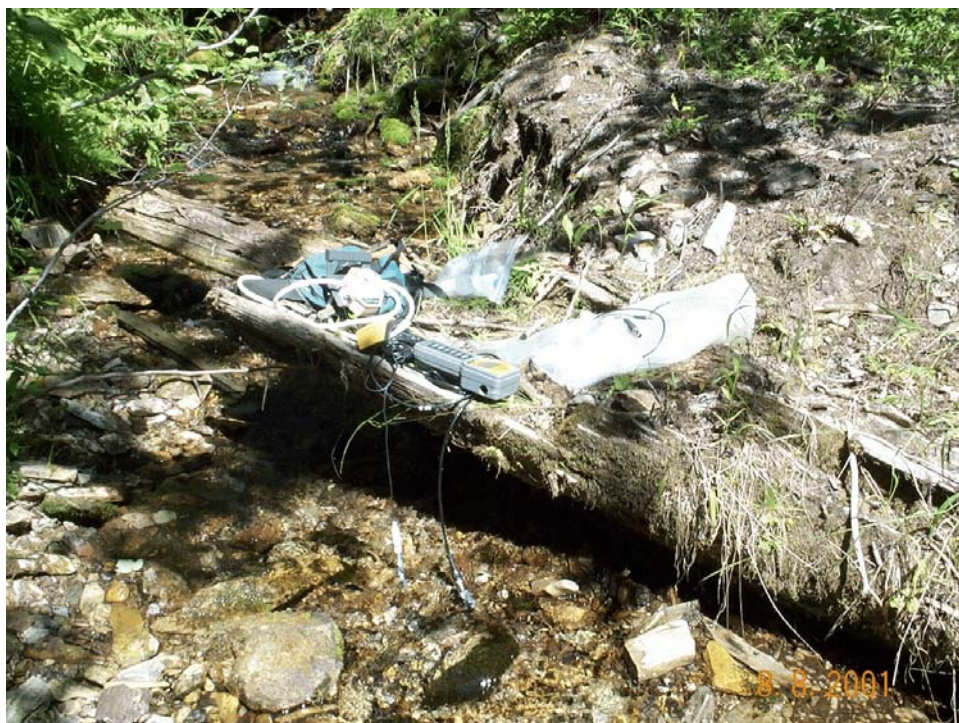
**Figure 12b.** The Silver Cable Mine sample site (BSCS10L) on Brimstone Creek, downstream from the mine site.

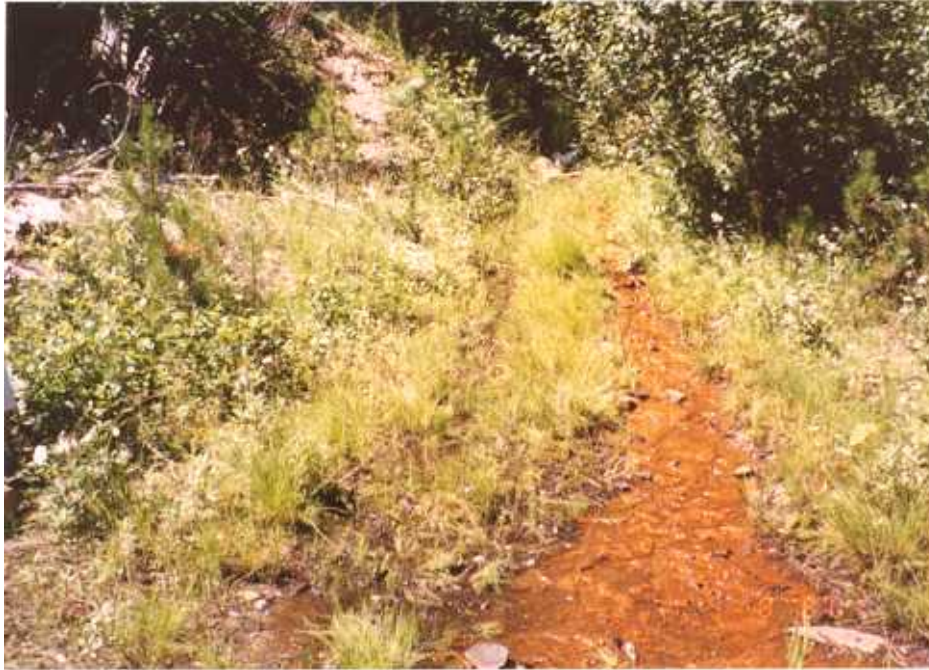
**Figure 13a.** The Last Chance adit discharged a flow that stained the channel a bright orange color.

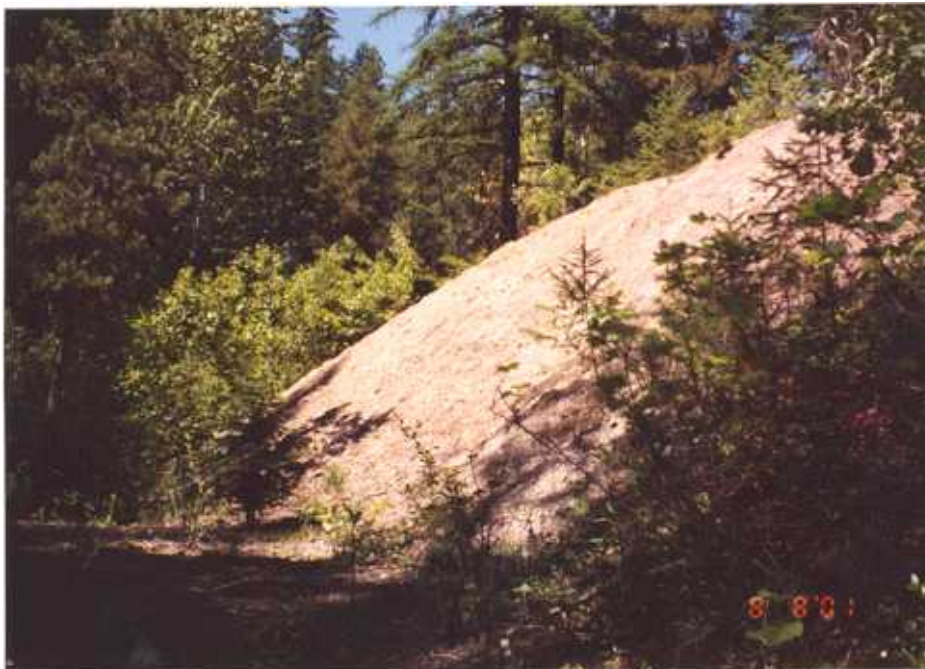
**Figure 13b.** The Last Chance waste dump had a low probability of failure on most slopes but was being undercut on the east side by Last Chance Creek.

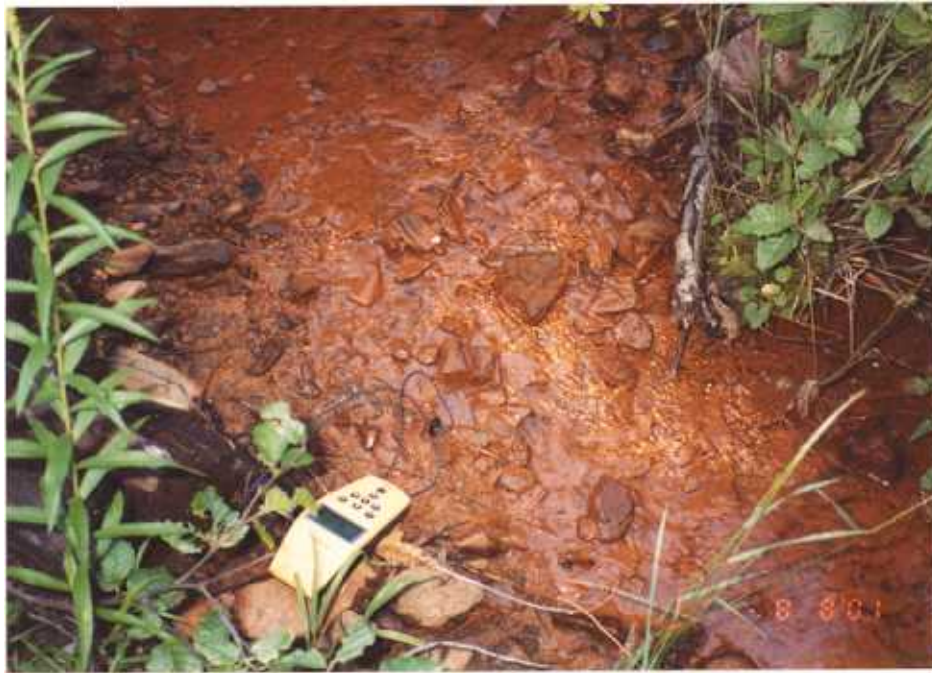
**Figure 15a.** The West Fork of Packer Creek, downstream of the Tarbox mine site, had an orange- stained substrate resulting from iron oxides. The waste-rock dump as well as the discharges were upstream from this sample site.

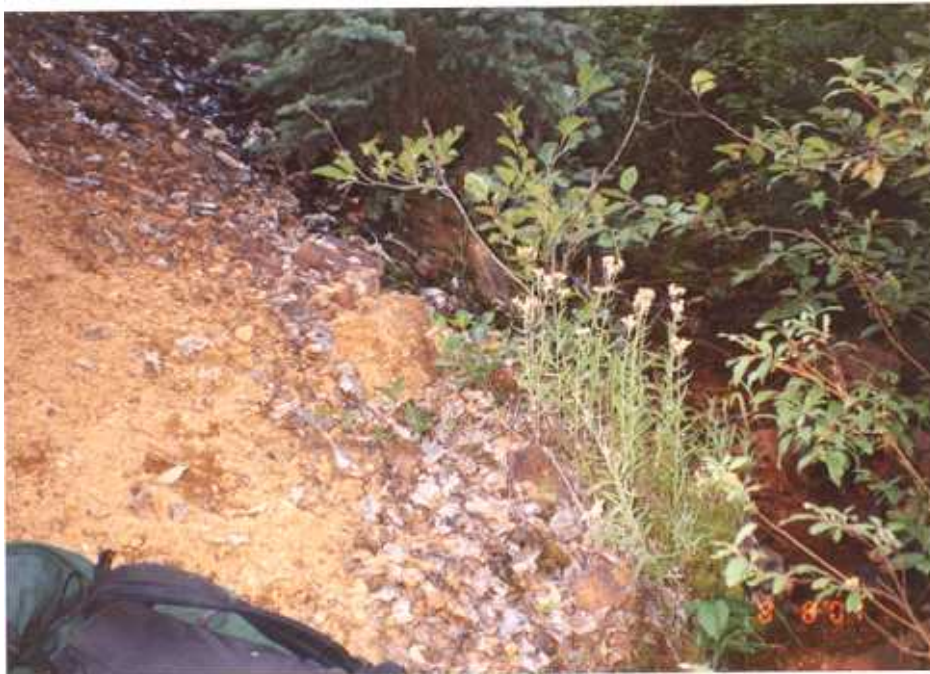
**Figure 15b.** The waste-rock dump at the Tarbox was partially cemented with iron oxides and was in contact with the West Fork of Packer Creek.

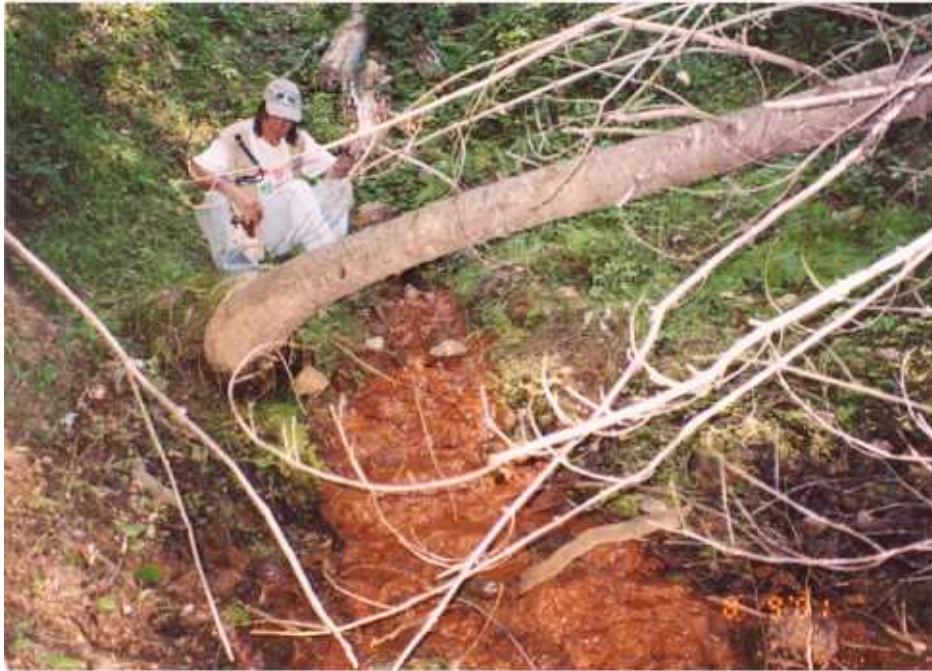
**Figure 16a.** The Meadow Mountain Mine adit discharge, looking toward where it emerged from the collapsed adit.

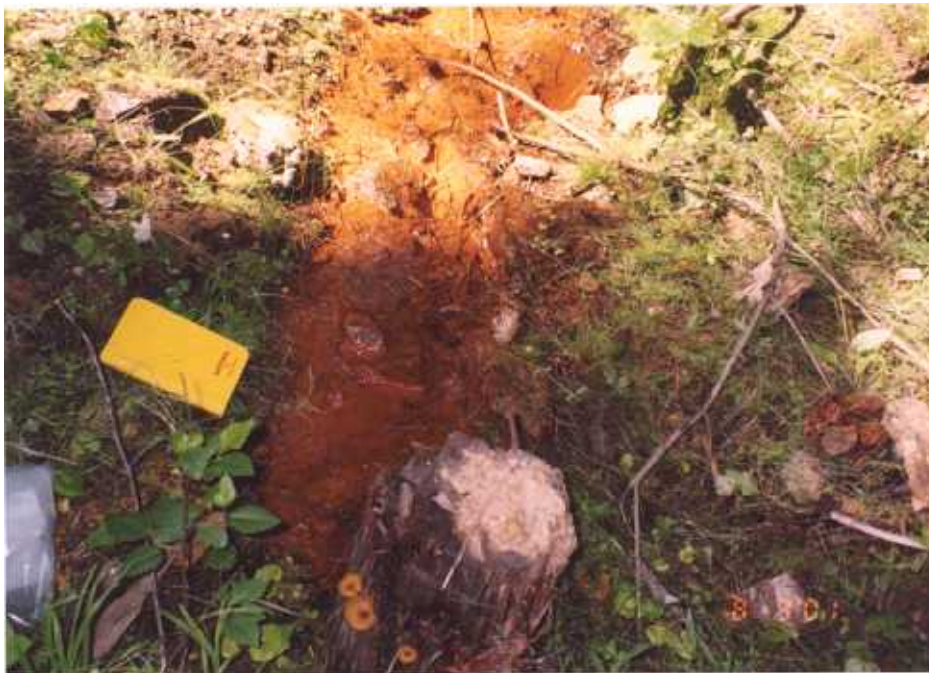
**Figure 16b.** The Meadow Mountain Mine adit discharge, looking toward the waste-rock dump where it completely infiltrated into the ground.

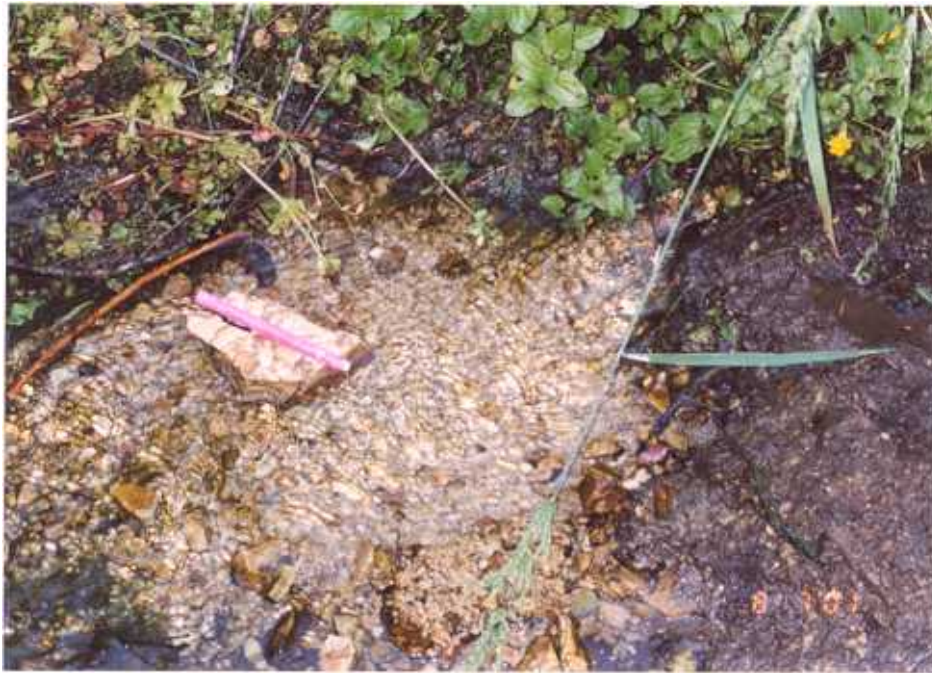
**Figure 17a.** The Saltese Consolidated Mine's adit discharge forms the headwaters of a tributary of the East Fork of Timber Creek.

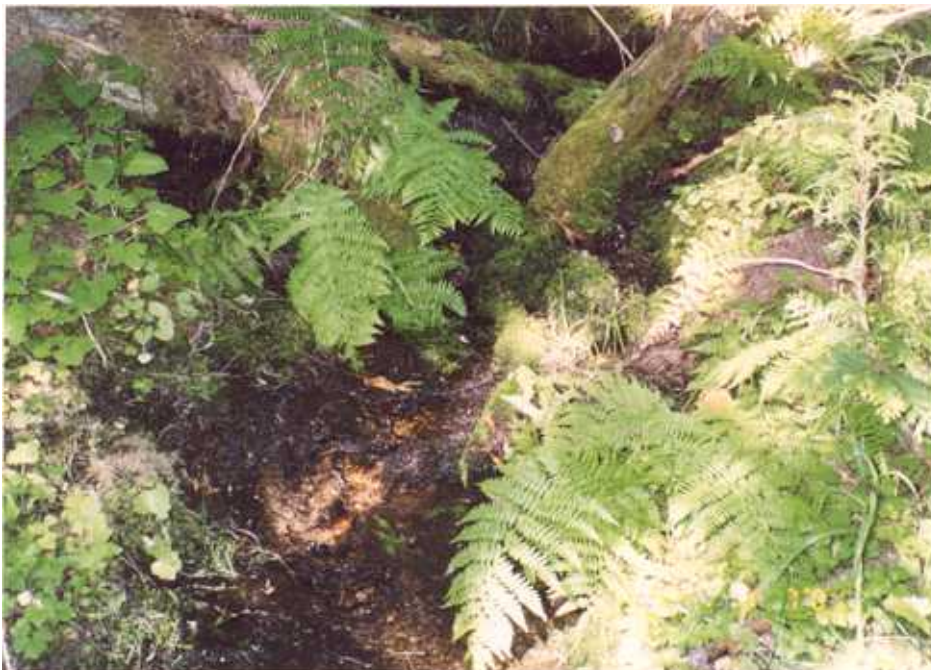
**Figure 17b.** The Saltese Consolidated downstream sample site had ferns and mosses growing along it.

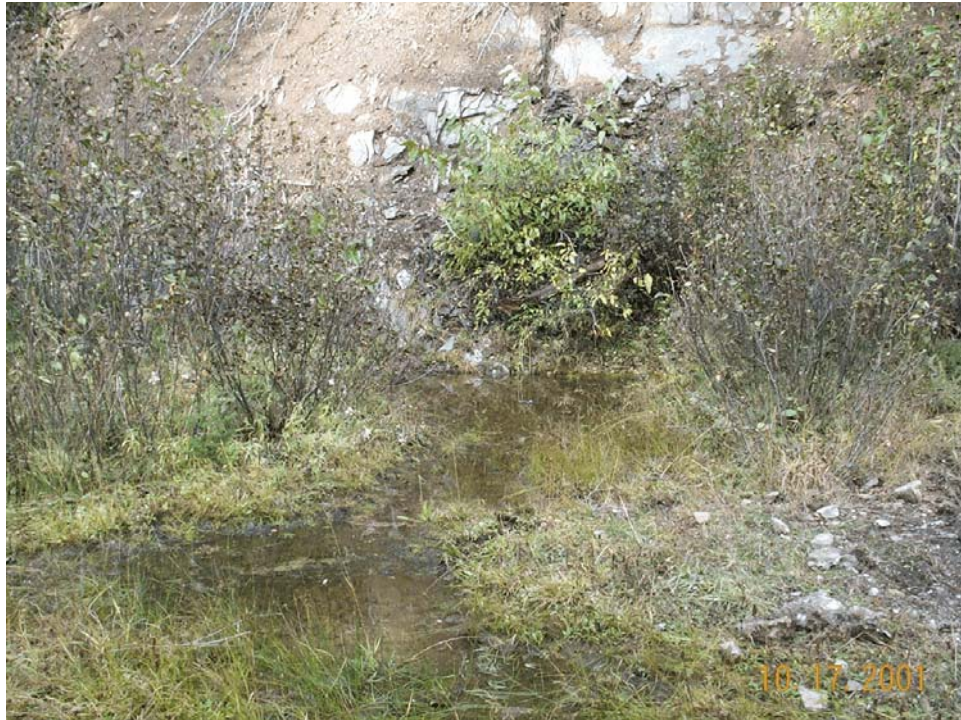
**Figure 18a.** A possible collapsed adit at the Rock Island Mine was in a marshy area with a seep. The source of the water was uncertain.

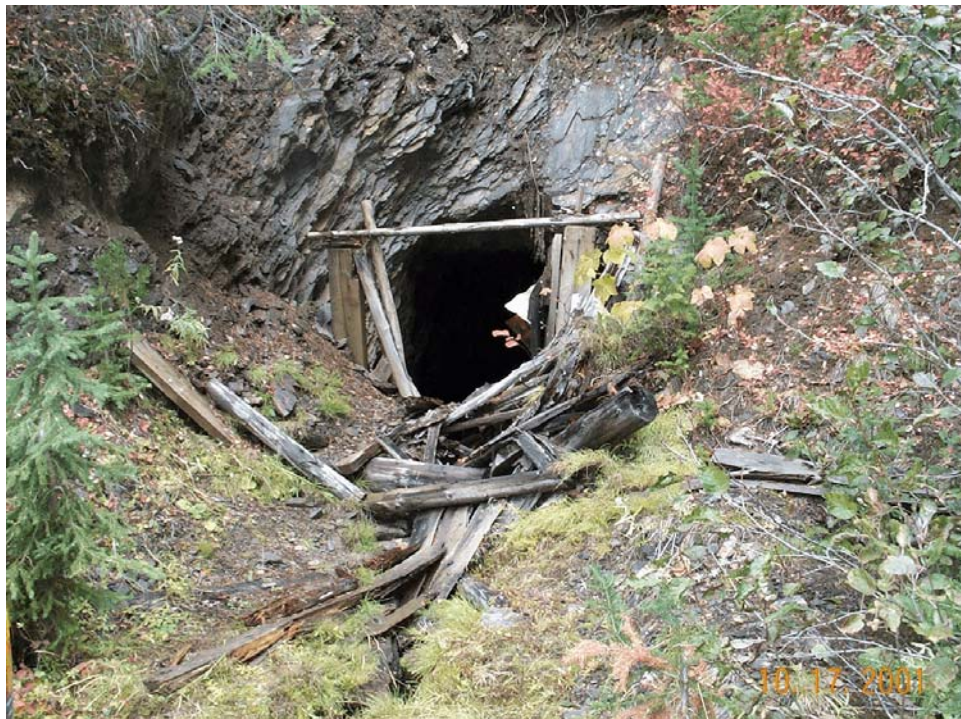
**Figure 18b.** Adit A01 at the Rock Island Mine was sampled (RRIS20M) where the adit discharged and flowed into the side drainage.

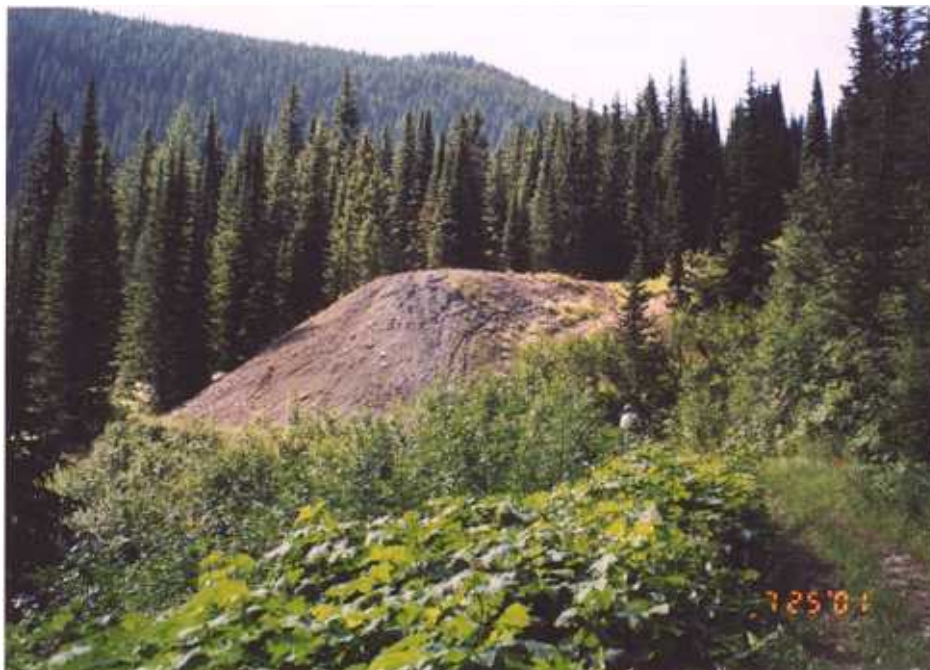
**Figure 19a.** Copper Gulch had a large, highly visible waste dump and was adjacent to Forest Trail 265.

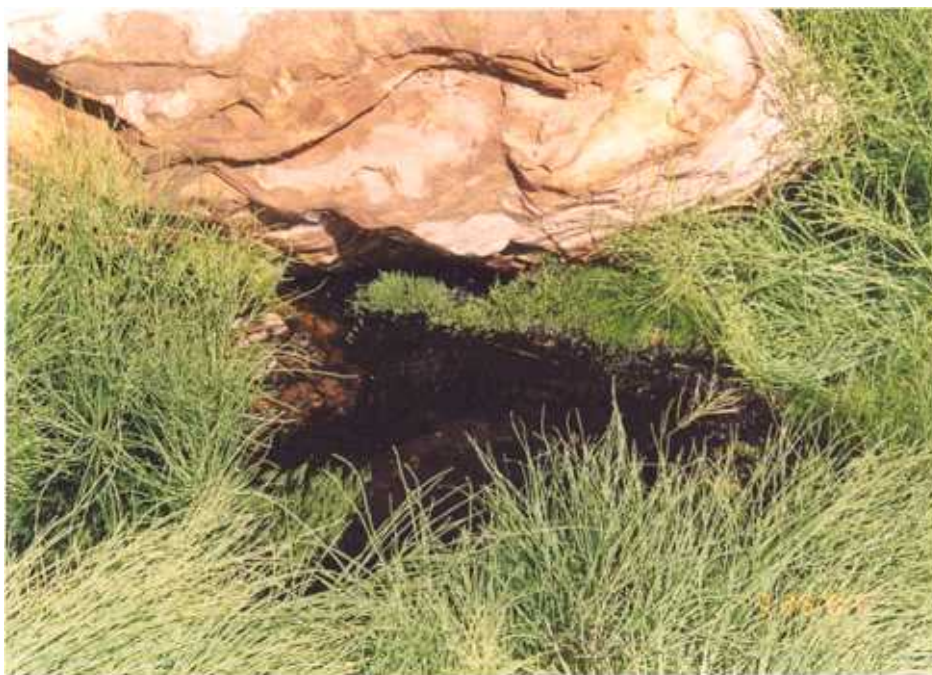
**Figure 19b.** Copper Gulch's adit discharge was sampled in a small pool near the point of origin at the adit.

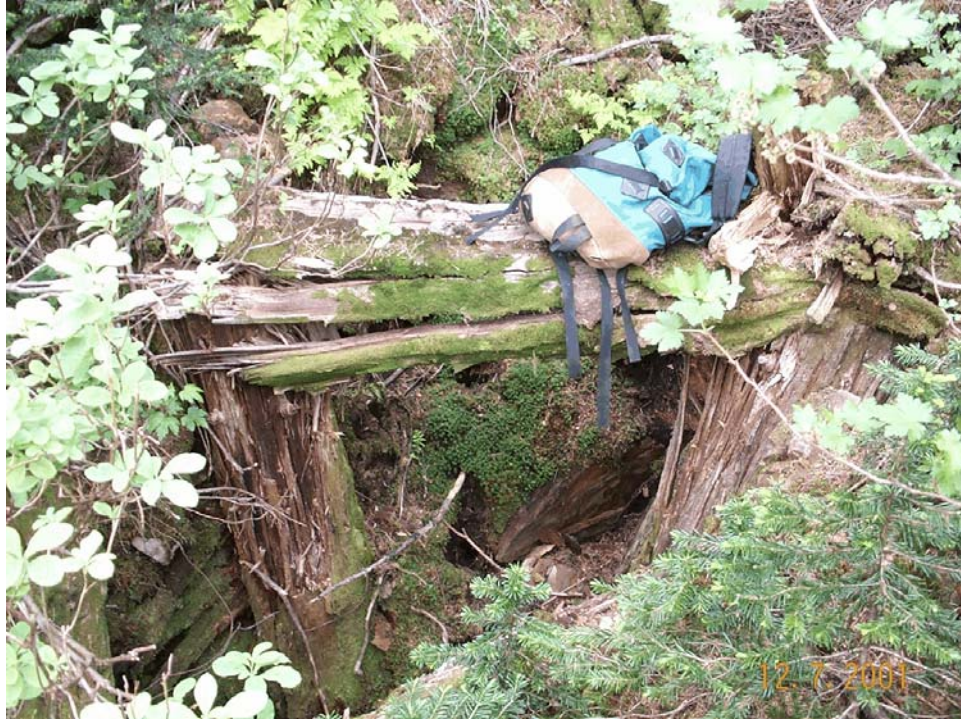
**Figure 20a.** The lower adit discharge at the St. Lawrence Mine, site of sample SSLS20L.

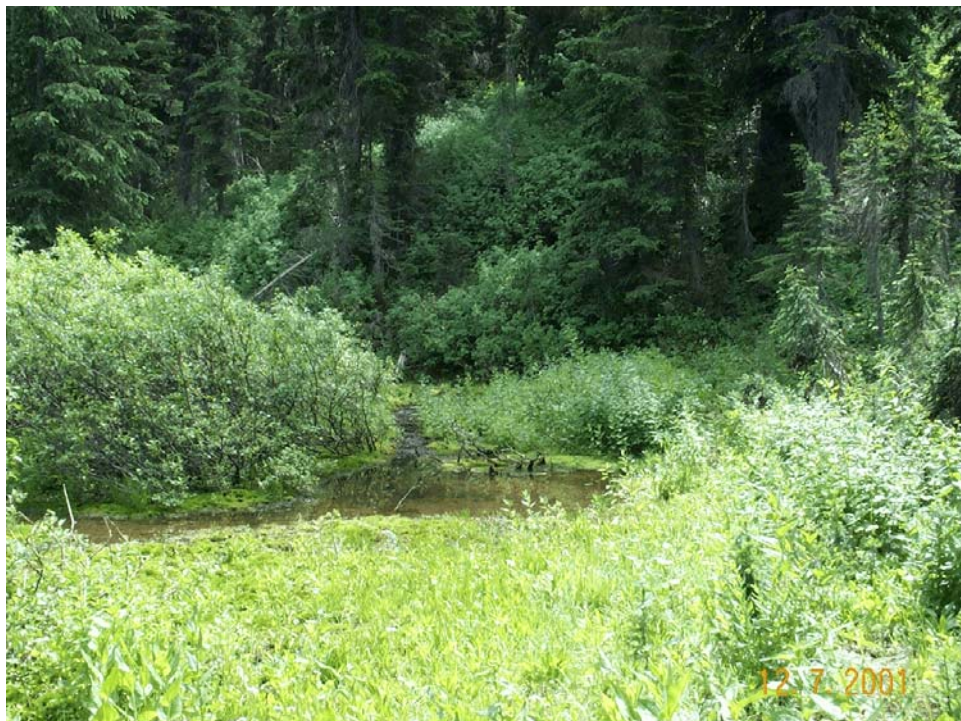
**Figure 20b.** Ponded water on the waste dump and staging area beyond the lower discharging adit at the St. Lawrence Mine.

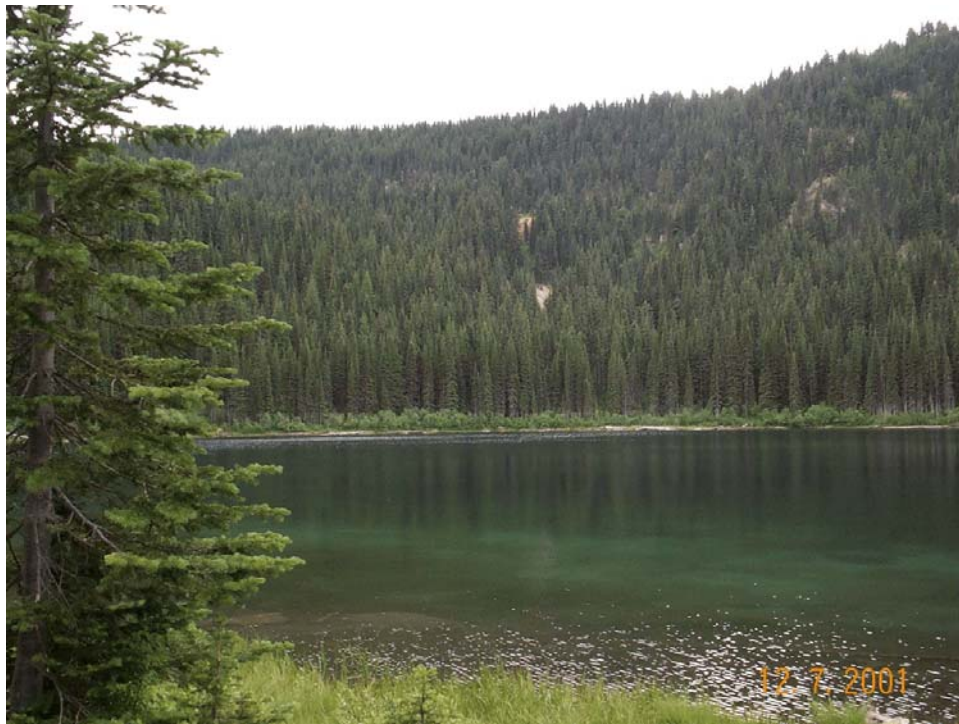
**Figure 20c.** Two waste dumps appear as light colored patches in the forest at the St. Lawrence Mine, looking south from Silver Lake.

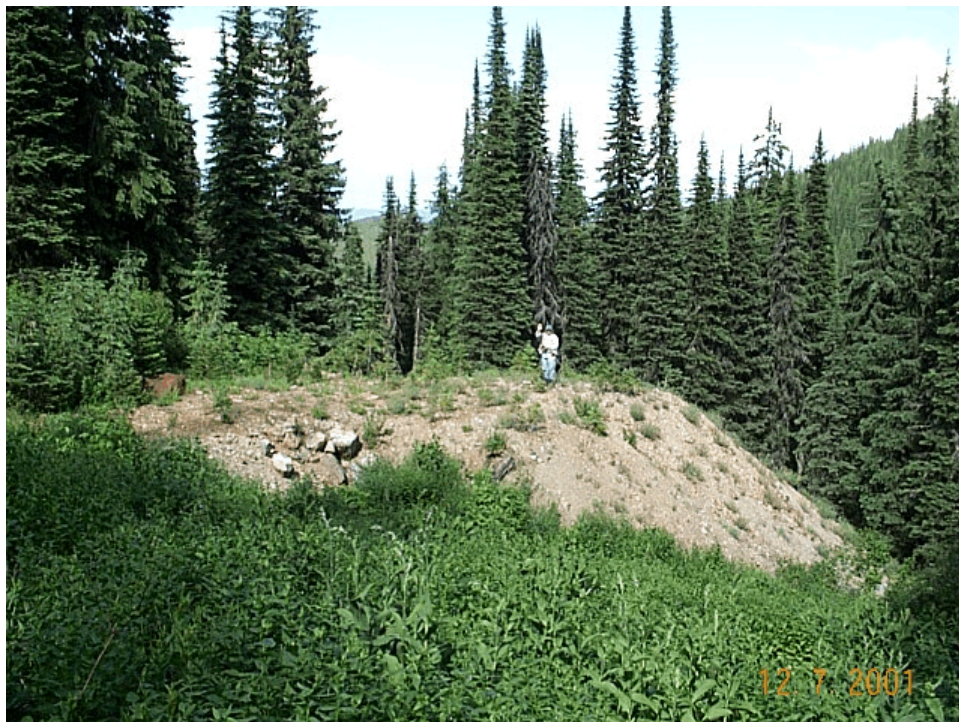
**Figure 20d.** Big Sunday Mine waste-rock dump was uphill from Big Sunday Creek. The adit discharge was to the left in the photo and infiltrated into the waste rock.

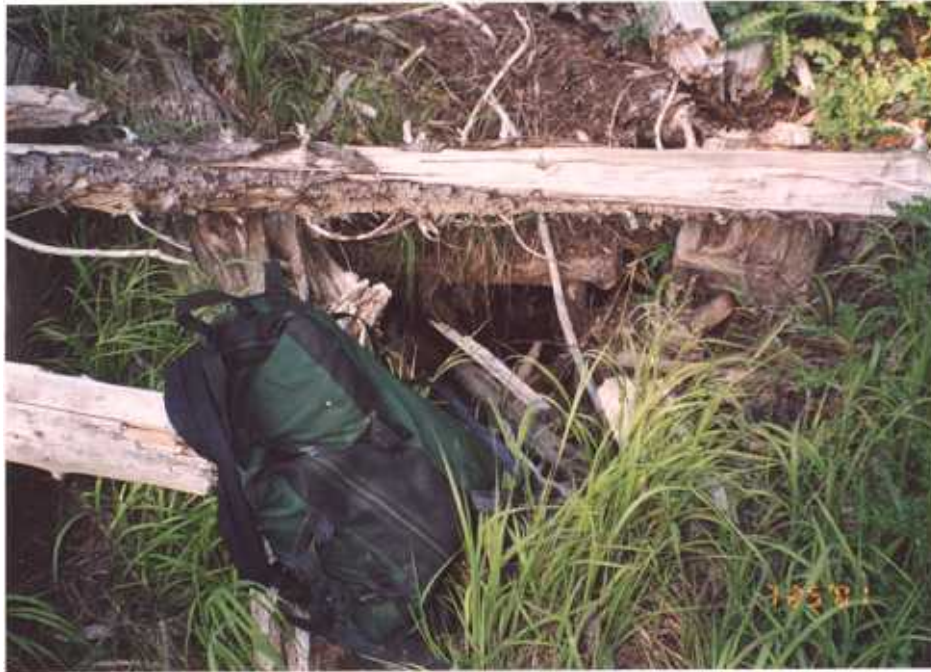
**Figure 21a.** One of the dry adits near Crystal Lake was almost entirely obliterated with only a few timbers showing.

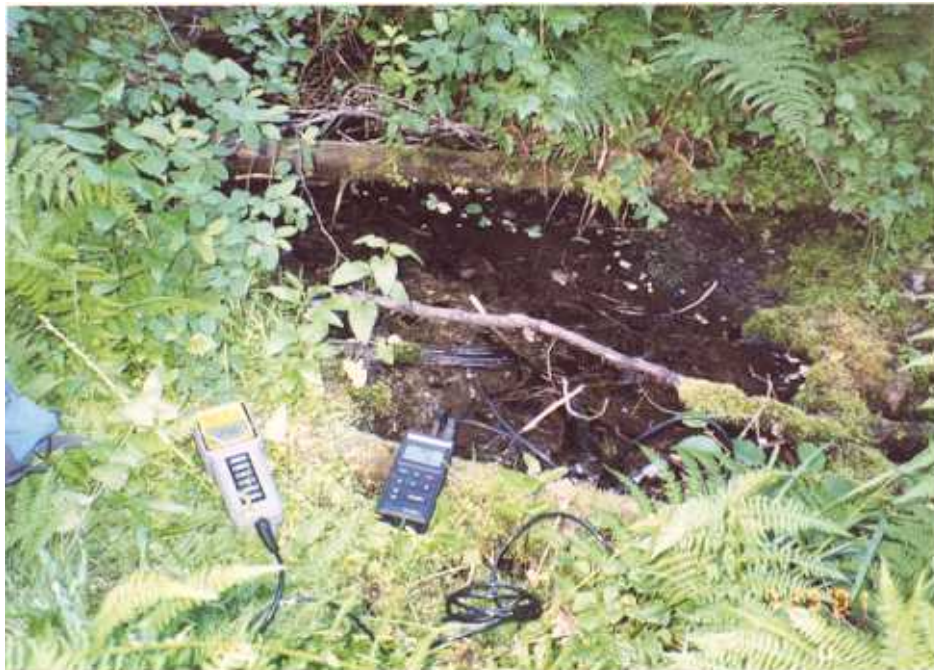
**Figure 21b.** Near the portal, the discharging adit at Crystal Lake formed a small pond that was sampled (DCLS10L) on 07/25/01.

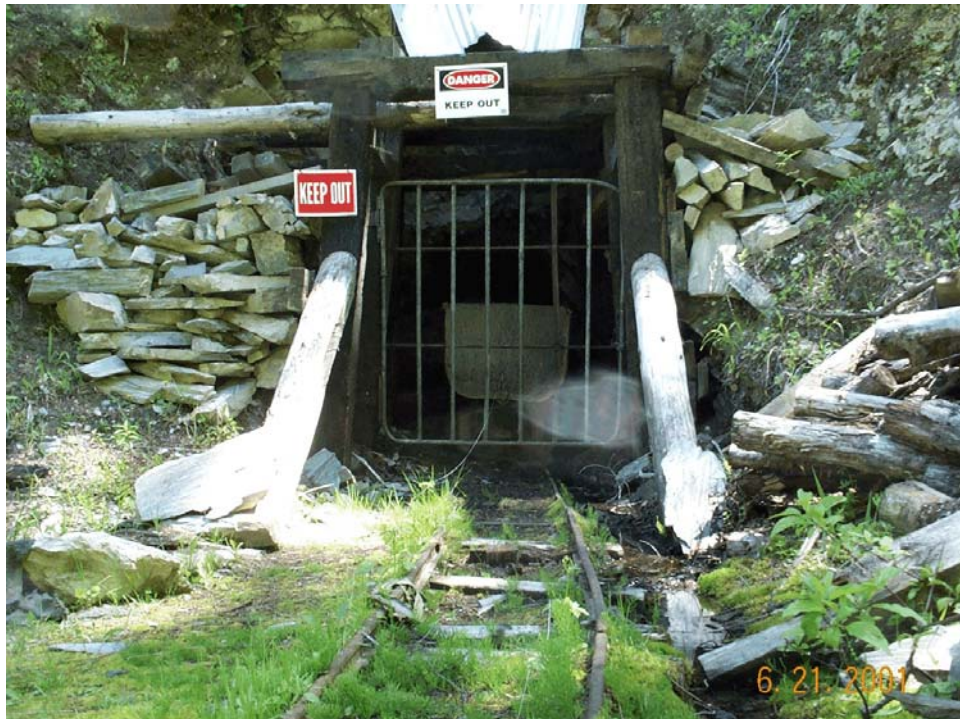
**Figure 22a.** The Upper Keystone Mine adit was open but had a locked gate when visited on 06/21/01.

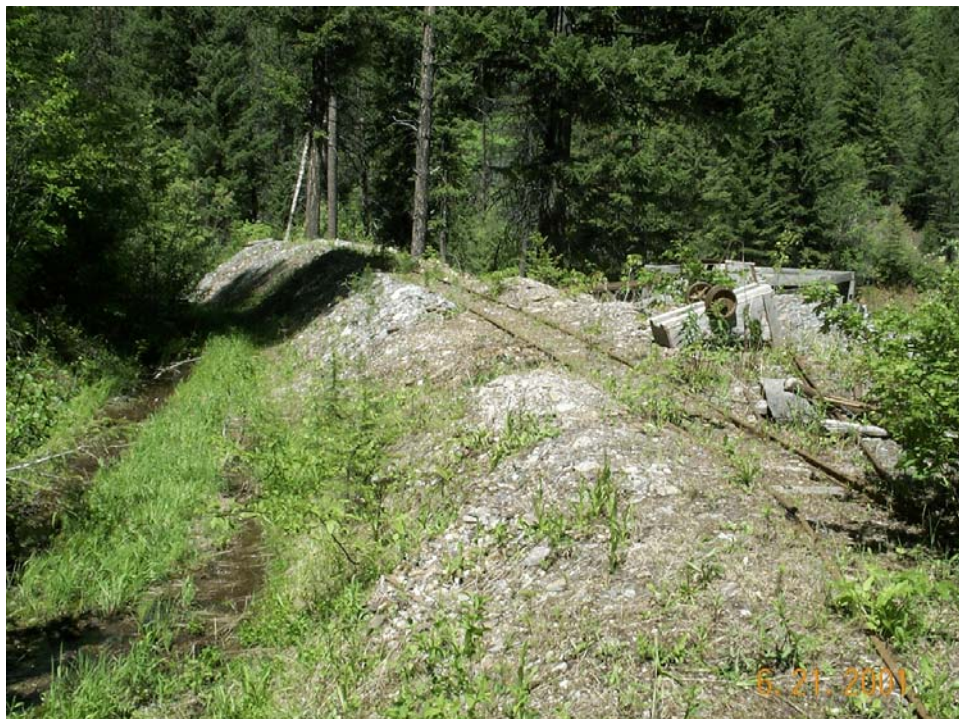
**Figure 22b.** Upper Keystone Mine waste dump had tracks and an ore bin. The discharge ran along the southwest side of the dump. (Left side in photo.)

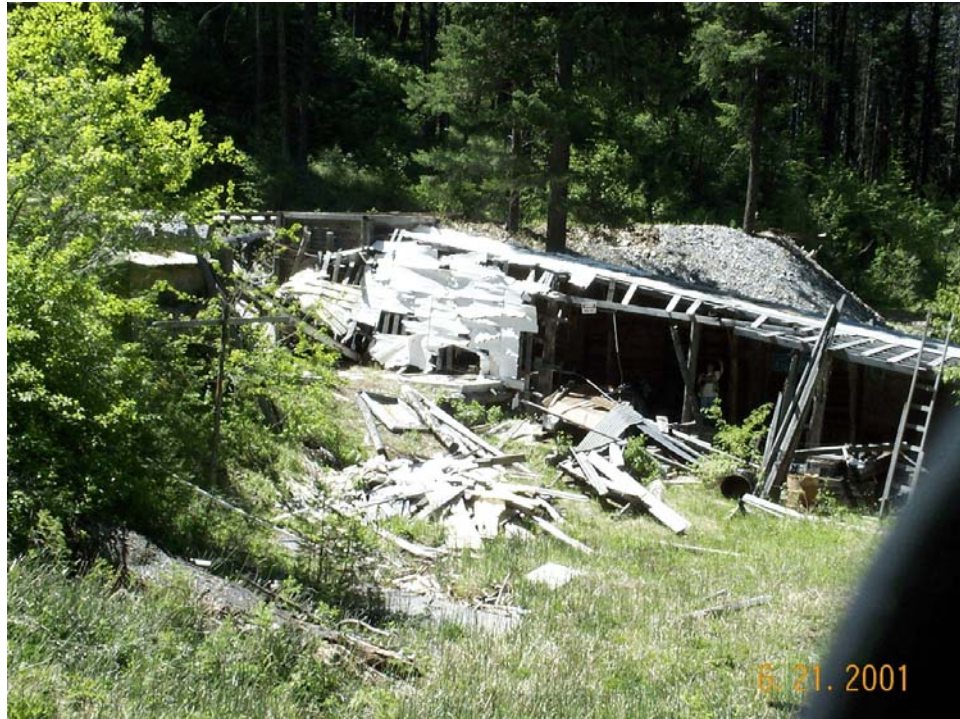
**Figure 22c.** The Upper Keystone Mine buildings were in poor condition.

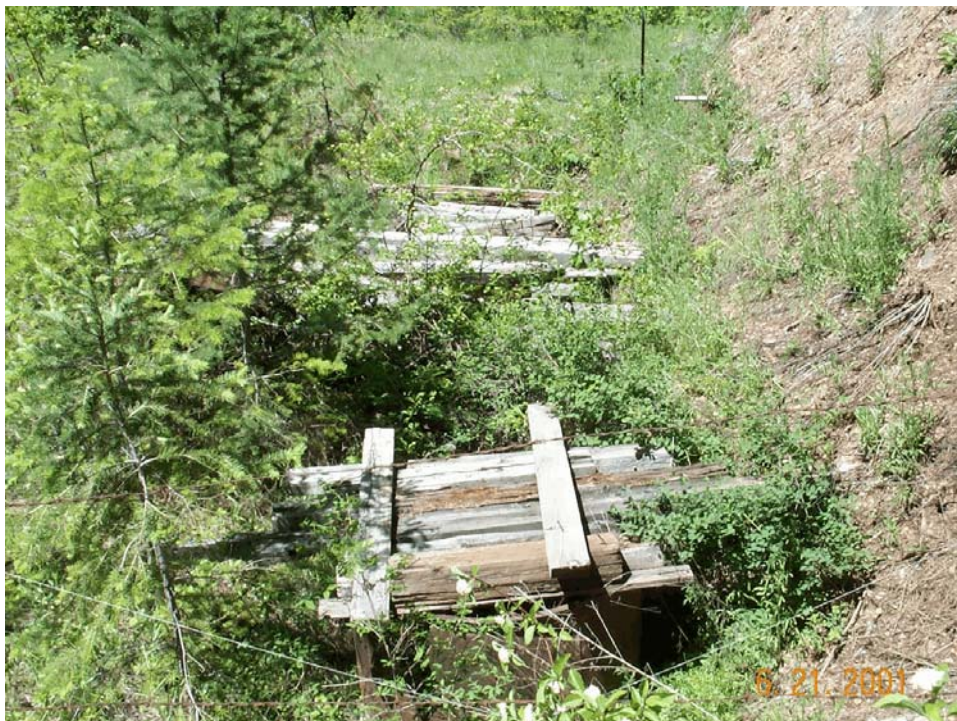
**Figure 22d.** The Upper Keystone Mine had a fenced structure, perhaps a shaft.

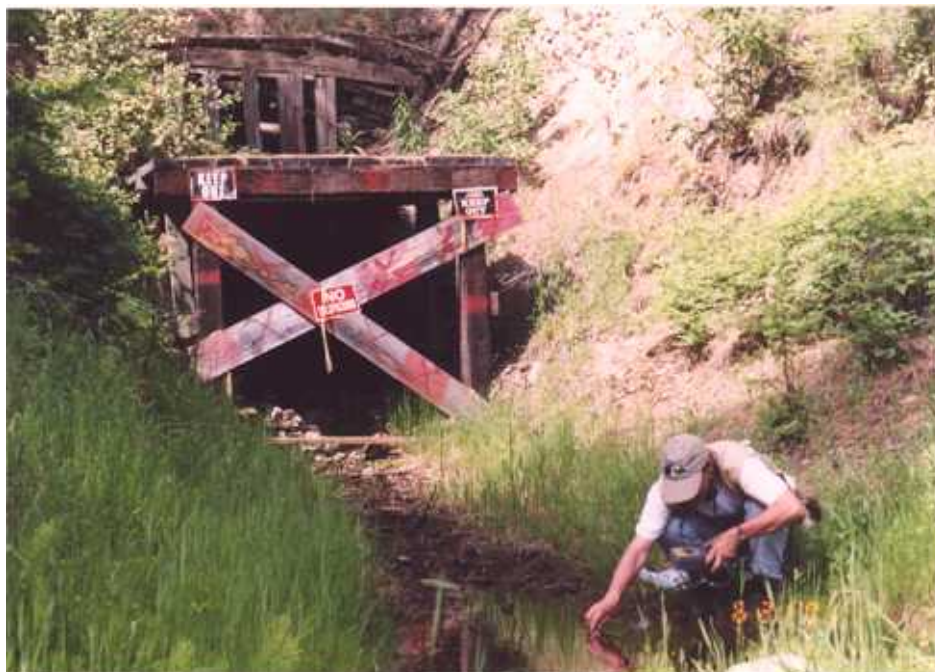
**Figure 23a.** Prosperity Mine's adit was gated and had a unique arched portal, as visited on 06/21/01.

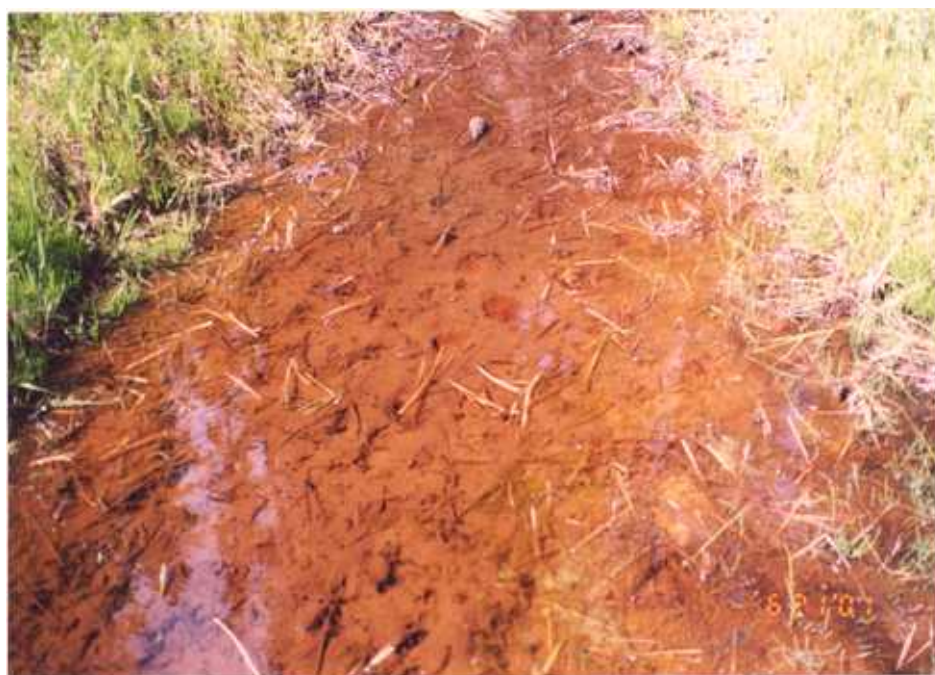
**Figure 22b.** The adit discharge at the Prosperity Mine flowed sluggishly along the top of the waste-rock dump.

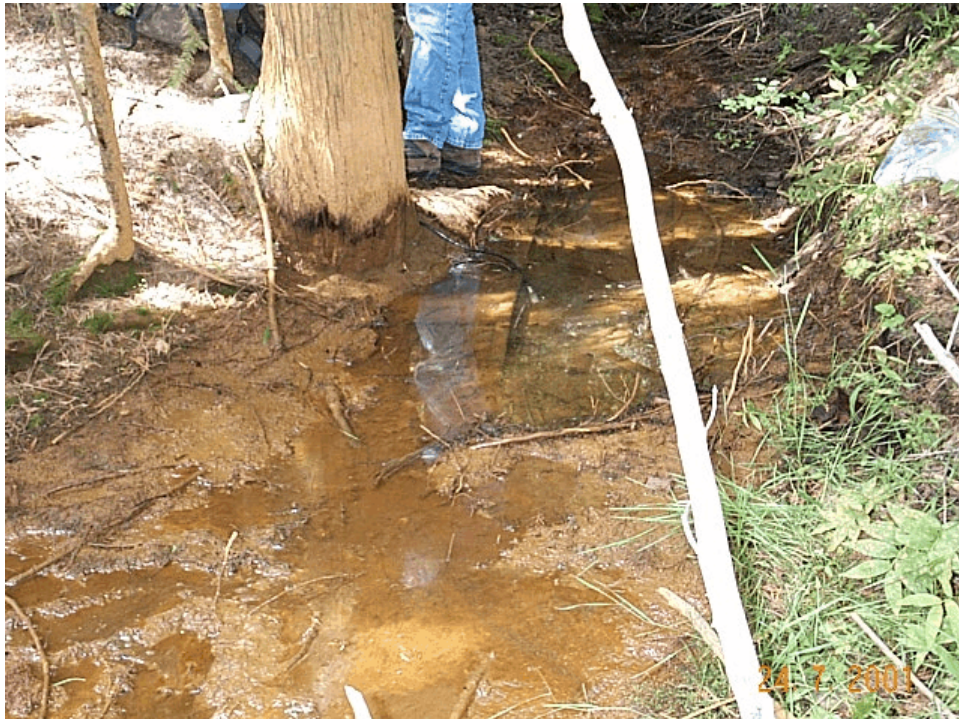
**Figure 24a.** Discharge from the Vulcan Tunnel emerged from a collapsed adit and ponded in front of the portal.
