# Abandoned-Inactive Mines on Lolo National Forest-Administered Land

## Open-File Report MBMG 476 April 2003

Prepared for the U.S. Department of Agriculture  
Forest Service-Region 1

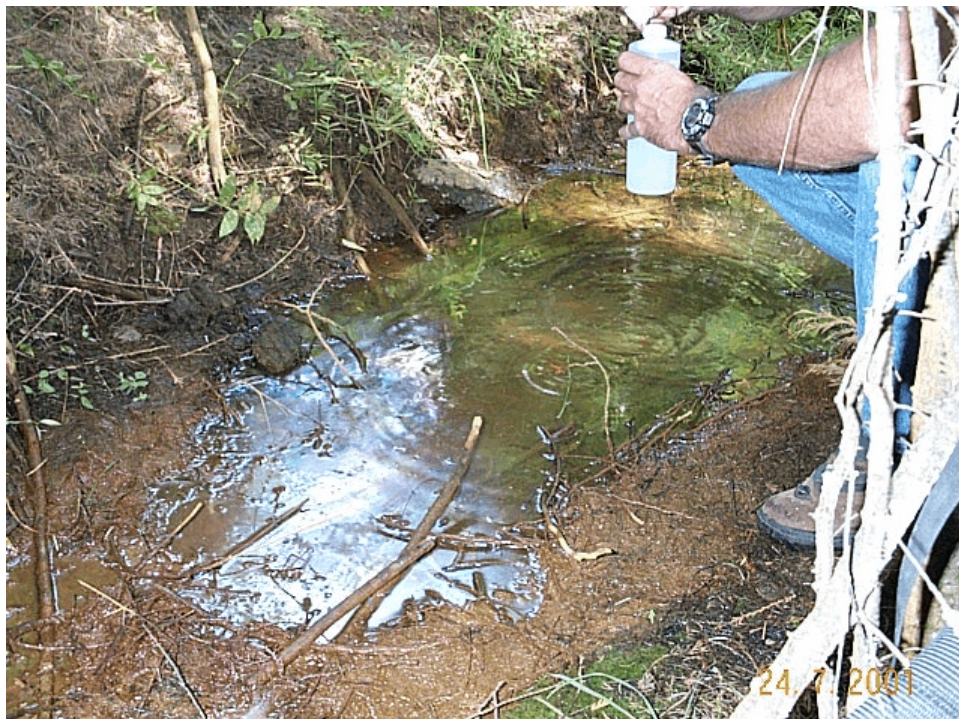
**Figure 24b.** Vulcan Tunnel's adit discharge had an oily sheen on the brightly orange-stained water.

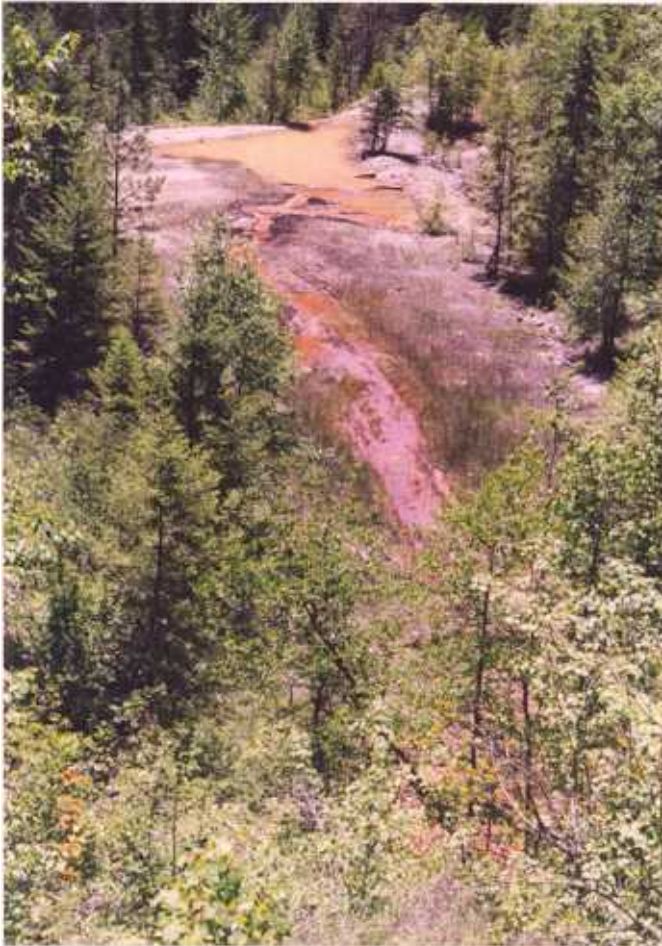
**Figure 25a.** Iron Mountain Mine's orange discharge flowed across the waste rock and ponded at the edge of the flat staging area, as seen from above on Forest Route 194.

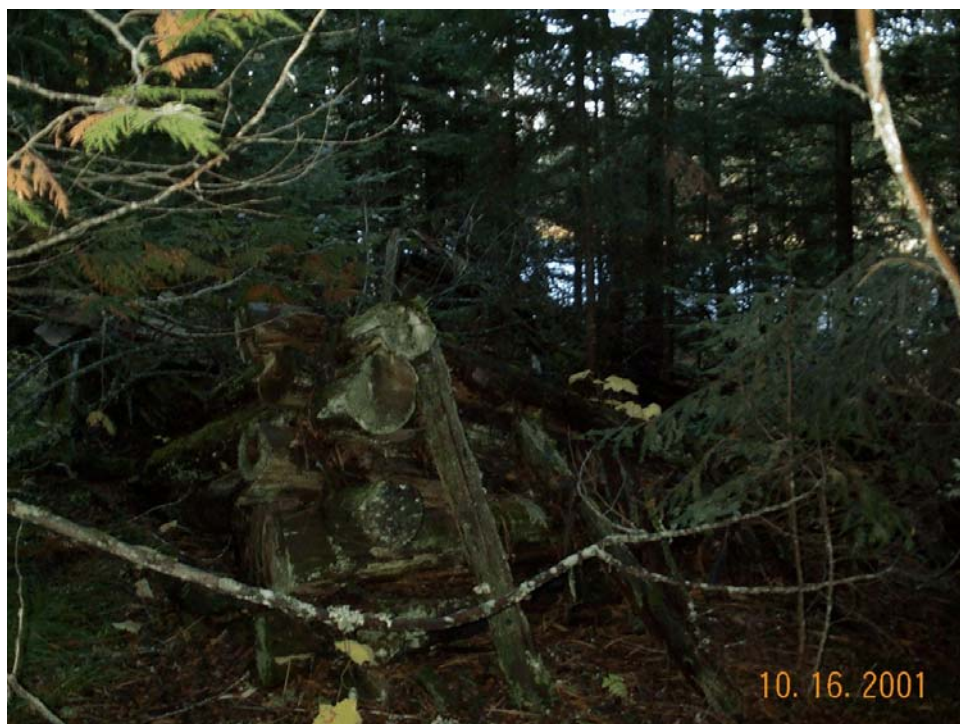
**Figure 26a.** Stobie-Hermiston Mine had a collapsed cabin that was nearly flattened.

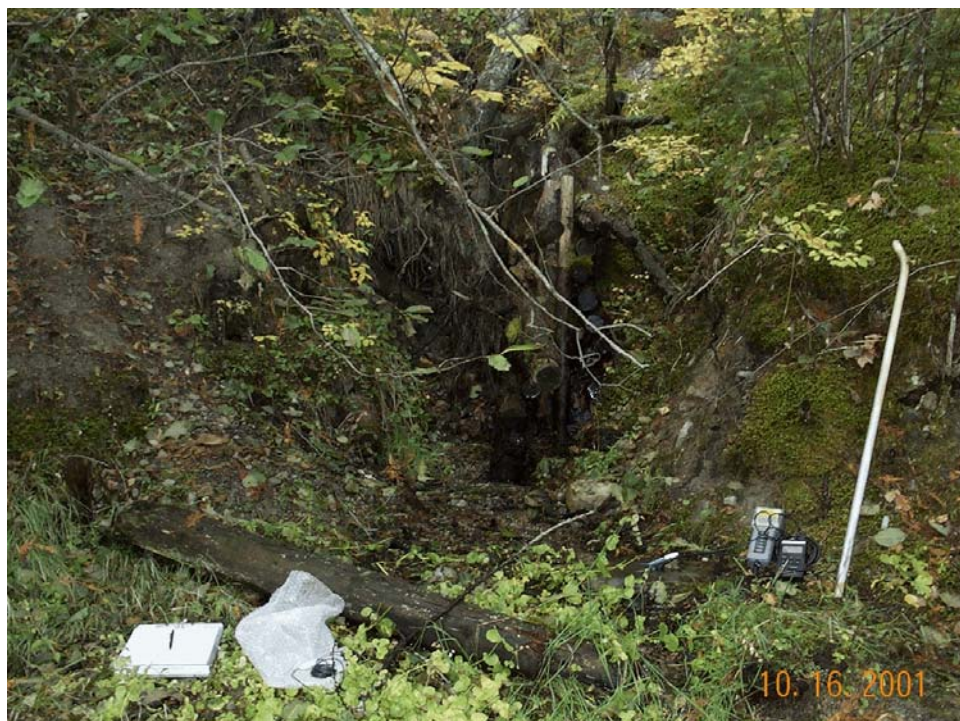
**Figure 26b.** The Stobie-Hermiston Mine's adit discharge flowed over the waste-rock dump and down toward the Clark Fork River.

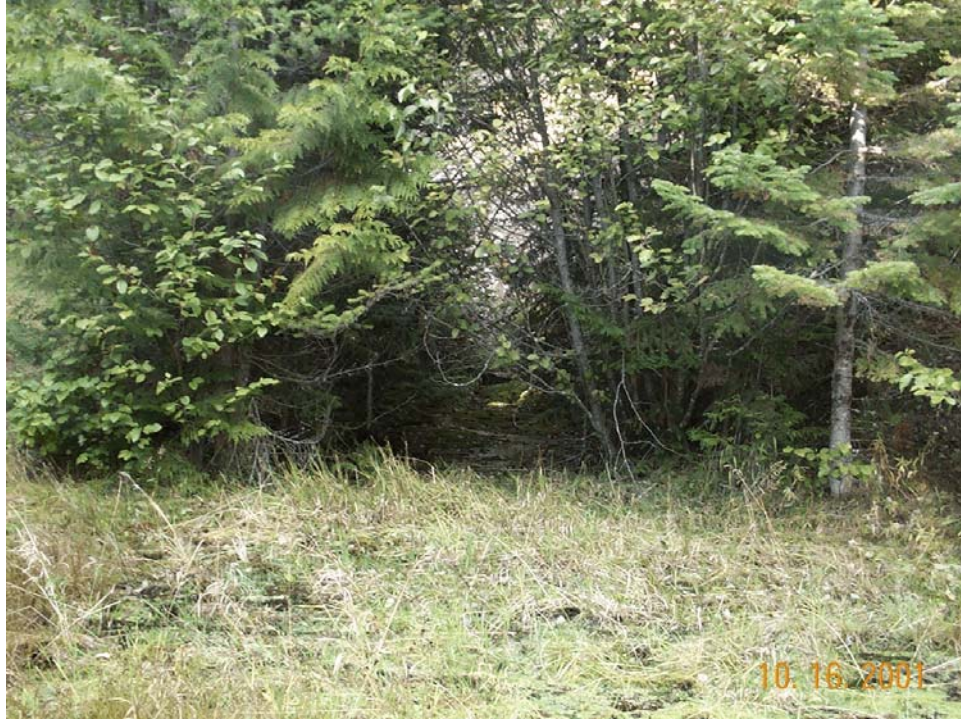
**Figure 28a.** Johnny Miller Mine's adit discharge was sampled on 10/16/01.

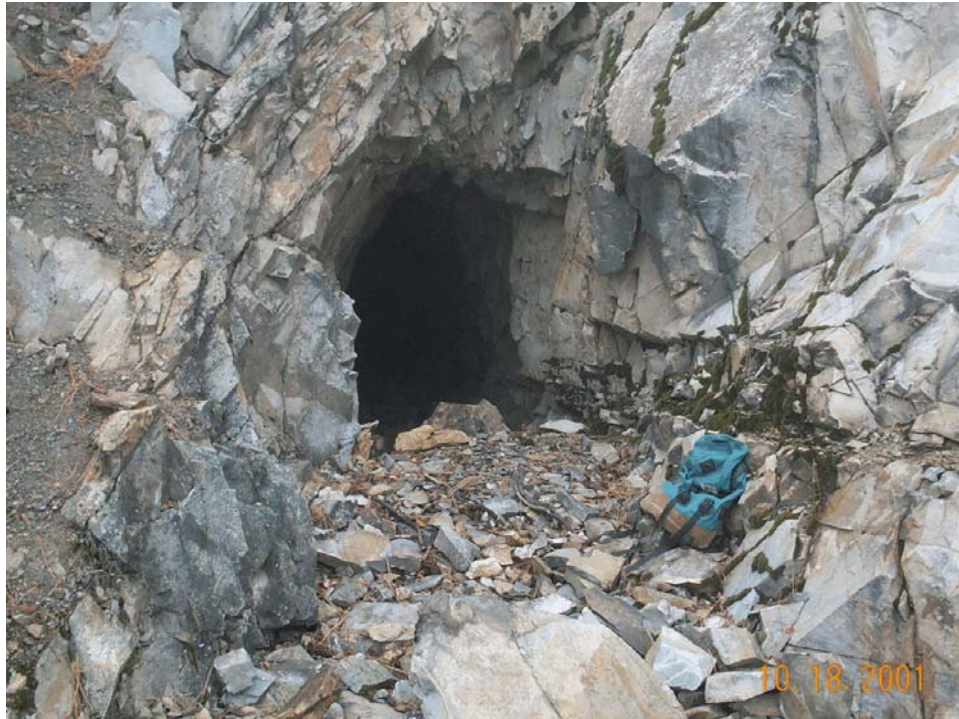
**Figure 29a.** One of the open adits at the Raven Mine.

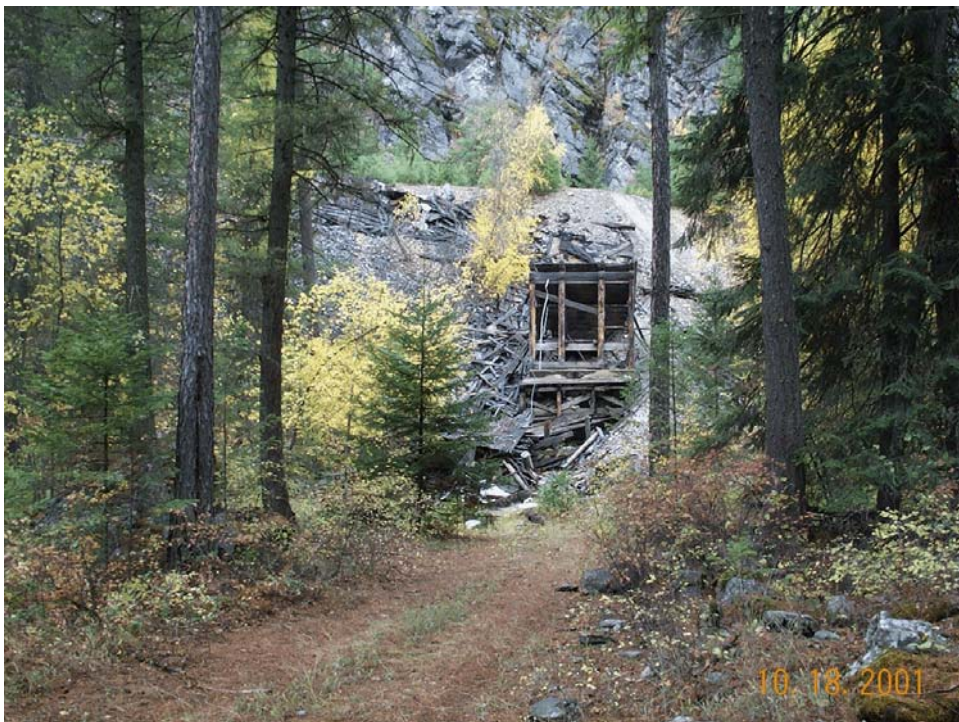
**Figure 29b.** Raven Mine main adit and ore chute on dump.
